MACROSCALE (1:50,000) LANDSLIDE SUSCEPTIBILITY MAPPING IN PARTS  
OF TOPOSHEETS NO. 48J/1, 48J/2, 48J/6, 48J/7, AND 48J/8,  
UTTAR KANNADA DISTRICT, KARNATAKA.

(FSP Code No: LSM/SR/KG/2015/097)

नेहा कुमारी, भू-वैज्ञानिक  
Neha Kumari, Geologist

तन्वी गुप्ता, भू-वैज्ञानिक  
Tanvi Gupta, Geologist

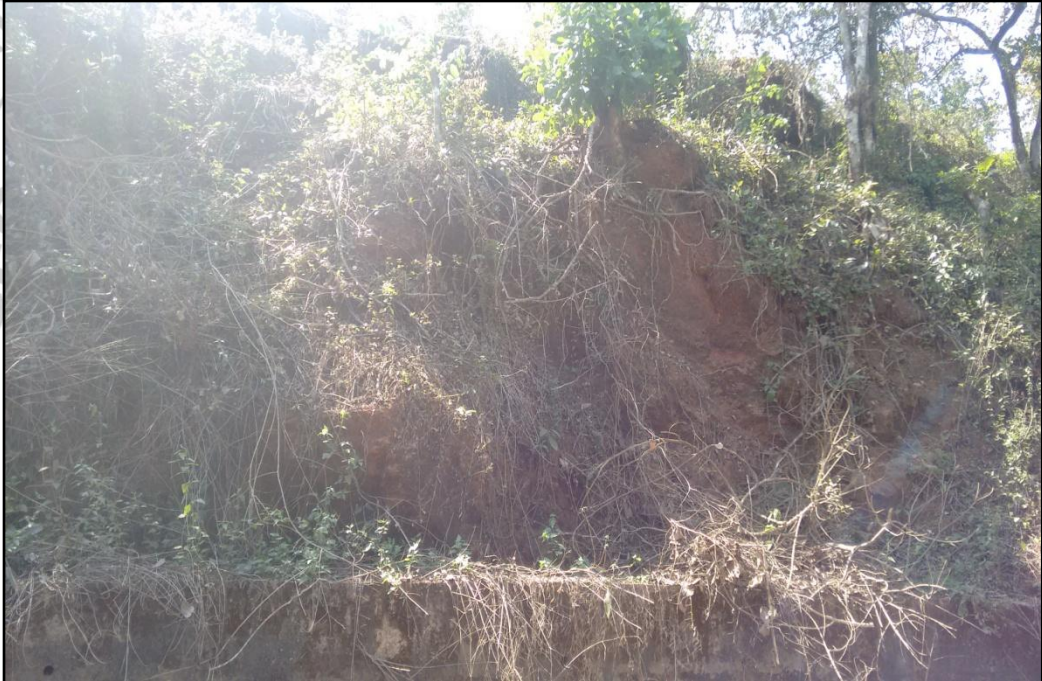
| 34. | Slide documentation | Remarks/ Abstract | Temple and building nearby at risk, danger to Life and property. |

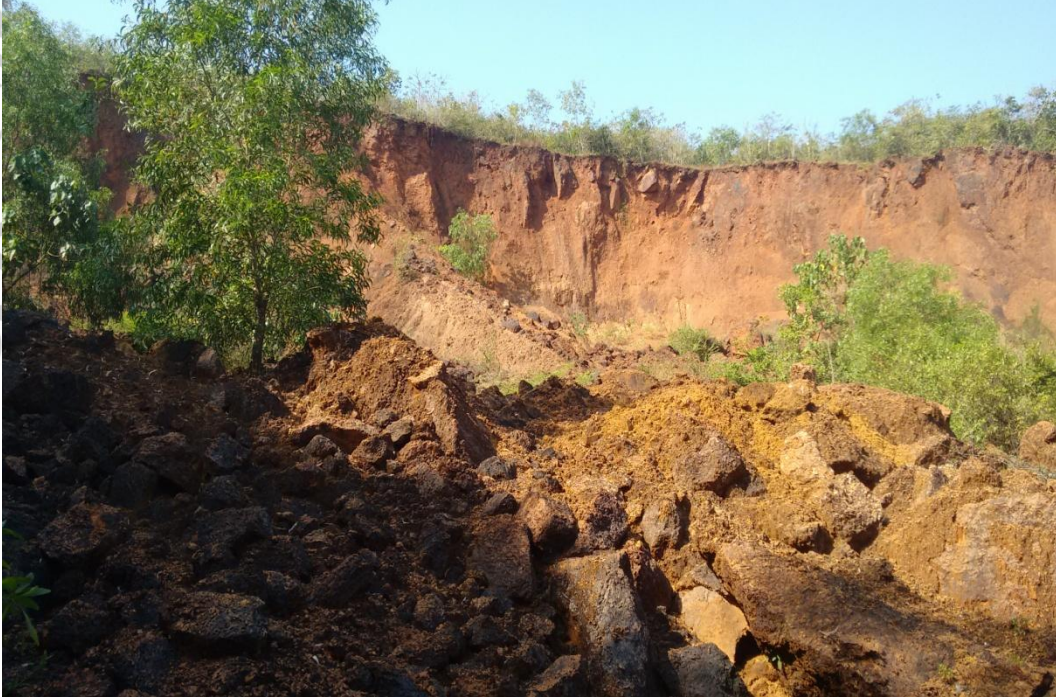
| 34. | Slide documentation | Remarks/ Abstract | Life and property is at risk |

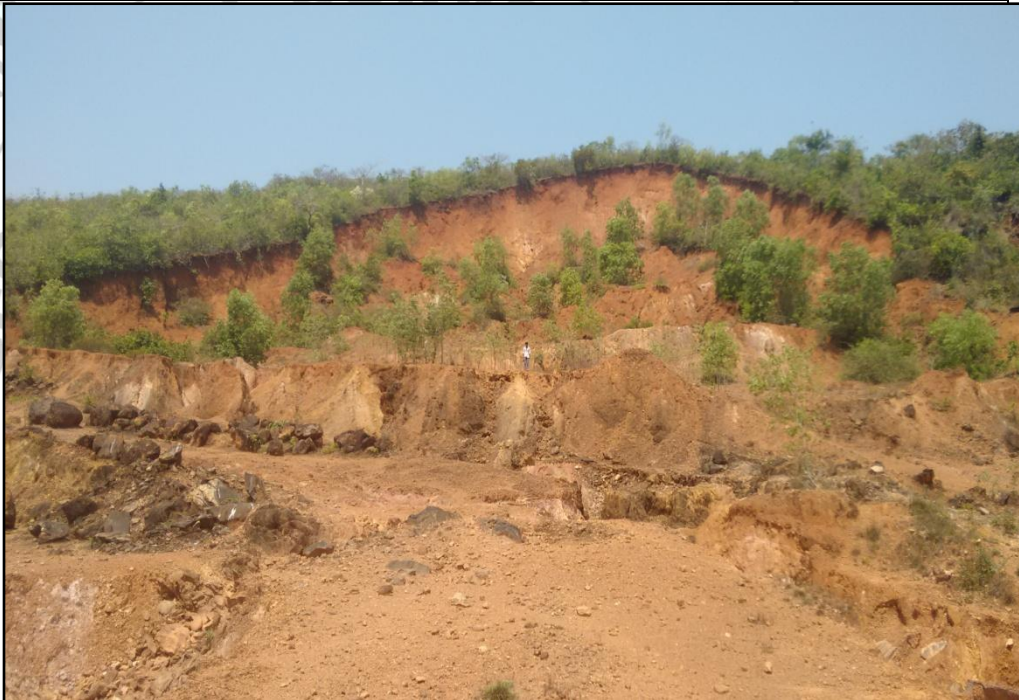
| 34. | Slide documentation | Remarks/ Abstract | Life and property is at risk, danger to communication line. |

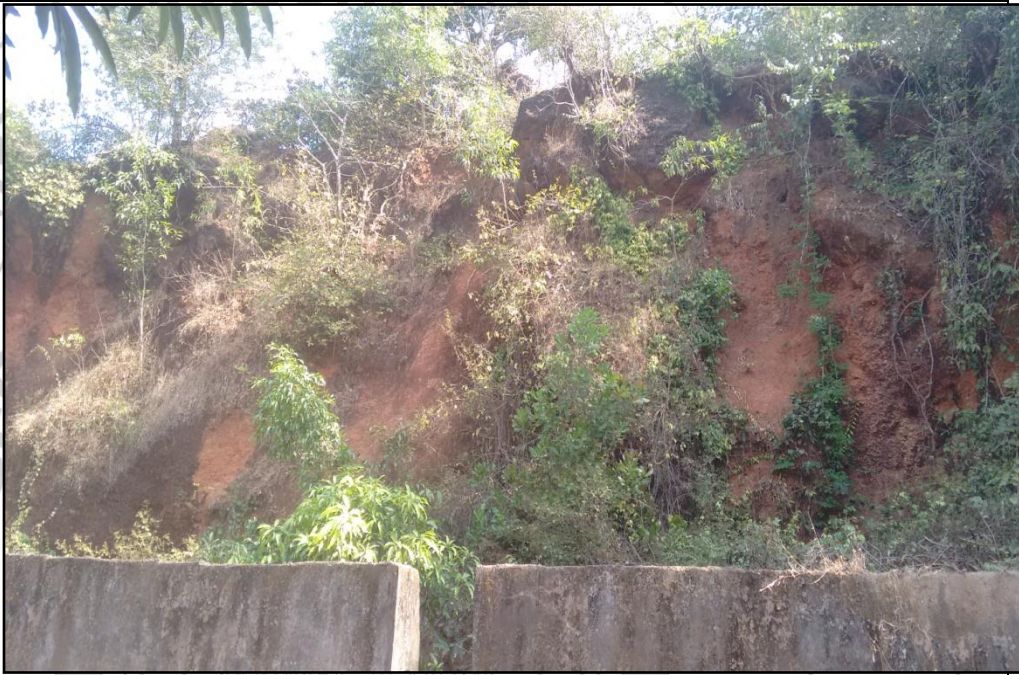
| 34. | | Remarks/ Abstract | Temple beside is at risk, danger to settlement and communication line. |

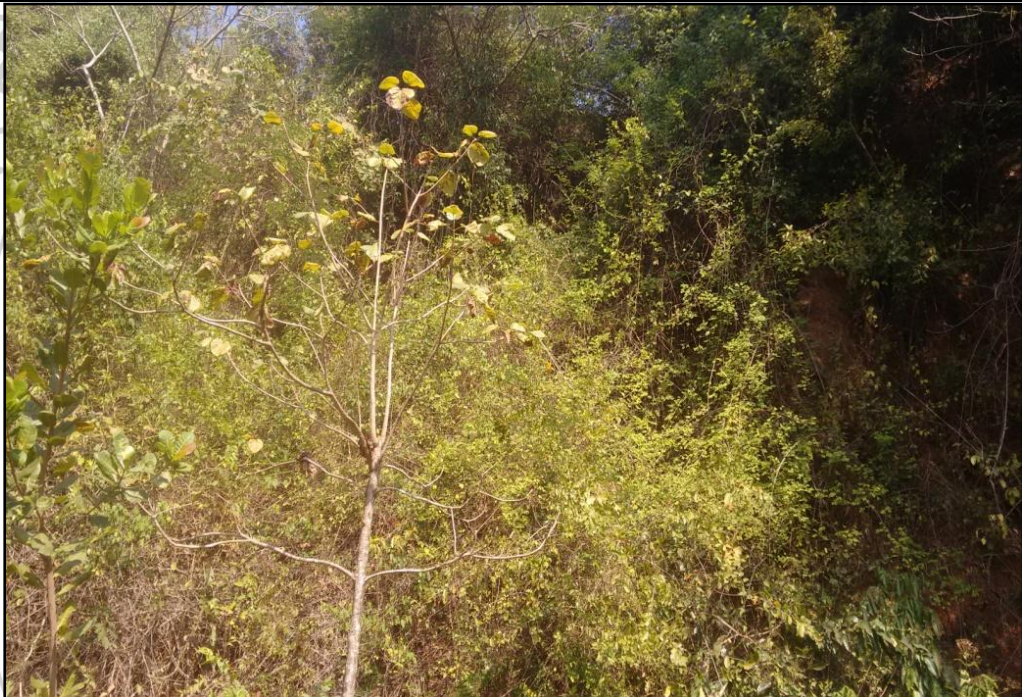
| 34. | Slide documentation | Remarks/ Abstract | unstable zone, moderate risk to man and material |

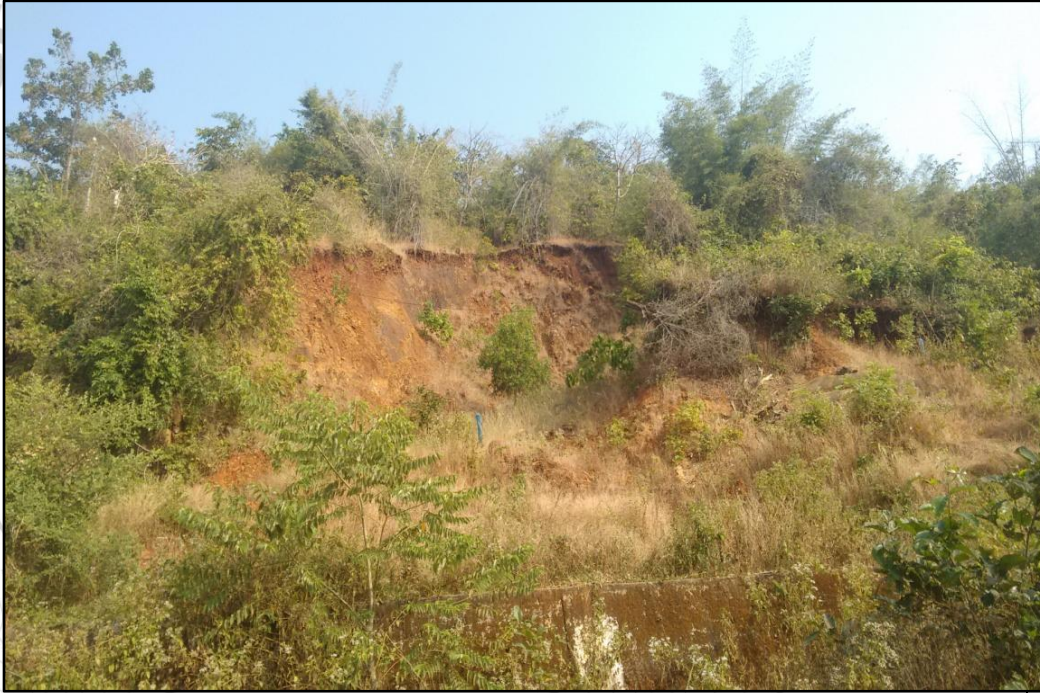
| 34. | Slide documentation | Remarks/ Abstract | The vertical cut made on the slope for road construction has induced high risk to man and material. The settlement and tower on top of the slope should be removed and shifted to stable and safer site. |

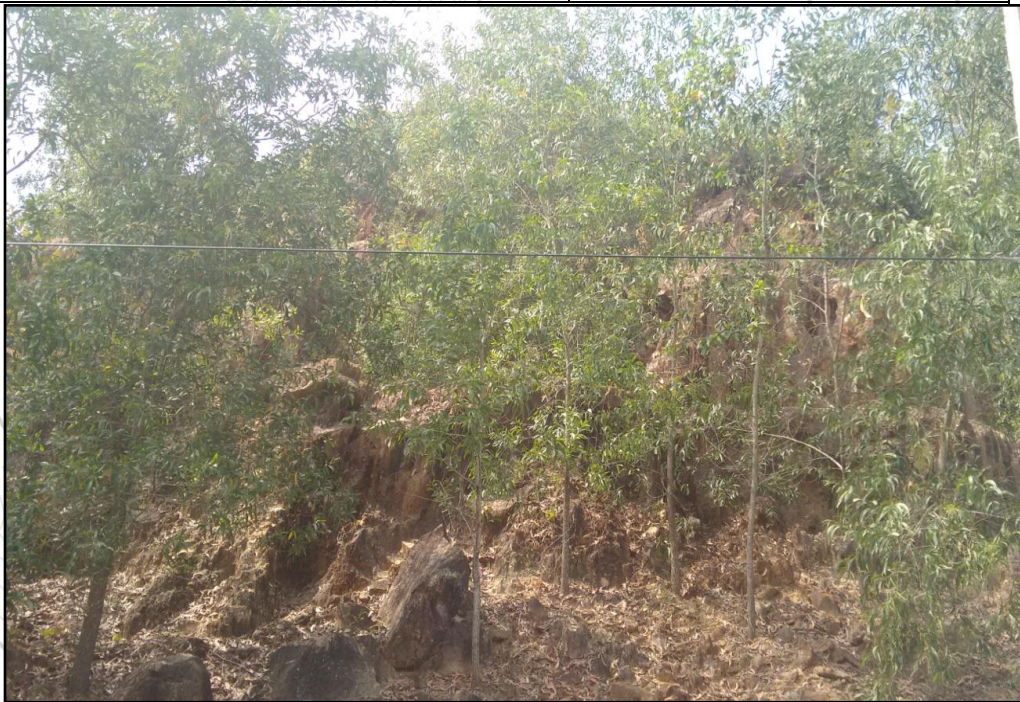
| 34. | Slide documentation | Remarks/ Abstract | The electric poles should be shifted and settlement at down slope and road communication is at risk . Rock bolting and netting may be done as additional safety and debris material should be removed. As plantation on slope may stabilize the slope. |

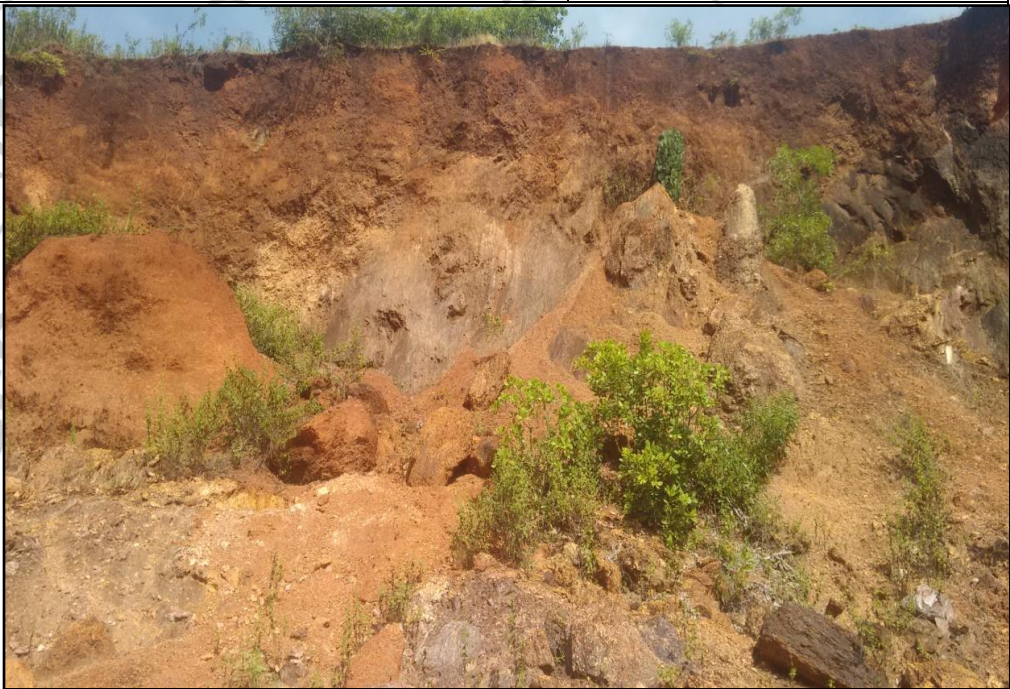
| 34. | Slide documentation | Remarks/ Abstract | Life and property is at risk |

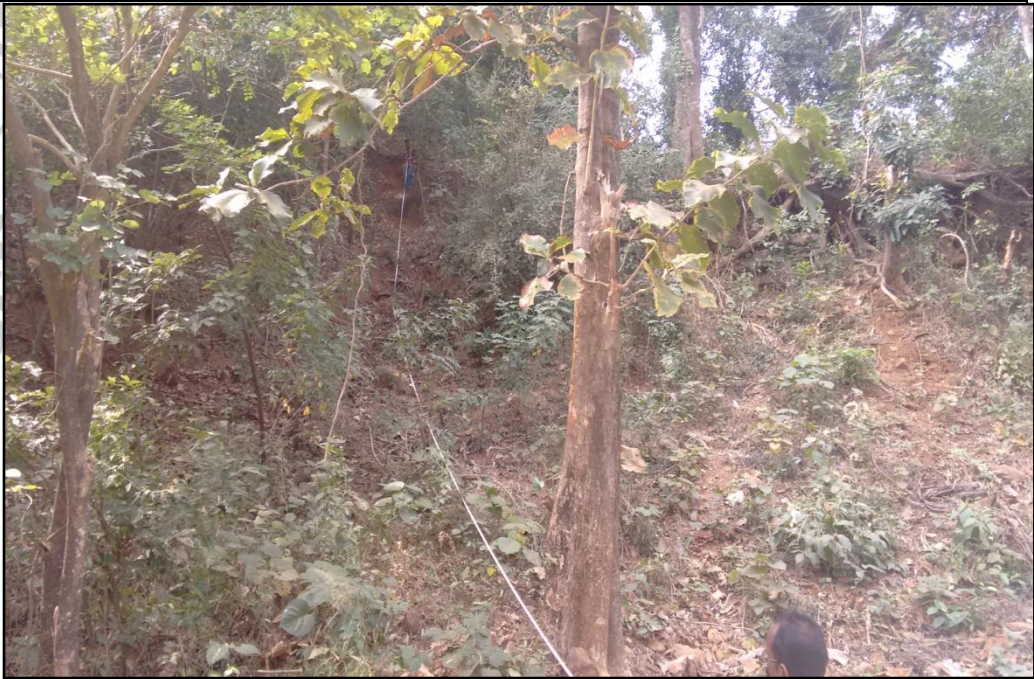
| 34. | Slide documentation | Remarks/ Abstract | Life and property is at risk |

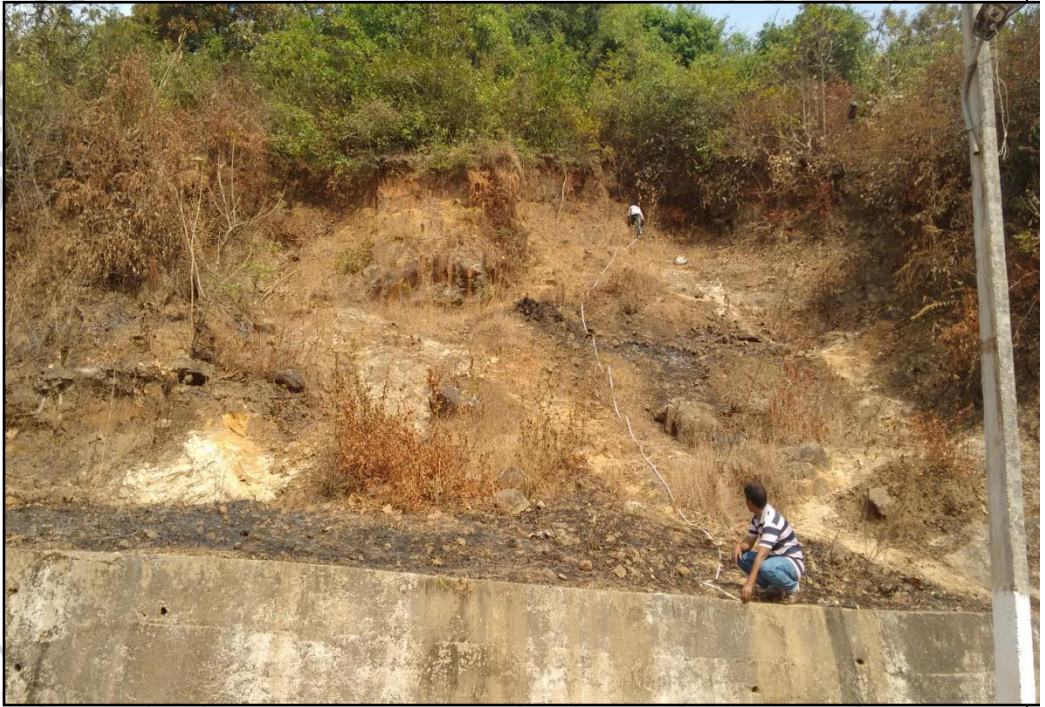
| 34. | | Remarks/ Abstract | Life and property is at risk |

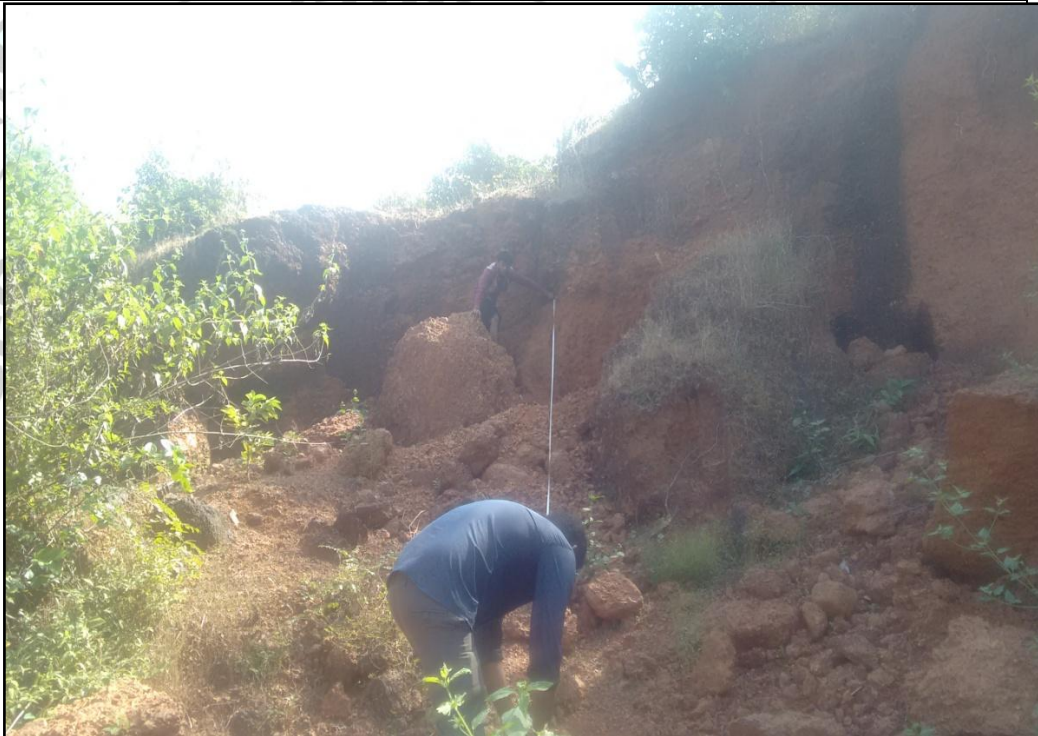
| 34. | Slide documentation | Remarks/ Abstract | Life and property is at risk |

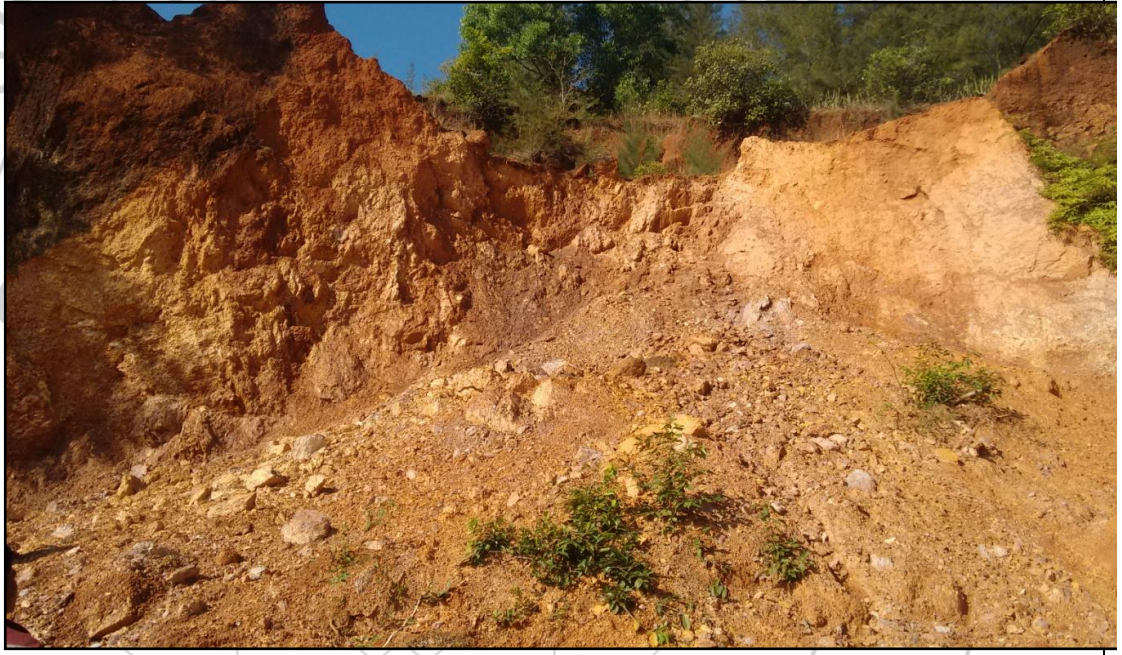
| 34. | Slide documentation | Remarks/ Abstract | Temple and community hall is at risk, danger to life and property |

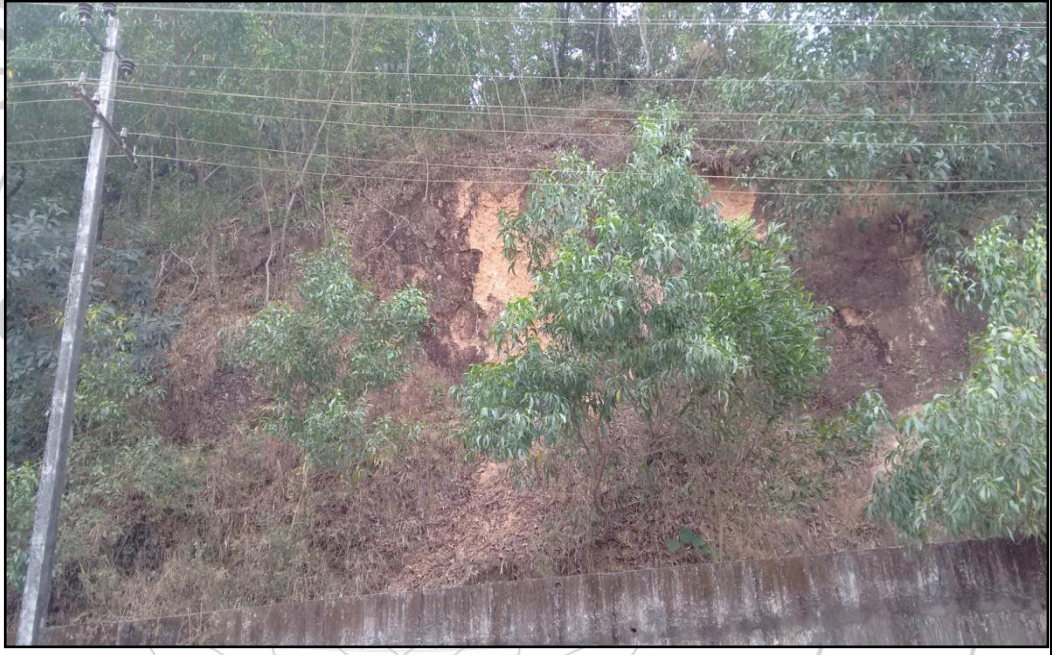
| 34. | Slide documentation | Remarks/ Abstract | The electric pole should be shifted to safer place. Although the retaining wall of 3m height with proper draining hole at toe part provides proper drainage and toe stabilization from further erosion. |

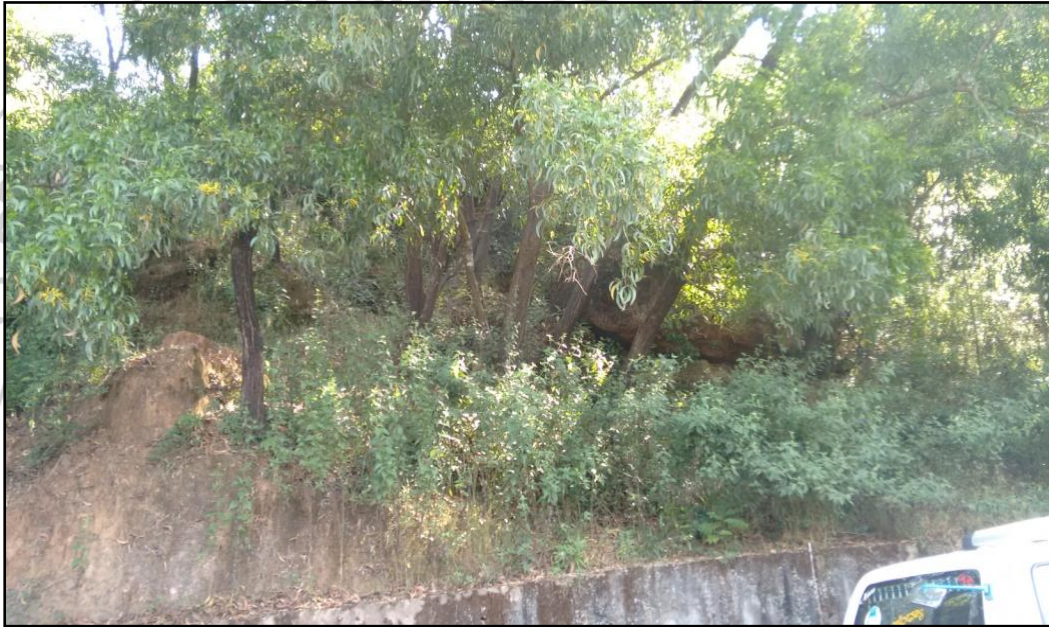
| 34. | | Remarks/ Abstract | 60.4m width and 2.5m high retaining wall constructed and toe part is supported with proper drainage. |

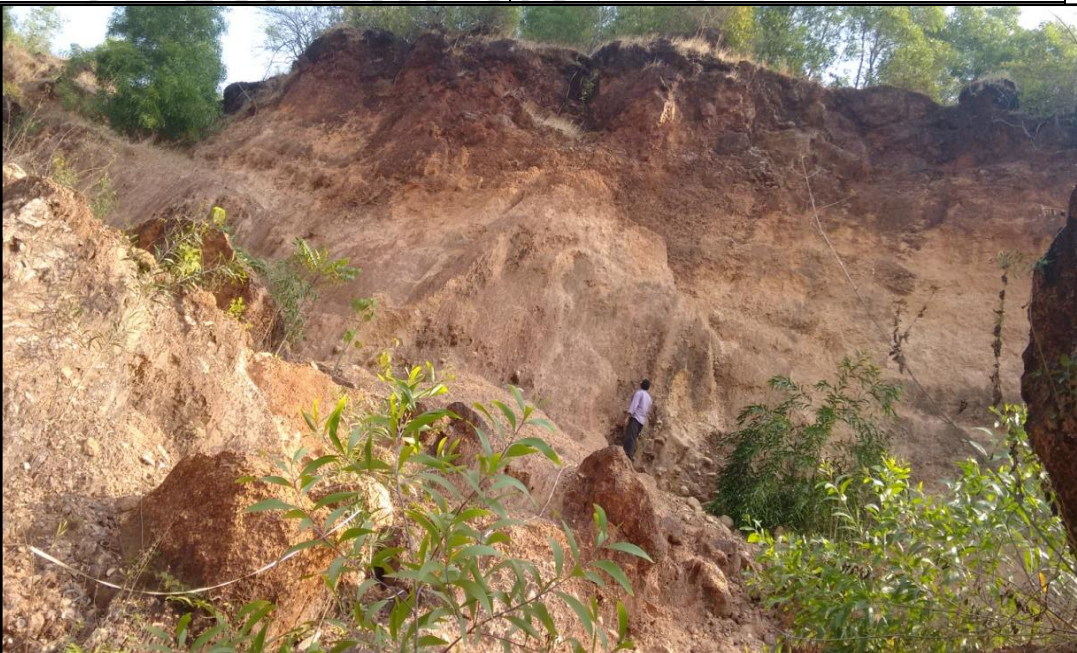
| 34. | Slide documentation | Remarks/ Abstract | Mortuary and communication line at risk |
