Macro-scale (1:50,000) Landslide Susceptibility Mapping in parts of Toposheets nos. 48O/11 & 48O/12 Chikmangaluru, Dakshin Kannad and Hassan districts, Karnataka.  
(FSP CODE NO.: M4LSSM/NC/SR/SU-KG/2017/12187)  
Field Season: 2017-18

Neha Kumari, Geologist  
&  
Kamal Kumar, Geologist

State Unit: Karnataka and Goa  
Southern Region

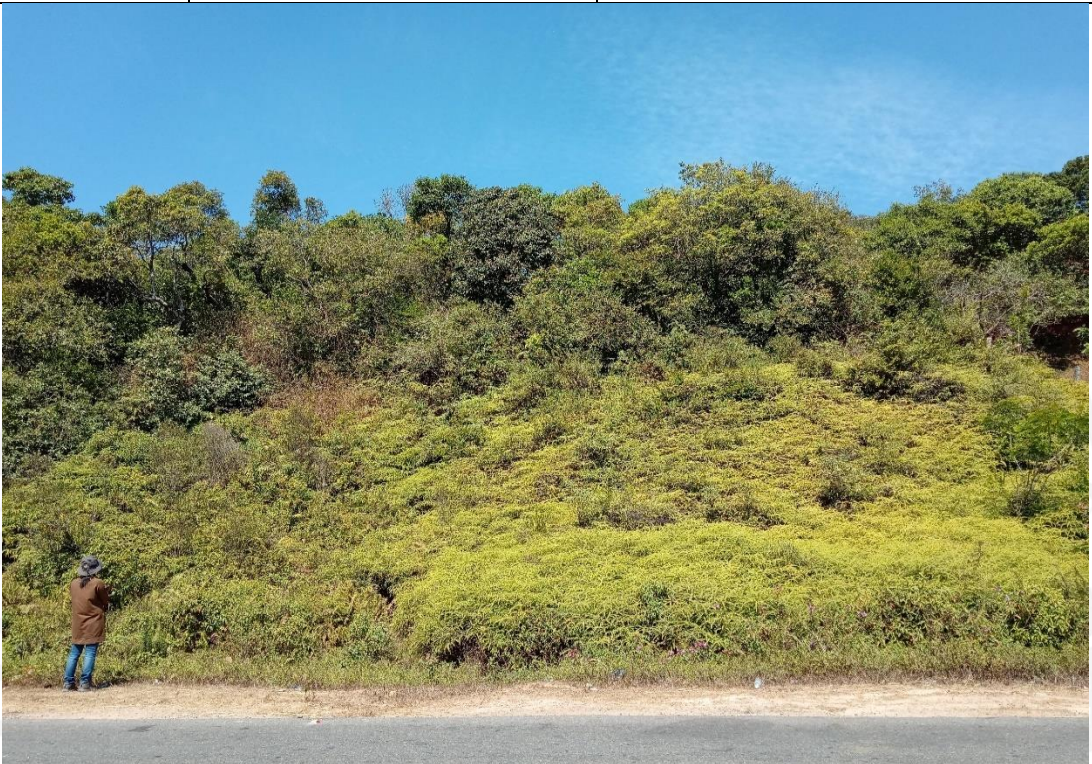
| 41. | Remarks | | In present condition the debris slide is suspended and stable and risk factor is low. |

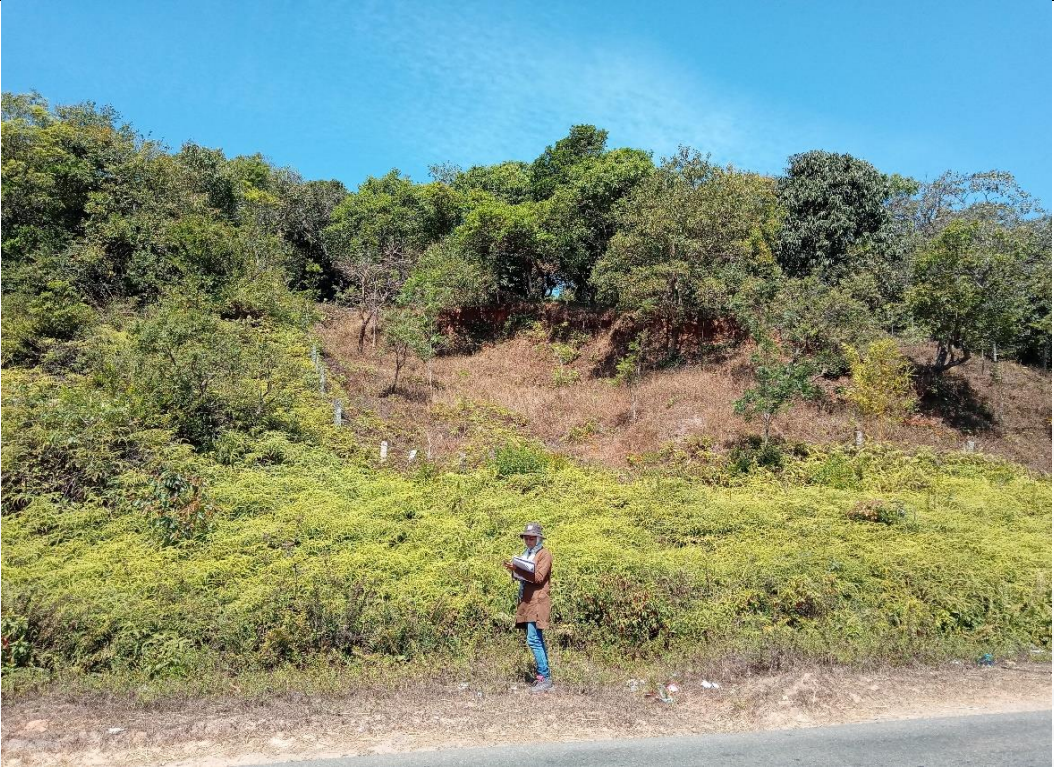
| 41. | | Remarks/ Abstract | In present condition the debris slide is suspended and stable and risk factor is low. |

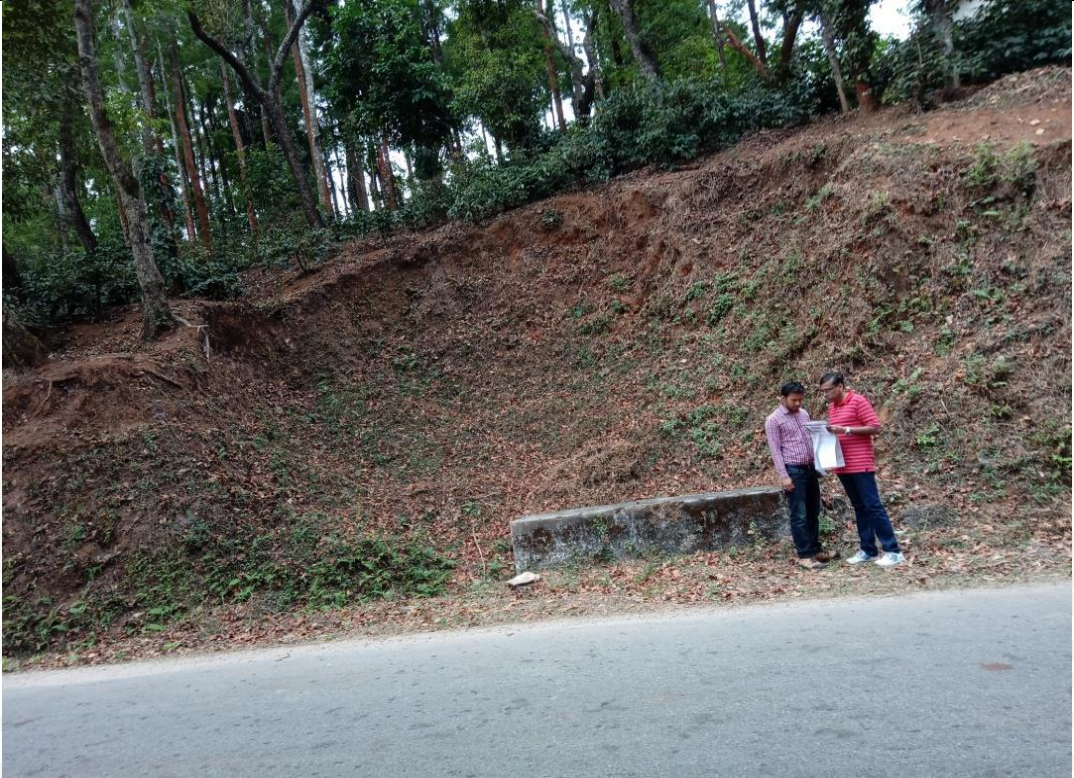
| 41. | Remarks/ Abstract | In present condition the debris slide is suspended and stable and risk factor is low. Risk to communication line |

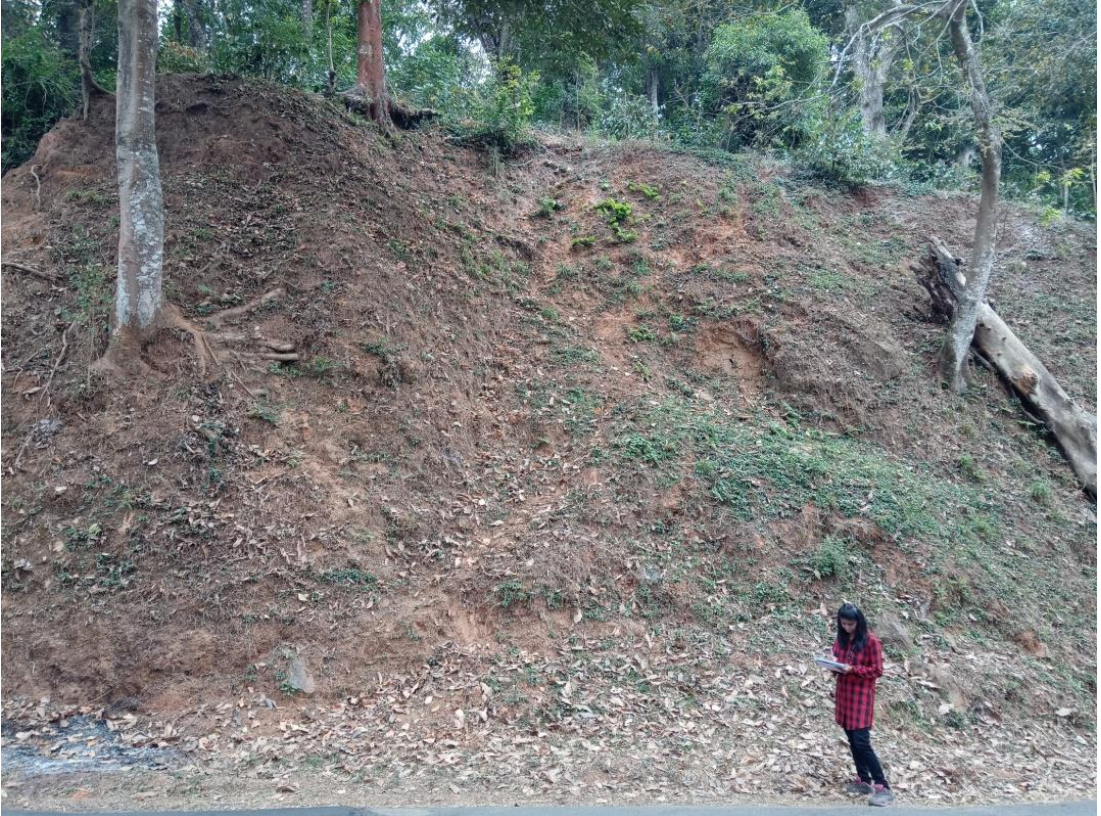
| 41. | Remarks/ Abstract | In present condition the debris slide/slump is active and risk factor is low. Fresh rock boulders are found lying. The area is demarcated as meta-stable to unstable zone. Risk to communication line. |

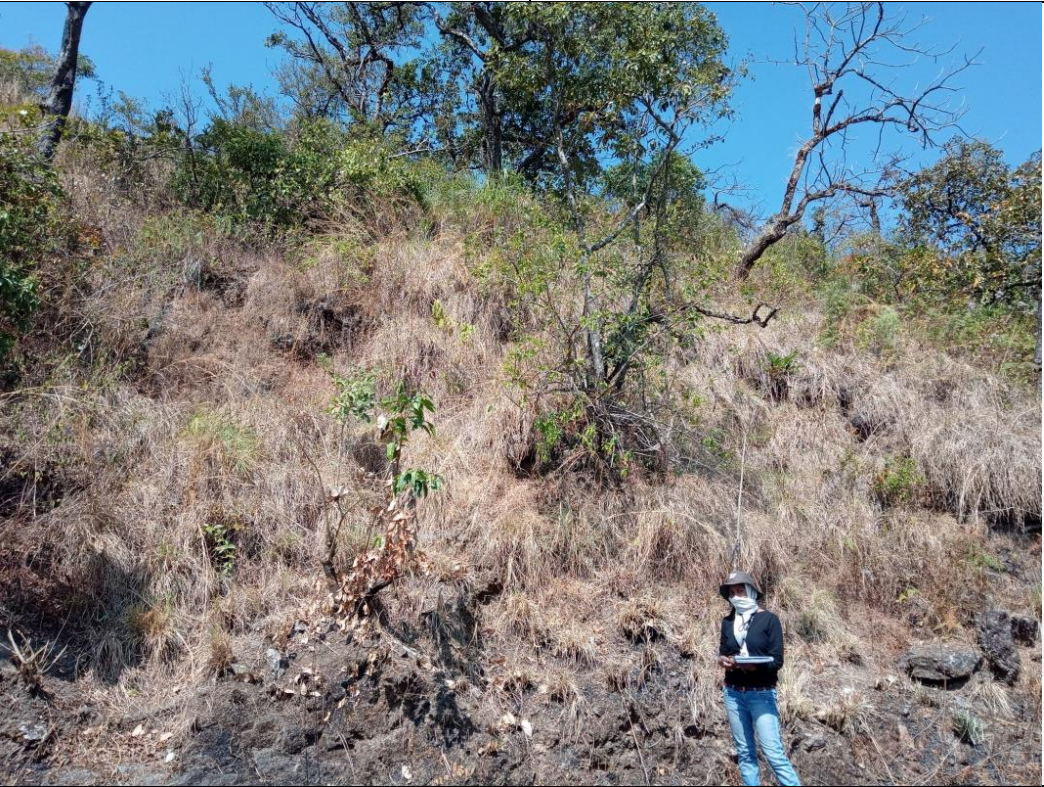
| 41. | Remarks/ Abstract | In present condition the debris slide is suspended and stable and risk factor is low. Risk to communication line. |

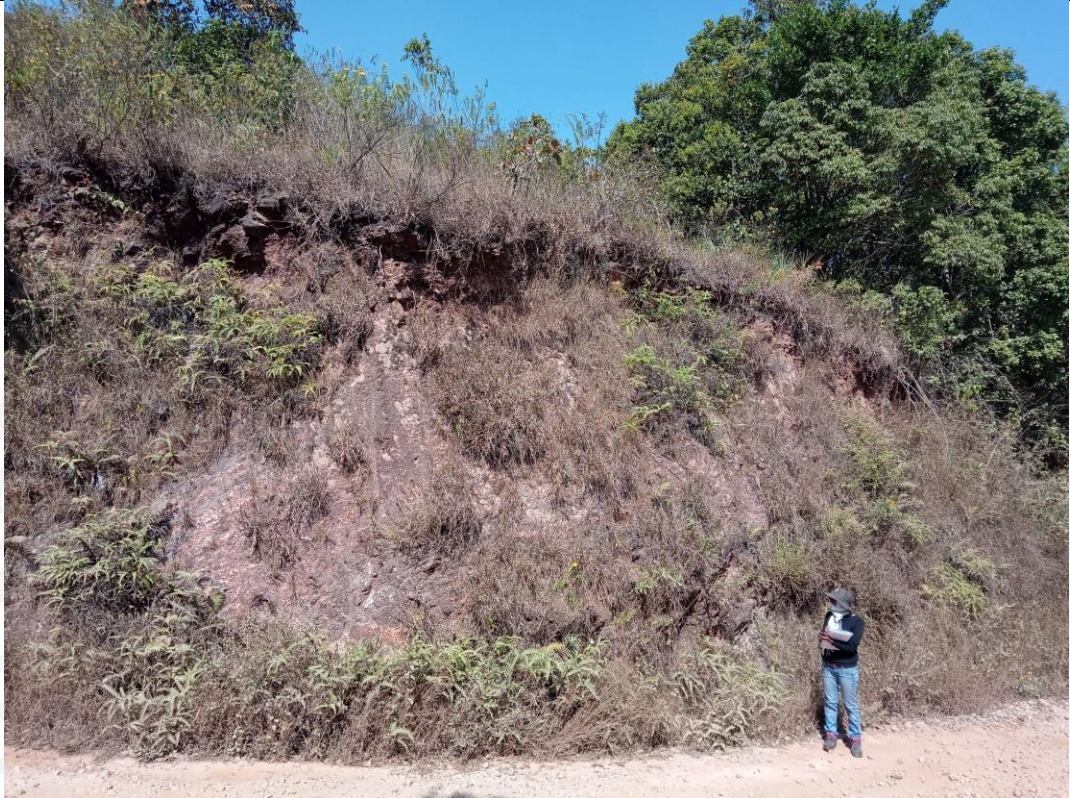
| 41. | Remarks/ Abstract | In present condition the debris slide is suspended and stable and risk factor is low. Risk to communication line. |

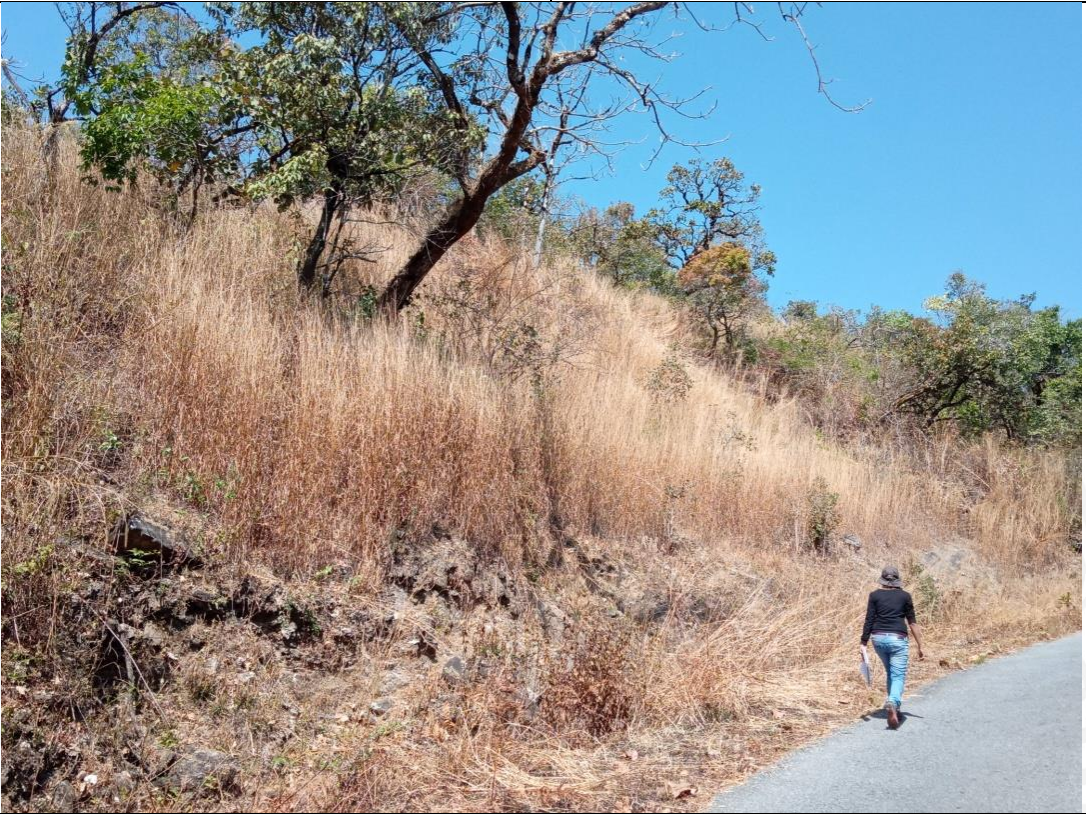
| 41. | Remarks/ Abstract | In present condition the debris slide is suspended and stable and risk factor is high. Risk to communication line |

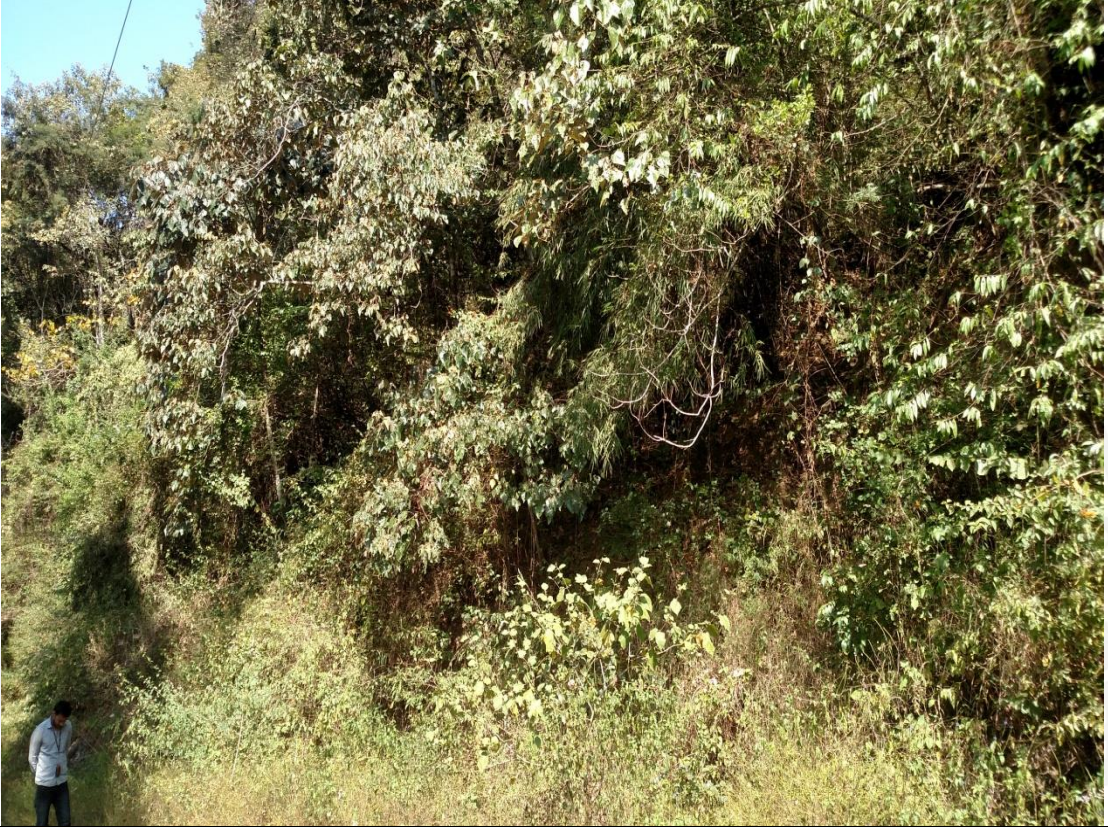
| 41. | Remarks/ Abstract | In present condition landslide is suspended and stable and risk factor is low. Risk to communication line |

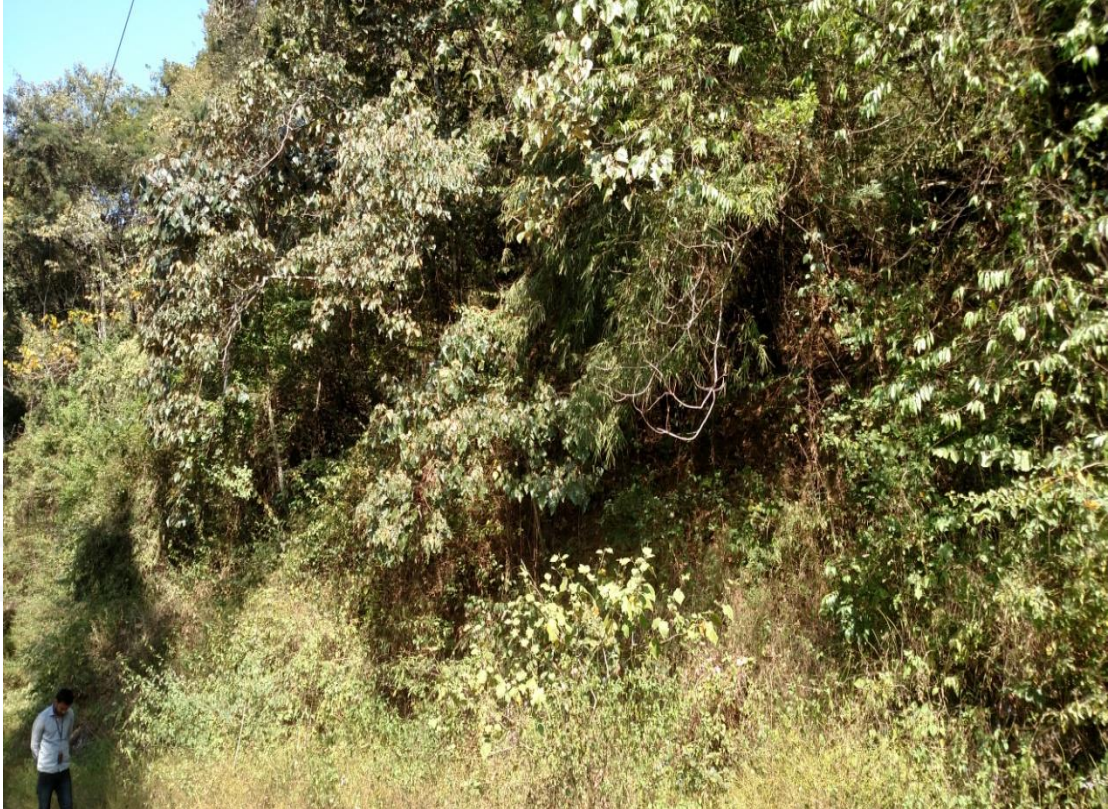
| 41. | Remarks/ Abstract | In present condition landslide is suspended and stable and risk factor is moderate. Risk to communication line and electric power line nearby is risky to man and material during slope failure. |

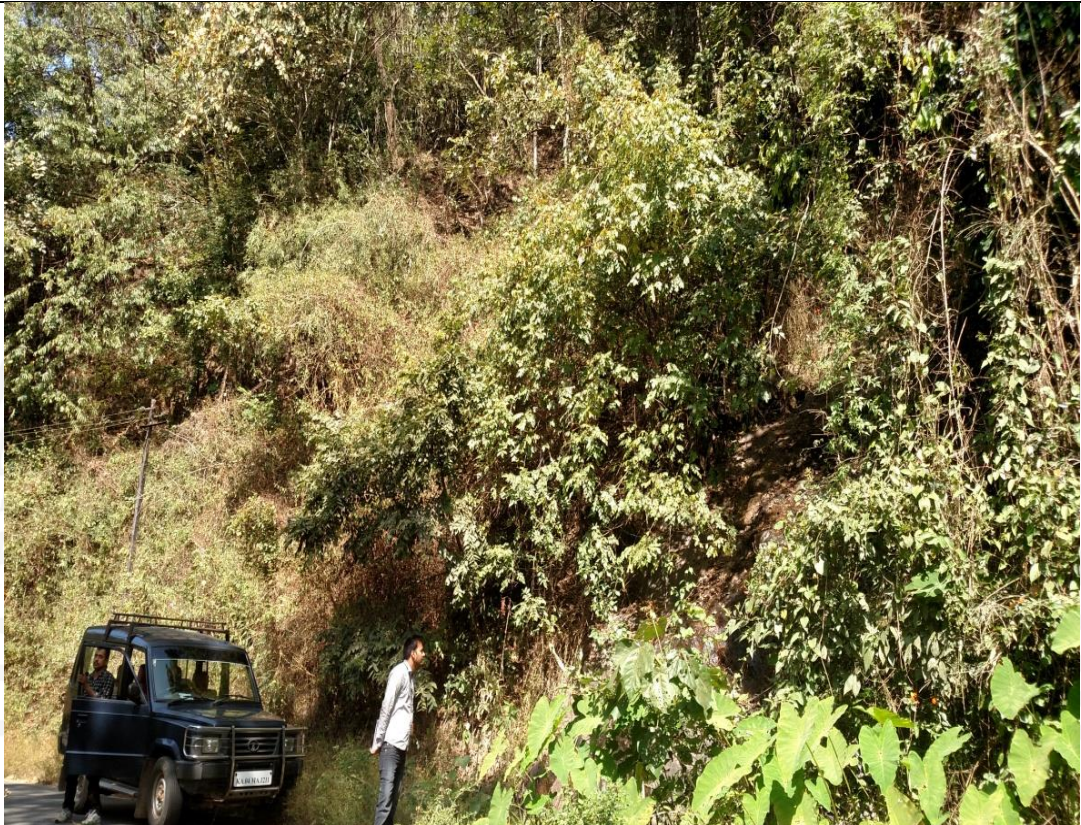
| 41. | Remarks/ Abstract | In present condition landslide is suspended and stable and risk factor is moderate. Risk to communication line. |

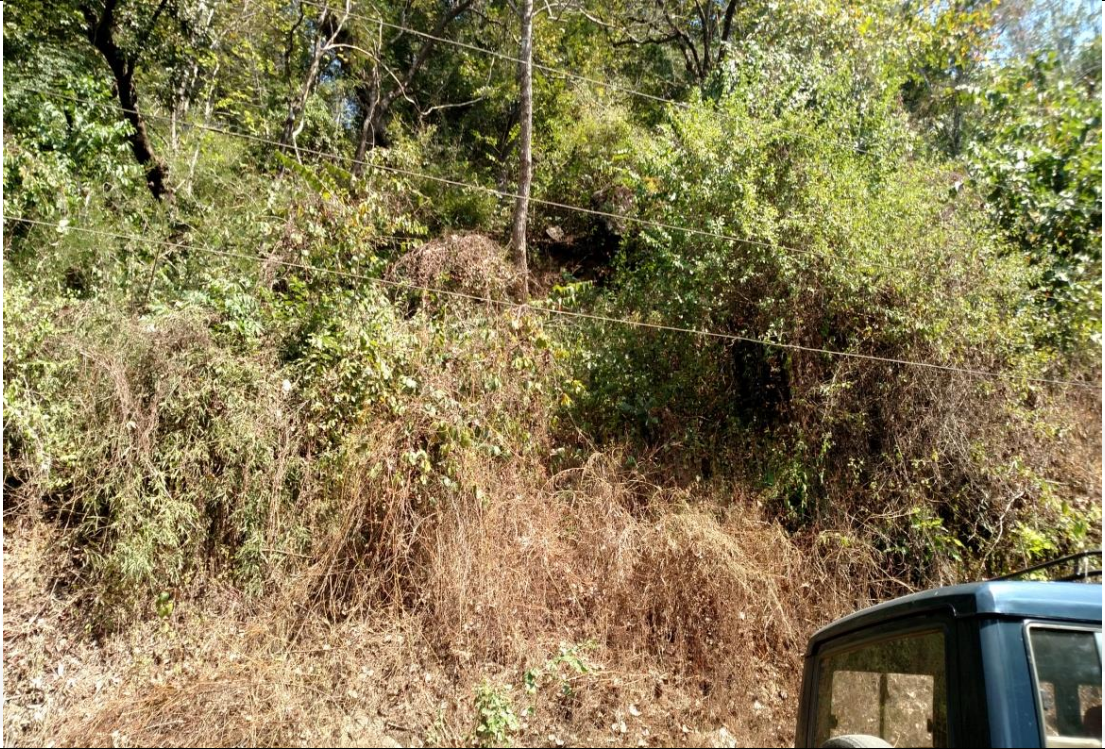
| 41. | Remarks/ Abstract | In present condition landslide is suspended and stable and risk factor is moderate. Risk to communication line. |

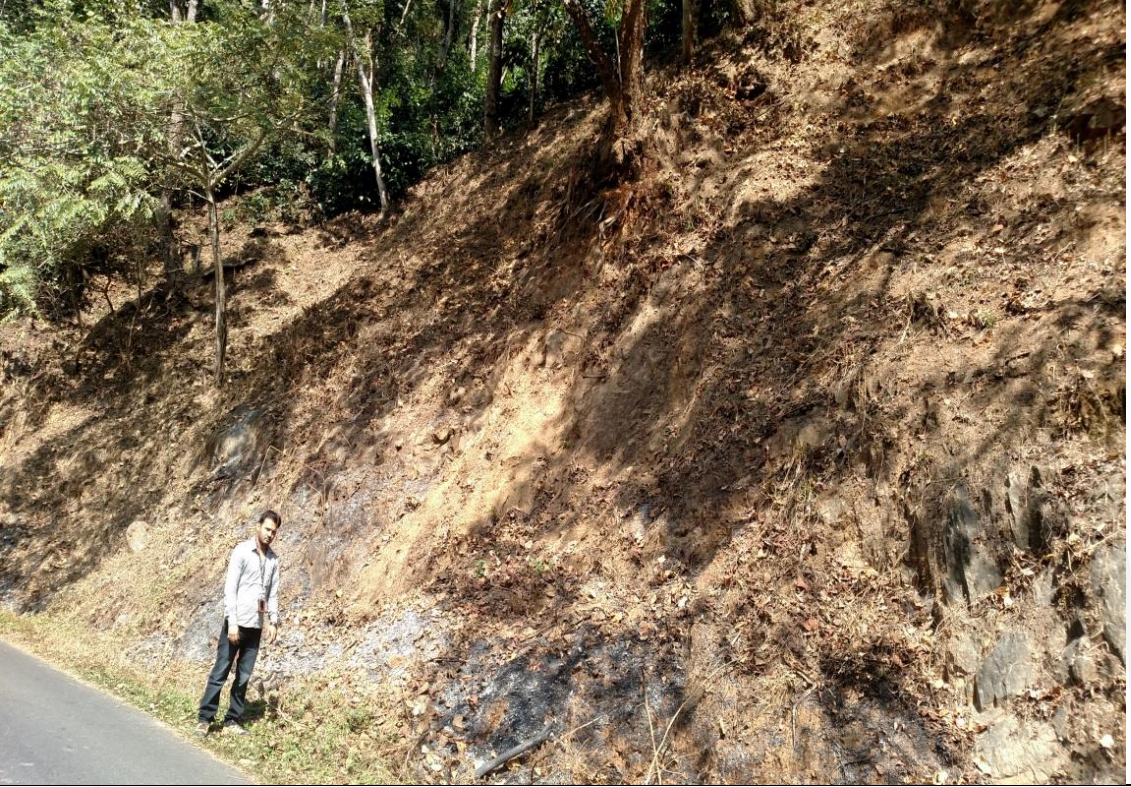
| 41. | Remarks/ Abstract | In present condition landslide is suspended and stable and risk factor is moderate. Risk to communication line, man and material. Slope is fragile upto 200 m extension. |

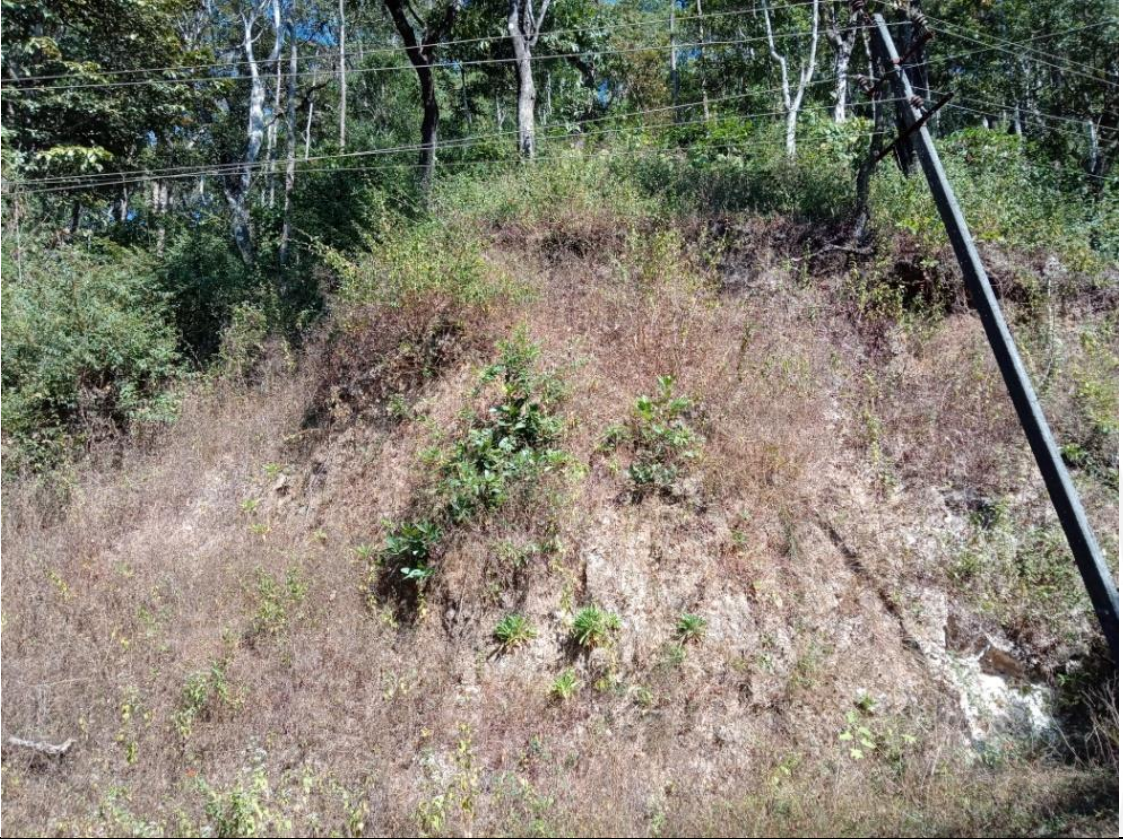
| 41. | Remarks/ Abstract | In present condition landslide is suspended and stable and risk factor is High. Electric pole nearby, Risk to communication line, man and material. |

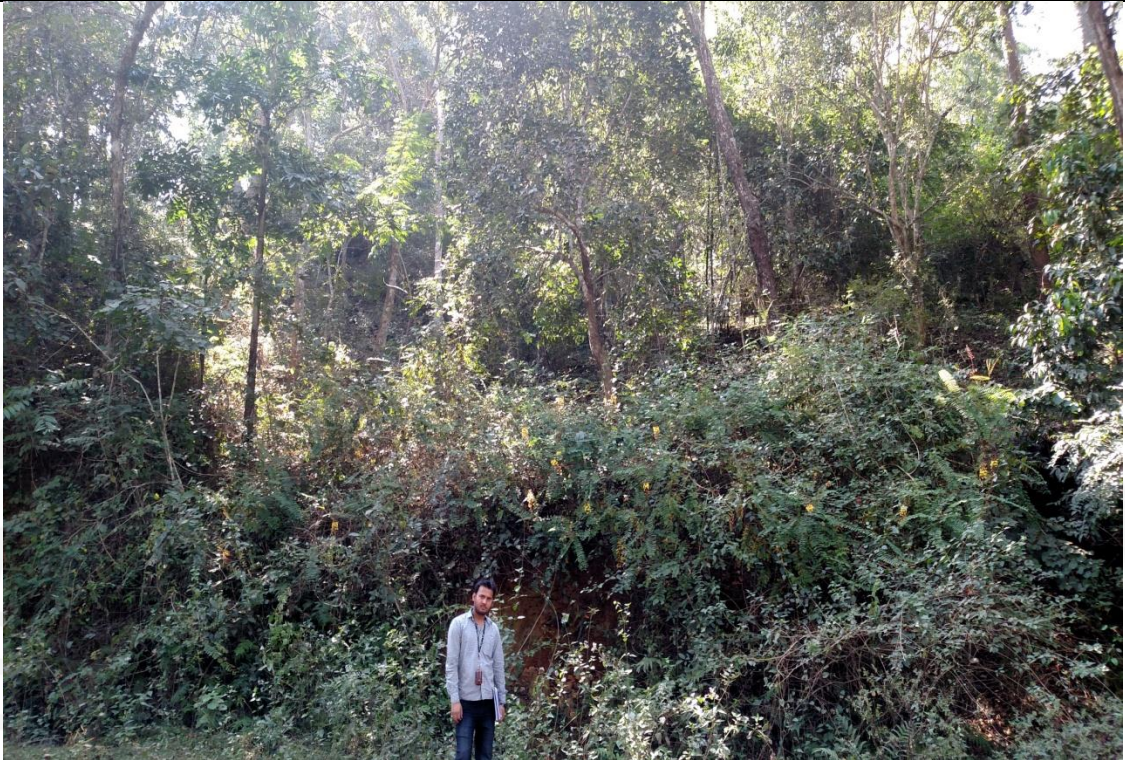
| 41. | Remarks/ Abstract | In present condition landslide is suspended and unstable and risk factor is high. Electric pole nearby, Risk to communication line, man and material. |

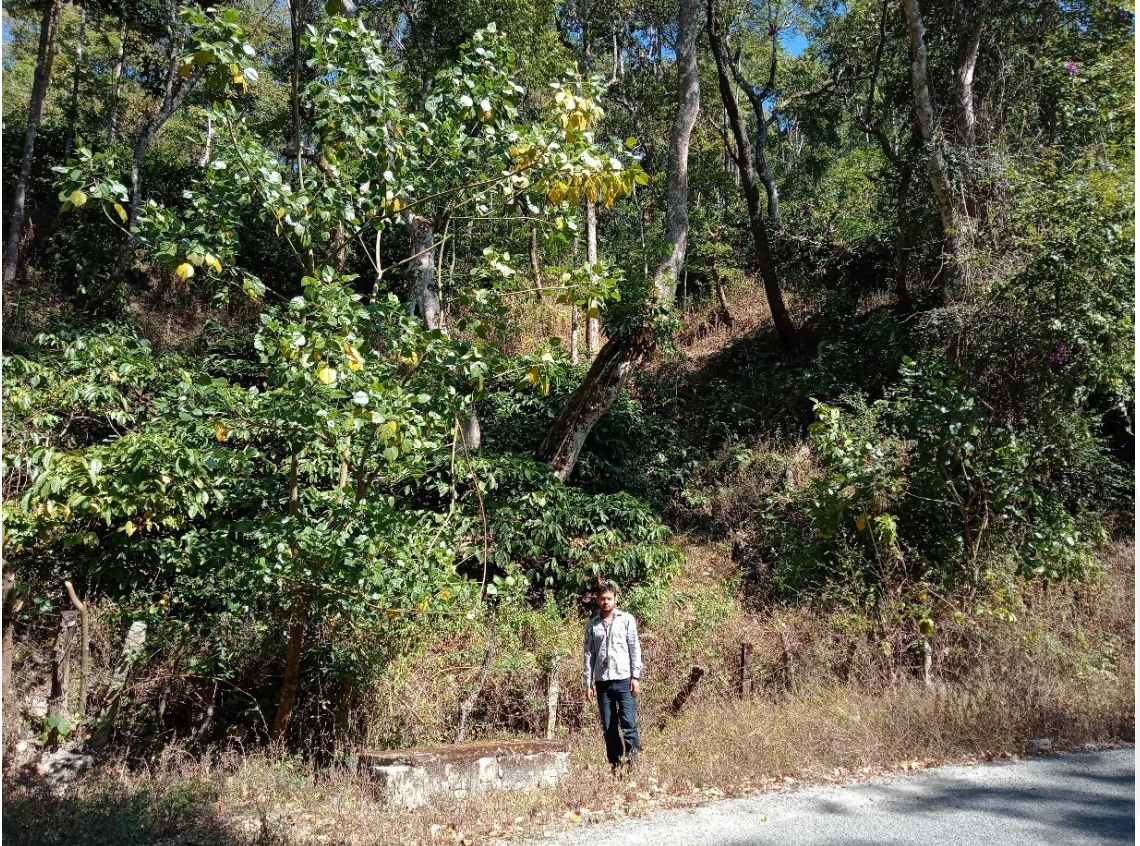
| 41. | Remarks/ Abstract | In present condition landslide is suspended and un stable and risk factor is High. Electric pole nearby, Risk to communication line, man and material. |

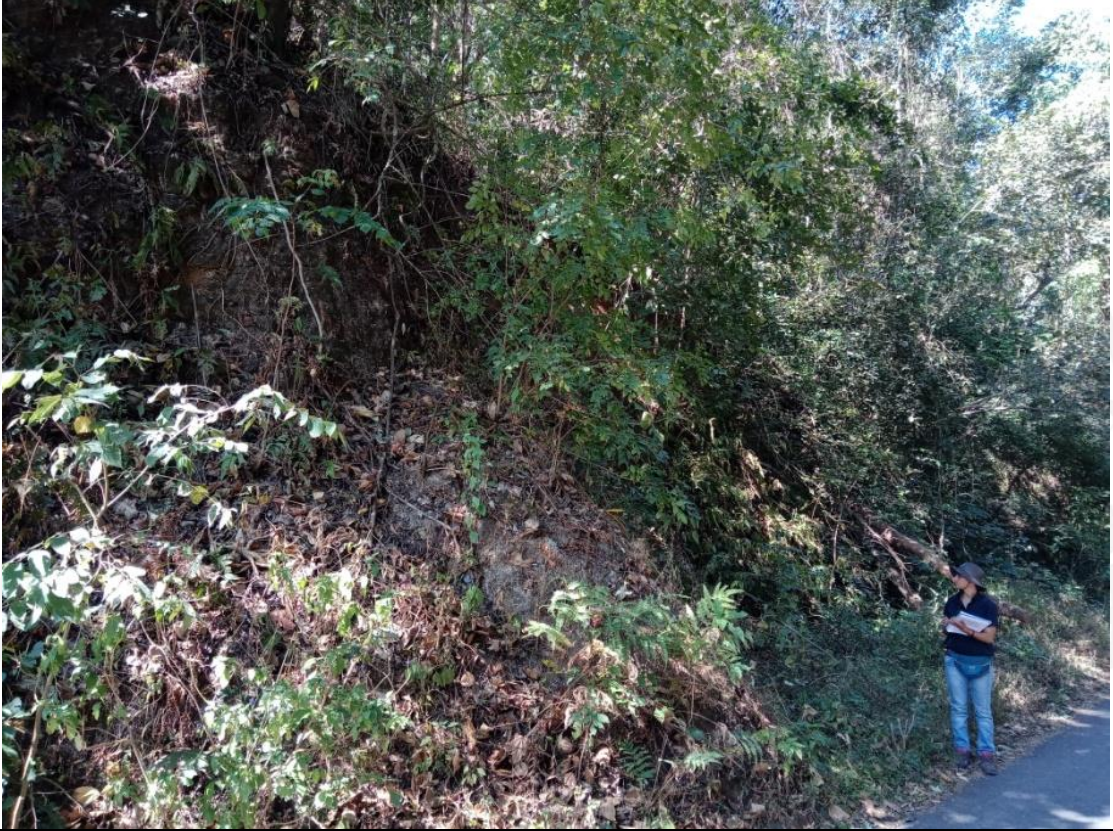
| 41. | Remarks/ Abstract | | In present condition landslide is suspended and un stable and risk factor is High. Electric pole nearby, Risk to communication line, man and material. |

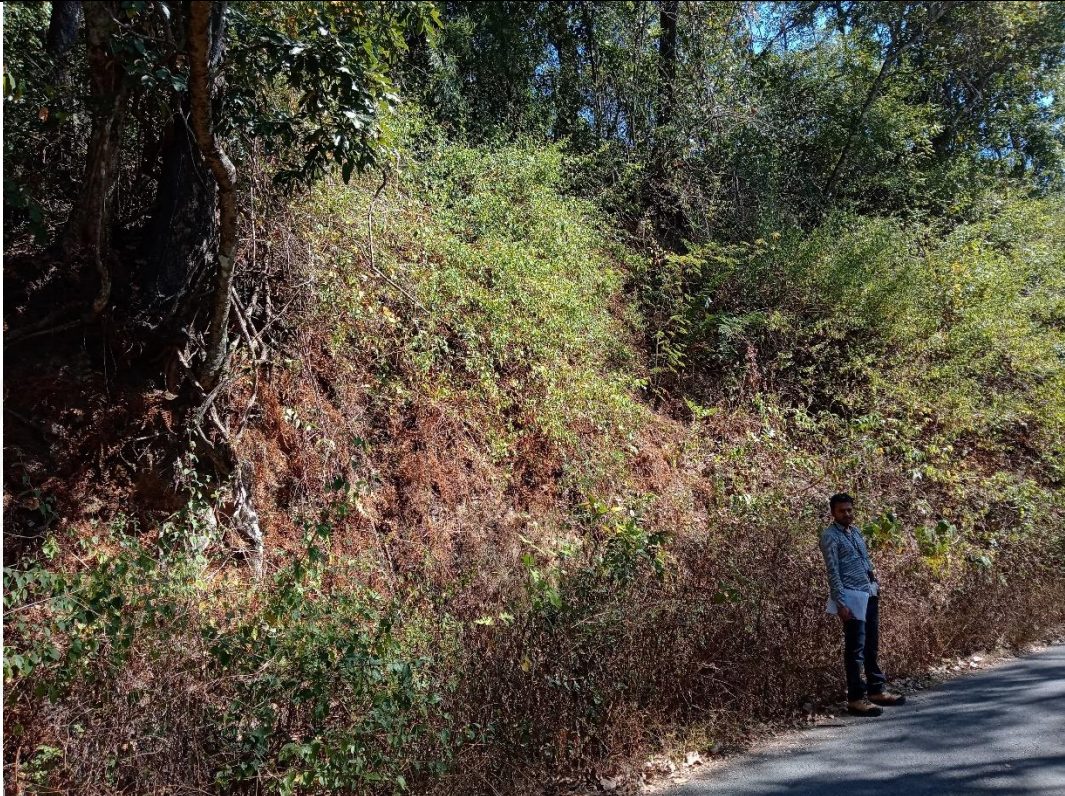
| 41. | Remarks/ Abstract | In present condition landslide is suspended and un stable and risk factor is High. Electric pole nearby, Risk to communication line, man and material. |

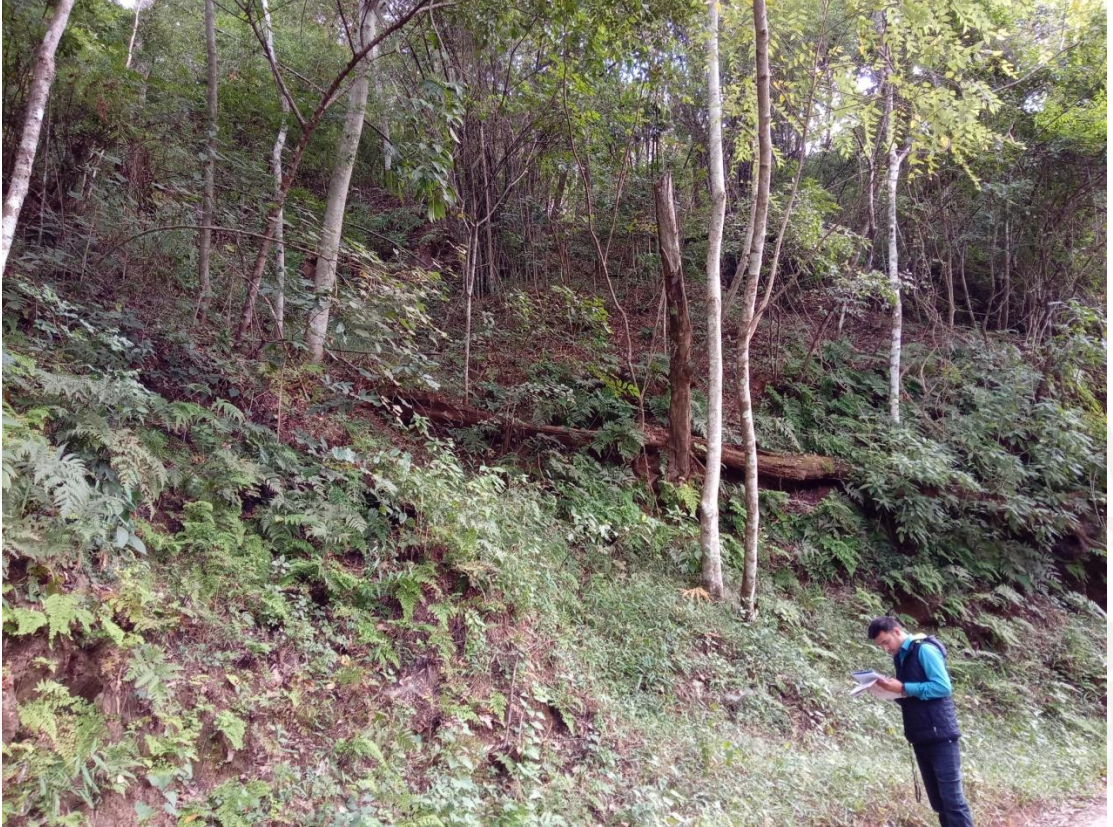
| 41. | Remarks/ Abstract | In present condition landslide is suspended and unstable and risk factor is moderate and the area is metastable, Risk to communication line, man and material. Old slide scars are visible. |

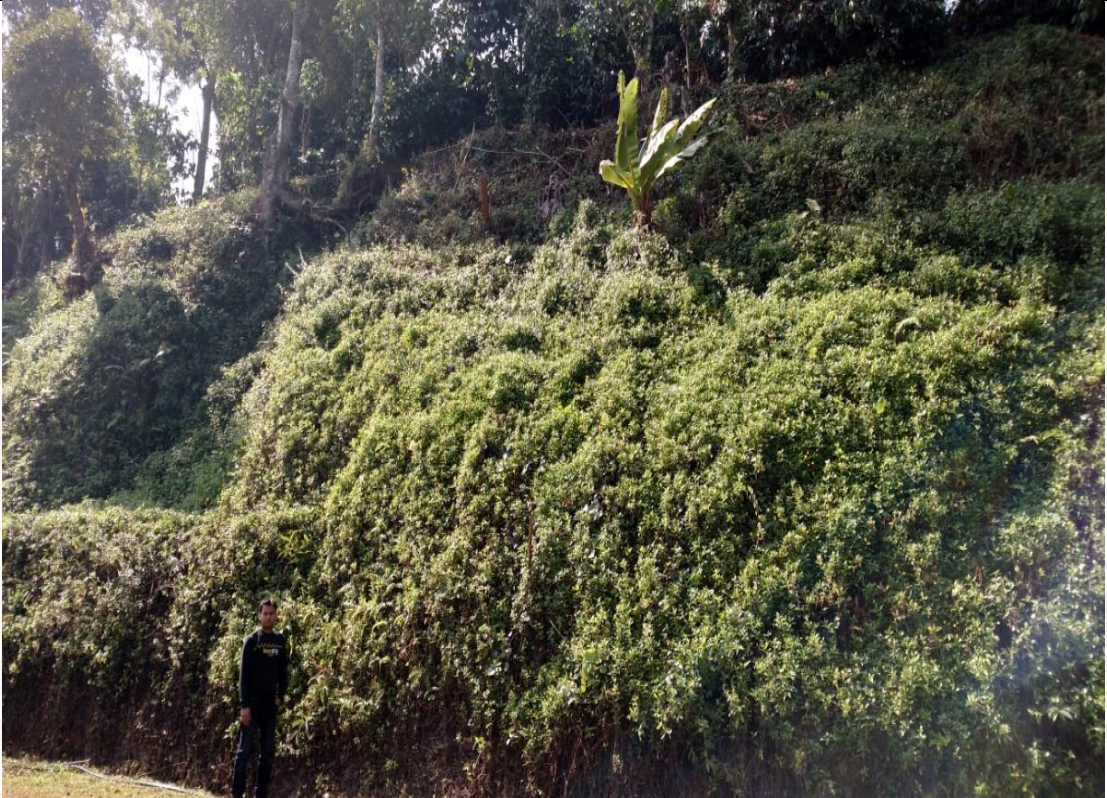
| 41. | Remarks/ Abstract | In present condition landslide is suspended and un stable and risk factor is moderate and metastable, Risk to communication line, man and material. |

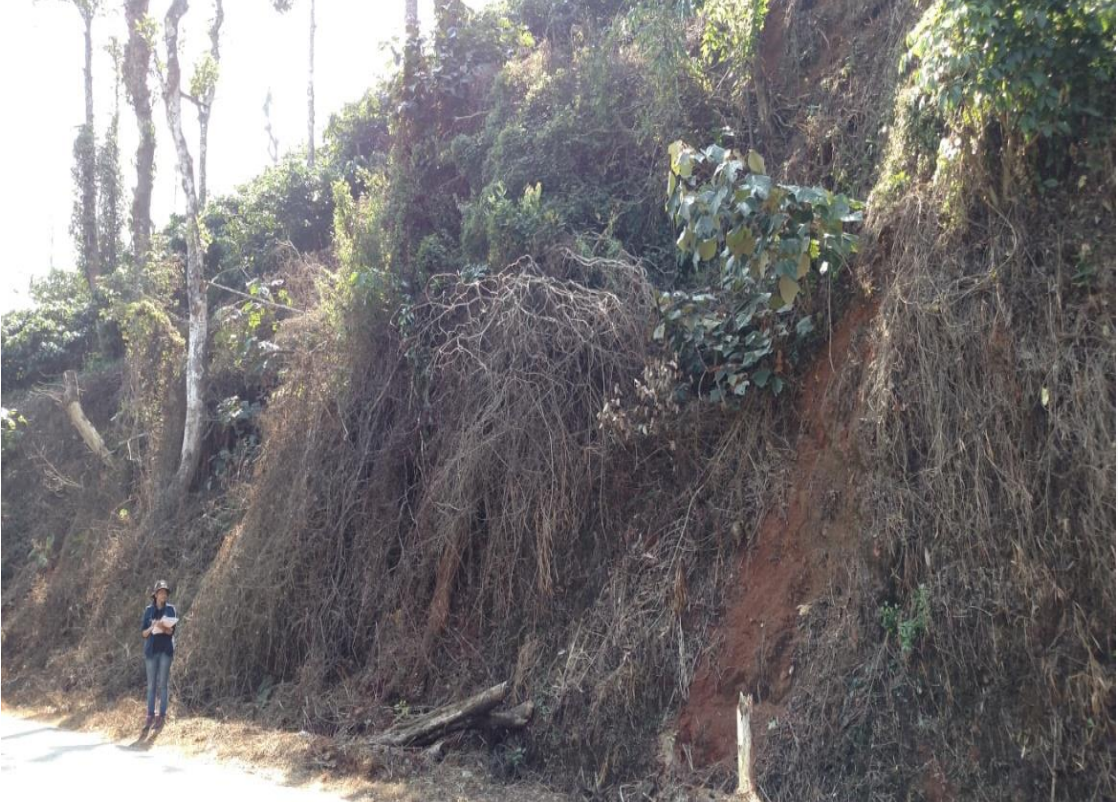
| 41. | Remarks/ Abstract | In present condition landslide is suspended and un stable and risk factor is moderate and metastable, Risk to communication line, man and material. |

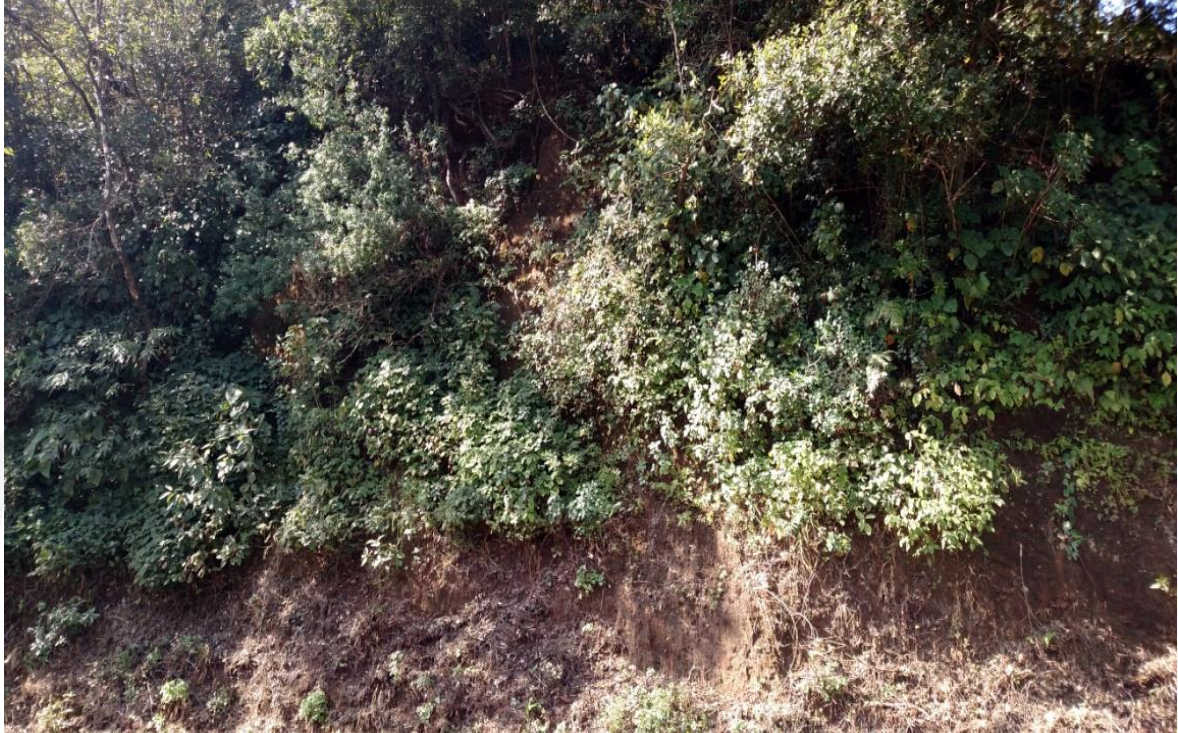
| 41. | Remarks/ Abstract | | In present condition landslide is suspended and unstable and risk factor is moderate and metastable, Risk to communication line, man and material. |

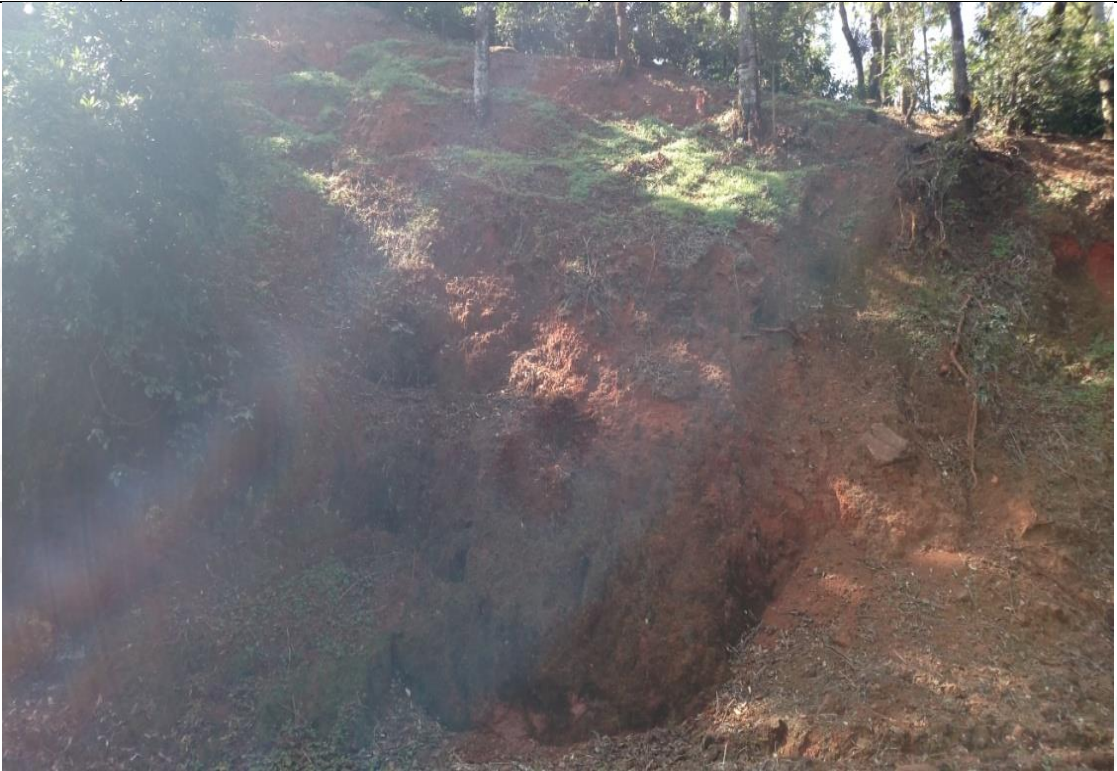
| 41. | | Remarks/ Abstract | In present condition landslide is suspended and unstable and risk factor is moderate and metastable, Risk to communication line, man and material. Vertical cut slope failure. |

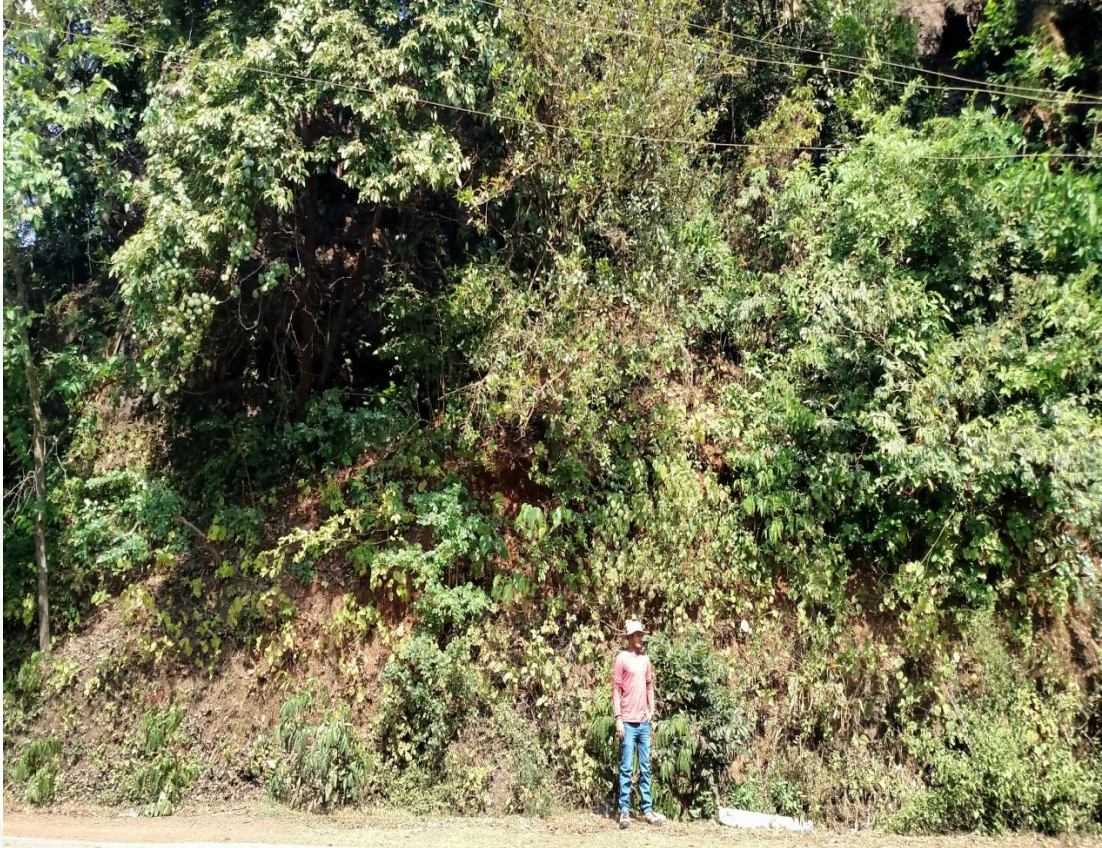
| 41. | Remarks/ Abstract | | In present condition landslide is suspended and un stable and risk factor is moderate and metastable, Risk to communication line, man and material. Vertical cut slope failure. |

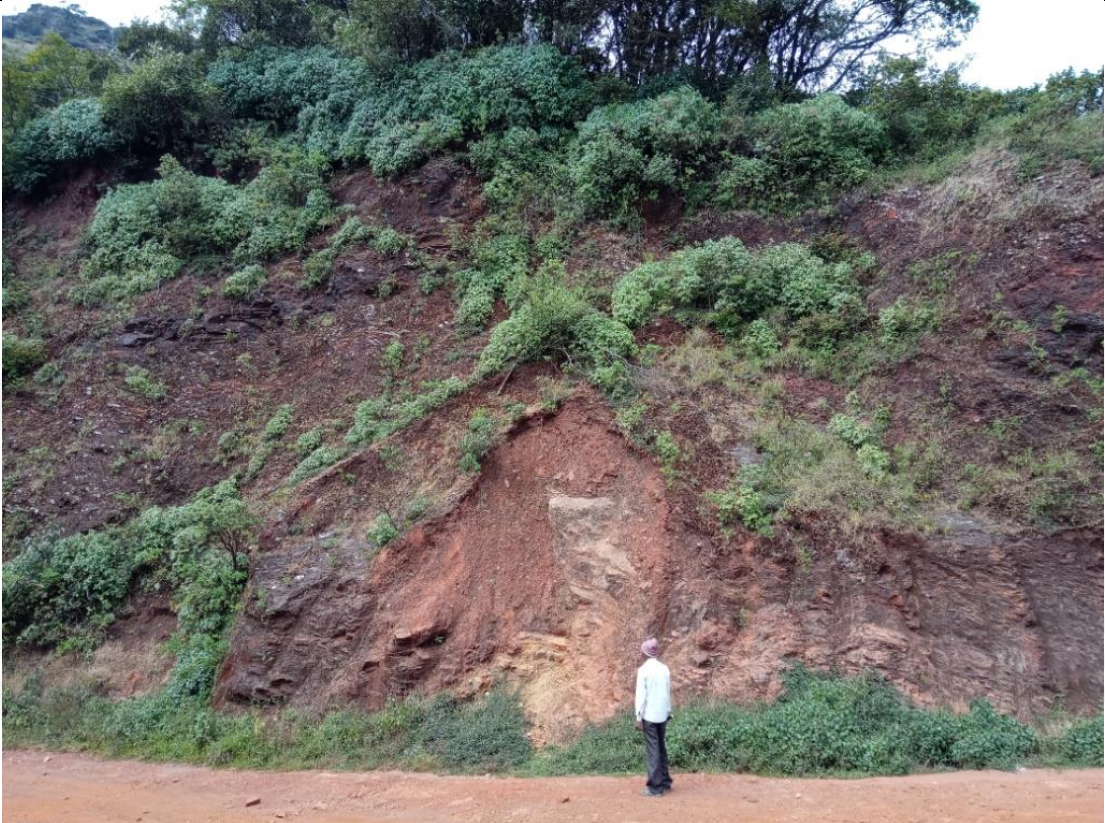
| 41. | Remarks/ Abstract | In present condition landslide is suspended and un stable and risk factor is moderate and metastable, Risk to communication line, man and material. Vertical cut slope failure. |

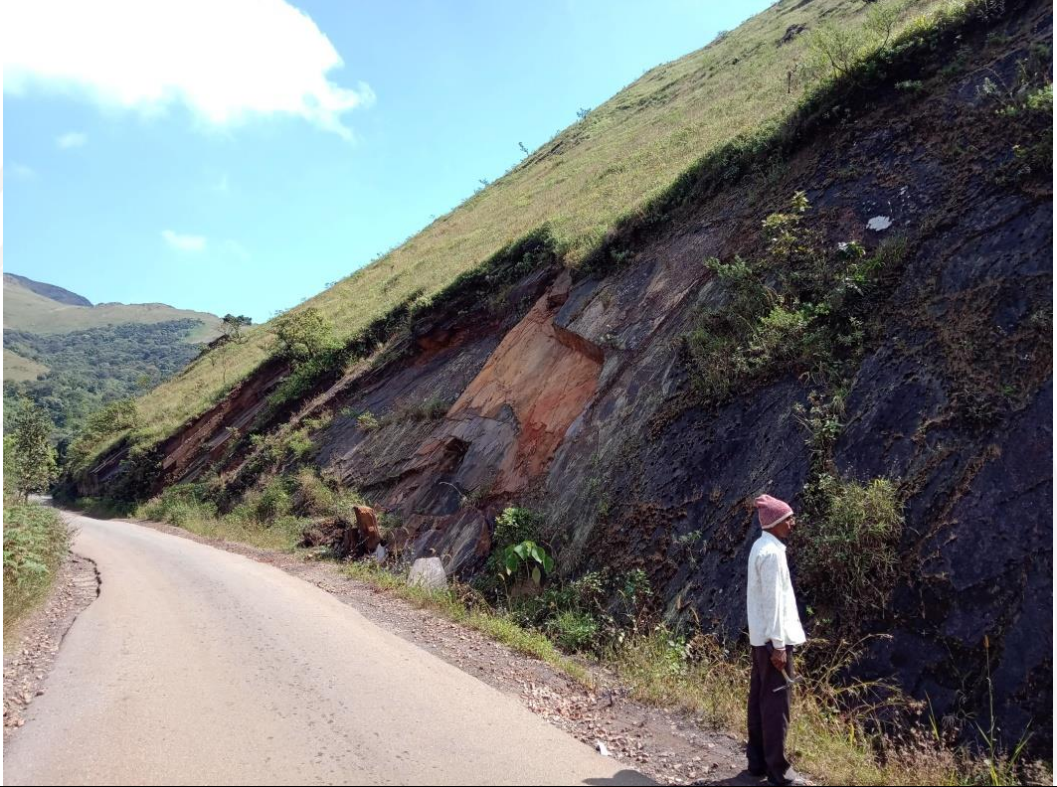
| 41. | | Remarks/ Abstract | In present condition landslide is active and un stable and risk factor is high and metastable, Risk to communication line, man and material. Vertical cut slope failure dipping towards road. |
