Macro-scale (1:50,000) Landslide Susceptibility Mapping in parts of Toposheets nos. 48O/11 & 48O/12 Chikmangaluru, Dakshin Kannad and Hassan districts, Karnataka.  
(FSP CODE NO.: M4LSSM/NC/SR/SU-KG/2017/12187)  
Field Season: 2017-18

Neha Kumari, Geologist  
&  
Kamal Kumar, Geologist

State Unit: Karnataka and Goa  
Southern Region

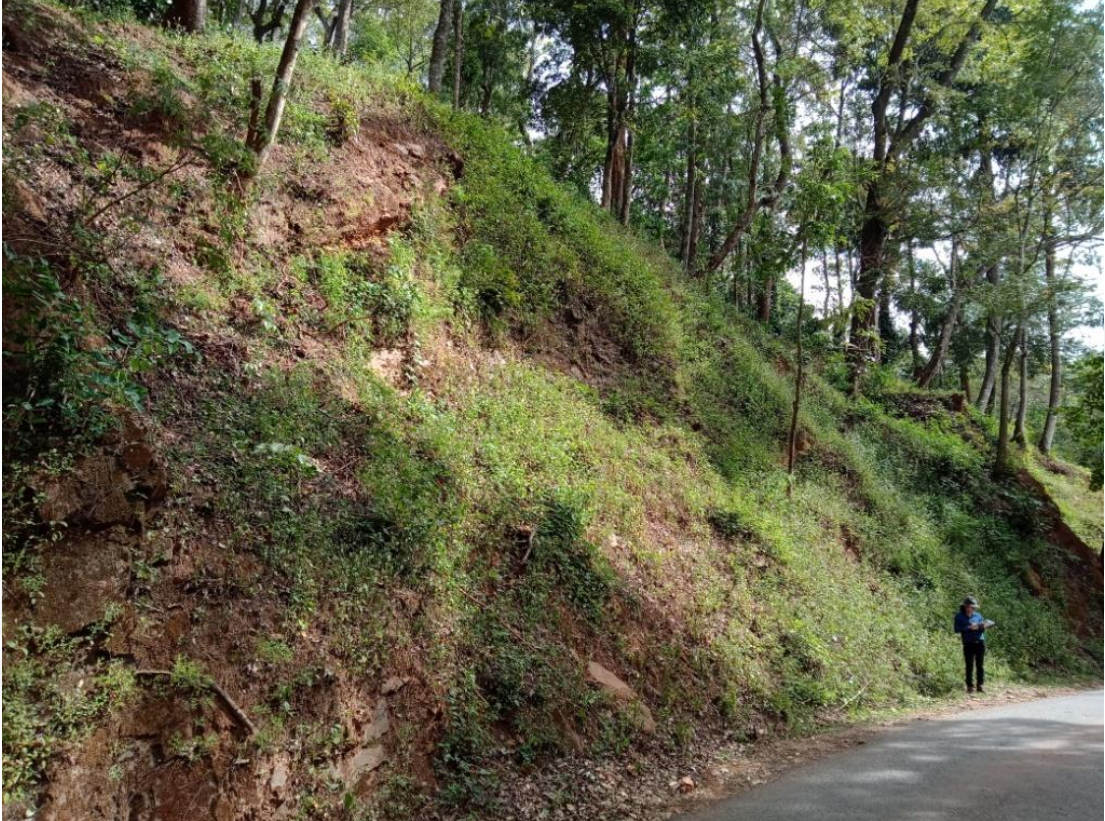
| 41. | Remarks/ Abstract | In present condition landslide is active and un stable and risk factor is high and metastable, Risk to communication line, man and material. Old slide plantation on slope. |

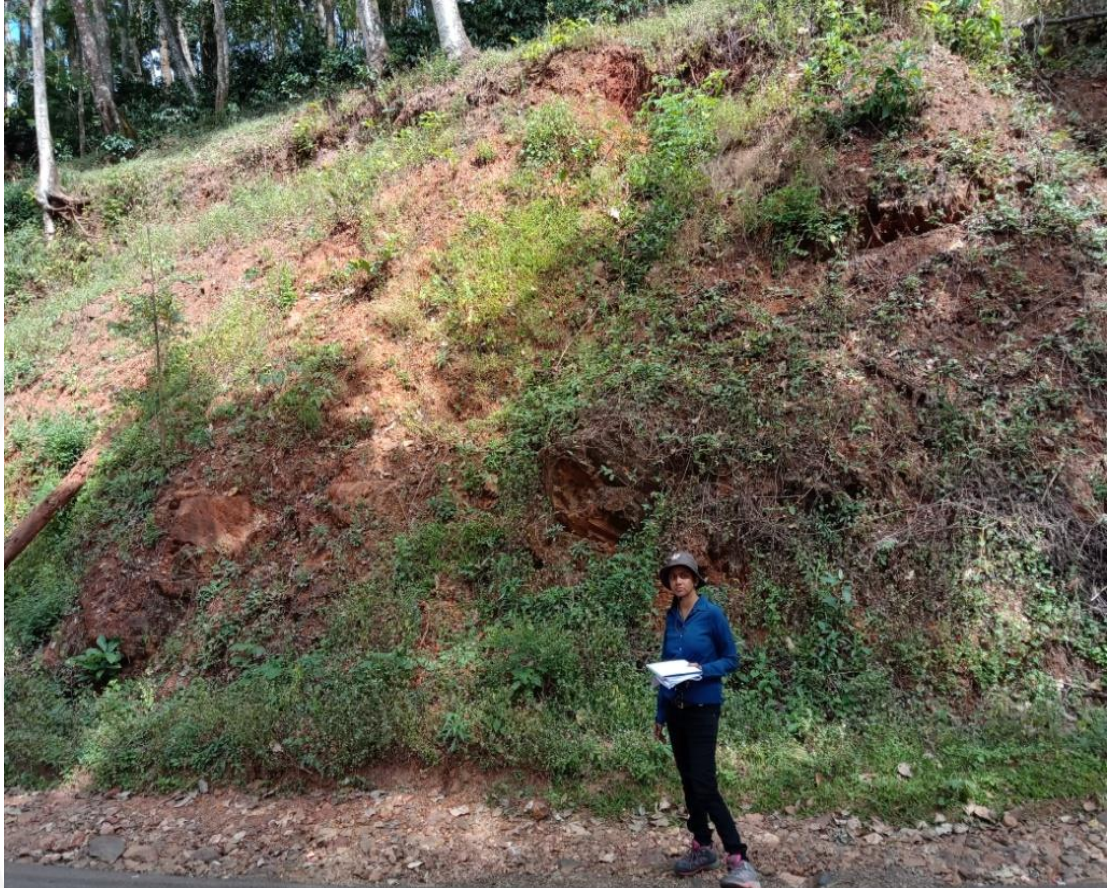
| 41. | Remarks/ Abstract | In present condition landslide is active and un stable and risk factor is high and metastable, Risk to communication line, man and material. Old scars present |

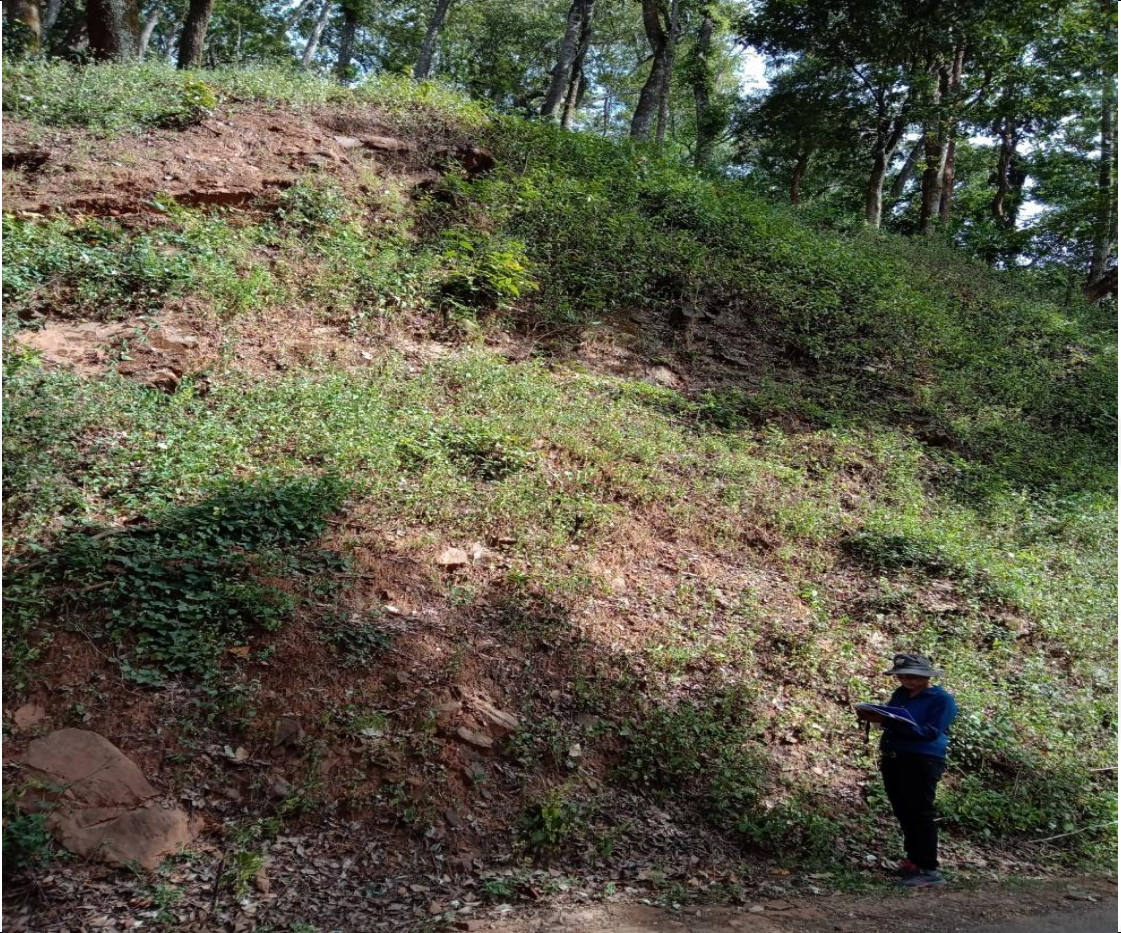
| 41. | Remarks/ Abstract | In present condition landslide is active and un stable and risk factor is high and metastable, Risk to communication line, man and material. Old scars present |

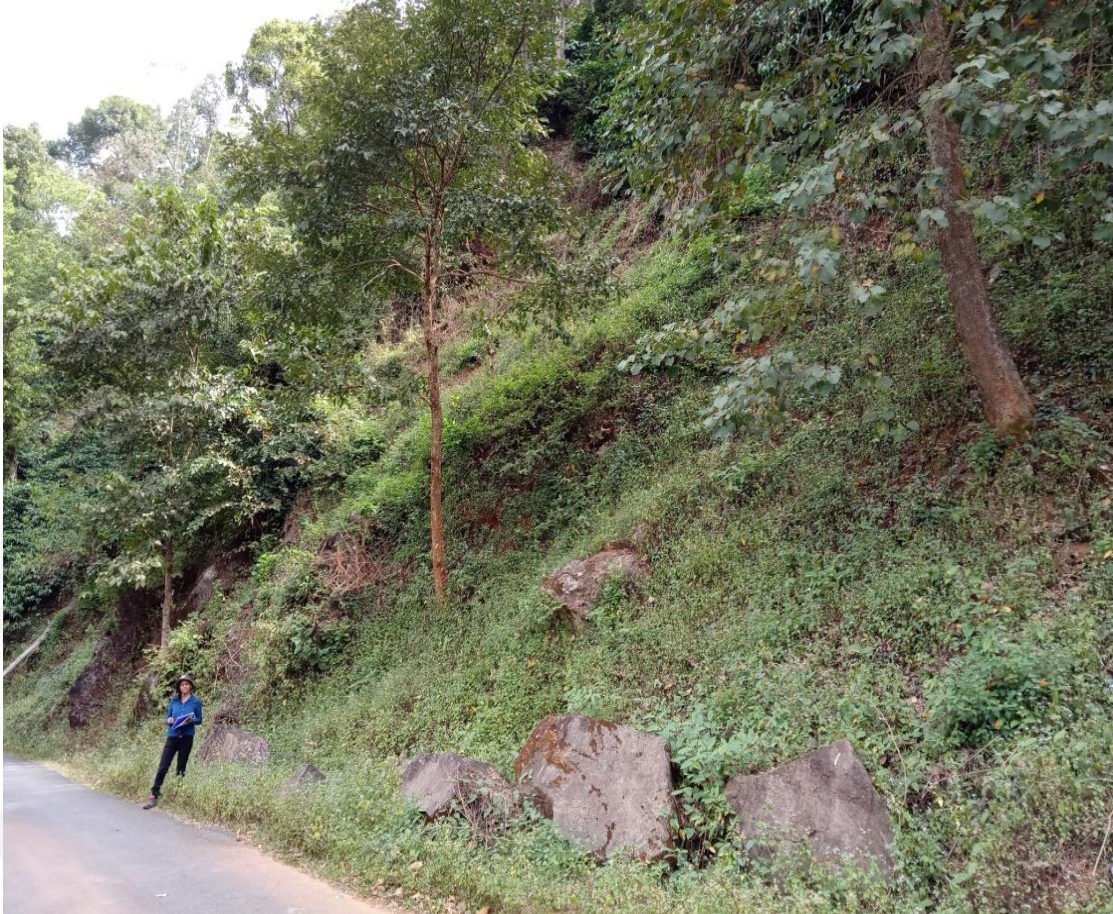
| 41. | Remarks/ Abstract | | In present condition landslide is active and unstable and risk factor is high and metastable, Risk to communication line, man and material. Old scars present |

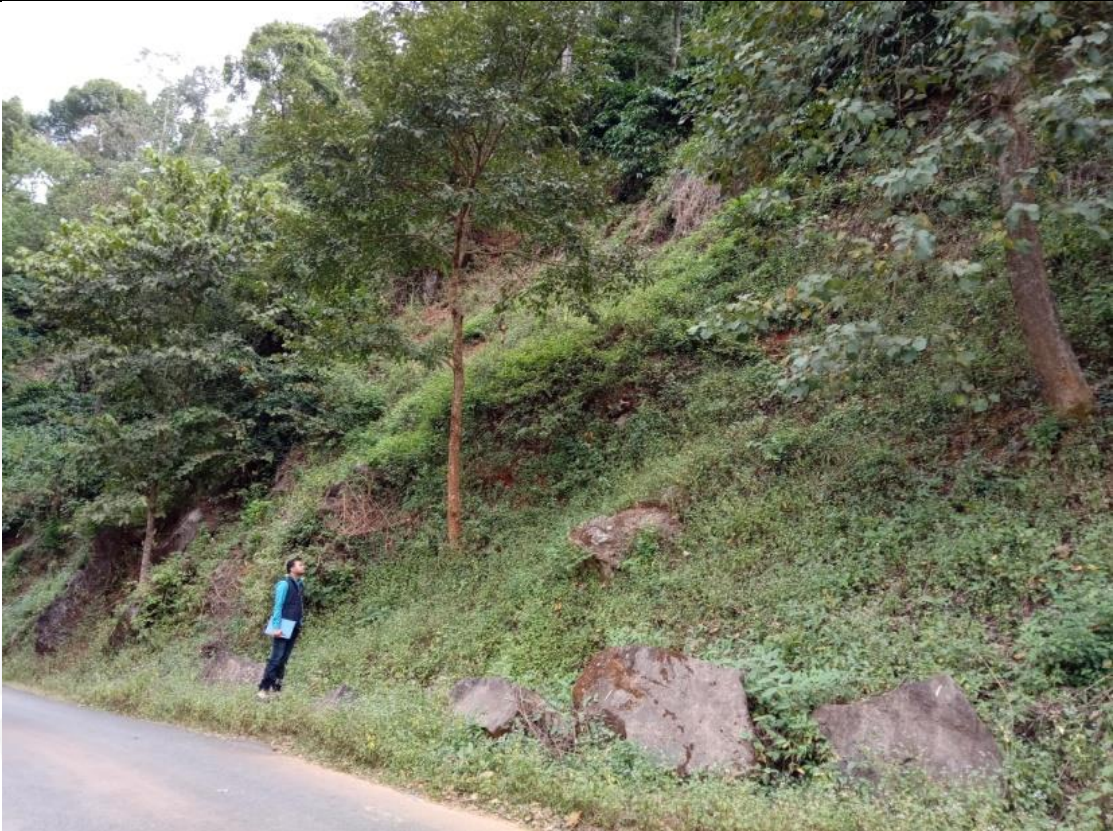
| 41. | Remarks/ Abstract | In present condition landslide is active and unstable and risk factor is high and metastable, Risk to communication line, man and material. Old scars present |

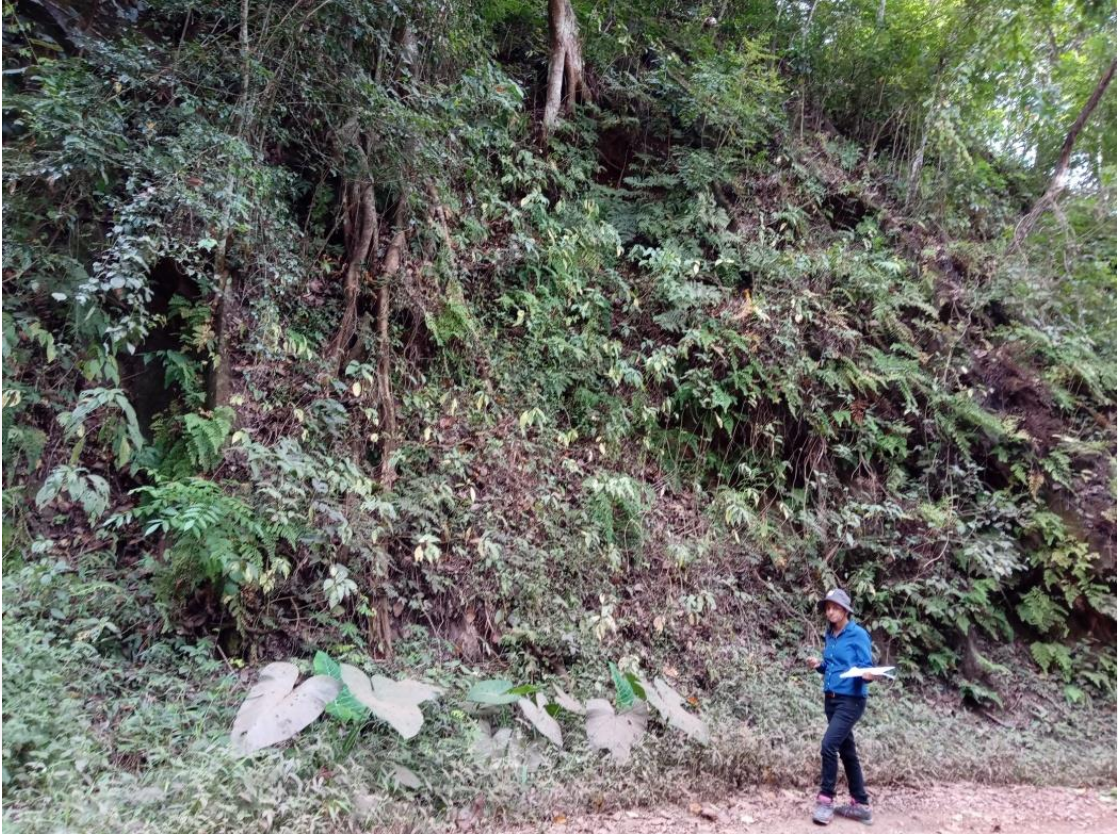
| 41. | Remarks/ Abstract | In present condition landslide is active and unstable and risk factor is high and meta-stable, Risk to communication line, man and material. Old scars present |

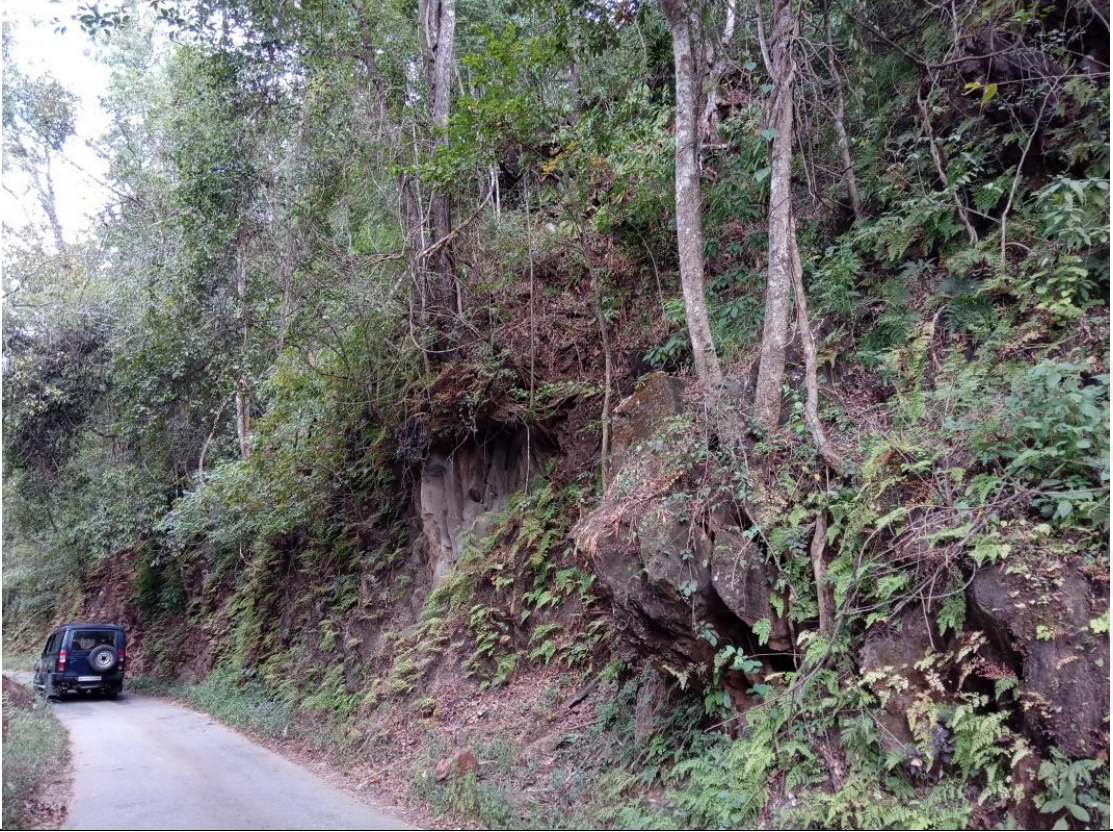
| 41. | Remarks/ Abstract | In present condition landslide is active and unstable and risk factor is high and meta-stable, Risk to communication line, man and material. Old scars present |

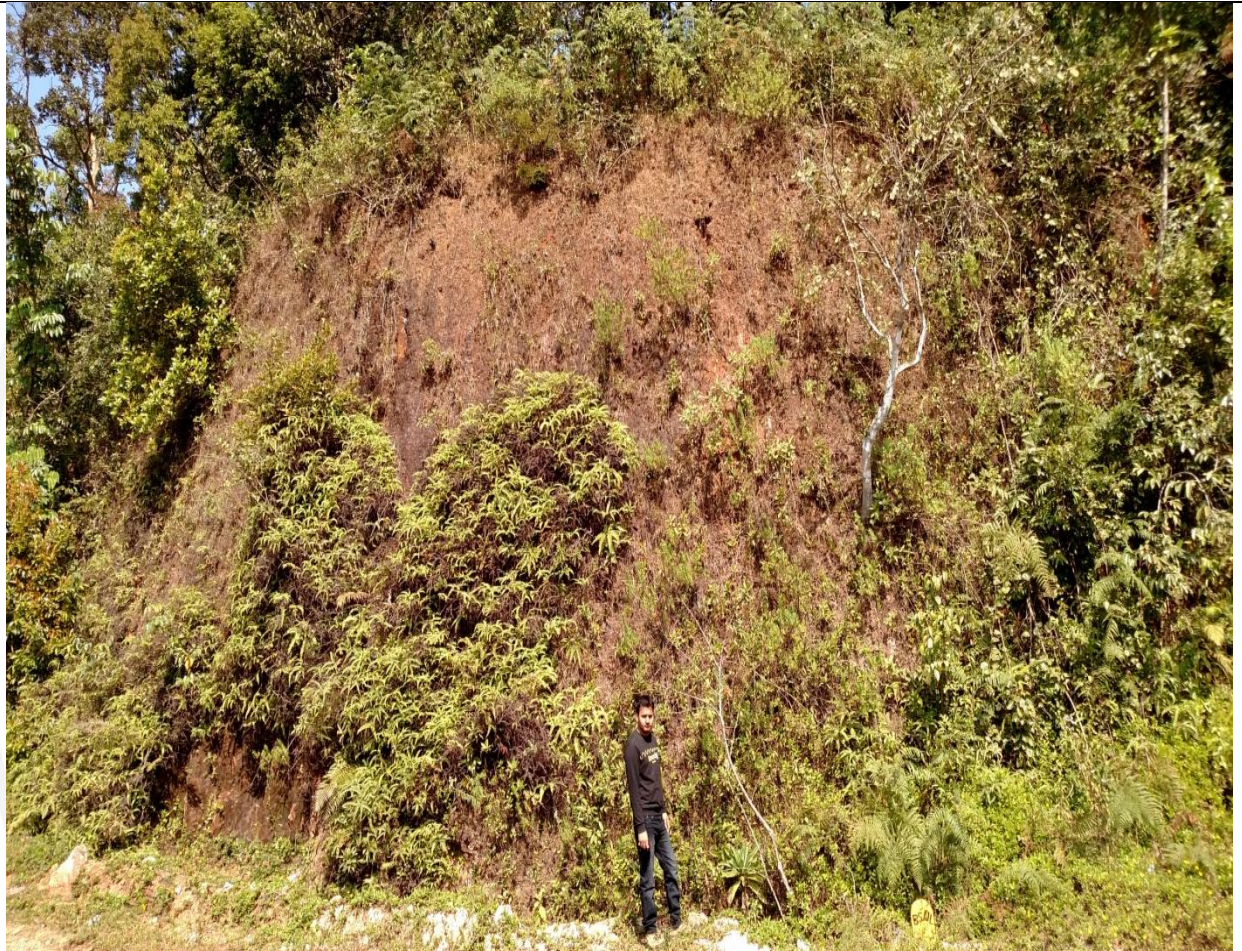
| 41. | Remarks/ Abstract | | In present condition landslide is active and unstable and risk factor is high and meta-stable, Risk to communication line, man and material. Old scars present |

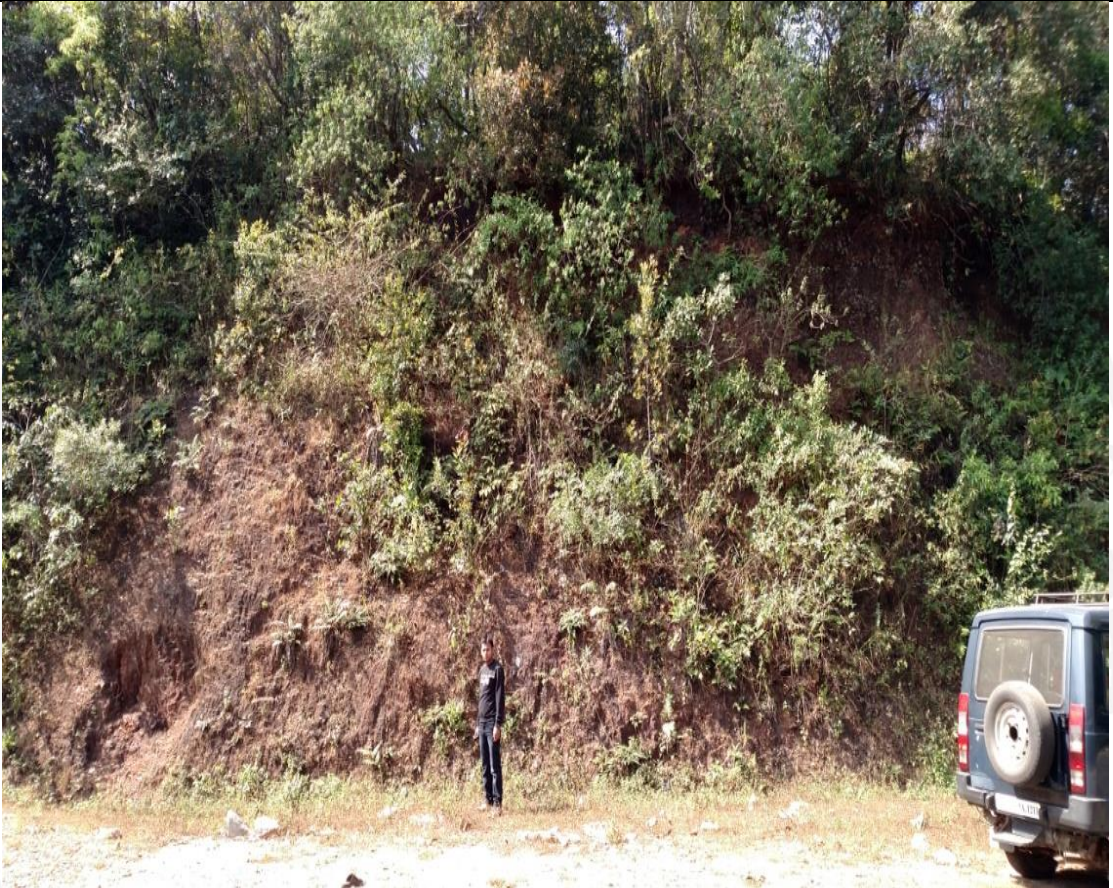
| 41. | Remarks/ Abstract | In present condition landslide is active and unstable and risk factor is high and meta-stable, Risk to communication line, man and material. Old scars present, vegetation on slope |

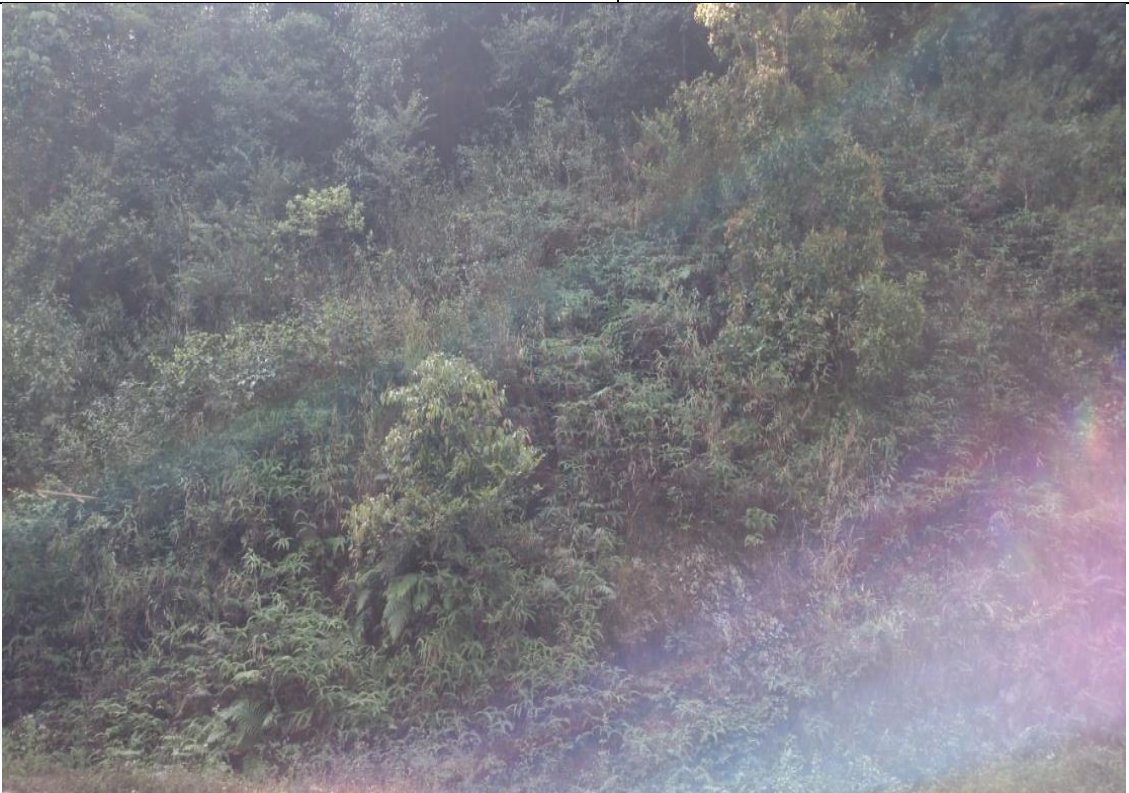
| 41. | Remarks/ Abstract | In present condition landslide is active and unstable and risk factor is high and meta-stable, Risk to communication line, man and material. Old scars present |

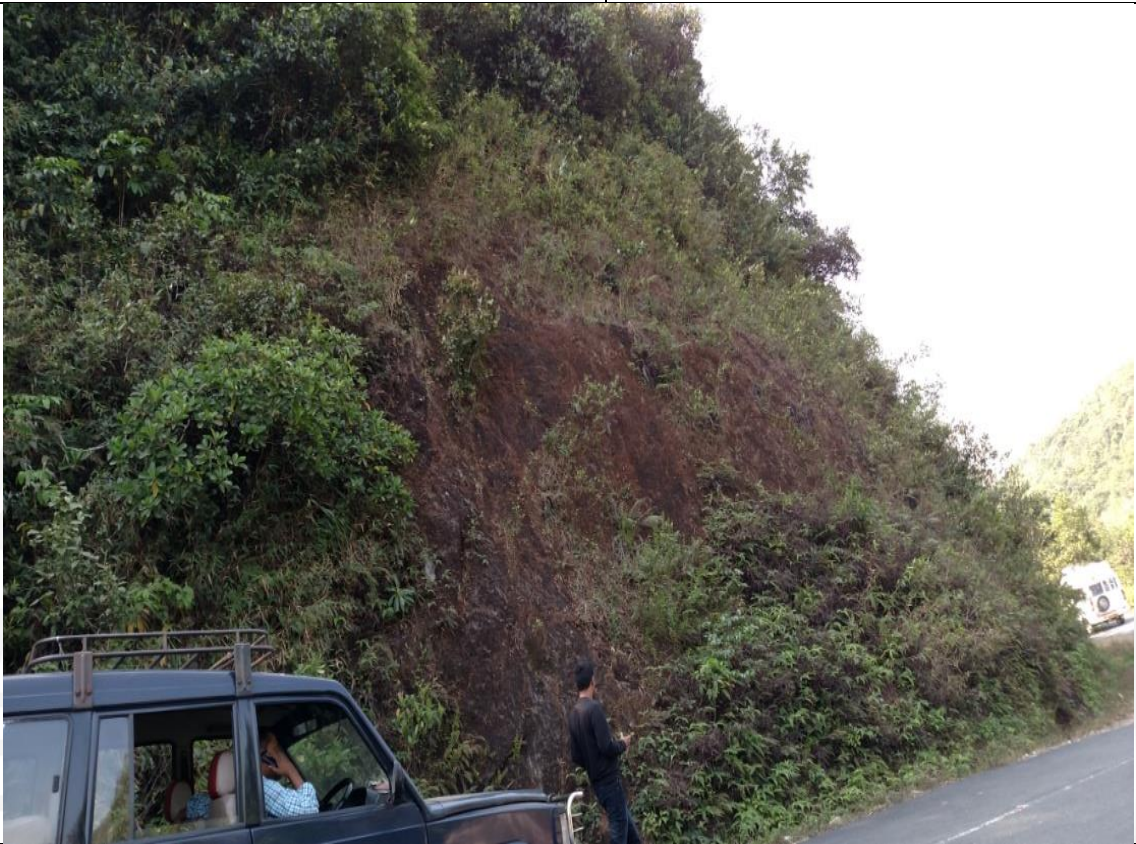
| 41. | Remarks/ Abstract | In present condition landslide is active and unstable and risk factor is high and meta-stable, Risk to communication line, man and material. Old scars present |

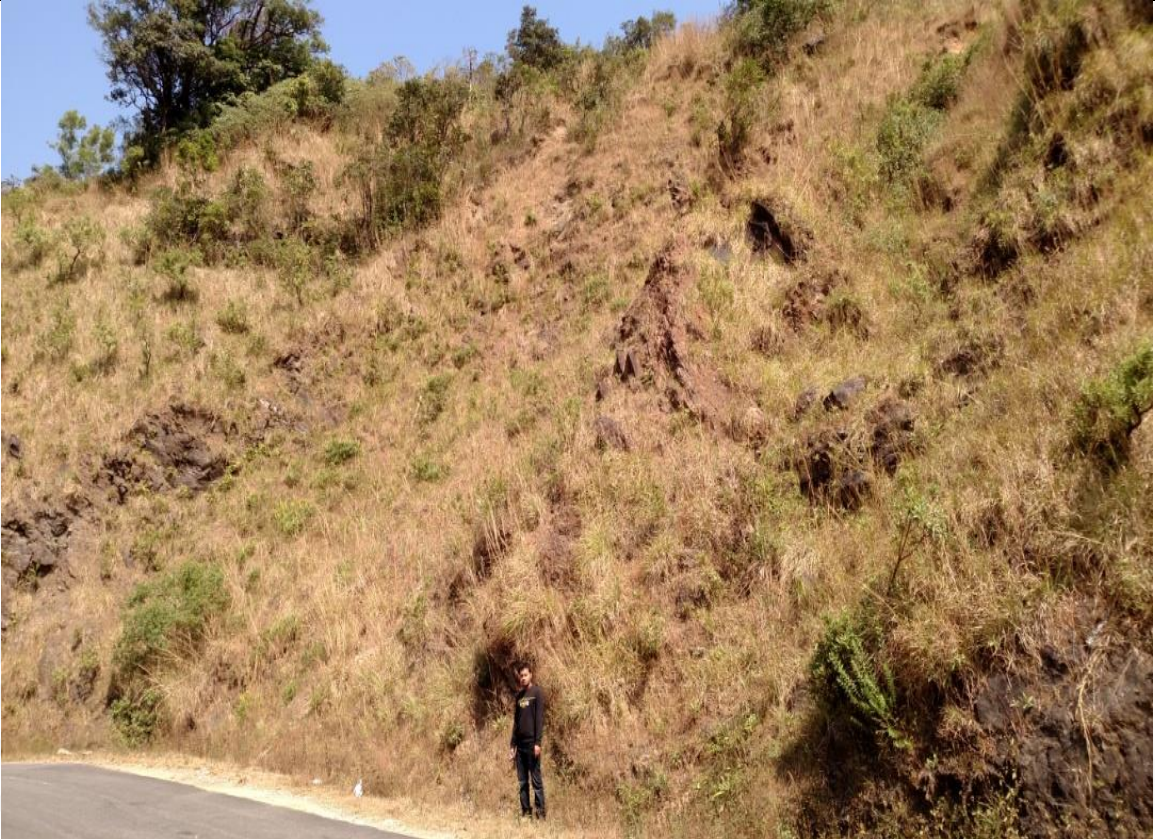
| 41. | Remarks/ Abstract | In present condition landslide is active and unstable and risk factor is high and meta-stable, Risk to communication line, man and material. Old scars present |

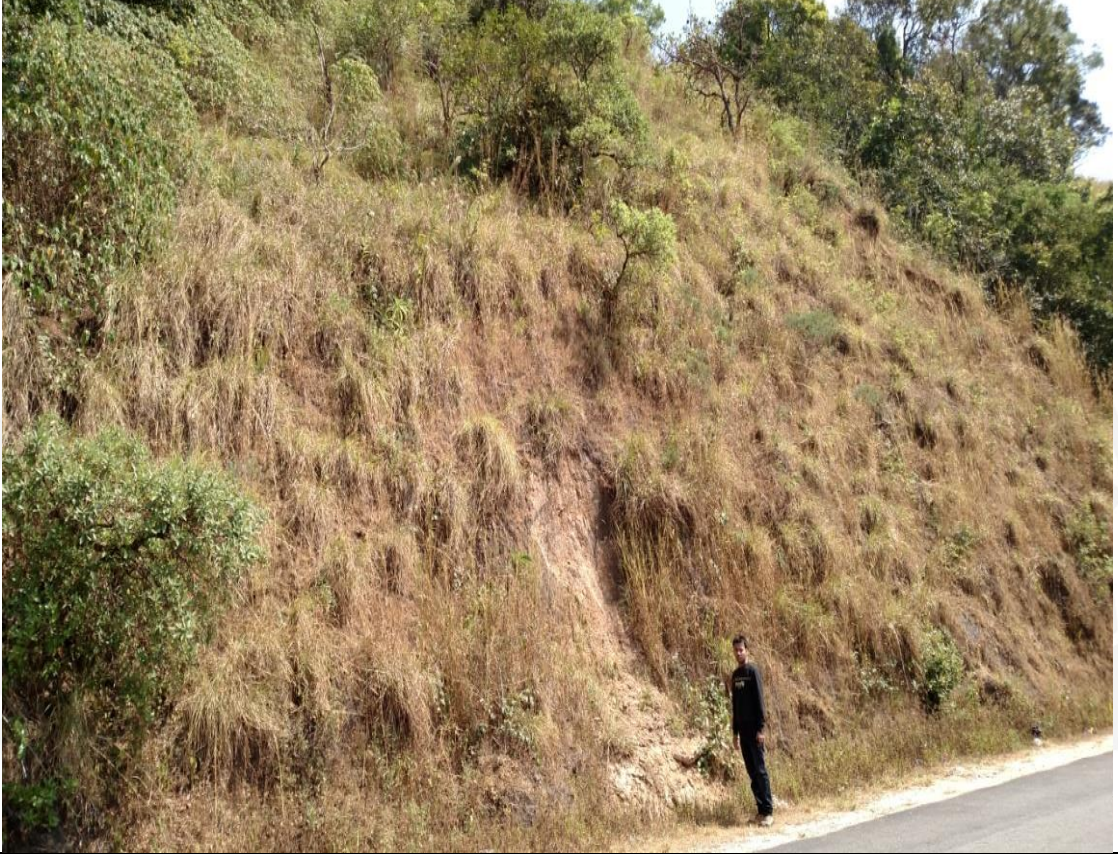
| 41. | Remarks/ Abstract | In present condition landslide is active and unstable and risk factor is high and meta-stable, Risk to communication line, man and material. Old scars present |

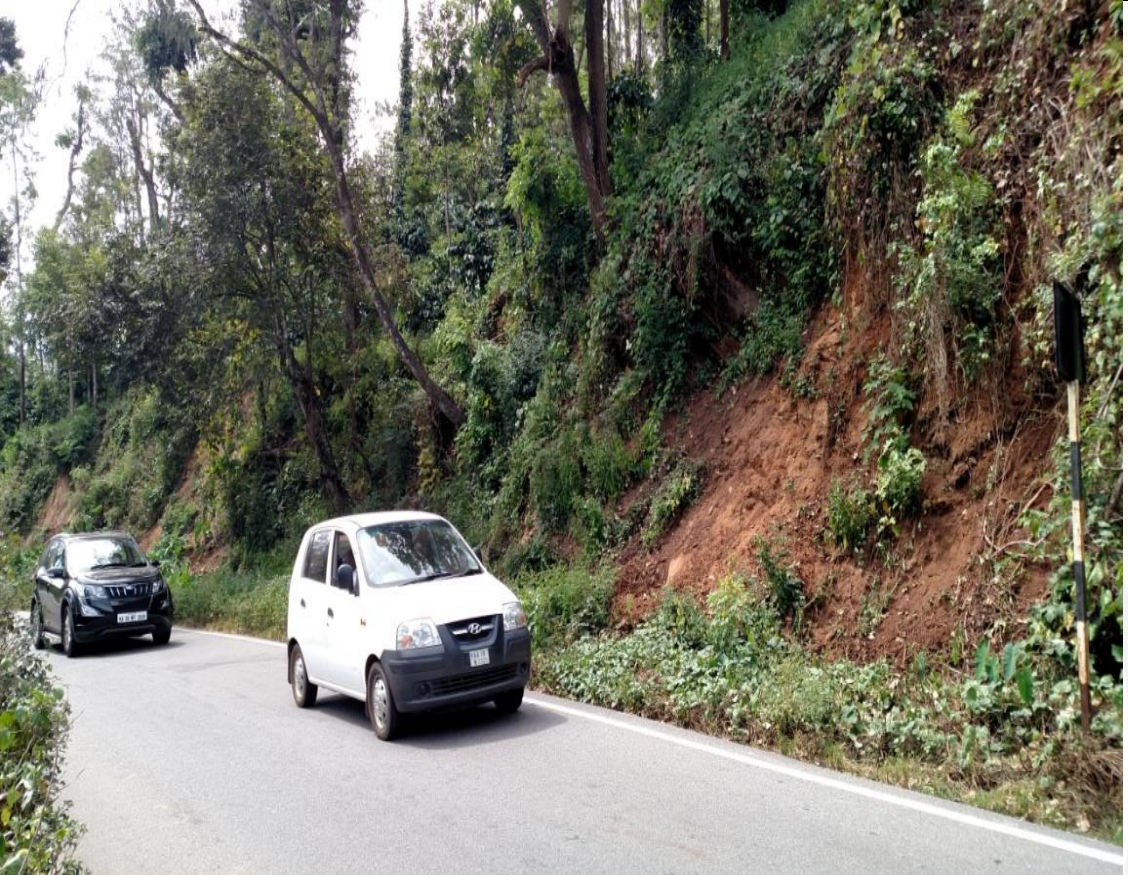
| 41. | Remarks/ Abstract | In present condition landslide is active and unstable and risk factor is high and meta-stable, Risk to communication line (Interuption), man and material. |

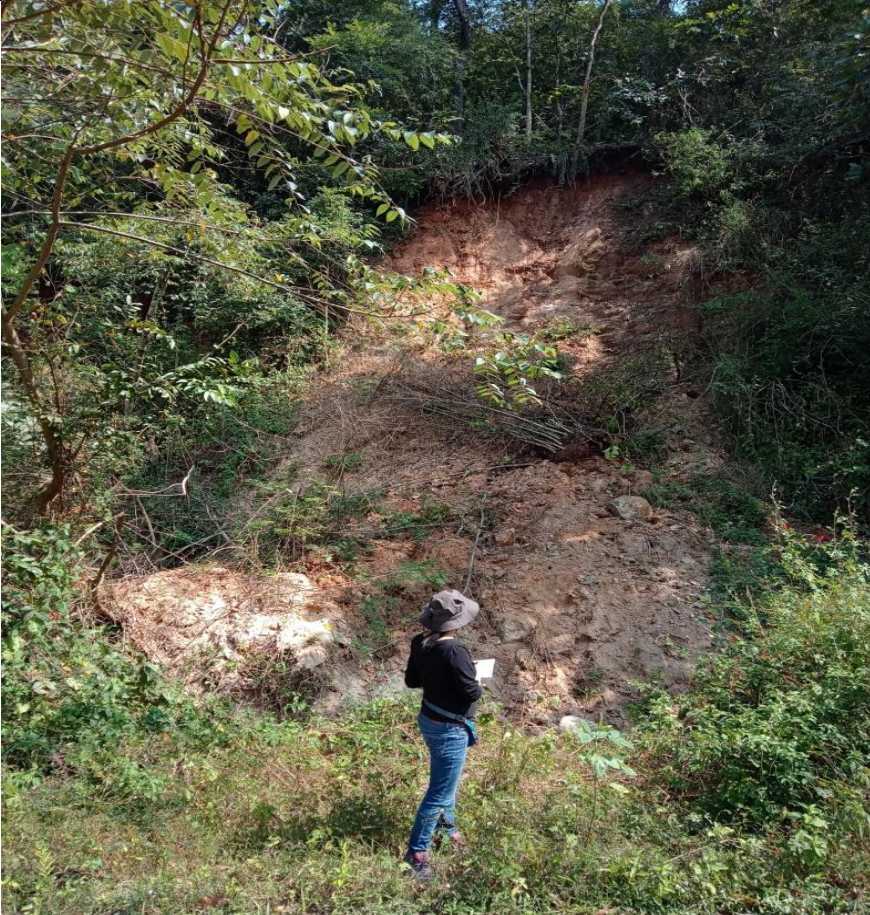
| 41. | | Remarks/ Abstract | In present condition landslide is active and unstable and risk factor is high and meta-stable, Risk to communication line (Interuption), man and material. |
