**Macro scale (1:50,000) Landslide Susceptibility Mapping in parts of  
Toposheets Nos. 48J/12 and 48J/16, Uttara Kannada  
and Shimoga Districts, Karnataka**

Item No.: M4LSSM/NC/SR/SU-KG/2018/20207

Final report for field season 2018-19

**K. Senthil Kumar, Geologist and Salu S, Senior Geologist (PT)**

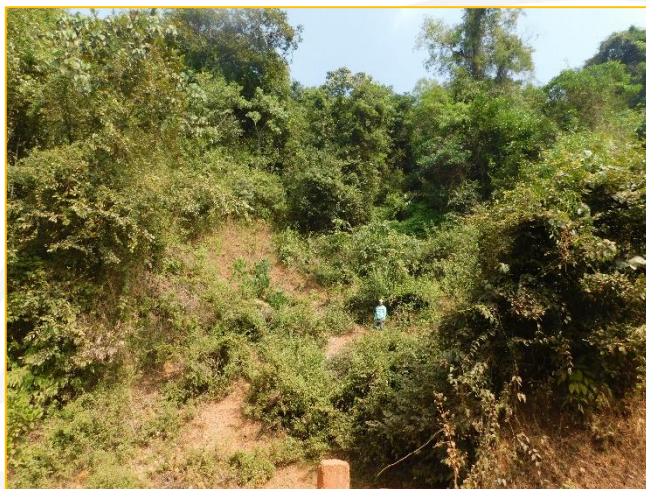
*Photo 3. 1, Old land slide observed near Magod village  
Lat: 14° 13' 34.2 Long: 74° 3' 1 51.6"*

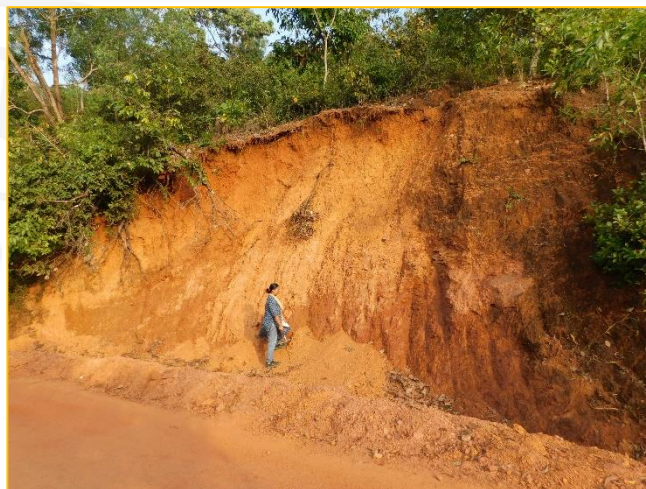
*Photo 3. 2a, Slope cut failure near Kodani village  
Lat: 14° 13' 53.24" Long: 74° 34' 1.88"*

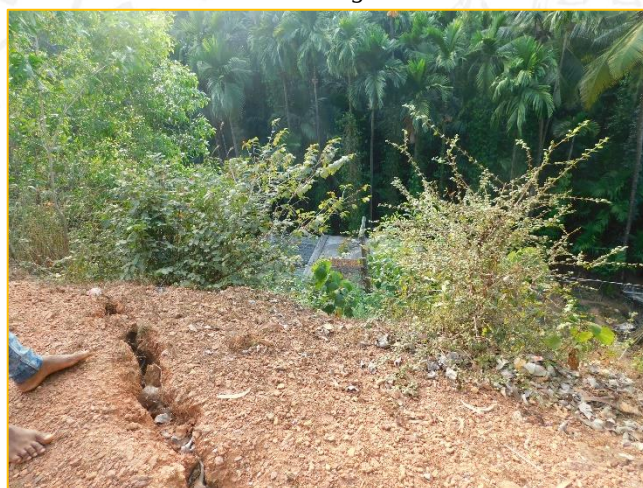
*Photo 3. 3b, Slope cut failure near Kodani village-  
Ground cracks Lat: 14° 1'3 53.24" Long: 74 34' 1.88"*

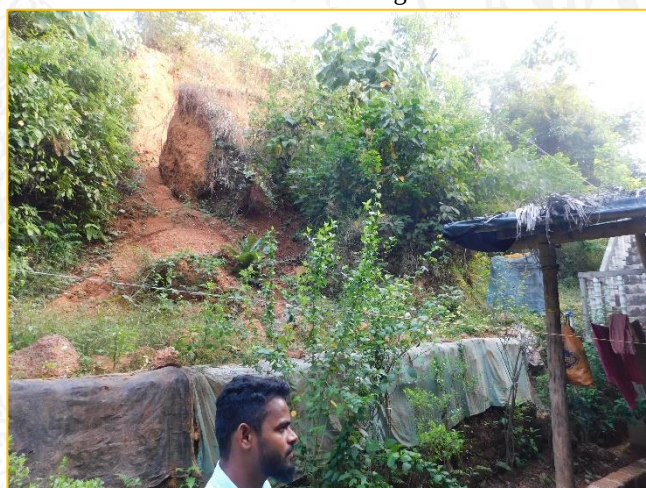
*Photo 3. 4c, Slope cut failure near Kodani village- Loose  
debris on the slope Lat: 14° 13' 53.24" Long: 74 34' 1.88"*

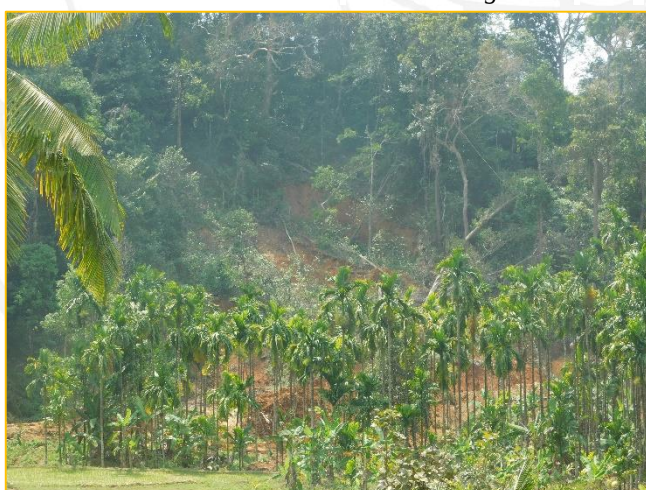
between the 0-35°. Most of the slides (photo no: 3.3a, 3.3b, 3.3c, 3.3d) are soil slide and larger in dimension when compared to the road cut failure and it exhibits maximum regolith thickness in the scarp faces and both flank of the slide.

*Photo 3. 3a, Soil slide  
Lat: 14°13' 9.88 "Long: 74° 49 50.71"*

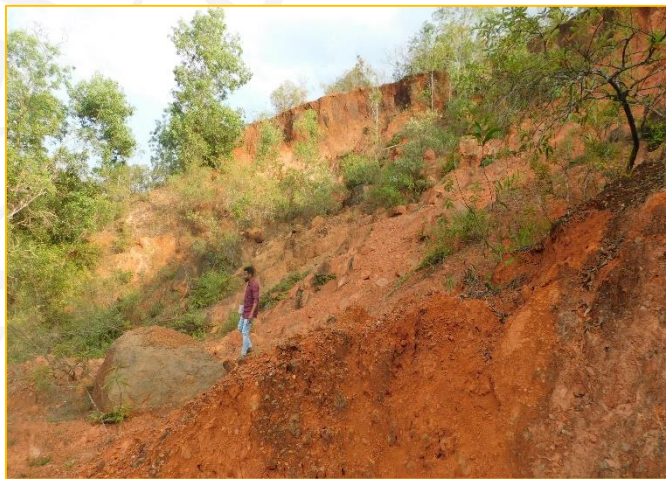
*Photo 4.k, Loose slide debris*

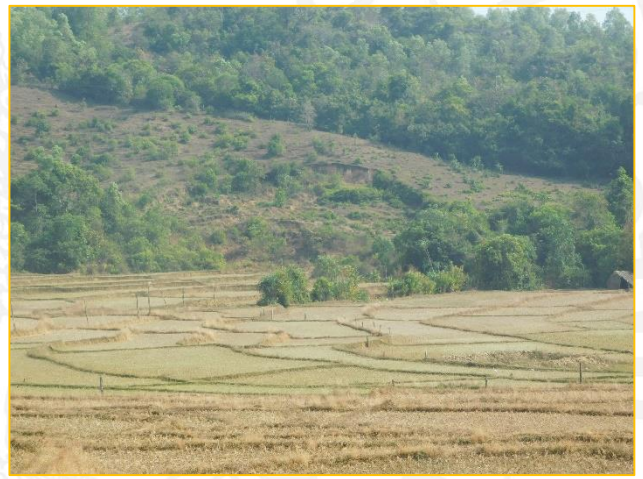
*Photo 4.l, Transported soil*
