**Macro-scale (1:50,000) Landslide Susceptibility Mapping in parts of Toposheets nos. 48I/05, 48I/06, & 48I/07 Belgaum, Uttar Kannada districts, Karnataka and North Goa & South Goa districts, Goa.**

टोपोशीट सं./ Toposheet No.: 48I/05, 48I/06, 48I/07  
मद संख्या: M4LSSM/एनसी/एस आर/SU-KG/2018/18717  
Item no.: M4LSSM/NC/SR/SU-KG/2018/18717

**कार्य सत्र 2018-19 का अंतिम प्रतिवेदन**  
**Final report for field season 2018-19**

**नेहा कुमारी, भू-वैज्ञानिक एवं कमल कुमार, भू-वैज्ञानिक**  
**Neha Kumari, Geologist And Kamal Kumar, Geologist**

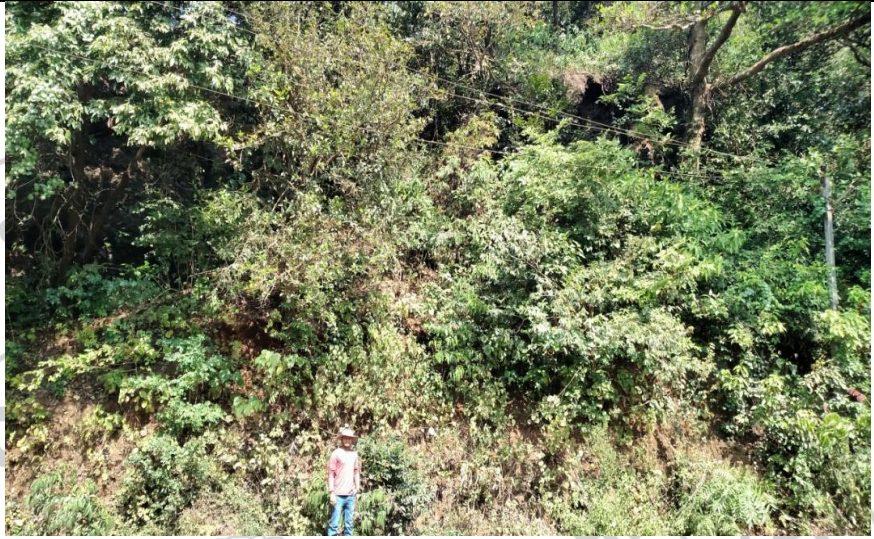
| 40 | Summary/Abstract | : | The debris slide occurred on lowly dissected hill slope on vertical cut slope. The slide is old and can get reactivated during monsoon. At present the area is meta-stable. |

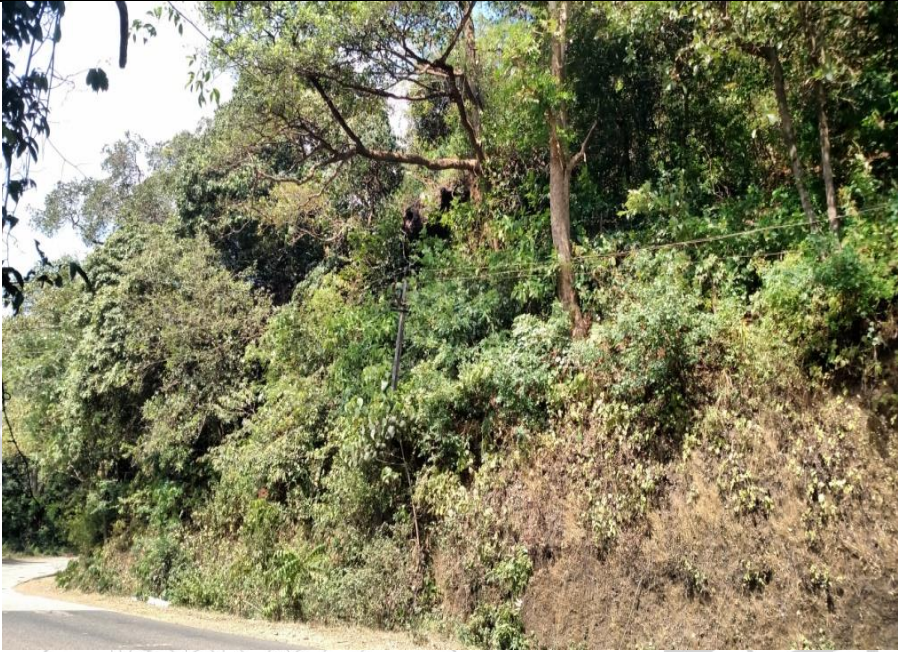
| 40 | Summary/Abstract | : | The debris slide occurred on lowly dissected hill slope on vertical cut slope. The slide is old and can get reactivated during monsoon. At present the area is meta-stable. |

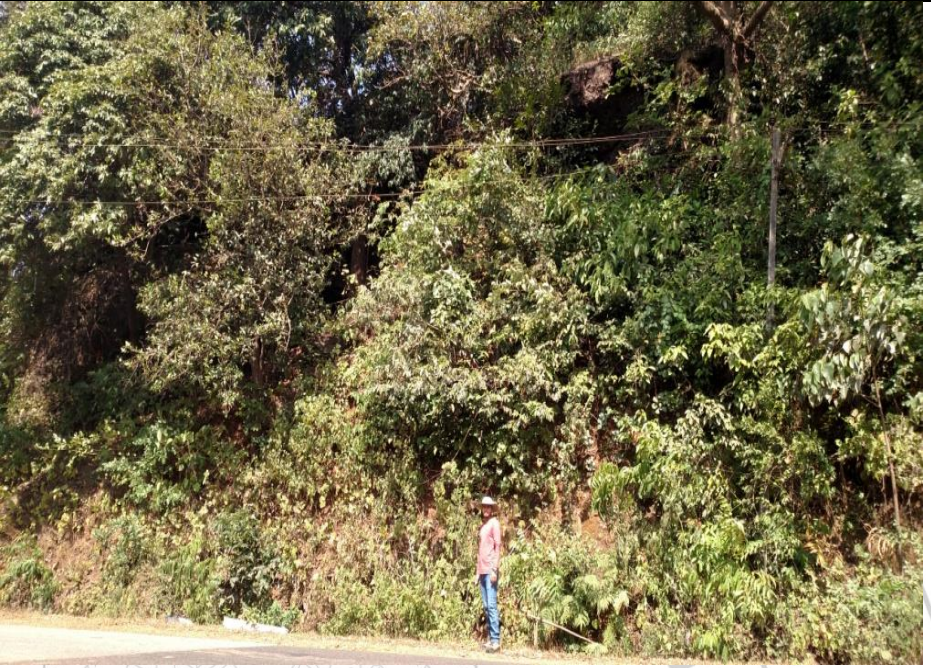
| 40 | Summary/Abstract | : | The debris slide occurred on lowly dissected hill slope on vertical cut slope. The slide is old and can get reactivated during monsoon. At present the area is meta-stable. |

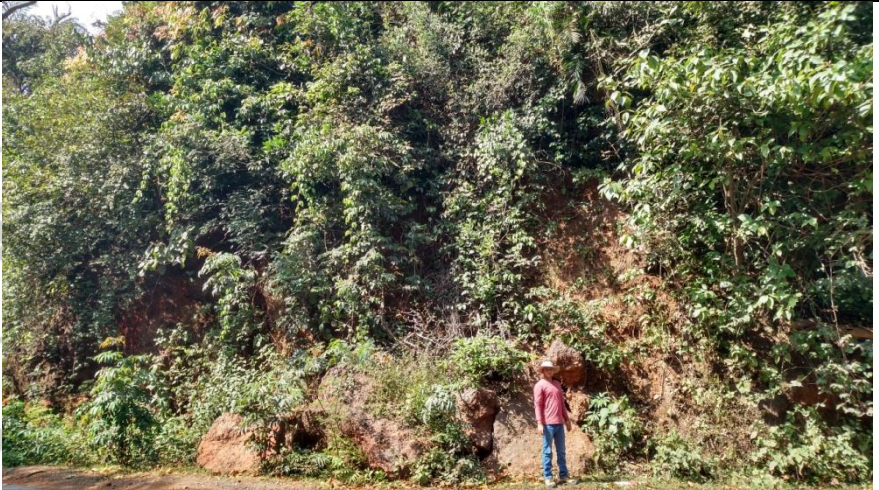
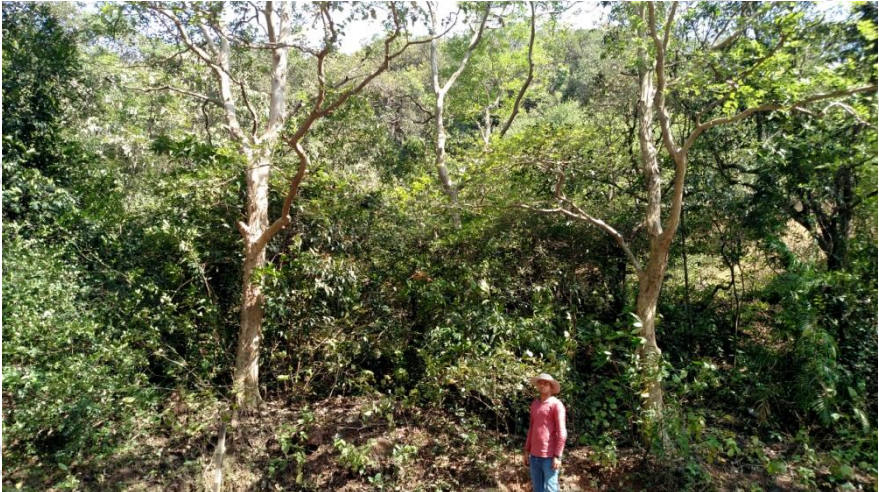
| 40 | Summary/Abstract | : | The slide is rock cum debris slide occurred on lowly dissected hill slope. At present the sliding zone is meta-stable and covered with dense vegetation. |

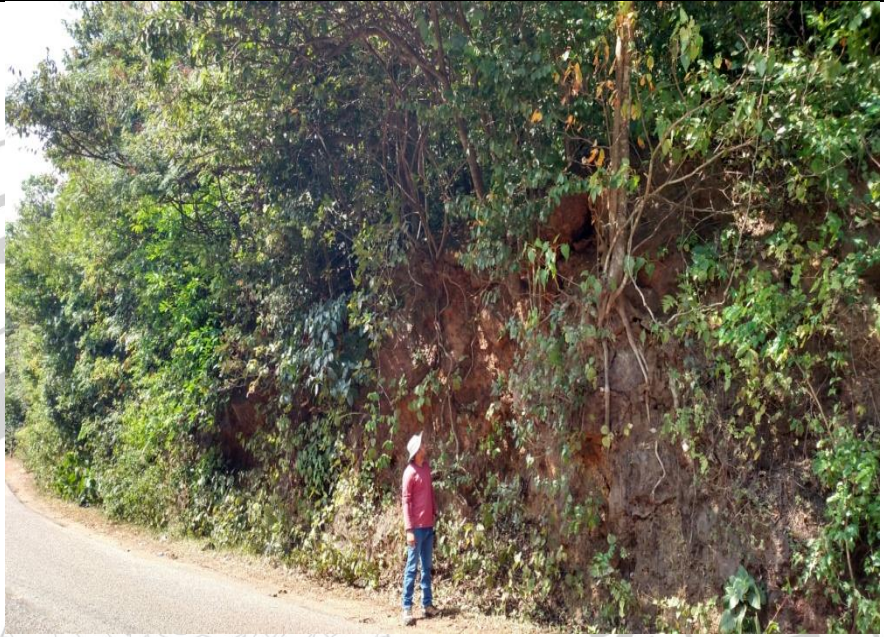
| 40 | Summary/Abstract | : | The debris slide occurred on lowly dissected hill slope on vertical cut slope. The slide is old and can get reactivated during monsoon. At present the area is meta-stable. |

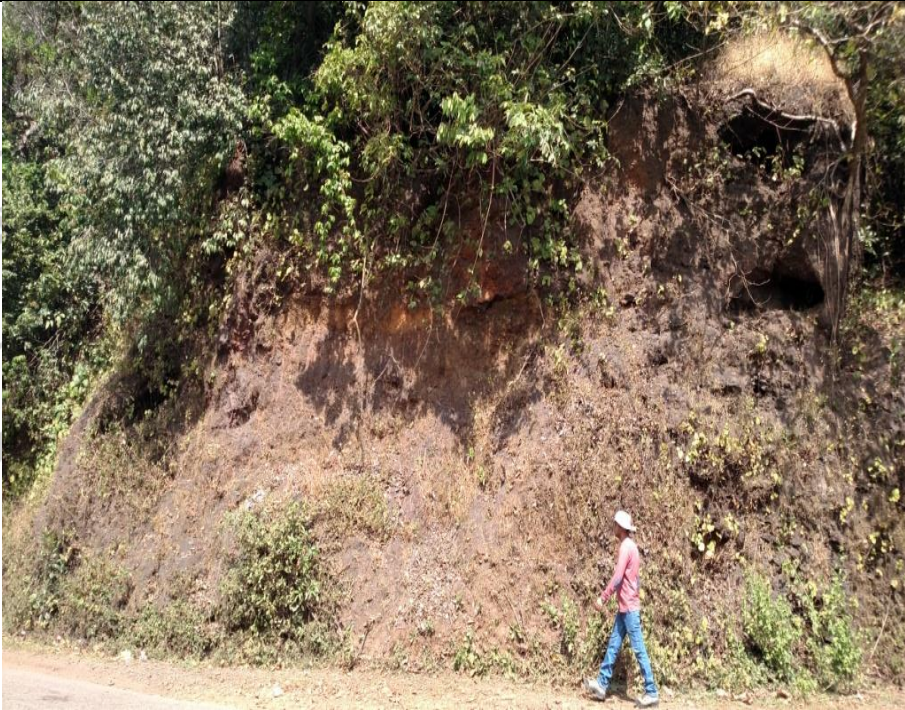
| 40 | Summary/Abstract | : | The debris slide occurred on lowly dissected hill slope on vertical cut slope. The slide is old and can get reactivated during monsoon. At present the area is meta-stable. |

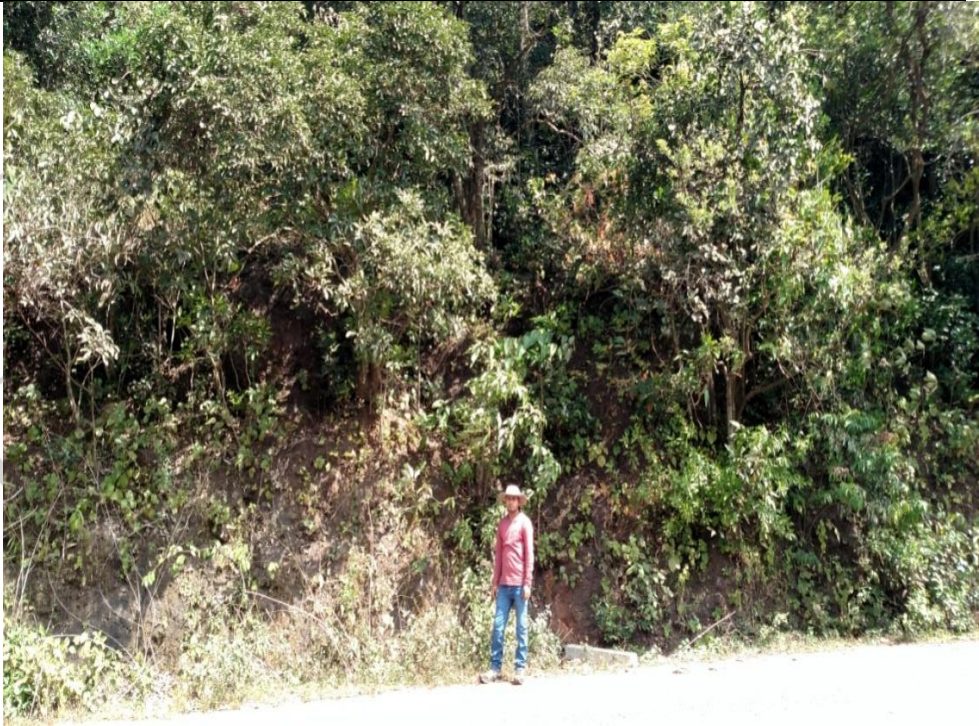
| 40 | Summary/Abstract | : | The debris slide occurred on lowly dissected hill slope on vertical cut slope. The slide is old and can get reactivated during monsoon. At present the area is meta-stable. |

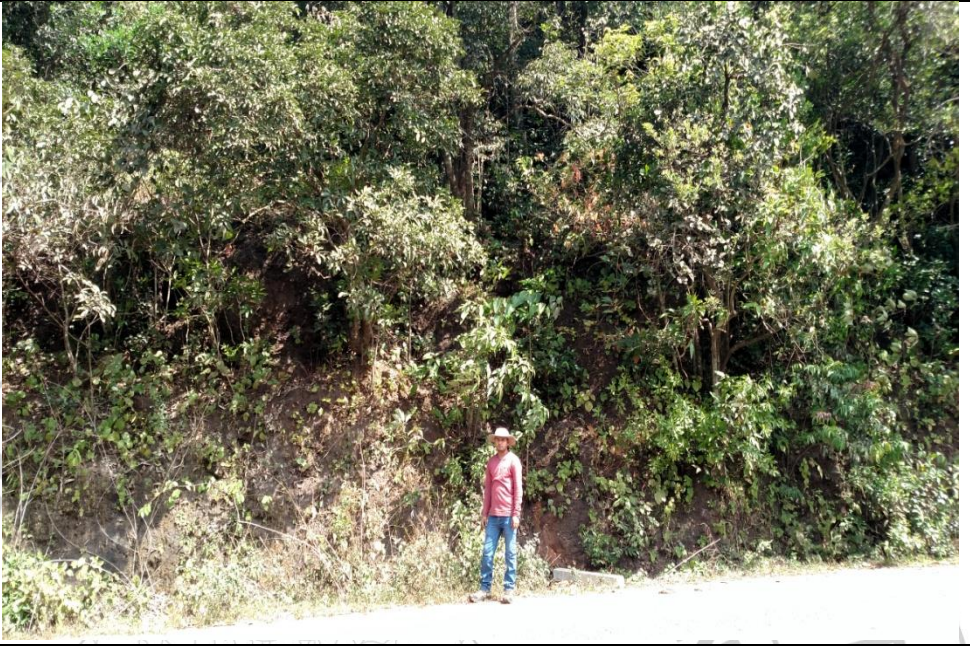
| 40 | Summary/Abstract | : | The slide is rock cum debris slide occurred on lowly dissected hill slope. At present the sliding zone is meta-stable and covered with dense vegetation. The area has undergone pronounced weathering and erosion. |

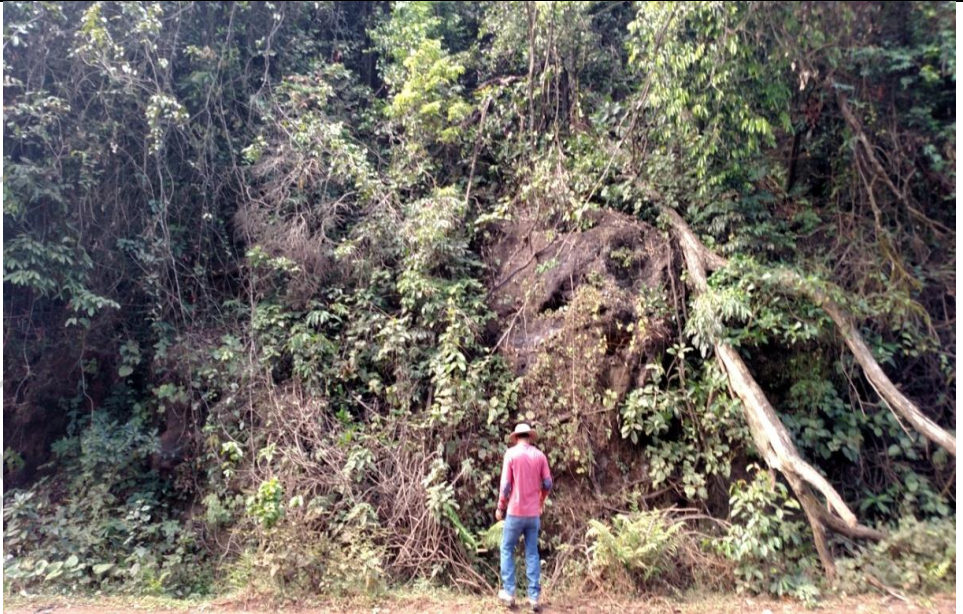
| 40 | Summary/Abstract | : | The rock slide occurred on the lowly dissected hill slope on ghat road section. The rock slide occurred due to intense weathering due to water seepage and saturation along the fracture and joints. The vertical cut slope failure is more intense during heavy rainfall. |

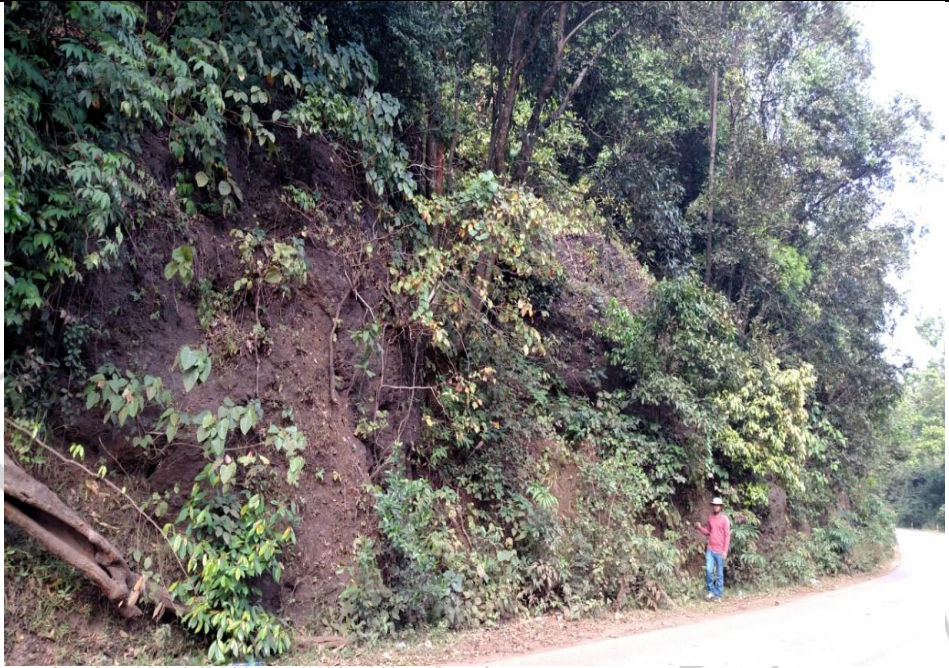
| 40 | Summary/Abstract | : | The debris slide occurred on lowly dissected hill slope on vertical cut slope. The slide is old and can get reactivated during monsoon. At present the area is stable. |

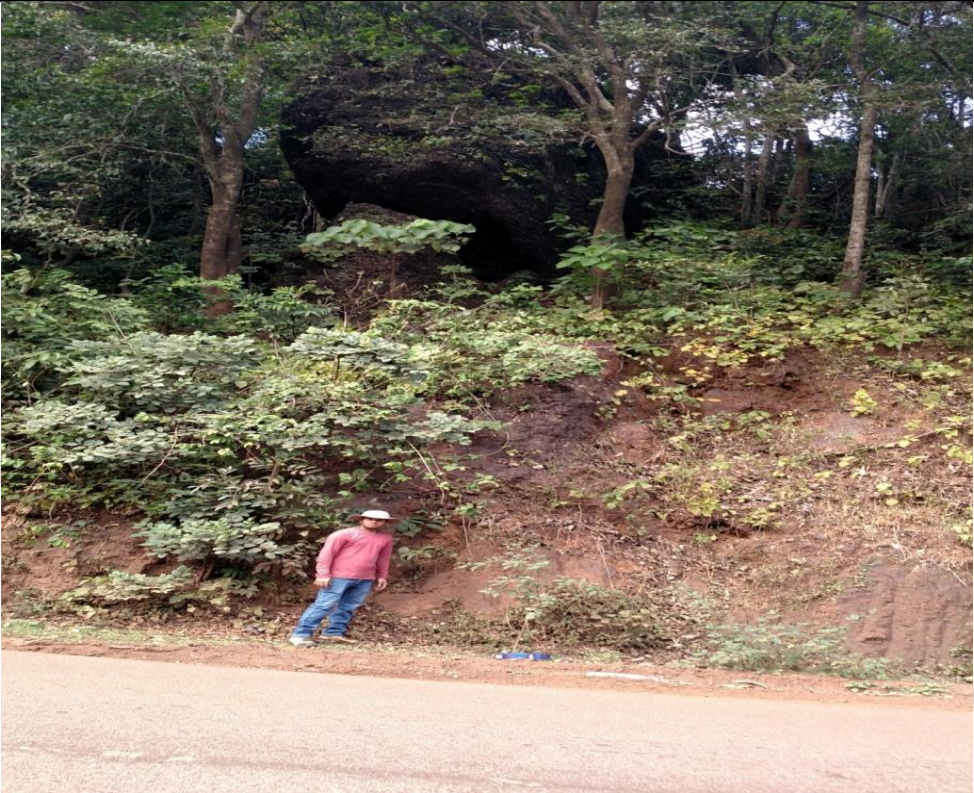
| 40 | Summary/Abstract | : | The debris slide occurred on lowly dissected hill slope on vertical cut slope. The slide is old and can get reactivated during monsoon. At present the area is stable. |

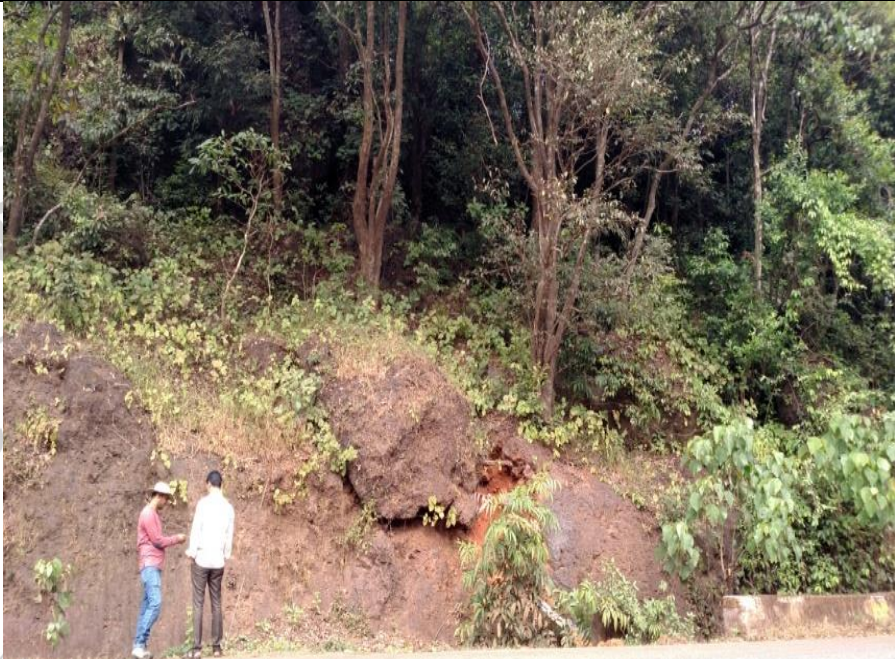
| 40 | Summary/Abstract | : | The debris slide occurred on lowly dissected hill slope on vertical cut slope. The slide is old and can get reactivated during monsoon. At present the area is stable. |

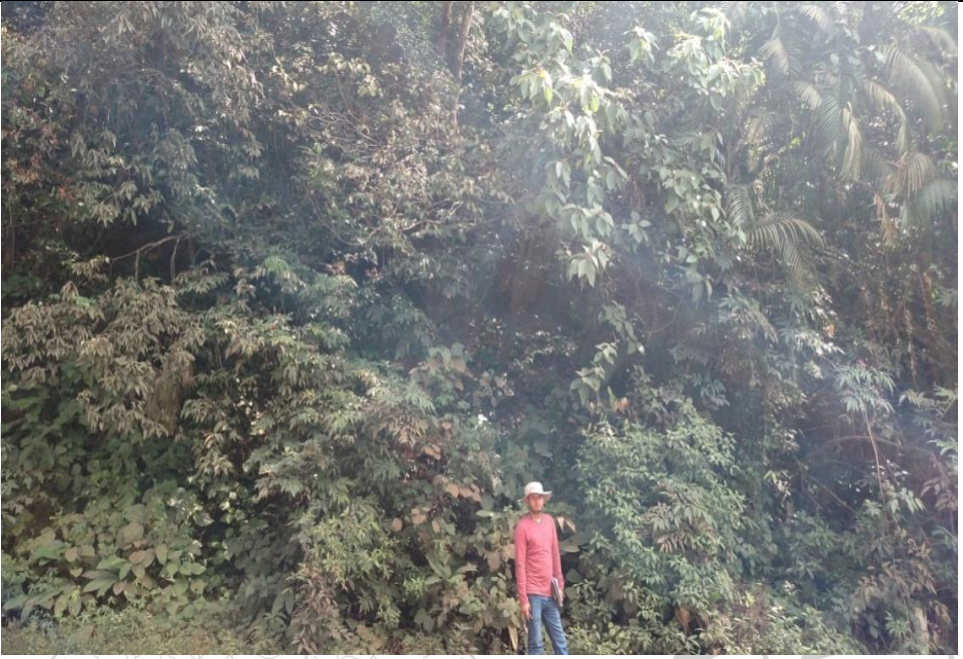
| 40 | Summary/Abstract | : | The debris slide occurred on lowly dissected hill slope on vertical cut slope. The slide is old and can get reactivated during monsoon. At present the area is stable. |

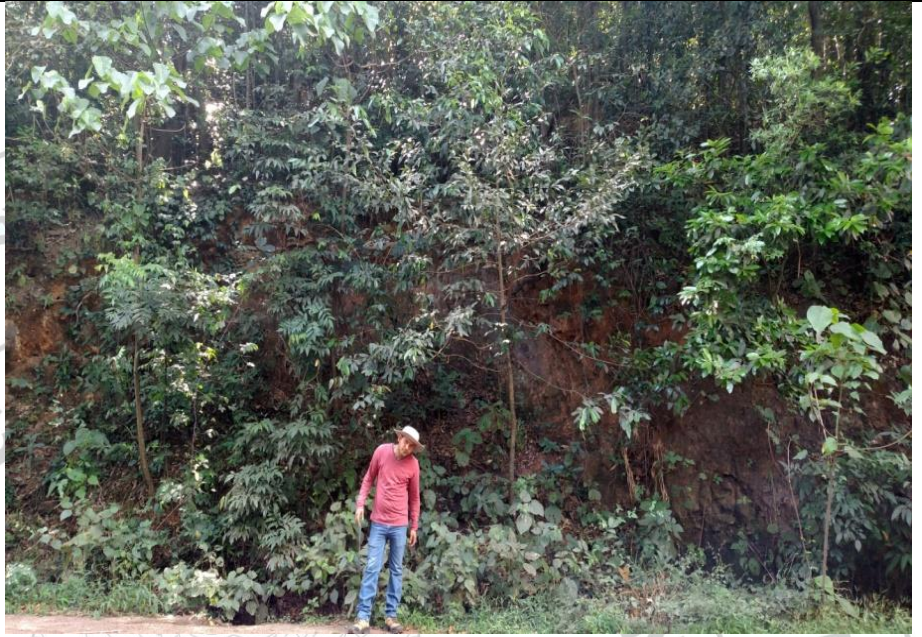
| 40 | Summary/Abstract | : | The debris cum rock slide occurred on lowly dissected hill slope on vertical cut slope. |

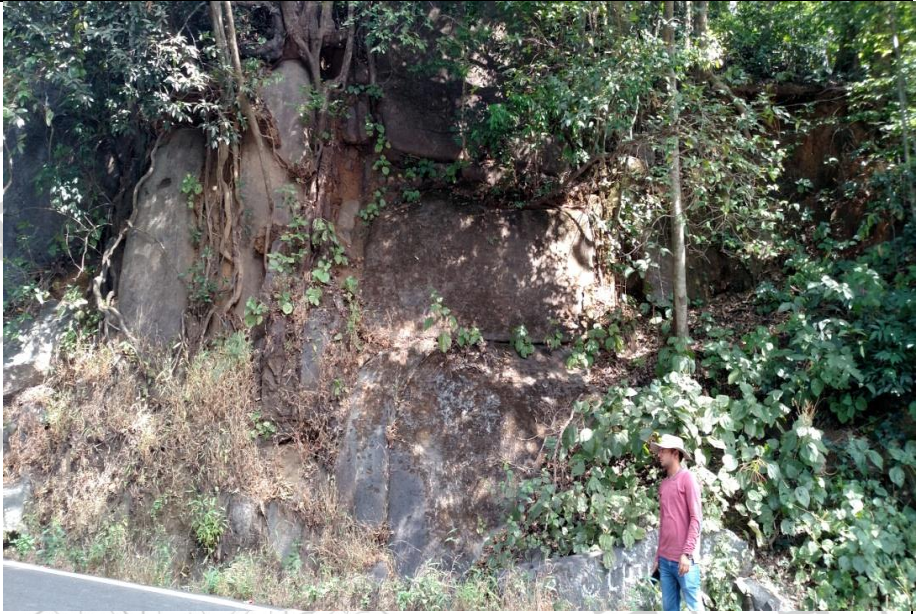
| 40 | Summary/Abstract | : | The debris cum rock slide occurred on the lowly dissected hill slope on ghat road section. The rock slide occurred due to intense weathering due to water seepage and saturation along the fracture and joints. The vertical cut slope failure is more intense during heavy rainfall. Vertical cut slope failure along the fractured and jointed rock. |

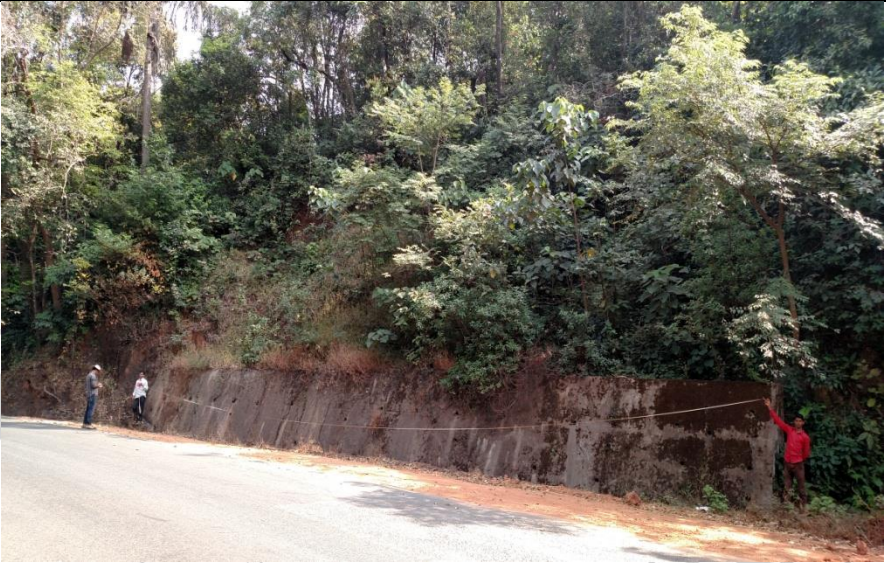
| 40 | Summary/Abstract | : | The debris slide is identified as shallow translational failure occurred on concave curve of highly dissected hillslope of ghat road (NH-4A). The upslope direction indicates the slide is progressive in nature and sliding surface is stabilized by providing proper drainage and toe support. |

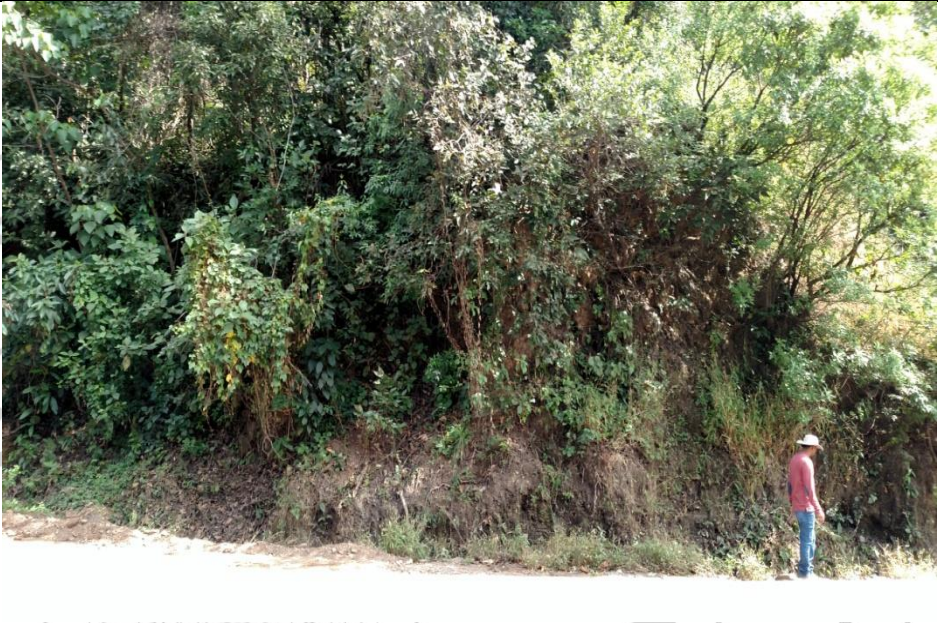
| 40 | Summary/Abstract | : | The debris slide occurred on the lowly dissected hill slope on ghat road section. The rock slide occurred due to intense weathering due to water seepage and saturation along the fracture and joints. The vertical cut slope failure is more intense during heavy rainfall. |

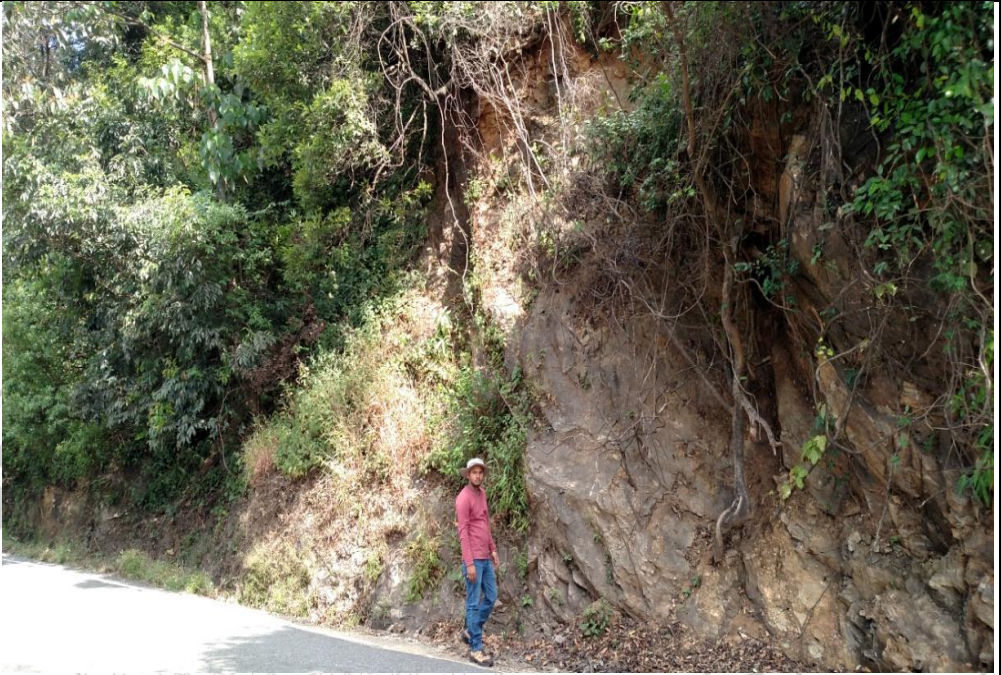
| 40 | Summary/Abstract | : | The rock slide occurred on the lowly dissected hill slope on ghat road section. The rock slide occurred due to intense weathering due to water seepage and saturation along the fracture and joints. The vertical cut slope failure is more intense during heavy rainfall. |

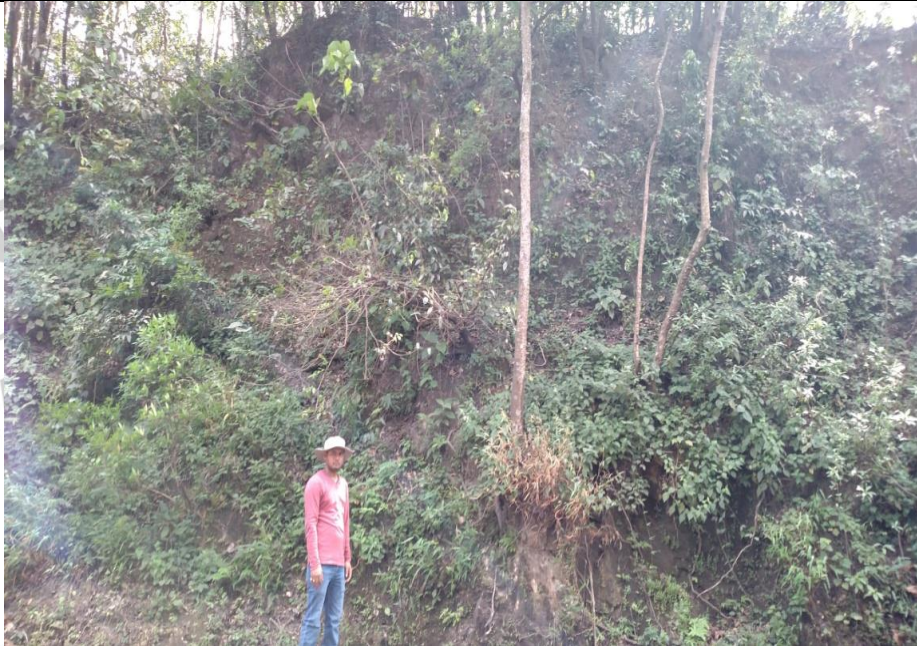
| 40 | Summary/Abstract | : | The rock cum debris slide occurred on lowly dissected hillslope that has weathered. The slide is retrogressive in nature and the chances of landslips are more during heavy rainfall. |

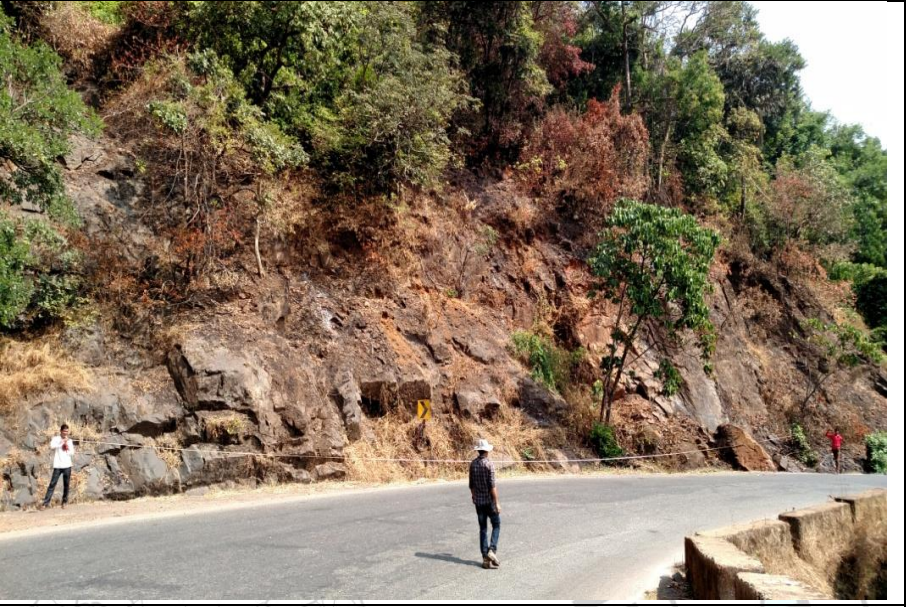
| 40 | Summary/Abstract | : | The sliding zone is adjacent to the 1 <sup>st</sup> order stream. So, water seepage and saturation along the weaker plane along joints and fracture may lead to sliding of material. |

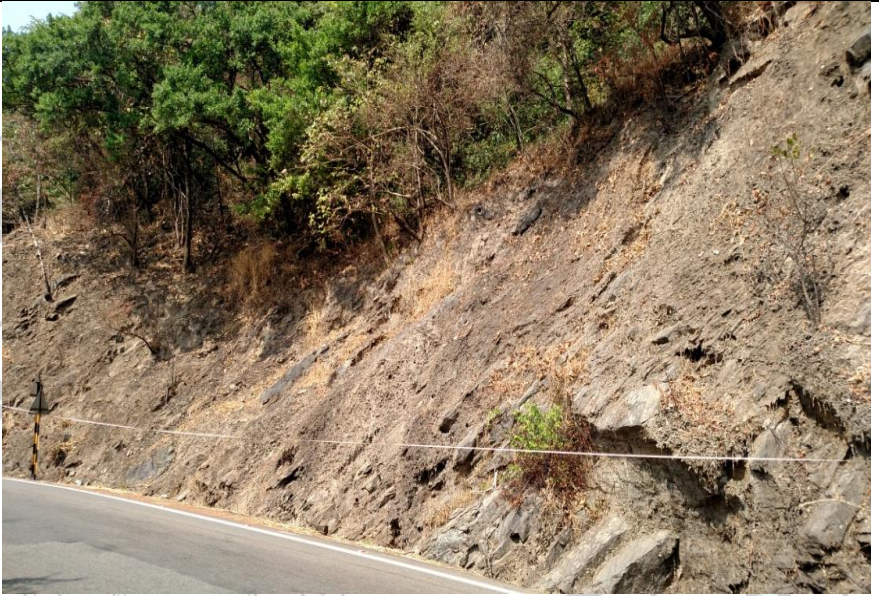
| 40 | Summary/Abstract | : | The sliding zone is adjacent to the 1 <sup>st</sup> order stream. So, water seepage and saturation along the weaker plane along joints and fracture may lead to sliding of material/planar failure. |

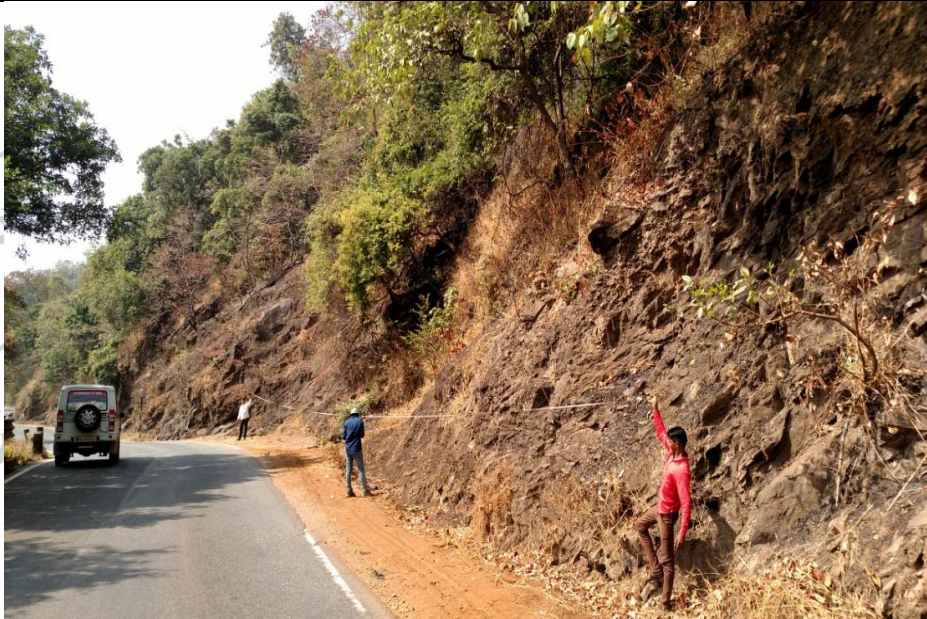
| 40 | Summary/Abstract | : | The risk factor is high in this zone. The slope forming material is likely to slide during intense rainfall. |

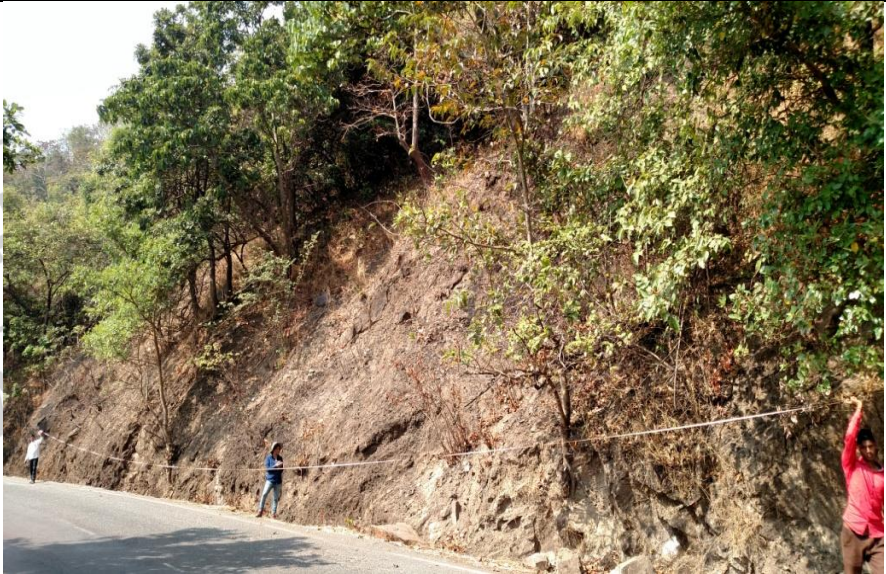
| 40 | Summary/Abstract | : | The rock cum debris slide occurred along the road cut slope. The weathered rock on slope is likely to failure during the heavy rainfall due to reduction in cohesive strength of the slope forming material due to over saturation of slope. |

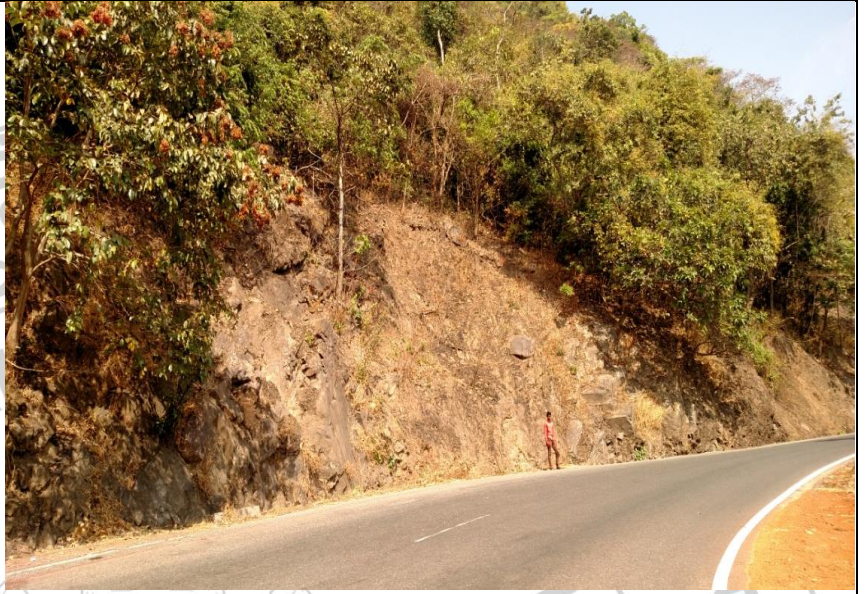
| 40 | Summary/Abstract | : | The shallow translational rock cum debris slide occurred on the road cut that paved the new pathway for water seepage and saturation during heavy rainfall. |

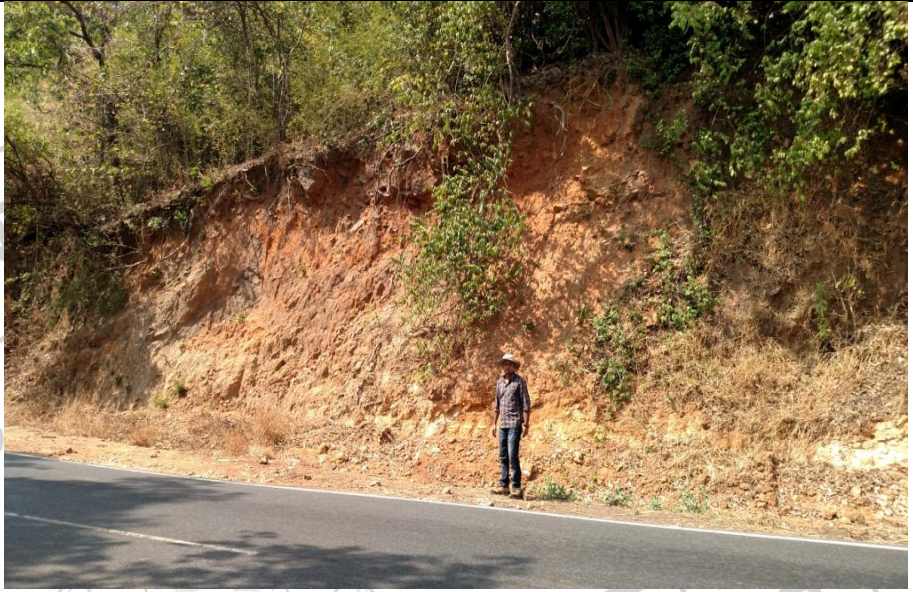
| 40 | Summary/Abstract | : | The shallow translational debris slide occurred on the road cut that paved the new pathway for water seepage and saturation during heavy rainfall. |

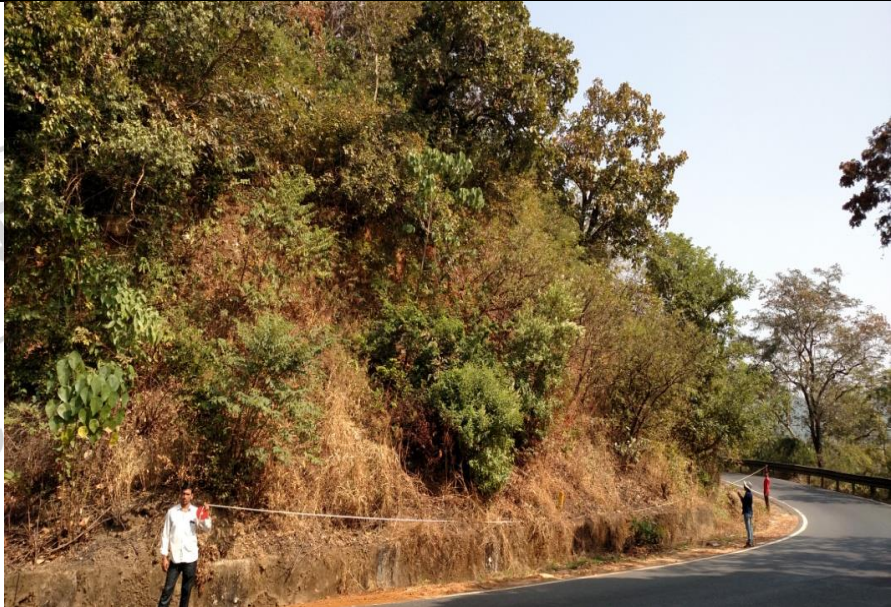
| 40 | Summary/Abstract | : | The shallow translational debris slide occurred on the road cut that paved the new pathway for water seepage and saturation during heavy rainfall. |

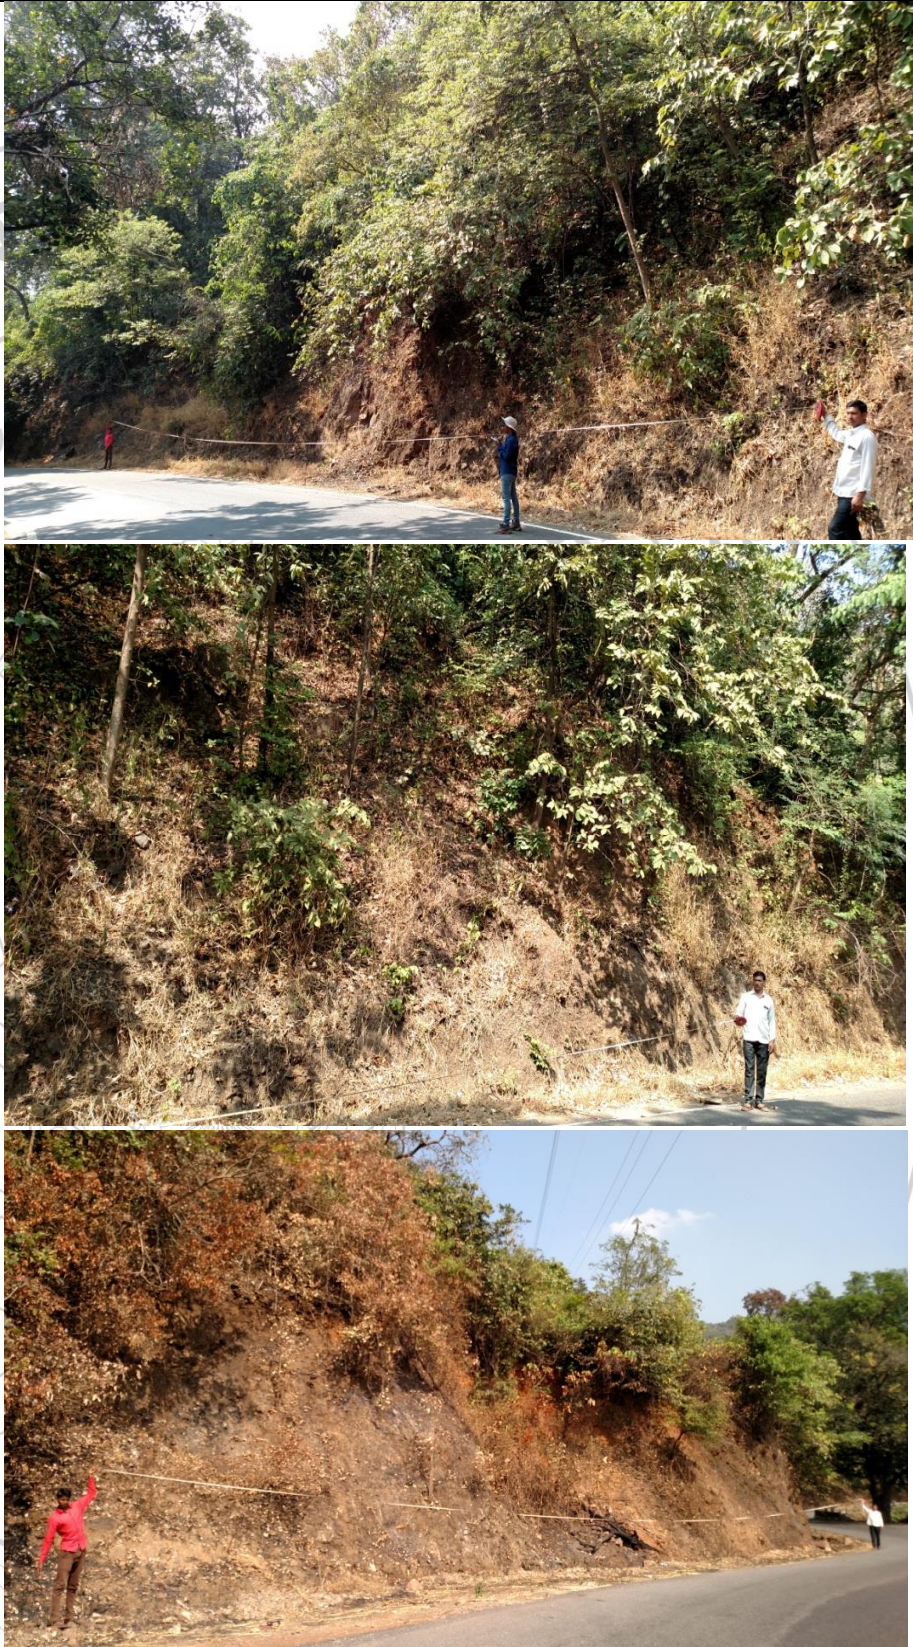
| 40 | Summary/Abstract | : | The shallow translational debris slide occurred on the vertical road cut that can damage the communication line. |

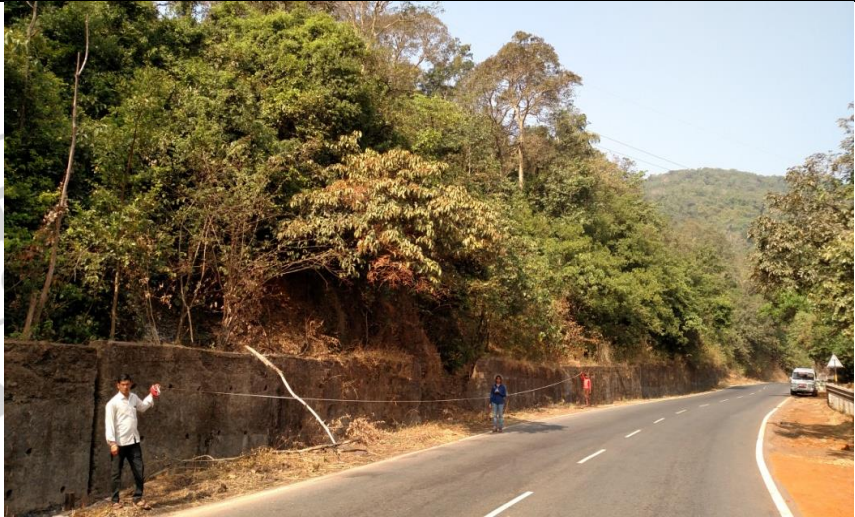
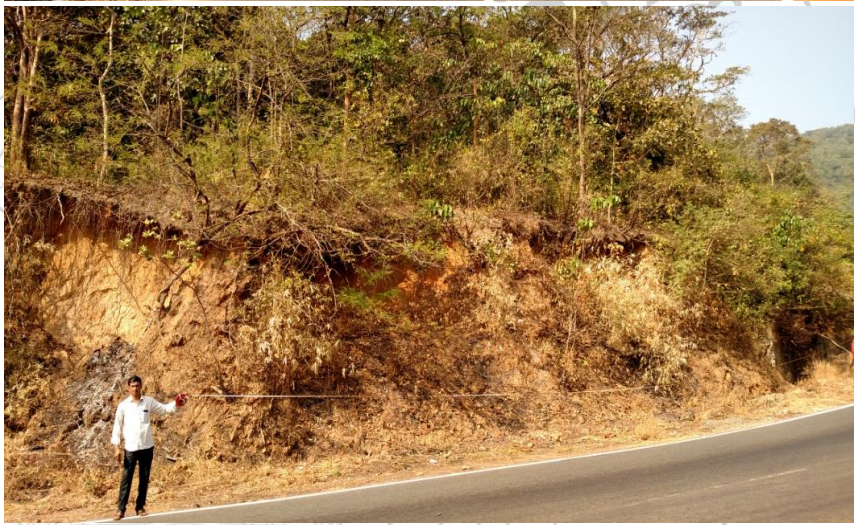
| 40 | Summary/Abstract | : | Multiple shallow debris slides occurred on highly dissected hill slope along NH-4A. The landslide is old, suspended and retrogressive in nature. The sliding material is in-situ soil (lateritic soil) and weathered rock covered with vegetation. The slide occurred on extensive cut slope made for road construction which got failed due to over water saturation of slope. The 2.5m high retaining wall with weep holes extending upto ~72m is constructed for providing toe support. The enlarging and widening disturbed zone indicated by debris slump in extension to present disturbed zone. So, the existing retaining wall should be extended upto the slumps. |

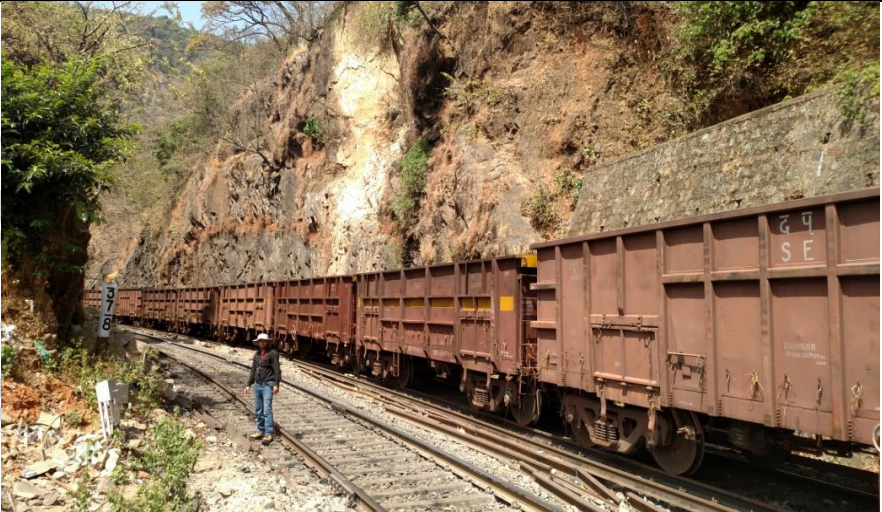
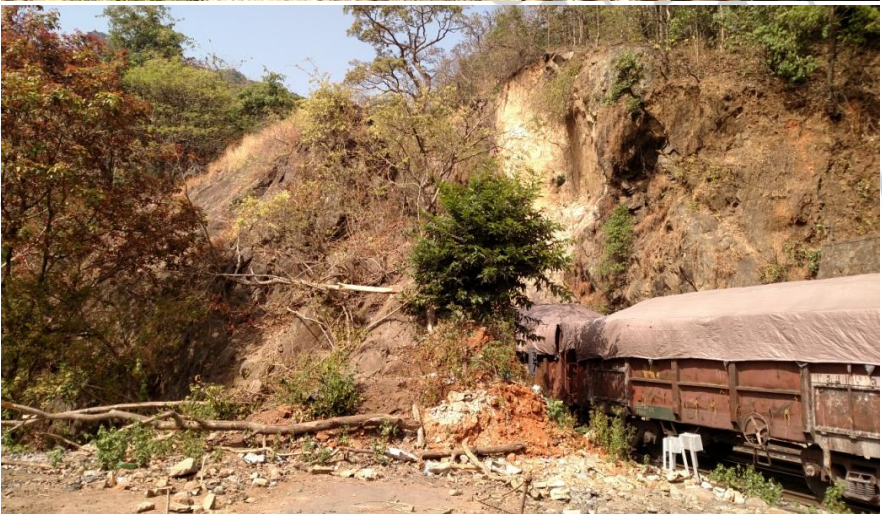
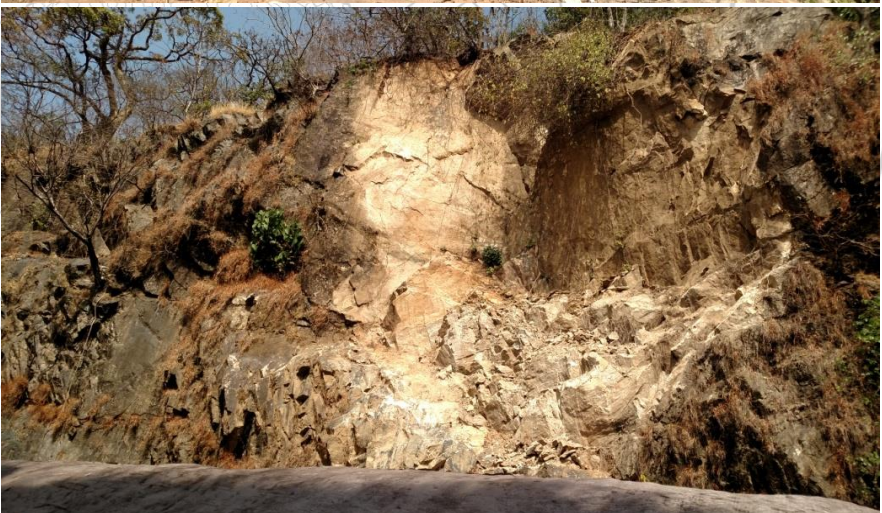
| 40 | Summary/Abstract | : | The crown cracks were perfectly visible and the slope failure occurred along the cross cutting Vertical joint sets. The large chunks and boulders got dislodged along the failure plane. The zone is highly susceptible to landslide during heavy rainfall. |

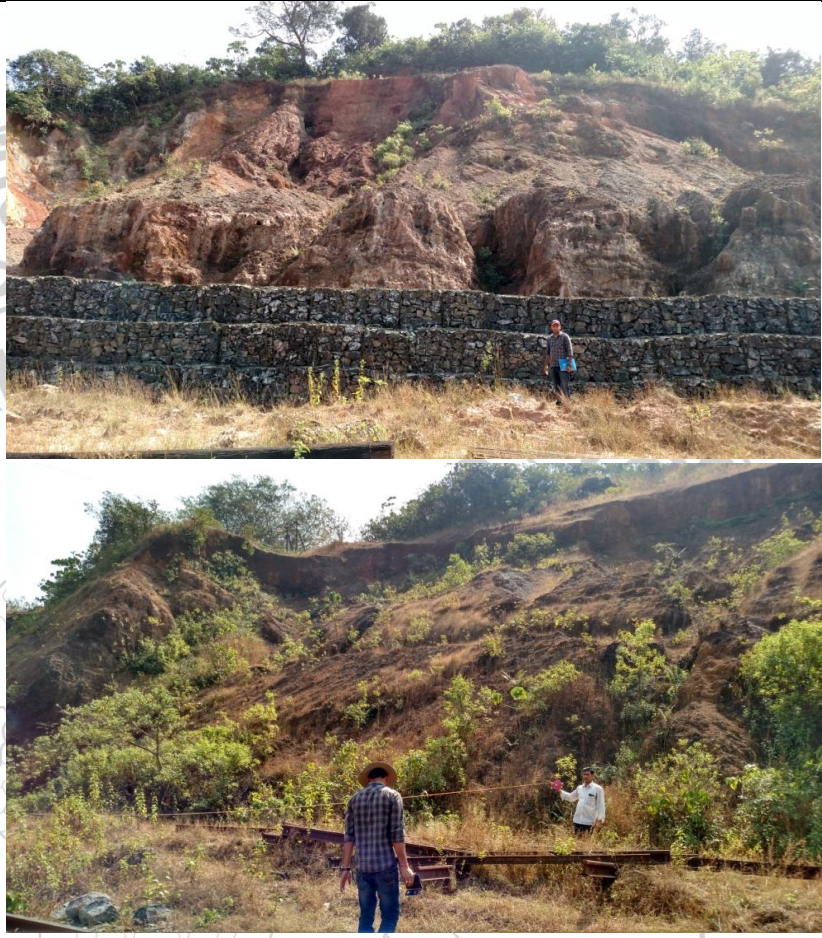
| 40 | Summary/Abstract | : | <p>At Castle rock railway line section, the debris slide of deep rotational failure are observed on extensive cut slope made on Lowly dissected hillslope for railway line extension are demarcated as Highly landslide susceptible zone. The slide is old, retrogressive in nature and can get reactivated during heavy rainfall. que i.e. The slope stablization techni low height gabion wallwith wire mess is constructedin successive benchesto provide toe support. And at lat/long: 15°23'52.85"N/74°20'10.87"E, the similar debris failure on vertical cut section is observed. The vertical cut section prone to slope failure is extending upto ~175m. The slope failure has occurred in successive benches made during slope gradation. The landslide is retrogressive, enlarging and widening in nature. The cutting of slopes and removal of soil transforms the slope and opens up new way for water seepage and runoff pattern during prolonged rainfall that destabilizes slope and leads to landslides/slope failures. The Ferruginous Phyllite of Joldal formation has undergone intense weathering and kaolinitization that triggers landslips. The existing gabion wall constructed at toe part need to be extended upto unstable zone and long term slope stability measures i.e. drainage trench on slopes should be provided to avoid soil slips.=</p> |
