**Macro-scale (1:50,000) Landslide Susceptibility Mapping in parts of Toposheets nos. 48I/05, 48I/06, & 48I/07 Belgaum, Uttar Kannada districts, Karnataka and North Goa & South Goa districts, Goa.**

टोपोशीट सं./ Toposheet No.: 48I/05, 48I/06, 48I/07  
मद संख्या: M4LSSM/एनसी/एस आर/SU-KG/2018/18717  
Item no.: M4LSSM/NC/SR/SU-KG/2018/18717

**कार्य सत्र 2018-19 का अंतिम प्रतिवेदन**  
**Final report for field season 2018-19**

**नेहा कुमारी, भू-वैज्ञानिक एवं कमल कुमार, भू-वैज्ञानिक**  
**Neha Kumari, Geologist And Kamal Kumar, Geologist**

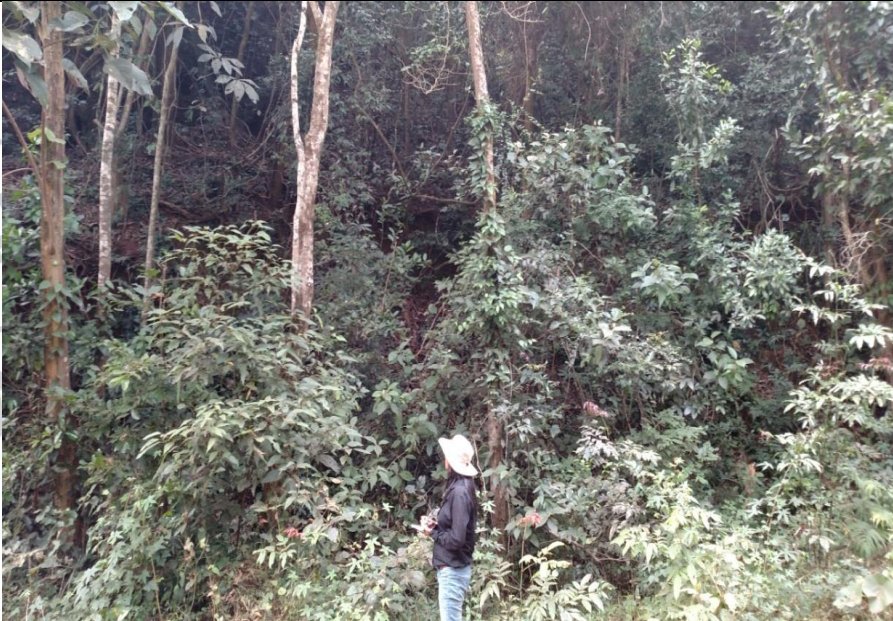
| 40 | Summary/Abstract | : | Long: 15°19'37.94"N/74°22'49.33"E nearly 400 m North of Tadki village areas old, suspended palaeo-debris flow recorded along natural course of stream occurring on lowly dissected hill slope with slope angle varies between 25°-35°. The litho-units have undergone intense lateritization and weathering. The ground evidence indicates the debris flow along the nala course brought the debris in downslope direction, however at present the stream is dry but can get reactivated during monsoon. The poor drainage at road bench level resulted in road subsidence. So, lined drainage with box culvert should be constructed for draining the flowing water diverted to suitable location as remedial measures to prevent road damage and water seepage and slope saturation. |

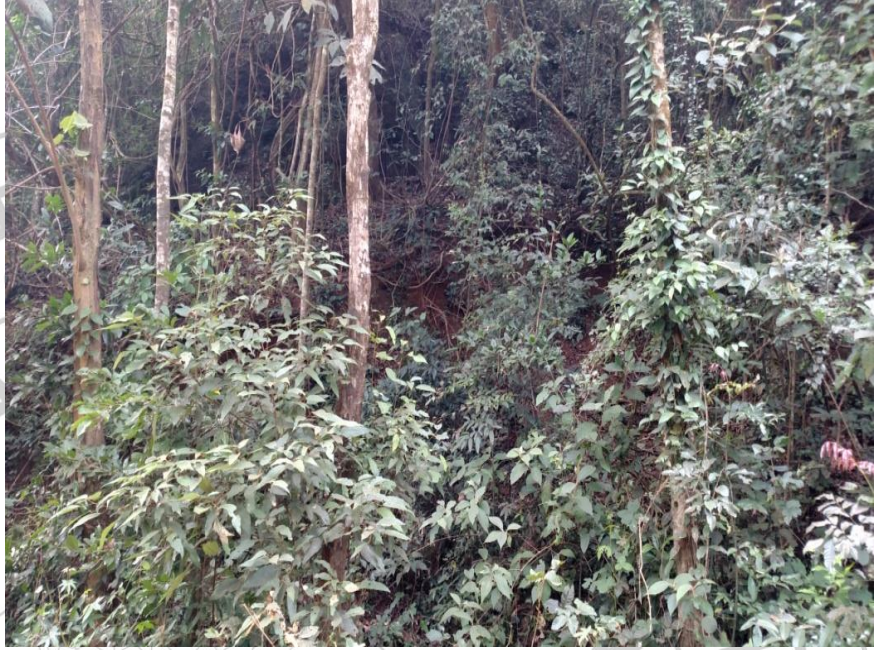
| 40 | Summary/Abstract | : | The old and suspended shallow debris slide of retrogressive in nature are recorded on lowly dissected hill slope with slope angle varies between 25°-35°. The scars of landslide and crown cracks are prominent, and precarious rock boulders were hanging on top. The adjoining area is damp and quite unstable. The causative factor for slope failure is prolonged water seepage and saturation from higher order stream from upper catchment adjoining supra reservoir that resulted in intense lateritization and weathering of litho-units. |

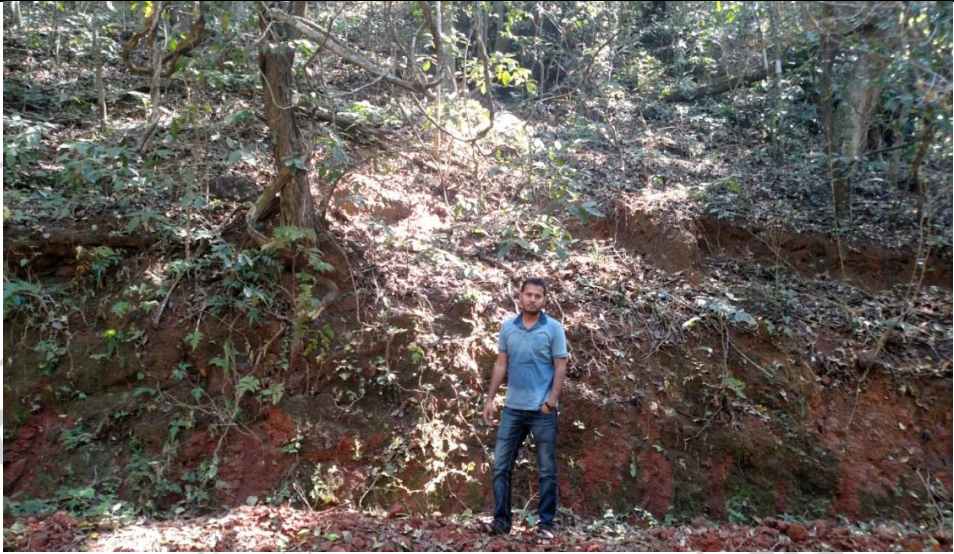
| 40 | Summary/Abstract | : | The slide is retrogressive in nature , the lateritization indicates the water saturation, weathering and erosion of slope forming material along the 1st order nala that saturated the slope during the monsoon along the weaker section along the nala. |

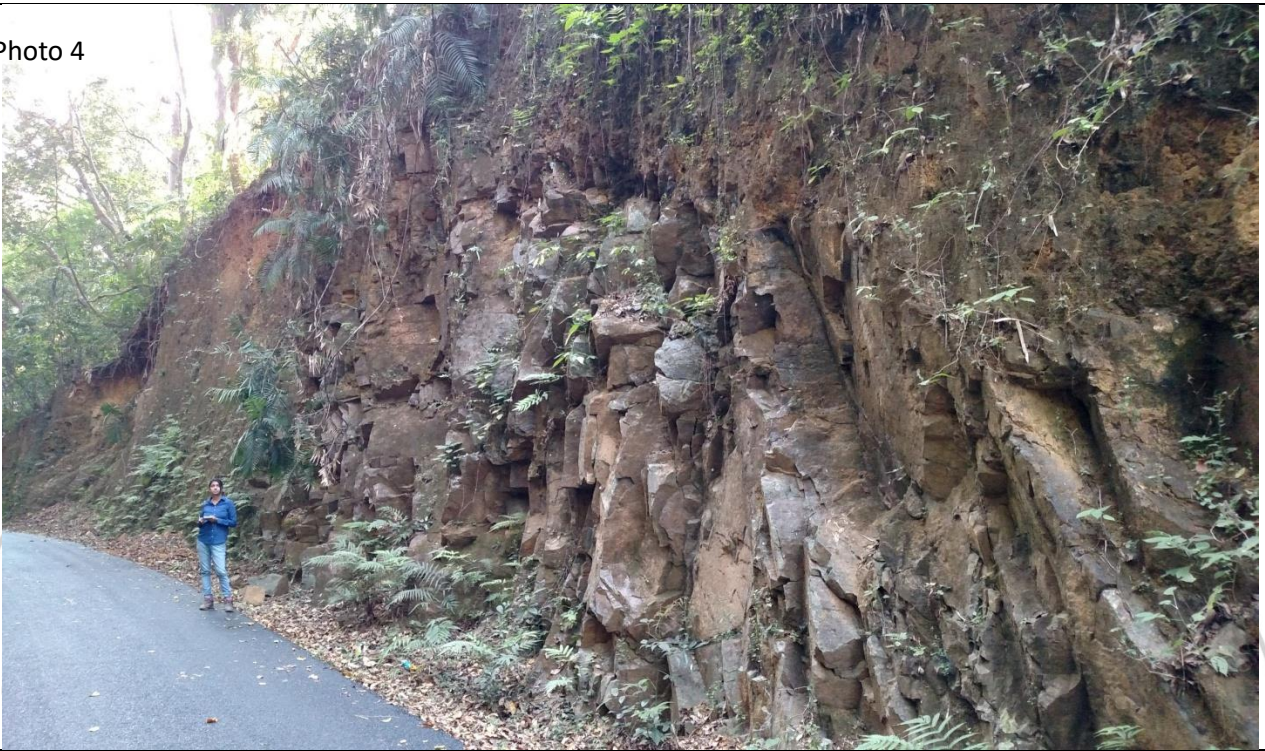
Photo 4

**Photo 4: Field Photographs showing Extensive Cut Slope along the metallised Anmod road**
