Macro-scale (1:50,000) Landslide Susceptibility Mapping in parts of Toposheets nos. 48O/2, O/6 Chikmangaluru, Shimoga, Dakshin Kannada districts, Karnataka.

टोपोशीट सं./ Toposheet Nos.: 48O/2, 48O/6

कार्य सत्र 2019-20 का अंतिम प्रतिवेदन  
Final Report for Field Season 2019-20

PROJECT: NLSM / परियोजना: एनएलएसएम

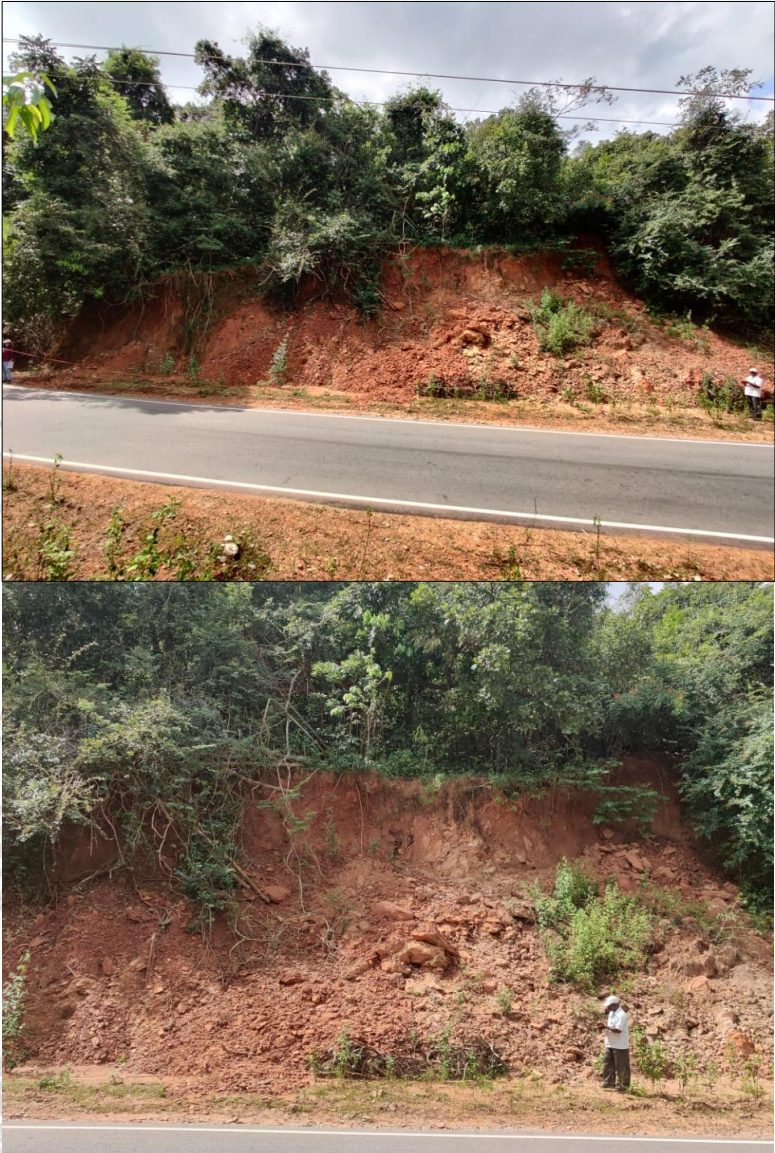
| 40 | Summary/Abstract | : | <p>The debris slide with multiple slope failures and slumps were observed on the convex curvature of the road cut on lowly dissected hillslope. The slope forming material consists of weathered rock and loose soil that failed during rainfall. The increased pore water pressure and pronounced weathering reduced the shear strength of the slope forming material during heavy rainfall. The low height lined drainage and culvert should be designed at road bench level to channelize or discharge excess water downslope at suitable location. The loose debris may block the road communication during heavy rainfall. The slope forming material consists of weathered rock and loose soil that failed during rainfall. The loose debris may block the road communication during heavy rainfall.</p> |

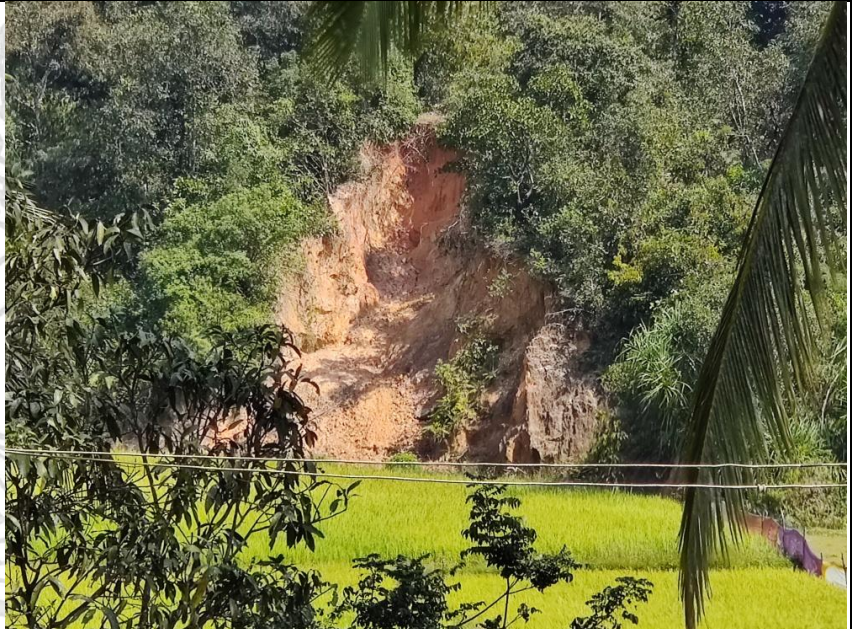
| 40 | Summary/Abstract | : | The shallow translation debris slide occurred on lowly dissected hillslope beside agricultural land where toe part of hillslope is saturated by naturally flowing stream. The scouring and under cutting by higher 2 <sup>nd</sup> order stream during heavy water discharge in monsoon at toe part of lowly dissected hillslope got destabilized due to toe erosion and subsequent removal of toe |

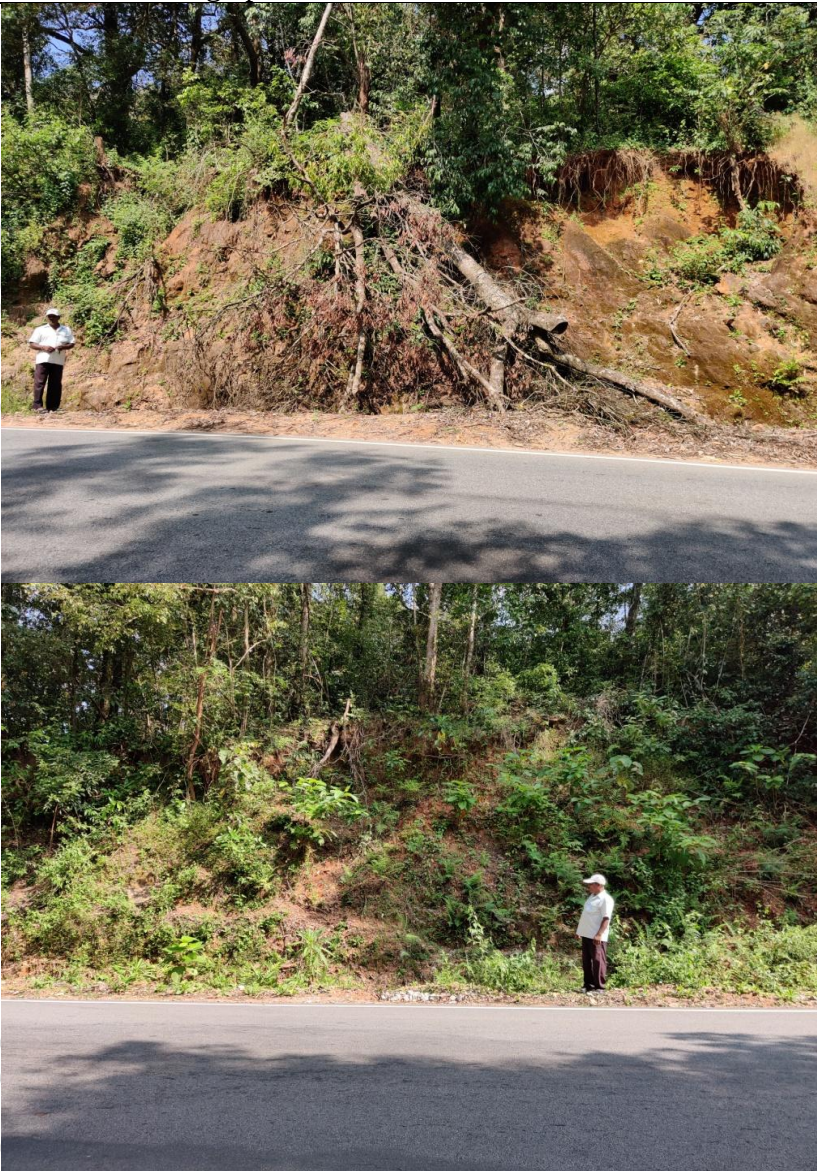
| 40 | Summary/Abstract | : | <p>The debris slide observed on lowly dissected hillslope at road bench level. The road cut is susceptible to failure during monsoon rainfall. The slope disturbance resulted due to unscientific way of removal of soil by toe cutting of the hillslope for road construction and communication network. The weaker plane is at contact of the intrusive granite within granite gneiss and vertical road cut opened up new pathway of water seepage &amp; slope saturation. Thus increased water infiltration increases pore water pressure that reduced the shear strength of the slope forming material during heavy rainfall. The lined drainage should be provided at toe part to minimize toe erosion and culvert should be designed for effective drainage at road bench level to avoid road subsidence due to sub-surface weathering and erosion. The area is slump zone and is quite unstable zone. The slumping zone is extending upto ~110m</p> |

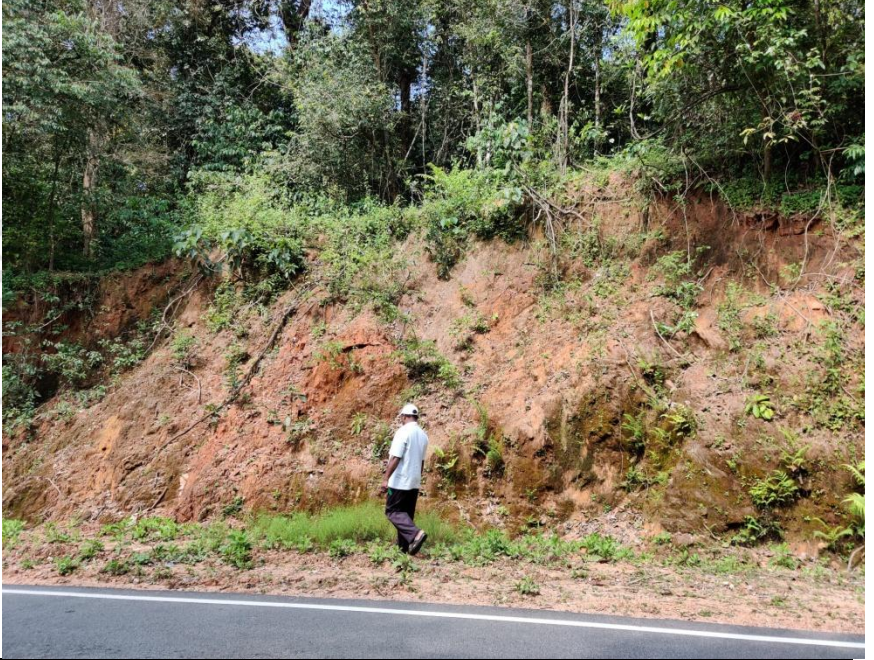
| 40 | Summary/Abstract | : | The debris slide observed on lowly dissected hillslope at road bench level. The slope disturbance resulted due to unscientific way of removal of soil by toe cutting of the hillslope for road construction and communication network. The slope transformation due to vertical cut of dimension ~65m width and weaker plane at contact of the intrusive granite within granite gneiss opened up new pathway of erosion, water seepage & slope saturation. Thus increased water infiltration increased pore water pressure that reduced the shear strength of the slope forming material during heavy rainfall. The road cut is susceptible to failure during monsoon rainfall. So, lined drainage with suitable dimension culvert should be designed and constructed at suitable location for effective drainage. |

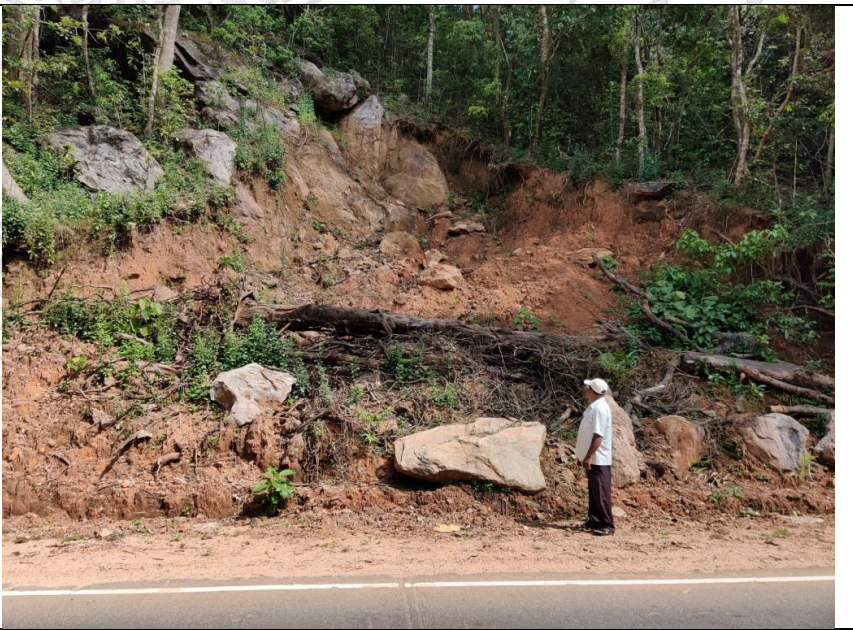
| 40 | Summary/Abstract | : | The shallow translational rock slide observed along road section on extensive road cut on lowly dissected slope with moderate vegetation cover. The landslide zone is active, retrogressive, widening and enlarging in nature. The landslide zone is ~35m wide. The slope disturbance resulted due to unscientific way of removal of soil by toe cutting of the hillslope for road construction and communication network. The seepage and infiltration is along the weaker plane along joint and fracture. Thus increased water infiltration and slope saturation increases the pore water pressure that reduced the shear strength of slope forming material during heavy rainfall. The differential weathering on slope was also observed. The provision of lined drainage with weep holes should be provided at toe part to drain excess water through existing culvert to avoid subsidence, toe erosion. The effective drainage at road bench level is required to avoid road subsidence due to sub-surface weathering and erosion. The precarious rock boulders should be removed. |

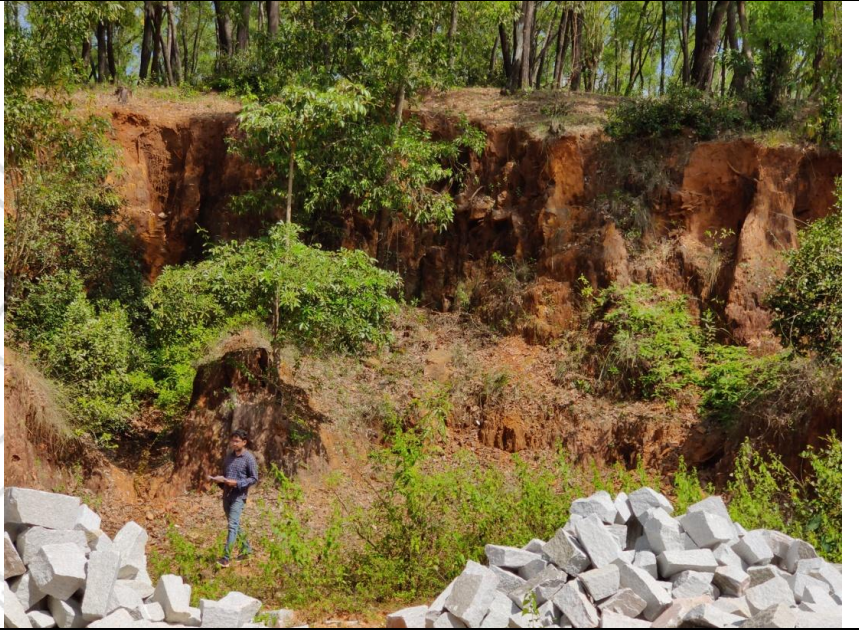
| 40 | Summary/Abstract | : | The slope failure occurred on extensive cut slope made on lowly dissected hill slope. The water infiltration and saturation of weathered granite gneiss resulted in increased pore water pressure and reduction in the shear and cohesive strength of the slope forming material during heavy rainfall. The modified natural slope should be eased. |

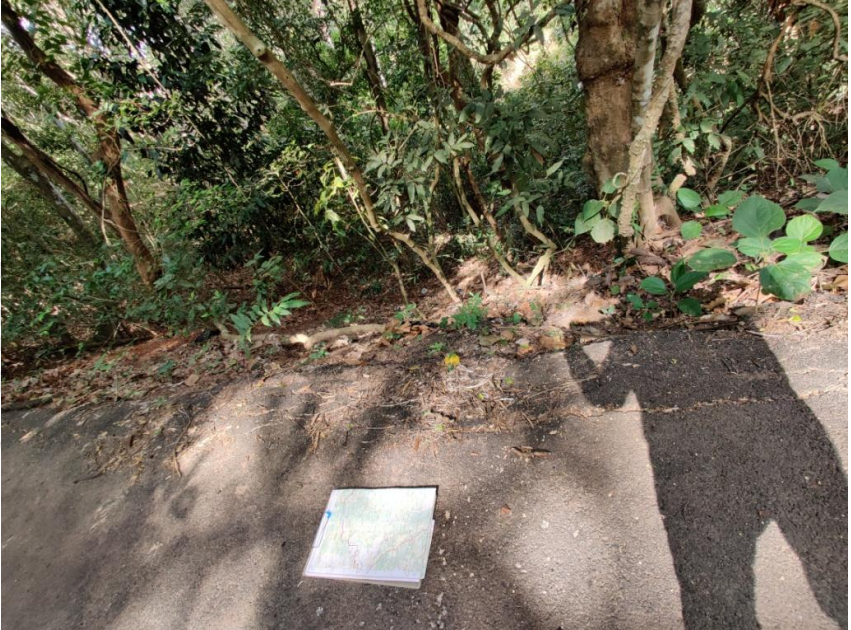
| 40 | Summary/Abstract | : | The cracks developed on road indicate ground subsidence due to slope saturation. The lack of effective drainage system on upslope has made the slope vulnerable. The provision of lined drainage and culvert should be designed on upslope for effective discharge of water to avoid slope saturation. The protective supporting breast wall with weep holes should be constructed in downslope direction to control the soil slip. The area is unstable zone and settlement at downslope is at risk. |

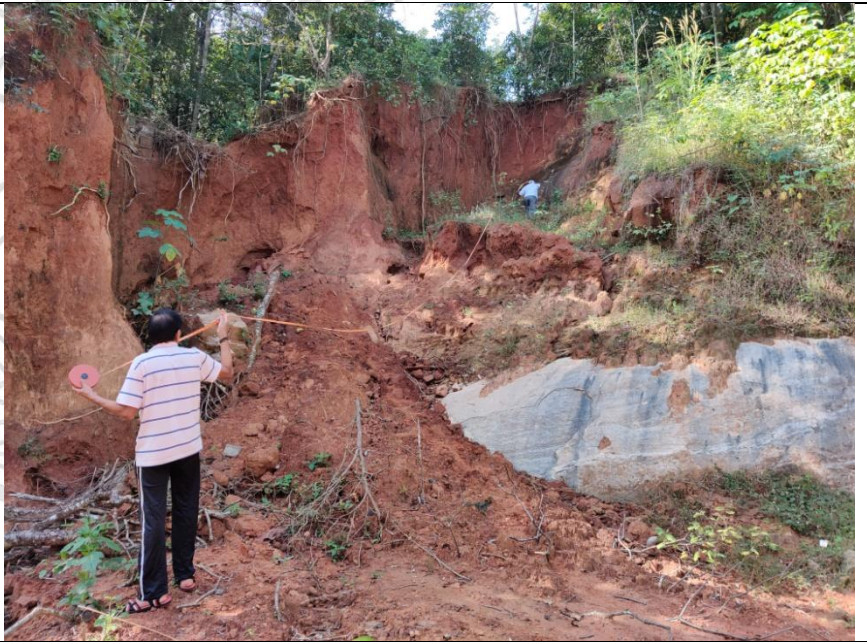
| 40 | Summary/Abstract | : | The debris slide occurred on lowly dissected hillslope due to unscientific way of modification of slope & removal of soil for construction. The vertical cut made for settlement purpose |

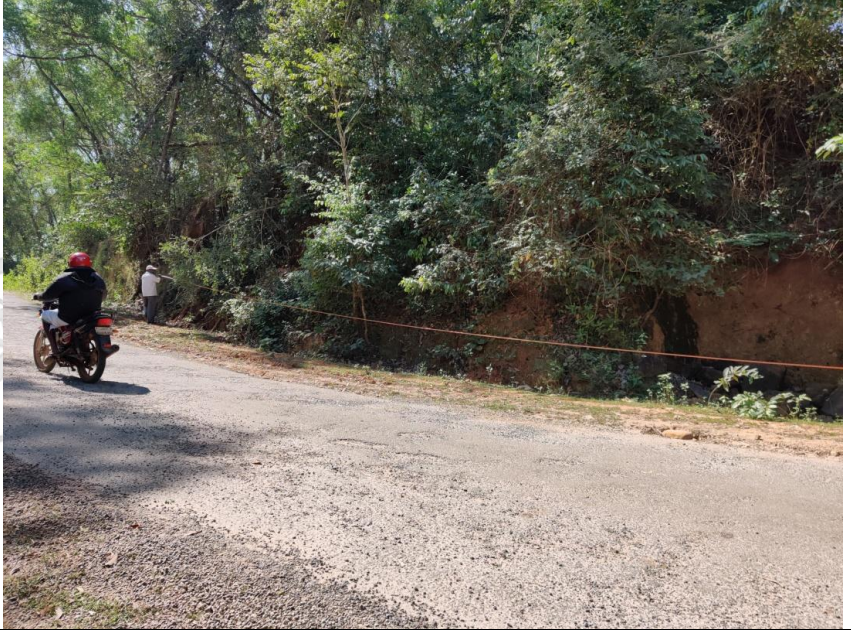
| 40 | Summary/Abstract | : | The Debris slump occurred on lowly dissected hill slope with sparse vegetation cover at concave turn of the road. The slope disturbance is observed due to unscientific way of modification of slope & removal of soil for construction. The slope transformation due to vertical opened up new way of water seepage & runoff pattern during heavy rainfall. The slope forming material consists of in-situ soil and weathered rock. The overburden thickness varies between 5-10m. The lined drainage and culvert at road bench level should be provided for effective drainage. The area is demarcated as meta-stable zone susceptible to slope failure during rainfall. The slumping zone is extending upto ~65m |

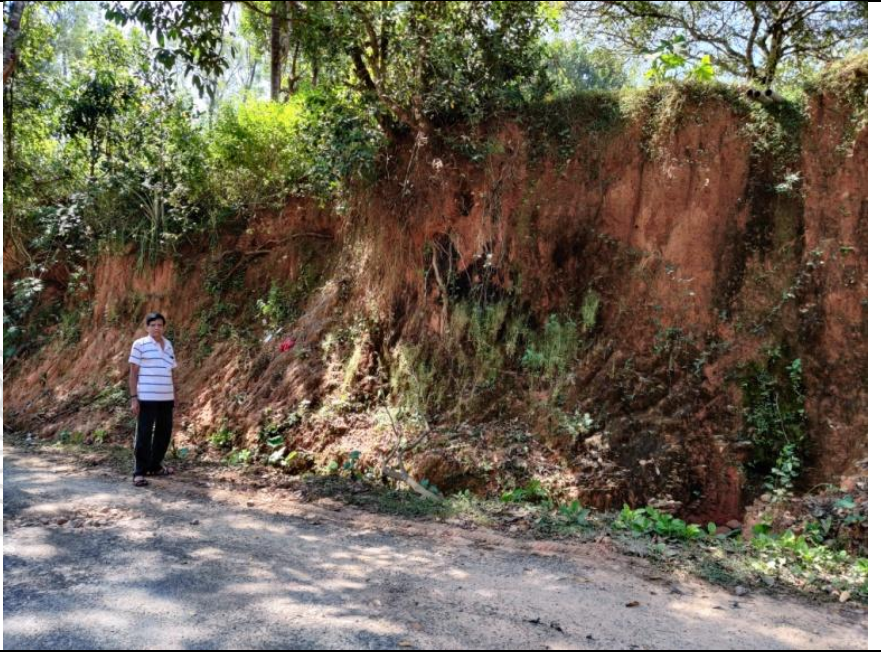
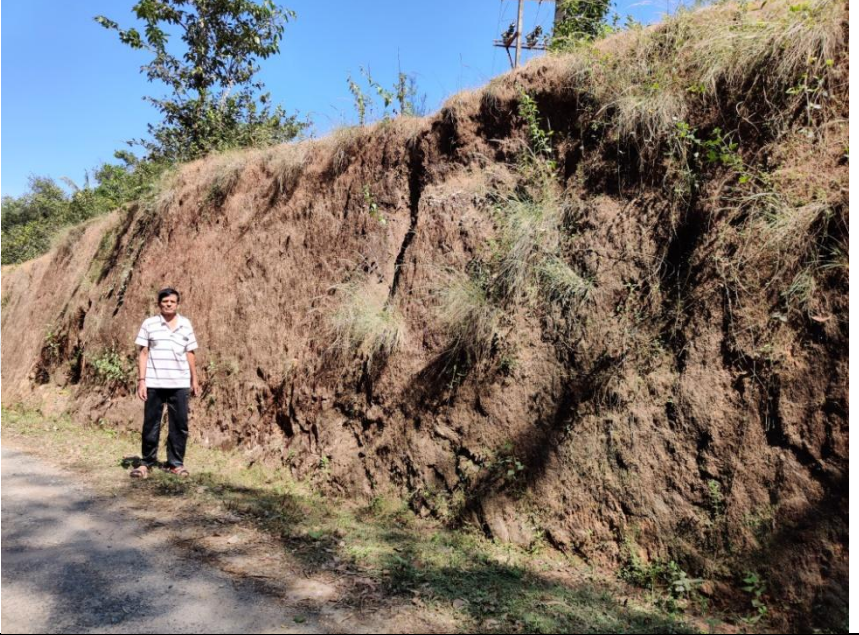
| 40 | Summary/Abstract | : | The vertical cut made for road construction leads to slope transformation that opened up new pathway for water seepage & slope saturation in fractured granite. The increased pore water pressure reduced the shear and cohesive strength of slope forming material that lead to slope failure during heavy rainfall. The area is demarcated as meta-stable zone susceptible to slope failure during rainfall. The slope forming material consists of in-situ soil and weathered rock. The overburden thickness varies between 5-10m. The slumping zone is extending upto 65m. The lined drainage and culvert at road bench level should be provided for effective drainage to avoid toe erosion and slope failure. |

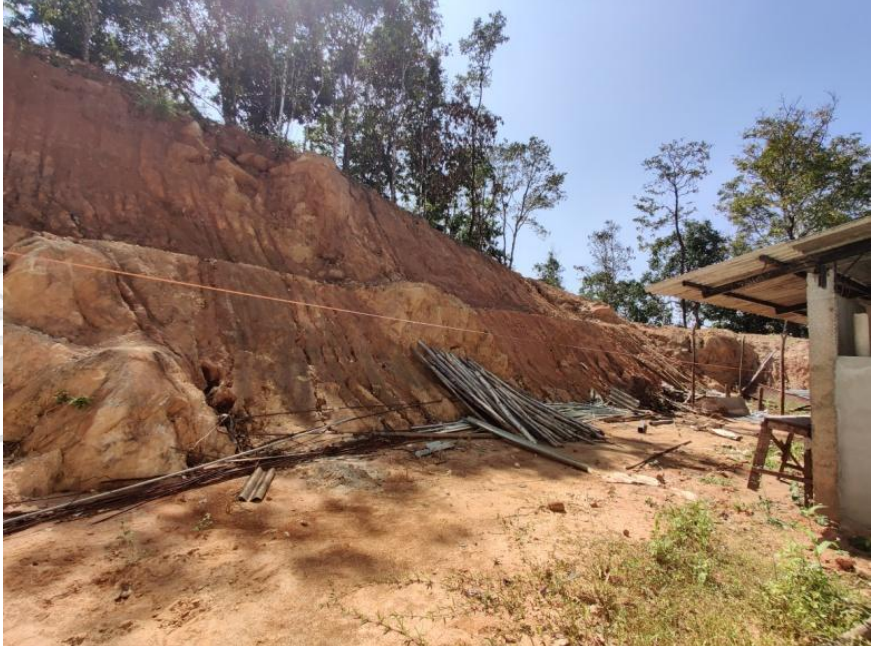
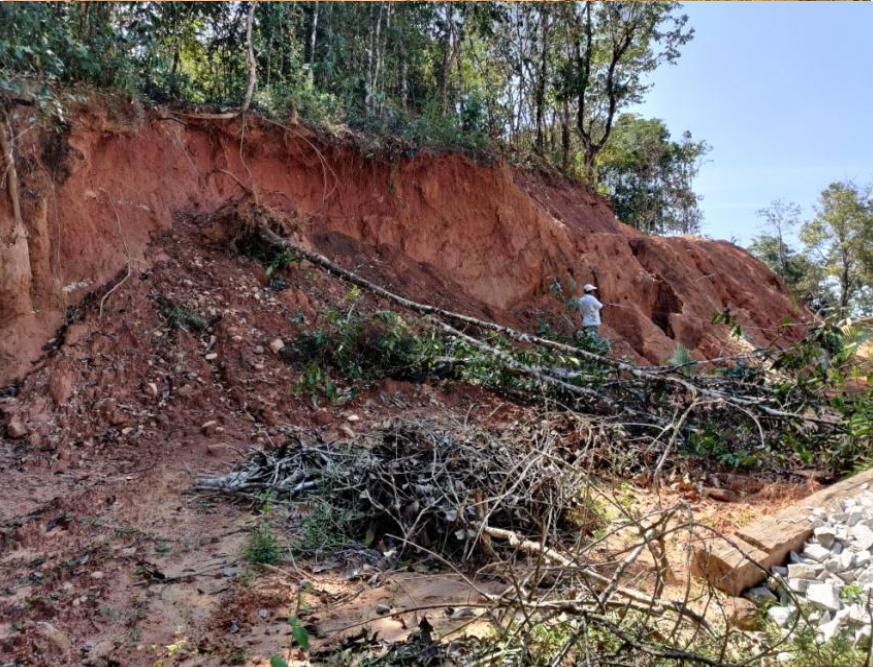
| 40 | Summary/Abstract | : | <p>The debris slide occurred on lowly dissected hillslope on extensive slope cut made for settlement purpose lead to slope transformation that opened up new pathway for water seepage &amp; runoff pattern. Thus increased infiltration rises pore water pressure that reduced the shear strength of the slope forming material during heavy rainfall. The slope forming material consists of in-situ soil and weathered rock. The overburden thickness varies between 5-10m.</p> |

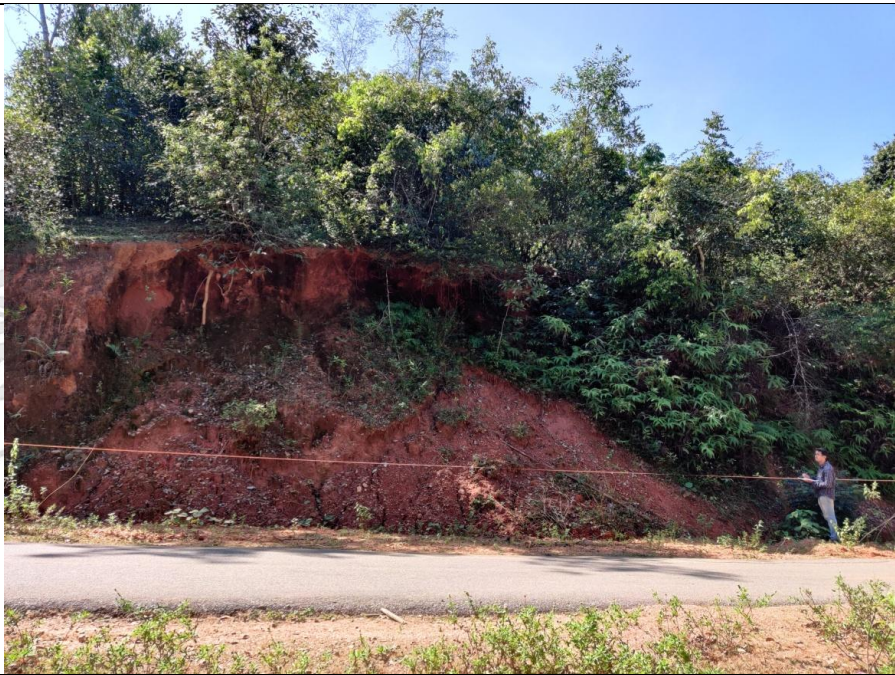
| 40 | Summary/Abstract | : | The debris slide occurred on vertical road cut made for road construction that lead to slope transformation that opened up new pathway for water seepage & slope saturation in fractured granite. The increased pore water pressure and reduced shear and cohesive strength lead to slope failure during heavy rainfall. The area is demarcated as meta-stable zone susceptible to slope failure during rainfall. The slope forming material consists of in-situ soil and weathered rock. The overburden thickness varies between 5-10m. The slumping zone is extending upto 25m. The lined drainage and culvert at road bench level should be provided for effective drainage and to avoid toe erosion and slope failure. |

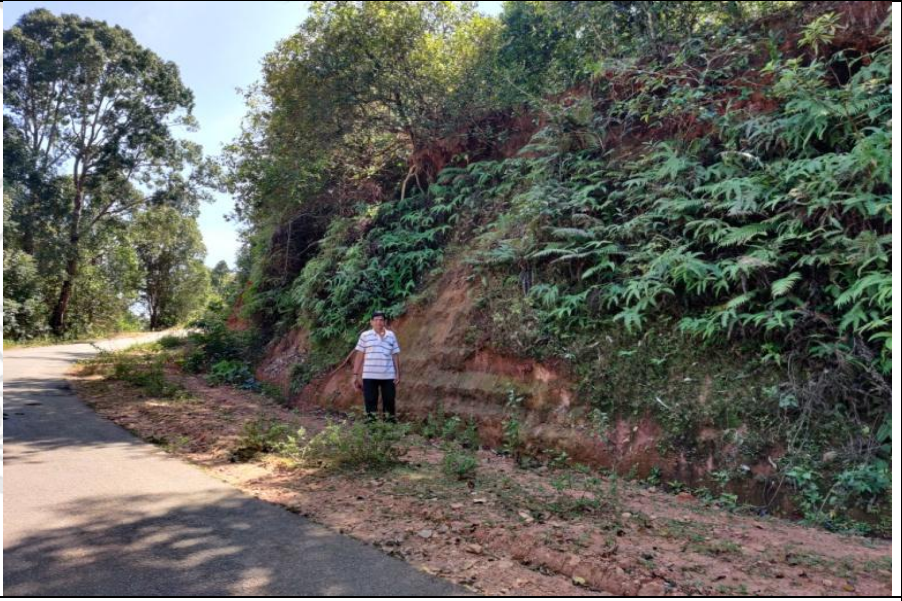
| 40 | Summary/Abstract | : | The debris slide occurred on convex curvature on vertical road cut made for road construction leads to slope transformation that opened up new way of water seepage & slope saturation. The increased pore water pressure lead to reduced shear and cohesive strength of slope |

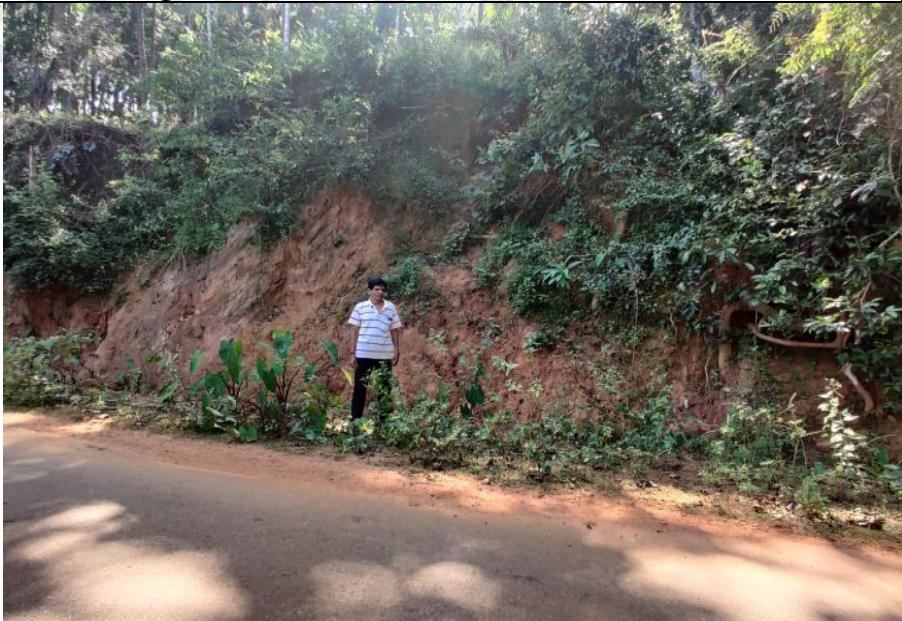
| 40 | Summary/Abstract | : | The debris slide occurred on lowly dissected hill slope with sparse vegetation cover. The vertical road cut lead to slope transformation that opens up new way of water seepage & slope saturation. The increased pore water pressure reduced the shear and cohesive strength leads to slope failure during heavy rainfall. Lined drainage at toe part should be made to control toe erosion and culvert of suitable dimension should be constructed at suitable location for draining excess water down the slope in order to avoid water seepage and slope saturation. The area is demarcated as meta-stable zone susceptible to slope failure during rainfall. |

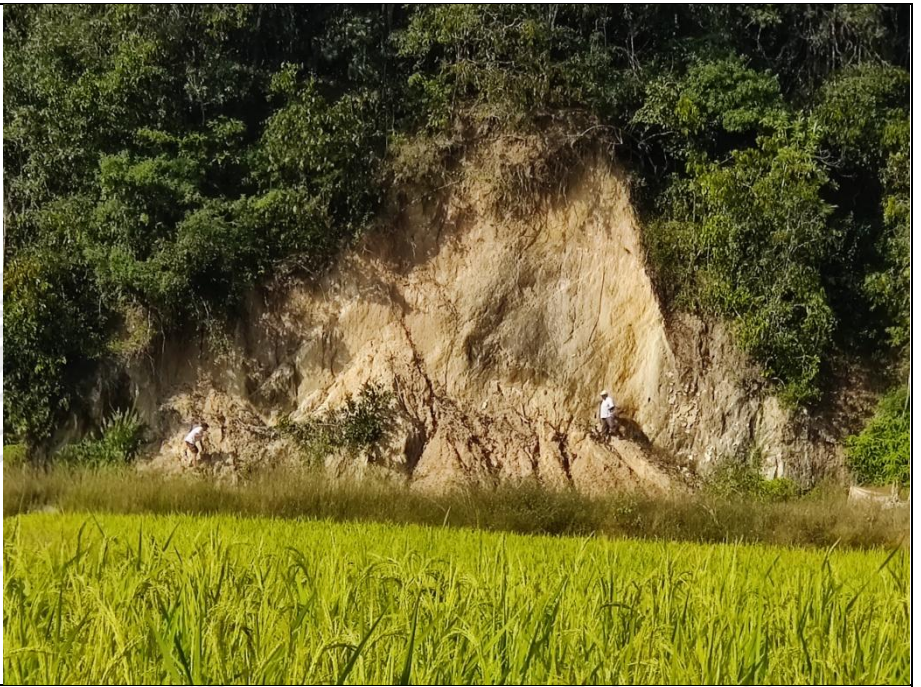
| 40 | Summary/Abstract | : | The shallow debris slide on lowly dissected hill slope with moderate vegetation cover. The joints opened up new pathway for water seepage & slope saturation in weathered rock and soil. Drainage at toe part of hillslope adjoining to cultivation for irrigation purposes induced scouring and toe erosion during heavy discharge in rainy season. Easing of slope required. Gabion wall with wire mesh should be constructed for toe support and erosion by flowing streams at toe part. |

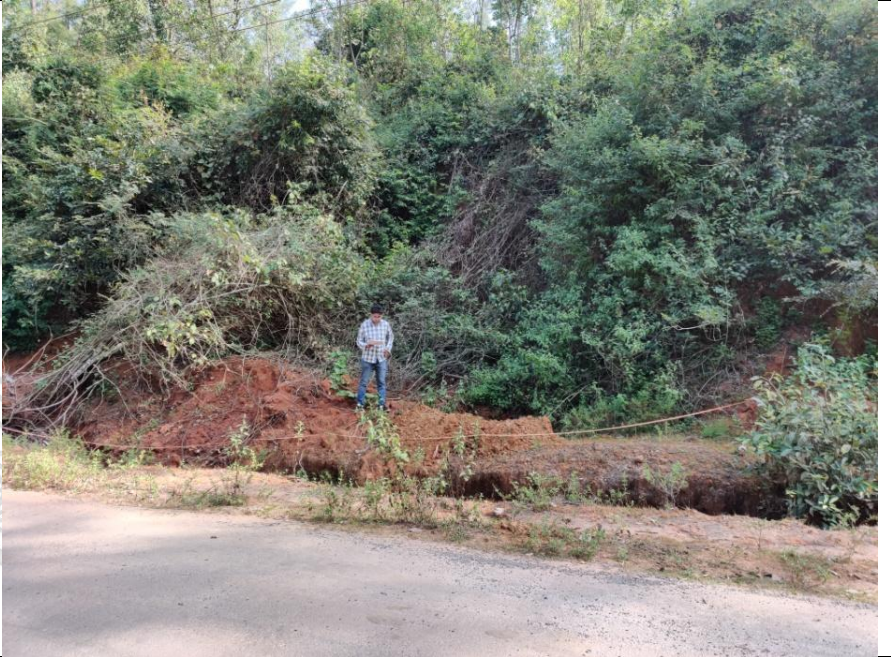
| 40 | Summary/Abstract | : | The shallow debris slide occurred on lowly dissected hill slope with Moderate vegetation cover. The vertical road cut opened up new pathway for water seepage & slope saturation in weathered rock. Drainage at toe part saturates the slope and induced toe erosion during heavy precipitation. The lined drainage at toe part and culvert should |

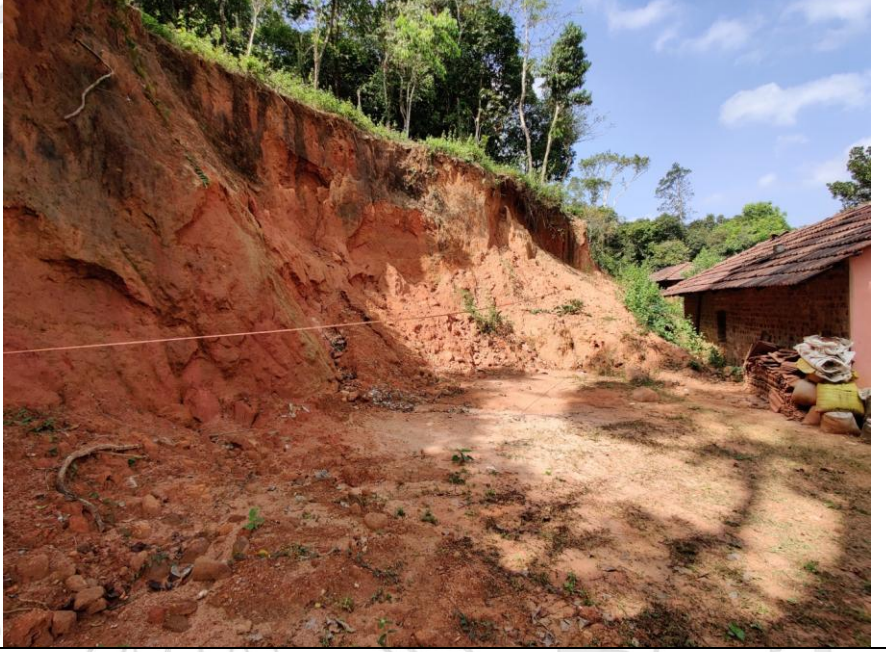
| 40 | Summary/Abstract | : | The debris slide occurred on lowly dissected hill slope due to made for settlement purposes that opened up new pathway for water seepage & slope saturation in weathered rock and soil. Water infiltration increased the pore water pressure and reduced the cohesive and shear strength of the slope forming material resulted in slope failure during intense incessant rainfall. The slope forming material consists of in-situ soil and weathered rock. The overburden thickness >10m. The settlement nearby is at high risk. The area is demarcated as unstable zone susceptible to slope failure during rainfall. |

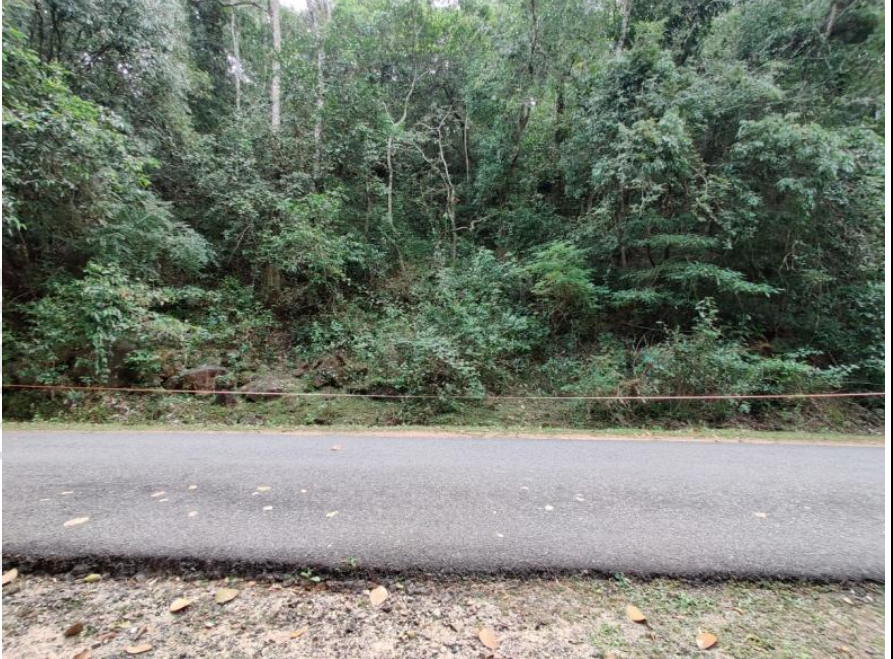
| 40 | Summary/Abstract | : | The Debris slide observed on lowly dissected hillslope. The slope failure occurred due to intense weathering and erosion. The water saturation increased pore water pressure and resulted in shear strength failure. The area is susceptible to failure during monsoon rainfall. The slumping zone is either side 50m prone to failure. The slope forming material consists of in-situ soil and weathered rock. The overburden thickness >10m. So, the lined drainage with suitable dimension culvert should be designed and constructed at suitable location for effective drainage. The area is demarcated as meta-stable zone susceptible to slope failure during rainfall. |

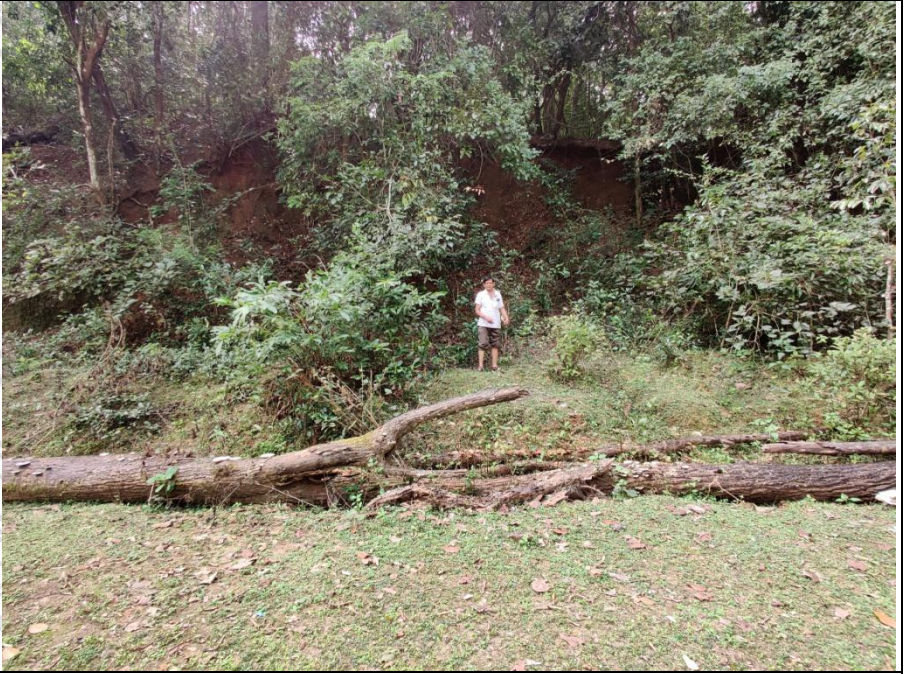
| 40 | Summary/Abstract | : | The Debris slide observed on lowly dissected hillslope. The slope failure occurred due to intense weathering & erosion. The toe erosion and water saturation increased the pore water pressure and induced shear strength failure. The area is susceptible to failure during monsoon rainfall. The slumping zone is either side 50m prone to failure. The slope forming material consists of in-situ soil and |

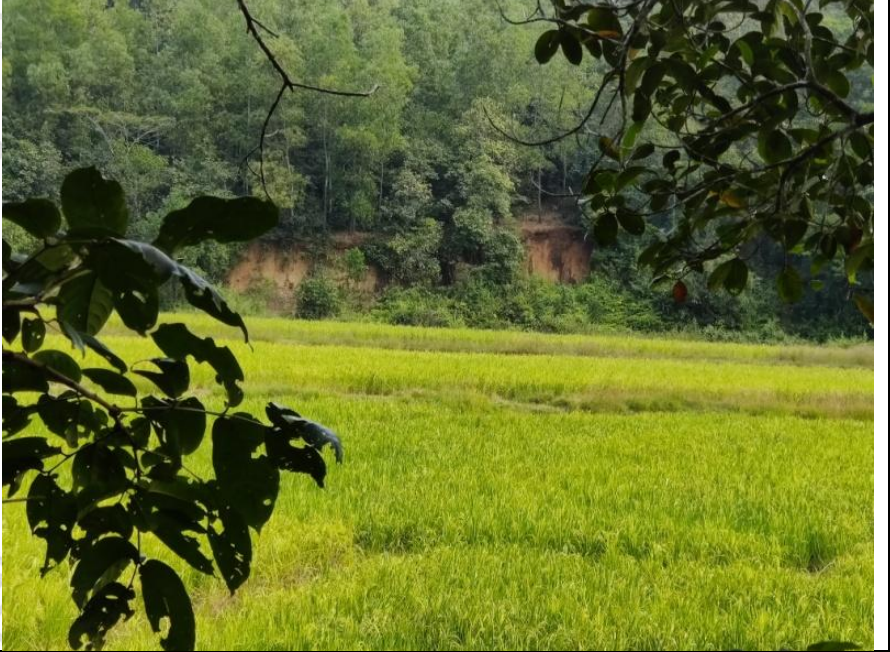
| 40 | Summary/Abstract | : | The shallow debris slide occurred on hillslope in vicinity of agricultural land. The slope is unstable and likely to fail during intense rainfall. The excavation of soil destabilized the hillslope. The toe erosion by flowing nala saturated the hillslope during rainy season. The increased pore water pressure reduced the shear and cohesive strength of slope forming material during intense rainfall. The gabion wall with wire mesh as protective wall should be constructed at failed soil mass for toe support and further arresting the movement of debris during rainfall to prevent loss of crop and agriculture land during monsoon. |

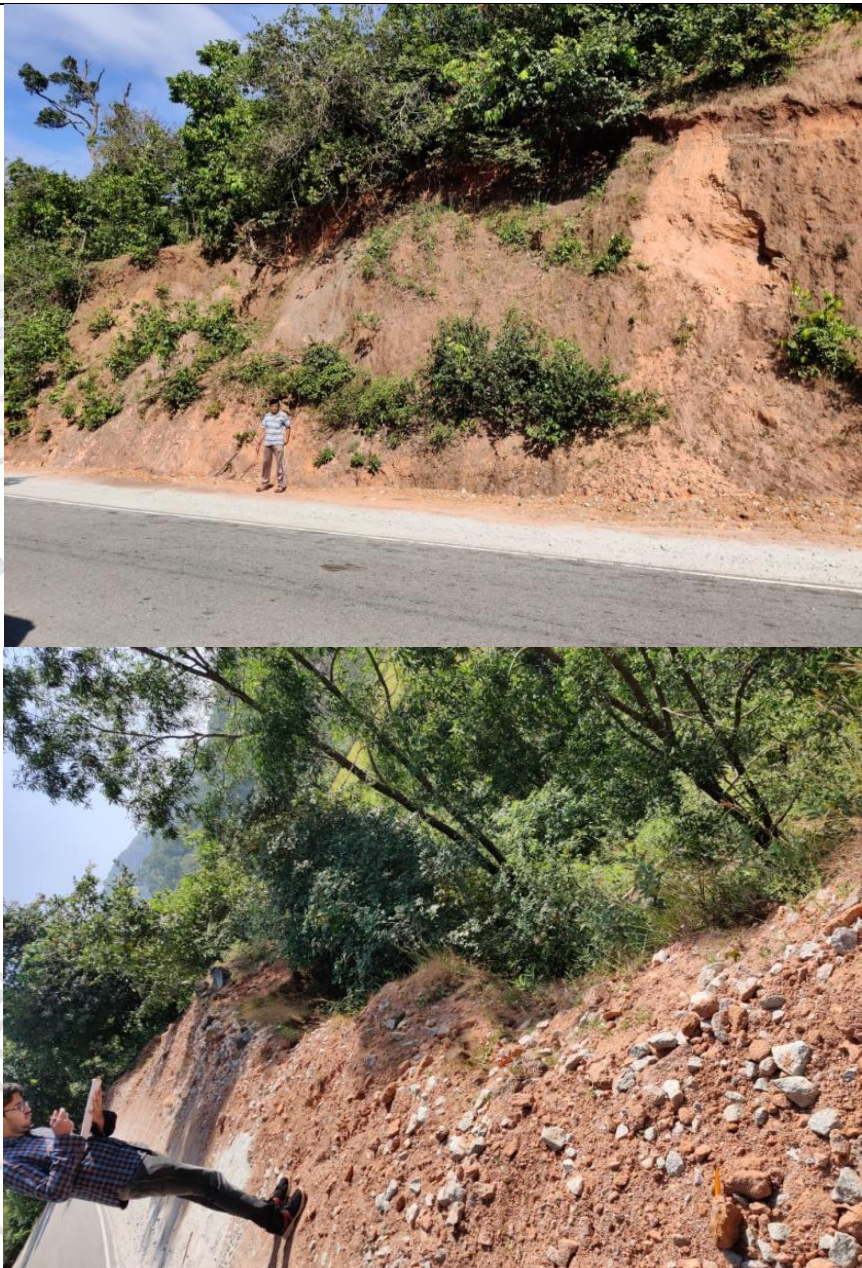
| 40 | Summary/Abstract | : | <p>The extensive slope cut made for road widening leads to slope transformation that opens up new pathway of water seepage and saturation in weathered rock and soil. Thus increased water infiltration destabilizes the slope due to increased pore water pressure that reduces shear and cohesive strength of slope forming material during heavy rainfall. The slope forming material consist of in-situ soil and weathered rock. The overburden thickness is &gt;10m. In downslope direction at road bench level multiple failures occurred having vertical height of ~15m from road bench and width ~115m. The drainage/nala at footslope causes toe erosion and water saturation that makes the slope vulnerable for mass movement. The area is demarcated as unstable zone susceptible to slope failure during rainfall. The slumping zone is either side 50m prone to failure.</p> |

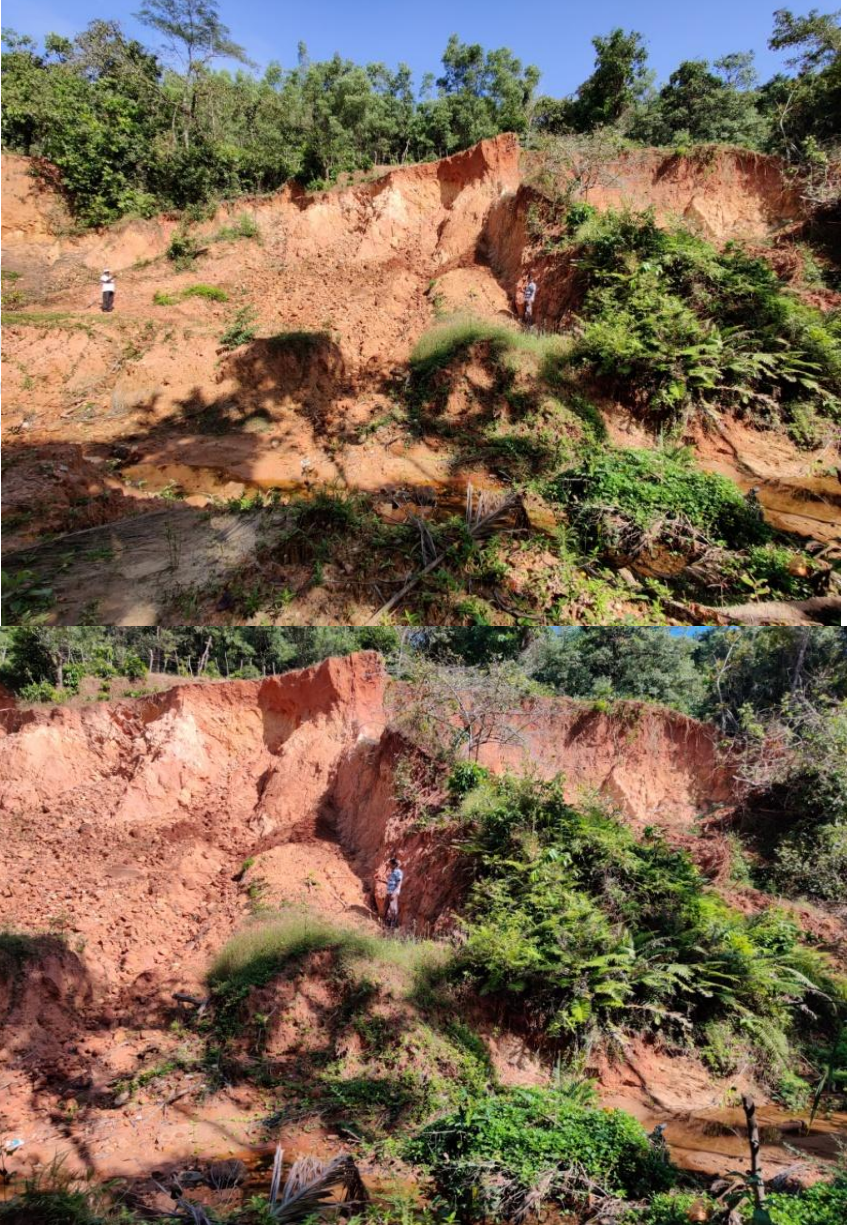
| 40 | Summary/Abstract | : | <p>The shallow translational debris slide observed along road section, South of Mastikatte village on lowly dissected slope with moderate vegetation cover. In present scenario the landslide zone is active, retrogressive, widening and enlarging in nature. The landslide zone is ~75m wide and vertical height of ~14m. The slope forming material consists of in-situ soil and weathered rock. The overburden thickness is &gt;10m. The slope failure in downslope direction resulted in road subsidences at road bench level. The multiple failures occurred at hillslope and stream/nala flowing in downslope direction lead to toe erosion and toe saturation causing slope failure. The retaining wall with weep holes should be constructed for toe support at downslope. Slope gradation or easing of slope is required. The lined drainage at toe part is required to avoid toe erosion.</p> |

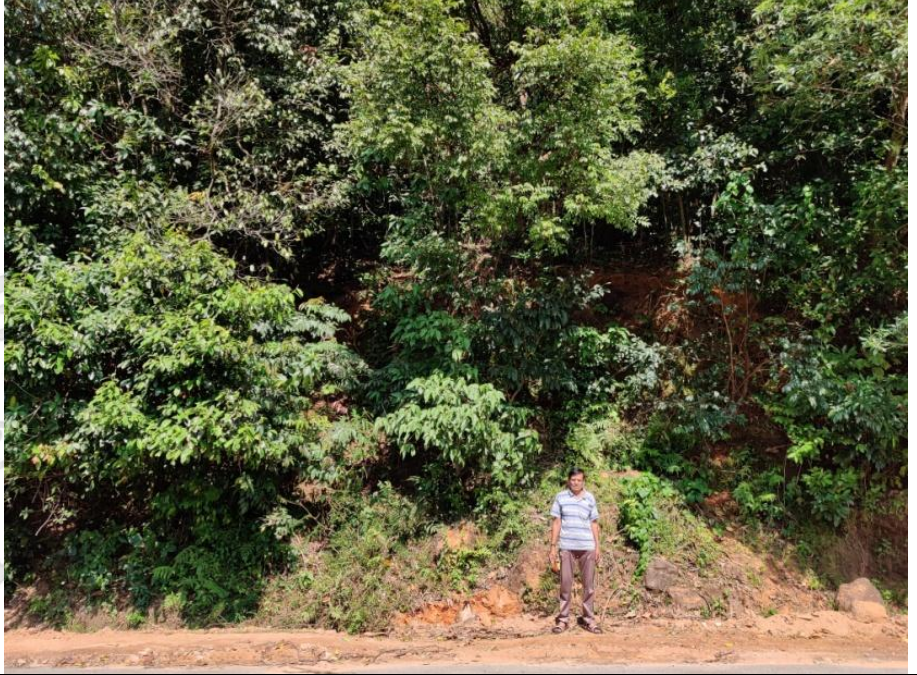
| 40 | Summary/Abstract | : | The road cut failure at road bench level is because of reduced cohesion and shears strength of slope forming material and caused due to intense weathering and erosional activity. The lined drainage at toe part is required to avoid toe erosion. The slope forming material consists of in-situ soil and weathered rock. The overburden thickness is 5-10m. The area is slumping zone. The area is demarcated as unstable zone susceptible to slope failure during rainfall. |

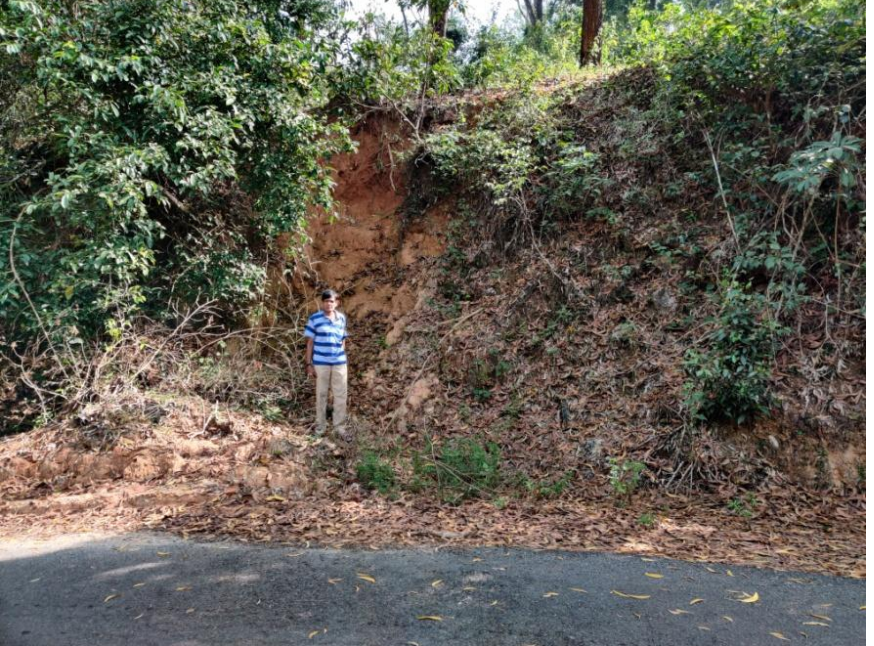
| 40 | Summary/Abstract | : | The road cut failure at road bench level occurred due to intense weathering and erosion and loss of cohesive strength of the soil. The area is slumping zone. The lined drainage at toe part is required to avoid toe erosion and culvert should be constructed at suitable location to drain excess water downslope to minimize water seepage and saturation. The slope forming material consists of in-situ soil and weathered rock. The overburden thickness is 5-10m. The area is demarcated as unstable zone susceptible to slope failure during rainfall. |

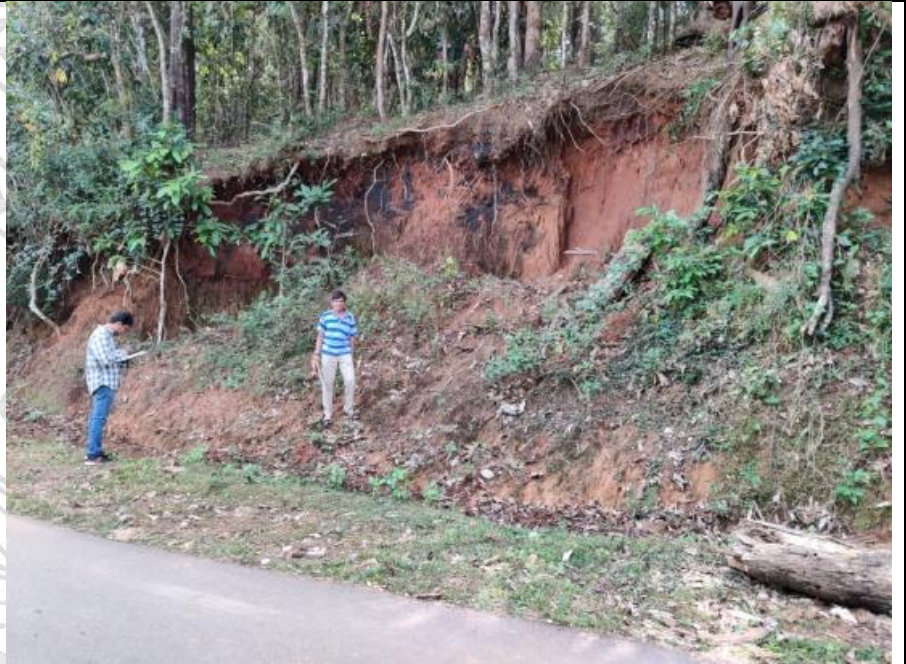
| 40 | Summary/Abstract | : | The road cut failure at road bench level occurred due to intense weathering and erosion lead to loss of cohesive strength of the soil. The area is slumping zone upto ~155m. The lined drainage at toe part is required to avoid toe erosion and culvert should be constructed at suitable location to drain excess water downslope to minimize slope seepage and saturation. The slope forming material consists of in-situ soil and weathered rock. The overburden thickness is 5-10m. The area is demarcated as unstable zone susceptible to |

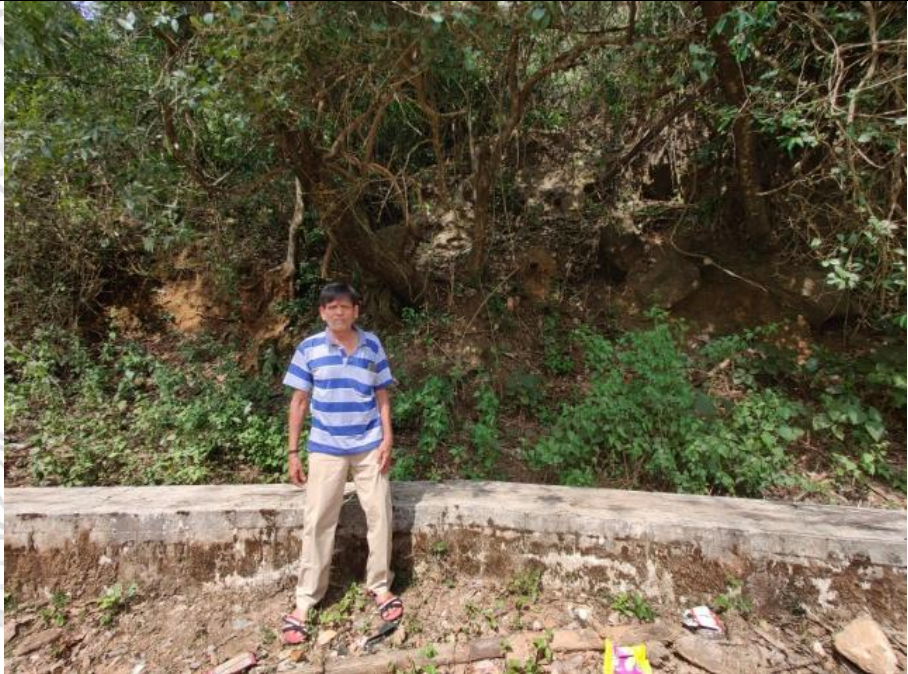
| 40 | Summary/Abstract | : | The vertical road cut failure is at concave curvature at road bench level. The primary cause of slope failure occurred due to intense weathering and erosion and loss of cohesive strength of the soil. The lined drainage at toe part is required to avoid toe erosion and culvert should be constructed at suitable location to drain excess water downslope to minimize slope seepage and saturation. The slope |
