Macro-scale (1:50,000) Landslide Susceptibility Mapping in parts of Toposheets nos. 48O/2, O/6 Chikmangaluru, Shimoga, Dakshin Kannada districts, Karnataka.

टोपोशीट सं./ Toposheet Nos.: 48O/2, 48O/6

कार्य सत्र 2019-20 का अंतिम प्रतिवेदन  
Final Report for Field Season 2019-20

PROJECT: NLSM / परियोजना: एनएलएसएम

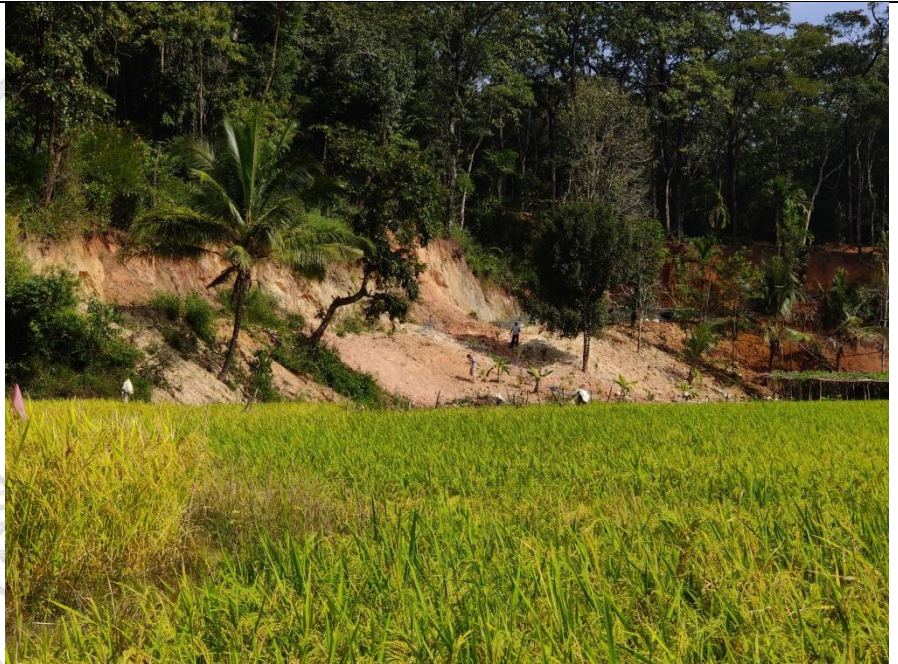
| 40 | Summary/Abstract | : | Debris slide occurred on lowly dissected slope with moderate to sparse vegetation. In present scenario the landslide is active & retrogressive in nature. The vertical cut provides new pathway for water seepage and saturation during intense rainfall. The flowing stream at toe part contributes to toe erosion and removal of toe support. The debris flow may results in loss of crop (Paddy) & agriculture land if get reactivated in monsoon. The construction of gabion wall with wire mesh should be provided at foot of hill slope adjoining the paddy field as protective remedial measures for toe support and arrest the movement of debris and prevent toe erosion and slope saturation by flowing streams that will lead to mass movement. The plantation should be done on failed mass to stabilize the slope. |

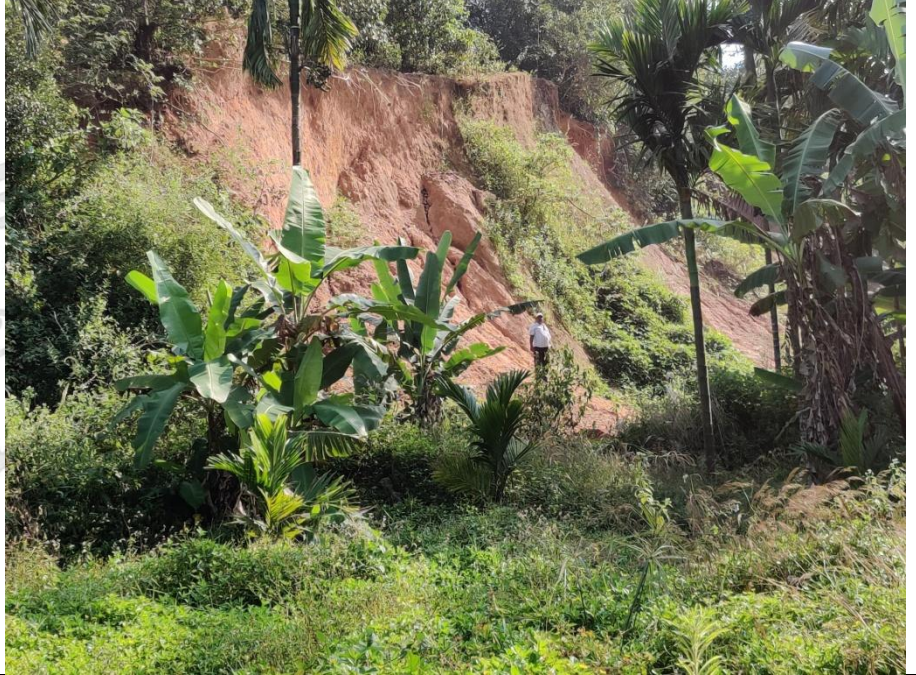
| 40 | Summary/Abstract | : | The slope disturbance resulted due to unscientific way of removal of soil by toe or piedmont cutting of the hillslope for widening the agricultural land and getting soil for arecanut plantation. The naturally flowing stream at toe part for irrigation purpose in adjoining paddy field has contributed in slope saturation, toe erosion and removal of toe support. The diverted nala along toe part of hillslope for irrigation purpose in adjoining paddy field resulted in toe erosion and removal of toe support. The shear failure occurred due to decreased cohesive strength of slope forming material as a result of prolonged weathering and erosion. The construction of gabion wall with wire mesh and lined drainage should be provided at foot of hill slope as protective remedial measures to arrest the movement of soil and reduce the chance of loss of agriculture land. The area is demarcated as unstable zone. |

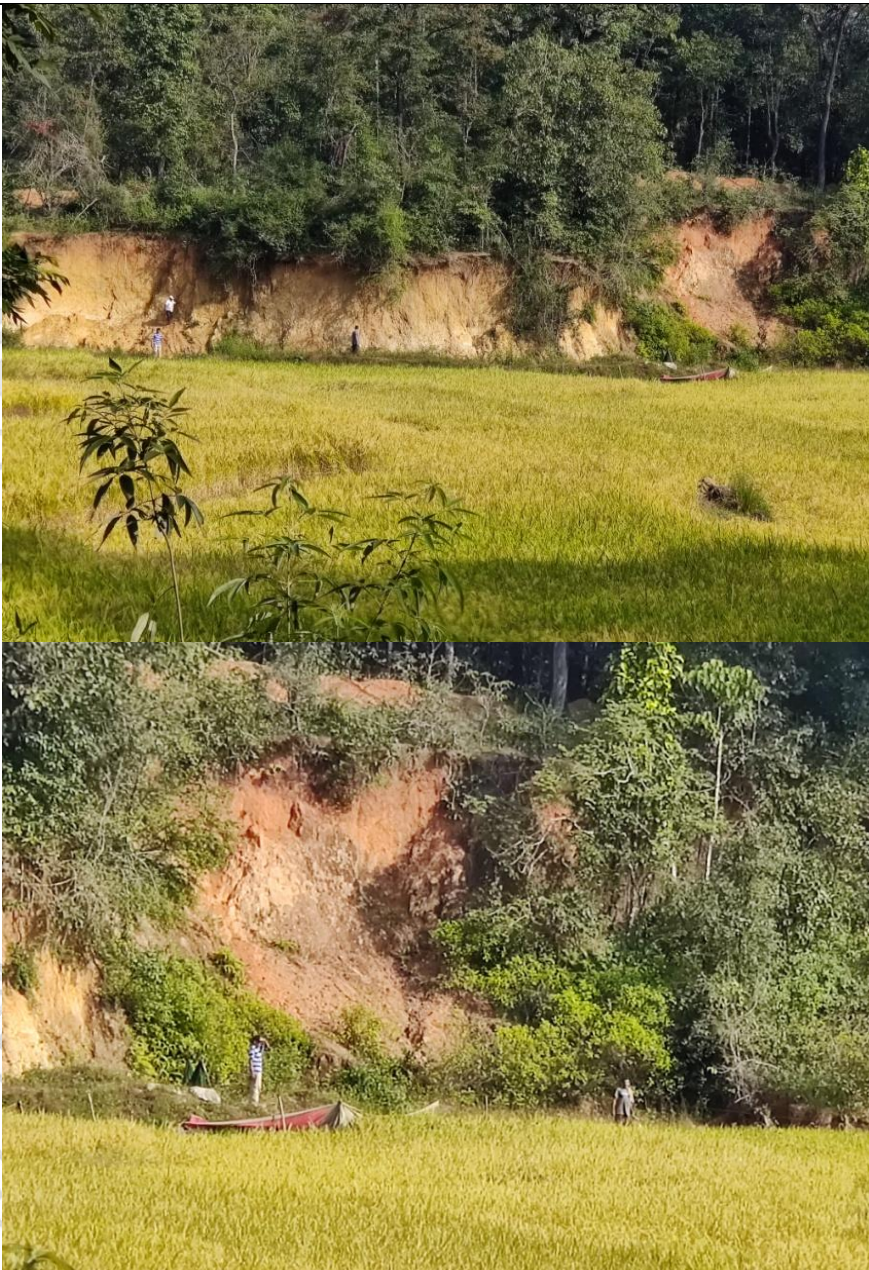
| 40 | Summary/Abstract | : | <p>The slope disturbance resulted due to unscientific way of removal of soil by toe or piedmont cutting of the hillslope for widening the agricultural land and getting soil for arecanut plantation. The naturally flowing stream at toe part for irrigation purpose in adjoining paddy field has contributed in slope saturation, toe erosion and removal of toe support. The diverted nala along toe part of hillslope for irrigation purpose in adjoining paddy field resulted in toe erosion and removal of toe support. The shear failure occurred due to decreased cohesive strength of slope forming material as a result of prolonged weathering and erosion. The construction of gabion wall with wire mesh and lined drainage should be provided at foot of hill slope as protective remedial measures to arrest the movement of soil and reduce the chance of loss of agriculture land. The area is demarcated as unstable zone.</p> |

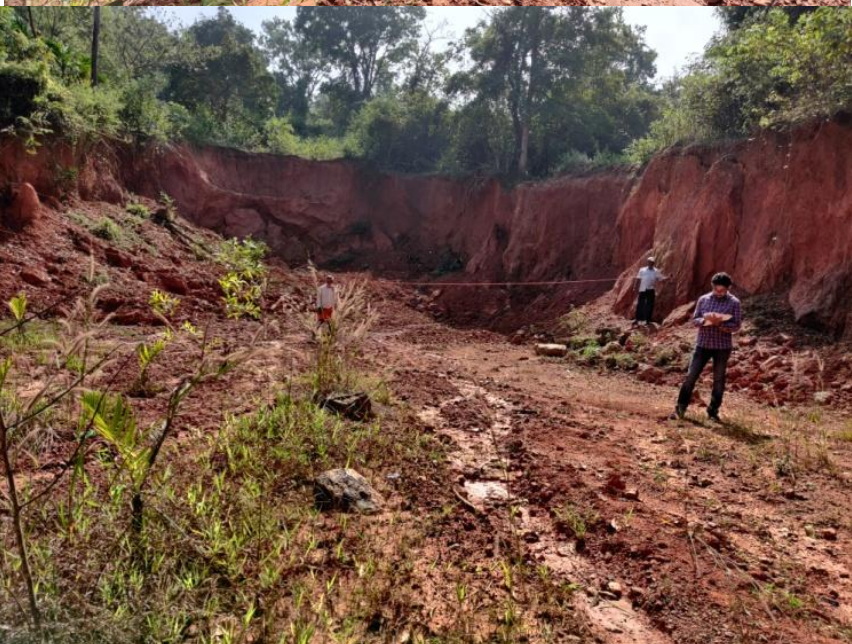
| 40 | Summary/Abstract | : | <p>The large dimension debris flow of ~100m run out distance recorded in Kanave village area on lowly dissected hillslope failed during heavy rainfall in August 2019. The water accumulated in trench made on top of hill under forest area resulted in water seepage and slope saturation. The over saturated slope failed during intense rainfall due to reduction in shear and cohesive strength of the slope forming material. The area is demarcated as unstable zone susceptible to slope failure during rainfall. The contact plane of ferruginous phyllite and quartz chlorite schist are prone to mass failure. The slope forming material consists of in-situ soil and highly weathered rock with overburden thickness is &gt;10m. The settlements in downslope direction are at high risk zone during rainfall.</p> |

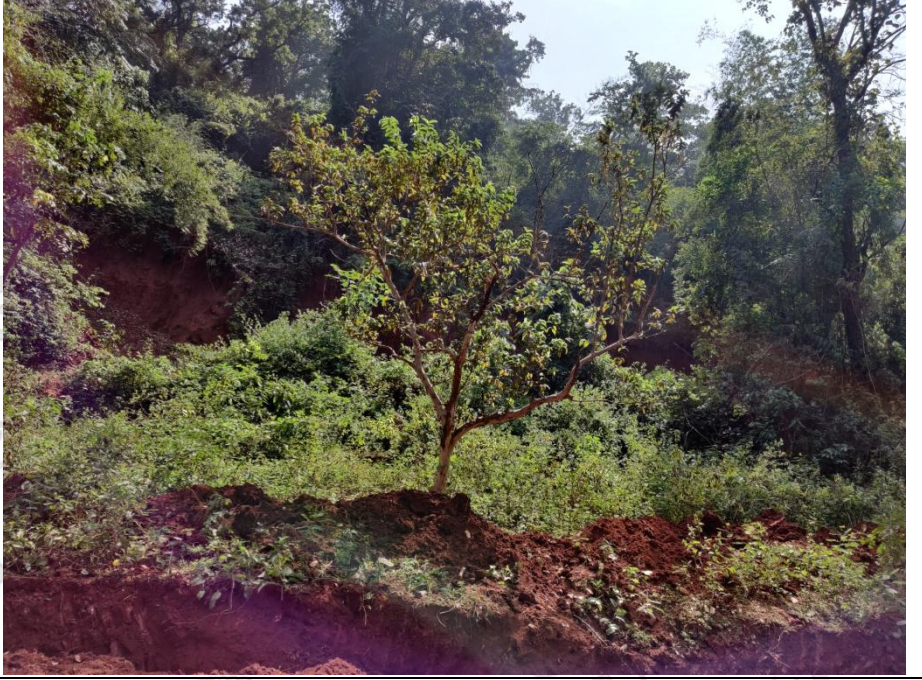
| 40 | Summary/Abstract | : | The vertical road cut failure is at concave curvature at road bench level. The vertical road cut failure at concave curvature at road bench level occurred due to intense weathering and erosion, increased pore water pressure resulted in cohesive and shear strength failure of the slope forming material. The lined drainage at toe part is required to avoid toe erosion and culvert should be constructed at suitable location to drain excess water downslope to minimize slope seepage and saturation. The slope forming material consists of in-situ soil and weathered rock. The overburden thickness is 5-10m. The area is demarcated as unstable zone susceptible to slope failure during rainfall. |

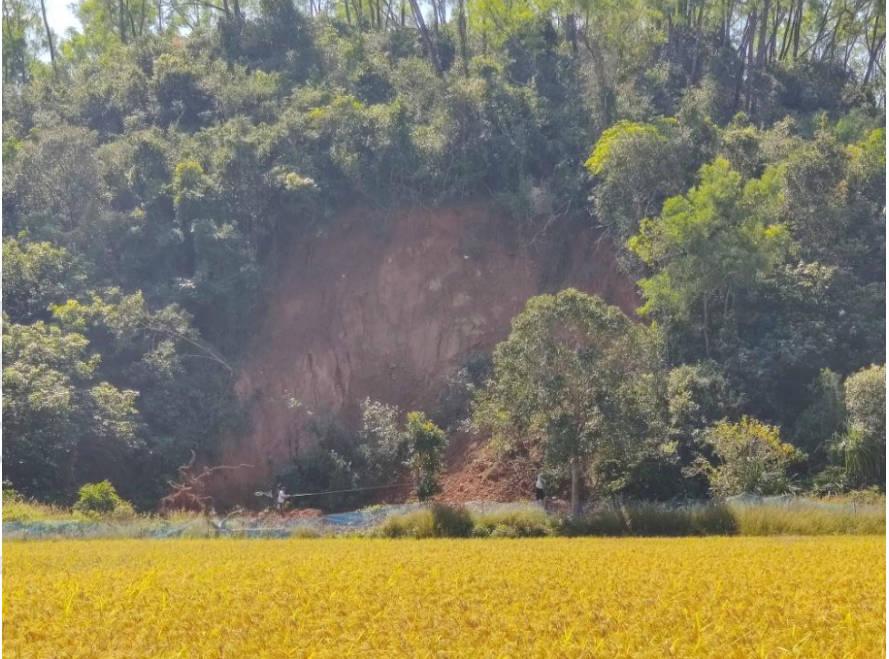
| 40 | Summary/Abstract | : | Debris slide occurred on lowly dissected slope with moderate to sparse vegetation. In present scenario the landslide is active & retrogressive in nature. The flowing stream at toe part contributes to toe erosion and removal of toe support. The shear failure occurred at Contact of highly weathered and kaolinised granite and amphibolites. The inundation of debris in agricultural land may results in loss of crop (Paddy) & agriculture land. The lined drainage with weep holes should be constructed and easing of slope should be done. The construction of gabion wall with wire mesh should be provided at foot of hill slope as protective remedial measures to arrest the movement of soil and reduce the chance of loss of agriculture land. |

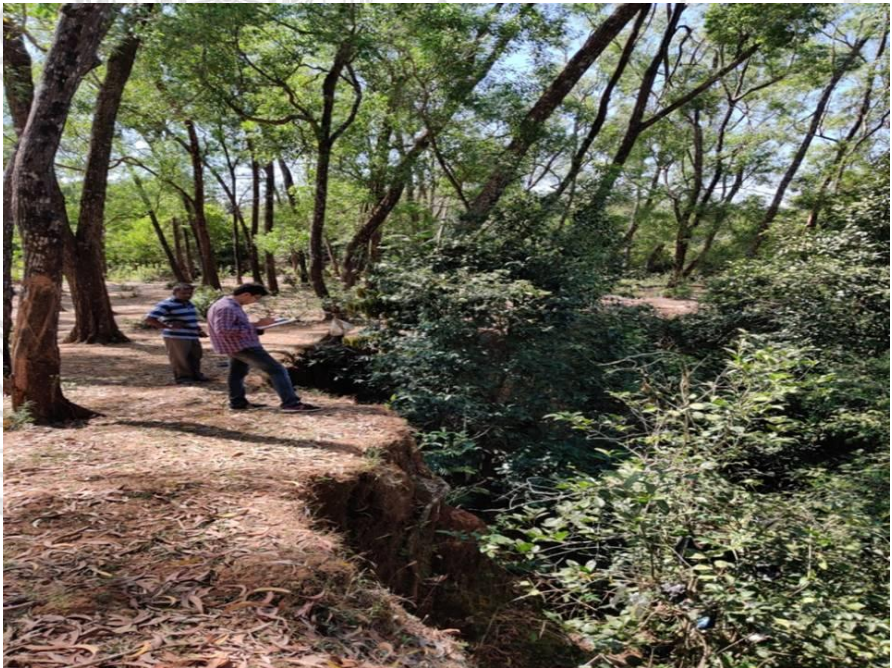
| 40 | Summary/Abstract | : | The debris slide occurred on hillslope due to unscientific way of removal of soil paved new pathway for water seepage that triggered |

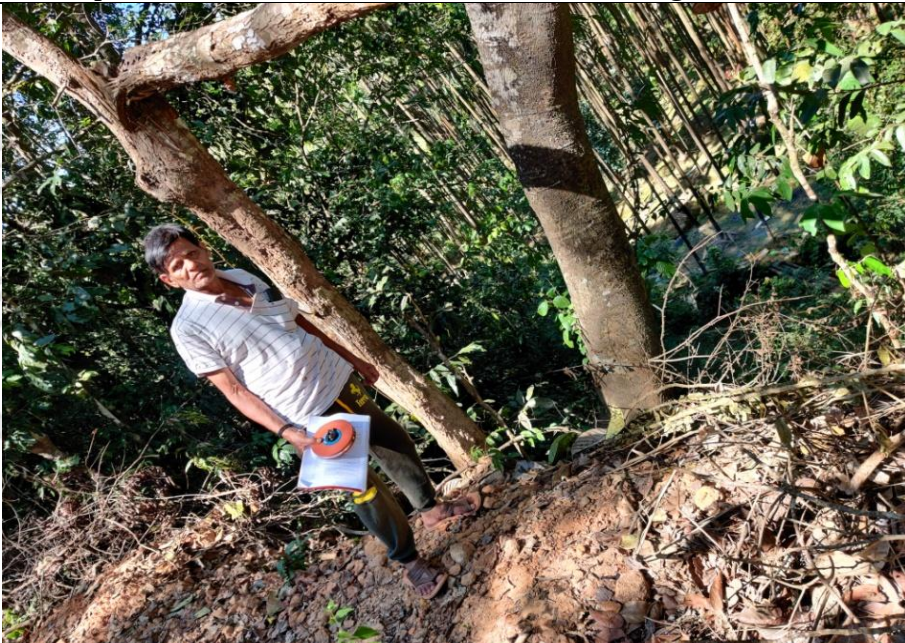
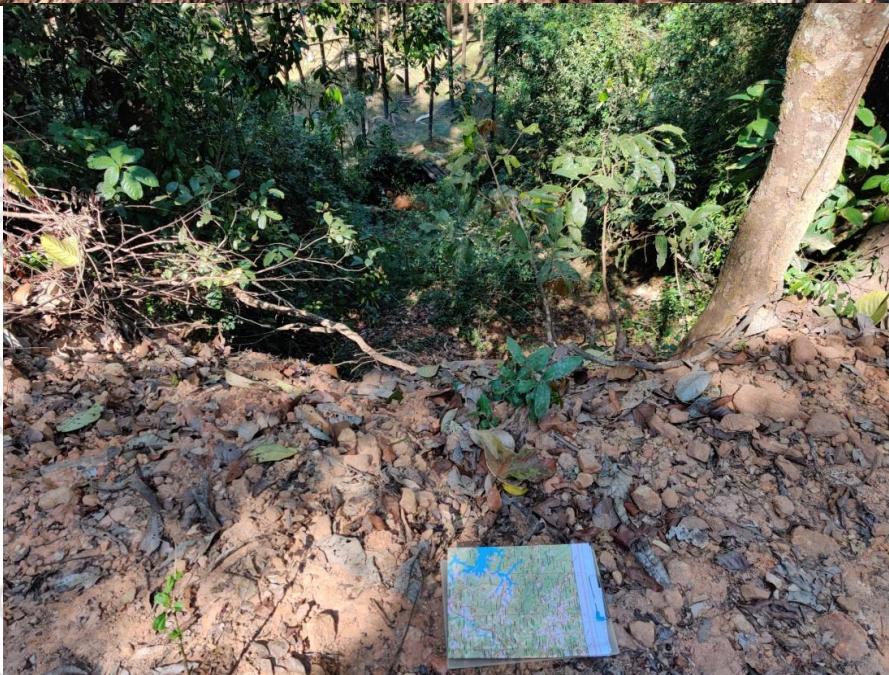
| 40 | Summary/Abstract | : | Creep movement in top slope resulted in small dimension debris slide at road bench level in downslope direction. Multiple slope failure occurred due to nala erosion by flowing nala at footslope. Cracks were observed on road are evidence of road subsidences. The lined drainage and culvert of suitable dimension should be constructed at suitable location to drain excess water downslope to minimise the chances of slope saturation and slope failure. The retaining wall with weep holes should be constructed in downslope direction for toe support. The slope is unstable and should be monitored during monsoon. |

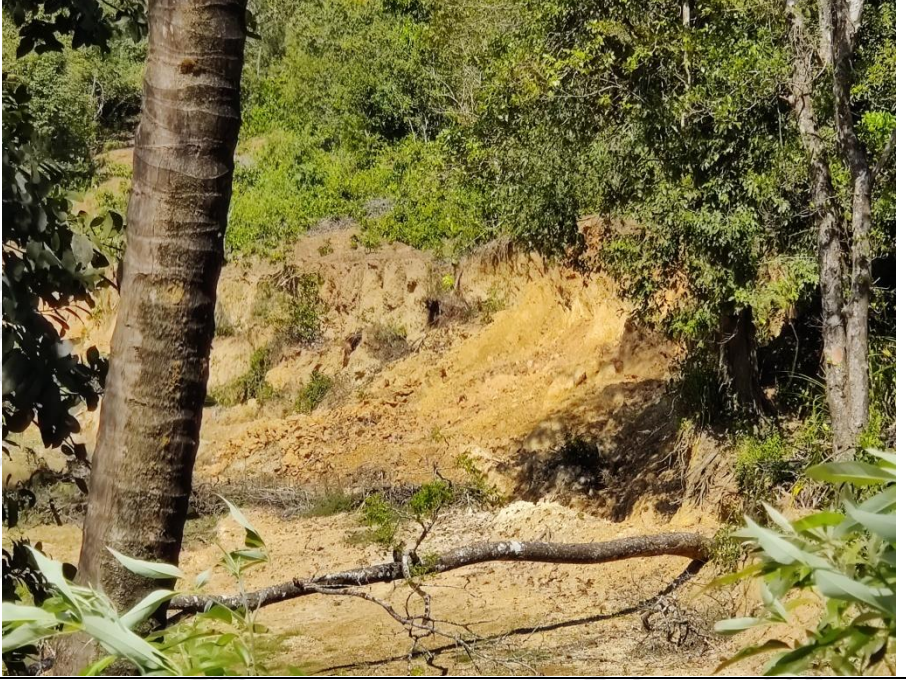
| 40 | Summary/Abstract | : | The debris slide occurred due to toe cutting of hillslope for widening of agricultural land. The drainage at toe part caused due to toe erosion and removal of toe support. The prolonged seepage and saturation resulted in hillside collapse due to loss in cohesive strength of slope forming material. Easing of slope is required. Gabion wall with wire mesh can be made to arrest the soil slip by toe erosion. The area is meta-stable. |

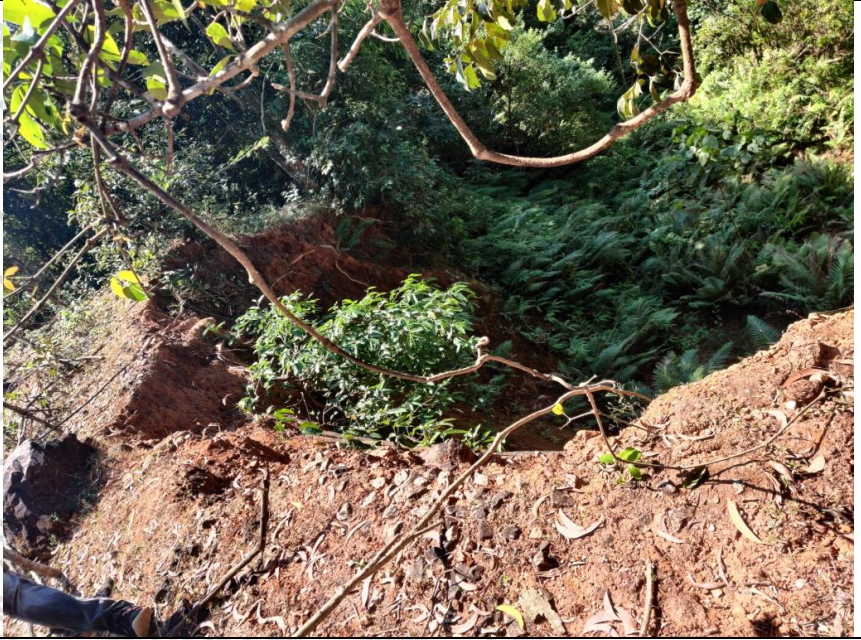
| 40 | Summary/Abstract | : | The multiple slope failures and road subsidences occurred at road bench level occurred due to creep movement in upslope and nala erosion at footslope. Effective drainage measures i.e. lined drainage and culvert of suitable dimension should be constructed at suitable location on upslope to drain excess water downslope to minimize slope saturation. |

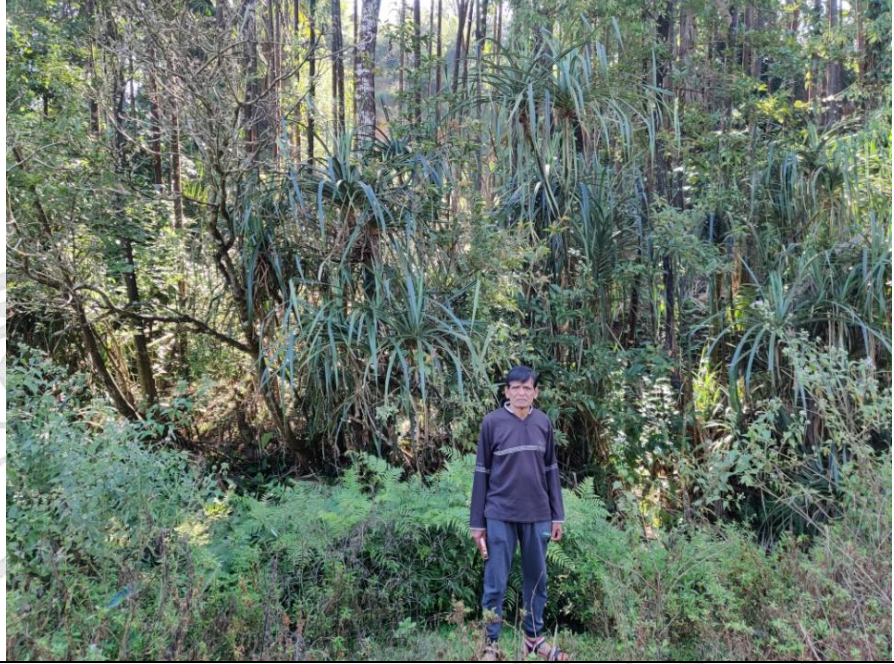
| 40 | Summary/Abstract | : | The slope failure occurred due to nala erosion and increased pore water pressure resulted in decreased shear strength failure of soil mass. Gabion wall may be constructed for toe support and to minimize toe erosion. |

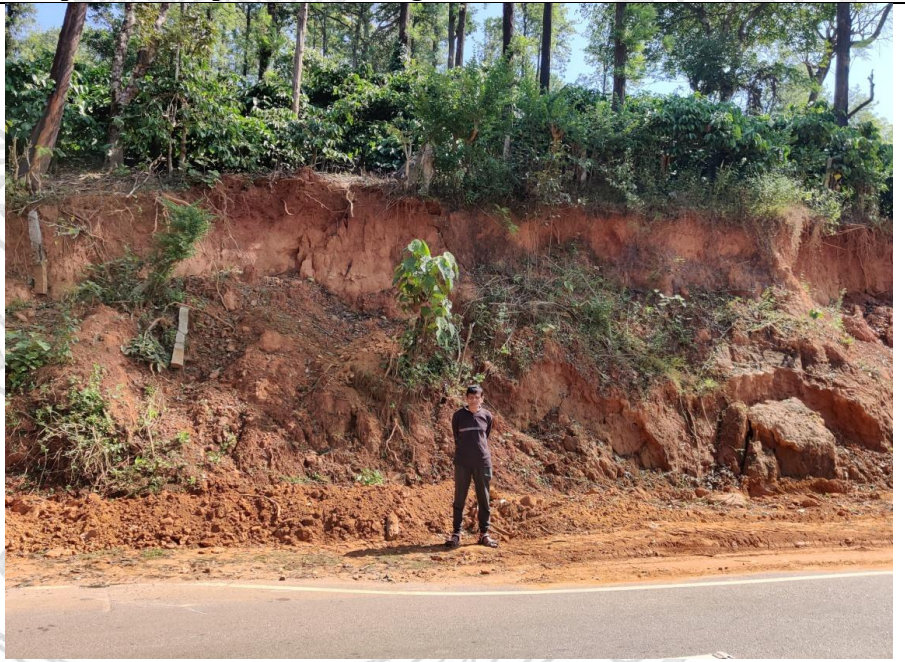
| 40 | Summary/Abstract | : | The vertical road cut failure is at concave curvature at road bench level caused due to intense weathering and erosion and loss of cohesive strength of the soil. Failure occurred along the contact of Quartz chlorite schist and Ferruginous phyllite. The slope forming material consists of in-situ soil and weathered rock. The overburden thickness is 5-10m. The lined drainage at toe part is required to avoid toe erosion and culvert should be constructed at suitable location to drain excess water downslope to minimize slope seepage and saturation. Slope gradation is required. The area is demarcated as unstable zone susceptible to slope failure during rainfall. |
