MESO-SCALE (1:10,000) LANDSLIDE SUSCEPTIBILITY MAPPING IN SUNKASALE  
AREA, CHIKMAGALUR DISTRICT, KARNATAKA.

Toposheet no. 48O/08

FSP CODE: M4LSSM/NC/SR/SU-KG/2022/42400

कार्य सत्र: 2022-23 का अंतिम प्रतिवेदन  
Final Report for Field Season 2022-2023

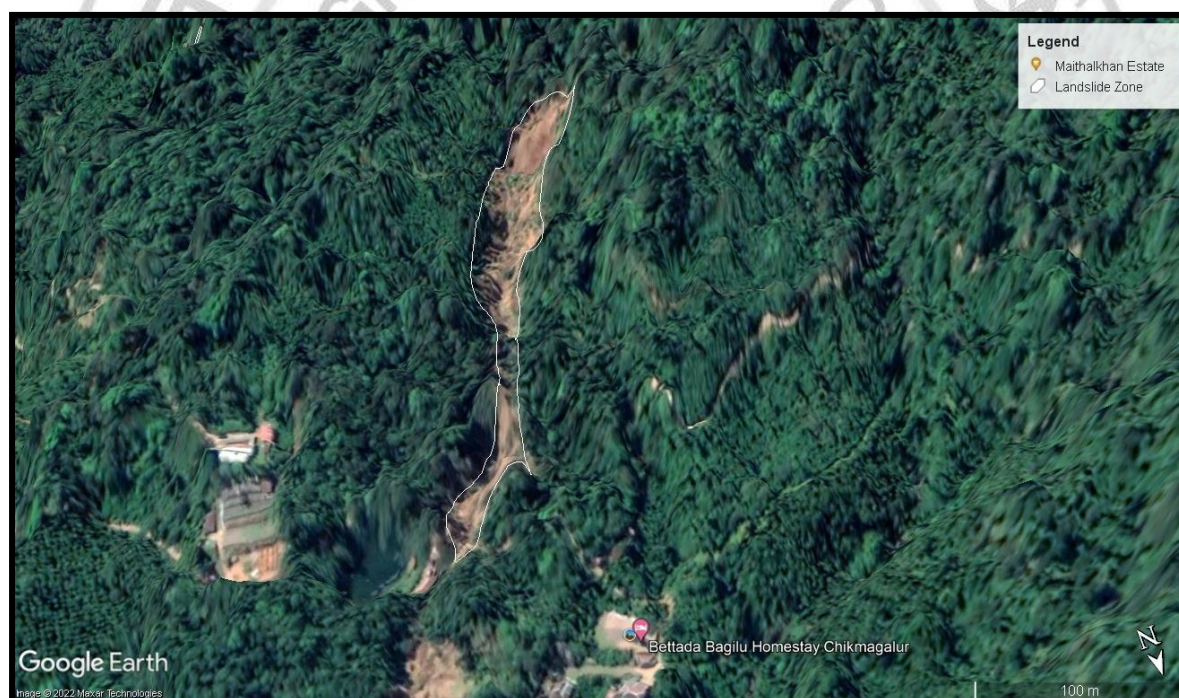
**Figure 39: Major Hulikatte landslide from Google image**

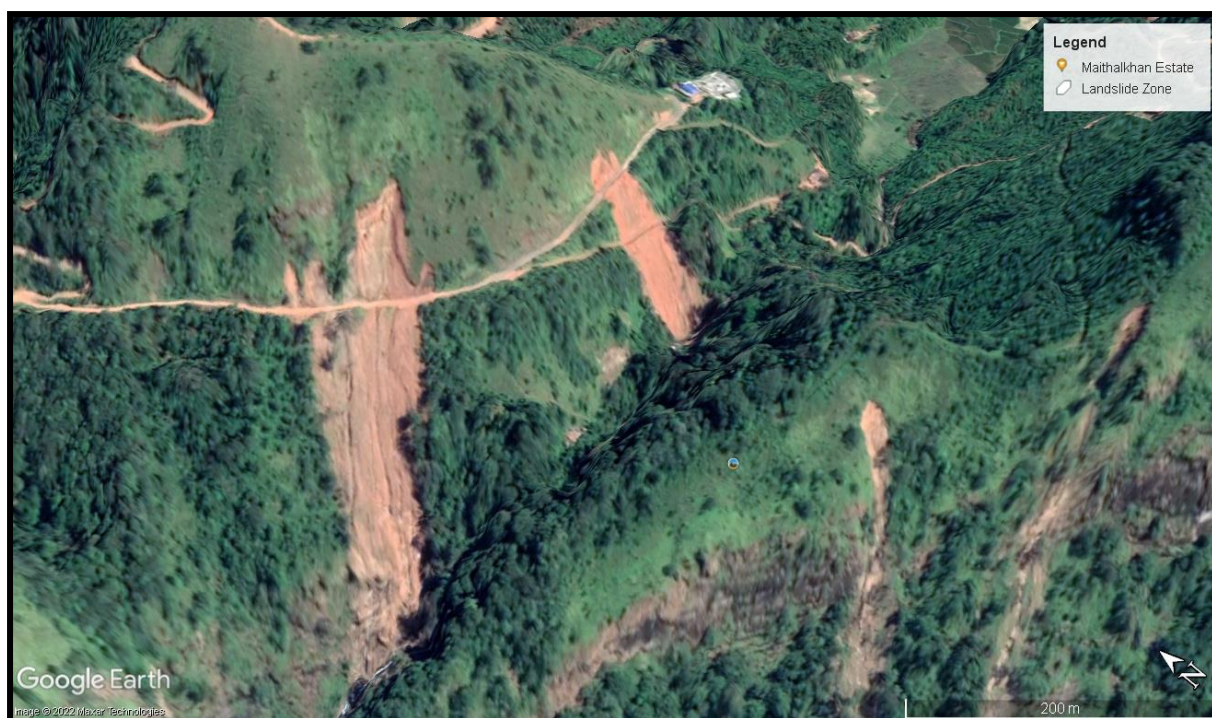
**Fig 40: Landslide near Maidadi Estate**

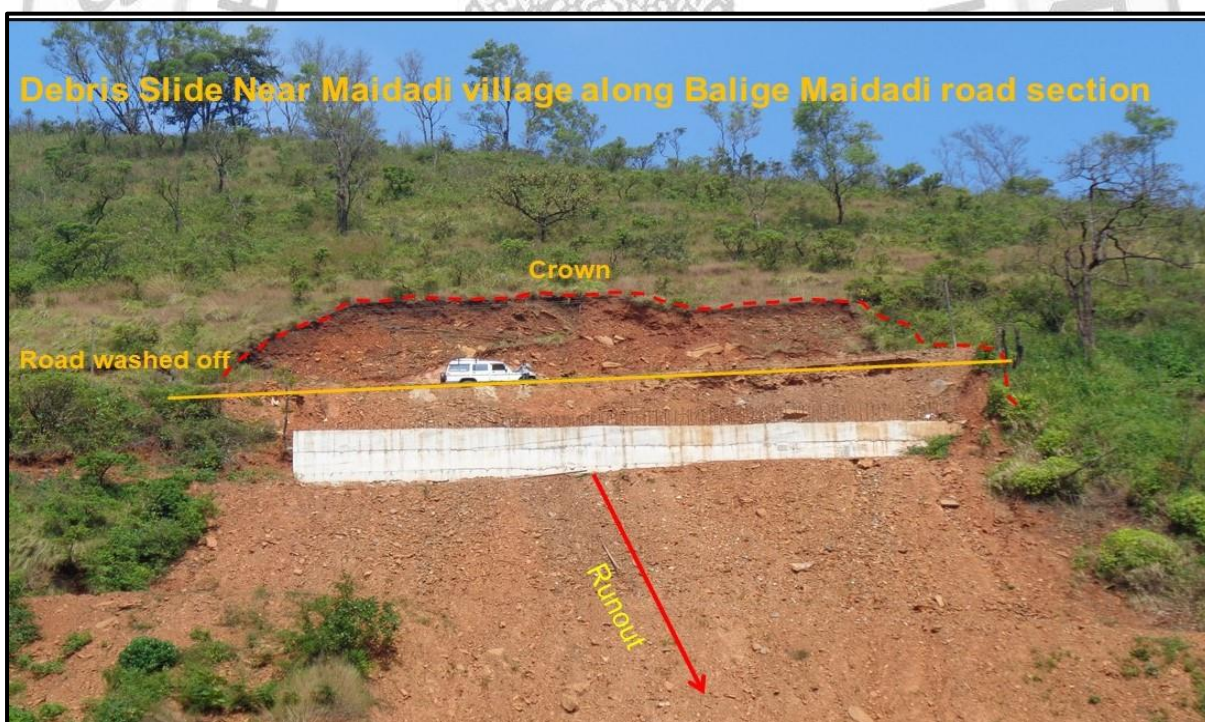
**Photo 4: Major treated landslide near Maidadi estate**

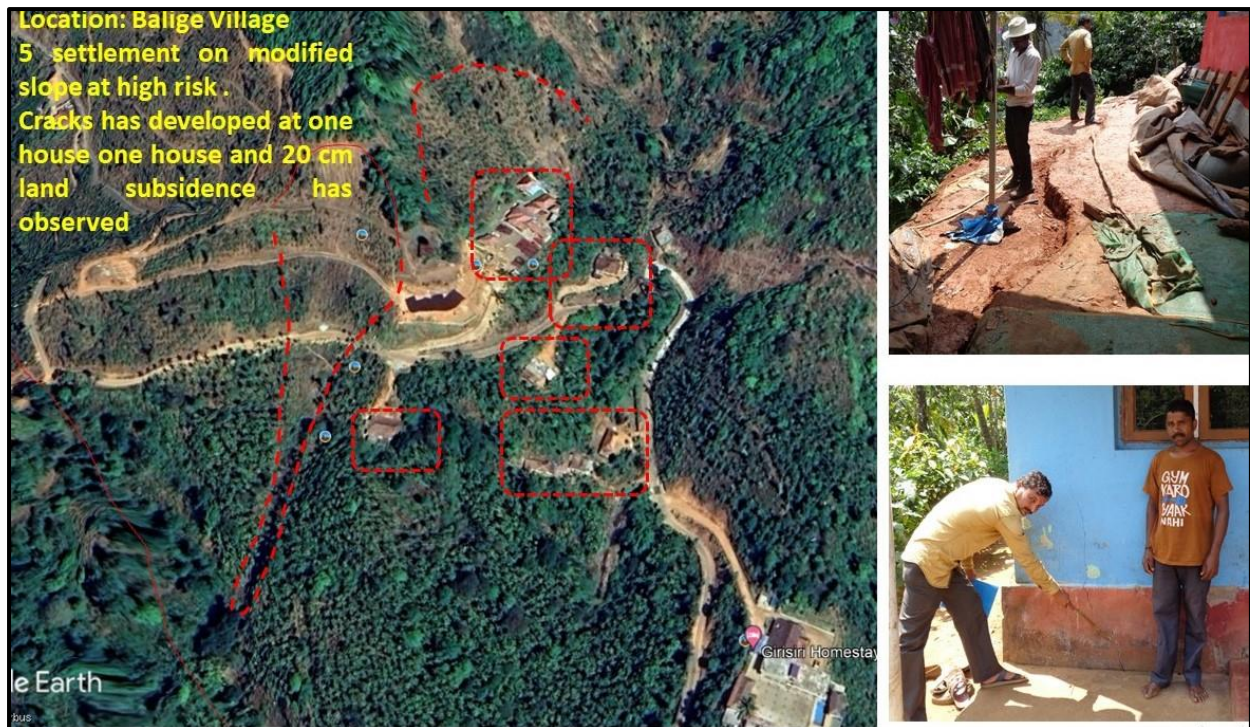
**Fig 41: Bommarrakallu homestay and the vulnerable spots.**

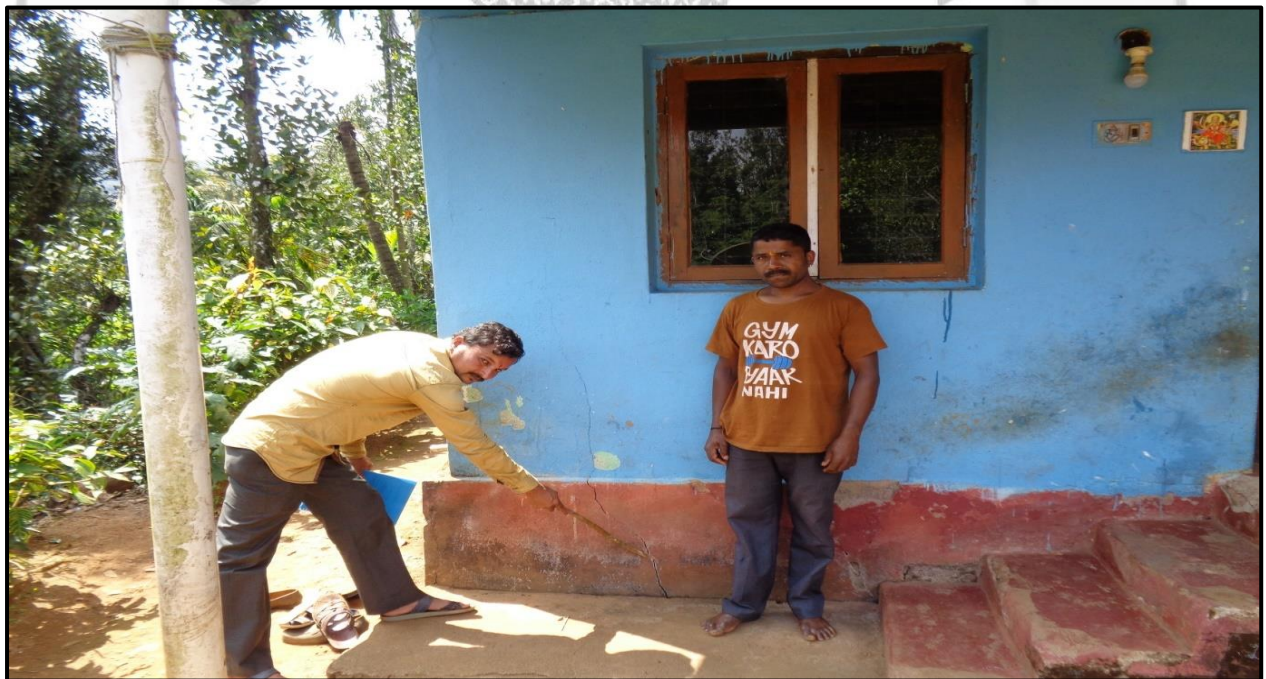
**Photo 5: Cracks affected house near Bomarakallu homestay.**

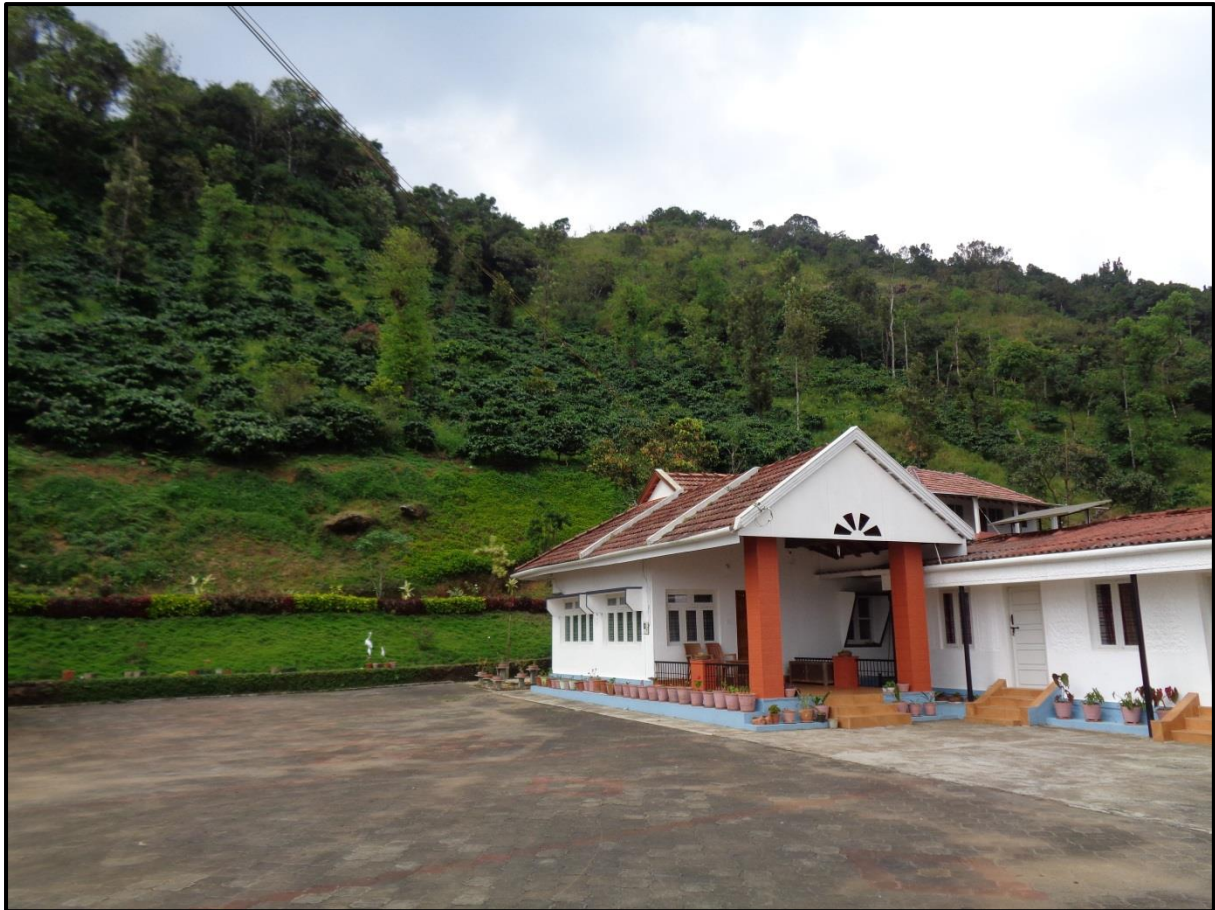
**Photo 6: Bomarakallu homestay located at the cut section of the hill.**

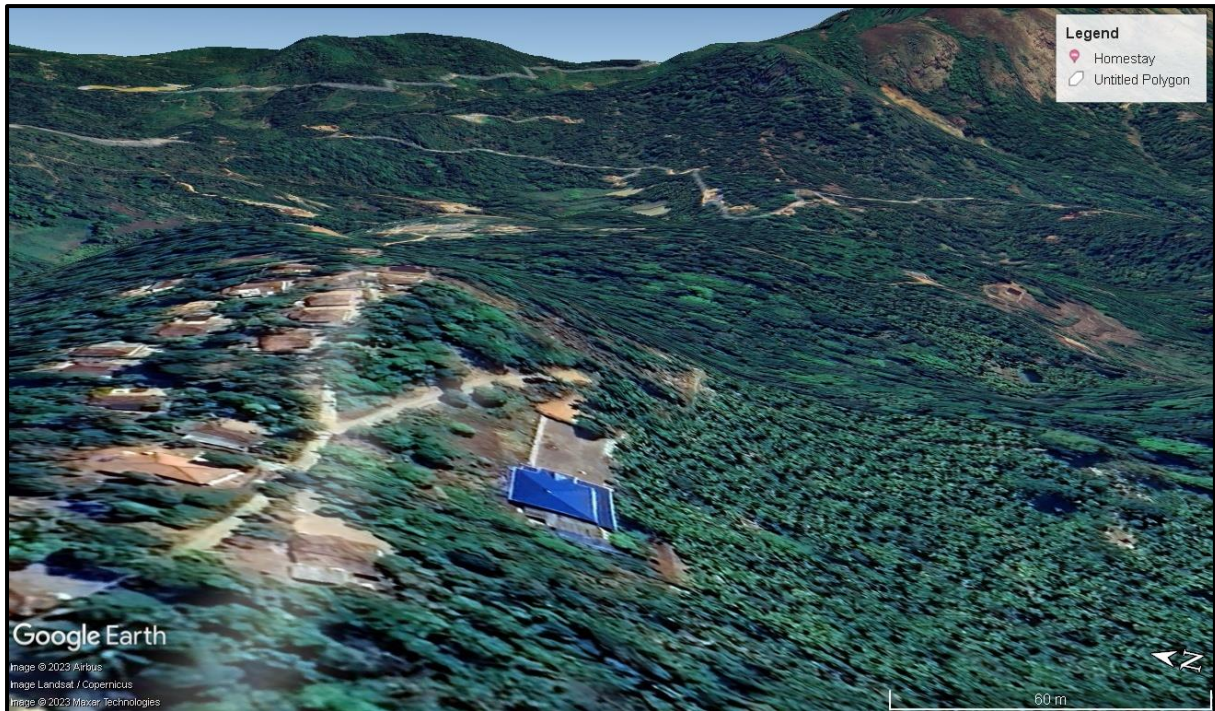
**Figure 42: Overview of Durgadhahalli vulnerable spot around the blue house.**

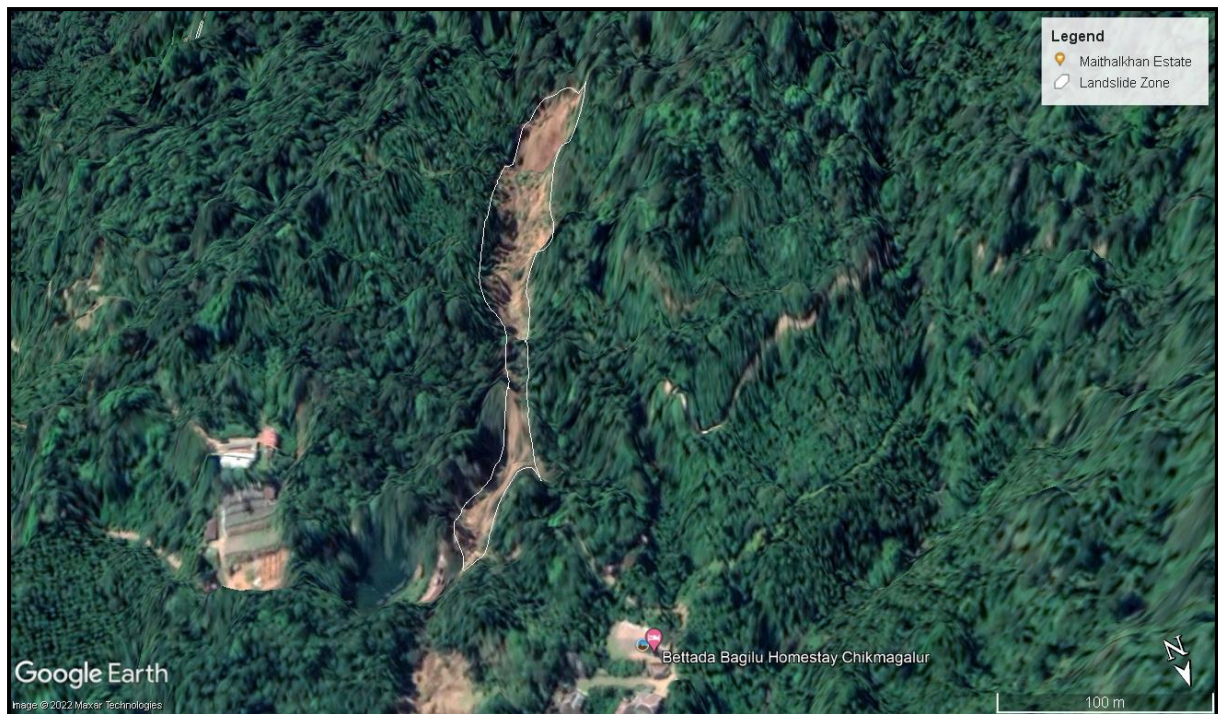
**Figure 43: Major Hulikatte landslide from Google image**

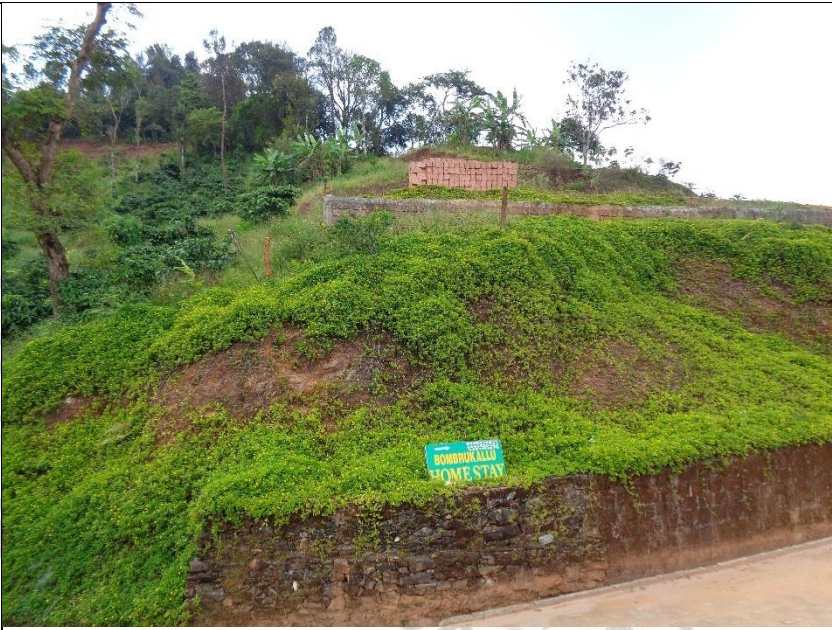
| 40 | Summary/Abstract | At the crown part one kutcha road has constructed and disturbed the natural slope with unplanned cutting. The overburden material is present. During intense rainfall, there are favorable condition for planar failure due to increasing of pore water pressure and reduction of strength on supersaturation of highly weathered material present at upslope and downslope. |

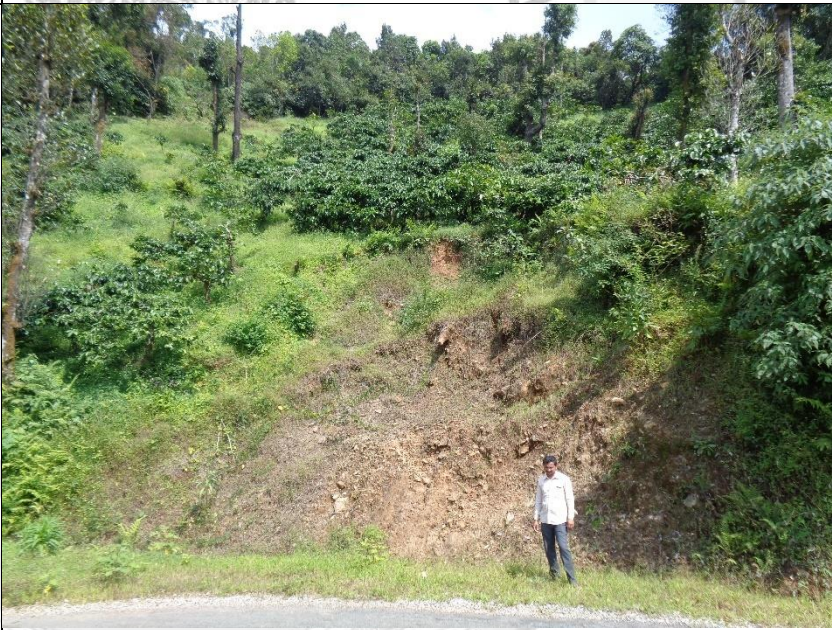
| 40 | Summary/Abstract | At this site upslope and downside coffee plantations are present. Highly weathered zone. Planar failure due to increasing of pore water pressure and reduction of strength on supersaturation. Anthropogenic activities which is unplanned cutting of slope. |

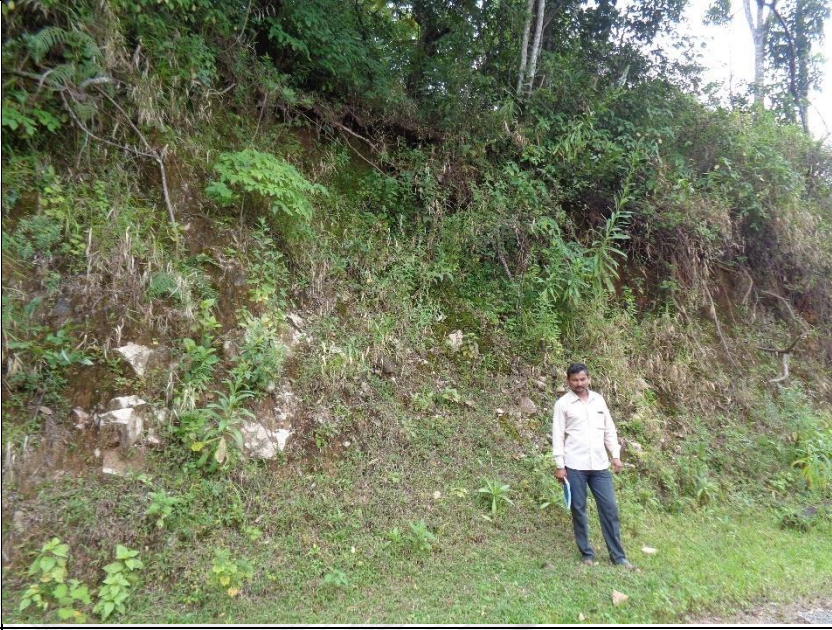
| 40 | Summary/Abstract | Planar failure due to increasing of pore water pressure and reduction of strength on supersaturation. Anthropogenic activities which is unplanned cutting of slope. Presently this is stable. |

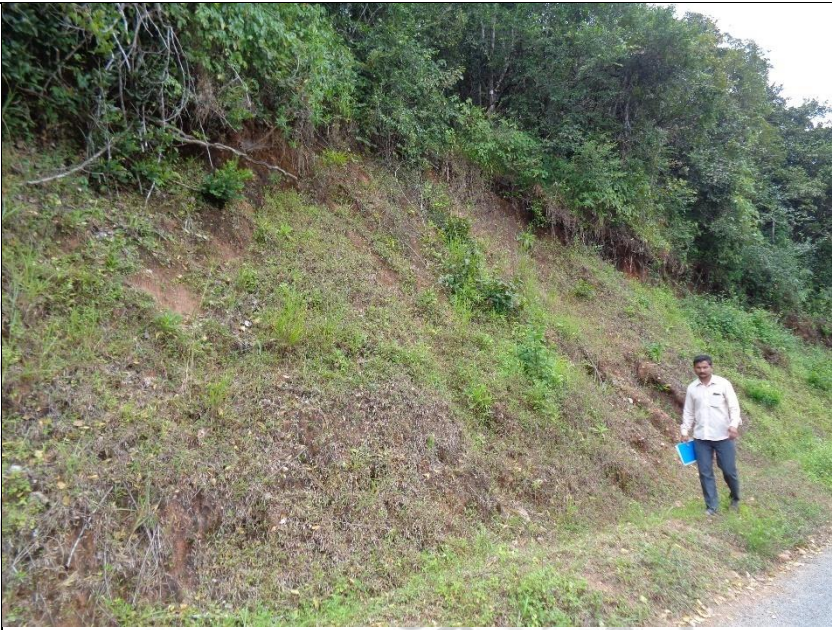
| 40 | Summary/Abstract | Planar failure due to increasing of pore water pressure and reduction of strength on supersaturation. Slope benching and one retaining structure is required as one settlement on modified slope is present. |

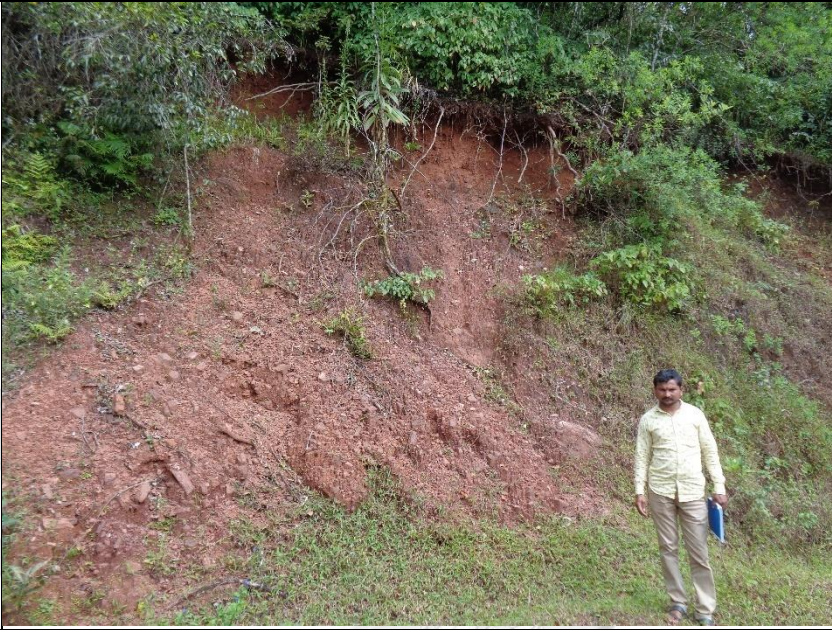
| 40 | Summary/Abstract | The area is fully weathered and have thick pile of overburdened material. Planar failure due to increasing of pore water pressure and reduction of strength on supersaturation. Anthropogenic activities which is unplanned cutting of slope. Slope benching and drainage with culvert is required. |

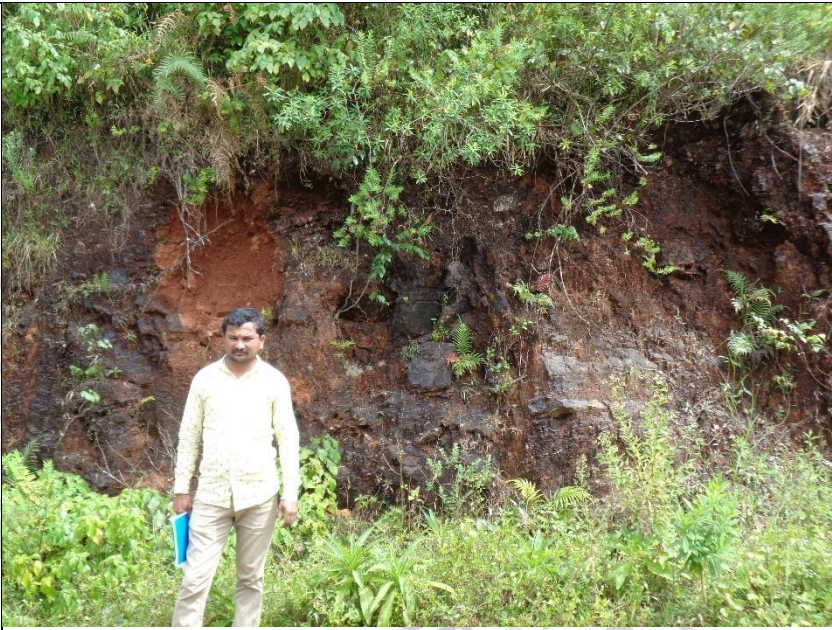
| 40 | Summary/Abstract | The site is moderately weathered. Planar failure due to increasing of pore water pressure and reduction of strength on supersaturation. Anthropogenic activities which is unplanned cutting of slope. Downside of the road one house is situated in the valley. |

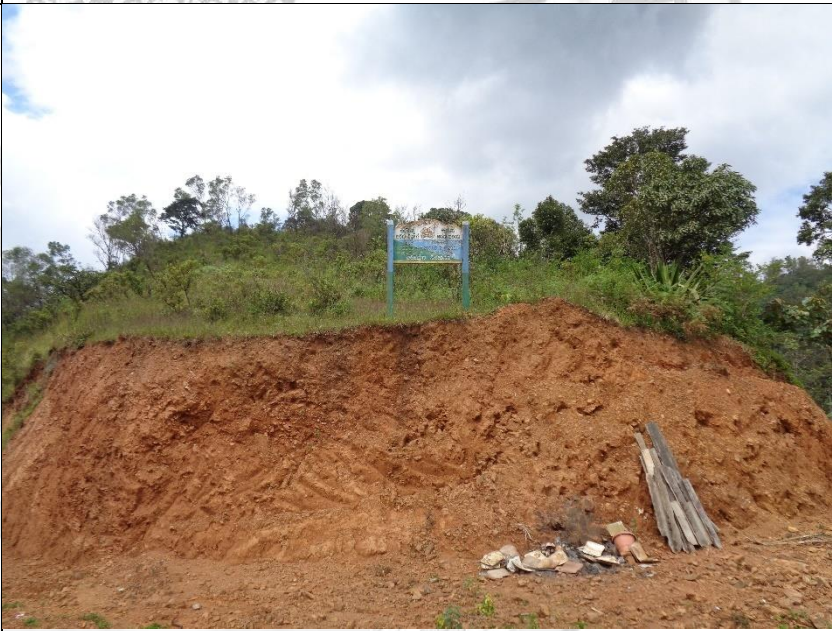
| 40 | Summary/Abstract | At upslope sparse vegetation is present and the area comes under government forest land. Planar failure due to increasing of pore water pressure and reduction of strength on supersaturation. Anthropogenic activities which is unplanned cutting of slope. Extensive cut slope has converted into landslide. |

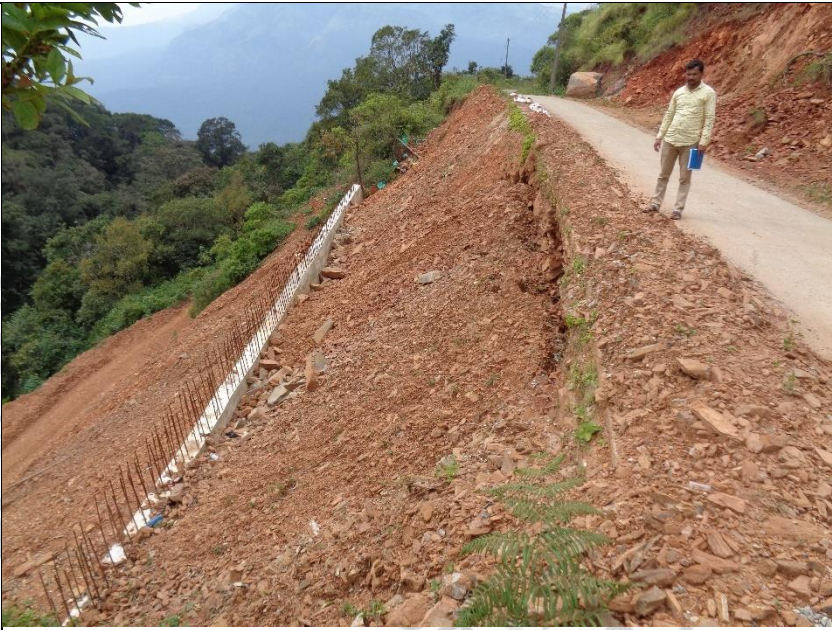
| 40 | Summary/Abstract | Planar failure due to increasing of pore water pressure and reduction of strength on supersaturation. Anthropogenic activities which is unplanned cutting of slope. Slope easing and retaining wall should be constructed at toe level with proper dimension with weep holes. Upslope line drainage are recommended. Retaining wall under construction at toe level. Downside higher order stream is flowing. |

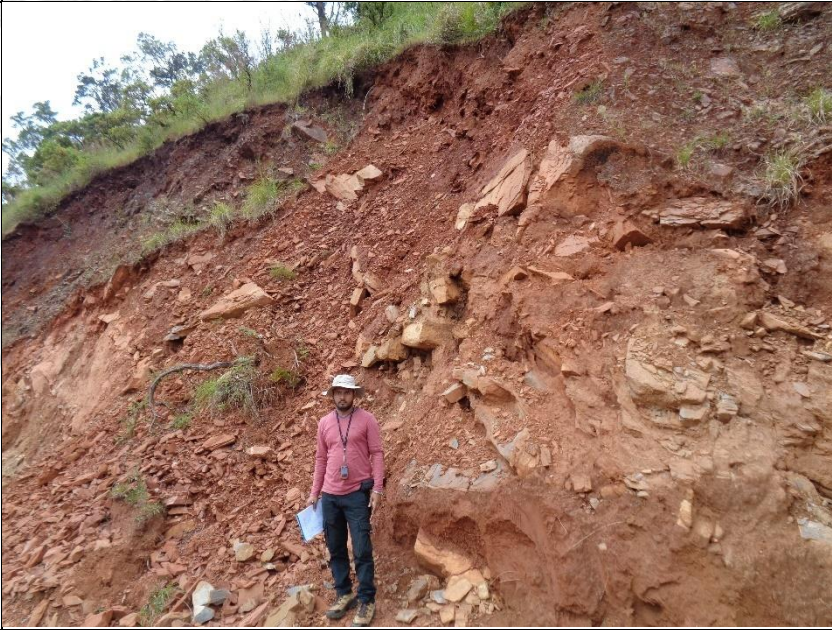
| 40 | Summary/Abstract | Slope easing and retaining wall should be constructed at toe level with proper dimension with weep holes. Upslope proper drainage are recommended. Retaining wall under construction at toe level. Downside higher order stream is flowing. |

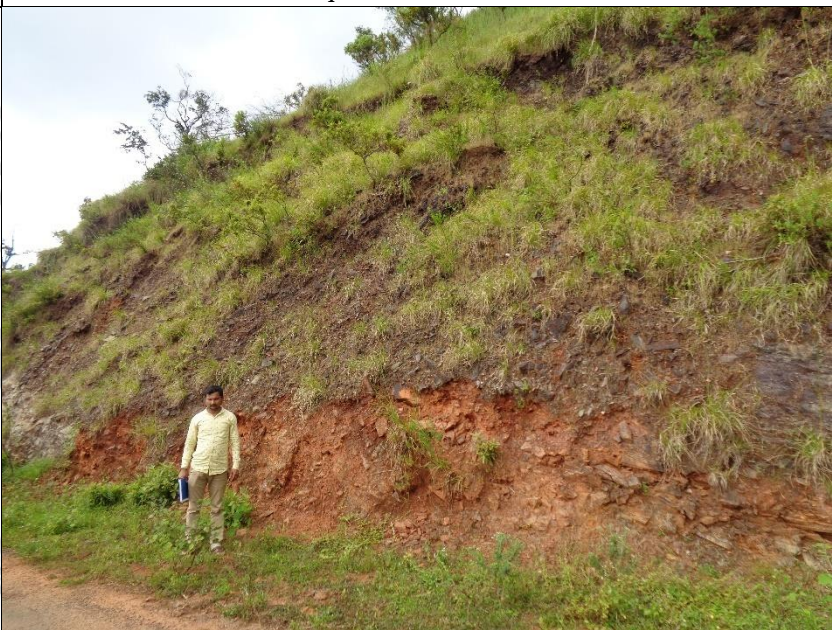
| 40 | Summary/Abstract | Planar failure due to increasing of pore water pressure and reduction of strength on supersaturation. Anthropogenic activities which is unplanned cutting of slope. Remove the debris from slope, Slope easing. Downside of the road drainage is recommended. For road safety remedial measure are required. |

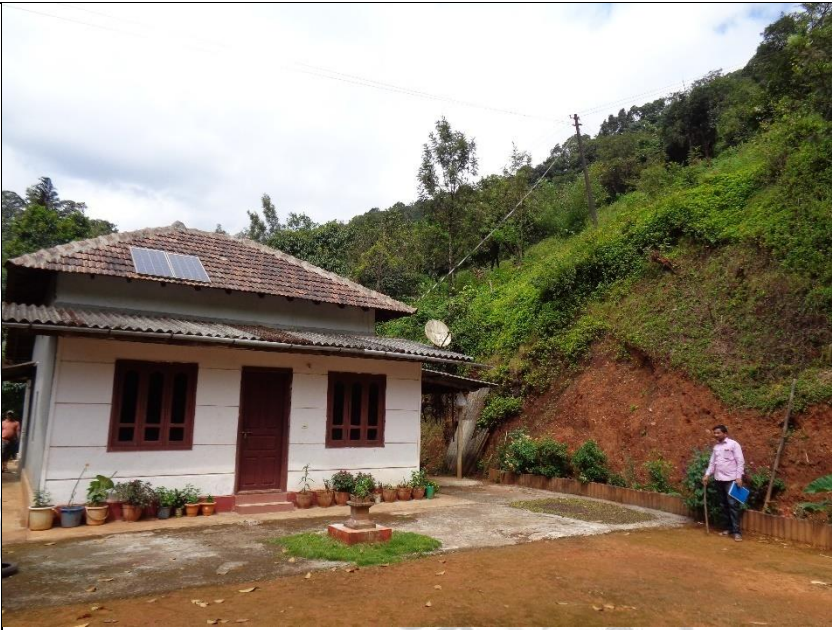
| 40 | Summary/Abstract | For house construction extensive cut slope made at downside and presently slumping is observed near boundary wall. Slope benching and drainage at toe level is recommended. |

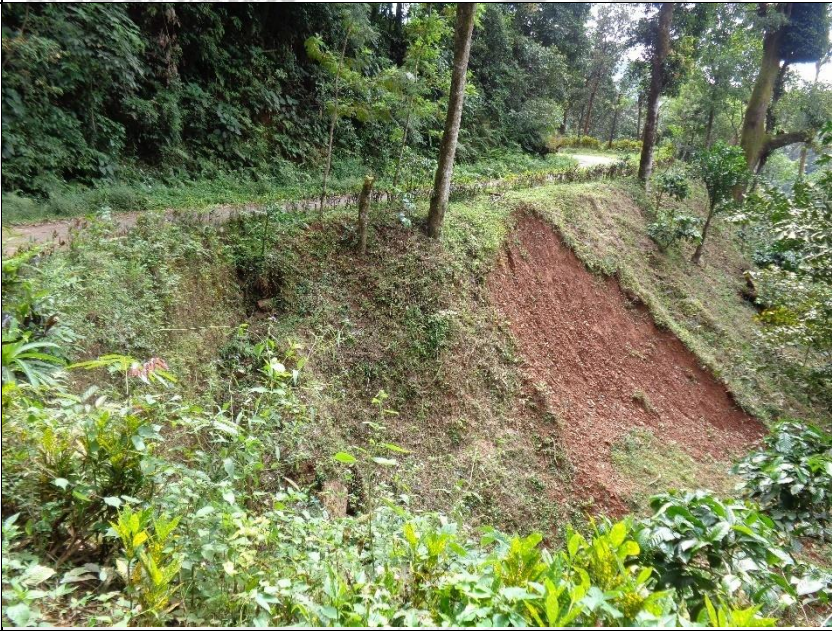
| 40 | Summary/Abstract | Toe erosion by stream causes landslide. At Upslope and downslope remedies are required. Stream is flowing, so to avoid toe erosion proper culvert is required for flowing stream. |

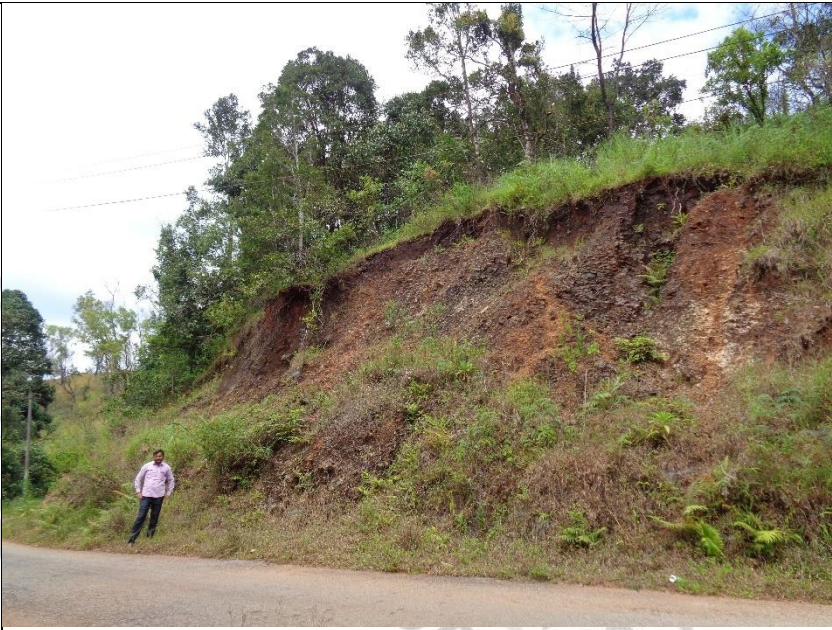
| 40 | Summary/Abstract | Upslope sparse vegetation and in valley portion moderate vegetation. Drainage has given which is earthen cemented drainage is required. |

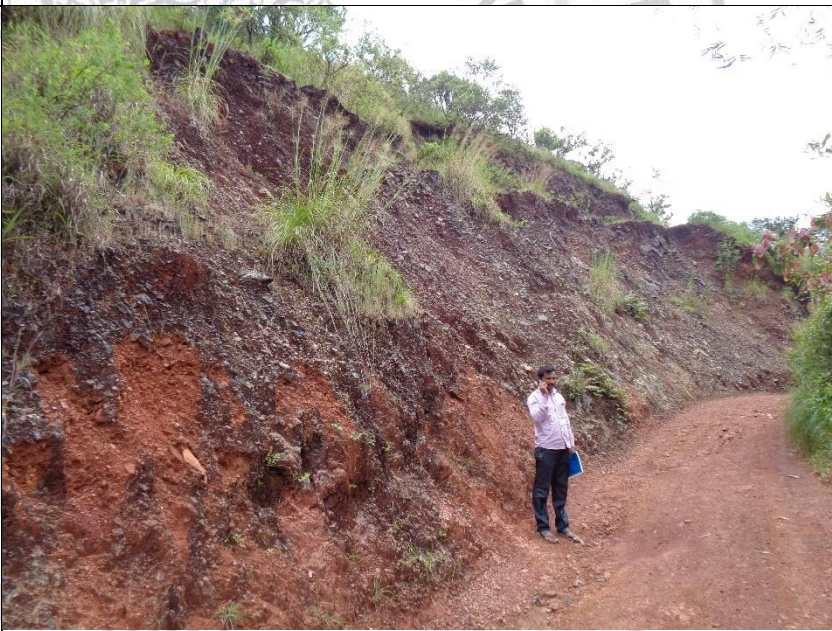
| 40 | Summary/Abstract | Planar failure due to increasing of pore water pressure and reduction of strength on supersaturation. Anthropogenic activities which is unplanned cutting of slope. Slope benching & drainage has recommended. |

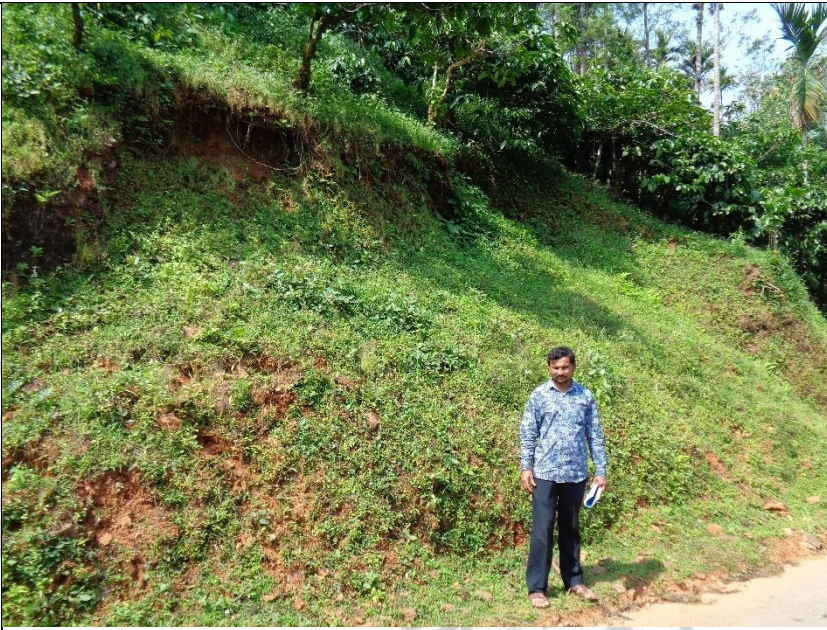
| 40 | Summary/Abstract | Planar failure due to increasing of pore water pressure and reduction of strength on supersaturation. Anthropogenic activities which is unplanned cutting of slope. Slope benching & drainage has recommended. |

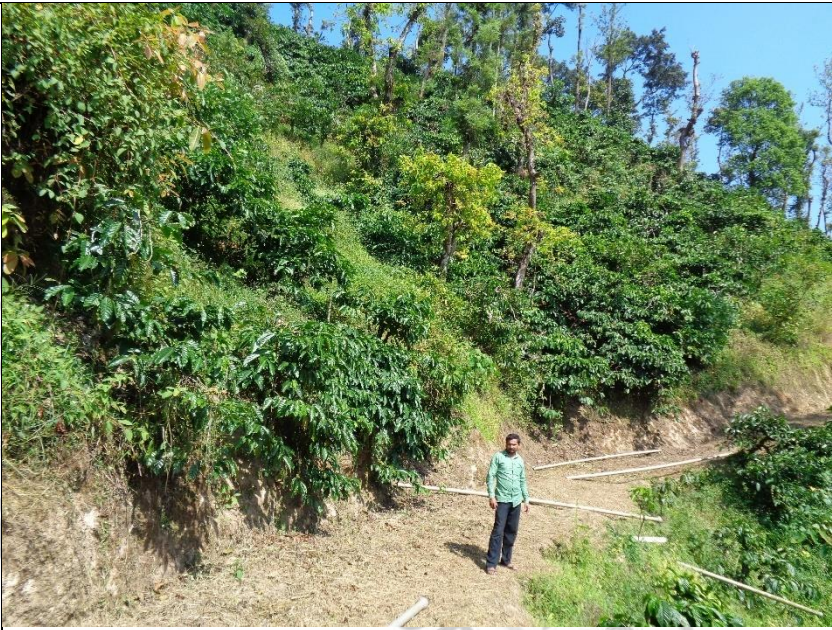
| 40 | Summary/Abstract | Both side of the slope coffee plantation are present. The rock is completely weathered and converted into overburden material. Planar failure due to increasing of pore water pressure and reduction of strength on supersaturation. Anthropogenic activities which is unplanned cutting of slope. Deep root plantations & benching should be done. |

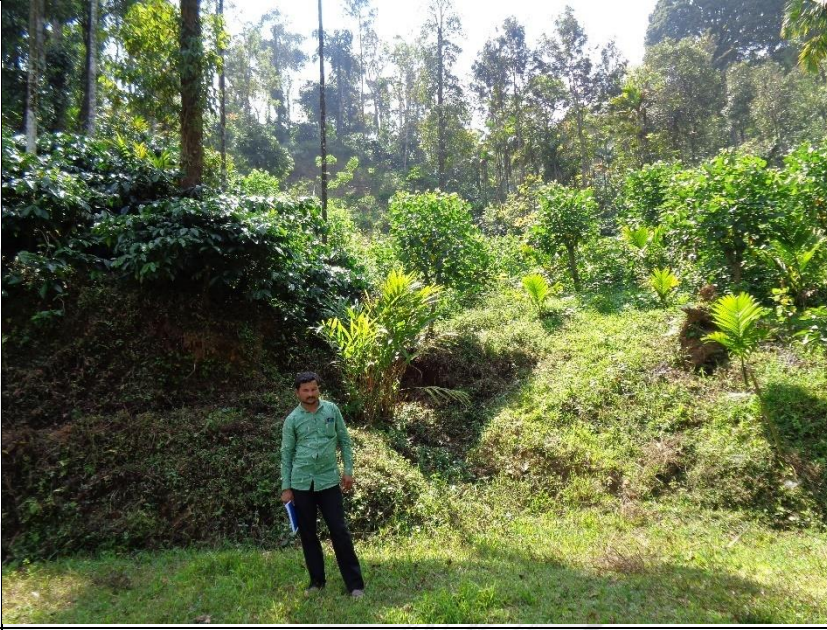
| 40 | Summary/Abstract | Deep rotational debris slide in coffee plantation along the road side multiple scar is present. Gulley erosion and rill wash is also observed. |

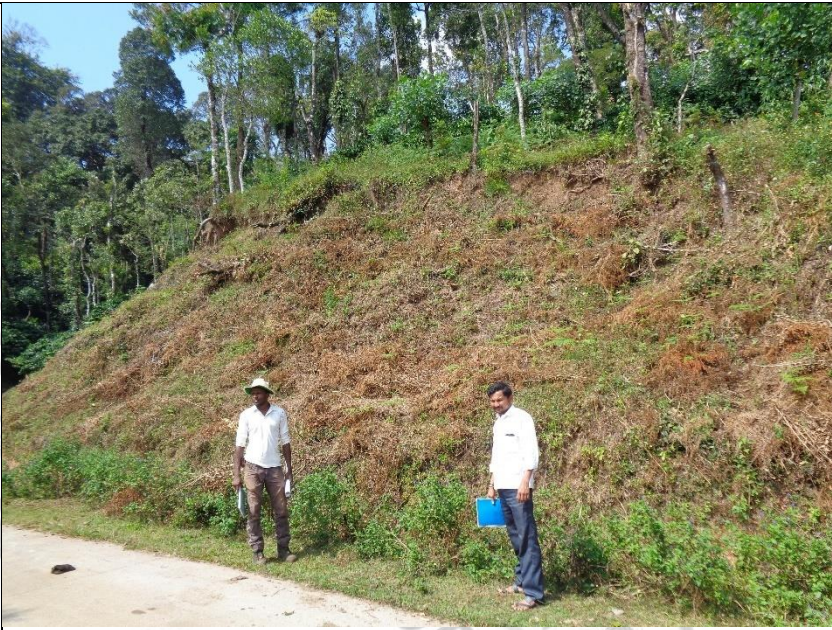
| 40 | Summary/Abstract | Planar failure due to increasing of pore water pressure and reduction of strength on supersaturation. Anthropogenic activities which is unplanned cutting of slope. Drainage are required to free flow of water& benching should be done. |

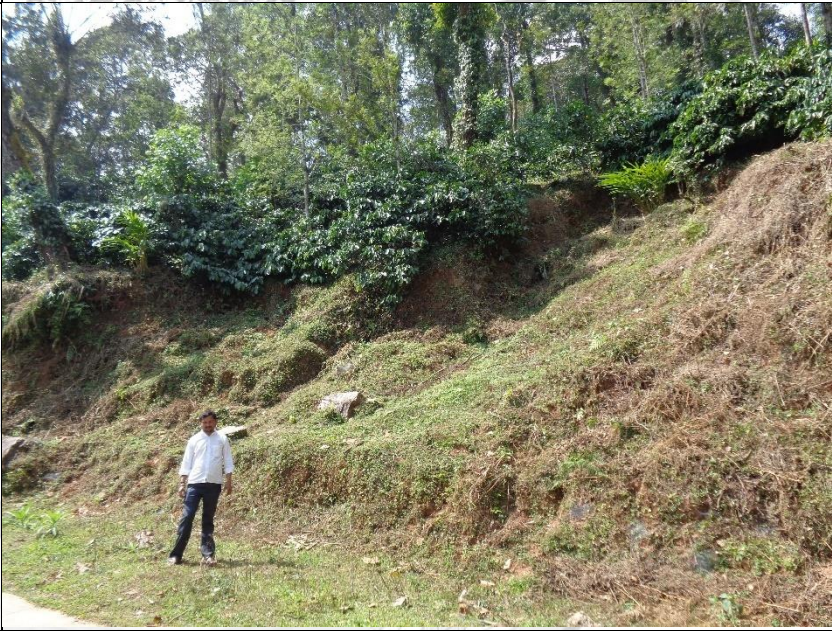
| 40 | Summary/Abstract | Planar failure due to increasing of pore water pressure and reduction of strength on supersaturation. Anthropogenic activities which is unplanned cutting of slope. Drainage are required to free flow of water, benching should be done & deep root plantation are suggested. |

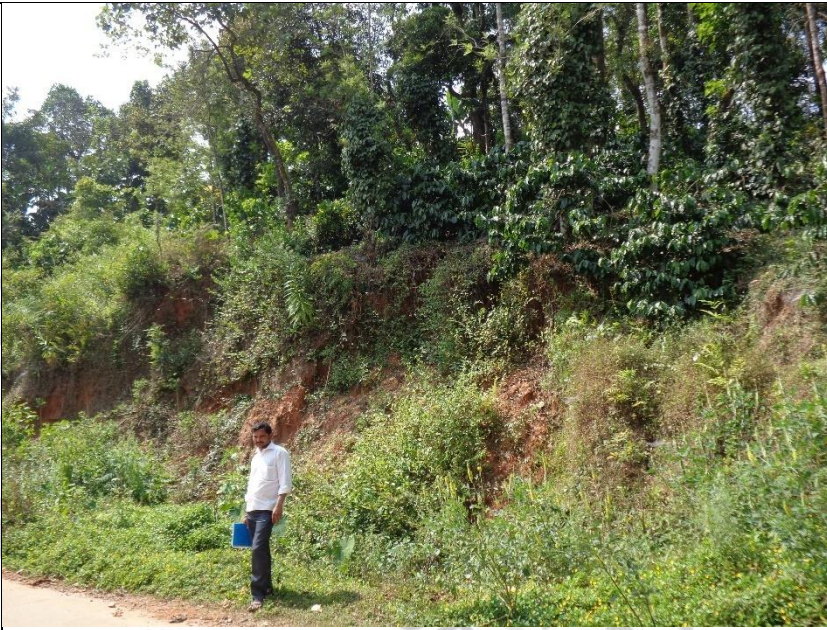
| 40 | Summary/Abstract | Planar failure due to increasing of pore water pressure and reduction of strength on supersaturation. Anthropogenic activities which is unplanned cutting of slope. Drainage are required to free flow of water, benching should be done & deep root plantation are suggested. |

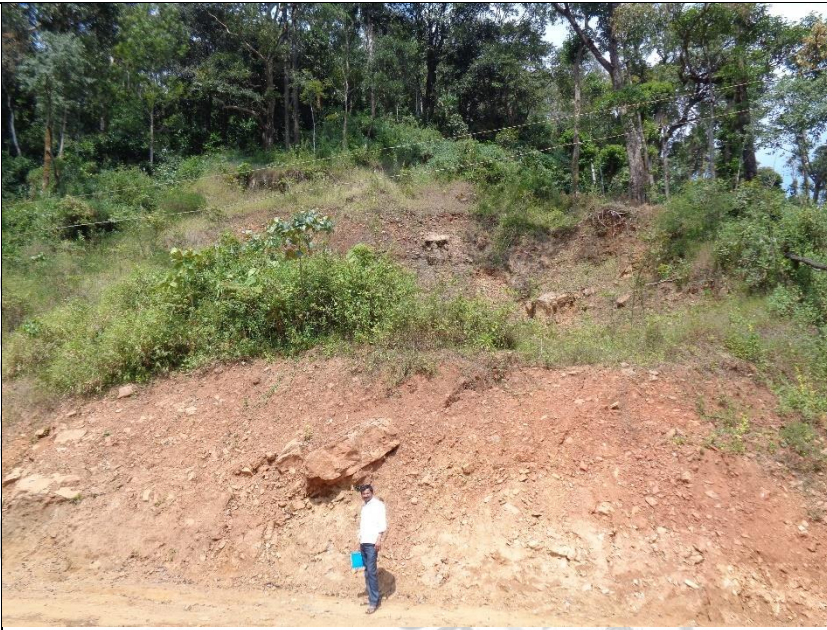
| 40 | Summary/Abstract | Planar failure due to increasing of pore water pressure and reduction of strength on supersaturation. Anthropogenic activities which is unplanned cutting of slope. Slope Benching & drainage with culvert required. This site is not safe for any construction for future. |

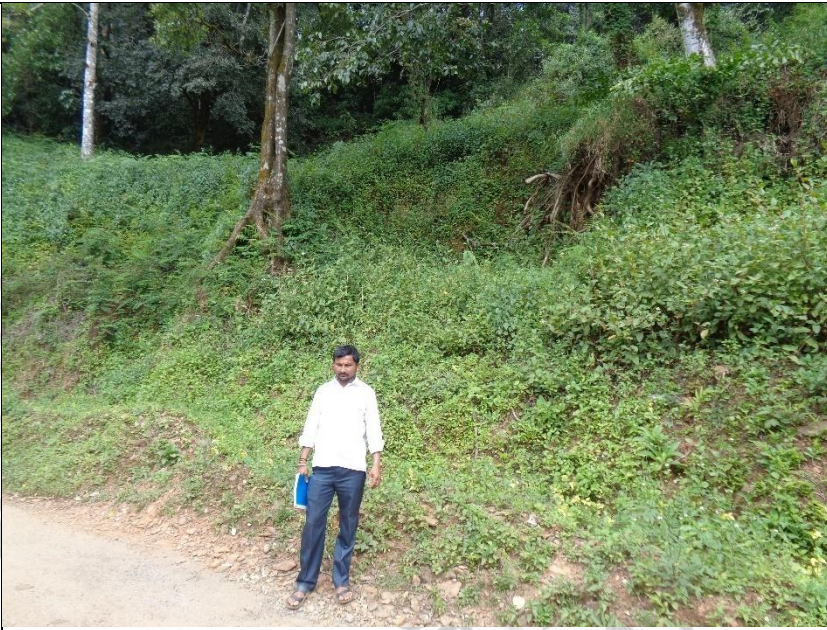
| 40 | Summary/Abstract | Planar failure due to increasing of pore water pressure and reduction of strength on supersaturation. Anthropogenic activities which is unplanned cutting of slope. Drainage with culvert required & slope benching and deep root plantations are suggested. |

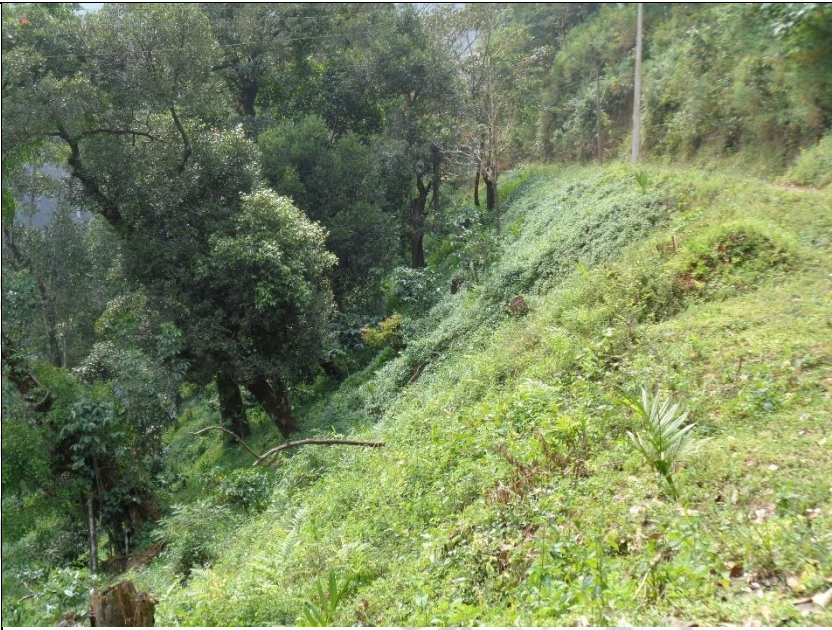
| 40 | Summary/Abstract | Planar failure due to increasing of pore water pressure and reduction of strength on supersaturation. Anthropogenic activities which is unplanned cutting of slope. Drainage with culvert required. Deep root plantations are suggested. |

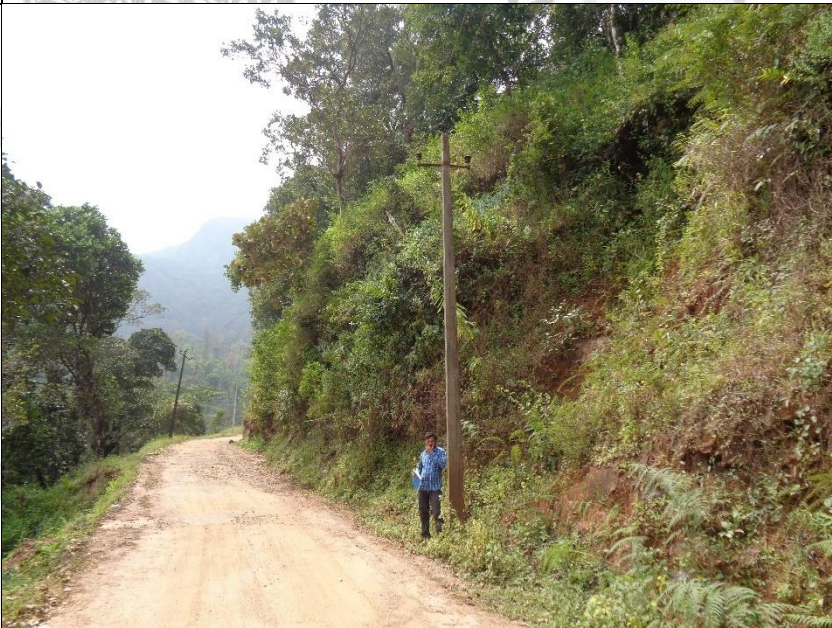
| 40 | Summary/Abstract | Planar failure due to increasing of pore water pressure and reduction of strength on supersaturation. Anthropogenic activities which is unplanned cutting of slope. Downside of slope retaining structure are required. Drainage management along the road side. Upslope slope grading required. |

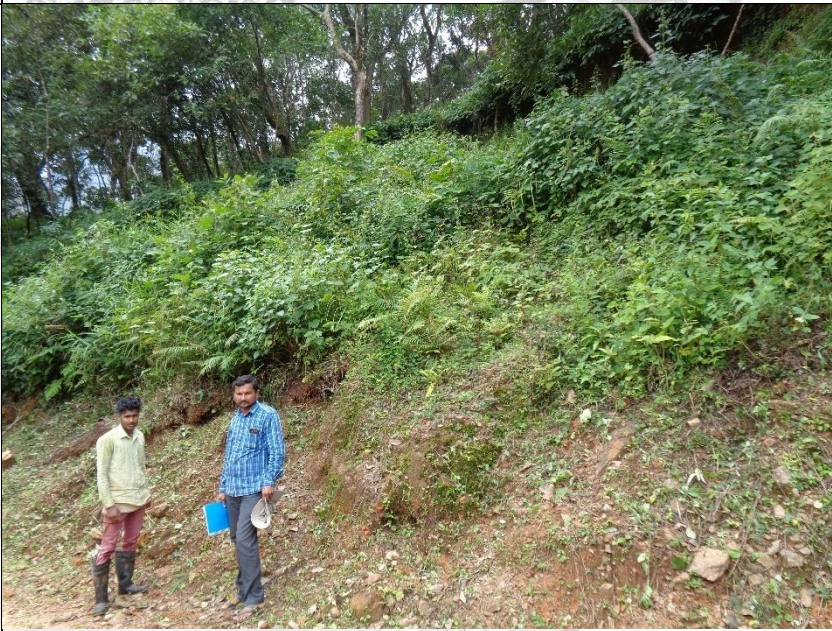
| 40 | Summary/Abstract | Planar failure due to increasing of pore water pressure and reduction of strength on supersaturation. Anthropogenic activities which is unplanned cutting of slope. Benching should be done. |

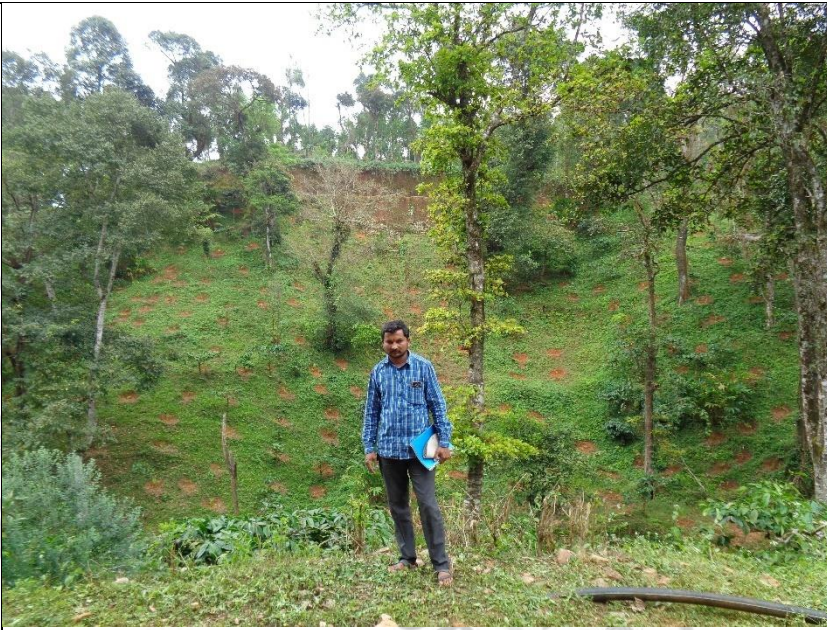
| 40 | Summary/Abstract | Planar failure due to increasing of pore water pressure and reduction of strength on supersaturation. Anthropogenic activities which is unplanned cutting of slope. Benching should be done & deep root plantations are suggested. |
