MESO-SCALE (1:10,000) LANDSLIDE SUSCEPTIBILITY MAPPING IN SUNKASALE  
AREA, CHIKMAGALUR DISTRICT, KARNATAKA.

Toposheet no. 48O/08

FSP CODE: M4LSSM/NC/SR/SU-KG/2022/42400

कार्य सत्र: 2022-23 का अंतिम प्रतिवेदन  
Final Report for Field Season 2022-2023

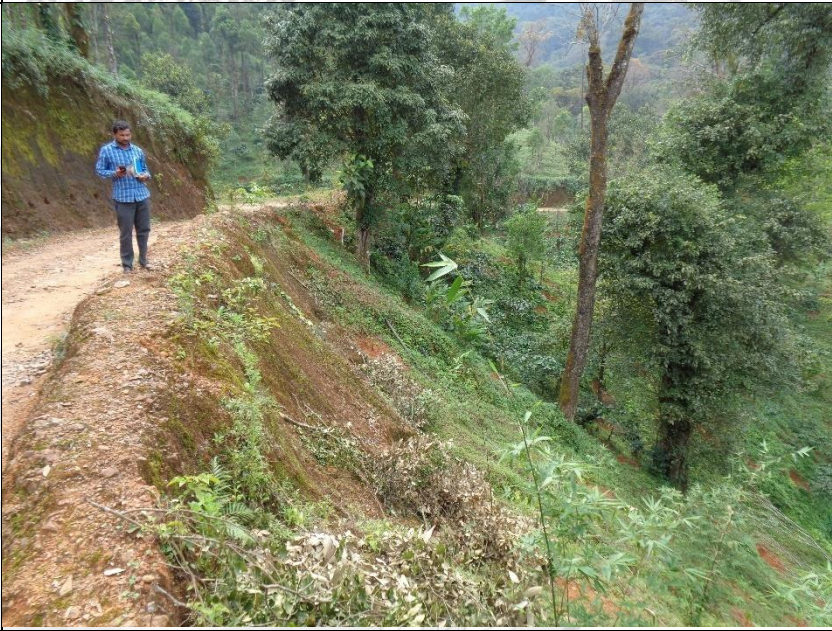
| 40 | Summary/Abstract | Planar failure due to increasing of pore water pressure and reduction of strength on supersaturation. Anthropogenic activities which is unplanned cutting of slope. Deep root plantation at downside as this site is falling in coffee estate so risk element is only agriculture land. |

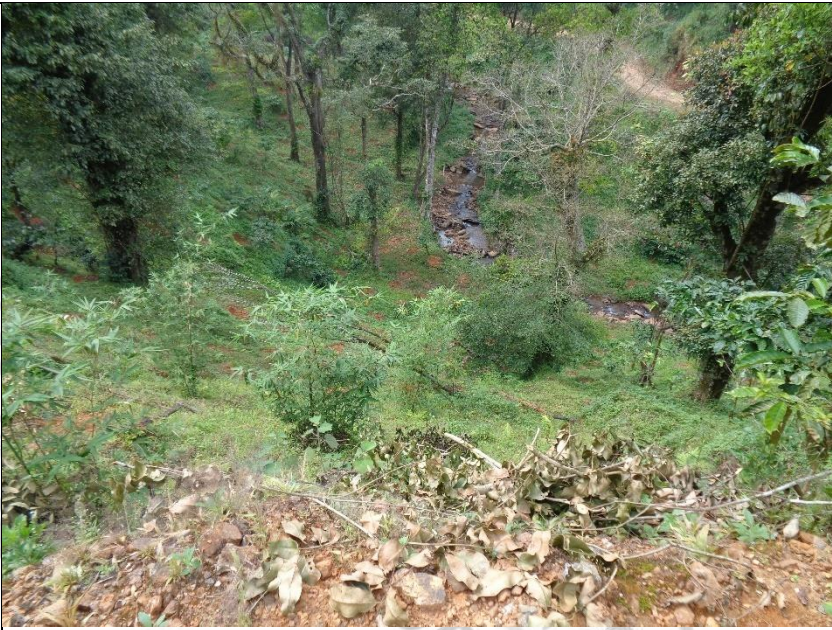
| 40 | Summary/Abstract | Planar failure due to increasing of pore water pressure and reduction of strength on supersaturation. Anthropogenic activities which is unplanned cutting of slope. Deep root plantation at downside as this site. Slope benching has suggested. |

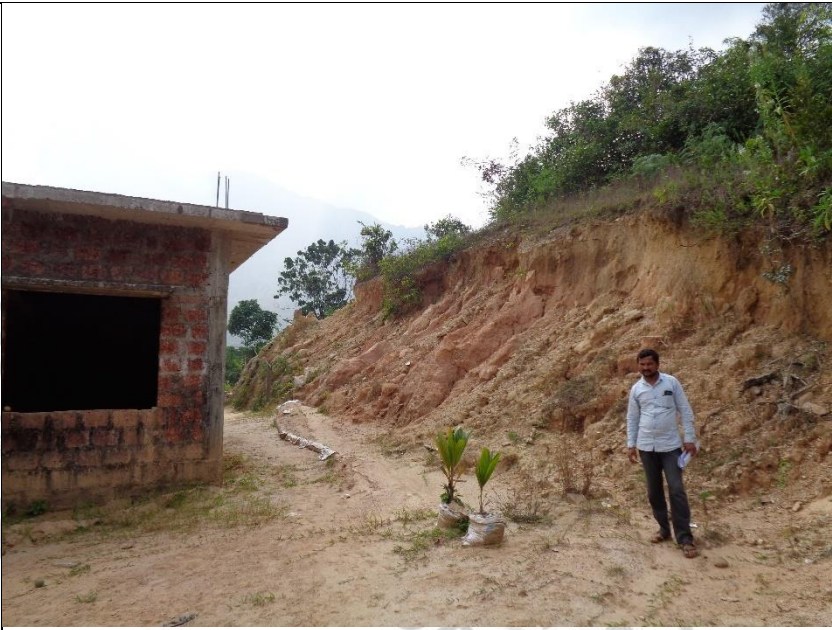
| 40 | Summary/Abstract | Cut slope made for settlement on modified slope which failed. After changing the location for house construction again failed the material behind the wall. |

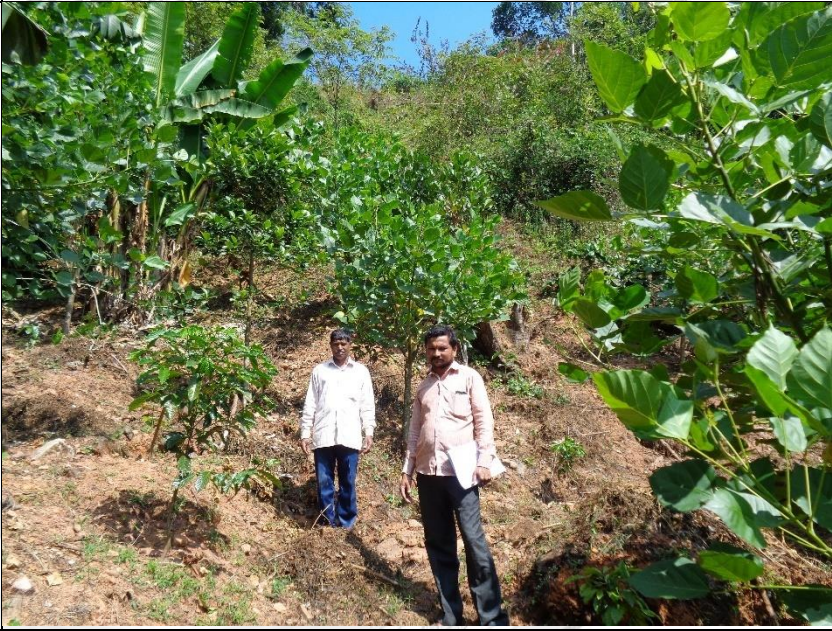
| 40 | Summary/Abstract | Cut slope made for road and house construction. All the catchment water of nearby area directly flowing to the same place. There is missing of proper rainwater drainage management. |

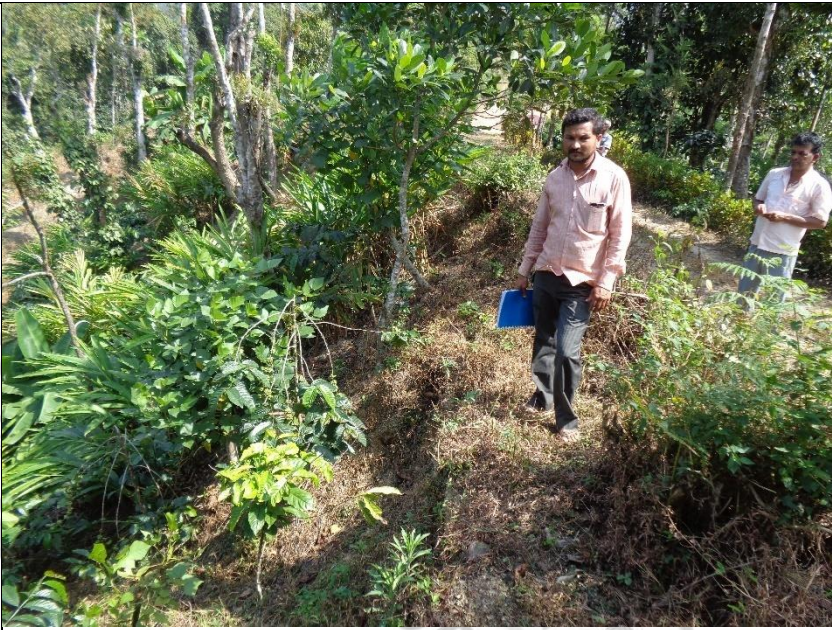
| 40 | Summary/Abstract | Planar failure due to increasing of pore water pressure and reduction of strength on supersaturation. Anthropogenic activities which is unplanned cutting of slope. Back filling required. |

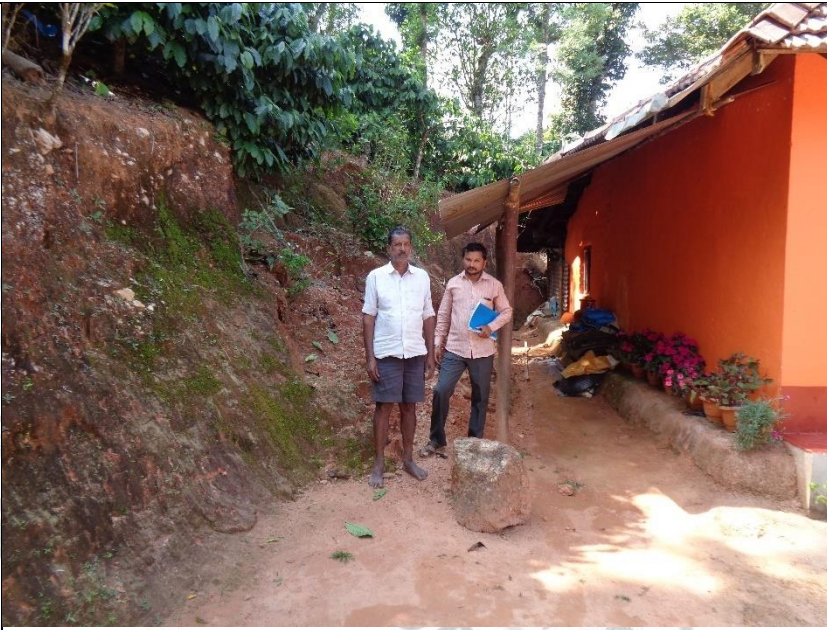
| 40 | Summary/Abstract | Erosion by flowing stream and leads to failed the upslope material. Landslide occurred in coffee estate and road is connected to two residential house. In one house slumping has been observed. This site has soil piping, rill wash and gulley erosion in cut slope. |

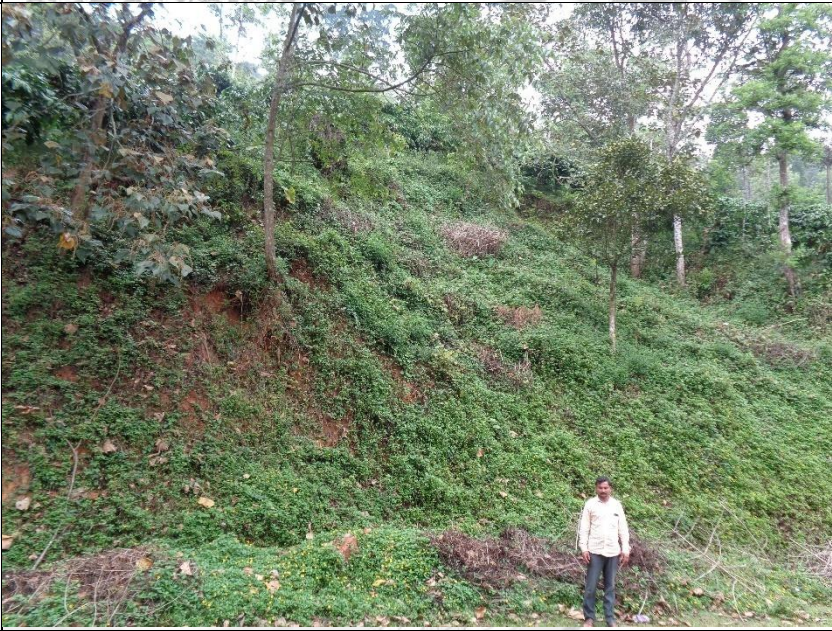
| 40 | Summary/Abstract | Planar failure due to increasing of pore water pressure and reduction of strength on supersaturation. Anthropogenic activities which is unplanned cutting of slope. Vertical cut made for road. Slope grading is required & drainage with culvert is required. |

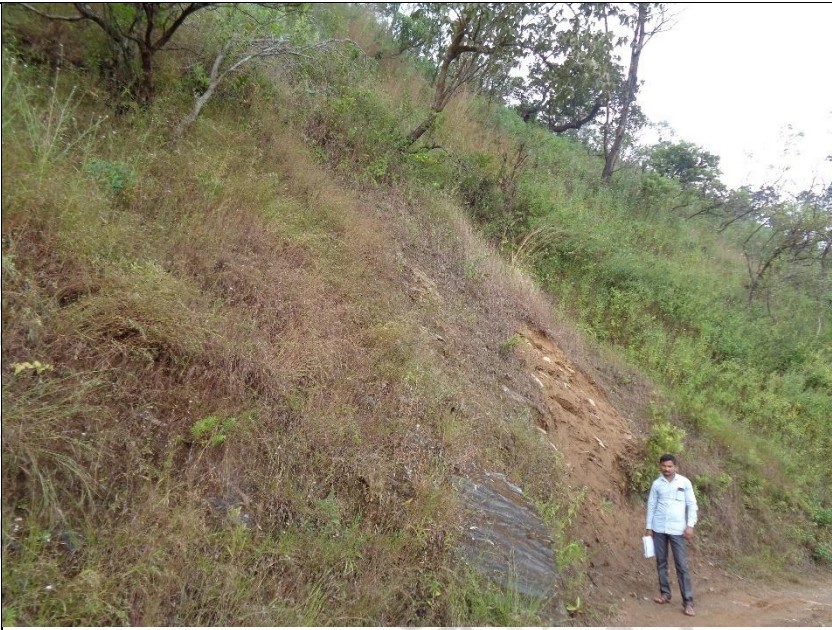
| 40 | Summary/Abstract | The slope cut to construct the road. Cut slope failed which triggered by heavy rain. The landslide occurred within coffee estate. The risk element is agriculture land & the unmetalled road is the risk factor which connected to Maitalkhan coffee estate. |

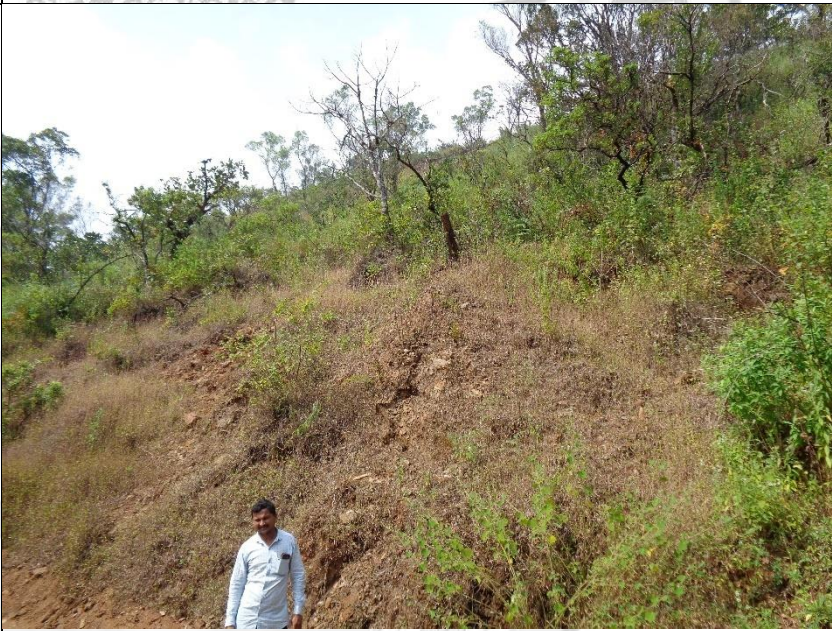
| 40 | Summary/Abstract | The slope cut to construct the road. Cut slope failed which triggered by heavy rain. The landslide occurred within coffee estate. The risk element is agriculture land & the unmetalled road is the risk factor which connected to Maitalkhan coffee estate. Slope benching is required, drainage management is required. Deep root plantations are suggested. |

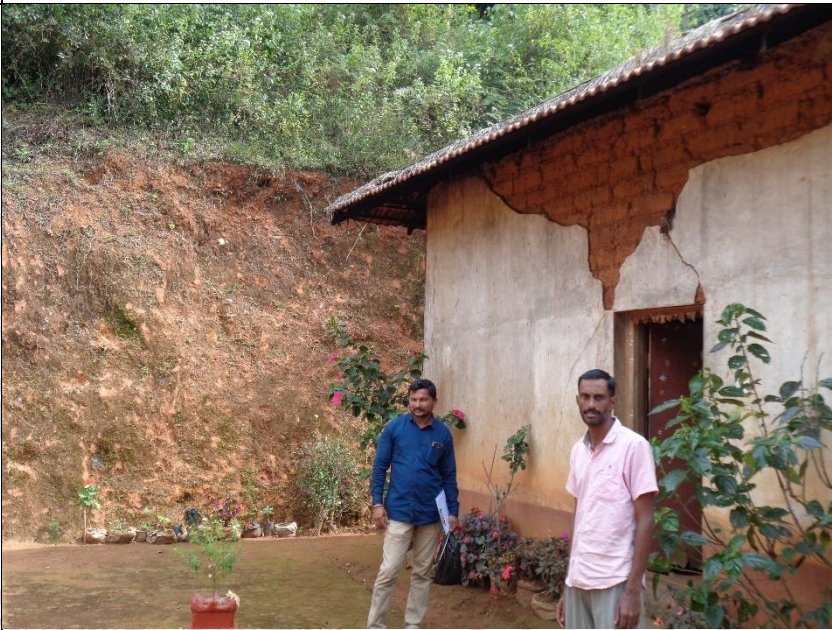
| 40 | Summary/Abstract | The landslide occurred adjacent to the residential house. Stream is also flowing adjacent to the house. Wall cracks has also developed. The house is at risk during heavy rain. |
