REPORT ON MESO-SCALE LANDSLIDE SUSCEPTIBILITY MAPPING (1:10,000) IN AND  
AROUND NIDUVATTU, MUKKODLU & MEGATTALU AREAS, KODAGU DISTRICTS OF  
KARNATAKA

Item no.: M4LSSM/NC/SR/SU-KG/2018/26601

Final report for field season 2018-19

Aijaz Ahmad Bhat, Senior Geologist & Dr. Zameer Ahmad Shah, Geologist

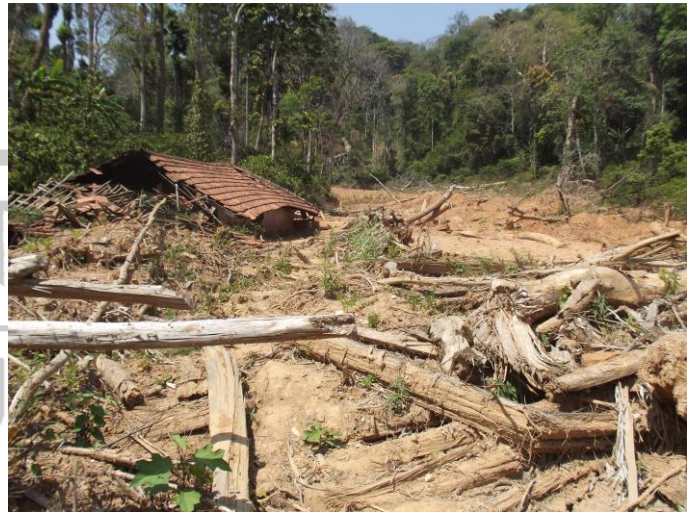
(l) Landslide debris moved by channel flow and checked with in 3<sup>rd</sup> order stream peripheries wherein few houses were buried and few damaged in south-east Mukodlu village

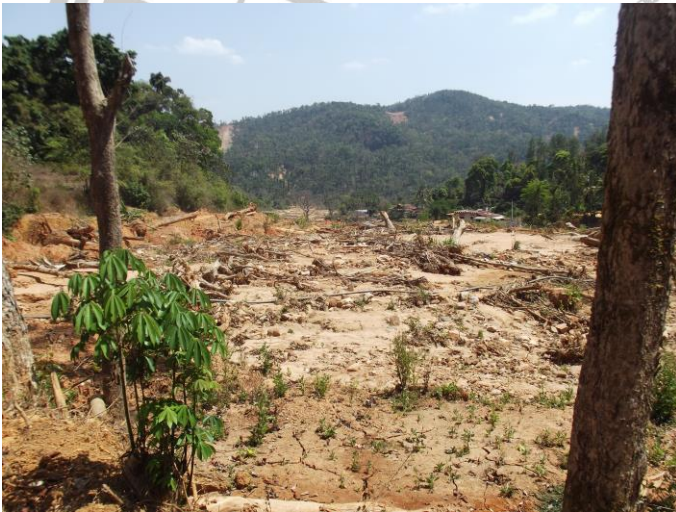
(m) Landslide debris material moved by channel flow of 5<sup>th</sup> order stream which is directly joined with 7<sup>th</sup> order main stream in the given watershed which has no development of 6<sup>th</sup> order streams in south-east Mukodlu village

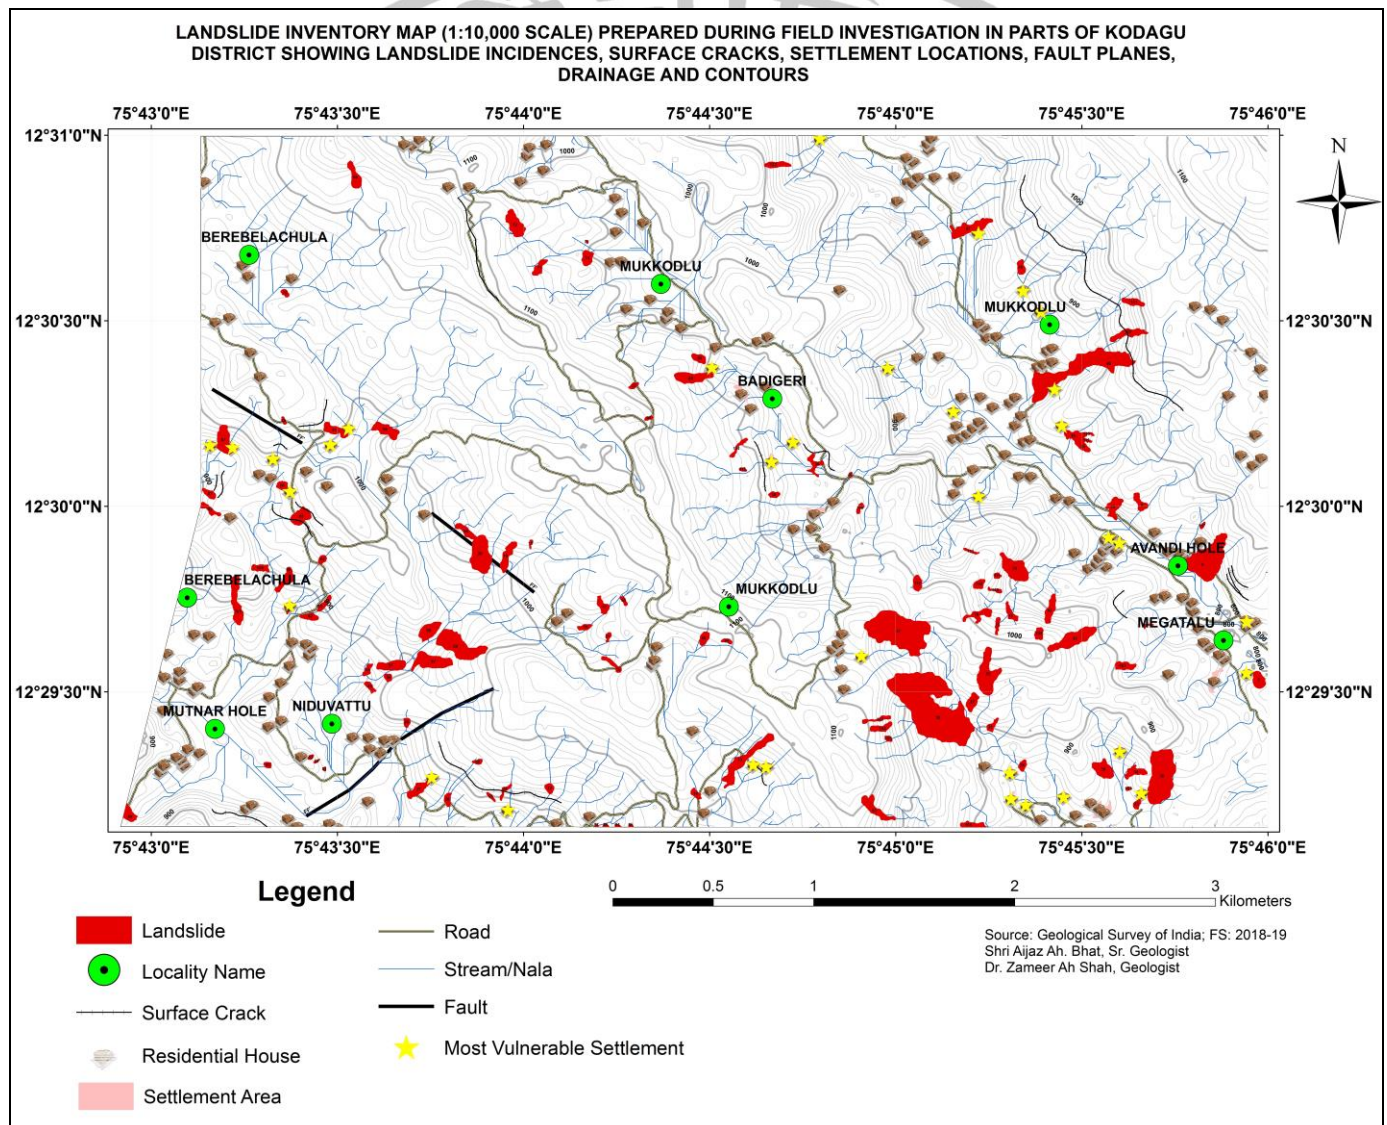
- ❖ Surface cracks are developed in various parts of study area ([fig. 3.3](#)) during 2018 rainfall. These surface cracks are running parallel to contours which indicate the initiation of slope movement and material adjustment. But at places these cracks run across contours irrespective of slope gradient which indicates the localized subsurface block movement either along a concealed fault plane or most probably along penetrative joint planes. At places the rocks have undergone in high strain conditions that reflected by shearing, development of localized faults/micro faults/joint systems/fractures. The areas where rocks are pulverized without any evidence of mineral grain stretching and shear sense are mapped as brittle shear zone. These areas are mostly landslide affected areas. Due to pulverization process huge volume of non-cohesive fine grain material is produced which moved directly as earthflows during heavy rains subsequently on water saturation.

*Figure-3.3: Shows landslides and surface cracks with contour, drainage, settlement, road, structural lineaments and most vulnerable settlements*

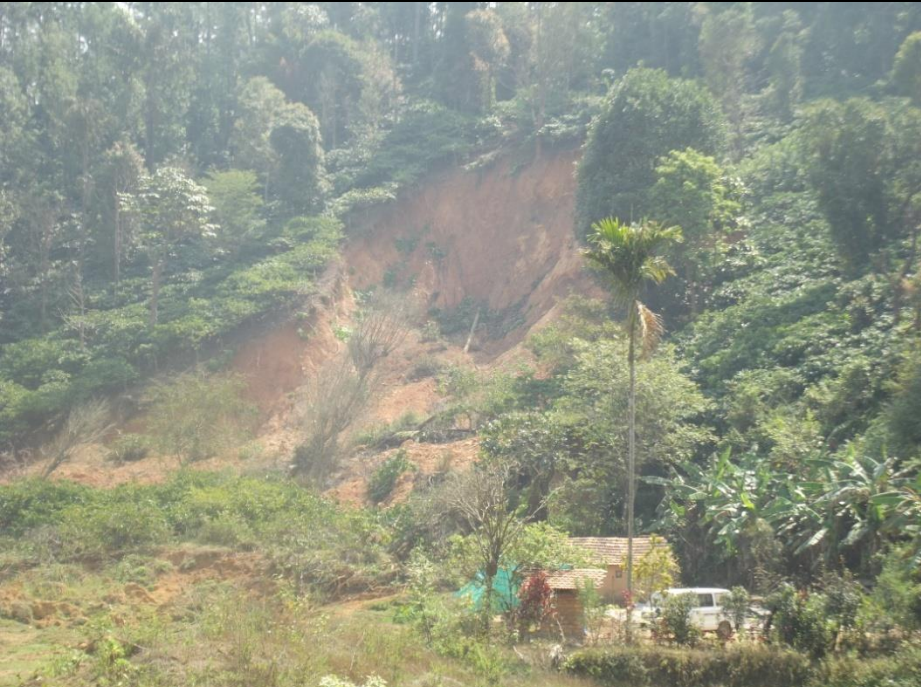
| Geo-parameter | Details |
|---|---|
| Failure mechanism | Deep planar failure |

| Summary/Abstract | <i>Here slope, high percolation due to slight convexity of the slope which lead to the increase in mass and gravity pull, oversaturation of the overlying material caused the movement of the overburden along contact of underlying rock and overburden material.</i> |

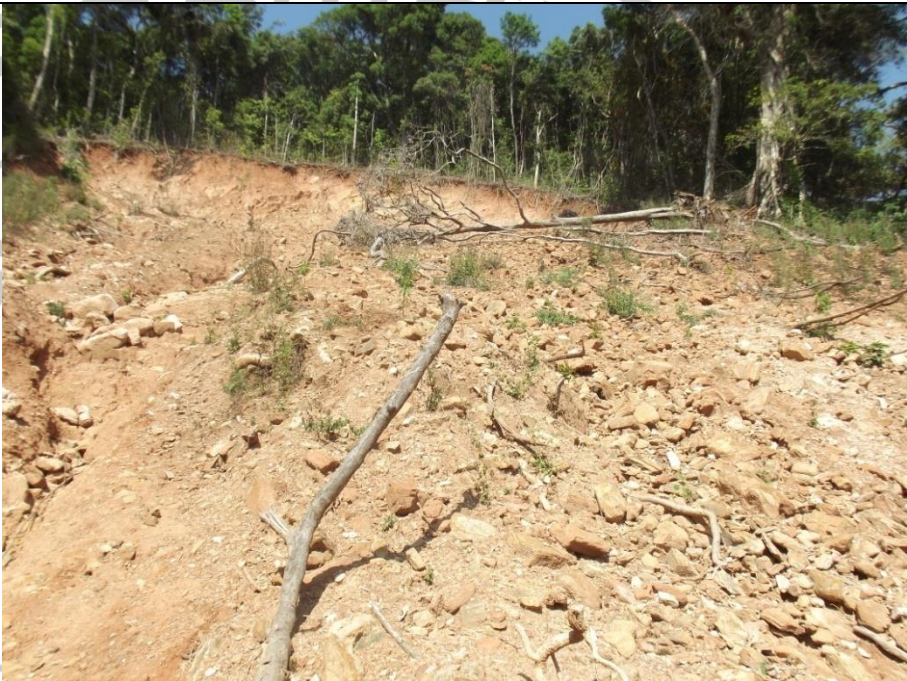
| Summary/Abstract | <i>Here some indications of shearing were observed in the form of elongated grains.</i> |

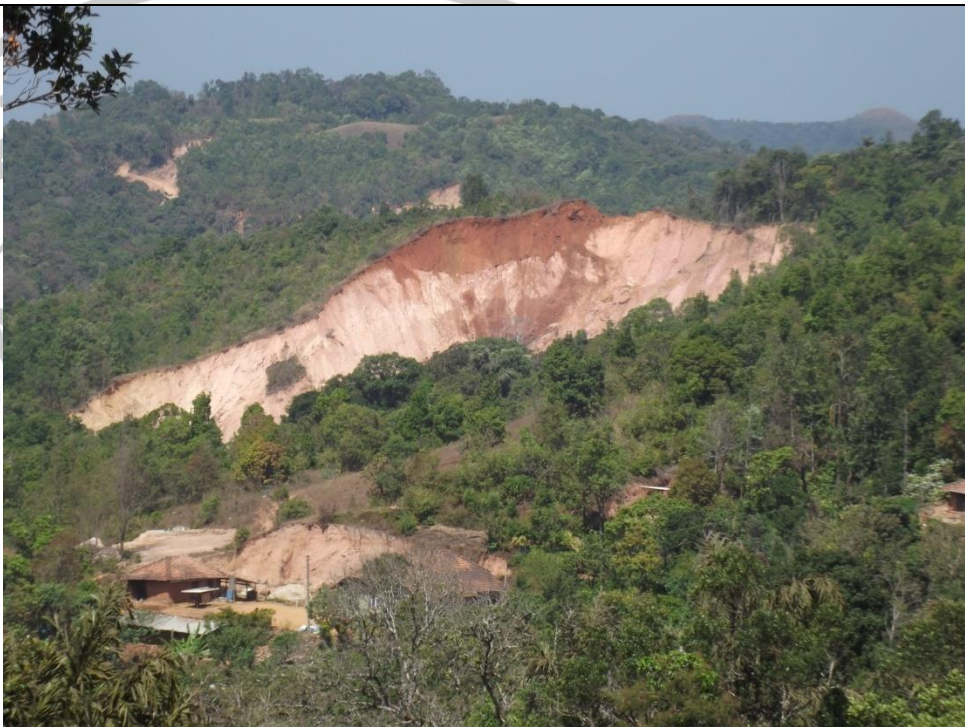
| Summary/Abstract | <p><i>Here the material is pulverized under brittle shear. Pillow like structures (probably de-watering structures) were observed along with pseudotachylite. Some pseudotachylites were observed along fault planes</i></p> |

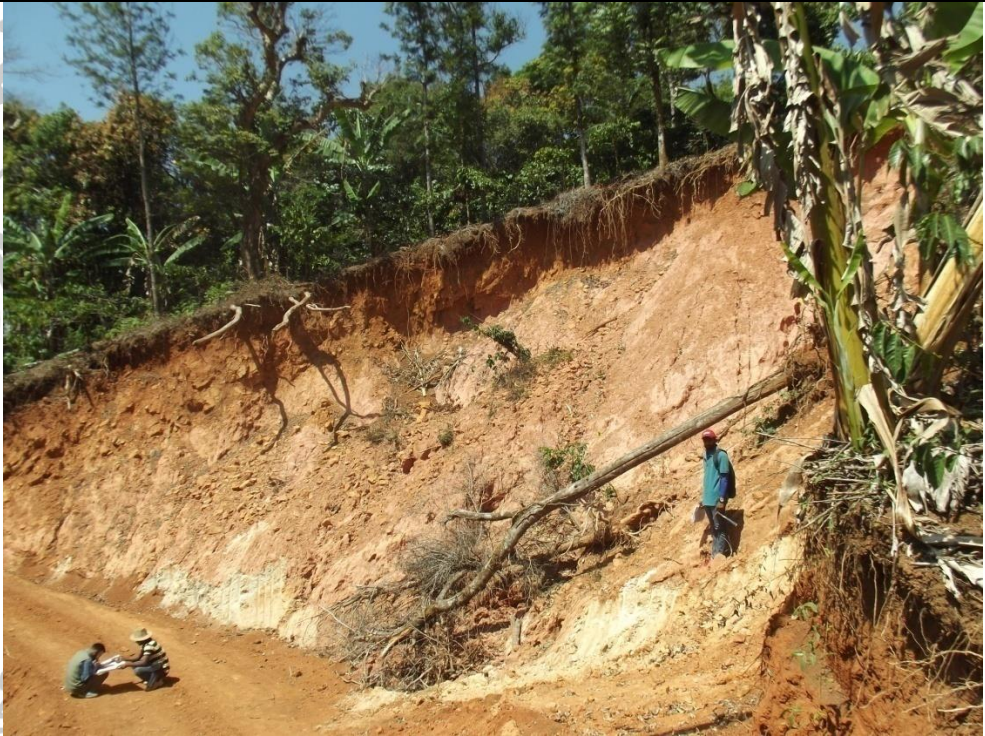
| Summary/Abstract | <i>Here the underlying rock, Granite gneiss is highly pulverized. The super saturation of this loose material including the weathered material has failed during the slide.</i> |

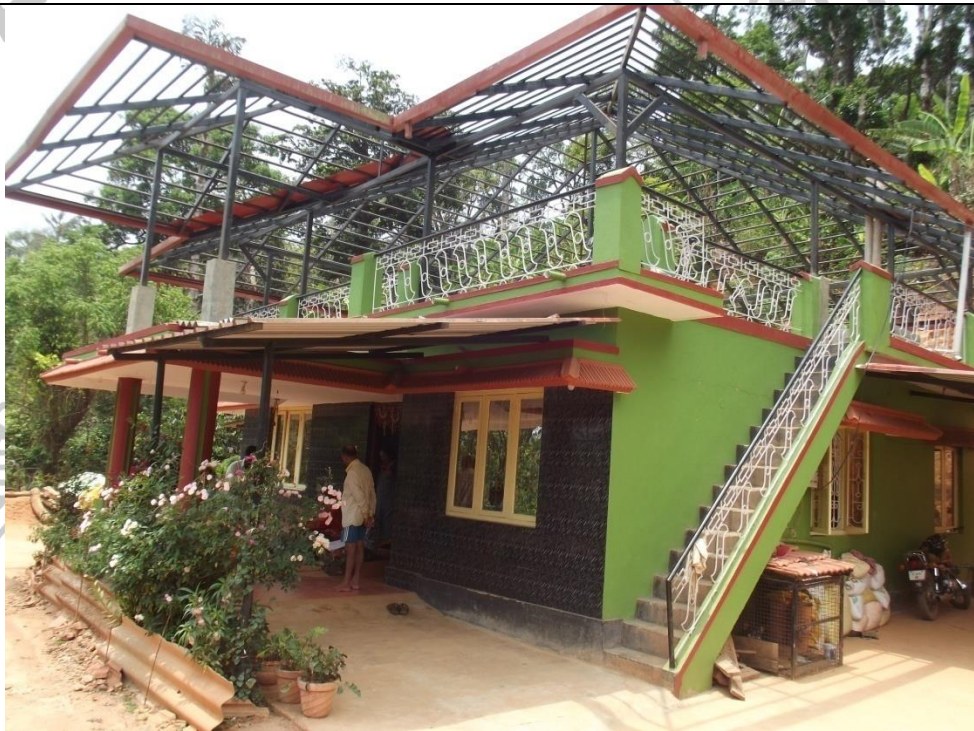
| Photos. Sketch of Plan & section of the slide<br><br>House with cracks | |
