**भारत सरकार**  
**Government of India**  
**भारतीय भूवैज्ञानिक सर्वेक्षण**  
**Geological Survey of India**

**Meso-scale (1:10,000) Landslide Susceptibility Mapping in and around Virajpet area,  
Kodagu district of Karnataka**  
टोपोशीट सं: 48 P/16; Toposheet No.: 48 P/16

एम4एलएसएसएम/एनसी/एसआर/एसयू-केजी/2020/32460  
Item no.: M4LSSM/NC/SR/SU-KG/2020/32460

कार्य सत्र 2020-21 का प्रतिवेदन  
**Report for field season 2020-21**

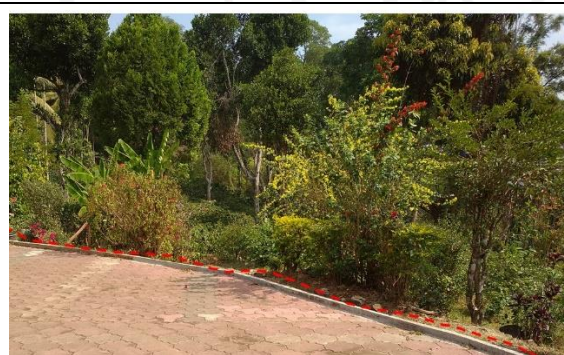
*Fig. 6.3a Transverse crack near the house of Smt. Buttiayana w/o Lt. Namchappa*

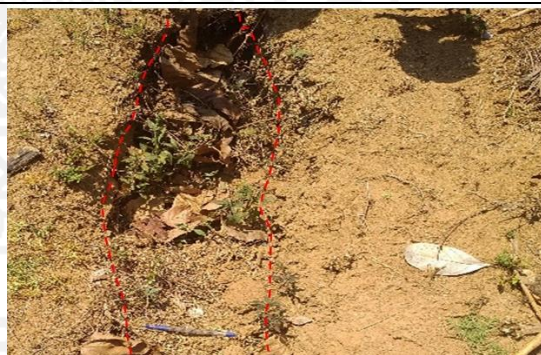
*Fig. 6.3b Transverse crack at downslope of the Ambatty road*

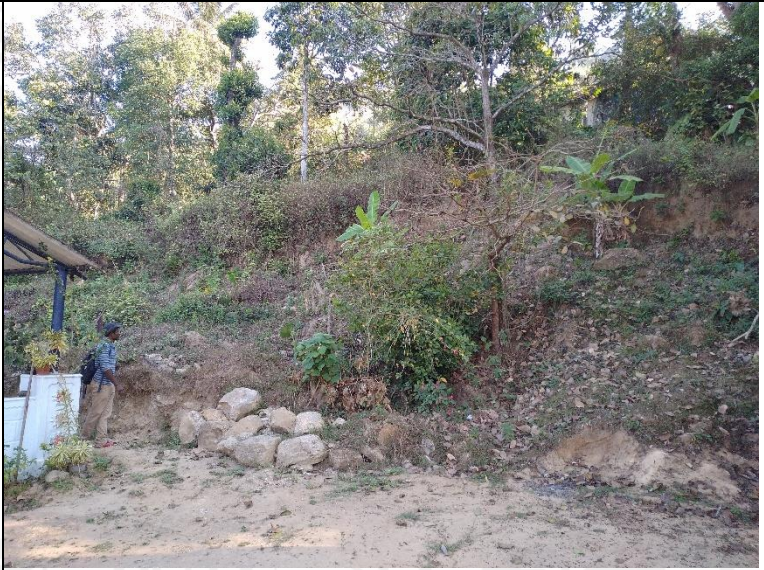
| 40 | Summary/Abstract | A shallow translational debris slide is caused due to steep cutting of the slope characterized by thick overburden/debris material at the midslope of Ayyappa hill. A breastwall construction at the toe and proper drainage maintenance is recommended. |

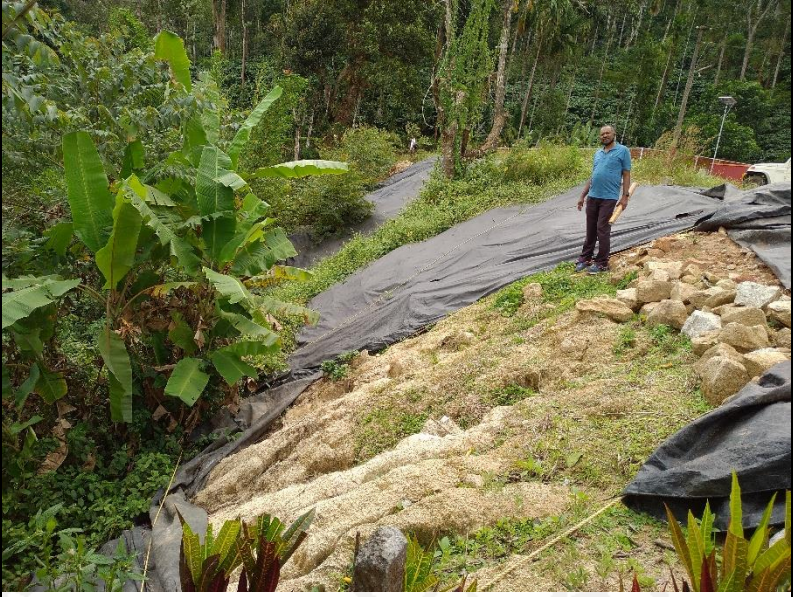
| 40 | Summary/Abstract | A shallow translational debris slide is documented which is caused due to active toe erosion by stream and slope characterized by uncompacted debris material. A breastwall construction at the toe and proper drainage maintenance is recommended. |

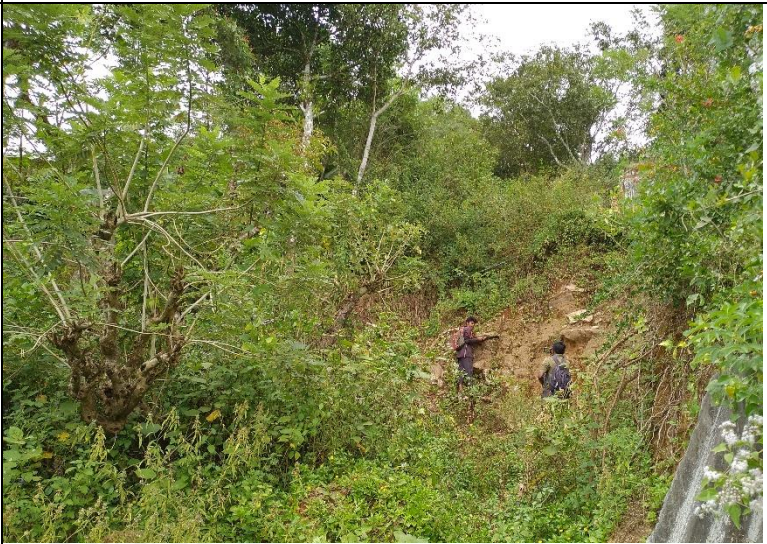
| 40 | Summary/Abstract | A shallow rotational failure at the central part of the Ayyappa hillslope is caused by the slope cutting without any structural support at the toe. A toe support system is recommended at the toe of the slide. |

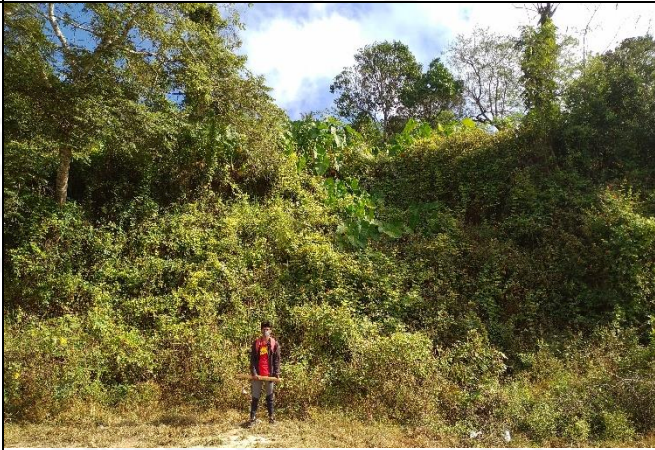
| 40 | Summary/Abstract | A soil slide is caused near the Ayyappa temple due to steep slope cutting for the widening of the road. The slope is characterized by highly weathered rock mass overlain by thick soil. It is recommended for the construction of breast wall with weep holes and toe drain and also contour drain above the crown of the slide. |

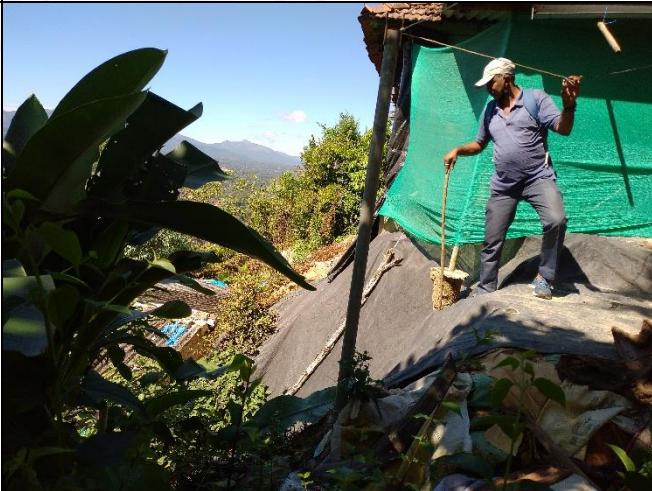
| 40 | Summary/Abstract | A minor shallow translational slide is caused by poor drainage to drain the surface water. The foundation material is clay-rich fill material over the highly weathered granite. It is recommended to install a proper drainage system to control the slope instability. |

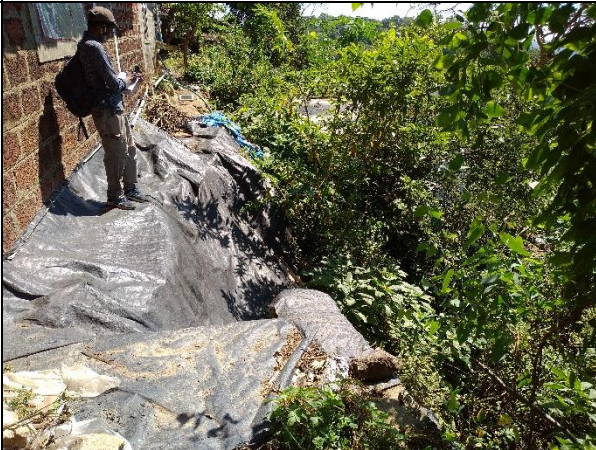
| 40 | Summary/Abstract | A minor shallow translational slide is caused by poor drainage to drain the surface water. The foundation material is clay-rich fill material over the highly weathered granite. It is recommended to install a proper drainage system to control the slope instability. |

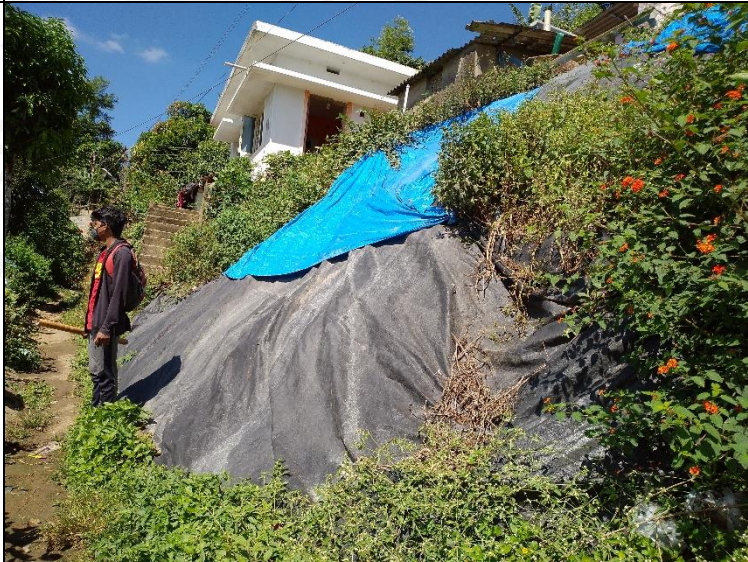
| 40 | Summary/Abstract | A debris slide is caused due to percolation of the water into the fill slope covered with thick overburden and weathered profile of the rock which reduced the shear strength of the material. It is recommended to construct a breast wall with a sufficient number of weep holes and channelization of the slope discharge. |

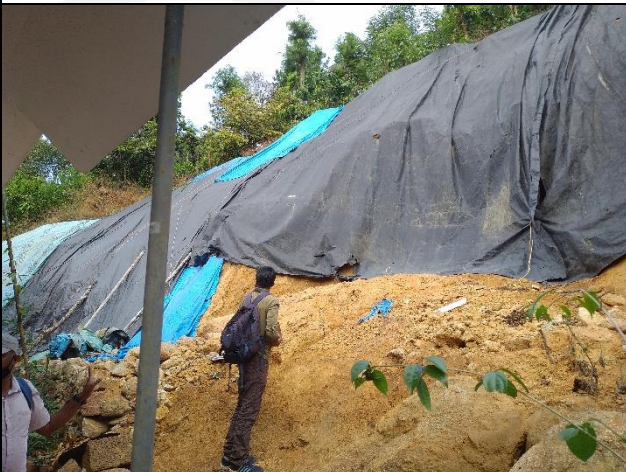
| 40 | Summary/Abstract | The shallow translational slide is caused by the steep cutting of slope beyond the angle of repose for construction of the building. The overburden thickness is about 6 m. It is recommended to ease the slope angle through benching. |

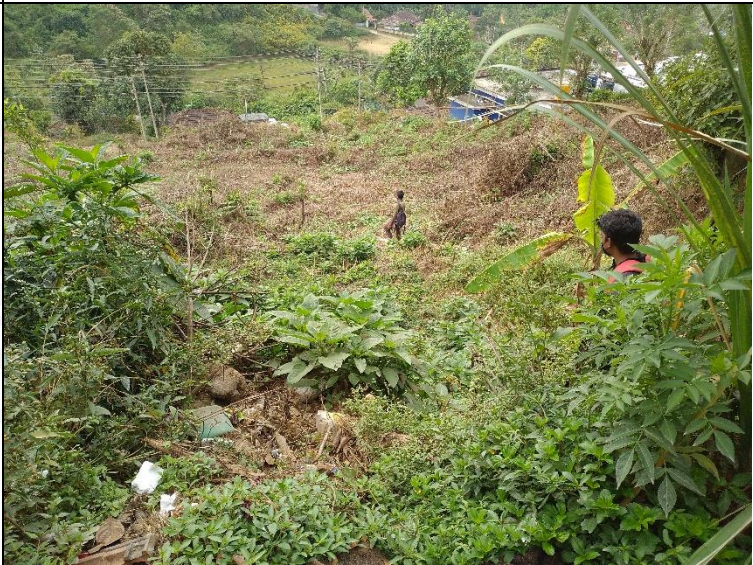
| 40 | Summary/Abstract | The shallow translational slide is caused by the confluence of surface drainage and sustained saturation of the overburden material. Contour drainage near the crown is recommended for the site. |

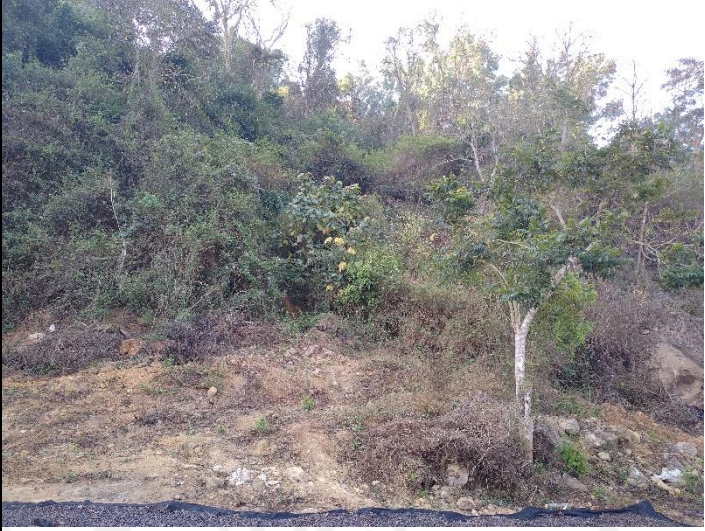
| 40 | Summary/Abstract | A shallow translational failure occurred due to debris overlying the granitic rock and percolation of water along the debris-rock interface |

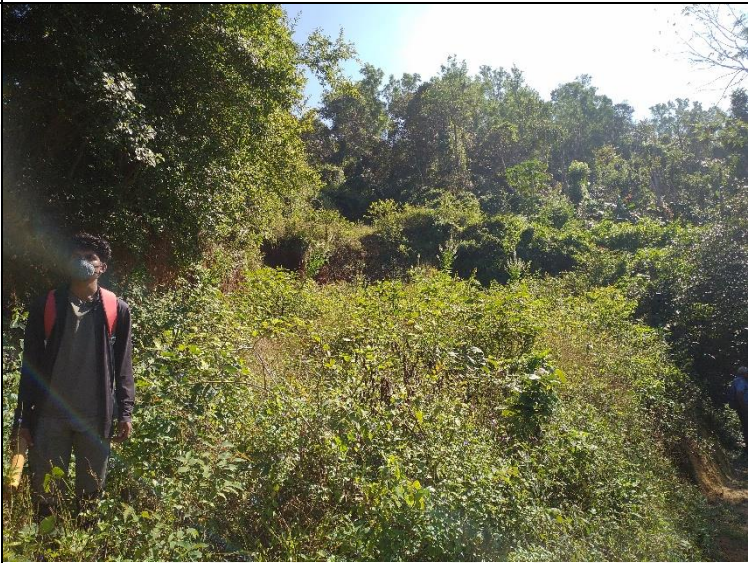
| 40 | Summary/Abstract | Thick soil overlying the highly weathered granitic rock and aggravated by removal toe buttress through excavation. It is recommended for the construction of a breast wall with weep holes and contour drain to divert the surface water away from the excavated area. |

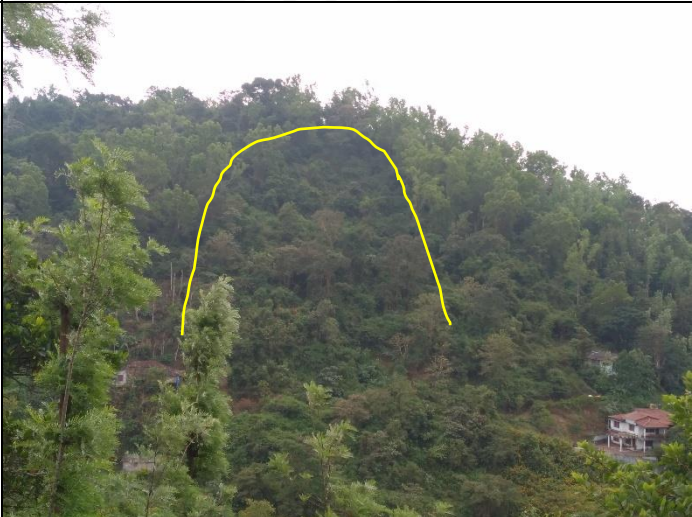
| 40 | Summary/Abstract | An old debris slide is reportedly triggered by the rainfall in 1960's along the steep slope of Magulla characterized by thick overburden. It is recommended to avoid unplanned deforestation on the slope. |

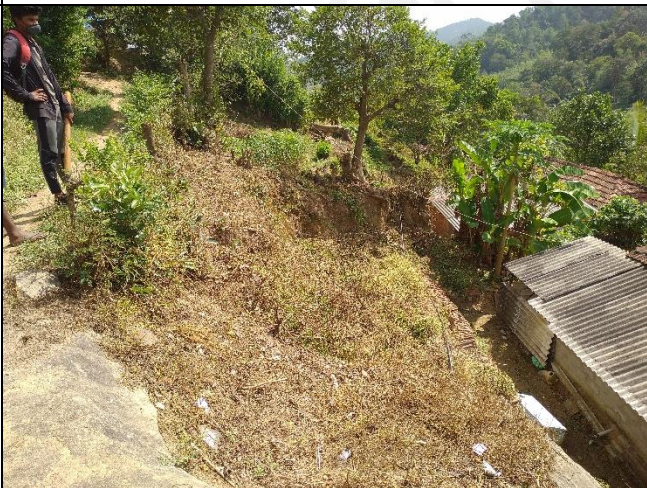
| 40 | Summary/Abstract | The shallow translational slide in Ayyappa is caused by the steep cutting of the slope characterized by thick overburden resting on the highly weathered rock mass. A contour drain near the road upslope or the crown area and a chute drain over the face or the flanks of the slide are recommended. |

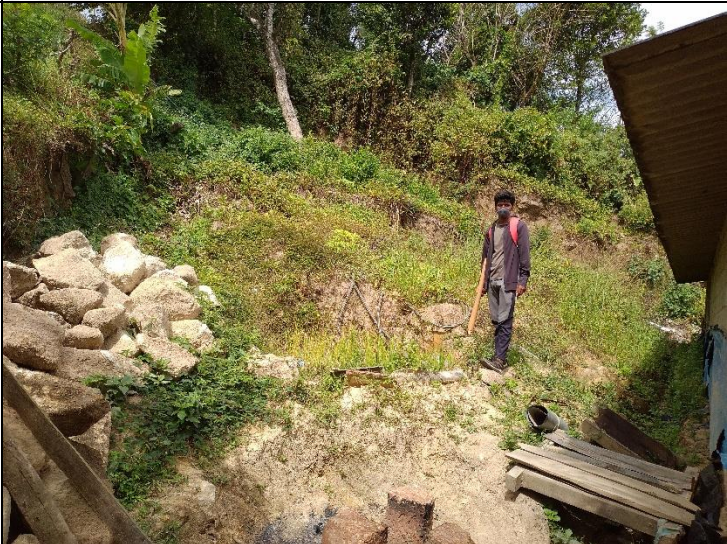
| 40 | Summary/Abstract | The shallow rotational slide in Ayyappa is caused due to steep cutting of an overburden-covered slope for settlement without proper toe buttress. The slope is characterized by highly weathered granite forming core-stones with about 4 m thick overburden/residual soil. It is recommended to construct a breast wall with sufficient weep holes and lined drainage to be provided on the hillside along with a chute drain on the flanks to prevent possible widening through erosion. |

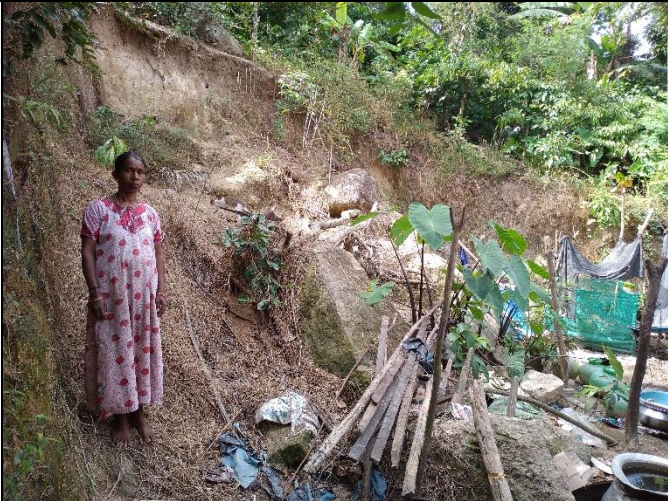
| 40 | Summary/Abstract | The shallow rotational slide in Ayyappa is caused due to steep cutting of an overburden-covered slope for settlement without proper toe buttress. The slope is characterized by highly weathered granite forming core-stones with thick overburden/residual soil. It is recommended to construct breast wall with sufficient weep holes and lined drainage to be provided on the hillside along with a chute drain on the flanks to prevent possible widening through erosion. |

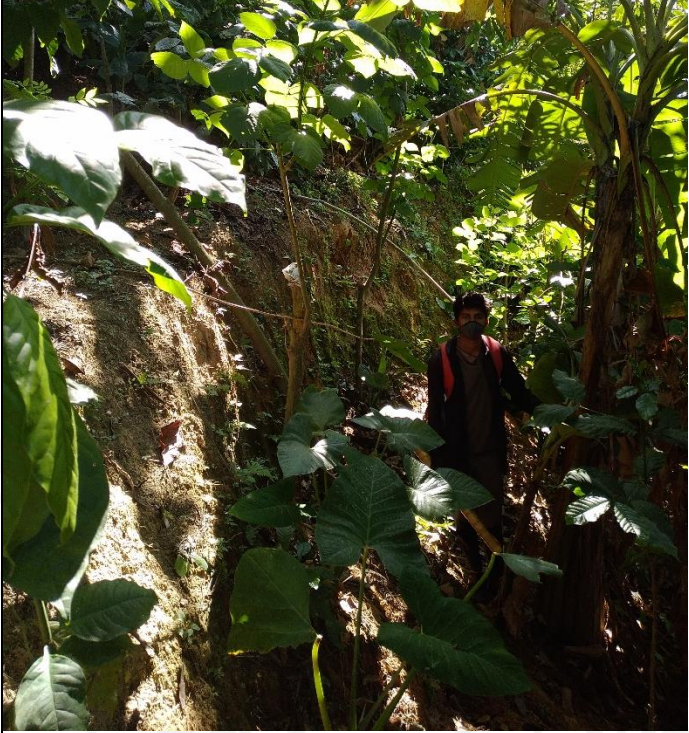
| 40 | Summary/Abstract | The shallow translational slide in Ayyappa is caused due active toe erosion and water infiltration over the thick overburden. It is recommended to construct a contour drain over the crown area to prevent surface water infiltration. |

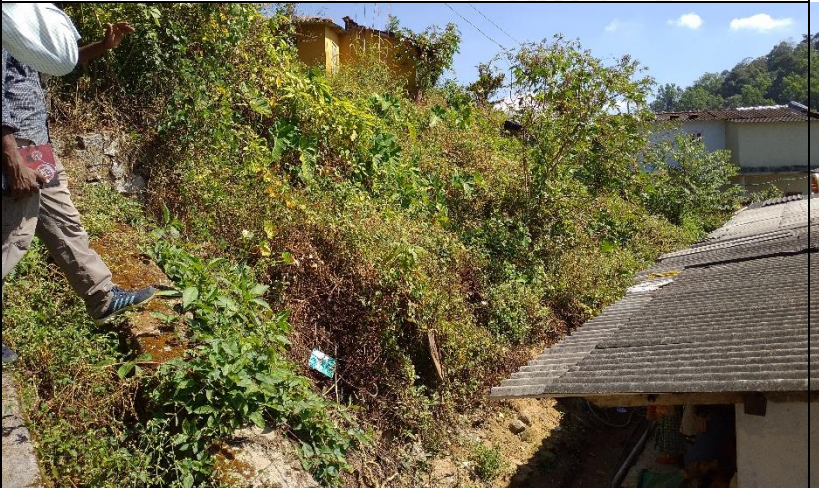
| 40 | Summary/Abstract | The shallow rotational slide in Ayyappa is caused due to steep |

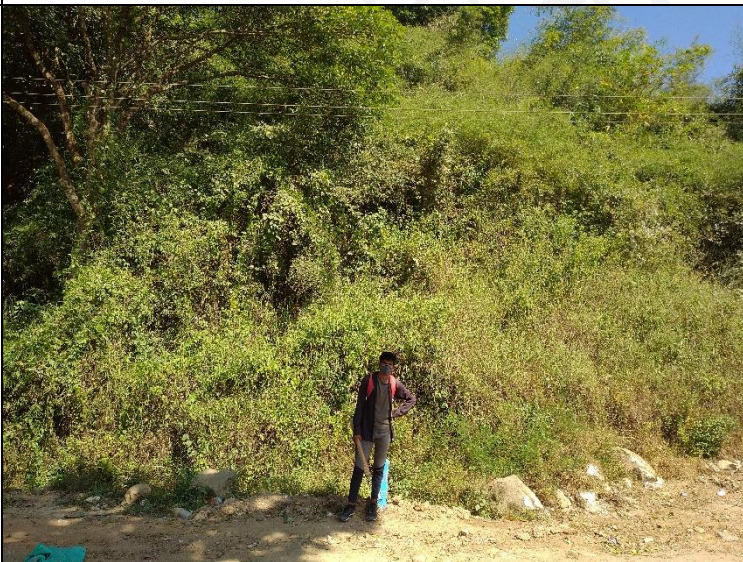
| 40 | Summary/Abstract | The shallow translational slide in south Ayyappa is caused due to steep cutting of overburden-covered slope for road widening. The slope is characterized by thick overburden/residual soil. It is recommended to construct a breast wall with sufficient weep holes and lined drainage to be provided on the hillside. |

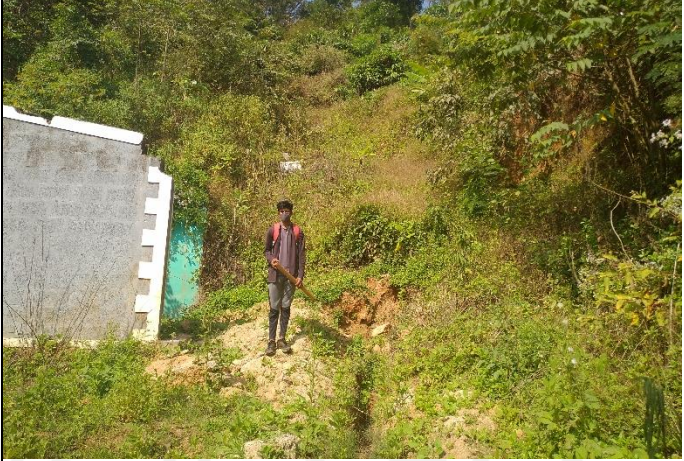
| 40 | Summary/Abstract | The shallow rotational slide in Ayyappa is caused due to steep cutting of an overburden-covered slope for settlement without toe support systems. The slope is characterized by thick overburden/residual soil. It is recommended to construct a breast wall with sufficient weep holes and lined drainage to be provided on the hillside. |

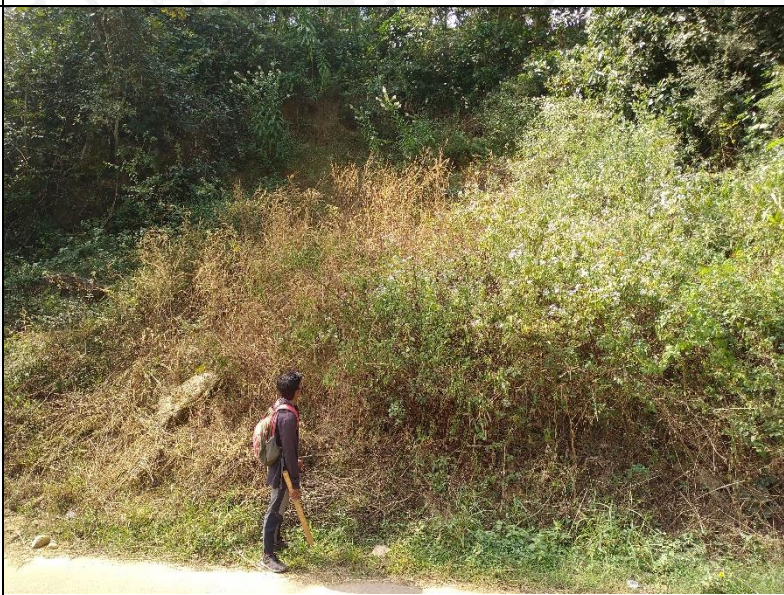
| 40 | Summary/Abstract | The shallow translational slide in east Ayyappa is caused due to steep cutting of an overburden-covered slope for road widening. The slope is characterized by thick |

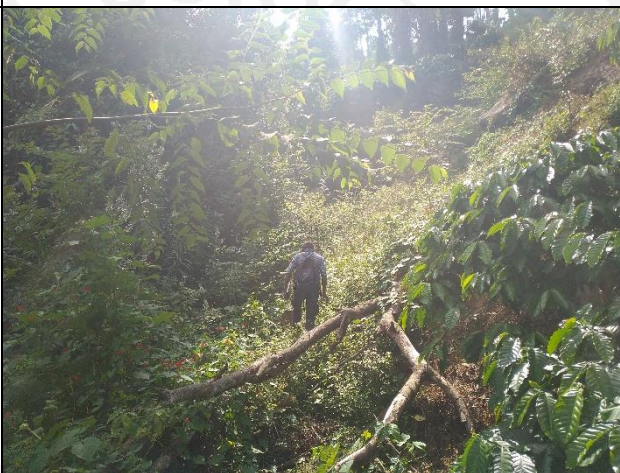
| 40 | Summary/Abstract | The shallow translational slide in the Aimangala Coffee plantation is caused due to infiltration of surface runoff into the overburden-covered slope. The slope is characterized by thick immature overburden/residual soil. It is recommended to construct a contour drain over the crown area and the flanks to divert water away from the slide area. |

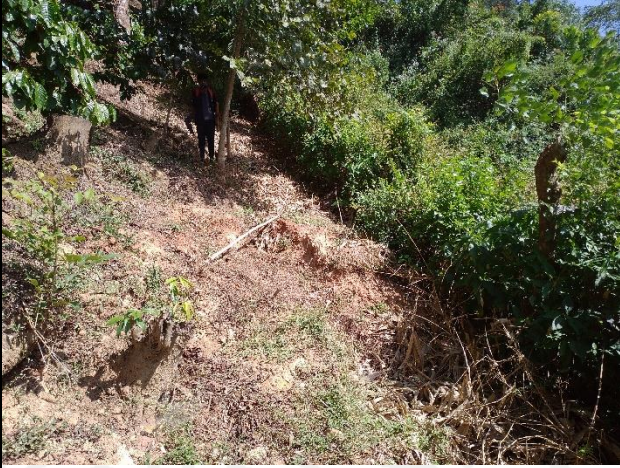
| 40 | Summary/Abstract | The shallow rotational slide in Nehru Nagar is caused due to steep cutting of an overburden-covered slope for construction of houses without any toe support systems. The slope is characterized by thick overburden/residual soil. It is recommended to construct a breast wall with sufficient weep holes and lined drainage to be provided on the hillside. |

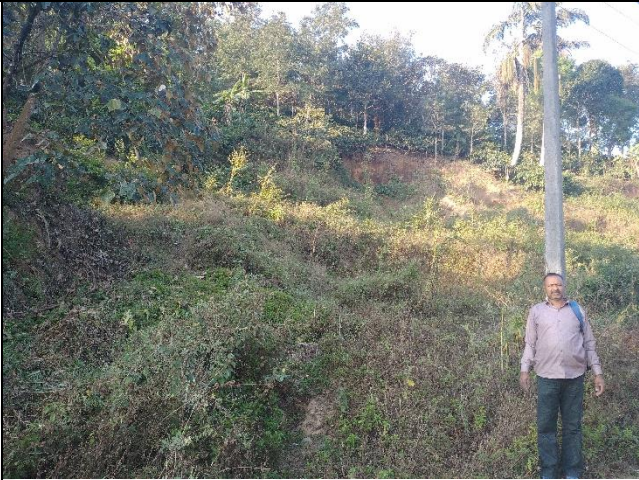
| 40 | Summary/Abstract | The shallow translational slide in Magulla is caused due to steep cutting of an overburden-covered slope for the road widening. The slope is characterized by thick overburden/residual soil. It is recommended to construct a breast wall with sufficient weep holes and lined drainage to be provided on the hillside. |

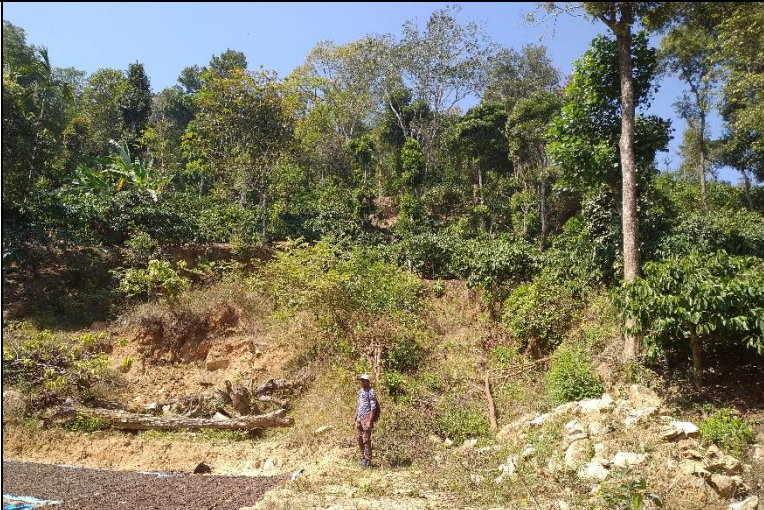
| 40 | Summary/Abstract | The shallow rotational slide in Ambatty is caused due to steep cutting of an overburden-covered slope for road widening without toe support. The slope is characterized by thick overburden/residual soil. It is recommended to construct a gabion wall with sufficient weep holes and lined drainage to be provided on the hillside. |

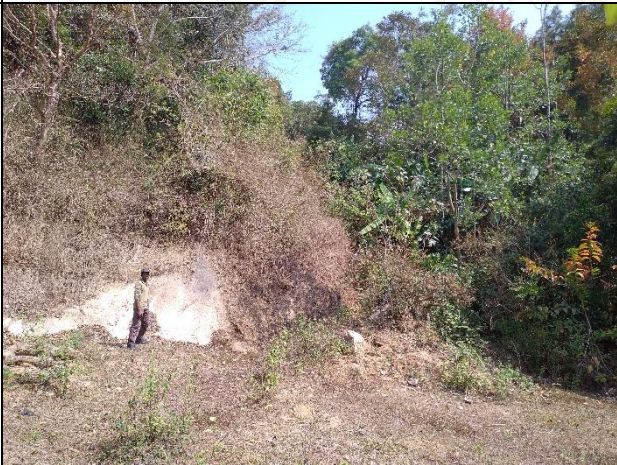
| 40 | Summary/Abstract | The shallow translational slide in east Ambatty is caused due |

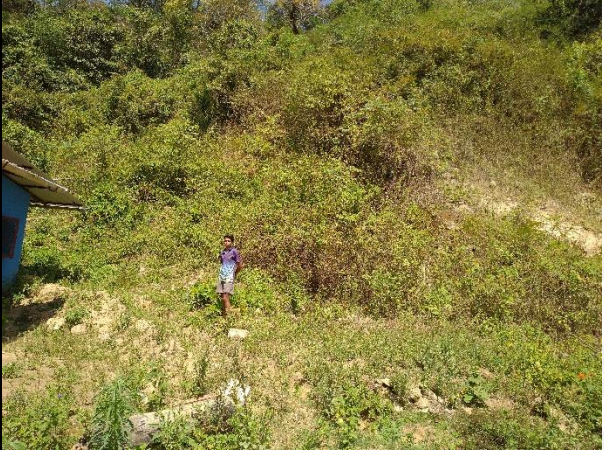
| 40 | Summary/Abstract | The shallow translational slide in east Ambatty is caused due steep cutting of overburden covered slope for house construction without toe support. The slope is characterized by thick overburden/residual soil. It is recommended to construct breast wall with sufficient weep holes and lined drainage to be provided on the hillside. |

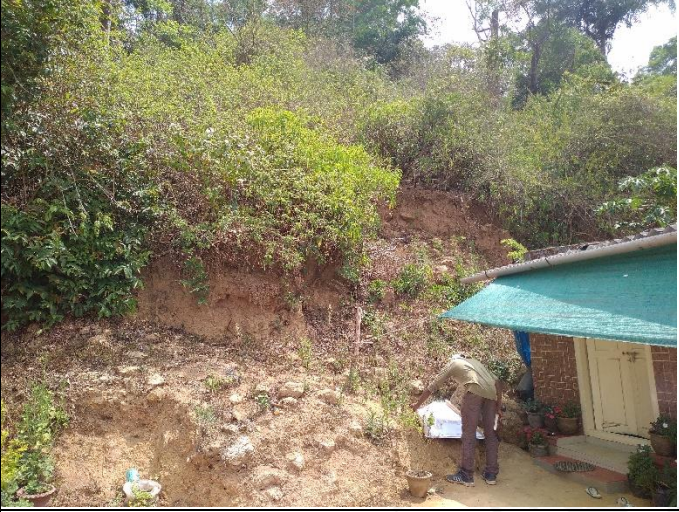
| 40 | Summary/Abstract | The shallow translational slide in West Nehru Nagar is caused due to steep cutting of an overburden-covered slope for house construction. The slope is characterized by thick overburden/residual soil. It is recommended to construct a breast wall with sufficient weep holes and lined drainage to be provided on the hillside. |

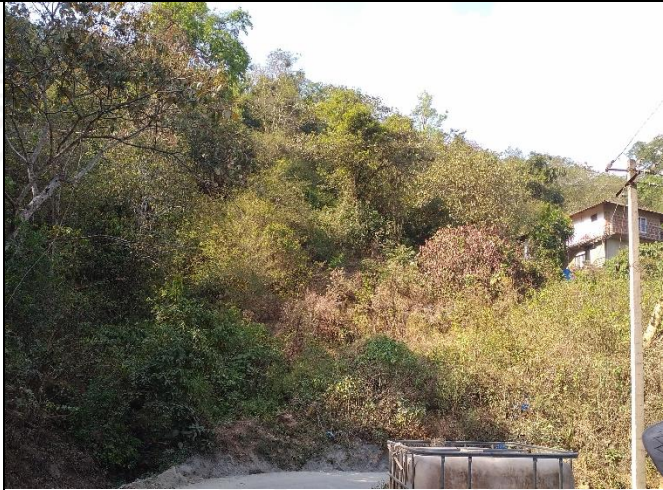
| 40 | Summary/Abstract | The shallow translational slide near Coorg Dental college is caused due steep cutting of overburden covered slope for road widening and sustained toe erosion by the stream. The slope is characterized by thick overburden/residual soil. It is recommended to construct a gabion wall with sufficient weep holes and lined drainage to be provided on the hillside. |

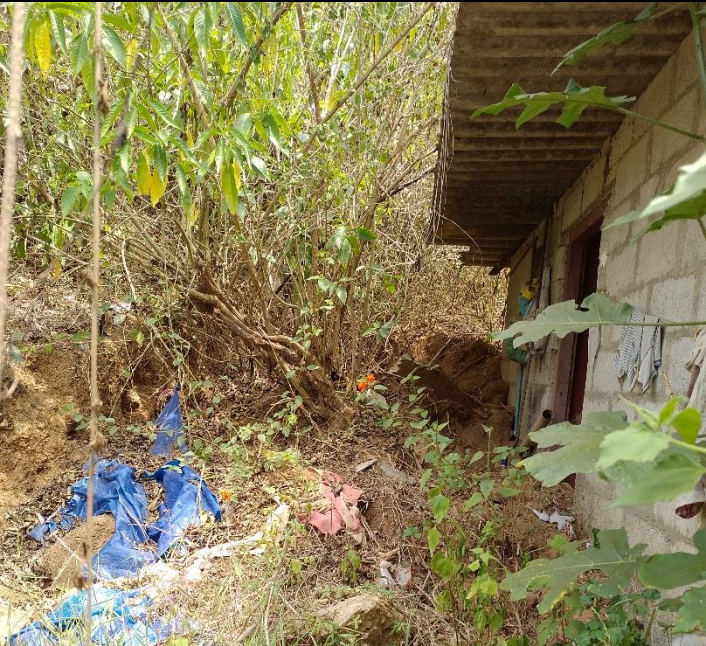
| 40 | Summary/Abstract | The shallow translational slide near midslope of Nehru Nagar is caused due steep cutting of overburden covered slope for house construction and sustained toe erosion by the stream. The slope is characterized by thick overburden/residual soil. It is recommended to construct a gabion wall with sufficient weep holes and lined drainage to be provided on the hillside. |

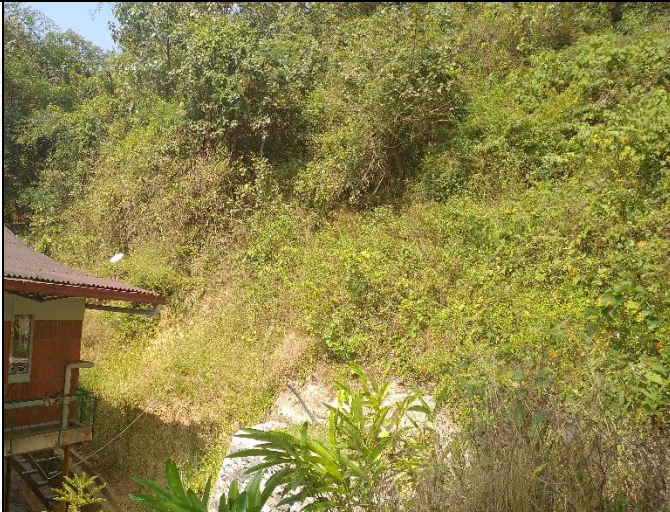
| 40 | Summary/Abstract | The shallow translational slide near midslope of Bittangala is caused due steep cutting of overburden covered slope for building construction and sustained toe erosion by the stream. The slope is characterized by thick overburden/residual soil. It is recommended to construct a gabion wall with sufficient weep holes and lined drainage to be provided on the hillside. |

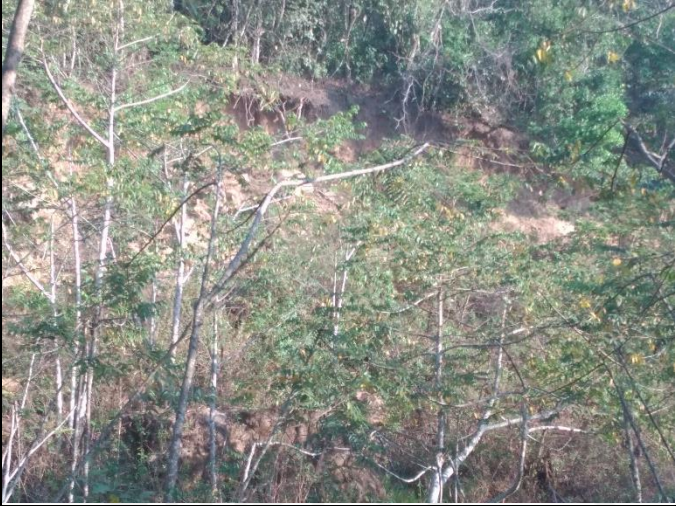
| 40 | Summary/Abstract | The shallow translational slide near upslope of Coorg Dental College is caused due steep cutting of overburden covered slope for building construction. The slope is characterized by thick overburden/residual soil. It is recommended to construct a gabion wall with sufficient weep holes and lined drainage to be provided on the hillside. |
