मेसो-स्केल (1:10,000) कलासा क्षेत्र के एनएनई में और एसएच-66 रोड कॉरिडोर के साथ,  
चिकमंगलूर जिला, कर्नाटक में भूस्खलन संवेदनशीलता मानचित्रण।  
**Meso-scale (1:10,000) Landslide Susceptibility Mapping in NNE of Kalasa area and  
along SH-66 road corridor, Chikmangalur District, Karnataka.**  
टोपोशीट सं: 48 O/8; Toposheet No.: 48 O/8

एम4एलएसएसएम/एनसी/एसआर/एसयू-केजी/2021/33518  
**Item no.: M4LSSM/NC/SR/SU-KG/2021/33518**

**कार्य सत्र 2021-22 का प्रतिवेदन**  
**Report for field season 2021-22**

इंजीनियरिंग भूविज्ञान तथा भूस्खलन विभाग/Engineering Geology and Landslide Division  
राज्य इकाई: कर्नाटक एवं गोवा/State Unit: Karnataka & Goa  
बेंगलूरु/Bengaluru-560078

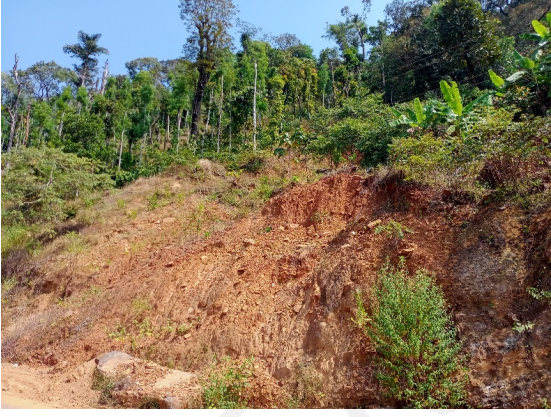
| <p>Fig. 7.1a Landslide inventoried at Chennahadlu which damaged a house.</p> | <p>Fig. 7.1b Landslide inventoried at Chennahadlu which damaged a house.</p> |

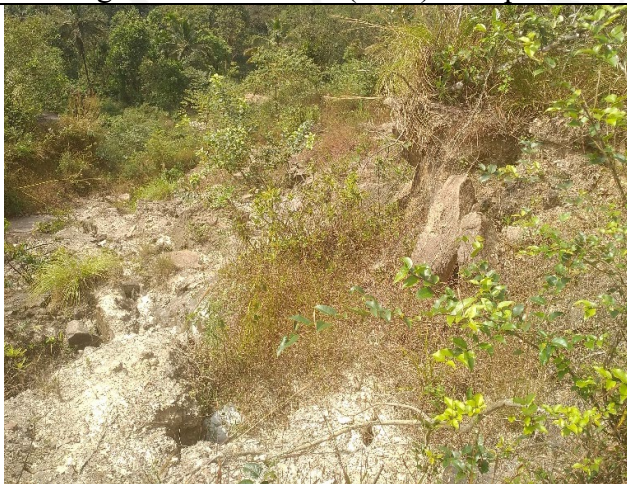
Fig. 7.2a Debris flow inventoried at Malleshwara which damaged the road

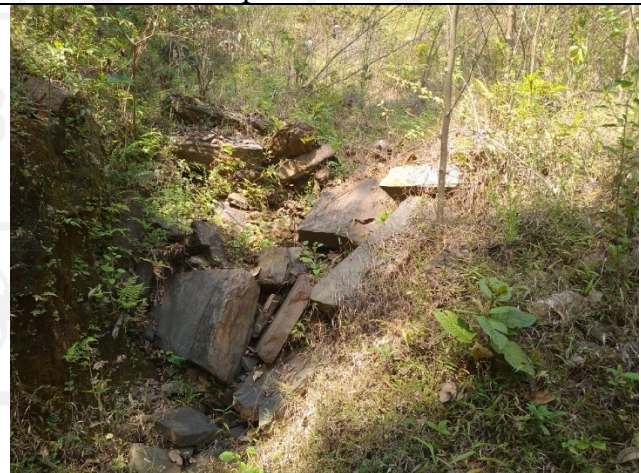
Fig. 7.2b Colluvium brought down with debris flow at Malleshwara midslope

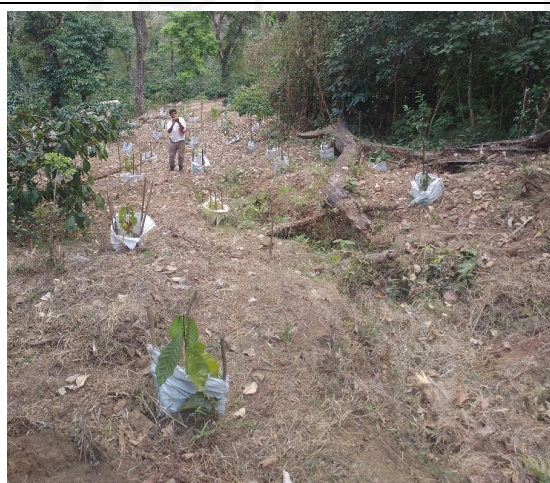
Fig. 7.3a Debris flow damaged coffee plantation

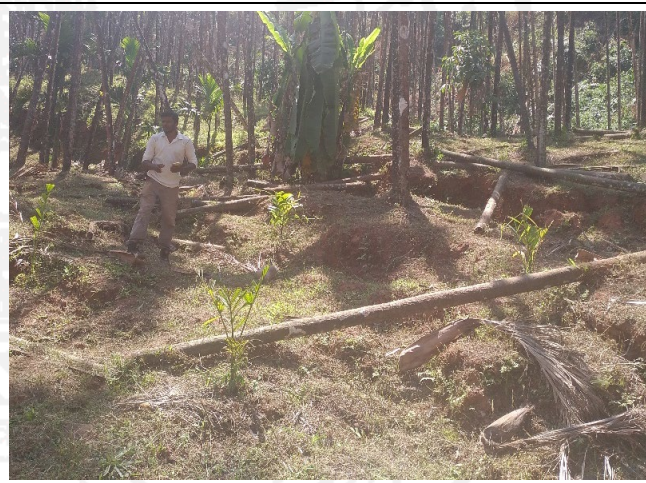
Fig. 7.3b Transverse cracks on the footslope of Bilagali

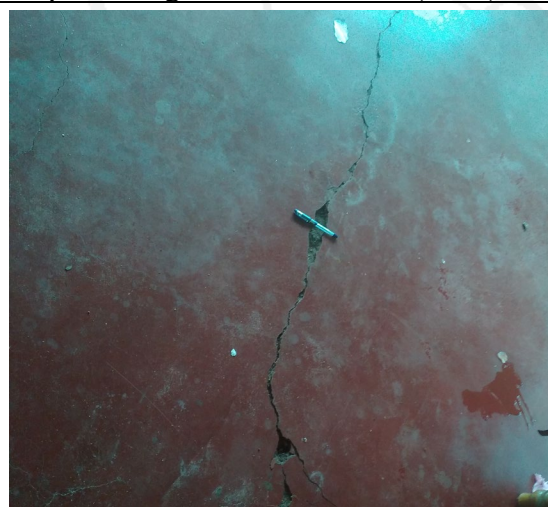
Fig. 7.4a Cracks observed on the floor of the building at Mallamara Hirebyle

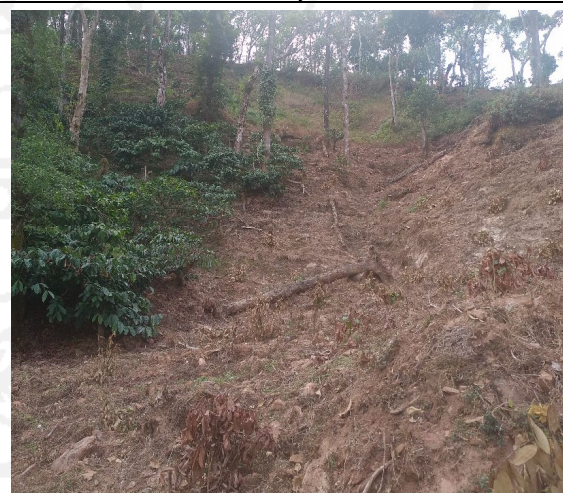
Fig. 7.4b Landslide scar on the NE facing slope of Mallamara Hirebyle

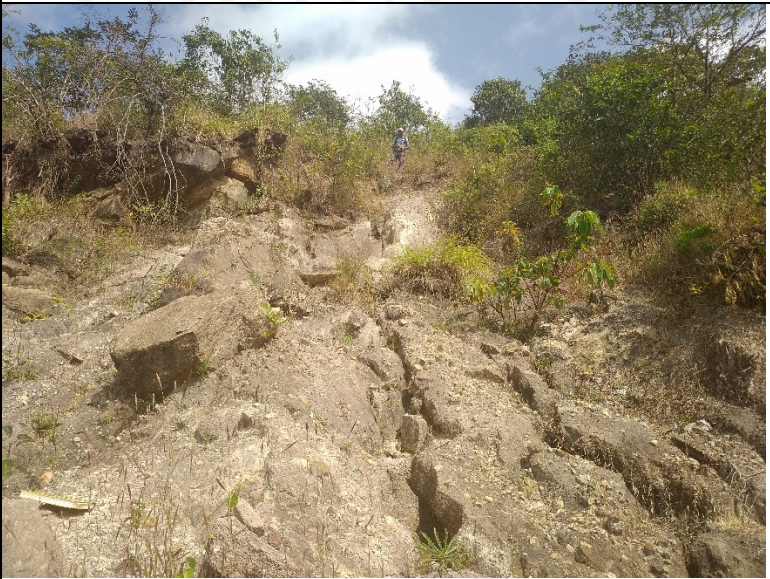
| 40 | Summary/Abstract | A shallow translational rock slide is caused due to highly deformed and weathered rock profile and the vulnerable joint set dipping valley ward and less than the slope angle. It was triggered by prolonged rainfall. |

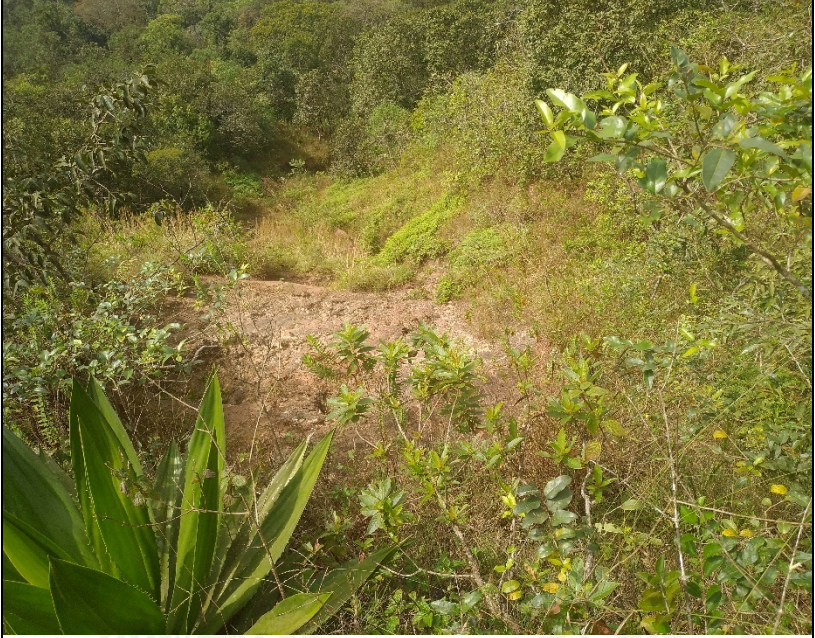
| 40 | Summary/Abstract | A shallow translational debris slide is inventoried which is caused due to presence of thick overburden with steep slope. A contour drain at the crown area to divert surface runoff is suggested. |

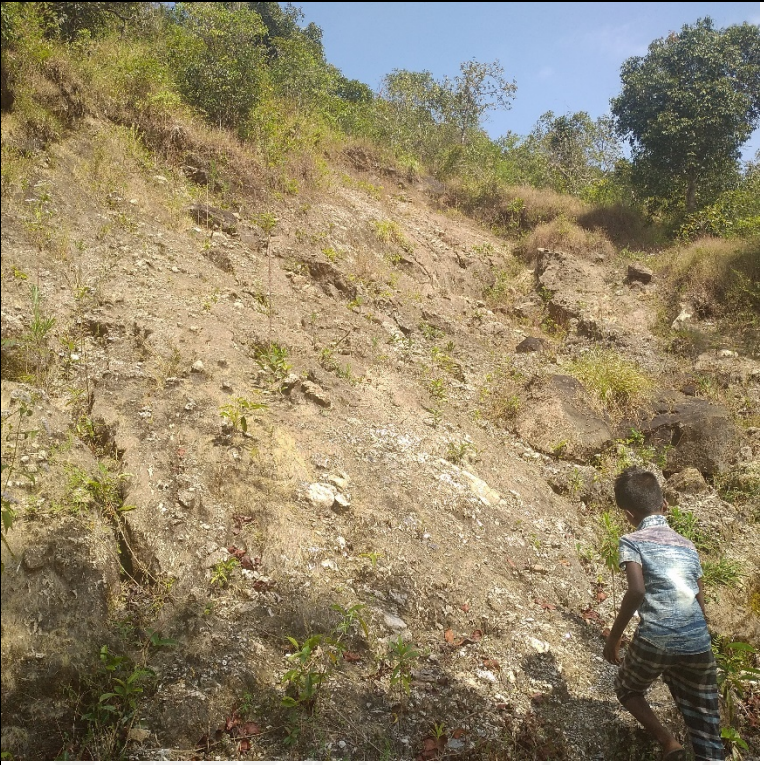
| 40 | Summary/Abstract | A shallow translational failure at the Yedur road hillslope is caused by the slope cutting without any structural support at the toe. A toe support system is recommended at the toe of the slide. |

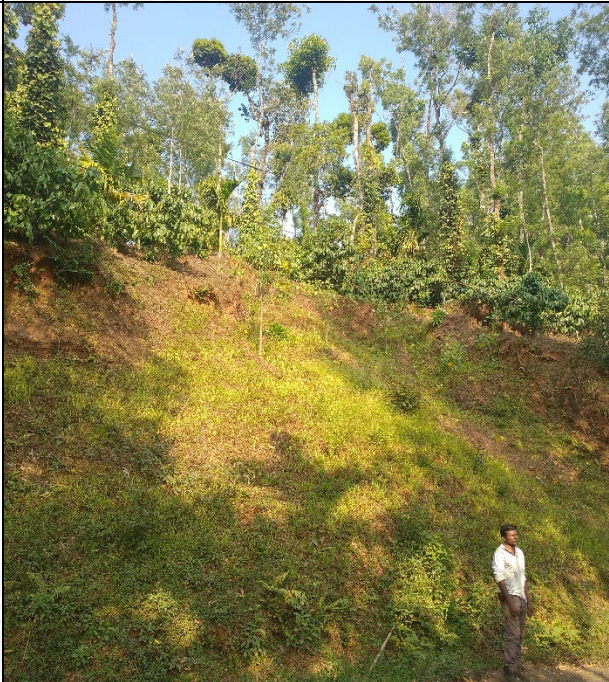
| 40 | Summary/Abstract | A soil slide is caused near Gumminkad due to steep slope cutting for the widening of the road. The slope is characterized by thick insitu soil. It is recommended for the construction of breast wall with weep holes and toe drain. |

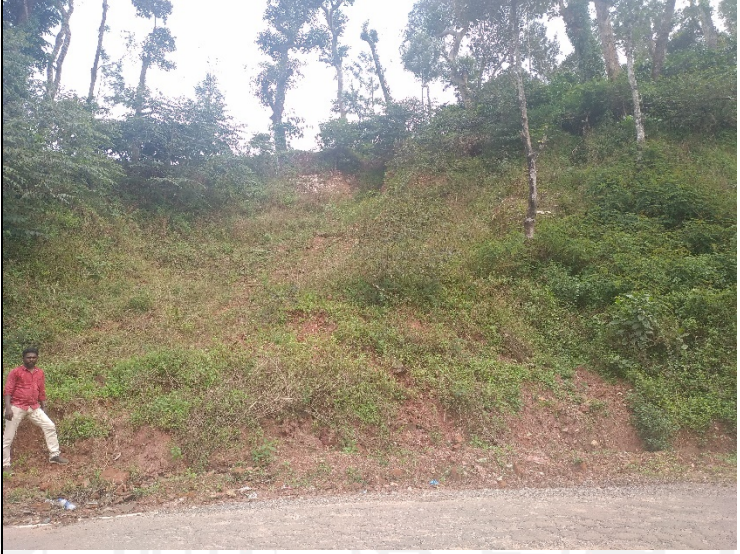
| 40 | Summary/Abstract | A shallow translational debris slide is caused by absence of drainage system to divert the surface water. It is recommended to install a proper drainage system to control the slope instability. |

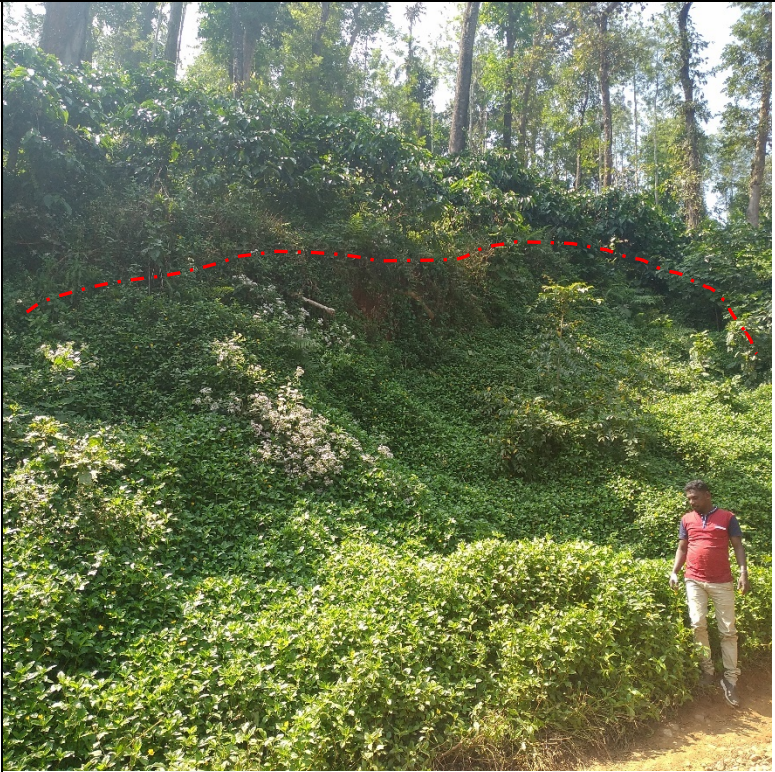
| 40 | Summary/Abstract | A minor shallow translational slide is caused by poor drainage system to drain the surface water subsequent erosion of the toe area of the cut slope. |

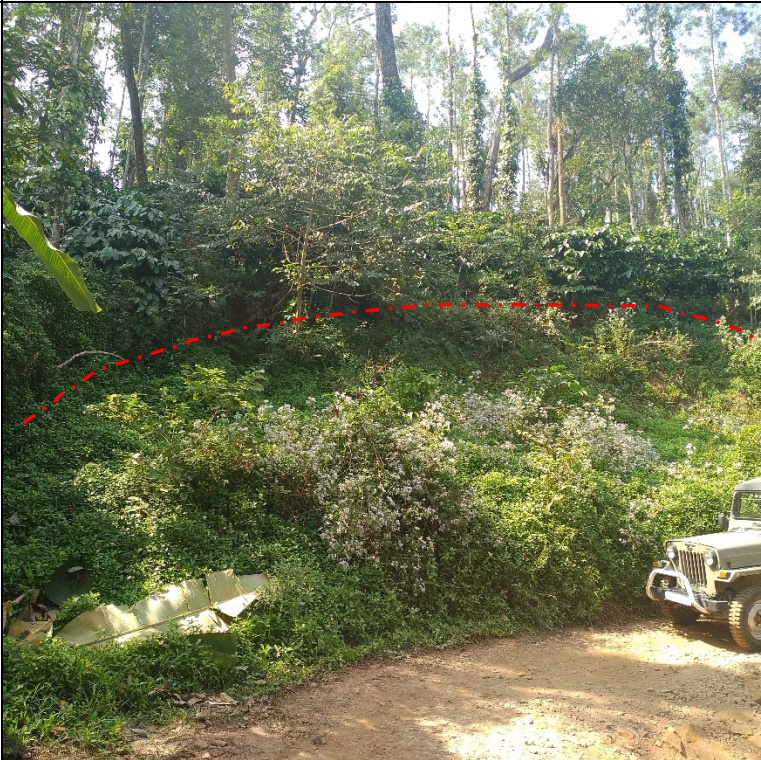
| 40 | Summary/Abstract | A soil slide is caused due to steep slope cutting without any provision of toe support system. The material is clay-rich thick insitu soil and aggravated by poor drainage to train the surface water. It is recommended to provide a lined hillside drainage to arrest further erosion. |

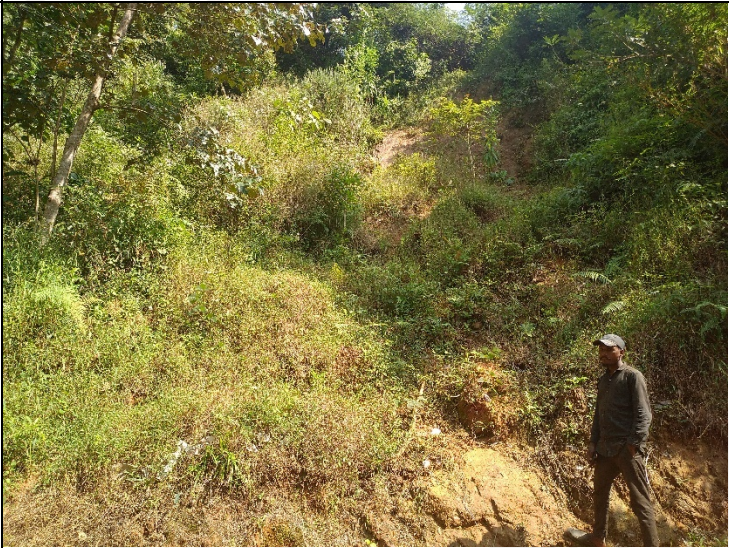
| 40 | Summary/Abstract | The shallow translational slide is caused by the steep cutting of slope beyond the angle of repose for construction of the road. The overburden thickness is about 1 m. It is recommended to ease the slope angle through benching. |

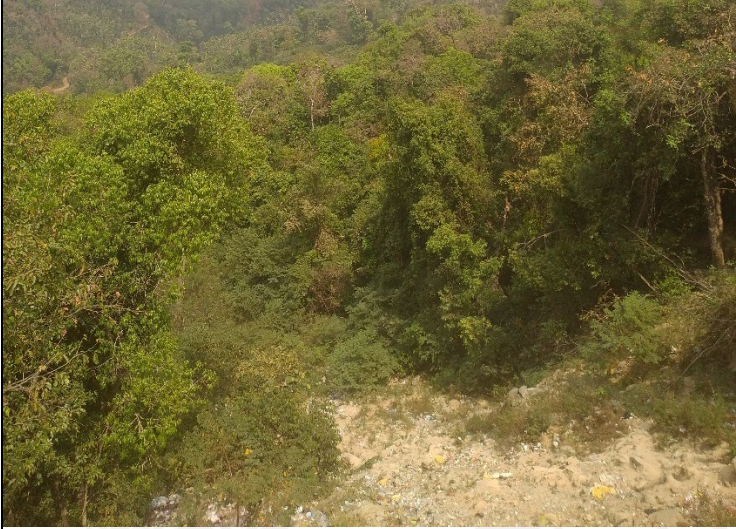
| 40 | Summary/Abstract | The shallow translational slide is caused by the confluence of surface drainage and sustained saturation of the overburden material. Linee hillside drainage near the crown is recommended for the site. |

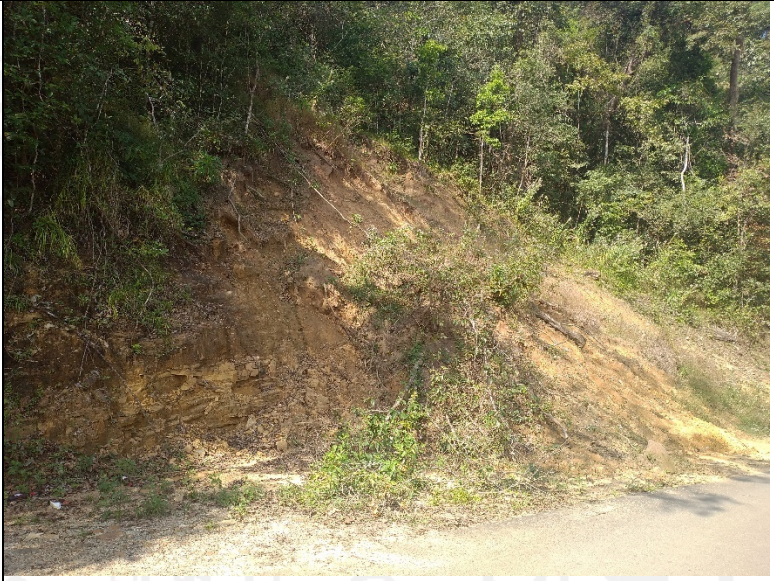
| 40 | Summary/Abstract | A shallow translational failure aggravated by debris overlying the weathered rock and percolation of water along the debris-rock interface. A breast wall along at the toe is recommended on this Hemmaki road stretch. |

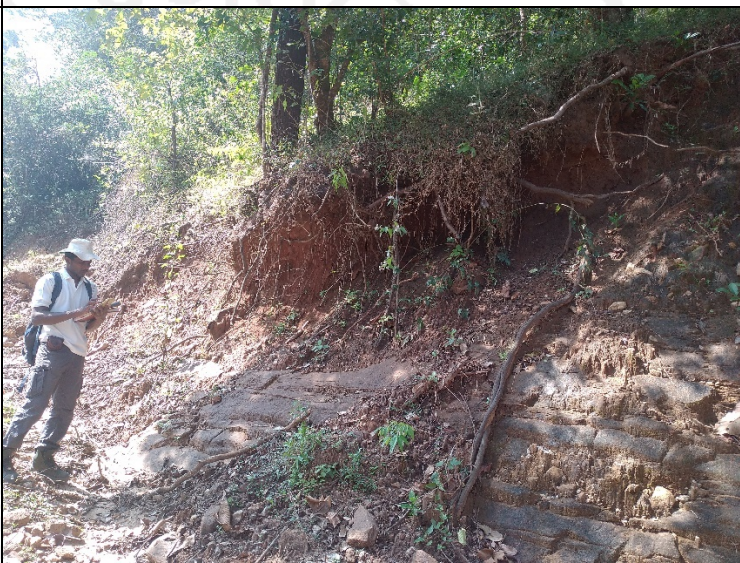
| 40 | Summary/Abstract | A shallow translational failure aggravated by debris overlying the weathered rock and percolation of water along the debris-rock interface. A breast wall along at the toe is recommended on this Hemmaki road stretch. |

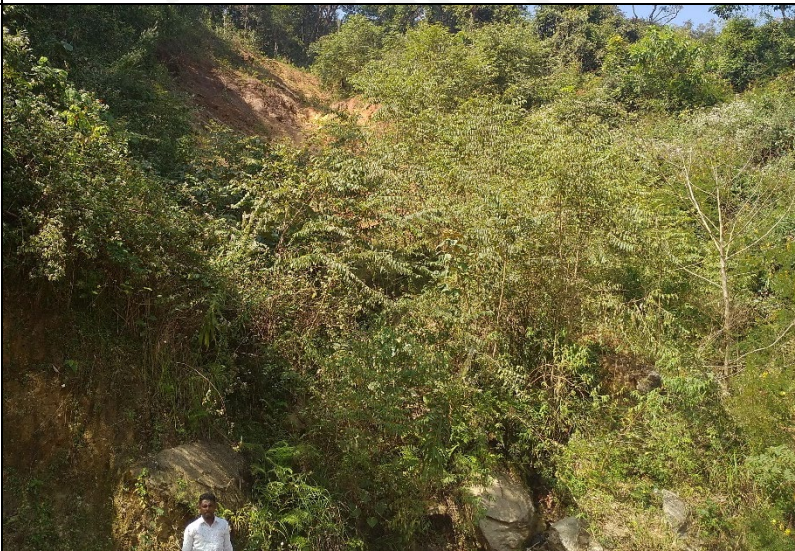
| 40 | Summary/Abstract | The shallow translational debris slide in is caused by the preponderance of colluvium on the steep slope at the flanks of the first order stream. It is inventoried along the Hemmaki road stretch. |

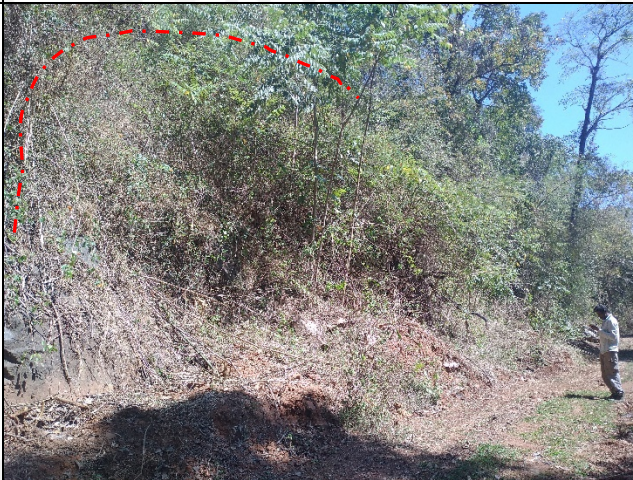
| 40 | Summary/Abstract | It is observed that about 1m thick overburden overlying the valley dipping rock and water percolation along the overburden-rock interface initiated the failure along the road north of Hemmaki. |

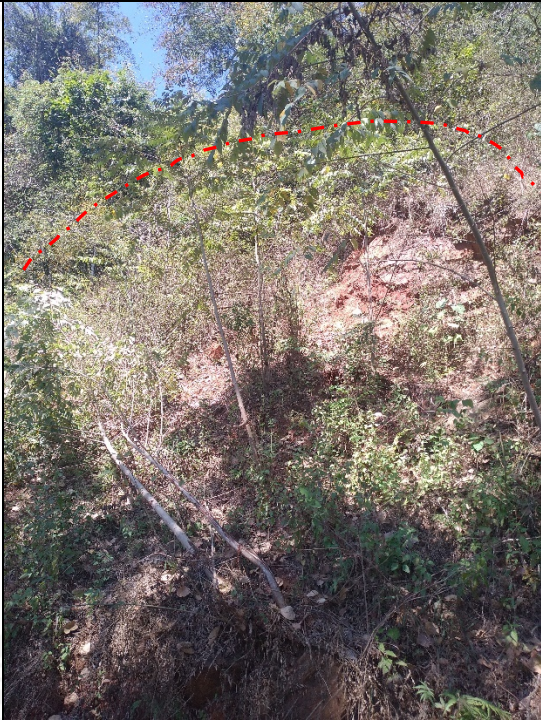
| 40 | Summary/Abstract | The shallow translational slide in is caused by steep cutting of the slope without any toe support and water infiltration over the overburden-rock interface. It is recommended to construct a hillside drain to prevent further toe erosion. |

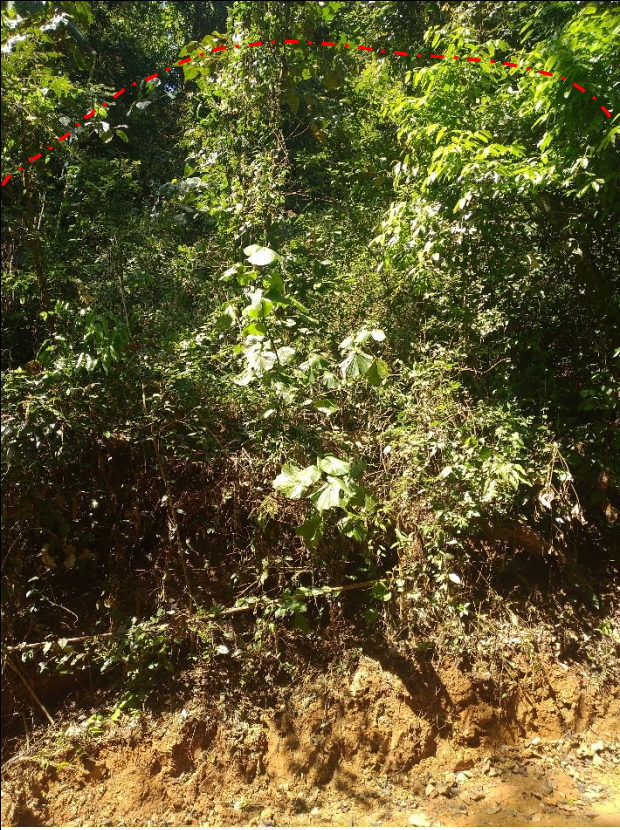
| 40 | Summary/Abstract | The shallow rotational slide in is caused due to steep cutting of an overburden-covered slope for road without proper toe buttress. The slope is characterized by thick overburden/residual soil. It is recommended to construct a breast wall with sufficient weep holes and lined drainage to be provided on the hillside. |

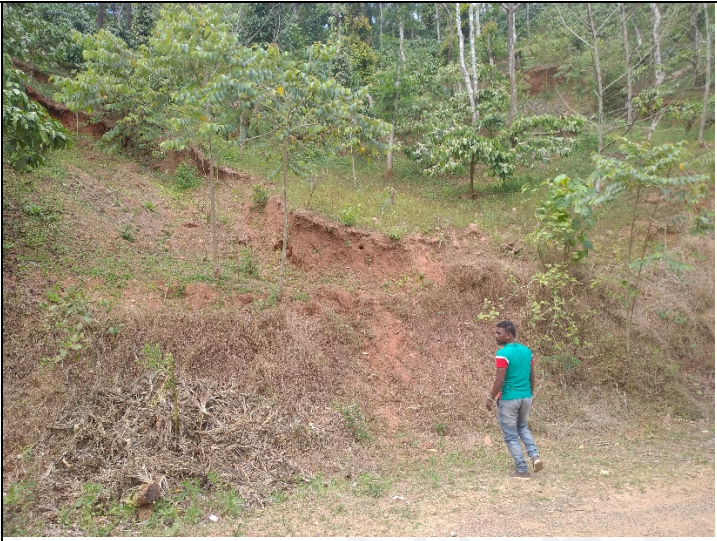
| 40 | Summary/Abstract | The shallow translational slide in is caused due to steep cutting of overburden-covered slope for road widening. The slope is characterized by thick overburden/residual soil. It is recommended to construct a breast wall with sufficient weep holes and lined drainage to be provided on the hillside. |

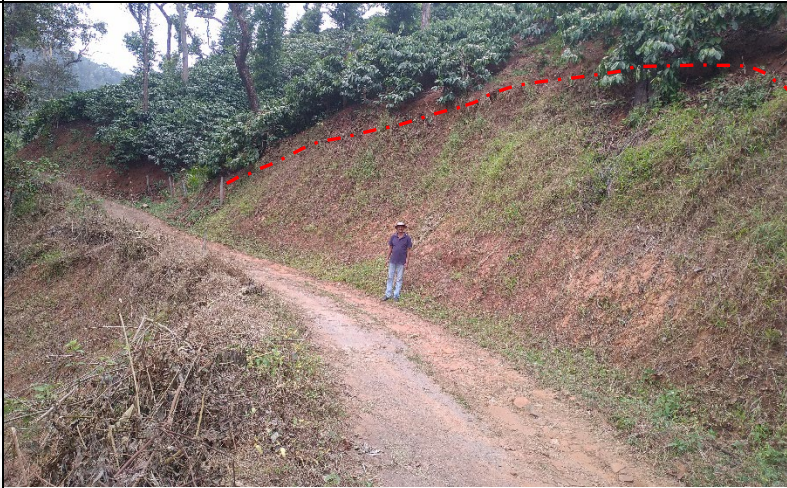
| 40 | Summary/Abstract | The shallow translational slide in is caused due to steep cutting of an overburden-covered slope for road without toe support systems. The slope is characterized by thick overburden/residual soil. It is recommended to construct a |

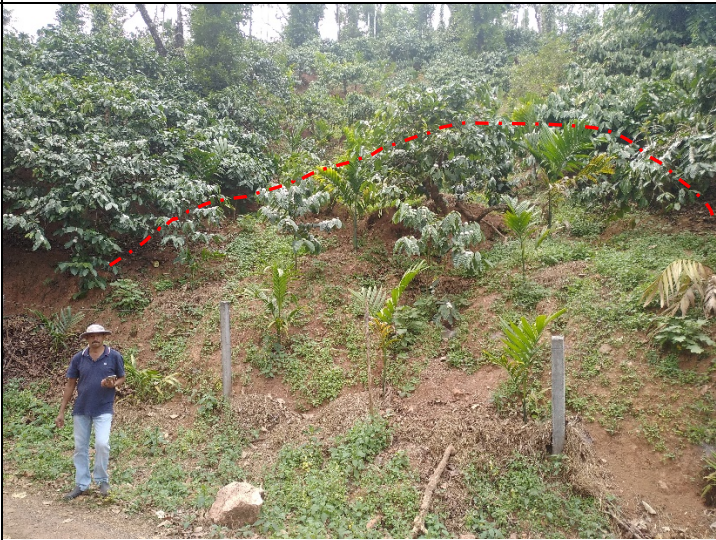
| 40 | Summary/Abstract | <p>The shallow translational slide in east is caused due to steep cutting of an overburden-covered slope for road widening. The slope is characterized by thick overburden/residual soil. It is recommended to construct a breast wall with sufficient weep holes and lined drainage to be provided on the hillside.</p> |

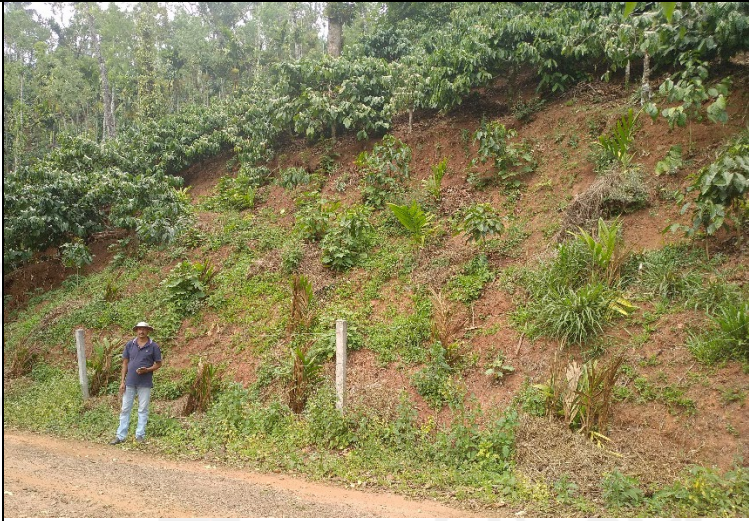
| 40 | Summary/Abstract | The shallow translational slide in the Hattla Coffee plantation is caused due to infiltration of surface runoff into the overburden-covered slope. The slope is characterized by thick mature overburden/residual soil. It is recommended to construct a breastwall at the toe of the slide. |

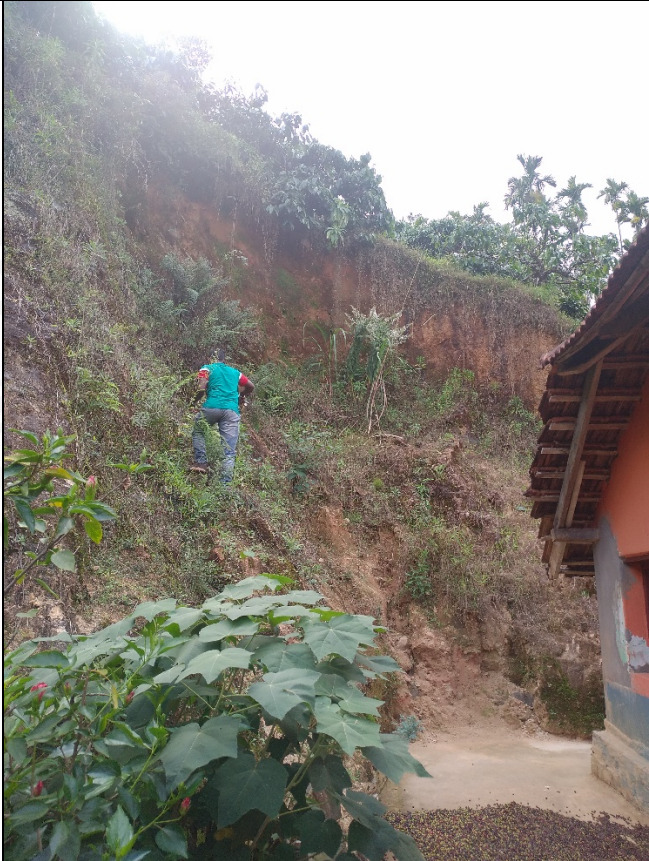
| 40 | Summary/Abstract | The shallow rotational slide in is caused due to steep cutting of an overburden-covered slope for construction of houses without any toe support systems. The slope is characterized by thick overburden/residual soil. It is recommended to construct a breast wall with sufficient weep holes and lined drainage to be provided on the hillside. |

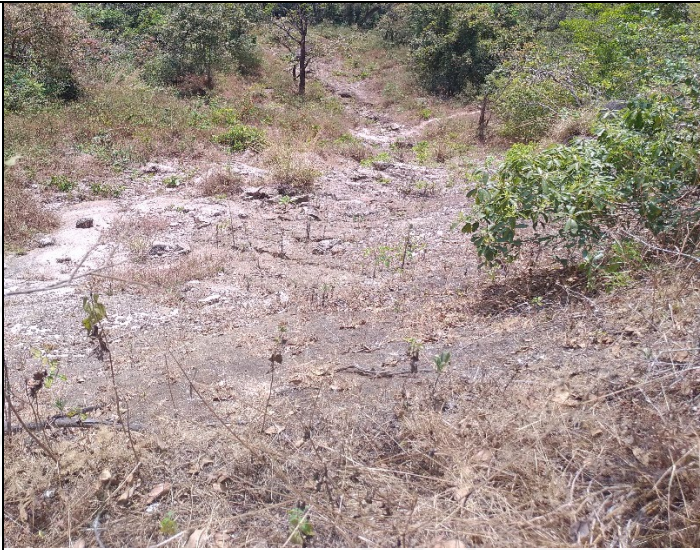
| 40 | Summary/Abstract | The shallow translational rock slide is caused due to highly fractured and unfavourable disposition and cutting of an overburden-covered slope for the road widening. It is recommended to avoid any slope cutting at the toe area of the slide. |

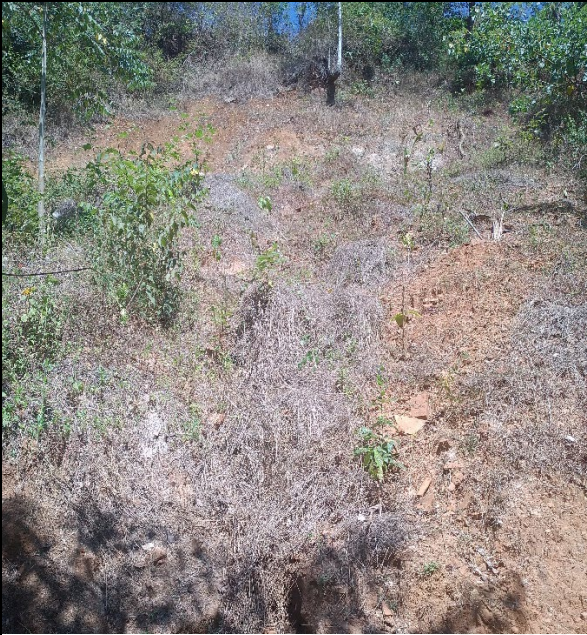
| 40 | Summary/Abstract | The shallow translational slide is caused due to steep cutting of an overburden-covered slope for widening of approach road for settlement. The slope is characterized by less compact debris and residual soil. It is recommended to construct a breastwall with sufficient weep holes and lined drainage to be provided on the hillside. |

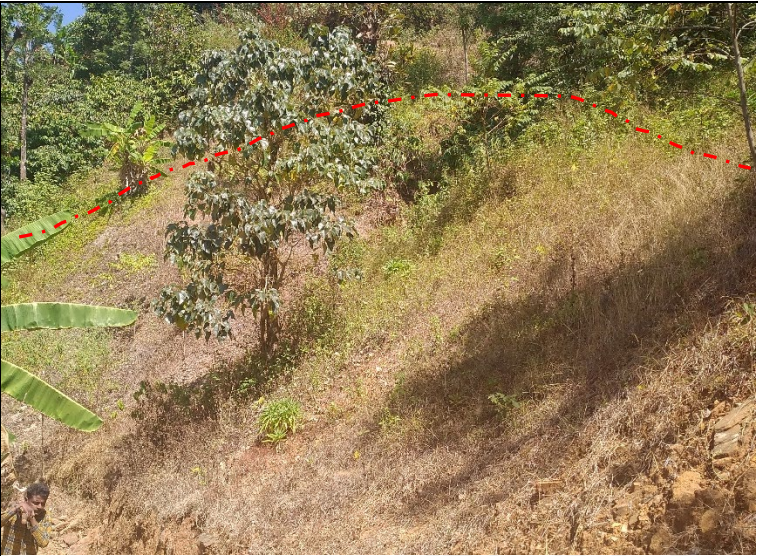
| 40 | Summary/Abstract | The shallow translational slide is caused due to steep cutting of an overburden-covered slope for widening of approach road for settlement and no structural support was provided. The slope is characterized by less compact debris and residual soil. It is recommended to construct a breastwall with sufficient weep holes and lined drainage to be provided on the hillside. |

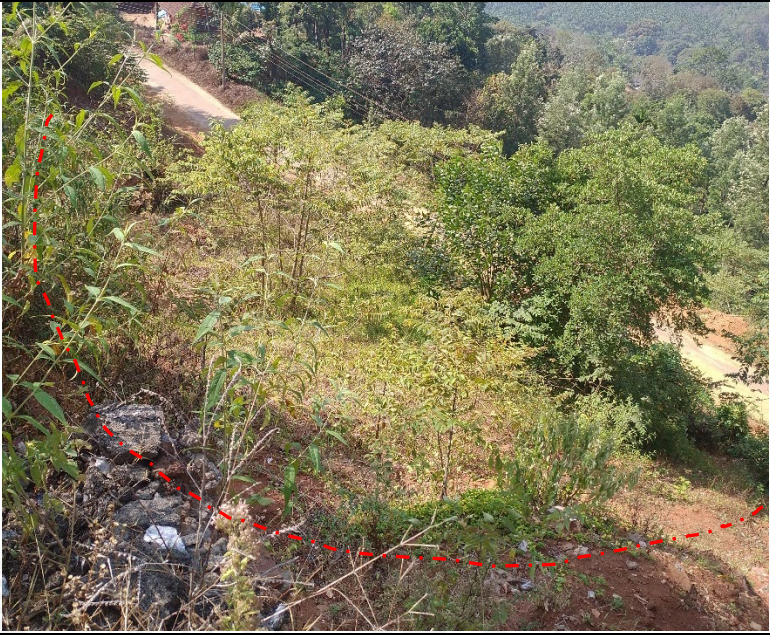
| 40 | Summary/Abstract | The shallow translational slide in is caused due to steep cutting of an overburden-covered slope for house construction and road widening. N structural support was provided at the time of investigation. It is recommended to construct a breast wall with sufficient weep holes and lined drainage to be provided on the hillside. |

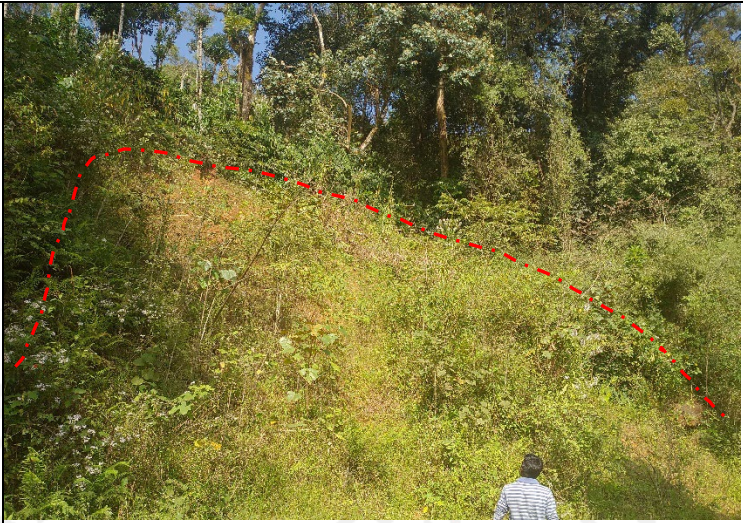
| 40 | Summary/Abstract | The shallow translational slide in Chennahadlu is caused by toe erosion of the slope characterized by 2-3m thick soil by first order stream. It is recommended for construction of breastwall with weep holes and hillside drainage to arrest further erosion. |

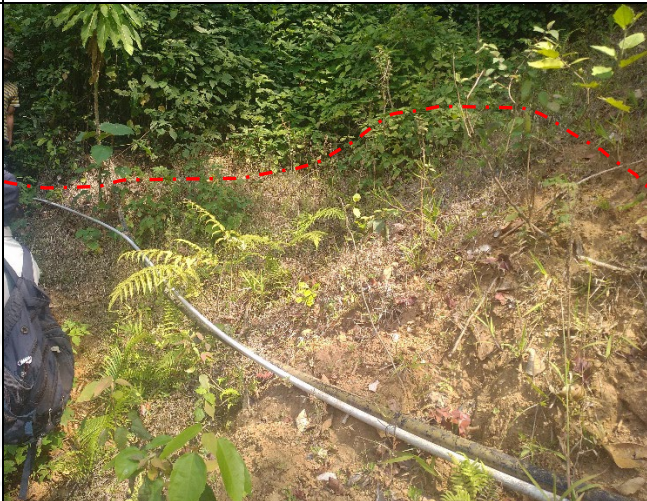
| 40 | Summary/Abstract | The shallow translational slide near midslope of Chennahadlu is caused due to sustained toe erosion by the stream at the downslope. The slope is characterized by 1-2m overburden/residual soil. It is recommended to construct a gabion wall with sufficient weep holes and lined drainage to at the toe of the slide. |

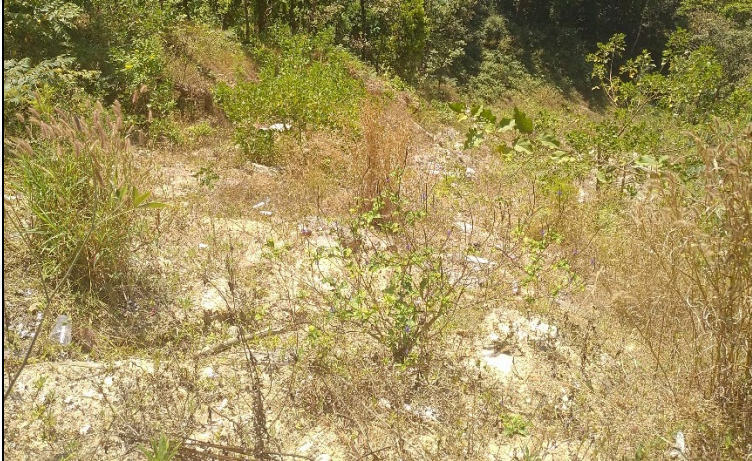
| 40 | Summary/Abstract | The shallow translational slide was observed within the fillslope with low compaction and poor drainage system at the crown area to divert the surface water flow. It is recommended to avoid further cutting of slope. The fillslope need to be properly compacted and provide suitable drainage system at the crown area. |

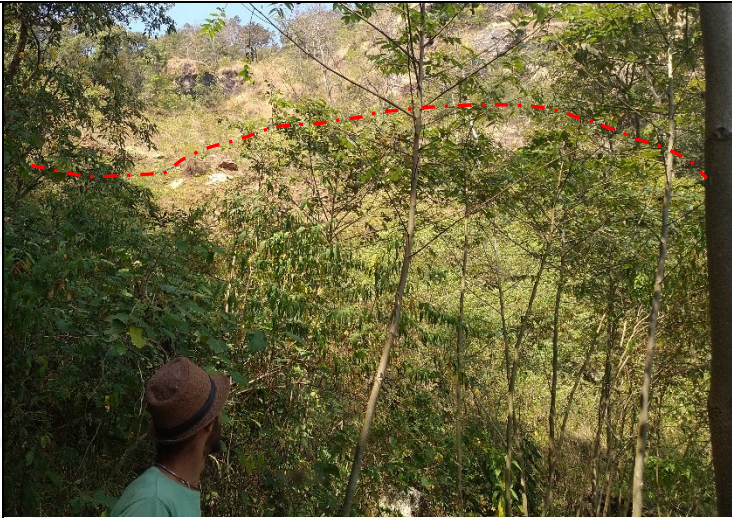
| 40 | Summary/Abstract | -It is observed that the slope here is characterized 1-2 m of colluvium and thickly forested. The first order stream has caused headward erosion and aggravated the slide. At the landslide initiation point no structural remedial measure may be required because the slide is in remote forest. However, it is recommended that proper lining of drainage and pre-cast pipe of adequate diameter be provided at the downslope where the Hemmaki road is intersected by the drainage. |

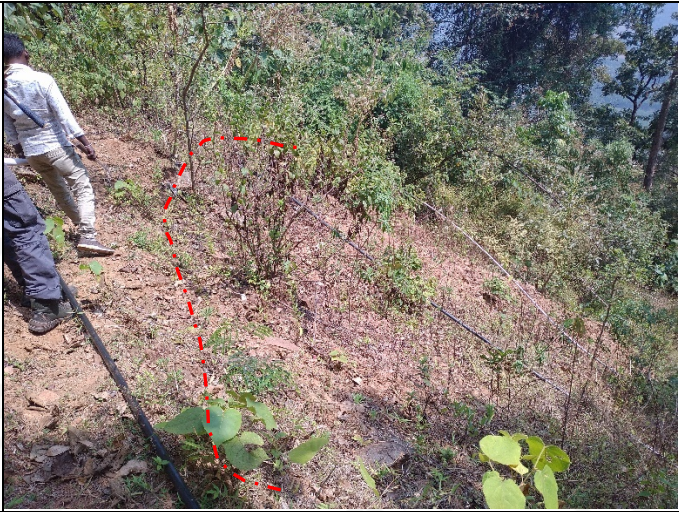
| 40 | Summary/Abstract | -It is observed that the slope here is characterized 1-2 m of colluvium and steeply dipping forested. The first order stream has caused headward erosion and aggravated the slide. The slide is in remote thickly forested area of Malleswara gudda and no immediate structural remedial measure may be required at the site. But the drainage downslope may be provided with suitable structural measures to accommodate debris flow. |

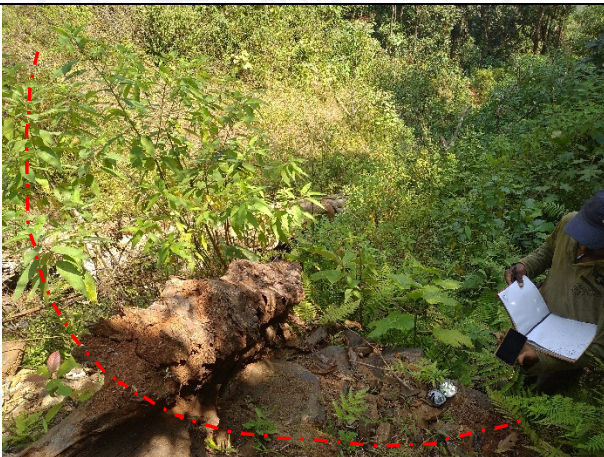
| 40 | Summary/Abstract | -It is observed that the slope here is characterized 1-2 m of colluvium and steeply dipping forested. The first order stream has caused headward erosion and aggravated the |

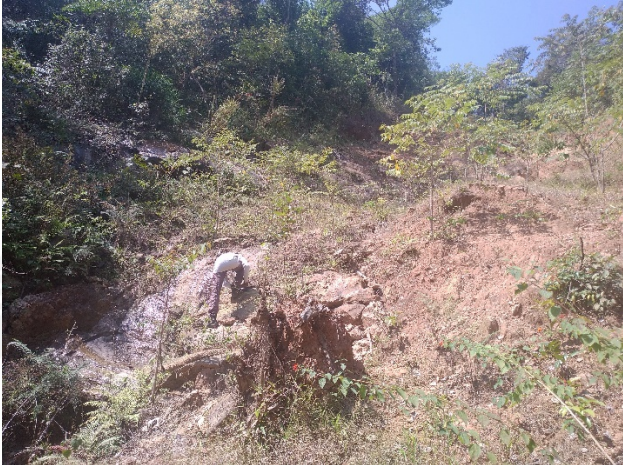
| 40 | Summary/Abstract | -The slide is inventoried at Malleswara gudda where the slope is characterized 1-2 m of colluvium resting over the moderately weathered amphibolite rock. The first order stream has caused headward erosion and aggravated the slide. It is a natural slide in remote forest with no elements at risk and therefore no immediate remedial measure may be required. But the point of intersection of drainage with Hemmaki road downslope may be provided with suitable structural measures to accommodate debris flow. |

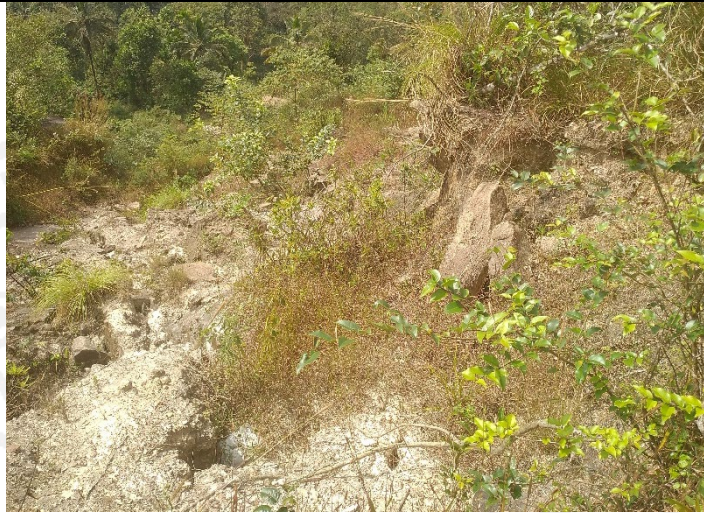
| 40 | Summary/Abstract | -It is observed that the slope here is characterized 1-2 m of colluvium and thickly forested. The first order stream has caused toe erosion and aggravated the slide. It is a natural slide in remote forest with no elements at risk and therefore no immediate remedial measure may be required at the landslide site but it is recommended that proper lining of drainage and pre-cast pipe of adequate diameter may be provided at the downslope where the Hemmaki road is intersected by the drainage in the event of debris flow. |

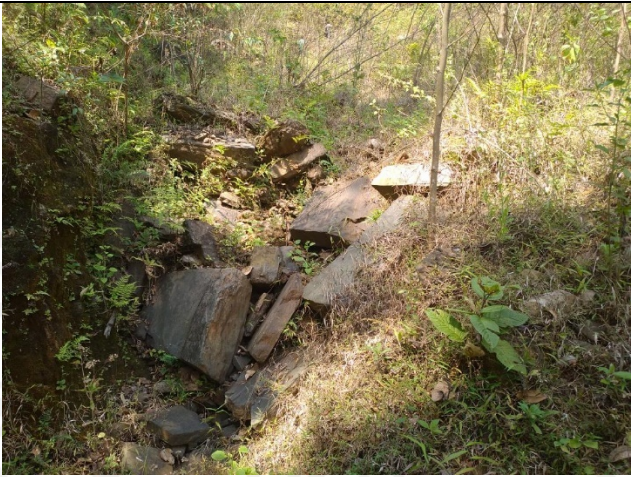
| 40 | Summary/Abstract | -It is observed that the slope here is characterized 1-2 m of colluvium and boulders. It is recommended that proper lining of drainage and pre-cast pipe of adequate diameter may be provided at the downslope where the Hemmaki road is intersected by the drainage in the event of debris flow. |
