**Note on the preliminary Assessment of Landslides at Dakshin Kannada Districts, Karnataka, 2023.**

M4LS/NC/SR/SU-KG/2023/47552

Field season 2023-24

Senthilkumar K  
Senior Geologist

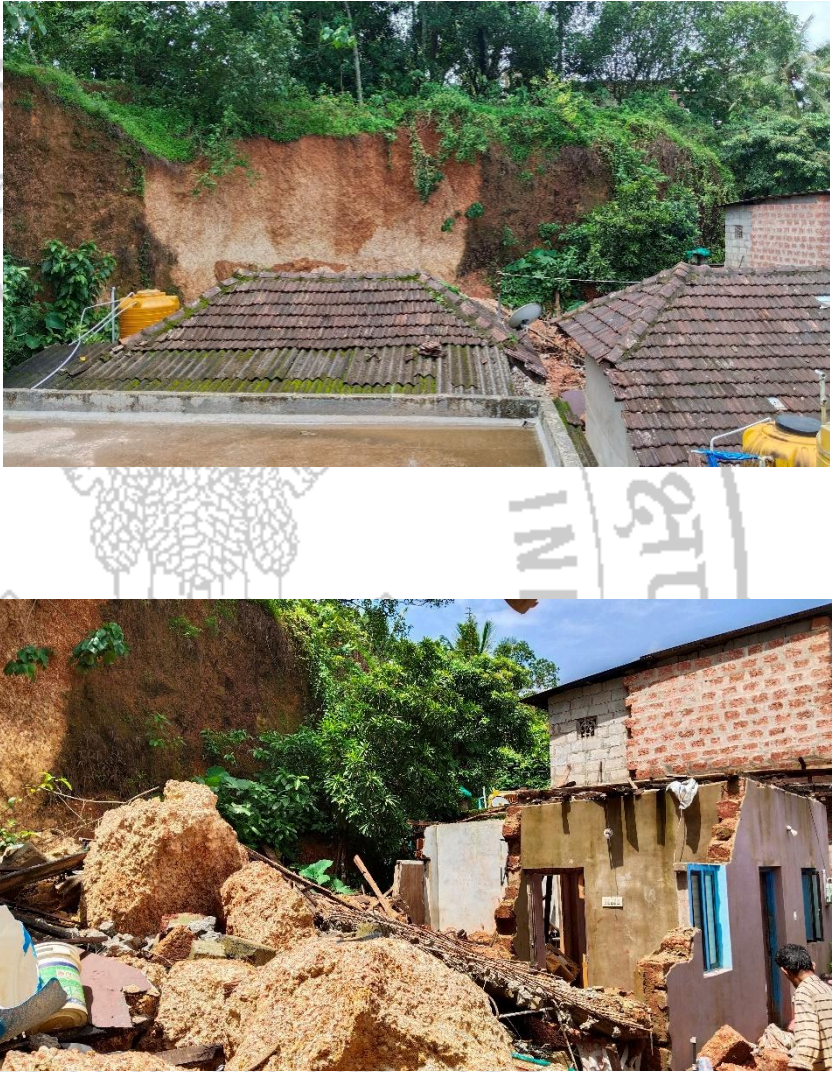
In Sajipamunnur village, Dakshin Kannada, the landslide that resulted in casualties initiated on a steep cut slope, approximately 7-8 meters high, which had been modified for settlement purposes but lacked essential features like a toe buttress system or benching to stabilize the slope. This slope had been excavated about 20 years ago, and the material comprising it was lateritic clay-rich soil with a thickness of 8-10 meters. The failure of this slope was triggered by

heavy rainfall. The primary contributing factor to the landslide was the presence of a thick layer of clay-rich soil on the cut slope section. This event led to the complete destruction of one settlement, one fatality, and severe injury to another individual. The adjacent areas with similar slope structure are susceptible to failure during intense rainfall, although no surface cracks are currently visible in the crown part of the slope.

| No | Field | |
|---|---|---|
| 36 | Geo-scientific Causes | Slope-forming material was lateritic clay-rich material and the<br>The cut slope was not protected by any retaining structure. During<br>rainfall time the clay-rich materials are over-saturated. |

| 40 | Summary/Abstract | On 07th July 2023, a landslide occurred due to a lack of proper slope stabilization. The slope had been cut vertically by 8m without any retaining structure at the base. The heavy rainfall caused the lateritic clay-rich soil to become saturated and collapse. To prevent further damage, a retaining wall with a solid foundation should be constructed or the slope angle should be reduced by creating benches. |

| 37 | Remedial measures | RCC retaining wall has to be constructed and backfilled with appropriate material or vertical cut slope angle to be reduced by benching. |

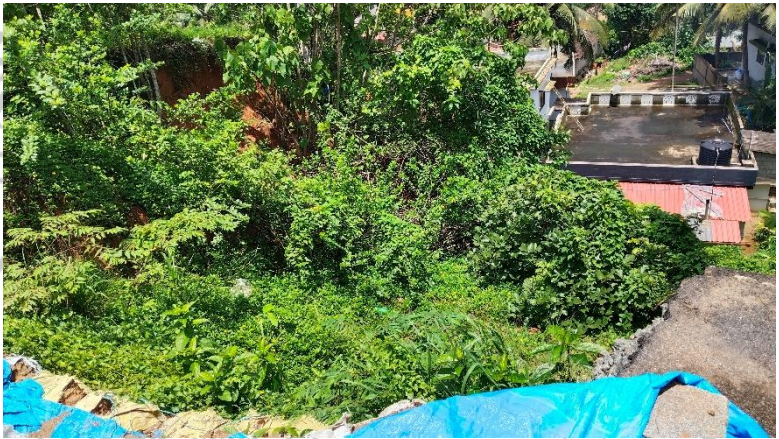
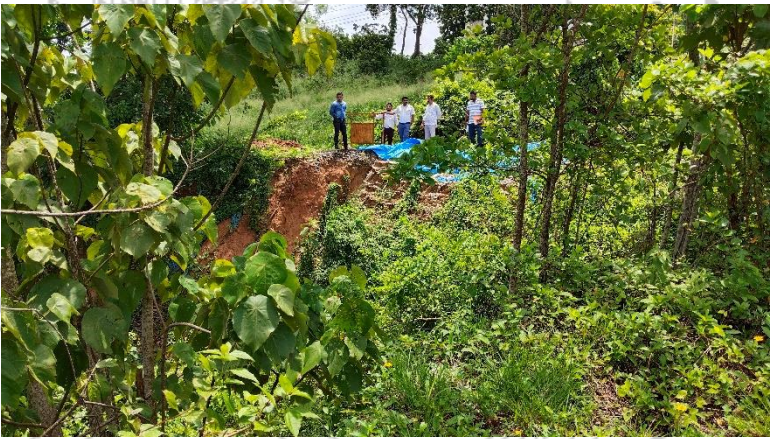
In Gudinapali village, a landslide occurred in 2022 (Particular date unknown) during the rainy season. The slope had been cut for settlement construction without implementing any remedial measures. The material forming the slope is thick in situ soil. The slide took place just below the road bench and impacted the settlement on the cut slope. The terrain upslope from the settlement exhibits a moderate dip with slope angles ranging from 15 to 20 degrees.

| No | Field | |
|---|---|---|
| 36 | Geo-scientific Causes | 1. The landslide initiated on the downslope of the village link road due to steep cutting for settlement without a toe buttress system. |

| | | 2. The slope-forming material is thick soil and the surface runoff from the road due to lack of proper drainage saturated the slope material. |
| 40 | Summary/Abstract | The construction of a settlement involved a steep toe cut on the slope, which was left unprotected. The thick in situ soil on the vertical cut slope became unstable and started to slide from the downslope of the road bench. The sliding material accumulated behind the settlement and exerted pressure on the structure. There were also fresh landslide scars near the settlement. To prevent further damage, a retaining wall should be built at the downslope of the road bench and behind the settlement. Additionally, proper drainage should be installed to divert the surface runoff. |

| 37 | Remedial measures | 1. A retaining wall to be constructed to protect the road as well as the cut slope settlement<br>2. Hill-side lined drainage to be provided to avoid surface runoff. |
