**A REPORT ON LANDSLIDE INVENTORY ALONG NH & SH  
OF GHAT ROADS IN KARNATAKA**

**(Progress Report for the Field Season 2007-08)**

**Code No.: LHZ/SR/KG/2007/044**

**Project: ENGINEERING GEOLOGY**

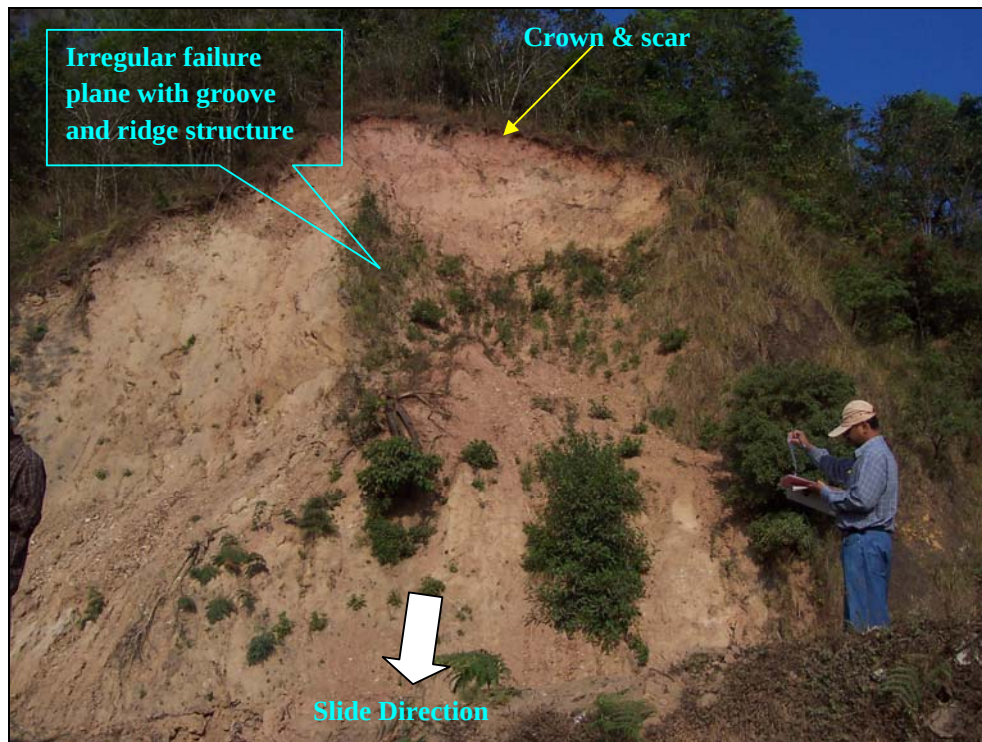
**CAUSES:** The contour road has been cut across the slope of the spur of the hill where both sides are drained by streams. The cut slope has exposed the toe of the slide on the road along the three sides of the slope thus increasing the instability. As the cut slope height was more at the middle part of the spur i.e. convex turn of the road, the maximum disturbing force was along this direction. The incumbent pore pressure development during monsoon triggered this slide as the slope forming debris material was highly saturated with rain water. Few old slide scars observed at the boundary of this slide were also caused due to the above reasons.

**NATURE OF DAMAGE:** The Madikere-Mangalore state highway (SH 88) was blocked due to the heaped debris material on the road.

**Photo-1:** The plan view of the landslide along Madikere-Mangalore road section (SH88)

- i) The crown part was found to be unstable hence the crown portion is to be completely removed.
- ii) The geometrical modification of the slope by grading or bench to be provided with height 2m with bench width 1 m at a slope angle of <30°.
- iii) Bio geotechnical measures of slope protection like plantation of Vetiver grass along the slope will reinforce this shallow slide.
- iv) Proper surface drainage and horizontal drainage is also recommended.

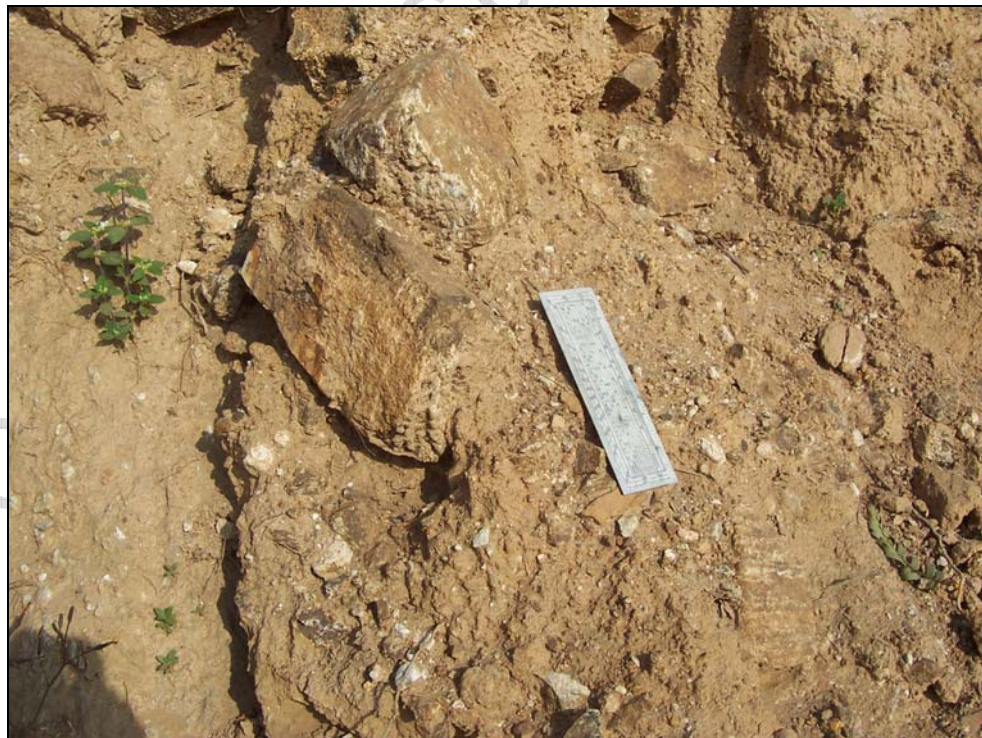
**Photo-2:** The highly weathered granite gneiss boulders in the debris on the slide plane

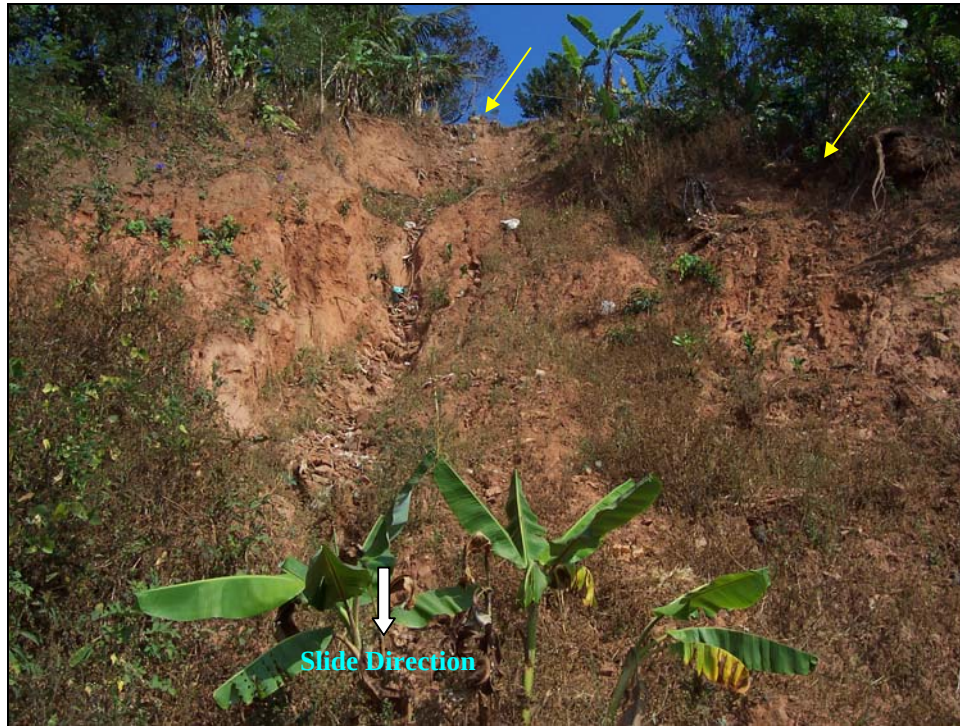
**CAUSES:** This slide was caused due to the blockage/obstruction of natural drainage. The mid section of the drainage was excavated for making construction space for the houses. The two small slides in the left flank of the major slide were on the cut slope at the mid section. To add to the woe the excavated material at the top of the hill are dumped in the slope. Both toe cutting and over saturation of the loose slope forming material caused this slide.

**NATURE OF DAMAGE:** The Madikere-Mangalore state highway (SH 88) was blocked due to the heaped debris material on the road.

**Photo-3:** The plan view of the landslide with several rills on the slide plane, the arrow mark shows the two source of the slide

- i). The loose material at the crown is to be removed.
- ii). The natural stream is to be restored for free flow.
- iii). No construction should be allowed along the flanks of the stream.
- iv). Small retaining wall of 2m height may be constructed at the base.

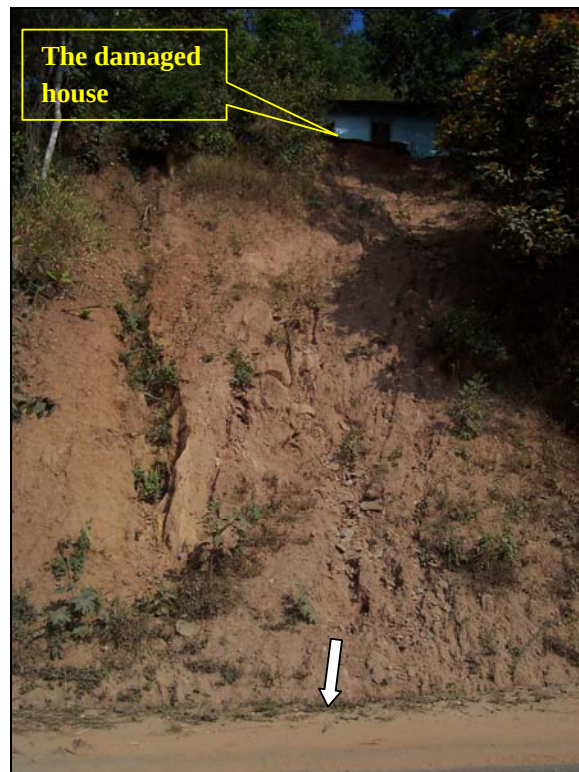
**CAUSES:** The house is located in the mid slope. The space for the construction of house has been carved out in the mid slope by excavation resulting in flattening of the slope. The loose unconsolidated dug out material was dumped in the lower slope (towards SH88). The pavement of the house was resting directly over this loose material. During monsoon of 2006 due to heavy rainfall the debris slid due to over saturation of the unconsolidated material taking with it a part of the varandah and developing concentric crown cracks all over the varandah, wall etc. To this the toe cutting of the slope at the back of the house caused the cut slope to fail and the slid debris ran into the back of the house damaging the back wall. The house was damaged due to the landslide.

**NATURE OF DAMAGE:** One house was damaged and SH88 was blocked.

**Photo 5:** The damaged house standing in the mid slope of the slide, rills formed all over the slide zone.

- i) The house is to be shifted and relocated to safer place.
- ii) The over hanging portion of the varandah is to be cleared totally as this portion is highly unstable and will slide down to SH88 in future with slight trigger.
- iii) Geometrical modification of the slope with grading .

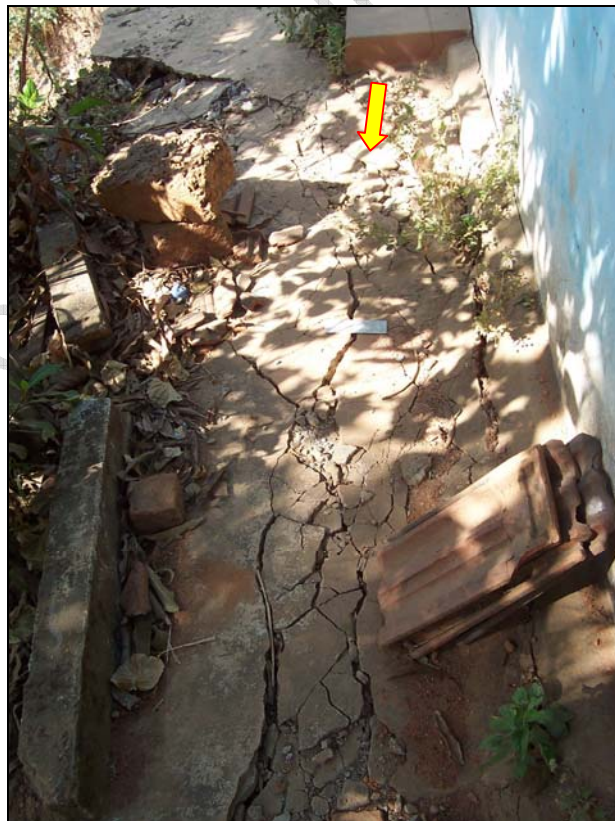
**Photo 6:** The arrow shows the damaged pavement with crown cracks

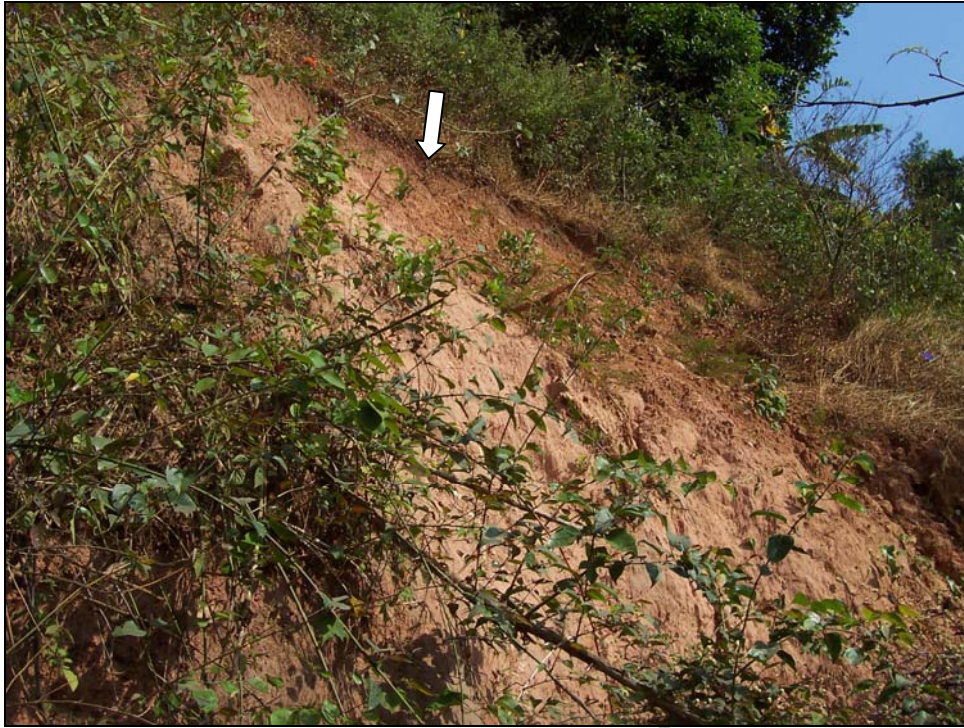
**Photo 7:** The land slide in the vertical cut slope with scar at the back of the house

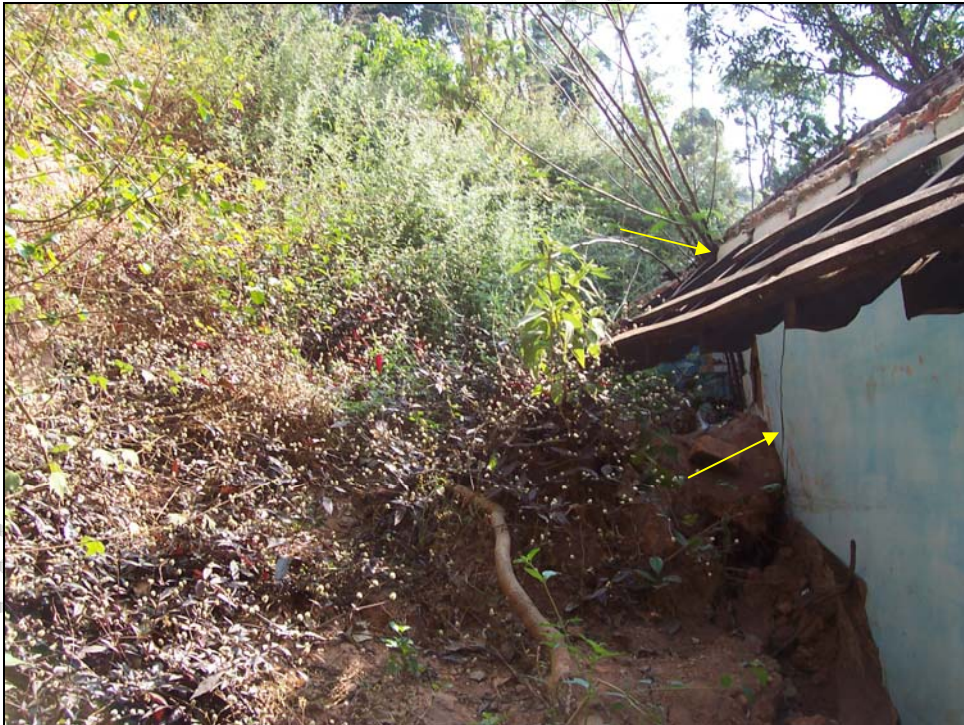
**Photo 8:** The debris accumulation and damage to the back wall and roof of the house.

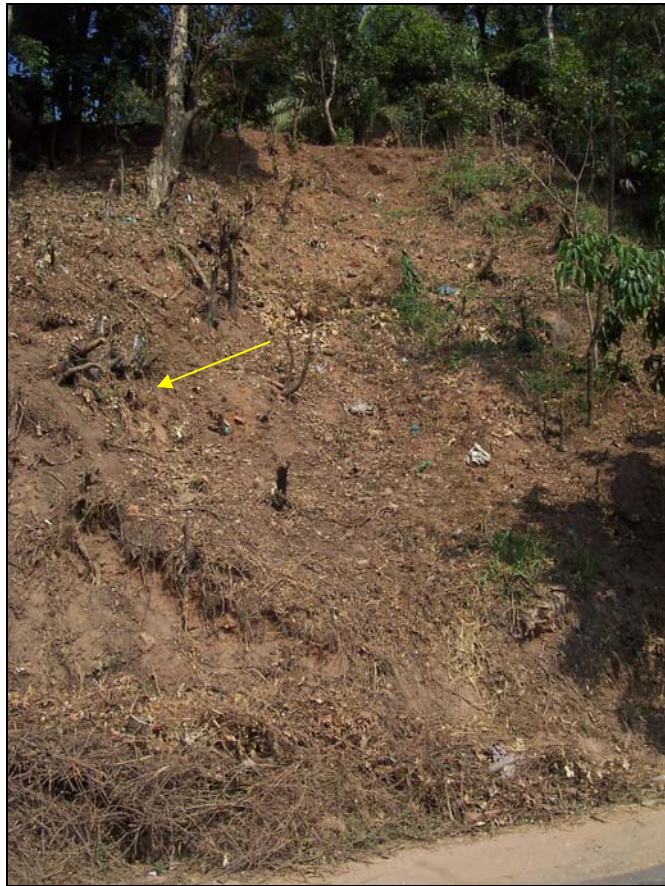
**Photo 9:** The debris dumped on the slope slid down on to the road, the arrow shows the undisturbed plants on the slope

- i). Geometrical modification of the slope is necessary to stabilize the slope.
- ii). As the slide is a shallow slide with depth of sliding less than 2m, deep rooted plants/shrubs with high tensile strength is to be planted in the benched slope to increase its stability.
- iii). Removal of loose material from the unstable crown.

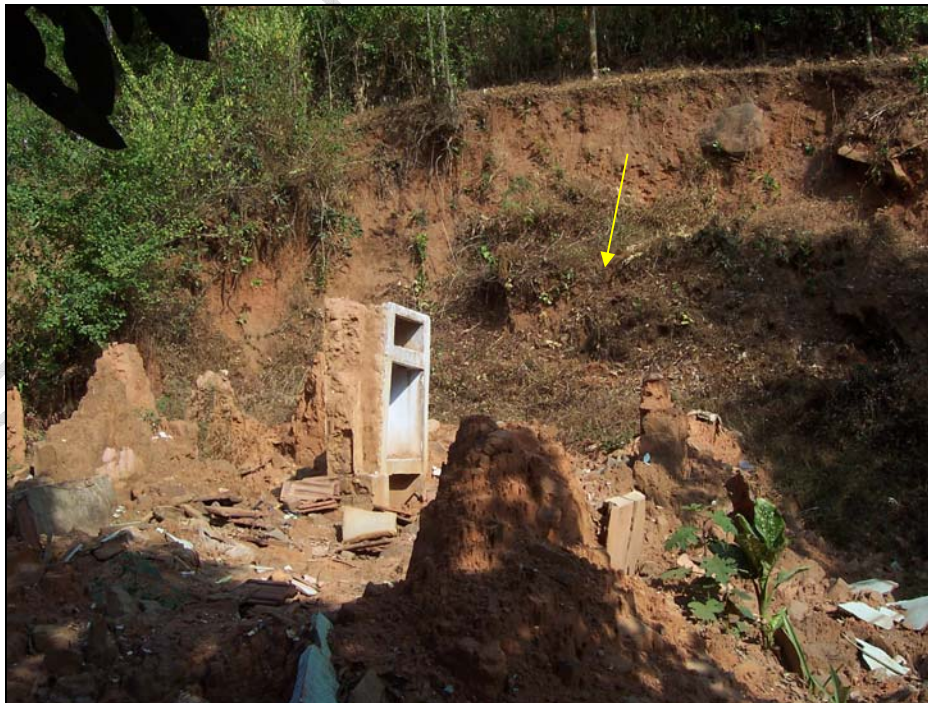
**CAUSES:** This slide occurred 100m west of the slide noKA03 in the same modified slope. The damaged house is located in the mid slope (Photo -10). The space for the house has been carved out in the mid slope by excavation (flattening the slope). The loose unconsolidated excavated material was dumped in the lower part of the slope (towards SH88). During monsoon of 2006 heavy rainfall caused over saturation of the unconsolidated slope material which slid down slope. The toe cutting of the slope at the back of the house caused the cutslope to fail and the slid debris ran into the back of the house damaging the back wall.

**NATURE OF DAMAGE:** One house damaged and Madikere-Mangalore (SH88) road was blocked.

**Photo 10:** The damaged house which was located along the run out path of the slide

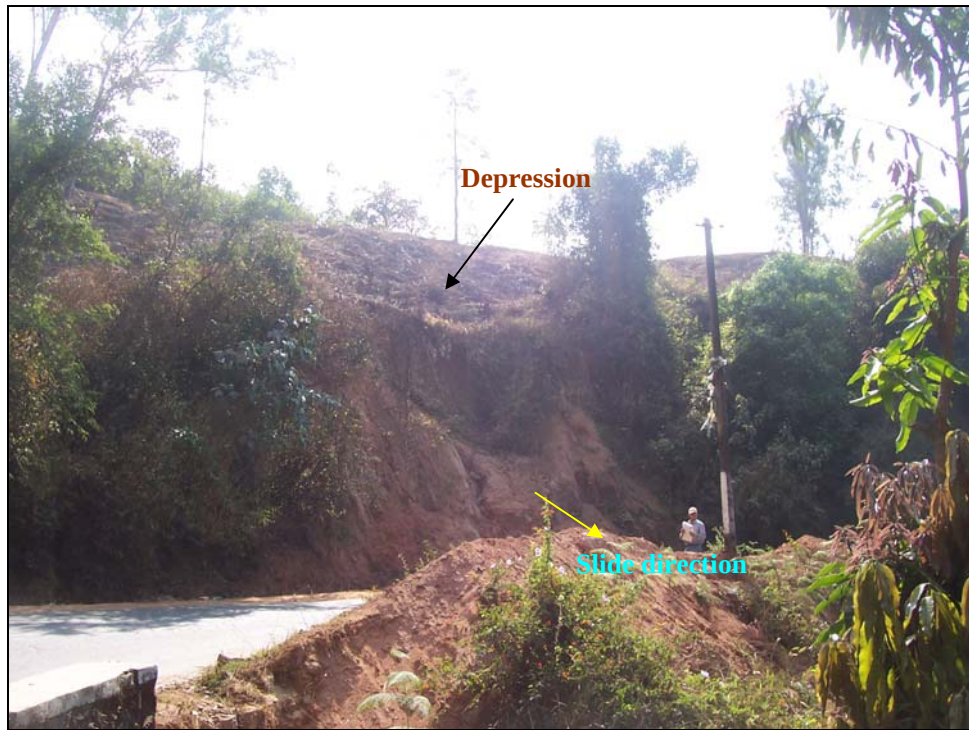
**CAUSES:** A small stream was crossing the hill slope before the construction of road. During the time of the road alignment the slope modification was carried out with the cutting of the stream course without providing an outlet. The depth of weathering along this stream section was more than the adjoining area of the slope. During monsoon of 2006 due to high recharge along this depression the oversaturated debris slid.

**NATURE OF DAMAGE:** The Madikere - Mangalore road (SH88) was partially blocked.

**Photo 11:** The view of the slide with the depression on the slope.

- i) The water flowing along the depression to be rearranged by proper drainage at the surface.
- ii) Retaining wall with weep holes may be provided as the slope is at very high angle after failure.
- iii) Modification of the slope with grading and benches.
- iv) Removal of the unstable material.

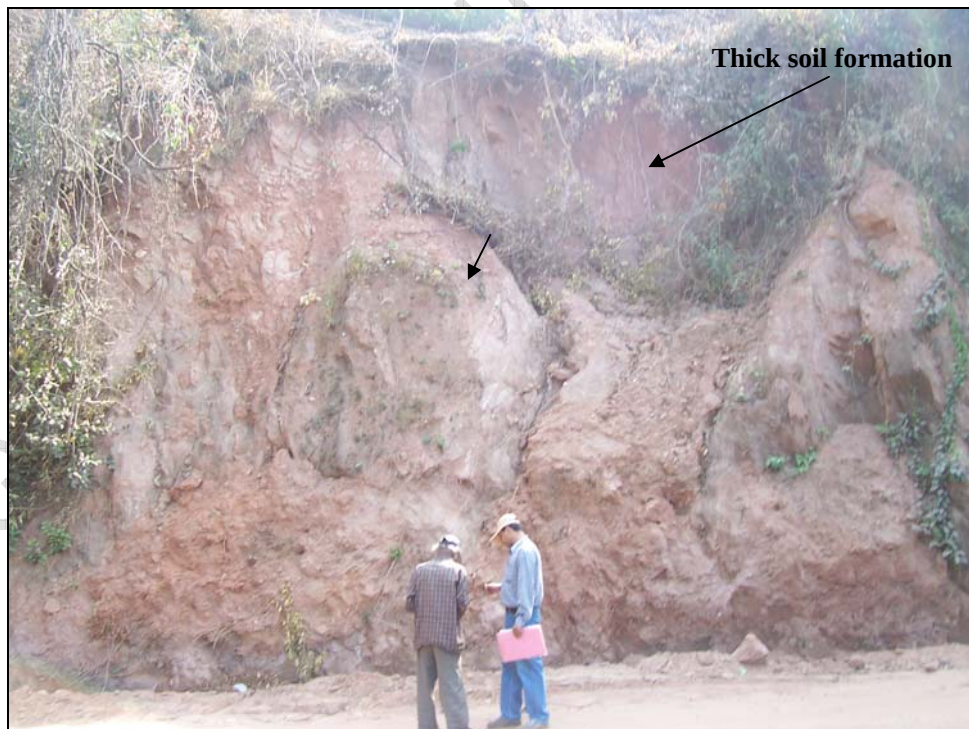
**Photo 12:** The circular failure of the slide with the exposed bedrock (weathered granite)

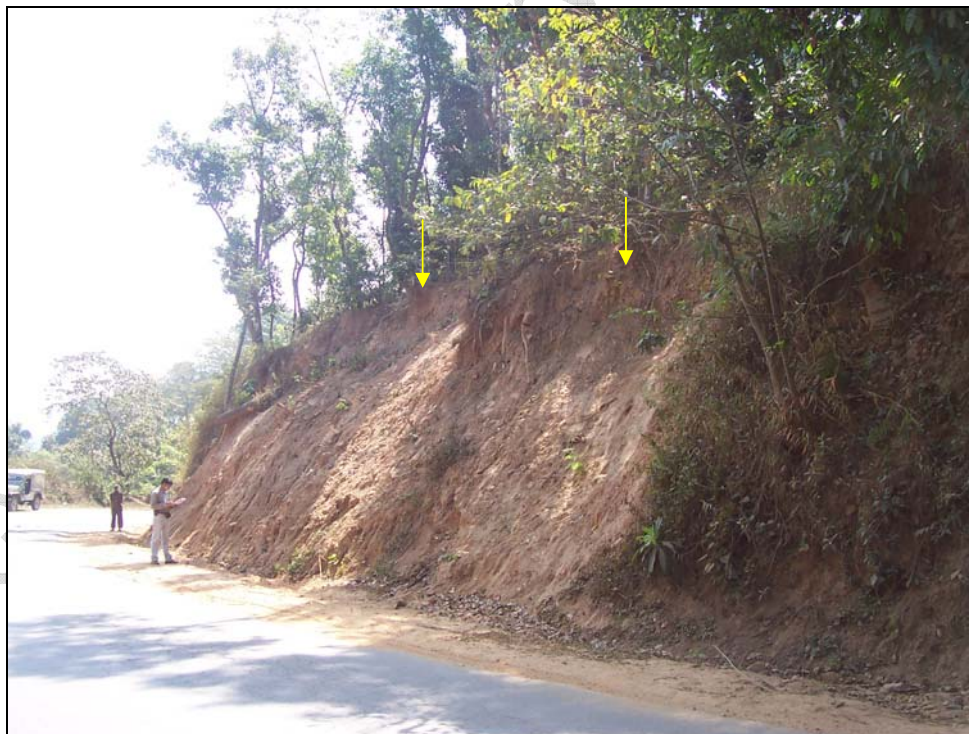
***Photo 20: Two sources of the shallow slide on the cut slope along SH88***

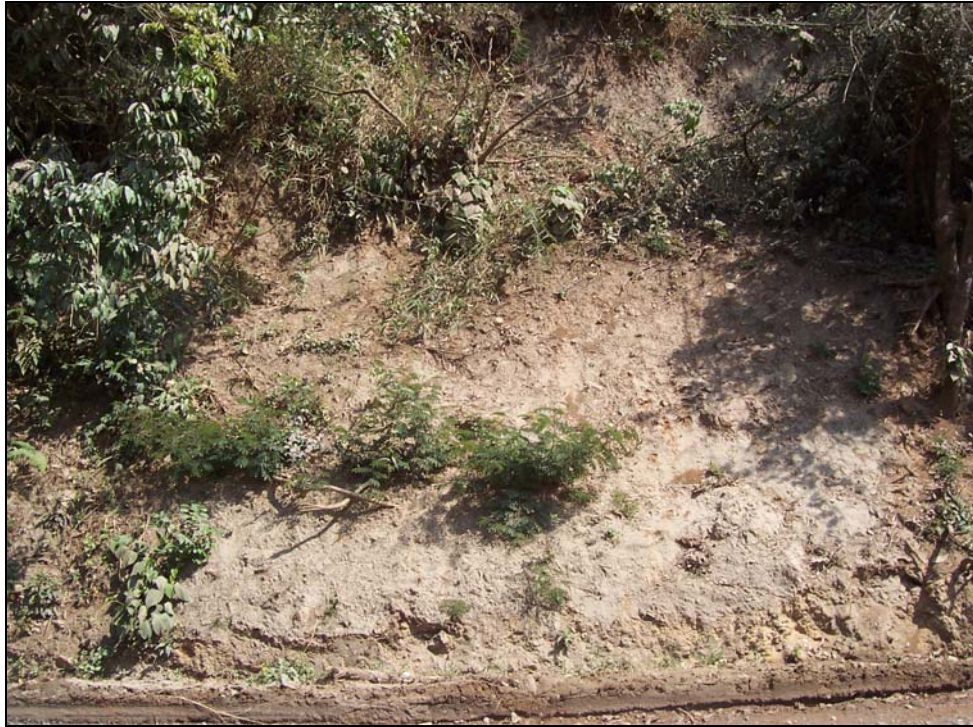
**Photo 23:** *The plan view of the debris slide with exposed bed rock.*

- i) The unstable crown should be completely removed.
- ii) Making contour drainage at the top of the slopes for decreasing infiltration and sub-surface horizontal drainage i.e. inserting horizontal perforated pipes in to the slopes will act as weep holes in the vertical slopes and thus reducing the pore pressure by draining out the excess water.

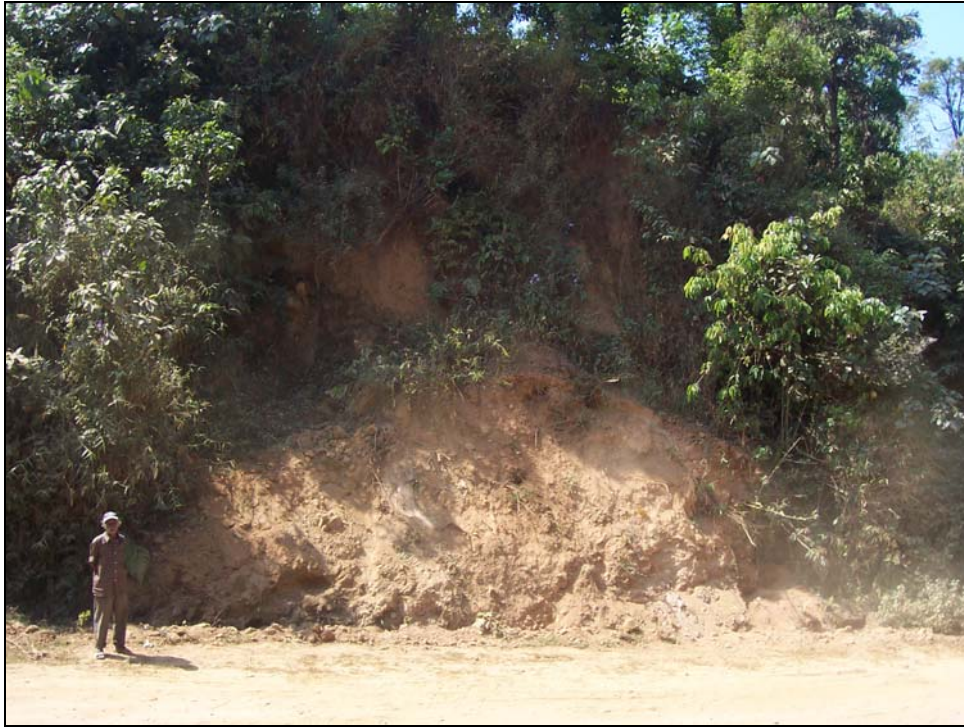
**Photo 25:** *The plan view of the debris slide with huge trees on the unstable crown.*

- i). Geometrical modification of the slope is necessary to stabilize the slope.
- ii) As the slide is a shallow slide with depth of sliding less than 2m, deep rooted plants/shrubs with high tensile strength is to be planted in the benched slope to increase its stability.
- iii) Removal of loose material from the unstable crown.

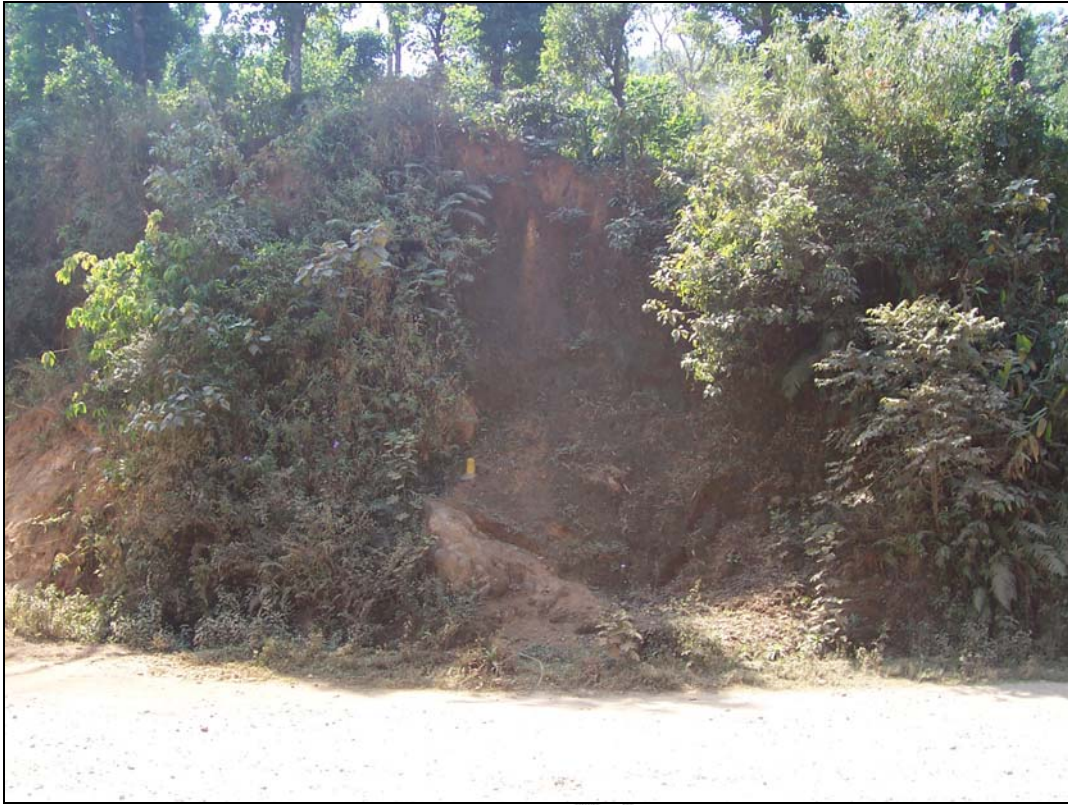
**Photo 27:** *The plan view of the debris slide with unstable crown.*

- i) The relative height of the slope is low hence benching of the slope with a average slope angle of 45° will ensure its stability in long run.
- ii) Deep rooted plants/shrubs with high tensile strength is to be planted in the benched slope to increase its stability.
- iii) The unstable crown portion should be removed.

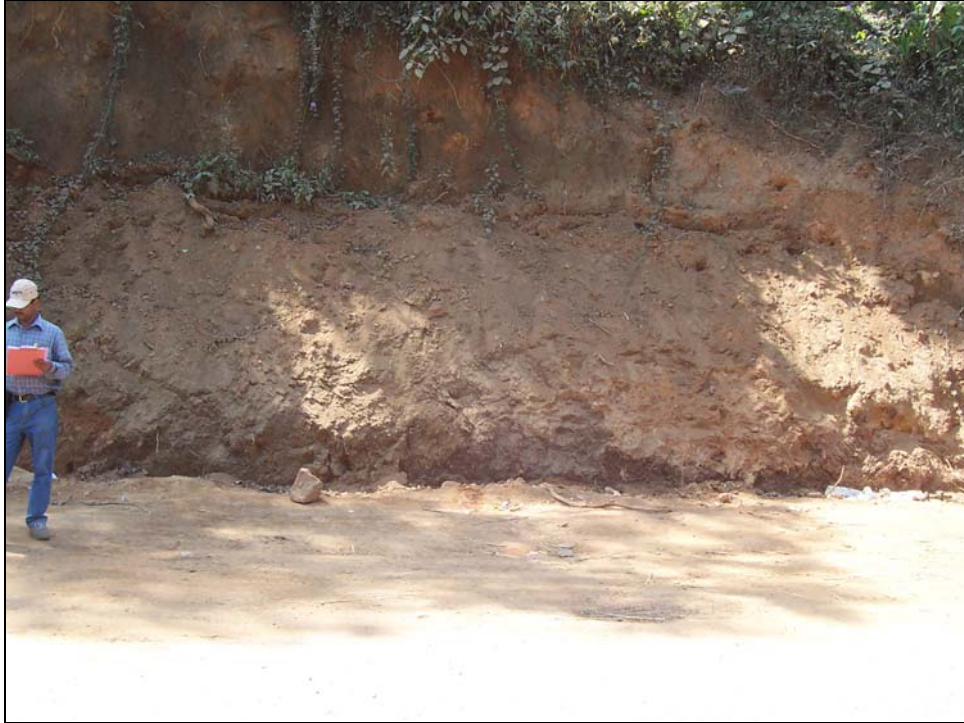
**Photo 28:** *The plan view of the debris slide with unstable crown.*

- i) The unstable crown part and slided debris material should be removed.
- ii) The slope angle should be reduced to <45°.
- iii) Plantation is suggested in the slope to reduce erosion and for slope stabilisation.
- iv) Making contour drainage at the top of the slopes for decreasing infiltration and sub-surface horizontal drainage i.e. inserting horizontal perforated pipes in to the slopes will act as weep holes in the vertical slopes and thus reducing the pore pressure by draining out the excess water.

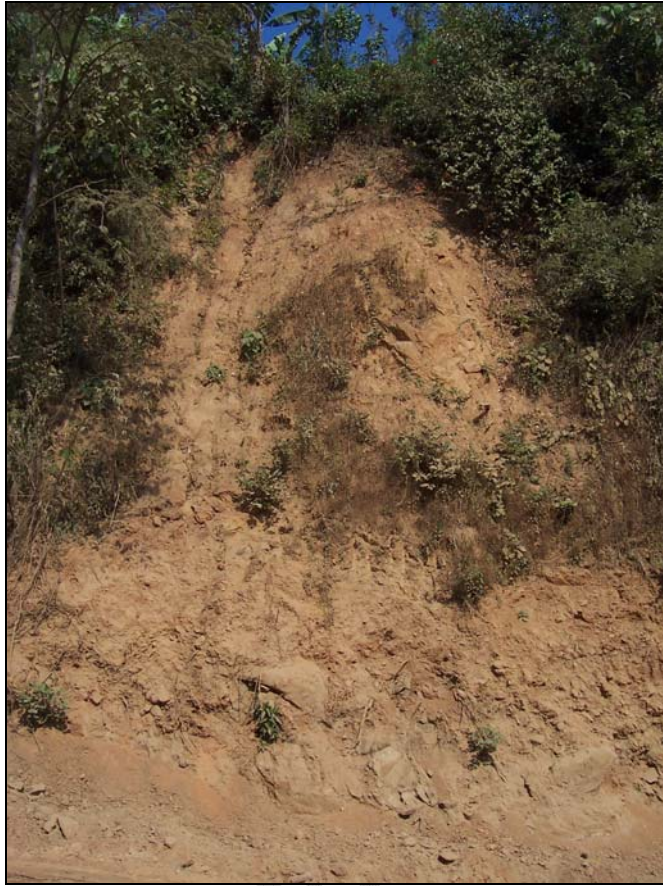
***Photo 30: The plan view of the debris slump***

- i) The unstable crown and slided debris material should be removed.
- ii) Geometrical modification of the slope.
- iii) Plantation is suggested in the slope to reduce erosion and for slope stabilisation.
- iv) Making contour drainage at the top of the slopes for decreasing infiltration and sub-surface horizontal drainage i.e. inserting horizontal perforated pipes in to the slopes will act as weep holes in the vertical slopes and thus reducing the pore pressure by draining out the excess water.

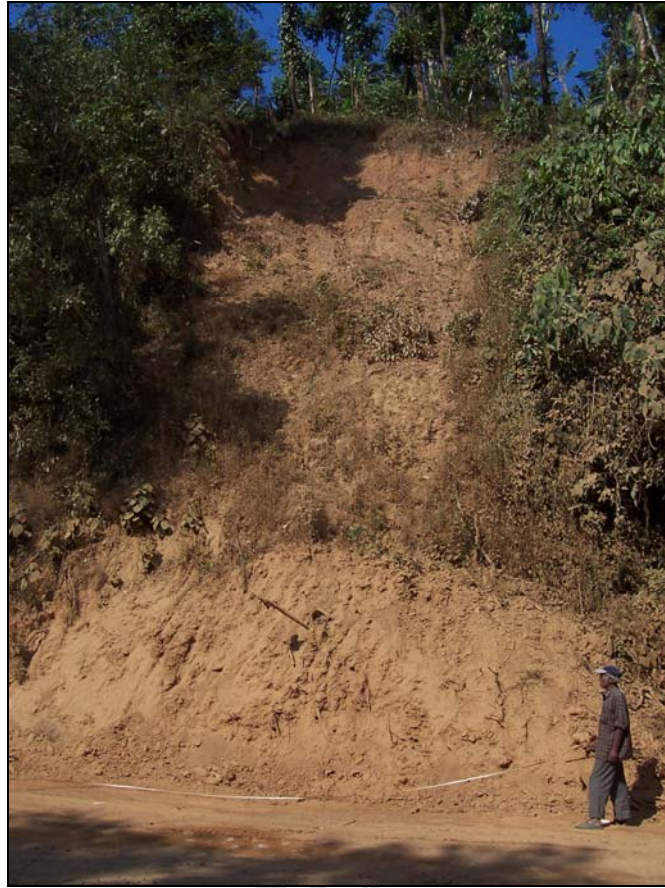
**Photo 32:** *The plan view of the debris slide with unstable crown*

- i) The unstable crown and slided debris material should be removed.
- ii) The slope angle should be reduced to <45°. The slope height should also be reduced by 5m.
- iii) Plantation is suggested in the slope to reduce erosion and for slope stabilisation. Horizontal drainage is suggested for removal of infiltrated water.

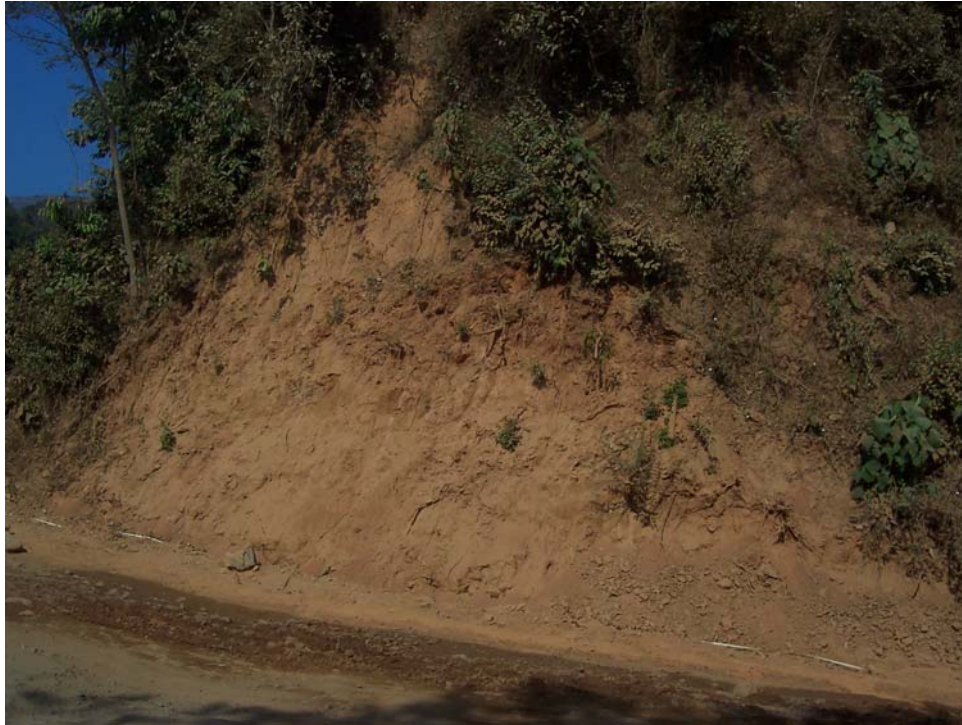
**Photo 34:** *The plan view of the debris slide with unstable crown*

- i) The unstable crown and slided debris material should be removed.
- ii) The slope angle should be reduced to <45°. The slope height should also be reduced by 5m.
- iii) Plantation is suggested in the slope to reduce erosion and for slope stabilisation.
- iv) Horizontal drainage is suggested for removal of infiltrated water.

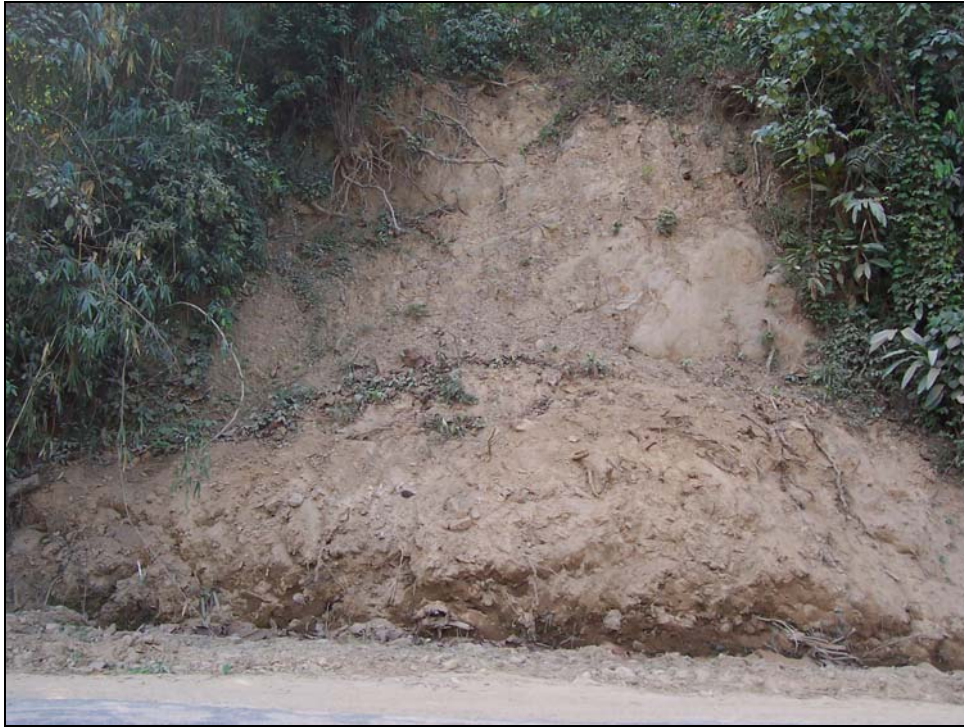
**Photo 36:** The plan view of the debris slide with unstable crown

- i) The relative height of the slope is low hence benching of the slope with a average slope angle of 45° will ensure its stability in long run.
- ii) Deep rooted plants/shrubs with high tensile strength is to be planted in the benched slope to increase its stability.
- iii) The unstable crown portion should be removed.

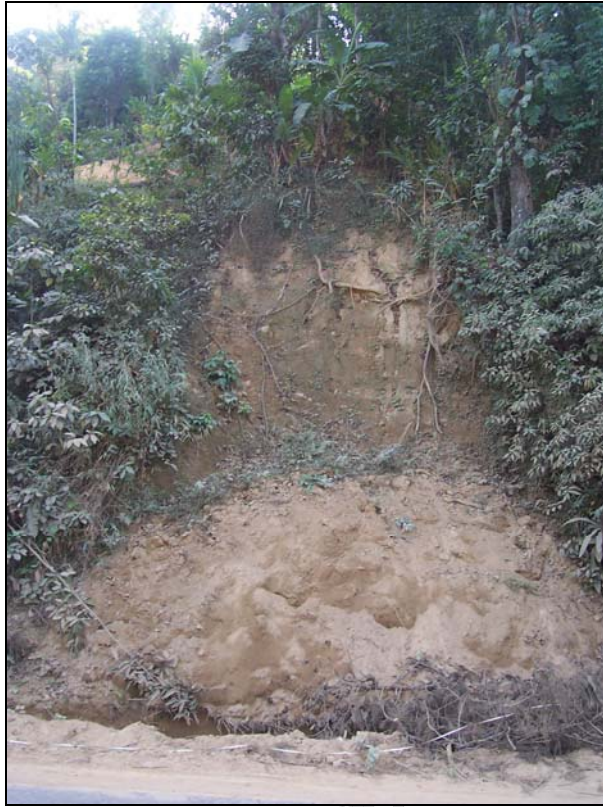
**Photo 38:** *The plan view of the debris slide with unstable crown*

- i) The relative height of the slope is low hence benching of the slope with a average slope angle of 45° will ensure its stability in long run.
- ii) Deep rooted plants/shrubs with high tensile strength is to be planted in the benched slope to increase its stability.
- iii) The unstable crown portion should be removed.
- iv) Making contour drainage at the top of the slopes for decreasing infiltration and sub-surface horizontal drainage i.e. inserting horizontal perforated pipes in to the slopes will act as weep holes in the vertical slopes and thus reducing the pore pressure by draining out the excess water.

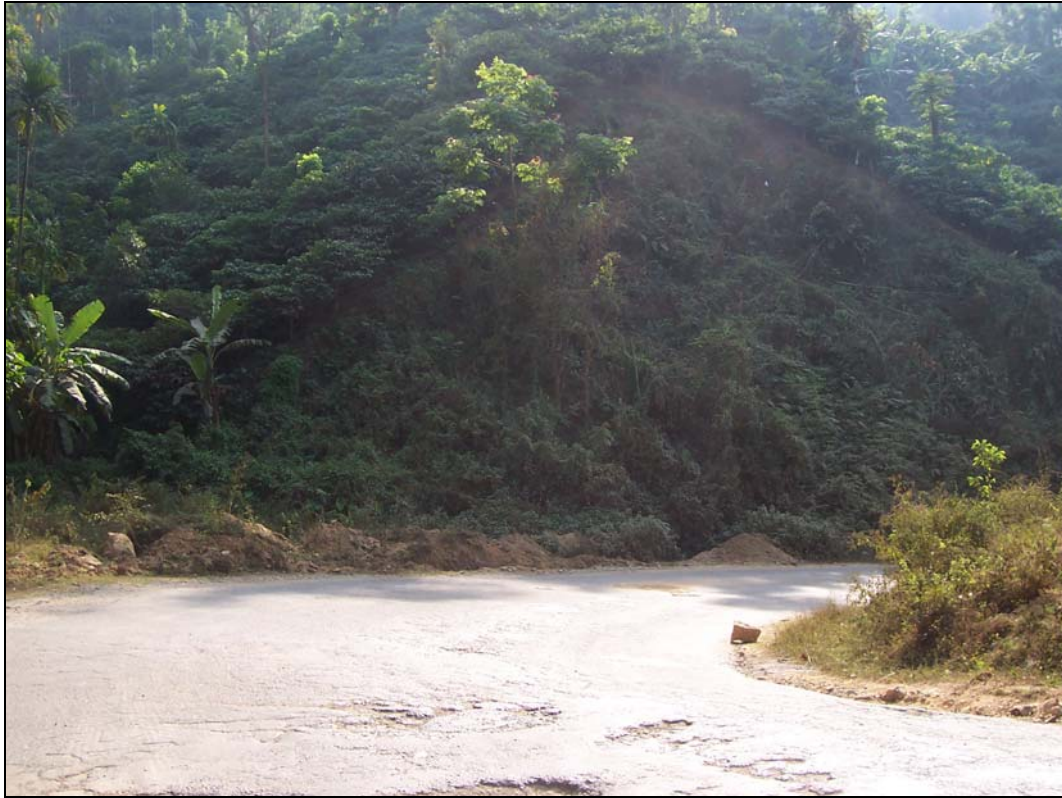
**Photo 40:** *The plan view of the debris slide covered by plants*

- i) The unstable crown and slided debris material should be removed.
- ii) Geometrical modification of the slope by reducing the slope angle.
- iii) Deep rooted plants/shrubs with high tensile strength is to be planted in the slope to increase its stability and reduce erosion.
- iv) Horizontal drainage is suggested for removal of infiltrated water.

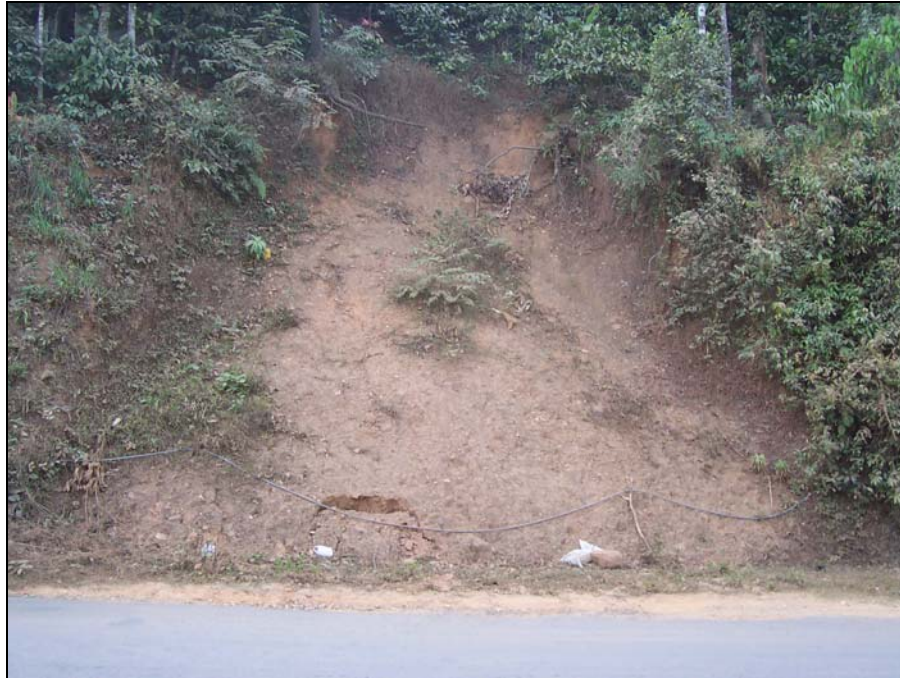
**Photo 41:** *The plan view of the debris slide with unstable crown*

- i) The unstable crown and slided debris material should be removed.
- ii) Horizontal and surface drainage is suggested for removal of infiltrated water.
- iii) Deep rooted plants/shrubs with high tensile strength is to be planted in the slope to increase its stability and reduce erosion.

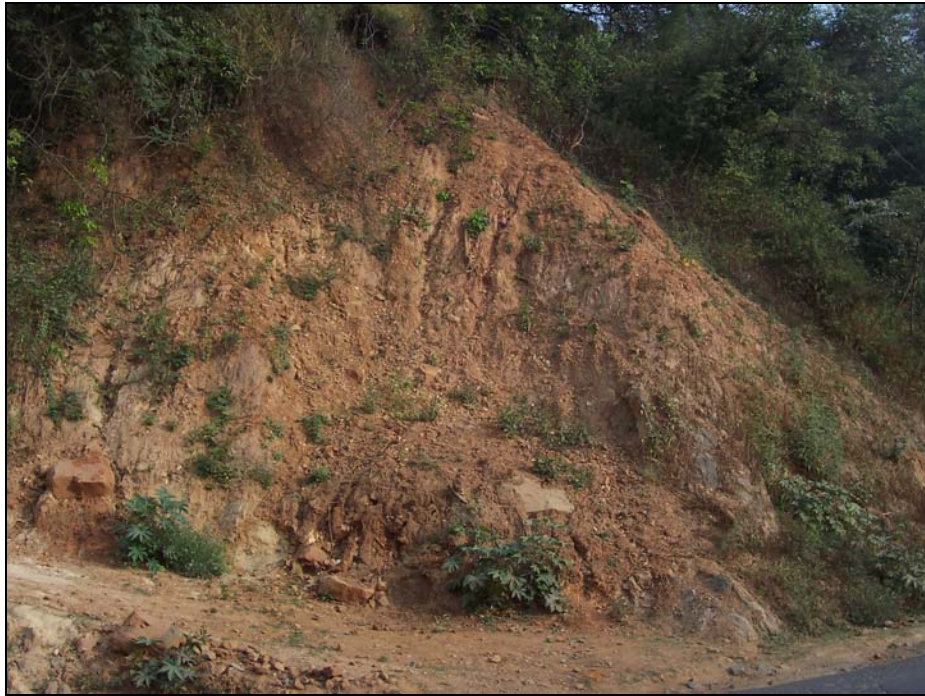
**Photo 43:** Plan view of the reactivated slide with exposed weathered granite

- i) The protective measures proposed at the site include removal of slide material from the slope
- ii) Grading of the slope with benches
- iii) Providing retaining wall for a height of 4 m.

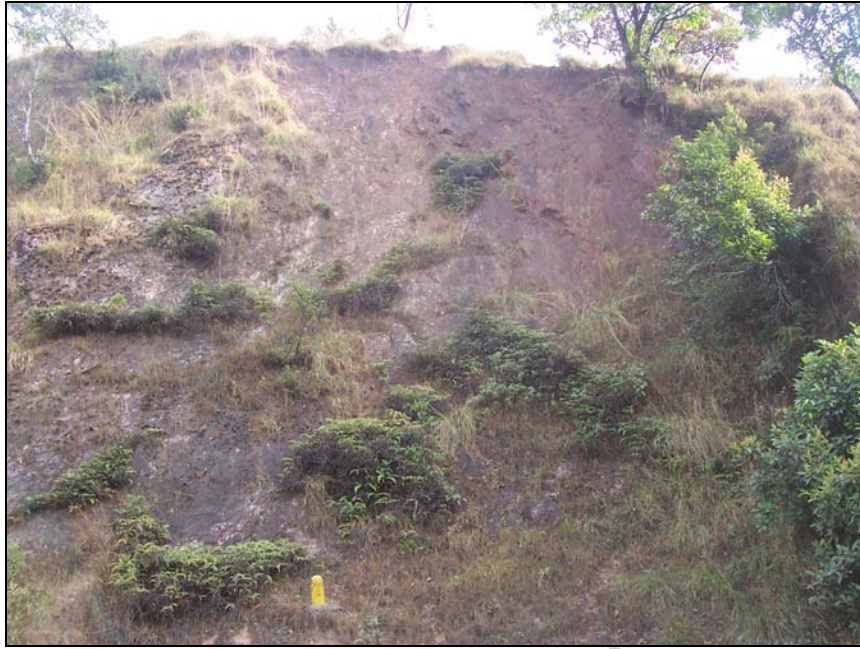
*Photo 49: View of the debris slump exposing the bed rock over which it has moved.*

- i) The protective measures proposed at the site include removal of weathered and loose material from the slope
- ii) Gradation of the slope to reduce the slope angle
- iii) Providing retaining wall of 4m height.

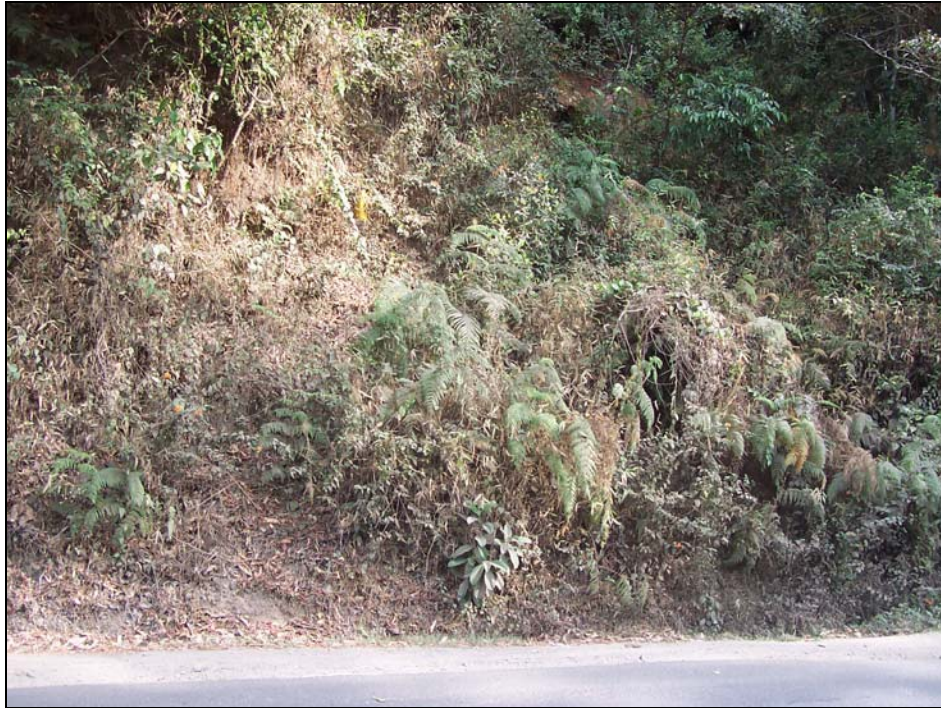
**Photo 51:** *The old debris slump covered by small trees*

- i) Removal of weathered and loose material from the slope
- ii) Geometrical modification of the slope with grading or making benches
- iii) Providing retaining wall at the toe of the slided area.

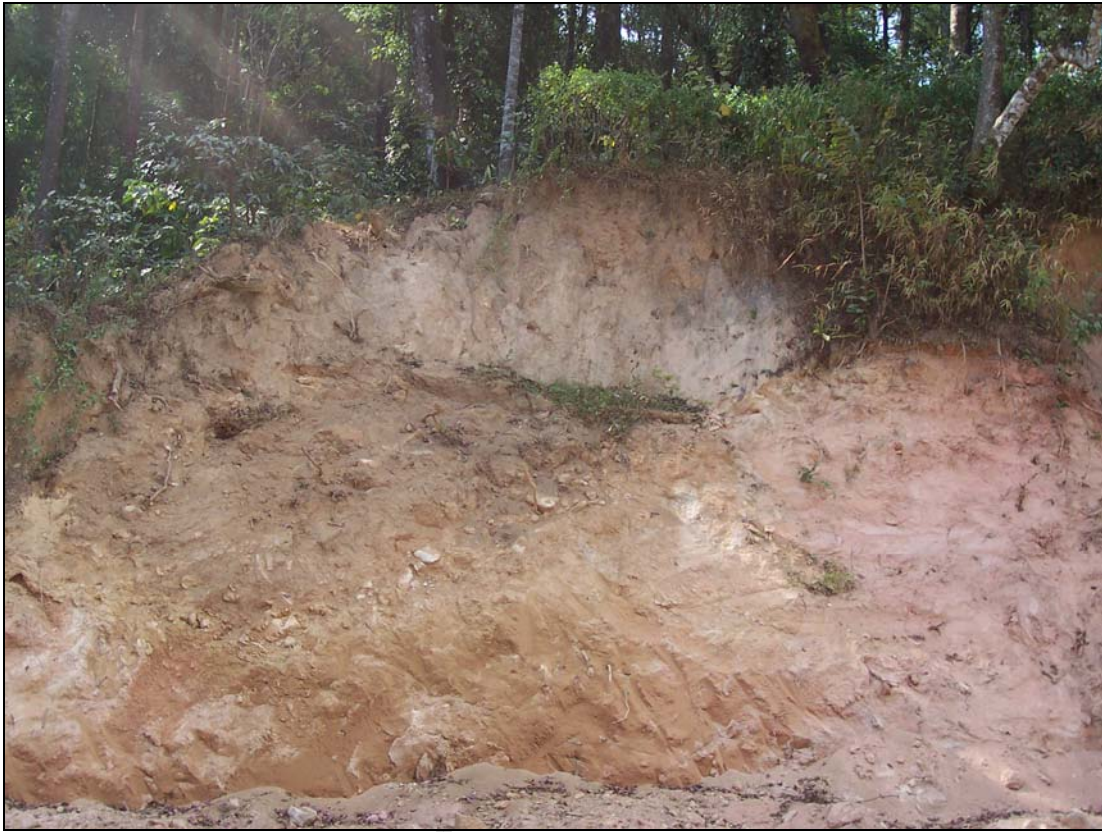
**Photo 55:** Plan view of the debris slide which has crown height of 2m and crown width of around 8 m.

- i) Decreasing the driving force by removal of load from the crown and slided material from the slope
- ii) Geometrical modification of slope by grading of the slope or benching
- iii) Providing retaining wall or gabion wall at the toe of the slide.

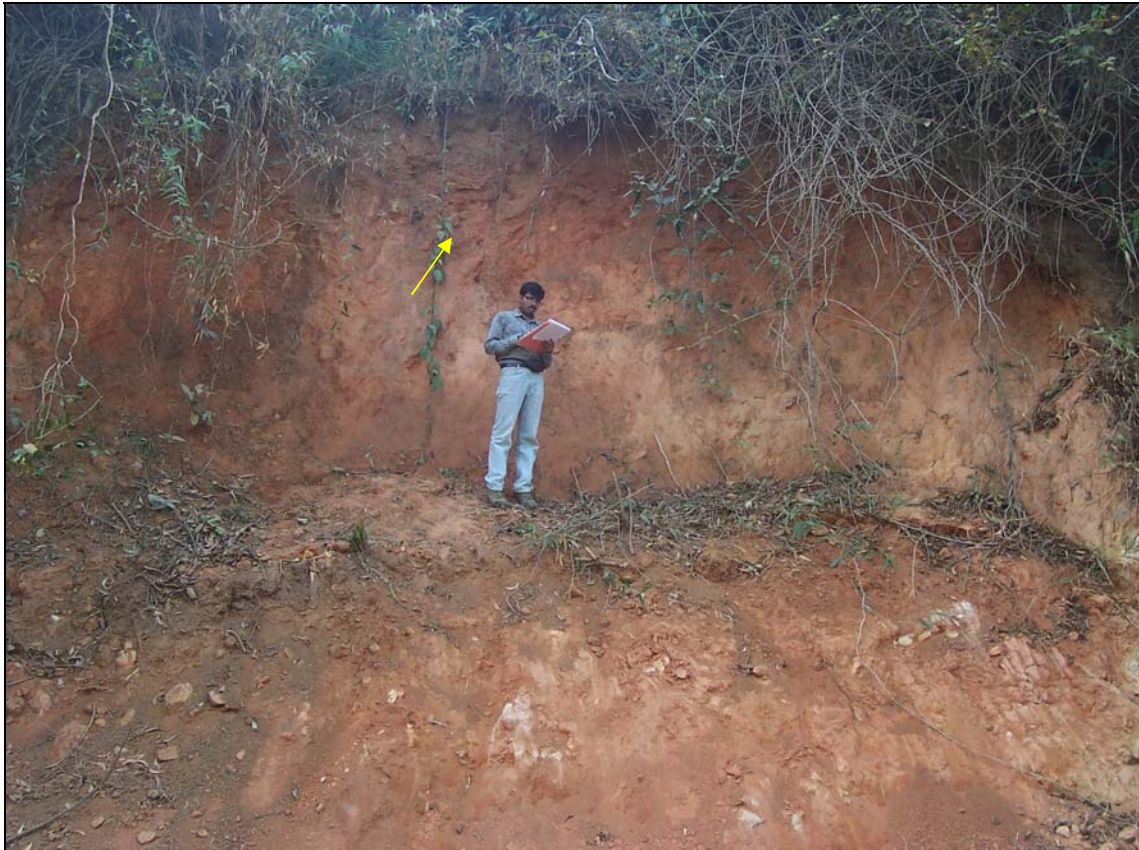
**Photo 56:** View of the debris slide on the

- i) Removal of load from the crown and slid material from the slope to reduce the driving force
- ii) Geometrical modification of the slide by grading of the slope or benches
- iii) Providing proper surface and horizontal drainage to decrease infiltration and reduce pore water pressure.
