**A REPORT ON LANDSLIDE INVENTORY ALONG NH & SH  
OF GHAT ROADS IN KARNATAKA**

**(Progress Report for the Field Season 2007-08)**

**Code No.: LHZ/SR/KG/2007/044**

**Project: ENGINEERING GEOLOGY**

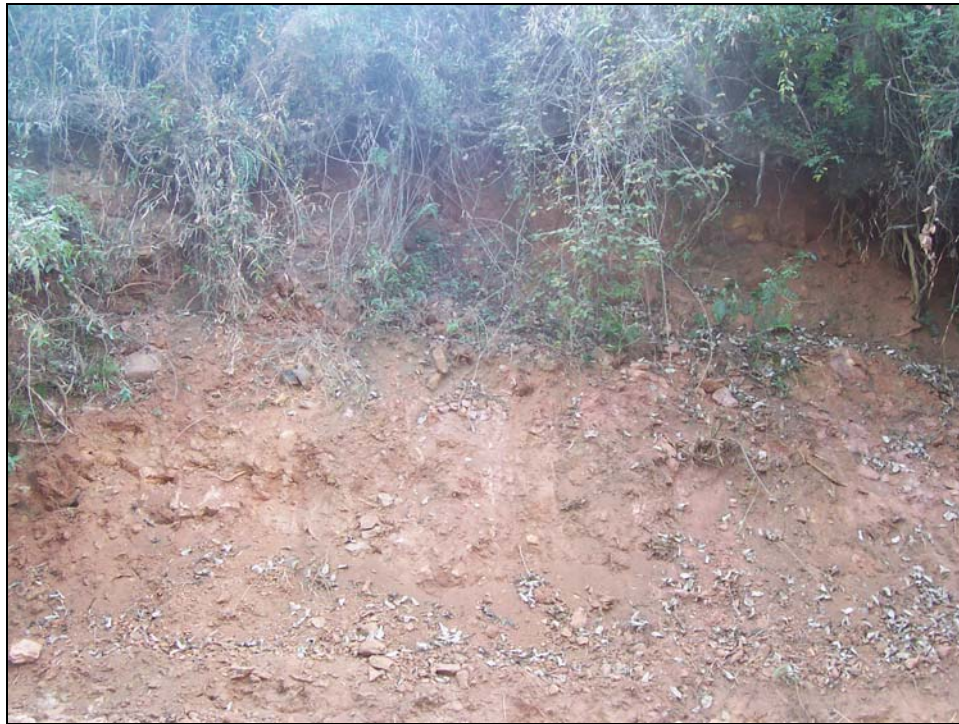
**Photo 57:** Plan view of the depletion zone of the above debris slump

- i) Removal of slide material from the slope and unstable material from the crown.
- ii) Proper surface and horizontal drainage is suggested to decrease infiltration and reduce pore water pressure.
- iii) Plantation of deep rooted vegetation on the slope is suggested to reduce erosion and increase slope stability.

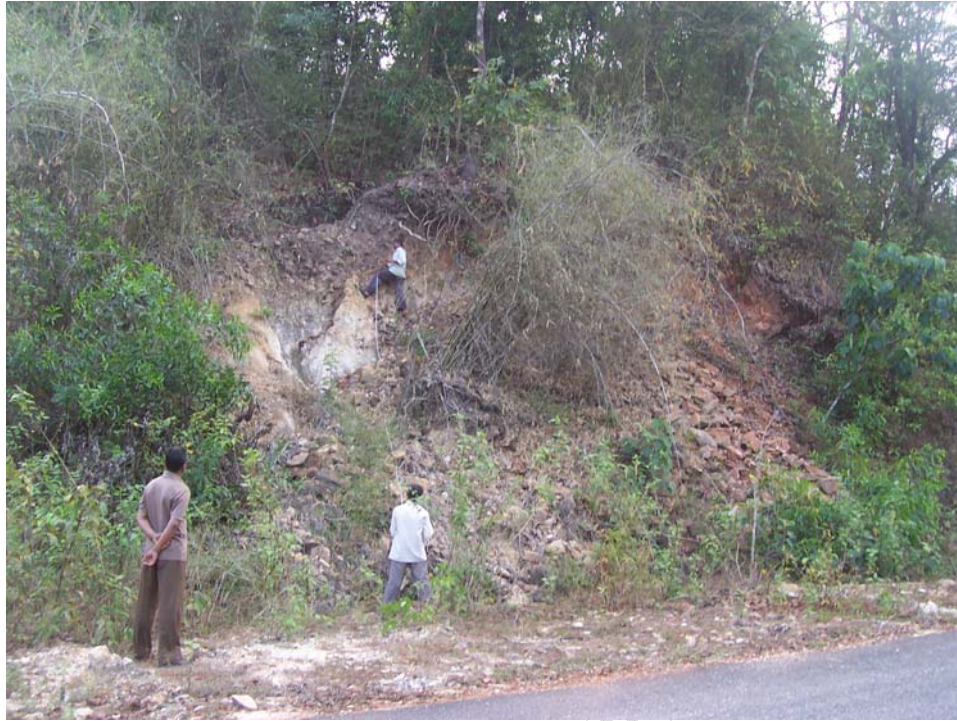
**Photo 58:** The plan view of the rock slide in a planar failure

- i) The crown part was found to be unstable hence the crown portion is to be completely removed.
- ii) The geometrical modification of the slope by grading or bench to be provided.
- iii) Proper drainage to be provided for safely discharge of water away from unstable slopes and decreasing the infiltration of water.
- iv) Netting with wire mesh is suggested as long term remedial measure.

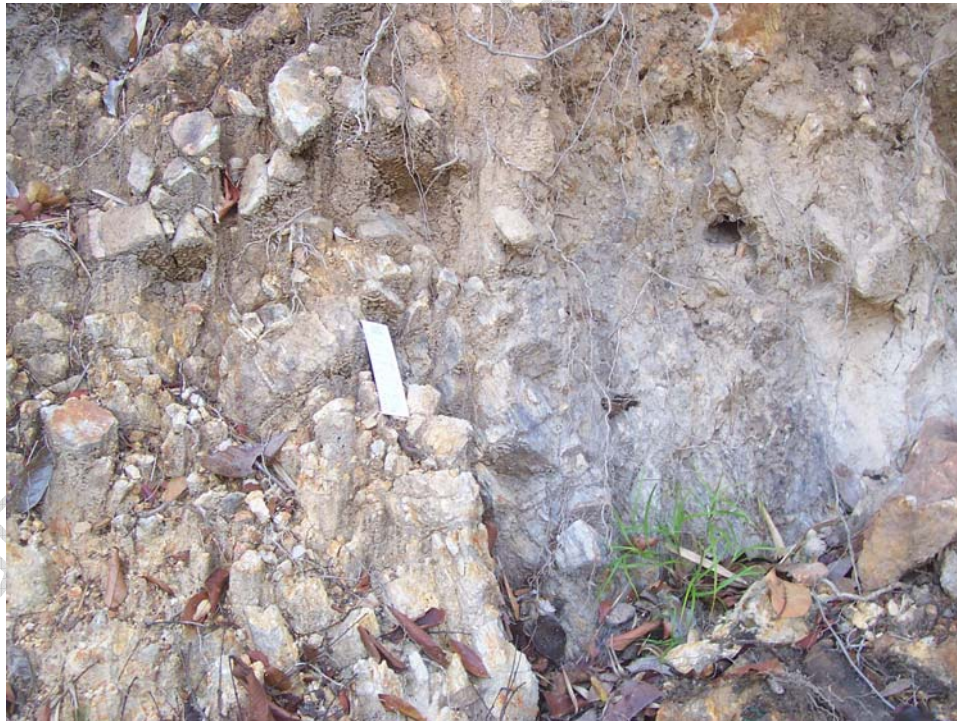
**Photo59:** The biotite gneiss exposed in the failure plane

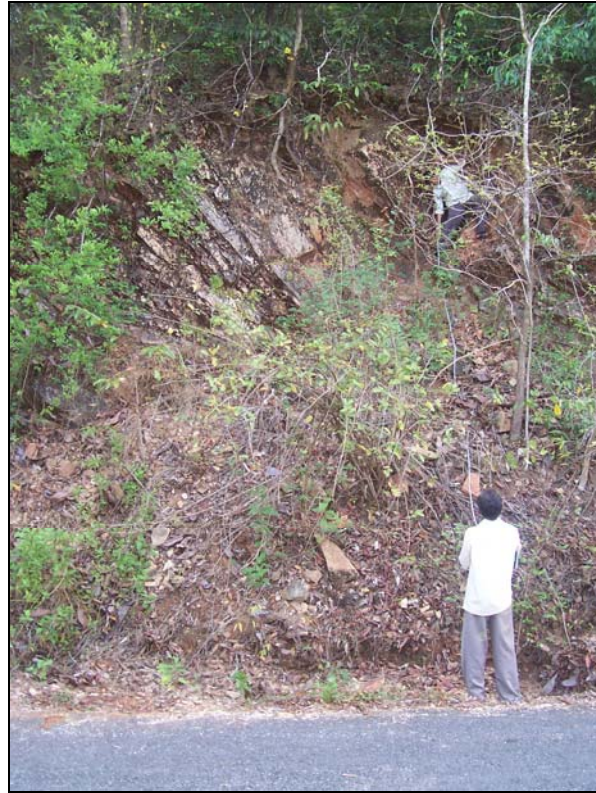
**Photo 60:** The plan view of the reactivated rock slide along day lighted plane.

- i) The crown part was found to be unstable hence the crown portion is to be completely removed.
- ii) Rock bolting is suggested to anchor the unstable blocks.
- iii) Proper drainage to be made to safely discharge water away from unstable slopes

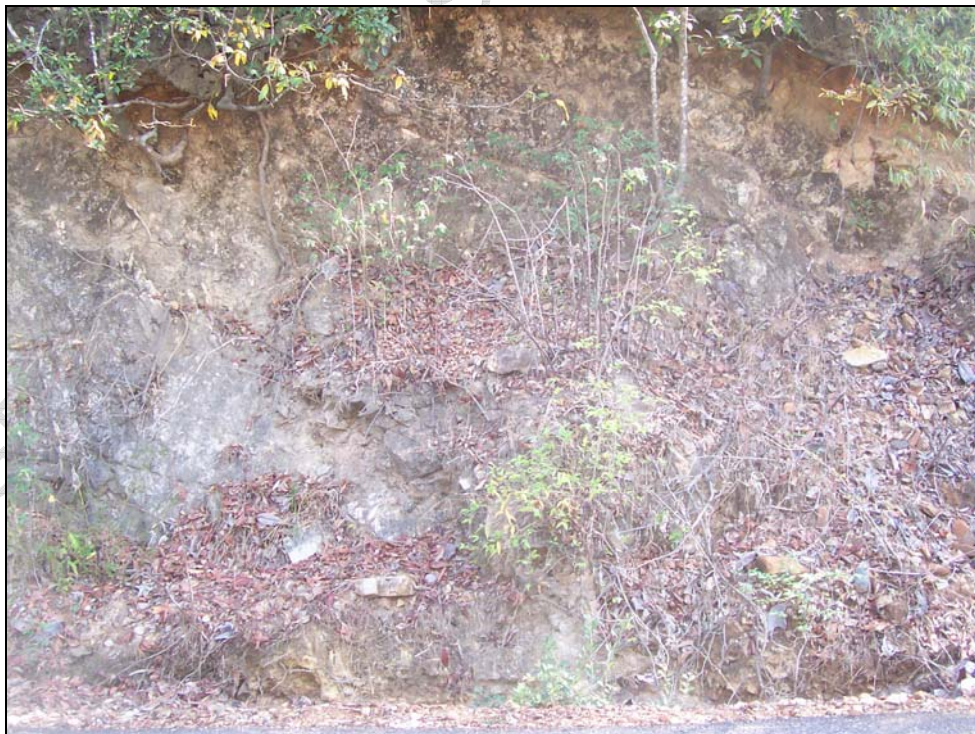
**Photo 61:** The plan view of rock slide along day lighted plane

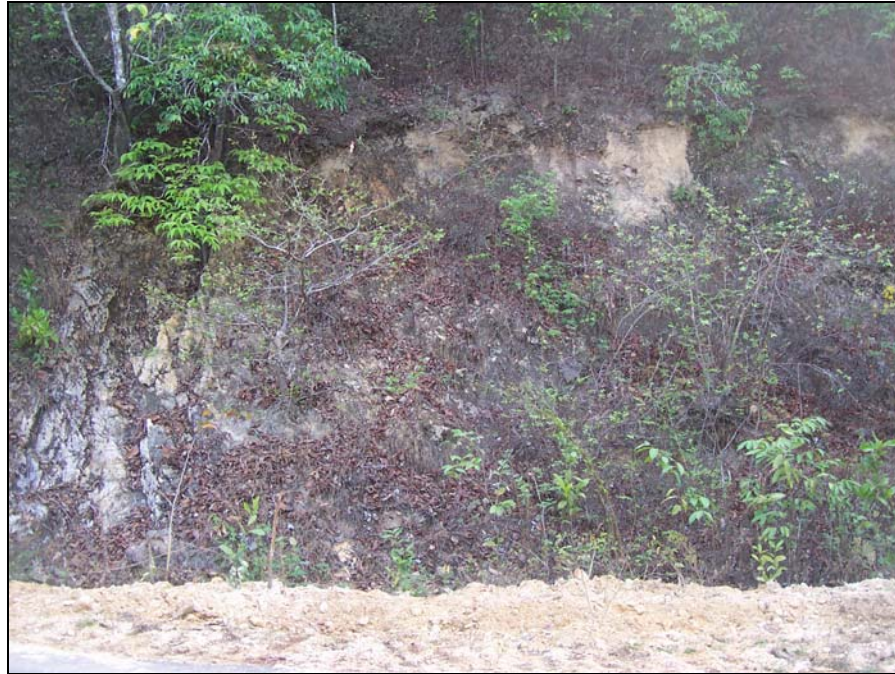
**Photo 62:** *The plan view of the reactivated rock slide along day lighted plane.*

- i) The crown part was found to be unstable hence the crown portion is to be completely removed.
- ii) The geometrical modification of the slope by graded or bench to be provided.
- iii) Proper drainage is to be provided for discharge of water away from unstable slopes.
- iv) Soil nailing and rock bolting is suggested to protect the vulnerable planes from sliding.

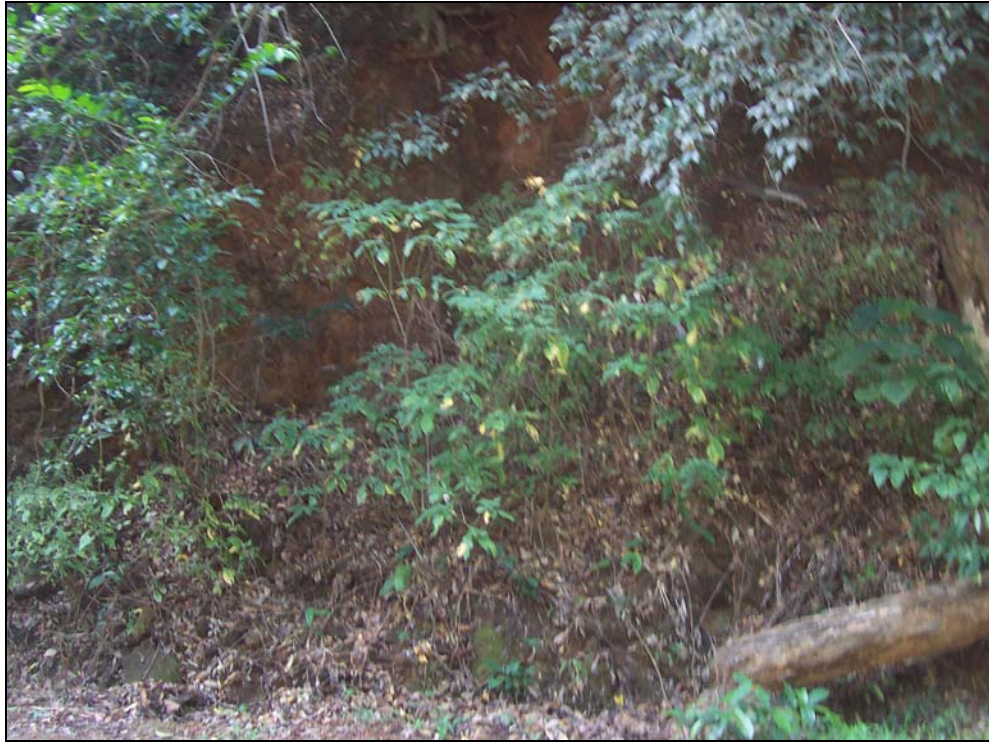
**Photo 64:** *The view of the debris slide where plants are tilted and uprooted.*

- i) The crown part was found to be unstable due to presence of huge trees; hence the crown portion is to be completely removed to decrease the driving force.
- ii) The geometrical modification of the slope by graded or bench to be provided with 2:1 height with bench width ratio at a slope angle of  $<40^{\circ}$ .
- iii) Plantation on the slope is also suggested to increase the cohesiveness of soil.
- iv) Retaining wall is to be constructed to protect the toe from further sliding.

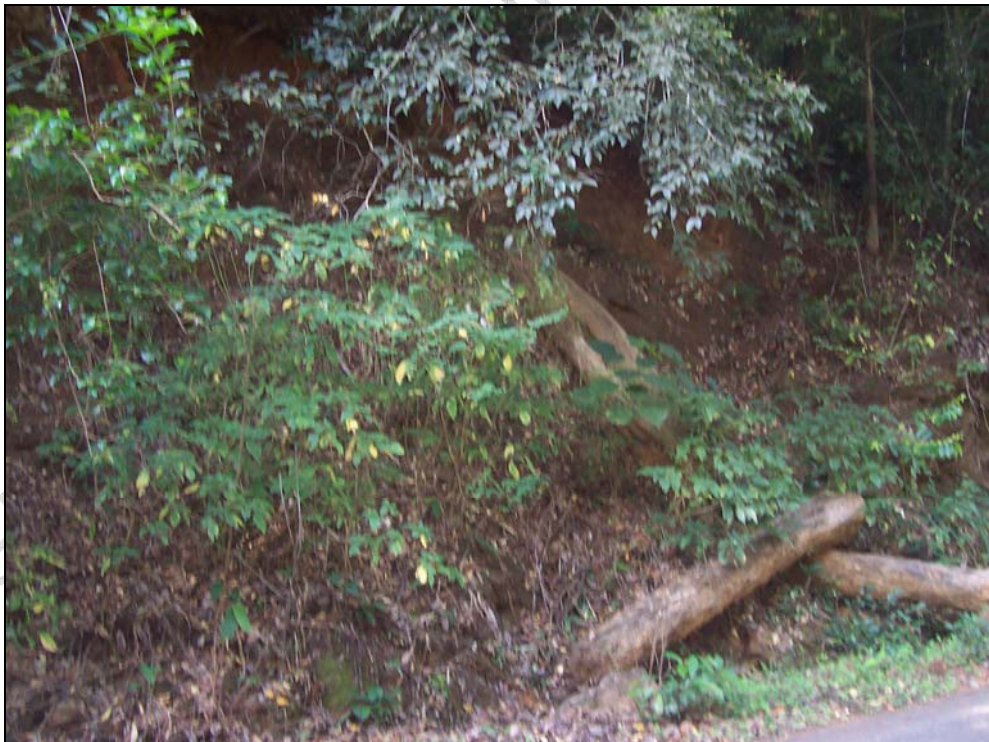
**Photo 65:** *The view of the toe portion debris slide where uprooted plants and debris are accumulated.*

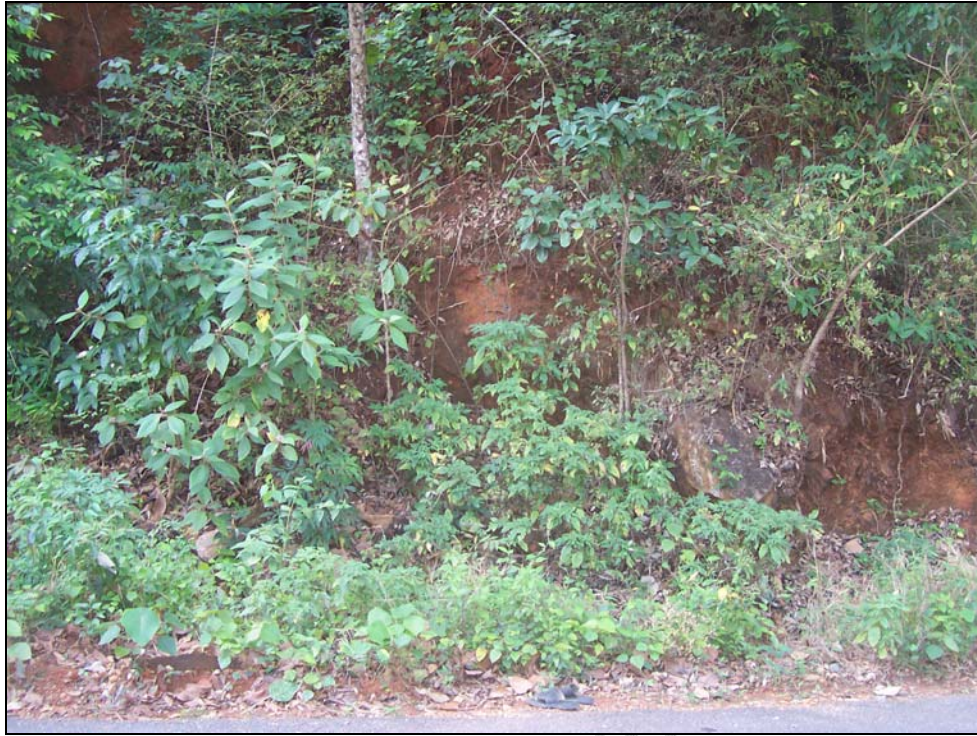
**Photo 66:** *The plan view of the debris slide with exposed bed rock*

- i) The crown part was found to be unstable due to presence of huge trees; hence the crown portion is to be completely removed.
- ii) The geometrical modification of the slope by graded or bench to be provided with 2:1 height with bench width ratio at a slope angle of  $<45^{\circ}$ .
- iii) Plantation on the slope is also suggested to increase the cohesiveness of soil.
- iv) Retaining wall or gabion wall is to be constructed to protect the toe from further sliding.

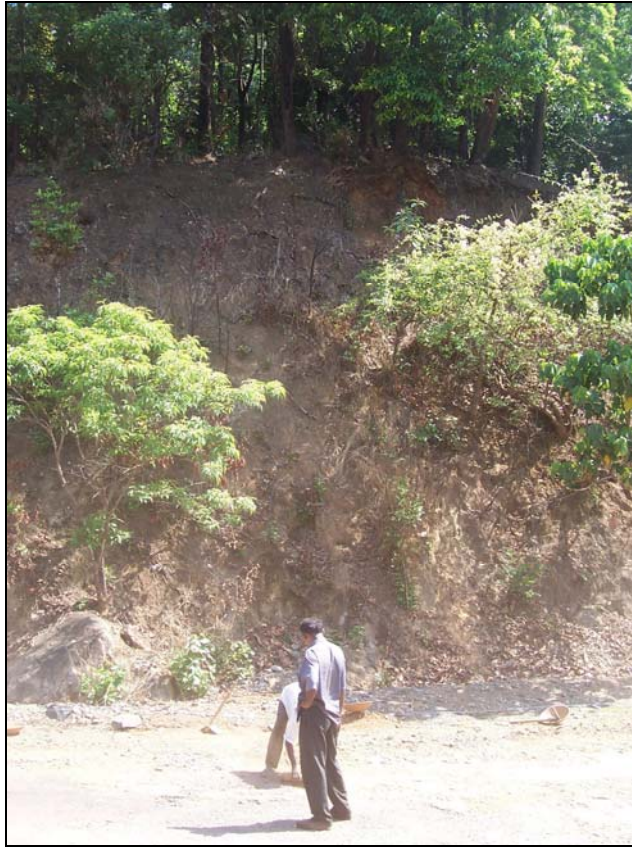
**Photo 68:** *The plan view of the debris slide with exposed bed rock*

- i) Removal of slide material from the slope and unstable material from the crown.
- ii) Proper surface and horizontal drainage is suggested to decrease infiltration and reduce pore water pressure.
- iii) Plantation of deep rooted vegetation on the slope is suggested to reduce erosion and increase slope stability.

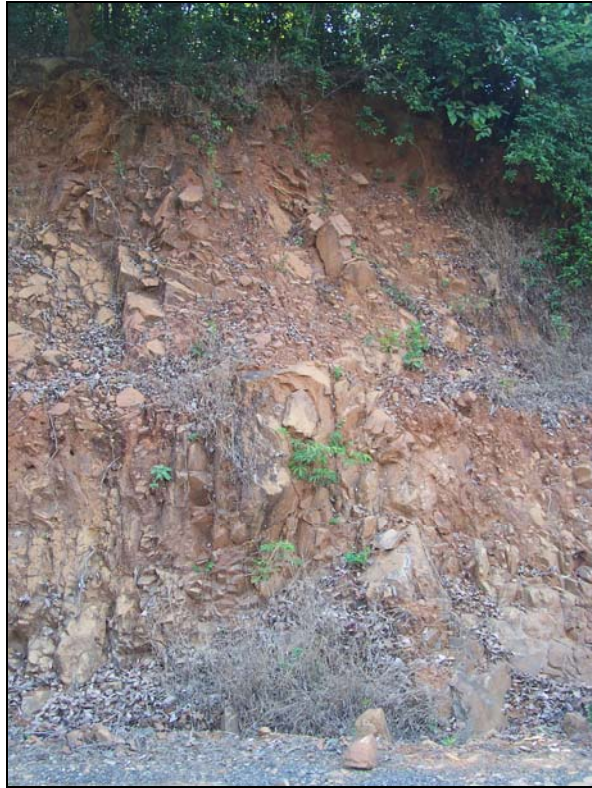
**Photo 70:** *The plan view of the rock slide with exposed bed rock*

- i) The crown part was found to be unstable hence the crown portion is to be completely removed.
- ii) The geometrical modification of the slope by graded or bench to be provided.
- iii) Proper drainage is to be provided for discharge of water away from unstable slopes.
- iv) Soil nailing and rock bolting is suggested to protect the vulnerable planes from sliding.
- v) Netting with wire mesh is suggested where the joint spacing's are less.

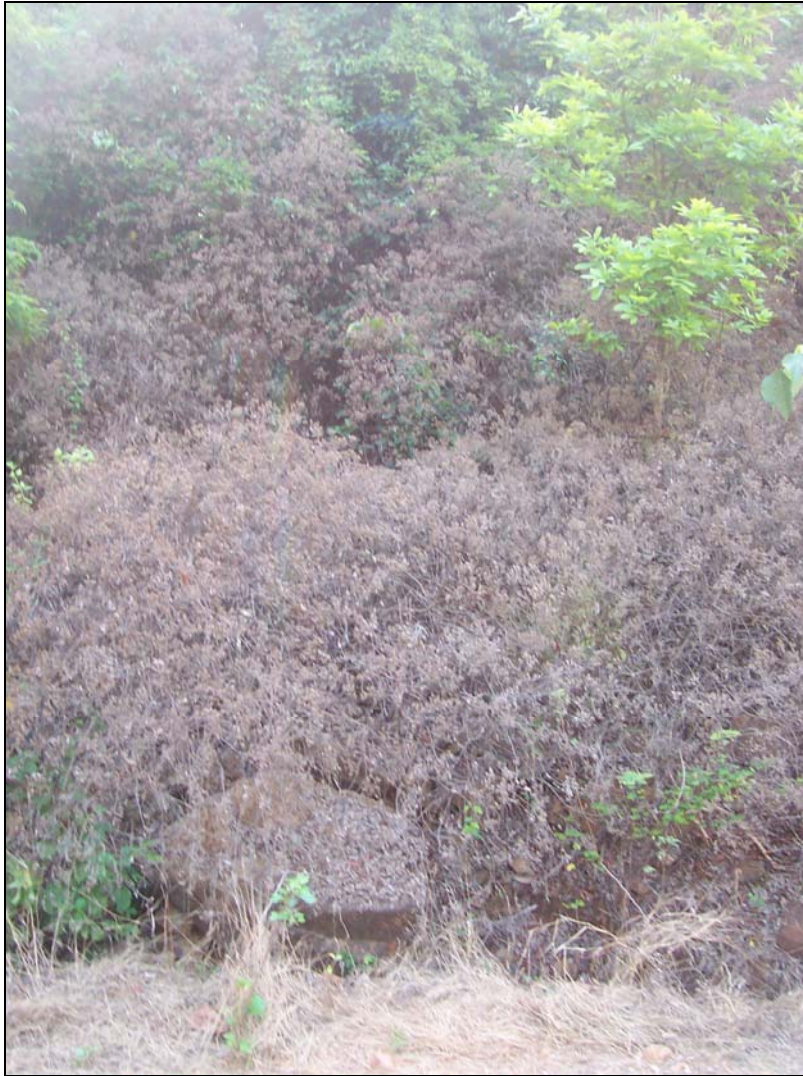
**Photo 72:** *The plan view of the rock slide covered with trees.*

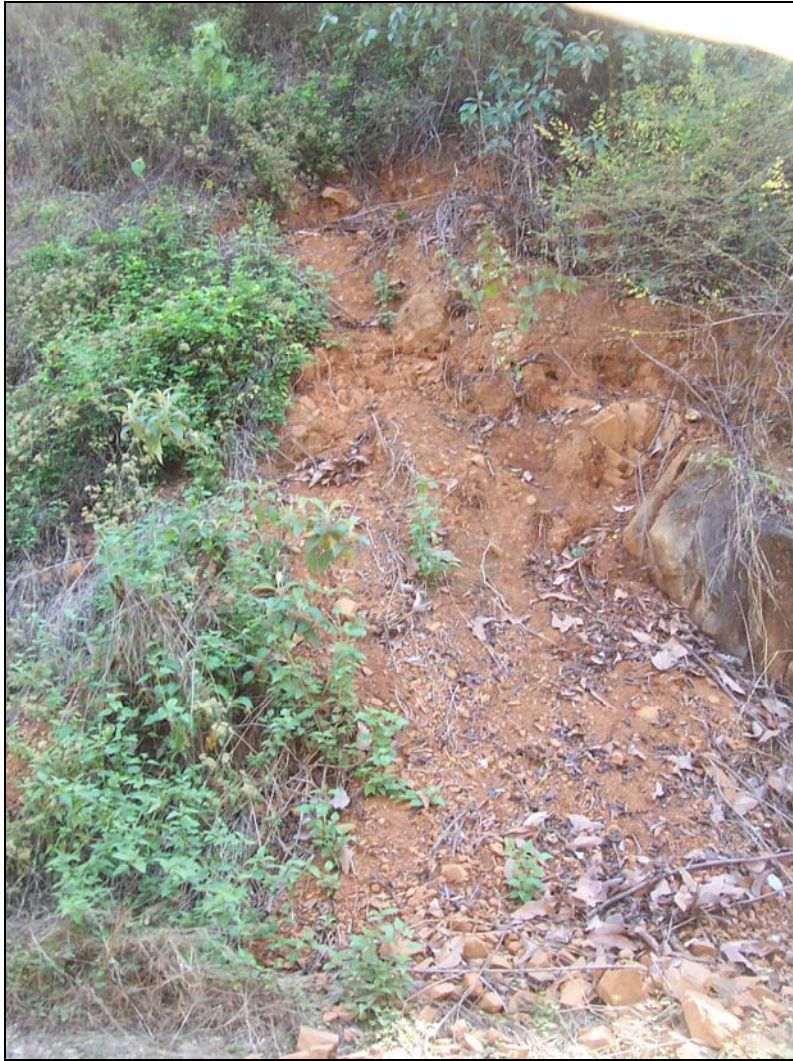
**Photo 73:** *The plan view of the debris slump with slided material in the slope.*

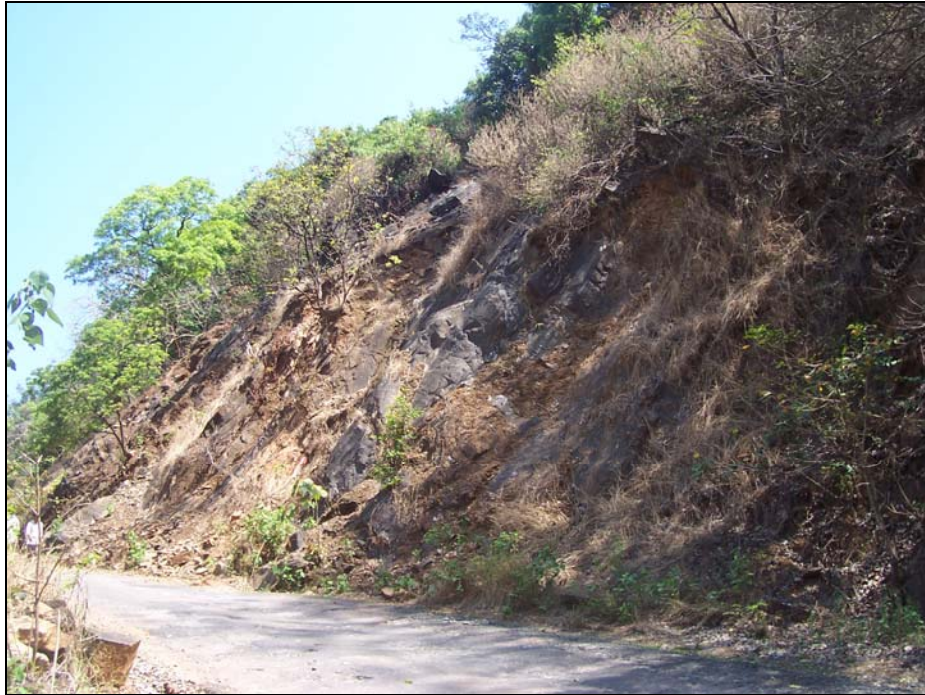
**Photo 78:** *The view of the rock slide with unstable crown.*

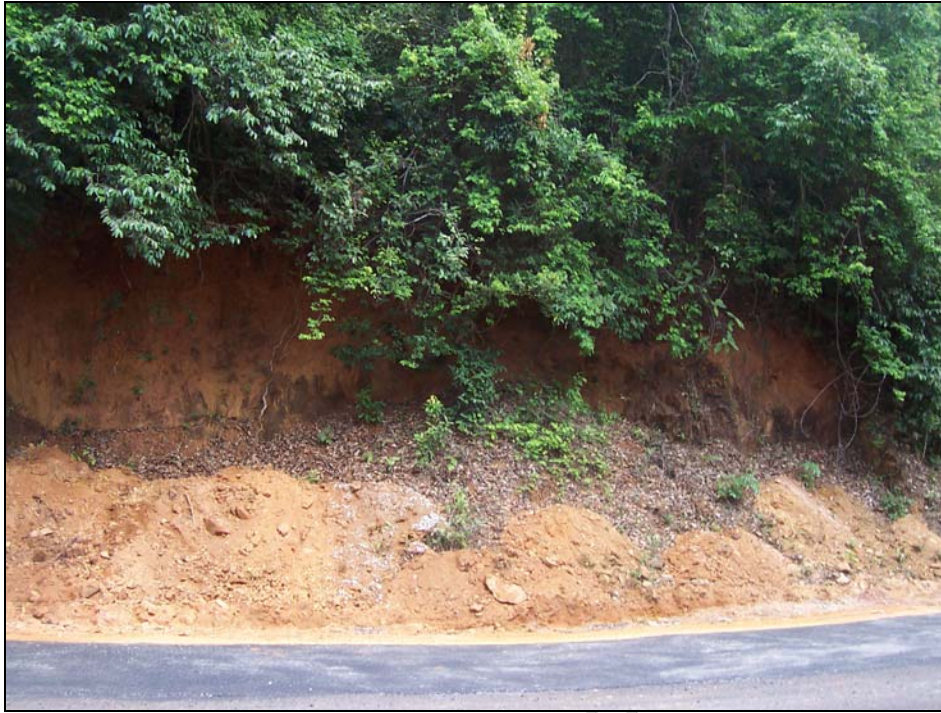
**Photo 80:** *The view of the debris slump with unstable crown.*

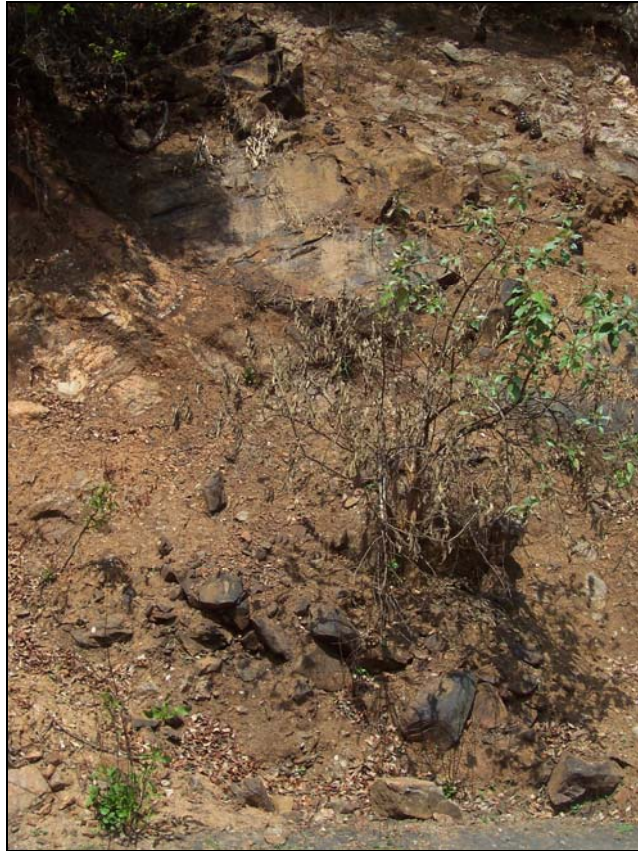
Photo 82: The view of the debris slide with unstable crown.

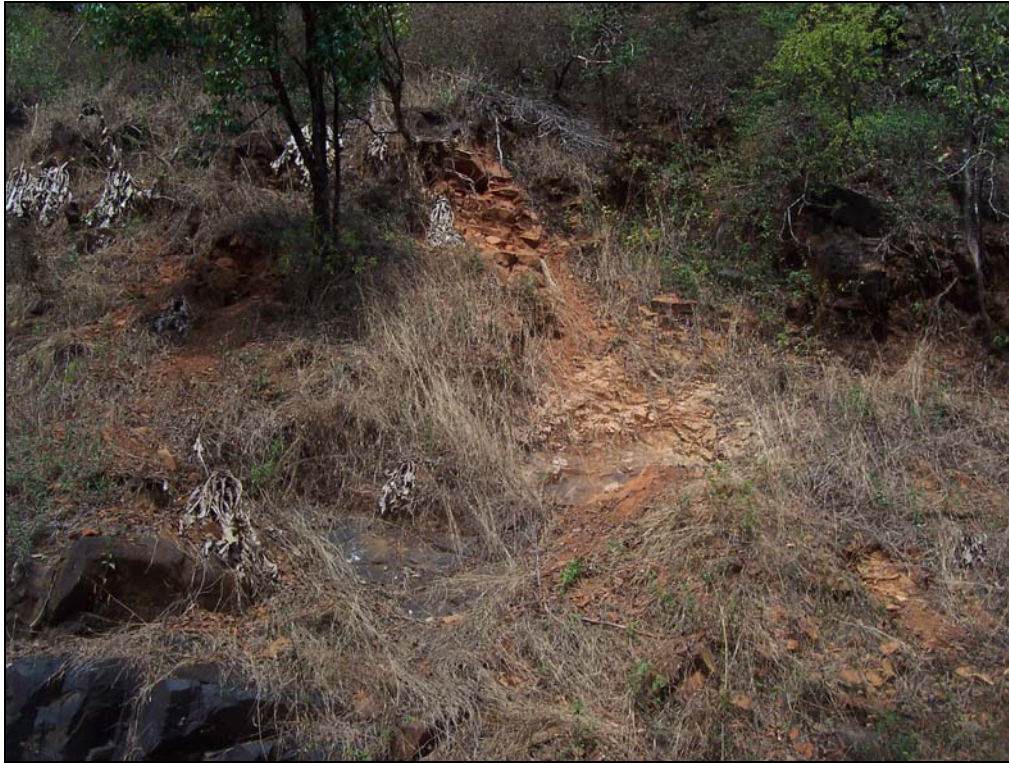
Photo 84: The plan view of the rock slide with loose boulders accumulated at the toe of the slide.

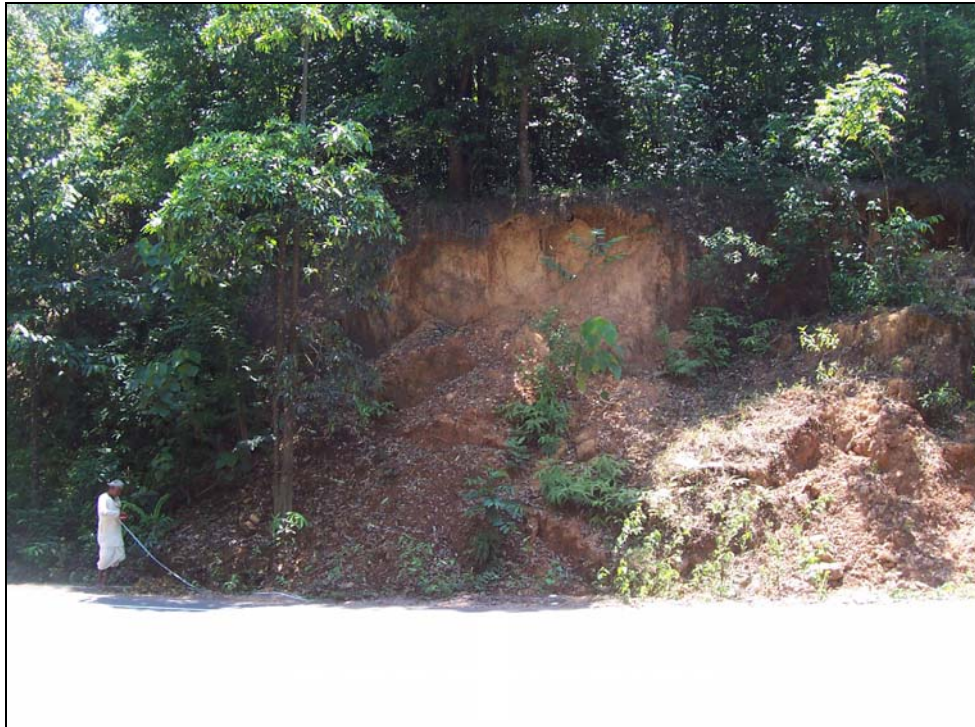
Photo-86: The plan view of the debris slide with unstable crown.

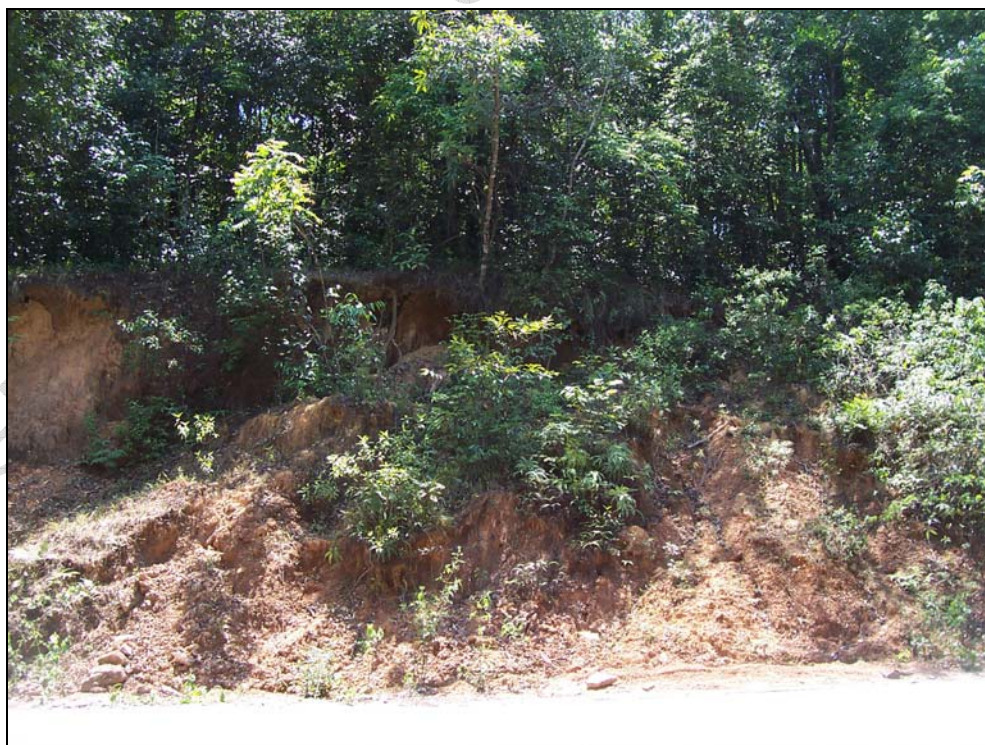
Photo 87: The plan view of the debris slide with accumulation at the toe.

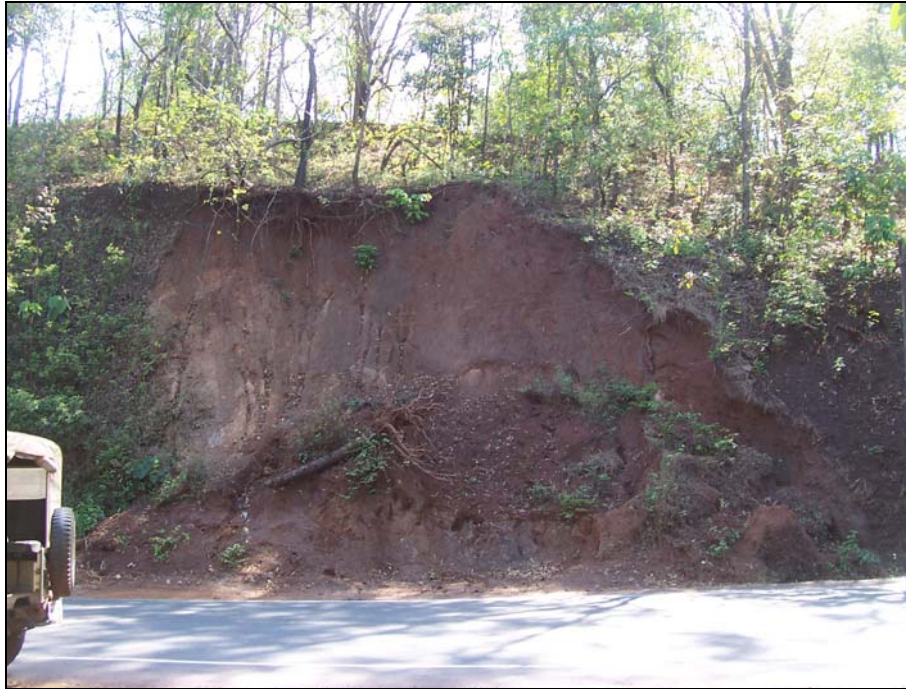
Photo 98: The view of the debris slide with unstable crown

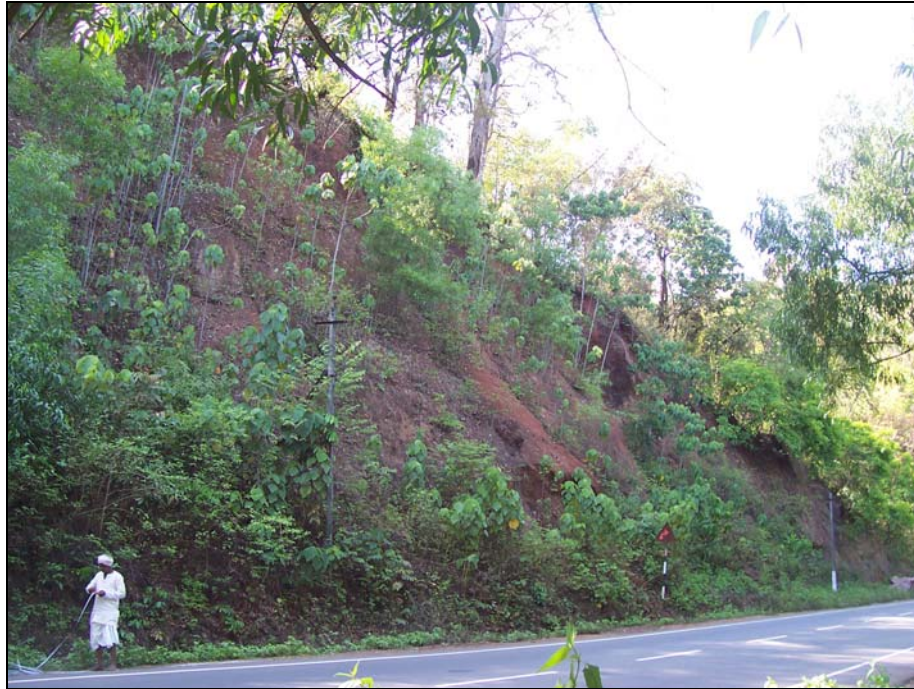
Photo 100: The side view of the debris slide with unstable crown

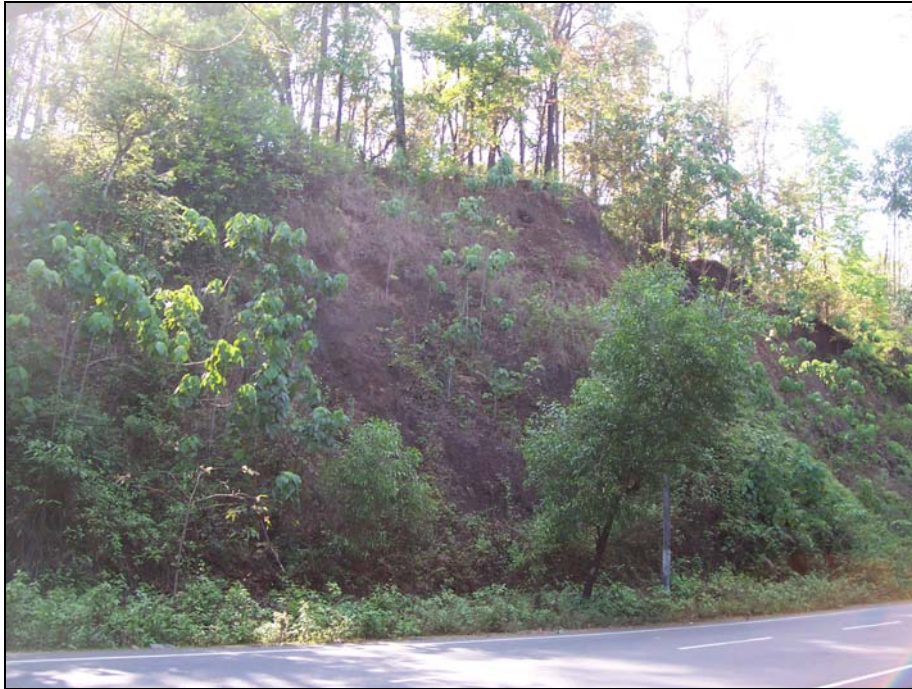
Photo 102: The plan view of the reactivated debris slide.

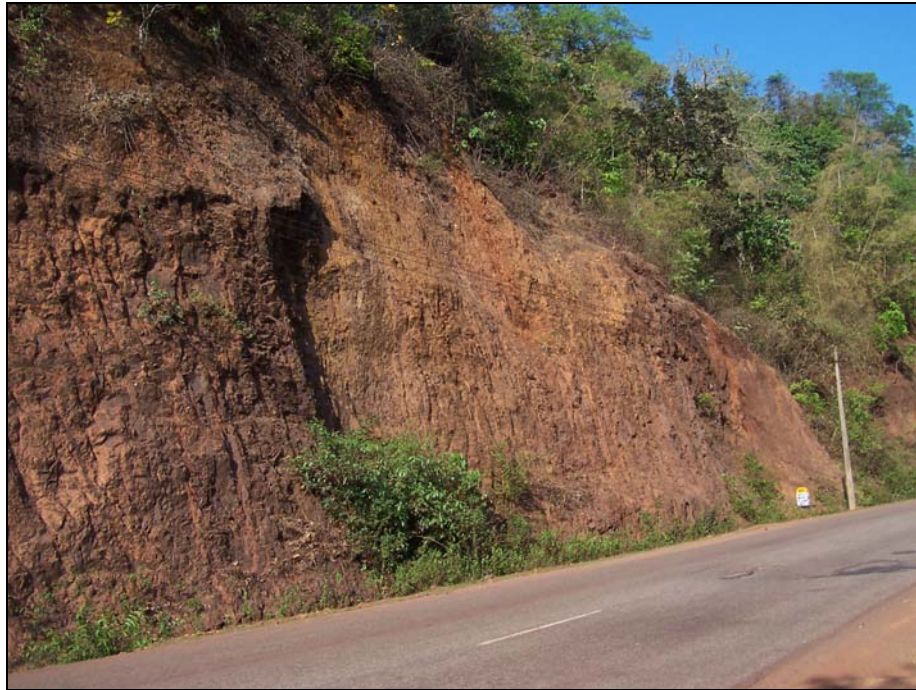
Photo 105: The side view of the reactivated debris slump with steep slope angle

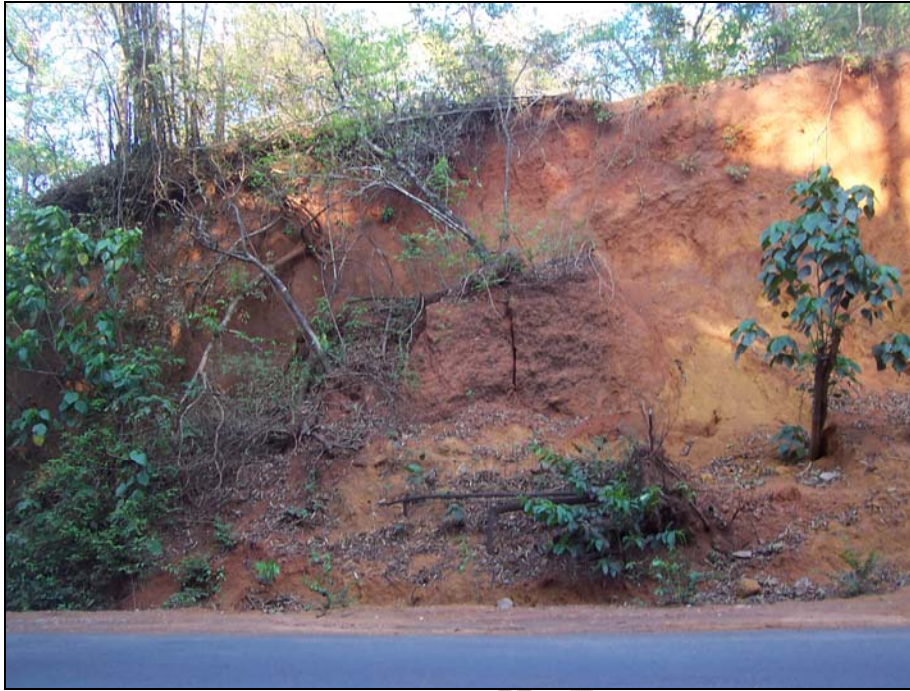
Photo 106: The side view of the debris slide showing steep slope angle.

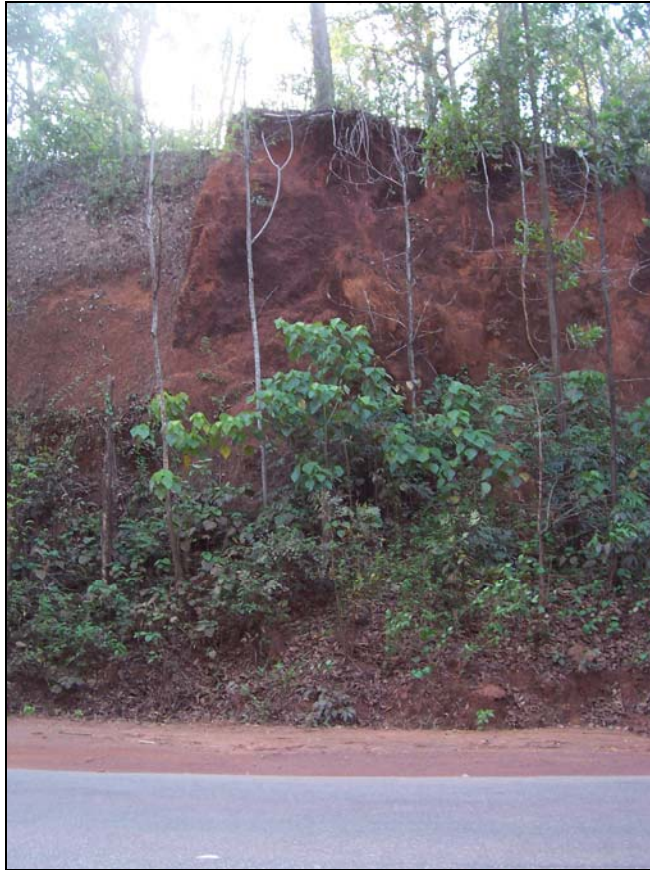
Photo 108: The plan view of the debris slide showing steep slope angle.

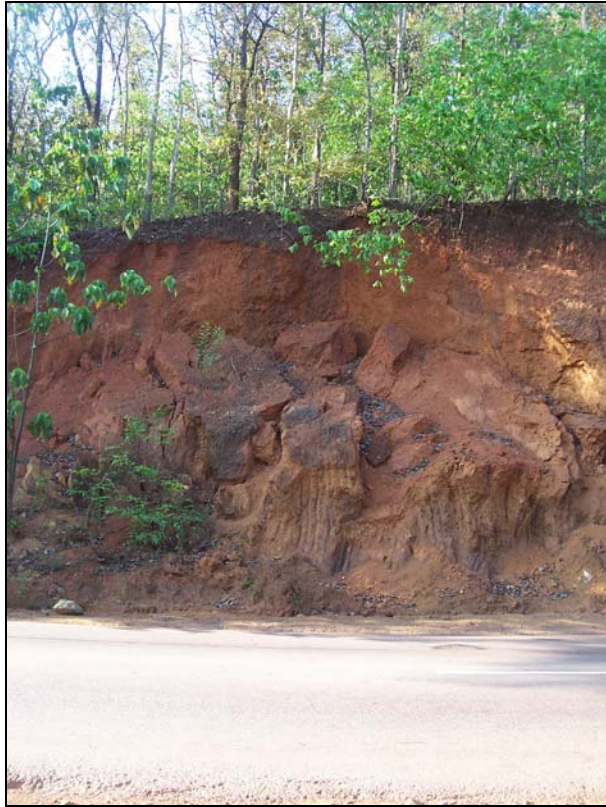
Photo 110: The side view of the debris slide showing steep slope angle.

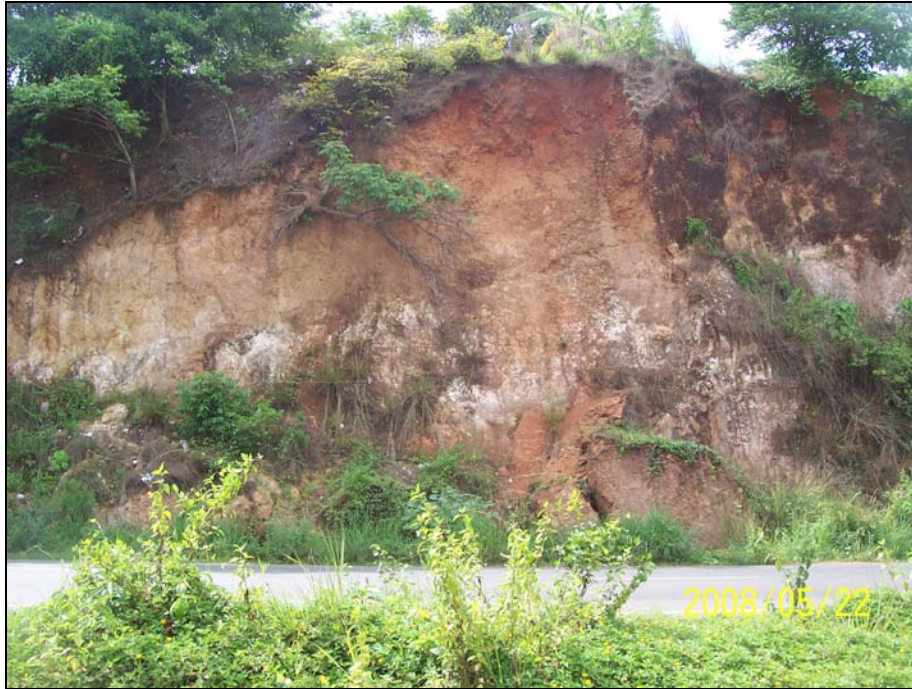
Photo 119: The plan view of the debris slump with unstable crown

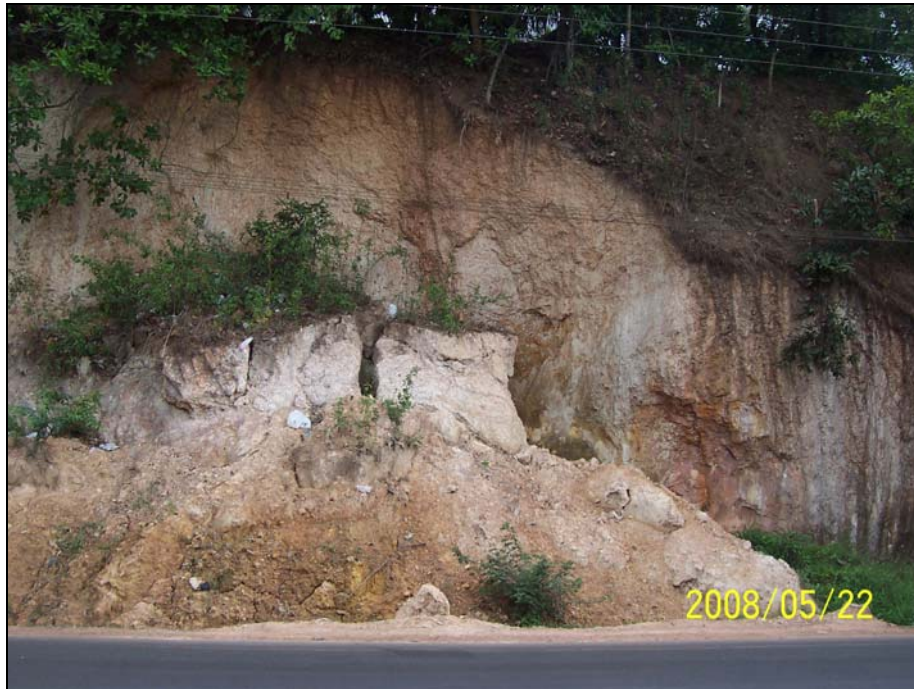
Photo 121: The plan view of the debris slump with steep unstable crown

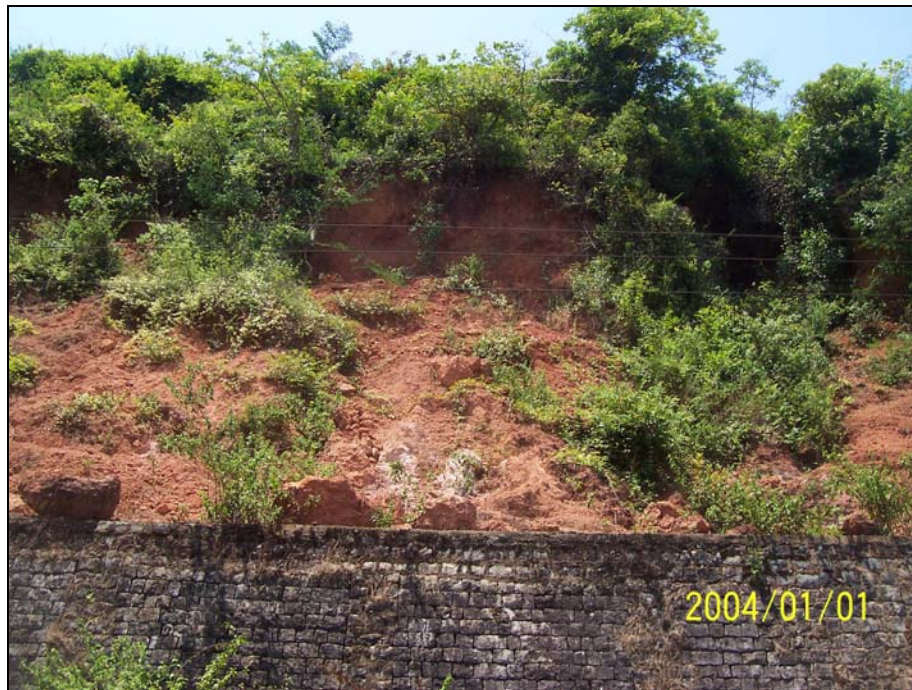
Photo 123: The plan view of the reactivated, debris slide with unstable crown.  
No protection at the crown

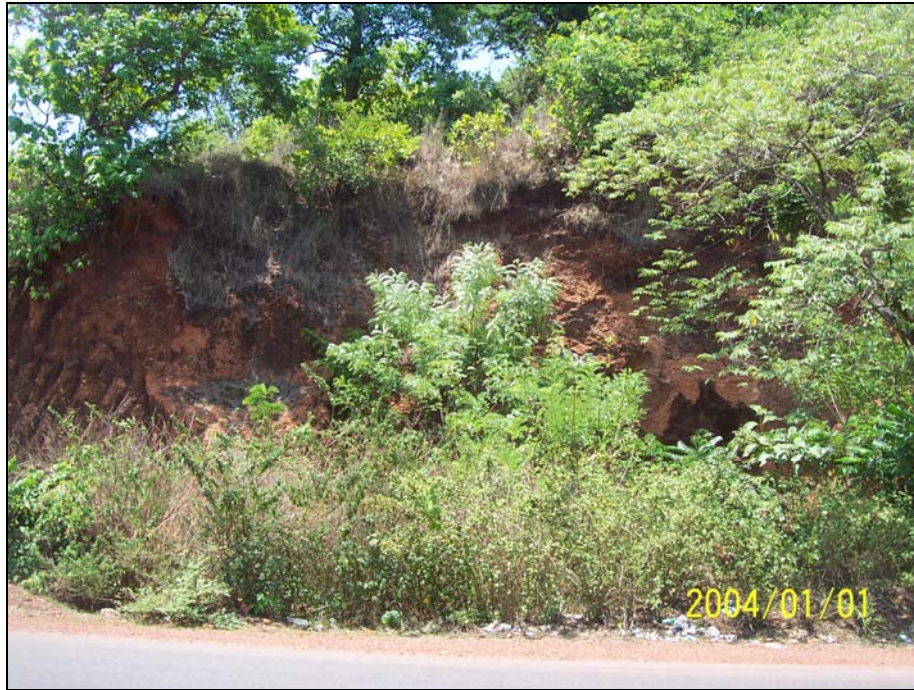
Photo 127: The side view of the reactivated, debris slide with unstable crown
