**REPORT ON THE PRELIMINARY POST DISASTER INVESTIGATION OF  
LANDSLIDE OCCURRED ON VITTAL-MANILA ROAD, BANTWAL  
TALUK, DAKSHINA KANNADA DISTRICT, KARNATAKA**

**K.V.MARUTHI  
K.V.CHANDRAN  
SENIOR GEOLOGISTS**

**ENGINEERING GEOLOGY DIVISION  
STATE UNIT: KARNATAKA AND GOA  
GEOLOGICAL SURVEY OF INDIA  
BANGALORE**

**2010**

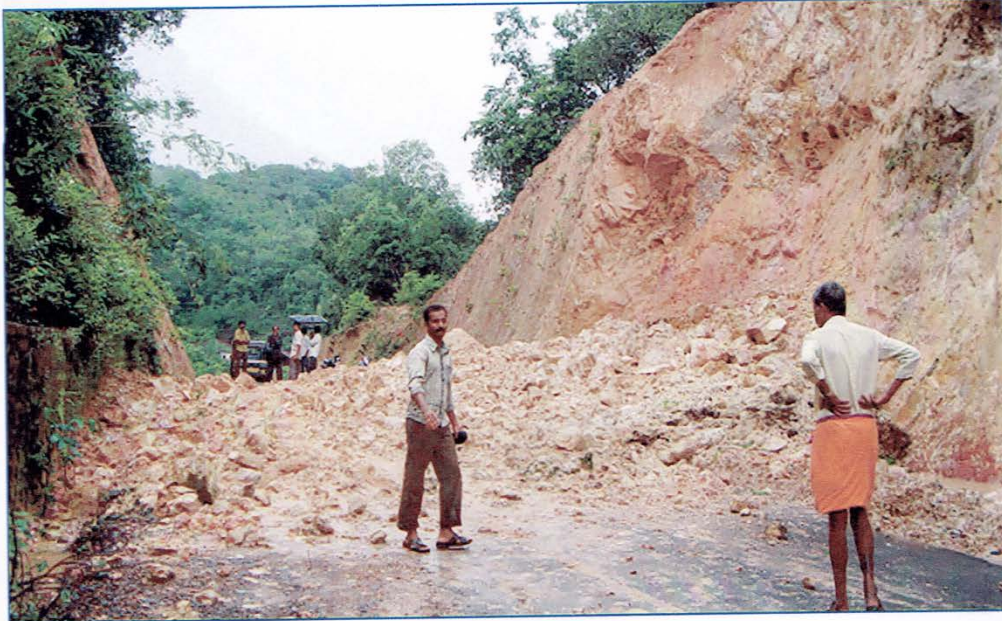
Photo 1: View of the landslide near Onibagilu on Peruvai- Pakalkunja road connecting Vittla and Manila on 21.07.2010(a day after the slide). [courtesy daijiworld.com](http://daijiworld.com)

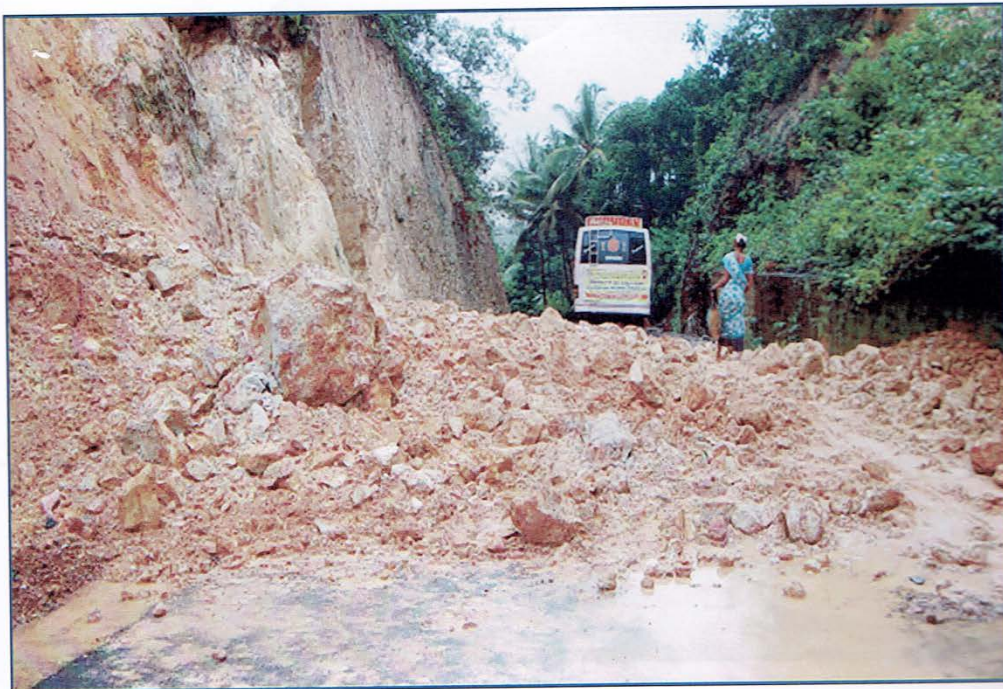
Photo 2: View of the landslide near Onibagilu on Peruvai- Pakalkunja road connecting Vittla and Manila on 21.07.2010(a day after the slide). [courtesy daijiworld.com](http://daijiworld.com)

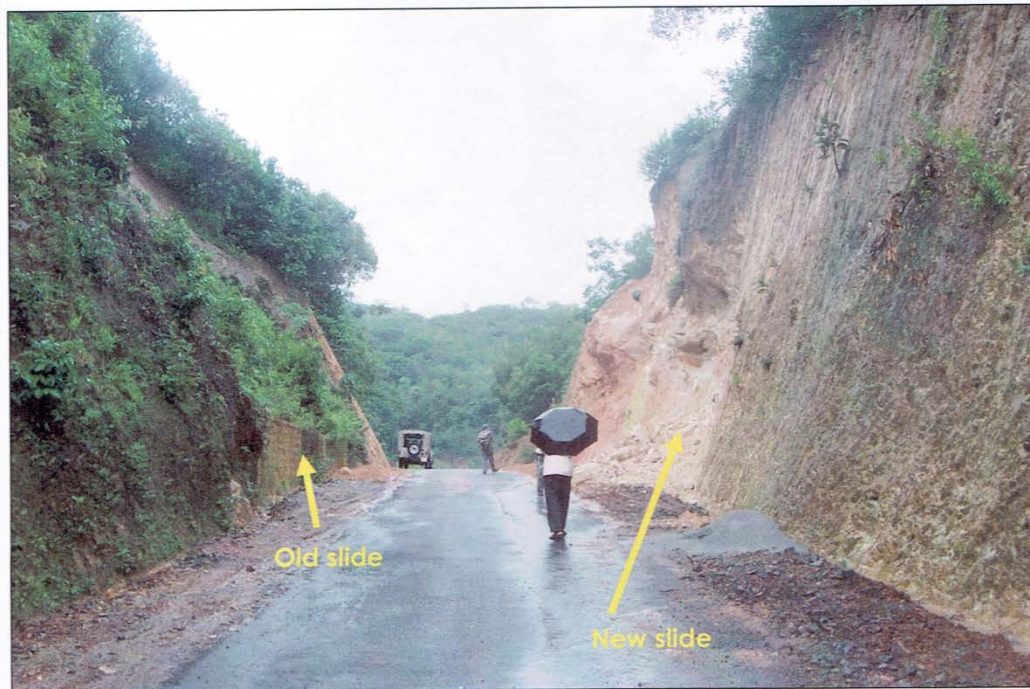
- a. Slope cut for road formation is vertical and cut slope height is very high (about 15m). (Photo 3)
- b. The failure is a wedge failure.
- c. The wedge failure occurred along other two major joint planes N50°E/ dipping 42°NW and EW/ dipping 70°N. (Photo 5)

Photo 3: landslide near Onibagilu on Peruvai- Pakalkunja road connecting Vittla and Manila. The right side of the road is new slide and left side is the old stabilised slide.

- a. The slided debris is to be removed from the slope.
- b. Remove all the loose boulders and hanging boulders.
- c. Reduction in the height of the cut slope by slope grading. The benches/berms, provided by the District administration has reduced the magnitude of the slide, the benches may be extended to full length of the road.
- d. Arrest infiltration of water at the top including diverting of the channels made for property demarcation.
- e. Make a proper drainage at the base with concrete lining.
- f. A retaining wall of 2m height is to be constructed at the toe.
- g. Backfilling the slope with stone pitching at 1:1 slope angle.
- h. Long term remedial measures if any may be given after detailed investigation.

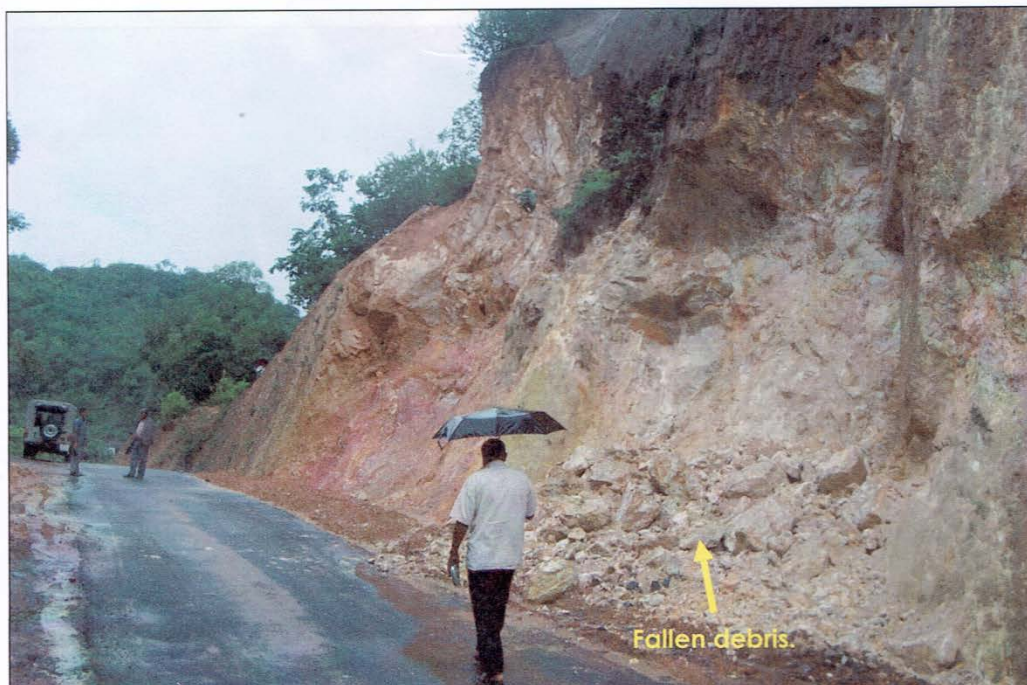
**Slide material:** The slide material in the zone of accumulation and depletion is debris comprising of different fraction of gneisses/weathered gneissic material. The gneisses are highly weathered and patches of limonitic clay are seen on the debris material. The size fraction of debris varies from huge gneissic boulders to small cobbles and pebbles and soil/clay material.

Photo 4: landslide near Onibagilu on Peruvai- Pakalkunja road connecting Vittla and Manila with fallen debris on toe part of the slide.

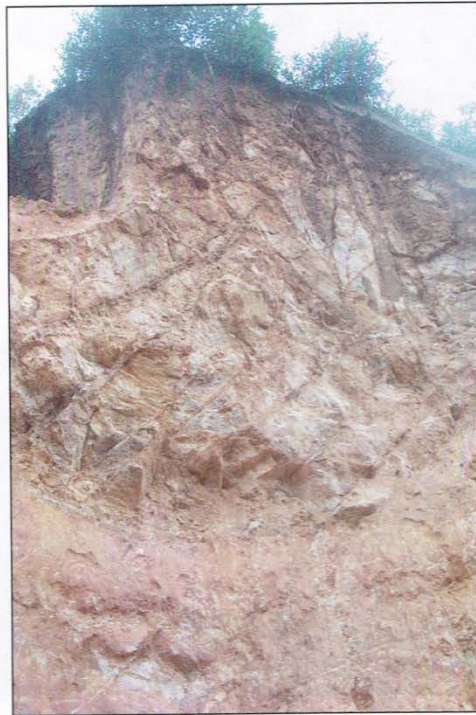
Photo 5: Head portion of the slide showing weathered Gneissic exposure with two sets of prominent joints.

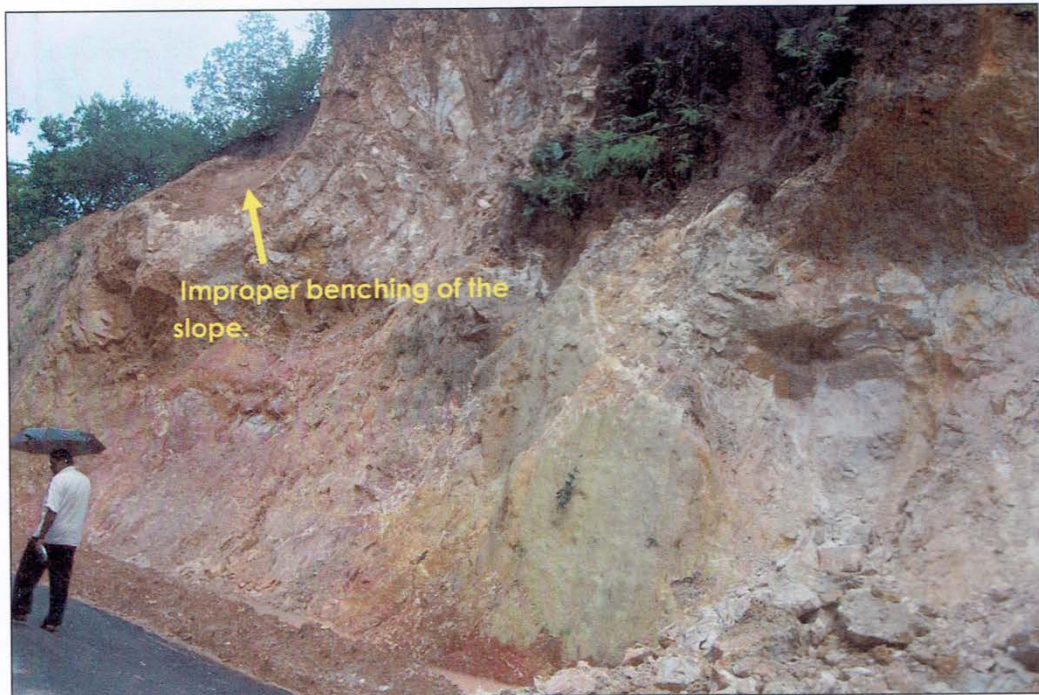
- g. The slope grading and benching done on the slide (the current slide) should have been complete for whole length of the road. It was stooped in the mid way otherwise the slope would have been stabilised. (Photo 6)

Photo 6: Improper benching at the mid slope, proper extension of bench to whole slope might have prevented the slide.

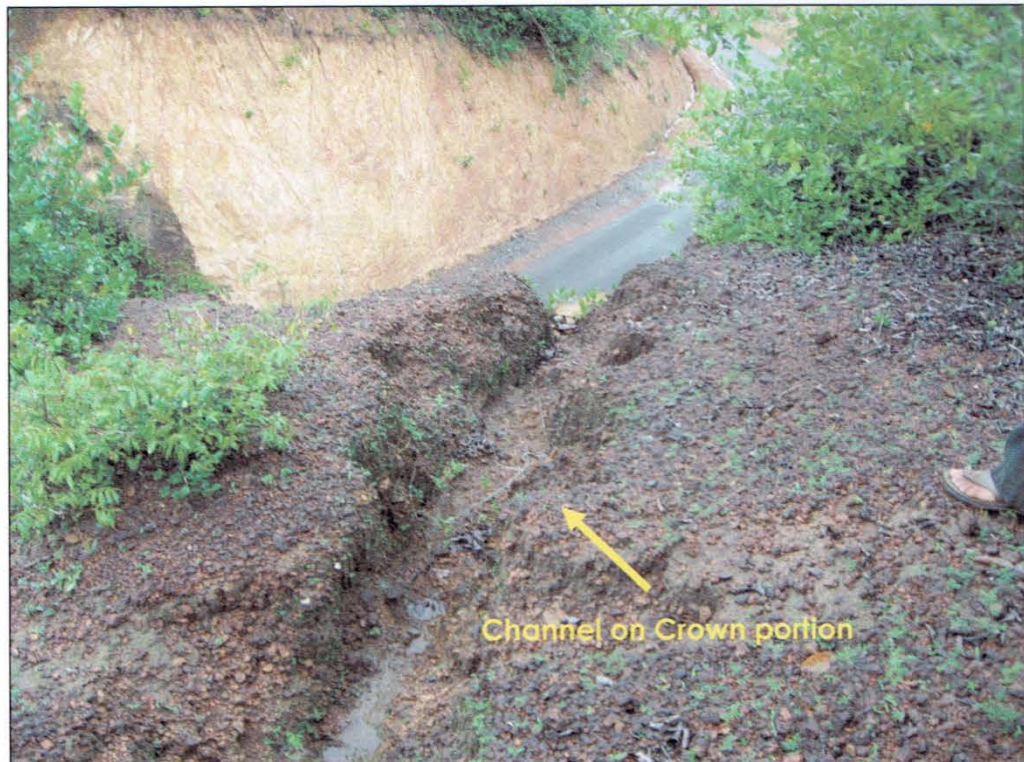
- d. High rainfall removed the material along these planes by infiltrating and acted as lubricant reducing the resisting force.
- e. Small trenches are seen above the slided area to demarcate the land and property in which the water is continuously flowing in rainy days. This acted as catalyst agent for infiltration. (Photo 7)

Photo 7: channels made for property demarcation on the crown portion of the slide from which water is directly draining in to the slide area.

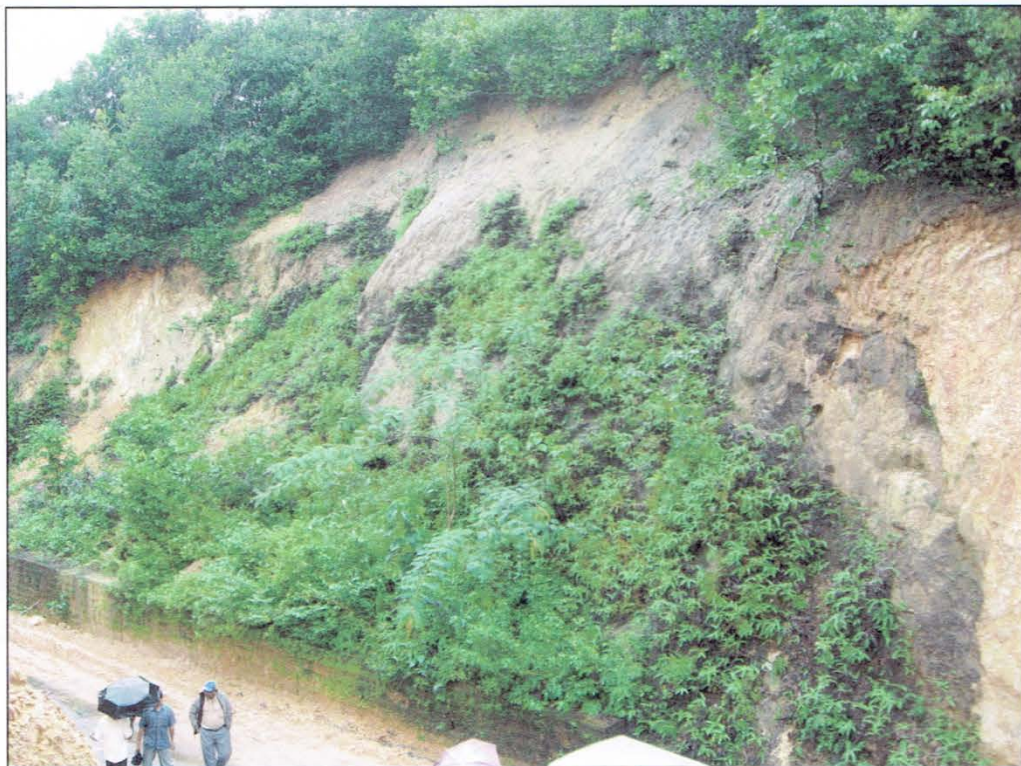
- f. The area is prone for landslides as the slope height is very high and highly weathered gneissic body. It is also evident from the fact that the other side of the road an old slide exists (the slide occurred some 10 years back and now stabilised by providing retaining structure). (Photo 8)

Photo 8: view of the landslide on the other side of the road which has been stabilised by providing retaining structure and slope grading.
