**GOVERNMENT OF INDIA  
GEOLOGICAL SURVEY OF INDIA**

**REPORT ON THE PRELIMINARY POST DISASTER INVESTIGATION OF  
LANDSLIDE OCCURRED AT HADGERI VILLAGE IN HONNAVAR  
TALUK, UTTAR KANDA DISTRICT, KARNATAKA**

**(Additional Item)**

**K.V.MARUTHI  
K.V.CHANDRAN  
SENIOR GEOLOGISTS**

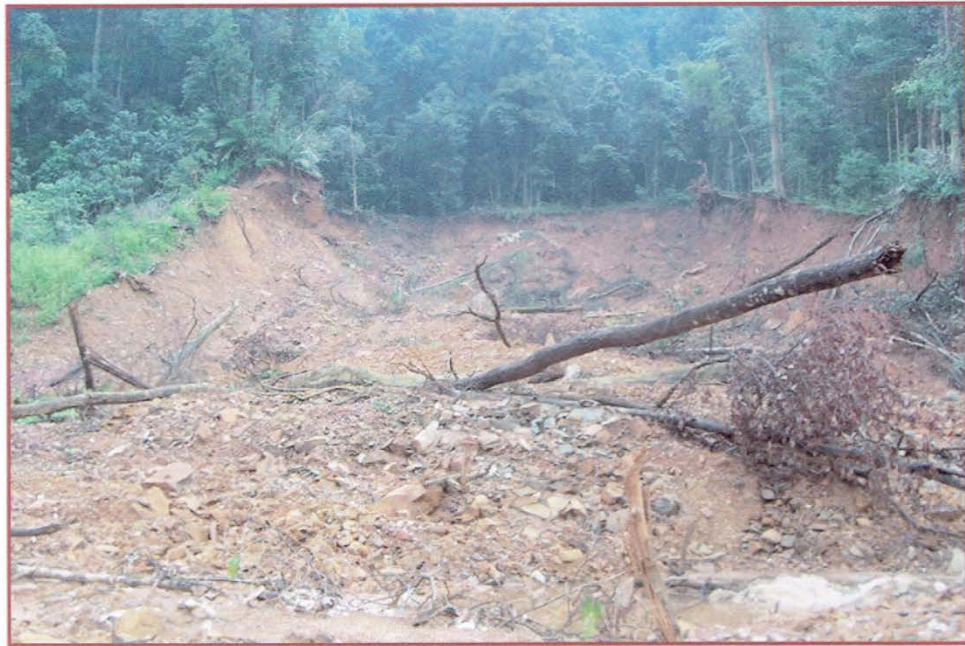
Photo1: Crown, scarp and the zone of depletion of the Hadgeri debris flow.

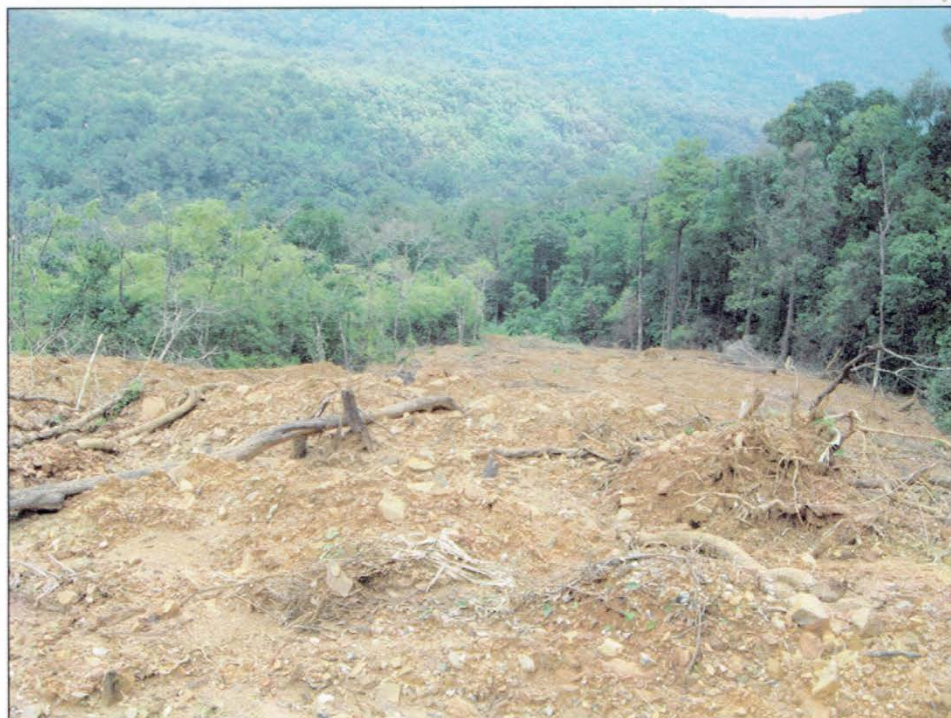
Photo2: Zone of accumulation of the Hadgeri debris flow.

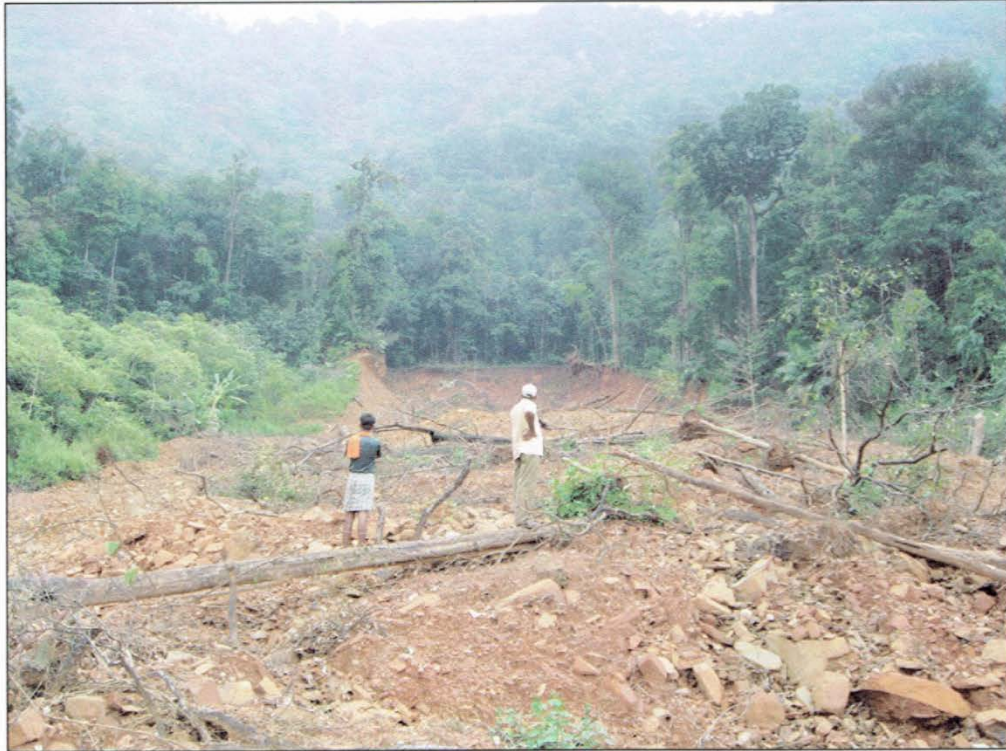
Photo 3: View of the Hadgeri debris flow from zone of accumulation.

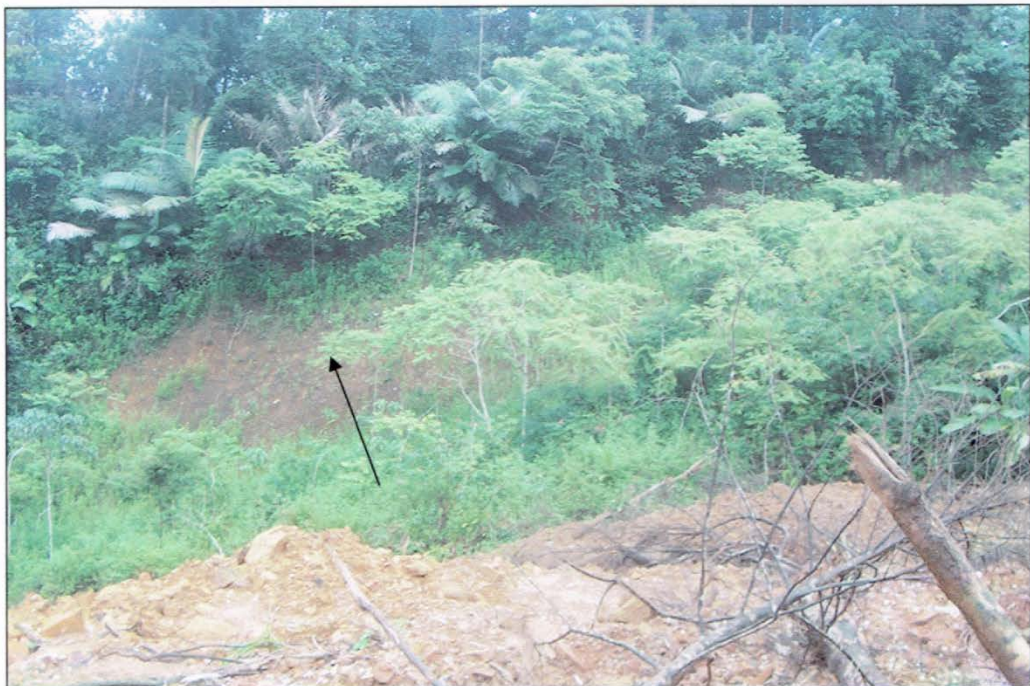
Photo 4: A view of old slide scarp on the right flank of the Hadgeri debris flow.

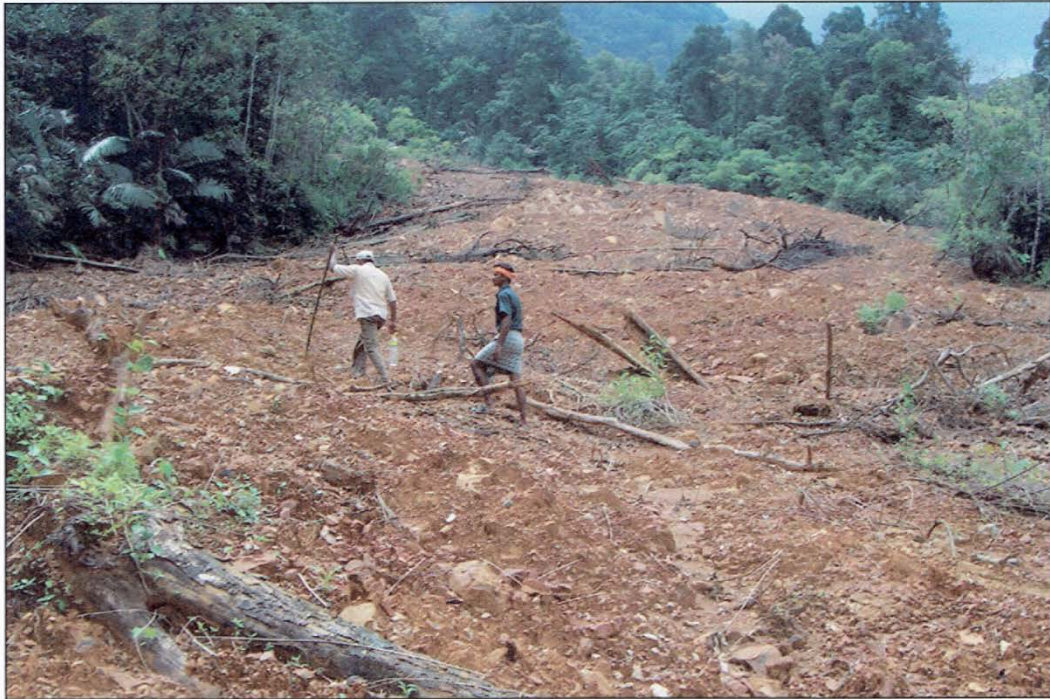
Photo 5: A view of zone of accumulation and toe part of the Hadgeri debris flow.

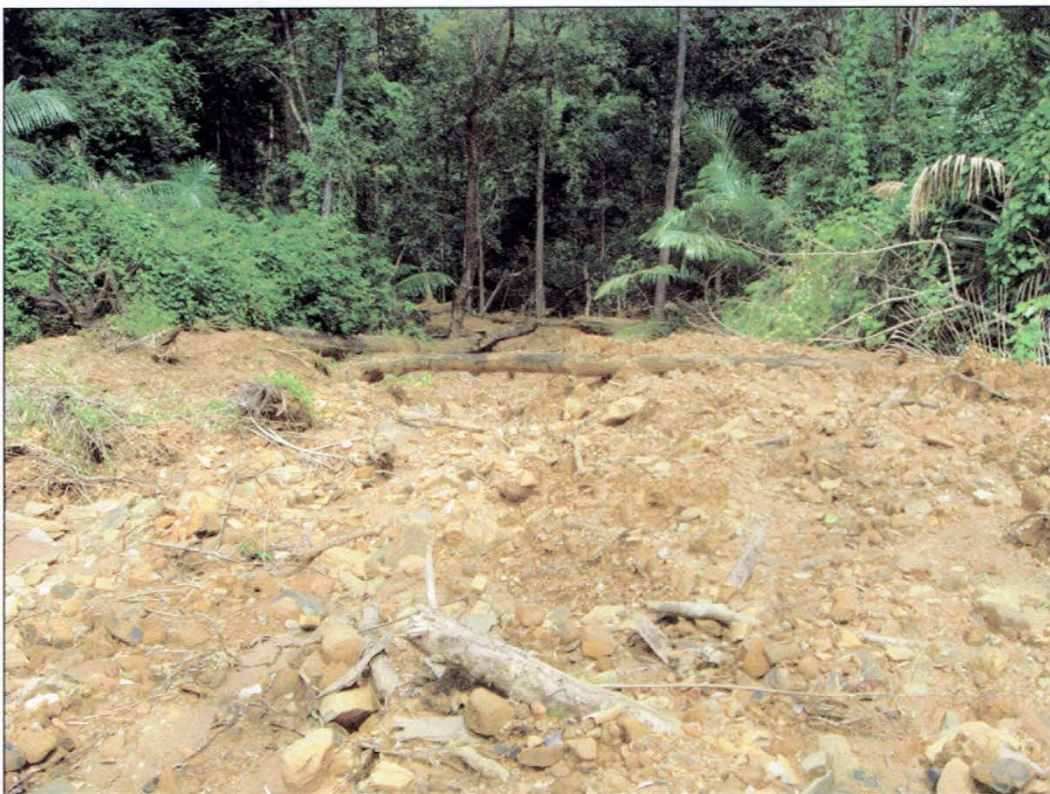
Photo 6: A view of zone of accumulation and toe part of the Hadgeri debris flows.

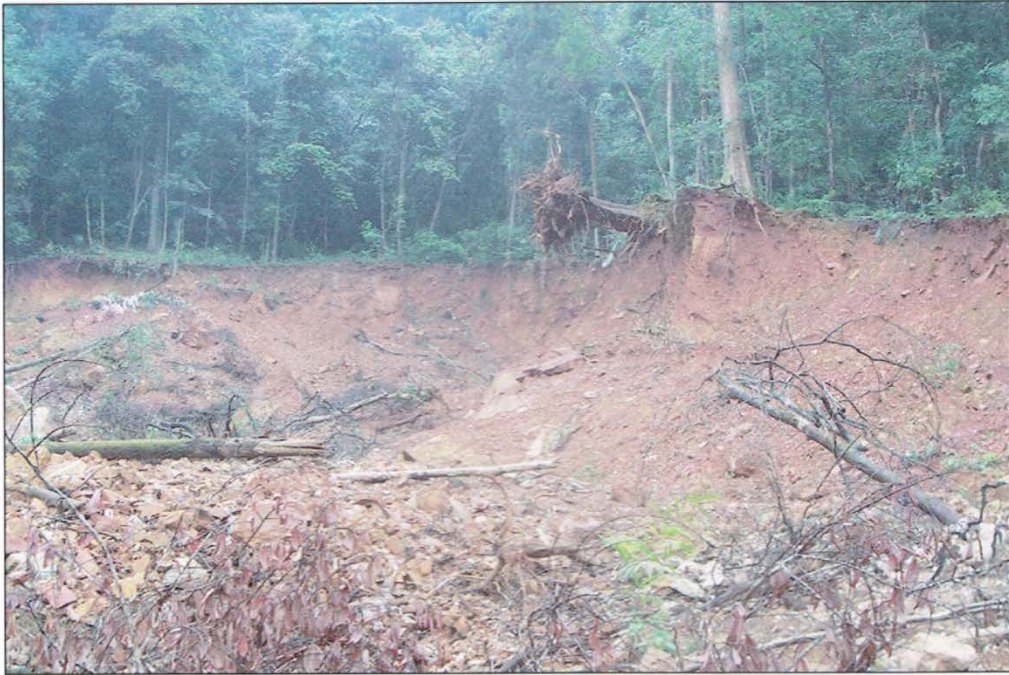
Photo 7: Left flank of the slide in the zone of depletion of the Hadgeri Landslide.

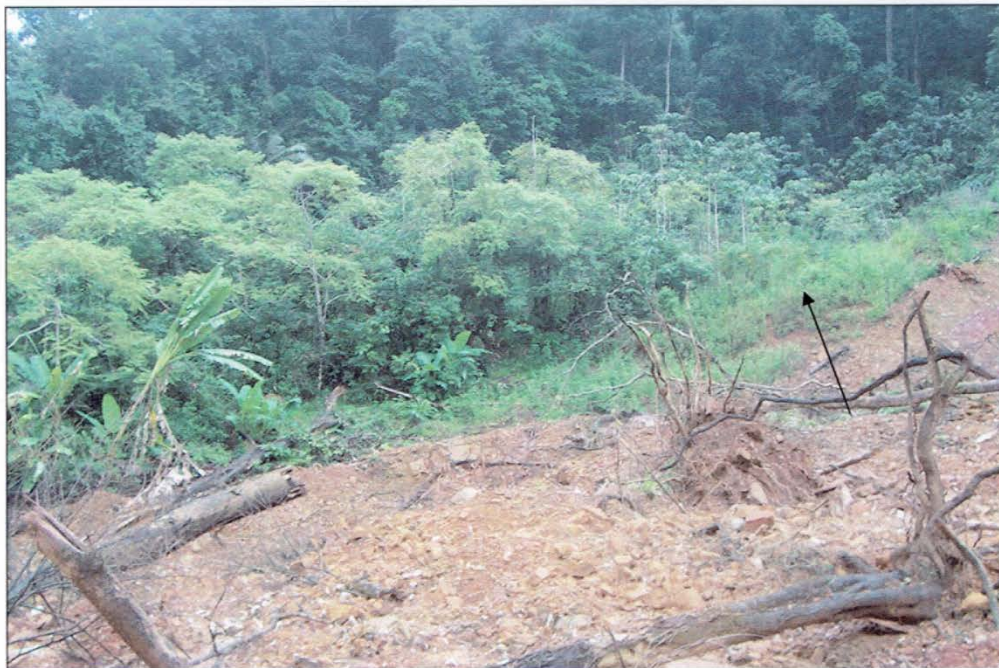
Photo 8: Right flank of the slide in the zone of depletion of the Hadgeri landslide. Old slide scarp is also seen.
