**REPORT ON LANDSLIDE INVENTORY ALONG NH & SH OF GHAT  
ROADS IN CHIKMAGALUR, COORG, DAKSHINA KANNADA,  
UDUPI AND SHIMOGA DISTRICTS, KARNATAKA**

**(Progress Report for the Field Season 2009-10)**

**Code No.: EG/SR/KG/2009/043**

**K.V.Maruthi, Senior Geologist**

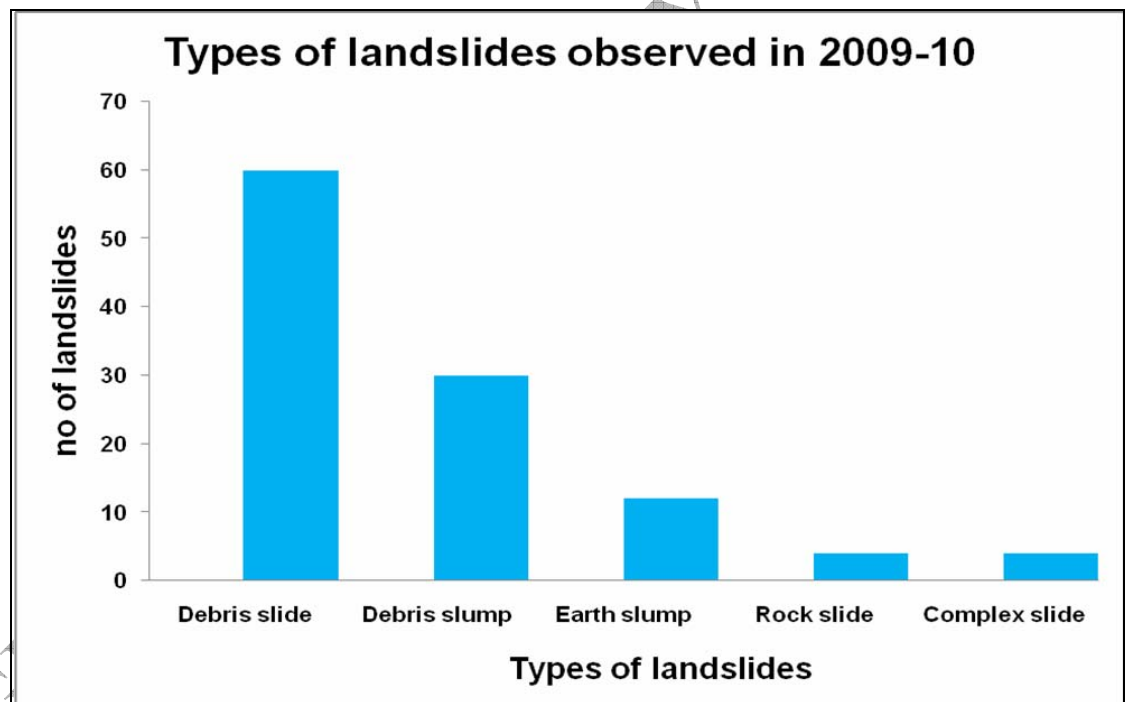
**Fig 1: Type of landslides in each section.**

Section wise analysis on the type of landslide revealed that Bhagamandala- Karike and around Madikeri sections are having maximum number of debris slides (16 no in each section) closely followed by Charmudi ghat section (15 no). Bhagamandala-Karike and around Madikeri sections are also having maximum number of debris slumps (10 no in each section). Earth slumps were noticed only in Bhagmandala-Karike and Charmudi ghat sections (6 no in each section). Out of

four rock slides three were observed in Charmudi ghat section and one in Aldur- Balehoonur section. Of the four complex slides where both rock slides and debris slides were noticed together are two in Bhagamandala-Karrike section and two in Balehonnur-Koppa section. (Table 2, 3).

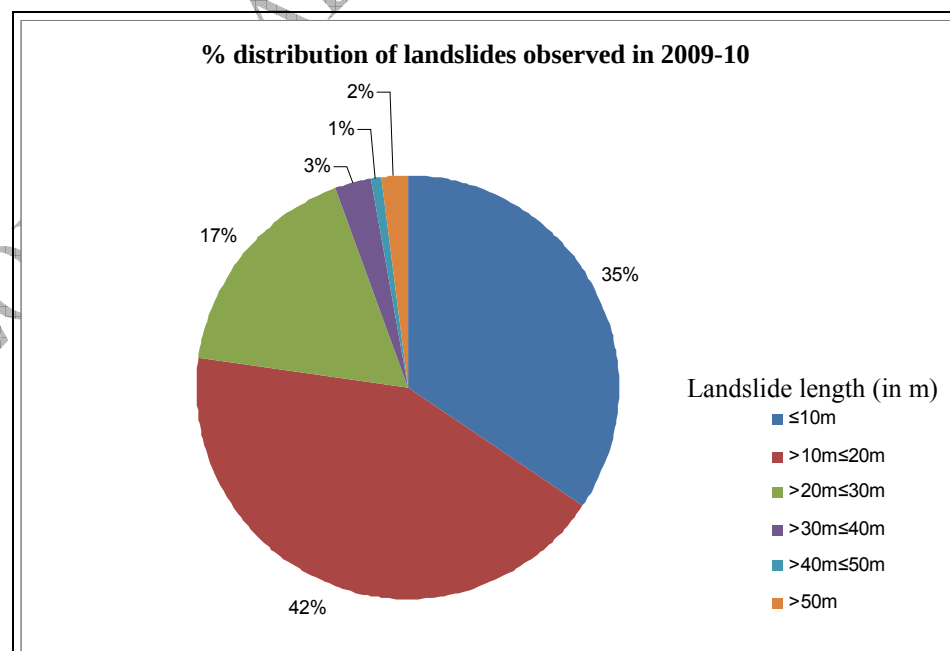
**Fig 2a: Percentage distribution of landslides with respect to their length.**

**IV. 2. Dimensions of landslides:** The length, width and depth of the slides studied in 2009-10 with respective percentages are presented in (Table 4, 5 and Fig 2a, 2b and 2c). It can be noted from the length and width that most of the landslides have length and width < 20.0 m. 77.28% of the slides have length < 20.0 m and 60.0% of the slides have width < 20.0 m. With regard to depth most of the slides are shallow with  $\leq 1.0$  m depth (79.09% of the total). The dimensions of slides in each road sections are also represented in Table 6, 7, 8, 9, 10 and 11 with corresponding percentage distribution.

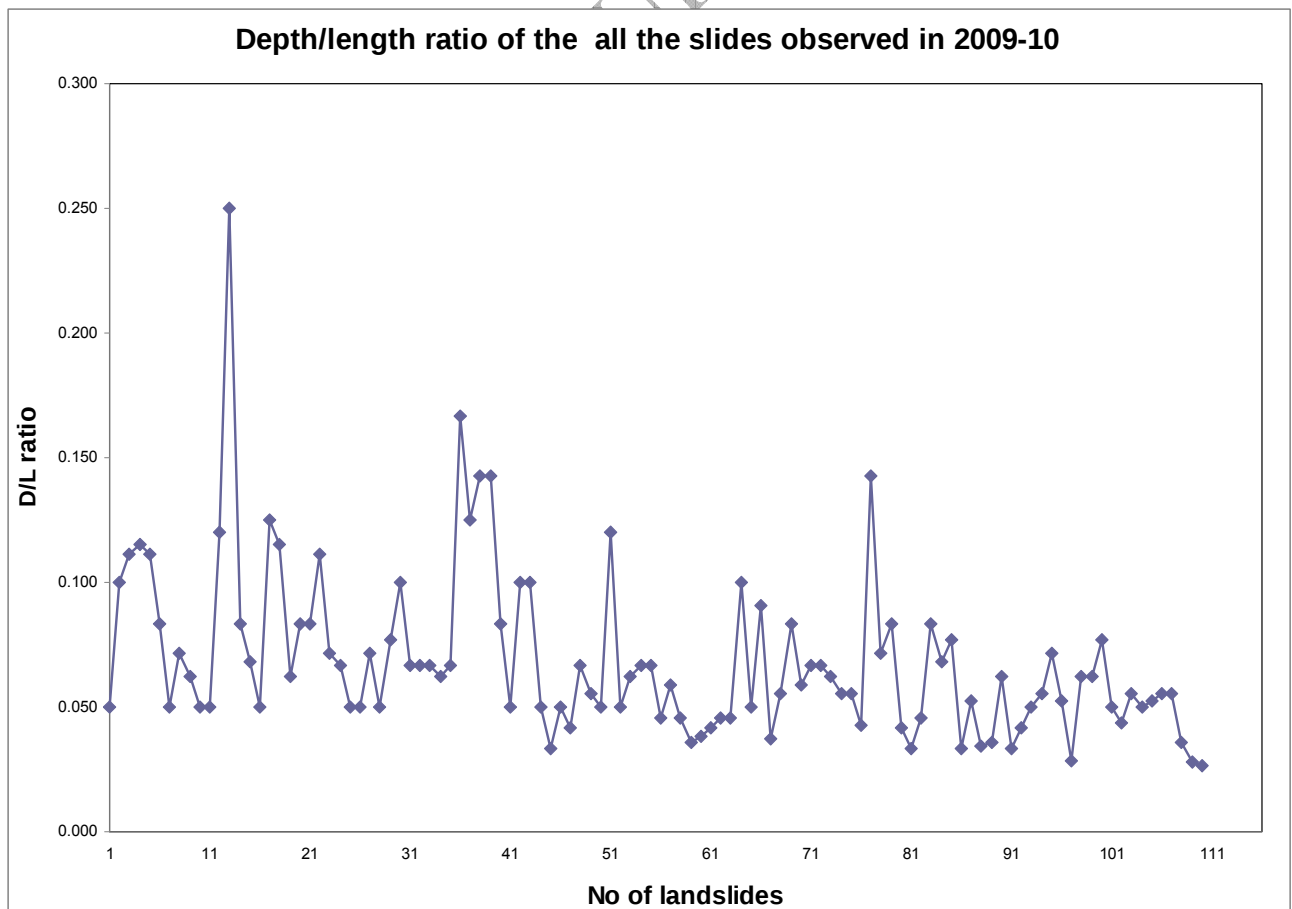
**Fig 3: Depth/length ratio of all sides observed in 2009-10.**

**IV. 4. Depth/length (D/L) ratio :** The depth to Length ratio (D/L) for most of the slides fall in between 0.03 to 0.15 indicating shallow depth of the landslides. One slide in Charmudi ghat is a quite deep landslide with D/L ratio going beyond 0.2(Fig 3)

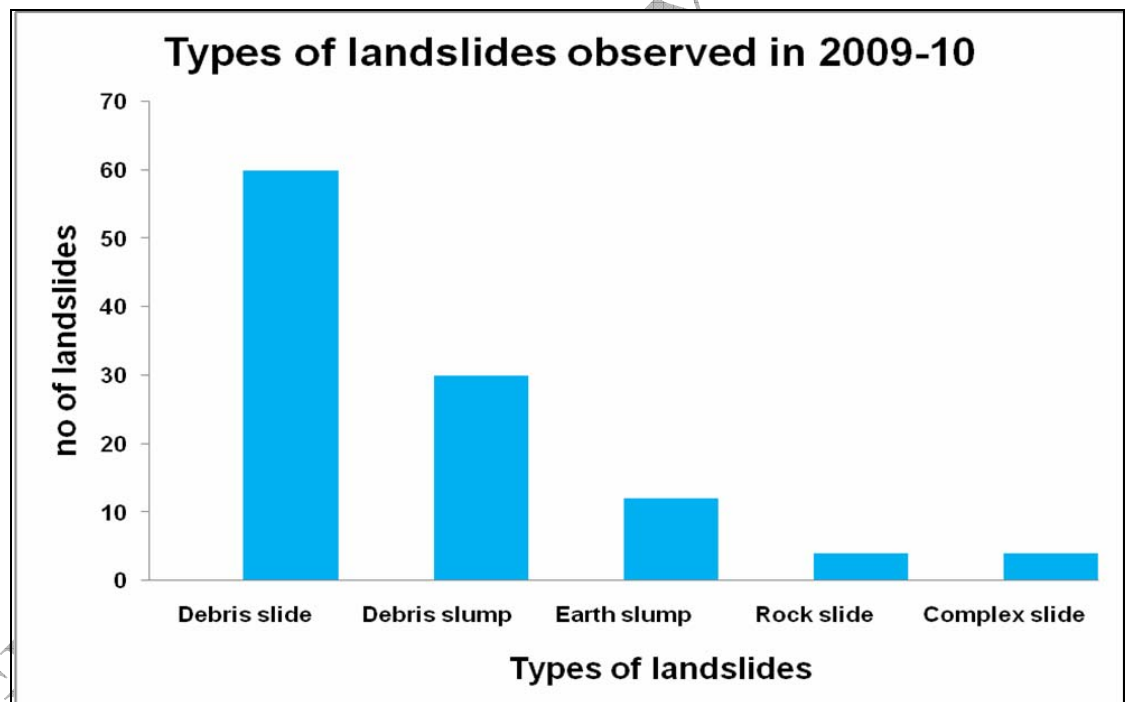
**Fig 1: Type of landslides in each section.**

Section wise analysis on the type of landslide revealed that Bhagamandala- Karike and around Madikeri sections are having maximum number of debris slides (16 no in each section) closely followed by Charmudi ghat section (15 no). Bhagamandala-Karike and around Madikeri sections are also having maximum number of debris slumps (10 no in each section). Earth slumps were noticed only in Bhagmandala-Karike and Charmudi ghat sections (6 no in each section). Out of

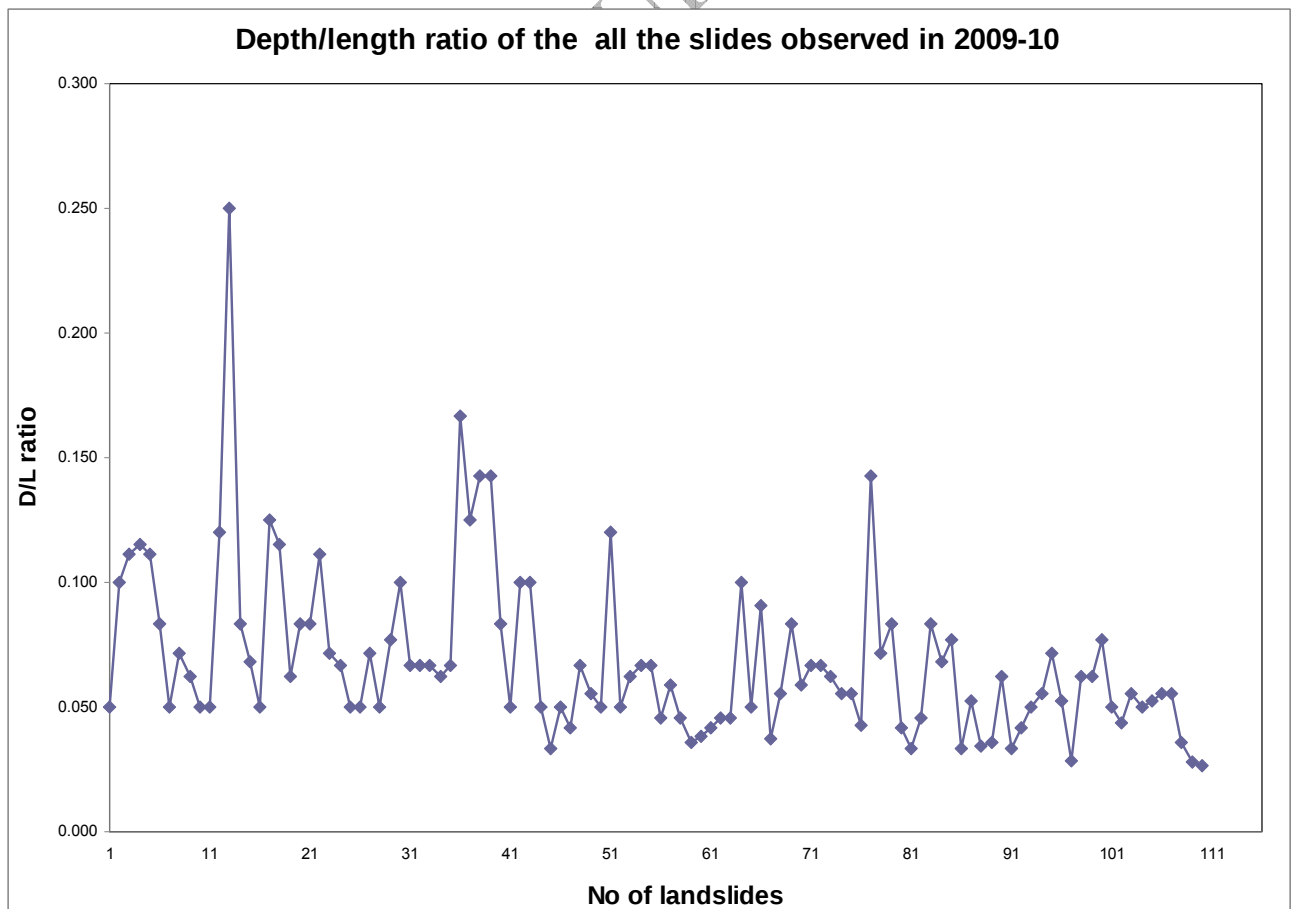
**Fig 3: Depth/length ratio of all sides observed in 2009-10.**

**IV. 4. Depth/length (D/L) ratio :** The depth to Length ratio (D/L) for most of the slides fall in between 0.03 to 0.15 indicating shallow depth of the landslides. One slide in Charmudi ghat is a quite deep landslide with D/L ratio going beyond 0.2(Fig 3)
