**GOVERNMENT OF INDIA  
GEOLOGICAL SURVEY OF INDIA**

**A NOTE ON THE PRELIMINARY POST DISASTER INVESTIGATION OF  
LANDSLIDES OCCURRED AROUND MADIKERI, COORG DISTRICT, KARNATAKA**

**K.V.MARUTHI  
SUPERINTENDING GEOLOGIST  
&  
Dr. VINODKUMAR  
GEOLOGIST**

**ENGINEERING GEOLOGY DIVISION  
STATE UNIT: KARNATAKA AND GOA  
GEOLOGICAL SURVEY OF INDIA  
BANGALORE  
2013**

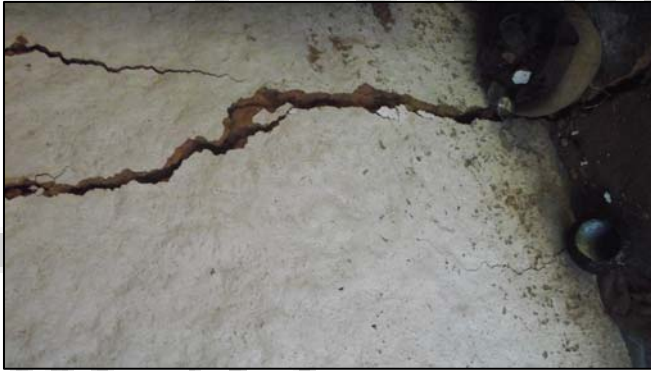
**Crack geometry:** The geometry of the cracks was difficult to delineate due to constant rainfall and ground covered with plantation and vegetation. The cracks at the house of Jayaprakash at the back wall are 10-15 cm wide. On the pavement of the house it is radial in nature with 12-15 cm wide (Photo 1). The cracks are extending down the valley for about 600-700 m (Photo 4) including the road leading to school of the village. There was no evidence of subsidence at the time of study.

- i. The cracks are mainly caused due to increase in pore water pressure due to heavy infiltration of rainwater. The increase in ground water level has reduced the cohesion and the shear strength of the slope material. The weathered gneissic material at places is converted to clay causing lower permeability of slope( slope material includes highly weathered granite gneiss rock particles of different size ranging from boulders to pebbles, soil, and clay derived from weathering) and increase in pore water pressure.

- iii. The rain fall is the triggering factor as the antecedent rainfall in July 2013 shows a sharp rise.
- iv. The cracks have appeared in the houses which are not constructed on best practiced structural construction methods. The houses are rather mud houses without any proper basement and structural design.

Photo 1: Cracks seen in house of Shri. Jayaprakash in Mannangeri village.

- i. The house of Shri. Jayaprakash is in grave danger and to be evacuated permanently (as of now it is temporarily evacuated) as it is not safe for habitation.
- ii. The cracks on the pavement of house, in front of house and road should be monitored regularly to see any new developments including widening, deepening, any subsidence or movement of slope material.
- iii. The drainage conditions in the study area have to be improved with channelizing the excess run off of rain water during the rain. Also horizontal perforated pipes may be inserted at suitable intervals and at different levels to drain excess water from the slope to reduce pore water pressure.

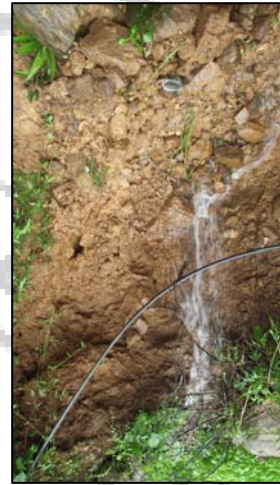
Photo 2: Nala flowing just behind the house of Shri. Jayaprakash in Mannangeri village

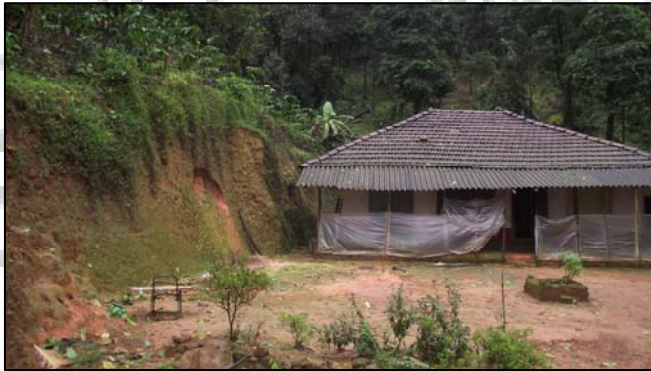
Photo 3: House of Shri. Jayaprakash in Mannangeri village constructed on nala course by slope cutting

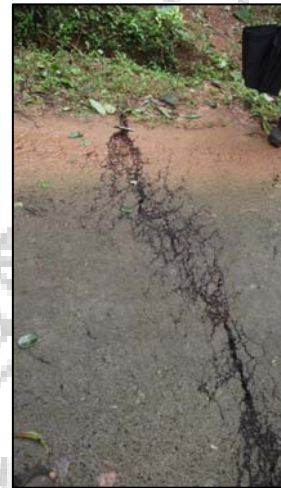
Photo 4: Cracks seen road leading to School in Mannangeri village.

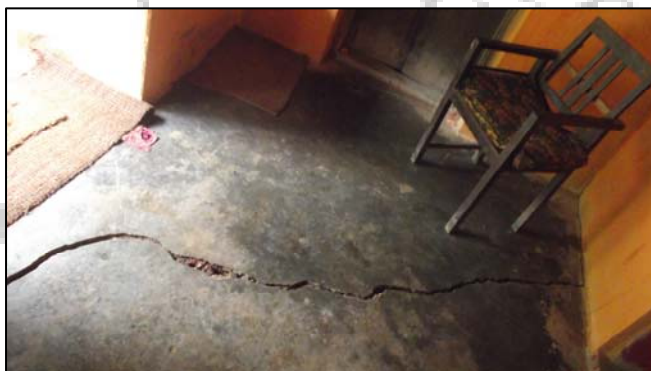
**Crack geometry:** The geometry of the cracks was difficult to delineate due to constant rainfall and ground covered with plantation and vegetation. The cracks on the back wall of house of Janaki are 7-13 cm wide. On the pavement of the house it is radial in nature with 12-15 cm width (Photo 5 & 7). There was a small evidence of subsidence of 40-50 cm seen 150.0 m upstream of the Janaki house (Photo 6). Longitudinal cracks are observed at the side of Sittamma house as well (Photo 8).

- i. The cracks are mainly caused due to increase in pore water pressure due to heavy infiltration of rainwater. The increase in ground water level has reduced the cohesion and the shear strength of the slope material. The weathered gneissic material at places is converted to clay causing lowering of the permeability of slope material and increase in pore water pressure.

- ii. The slope has been modified for construction of house and plantations .The modification of slope geometry for plantations and settlements in long term has reduced the slope stability.
- iii. The rain fall is the triggering factor as the antecedent rainfall in July 2013 shows a sharp rise.
- iv. The cracks have appeared in the houses which are not constructed on best practiced structural construction methods. The houses are rather mud houses without any proper basement and structural design.

Photo 5: Cracks seen in house of Smt. Janaki in Makandur village.

- i. The house of Smt. M.D.Janki is in grave danger and to be evacuated immediately as it is not safe for habitation.
- ii. The cracks at the house of Janaki and side of the house of Sitamma( ground cracks) should be monitored regularly to see any new developments including widening, deepening, any new subsidence or movement of slope material.
- iii. The drainage conditions in the study area have to be improved with channelizing the excess run off of rain water during the rain. Also horizontal perforated pipes may be inserted at suitable intervals and at different levels to drain excess water from the slope to reduce pore water pressure.

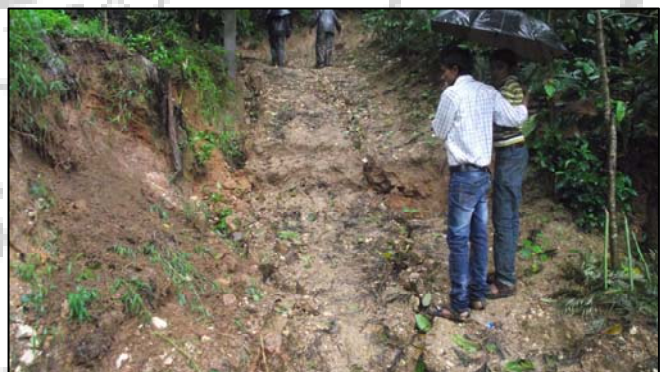
Photo 6: Subsidence observed Upstream of Smt. Janaki house.

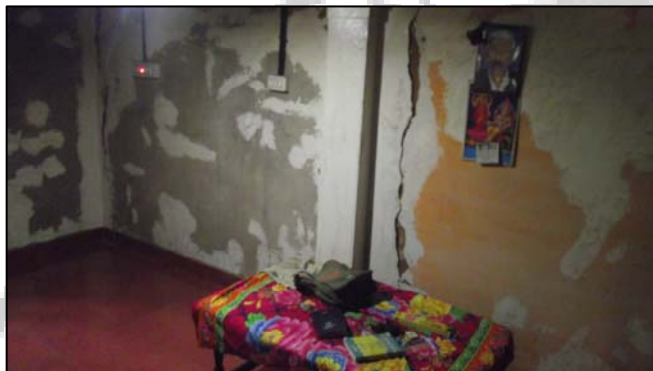
Photo 7: Cracks seen in house of Smt. Janaki in Makandur village.

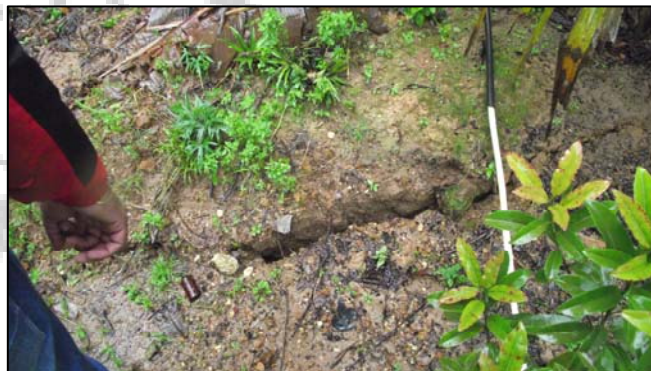
Photo 8: Cracks seen besides house of Smt. Sitamma in Makandur village.

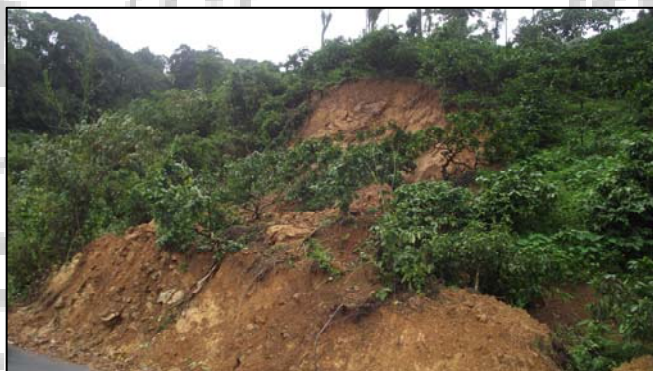
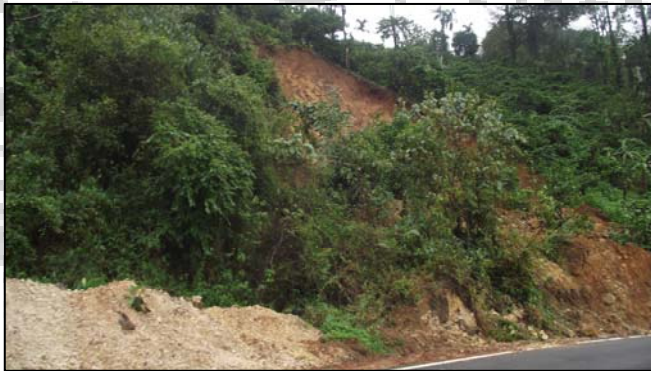
**Geology at site:** Lithologically the area exposes weathered gneiss. Two sets of prominent joints are noticed in the gneiss J1-S22°E/80° E dipping, 10-20 cm spacing and is tight and J2-S80° W/82° W dipping 10-20 cm spacing and is tight. The two joints are making a wedge failure also.

- d) Base Length: 21.9 m
- e) Scarp radius: ~8.0m
- f) Scarp height: ~7.0m
- g) Scarp angle: ~vertical to  $85^{\circ}$
- h) Run out distance :~50.0m
- i) Cut slope angle near the toe:  $90^{\circ}$
- j) Cut slope height near the toe: 10-12 m
- k) Slide direction: N25°E
- l) Slope prior to failure:  $70^{\circ}$
- m) Slope after failure:  $65^{\circ}$
- n) Overburden thickness: soil of 0.5m
- o) Crown condition: Unstable
- p) Head condition: Unstable
- q) Toe condition: Unstable

- i. Slope cut for road formation is vertical and cut slope height is very high (about 12.0 m). The slope is modified for coffee plantation.
- ii. The failure is a wedge failure. The wedge failure occurred along two major joint planes J1-S22°E/80° E and J2-S80° W/82° W. High rainfall removed the material along these planes by infiltrating and acted as lubricant reducing the resisting force.
- iii. No proper drainage at toe and crown portions. The drainage at the toe is clogged.
- iv. The high rainfall during July 2013 acted as triggering factor.

Photo 9: View of Landslide on SH-88 between Madikeri-Samapje

Photo 10: View of slide Landslide on SH-88 between Madikeri-Samapje

- i. The slid debris is to be removed from the slope. The heaped up debris on the other side of the road has to be removed.
- ii. Remove all the loose boulders and hanging boulders.
- iii. Reduction in the height of the cut slope by slope grading.
- iv. Arrest infiltration of water at the top. Make a proper drainage at the base with concrete lining.
- v. A retaining wall of 2m height is to be constructed at the toe. Backfilling the slope with stone pitching at 1:1 slope angle.

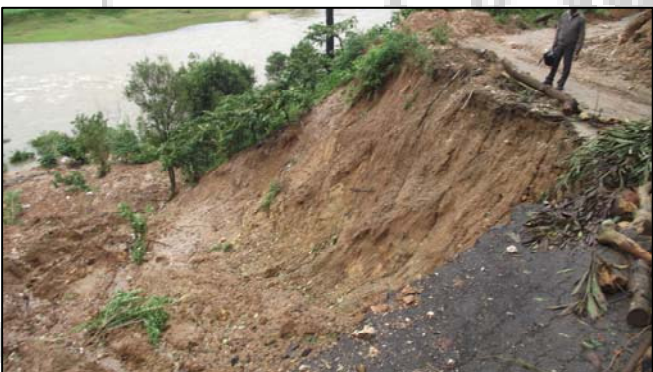
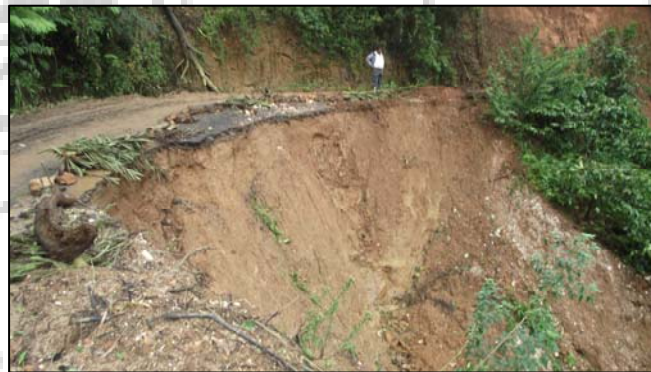
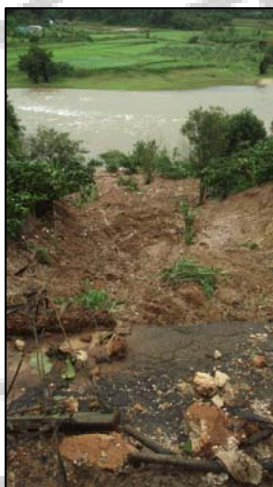
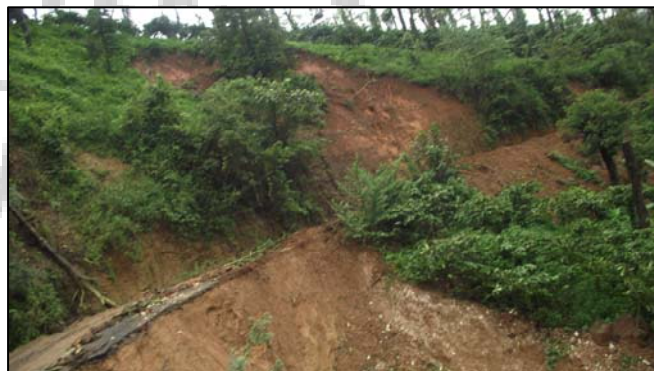
**Slide morphometry:** The slide is a new debris slide (>1950.0 m<sup>2</sup> area). It is a multiple slide zone as three slides nearby have occurred during the same time. The slide has occurred on cut slope and slide debris flown over the road in to the nala, (Kalur nala- Photo 13& 14). The zone is still unstable as the crown cracks are seen .The different morphometric parameters of the main slide are as follows:

- a) Length of slide: 120.0-130.0 m
- b) Width of slide: 30.0 m
- c) Depth of slide: ~ 1.0m
- d) Run out distance :~50.0m
- e) Cut slope angle near the head: 70°
- f) Cut slope height near the head: 10-12 m
- g) Original slope angle: 17°
- h) Slide direction: N30°W
- i) Slope prior to failure: 70°
- j) Slope after failure: 65°
- k) Overburden thickness: soil of 0.5m
- l) Crown condition: Unstable
- m) Head condition: Unstable
- n) Toe condition: Unstable

Photo 11: View of Landslide on Makandur-Mukkodlu tantipal road.

Photo 12: View of Landslide on Makandur-Mukkodlu tantipal road.

Photo 13: Runout of Landslide on Makandur-Mukkodlu tantipal road in to Kalur Nala.

Photo 14: View of first Landslide on Makandur-Mukkodlu tantipal road.

- i. As whole road has been washed away the road for a stretch of 500 m is to be realigned.
- ii. Retaining wall has to be constructed with back filling and stone pitching for the down slope at 1:1 slope angle.
- iii. The slide debris is to be removed from the slope and down slope.
- iv. Arrest infiltration of water at the top with proper concrete lined drainage.
- v. Erect proper sign boards indicating slide zone on either end of the distressed stretch.

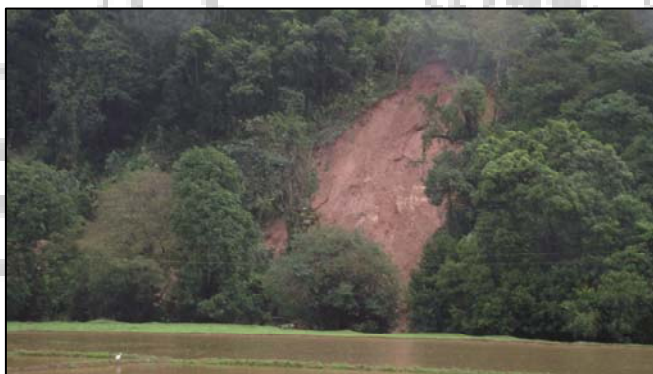
- a) Length of slide: 90.0-100.0 m
- b) Width of slide: 30.0 m
- c) Depth of slide: ~ 1.0m
- d) Run out distance :~100.0.0m
- e) Cut slope angle near the head: 90°
- f) Cut slope height near the head: 13-15 m
- g) Original slope angle: 20°
- h) Slide direction: S70°W
- i) Slope prior to failure: 90°
- j) Slope after failure: 65°
- k) Overburden thickness: soil of 0.5m
- l) Crown condition: Unstable
- m) Head condition: Unstable
- n) Toe condition: Unstable

- i. The slide is a overburden slide with weight of the overburden coupled with saturation of water increasing the pore water pressure.
- ii. Highly weathered gneissic rock on surface has failed on J1 joint plane but as the base rock has exposed no further sliding has taken place. Danger still persists as Overburden material is still there on the exposed bed rock.
- iii. The slope modification for making road and for plantations.
- iv. The nala is flowing at toe and has undercut/ eroded the toe of slope
- v. High rainfall removed the slope material which is highly weathered gneiss. No proper drainage at toe and crown portions. The high rainfall during July 2013 acted as triggering factor.

Photo 15: Birds eye view of the Landslide on Hattihole-avandi road.

- i. The remaining about 10.0 m overburden material may cause reactivation of the slide. Management of this overburden in the form of slope gradation, benching is recommended.
- ii. The slide debris is to be removed from the slope and down slope.
- iii. Arrest infiltration of water at the top with proper concrete lined drainage.
- iv. Precariously hanging tree from the slope should be removed. An abandoned house located at crown portion to be removed as this gives dead weight and may fall if slide is reactivated.
- v. Erect proper sign boards indicating slide zone on either end of the distressed stretch.

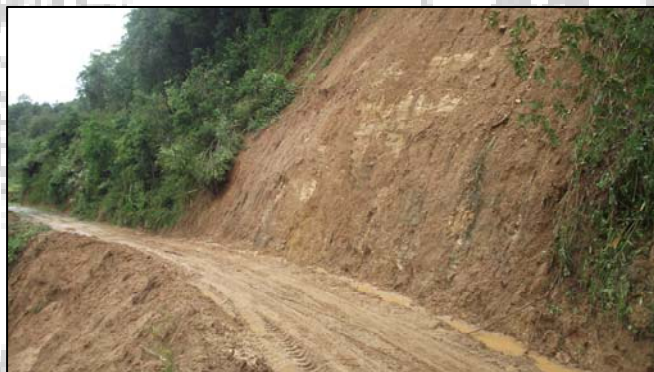
**Geology at site:** Lithologically the area exposes weathered gneiss. Two sets of prominent joints are noticed in the gneiss J1-S40°E/59° W dipping, 10-20 cm spacing and is tight and J2-N40° E/60° E dipping 10-20 cm spacing and is tight. The failure occurred along J1 joint plane and it is a planar failure (Photo 16).

Photo 16: View of the Hattihole-Avandi road landslide with fresh gneissic bed rock exposed.

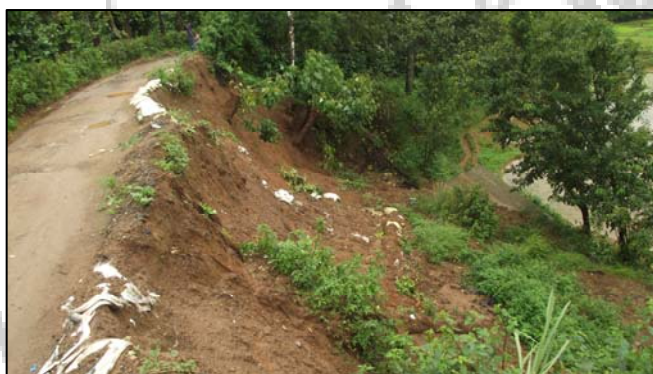
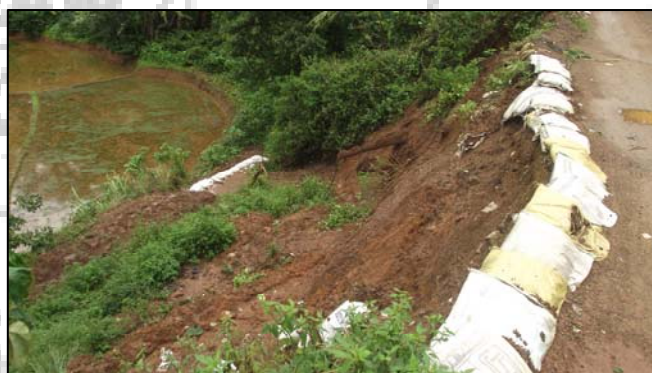
The landslide near Makandur village occurred on 20.07.2013. It is a reactivated slide and shows clear evidences of failure due to unscientific implementation of remedial measures. The retaining structure constructed at toe has been washed away.

- a) Length of slide: 15.0 m
- b) Width of slide: 12.0 m
- c) Depth of slide: ~ 0.5 m
- d) Run out distance :~16.0 m
- e) Cut slope angle near the head: 90°
- f) Cut slope height near the head: 10.0 m
- g) Original slope angle: 9°
- h) Slide direction: S50°W
- i) Slope prior to failure: 90°
- j) Slope after failure: 70°
- k) Overburden thickness: soil of 0.5m
- l) Crown condition: Unstable
- m) Head condition: Unstable
- n) Toe condition: Unstable

- i. The slide is a filled slope failure as the road is constructed by filling the slope. The retaining wall constructed at toe without backfilling has added dead weight on toe portion.
- ii. No proper drainage to drain out excess water from the slope and weep holes is absent.
- iii. The slope modification for making road and for plantations.
- iv. The nala/ paddy field at toe have increased the water content of the slope material and in turn pore water pressure.
- v. The high rainfall during July 2013 acted as triggering factor.

Photo 17: View of landslide near Makandur village, Sinchona estate road.

Photo 18: View of landslide near Makandur village, Sinchona estate road.

- i. The retaining structure at toe has to be rebuilt with proper backfilling and provision for water leak out in the form of weep holes.
- ii. The slide debris is to be removed from the slope and down slope.
- iii. Arrest infiltration of water at the top with proper concrete lined drainage.

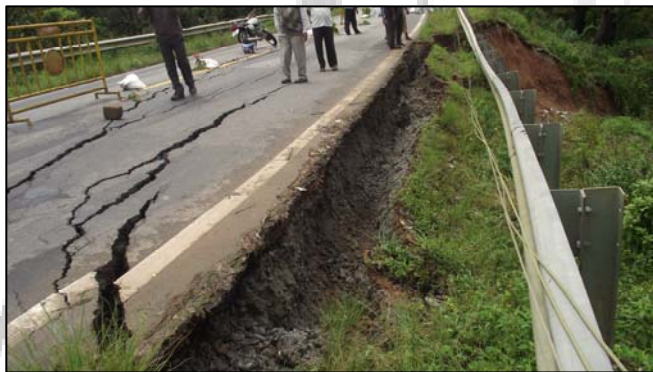
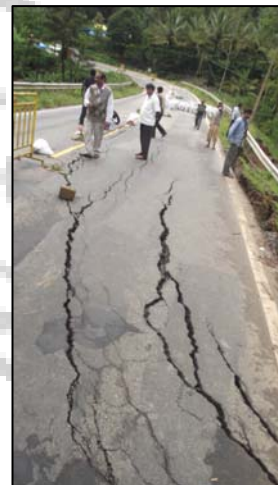
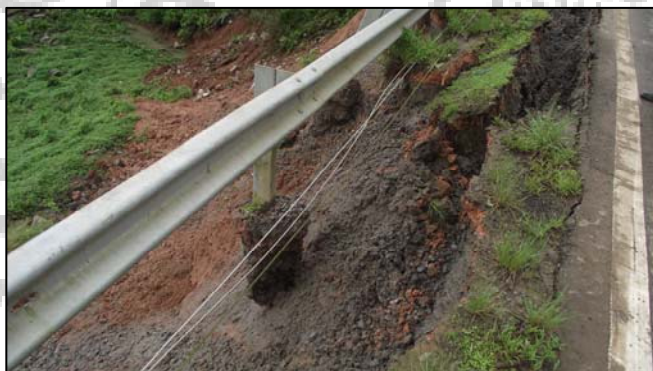
The cracks on SH-88 near Sinchona estate (Bovikere) between Madikeri-Suntikoppa appeared on 26.07.2013 and followed by subsidence and flow of the debris material on the toe part (Photo 19, 20 & 21). Due to grave dangerous condition of the road the district administration has stopped the vehicular movement immediately.

- i. It is a filled slope failure. The road is constructed on a depression/lake by filling. The filled up material consisted of different fraction of gneissic material which are locally available.
- ii. There was a very little provision for drainage and to prevent water infiltration in to the filled up slope. The filled up slope material was saturated from both by infiltration from lake and from rain water runoff.
- iii. Heavy vehicular movements may to a certain extent have added weight to destabilize the filled slope.
- iv. The high rainfall during July 2013 acted as triggering factor which has made the slope material to be oversaturated and decreased the resisting force.

Photo 19: Cracks on SH-88 near Sinchona estate (Boyikere) between Madikeri – Suintikoppa with subsidence.

Photo 20: Cracks on SH-88 near Sinchona estate (Boyikere) between Madikeri – Suintikoppa.

Photo 21: Subsidence on SH-88 near Sinchona estate (Boyikere) between Madikeri – Suintikoppa.

- i. Reconstruction of road with grade separator is needed. Unstable material may be removed and refilled properly and road may be reconstructed. The slopes on either side of the road may be constructed with gabion walls or Backfilling the slope with stone pitching at 1:1 slope angle.
- ii. The drainage maintenance is of paramount, arrange proper drainage facilities at top of the road and toe portion so that no water infiltrates in to the filled slope. Also arrangements may be made to block infiltration of water from lake.
- iii. Proper handling of the vehicular traffic till slope stabilizes viz., one vehicle at time
- iv. Proper sign boards on either side of the road.

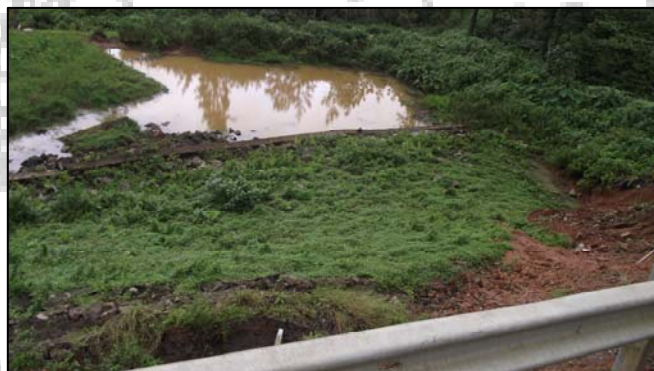
**Slide morphometry:** It is a new subsidence followed by some debris flow at the toe. The toe wall constructed to prevent lake water from entering the filled slope has been moved 10-12 m from its original position (Photo 22). The crown cracks above the zone of subsidence are longitudinal in nature with 60-70 m length wise some are 25-40 cm width with opening of 1-2 m. The subsidence depth at the crown varies from 1.0 to 1.5 m. The different morphometric parameters of the subsidence are as follows:

Photo 22: Movement of toe wall after subsidence on SH-88 near Sinchona estate (Boyikere) between Madikeri – Suintikoppa.

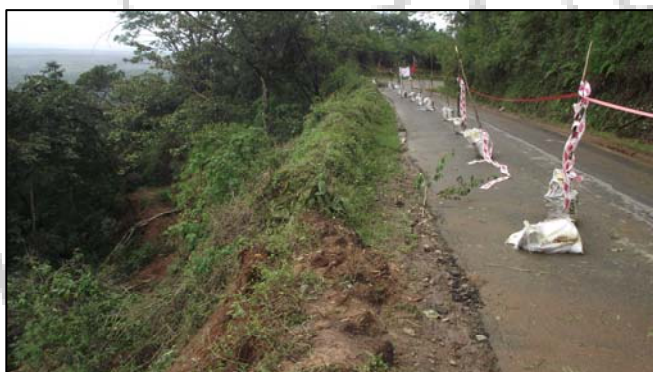
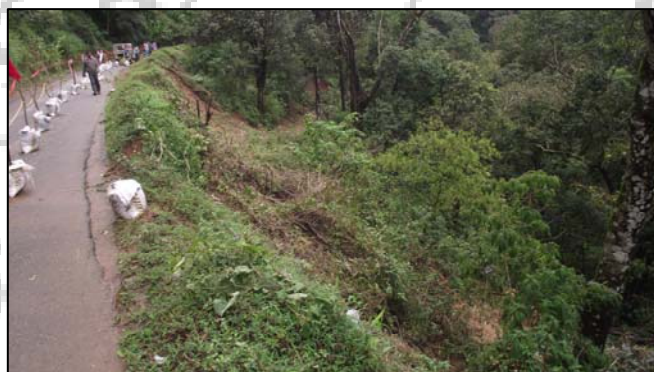
The landslide near Kattalekadu on SH-89 road between Madikeri-Chettali occurred on 22.07.2013. The road was partly damaged as the part of road towards valley side has fallen and district administration has stopped vehicular movement on this stretch (Photo 23&24).

- a) Length of slide: 22.0-24.0 m
- b) Width of slide at crown: 70.0 m
- c) Depth of slide: ~ 1.0m
- d) Run out distance :~25.0.0m
- e) Cut slope angle near the head: 90°
- f) Cut slope height near the head: 13-15 m
- g) Original slope angle: 20°
- h) Slide direction: S70°W
- i) Slope prior to failure: 70°
- j) Slope after failure: 65°
- k) Overburden thickness: soil of 0.5m
- l) Crown condition: Unstable
- m) Head condition: Unstable
- n) Toe condition: Unstable

- i. The slide happened due to toe removal in the form of construction of road below the SH-89, the toe removal of the slope has made the slope unstable and opening of the slope face has increased the infiltration and increase in pore water pressure.
- ii. The hill side slope of the road is intact with massive gneiss .While constructing the road the slope was not fully cut rather it was filled slope construction.
- iii. High rainfall removed the slope material which is highly weathered gneiss. No proper drainage at toe and crown portions. The high rainfall during July 2013 acted as triggering factor.

Photo 23: View of landslide near Kattalekadu on SH-89 between Madikeri-Chettali.

Photo 24: View of landslide near Kattalekadu on SH-89 between Madikeri-Chettali.

- i. Construction of retaining wall with back filling and stone pitching for the down slope at 1:1 slope angle.
- ii. The slide debris is to be removed from the slope and down slope.
- iii. Arrest infiltration of water at the top with proper concrete lined drainage.
- iv. Erect proper sign boards indicating slide zone on either end of the distressed stretch.

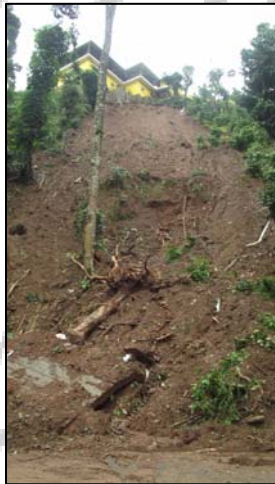
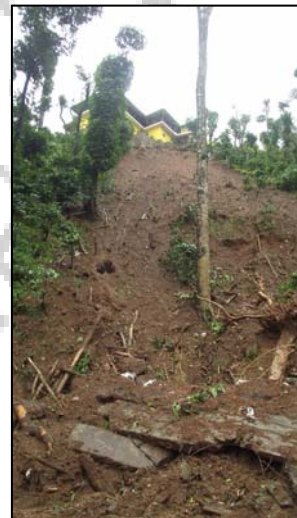
The landslide near Abbiyala on SH-89 road between Madikeri-Chettali occurred on 18.07.2013. The road was partly damaged and district administration has stopped vehicular movement on this stretch. The resort building at the crown portion is in grave danger (Photo 25 & 26).

- a) Length of slide: 85.0-90.0 m
- b) Width of slide: 20.0 m
- c) Depth of slide: ~ 1.0m
- d) Run out distance :-95.0 m
- e) Cut slope angle: 80°
- f) Cut slope height: 13-15 m
- g) Original slope angle: 20°
- h) Slide direction: S70°W
- i) Slope prior to failure: 70°
- j) Slope after failure: 65°
- k) Overburden thickness: soil of 0.5m
- l) Crown condition: Unstable
- m) Head condition: Unstable
- n) Toe condition: Unstable

- i. The slide happened due to Crown/ head loading in the form of construction of a resort above the SH-89. The crown loading has made the slope unstable and opening of the slope face has increased the infiltration of water and increase in pore water pressure.
- ii. The wall constructed by resort people has added to the dead weight on the top.
- iii. The slope height is added to the destabilization and the slide has been reactivated by increase in pore water pressure by prolonged rainfall. High rainfall removed the slope material which is highly weathered gneiss. No proper drainage at toe and crown portions. The high rainfall during July 2013 acted as triggering factor.

Photo 25: View of landslide near Abbiyala on SH-89 between Madikeri-Chettali.

Photo 26: View of landslide near Abbiyala on SH-89 between Madikeri-Chettali.

- i. Construction of retaining wall with back filling and stone pitching for the down slope at 1:1 slope angle.
- ii. The slide debris is to be removed from the slope and down slope.
- iii. Arrest infiltration of water at the top with proper concrete lined drainage. Give perforated contour drains at different levels to push away the excess seepage water.
- iv. Erect proper sign boards indicating slide zone on either end of the distressed stretch

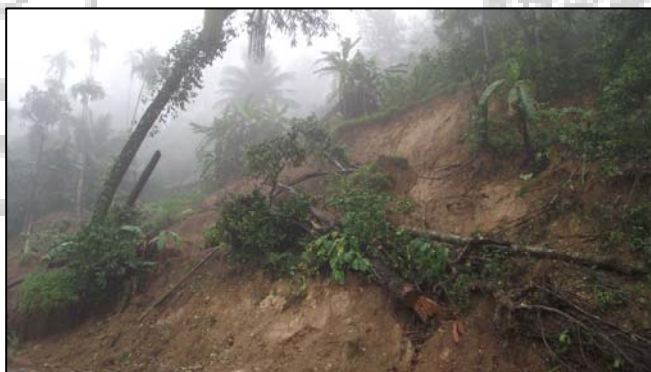
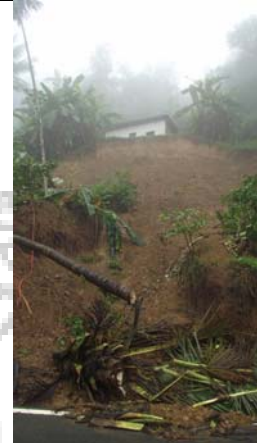
The landslide near Jodpal on SH-88 road between Madikeri-Sampaje occurred on 17.07.2013. The road was partly damaged and plantations mainly coffee, banana and areca nut belonging to one Shri. Abdulla was completely destroyed (Photo 27 & 28).

- i) Cut slope height: 13-15 m
- j) Original slope angle: 20°
- k) Slide direction: S70°W
- l) Slope prior to failure: 80°
- m) Slope after failure: 70°
- n) Overburden thickness: soil of 0.5m
- o) Crown condition: Unstable
- p) Head condition: Unstable
- q) Toe condition: Unstable

- i. Slope cut for road construction is vertical and cut slope height is very high (about 12.0 m). The slope is modified for coffee plantation.
- ii. Highly weathered gneissic rock is seen in debris. Water due to high rainfall removed the material along weak planes by infiltrating and acted as lubricant reducing the resisting force.
- iii. No proper drainage at toe and crown portions. The drainage at the toe is clogged.
- iv. The high rainfall during July 2013 acted as triggering factor.

Photo 27: View of landslide near Jodpal on SH-88 between Madikeri-Sampaje.

Photo 28: View of landslide near Jodpal on SH-88 between Madikeri-Sampaje.

- i. The slide debris is to be removed from the slope. The heaped up debris on the other side of the road has to be removed. The House at the top should be vacated permanently as it adds dead weight (temporarily the house is vacated)
- ii. Remove all the loose boulders and hanging boulders.
- iii. Reduction in the height of the cut slope by slope grading.
- iv. Arrest infiltration of water at the top. Make a proper drainage at the base with concrete lining.
- v. A retaining wall of 2m height is to be constructed at the toe.
- vi. Backfilling the slope with stone pitching at 1:1 slope angle.

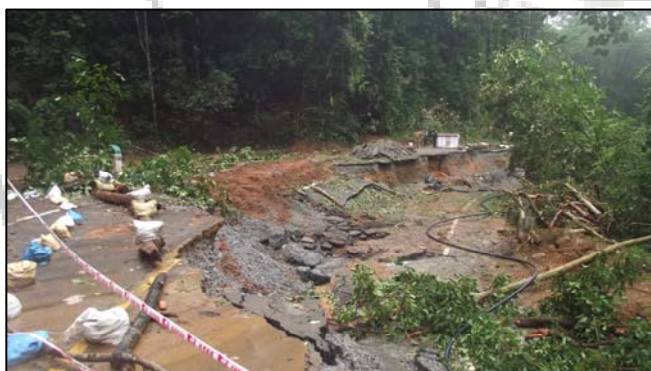
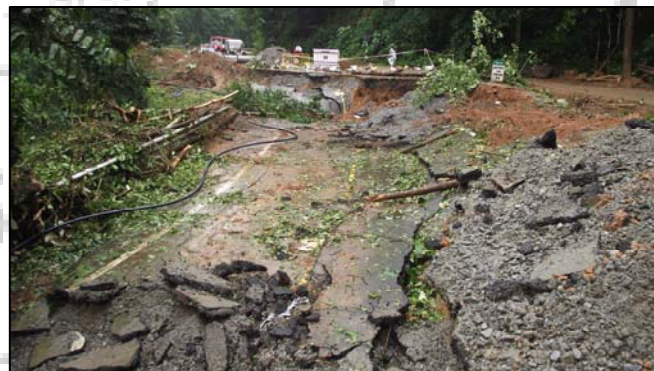
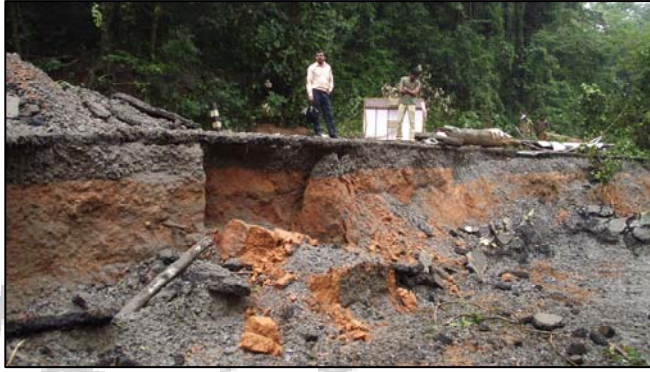
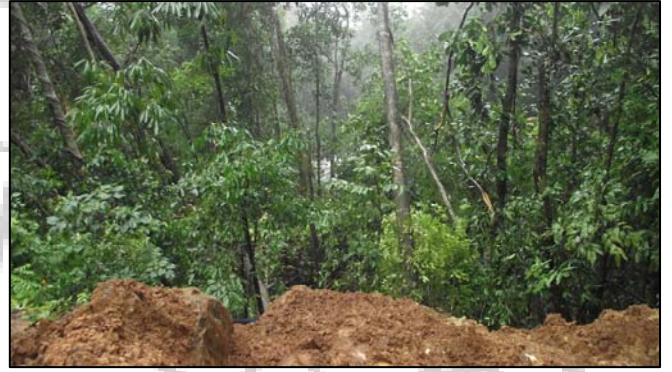
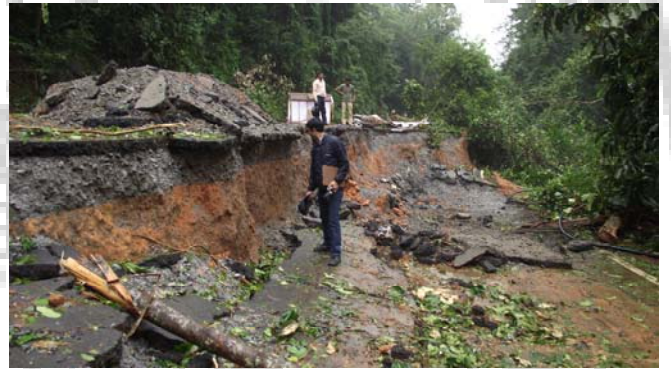
The cracks on SH-88 near Koynad between Madikeri-Sampaje appeared on 02.08.2013 and followed by subsidence and little flow of the debris material at the toe part (Photo 29, 30, 31, 32 & 34). Due to grave dangerous condition of the road the district administration stopped the vehicular movement immediately.

**Slide morphometry:** It is a new subsidence followed by some debris flow at the toe. The road has been built about 2-3 years back when the road was widened (Old road still exists and presently repaired and reopened for light vehicular traffic). The new road is built on edge of the hill slope very near to the river flowing down. The crown cracks above the zone of subsidence are longitudinal in nature with 40 to 50 m length, 25 to 40 cm width with opening of 1 to 2 m (Photo 33). The subsidence depth at the crown varies from 1.0 to 2.5 m. The different morphometric parameters of the subsidence are as follows:

- i. It is a partly filled slope failure and caused mainly due to saturation and toe infiltration and toe cutting by the river. The new road was on the edge of hill slope and the material involved was highly weathered gneiss which at places was converted to clay particles.
- ii. There was a very little provision for drainage and prevention of water infiltration in to the filled up slope. The filled up slope was saturated from both by infiltration from river and from rain water runoff.
- iii. Heavy vehicular movements may to a certain extent have added weight to destabilize the filled slope.
- iv. The high rainfall during July 2013 acted as triggering factor which has made the slope material to be oversaturated and decreased the resisting force.

Photo 29: View of subsidence on SH-88 near Koynad between Madikeri -Sampaje.

Photo 30: View of subsidence on SH-88 near Koynad between Madikeri -Sampaje.

Photo 31: View of subsidence on SH-88 near Koynad between Madikeri –Sampaje.

Photo 32: Run out after subsidence in to Sampaje hole.

Photo 34: View of subsidence on SH-88 near Koynad between Madikeri –Sampaje.

- ii. The drainage maintenance is very important; arrange proper drainage facilities at top of the road and toe portion may be made so that no water infiltrates in to the filled slope.
- iii. Proper handling of the vehicular traffic till slope stabilizes viz., one vehicle at time
- iv. Proper sign boards on either side of the distressed stretch of the road.

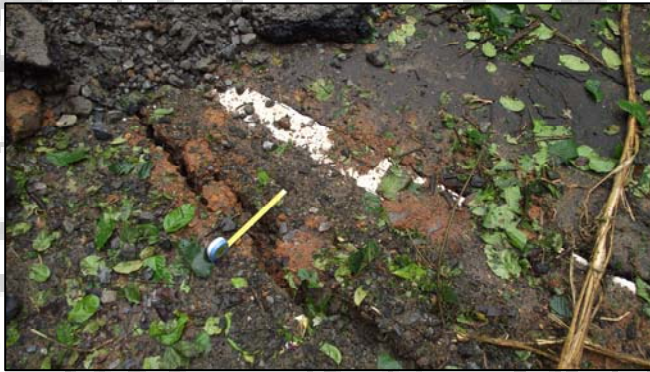
Photo 33: Ground cracks on SH-88 Near Koynad.
