**DETAILED SITE SPECIFIC INVESTIGATION OF THE LANDSLIDE AT NERIYA,  
BELTANGADY TALUK, DAKSHINA KANNADA DISTRICT, KARNATAKA  
(Progress Report for Field Season 2009-2010)  
Code No.: LHZ/SR/KG/2009/045**

**Project: ENGINEERING GEOLOGY  
Operation: Karnataka and Goa**

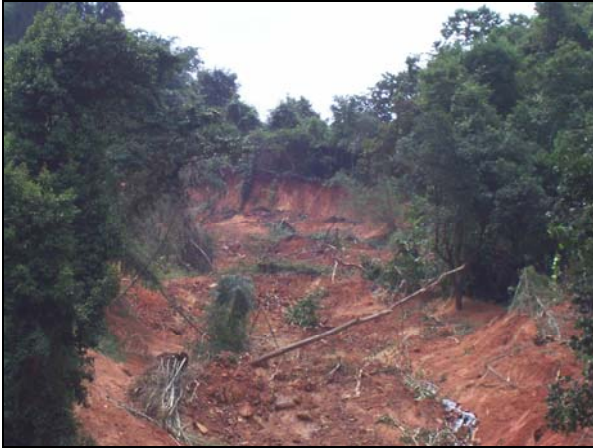
Photo 1: Scarp of the Neriya debris flow with small water channel formed in the zone of depletion of the slide (Photo Pradhan, 2008)

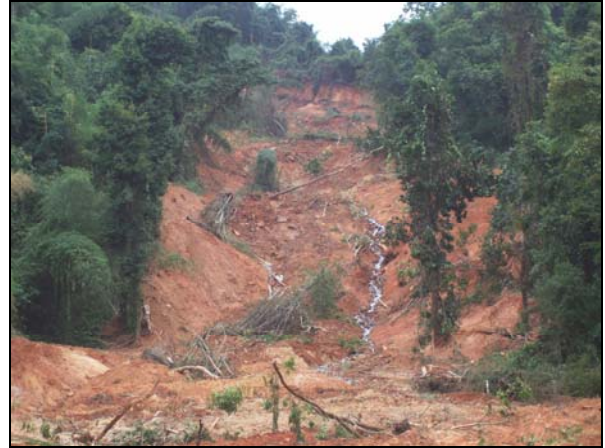
Photo 2: Scarp of the Neriya debris flow with small water channel formed in the zone of depletion of the slide (Photo Pradhan, 2008)

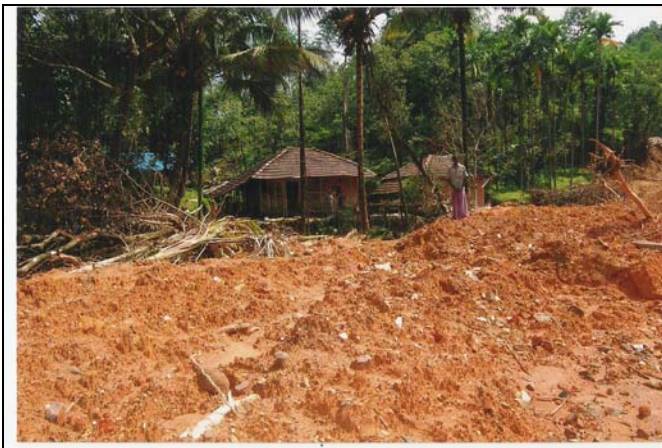
Photo 3: The heaped up debris material at toe part day after slide on 14.08.08. (Photo courtesy Village Panchayat Neriya)

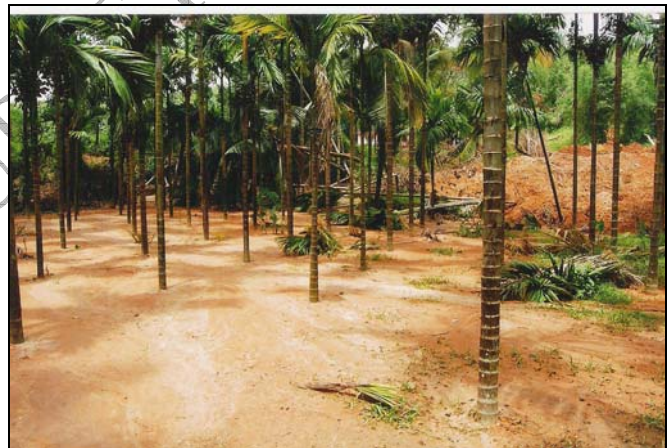
Photo 4: The heaped up debris material/ slush at toe part day after slide on 14.08.08.(Photo courtesy Village Panchayat Neriya)

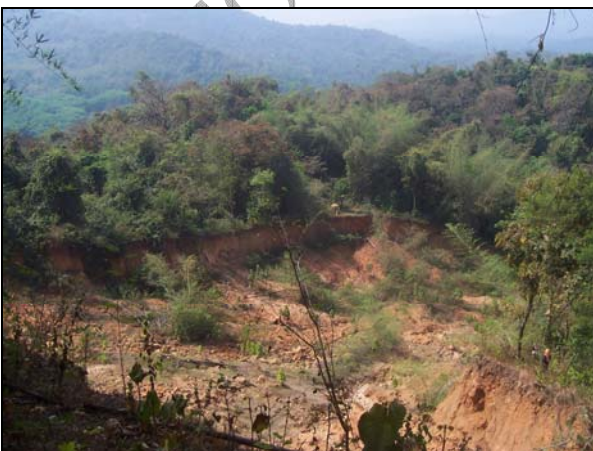
Photo 5: Down stream view of present day Neriya debris flow from the crown portion.

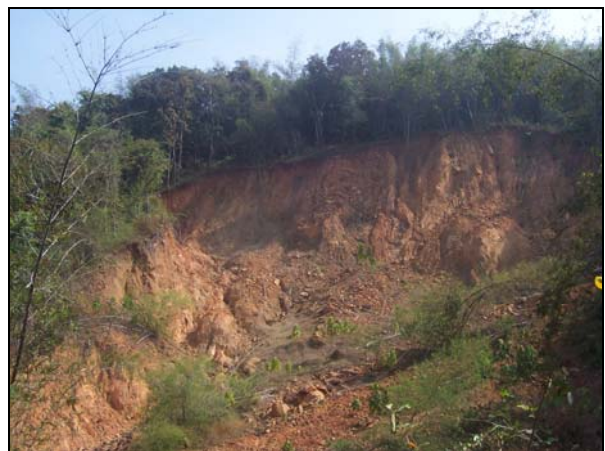
Photo 6: Crown portion showing distinct scarp of Neriya debris flow.

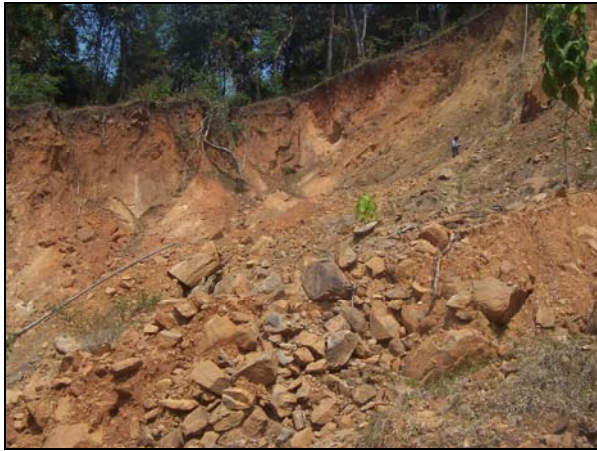
Photo 7: Dislodged blocks of dyke rock exposure just below crown portion

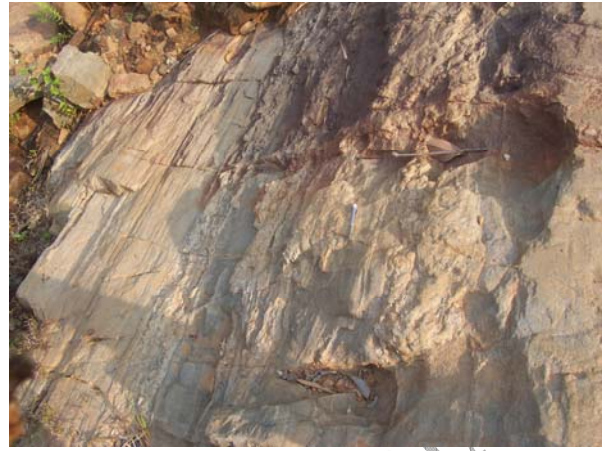
**III.2.1. BIOTITE GNEISS:** The rocks are well exposed in the crown scarp, at the head portion behind the slide scarp around 240 R.L, at mid slope region and behind Janardhan shetty house at the toe region (Plate-2, 3) It is coarse grained, light grey, foliated granite gneiss with gneissosity varying from N21°W to N10°E dipping 42° towards south to vertical (Photo 9&10). The boulders of gneiss are also found in the debris as float mass. Six sets of joints are observed from gneiss in the slide zone (Photo 8 & 9) characteristics of these joints are given in Table-2.

Photo 8: Major joint planes in gneiss.

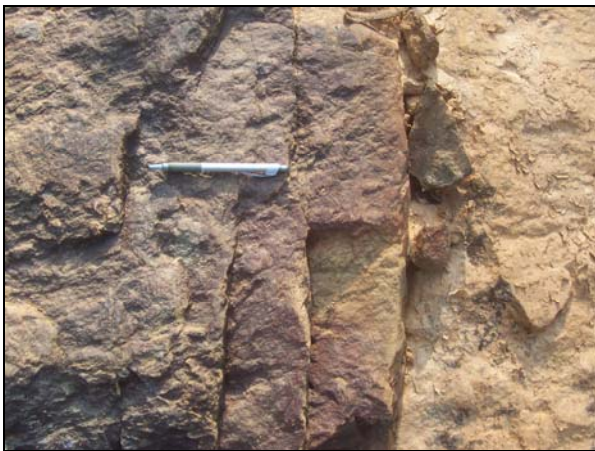
Photo 9: Major joint planes in gneiss.

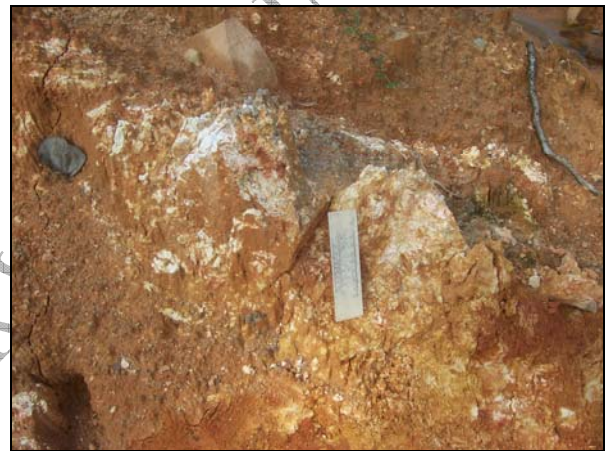
**III.2. LITHOLOGY AT SITE:** The lithology of the Neriya, Beltangady area exposes Biotite gneiss intruded by dolerite. The gneiss is highly weathered in the slide zone ( photo 10,11,12) and partially weathered in the top of the crown.

1. The high degree and depth of weathering, wherein the biotite gneiss has been kaolinised (Photo 10, 11 & 12).
2. The lateritization of gneissic rock (as seen in debris) with clay particles.
3. The adversely oriented gneissosity dipping perpendicular to stream direction.
4. The weakened contact between gneiss and the dolerite dyke due to weathering and soil/ laterite formation.
5. Part of the slide took place in a negative slope in the right flank where the volume of material is less and failed from the top of the slope.

Photo 10: Highly weathered gneiss converted to clay particles.

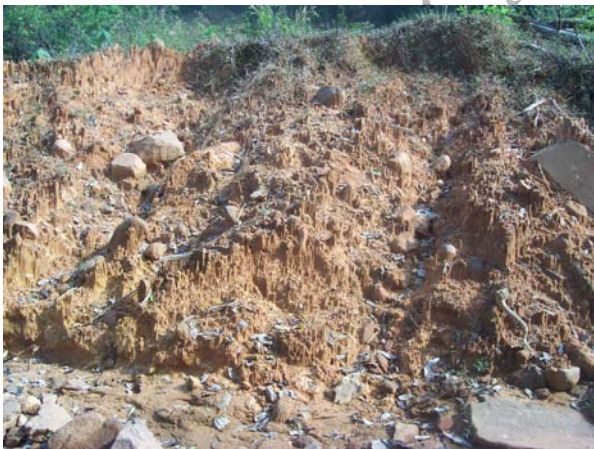
Photo 11: Highly weathered gneiss converted in to clay particles.

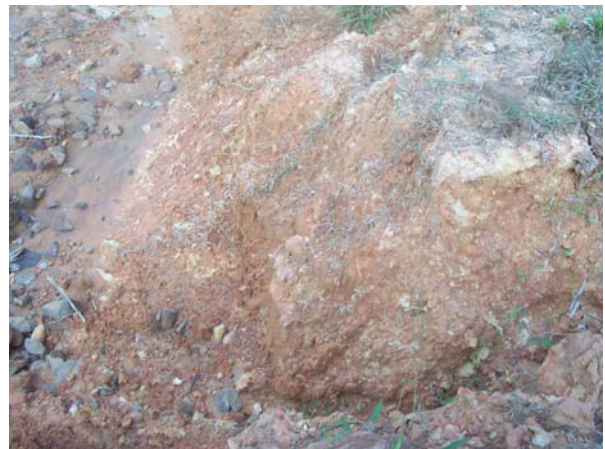
Photo 12: Highly weathered gneiss converted in to clay particles.

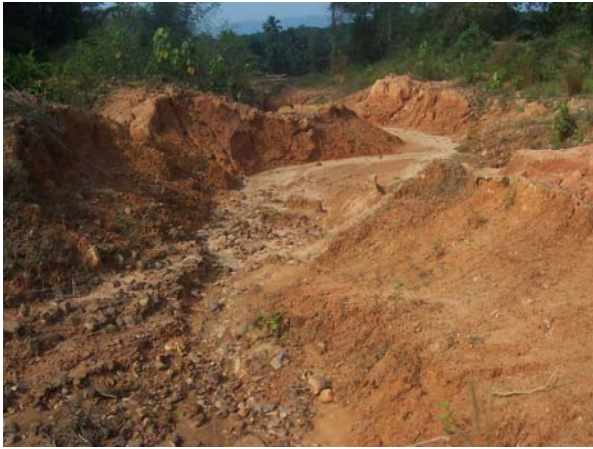
Photo 13: Nala cutting through the debris material.

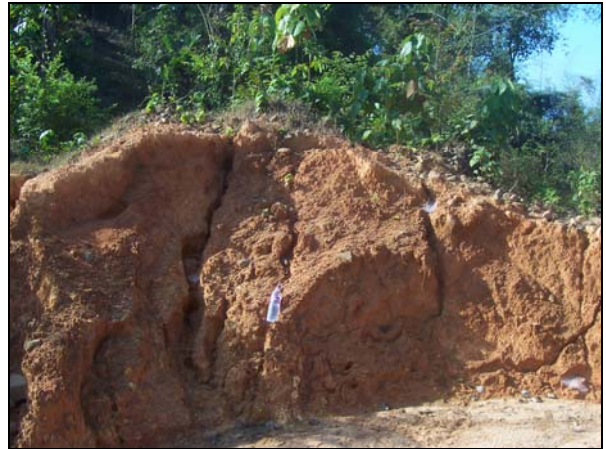
Photo 14: Gully erosion in the zone of depletion.

3. At the mid section of the flow: The gully erosion is continuing and the debris in the stream bed will be eroded and could cause more silt and clay deposition in the downstream hence plantation of vetiver grass all along the mid section can be done till survey station 4 as the depth of debris does not exceed 3 m. The grass can reduce further erosion and will also help people in the vicinity an economical benefit.

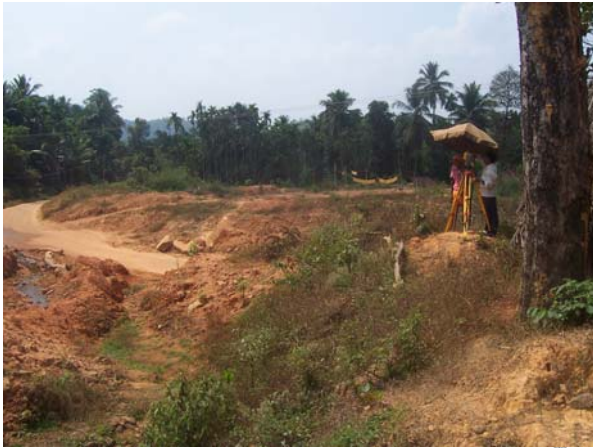
Photo 15: Heaped up material at toe may act as natural barrier for future.

8. If ever the slope at the upper reach fails in future this accumulated debris will act as a restraining structure for movement of the material by reducing the gradient.

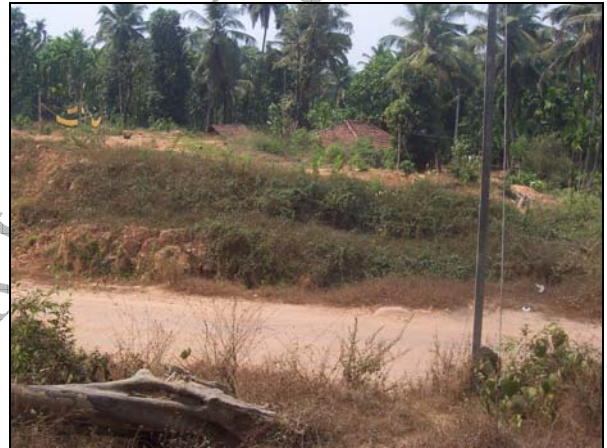
Photo 16: Heaped up material at toe may act as natural barrier for future for two houses.

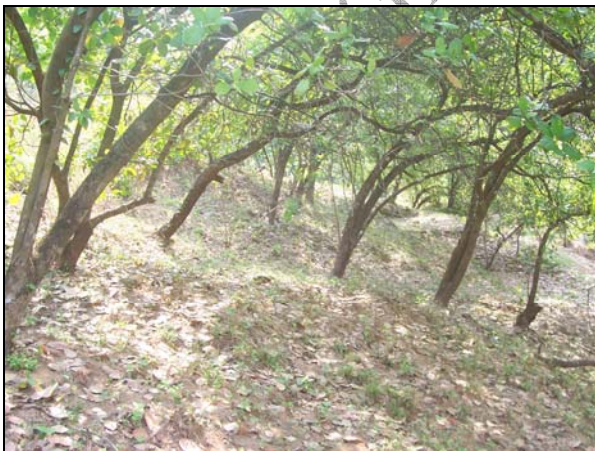
Photo 17: Tilting of trees above crown portion suggesting distress.
