**MACRO-SCALE (1:50,000) LANDSLIDE SUSCEPTIBILITY MAPPING IN PARTS  
OF TOPOSHEET NOS. 48O/1, 48O/5 AND 48N/8 SHIMOGA AND CHIKMAGALUR  
DISTRICTS, KARNATAKA**

Item no.: M4LSSM/NC/SR/SU-KG/2019/25180

कार्य सत्र: 2019-20/Field Season 2019-20

रस्या रघु, वरिष्ठ भूवैज्ञानिक/Resya Reghu, Senior Geologist  
सेंतिलकुमार. के, भूवैज्ञानिक/Senthilkumar.K, Geologist

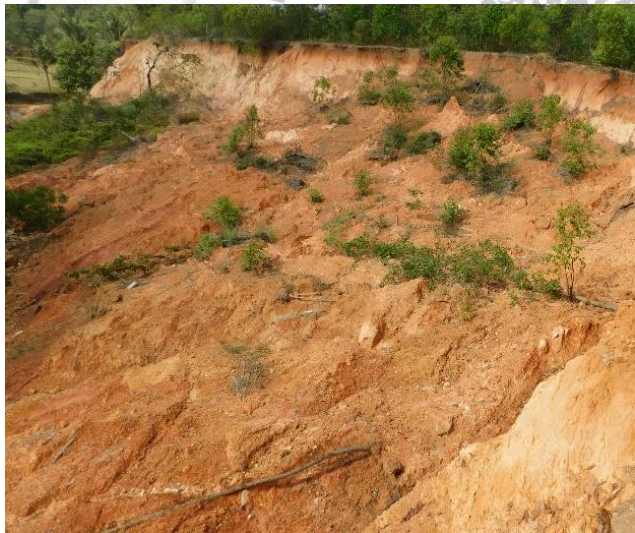
**Photo 4.3c** Loose slide debris  
(Lat: 13°50'36" Long: 75° 08'31.7")

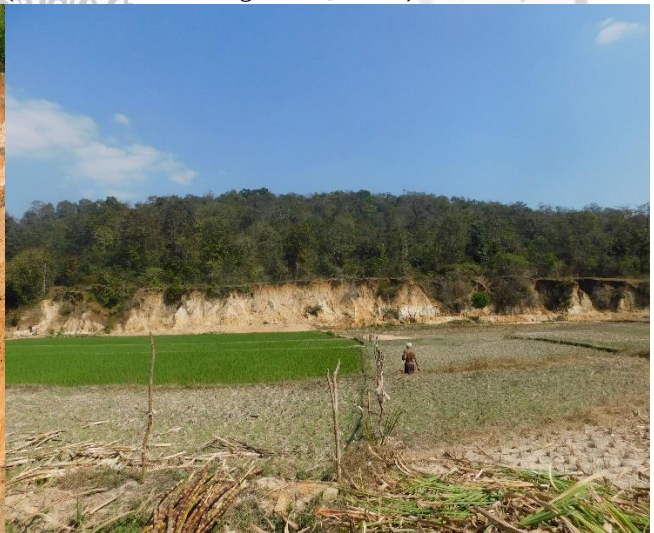
**Photo 4.3d** Transported soil  
(Lat: 13°52'54.38" Long: 75° 09'27.79")
