**A REPORT ON LANDSLIDE HAZARD ZONATION ON MACRO  
SCALE OF CHARMUDI GHAT SECTION FROM CHARMUDI TO  
KOTIGEHARA, KOTIGEHARA TO KALASA AND SAKLESHPUR  
TO UPPINANGADI IN DAKSHIN KANNADA AND  
CHIKMAGALUR DISTRICTS, KARNATAKA**

**(Field Season 2008-2009 & 2009-2010)**

**Code No.: LHZ/SR/KG/2008/044**

**Project: ENGINEERING GEOLOGY  
State Unit: Karnataka and Goa  
BANGALORE**

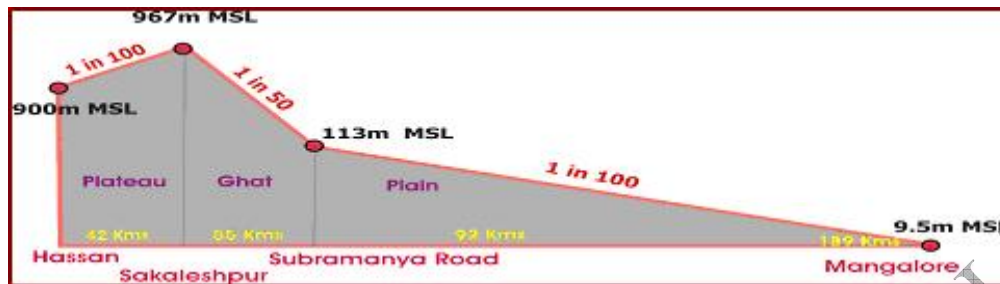
**Fig: 1** Sakleshpur –Subrahmanya railroad section.

Fig. 1 shows the schematic cross section of the railroad between Sakleshpur and Subrahmanya. The railroad has an elevation difference of 854 m and has an average gradient of 1 in 50.

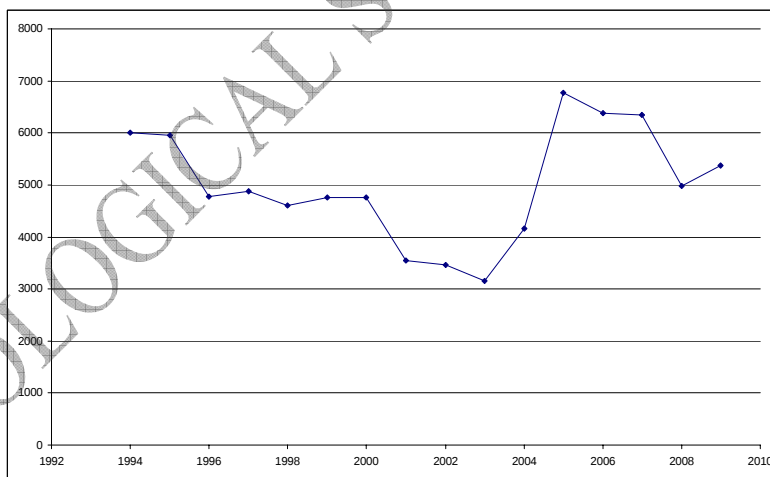
**Fig 16.** Distribution of rainfall in Maranhalli area between 1994 and 2009. The annual rainfall is 4993 mm.
