MACRO-SCALE (1:50,000) LANDSLIDE SUSCEPTIBILITY MAPPING IN PARTS  
OF TOPOSHEET NO. 48P/07, 11 & 12, KODAGU DISTRICT, KARNATAKA

(FSP CODE NO : LSM/SR/K&G/2016/109)

FIELD SEASON: 2016-17

PROJECT: NLSM / परियोजना: एन एल एस एम्

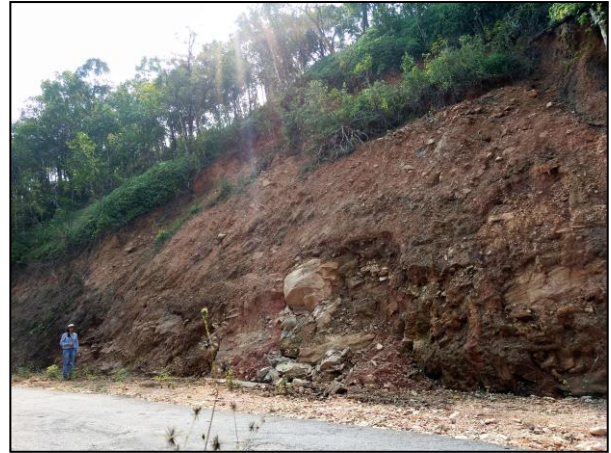
Photo:2 Debris slide on Hacchinadu – Galibidu road, T.S. No. 48P/11.

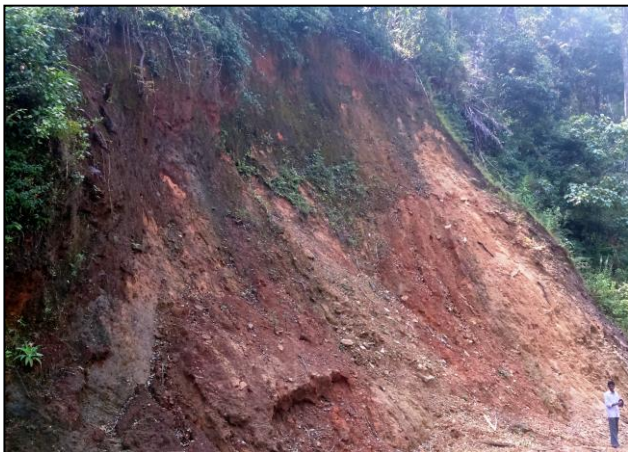
Photo:3 Debris slide on Hacchinadu – Galibidu road, T.S. No. 48P/11.

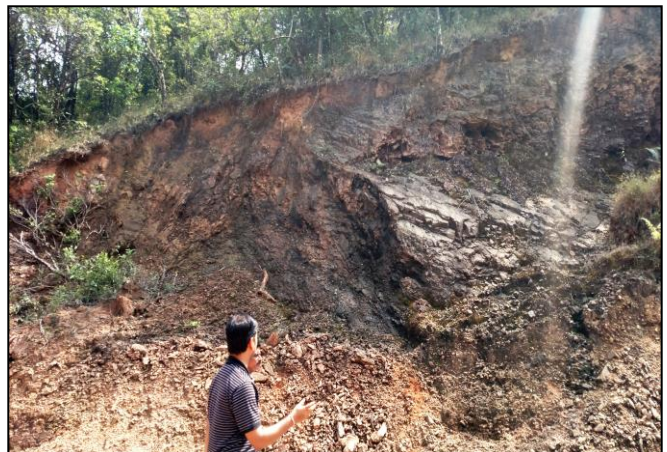
Photo: 4 Debris slide on Talakaveri – Korangla road, T.S. No. 48P/11.

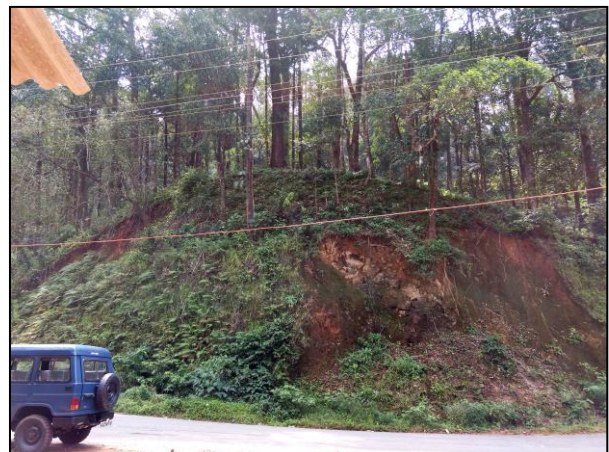
Photo: 6 Small debris slide on Madikeri – Sampaje road, NH-275.

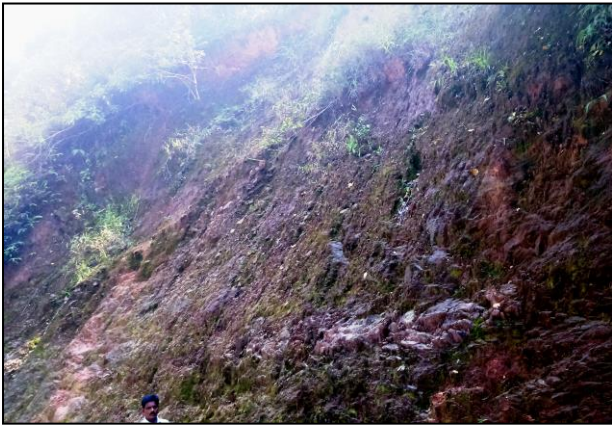
Photo:7 Landslide near Koyanadu, Madikeri – Sullya road, NH-275.

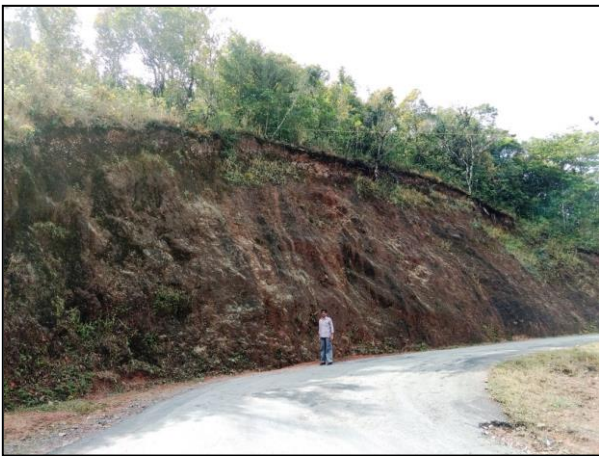
Photo:9 LULC class Extensive Cut Slope, T.S No. 48P/11, west of Made village.

**Extensive slope cut:** Roads and railways are required for improving connectivity and communication in any area. The study area also has good connectivity by road though at the cost of extensive damage to slopes. Slopes need to be cut in order to construct roads in the hilly terrains of the Western ghats. This weakens the slopes a great deal. This class has been given high rating for the same.

Areas North of Madikeri, NNE of Galibidu and NNW of Hebbatageri fall into high to moderate susceptibility zones. This may be attributed to high degree of slope disturbance for construction of roads and overburden thickness of about 0.5 to 5m and more. Extensive slope cuts and deforestation may also be the primary reasons for slope failure in this area **(Photo-9)**.

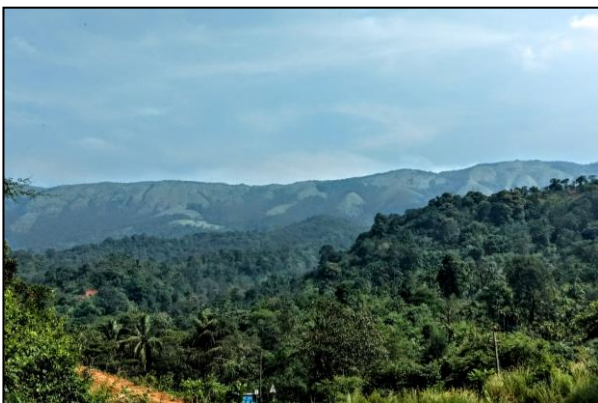
Photo:15 Geomorphology class MDS, T.S No. 48P/11, West of Koyanadu village.

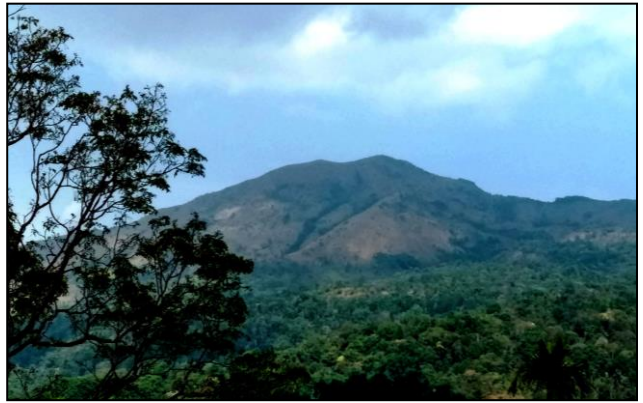
Photo:16 Geomorphology class LDS, T.S No. 48P/11, North of Baghamandala.

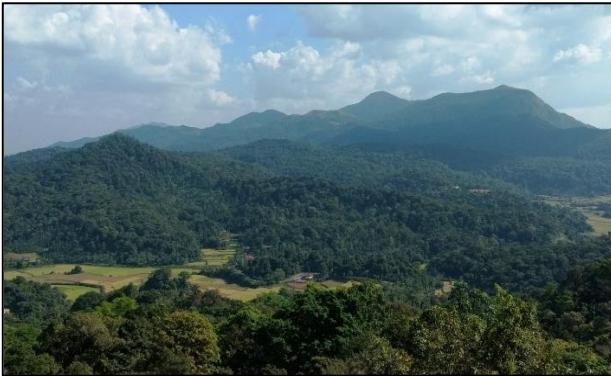
Photo:17 Geomorphology class Pediment-pediplain complex, T.S No. 48P/07, West of Talakaveri.

**Pediment – Pediplain complex:** A complex landform where both pediplain and pediments occur and it is difficult to separate them. These are observed near Talakaveri (**Photo -17**).

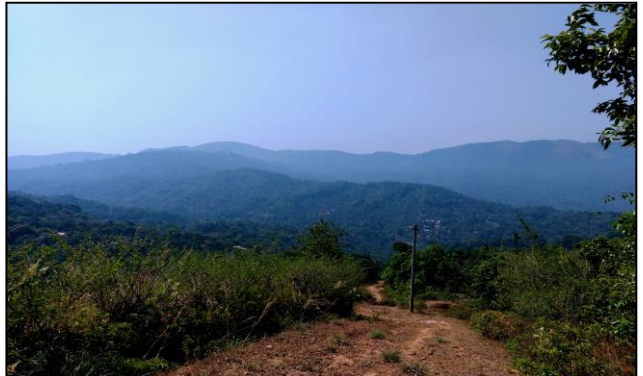
Photo:18 Geomorphology class Ridge top, T.S No. 48P/11, West of Koyanadu village.

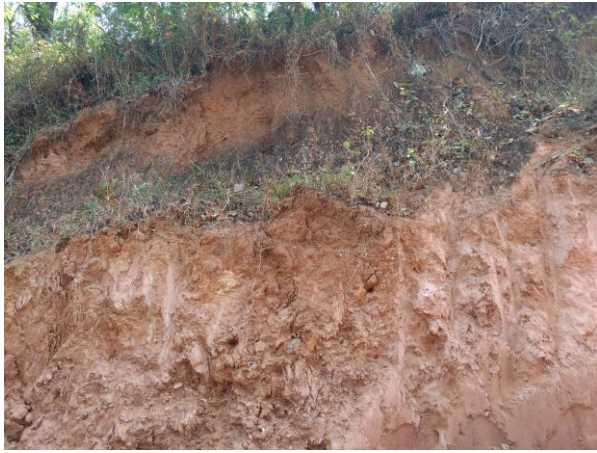
Photo:19 SFM class In situ soil, T.S No. 48P/11, West of Bettegeri village.

On slopes as well as ridge tops, barren rock is present at places where the slope gradient in general is more than  $35^\circ$ , most of the study area (about 44.57%) is covered by in-situ, granitic soil (**Photo-19**), rock (24.7%) and weathered rock (**0.097%**). The factor class rock includes overburden material of 0.5m thickness. For this class different rock names are taken from the geological map of the study area by GSI. Laterite (Photo-20) is observed in patches near Sampaje. Weathered rock (Photo-22) is also observed along road cuts near Baghamandala, Chettimani and NW of Ballamwati. The weathered rock factor class is assigned maximum weightage as weathered rocks on slope are highly vulnerable, similarly

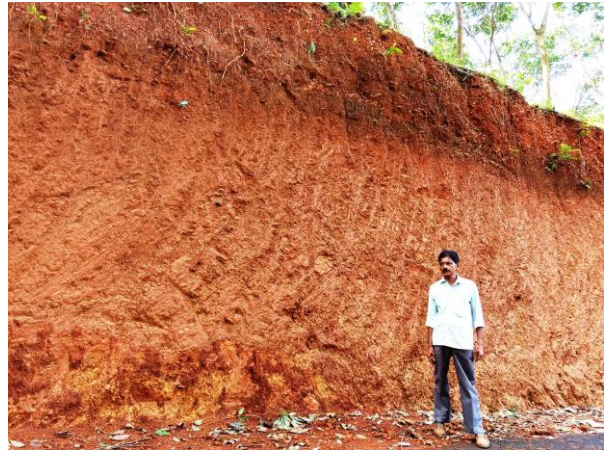
Photo:20 SFM class Laterite (rock), T.S No. 48P/11, West of Sampaje village.

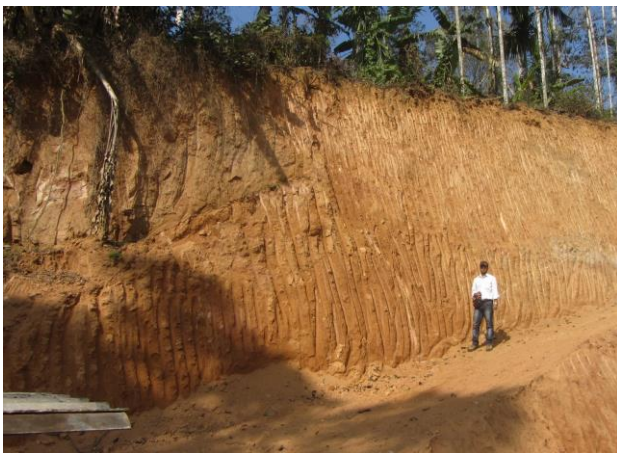
Photo:21 Regolith thickness class 5m -10m, North of Kadamullur, T.S. No.48P/12.

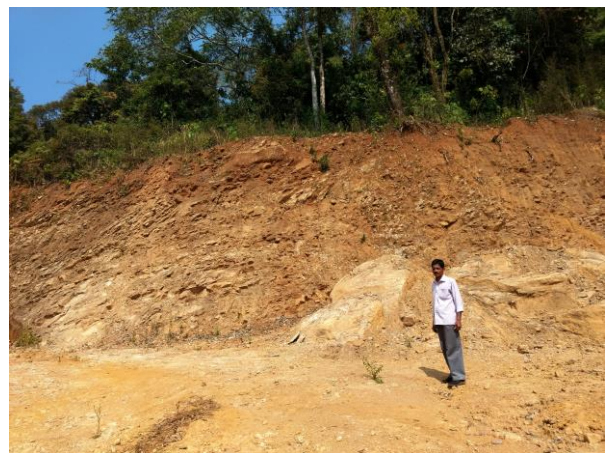
Photo:22 SFM class weathered rock, T.S No. 48P/11, near Korangala village.
