**MACRO – SCALE (1:50,000) LANDSLIDE SUSCEPTIBILITY MAPPING IN PARTS  
OF TOPOSHEET NOS. 48P/05 AND 48P/09, DAKSHIN KANNAD AND HASSAN  
DISTRICTS, KARNATAKA**

***FSP Code No. LSM/SR/KG/2016/111***

**Tanvi Gupta, Geologist**  
**Sunandan Basu, Geologist**

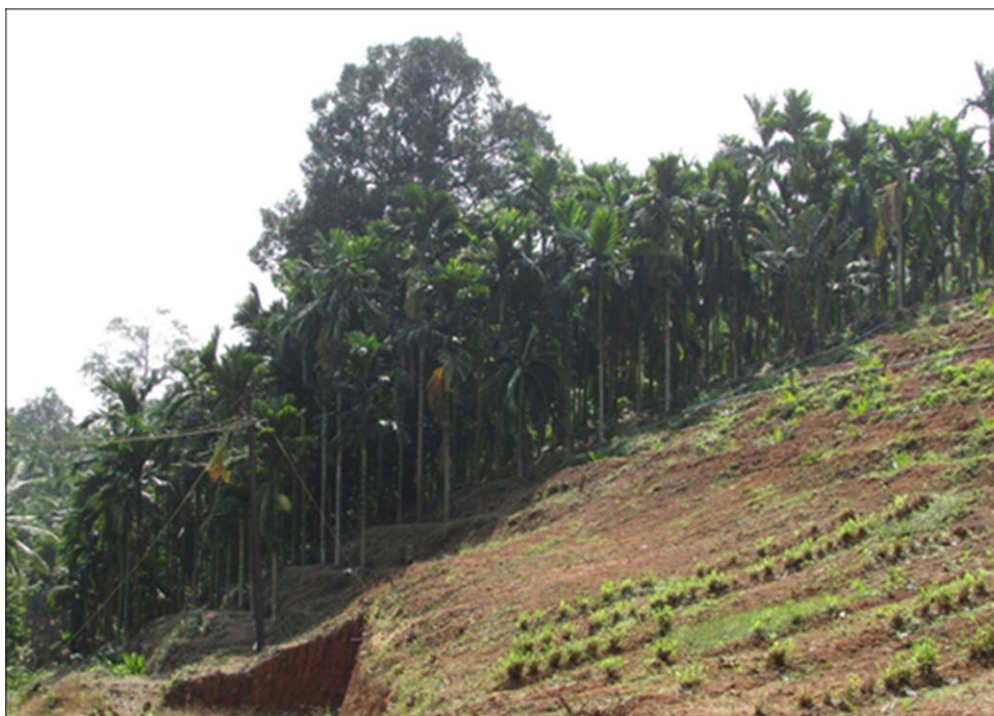
Photo – 2: Modification of slope for High Height Plantation (HHP) in the south east of Kuppettu village (Toposheet No 48P/05).

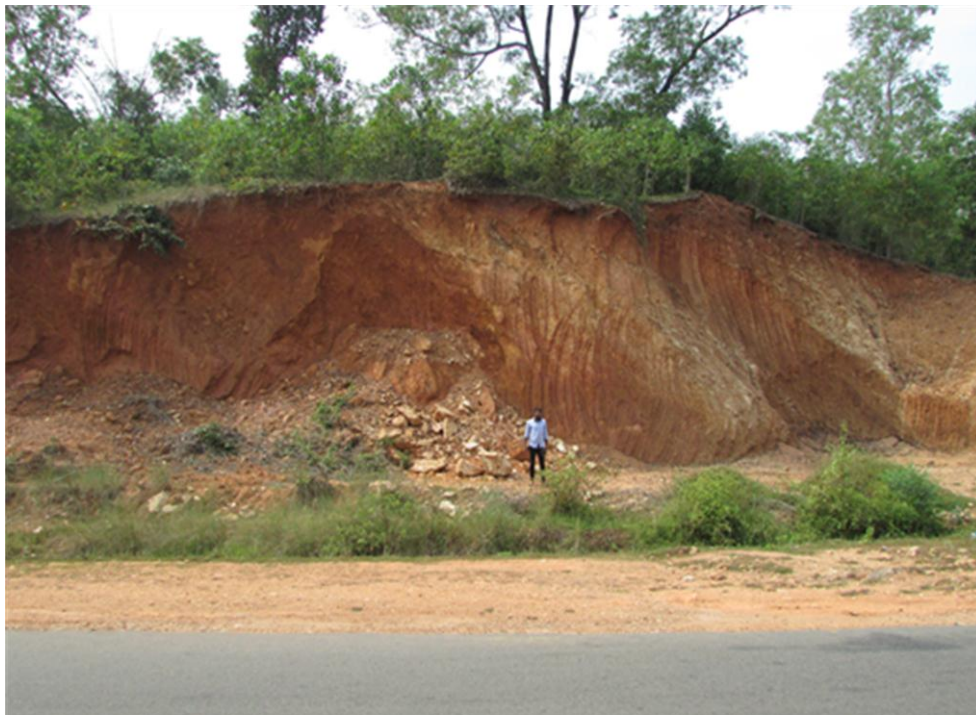
Photo – 3: Extensive Slope Cut along NH – 75 (formally known as NH – 48) in the east of Uppinangadi (Toposheet No 48P/05).

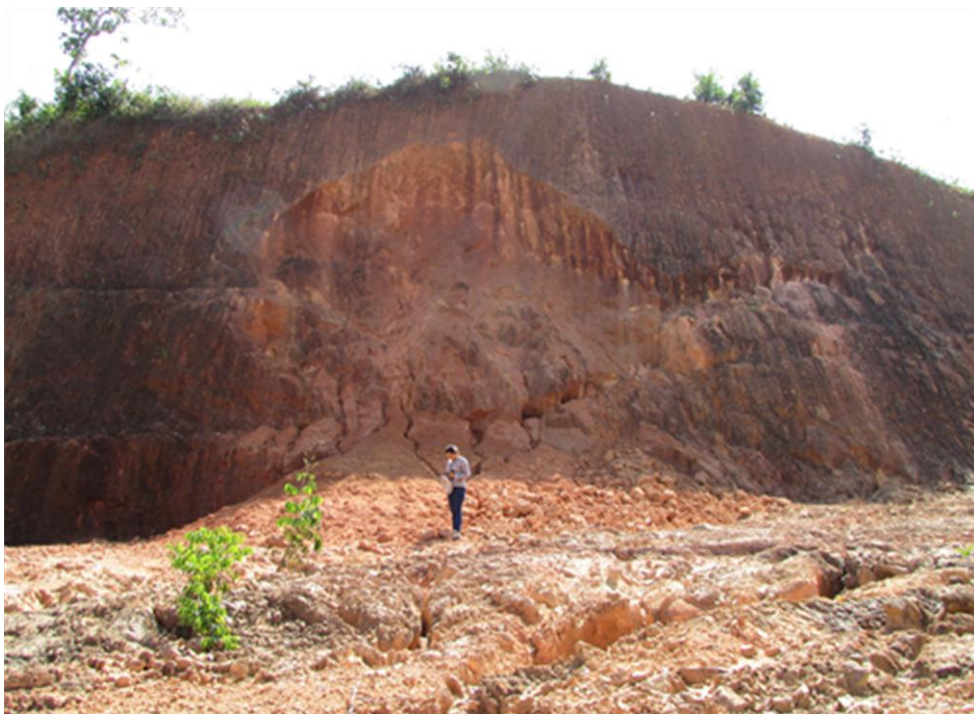
Photo – 4: Extensive Slope Cut near Indamogru Village (Toposheet No 48P/05). The material has already started moving due to rain.

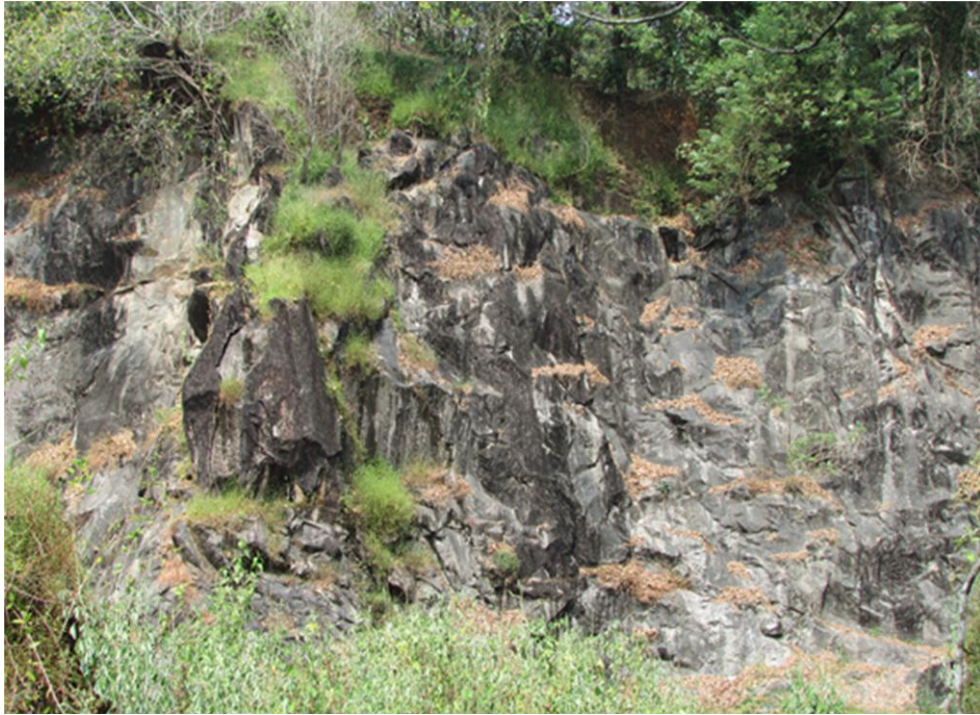
Photo – 5: Granite gneiss present as slope forming material near Sullia village (Toposheet No 48P/05).

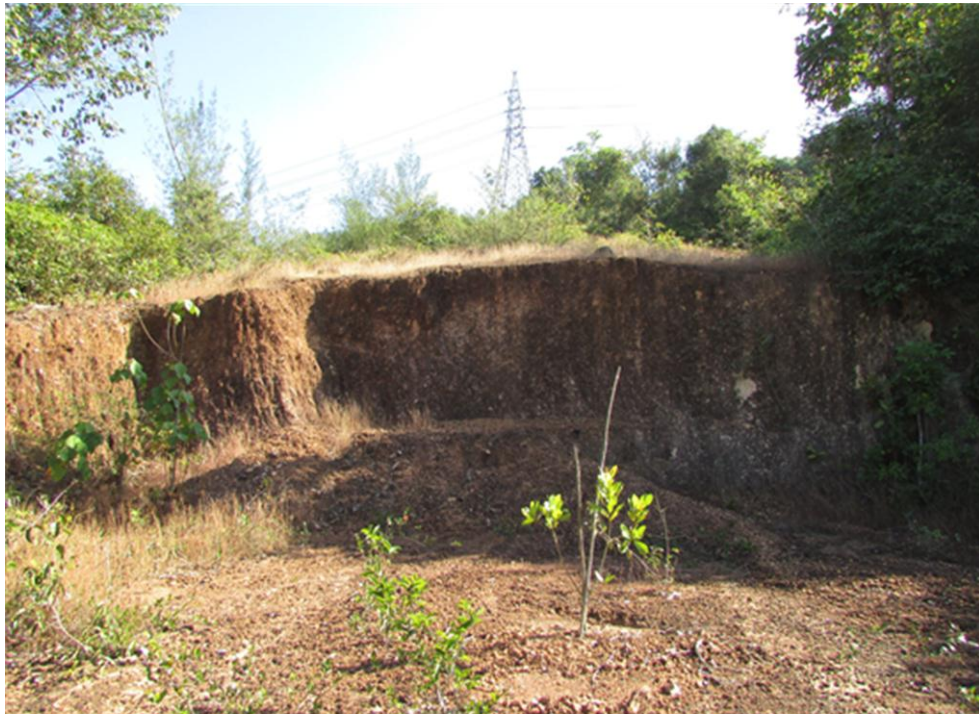
Photo – 6: Weathered Rock present as slope forming material near Bandaru Village (Toposheet No 48P/05).

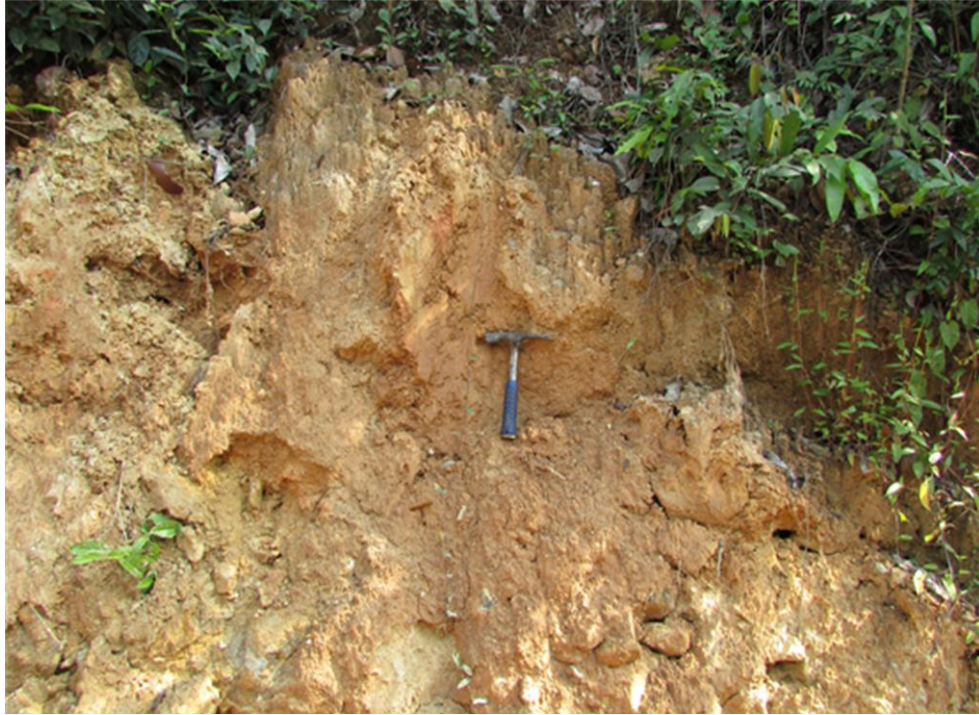
Photo – 7: In – situ soil present as slope forming material near Gerukatte village (Toposheet No 48P/05).

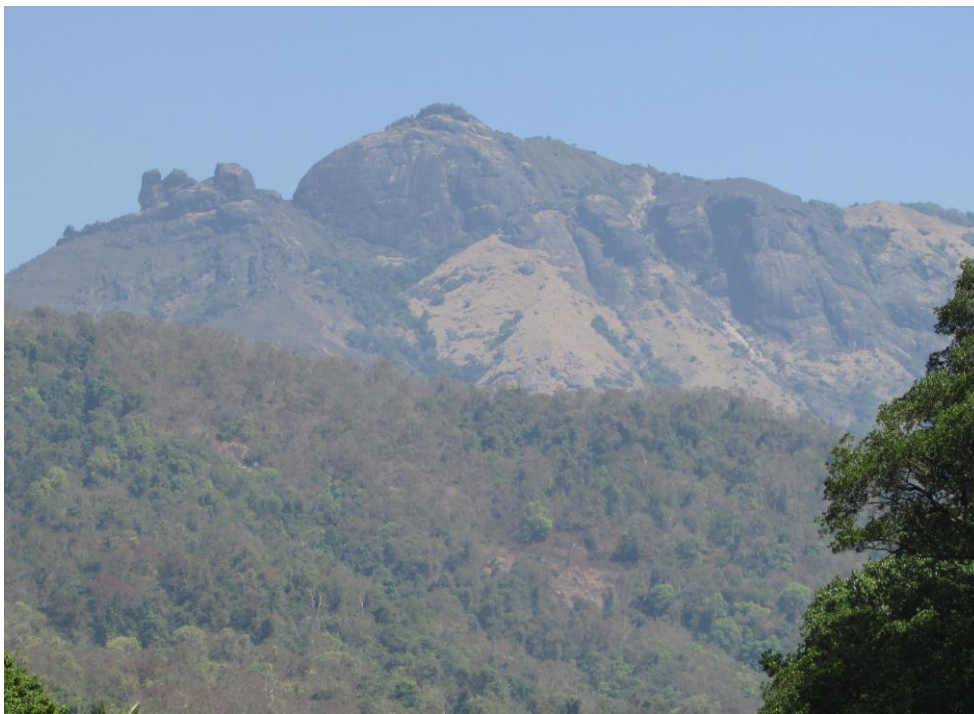
Photo – 10: View of Moderately Dissected Slope in north of Gundia (Toposheet No – 48P/09).

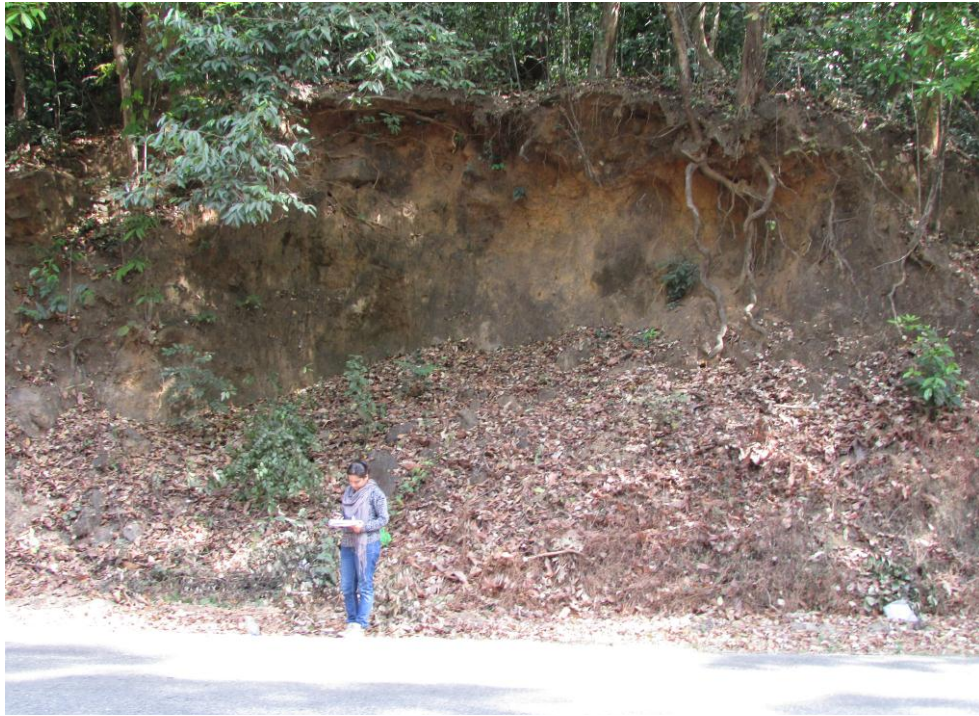
Photo – 11: View of debris slide along NH – 75 (formally known as NH – 48) in the east of Shradigadi (Slide Name – KAR/HAS/48P09/2016/01) (Toposheet No – 48P/09).

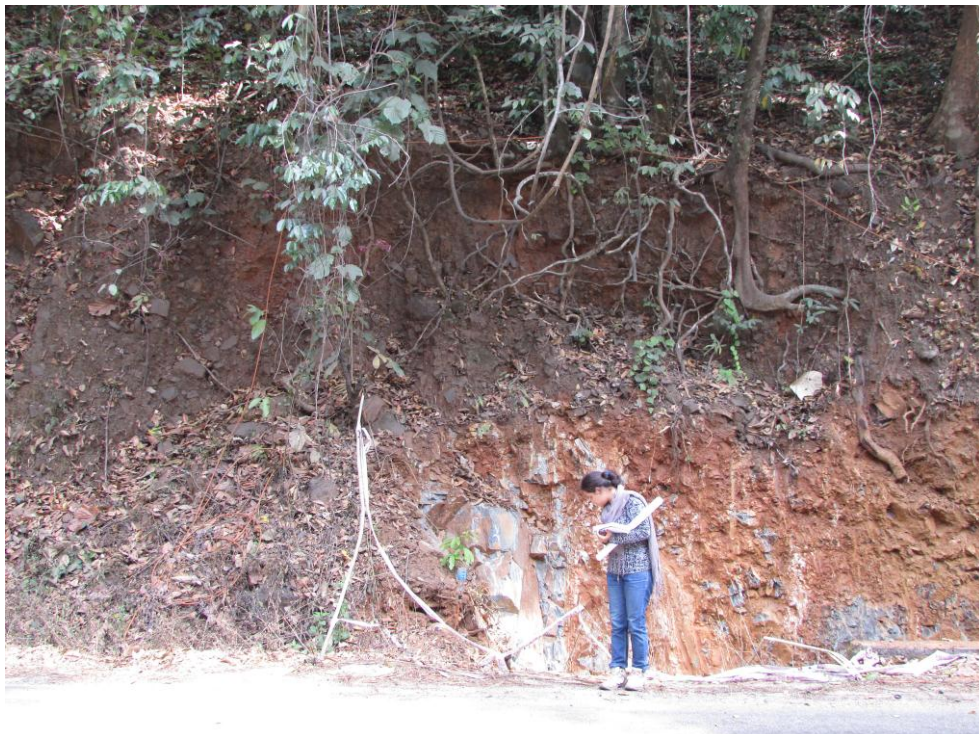
Photo – 12: View of debris slide along NH – 75 (formally known as NH – 48) in the east of Shradigadi (Slide Name – KAR/HAS/48P09/2016/03) (Toposheet No – 48P/09). The slide is almost wholly removed for maintenance of the NH.

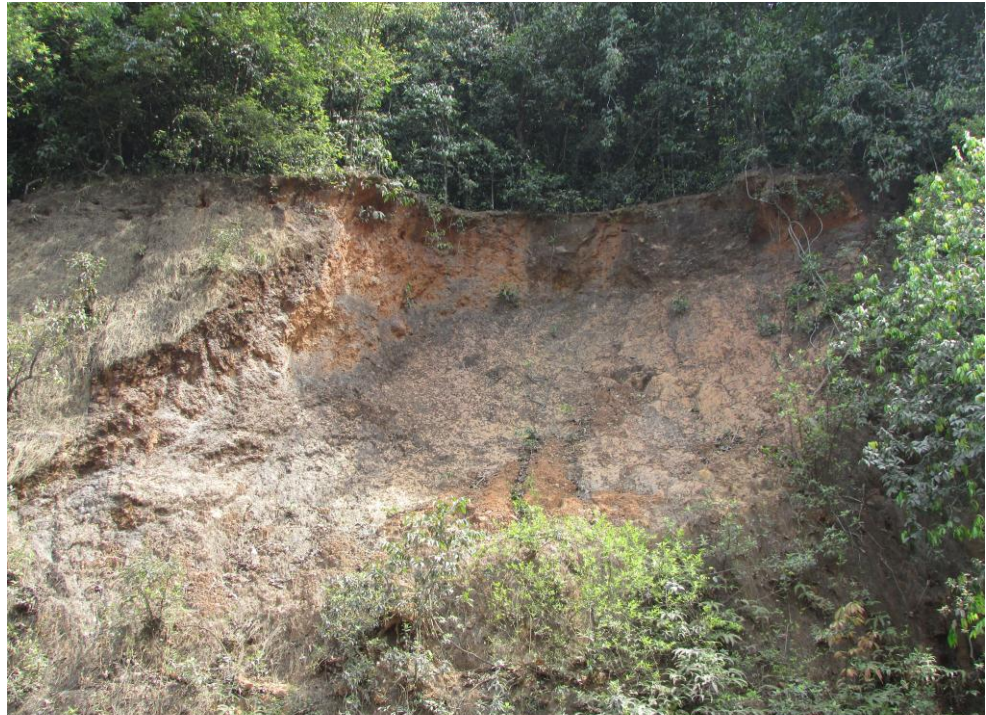
Photo – 13: View of debris slide along NH – 75 (formally known as NH – 48) in the east of Shradigadi (Slide Name – KAR/HAS/48P09/2016/04) (Toposheet No – 48P/09).

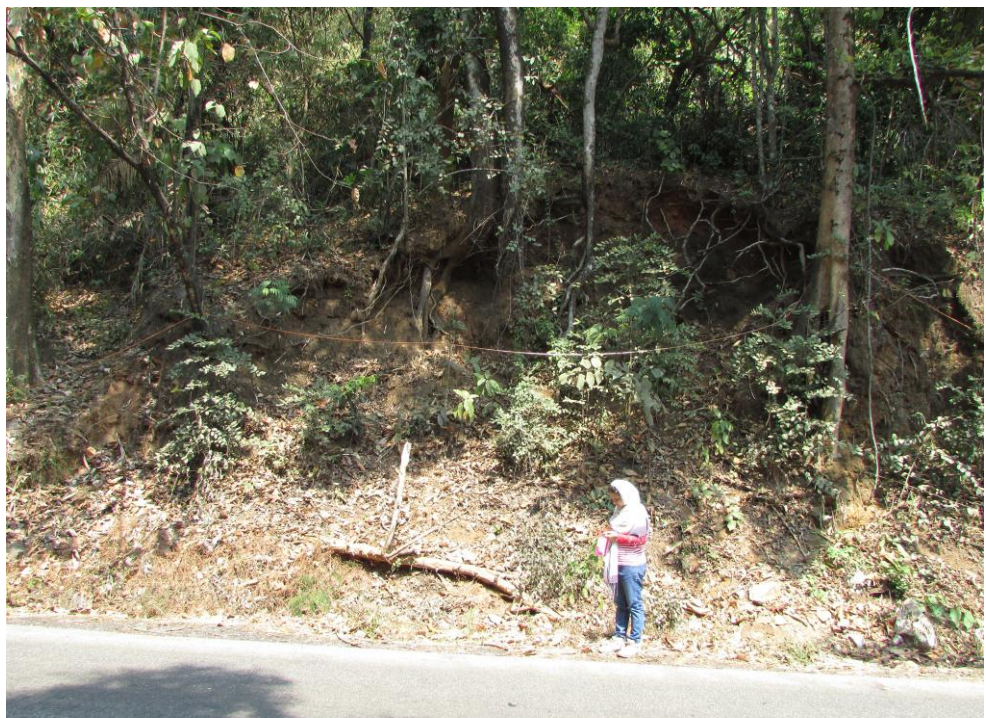
Photo – 14: View of debris slide along NH – 75 (formally known as NH – 48) in the east of Shradigadi (Slide Name – KAR/HAS/48P09/2016/05) (Toposheet No – 48P/09).

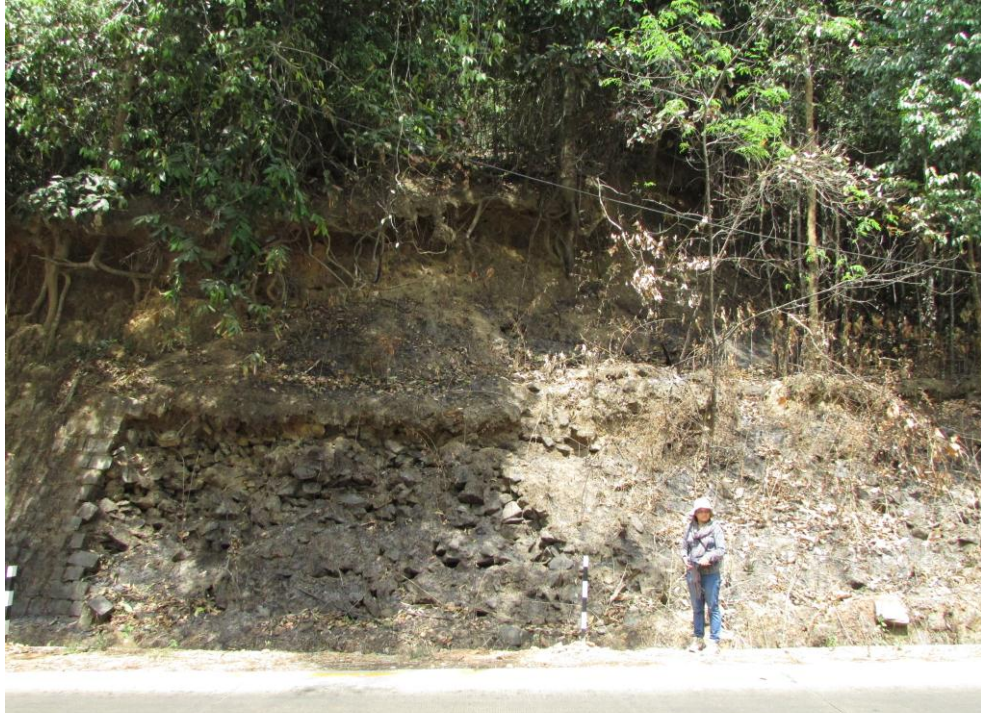
Photo – 15: View of debris slide along NH – 75 (formally known as NH – 48) in the east of Shradigadi (Slide Name – KAR/HAS/48P09/2016/11) (Toposheet No – 48P/09). The retaining wall has started to collapse due to movement that clearly suggests that the slide is active.

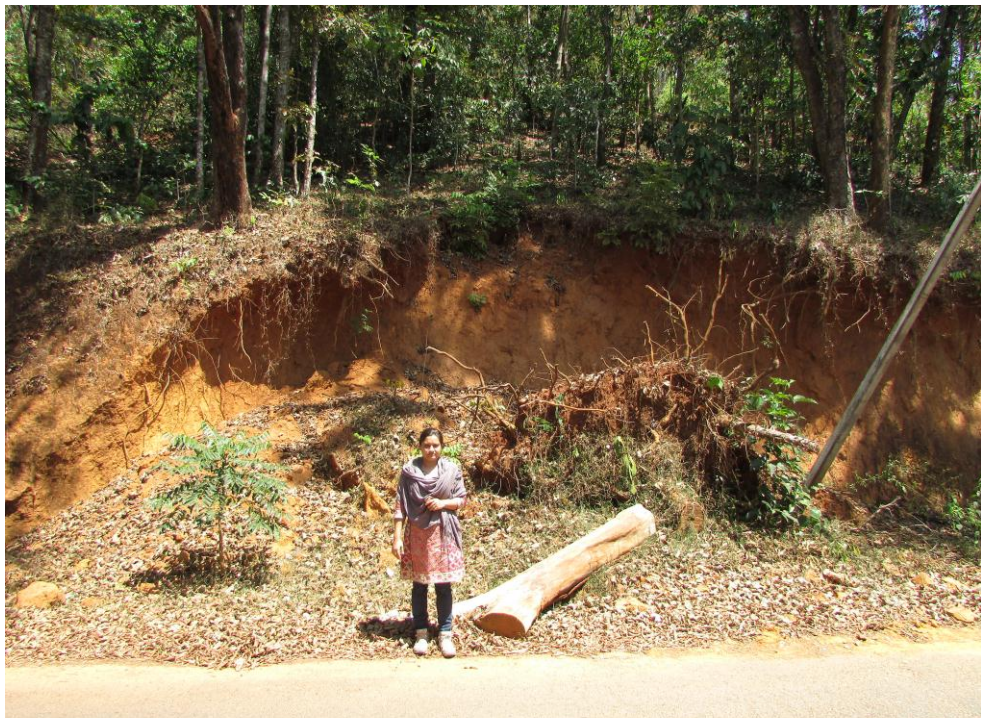
Photo – 16: View of debris slide in the west of Pudevettu (Slide Name – KAR/DK/48P09/2016/16) (Toposheet No – 48P/05).
