MACRO-SCALE (1:50,000) LANDSLIDE SUSCEPTIBILITY MAPPING IN PARTS OF  
TOPOSHEET NO. 48 L/13, L/14, P/1 & P/2, DAKSHIN KANNADA DISTRICT, KARNATAKA  
(CODE NO : LSM/SR/KG/2016/112)  
(Field Season 2016-17)

भूस्खलन संवेदनशीलता मानचित्रण  
Landslide Susceptibility Mapping

State Unit: Karnataka and Goa  
Southern Region

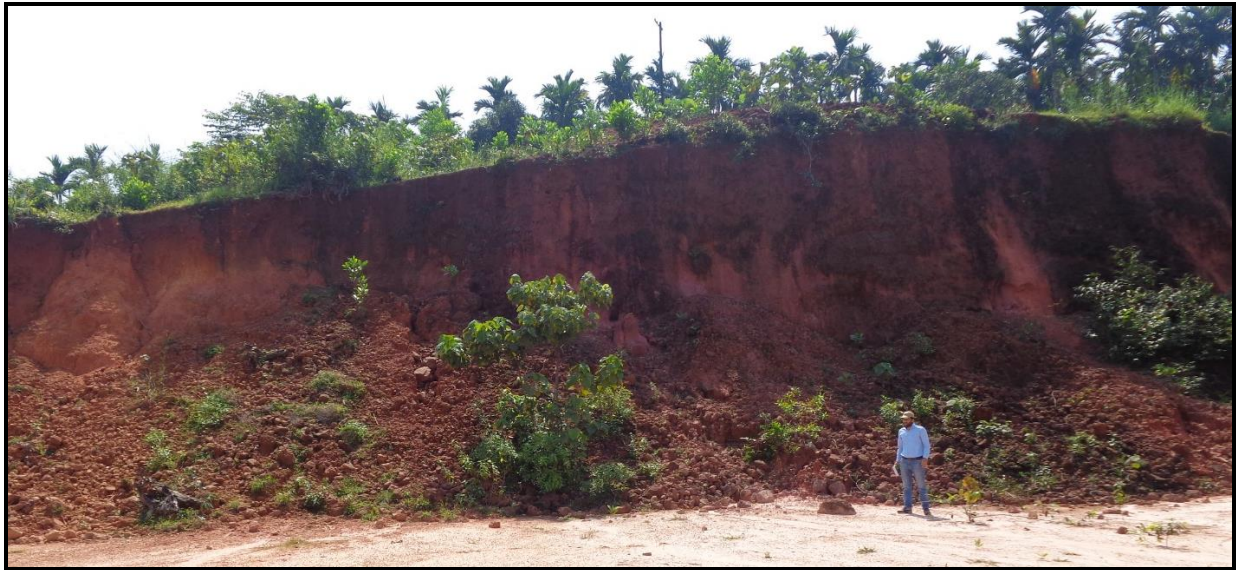
*Photo 1: Extensive cut slope in soil near Punjalkatte*

The spatial distribution of mapped landslides is shown in Annexure-I, which gives detailed inventory of 18 landslides for which 41-point inventory data were prepared. Cut slope failures (Photos 1 to 4) are very much wide spread along modified slopes and roads in the area. Many of the cut slope transform into landslides during rainy season in the area.

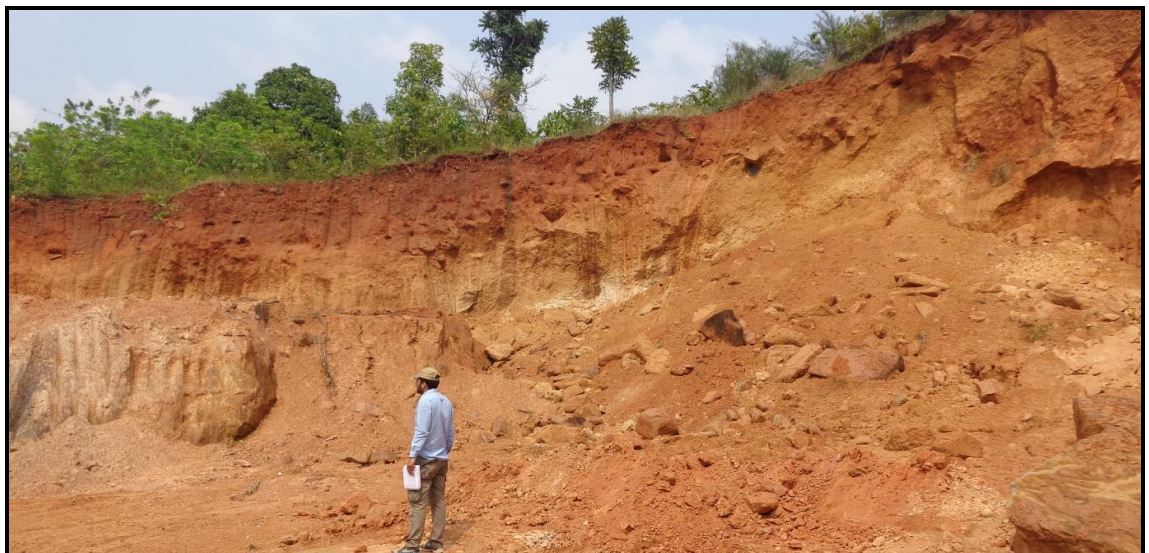
*Photo 2: Extensive cut slope in soil along Kalladka-Melkar Road section*

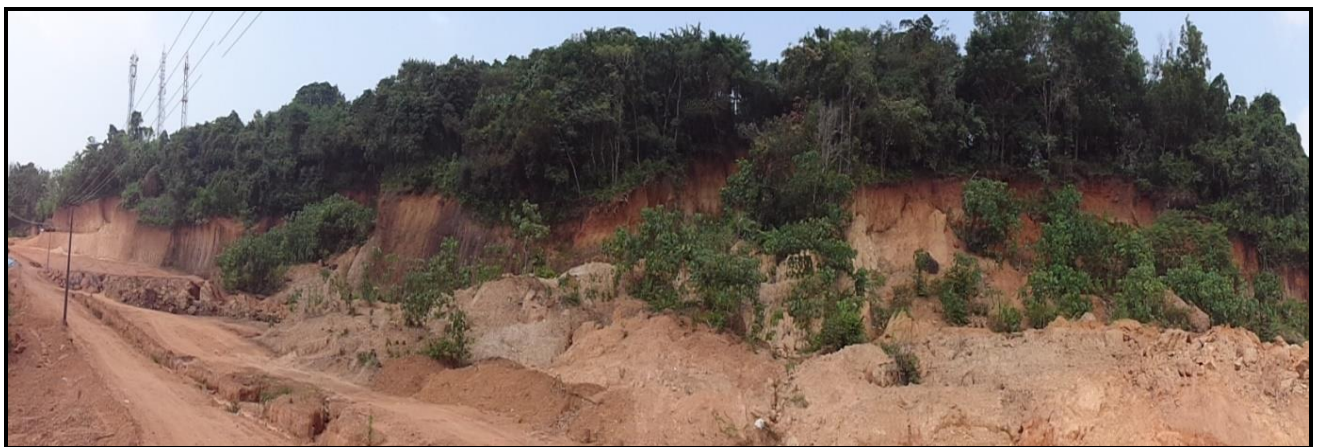
*Photo 3: Extensive cut slope along Bantval-Lorettopadavu Road section*

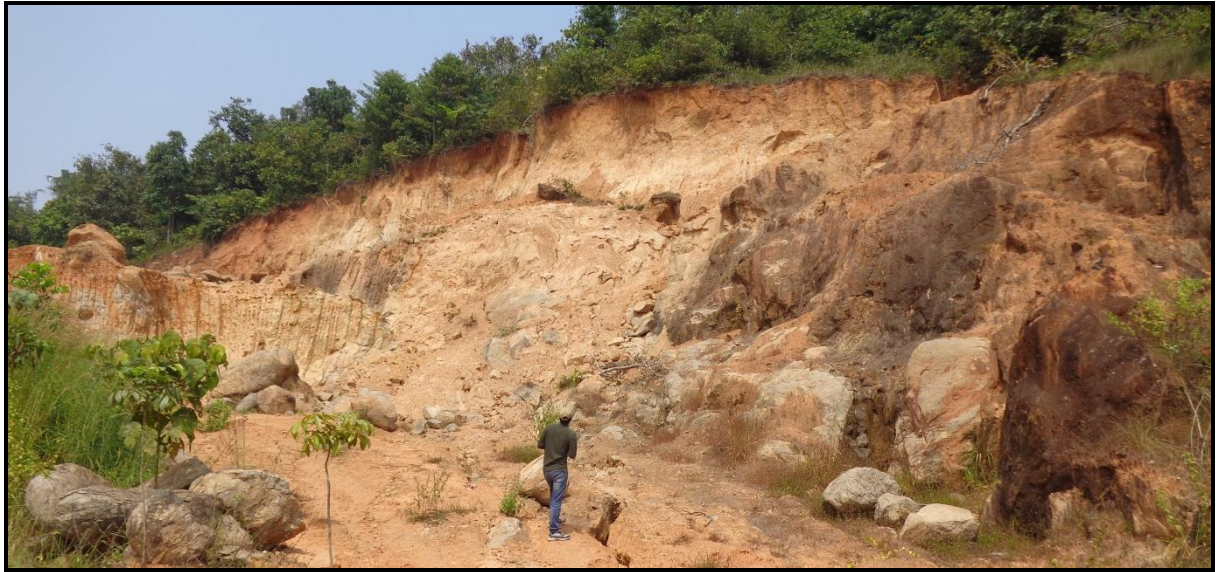
*Photo 4: Extensive cut slope along Bantval-Amtadi Road section*

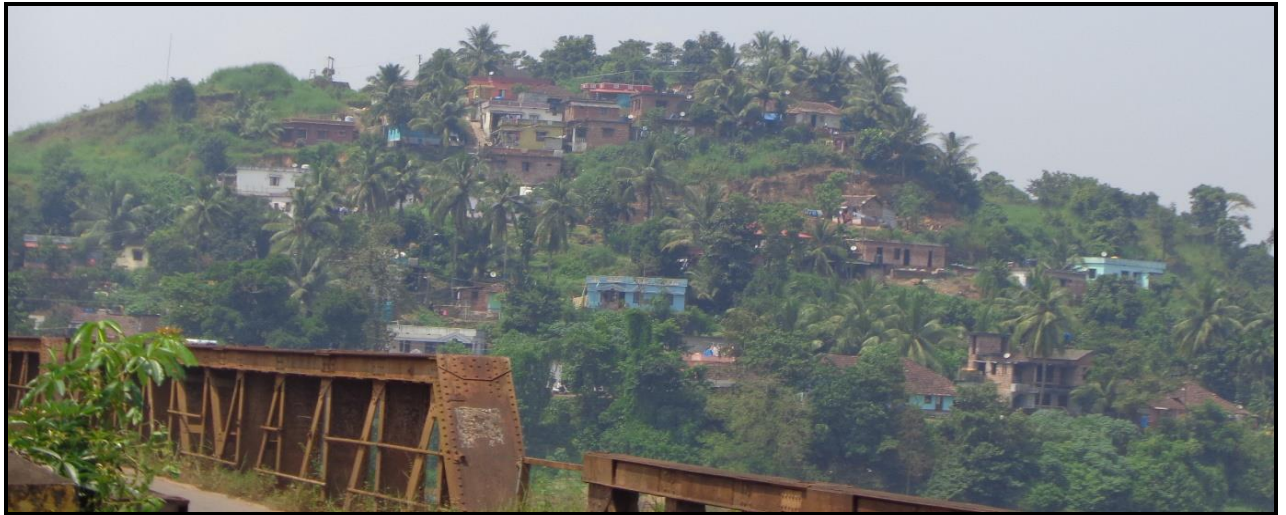
*Photo 5: Settlements on modified slope near old road bridge on Netravati river*

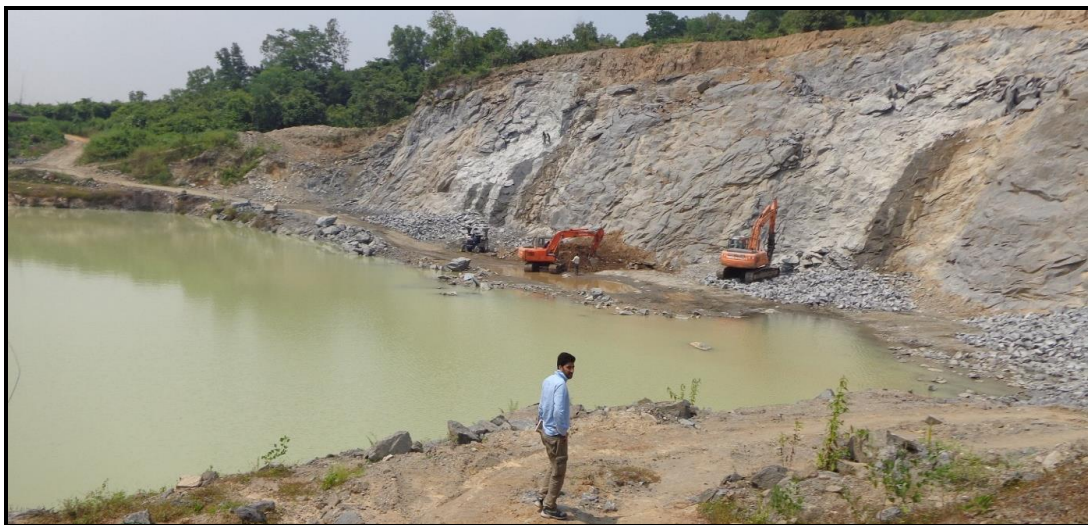
*Photo 6: Rock quarry Near Harekallu river*

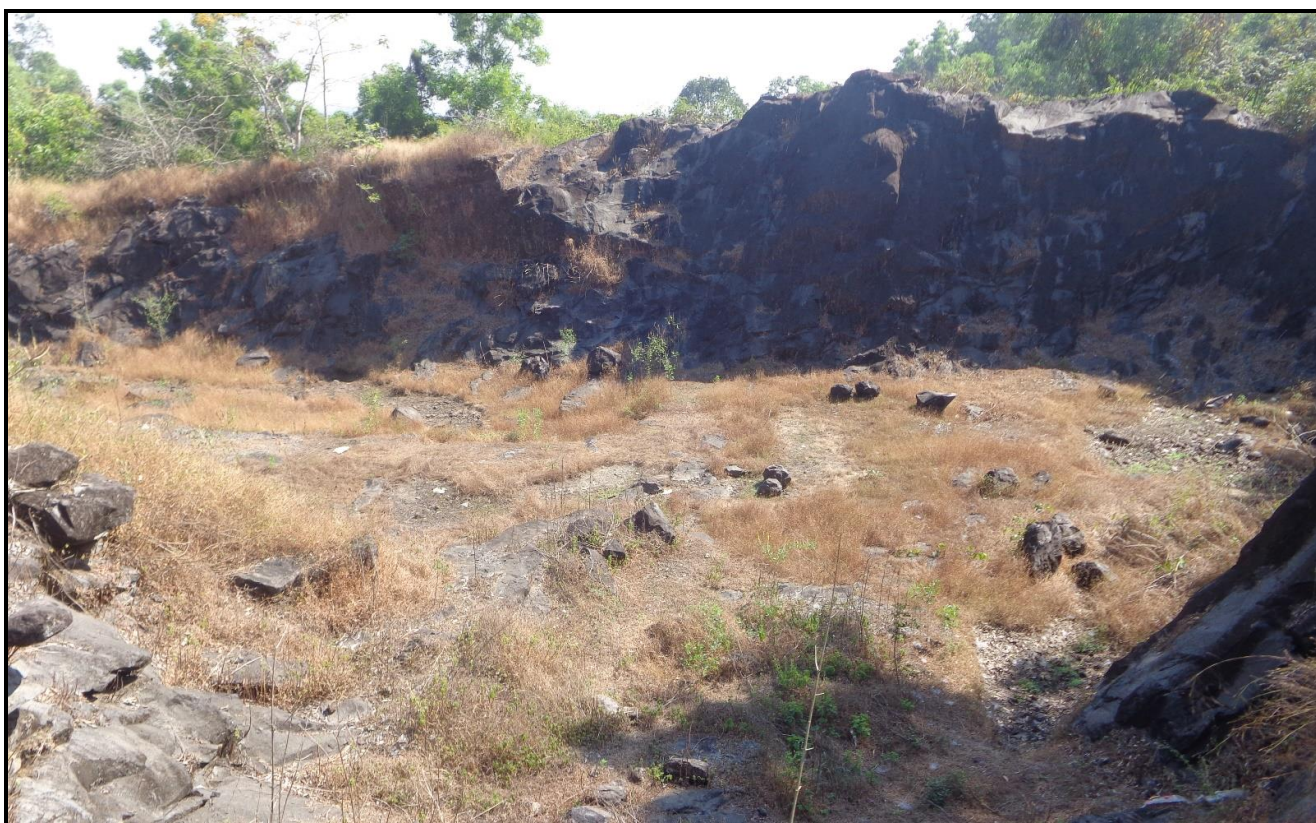
*Photo 10: Exposed rock near Manjalvadi (Old Quarry)*

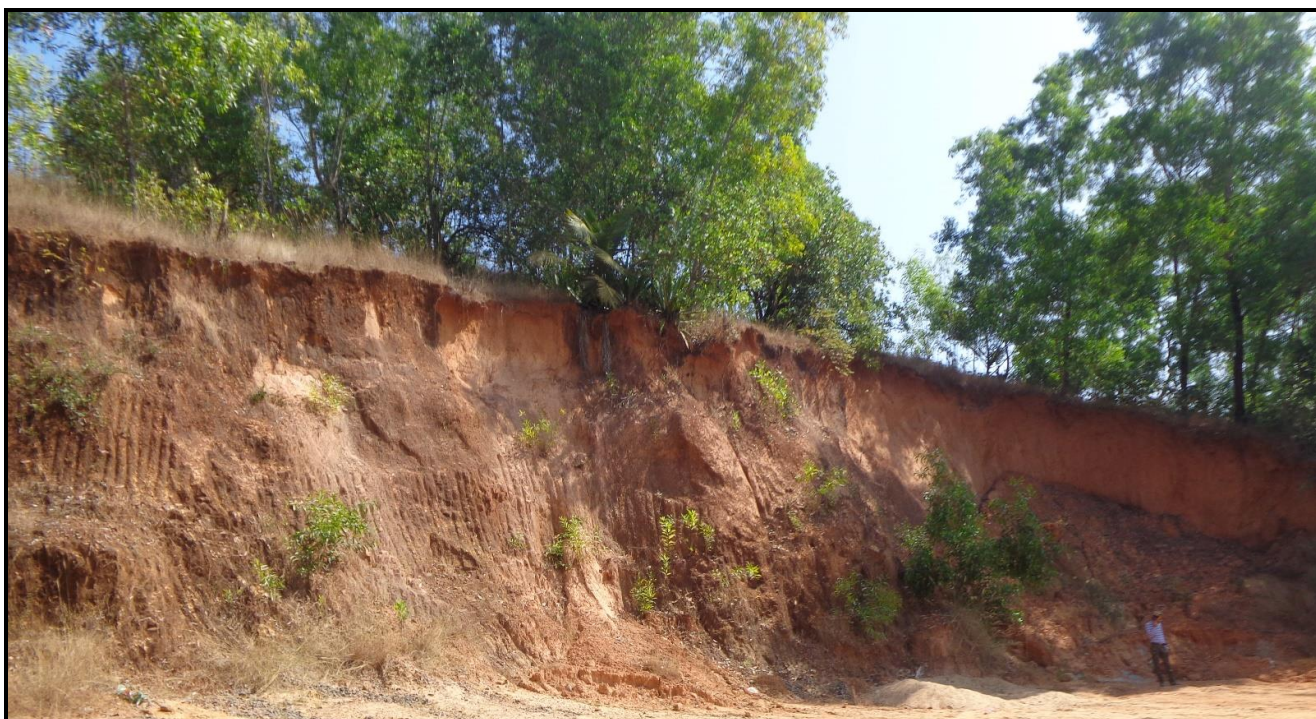
*Photo 11: Lateritic (insitu) soil near Maragadangadi*

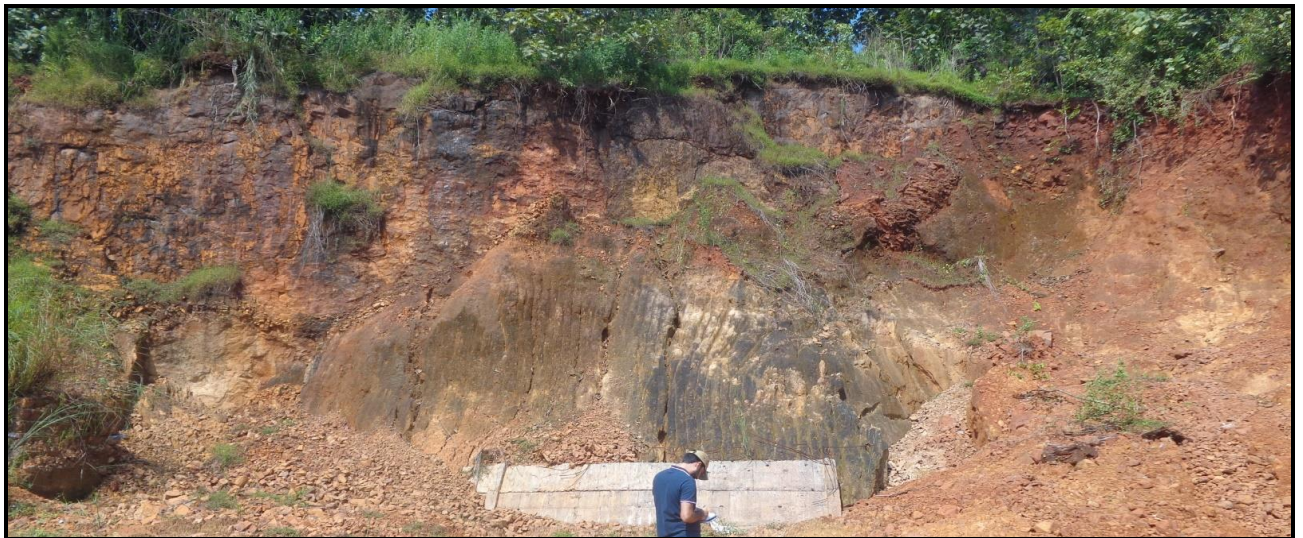
*Photo 13: Regolith thickness less than 0.5m along the road connecting Bantval to NH-48*

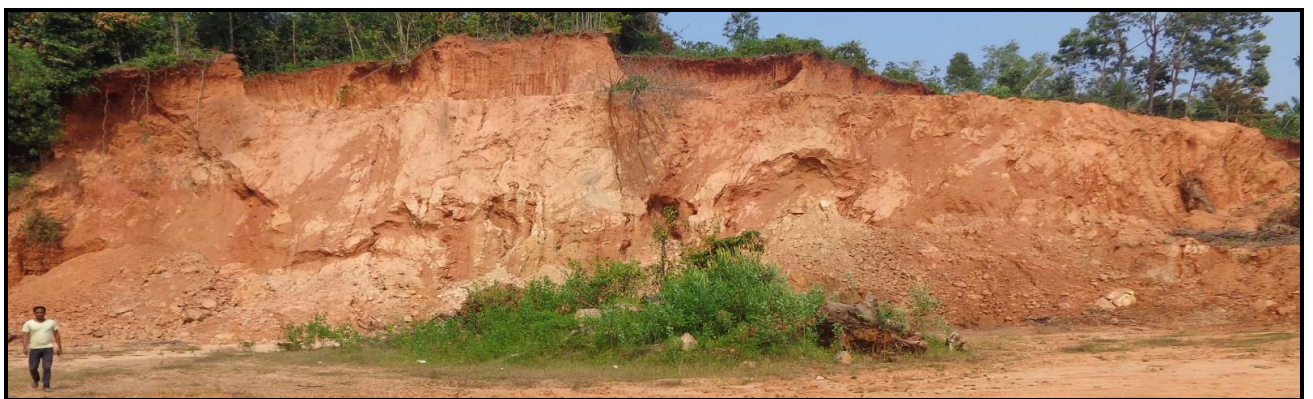
*Photo 14: Regolith thickness greater than 0.5m near Navur-Bantval road junction*

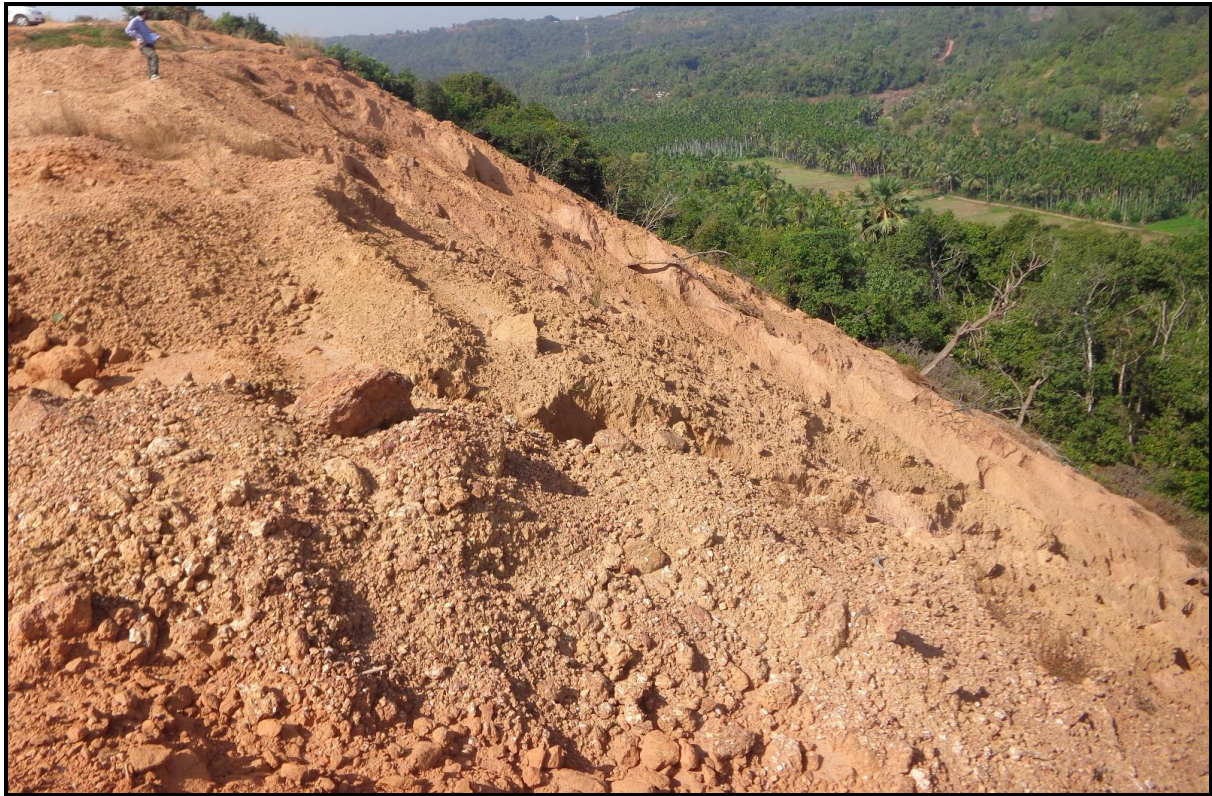
*Photo 15: Loose debris hump on the downslope side along the road, North of Farangipet*

Areas with visible soil profile were categorized under in-situ soil category. On slopes, barren rock is present at places where the slope angle in general is more than 35 degrees. Most of the study area is covered by In-situ (lateritic soil), soil of granitic origin (Photo 11). Some old outcrops which represent old quarries were observed near village Manjalvadi (Photo 10). Weathered exposures were observed on Farangipet-Nagori road with blackish and reddish soil representing the underlying lithology i.e charnockites and granites. At places, humps of loose debris which are left un-treated are found on barren slopes (Photo 15). The area covered in pixels LOFS and rank in given in table 7.

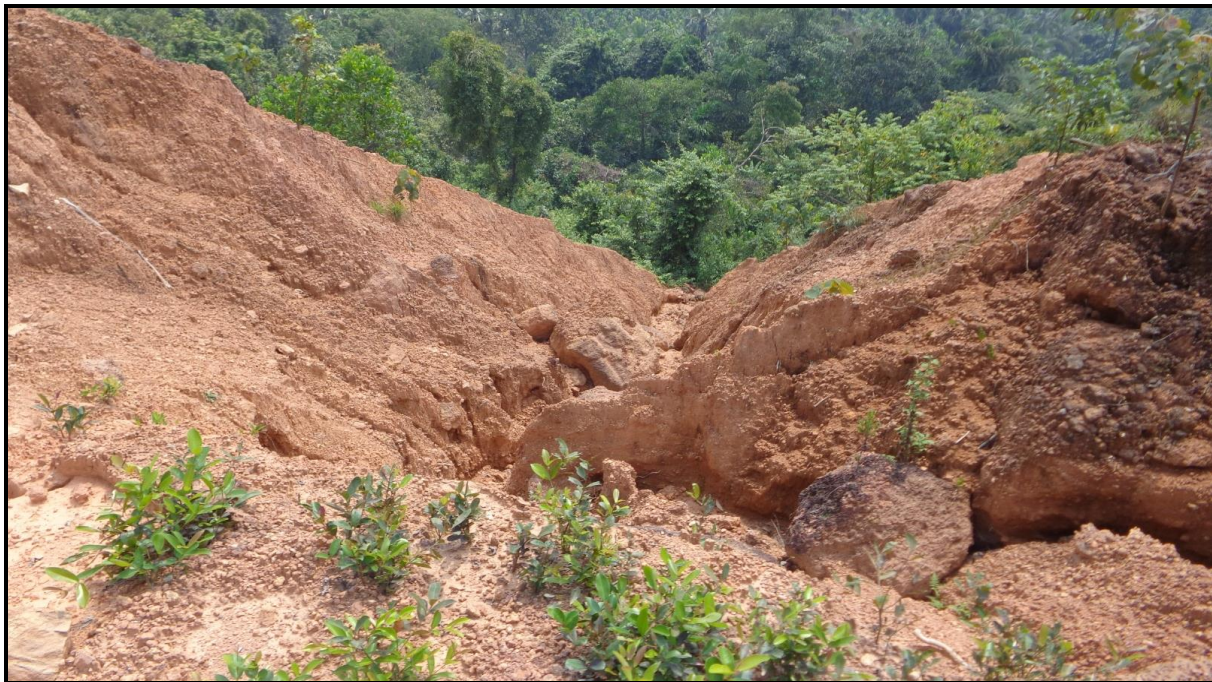
*Photo 16: Loose debris dump on the downslope side along the Bantval-Lorettopadavu road section*

2. The loose material named as loose debris in the slope forming material map is highly vulnerable to slides especially during rainy season. This material generated in laterite quarries, rock quarries and in areas under excavation and some constructional works is dumped indiscriminately on slopes. Some of these loose humps in toposheet 48 L/13 are near Bajpe, Farangipet in central parts, Mudungarukatte and in toposheet 48P/1 near Nujibail and Loretto. These loose humps are very risky especially during rainy season and have caused few casualties in the recent past like that of Derebail, Konchady behind AJ hospital on 20<sup>th</sup> November, 2012. Dumping of any loose material in any area must be done with proper care especially in areas with small settlements near slopes when the slope modification for settlements is unscientific. The vulnerability of these loose humps is enhanced when extensive cut slopes and weathered rock materials are nearby.

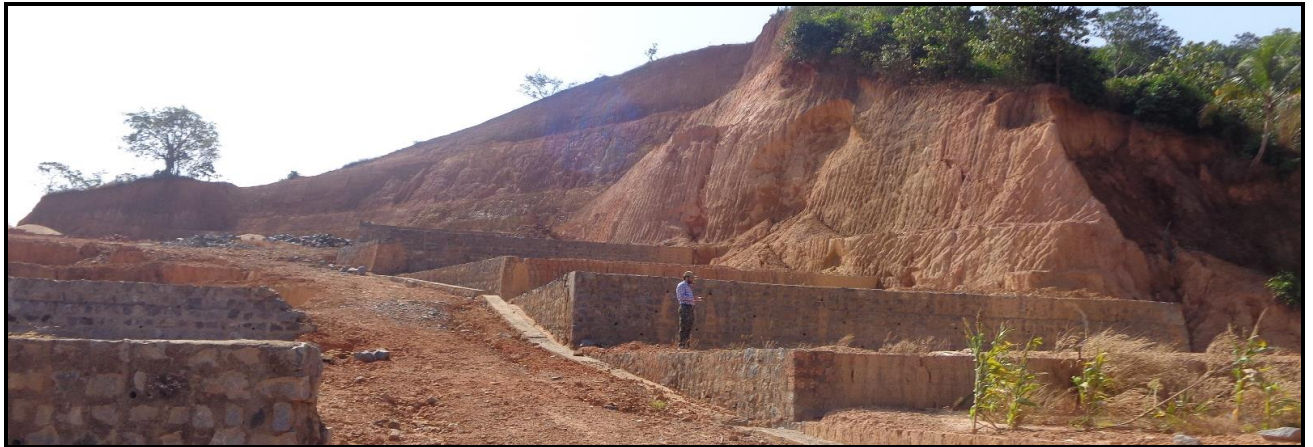
*Photo 17: Slope modification for settlement on the road, North of Farangipet*

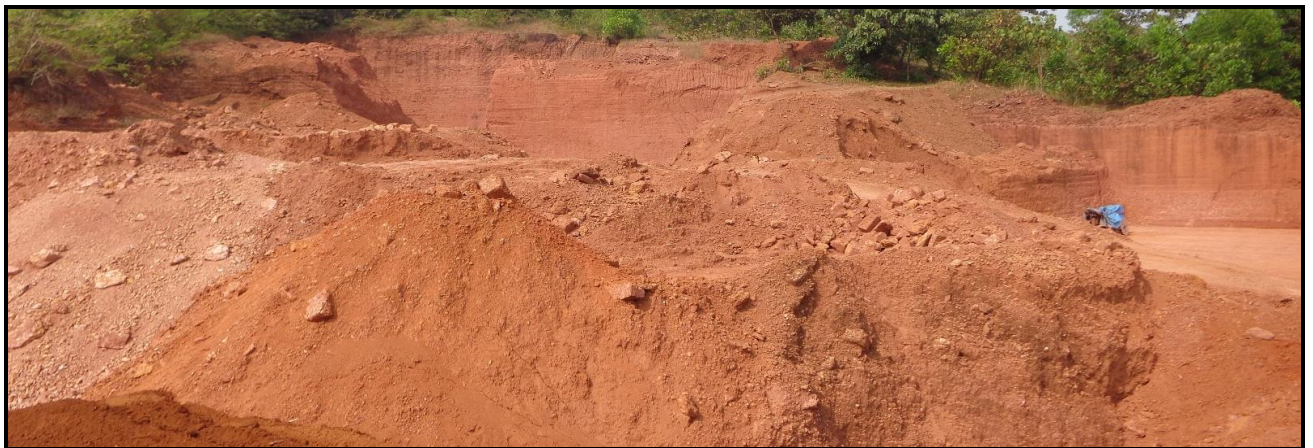
*Photo 18: Slope modification through quarrying of lateritic soil for brick making near Dambe*

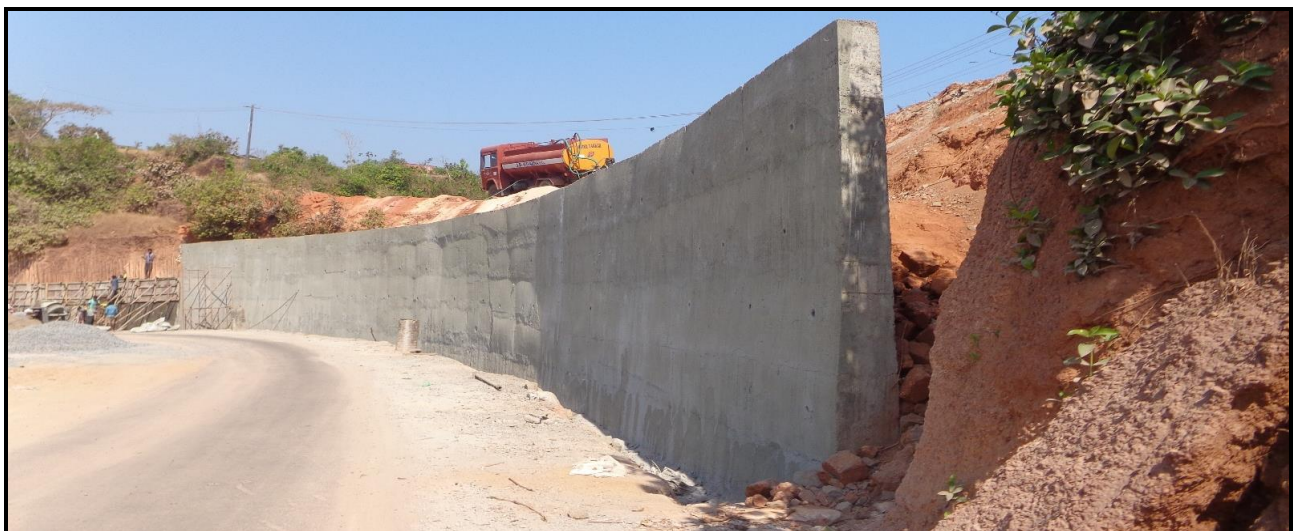
*Photo 19: Retention wall being constructed near Vamajoor for prevention of loose material from sliding*

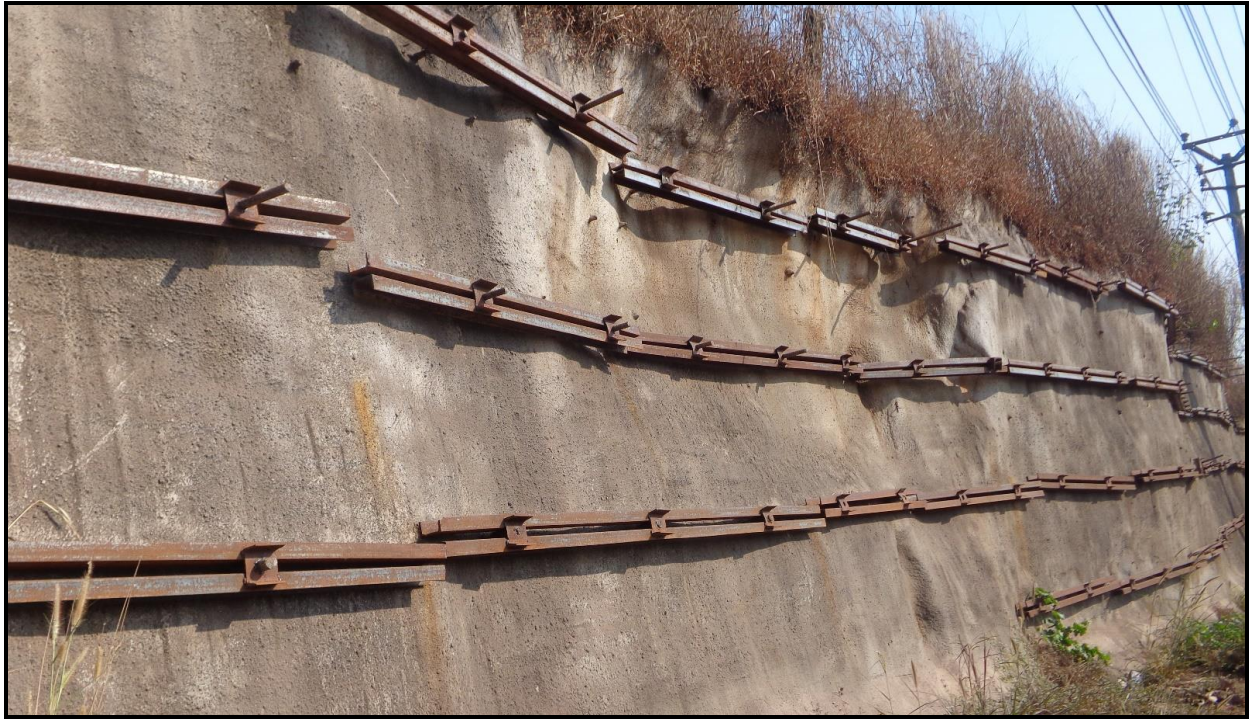
*Photo 20: Rock bolting along NH-48 near Padil for stabilizing slope*

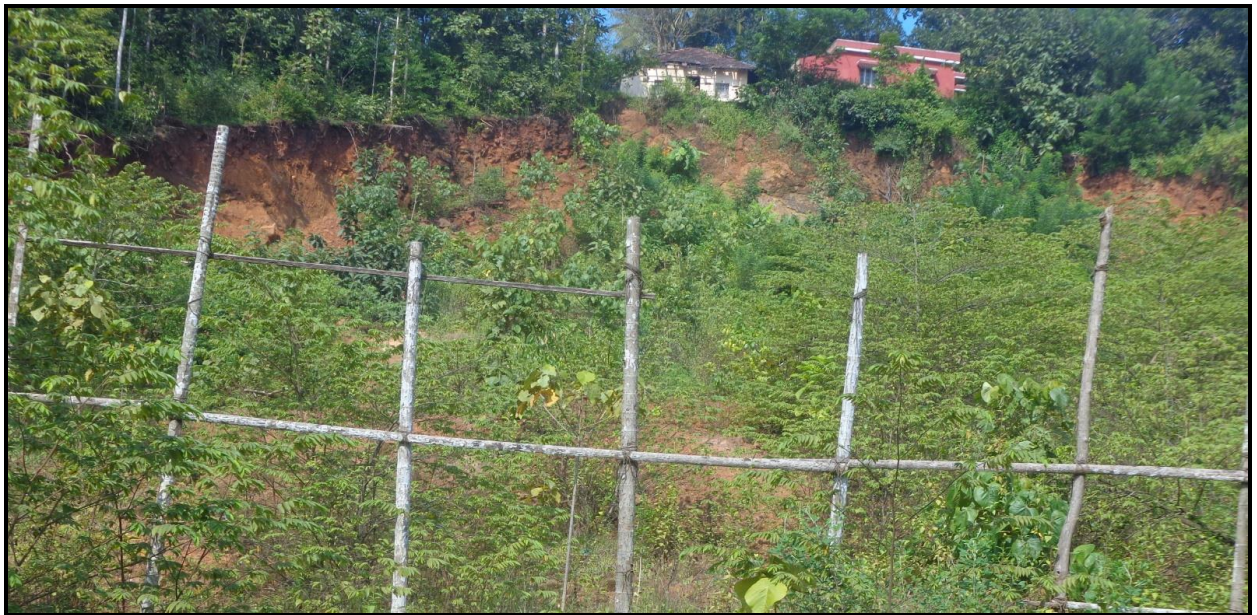
*Photo 21: Debris slide initiated by excavation for settlement along the Bantval road connecting to NH-48 (Earlier reported in local newspaper; causes collapse of the houses and loss of life)*

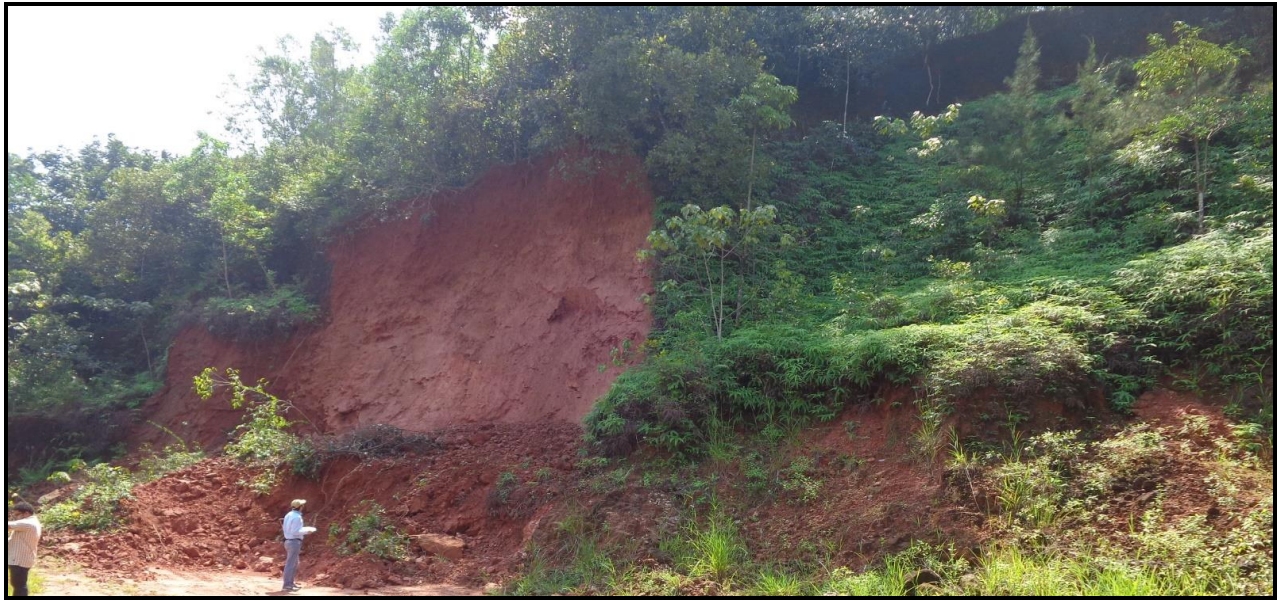
*Photo 22: Debris slide initiated by road cutting along the road near Modanthyar*

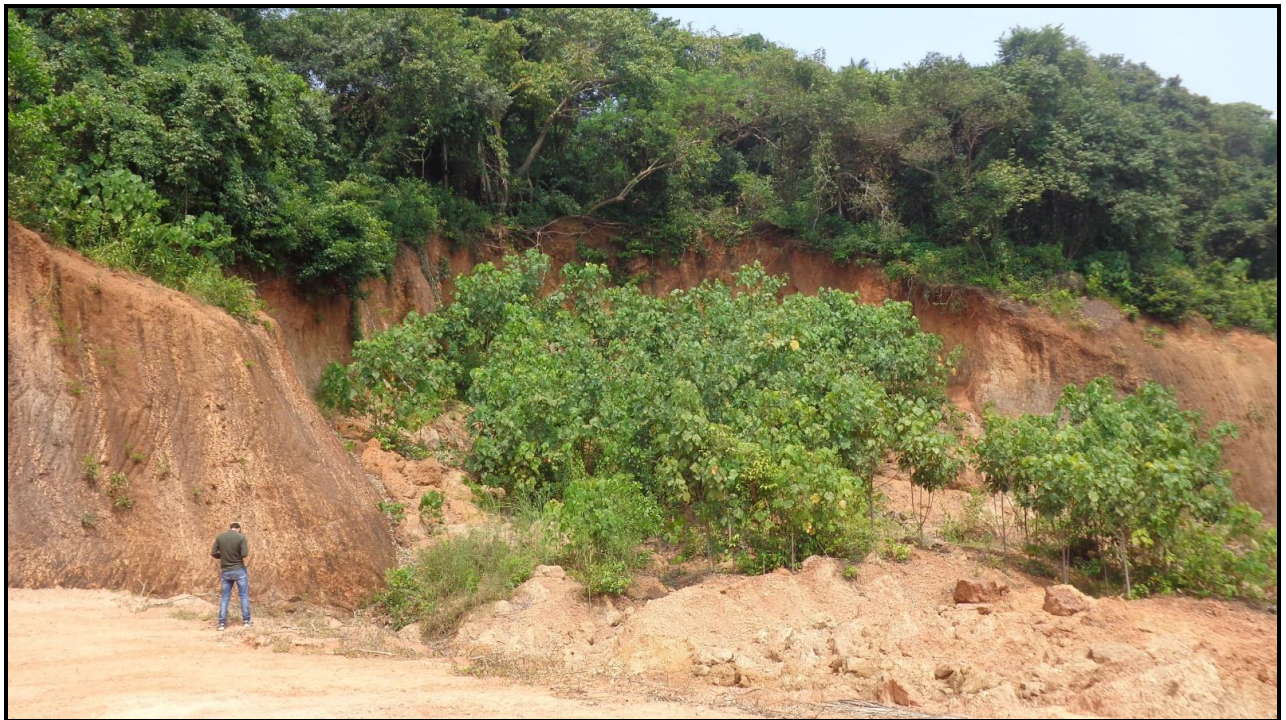
*Photo 23: Debris slide caused due to toe removal along Bantval-Lorettopadavu Road section*

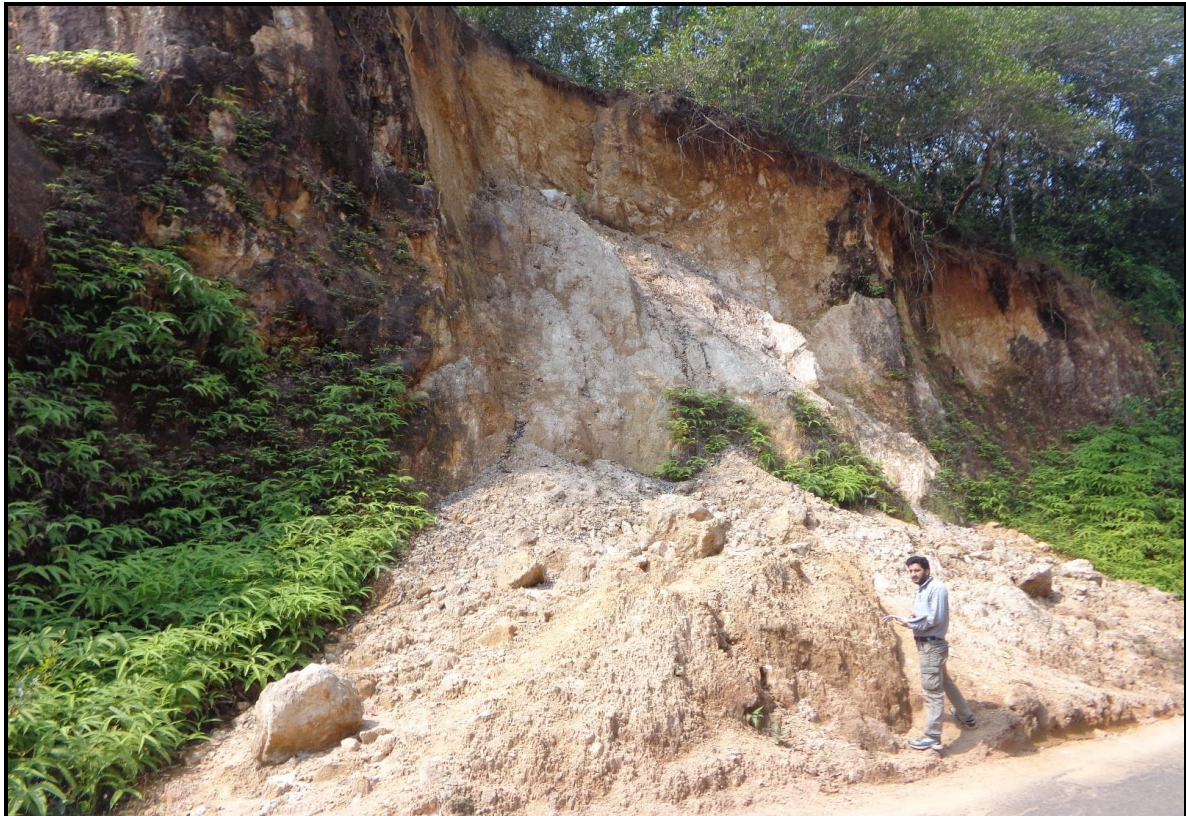
*Photo 24: Debris slide initiated by road cut ,triggered by rainfall along the Kollatadaka-Delantamajalu road*

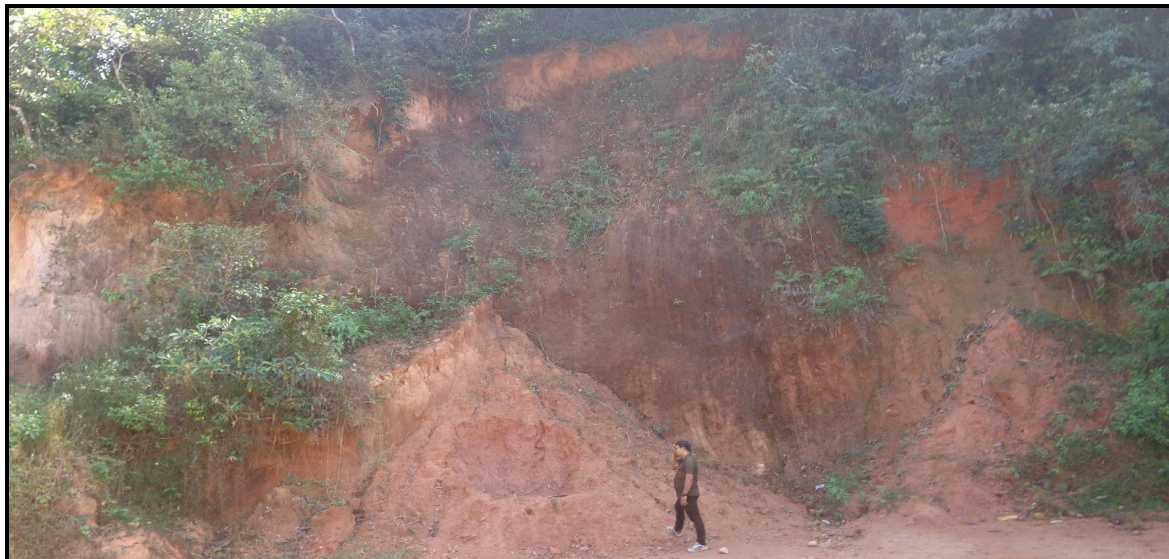
*Photo 25: Debris slide along the road section Kabelá-NH-48*
