**MACRO – SCALE (1:50,000) LANDSLIDE SUSCEPTIBILITY MAPPING IN PARTS  
OF TOPOSHEET NOS. 48O/07 AND 48O/08, CHIKMANGALURU AND DAKSHIN  
KANNAD DISTRICTS, KARNATAKA**

**FSP Code No: M4LSSM/NC/SR/SU-KG/2017/12200**

**Field Season: 2017 – 2018**

**Project: NLSM**  
**State Unit: Karnataka & Goa**  
**Bengaluru**  
**2018**

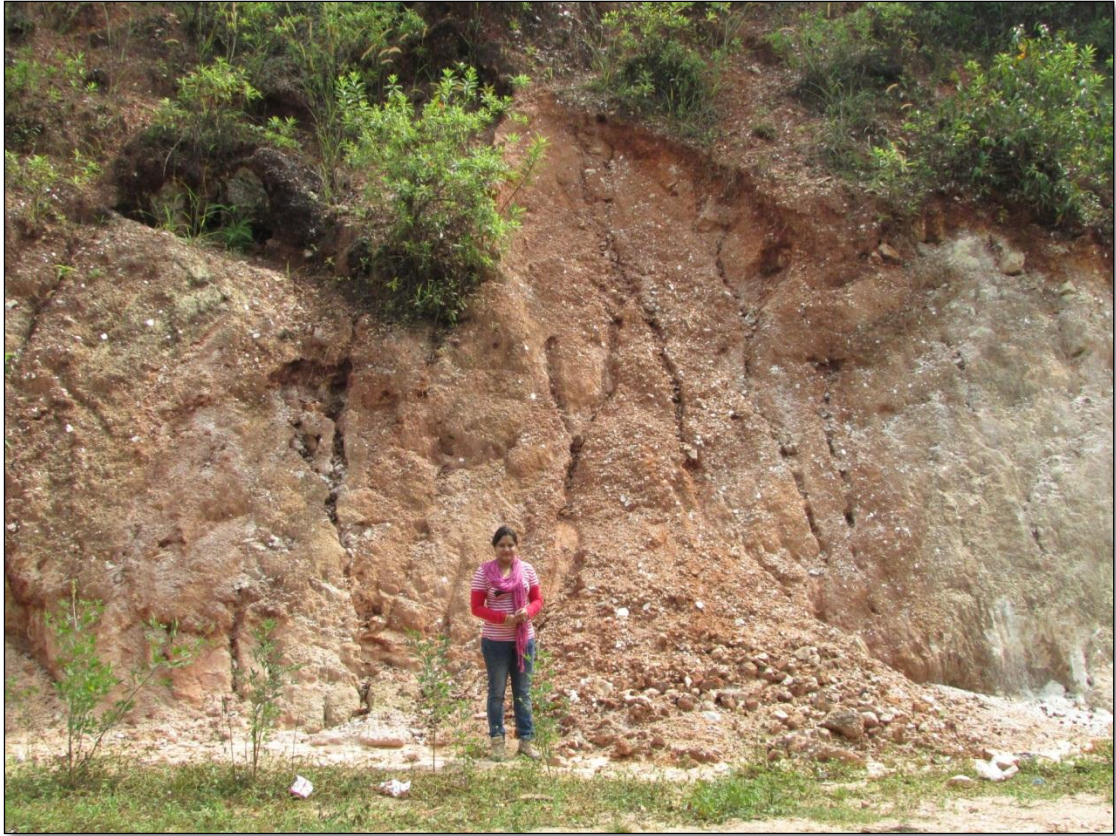
Photo – 1: Active debris slide (Slide Name: KAR/CKM/48O08/2017/001) along Kalasa – Kotighere road section in TS no 48O/08 (Latitude -  $13^{\circ} 13' 22.64''$  N, Longitude -  $75^{\circ} 21' 59.47''$  E).

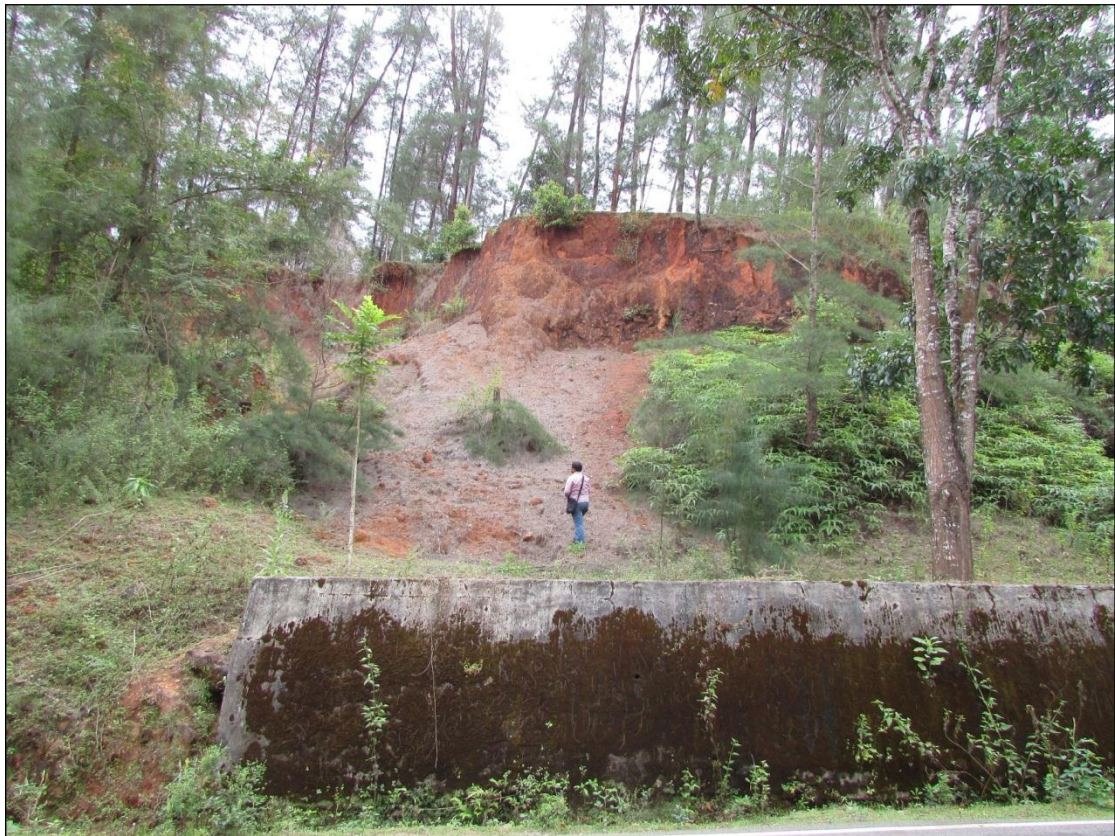
Photo – 2: Active debris slide (Slide Name: KAR/CKM/48O08/2017/013) along Kalasa – Kudremukh road section in TS no 48O/08 (Latitude -  $13^{\circ} 13' 37.07''$  N, Longitude -  $75^{\circ} 21' 11.93''$  E).

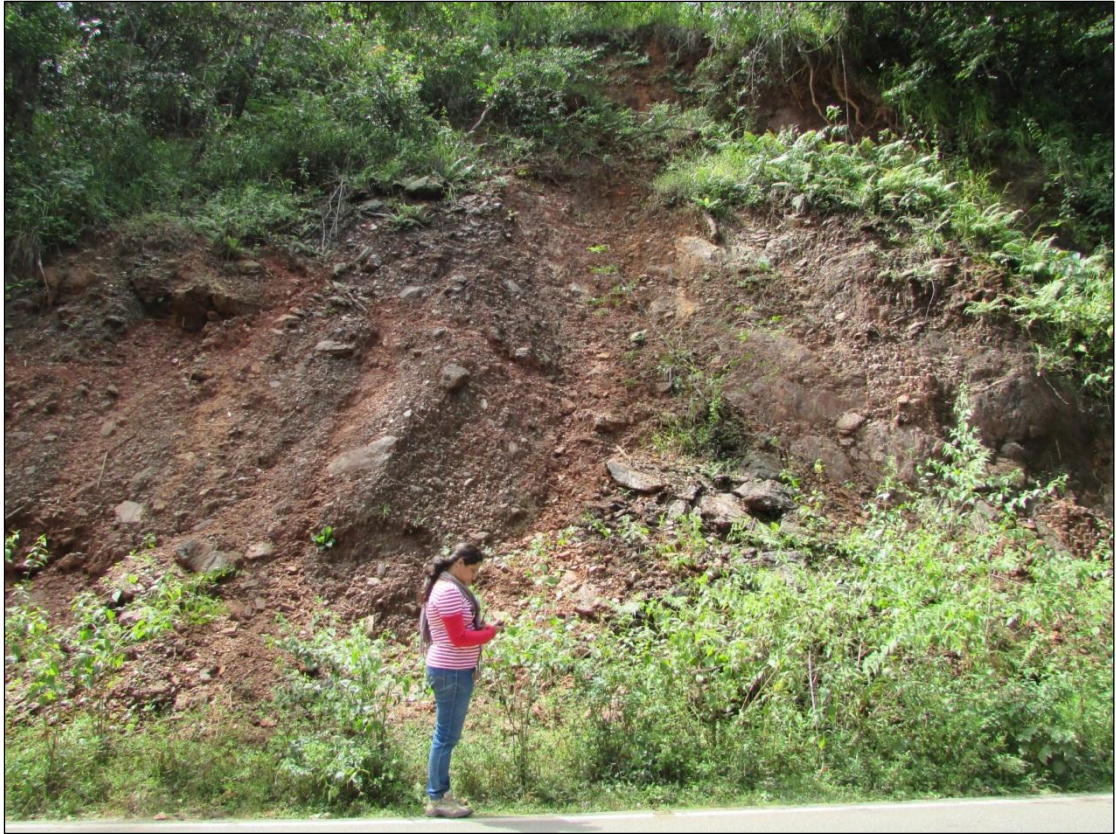
Photo – 3: Reactivated rock slide (Slide Name: KAR/CKM/48O08/2017/017) along Kalasa – Kudremukh road section in TS no 48O/08 (Latitude -  $13^{\circ} 12' 38.17''$  N, Longitude -  $75^{\circ} 15' 31.84''$  E).

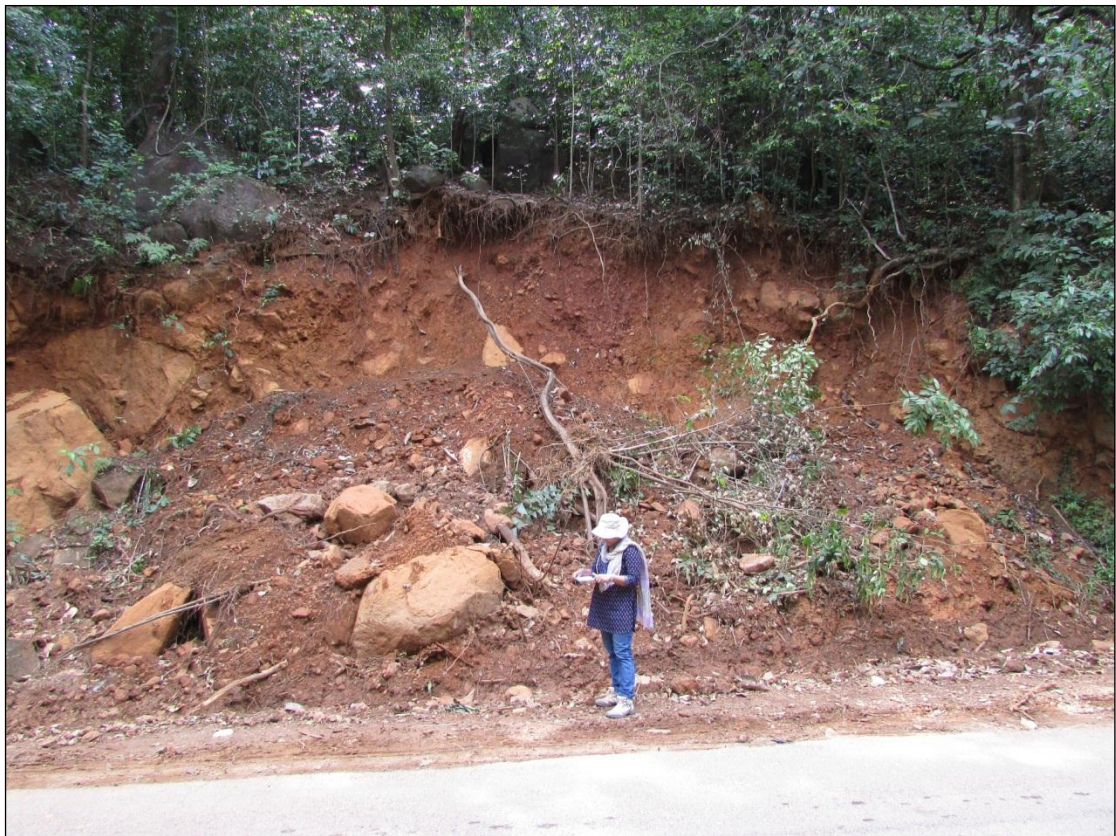
Photo – 4: Active debris slide (Slide Name: KAR/CKM/48O08/2017/053) along Kotighere – Ujire road section in TS no 48O/08 (Latitude -  $13^{\circ} 4' 44.61''$  N, Longitude -  $75^{\circ} 28' 11.12''$  E).

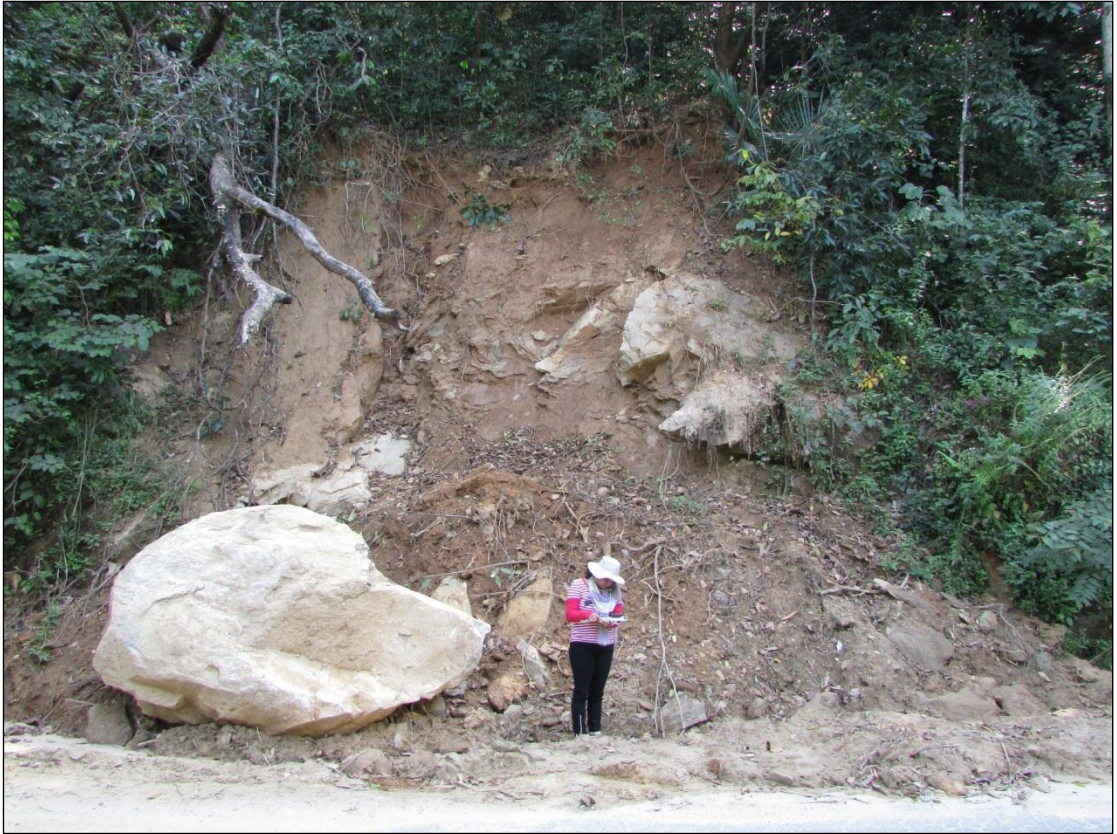
Photo – 5: Active debris slide (Slide Name: KAR/CKM/48O08/2017/077) along Kotighere – Ujire road section in TS no 48O/08 (Latitude -  $13^{\circ} 4' 36.88''$  N, Longitude -  $75^{\circ} 27' 22.63''$  E).

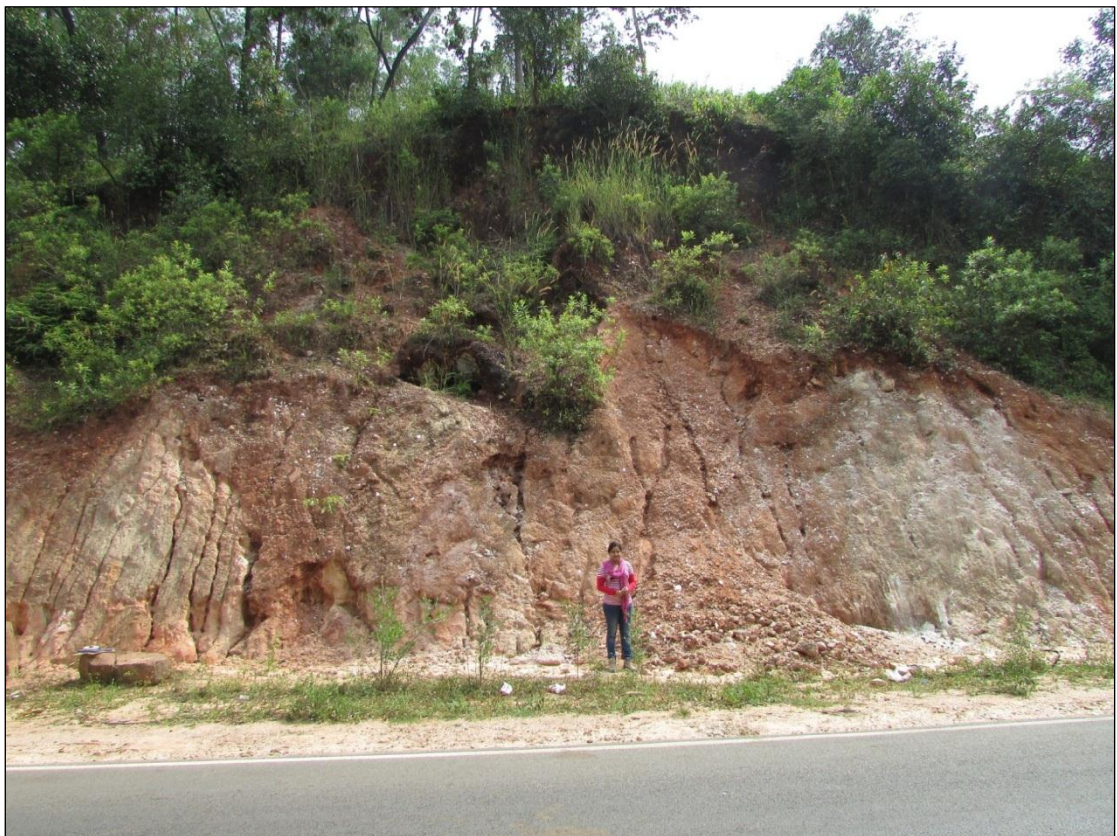
Photo – 6: Extensive Cut Slope near Kalasa along Kalasa – Kotighere road section in TS no 48O/08.

**Extensive Slope Cut:** Extensive Slope Cut in the study area refers to vertical to near vertical slope cuts along road sections (refer Photo – 6). In some places, extensive slope cut is observed adjacent to houses constructed on the hill slopes.

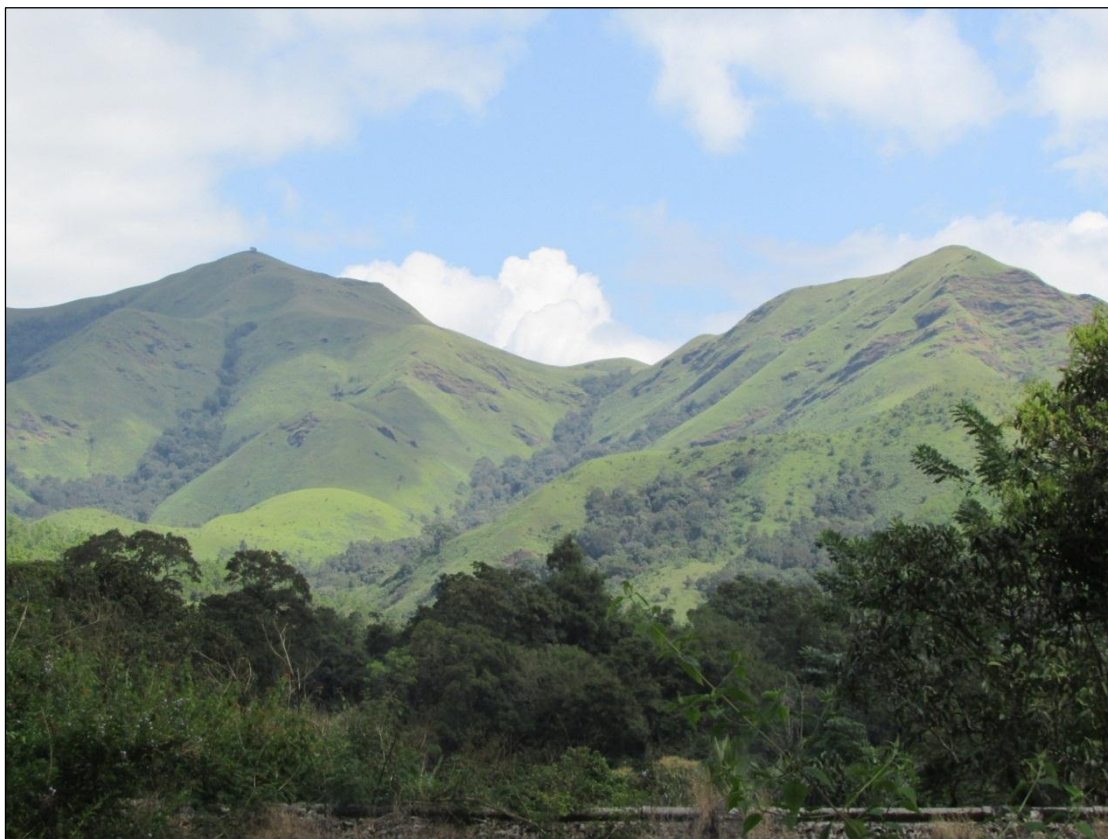
Photo – 10: View of Lowly Dissected Slope (LDS) (Geomorphology) near Kudremukh in TS no 48O/08.

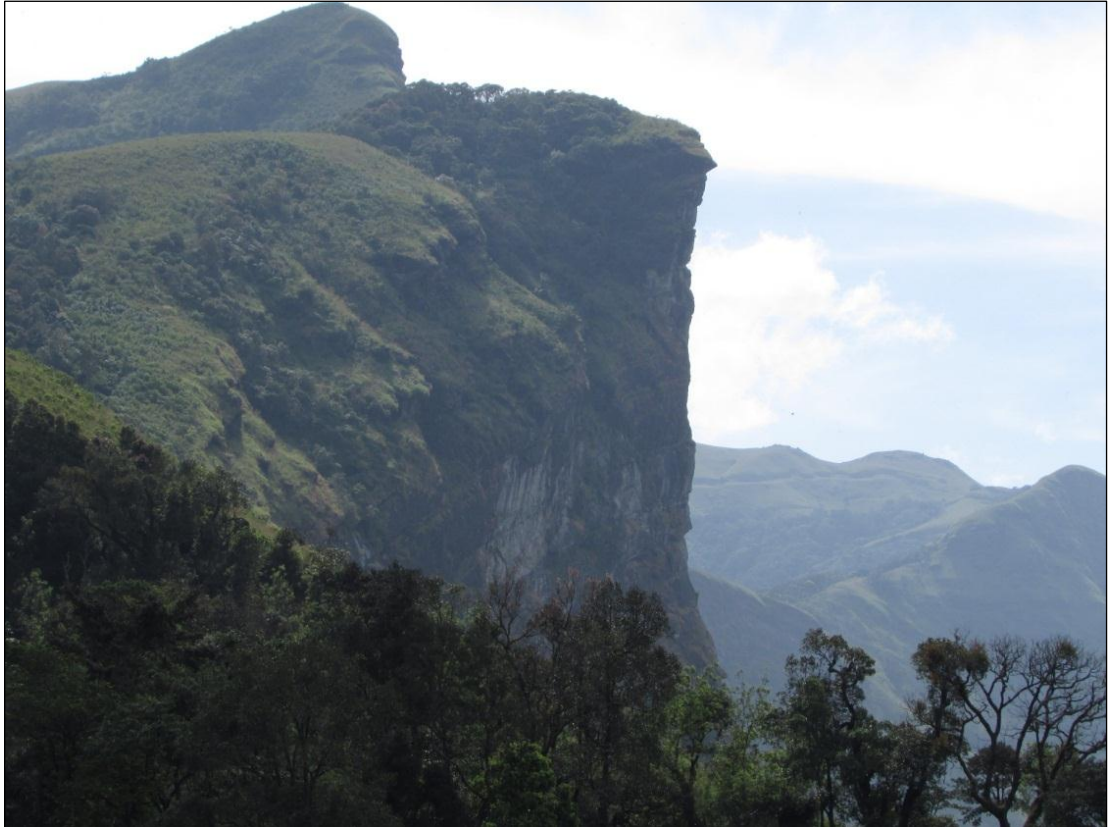
Photo – 11: View of Escarpment (Geomorphology) near Maidadi in TS no 48O/08.

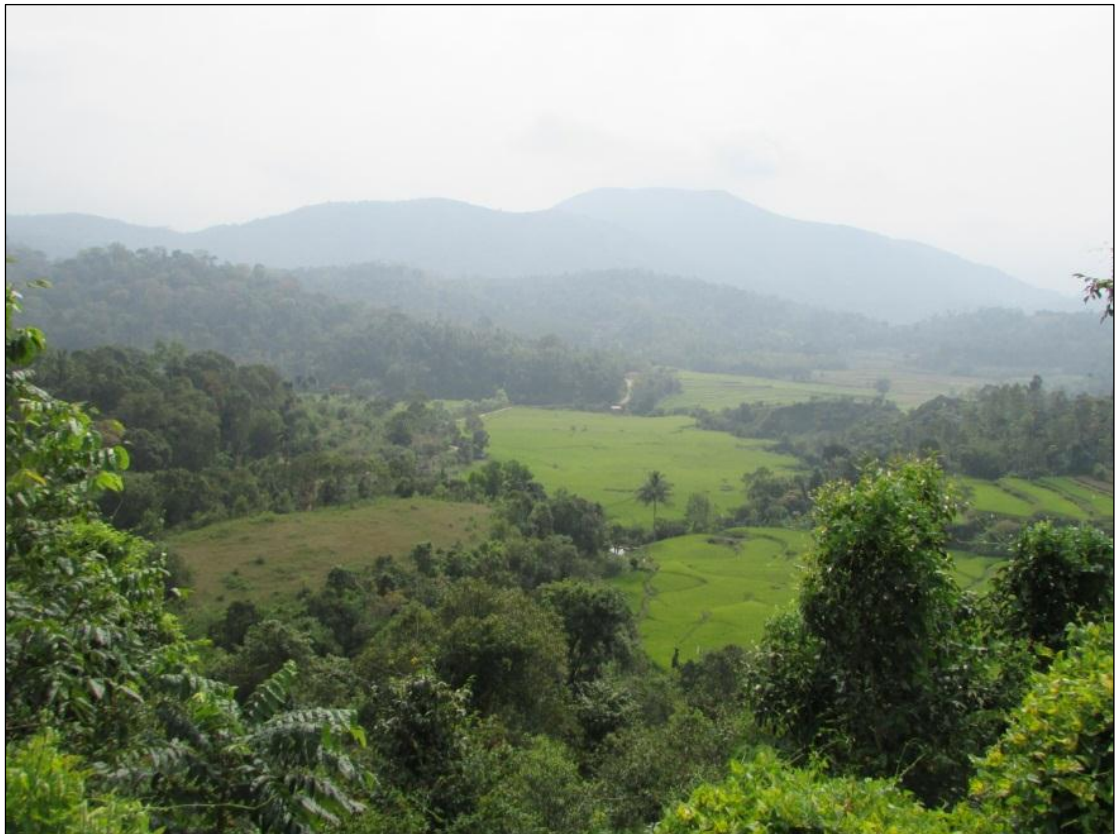
Photo – 12: View of Valley Fill (Geomorphology) covered with Cultivation (LULC) near Javali in TS no 48O/08.

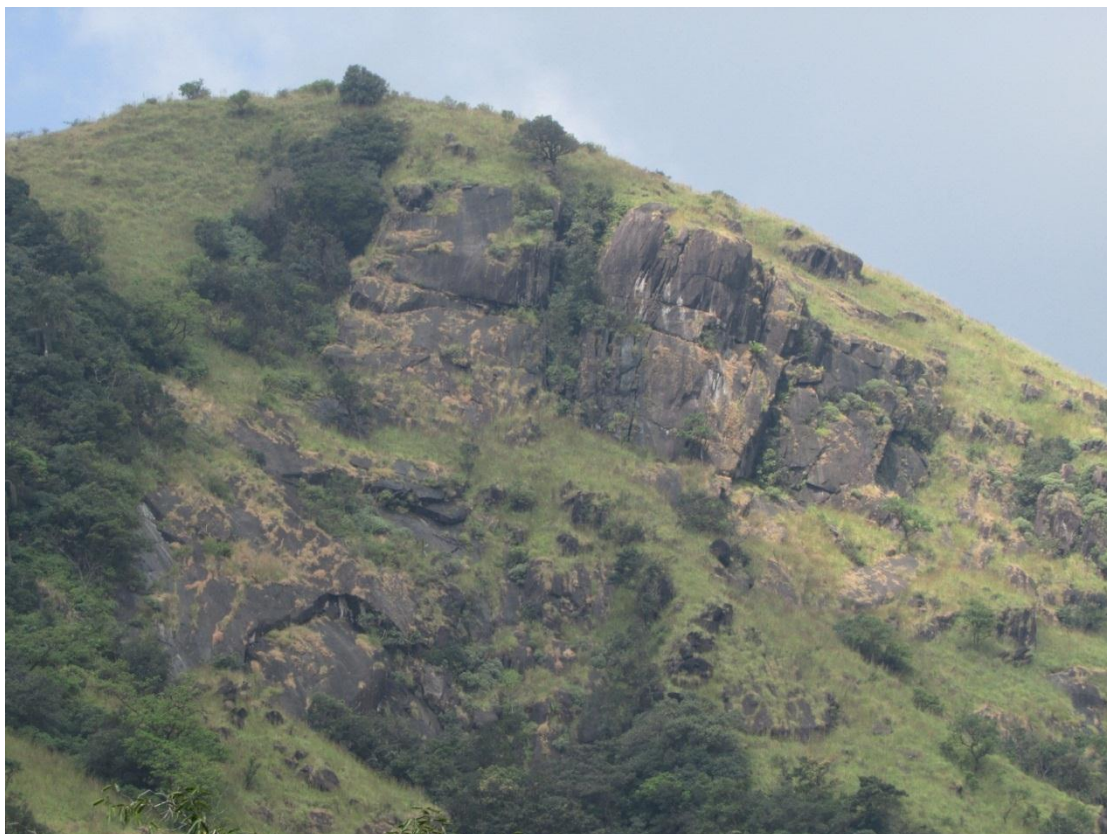
Photo – 13: Rock (SFM) is exposed along hill slope (LULC: Barren and RT is  $<0.5\text{m}$ ) near Jenu Kallu in TS no 48O/08.

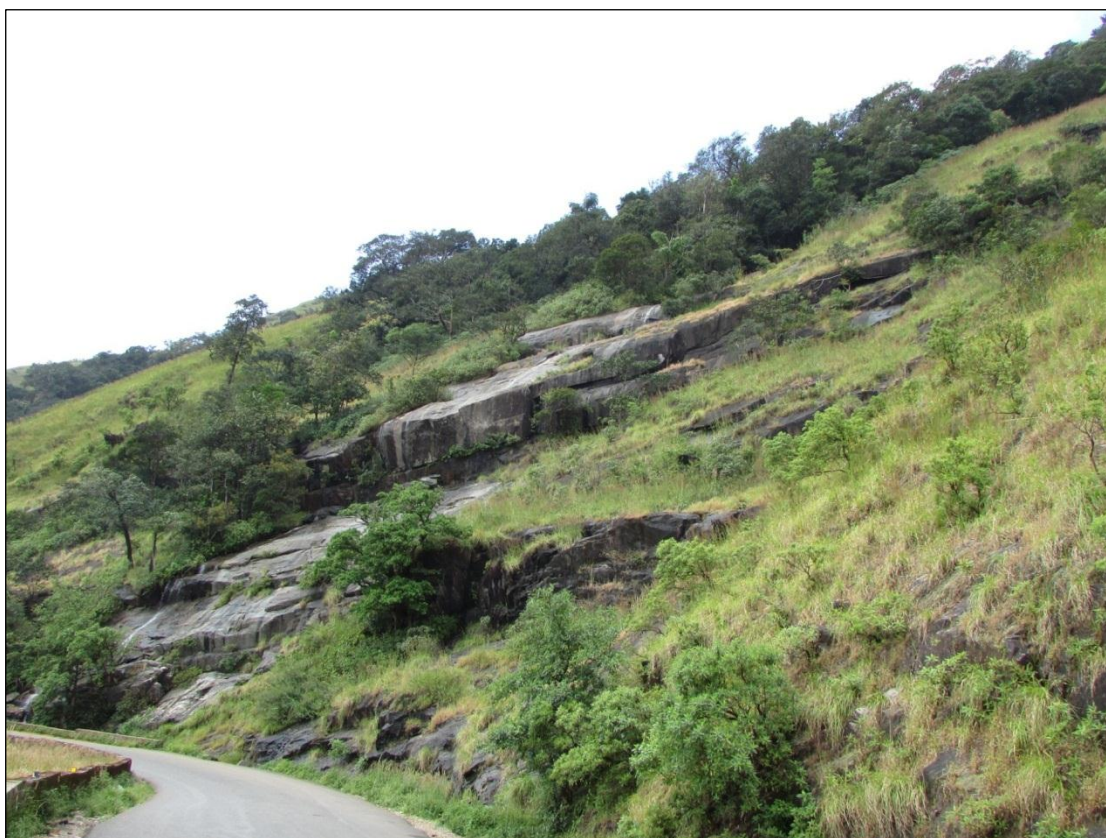
Photo – 14: Valley side dipping jointed rock (granite gneiss) exposed along Charmudi Ghat section in TS no 48O/08.
