**MACRO-SCALE (1:50,000) LANDSLIDE SUSCEPTIBILITY MAPPING IN PARTS OF TOPOSHEET NOS. 48I/8, 48I/10 AND 48I/11 BELGAUM AND UTTAR KANNADA DISTRICTS, KARNATAKA AND SOUTH GOA DISTRICT, GOA**

कार्य सत्र २०१८-१९ का अंतिम प्रतिवेदन  
Final report for field season 2018-19

PROJECT: NLSM / परियोजना: एनएलएसएम  
STATE UNIT: KARNATAKA & GOA/ राज्य इकाई: कर्नाटक एवं गोवा

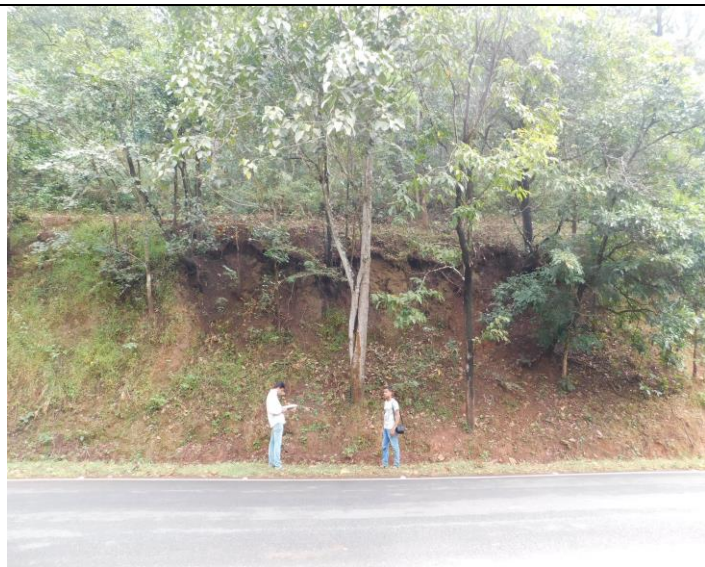
**Photo 1: Extensive Cut Slope in in-situ soil. South-West of Usoda, TS No. 48I/11.**

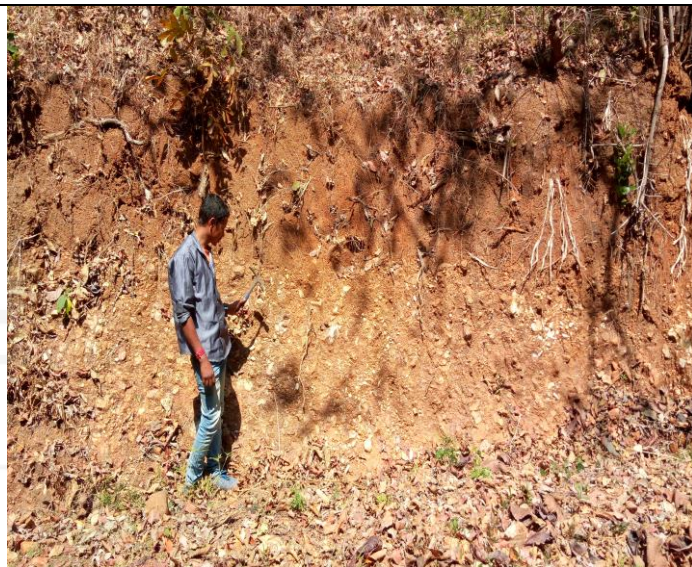
**Photo 2: Regolith thickness (~5m), E of Jhalavali, TS No. 48I/08.**

On slopes as well as ridge tops, barren rock is present at places where the slope gradient in general is more than 35°, most of the study area (about 89.8%) is covered by in-situ, granitic soil (**Photo-2, 6, 11, 12**) and rock (**Photo 9, 10**) (9.11%). The factor class rock includes overburden material of  $\leq 0.5\text{m}$  thickness. For this class different rock names are taken from the geological map of the study area by GSI. The class in-situ soil and amphibolites are assigned maximum weightage because minerals present in amphibolites are highly susceptible to weathering and the loose in-situ soil has poor shear strength due to

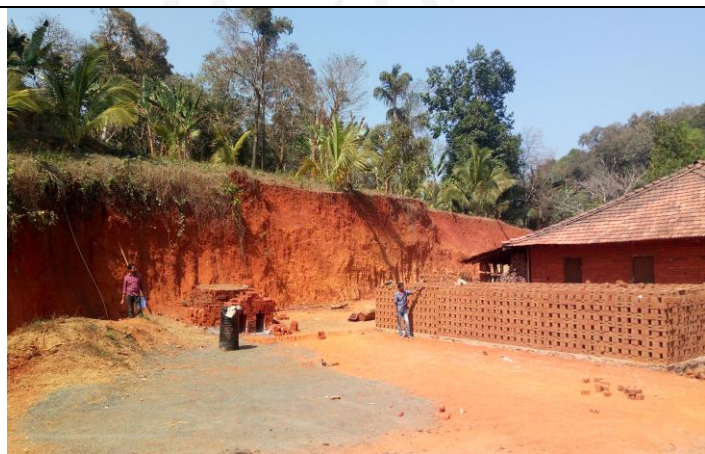
**Photo 3: Extensive Cut Slope for making bricks & settlement, Vill. Chandrali, TS No. 48I/8.**

Construction of roads, railways and reservoirs has opened channels for exploitation and caused rapid changes in LULC of the area. The land use and land cover (LULC) map (**PLATE 5**) was prepared from the Google Earth data of the year 2012-time frame. Following the normal mapping procedure in Google Earth, first the polylines of different land use/cover classes were drawn and the same were imported in Arc GIS through kml to feature conversion. In Arc GIS the features were converted into polygons and then again exported to Google Earth through layer to kml conversion. Each polygon was named as per its LULC class and reconverted into a shape file through kml to layer conversion. The obtained pre-field landuse/landcover map was checked in the field at all accessible locations. The area in terms of landuse/landcover can be classified in to the following classes: Barren, cultivation, settlement, settlement on modified slope, sparse vegetated areas, moderate vegetated areas, thick vegetated areas, river, low height plantation, high height plantation, extensive cut slope and fallow land. The area along river banks is covered with alluvial material and along low lying valleys is covered with overburden material and are being used for cultivation. Major part of the area (about 71.22%) is covered with thick forest in all of the study area. The next class of highest percent is occupied by cultivation that constitutes about 11.83% of the area. Moderate vegetation covers 7.46% of the study area followed by 1.43% of sparse vegetation. Settlements and settlement on modified slopes occupy about 1 % of the area. The total plantation area covered is 1.43% & Barren part (**Photo-8**) is 1.70% of the total area. LU/LC factor class 'Extensive slope cut' is observed to be most vulnerable sites for slope failures and occupies about 0.03% of the study area. The maximum weightage is given to extensive slope cut (Photo-1,3) followed by sparse vegetation and settlement on modified slopes which

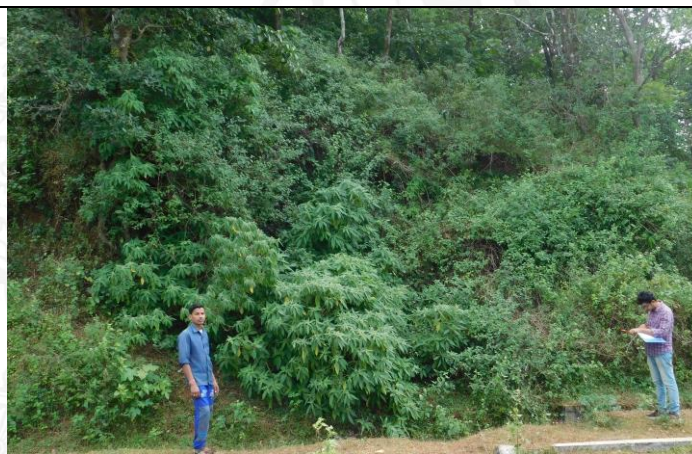
**Photo 4: Old landside scar, near Umbarpani, TS No. 48I/11.**

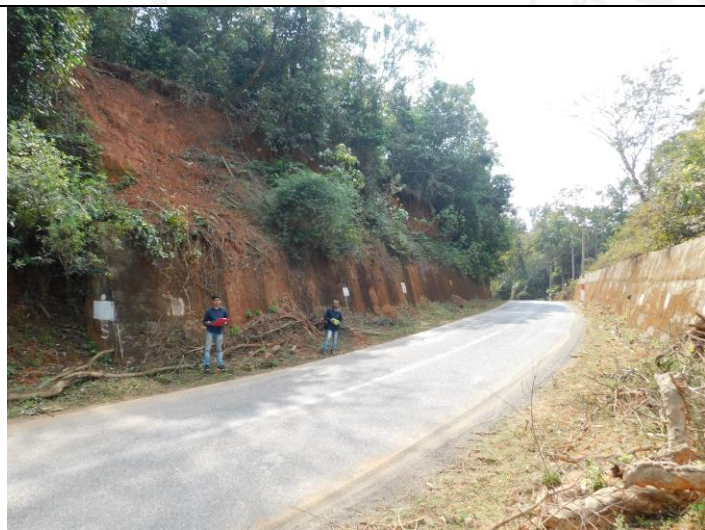
**Photo 5: Slope failure with retaining wall on both the side of road, West of Vill. Ghotaki, TS No. 48I/8**

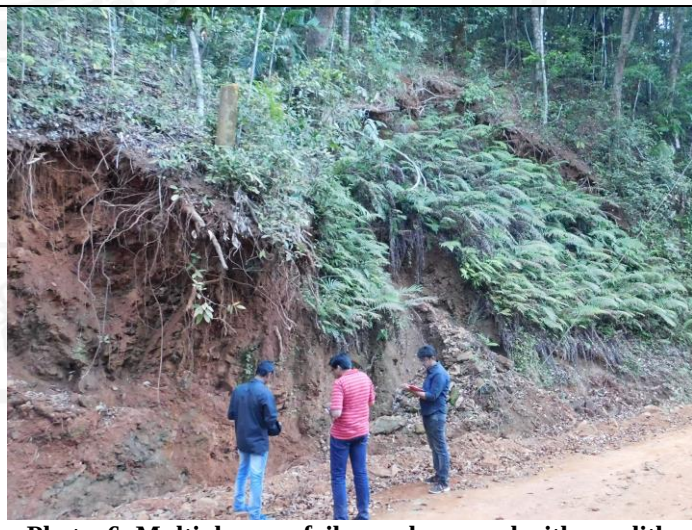
**Photo 6: Multiple mass failures along road with regolith thickness >5m, NW of Terali, TS No. 48I/8**

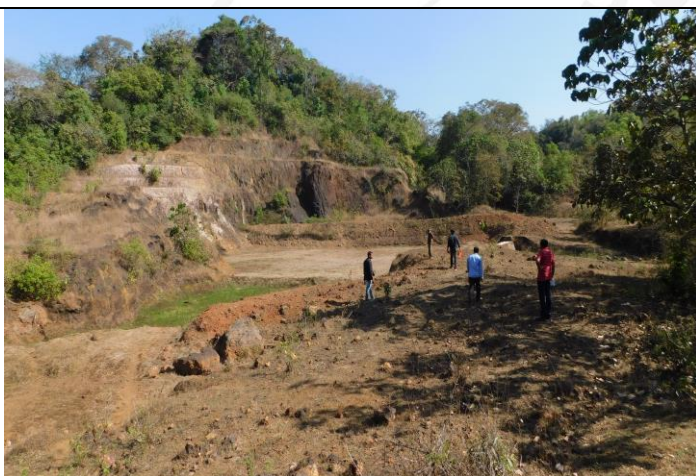
**Photo 9: Abandoned/Old Manganese ore mine at fold closure, ESE of Dudalimala; TS No. 48I/8.**

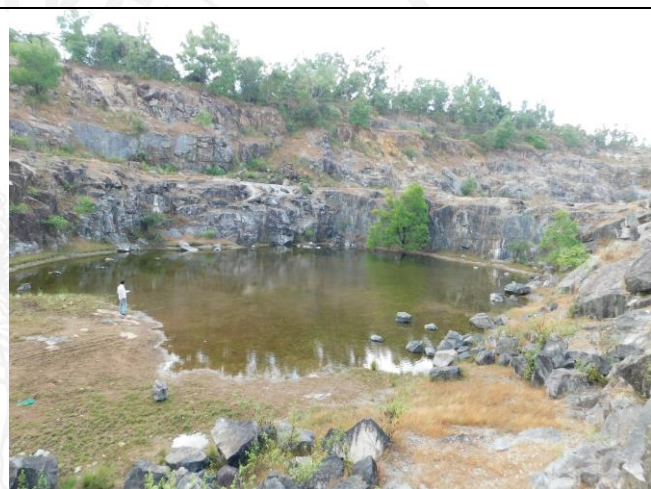
**Photo 10: Granite Quarry, North of Kumbhal; TS No. 48I/11.**

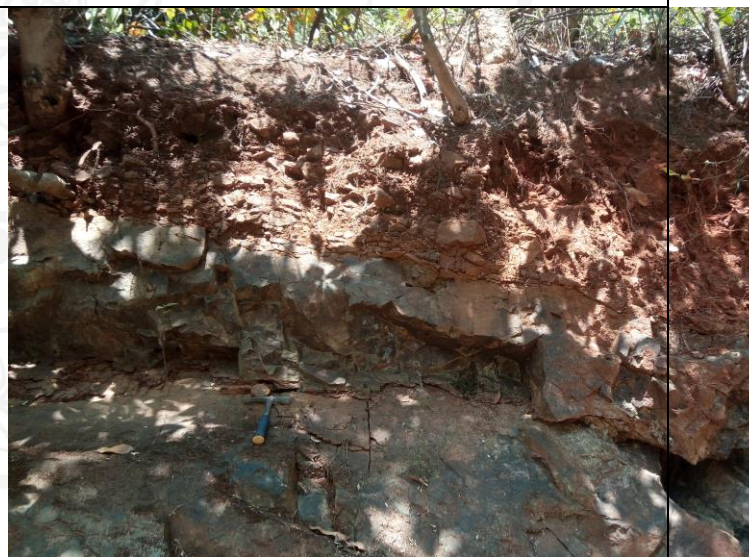
**Photo 12: Litho-Contact between Pyroxenite & weathered Gabbro. Mass Failure has been distinct along the discontinuity plane, East of Jhalavali; TS No. 48I/8.**

- Photo 11: Shallow translational failure in BIF (closely jointed) occurred in contact with Phyllite, NW of Virkhol; TS No. 48I/11.
- Photo 12: Litho-Contact between Pyroxenite & weathered Gabbro. Mass Failure has been distinct along the discontinuity plain, East of Jhalavali; TS No. 48I/8.

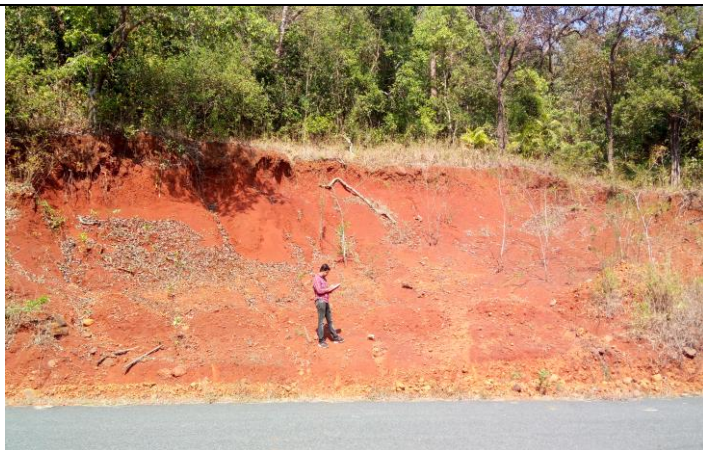
**Photo 13: Change in Land use Pattern, Soil excavation for construction purpose, East of Jhalavali; TS No. 48I/8.**

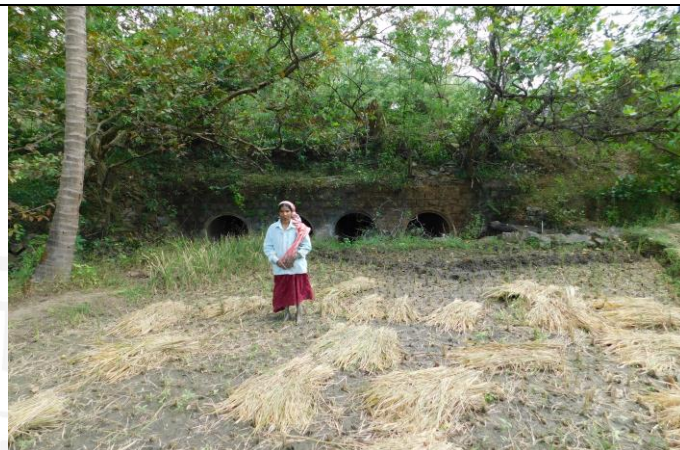
**Photo 14: Change in Land use Pattern, Nala has been converted into cultivation land, North of Kumbral ; TS No. 48I/11**

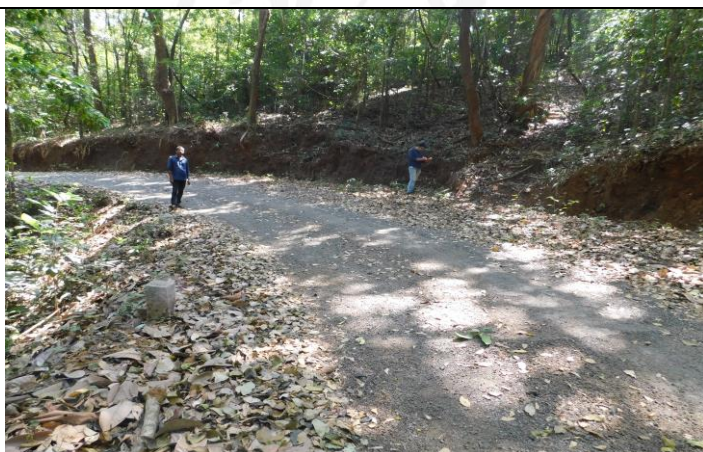
**Photo 15: Natural course of nala obstructed, Road cracks observed due to removal of soil underneath indicating subsidence, SW of Kanangaon; TS No. 48I/8**

- Photo 15: Natural course of nala obstructed, Road cracks observed due to removal of soil underneath indicating subsidence, SW of Kanangaon; TS No. 48I/8.

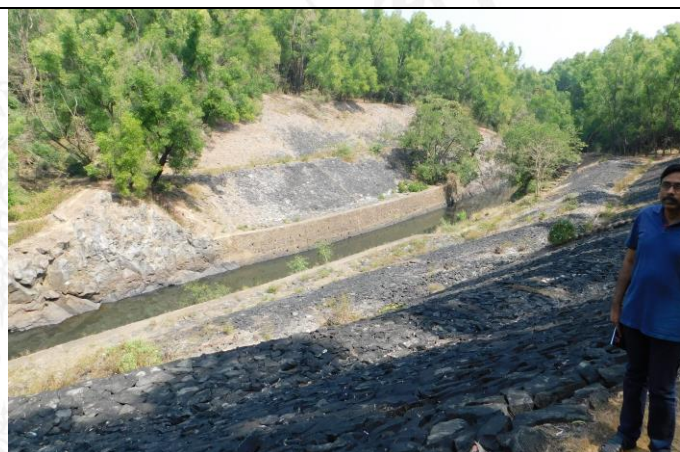
**Photo 16: Transportational water Tunnel, Benching & Rock pitching provided for slope stabilization, East of Kumbharvada; TS No. 48I/8.**

- Photo 16: Transportational water Tunnel, Benching & Rock pitching provided for slope stabilization, East of Kumbharvada; TS No. 48I/8.
- Photo 17: Extensive vertical cut slope observed in West of Kutvali; TS No. 48I/8.

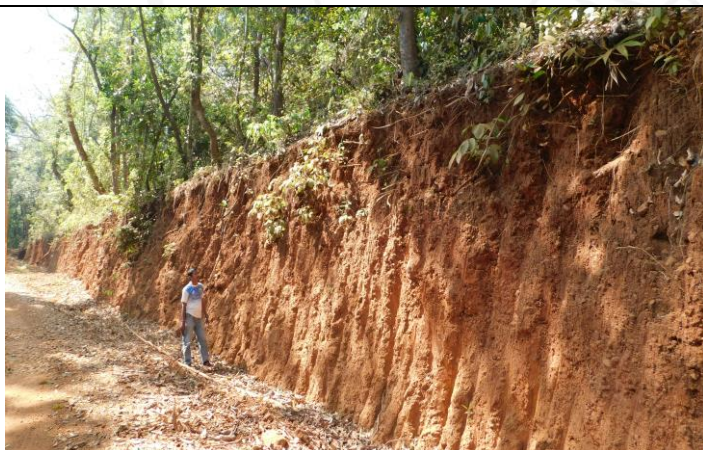
**Photo 17: Extensive vertical cut slope observed in West of Kutvali; TS No. 48I/8.**

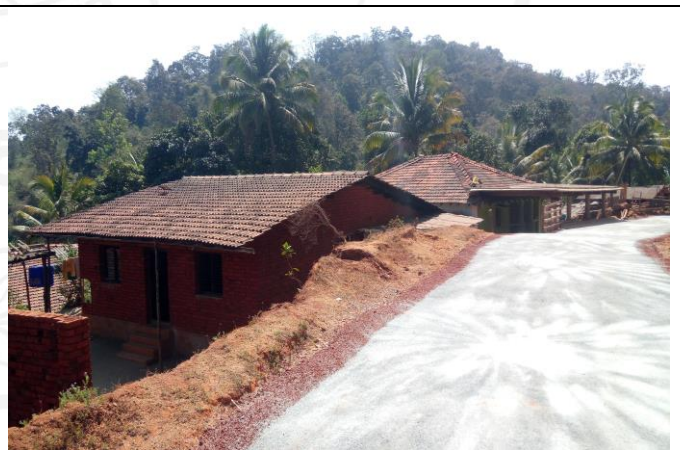
**Photo 18: Settlements on modified slope observed in Vill. Chandrali, TS No. 48I/8**

- Photo 18: Settlements on modified slope observed in Vill. Chandrali, TS No. 48I/8.

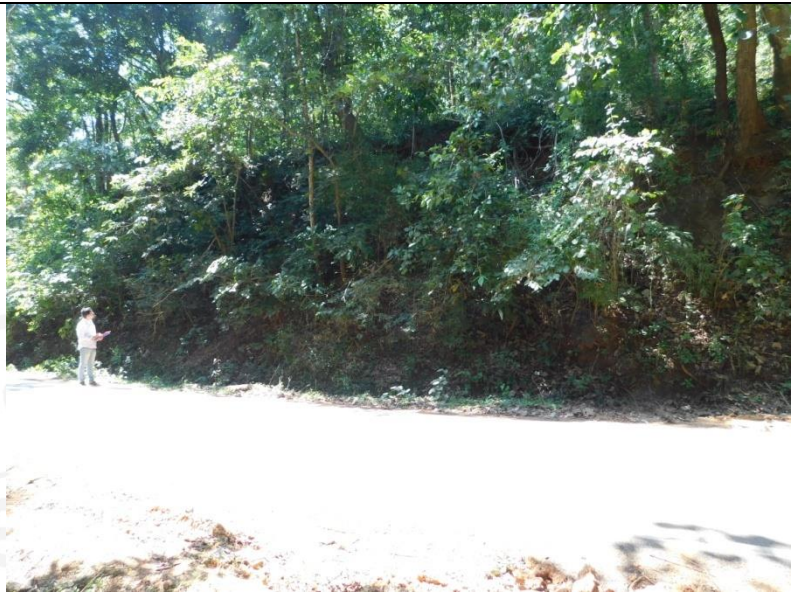
| 40 | Summary/Abstract | : | 36m wide multiple earth slides of retrogressive nature and shallow rotational failure is noticed. Toe cutting for road construction is responsible for slope destabilization. Retaining wall with weep holes are recommended as remedial measure. |

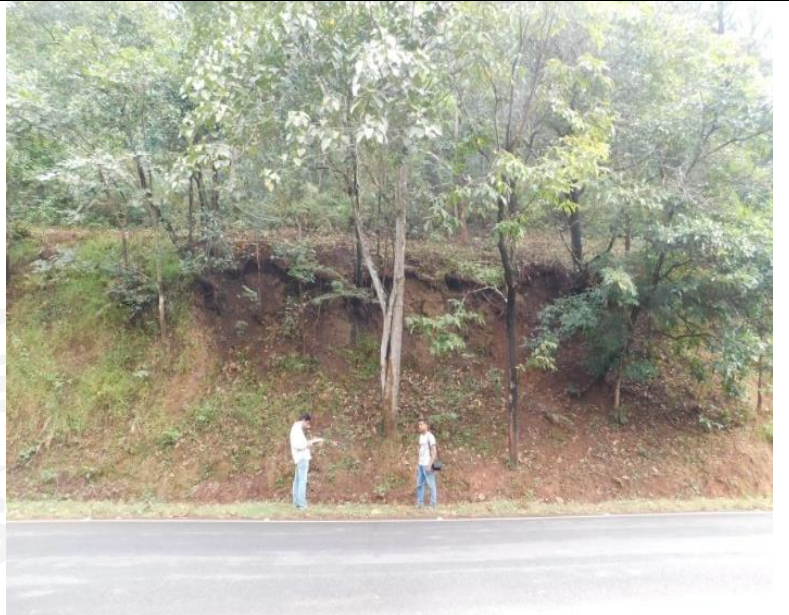
| 40 | Summary/Abstract | : | Active landslide occurs due to toe cutting of slope for road construction. Shallow rotational failure and retrogressive nature are evident from slope face. |

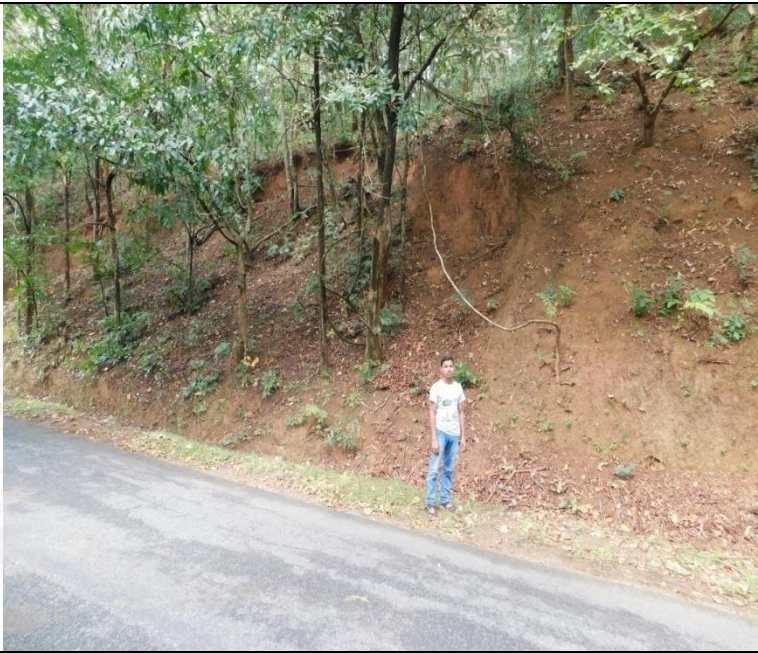
| 40 | Summary/Abstract | : | Toe cutting of slope in argillitic terrain causes retrogressive shallow rotational failure. |

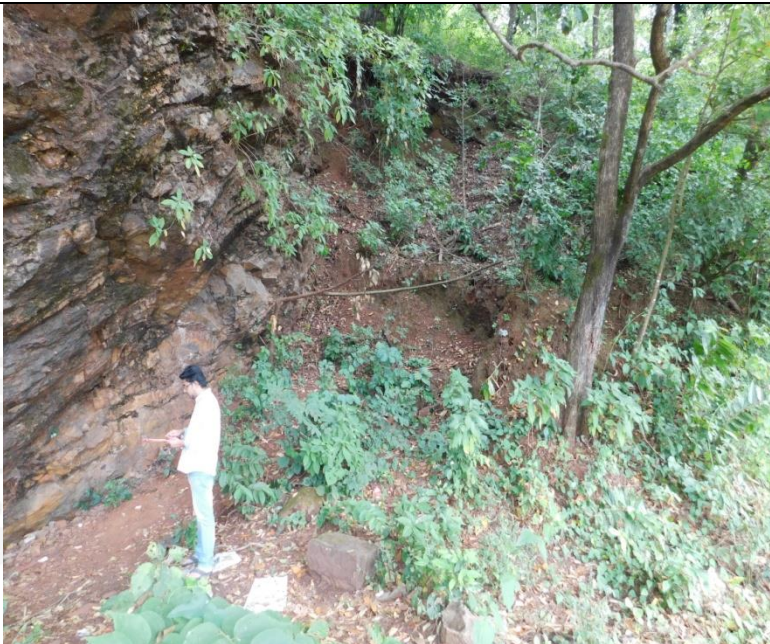
| 39 | Photos. Sketch of Plan & section of the slide | : | |

| No | Field | | Description |
|---|---|---|---|
| 38 | Remarks, if any | | Landslide is getting widened gently. The passing through spring can be triggered in monsoons. |

| 40 | Summary/Abstract | : | Saturation due to water seepage makes the location prone to landslide incidences. |

| No | Field | | Description |
|---|---|---|---|
| 37 | Remedial measures | : | Breast wall with weep holes is suggested |

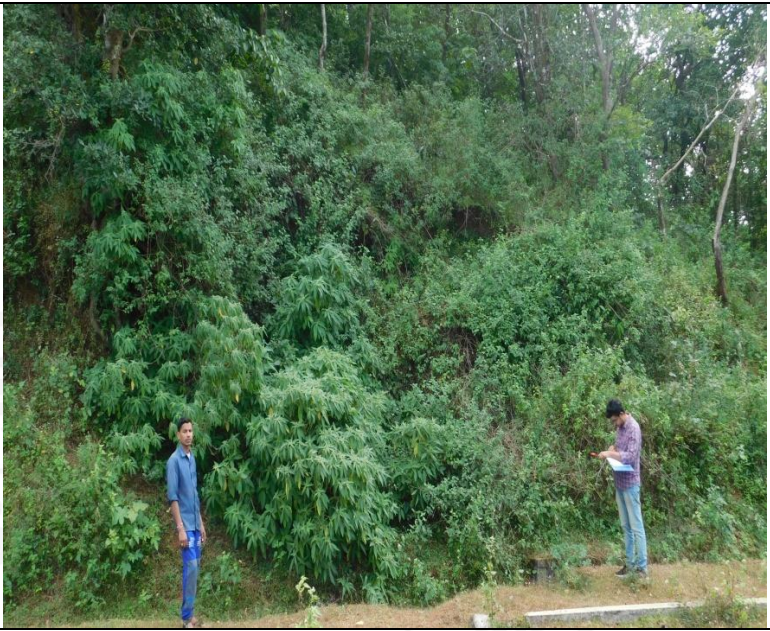
| 40 | Summary/Abstract | : | High slope angle and stream cutting across the slope makes it vulnerable for landslide. Loose boulders are observed on slope so wire mesh need to be provided. |

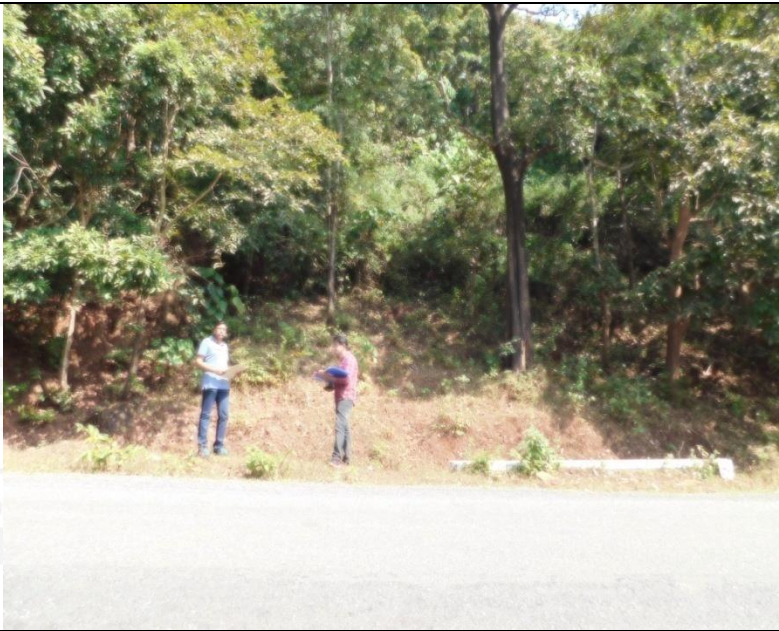
| 39 | Photos. Sketch of Plan & section of the slide | : | |

| No | Field | | Description |
|---|---|---|---|
| 38 | Remarks, if any | | Nala is cutting across slope and road. |

| 40 | Summary/Abstract | : | Suspended retrogressive earth slide due to toe cutting of slope. |

| No | Field | | Description |
|---|---|---|---|
| 37 | Remedial measures | : | Removal of boulders from culvert thereby maintaining the flow of drainage during rainfall. |

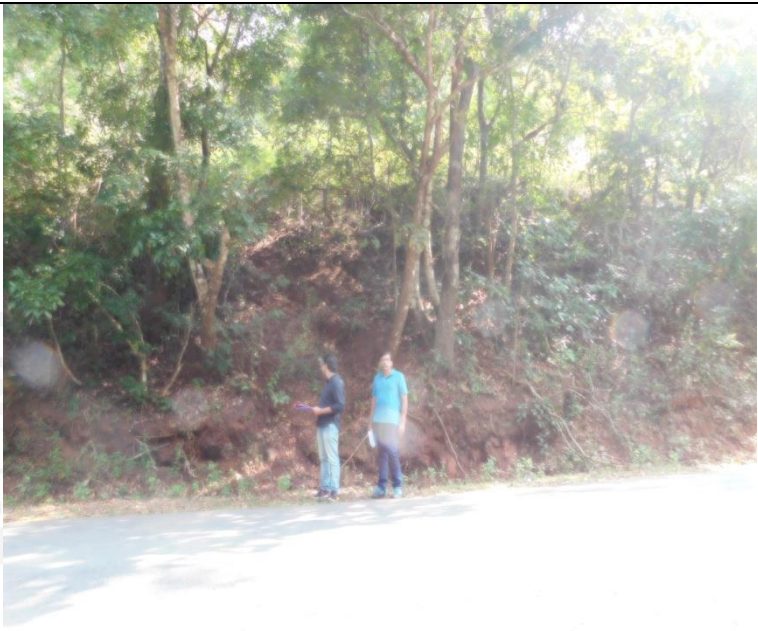
| 39 | Photos. Sketch of Plan & section of the slide | : | |

| No | Field | | Description |
|---|---|---|---|
| 38 | Remarks, if any | | Uprooting of trees is observed. The same may be removed. |

| 40 | Summary/Abstract | : | Debris-cum-earth slide is occurring in phyllitic terrain due to improper drainage network. |

| No | Field | | Description |
|---|---|---|---|
| 37 | Remedial measures | : | Retaining wall with weep holes and proper drainage |

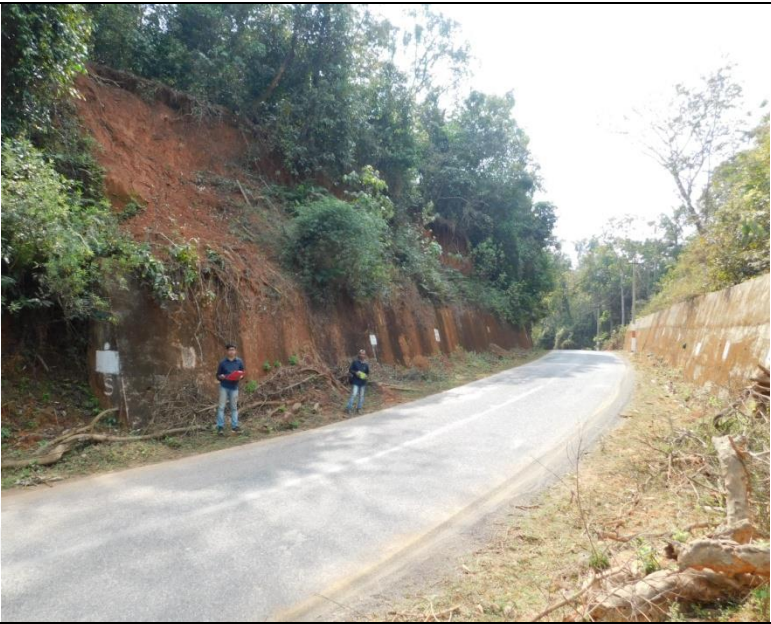
| 40 | Summary/Abstract | : | Active slide of 45m width is observed on State highway 34, Increasing the width of the retaining wall and easing the slope above it will prove beneficial in restraining slide. |

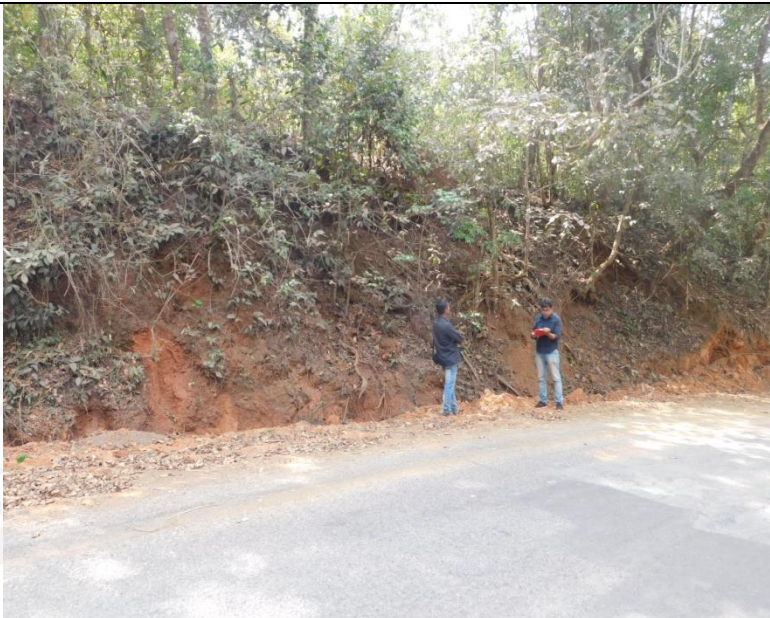
| 39 | Photos. Sketch of Plan & section of the slide | : | |

| No | Field | | Description |
|---|---|---|---|
| 38 | Remarks, if any | | Creeping of trees and hanging roots are observed. |

| 40 | Summary/Abstract | : | Suspended retrogressive shallow rotational slide is observed on granitic terrain. |

| No | Field | | Description |
|---|---|---|---|
| 37 | Remedial measures | : | Retaining wall with weep holes is suggested |

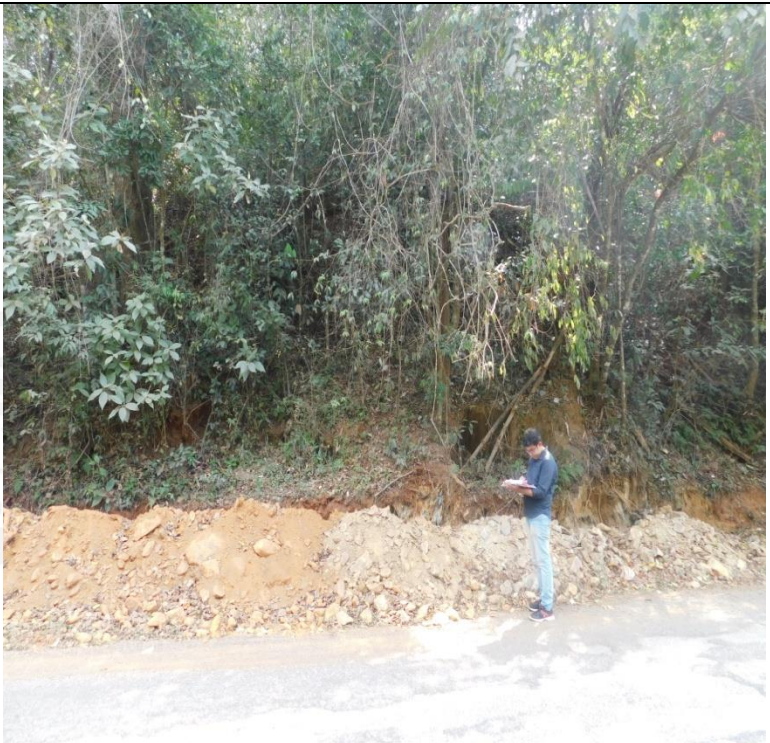
| 39 | Photos. Sketch of Plan & section of the slide | : | |

| 40 | Summary/Abstract | : | Oversaturation by ground water and closely spaces jointed causes landslide aided by toe cutting and heavy rainfall. |

| No | Field | | Description |
|---|---|---|---|
| 37 | Remedial measures | : | Breast wall with weep holes is suggested. Proper drainge should be provided at downslope to avoid road subsidence. |

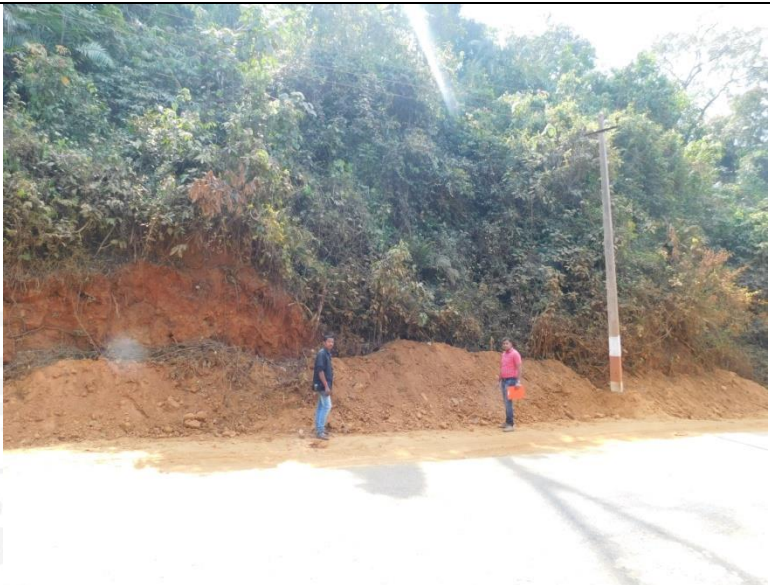
| 39 | Photos. Sketch of Plan & section of the slide | : | |

| No | Field | | Description |
|---|---|---|---|
| 38 | Remarks, if any | | Weathered rocks are observed on slope. |

| 40 | Summary/Abstract | : | Suspended retrogressive shallow rotational slide is observed on granitic terrain. |

| No | Field | | Description |
|---|---|---|---|
| 37 | Remedial measures | : | Retaining wall with weep holes is suggested |

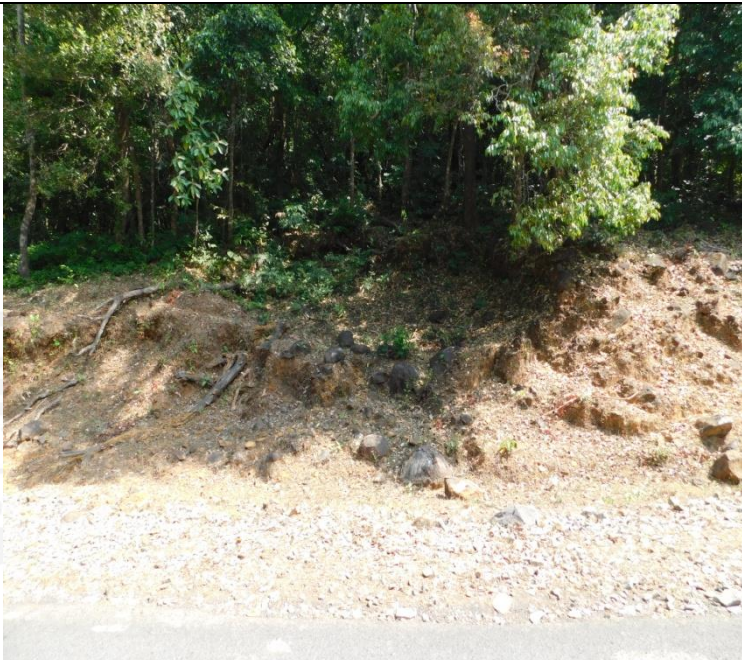
| 40 | Summary/Abstract | : | High slope angle and toe cutting of the slope makes it vulnerable for landslide. Loose boulders are observed on slope so a protective wall is to be provided. |

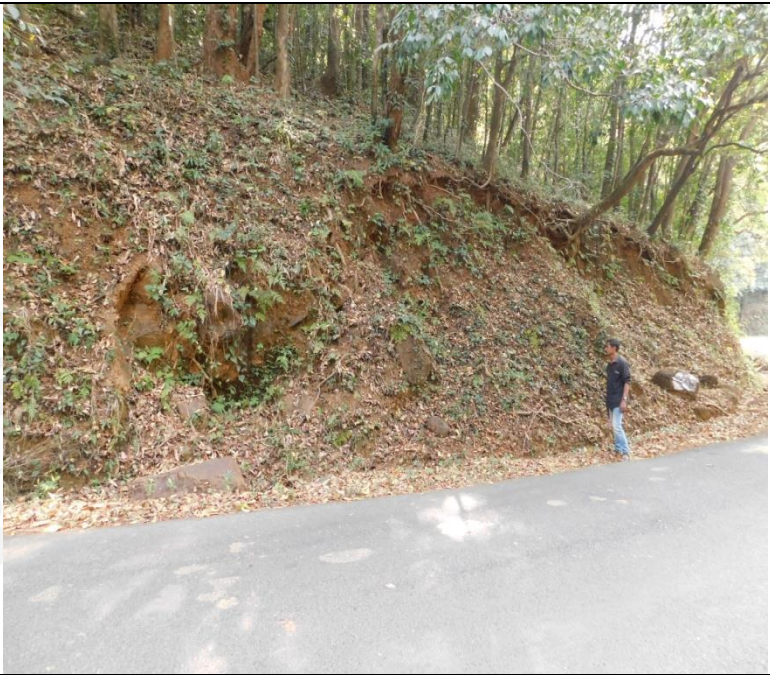
| 39 | Photos. Sketch of Plan & section of the slide | : | |

| 40 | Summary/Abstract | : | Retrogressive composite slide is occurring at rock-soil interface at curve of road. Damp condition prevails. |

| No | Field | | Description |
|---|---|---|---|
| 37 | Remedial measures | : | Breast wall with weep holes is suggested |

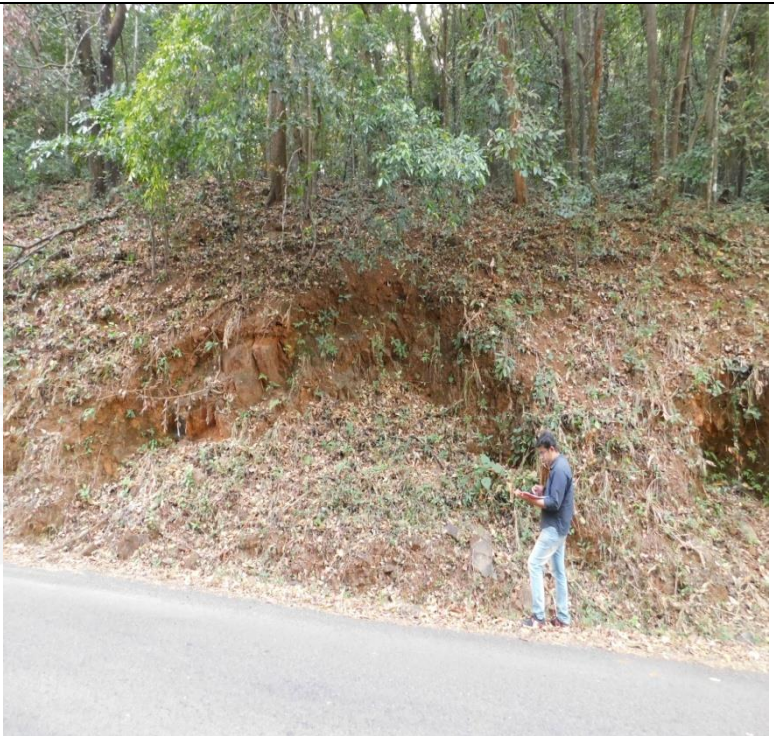
| 39 | Photos. Sketch of Plan & section of the slide | : | |

| No | Field | | Description |
|---|---|---|---|
| 38 | Remarks, if any | | Damp soil on slope. |

| 40 | Summary/Abstract | : | Suspended retrogressive shallow rotational slide is observed on granitic terrain. |

| No | Field | | Description |
|---|---|---|---|
| 37 | Remedial measures | : | Retaining wall with weep holes is suggested |

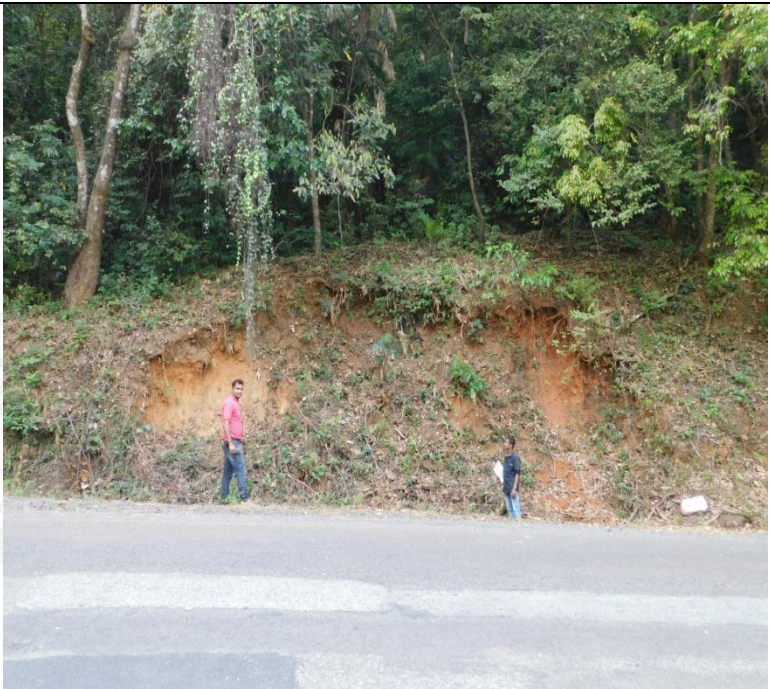
| 39 | Photos. Sketch of Plan & section of the slide | : | |

| 40 | Summary/Abstract | : | Suspended retrogressive shallow rotational slide is observed on granitic terrain. |

| No | Field | | Description |
|---|---|---|---|
| 37 | Remedial measures | : | Retaining wall with weep holes is suggested |

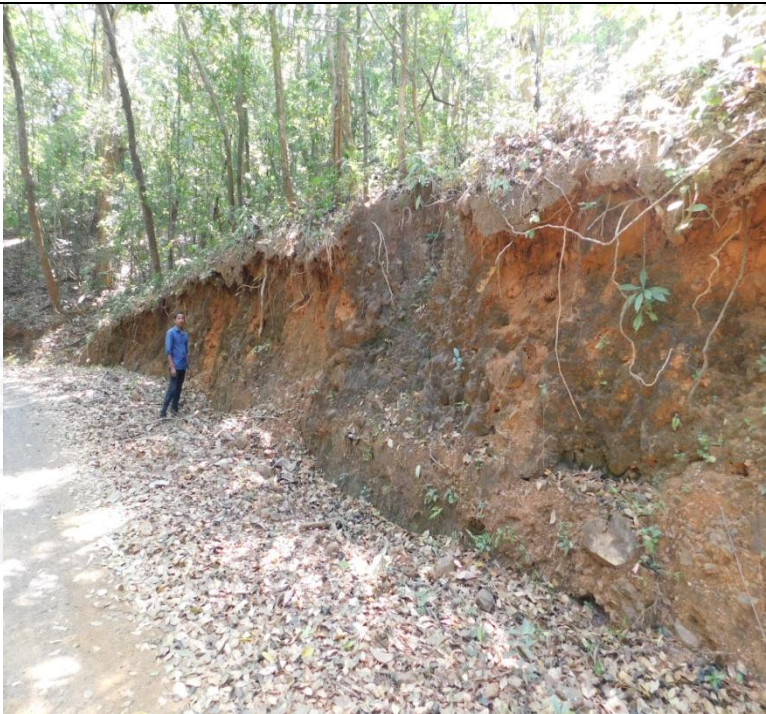
| 39 | Photos. Sketch of Plan & section of the slide | : | |

| No | Field | | Description |
|---|---|---|---|
| 38 | Remarks, if any | | Obstruction of Natural course of Nala results in subsidence of road due to removal of soil underneath. |

| 40 | Summary/Abstract | : | Oversaturation by ground water and closely spaces jointed caused landslide aided by toe cutting and heavy rainfall. |

| No | Field | | Description |
|---|---|---|---|
| 37 | Remedial measures | : | Providing culvert and construction of retaining wall are recommended. |

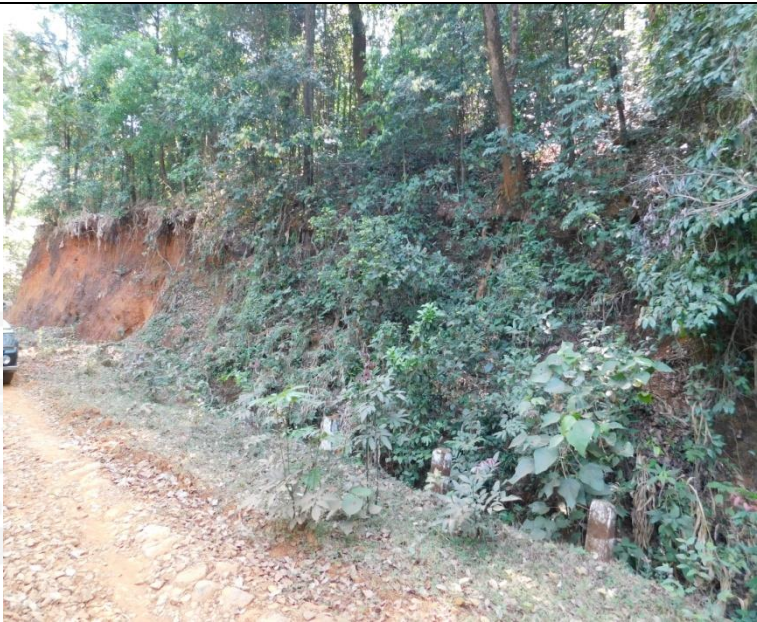
| 39 | Photos. Sketch of Plan & section of the slide | : | |

| No | Field | | Description |
|---|---|---|---|
| 38 | Remarks, if any | | Slided material are lying on the base of slope. |

| 40 | Summary/Abstract | : | Suspended retrogressive shallow rotational slide is observed on granitic terrain. |

| No | Field | | Description |
|---|---|---|---|
| 37 | Remedial measures | : | Retaining wall with weep holes and proper management of drainage |

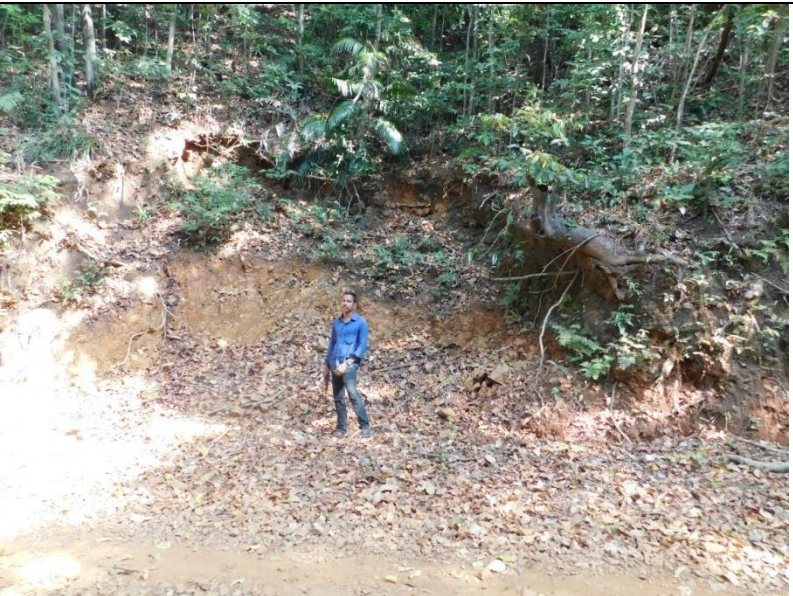
| 39 | Photos. Sketch of Plan & section of the slide | : | |

| No | Field | | Description |
|---|---|---|---|
| 38 | Remarks, if any | : | Weathered rocks are observed on slope. |

| 40 | Summary/Abstract | : | Suspended shallow rotational slide is observed. Slide is Widening and retrogressive in nature. Improper drainage played a major role in causing the slide. |

| No | Field | | Description |
|---|---|---|---|
| 37 | Remedial measures | : | Retaining wall with weep holes and proper management of drainage |

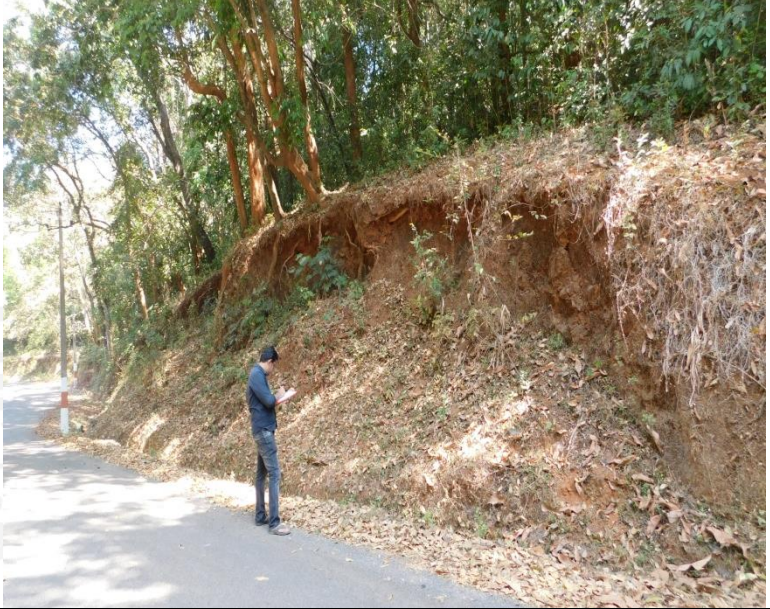
| 39 | Photos. Sketch of Plan & section of the slide | : | |

| No | Field | | Description |
|---|---|---|---|
| 38 | Remarks, if any | | Cracks are visible at the crown of slide. |

| 40 | Summary/Abstract | : | Suspended retrogressive shallow rotational slide is observed at contact zone of granite gneiss and metabasalt. |

| No | Field | | Description |
|---|---|---|---|
| 37 | Remedial measures | : | Retaining wall with weep holes is suggested |

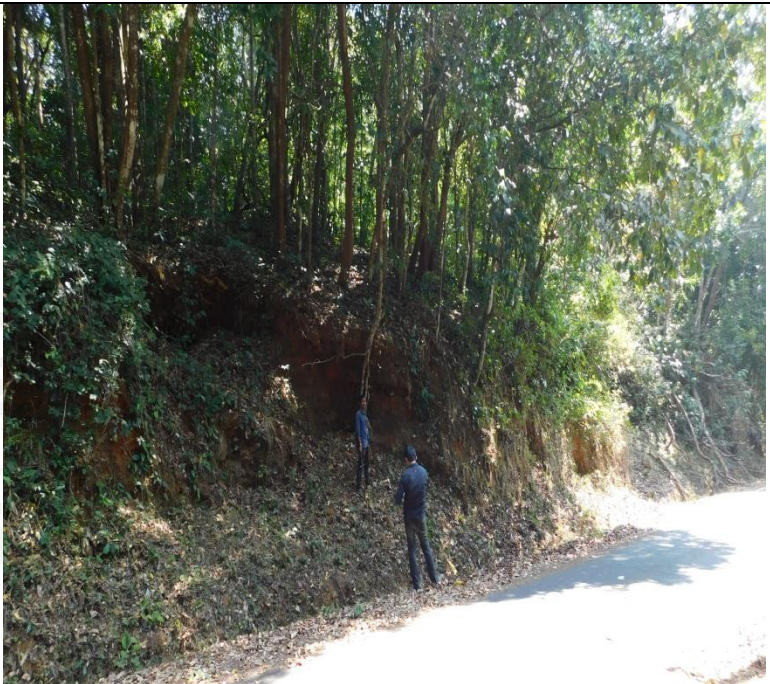
| 39 | Photos. Sketch of Plan & section of the slide | : | |

| No | Field | | Description |
|---|---|---|---|
| 38 | Remarks, if any | | Uprooting of trees is observed. The same may be removed. |

| 40 | Summary/Abstract | : | Debris-cum-rock slide occurred due to toe cutting of slope facilitated by well jointed rock mass. It's a composite slide. |

| No | Field | | Description |
|---|---|---|---|
| 37 | Remedial measures | : | Retaining wall with weep holes is suggested |

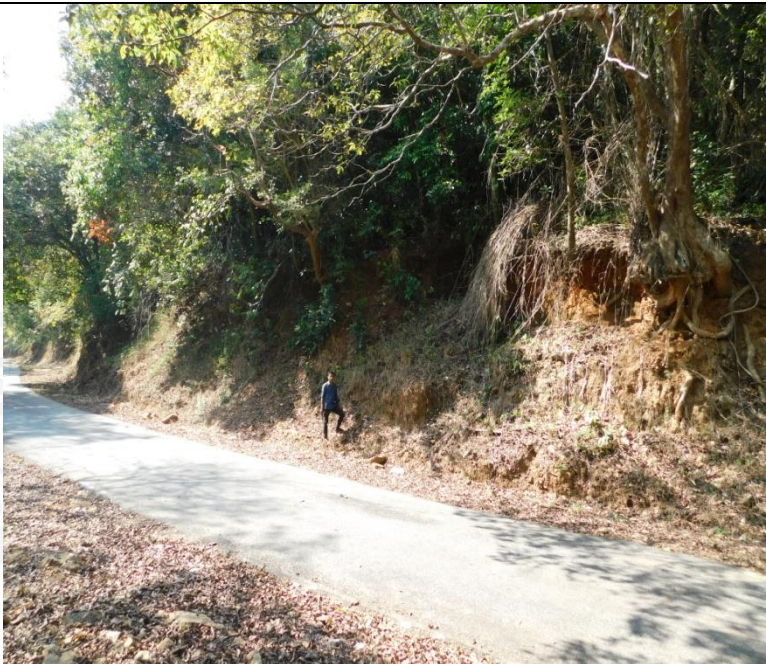
| 39 | Photos. Sketch of Plan & section of the slide | : | |

| No | Field | | Description |
|---|---|---|---|
| 38 | Remarks, if any | | Cracks are visible at the crown of slide. |

| 40 | Summary/Abstract | : | Suspended retrogressive shallow rotational slide is observed on granitic terrain. |

| No | Field | | Description |
|---|---|---|---|
| 37 | Remedial measures | : | Retaining wall with weep holes is suggested |

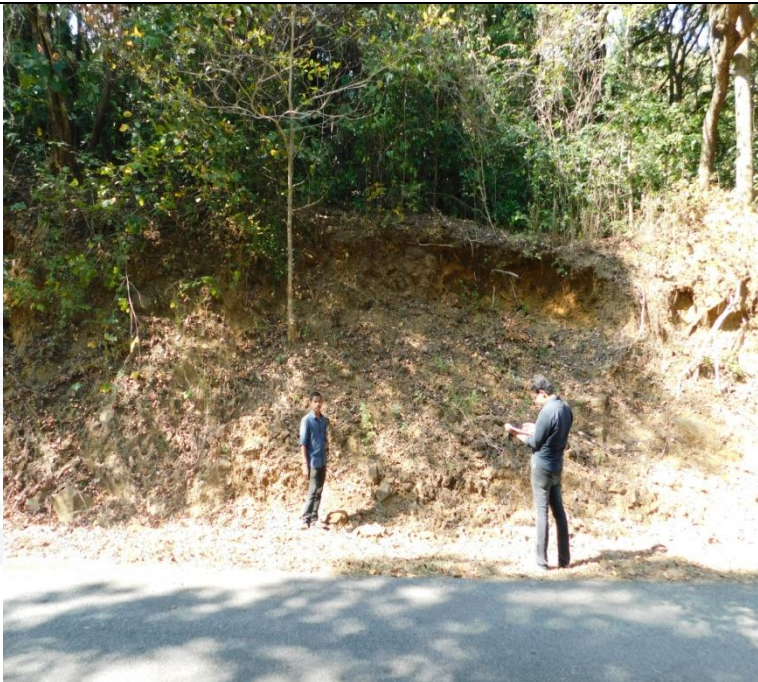
| 39 | Photos. Sketch of Plan & section of the slide | : | |

| No | Field | | Description |
|---|---|---|---|
| 38 | Remarks, if any | | Stream is flowing on down slope side of road. |

| 40 | Summary/Abstract | : | Suspended retrogressive shallow rotational slide is observed on granitic terrain. |

| No | Field | | Description |
|---|---|---|---|
| 37 | Remedial measures | : | Retaining wall with weep holes is suggested |

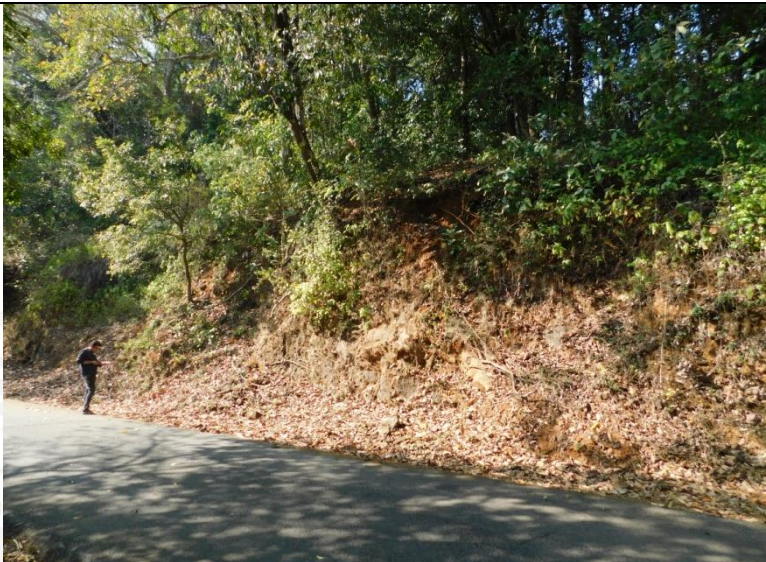
| 39 | Photos. Sketch of Plan & section of the slide | : | |

| No | Field | | Description |
|---|---|---|---|
| 38 | Remarks, if any | | Stream is flowing on down slope side of road. |

| 40 | Summary/Abstract | : | Debris-cum-rock Suspended retrogressive shallow rotational slide is observed on granitic terrain. |

| No | Field | | Description |
|---|---|---|---|
| 37 | Remedial measures | : | Retaining wall with weep holes is suggested |

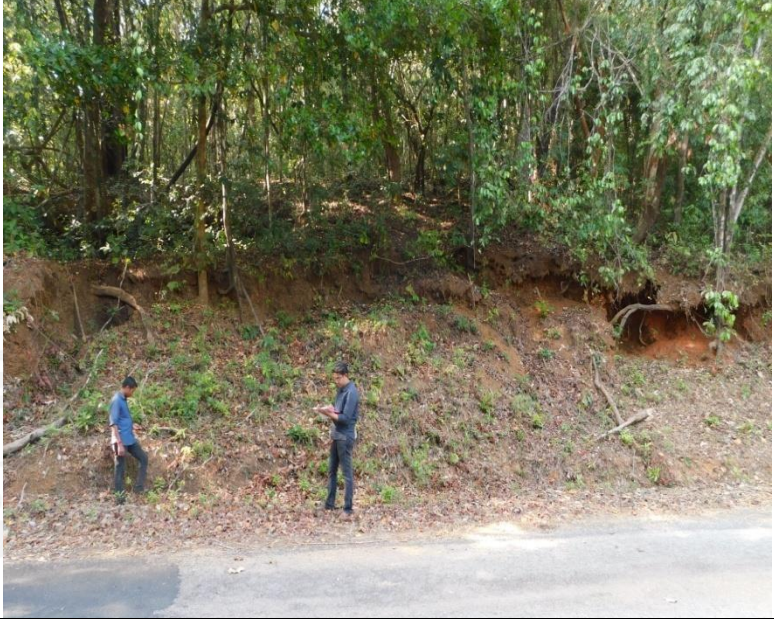
| 39 | Photos. Sketch of Plan & section of the slide | : | |

| 40 | Summary/Abstract | : | Suspended retrogressive shallow rotational debris slide is observed on granitic terrain. |

| No | Field | | Description |
|---|---|---|---|
| 37 | Remedial measures | : | Breast wall with weep holes is suggested |

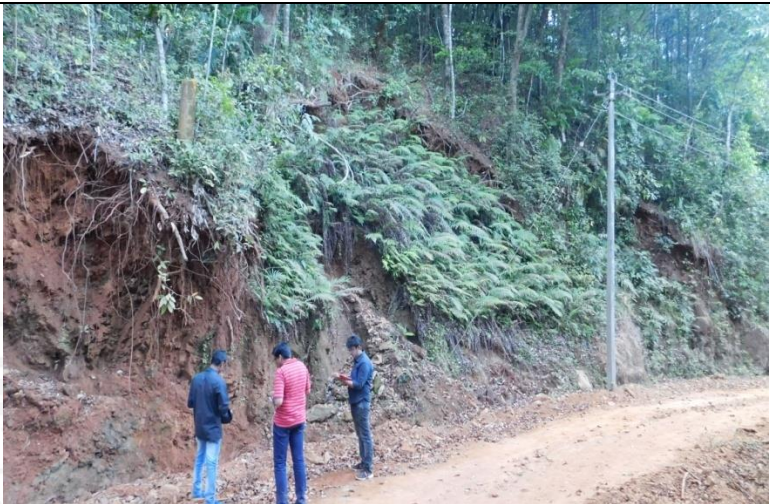
| 40 | Summary/Abstract | : | Active slide of 40m width occurred due to toe cutting on high slope gradient .Quartz chlorite schist is the underlying lithology which is observed to be highly jointed. Multiple failures observed at different interval. |

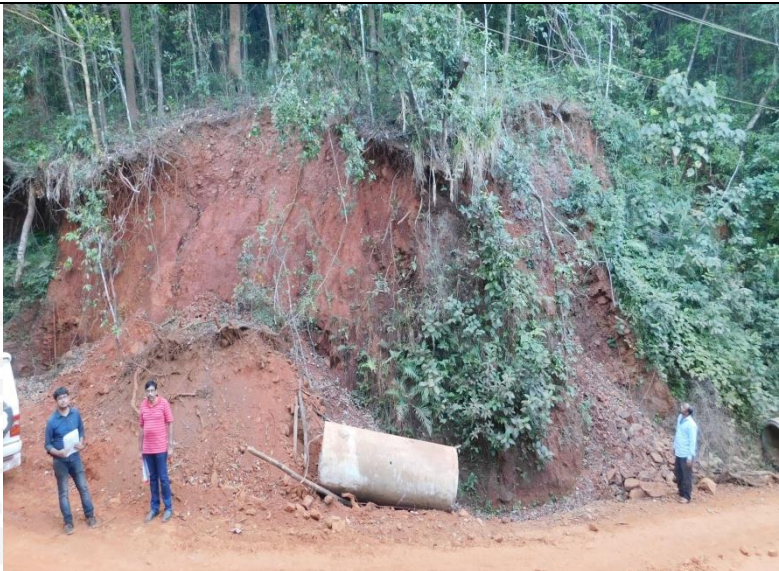
| 39 | Photos. Sketch of Plan & section of the slide | : | |

| No | Field | | Description |
|---|---|---|---|
| 38 | Remarks, if any | | Loose debris are observed at crown of slide. |

| 40 | Summary/Abstract | : | Debris-cum-rock slide occurred due to toe cutting of slope facilitated by well jointed rock mass. |

| No | Field | | Description |
|---|---|---|---|
| 37 | Remedial measures | : | Retaining wall with weep holes is suggested |

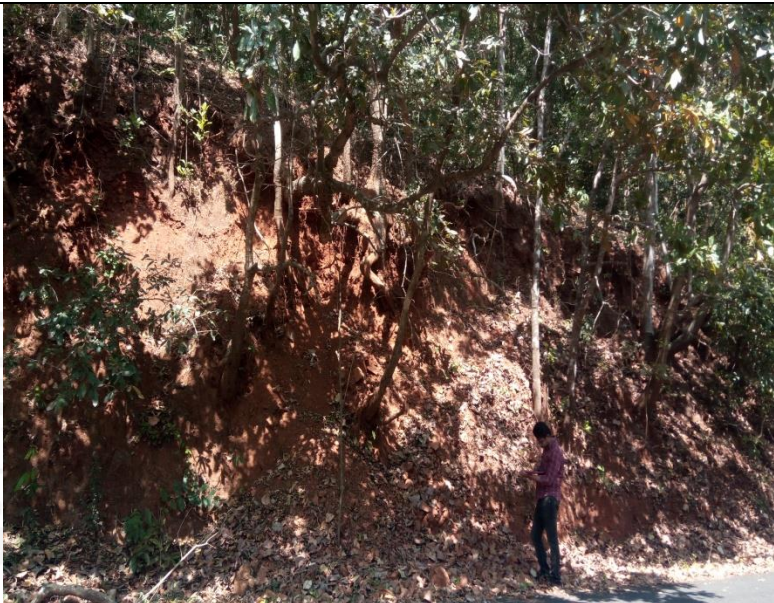
| 39 | Photos. Sketch of Plan & section of the slide | : | |

| No | Field | | Description |
|---|---|---|---|
| 38 | Remarks, if any | | Dolerite dyke has intruded metabasalts at the location. |

| 40 | Summary/Abstract | : | Suspended retrogressive shallow rotational slide is observed. Jointed metabasalts are present. |

| No | Field | | Description |
|---|---|---|---|
| 37 | Remedial measures | : | Breast wall with weep holes is suggested |
