REPORT ON MACRO-SCALE (1: 50,000) LANDSLIDE SUSCEPTIBILITY  
MAPPING IN PARTS OF TOPOSHEET NO. 48I/01, 48I/02 AND 48I/03, BELAGAVI  
DISTRICT, KARNATAKA AND NORTH GOA AND SOUTH GOA DISTRICTS,  
GOA

(FSP Code No: FSP CODE NO: M4LSSM/NC/SR/SU-KG/2019/27977)

FIELD SEASON: 2019-20

PROJECT: NLSM / परियोजना: एनएलएसएम

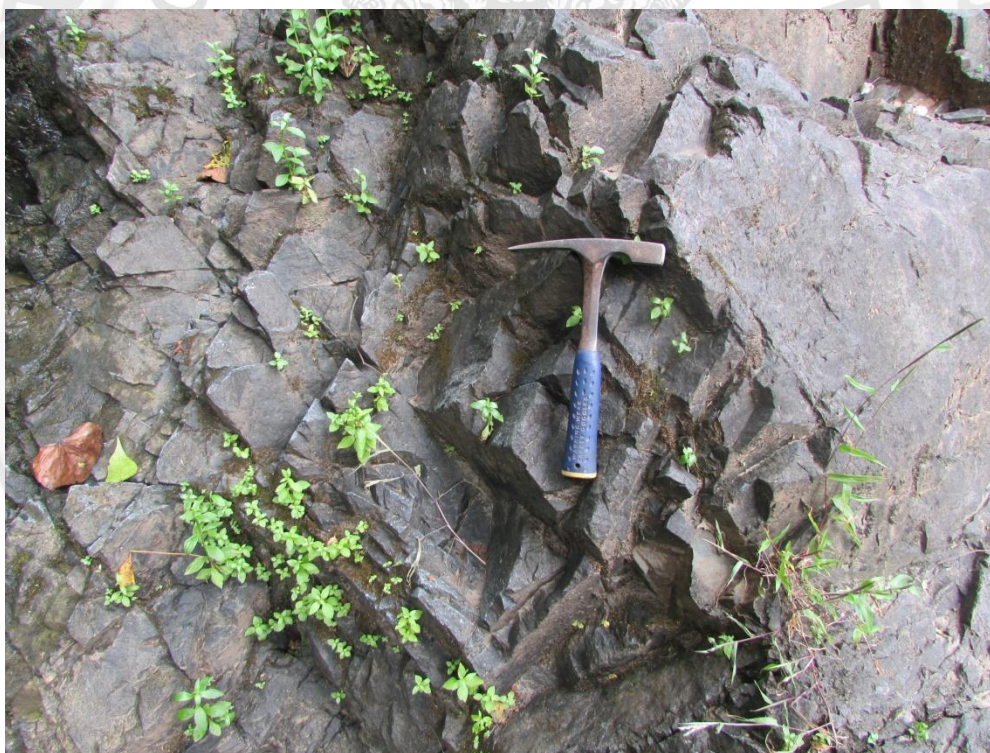
Fig. 1.3: Granite gneiss exposed along Anmod Ghat section.

Peninsular Gneiss – I form the basement of overlying volcano-sedimentary rocks. It shows foliation parallel to the trend of volcano-sediments and it is traversed by quartzo-feldspathic veins. Granite gneisses are tonalitic - trondhjemitic in composition which is locally called Anmod Ghat gneisses ( Fig. 1.3) and exposed in the eastern part of the study area. The rock is light grey in colour; medium to coarse grained, foliated and shows prominent gneissosity. Enclaves of amphibolite and garnetiferous mica schists are found within the gneiss. Granite Gneiss of PGC is exposed mainly in the Eastern part of the study area in Anmod Ghat.

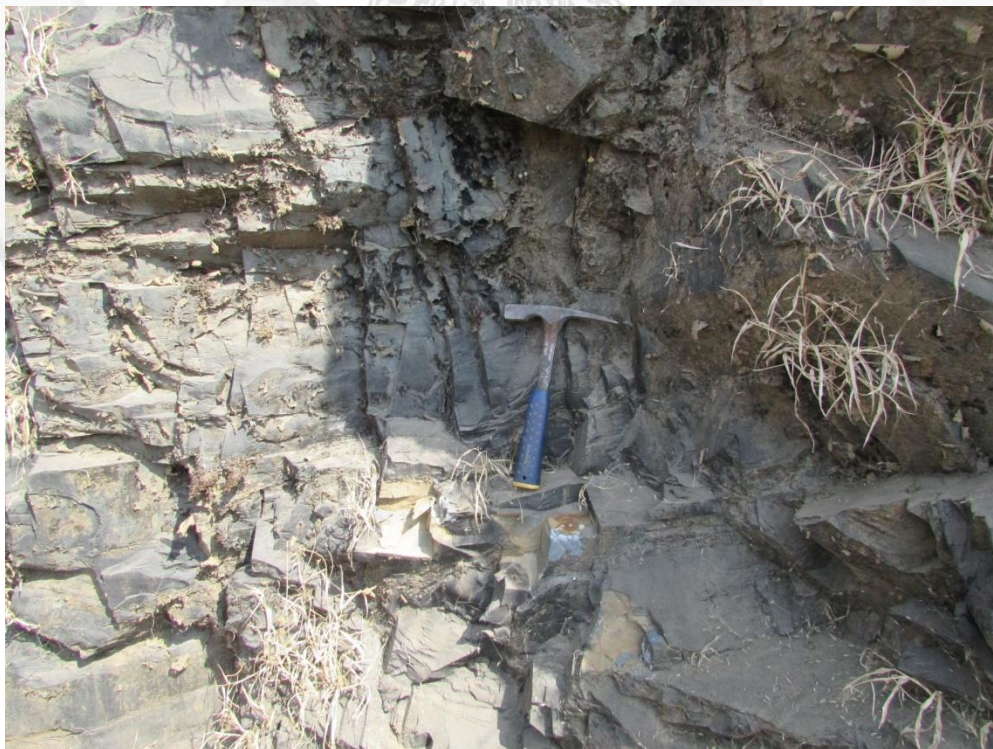
Argillites are extensively exposed in the area. The rock is fine to medium grained, grey to greenish in colour, hard and schistose at places. Argillite consists of rock fragments, quartz, chlorite, sericite and feldspar. Argillite is exposed near Keri and Anjuna Dam area ( Fig. 1.4).

Fig. 1.4: Argillite exposed near Anjuna Dam along Chorla Ghat section.

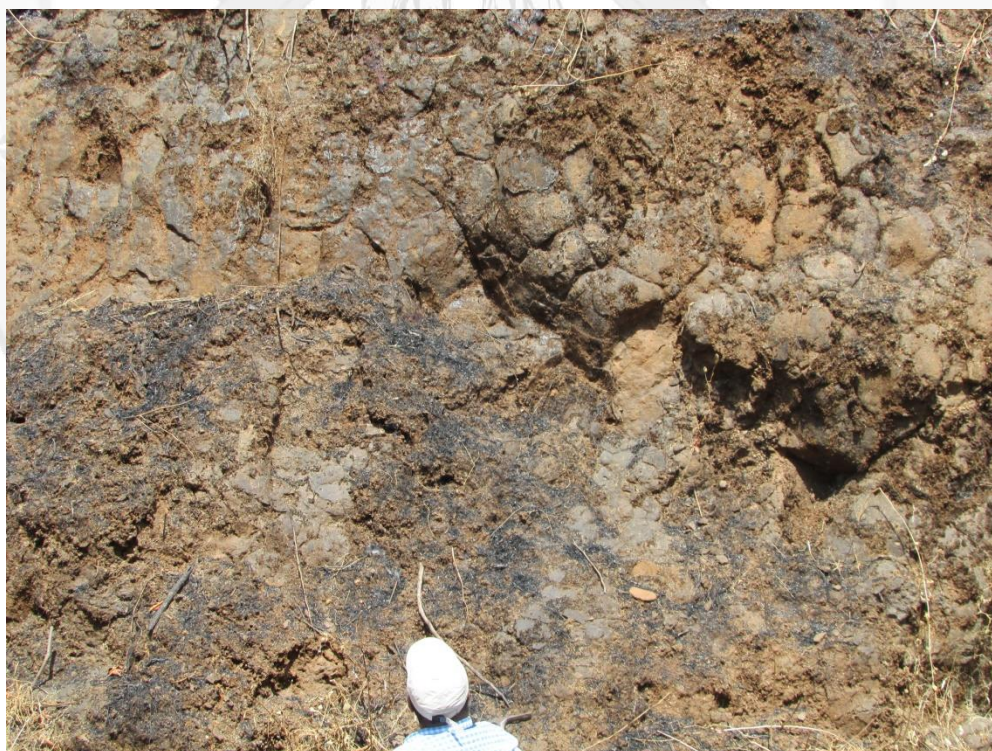
The basaltic lava flows of deccan trap are exposed in the north and north eastern part of the area near Chorla (refer: Fig. 1.5). These undifferentiated flows have been lateralized to varying extent and bauxitic at places.

Fig. 1.5: Deccan Basalt exposed near Chorla along Chorla Ghat section.

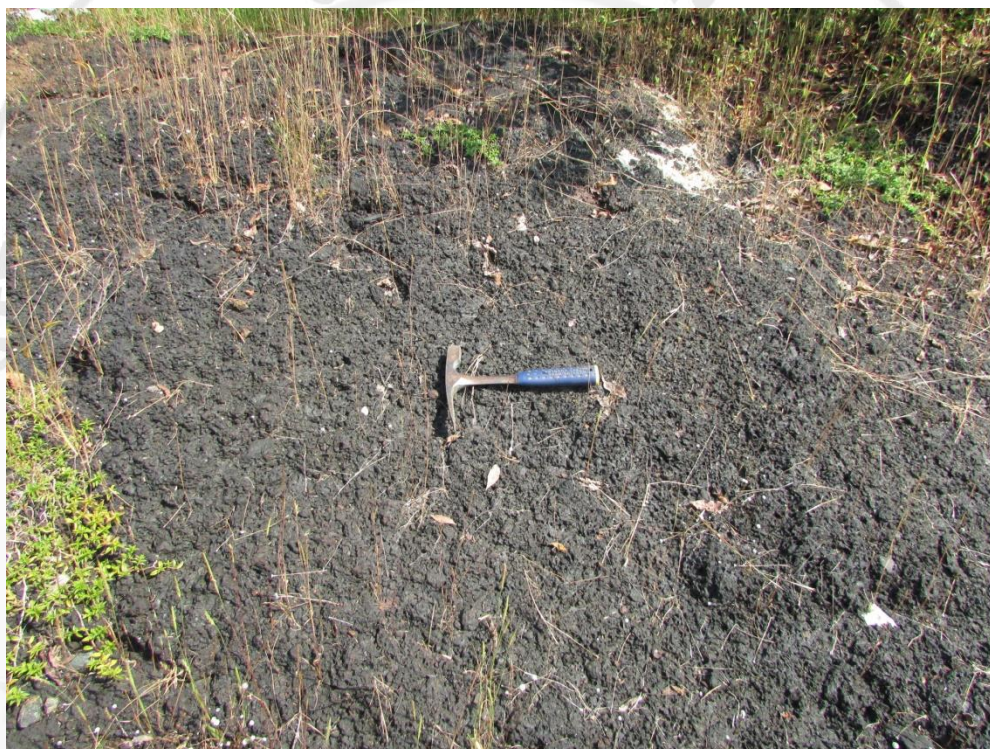
Majority of the present area is covered with laterites, reddish in colour and rich in ferric / aluminium oxides. The lateritic weathering profiles exhibits three zones viz. duricrust, underlying clays and bottom saprolite up to 100m depth over schistose rocks, green stones and BIF units, up to 10 m over ultramafics and about 5m over Deccan traps. Variation in mineralogy and texture of the parent rock has resulted in the Formation of ferruginous, manganiferous and aluminous laterite. Laterite duricrust is well exposed near Kolem ( Fig. 1.6) and Ambegal areas.

Fig. 1.6: Laterite duricrust exposed near Kolem.

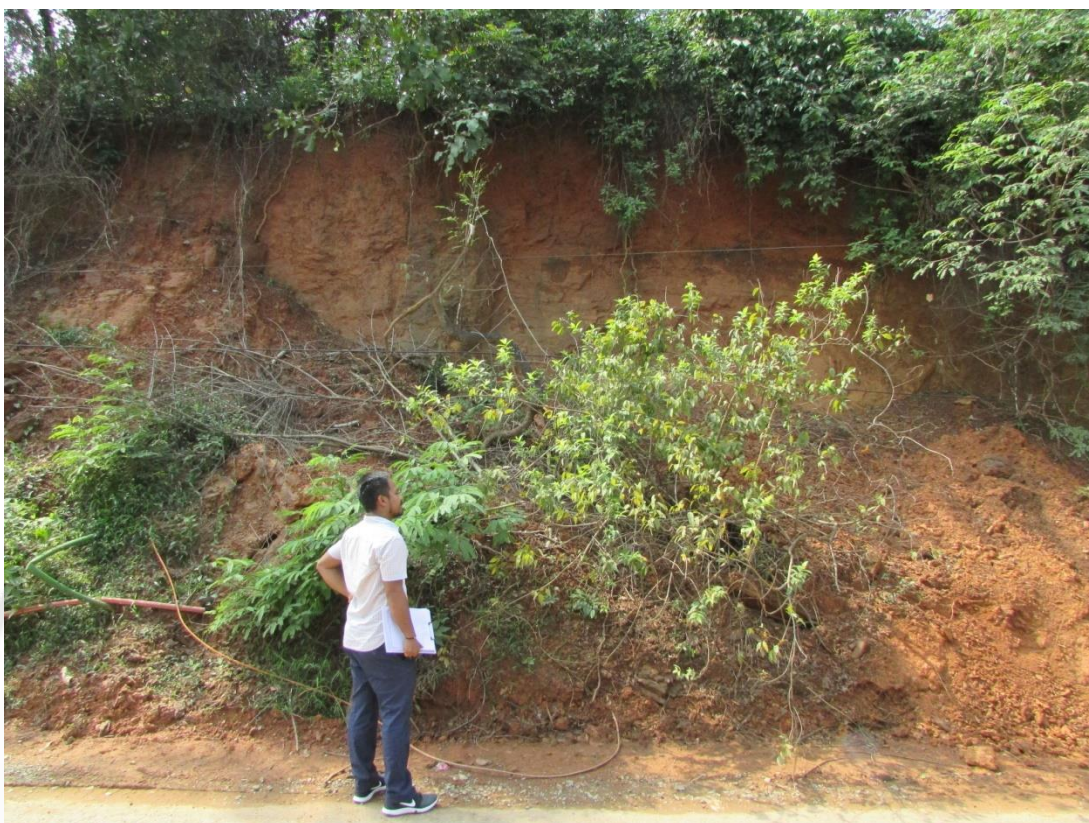
Fig. 3.3: Active debris slide along Sanverdam - Siroda road (slide Name: GOA/SG/48I03/2019/03).

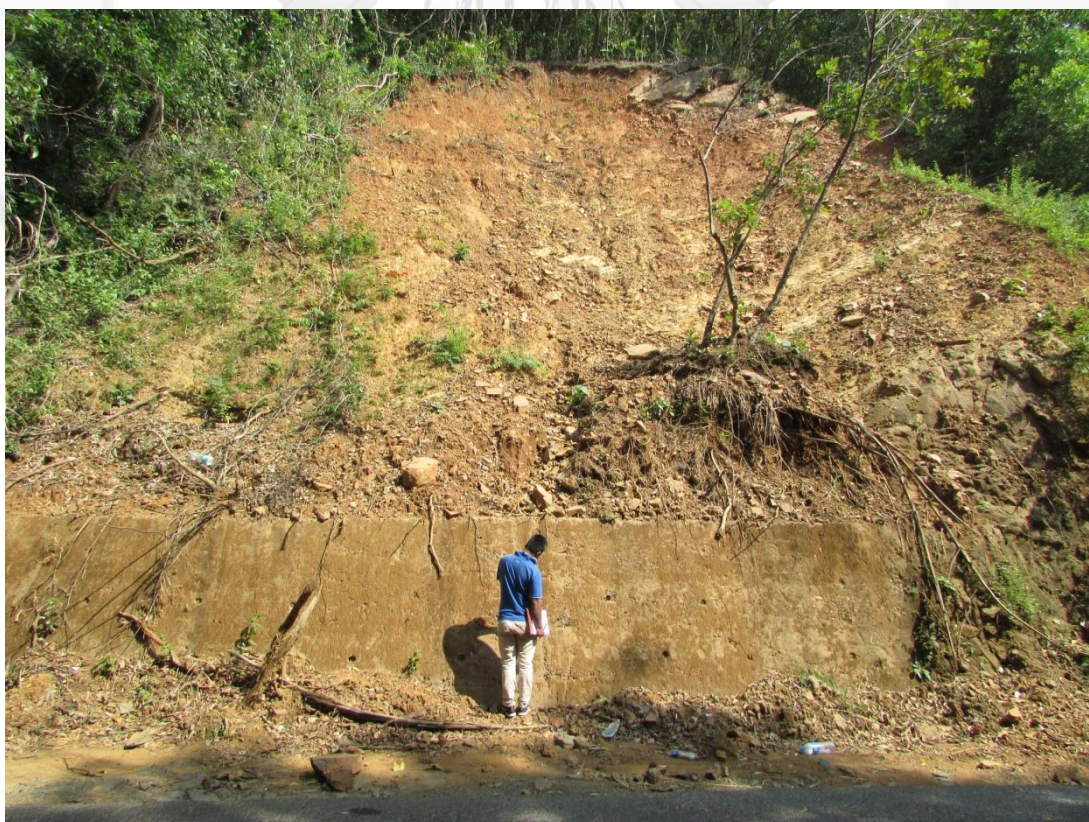
Fig. 3.4: Reactivated debris slide along Chorla Ghat road (slide Name: GOA/NG/48I02/2019/13).

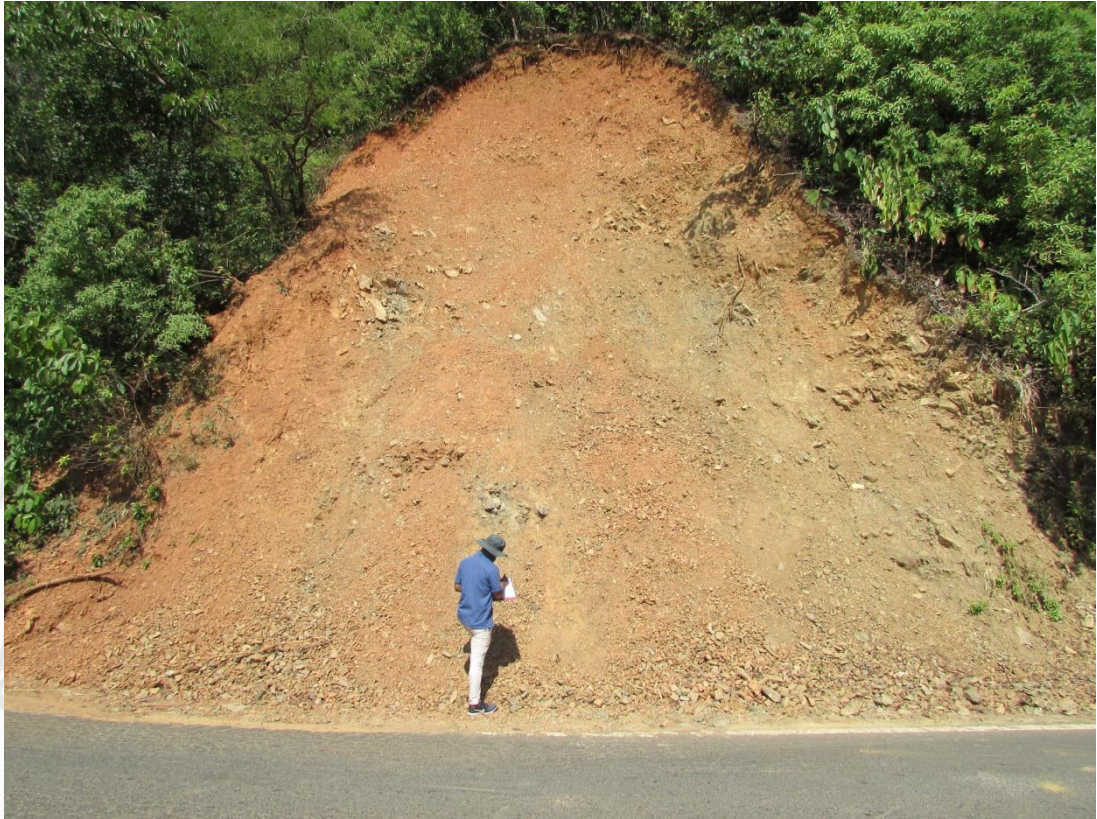
Fig. 3.5: Active debris slide along Chorla Ghat road (slide Name: GOA/NG/48I02/2019/15).

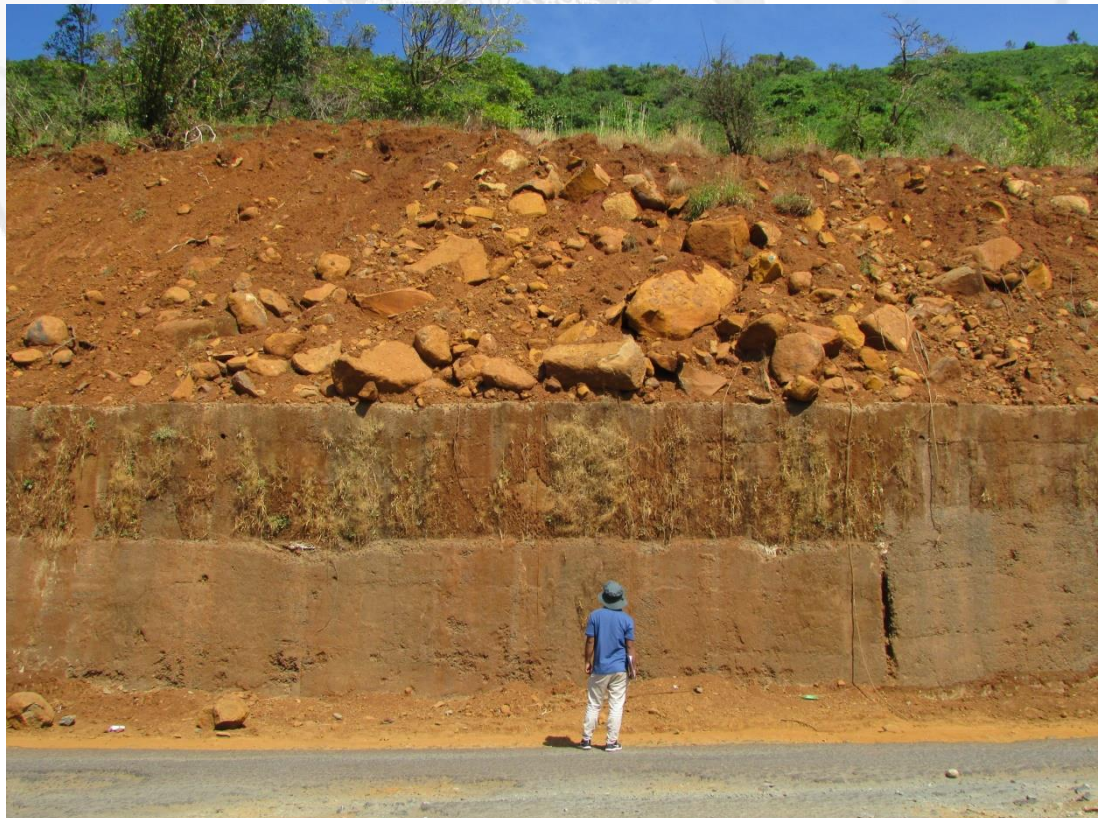
Fig. 3.6: Reactivated debris slide along Chorla Ghat road (slide Name: GOA/NG/48I02/2019/18).

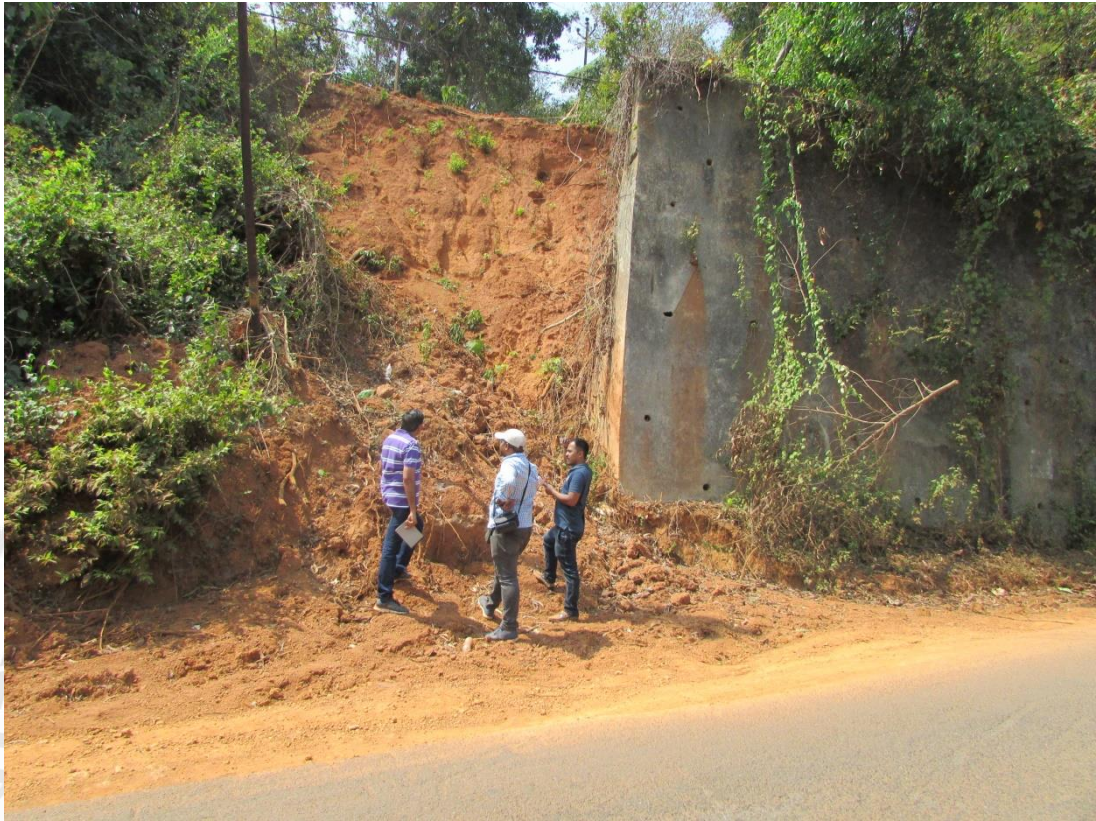
Fig. 3.7: Active debris slide along Khandepar - Opa road near Opa water tank (slide Name: GOA/SG/48I03/2020/22).

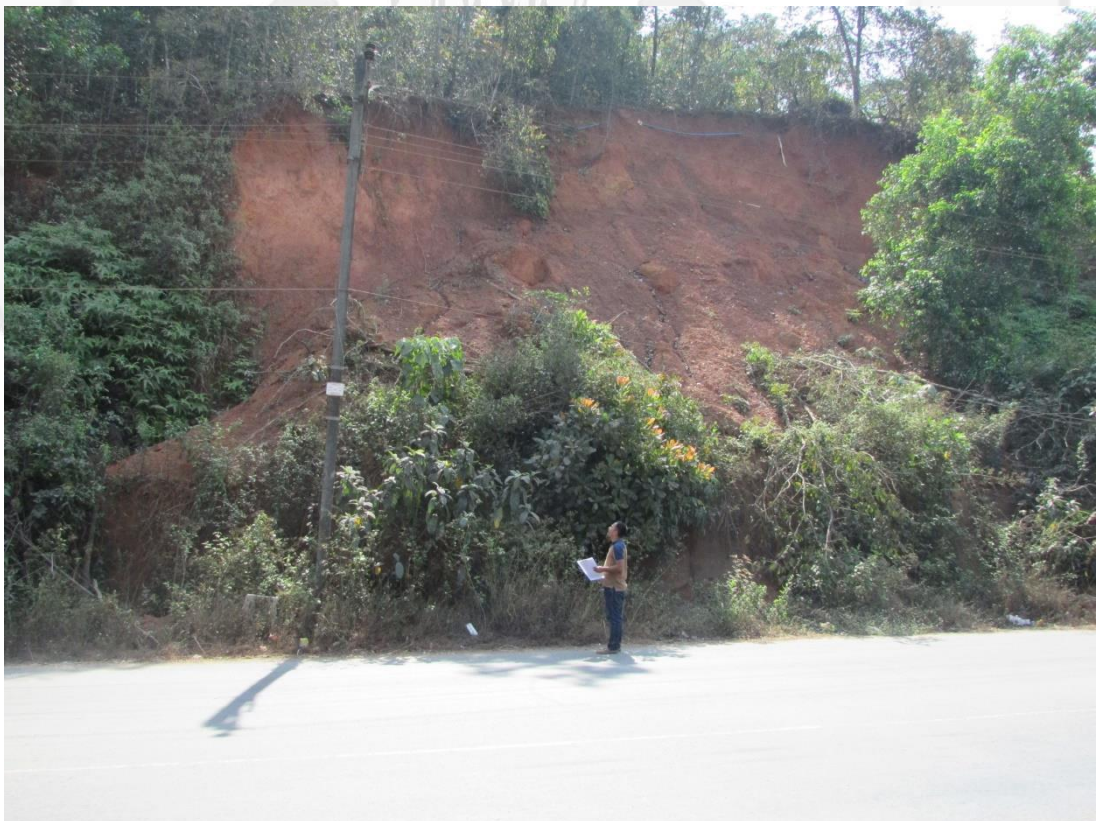
Fig. 3.8: Reactivated debris slide along Borim - Ponda bypass road (slide Name: GOA/SG/48I03/2020/23).

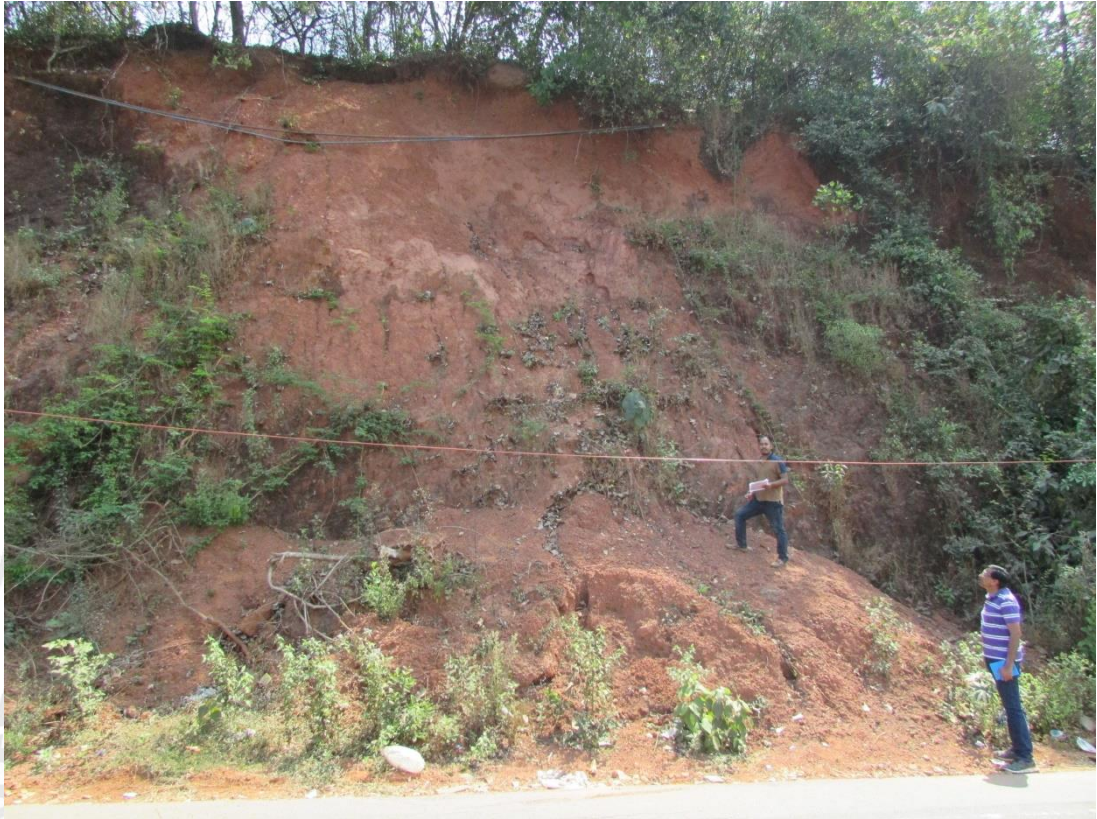
Fig. 3.9: Active debris slide along Borim - Ponda bypass road (slide Name: GOA/SG/48I03/2020/23).

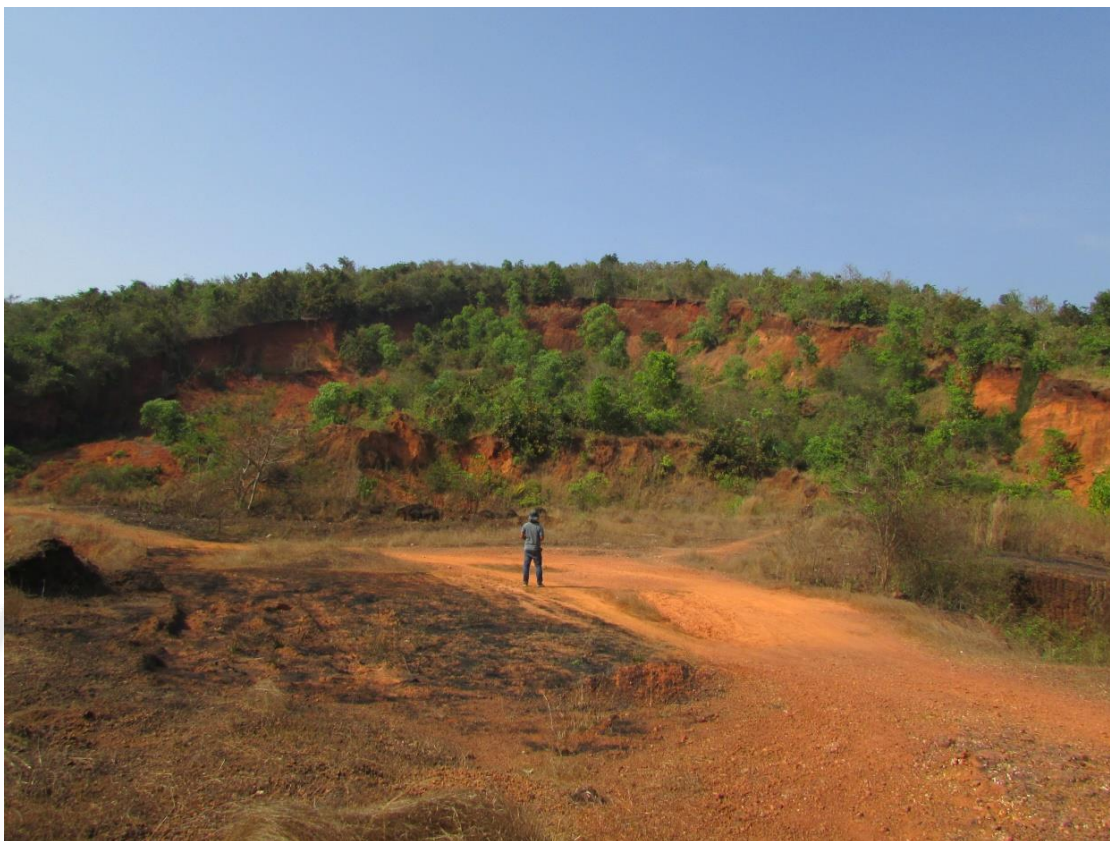
Fig. 3.11: Active earth slide near Mayna (slide Name: GOA/SG/48I03/2020/25).

In the study area, one landslide (GOA/SG/48I03/2020/25) was recorded along the natural slope near Mayna, South Goa district (refer: Fig. 3.11). The landslide was active earth slide, deep translational in nature. The geo-scientific cause of the landslide was super situation of the overburden material and higher regolith thickness.

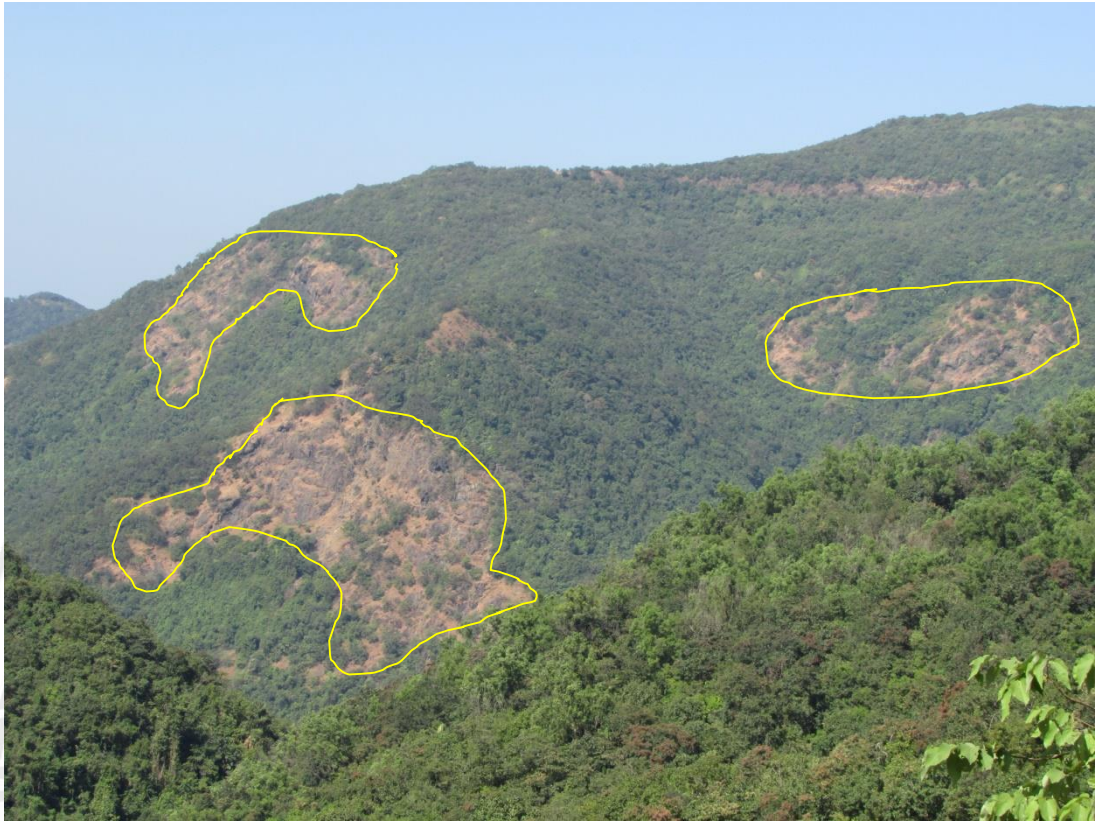
- **Barren:** The barren class in the study area refers to barren slopes with rock exposers (Fig. 4.2).
- **Cultivation:** Cultivation in the study area refers to agricultural lands. The different agricultural verities are rice, wheat and different vegetables.
- **Dumping Ground:** Dumping ground in the area refers to the waste dump areas of the iron manganese mines (Fig. 4.3).
- **Extensive Slope Cut:** Extensive Slope Cut in the study area refers to vertical to near vertical slope cuts along road sections (Fig. 4.4, Fig. 4.5 & Fig. 4.6). In some places, extensive slope cut was also observed adjacent to civil constructed modifying the hill slopes.

Fig. 4.2: Barren rocky slopes present in the north east of Anjune Dam.

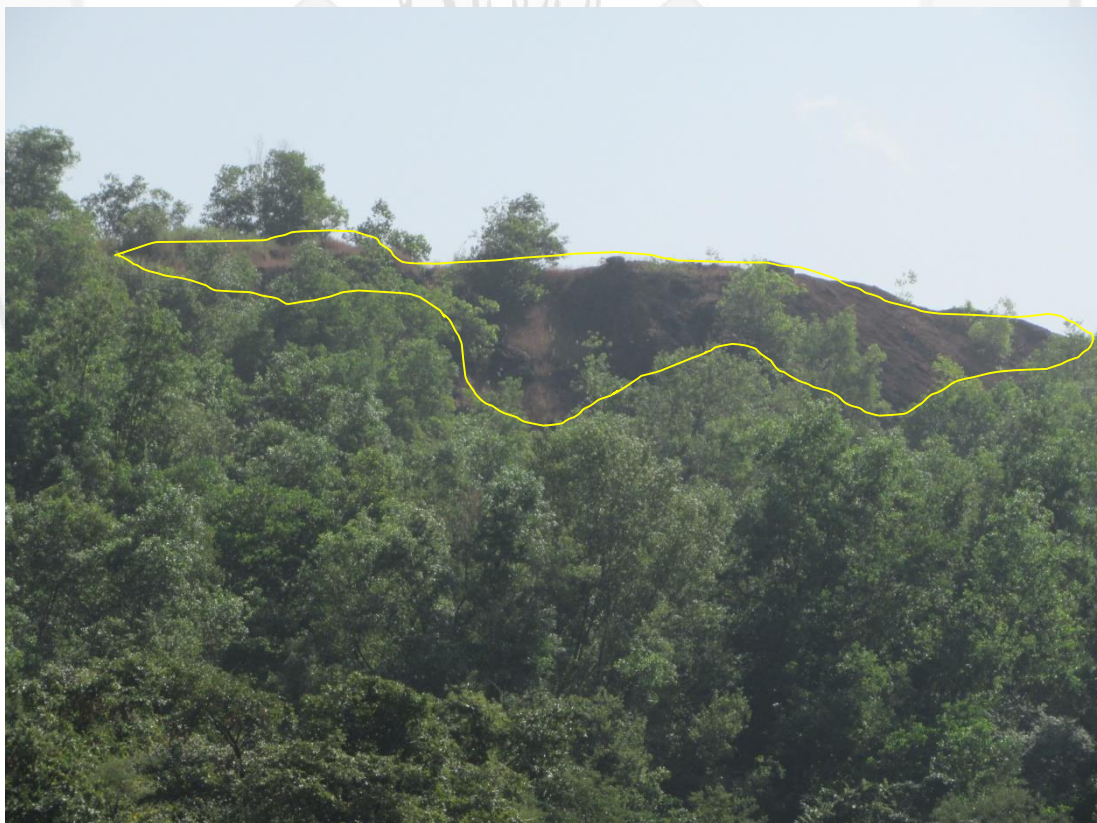
Fig. 4.3: Dumping Ground present near Dhabal. The marking shows the loose unconsolidated nature of the mine dump materials.

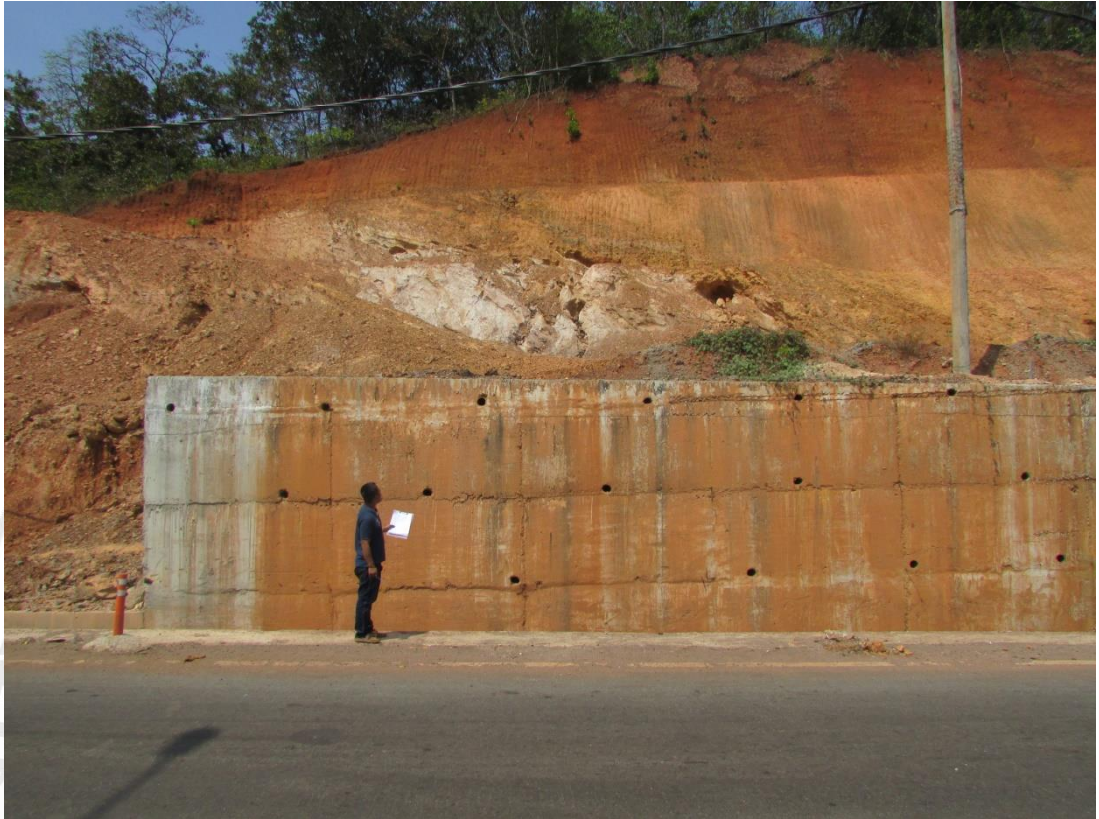
Fig. 4.4: Extensive Slope Cut along Ponda – Molen road near Ponda. The height of the retaining structures should be increased.

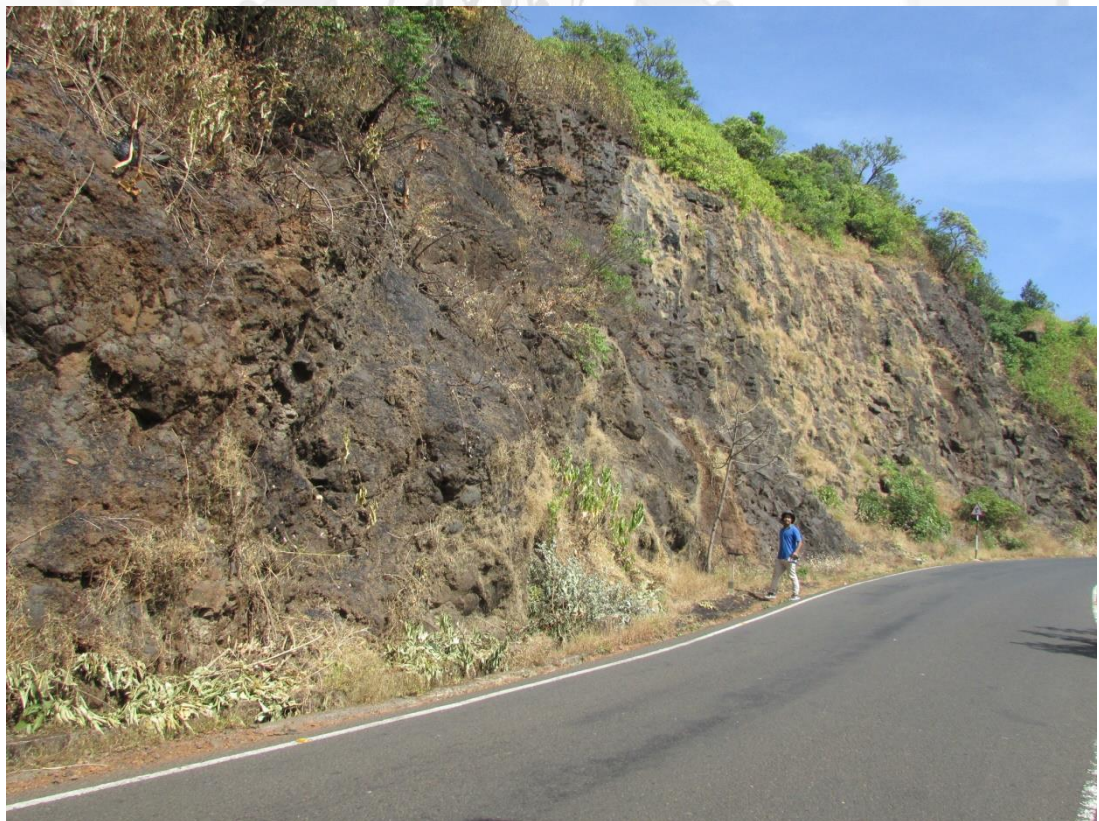
Fig. 4.5: Extensive Slope Cut along Keri – Chorla road near Chorla.

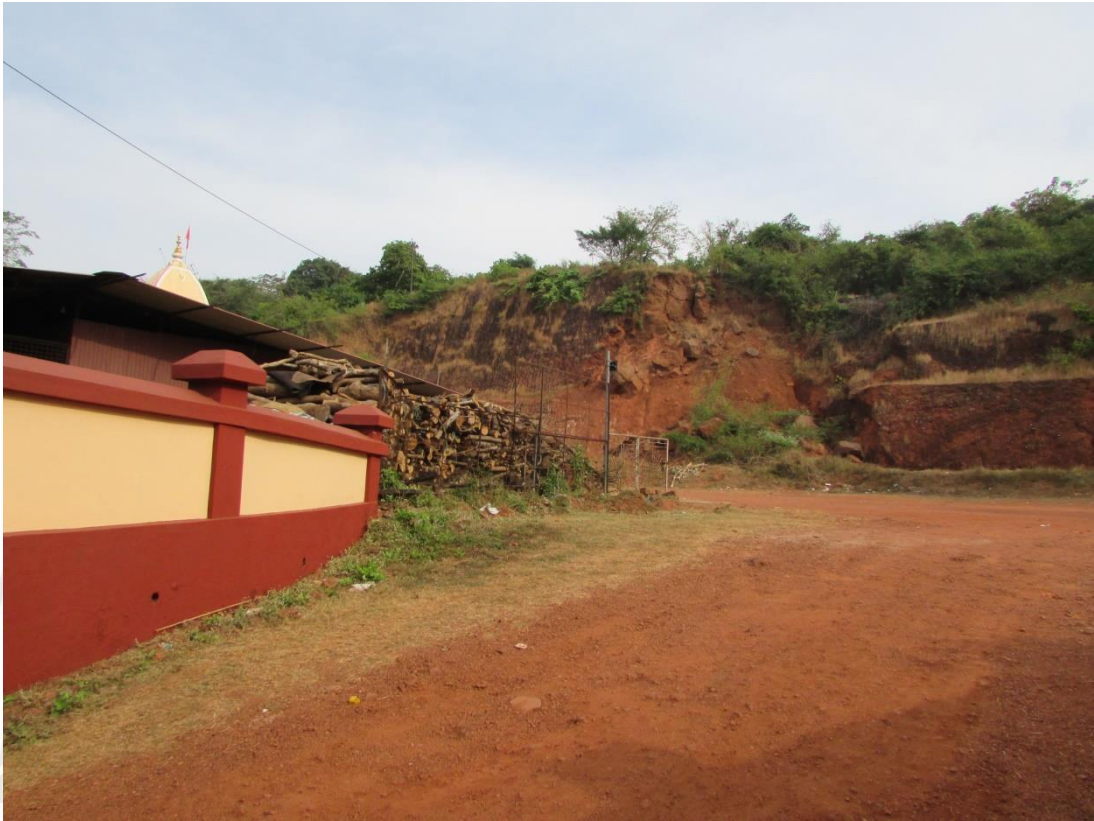
Fig. 4.6: Extensive Slope Cut just behind the Sai Baba Temple at Borim.  
Retaining structures should be provided to the unsupported slopes.

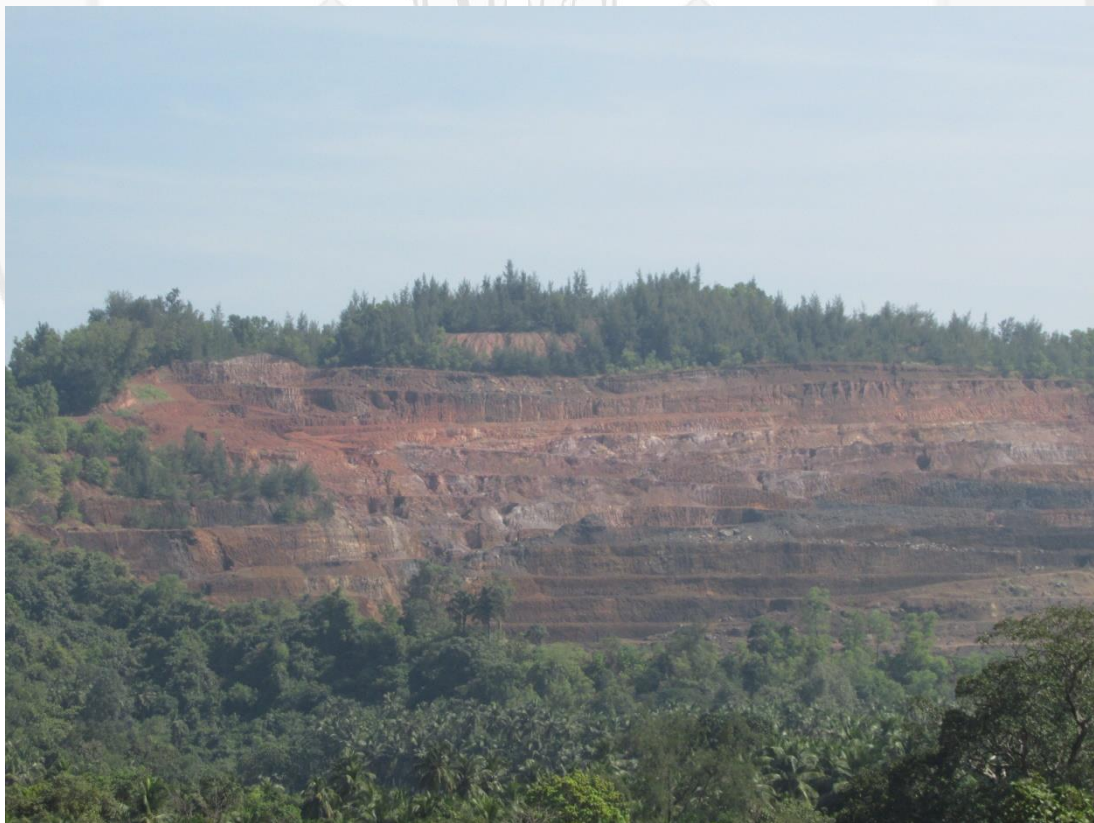
- **Quarry:** Quarry in the study area refers to places from where mining activities were going on. Both the active and abandoned mining areas were considered under this class (Fig. 4.10).

Fig. 4.10: Quarry section near Ambegal.

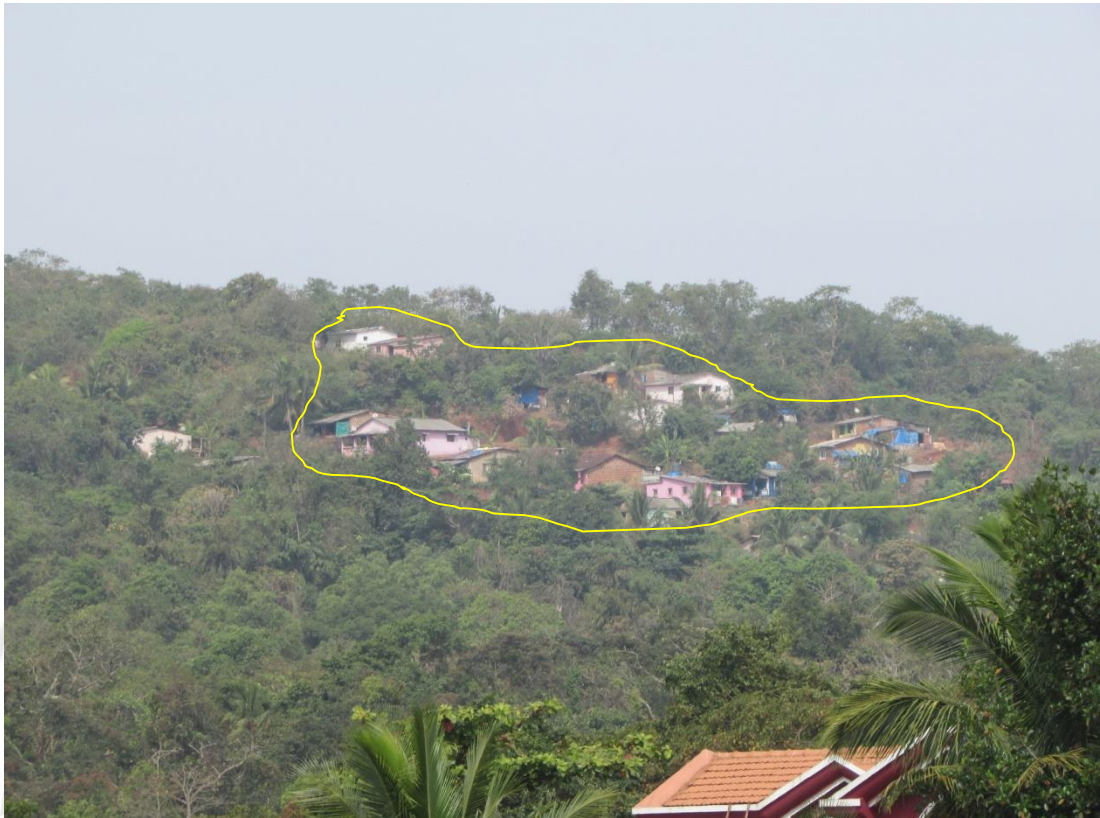
- **Settlement:** Settlement in the study area refers to the clusters of houses / villages / townships where people live.
- **Settlement on modified slope:** Settlement on modified slope in the study area refers to any houses / cluster of houses that are constructed modifying the natural hill slopes ( Fig. 4.11).

Fig. 4.11: Settlement on modified slope near Mayna.

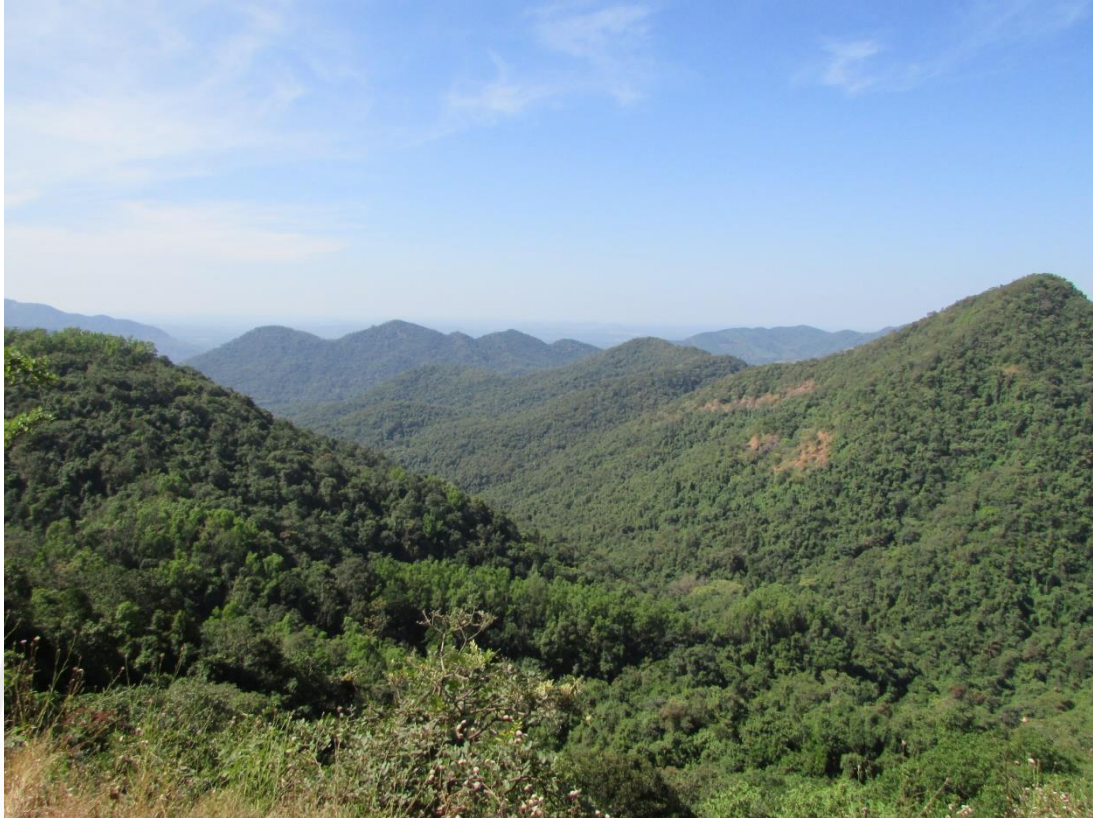
**Dissected Slope (Lowly and Highly):** The dissected hill slopes in the study area are of two types i.e. lowly dissected slope (Fig. 4.16) and highly dissected slope. This demarcation from low to high is based on the intensity dissections on hill slope in the increasing order.

Fig. 4.16: Lowly Dissected Slope near Anjune Dam.

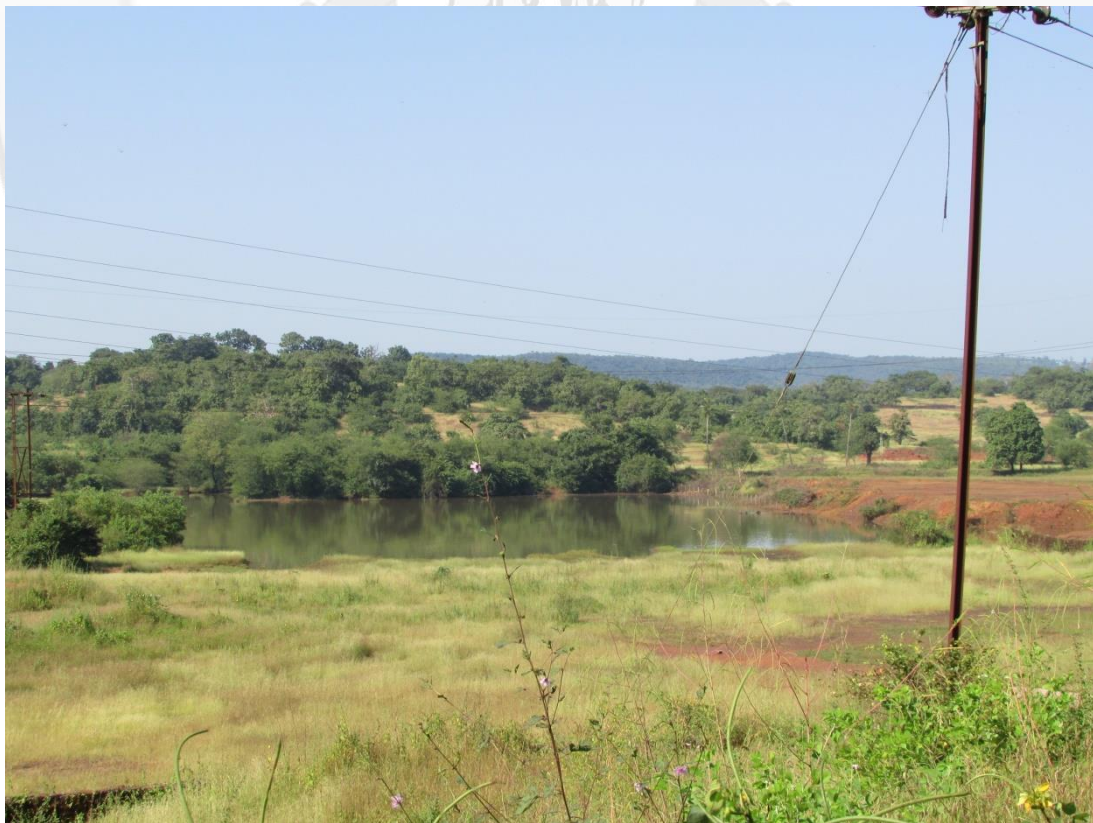
**Rolling Plain:** Rolling plain in the study area refers to undulating plains / cluster of small mounds which cannot be mapped separately in 1:50000 scale ( Fig. 4.17).

Fig. 4.17: Rolling Plain near Tiskar.

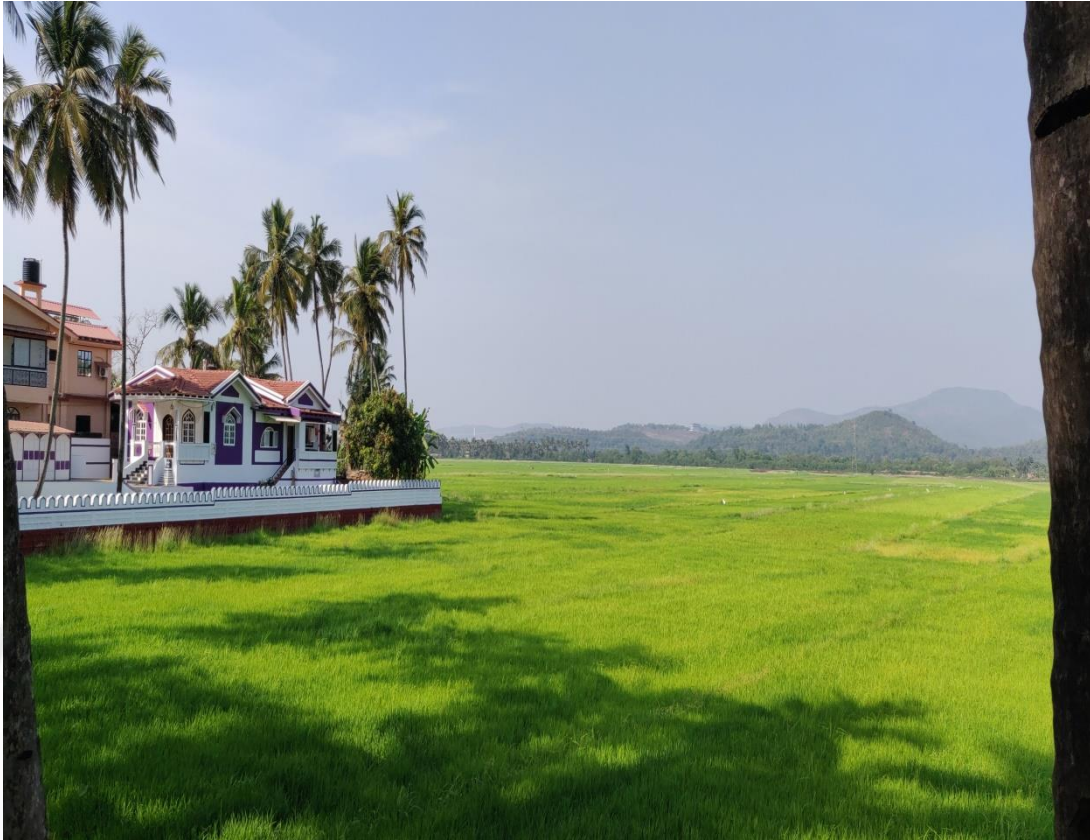
**Pediment Pediplain Complex:** Pediment pediplain complex (refer: Fig. 4.18) in the study area refers to combination of very gently sloping ( $5^\circ - 7^\circ$ ) bedrock surfaces near the foothill area (pediments) and an extensive plain formed by the coalescence of pediments (pediplain).

Fig. 4.18: Pediment Pediplain Complex near Kavonn.

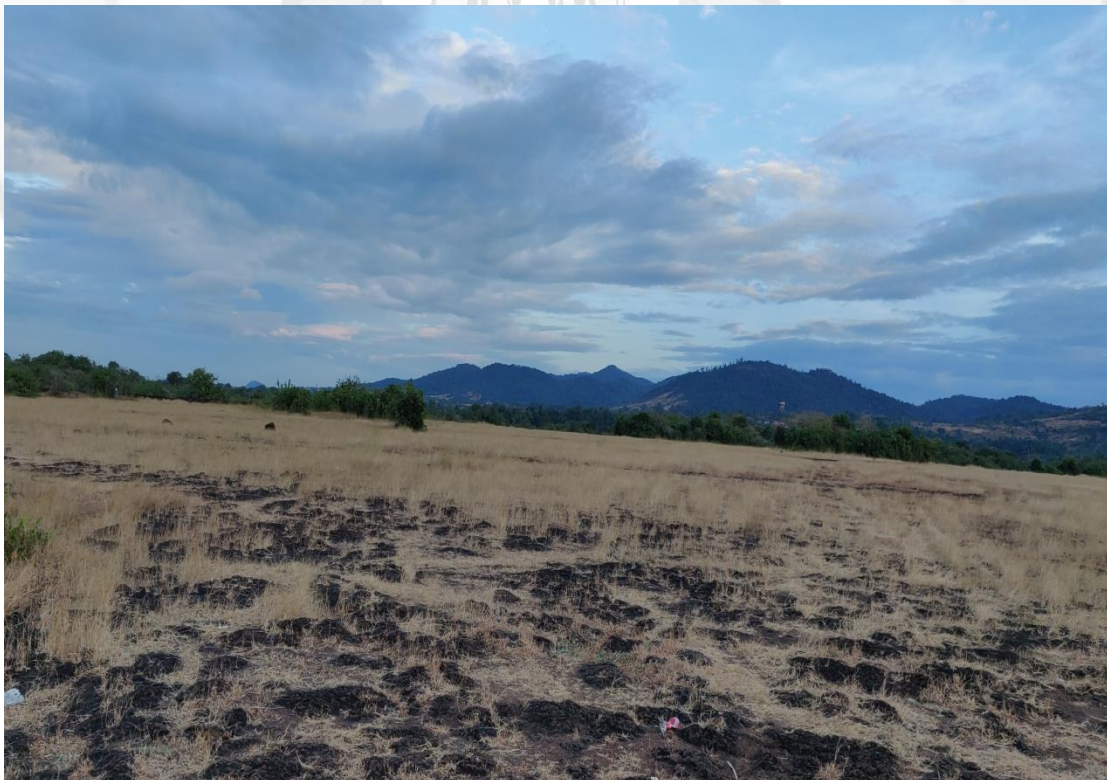
**Plateau Top (Flat):** Plateau Top (Flat) in the area refers to high plains or tablelands usually consisting of relatively flat terrain and raised significantly above the surrounding area (Fig. 4.19).

Fig. 4.19: Plateau Top (Flat) near north of Ponda.

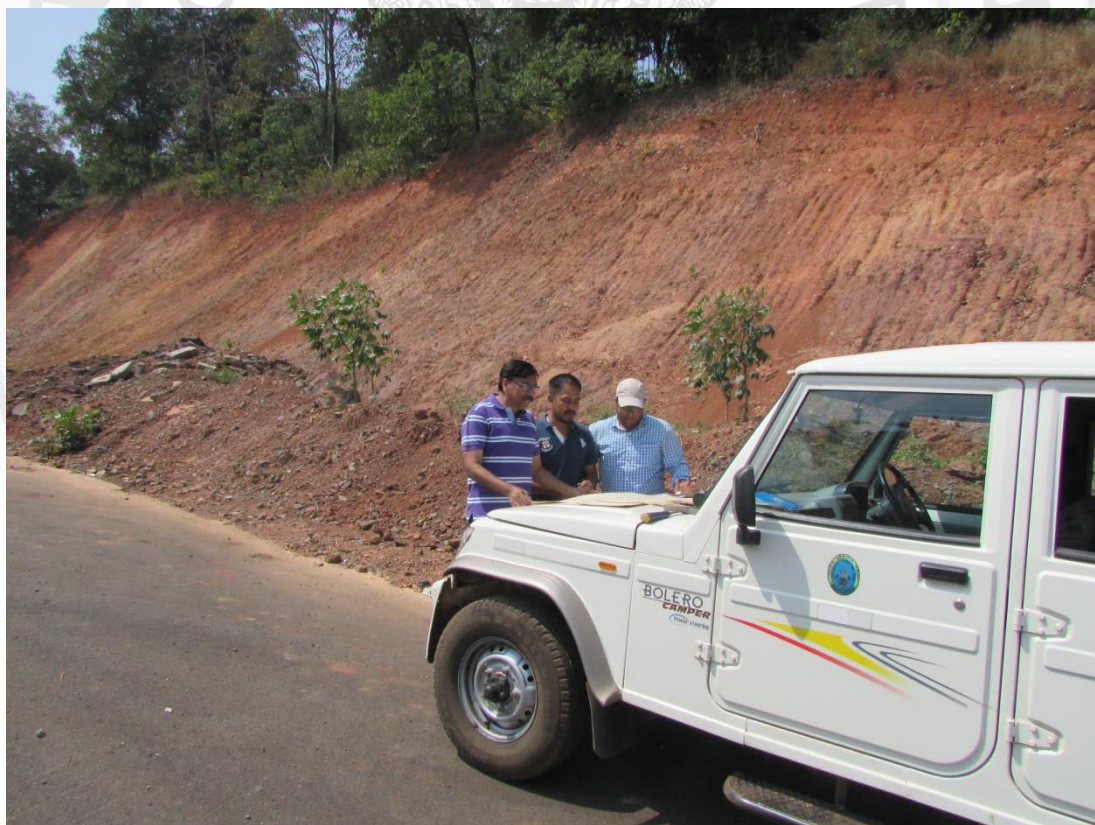
Fig. 4.20: In-situ soil present as slope forming material near Ponda.
