REPORT ON MACRO-SCALE (1: 50,000) LANDSLIDE SUSCEPTIBILITY  
MAPPING IN PARTS OF TOPOSHEET NO. 48I/01, 48I/02 AND 48I/03, BELAGAVI  
DISTRICT, KARNATAKA AND NORTH GOA AND SOUTH GOA DISTRICTS,  
GOA

(FSP Code No: FSP CODE NO: M4LSSM/NC/SR/SU-KG/2019/27977)

FIELD SEASON: 2019-20

PROJECT: NLSM / परियोजना: एनएलएसएम

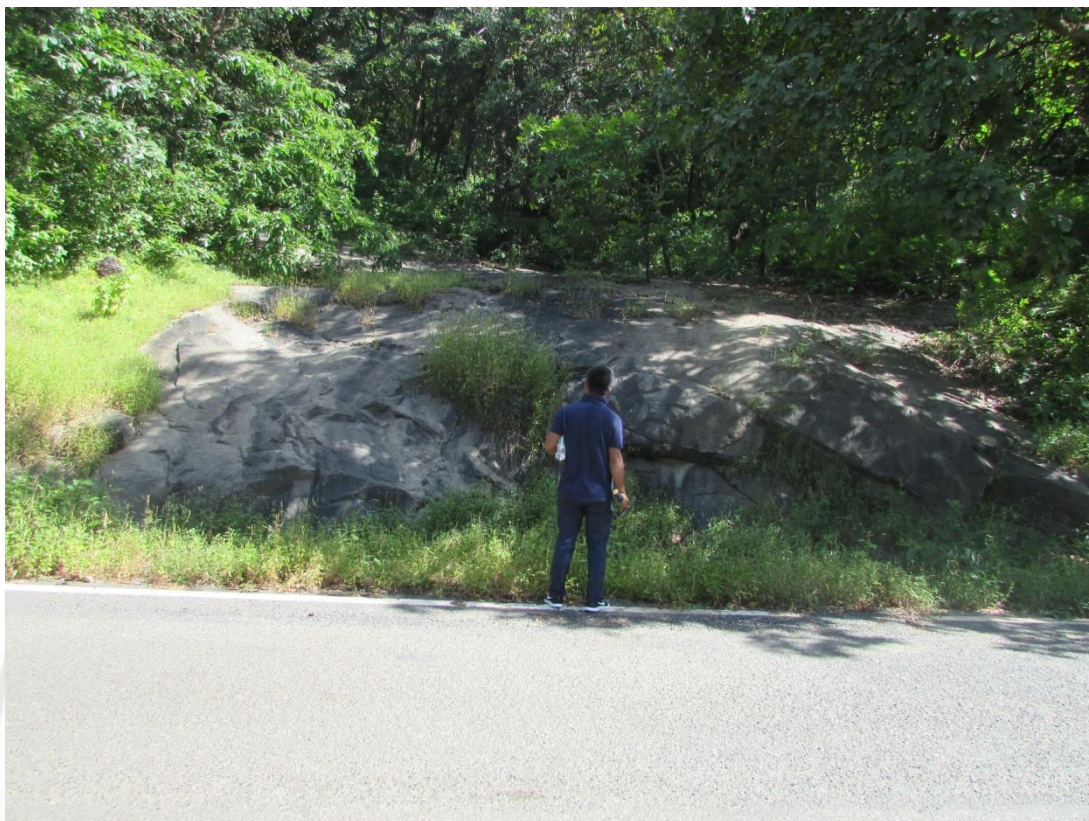
Fig. 4.23: Regolith Thickness  $<0.5\text{m}$  in north east of Molen along Anmod Ghat section.

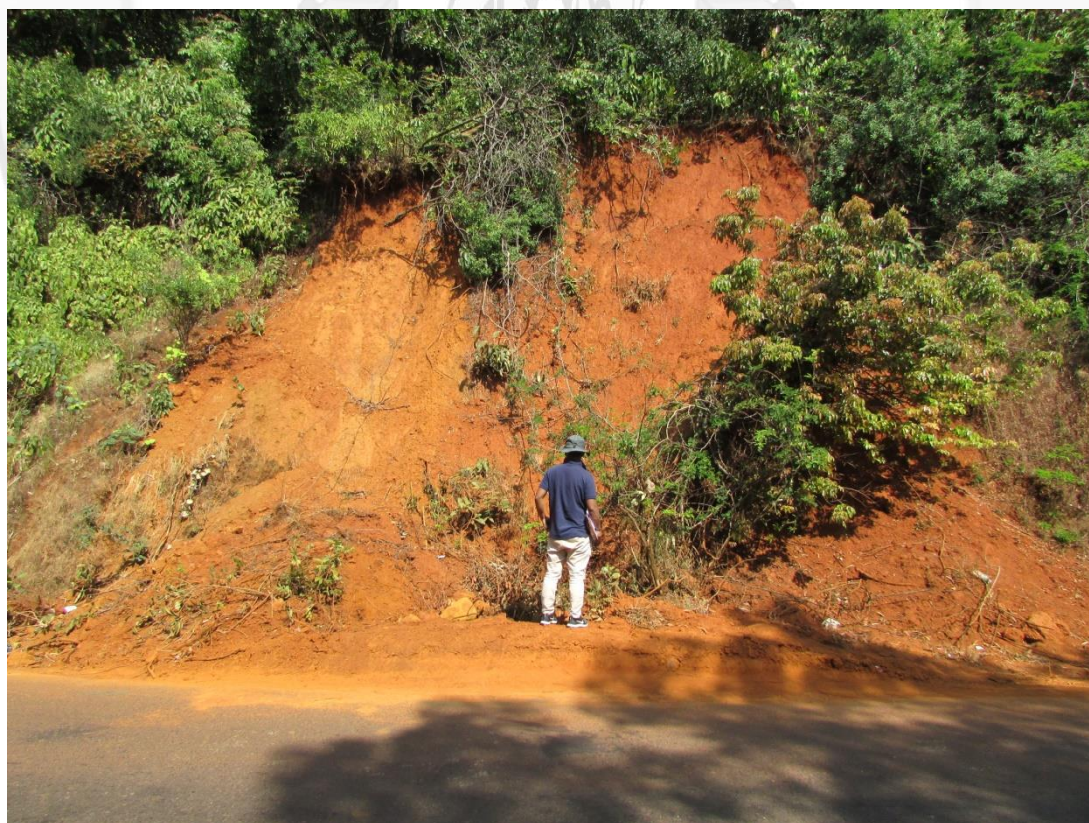
Fig. 4.24: Regolith Thickness  $0.5 - 5\text{ m}$  near Chorla along Chorla Ghat section.

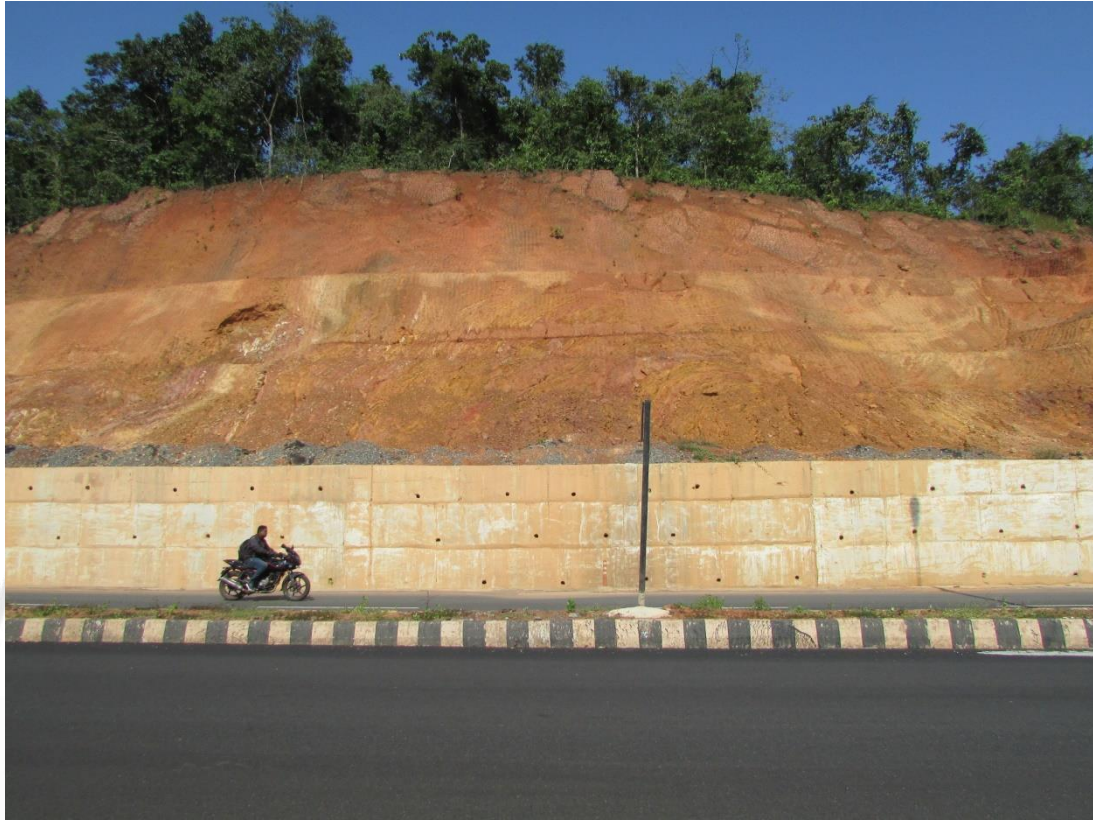
Fig. 4.25: Regolith Thickness >10 m near Ponda.

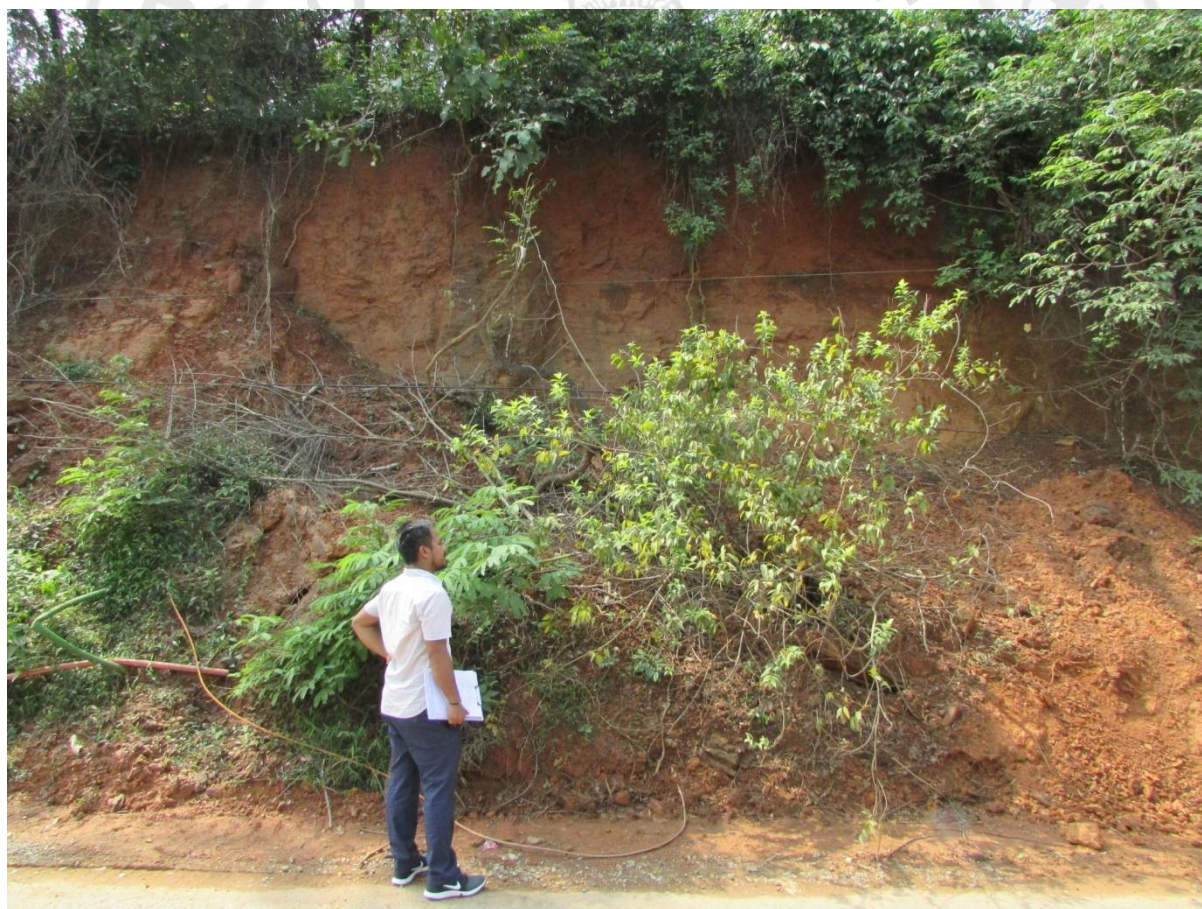
Field photograph of landslide no: GOA/SG/48I03/2019/03

| 42 | Landslide category | Category - II |

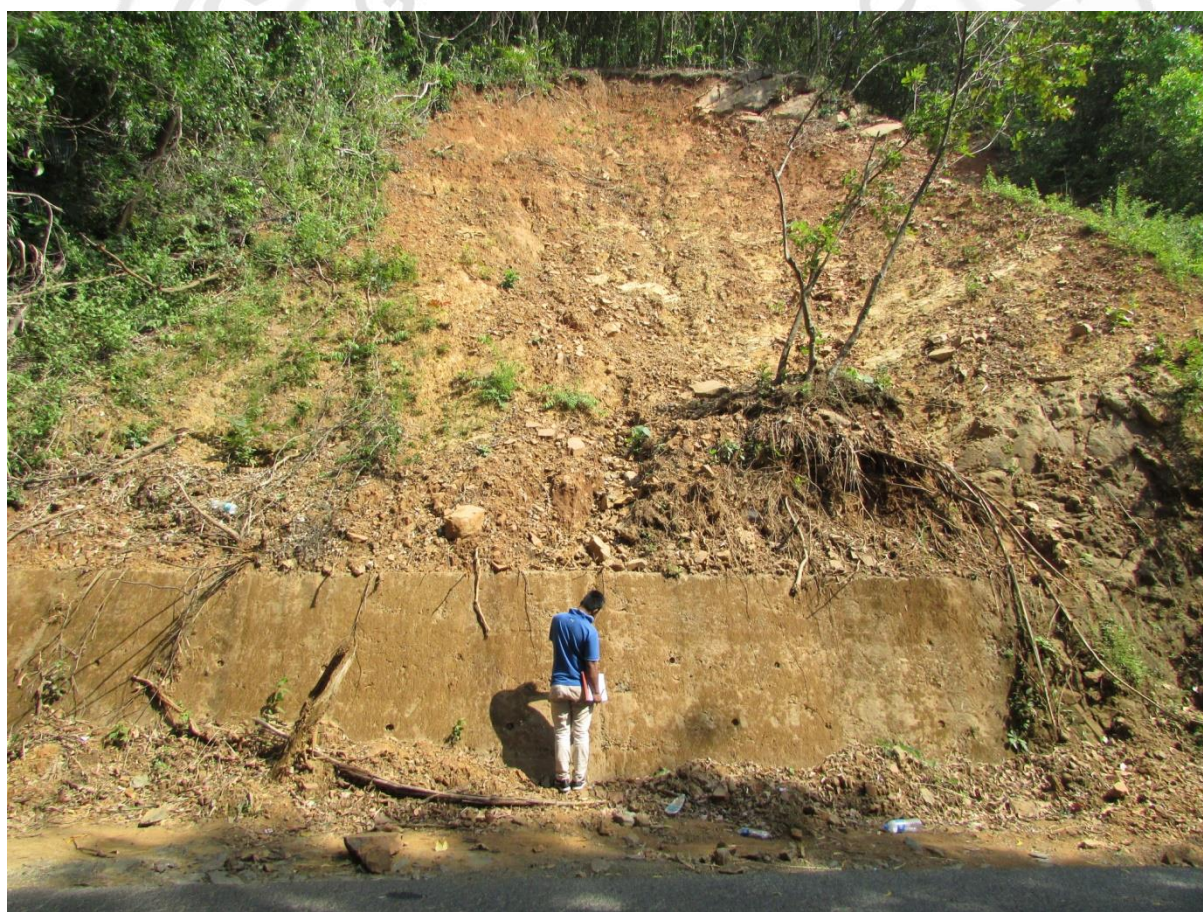
Field photograph of landslide no: GOA/NG/48I02/2019/13

| 42 | Landslide category | Category - II |

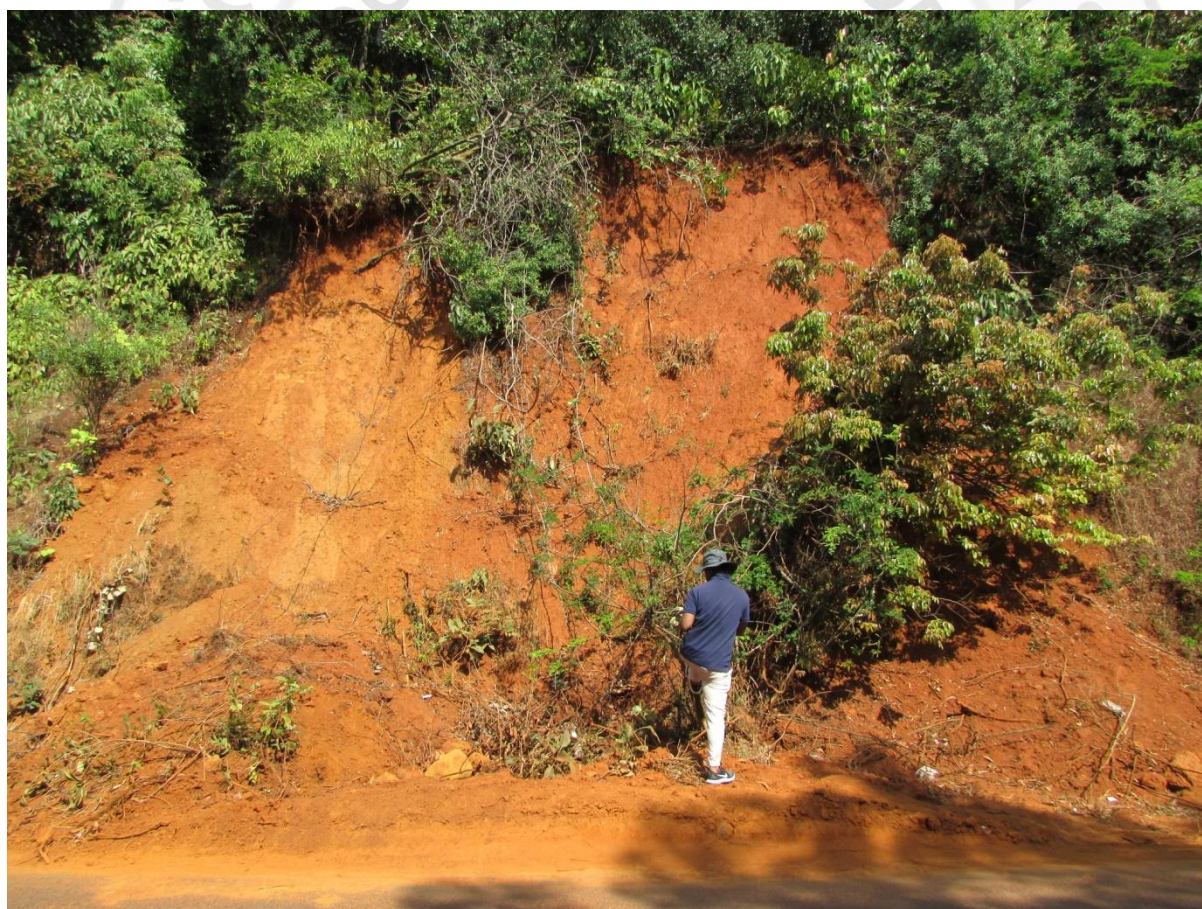
Field photograph of landslide no: KAR/BEL/48I02/2019/20

| 5 | Name of the slide | Cut Slope failure along Chorla ghat road |
| 22 | Failure mechanism | Shallow translational |
| 36 | Geo-scientific Causes | Reduction of strength of overburden material on super saturation, cutting of slope for road construction |

| 40 | Summary/Abstract | The landslide is located along Chorla ghat road at 570 m south of Chorla. It is an active debris slide, shallow translational in nature. The length of the slide is 10m, width 15 m, height 9m and depth 1 m. The geo scientific causes of the landslide are reduction of strength of overburden material on super saturation and cutting of the slope for road construction. This landslide caused temporary blockage of Chorla ghat road. |

| 37 | Remedial measures | Removal of loose materials |

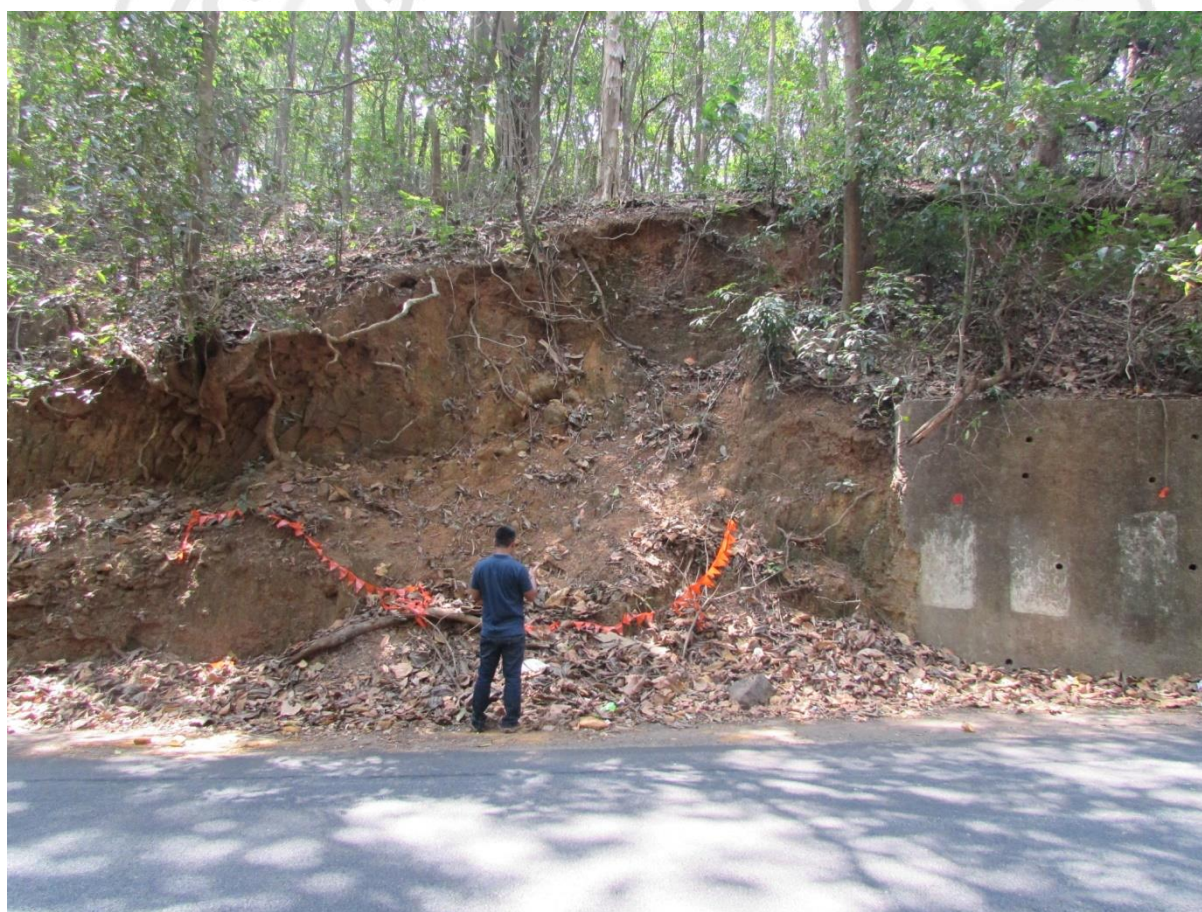
Field photograph of landslide no: GOA/NG/48I02/2020/21

| 5 | Name of the slide | Cut Slope failure along Honda – Valpoi road |
| 22 | Failure mechanism | Shallow translational |
| 36 | Geo-scientific Causes | Reduction of strength of overburden material on super saturation, cutting of slope for road construction |

| 40 | Summary/Abstract | The landslide is located along Honda – Valpoi road at 3.5 km west of Valpoi. It is an reactivated debris slide, shallow translational in nature. The length of the slide is 6m, width 66 m, height 6m and depth 1 m. The geo scientific causes of the landslide are reduction of strength of overburden material on super saturation and cutting of the slope for road construction. This landslide caused temporary blockage of Honda – Valpoi road. |

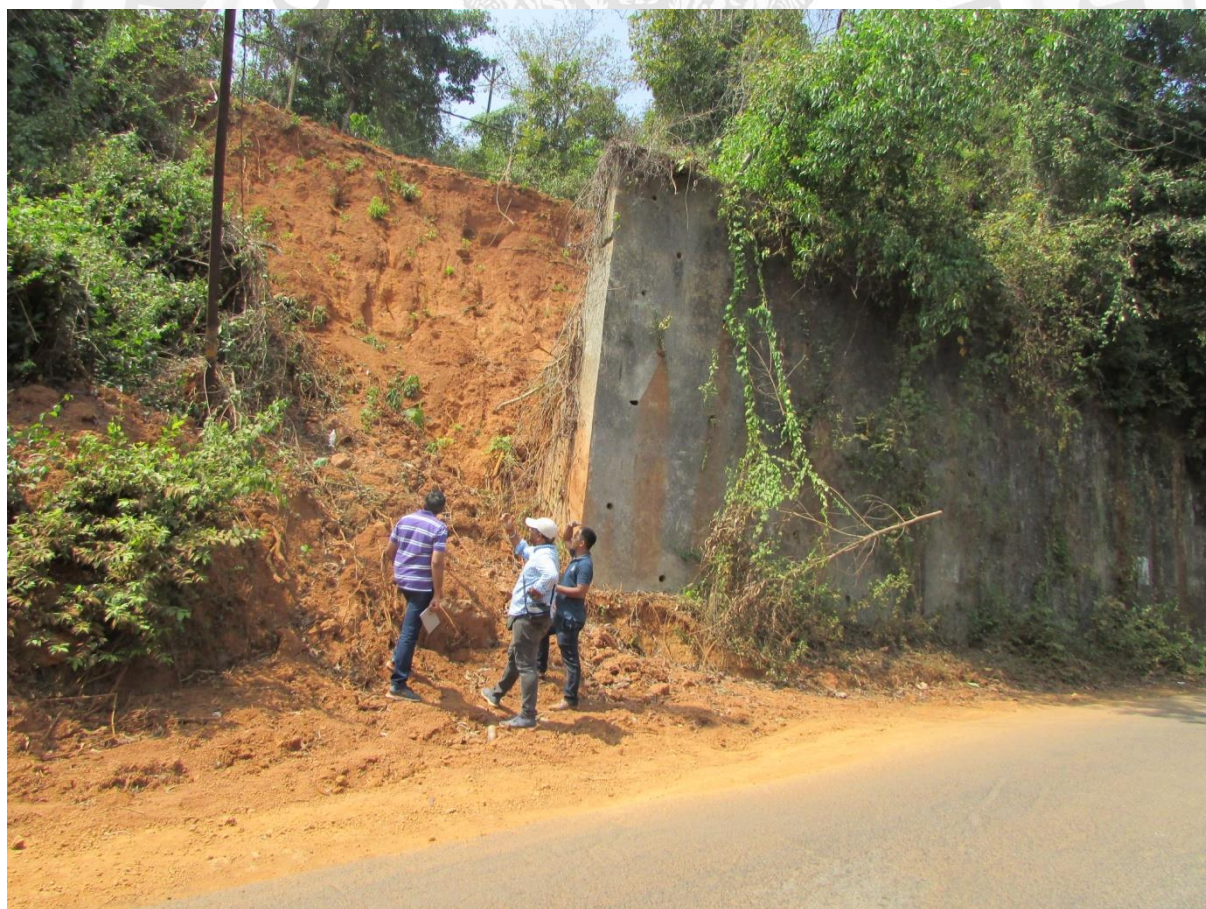
Field photograph of landslide no: GOA/SG/48I03/2020/22

| 5 | Name of the slide | Cut Slope failure along Khandepar – Opa road, Near Opa water tank |
| 22 | Failure mechanism | Shallow translational |
| 36 | Geo-scientific Causes | Reduction of strength of thick overburden material on super saturation, cutting of slope for road construction |

| 40 | Summary/Abstract | The landslide is located along Khandepar – Opa road at 1.5 km north east of Ponda. It is an active debris slide, shallow translational in nature. The length of the slide is 18m, width 60 m, height 14m and depth 1 m. The geo scientific causes of the landslide are reduction of strength of thick overburden material on super saturation and cutting of the slope for road construction. This landslide caused temporary blockage of Khandepar – Opa road. |

| 37 | Remedial measures | Removal of loose materials, extension of retaining wall |

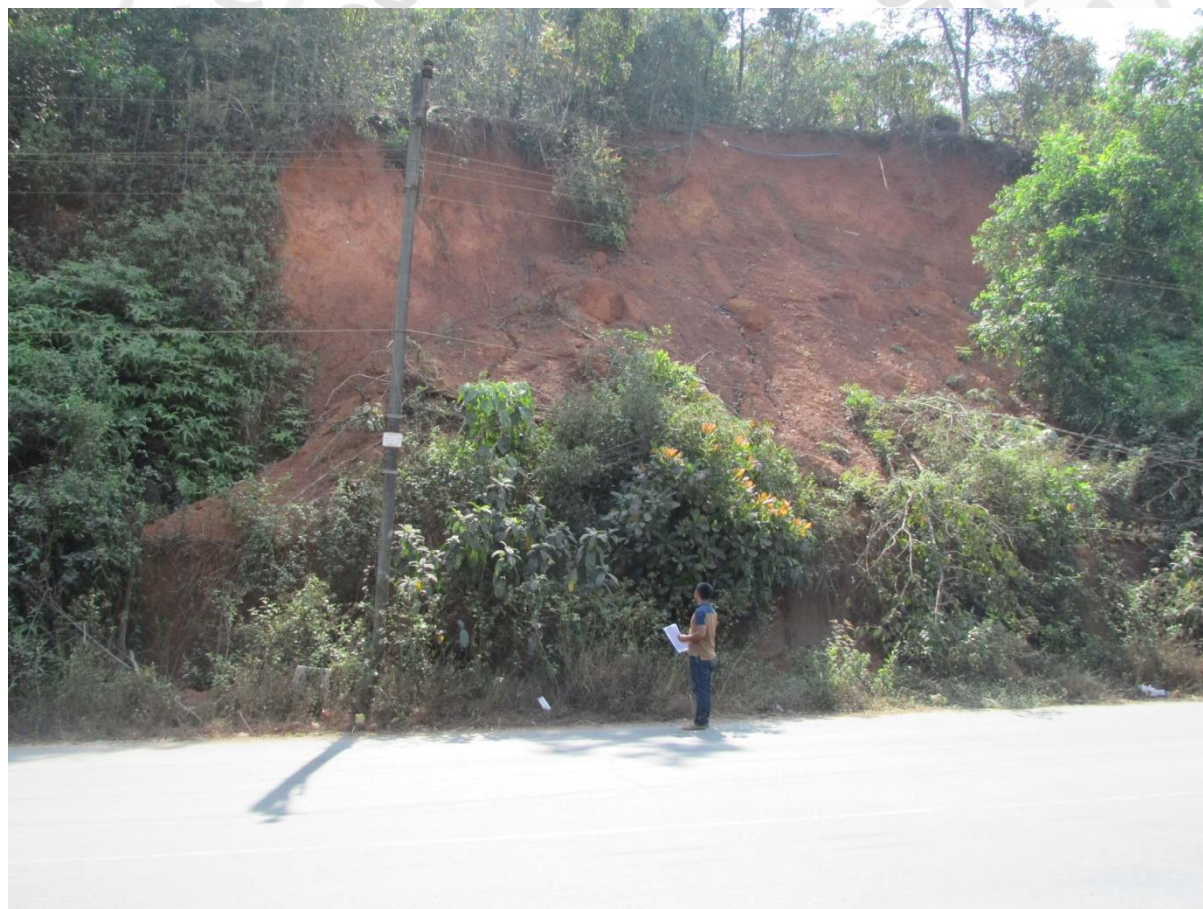
Field photograph of landslide no: GOA/SG/48I03/2020/23

| 5 | Name of the slide | Cut Slope failure along Ponda – Borim bypass road |
| 22 | Failure mechanism | Shallow translational |
| 36 | Geo-scientific Causes | Reduction of strength of thick overburden material on super saturation, cutting of slope for road construction |

| 40 | Summary/Abstract | The landslide is located along Ponda – Borim bypass road. It is an active debris slide, shallow translational in nature. The length of the slide is 30m, width 82 m, height 25m and depth 3 m. The geo scientific causes of the landslide are reduction of strength of thick overburden material on super saturation and cutting of the slope for road construction. This landslide caused temporary blockage of Ponda – Borim bypass road. |

| 37 | Remedial measures | Removal of loose materials, slope grading, construction of retaining wall with weep holes. |

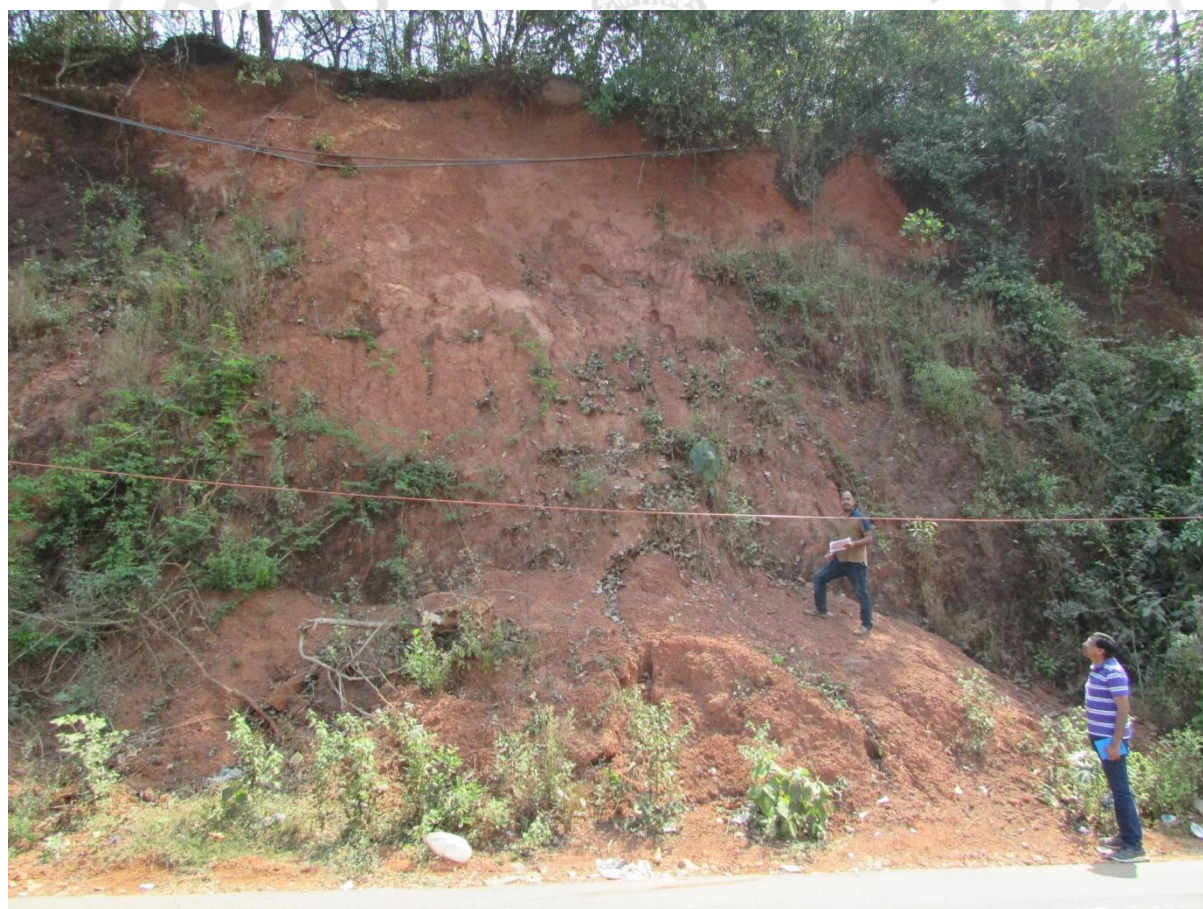
Field photograph of landslide no: GOA/SG/48I03/2020/24

| 5 | Name of the slide | Cut Slope failure along Ponda – Borim bypass road |
| 22 | Failure mechanism | Shallow translational |
| 36 | Geo-scientific Causes | Reduction of strength of thick overburden material on super saturation, cutting of slope for road construction |

| 37 | Remedial measures | Removal of loose materials, slope grading, construction of retaining wall with weep holes. |

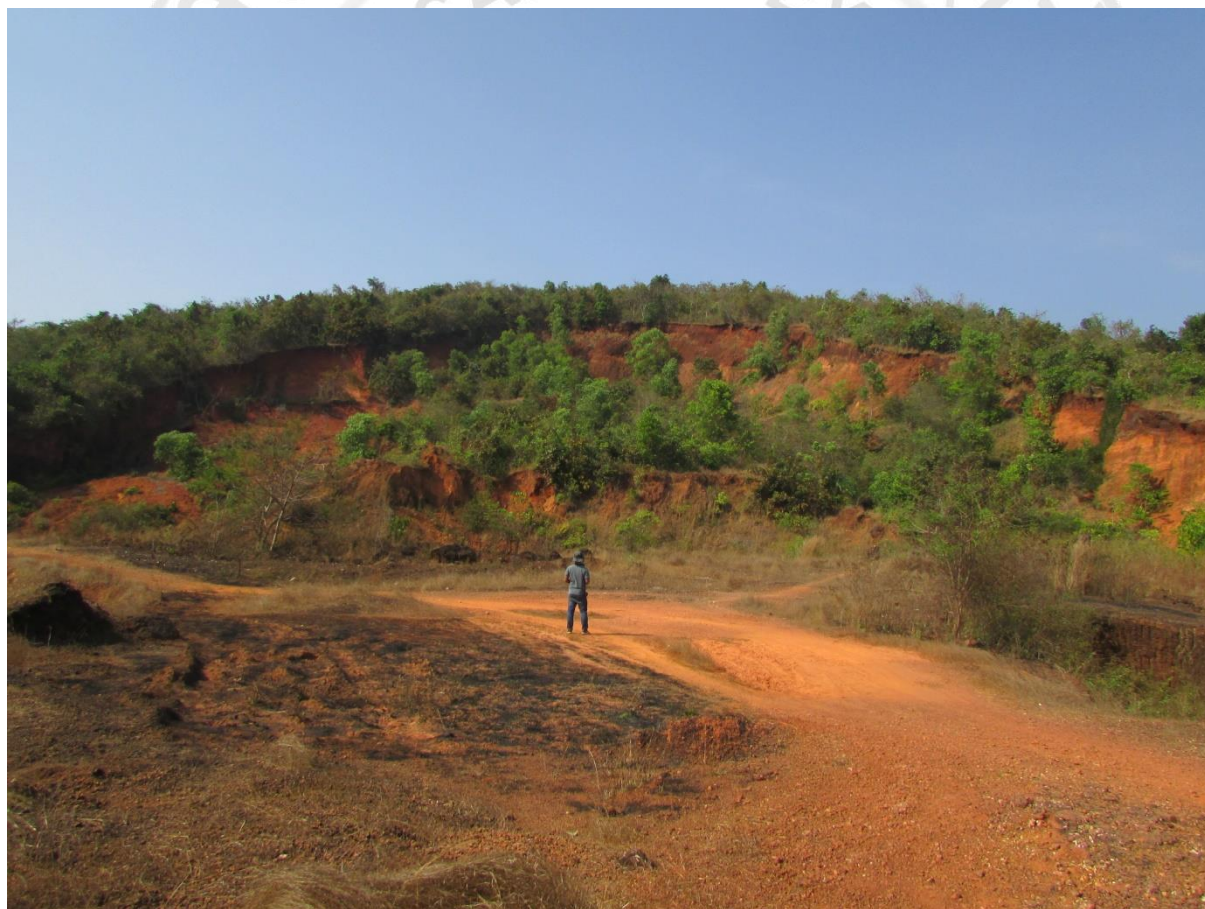
Field photograph of landslide no: GOA/SG/48I03/2020/25

| 42 | Landslide category | Category - III |
