MESO-SCALE (1:10,000) LANDSLIDE SUSCEPTIBILITY MAPPING IN  
BHAGAMANDLA AND TALAKAVERI HILL TOWNSHIPS, KODAGU DISTRICT,  
KARNATAKA.

कार्य सत्र 2022-23 का अंतिम प्रतिवेदन  
Final report for Field Season 2022-23

राज्य इकाई: कर्नाटक एवं गोवा /State Unit: Karnataka and Goa  
दक्षिण क्षेत्र/ Southern Region  
बेंगलूरु/Bengaluru

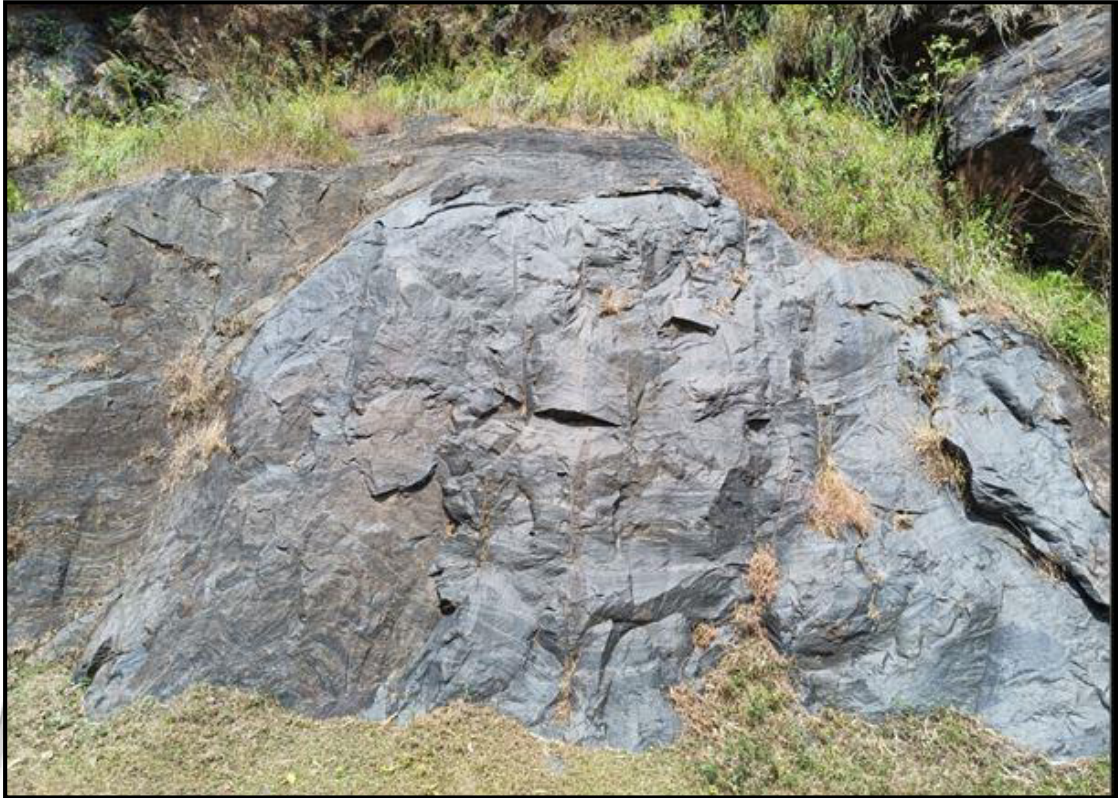
Fig. 2.3: Enderbite exposed in road section, near Cherengala

The dominant litho unit in the study area is Enderbite. (Fig. 2.2) The rock is generally massive (Fig. 2.3) in most of the places; however, it shows metamorphic bandings at few localities. The Enderbite is intruded by white to buff colored granite at places. The granite body is sheared and show elongated quartz grains (Fig. 2.5). The Enderbite has also undergone alteration which has been classified as altered enderbite (Fig. 2.4).

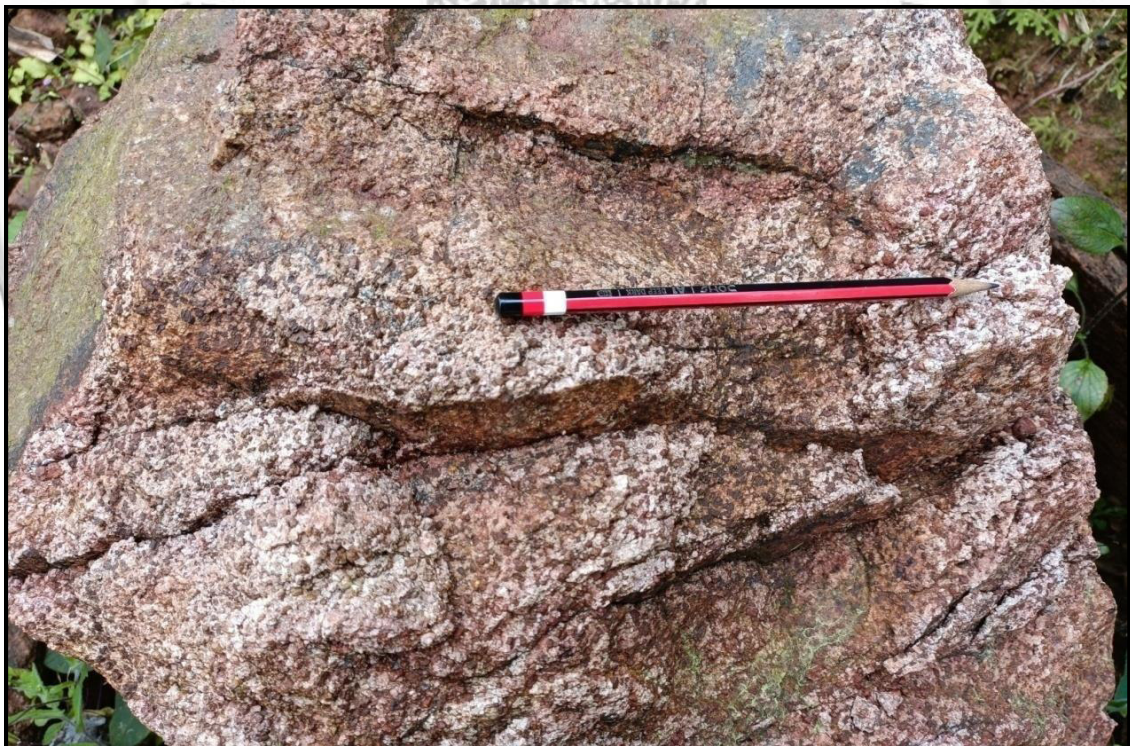
Fig. 2.4: Altered enderbite exposed near Cherengala

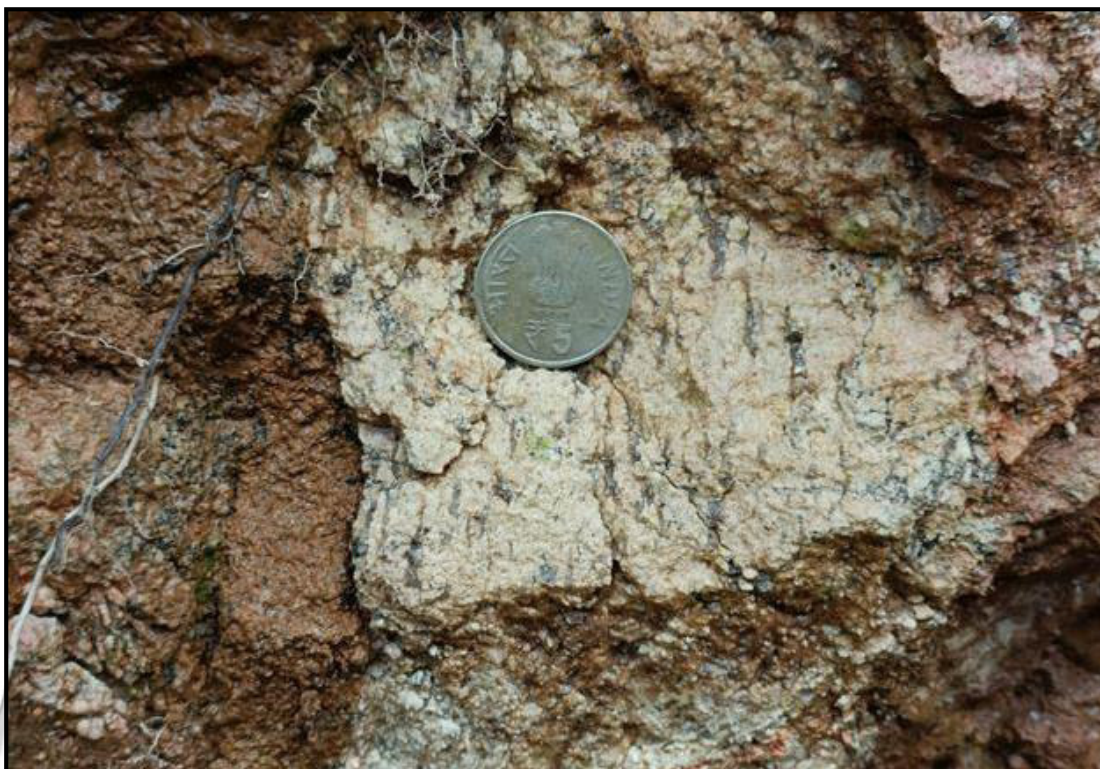
Fig. 2.5: Sheared granite showing elongated quartz grain

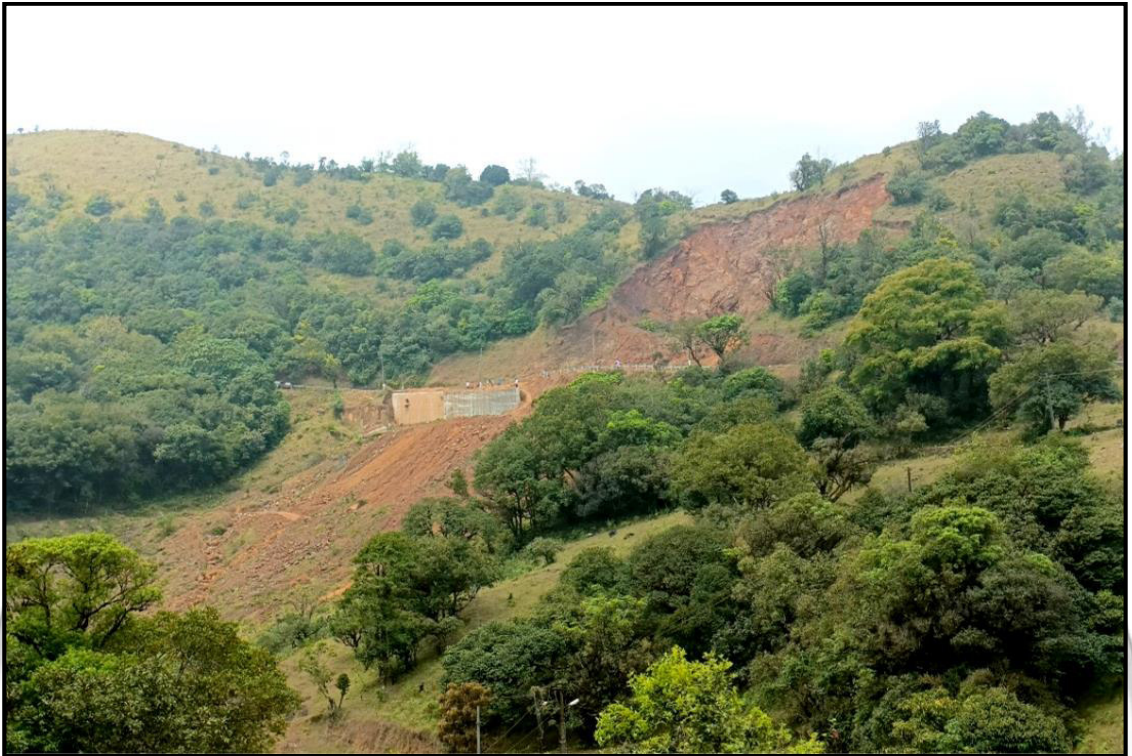
Fig. 4.1: A distant view of Talakaveri landslide

Majority of the landslides in the study area are along the cut slopes of road and in the back slopes of few settlements (Fig. 4.4) where the slope has been modified and have their causative factors linked to anthropogenic activities. These landslides are observed to be smaller in dimensions; however, they may reactivate during incessant rainfalls. The most prominent landslide is the Talakaveri slide (Fig. 4.1) which is a debris slide that occurred in the year 2020. The slide is ~55m in length and has a run out distance of >1000m. There were 5 human casualties due to the Talakaveri landslide.

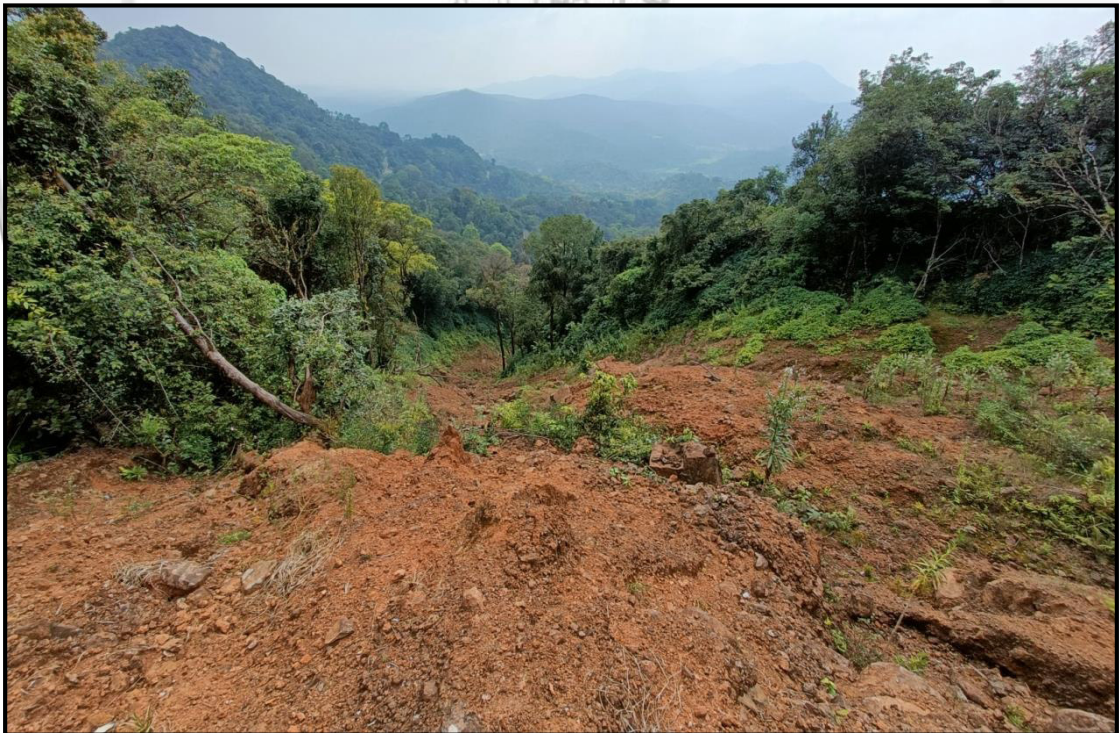
Fig. 4.2: Run out path of a landslide near Talakaveri

The Western Ghat ranges receive heavy rainfall and have thick soil cover due to extensive weathering of the rock units. Hence landslides in slopes with thick debris cover can destabilise huge volumes of material and have run outs that reach up to hundreds of meters in length (Fig. 4.2). Two such landslides are observed in the study area where the run out material has travelled to approximately 1km downstream. The slope forming material in such landslide zones was debris and highly weathered rock and had anthropogenic slope modification in the

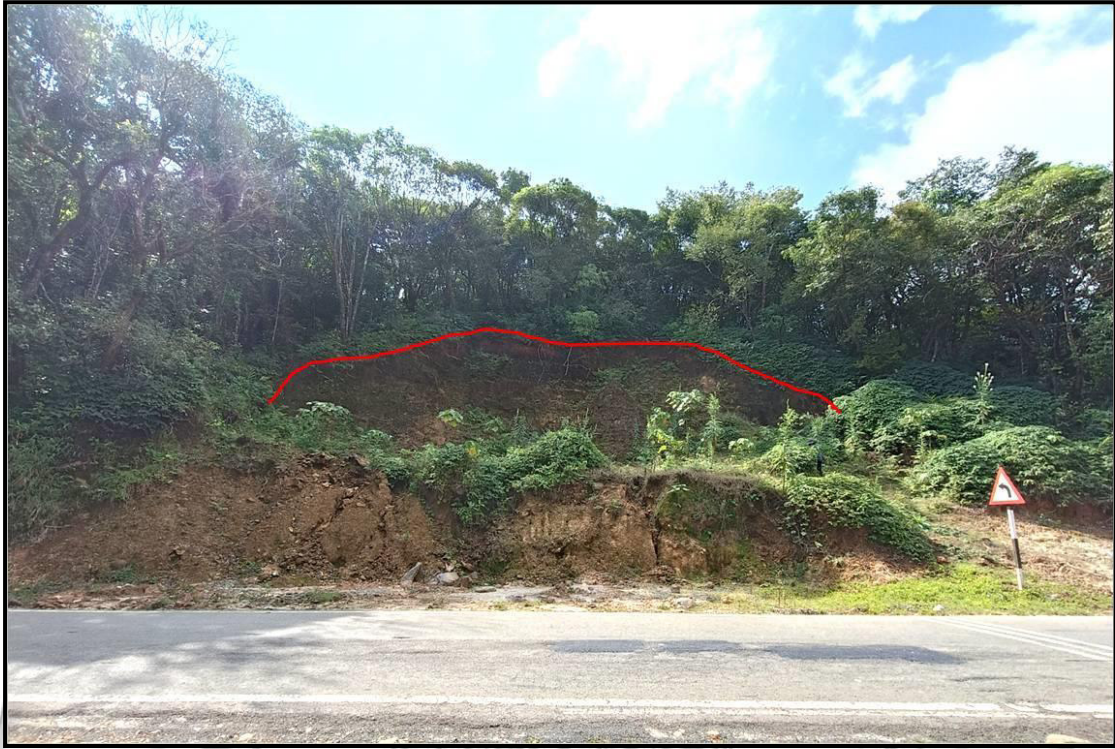
Fig. 4.3: A suspended landslide on Bhagamandla Talakaveri road

Altering the natural slopes for plantation without provisions for surface water runoff leads to the oversaturation of debris material and results in slope instabilities in the area. Providing such slopes with proper drainage will reduce water infiltration to the debris materials. Unplanned excavation of hill slopes in few localities without proper retaining structures is another cause of slope failures in the area. Majority of the landslides in the area are active in nature, however a few suspended (Fig. 4.3) and inactive landslides were also recorded during the course of field work.

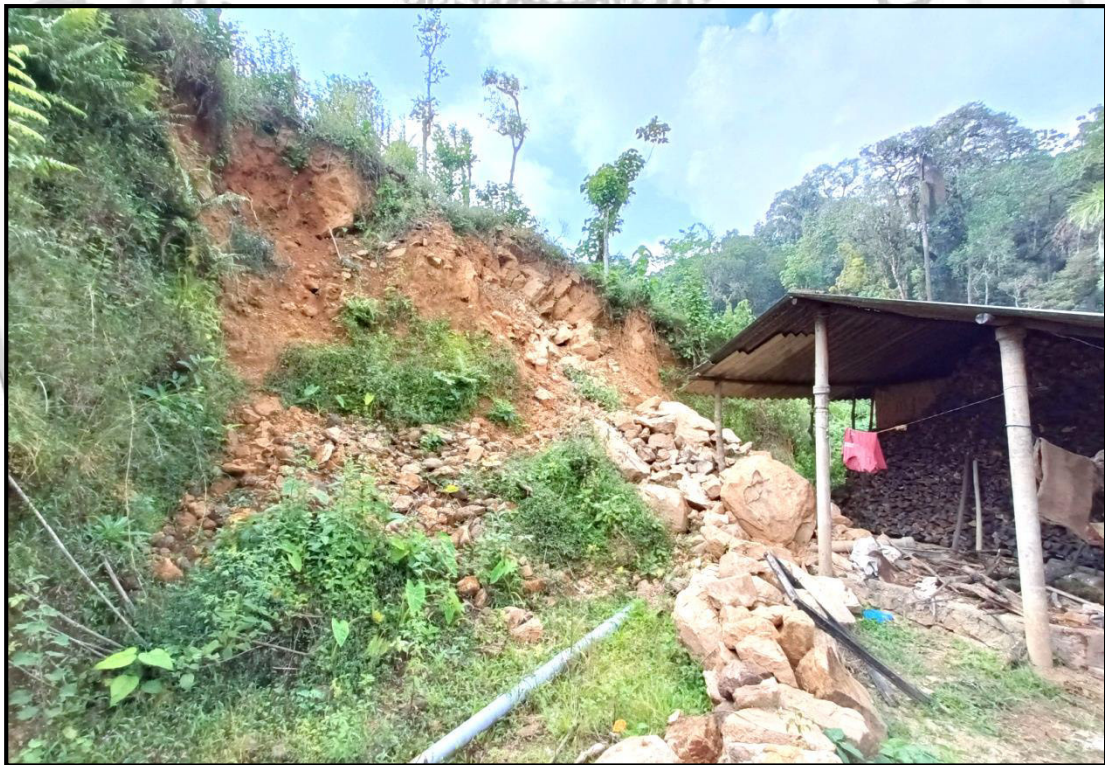
Fig. 4.4: Landslide initiated on a cut slope near a house in Cherengala

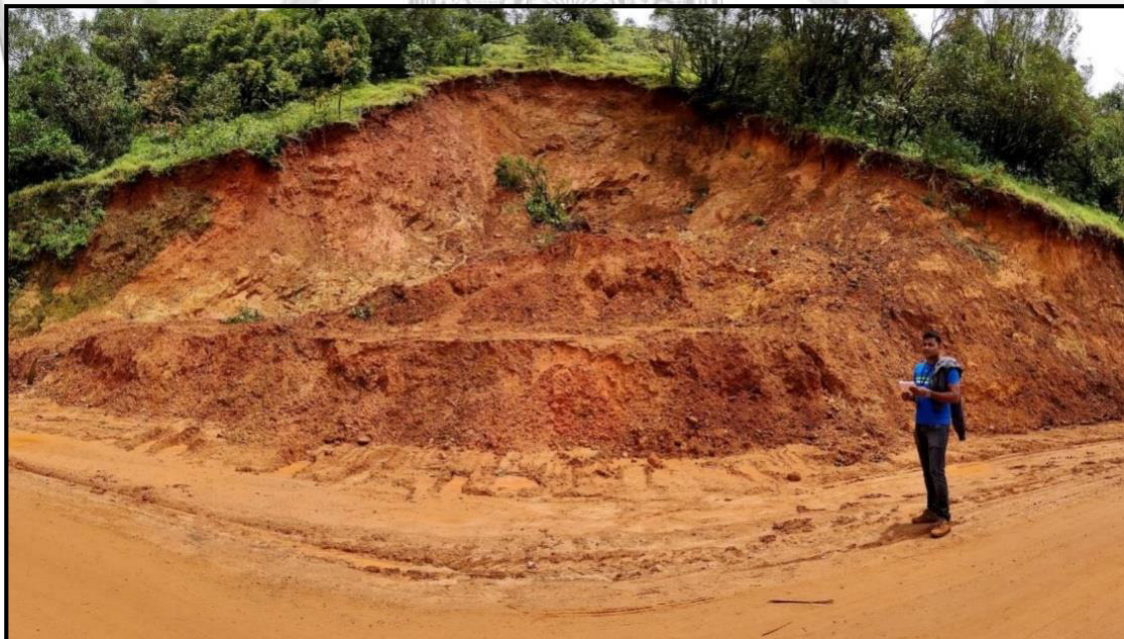
Fig. 4.7: A view of the landslide in 2019  
(Source: 2019 GSI post-disaster report)

The Talakaveri landslide was first reported by GSI in 2017 when cracks were identified in the crown area. It was subsequently reported when it reactivated on 09/08/2019 blocking the approach road to the temple (Fig. 4.7). Another minor cut slope failure was reported adjacent to the Talakaveri slide, indicating that the area is prone to slope failures. The Talakaveri landslide which initiated as a cut slope failure retrogressed over the years before reactivating on 06/08/2020 after intense rainfall (Fig.2).

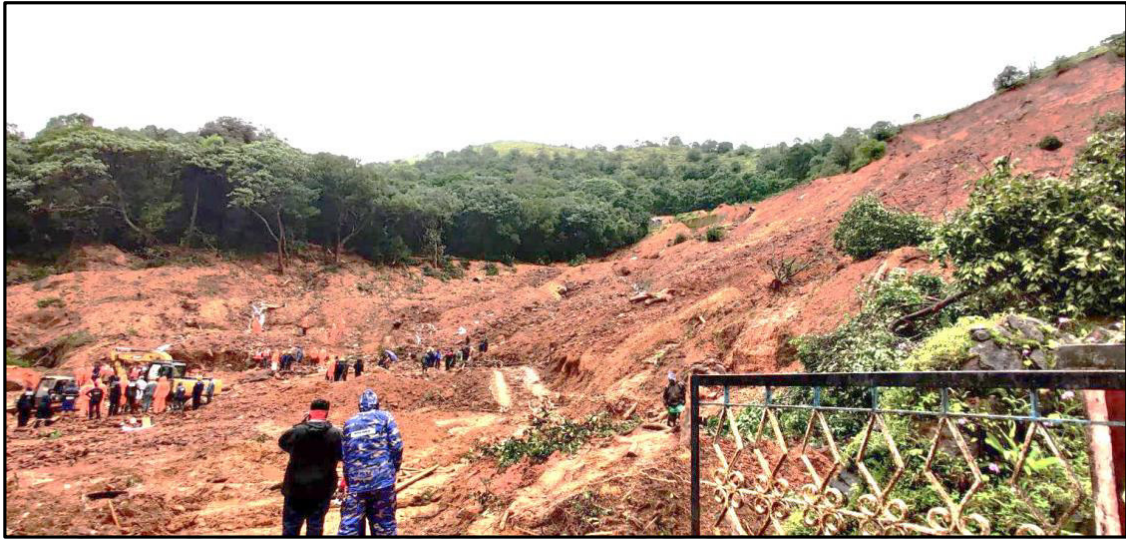
Fig. 4.8: A view of the landslide in 2020  
(Source: 2020 GSI post-disaster report)

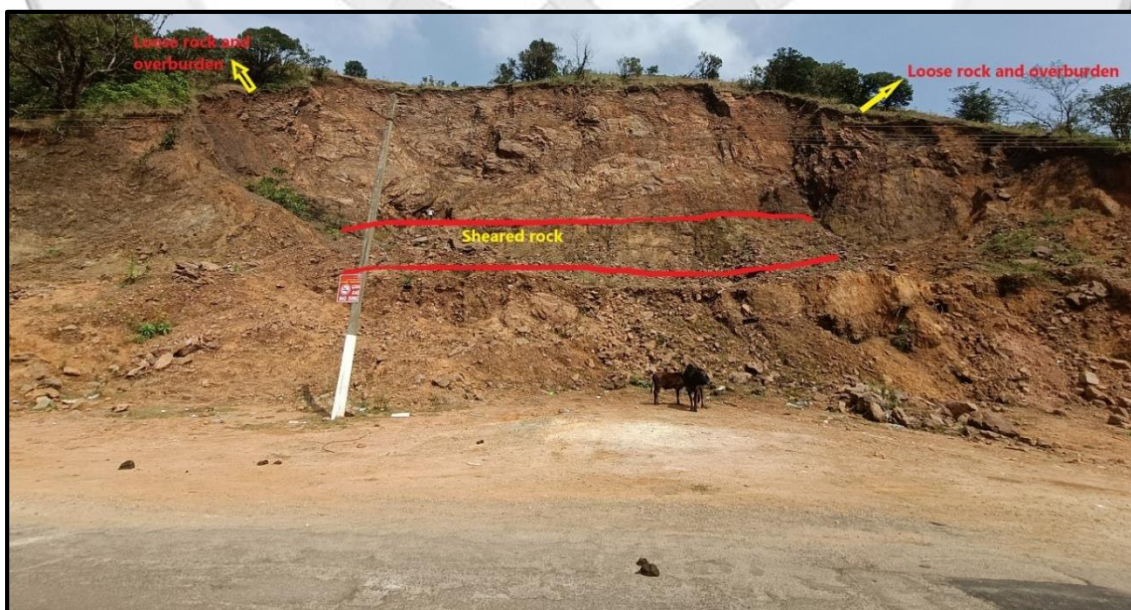
The area is occupied by Enderbite which is moderately weathered. The cut slope also exposes a band of sheared rock which is highly deformed and friable. The UCS values of the rocks in the slide area give an average value of 28MPa whereas the UCS value from the shear zone is 16MPa. Previous photographs of the slide zone reveal a considerable amount of debris material in the slope. The antecedent rainfall during 04/08/2020 to 06/08/2020 might have oversaturated the debris material and the rainfall event of 478 mm on 06/08/2020 acted as a trigger. The landslide would have washed out the debris material in the down slope leading to the massive debris flow. Traverses in and around the landslide revealed that there are no tension cracks above the landslide. This means the chances of any large scale retrogression is low. However, the flanks of the landslide still have debris as well as loose rocks exposed. Fig. 4.9.

Fig. 4.9: Latest photograph of Talakaveri landslide

Some remedial measures for Talakaveri landslides are described as follows:

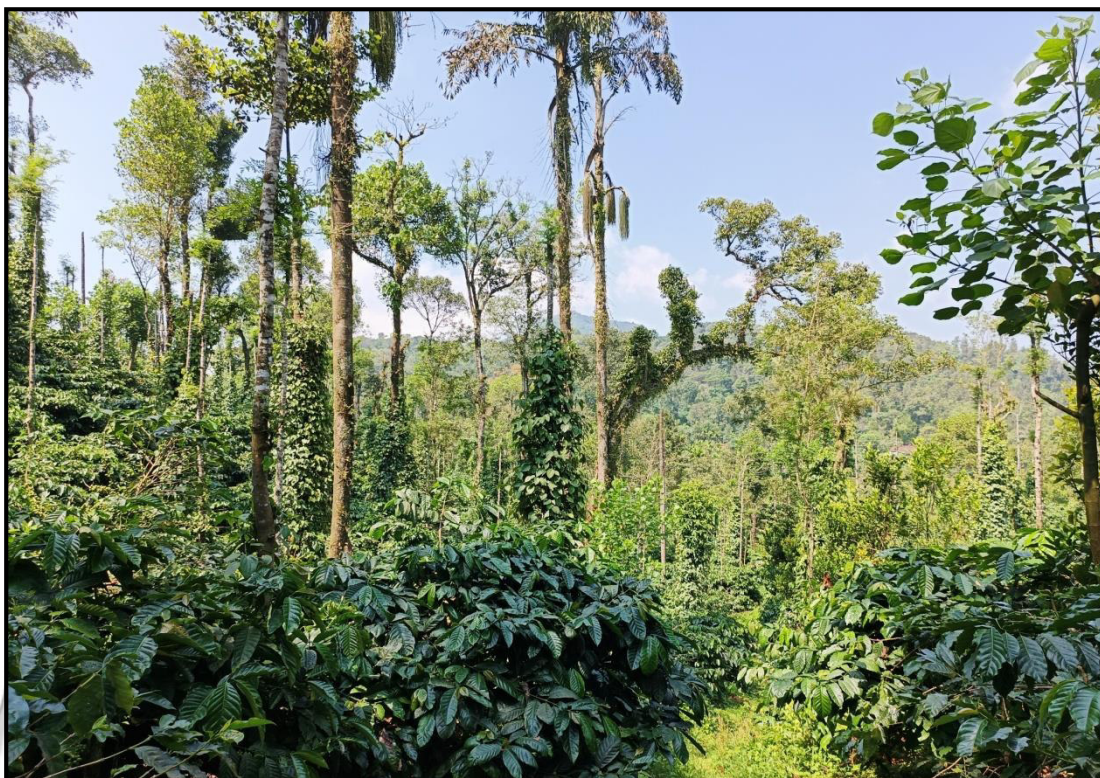
Fig. 5.11: Coffee and black pepper plantation mixed with vegetation near Cherengala

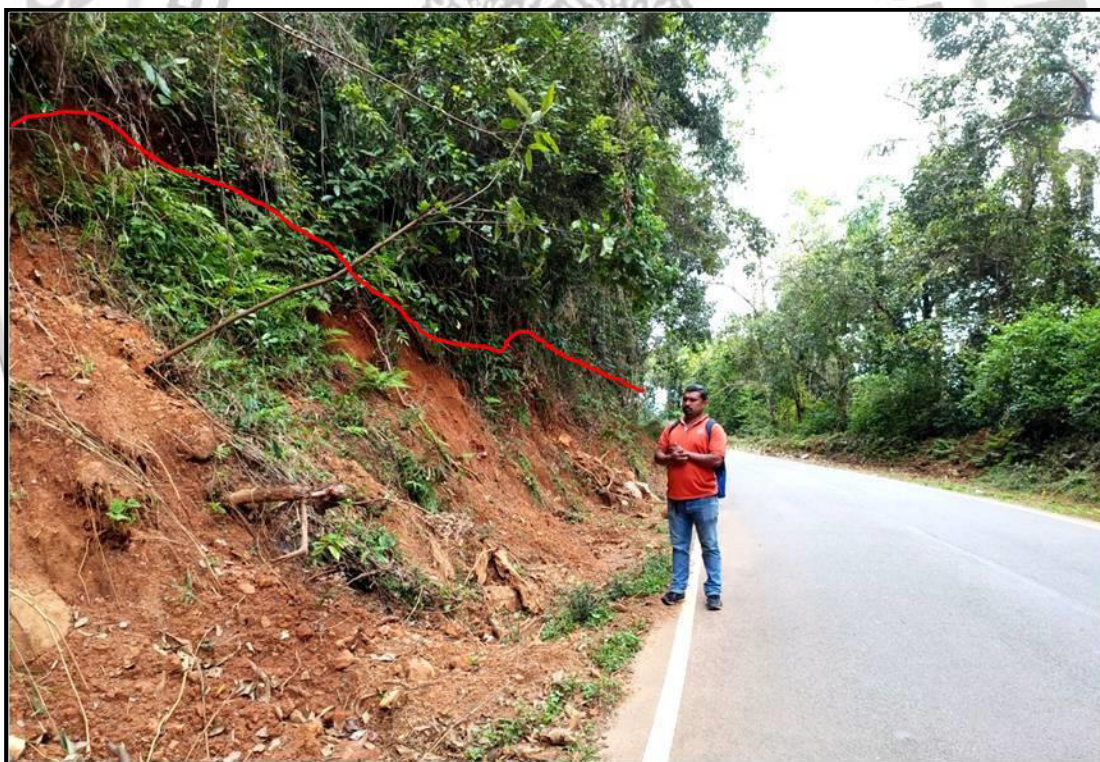
Fig. 5.12: A cut slope along Bhagamandla Talakaveri road near Cherengala

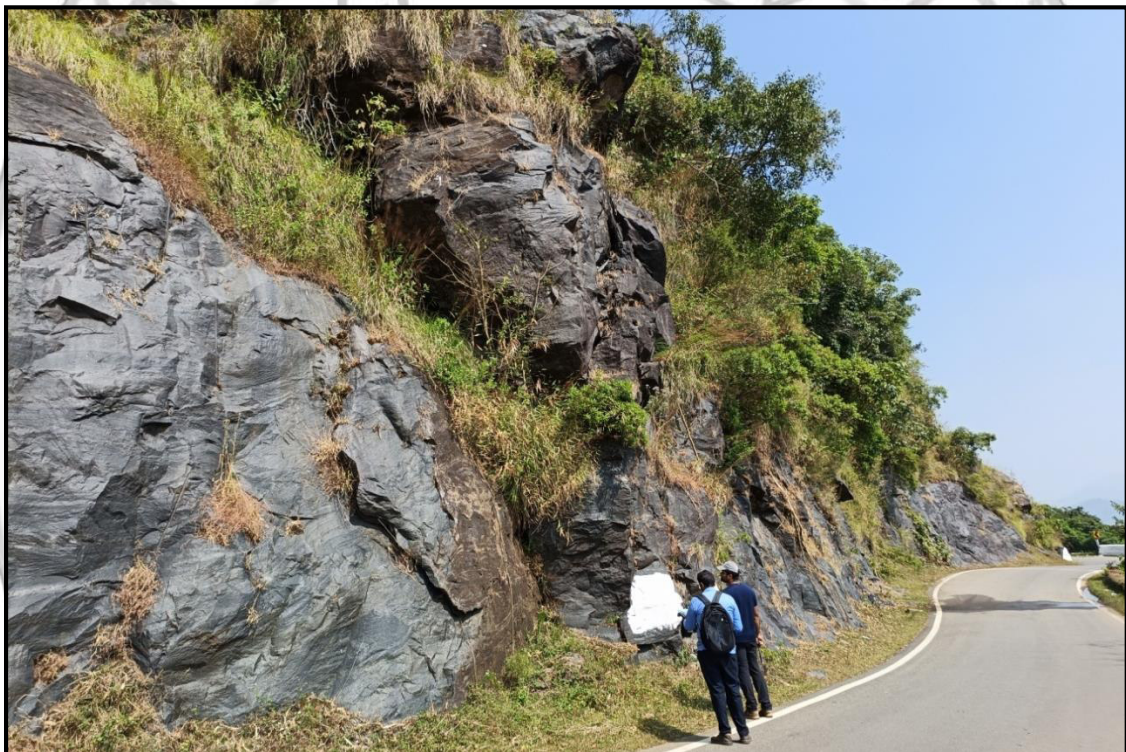
Fig. 5.17: Exposed rock along Bhagamandla Talakaveri road

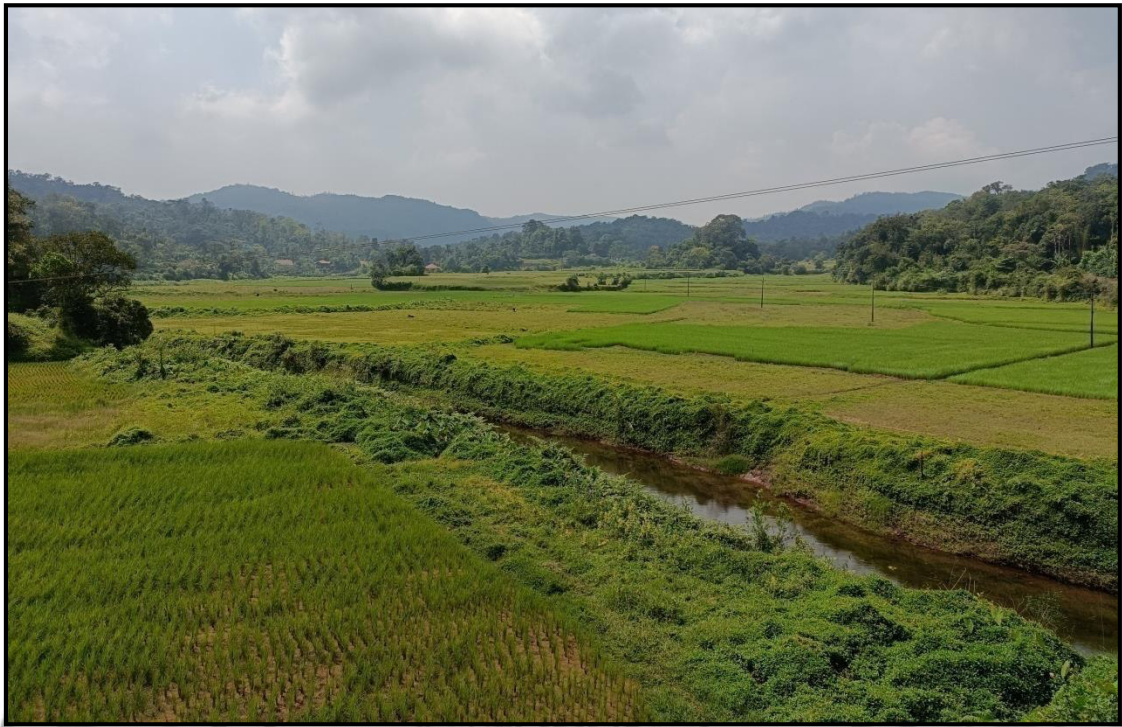
Fig. 5.18: Alluvium material near Bhagamandla

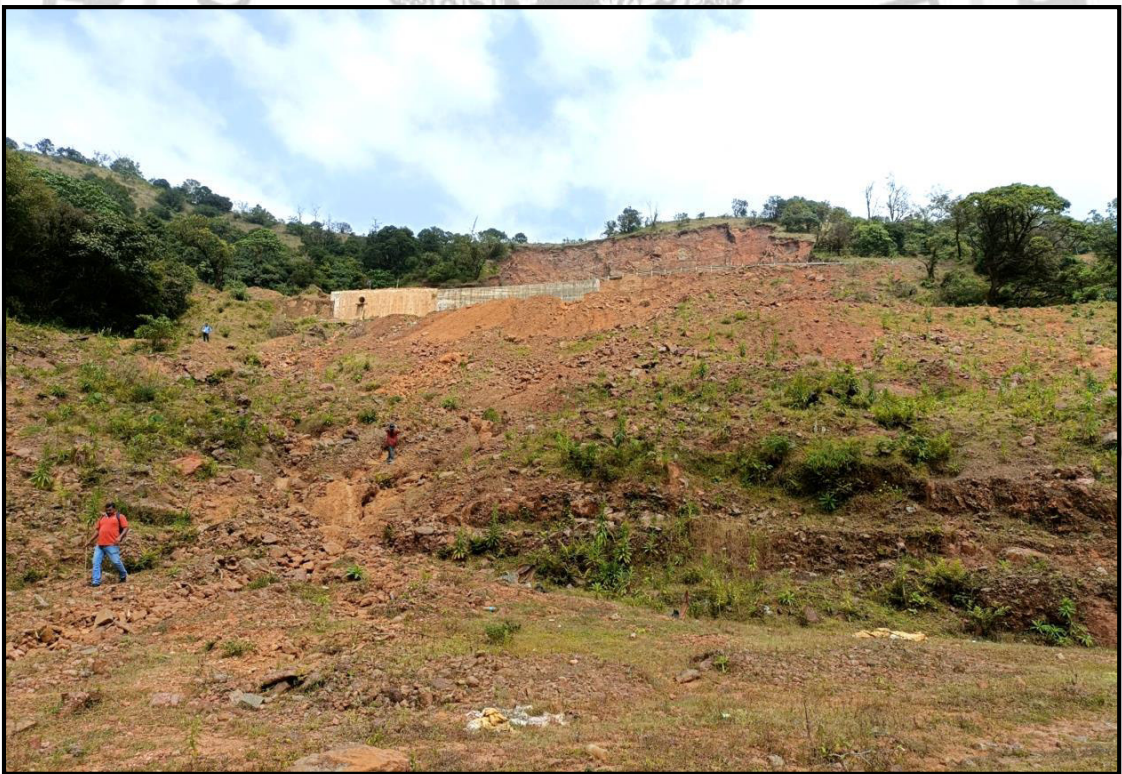
Fig. 5.19: Younger loose debris exposed in Talakaveri landslide runout zone

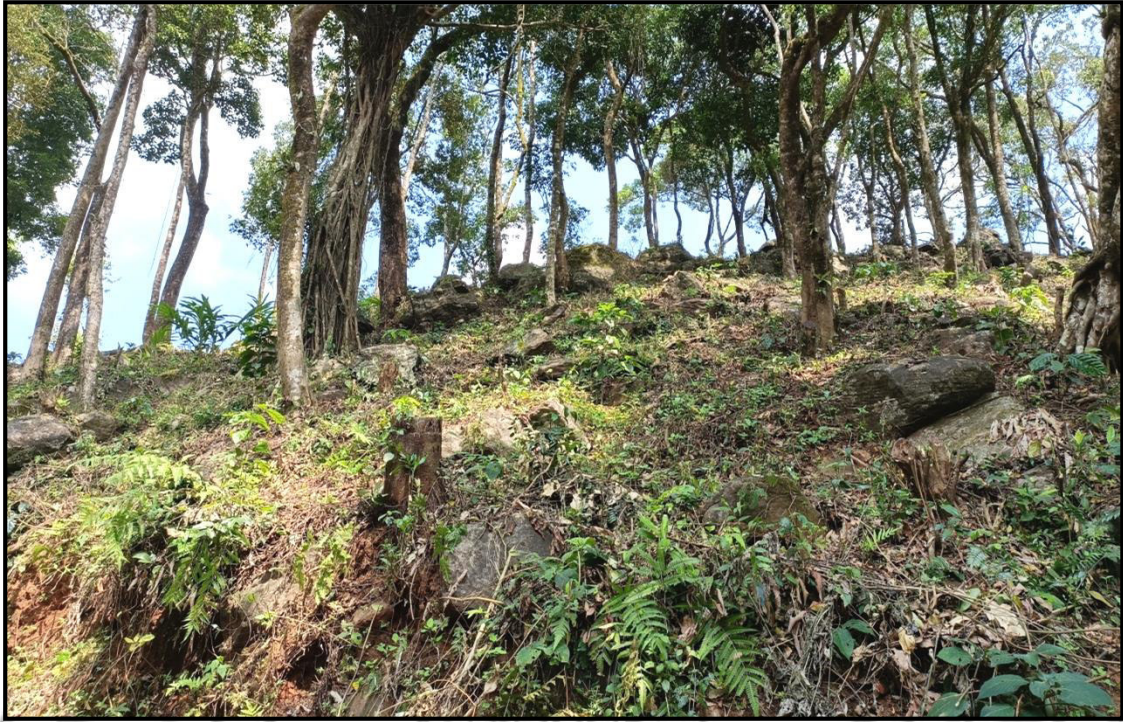
Fig. 5.20: Thin soil cover exposed near Cherengala

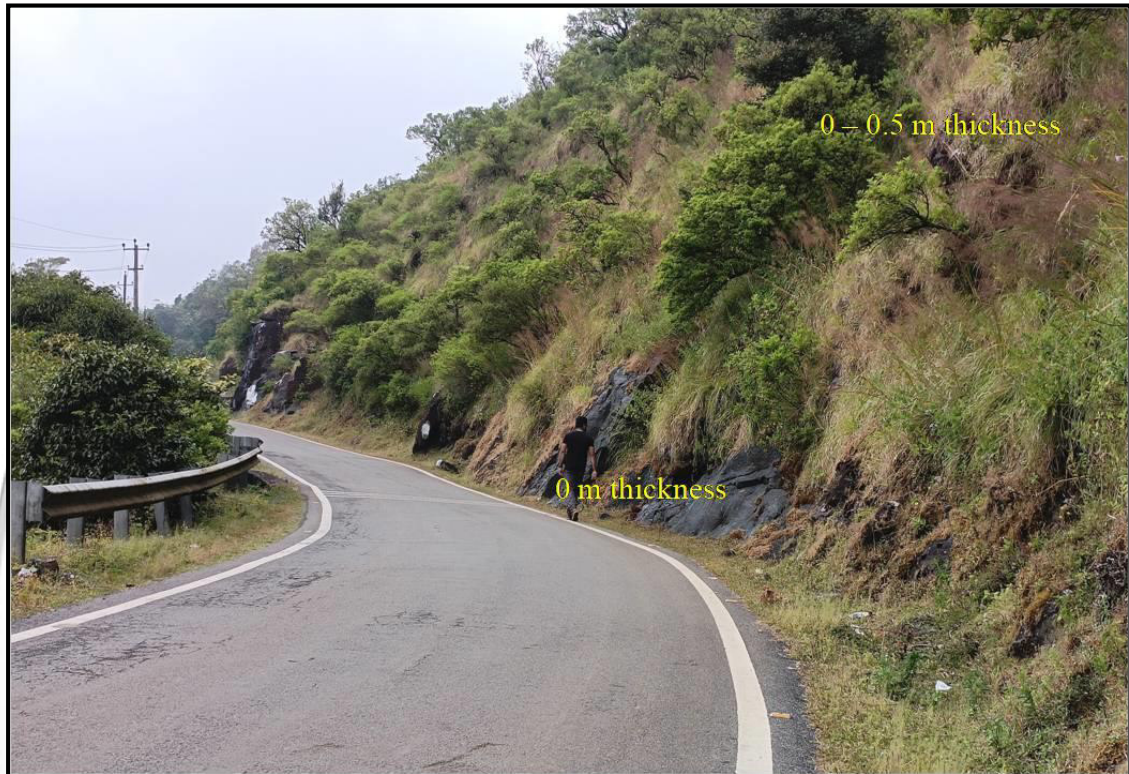
Fig. 5.23: 0 m thickness and 0-0.5m thickness classes along Bhagamandla Talakaveri road

The Overburden thickness map has values ranging from 0 m to >5m and is classified into 6 classes viz. 0m, 0-0.5m, 0.5m-1m, 1-2m, 2-5m and >5m (Fig. 5.21). Thicker overburden is mostly observed in the central and southern part of the area where alluvium and colluviums are exposed. Exposed rocks are given thickness 0 m and rocky slopes with thin soil cover have given thickness of 0-0.5m, which covers nearly 57% of the study area (Fig. 5.22). 58% of the total landslide area fall in the thickness class of 0m i.e., areas with exposed rock, followed by 26% in the 0-0.5 m class and 9% in 1-2m class (Fig. 5.22). Field photographs of some overburden thickness classes have been shown in Fig. 5.23, 5.24 and 5.25.

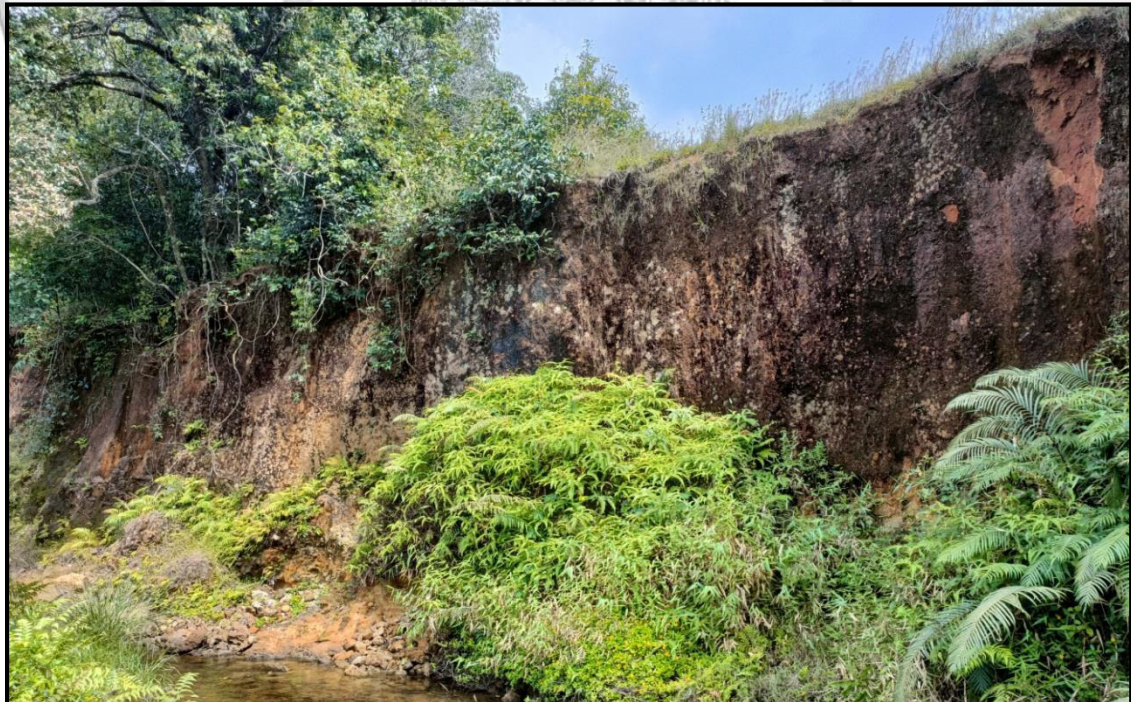
Fig. 5.24: Older well compacted debris with 1-2m thickness exposed near Cherengala

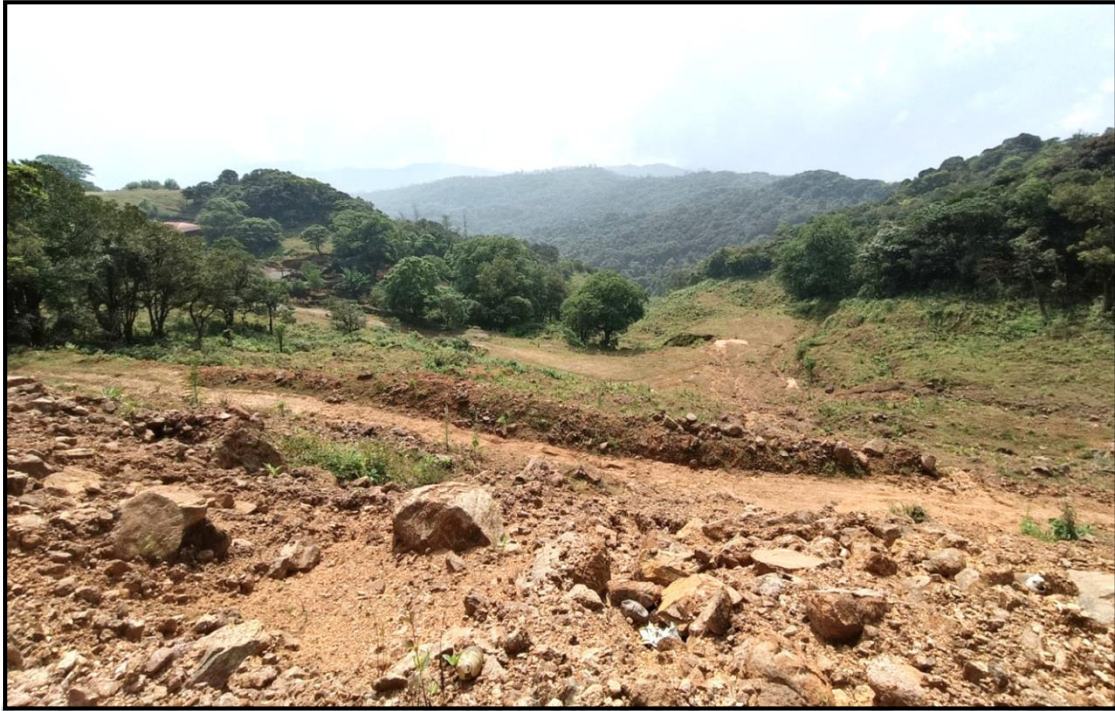
Fig. 5.25: Younger loose debris with >5m thickness exposed near Talakaveri

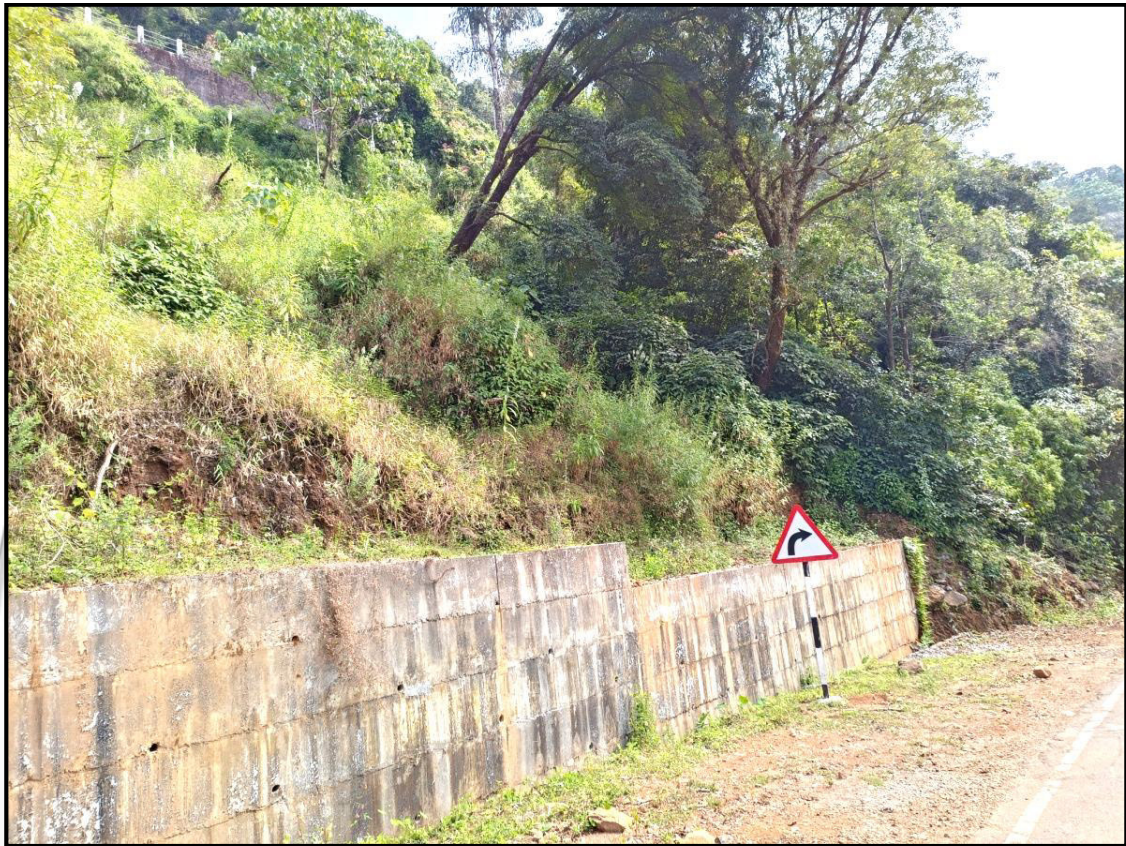
Fig. 6.5: A high susceptibility zone on SH-90

vulnerable due to cut slopes and poor rock condition. The high susceptibility zone, south-east of the Talakaveri slide, below the road is of minimal risk as the down slope areas do not have any human settlement.

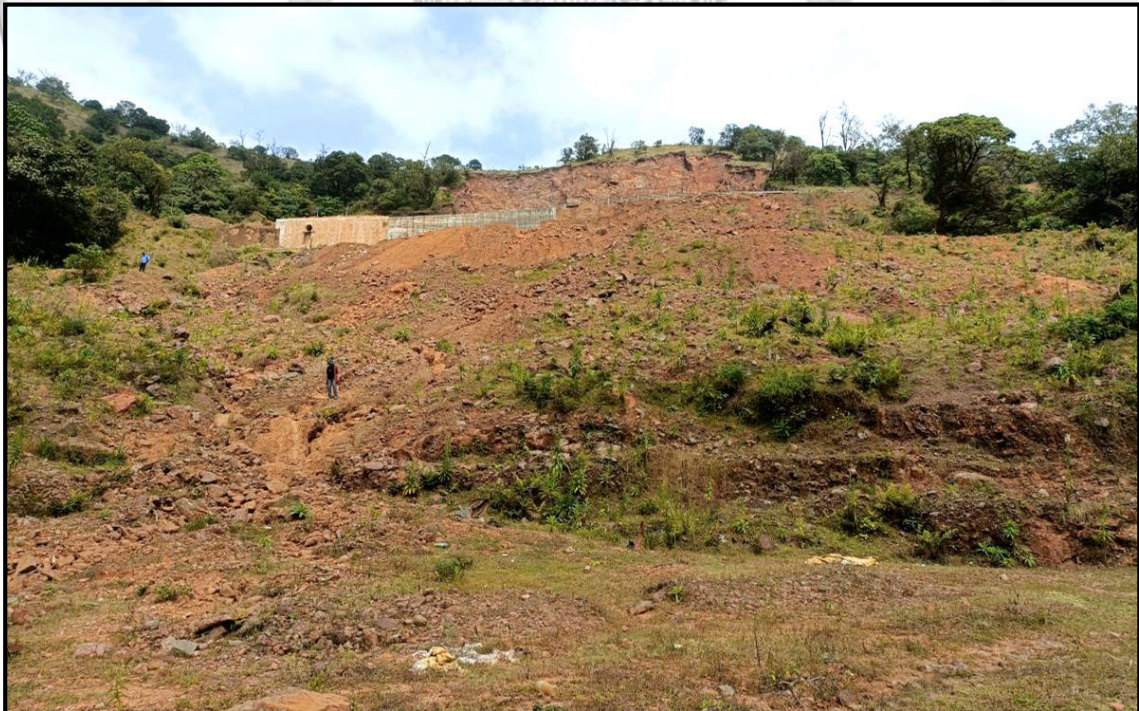
Fig. 6.6: Talakaveri landslide in the high susceptibility zone

The high susceptibility zone in the north-western part of the area near Talakaveri temple (Fig. 6.6) extends a distance of about 350 m and is characterised by loose debris which has accumulated in the run-out part of the landslide and adjacent hill slopes which is having weak rock mass. This area is having a previous record of having few debris slides and is still

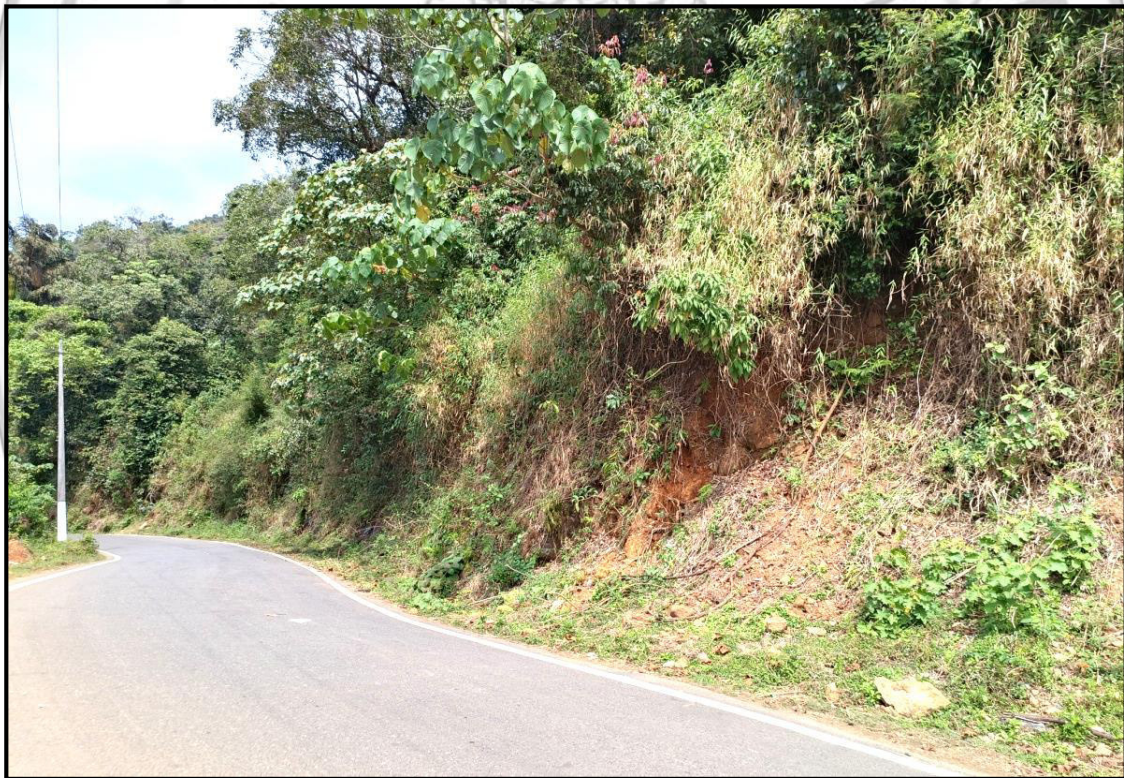
Fig. 6.7: A moderately susceptible cut slope on SH-90

The moderate susceptibility class is observed throughout the study area flanking the high susceptibility zones. 22% of the study area falls under moderate susceptibility zone. Majority of the moderate susceptibility zone is observed in the debris slide domain. The moderate susceptibility patches are observed in the south-east part of the study area. This area is characterised by dense and moderate vegetation and thin soil cover. The landslides observed in the moderate susceptibility zones are shallow landslides with less run out areas (Fig. 6.7). However, in case of extreme or incessant rainfall, the slide run out material may be more.

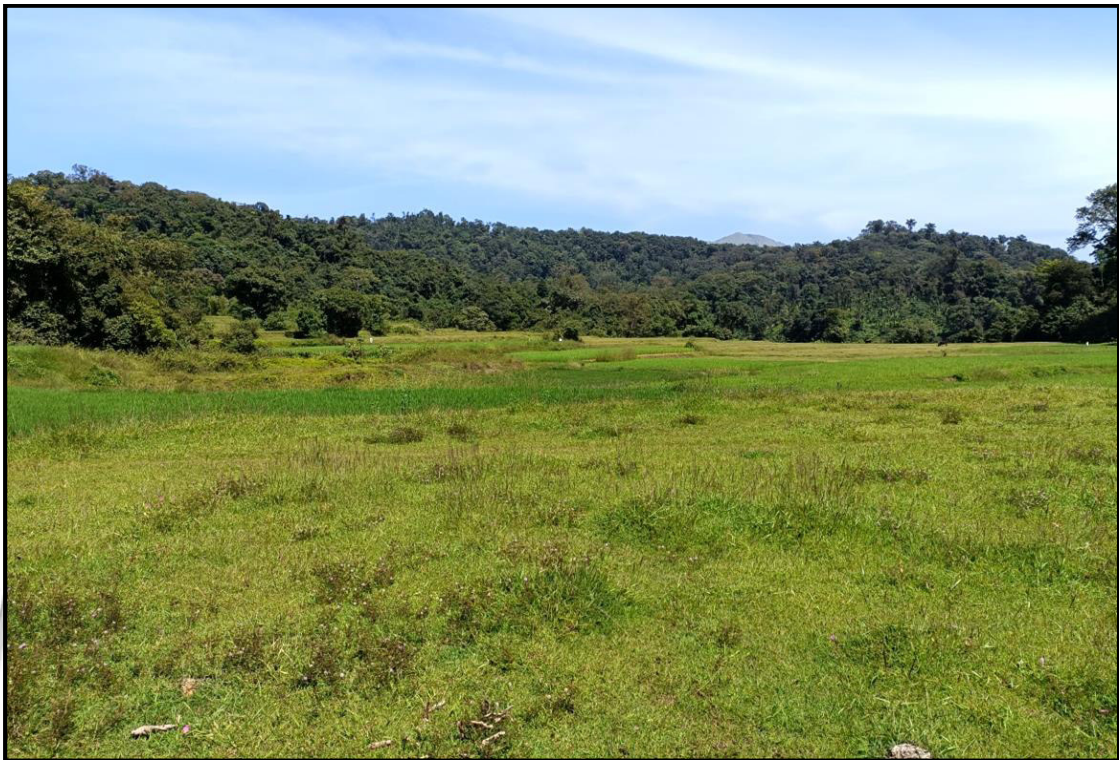
Fig. 6.8: Gently sloping low susceptibility zone near Bhagamandla

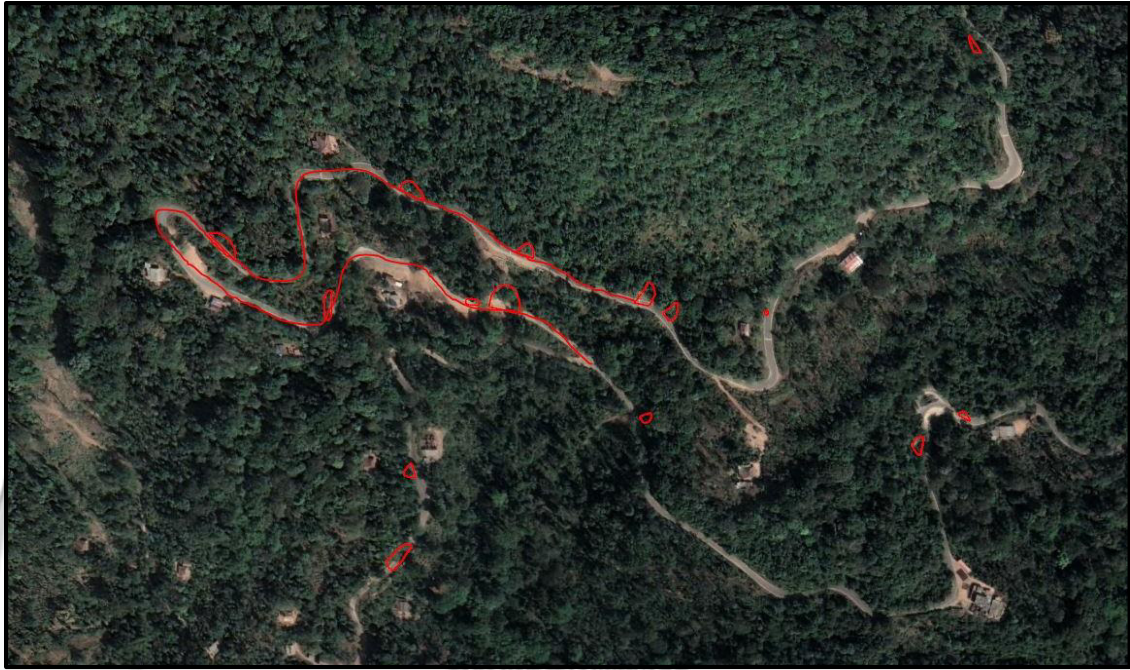
Fig. 7.2: Vulnerable zone at the hairpin bend on Bhagamandala-Talakaveri road

has already been done in the area. Any roadblock in this region will cut off the vehicular traffic to Talakaveri as this is the only approach road to the temple. It is recommended to stabilize the landslide-affected stretches by providing support measures for existing landslides and avoid any further slope modification or deforestation in the zone.

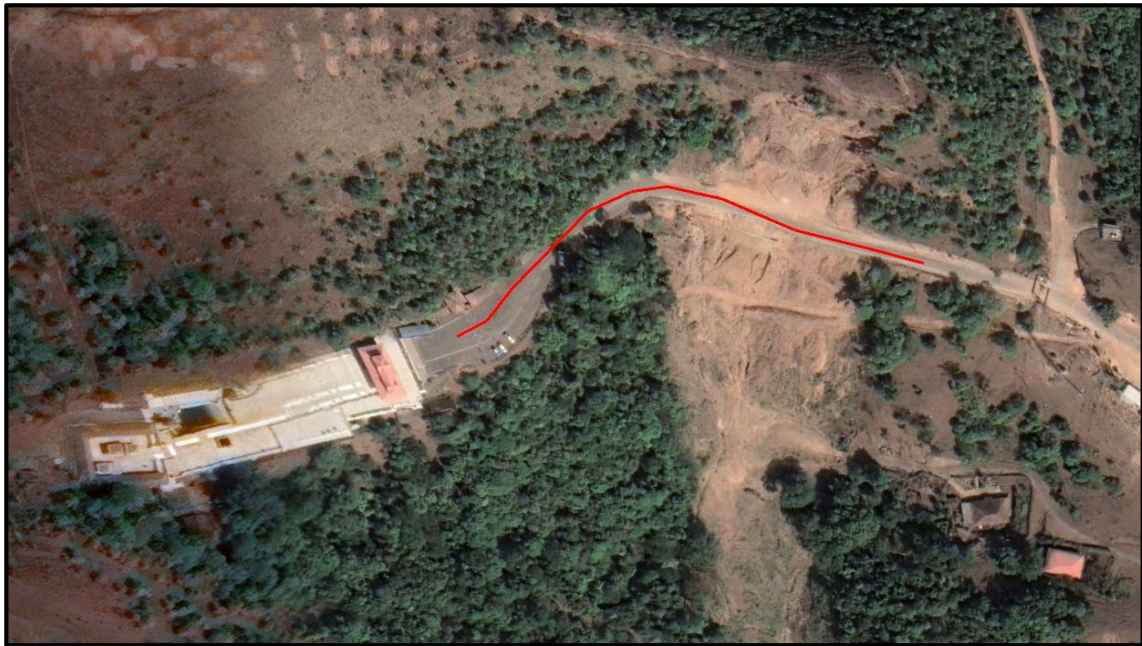
Fig. 7.3: Vulnerable road stretch near Talakaveri temple

The vulnerable road stretch near Takalaveri temple starts after the entry gate of the temple and extends till the police outpost near the temple as marked in Fig. 7.3. It is recommended to provide stabilization to all the cut slopes in this zone as the area has a huge influx of tourists throughout the year. Proper drainage channelization should also be done to carry the excess runoff away from the area. Any further slope cuts in the zone should be avoided.
