MESO-SCALE (1:10,000) LANDSLIDE SUSCEPTIBILITY MAPPING IN  
BHAGAMANDLA AND TALAKAVERI HILL TOWNSHIPS, KODAGU DISTRICT,  
KARNATAKA.

कार्य सत्र 2022-23 का अंतिम प्रतिवेदन  
Final report for Field Season 2022-23

राज्य इकाई: कर्नाटक एवं गोवा /State Unit: Karnataka and Goa  
दक्षिण क्षेत्र/ Southern Region  
बेंगलूरु/Bengaluru

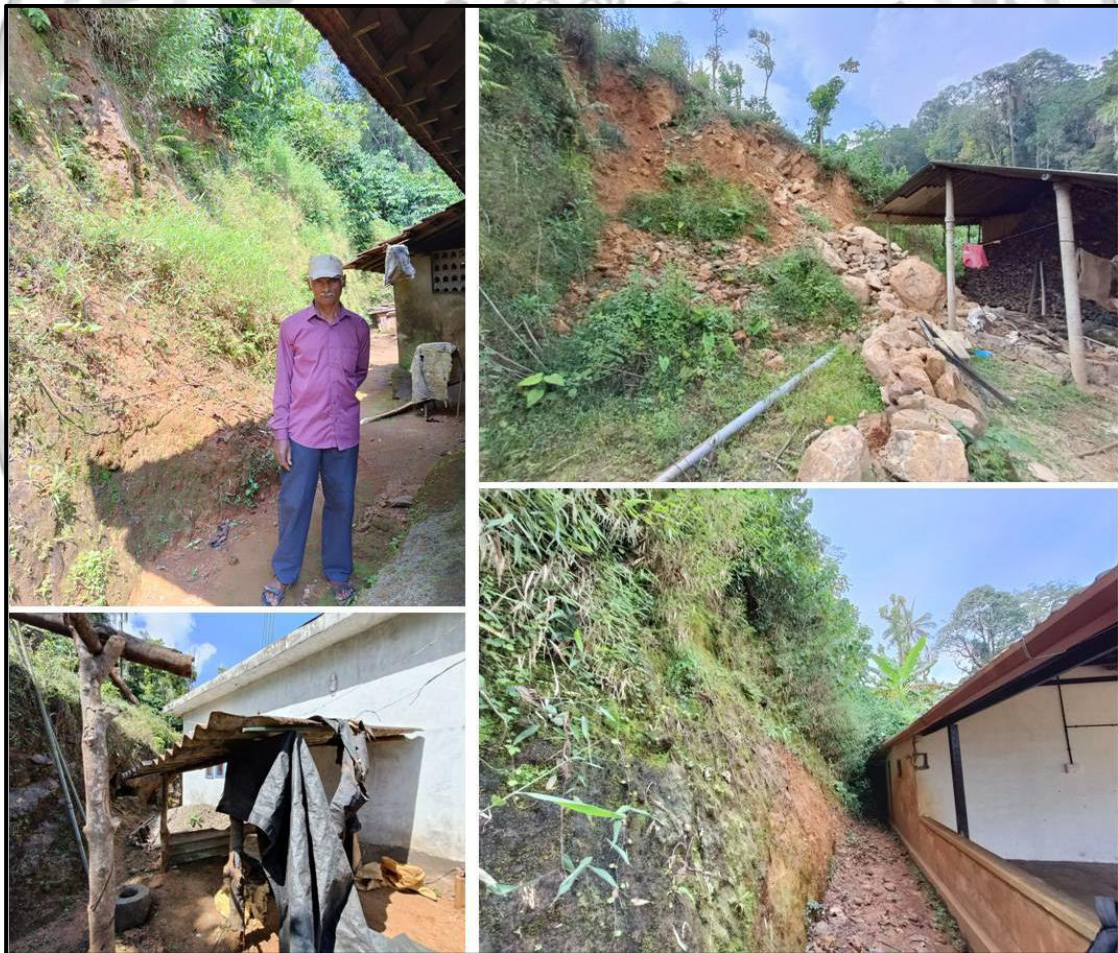
Fig. 7.4: Vulnerable houses near Cherengala

Landslide management map serves as a reference for the stakeholders on the mitigation measures to be taken up in the area of study. A total of four houses have been observed to be affected by landslides in the study area. All the houses have steep cut slopes and minor landslides on these slopes (Fig. 7.4). Apart from this, the road stretch from Bhagmandala to Talakaveri has many vulnerable zones which are marked in the Element at risk map (Fig. 7.1). Out of these, the important stretches are a 1.1 km zone along the hairpin bend (Fig.7.2) and a 250m zone near the Talakaveri temple (Fig. 7.3).

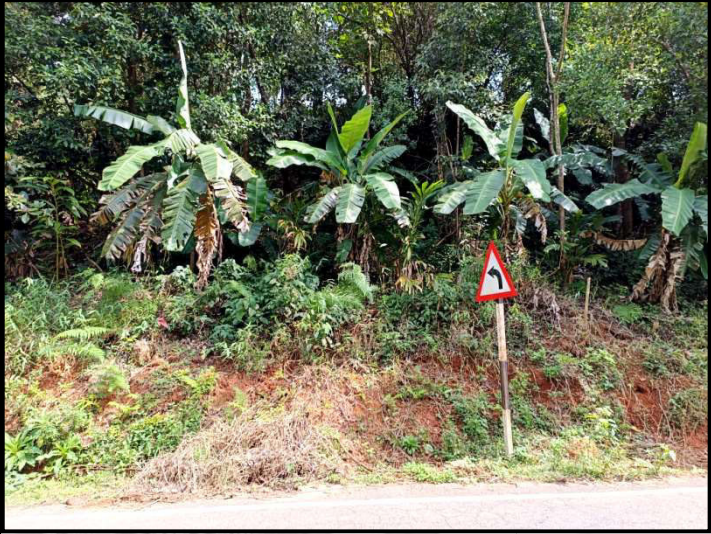
| No | Field | |
|---|---|---|
| 23 | Failure mechanism | Deep rotational |

| 38 | Geo-scientific Causes | Loose debris saturation by rainfall. |

| 39 | Remedial measures | -- |

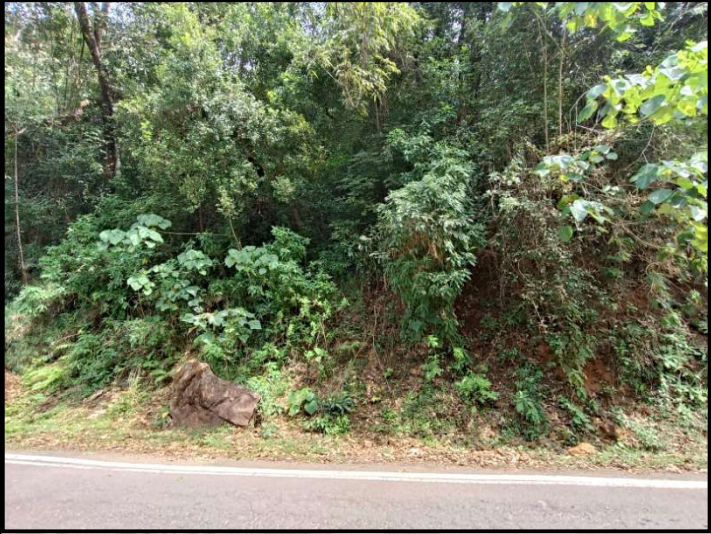
| No | Field | |
|---|---|---|
| 23 | Failure mechanism | Shallow rotational |

| 38 | Geo-scientific Causes | Highly weathered rock and debris saturation due to rainfall |

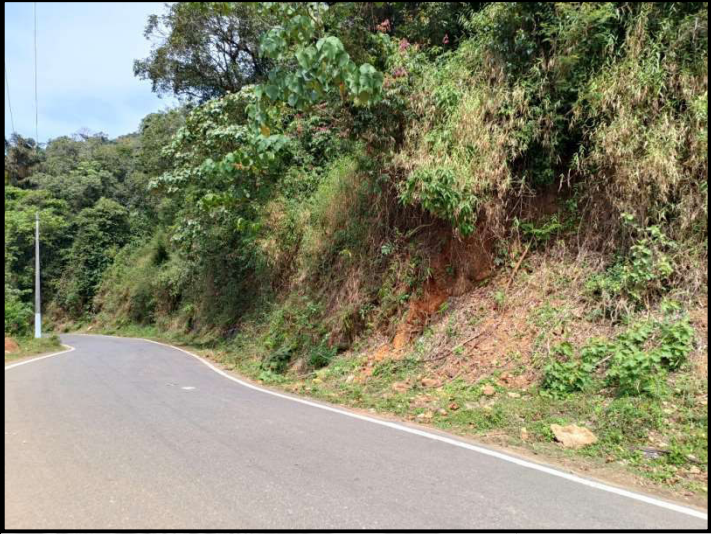
| No | Field | |
|---|---|---|
| 23 | Failure mechanism | Shallow rotational |

| 38 | Geo-scientific Causes | Debris saturation by rainfall |

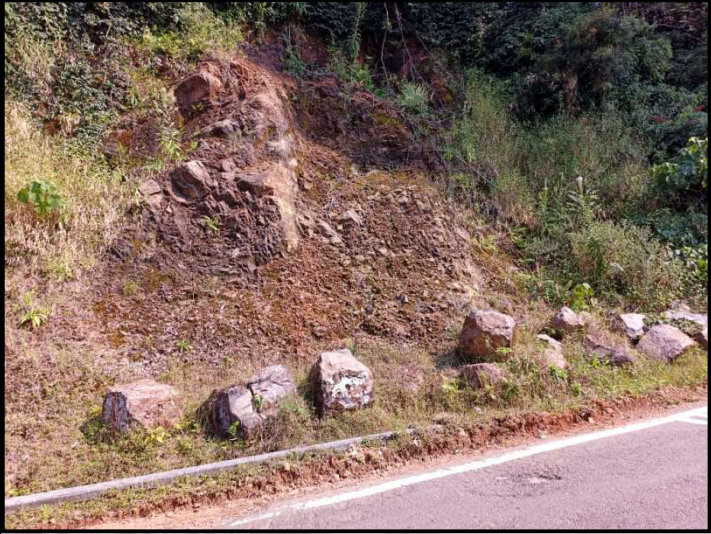
| No | Field | |
|---|---|---|
| 23 | Failure mechanism | Shallow translational |

| 38 | Geo-scientific Causes | Valley dipping joint daylighted in cut slope, heavy rainfall |

| 39 | Remedial measures | Loose scaling, RCC breast wall |

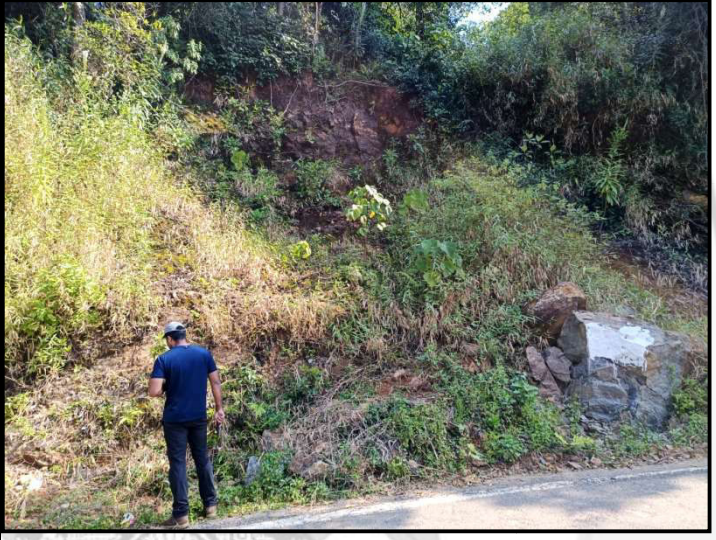
| No | Field | |
|---|---|---|
| 23 | Failure mechanism | Shallow translational |

| 38 | Geo-scientific Causes | Valley dipping joint daylighted in cut slope, heavy rainfall |

| 39 | Remedial measures | Loose scaling, RCC breast wall |

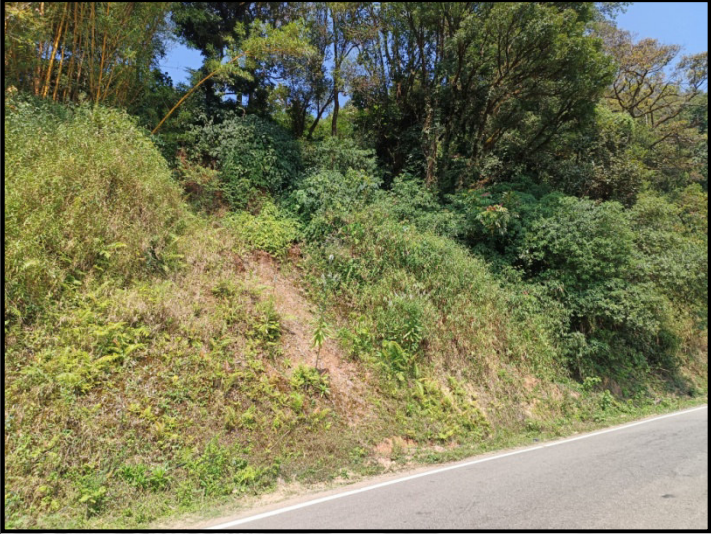
| No | Field | |
|---|---|---|
| 23 | Failure mechanism | Shallow rotational |

| 38 | Geo-scientific Causes | Debris saturation by rainfall |

| 39 | Remedial measures | Lined drainage, gabion wall |

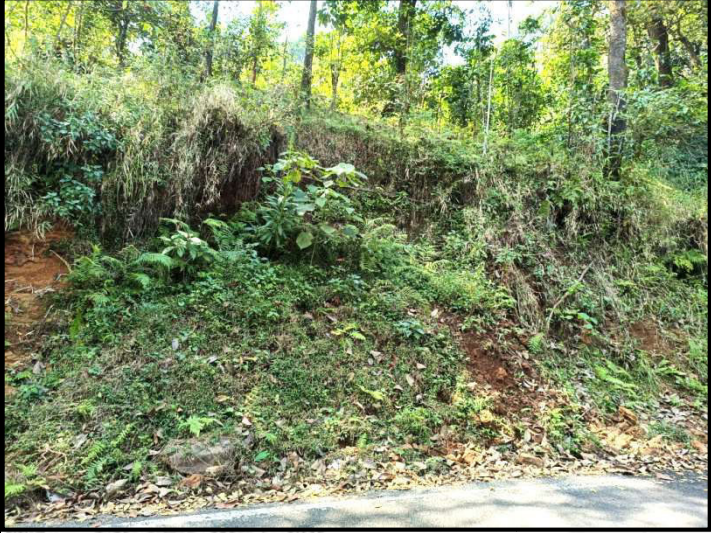
| No | Field | |
|---|---|---|
| 23 | Failure mechanism | Shallow translational |

| 38 | Geo-scientific Causes | Highly weathered rock failed along valley facing joints |

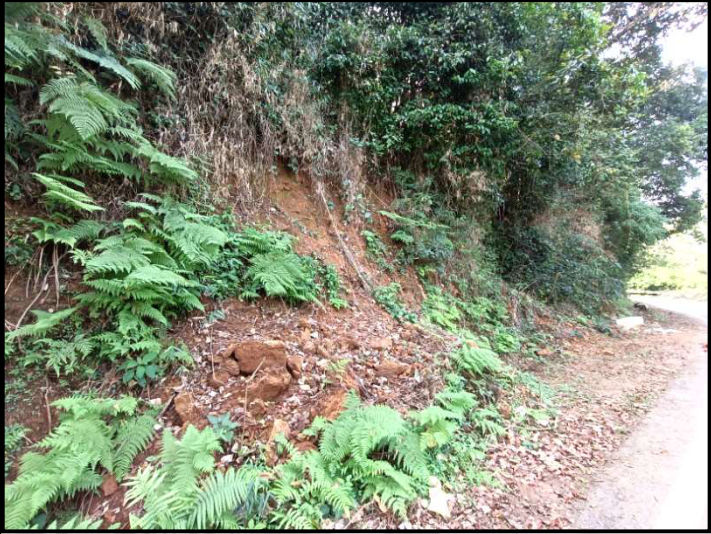
| No | Field | |
|---|---|---|
| 23 | Failure mechanism | Shallow translational |

| 38 | Geo-scientific Causes | Planar failure along valley facing joints |

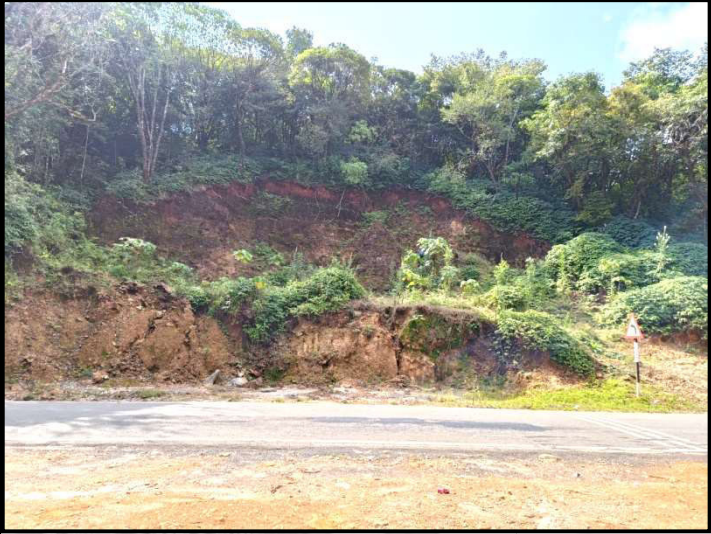
| No | Field | |
|---|---|---|
| 23 | Failure mechanism | Deep translational |
| 35 | Communication affected | Road blocked and damaged |

| 38 | Geo-scientific Causes | Highly weathered rock behaving as debris material failed due to rainfall |

| 39 | Remedial measures | Retaining wall given |

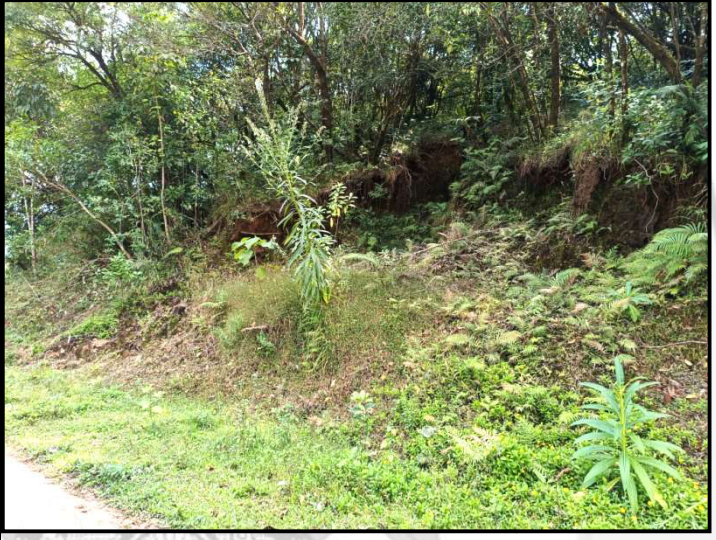
| No | Field | |
|---|---|---|
| 23 | Failure mechanism | Deep translational |
| 35 | Communication affected | Road blocked and damaged |

| 38 | Geo-scientific Causes | Highly weathered rock behaving as debris material failed due to rainfall |

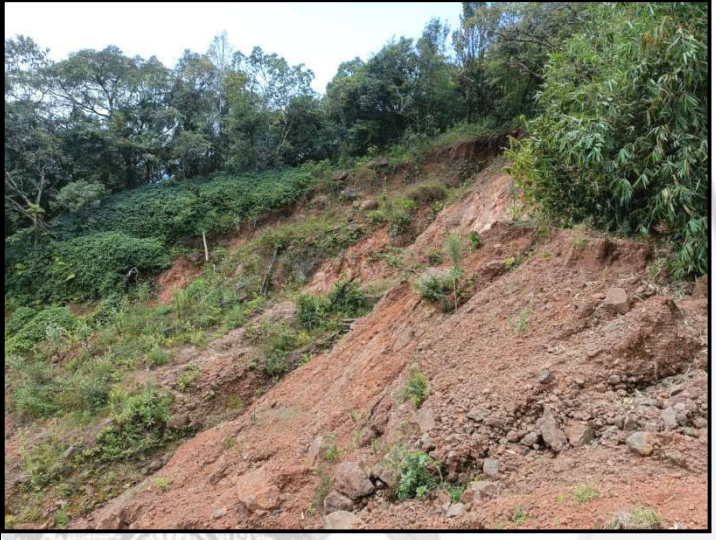
| No | Field | |
|---|---|---|
| 23 | Failure mechanism | Deep translational |

| 38 | Geo-scientific Causes | Highly weathered rock behaving as debris material failed due to rainfall |

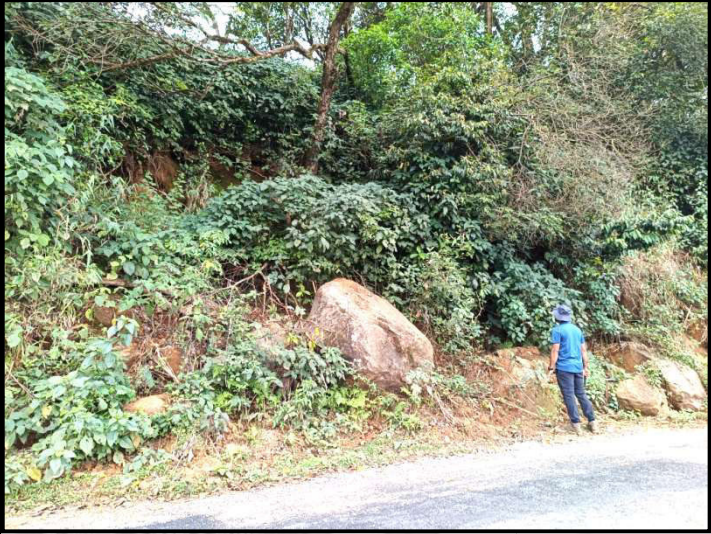
| No | Field | |
|---|---|---|
| 23 | Failure mechanism | Shallow translational |

| 38 | Geo-scientific Causes | Weathered rock exposed along cut slope |

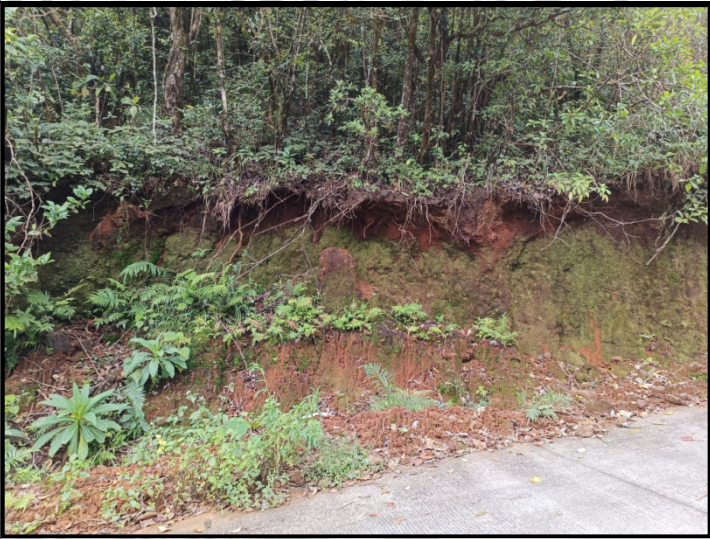
| No | Field | |
|---|---|---|
| 23 | Failure mechanism | Shallow rotational |

| 38 | Geo-scientific Causes | Debris saturation due to rainfall |

| 39 | Remedial measures | Provision of lined drainage along road |

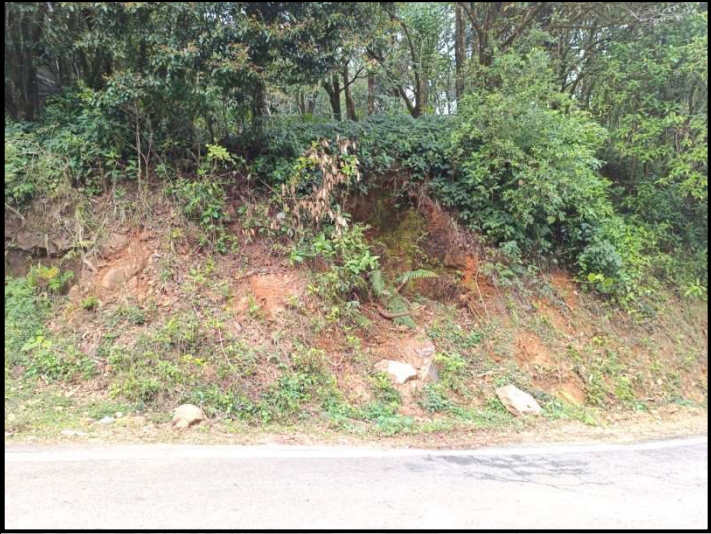
| No | Field | |
|---|---|---|
| 23 | Failure mechanism | Shallow translational |

| 38 | Geo-scientific Causes | Cut slope failure, |

| 39 | Remedial measures | No further slope cut is recommended |

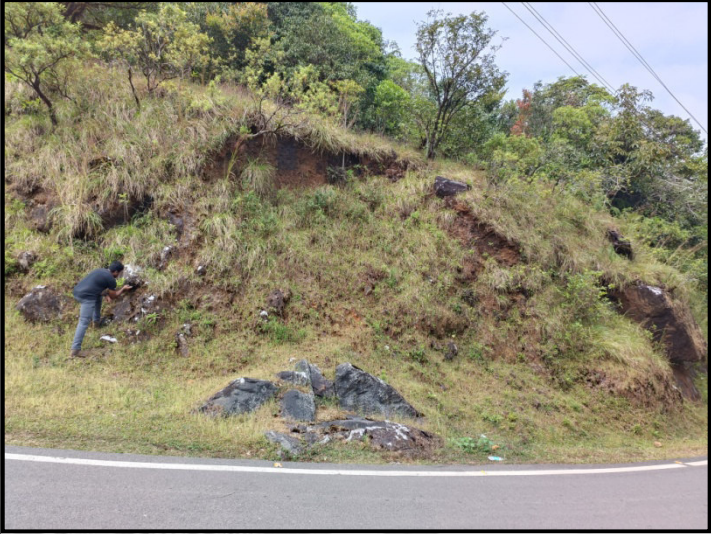
| No | Field | |
|---|---|---|
| 23 | Failure mechanism | Shallow translational |

| 38 | Geo-scientific Causes | Cut slope failure on a spur, |

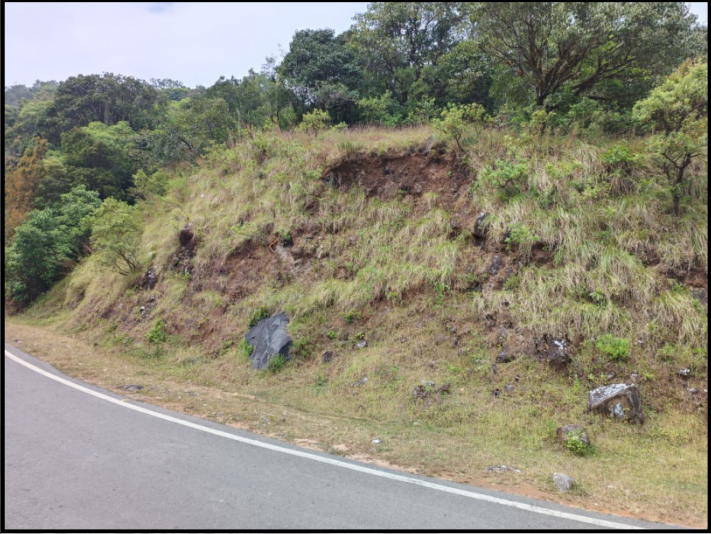
| No | Field | |
|---|---|---|
| 23 | Failure mechanism | Shallow translational |

| 38 | Geo-scientific Causes | Cut slope failure on a spur, |

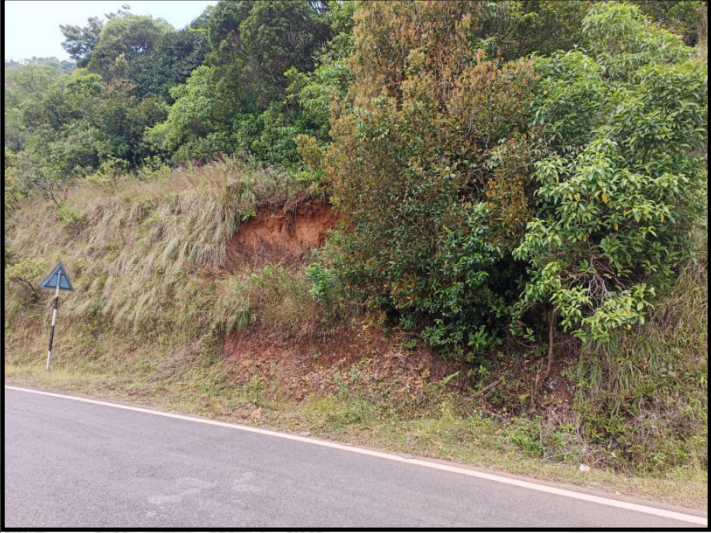
| No | Field | |
|---|---|---|
| 23 | Failure mechanism | Shallow translational |

| 38 | Geo-scientific Causes | Weathered rock exposed along road cut |

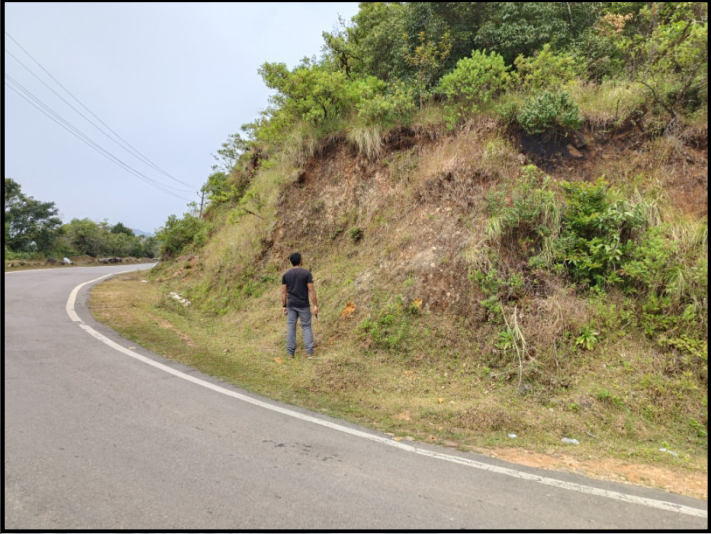
| No | Field | |
|---|---|---|
| 23 | Failure mechanism | Shallow translational |

| 38 | Geo-scientific Causes | Weathered rock exposed along road cut |

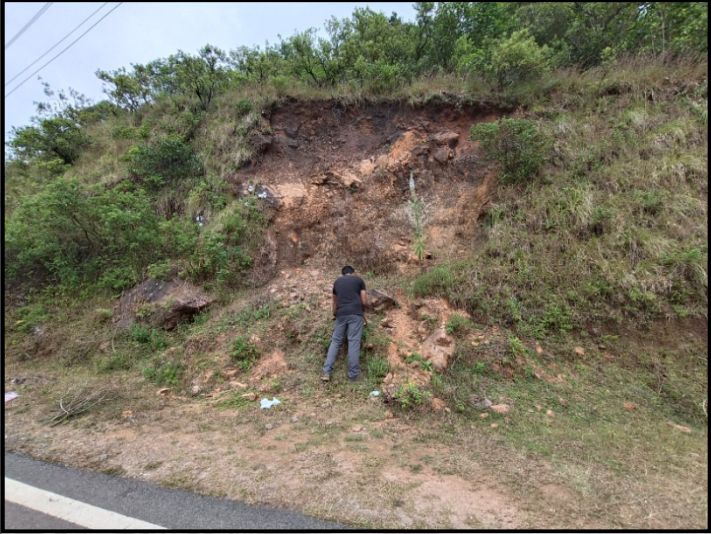
| No | Field | |
|---|---|---|
| 23 | Failure mechanism | Shallow translational |

| 38 | Geo-scientific Causes | Weathered rock exposed along road cut, Failure along valley dipping joint |

| 39 | Remedial measures | Breast wall |

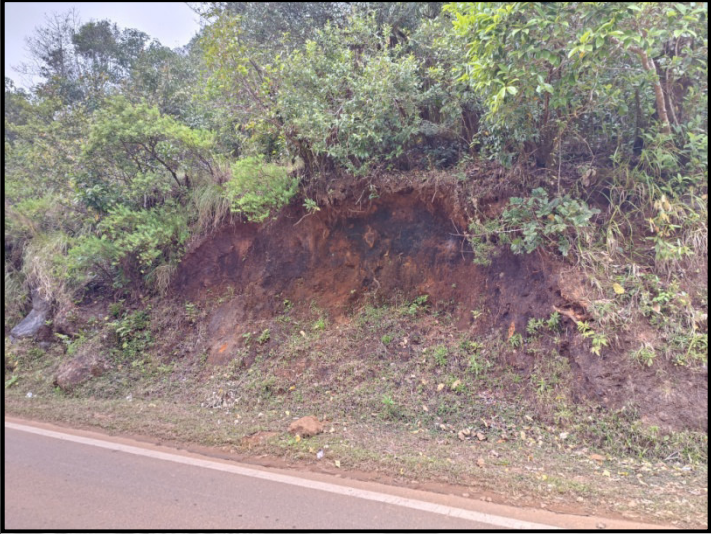
| No | Field | |
|---|---|---|
| 23 | Failure mechanism | Shallow rotational |

| 38 | Geo-scientific Causes | Debris saturation due to rainfall |

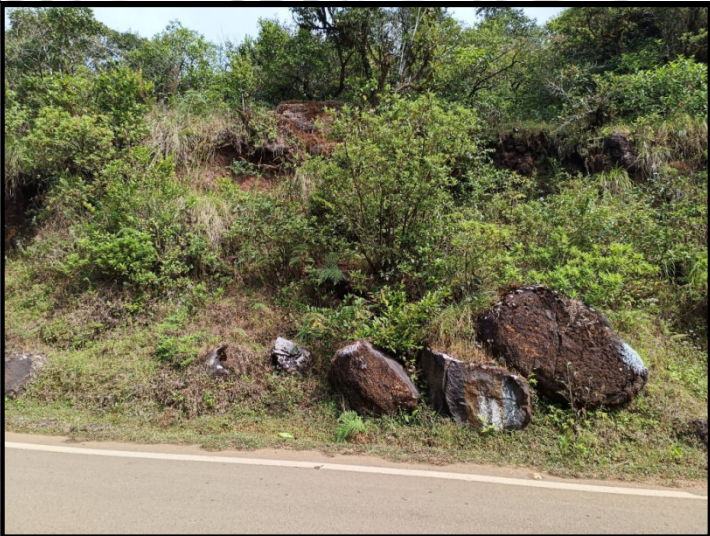
| No | Field | |
|---|---|---|
| 23 | Failure mechanism | Shallow rotational |

| 38 | Geo-scientific Causes | Debris saturation due to rainfall |

| 39 | Remedial measures | Retaining wall with adequate weep holes |

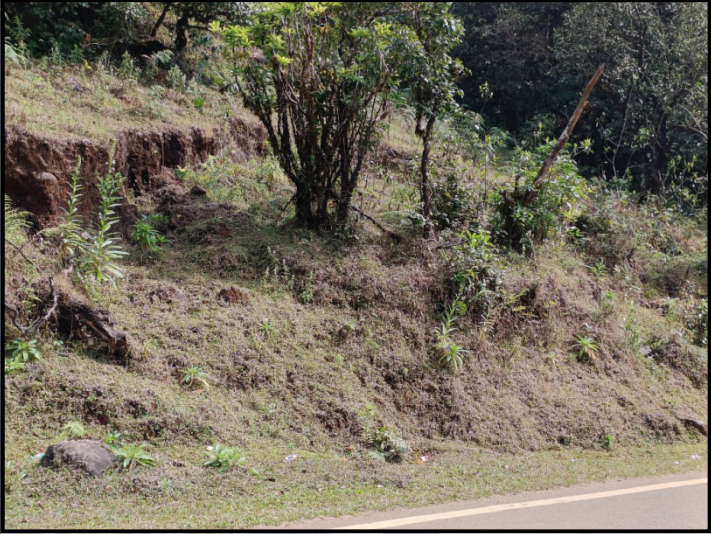
| No | Field | |
|---|---|---|
| 23 | Failure mechanism | Shallow rotational |

| 38 | Geo-scientific Causes | Debris saturation due to rainfall |

| 39 | Remedial measures | Retaining wall with adequate weep holes, lining of drainage and maintenance of the same |
