**Meso-scale (1:10,000) Landslide Susceptibility Mapping in and around Kedamallur  
(Torah) of Virajpet Block, Kodagu District, Karnataka**

मद सं: एम४एलएसएसएम/एनसी/एसआर/एसयू-केजी/२०२२/४२४०२  
Item no.: M4LSSM/NC/SR/SU-KG/2022/42402

अन्तिम प्रतिवेदन – एफ.एस २०२२-२३  
Final report for field season 2022-23

राज्य इकाई: कर्नाटक व गोवा/State Unit: Karnataka & Goa  
दक्षिणी क्षेत्र/Southern Region

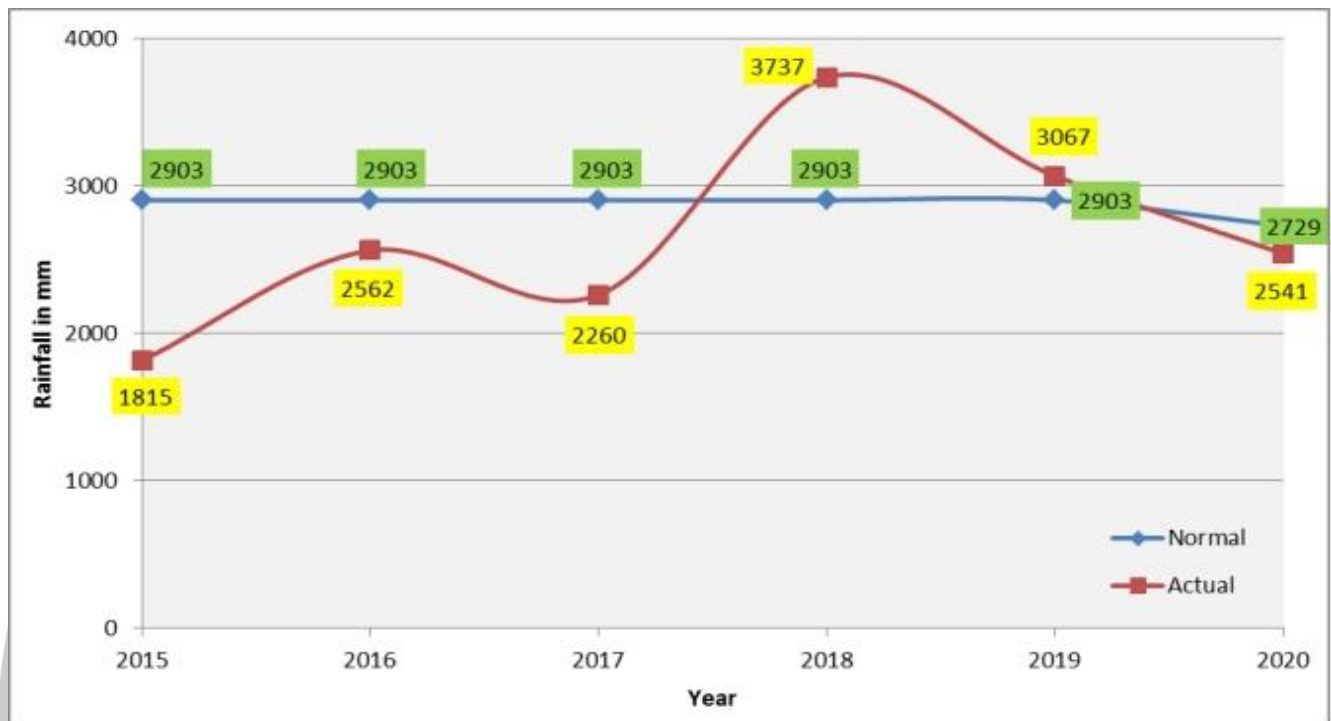
Figure-1.2: Trend of average annual normal and actual rainfall pattern in Kodagu district from 2015-2020 period. (Source: KSNDMC)

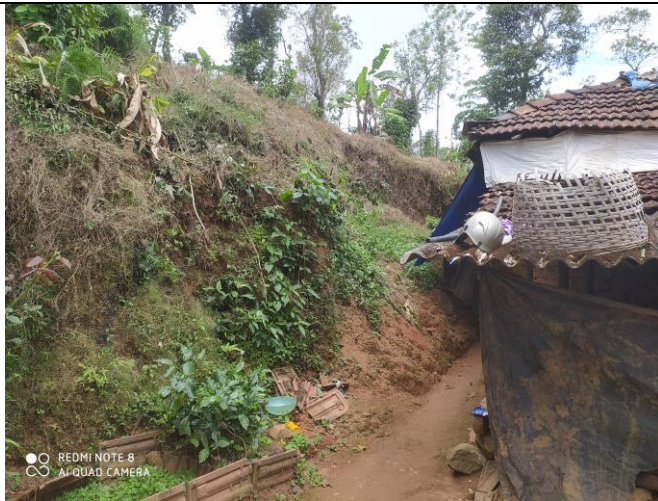
A) Cut-slope failure in Korthikad Thomara village  
(12°09'14.92"N/75°42'55.17"E)

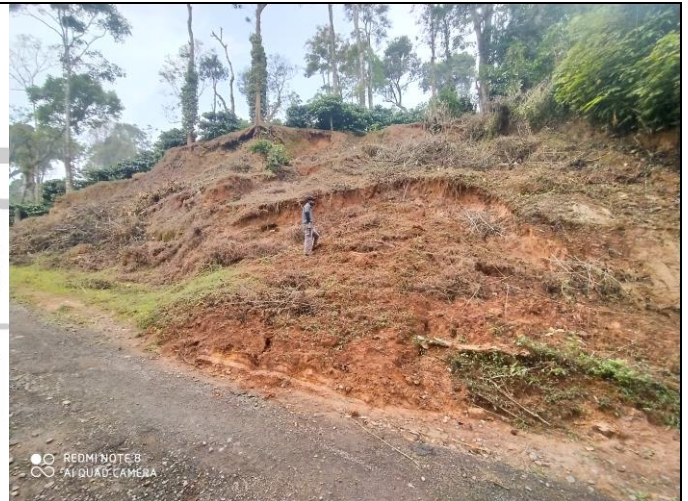
B) Cut-slope failure in Thomara village  
(12°10'16.89"N/75°43'27.96"E)

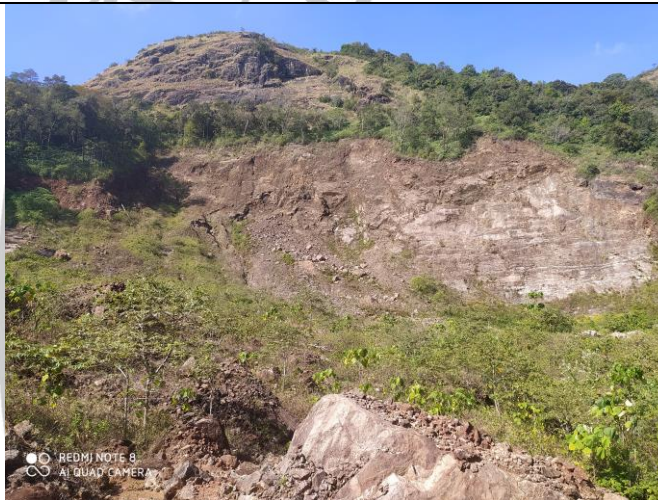
C) Rock cum debris flow in Thomara village (Tohra landslide)  
(12°09'52.06"N/75°43'32.71" E)

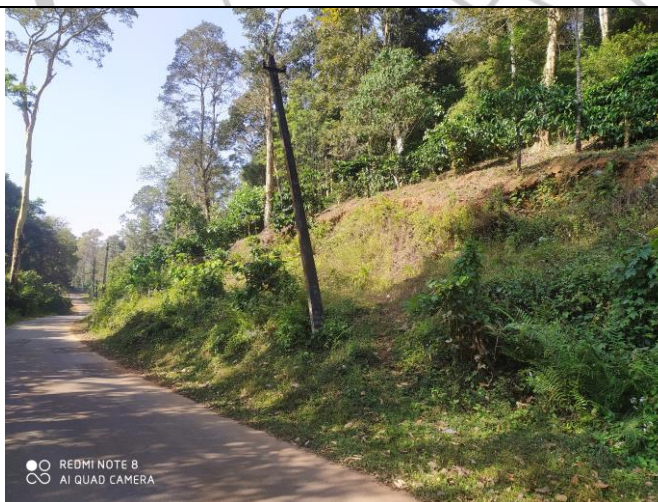
E) Cut-slope failure in Thomara village  
(12°09' 52.56"N/75°43' 37.27" E)

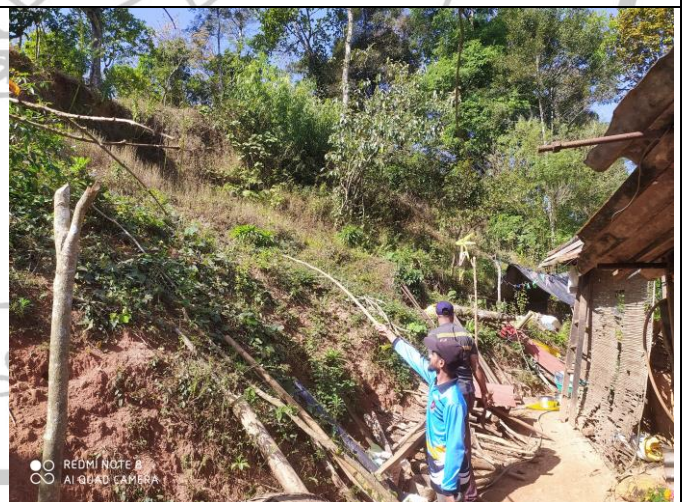
F) Cut-slope failure in Kottachi Kedhamallur village  
(12°09'28.16"N/75°44'9.32" E)

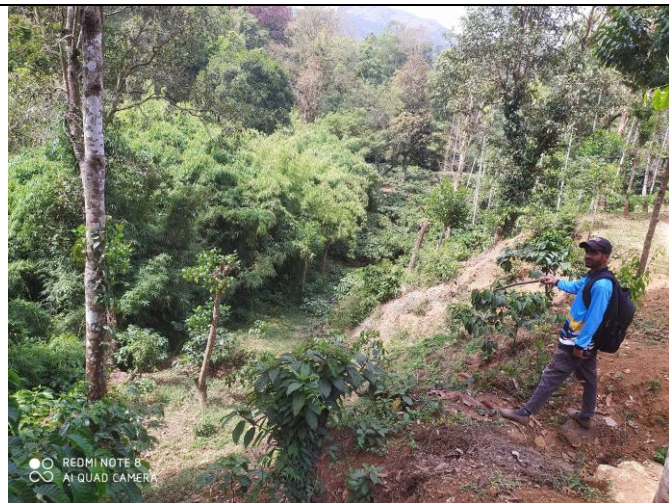
G) Debris slide occurred in Thomara village due to toe erosion  
(12°09'8.37"N/75°43'18.32"E)

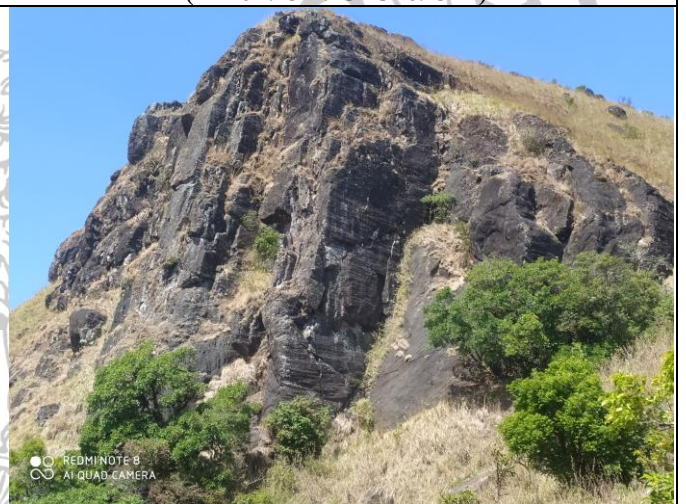
J) Rock wedge failure due to favorable joint interference  
(12°09'14.23"N/75°42'28.95"E)

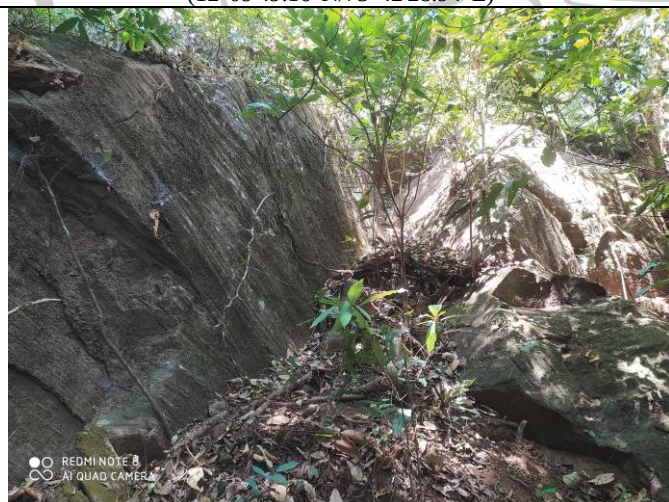
K) Rock wedge failure due to favorable joint interference  
(12°09'11.37"N/75°42'34.31"E)

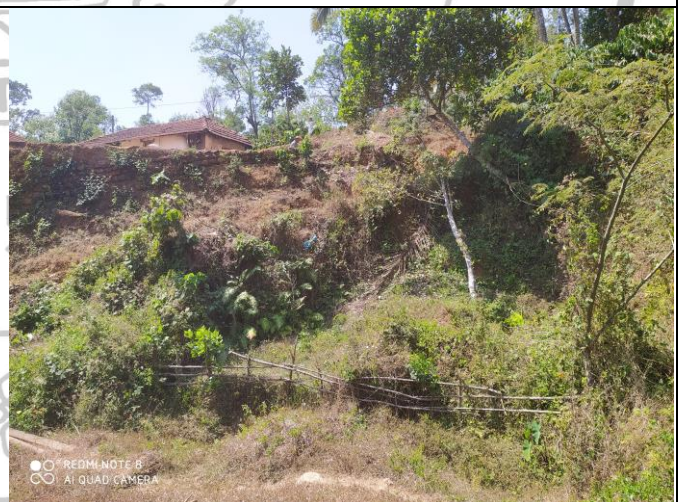
L) Debris slide occurred in Thomara village due to toe erosion  
(12°09'25.6"N/75°43'27.07"E)
