Meso-scale (1:10,000) Landslide Susceptibility Mapping in Jodpal area, Kodagu district of  
Karnataka

Item no.: M4LSSM/NC/SR/SU-KG/2020/32438

अंतिम रिपोर्ट कार्य –सत्र 2020-21  
Final report for field season 2020-21

एजाज अहमद भट, वरिष्ठ भूवैज्ञानिक/Aijaz Ahmad Bhat, Senior Geologist  
सैंथिलकुमार के, भूवैज्ञानिक/Senthilkumar K, Geologist

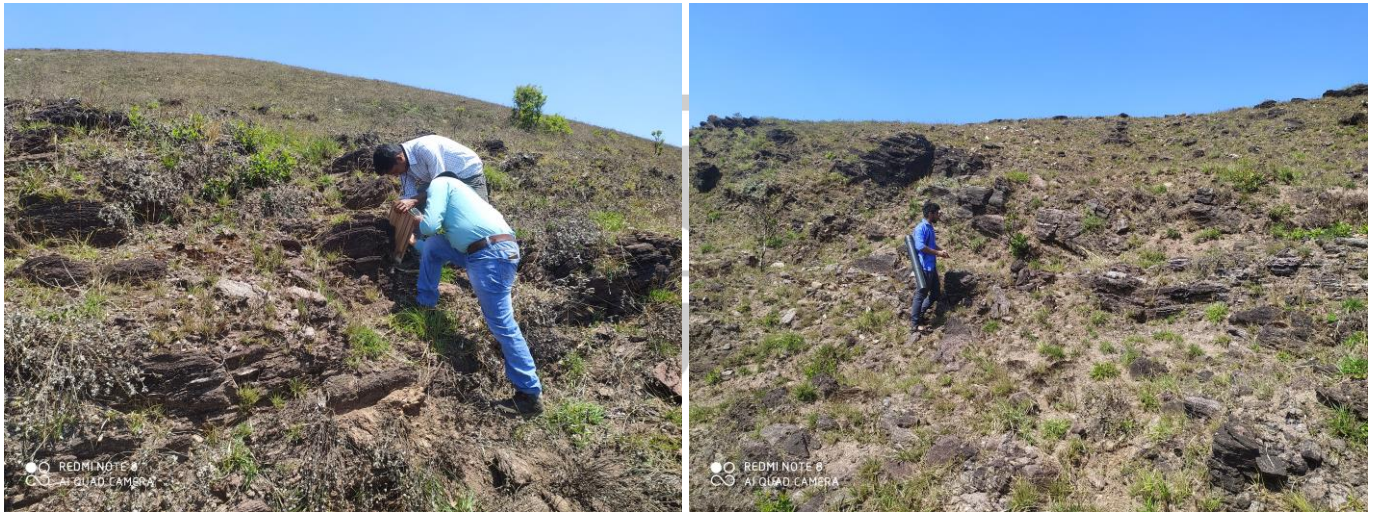
Figure-2.2: Garnet-Silliminite-Graphite Schist rock outcrops in Galibedu ridge, Madikeri, Kodagu

**Garnet-Silliminite-Graphite Schist:** This rock type is highly metamorphosed seen as narrow and discontinues patches and/or bands enclaved within Granite Gneiss (Biotite Gneiss) essentially made of quartzite, garnet, and sillimanite with few flakes of graphite whereas apatite and magnetite are the accessory minerals present (*B.R.C. Iyengar, 1954*). This rock type is exposed along the Galibedu ridge and in the Koynad area. Foliation is trending in NW-SE direction and dipping at 40°-70° both in south-westerly and north-easterly direction because of the folding pattern. This rock type is highly prone to weathering. As observed in field its weathering pattern varies from III to IV grade in the study area. Many landslides have occurred in the proximity of this rock type. The weathered portions of this rock type are showing light pink to light red colour.

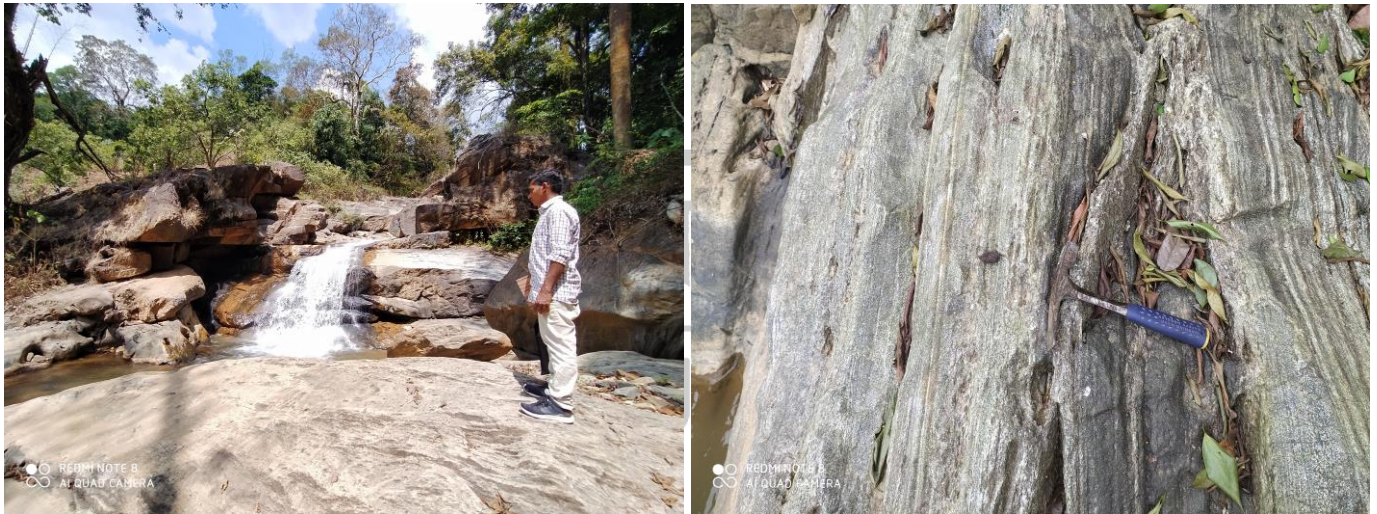
*Figure-2.3: Granite Gneiss rock outcrops observed in the study area along Sampaji nala section, Madikeri Kodagu.*

**Granite Gneiss:** This rock type is commonly known as Granite Gneiss which belongs to Peninsular Gneiss-I or PGC. This rock type is coarse-grained, leucocratic to mesocratic consisting of quartz, plagioclase, and minor amounts of mafic minerals (*T.S.S. Murthy et al., 1979, GSI*) while *B.R.C Iyengar, 1954* reported common varieties containing quartz and acid to intermediate varieties of feldspars, biotite and rarely hornblende. The accessory minerals include apatite, magnetite, and mica with pink garnet widespread and frequent (*B.R.C Iyengar, 1954*) and they vary in color from grey to pink with a regional strike of foliation N25°W (*C.R. Veeraraghavan, 1961*), NNW-SSE (*B.R.C Iyengar, 1954*). However, *C.R. Veeraraghavan, 1961* witnessed from its microscopic study the presence of quartz, plagioclase feldspar, and biotite mica with microcline showing cross-hatched twinning. In the present study, various discontinuous amphibolite patches and/or bands up to a few meters thickness (<5m) have been observed occurring parallel to regional foliation NNW-SSE direction of Granite Gneiss. These amphibolite bands are resistant to weathering and are standing alone running parallel to the regional foliation direction of Granite Gneiss in the area.

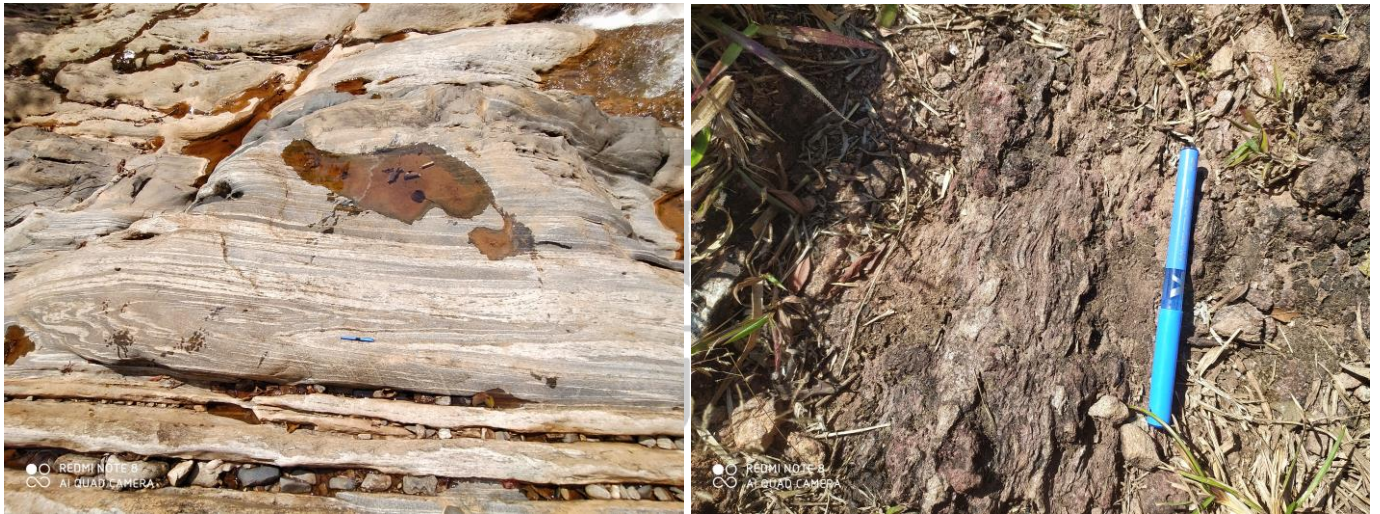
Figure-2.4: Two types of folds observed in the study area; (left) one fold in which axial plane is parallel to regional foliation observed in Sampaji nala section, Madikeri Kodagu; (right) second fold type in which axial plane is in orthogonal relationship with regional foliation observed in Galibedu ridge, Madikeri Kodagu.

Two minor fold types were observed in the study area which is localised in distribution. One fold is observed in Granite Gneiss which is tight, plunging vertically and its axial plane is parallel to the regional foliation strike. However second fold is observed in Garnet Schist of Sargur Group which is open, also plunging vertically and its axial plane is perpendicular to the regional foliation strike. This signifies that these two minor folds have developed in different folding phases under different stress regimes applied in the study area. Two to three joint sets are recorded in the study area. Among these, the NE-SW trending joint sets (J2 and J4) are observed frequently in the study area. These joint sets are closely spaced and have a dependent relationship with the regional foliation in the area. Joint set J2 would be the cleavage plane of the regional fold in the area. These joint sets play a prominent role in the evolution of hilly terrains and the development of different geomorphological features in the area. The southwestern side of Galibido ridge has torn out under the orthogonal relationship of these joint sets with regional foliation. The small sized broken rock fragments fall in the opposite direction of dip of regional foliation under gravity effect which leads to the formation of small to large size escarpments on Galibido ridge. The barren hill tops in the area would be the result of the same phenomenon. The small sized broken rock fragments on these barren hilltops frequently washed out to downslope side during the rainfall periods. This factor has minimized the chances of natural plant growth on barren hilltops in the area. Most importantly, the barren hilltops have developed convex slopes under the same phenomenon. These convex slopes are most vulnerable for slope movement under gravity effect. The second possibility is the dislocation of wedge blocks by the interference of J1, J2 joint sets, and foliation plane (see stereonet-9).

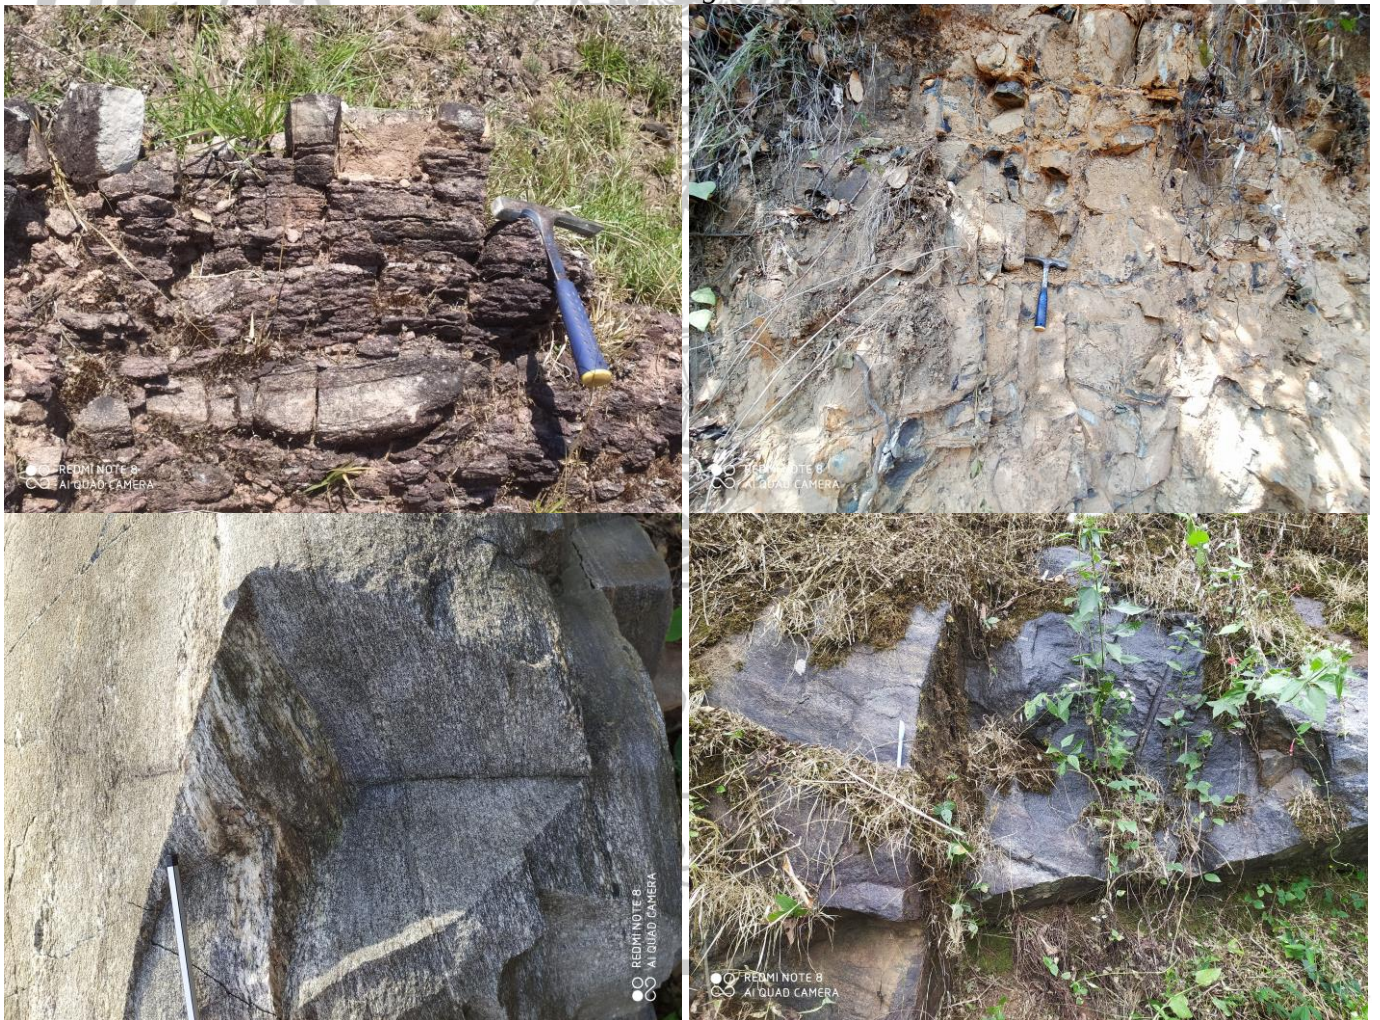
Figure-2.5: Different joint sets observed in the study area are among major factors that control the regional topographic changes

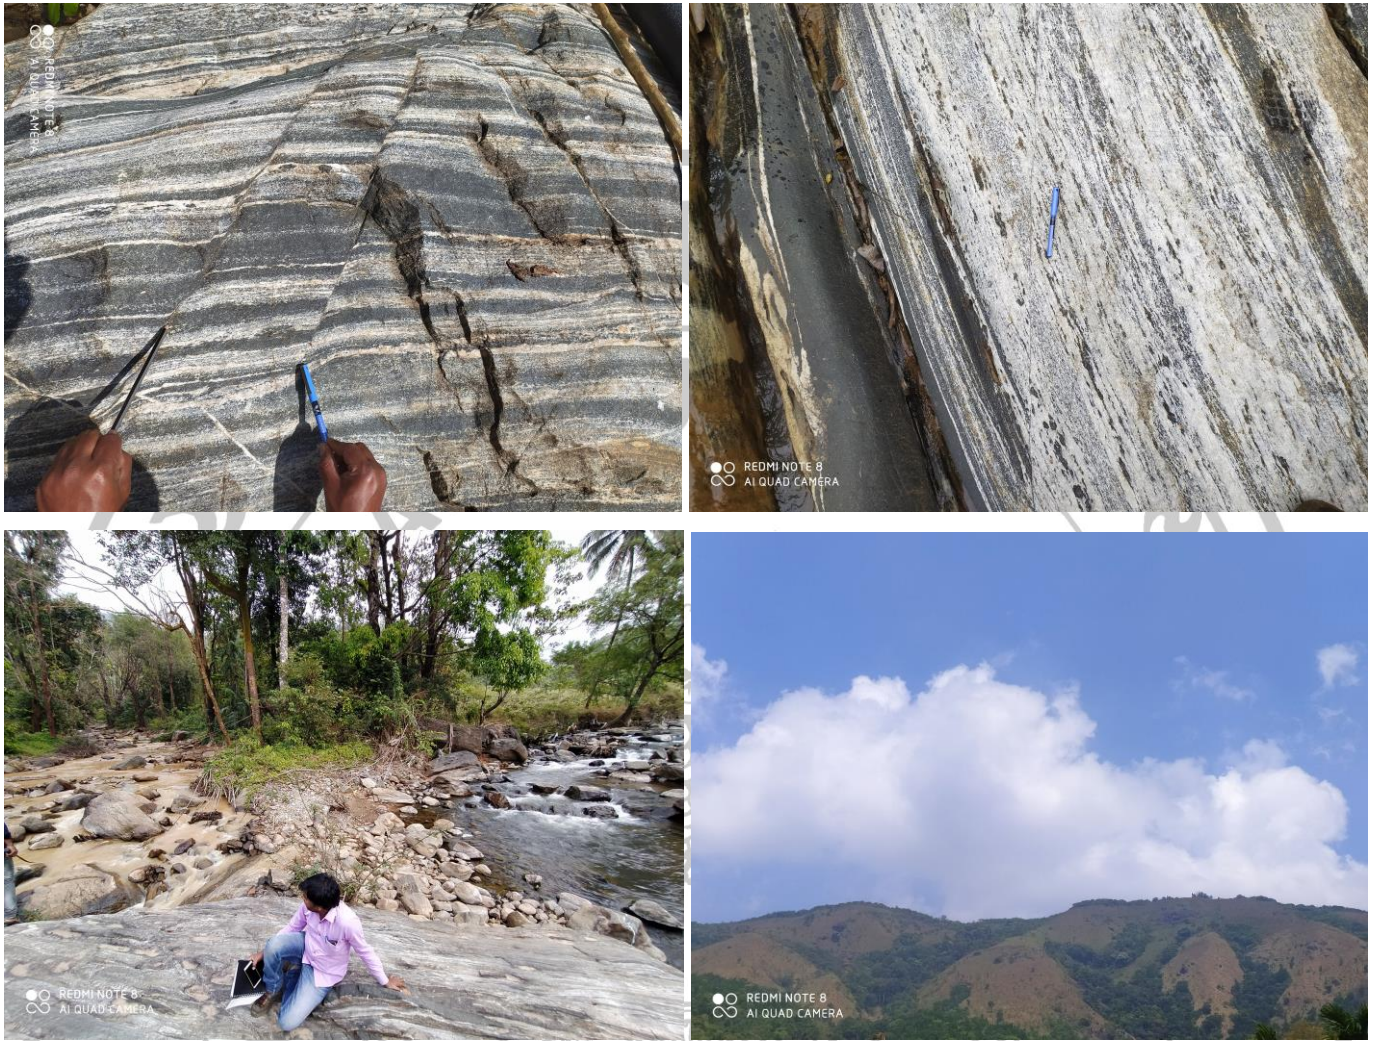
*Figure-2.6: Different fault-related geomorphological and lithological evidence observed along a particular zone in the study area including; (from top left); lithological displacement in Granite Gneiss in Sampaji nala section near Abbikolli waterfalls; shifting of stream confluence point near Abbikolli waterfalls; and high stream density along the faulted zone on the south western face of Galibedu ridge, Madikeri Kodagu*

Some fault-related geomorphological and lithological evidence have been observed along a zone in the NE and SW direction of Abbikolli waterfalls. The displacement of litho-units in this zone shows both sinistral and dextral sense of movement. Along this zone, drainage density is high resulted by headward erosion of hilly terrains at a high rate, detached rock fragments with overburden cover have moved down

the stream frequently, stream confluence point of 5<sup>th</sup> and 6<sup>th</sup> order has shifted from the original position. Besides, a waterfall has been developed on a steep escarpment face which is locally known as Abbikolli waterfall. Few surface cracks trending almost in EW direction were observed along this zone in overburden cover and one among these is traversing across a ridge which is exceptionally seen in block movement scenarios along a faulted zone. These pieces of evidence suggested that a fault is traversing through the area wherein there would be more chances of mass movement in the future.

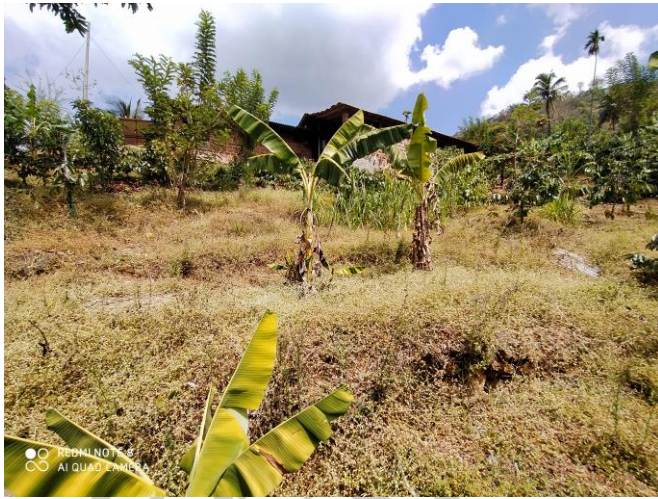
(g) Creep movement observed on a gentle slope with multiple surface cracks in Monannageri 2<sup>nd</sup> village Madikeri Kodagu

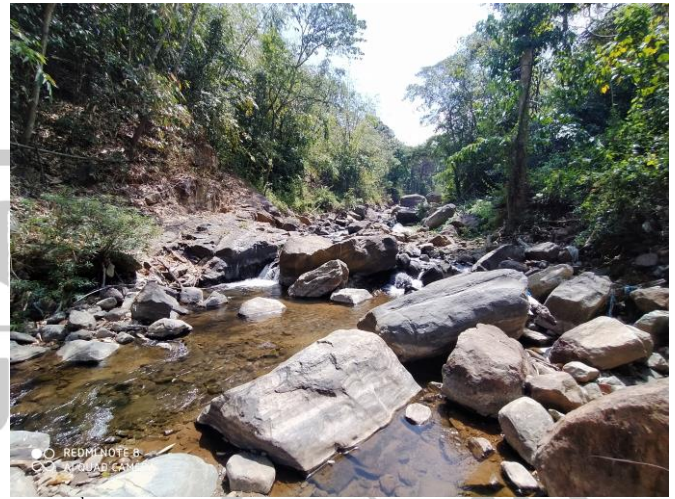
(h) 2<sup>nd</sup> order stream which has the potential to carry boulder material downstream during high water conditions exists in the upslope side of Abbikolli waterfalls where high drainage density is observed.

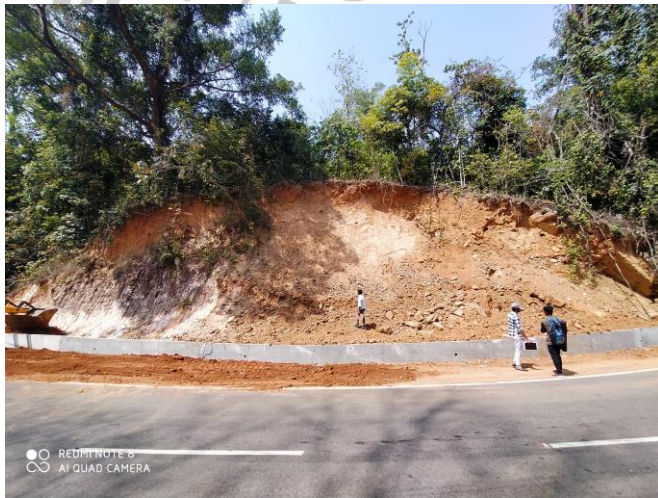
(i) Road cut slope along NH 275 near 10<sup>th</sup> mile village Madikeri Kodagu
