भारत सरकार  
GOVERNMENT OF INDIA  
भारतीय भूवैज्ञानिक सर्वेक्षण  
GEOLOGICAL SURVEY OF INDIA

Meso-scale (1:10,000) Landslide Susceptibility Mapping in Hadagal Hole Sub-Watershed of Madapur Hole Watershed of Harangi Sub-Basin, Kodagu District, Karnataka

Final report for field season 2021-22

एजाज अहमद भट, वरिष्ठ भूवैज्ञानिक/Aijaz Ahmad Bhat, Senior Geologist

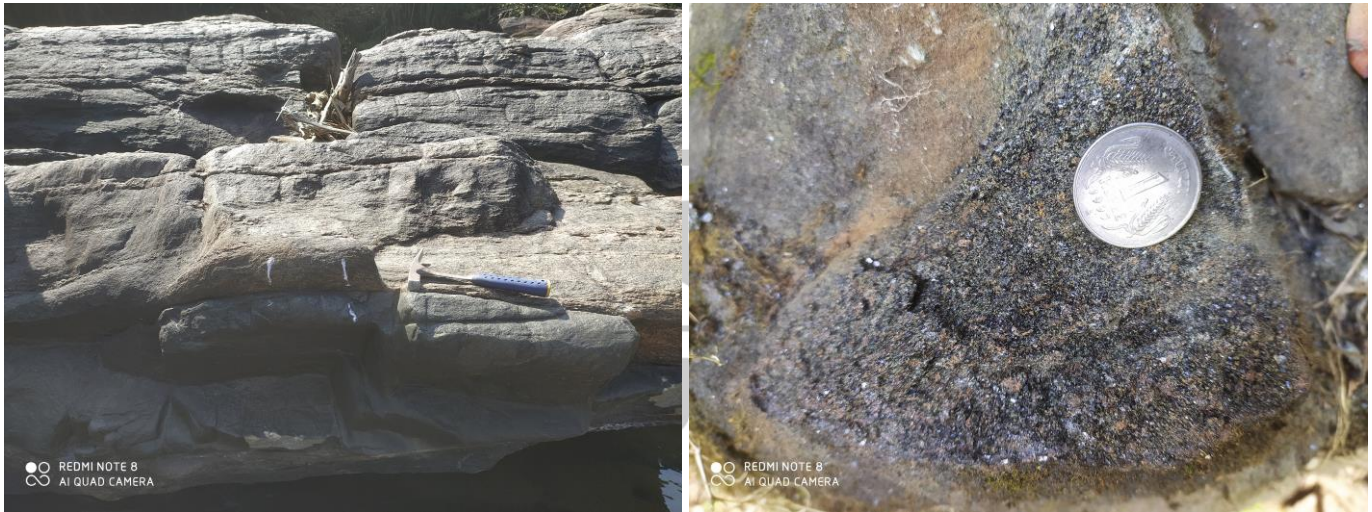
Figure-2.2: Amphibolite rock reported in Billigeri village, Somvarpet taluk Kodagu

**Amphibolite:** This rock type is shiny black to dark green colour, medium to coarse-grained seen as enclaves of narrow bands oriented parallel to regional foliation within the Granite Gneiss. It is composed of amphibole and plagioclase in varying proportions with a minor amount of quartz, biotite, garnet, magnetite, and ilmenite (*Prantick Santra et al., 2021*). It is highly prone to chemical weathering as observed in the study area. At several places in the study area, this rock type occurs in large dimensions in association with complex dyke systems wherein the litho-contact of amphibolite with host rock has been observed as very vulnerable to slope failures.

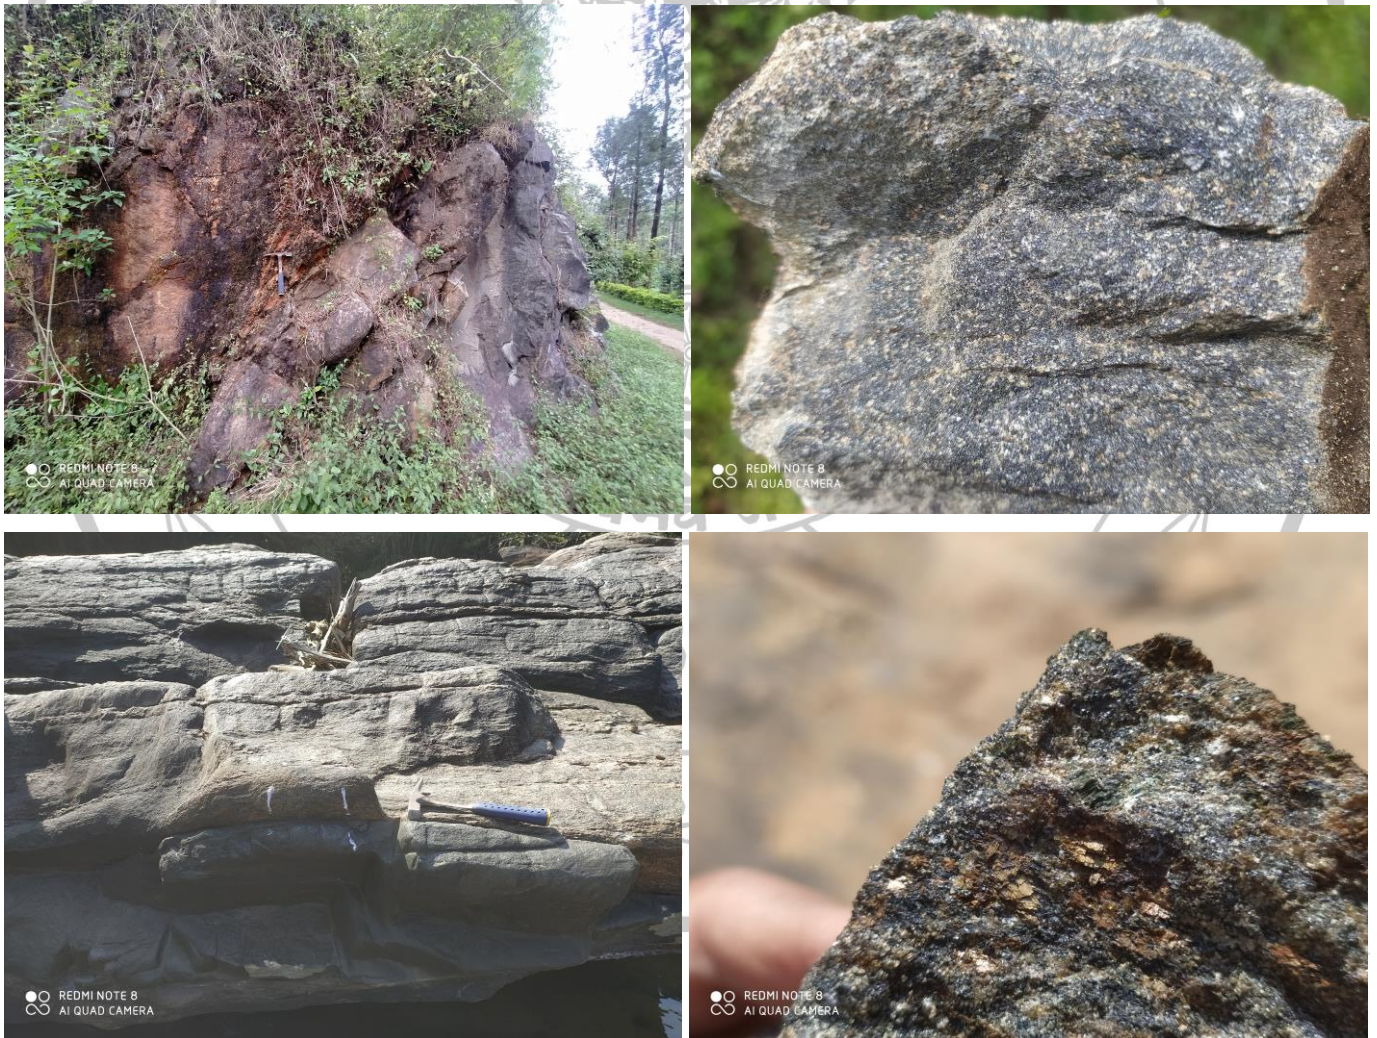
Figure-2.4: Charnockite and Mafic Granulite rock types occurring in the study area

The Charnockite suite of rocks varies from Enderbite to Charnockite which contains K-feldspar, quartz, plagioclase, and orthopyroxene with a minor amount of garnet and hornblende and the proportion of plagioclase, quartz and K-feldspars vary widely (*Prantick Santra et al., 2021*). The Charnockite Group also comprises Mafic Granulites which are very dark in colour and contains garnet, clinopyroxene, orthopyroxene, plagioclase, and hornblende with minor amounts of magnetite, quartz and pyrite (*Prantick Santra et al., 2021*). The granoblastic texture is very prominently observed in the hand specimen. On the weathered surface, it shows reddish-brown colour.

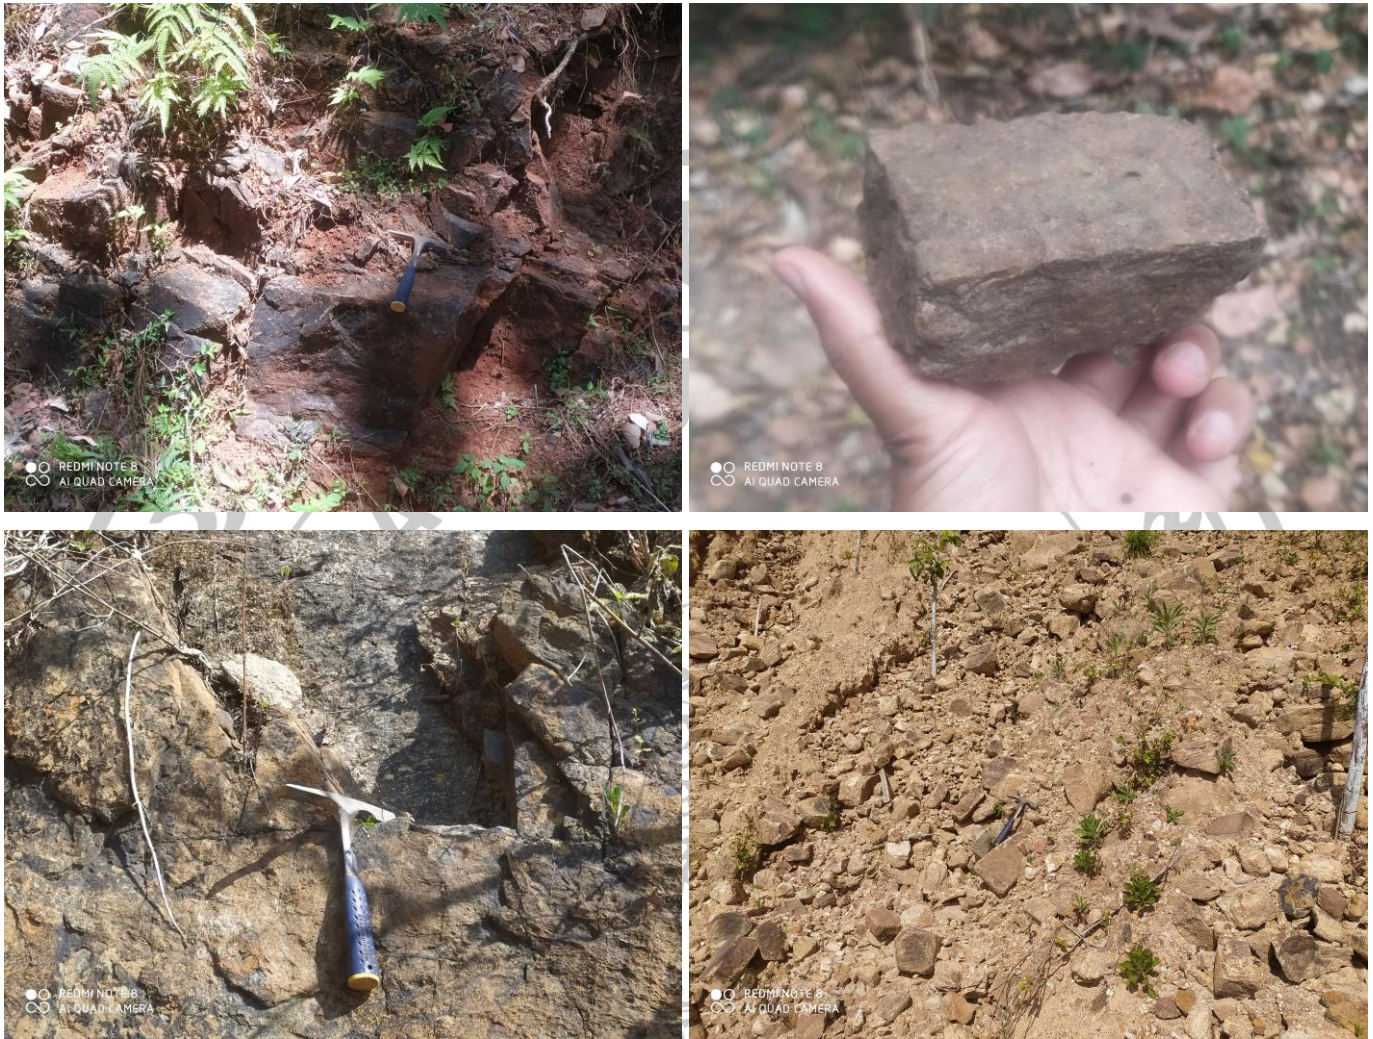
*Figure-2.6: Disintegration of rock into smaller orthogonal pieces due to joint interference impact in the study area*

The geological structures including foliation and four joint sets have been analysed thoroughly in kinematic analysis. At several places in the study area, the interference of these geological structures is one major cause for occurring landslide incidences. The foliation and joint set data of three different locations in the study area have been plotted on a stereonet plot which revealed three different conditions of interference (*figure-2.7*) among which joint interference between foliation+J1+J4 (condition 1) is the most favourable condition in the area to dislocate the rock blocks/fragments which later move down in south-west direction. The result of this joint interference has evolved the regional topography of the area and formed long ridges and valleys trending in the NW-SE direction and steep slopes in the SW direction. Besides these three different conditions of interference in the study area are making the rock domains vulnerable to planer, wedge, and topple failures where all eligible conditions meet w.r.t slope angle and direction.

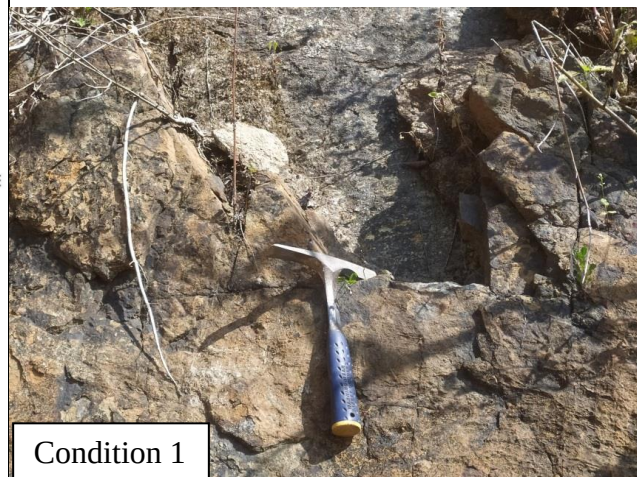
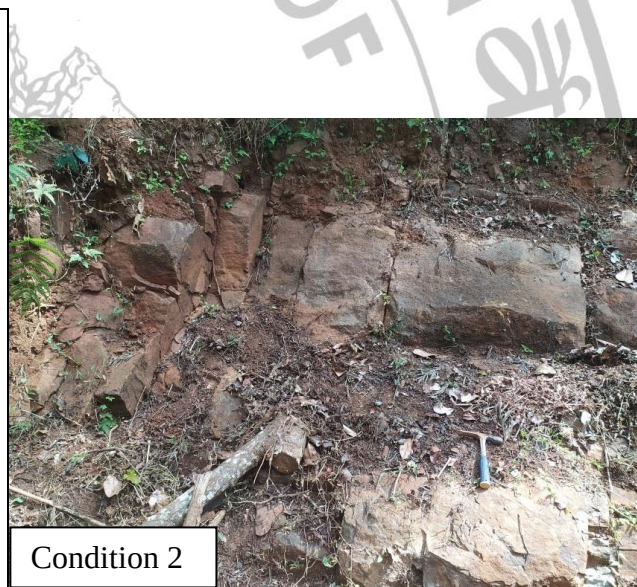
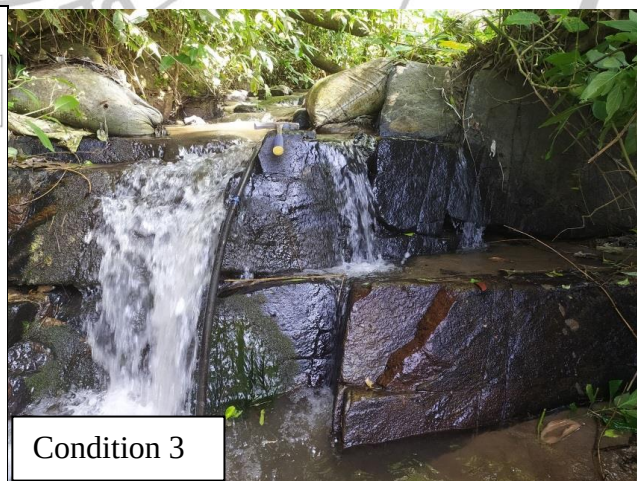
Figure-2.7: Stereonet plots of the geological structure of three different locations in the study area which show eligible conditions for different types of failures in the rock domain. The angle of internal friction used is determined from the RMR value

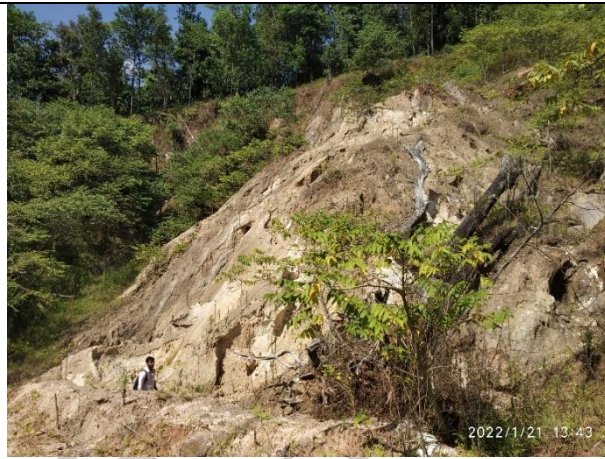
A)Debris flow near kalladi ( $12^{\circ}33' 47.88''\text{N}/75^{\circ}48' 1.06'' \text{ E}$ )

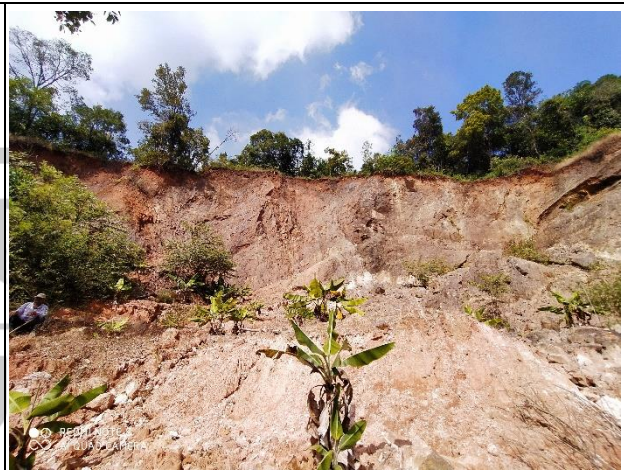
B)Debris flow near Hosakaralli ( $12^{\circ}33' 30''\text{N}/75^{\circ}47' 26.26'' \text{ E}$ )

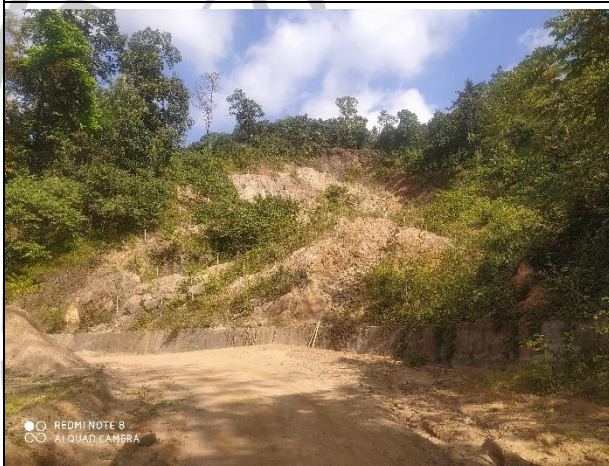
C)Debris flow near the Kirudale road section  
( $12^{\circ}33' 16.67''\text{N}/75^{\circ}47' 18.78'' \text{ E}$ )

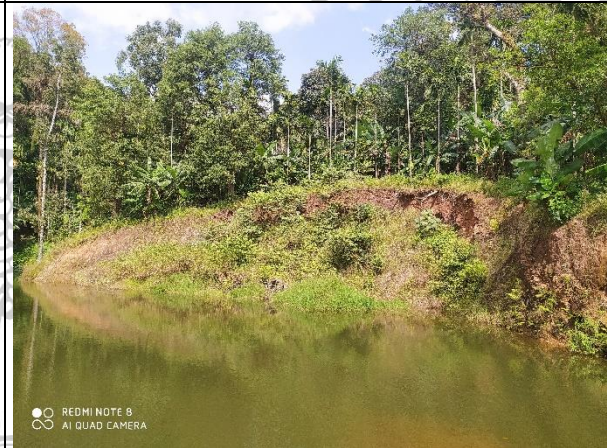
D)Cut slope failure ( $12^{\circ}33' 1.51''\text{N}/75^{\circ}47' 42.73'' \text{ E}$ )

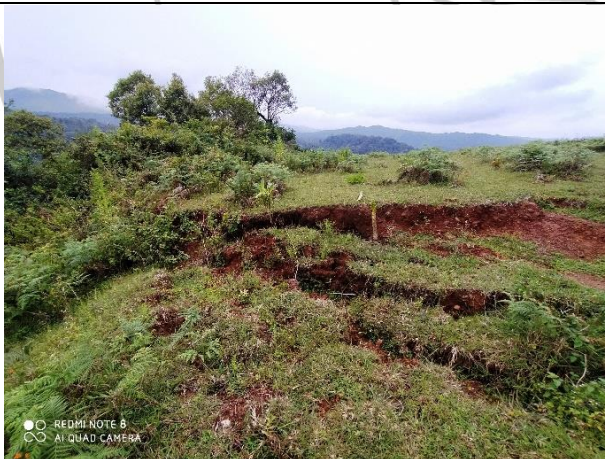
E)Surface cracks and its vertical displacement near kurra motte bane ( $12^{\circ}34' 10.54''\text{N}/75^{\circ}47' 45.25'' \text{ E}$ )

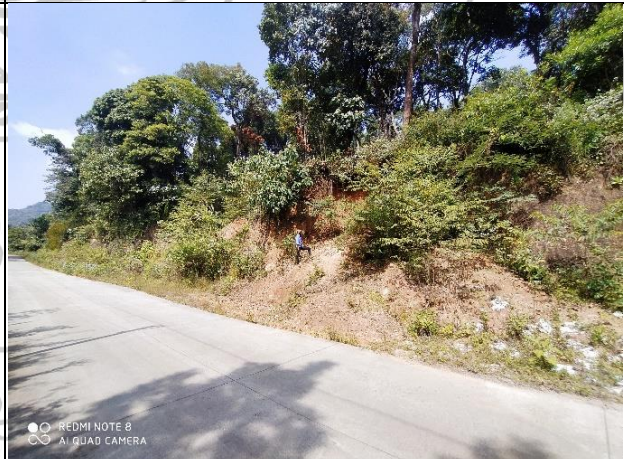
F)Cutslope failure near Shrangalli  
( $12^{\circ} 33'6.78''\text{N}/75^{\circ} 47' 3.77'' \text{ E}$ )

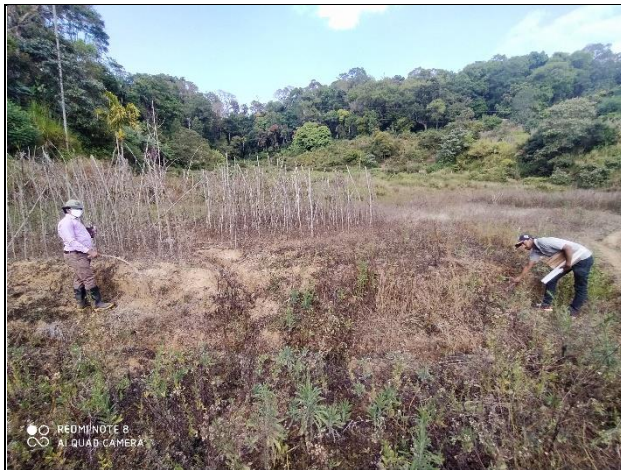
G) Surface cracks and its vertical displacement in and around Garwale ( $12^{\circ} 33' 38.10''\text{N}/75^{\circ} 47' 6.80''\text{E}$ )

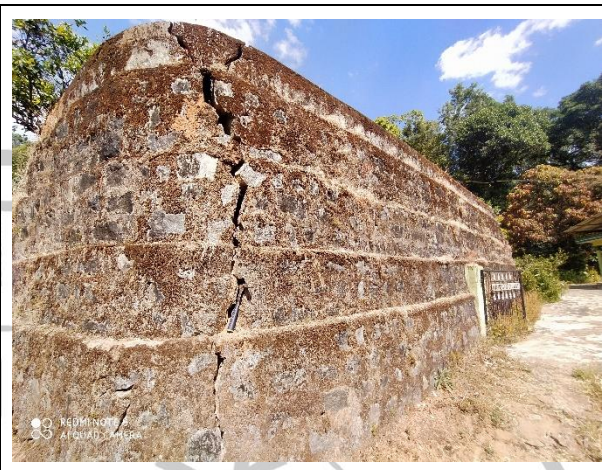
H) Developments of the cracks on the drying yard in and around Garwale ( $12^{\circ} 33' 38.96''\text{N}/75^{\circ} 47' 3.95''\text{E}$ )

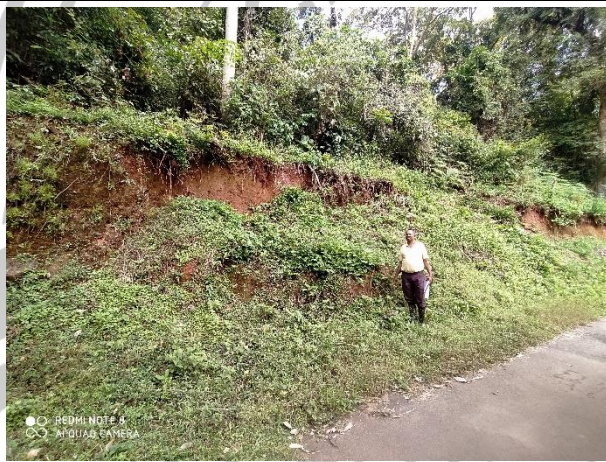
I) Cut slope failures along Kirudale road section ( $12^{\circ} 32' 42.31''\text{N}/75^{\circ} 48' 5.93''\text{E}$ )

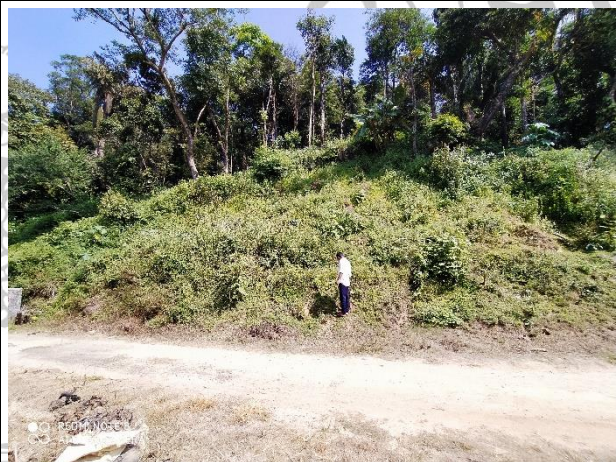
J) Cut slope failure near Biligeri school ( $12^{\circ} 33' 25.50''\text{N}/75^{\circ} 39.96''\text{E}$ )

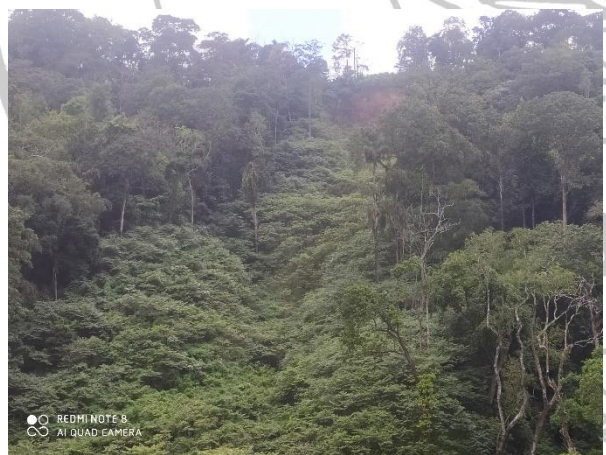
K) Debris slide in and around Shrangalli falls ( $12^{\circ} 32' 59.74''\text{N}/75^{\circ} 47' 11.16''\text{E}$ )

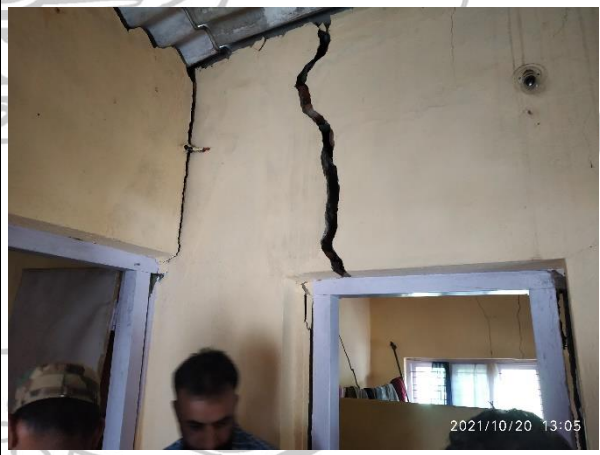
L) Development of cracks on the wall at Biligeri Ghandi house ( $12^{\circ} 27' 28.33''\text{N}/75^{\circ} 48' 26.83''\text{E}$ )

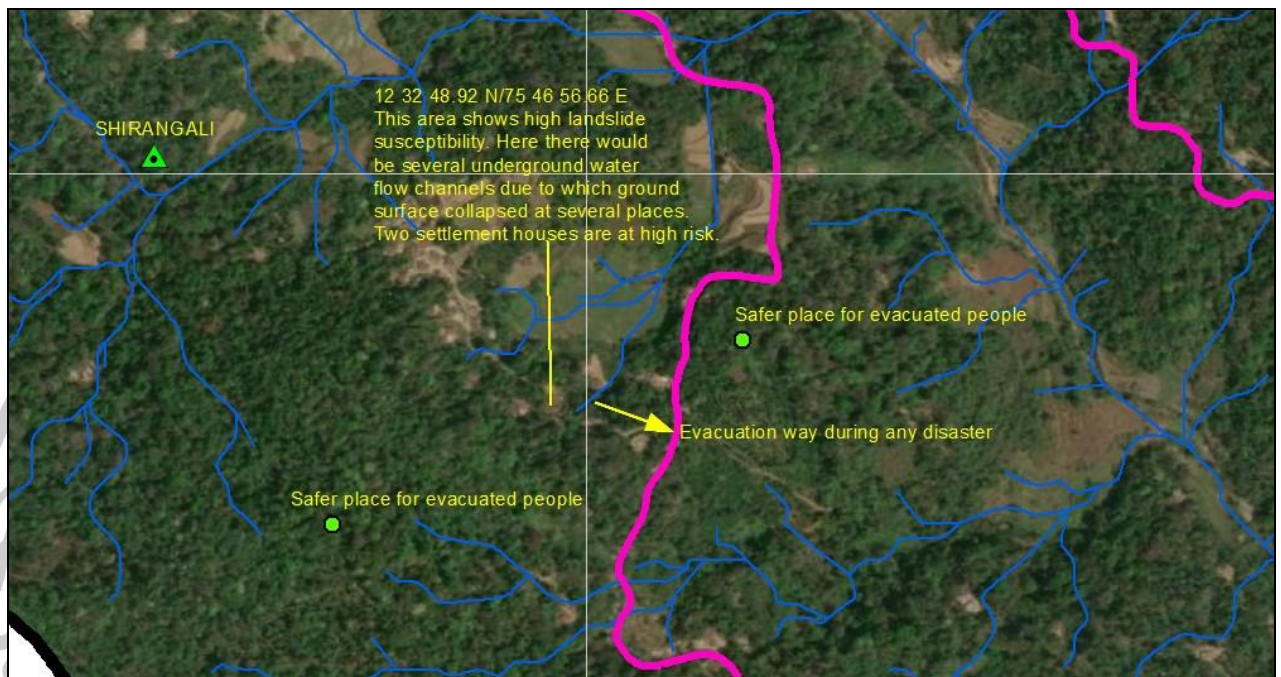
4. In Shirangali village at  $12^{\circ} 32' 48.92''$  N/ $75^{\circ} 46' 56.66''$  E, there would be several underground water flow channels due to which the ground surface has been subsided at several places in the settlement

zone. There is a need to give immediate attention and shift the settlements at high risk to safer places until a permanent solution would be suggested after a detailed investigation.

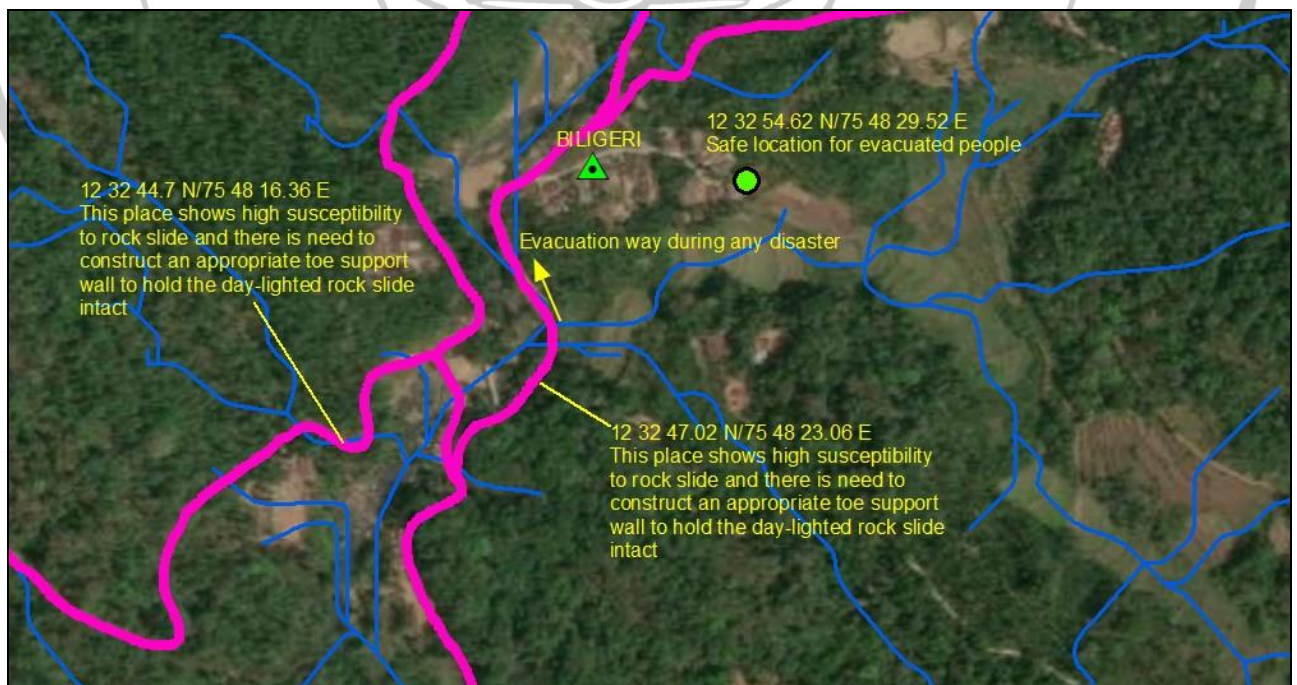
- It has been found that the below-mentioned rocky slope in the Biligeri area has high susceptibility to a rock slide. Therefore it is suggested that an appropriate toe support wall may be constructed to hold these vulnerable rocky slopes. If any disaster situation arises then people may be evacuated towards the north and can be shifted to a safer place as shown in the map below;

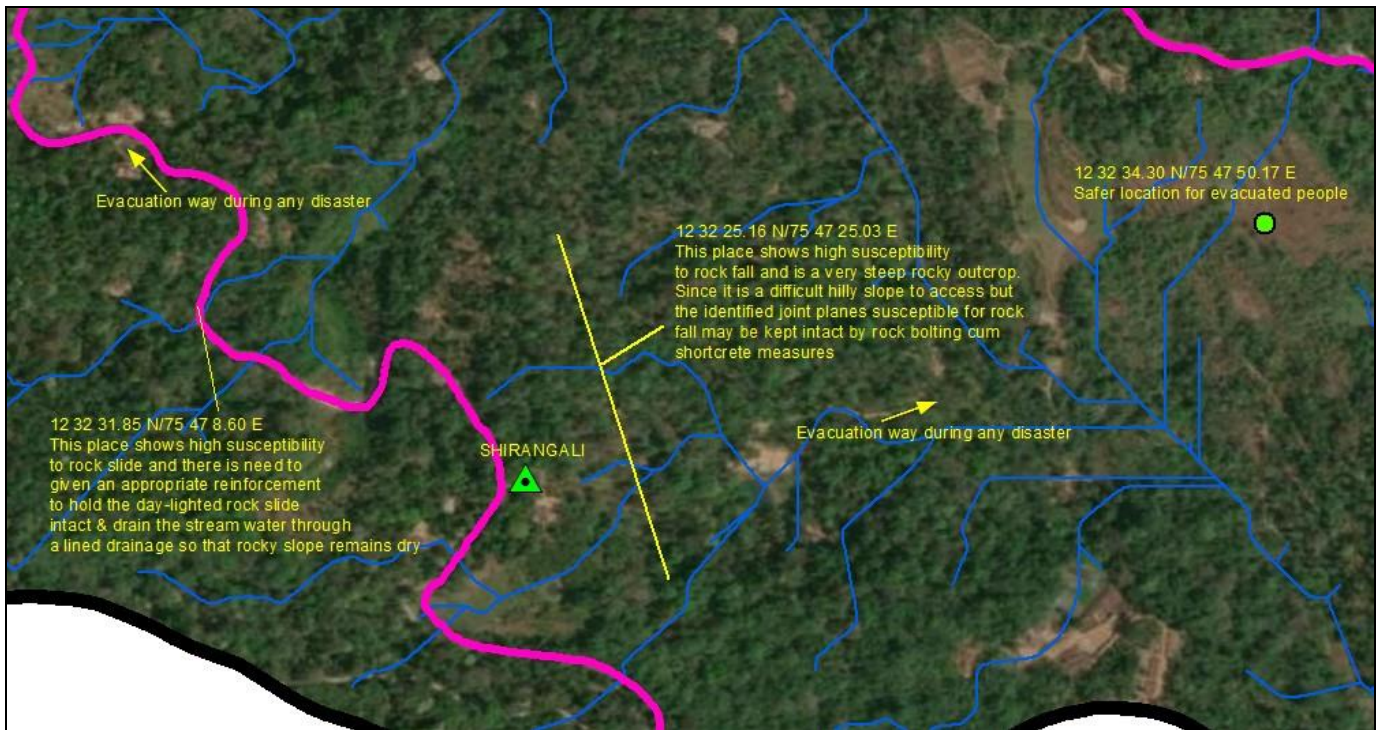
7. Along the Shirangali to Madapur road stretch below mentioned rocky outcrops show high susceptibility to rock slides & rock falls. Therefore it is also suggested that at  $12^{\circ} 32' 44.7''$  N/ $75^{\circ} 48' 16.36''$  E where there is moderate to high susceptibility for rock slide, there is a need to give an appropriate reinforcement to hold the day-lighted rock slide intact & drain the stream water through lined drainage so that rocky slope remains dry. At  $12^{\circ} 32' 25.16''$  N/ $75^{\circ} 47' 25.03''$  E a steep rock slope shows high susceptibility to rock fall. Since it is a difficult hilly slope to access but the identified joint planes susceptible to rock fall may be kept intact by rock bolting cum shotcrete measures. If any disaster situation arises then people may be evacuated towards north-west and east directions and can be shifted to a safer place as shown in the map below;

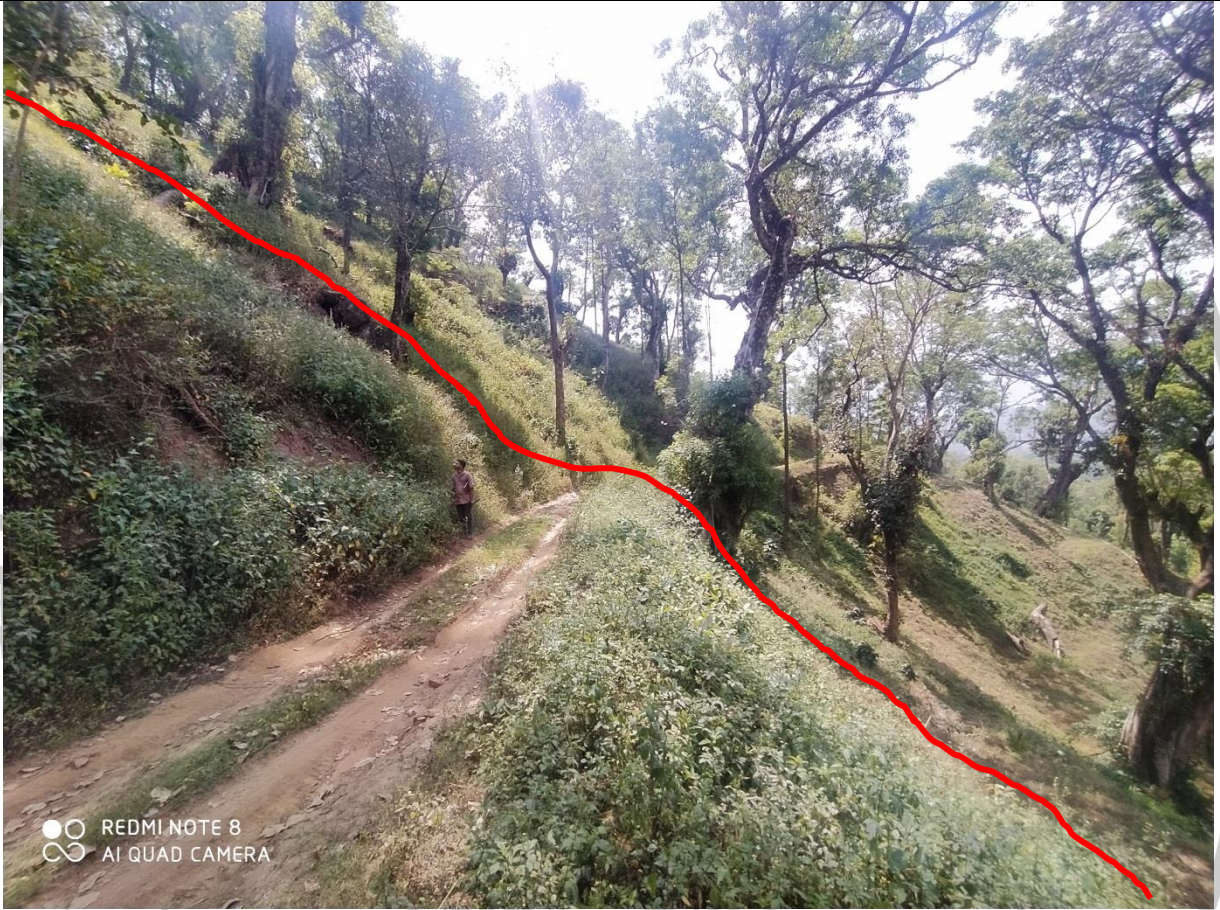
| <b>Landslide No.</b> | ls39 |

| <b>Failure Mechanism</b> | Translational shallow |
| <b>Hydrological Condition</b> | Dry |
| <b>Geo-scientific Cause</b> | Unplanned cut-slope for road construction; steep upslope gradient; sparse vegetation |

| Alert | II |
| Remarks | Overburden domain |

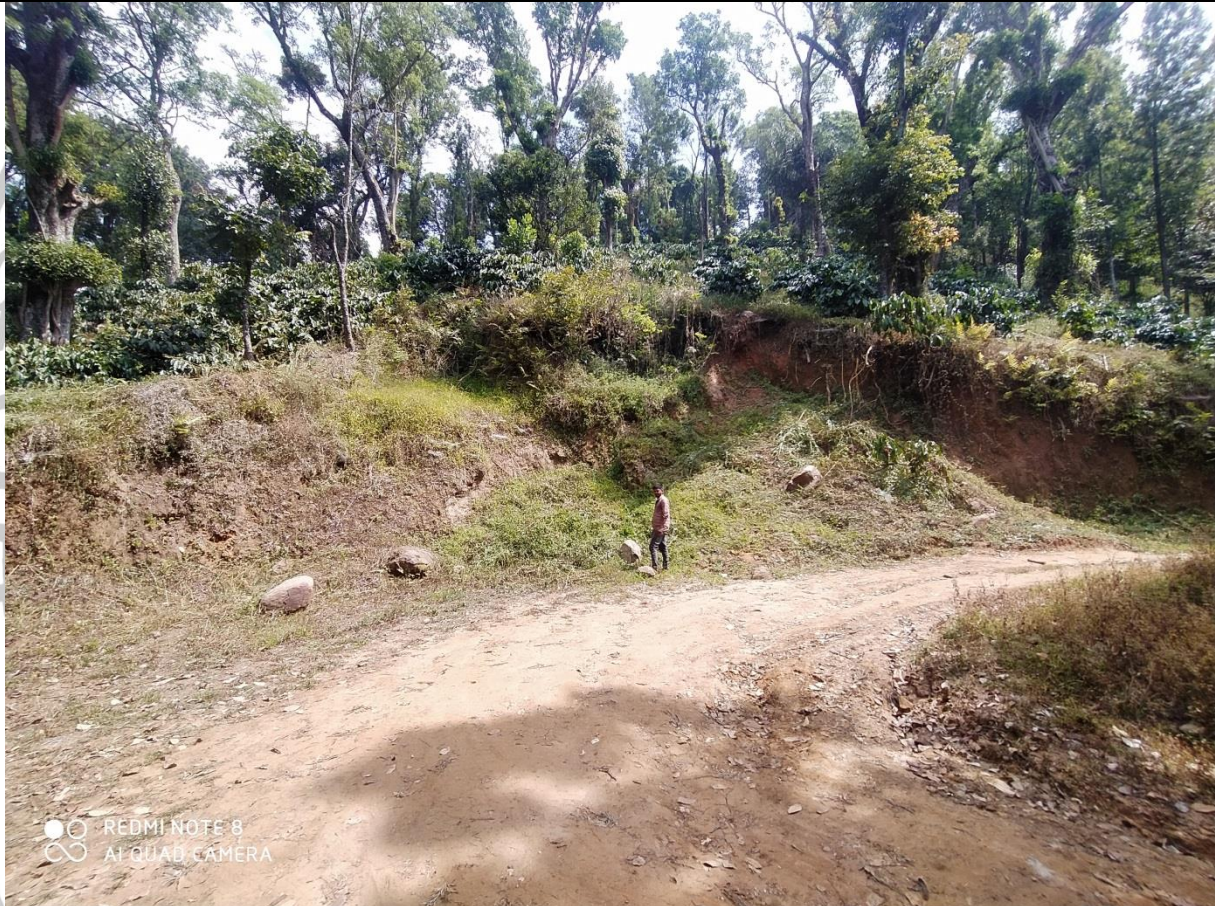
| <b>Landslide No.</b> | ls40 |

| <b>Failure Mechanism</b> | Translational shallow |
| <b>Hydrological Condition</b> | Dry |
| <b>Geo-scientific Cause</b> | Unplanned cut-slope for road construction;<br>steep upslope gradient |

| <b>Alert</b> | I |
| <b>Remarks</b> | Cut-slope domain (overburden) |

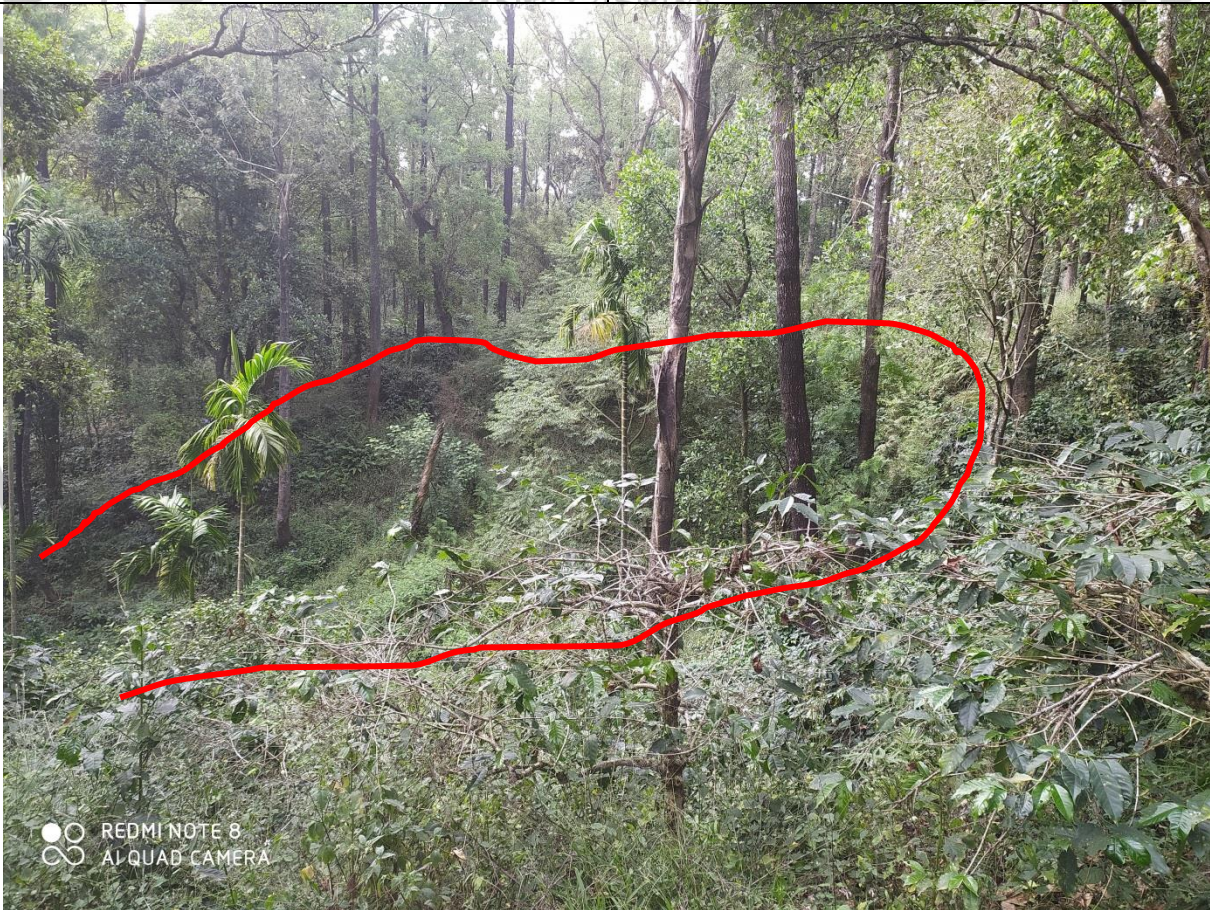
| <b>Landslide No.</b> | ls41 |

| <b>Failure Mechanism</b> | Translational deep |

| <b>Hydrological Condition</b> | Dry |
| <b>Geo-scientific Cause</b> | Excess water influx during rainfall;<br>reduction of material strength in saturation;<br>blockage of drainage course |
| <b>Alert</b> | II |
| <b>Remarks</b> | Overburden domain |

| <b>Remedial Measures</b> | Avoid blockage of drainage course; need<br>to give wooden walls at regular contour<br>intervals to stop erosion of loose earth<br>material and strengthen the base of slope |

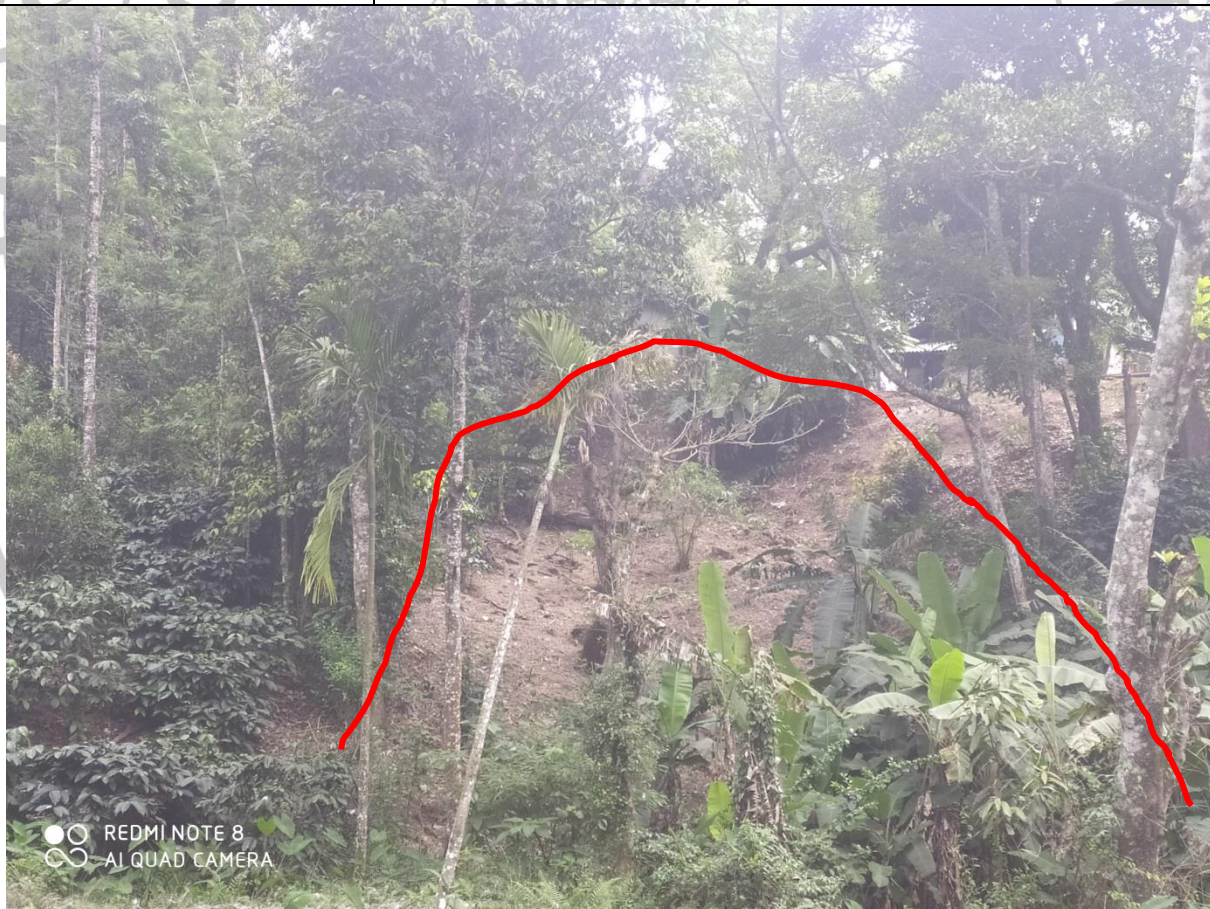
| <b>Landslide No.</b> | ls42 |

| <b>Failure Mechanism</b> | Translational shallow |

| <b>Hydrological Condition</b> | Flowing |
| <b>Geo-scientific Cause</b> | Toe erosion by 2nd order stream; blockage of drainage course |
| <b>Alert</b> | I |
| <b>Remarks</b> | Overburden domain |

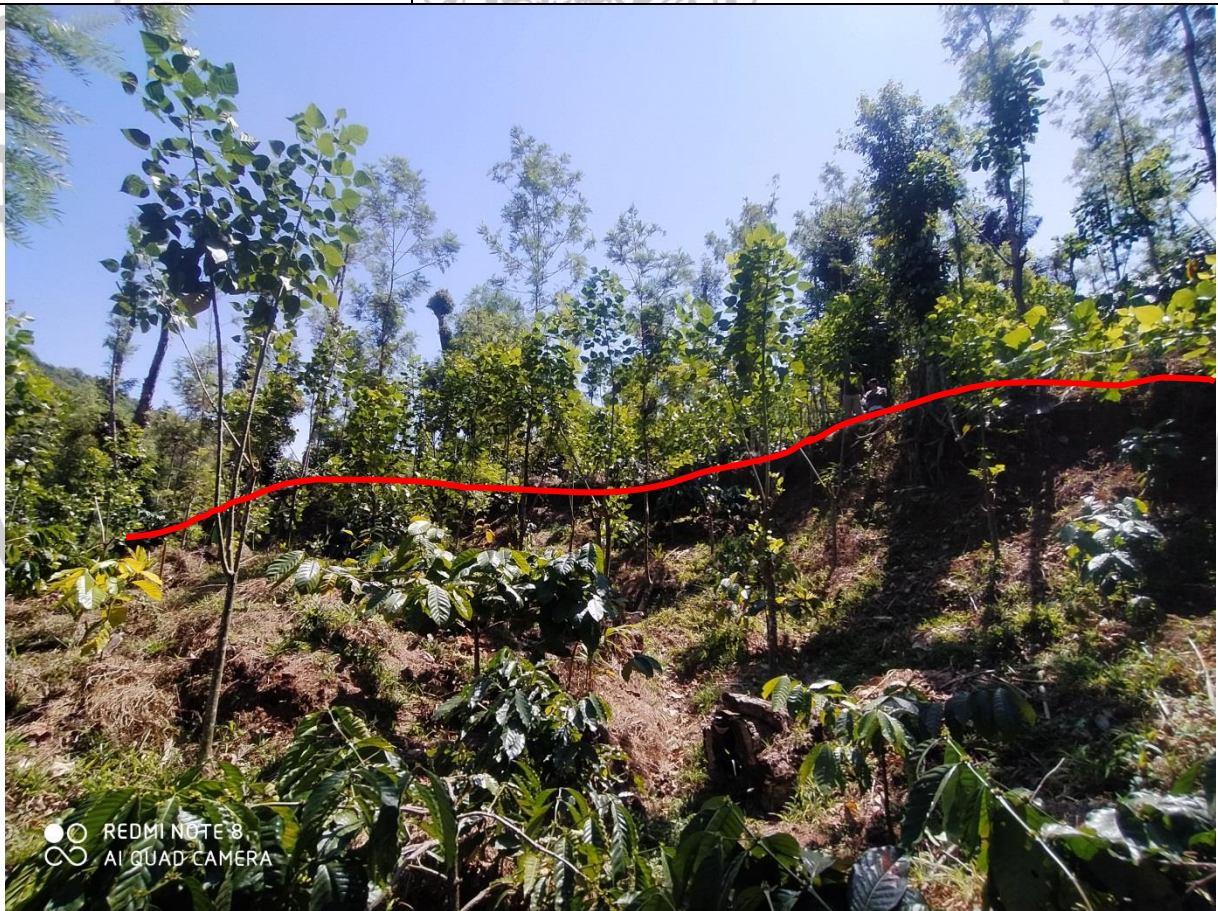
| <b>Landslide No.</b> | ls43 |

| <b>Failure Mechanism</b> | Translational deep |

| <b>Hydrological Condition</b> | Dry |
| <b>Geo-scientific Cause</b> | Toe erosion by 4th order stream; shifting of natural drainage course towards stream bank |
| <b>Alert</b> | I |
| <b>Remarks</b> | Overburden domain |

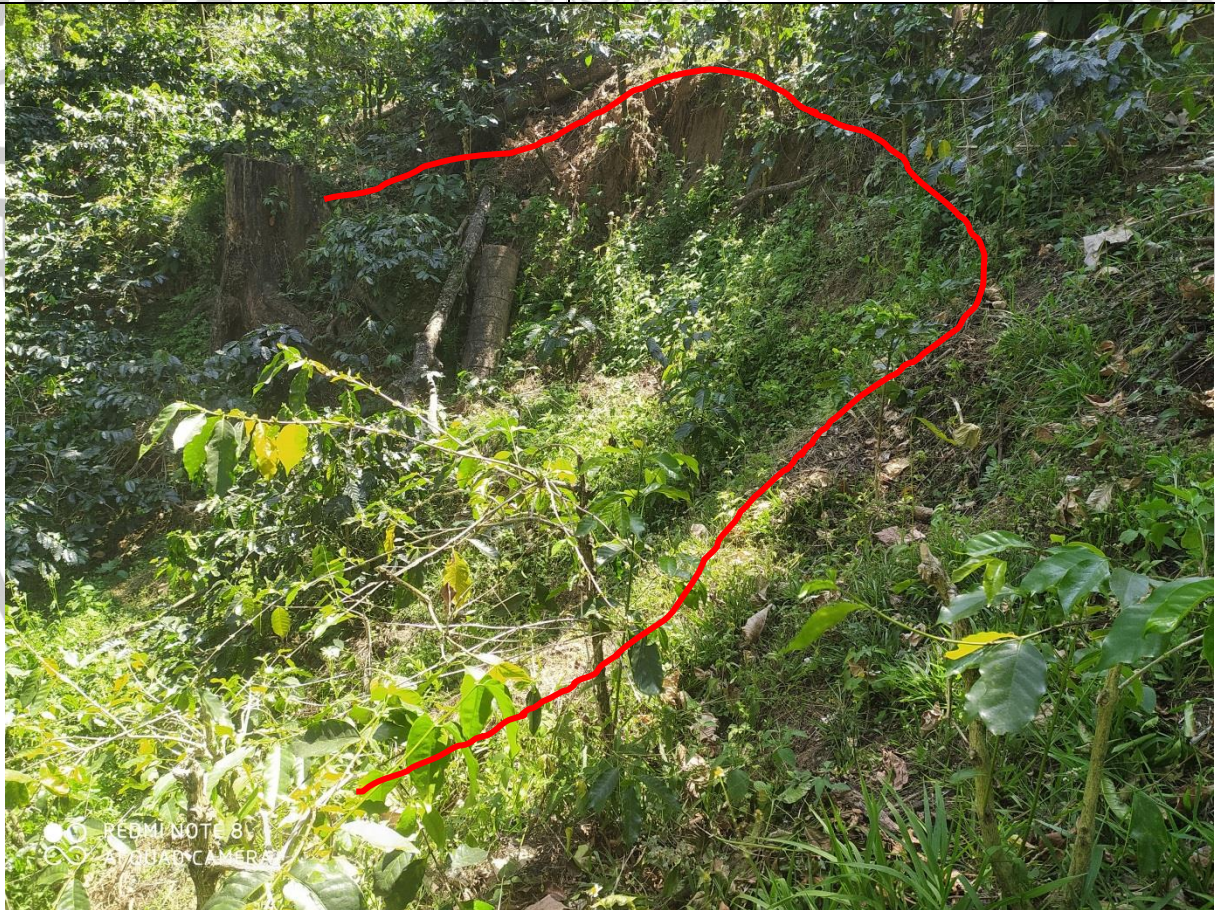
| <b>Landslide No.</b> | ls44 |

| <b>Failure Mechanism</b> | Translational shallow |

| <b>Hydrological Condition</b> | Dry |
| <b>Geo-scientific Cause</b> | Toe erosion by stream |
| <b>Alert</b> | III |
| <b>Remarks</b> | Overburden domain |

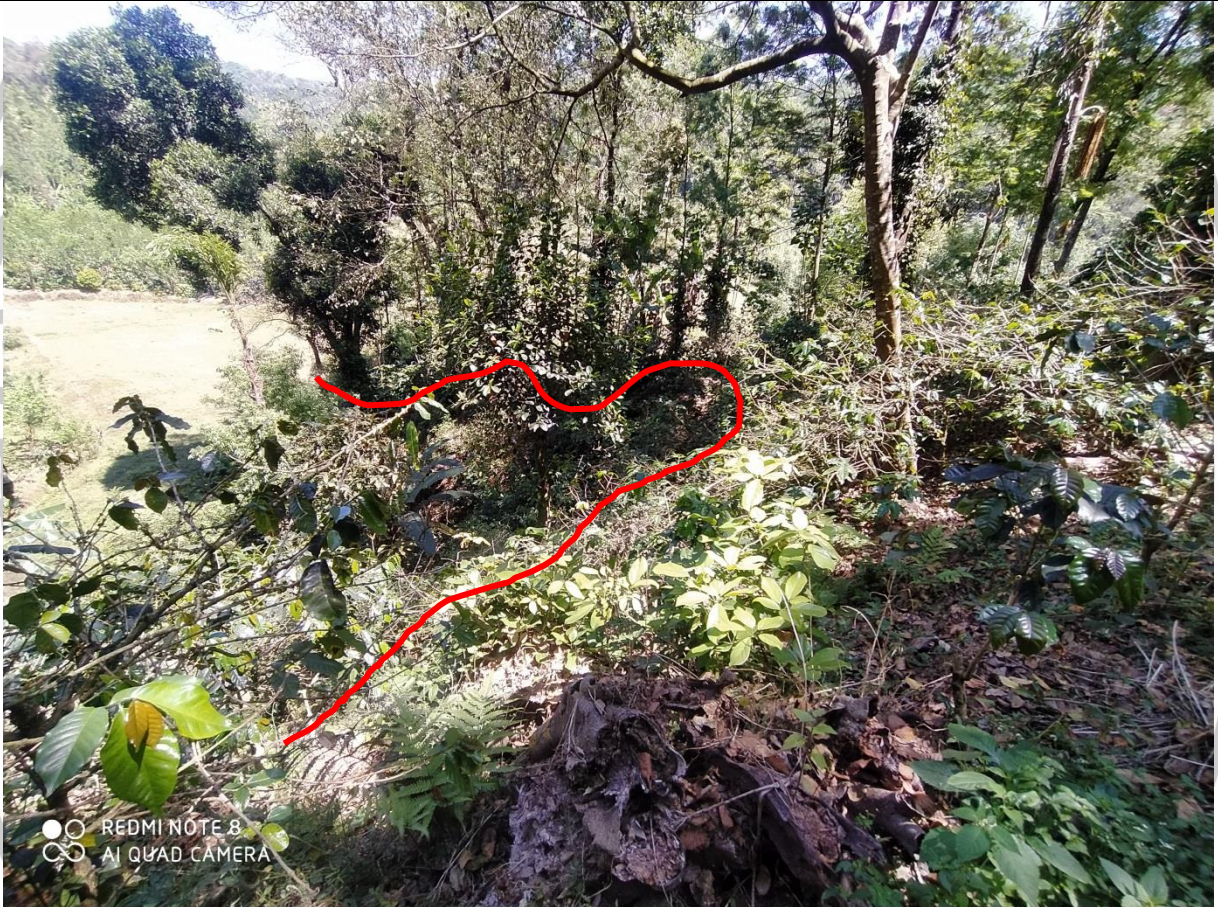
| <b>Landslide No.</b> | ls45 |

| <b>Failure Mechanism</b> | Translational shallow |
| <b>Hydrological Condition</b> | Flowing |
| <b>Geo-scientific Cause</b> | Toe erosion by 4th order stream; shifting of natural drainage course towards stream bank |

| Alert | II |
| Remarks | Overburden domain |

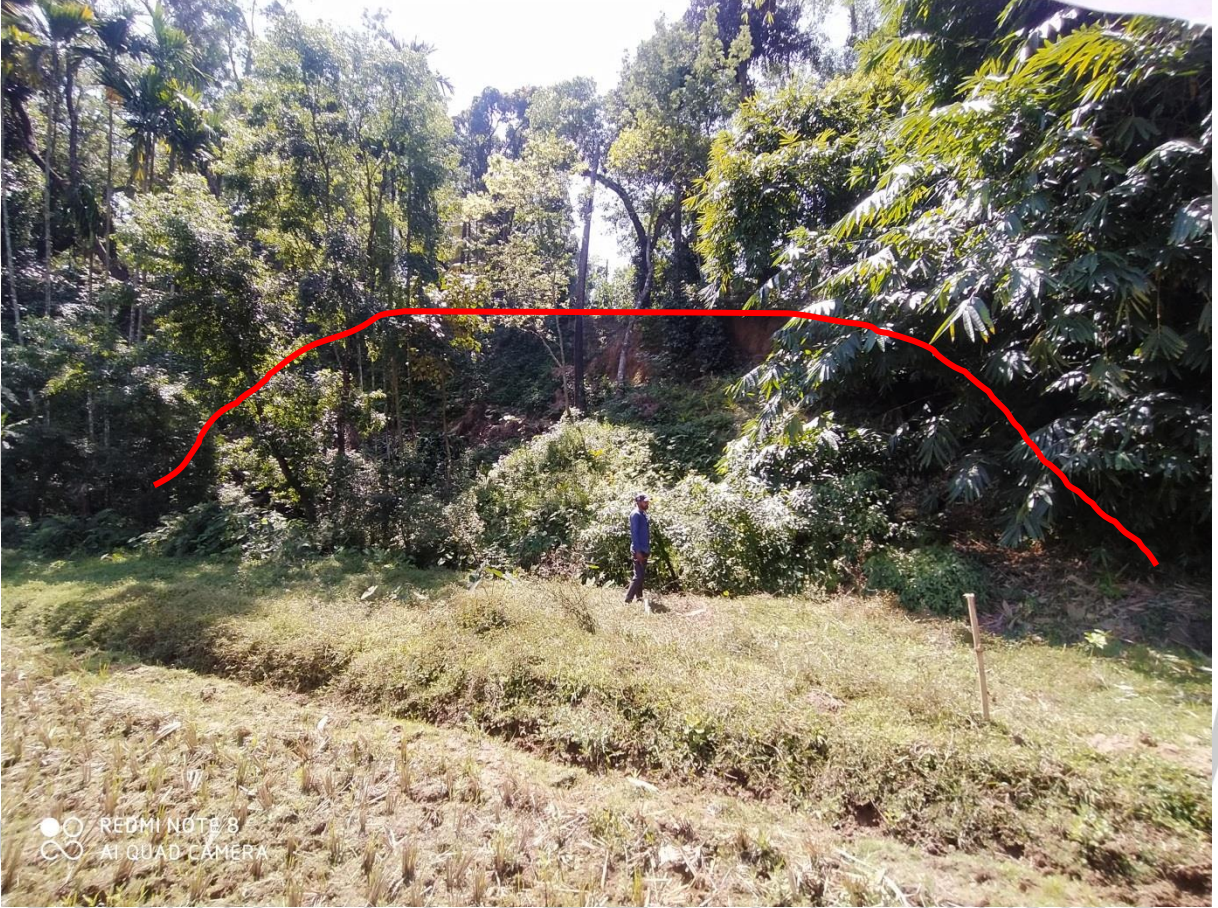
| <b>Landslide No.</b> | ls46 |

| <b>Failure Mechanism</b> | Translational shallow |
| <b>Hydrological Condition</b> | Flowing |
| <b>Geo-scientific Cause</b> | Toe erosion by 4th order stream; shifting of natural drainage course towards stream bank; blockage of drainage course |

| <b>Alert</b> | I |
| <b>Remarks</b> | Overburden domain |
