भारत सरकार  
GOVERNMENT OF INDIA  
भारतीय भूवैज्ञानिक सर्वेक्षण  
GEOLOGICAL SURVEY OF INDIA

Meso-scale (1:10,000) Landslide Susceptibility Mapping in Hadagal Hole Sub-Watershed of Madapur Hole Watershed of Harangi Sub-Basin, Kodagu District, Karnataka

Final report for field season 2021-22

एजाज अहमद भट, वरिष्ठ भूवैज्ञानिक/Aijaz Ahmad Bhat, Senior Geologist

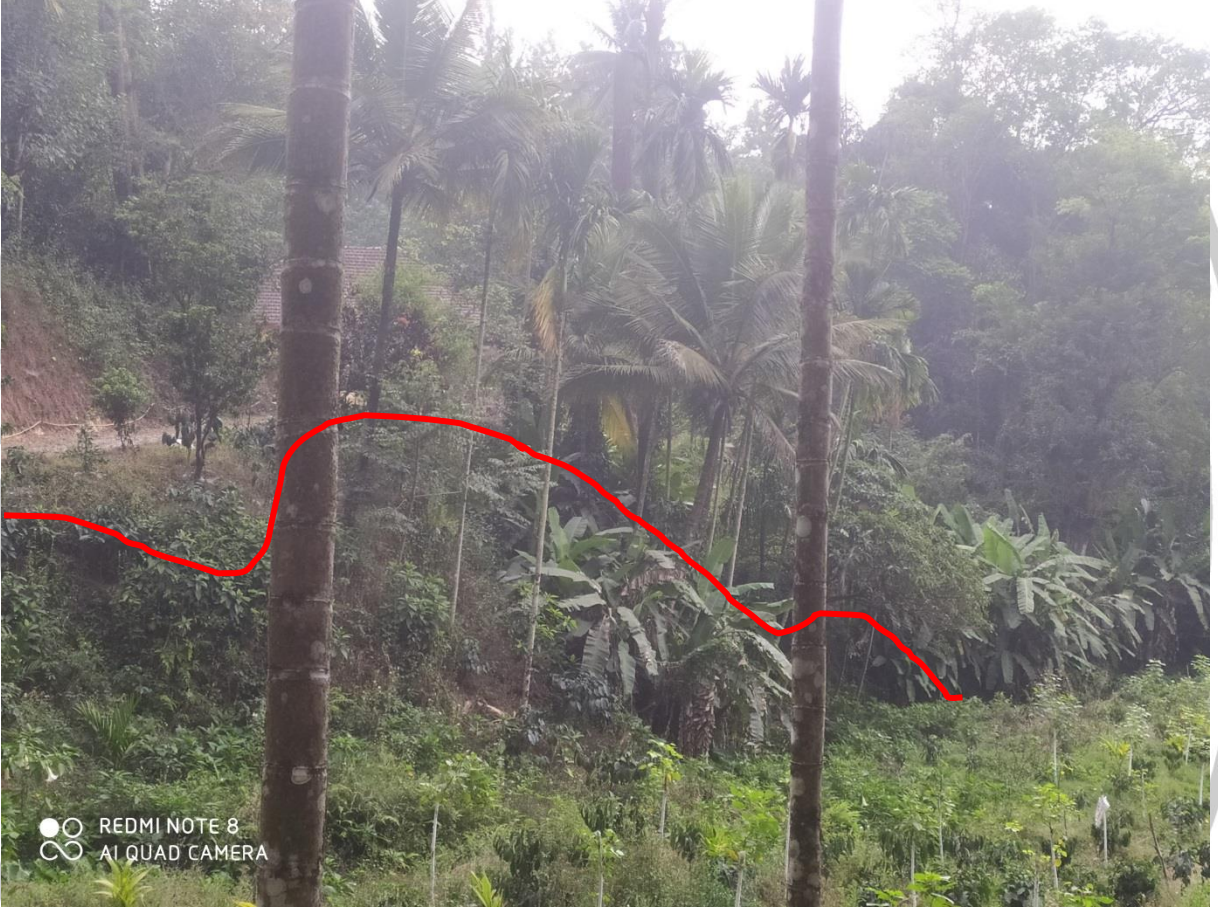
| <b>Landslide No.</b> | ls47 |

| <b>Failure Mechanism</b> | Translational shallow |
| <b>Hydrological Condition</b> | Flowing |
| <b>Geo-scientific Cause</b> | Toe erosion by 3rd order stream |

| <b>Alert</b> | I |
| <b>Remarks</b> | Cut-slope domain (overburden) |

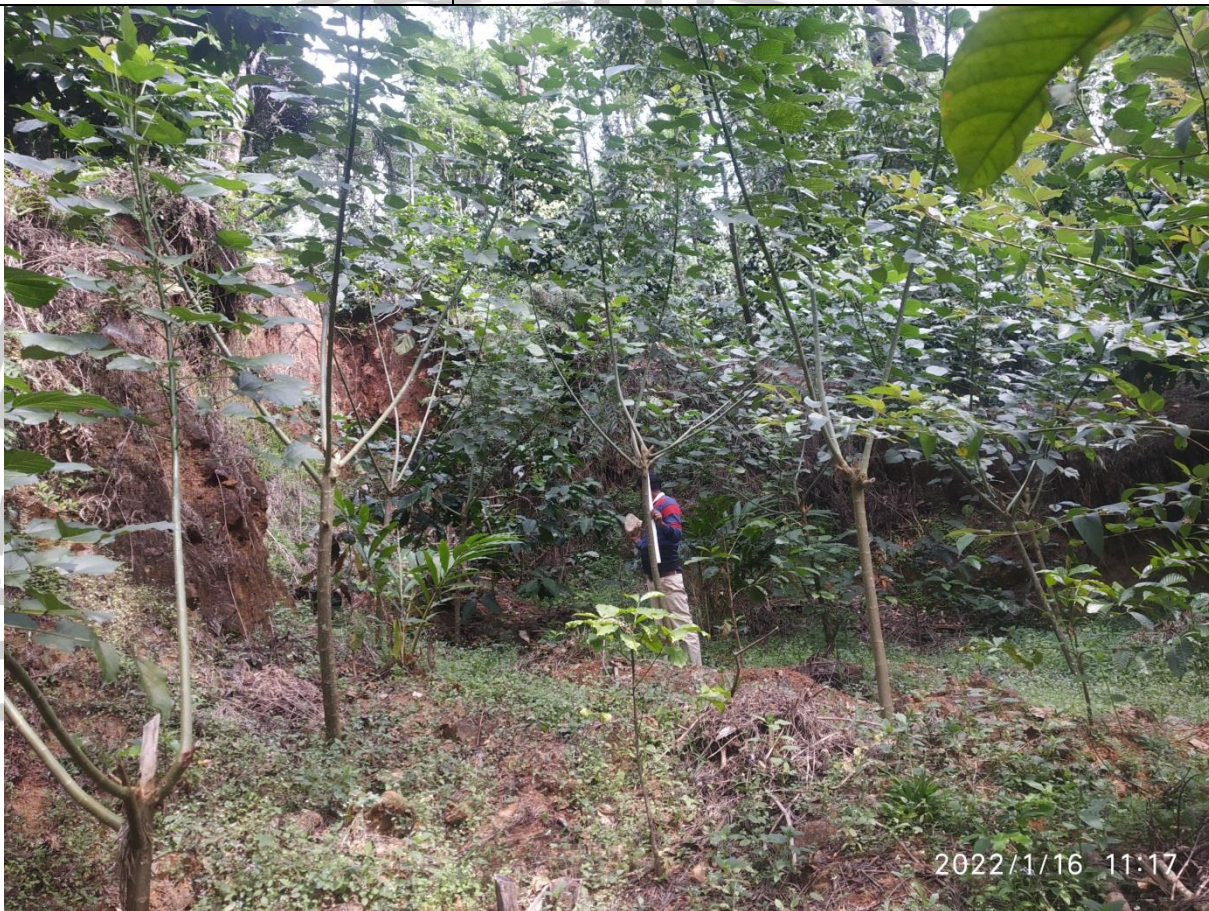
| <b>Failure Mechanism</b> | Shallow translational |
| <b>Hydrological Condition</b> | Dry |
| <b>Geo-scientific Cause</b> | Poor slope forming material (highly weathered granite gneiss) |

| <b>Alert</b> | III |
| <b>Remarks</b> | Overburden domain |

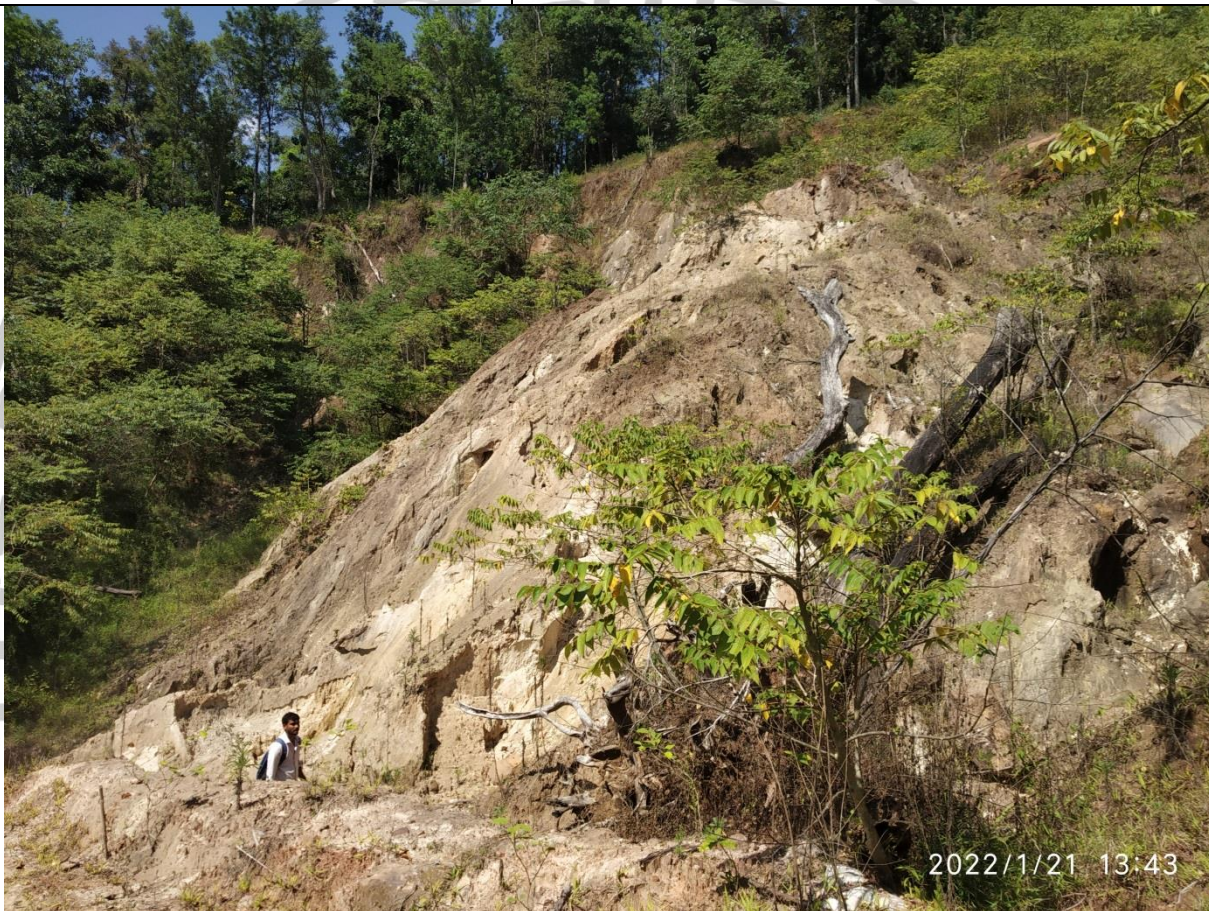
| <b>Failure Mechanism</b> | Shallow translational |

| <b>Alert</b> | III |
| <b>Remarks</b> | Overburden domain |

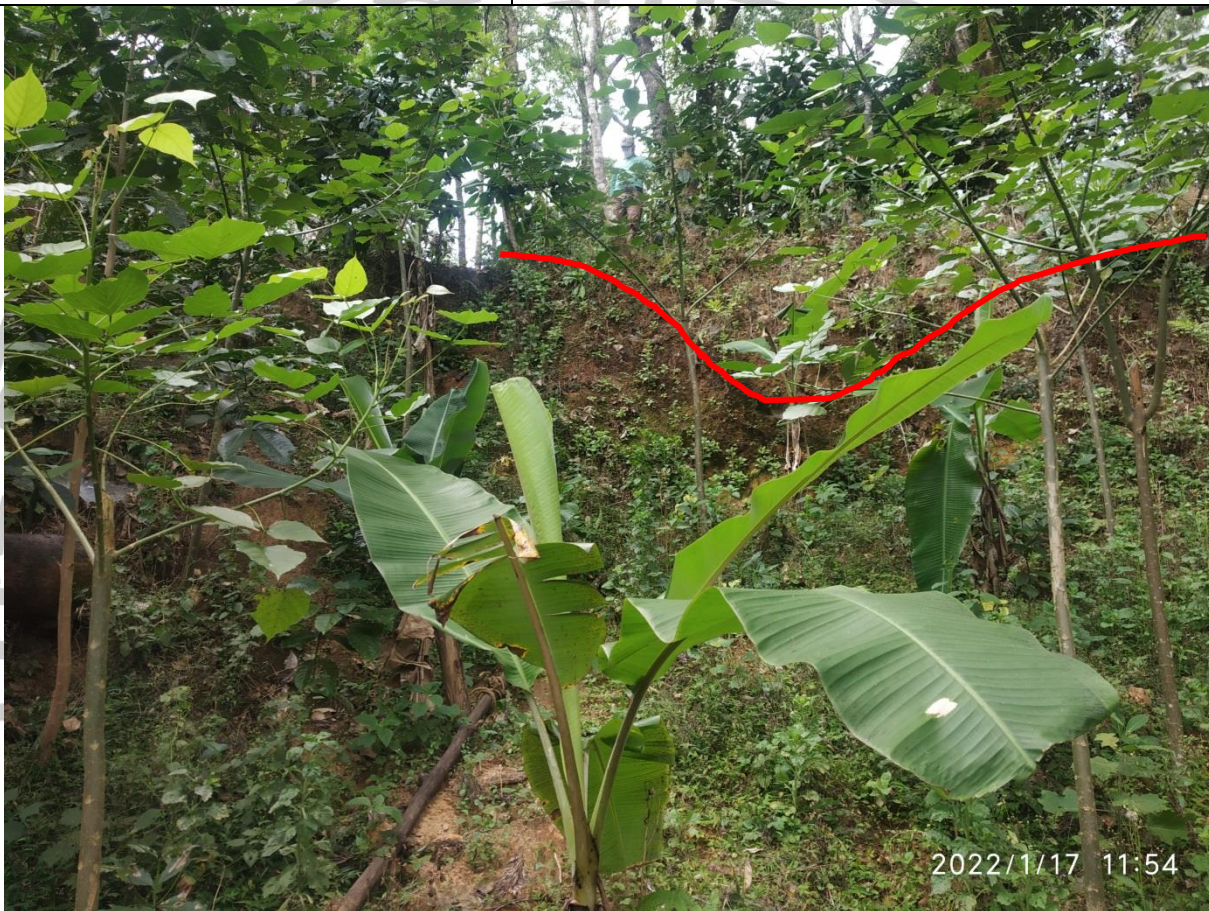
| <b>Landslide No.</b> | ls53 |

| <b>Alert</b> | III |
| <b>Remarks</b> | Overburden domain |

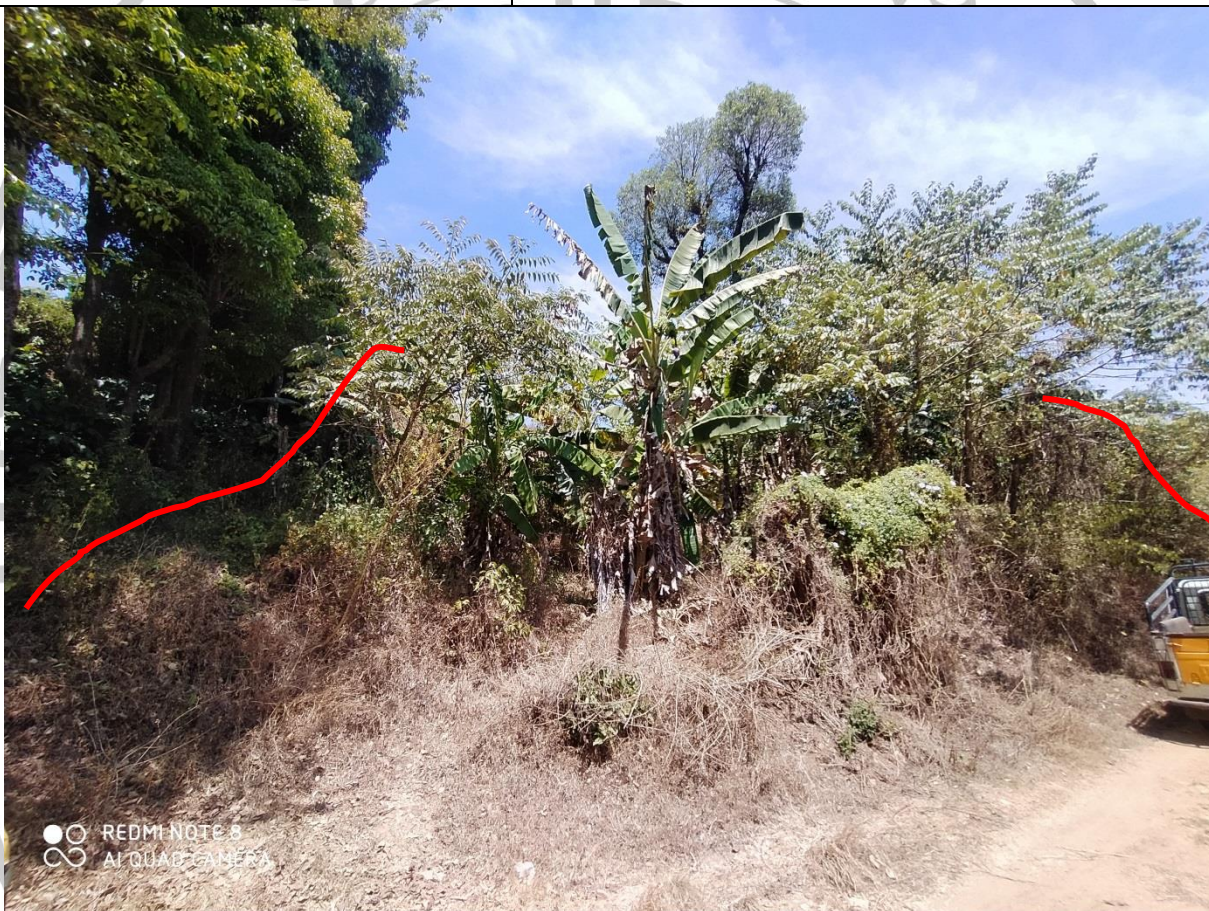
| <b>Landslide No.</b> | ls54 |

| <b>Alert</b> | III |
| <b>Remarks</b> | Overburden domain |

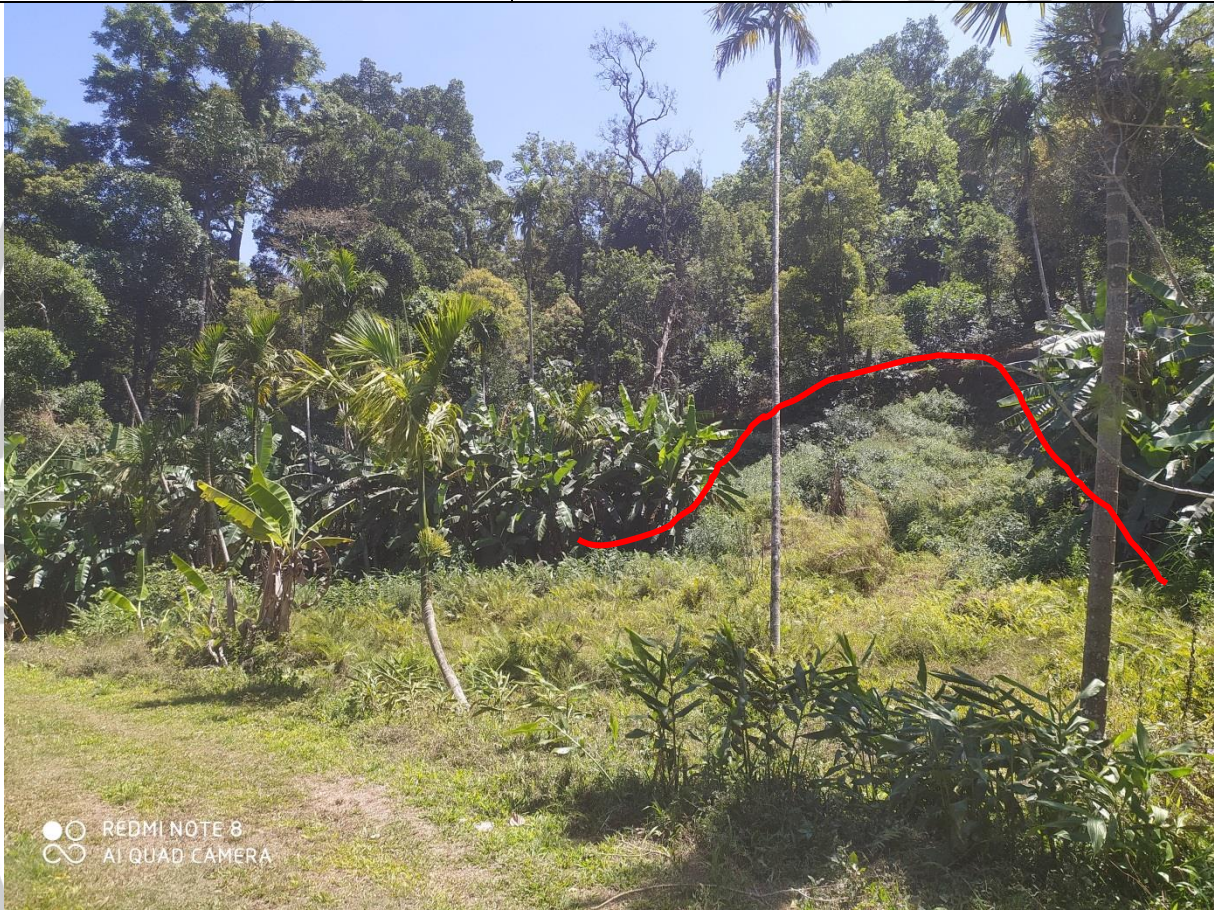
| <b>Landslide No.</b> | ls55 |

| <b>Alert</b> | I |
| <b>Remarks</b> | Overburden domain |
