**GOVERNMENT OF INDIA  
GEOLOGICAL SURVEY OF INDIA**

**A NOTE ON SCIENTIFIC ASSESSMENT OF THE AMBARGUDDA AREA,  
KODCHADRI, SHIMOGA DISTRICT, KARNATAKA**

**(Additional Item FS 2009-10)**

**Project: ENGINEERING GEOLOGY  
OP: KARNATAKA & GOA  
BANGALORE  
2010**

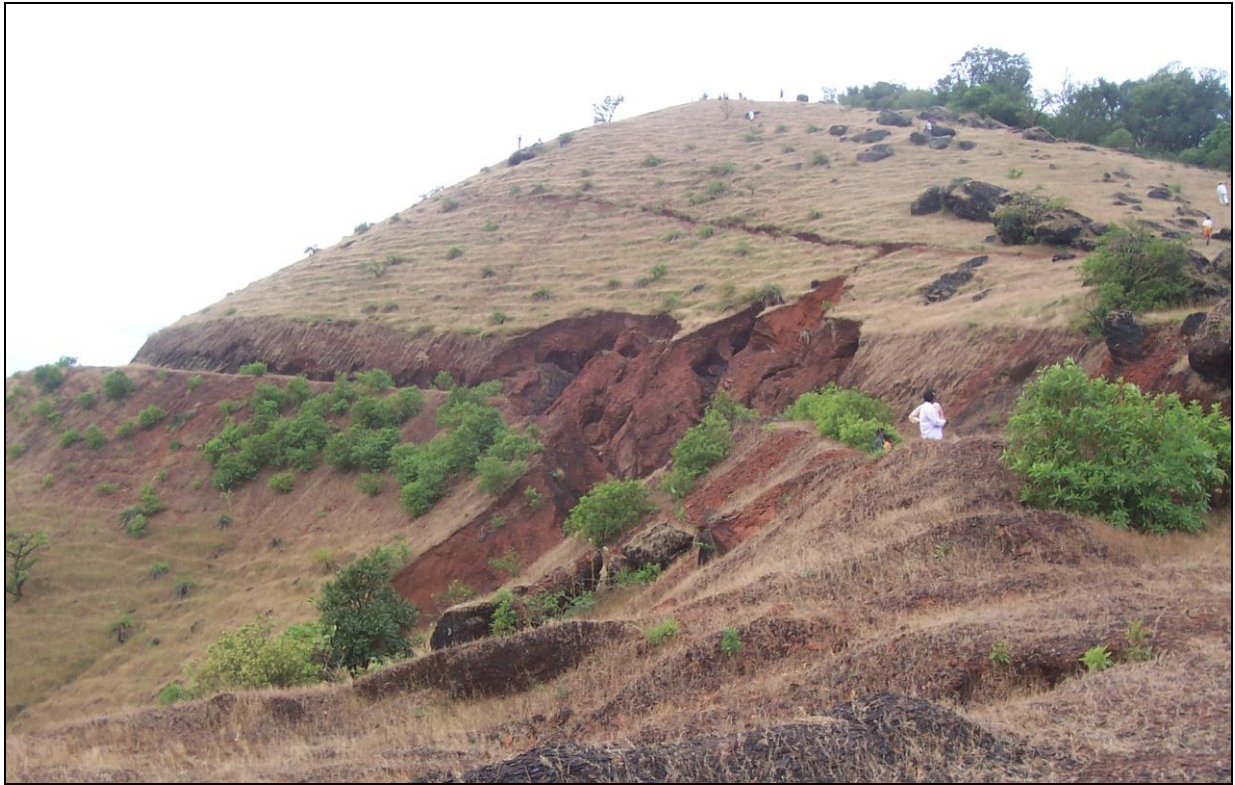
The landslide is a Debris slide (Photo 1, 2 & 3). The detailed morphometric parameters of the slide are given in Table 1. The debris has moved nearly 100 m downstream and as there is no protective measures to stabilise the slide and every year with rain fall during monsoon the slide is prograding both laterally and longitudinally. The material involved is mainly fragile BIF and the washed away silt is being deposited on the fields and cultivated area of village in downstream.

**Photo 1: The view of Landslide caused due to mining activity at Ambargudda area.**

The Mining activity is the main triggering factor of this slide. The unscientific way of bench and pits made for mining activity has changed the slope geometry. The slide has occurred on the centre of the non-perennial Nala. The area receives heavy amount of rainfall during monsoons, and the fragile nature of the BIF with slope modification for mining activity has caused the slide.

1. Modification of slope geometry with grading of slope.
2. Erection retaining structure near the stream valley and back filling the slope.
3. Proper surface drainage to be provided as the nala is flowing on the debris.
4. As the whole Ambargudda area's slope geometry is disturbed by mining activity and if mining activity is continued there are several weak zones wherein new landslides may occur.

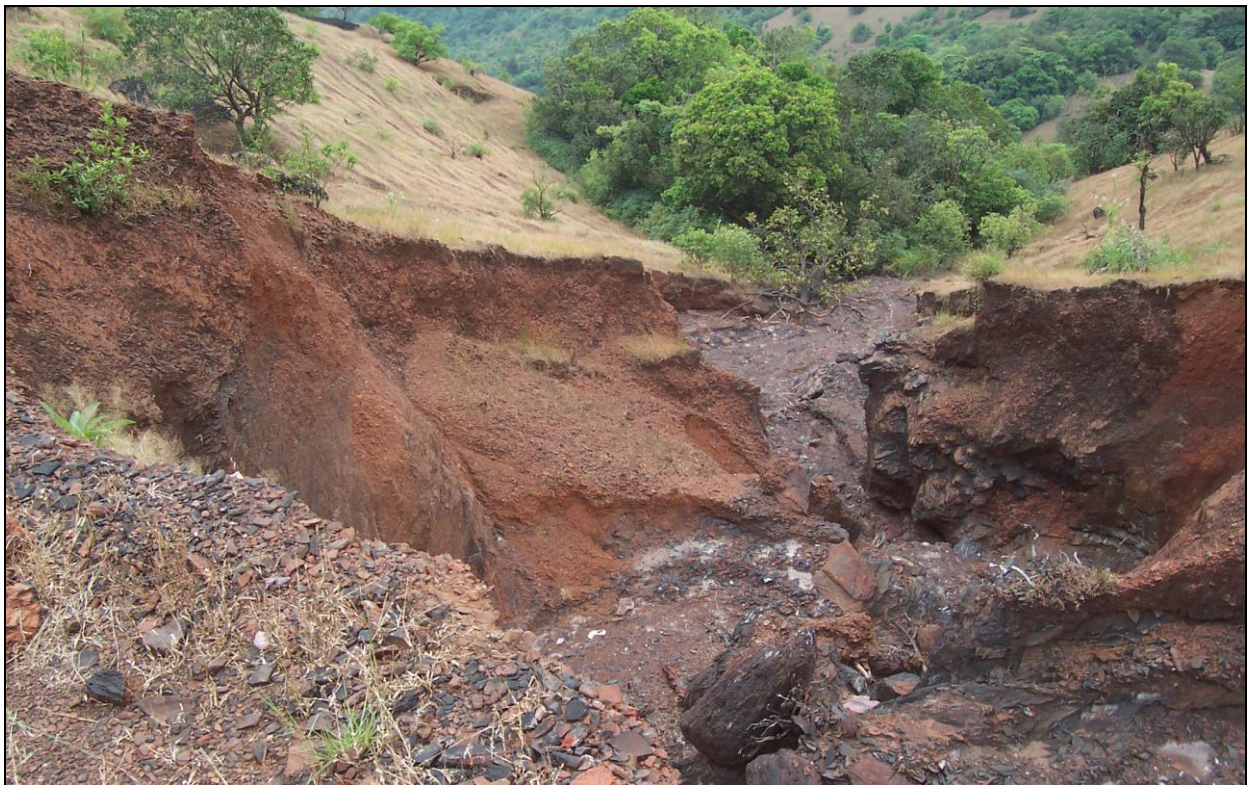
**Photo 2: The Run out zone of the Landslide caused due to mining activity at Ambargudda area.**

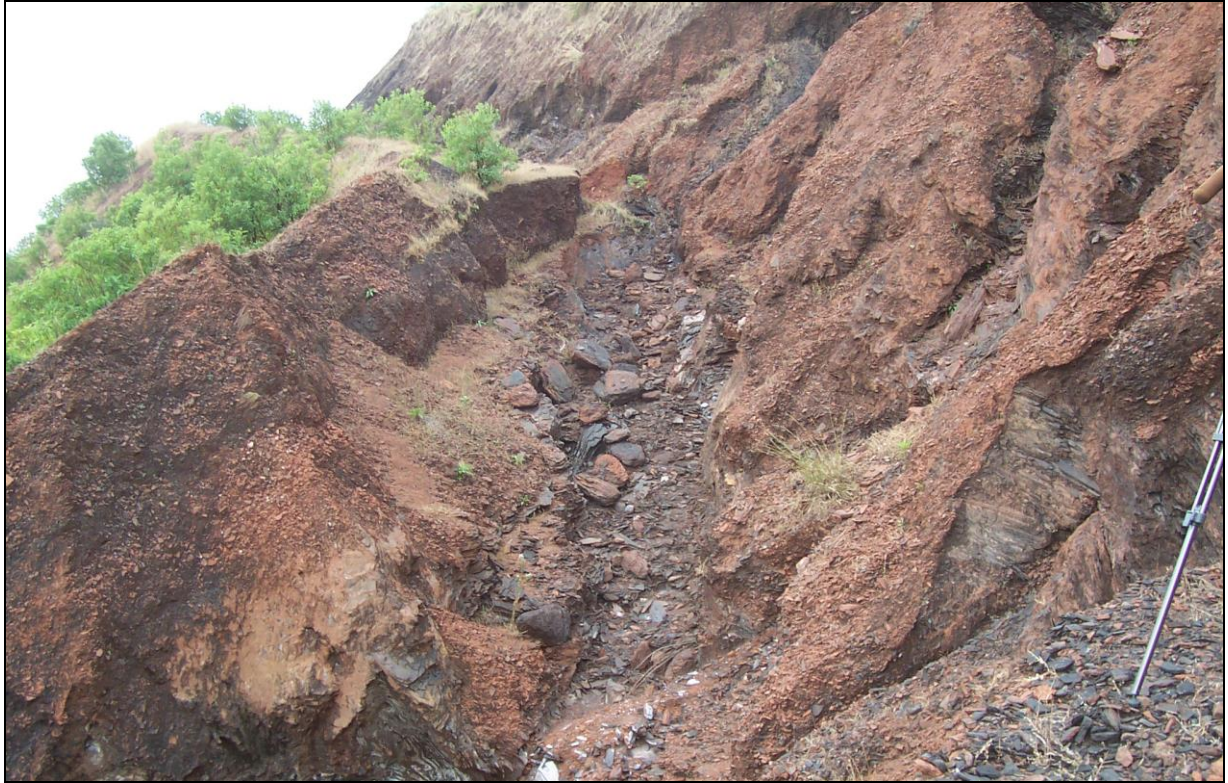
**Photo 3: The Depletion zone of the Landslide caused due to mining activity at Ambargudda area.**
