**DETAILED SITE SPECIFIC STUDY OF THE KADWAD LANDSLIDE,  
KARWAR TALUK, UTTAR KANNADA DISTRICT, KARNATAKA  
(Progress Report for Field Season 2010-2012)  
Code No.: EG/SR/KG/2010/058**

**Project: Engineering Geology  
State unit: Karnataka and Goa**

**Project: Engineering Geology  
State unit: Karnataka and Goa  
BANGALORE  
2012**

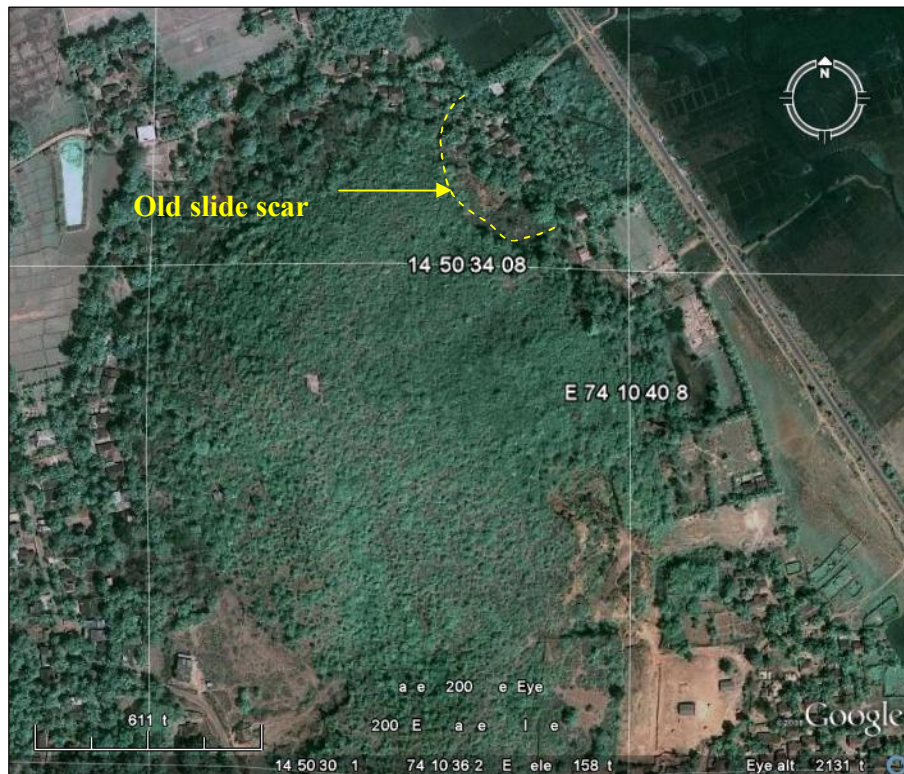
**Fig-2: The Google image showing the slope prior to failure and the probable old slide scar**

**IV.2.INFORMATION FROM THE IMAGERY:** The slide appears to represent reactivation of old slide that could also be conformed to the Google image wherein the old Palaeo scar line could be marked. The elderly locals also confirmed that a landslide was occurred during late fifties (Fig-2).

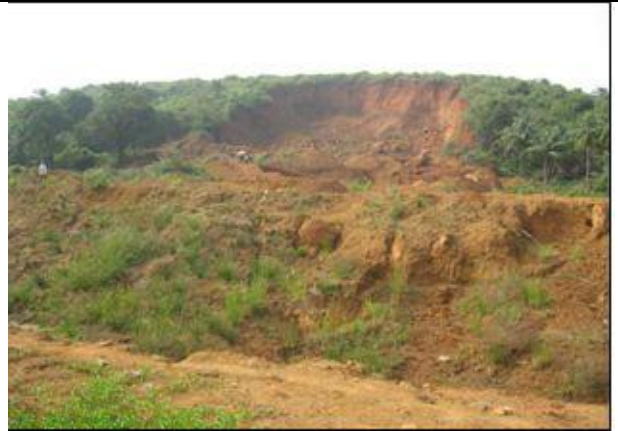
Photo 2: A panoramic view of Kadwad landslide from Konkan railway track

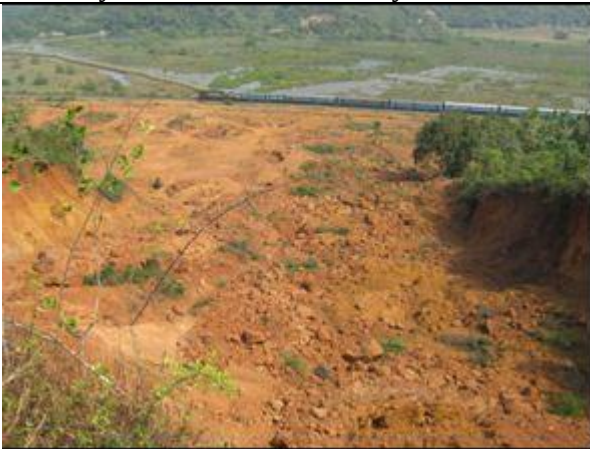
Photo 3: A view of Kadwad landslide from top of crown portion

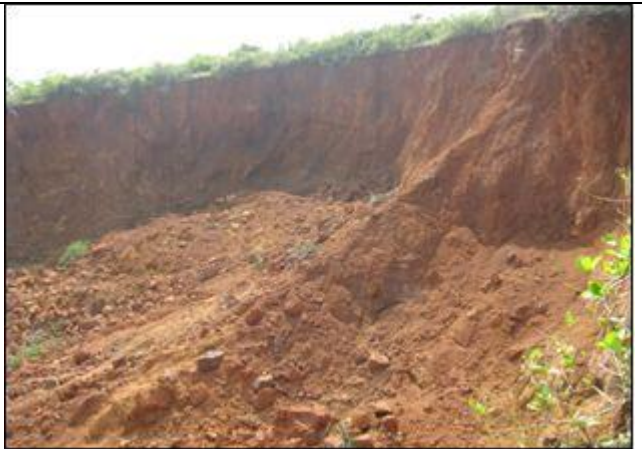
Photo 4: View of top portion of Kadwad landslide

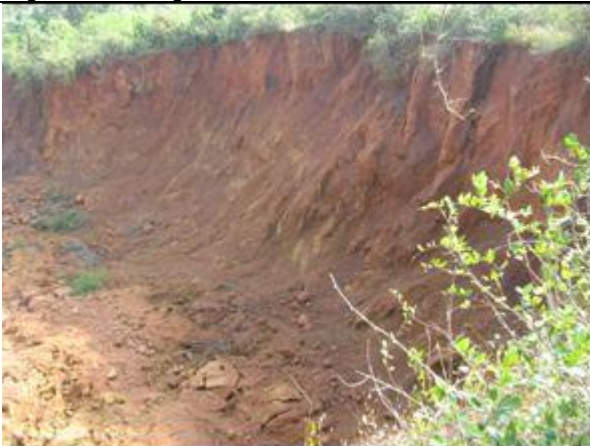
Photo 5: View of left flank of Kadwad landslide with distinct clay horizon

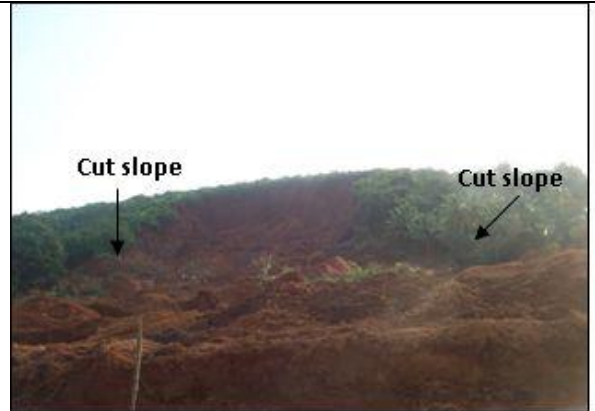
- The original slope angle being very low  $\sim 20^\circ$ , the slope was stable prior to human interference. The modification of the slope by cutting 15-20m vertical slope (as observed on either flanks of the slide zone) for settlement as well as plantation purposes, have increased instability (Photo 6).

Photo 6: View of the landslide from the toe of the slide showing the original cut slopes

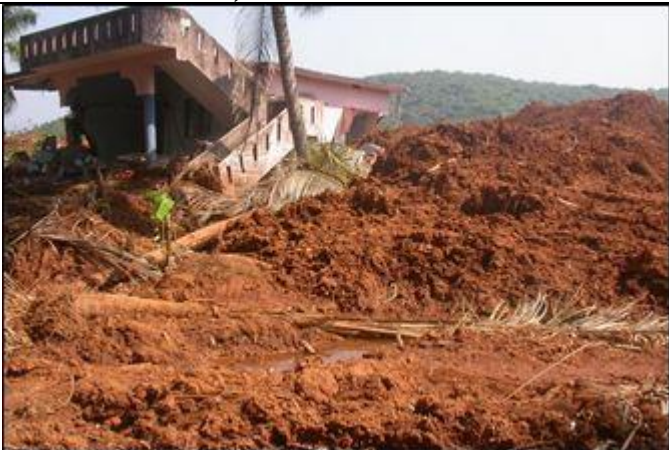
Photo 9: The damaged house that has been carried down slope by about 15 m, near the toe part of the Kadwad land slide

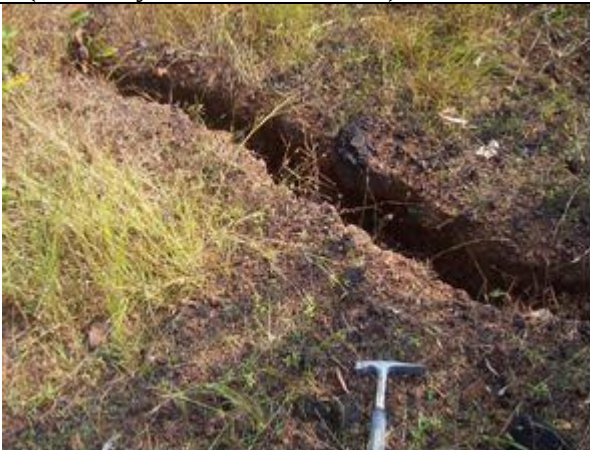
Photo 10: Cracks observed in the mid portion of crown

1. The hanging crown part needs to be graded as it is still unstable (as subsidence and crown cracks were observed) The major part of the intact slope exposed is either Laterite or clayey soil hence the vertical, 20m high crown scarp (Photo 10) should be graded to 35°-45° slope.

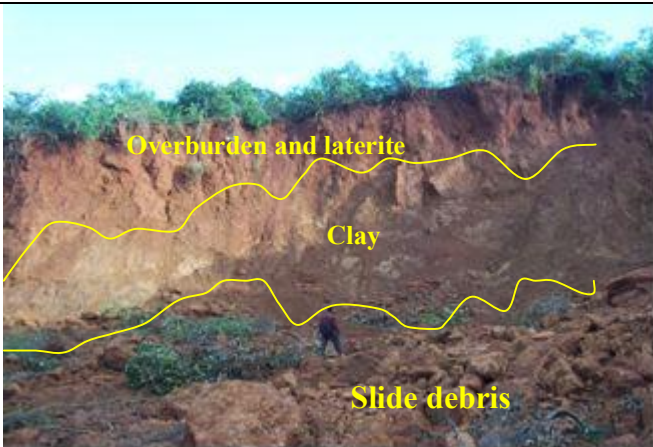
Photo 11: The geological section at the left flank of Kadwad landslide

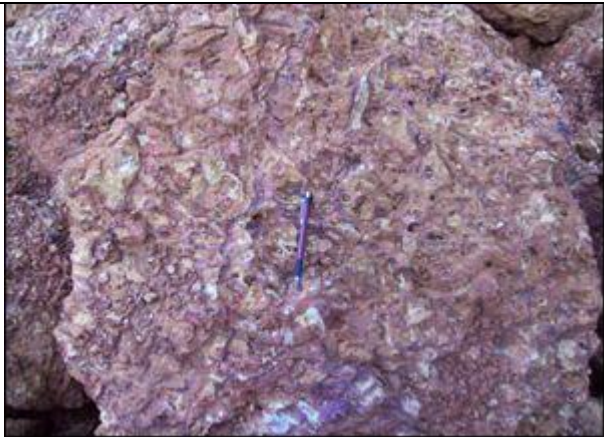
Photo 12: Vesicular laterite boulder in the debris in the mid slope

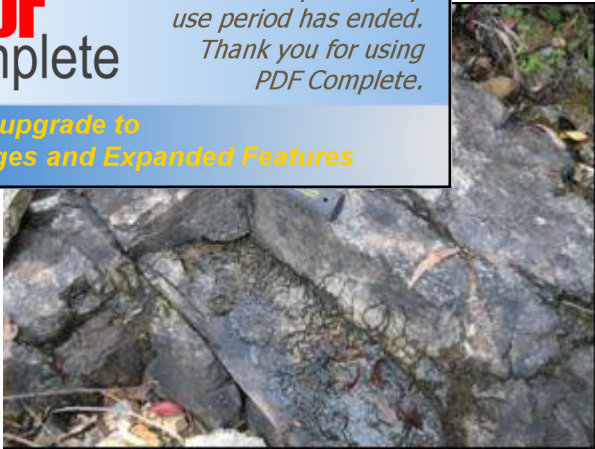
Photo 13: Prominent set of joint (J1-N20°W/84°NE) on Granite outcrop on the right flank of the Kadwad landslide

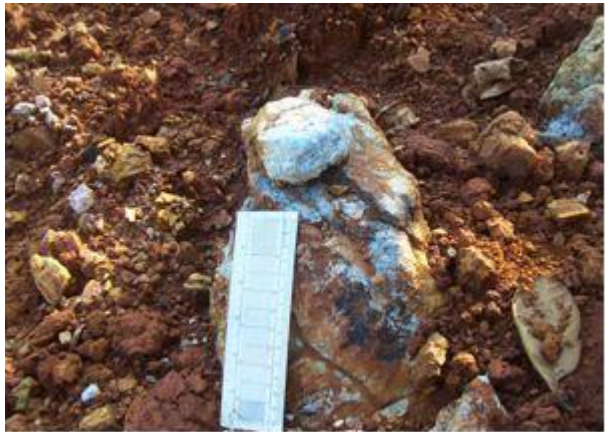
**III.2.4. Saprolite (Weathered granite):** Saprolite or weathered granite is exposed below the lateritic clay in the scarp and found extensively in the debris material (Photo 14). Saprolite is yellowish to grey in colour (Photo 16).

Photo 14: Weathered granite (saprolite) in the slide debris in the mid slope (right flank)

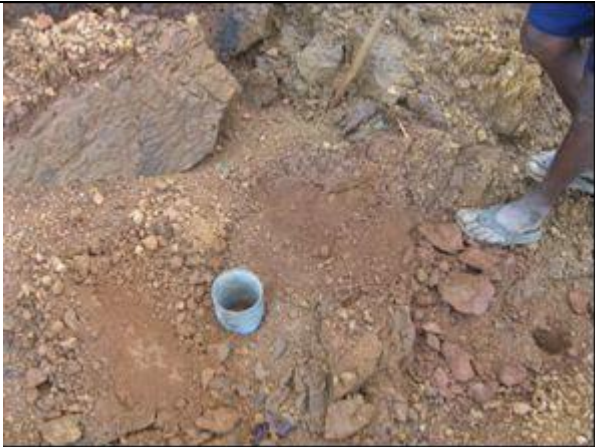
Photo 15: Collection of undisturbed sample (UDS) just below the crown

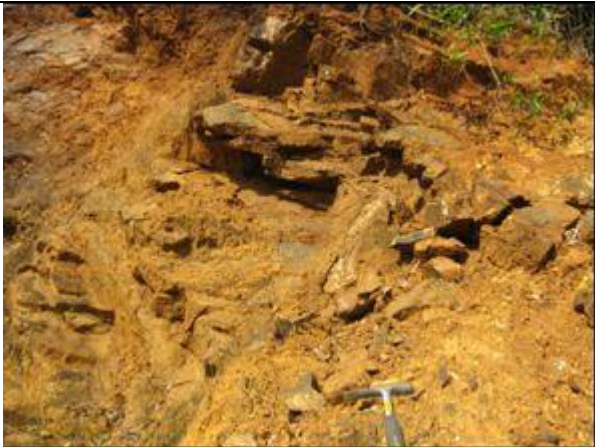
Photo 16: Weathered granite (saprolite) in the slide debris in the mid slope (left flank)

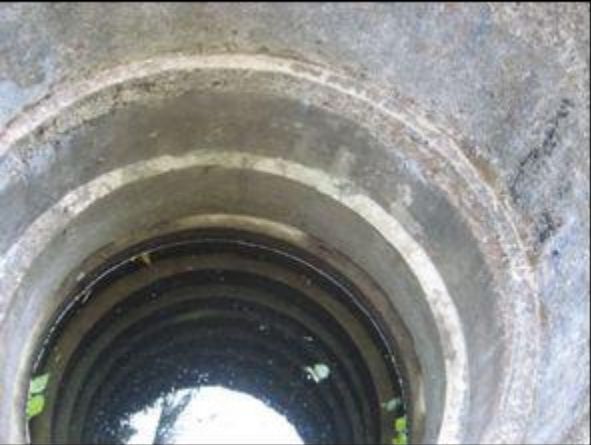
Photo 17: Dug well at the toe

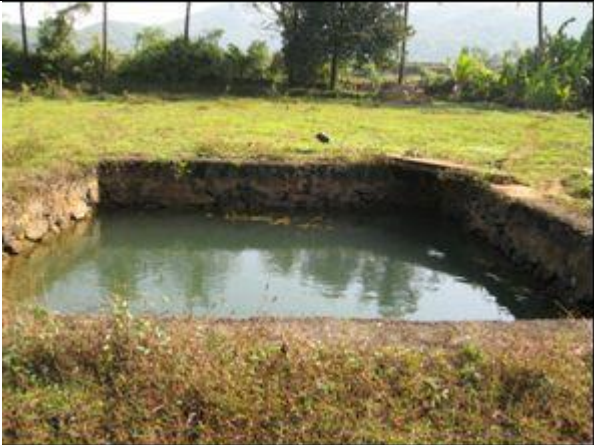
**II.4. GROUND WATER:** The seasonal fluctuation of the Water Table is not high in the area. The Water table is shallow in the Kadwad village and even during summer months, the level in dug wells is within a few meters. The groundwater regime is in general influenced by the Kali river estuary. The Ground water level, observed in the dug wells (Photo 17) distributed at the toe part of the slide is given below (Table-2, Plate-3). During the time of investigation i.e., December 2010 Depth to water table (DTW) in the wells was at 1.5 to 2.5 m indicating shallow depth of water table (Photo 18).

Photo 18: Ground water level in the open dug well at the toe part of the slide
