**DETAILED SITE SPECIFIC STUDY OF SASANWAD LANDSLIDE,  
KARWAR TALUK, UTTAR KANNADA DISTRICT, KARNATAKA  
(Progress Report for Field Season 2010-2012)  
Code No.: EG/SR/KG/2010/059**

**Project: Engineering Geology  
State unit: Karnataka and Goa**

# **FIELD STUDY OF SASANWAD LANDSLIDE IN KANNADA DISTRICT, KARNATAKA**

**(Progress Report for Field Season 2010-2012)**

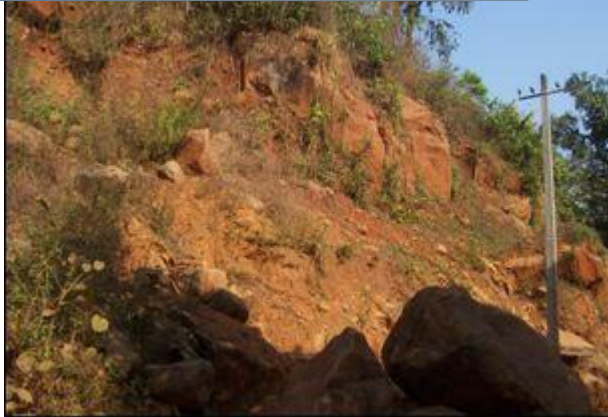
As per observation, the Slide No-1 is a "Rock fall" wherein both planar and wedge failures are noticed. The planar failure appears to have occurred along the daylighted joint trending N70°W with 20°NE dip. The overburden material might have slipped along the same daylighted plane. The wedge failure appears to have occurred along intersect of joints N50°W/ dipping vertical and N40°E/ dipping 78°NW.

Photo 1: A view of Sasanwad slide no-1.

- Removal of all the loose boulders and hanging boulders and the slid debris from the slope.
- While providing with rock bolts, three rows of staggered rock bolting at an angle of  $45^0$  from horizontal to a depth of 3.5 meters with 1.0 meter spacing is suggested.
- For arresting infiltration at the top, the slope should be provided with proper drainage with concrete lining at the base.

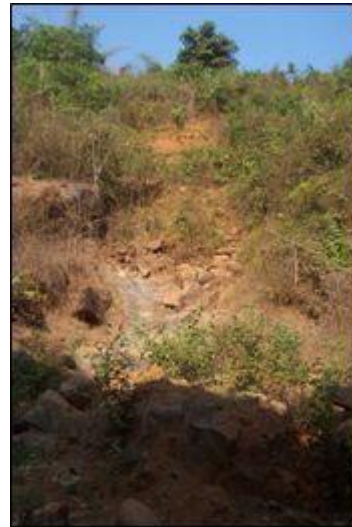
The Slide No-2 is a "Composite slide" wherein both "Rock fall" and "Debris slide" are seen. The planar failure might have occurred along the daylighted joint trending N50°W/ dipping 45°NE. The high rainfall might have enabled removal of the weathered material along these planes by infiltration and the fluid might have acted as a lubricant causing reduction in the resisting force, resulting in slope failure.

Photo 2: A view of Sasanwad slide no-2.

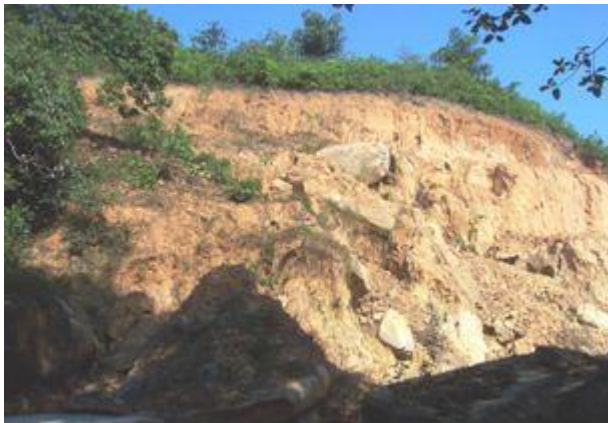
The Slide No-3 classified as a "Debris slide" and the planar failure appears to have occurred along the daylighted joint trending N55°W/ dipping 42°NE.

Photo 3: A view of Sasanwad slide no-3.

- Removal of all the loose boulders and hanging boulders and the slided debris from the slope is suggested as above
- The benches/berns as well as the drainage facilities provided by the District administration although has reduced the magnitude of the slide, the benches may be extended further into the hillock for at least a meter. Proper yearly maintenance including the removal of washed out debris and maintaining the bench width is recommended.

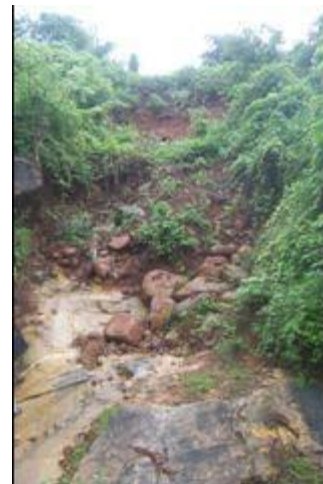
Photo 4: A view of top portion of Sasanwad slide no-2.

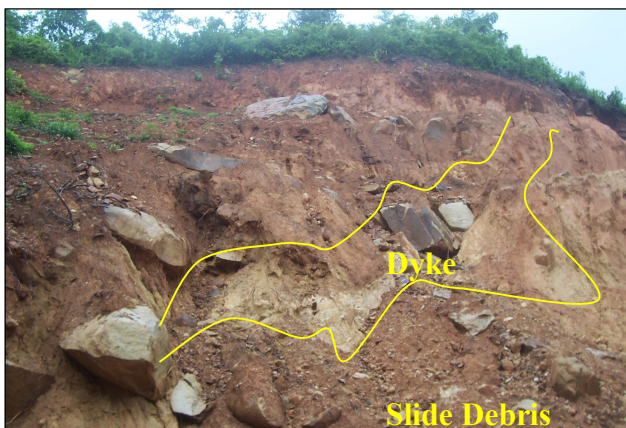
Photo 5: view of dyke exposure in Sasanwad slide no-3.

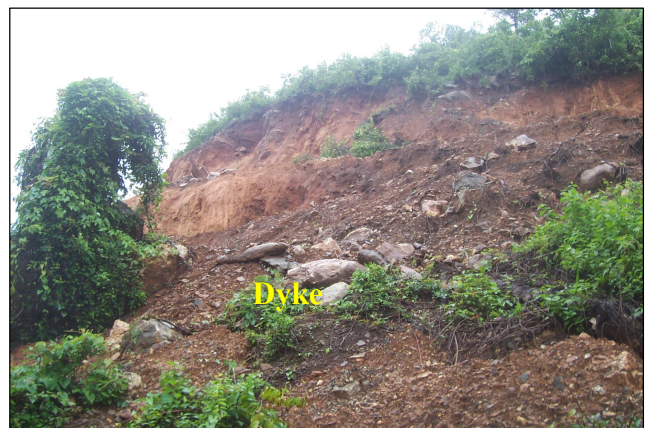
Photo 6: view of the Sasanwad slide no-3 from the toe of the slide.

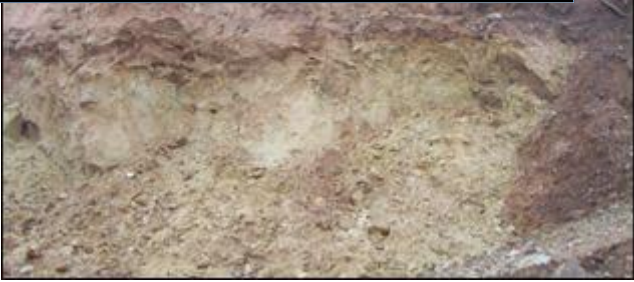
Photo 7: Highly wetahered dyke in Sasanwad slide no-3.

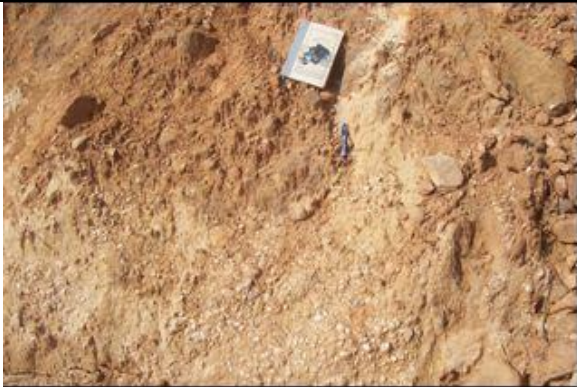
Photo 9: The weathered gneiss in the slide debris in the mid slope of Sasanwad slide no-3.

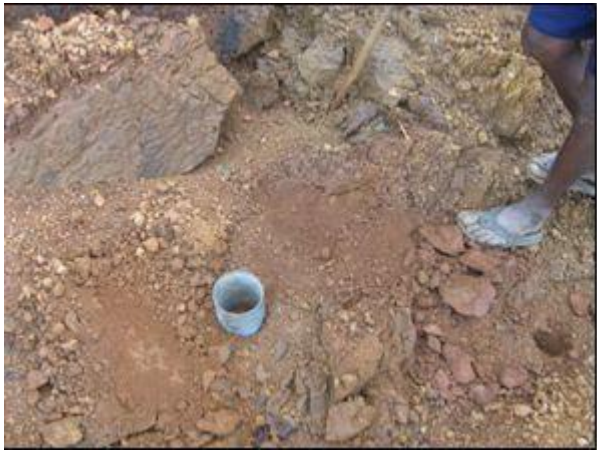
Photo 11: Collection of undisturbed sample just below the crown of Sasanwad slide no-3.

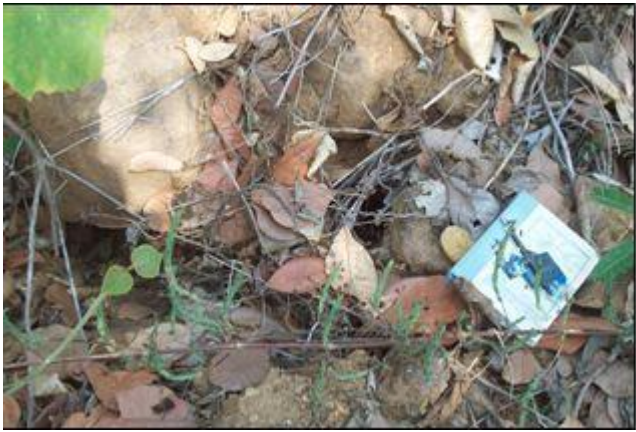
Photo 8: Crown cracks observed in between Sasanwad Slide no-2 & slide no-3.

- Removal of all loose boulders, hanging boulders and the slided debris from the slope,
- Grading of the hanging crown part is suggested as the crown part appears unstable due to the presence of crown cracks (Photo 8 & 10). Also since major part of the intact slope exposed is either weathered Gneiss or soil the near vertical, 8 m high crown scarp should be graded to  $35^0$ - $45^0$ .
- A *nala* is flowing right at the centre of the slide proper drainage is required for this *nala*.
- In order to arrest infiltration at the top, the slope should be provided with proper concrete lined drainage at the base.

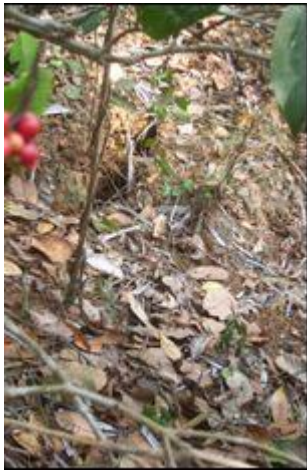
- Even though the crown was moderately vegetated with shrubs and cashew plants (Photo 16), vegetation is not having deep penetrating root system to hold the slope material intact. The crown portion on the right flank appears still unstable in view of presence of a large crack (Photo 10).

Photo10:Crown cracks observed in between Sasanwad Slide no-2 & slide no-3.

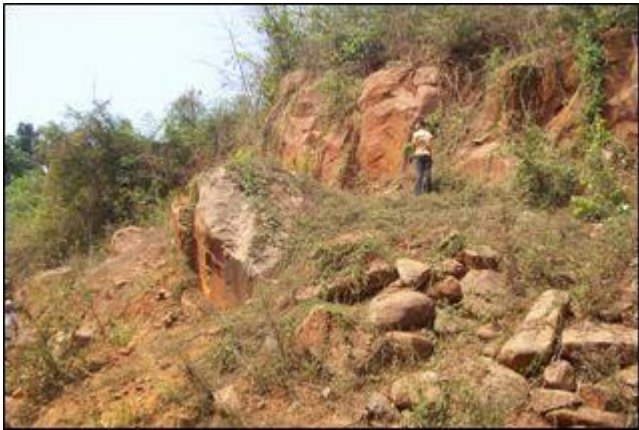
**III.2.2.GRANITE:** Minor exposures of granite are seen at the head portion above the Crown in respect of Slide No.-1 (Photo 12). The granite is massive, is generally coarse grained, porphyritic, grey in colour consisting of quartz, potash feldspars, plagioclase and biotite. An abandoned quarry is seen in the northeastern corner of the study area (Photo 18). Three sets of joints noticed in the granite and the characteristics are given in Table-5.

Photo 12: Granite exposure near Sasanwad Slide no-1.

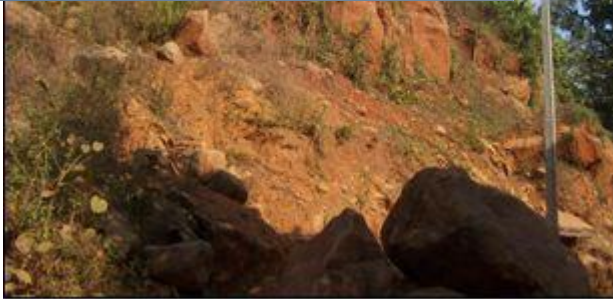
**III.2.1.GNEISS:** Gneiss is well exposed at the "Crown scarp" (Plate-3). The rock is coarse grained, light grey and foliated with gneissosity trending N24°W to N20°E. The rock is seen to have varying dips from ~ 42°easterly to near vertical. Three major sets of joints are observed (Photo 13) and the characteristics are given in Table-3.

Photo 13: Prominent set of joint in Gneiss outcrop on the right flank of the Sasanwad slide no-2.

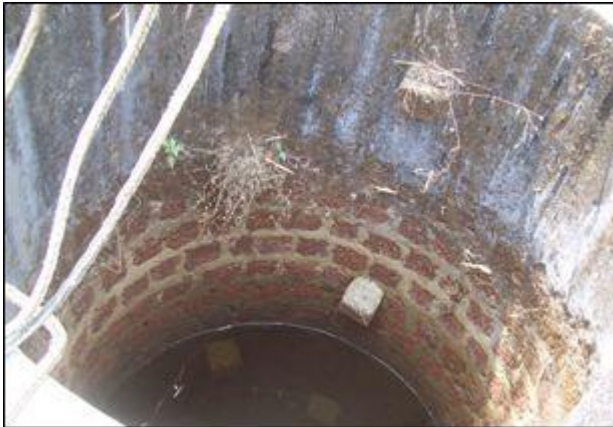
**II.4. GROUND WATER:** The seasonal fluctuation of the water table is not high in the area. Water table is very shallow in the village, even during summer. The water table at the site was deciphered from the study of dug wells situated at the toe part of the slide (Table-2, Plate-3, and Photo-15). During the time of investigation (March 2011) depth to water table was at 1.63 to 2.40 m.

Photo 15: Ground water level in the open dug well at the toe part of the Sasanwad slide.

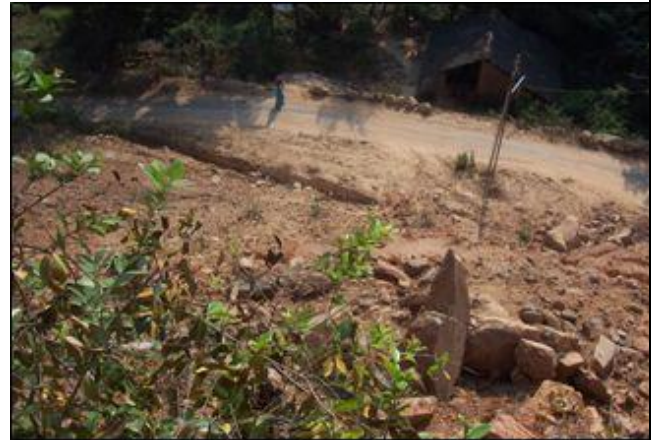
Photo 16: Survey work in progress at the top of Sasanwad slide no-3 with lush vegetation of cashew plantation all around.

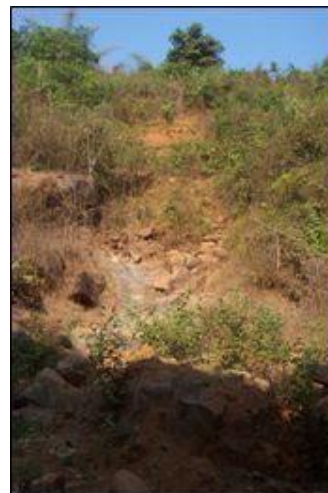
Photo 18: Granite quarry (abandoned) in the north eastern corner of the Sasanwad slide study area.
