Macro-scale (1:50,000) Landslide Susceptibility Mapping in parts of Toposheets nos. 48O/11 & 48O/12 Chikmangaluru, Dakshin Kannad and Hassan districts, Karnataka.  
(FSP CODE NO.: M4LSSM/NC/SR/SU-KG/2017/12187)  
Field Season: 2017-18

Neha Kumari, Geologist  
&  
Kamal Kumar, Geologist

State Unit: Karnataka and Goa  
Southern Region

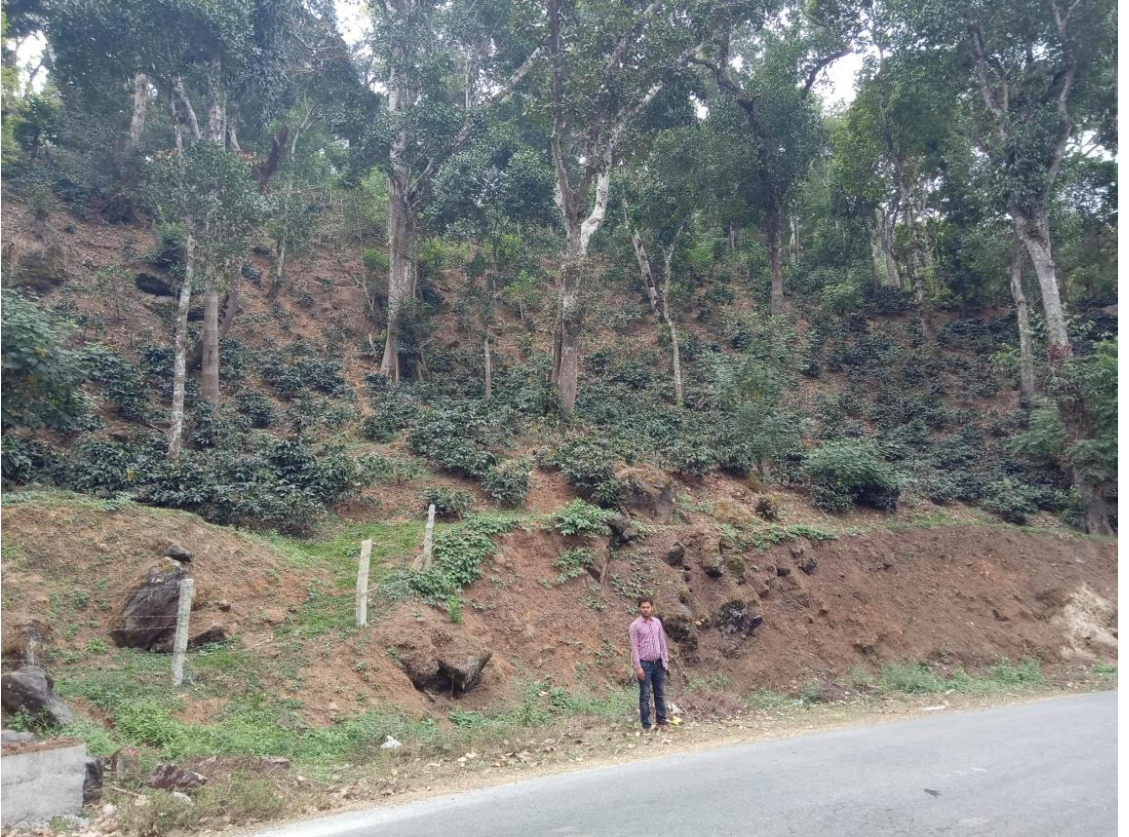
| 41. | | Remarks/ Abstract | In present condition the debris slide is suspended but active and however single bench are made to reduce the risk factor. The subsidence and creep movement cannot be denied as the bending of trunk can clearly be examined. The zone of 120m is demarcated as unstable zone. Downslope settlement is at risk. Risk to communication line and man and material. |

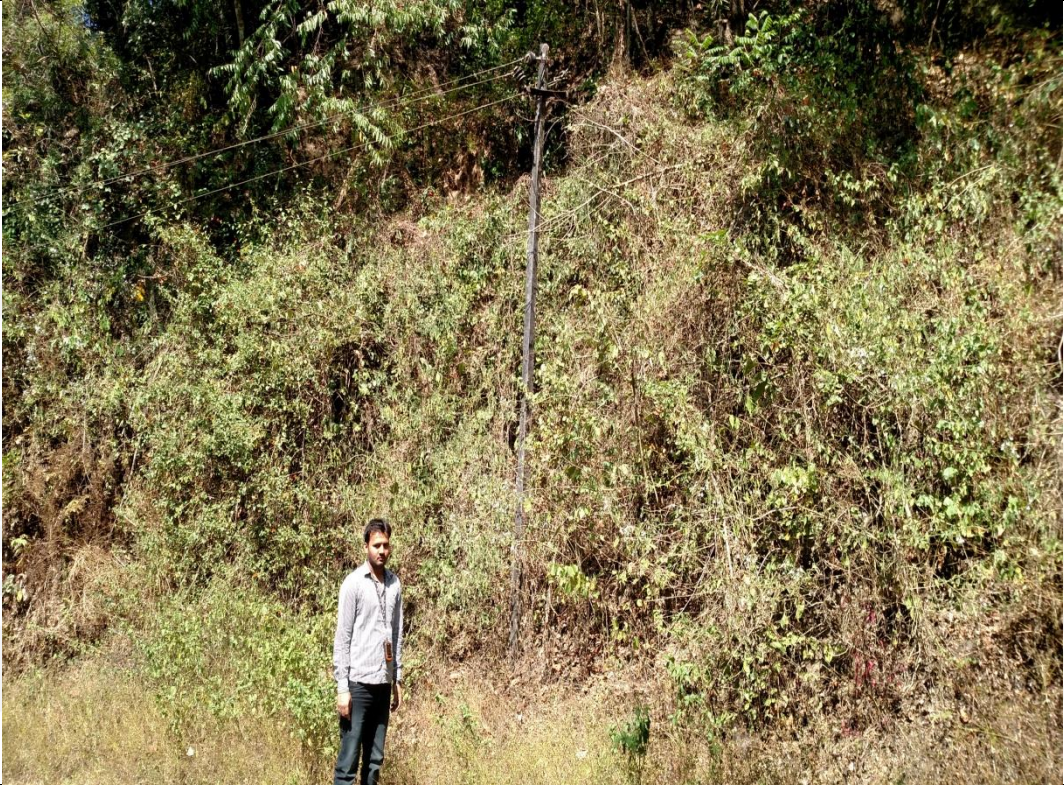
| 41. | Remarks/ Abstract | | In present condition landslide is suspended and stable and risk factor is low. Risk to communication line. Vegetation on slope present. |

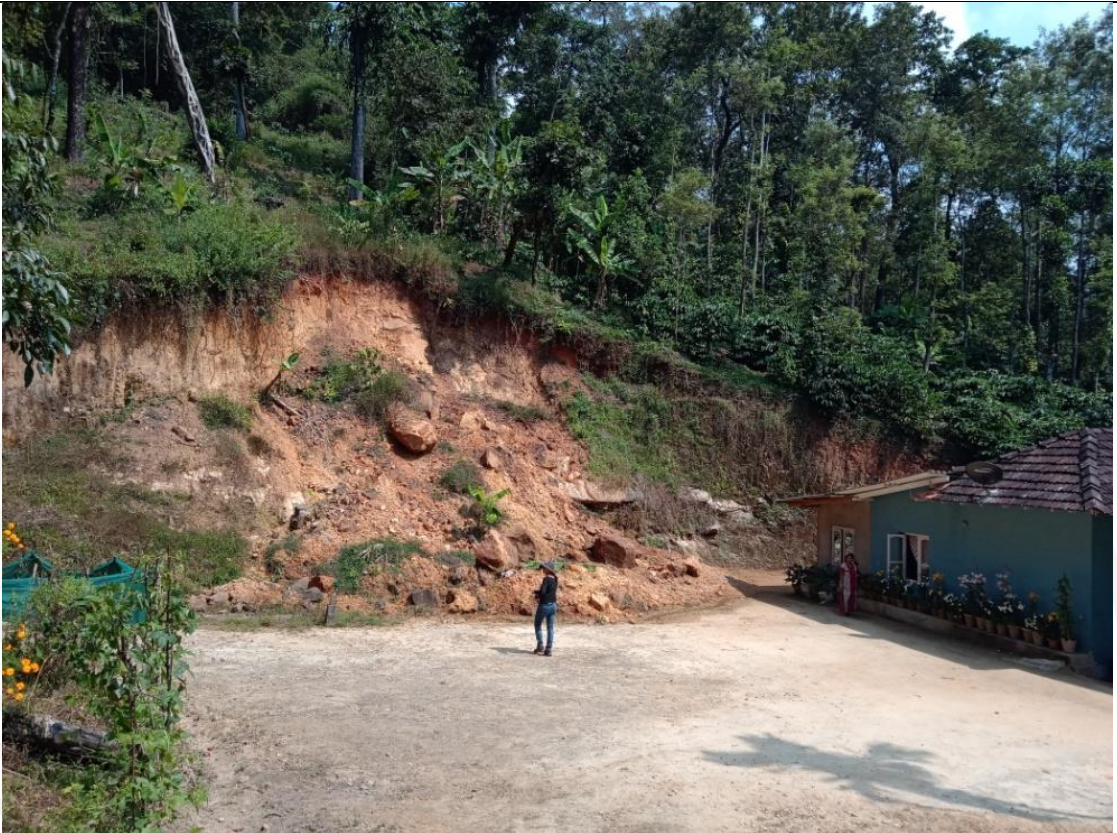
| 41. | Remarks/ Abstract | In present condition landslide is active and unstable and risk factor is high and meta-stable, man and material and settlement nearby. |

| Sl. No | Data Set | Geoparameters | Details |
|---|---|---|---|
| 40. | Remedial measures | | Slope Gradation required. Removal of loose material |

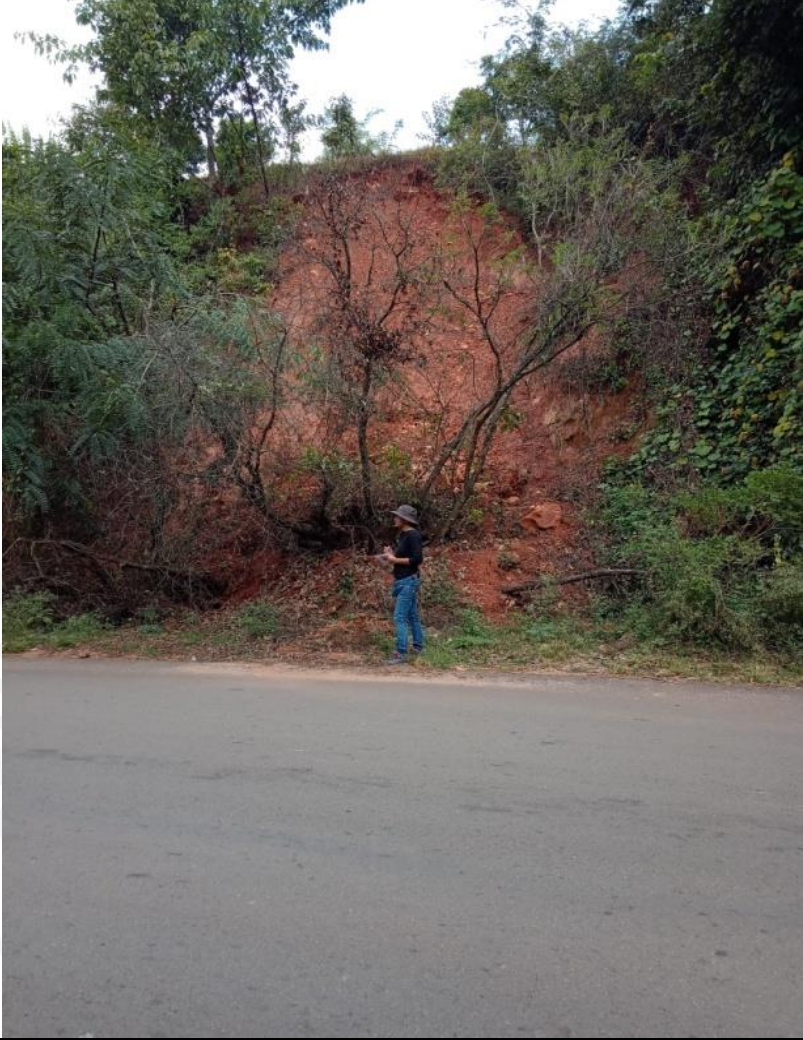
| 41. | Remarks/ Abstract | In present condition landslide is active and unstable and risk factor is moderate and meta-stable. |

| 40. | Remedial measures | Slope Gradation required. Removal of loose material |

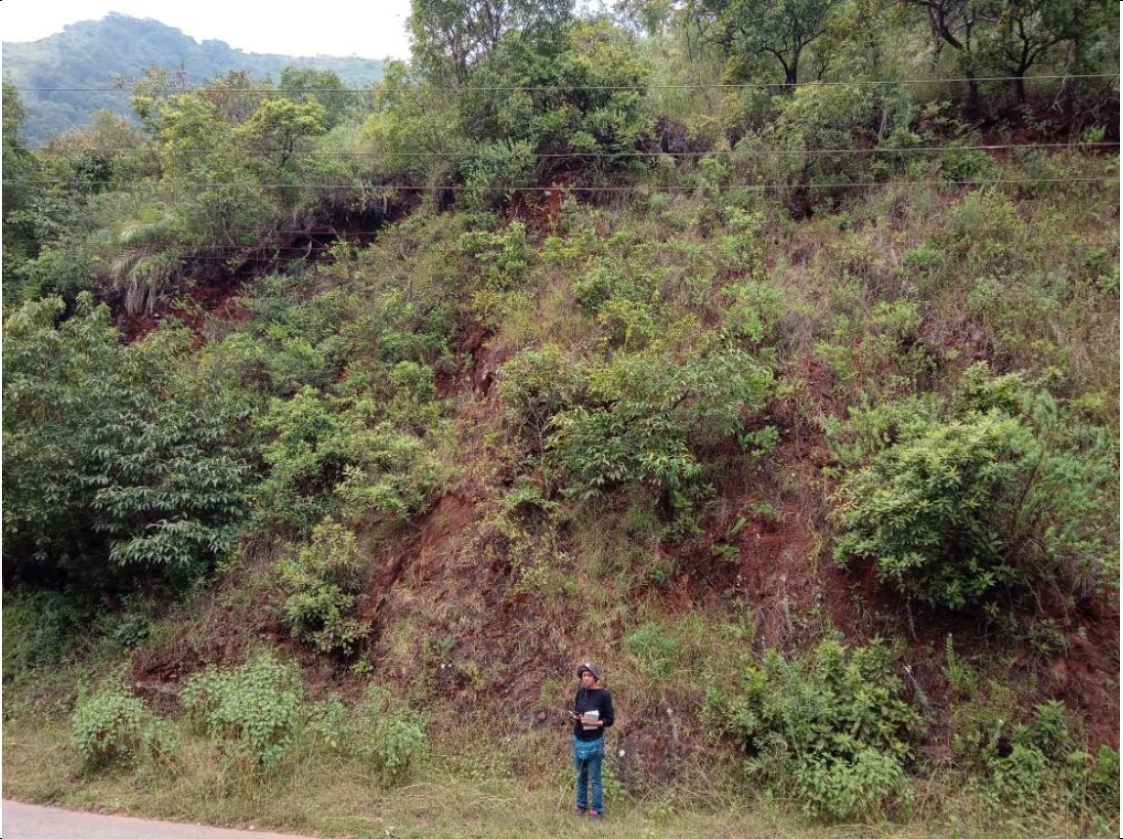
| 41. | Remarks/ Abstract | In present condition landslide is suspended and unstable and risk factor is moderate and meta-stable, |

| Sl. No | Data Set | Geoparameters | Details |
|---|---|---|---|
| 40. | Remedial measures | | Slope Gradation required |

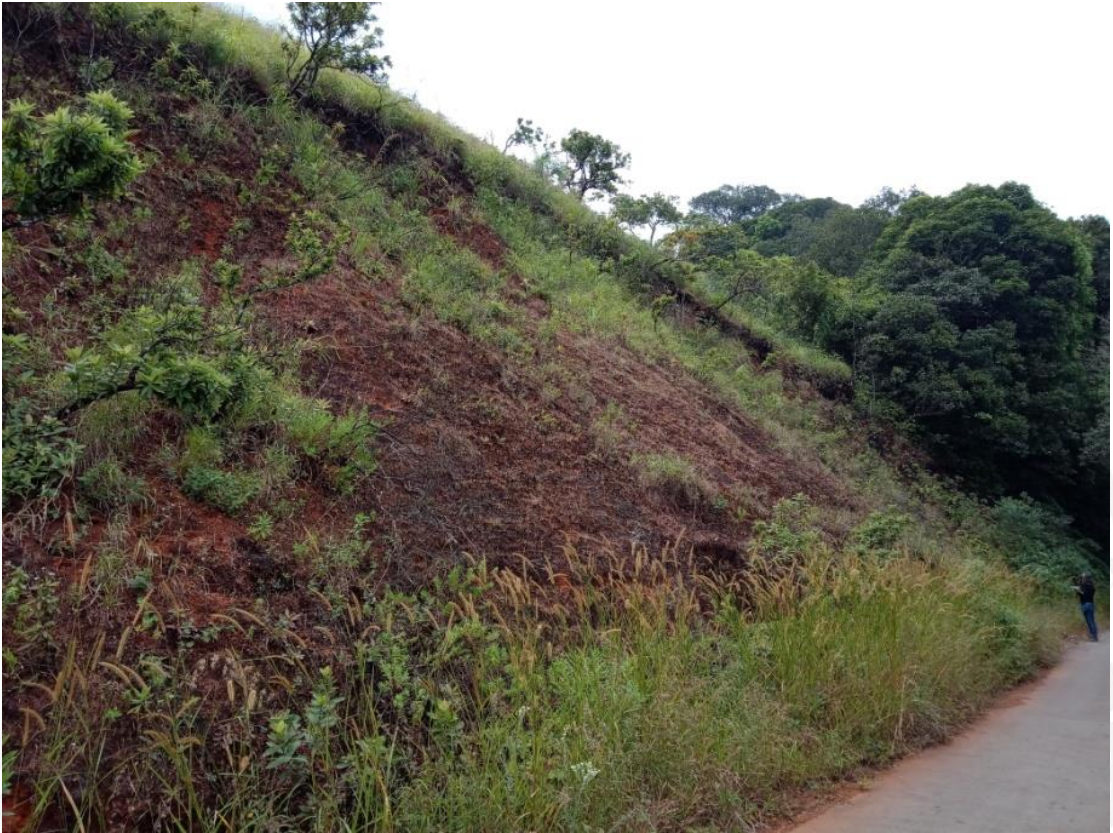
| 41. | Remarks/ Abstract | In present condition landslide is suspended and unstable and risk factor is moderate and meta-stable. |

| Sl. No | Data Set | Geoparameters | Details |
|---|---|---|---|
| 40. | Remedial measures | | Slope Gradation required |

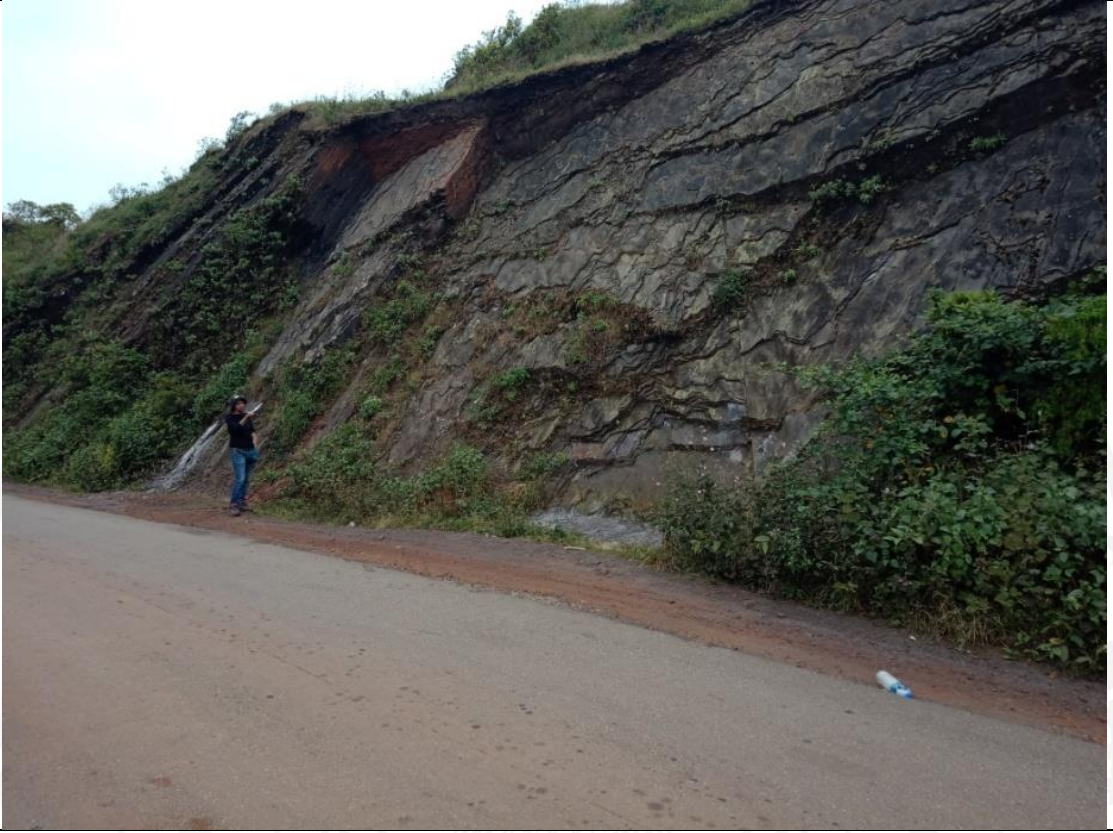
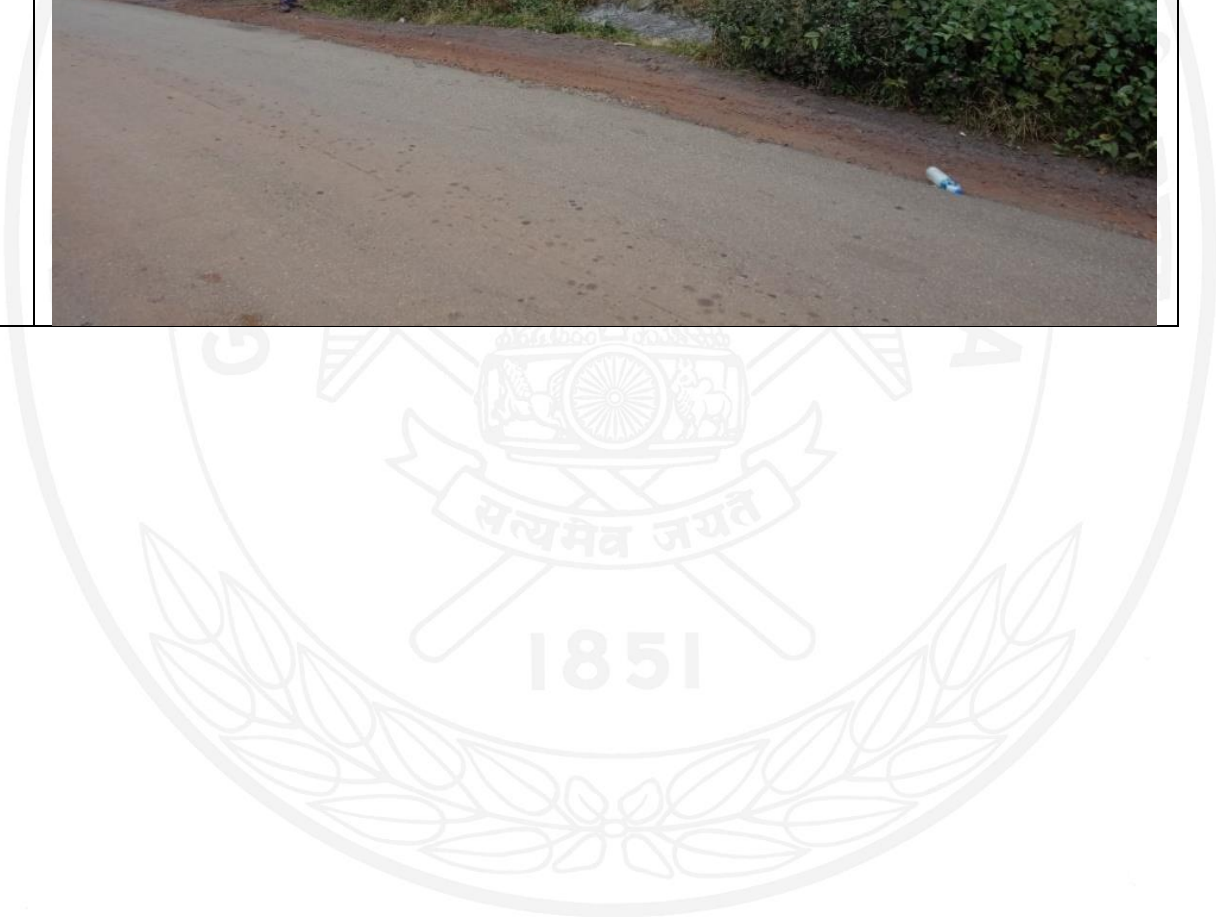
| 41. | Remarks/ Abstract | In present condition landslide is suspended and unstable and risk factor is moderate and meta-stable. |

| 40. | Remedial measures | Slope Gradation required |

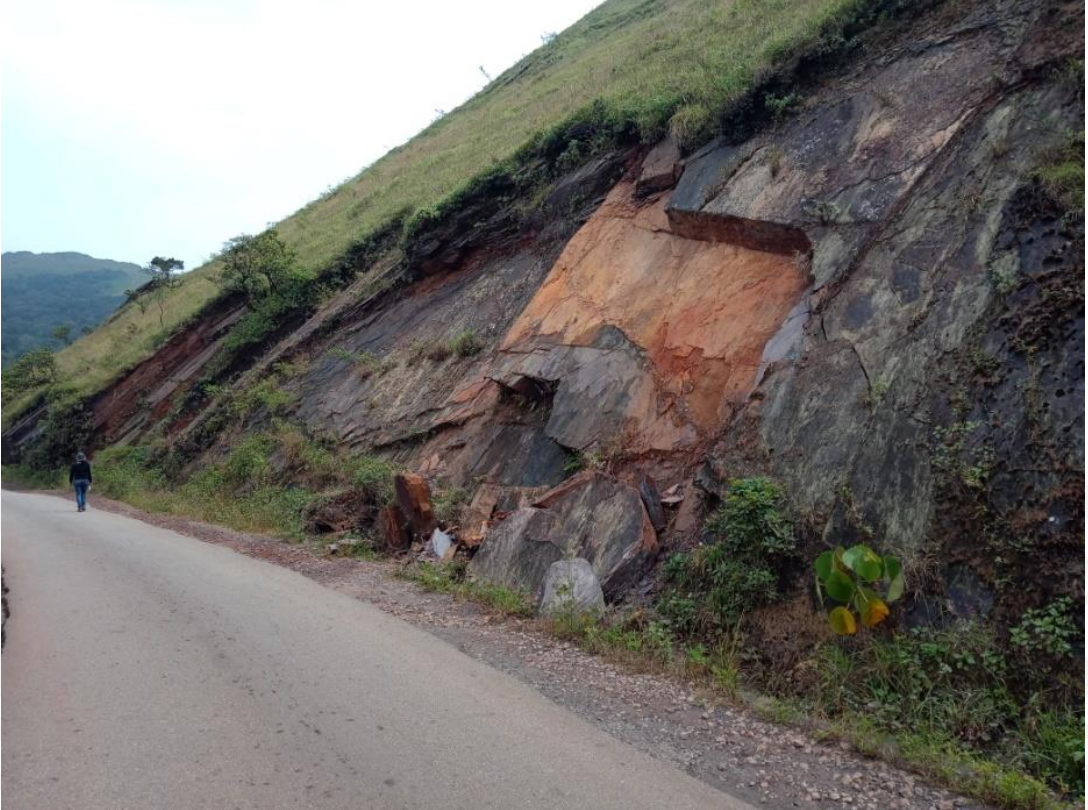
| 41. | Remarks/ Abstract | In present condition landslide is suspended and unstable and risk factor is moderate and meta-stable. |

| Sl. No | Data Set | Geoparameters | Details |
|---|---|---|---|
| 40. | Remedial measures | | Slope Gradation required |

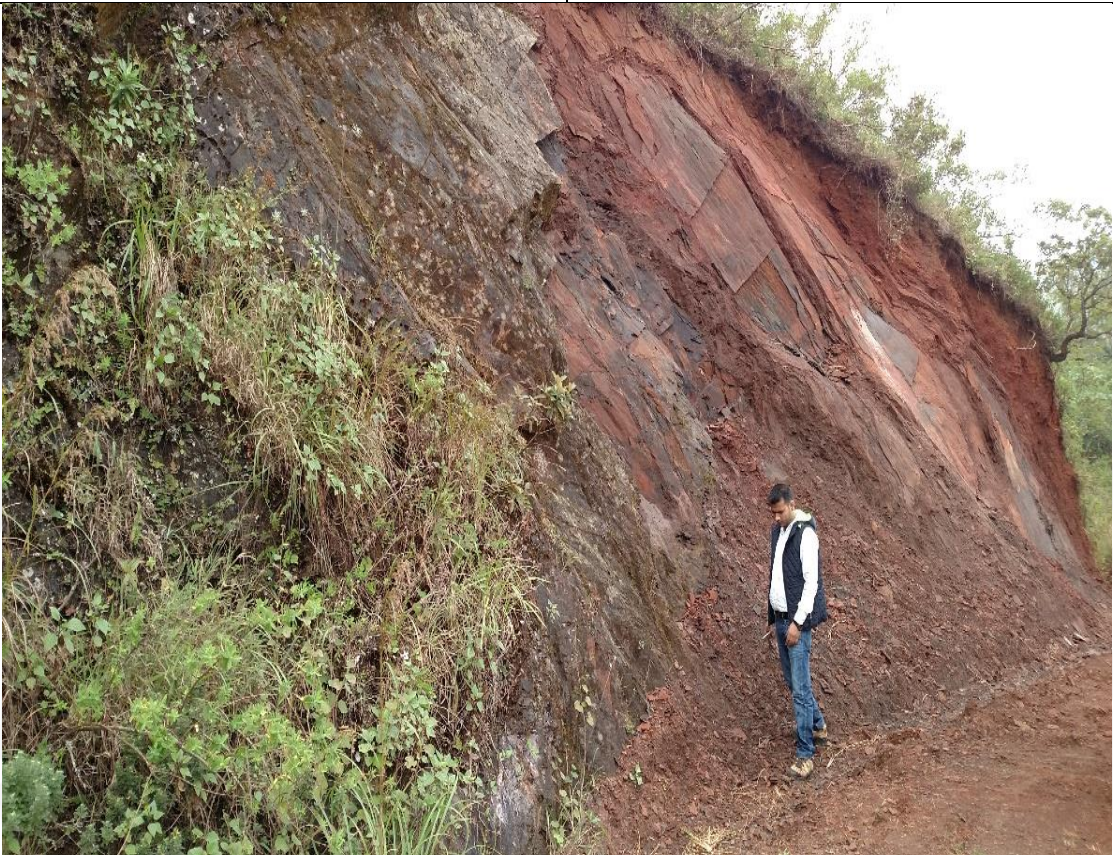
| 41. | Remarks/ Abstract | In present condition landslide is suspended and unstable and risk factor is moderate and meta-stable. |

| 40. | Remedial measures | Slope Gradation required |

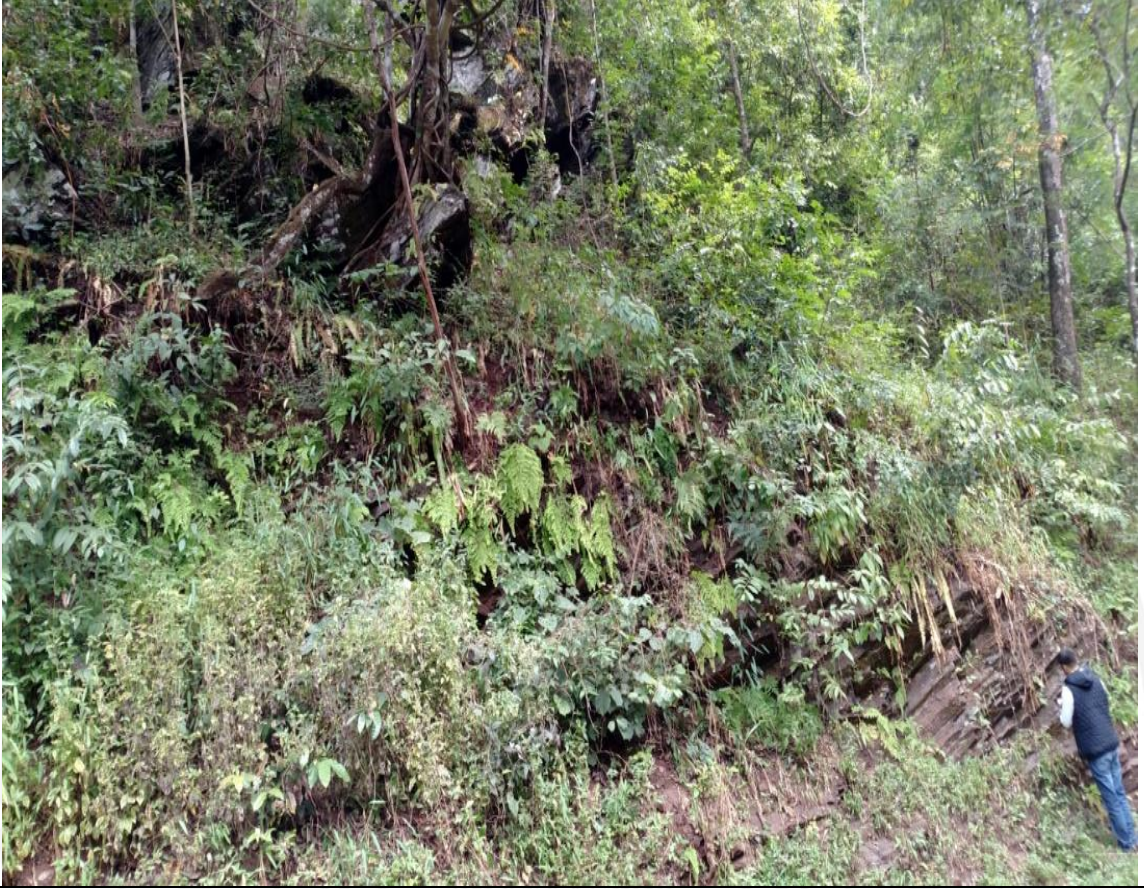
| 41. | Remarks/ Abstract | In present condition landslide is suspended and unstable and risk factor is moderate and meta-stable, |

| Sl. No | Data Set | Geoparameters | Details |
|---|---|---|---|
| 40. | Remedial measures | | Slope Gradation required |

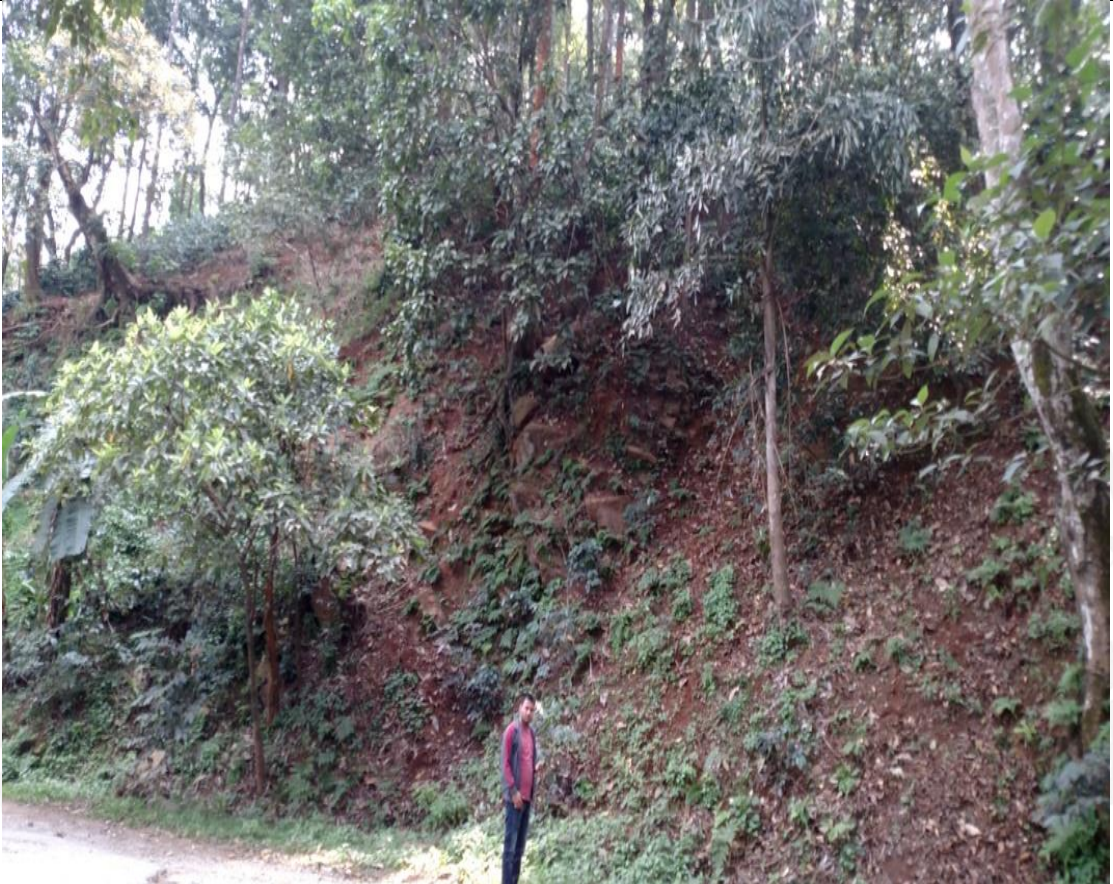
| 41. | Remarks/ Abstract | In present condition landslide is suspended and unstable and risk factor is moderate and meta-stable |

| 40. | Remedial measures | Slope Gradation required |

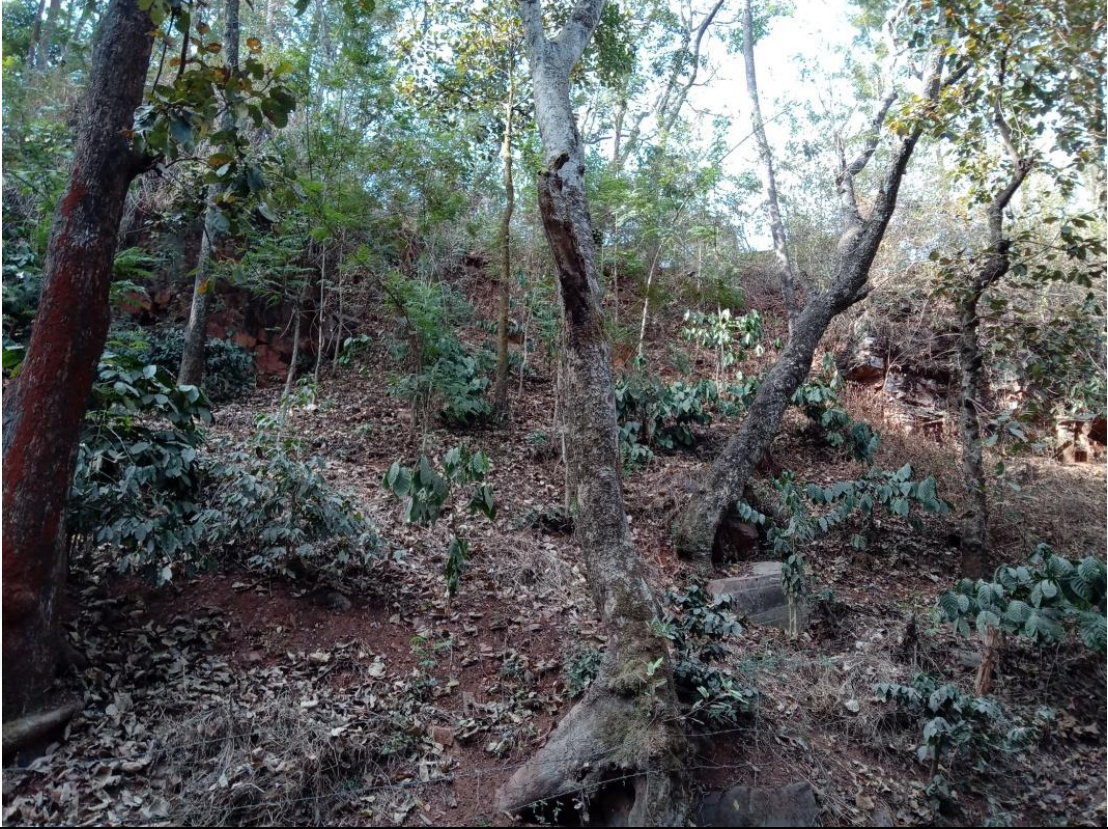
| 41. | Remarks/ Abstract | | In present condition landslide is suspended and unstable and risk factor is moderate and meta-stable, few settlements were there at downslope/foothill are at low risk |

| 40. | Remedial measures | | Slope Gradation required |

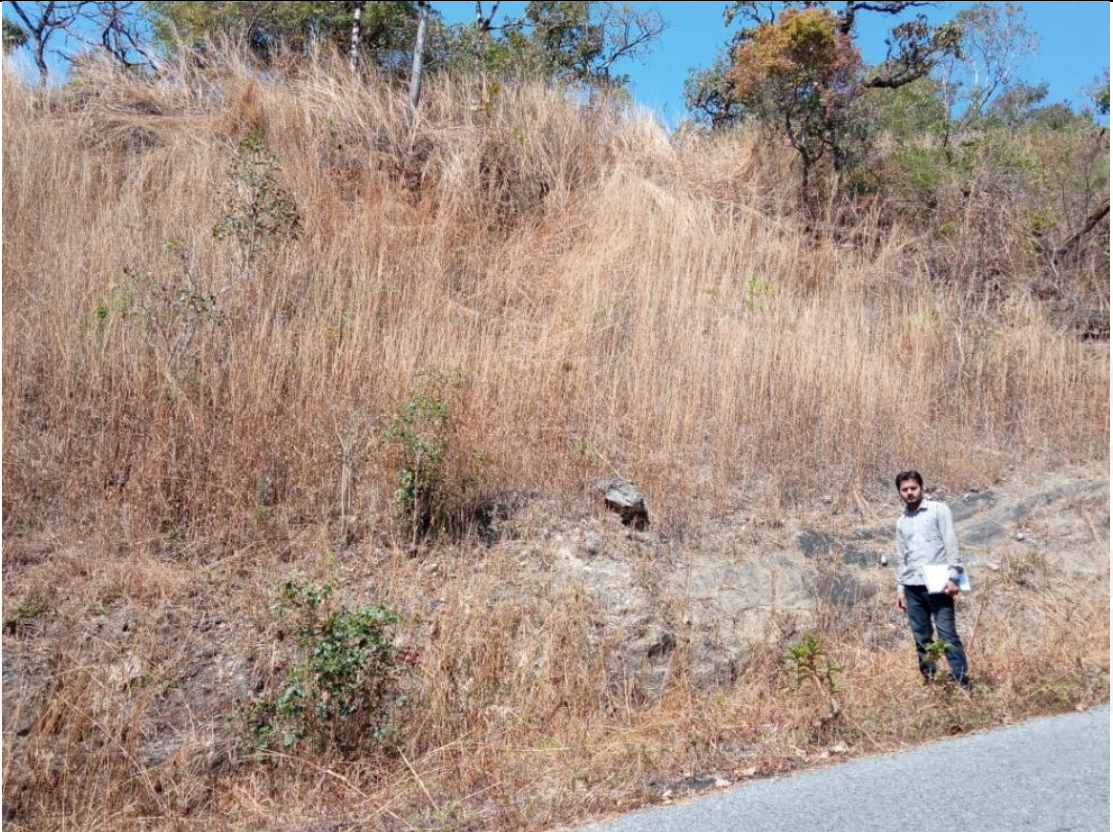
| 41. | Remarks/ Abstract | In present condition landslide is suspended and unstable and risk factor is moderate and meta-stable, few settlements were there at downslope/foothill are at low risk/ |

| 40. | Remedial measures | Slope Gradation required |

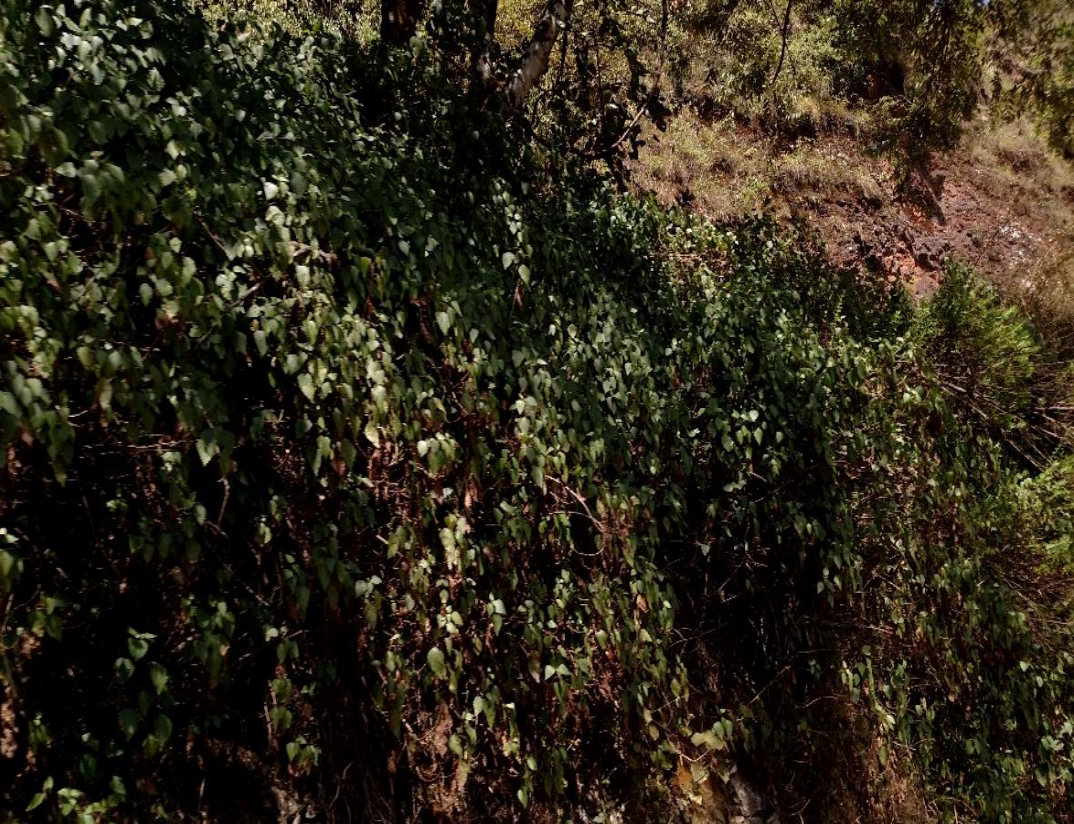
| 41. | Remarks/ Abstract | | Road cut failure |

| 40. | Remedial measures | | Slope Gradation/Benching required |

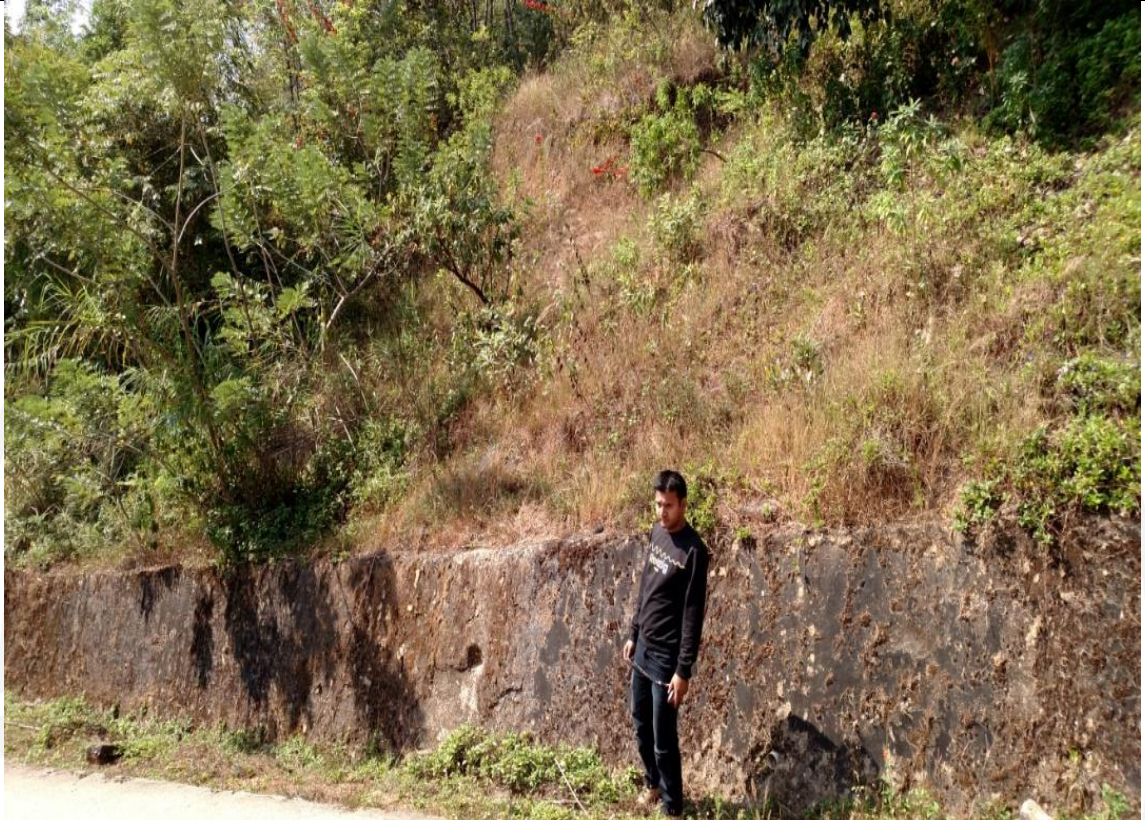
| 41. | Remarks/ Abstract | In present condition the slide is suspended and stable and risk factor is low. |

| 40. | Remedial measures | Retaining with weep holes already constructed, stabilized |

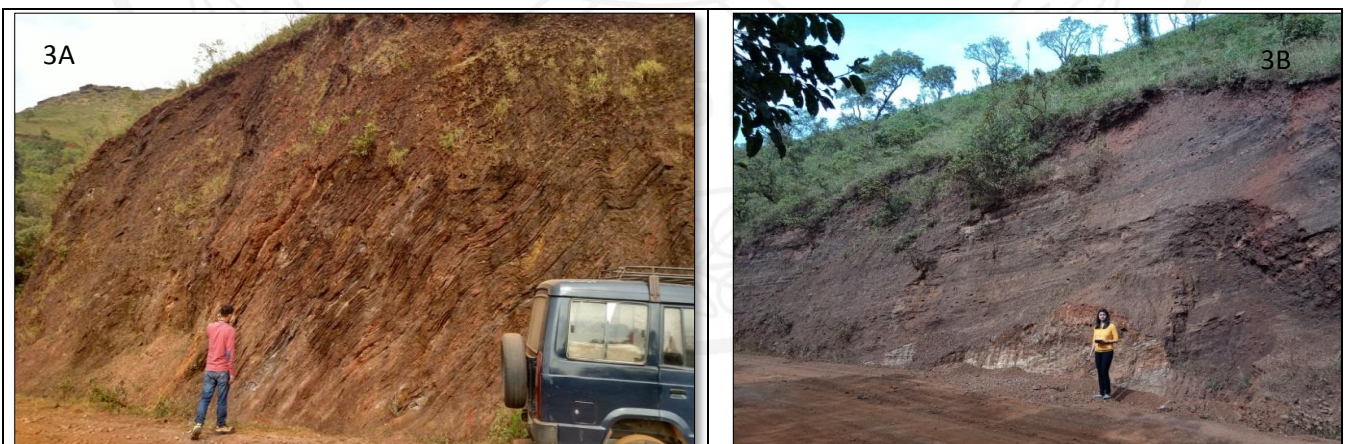
**Photo 3A & Photo 3B :Field Photographs showing Extensive Cut Slope on Mulliyangiri-Attigudi-Bababudan giri Road section**

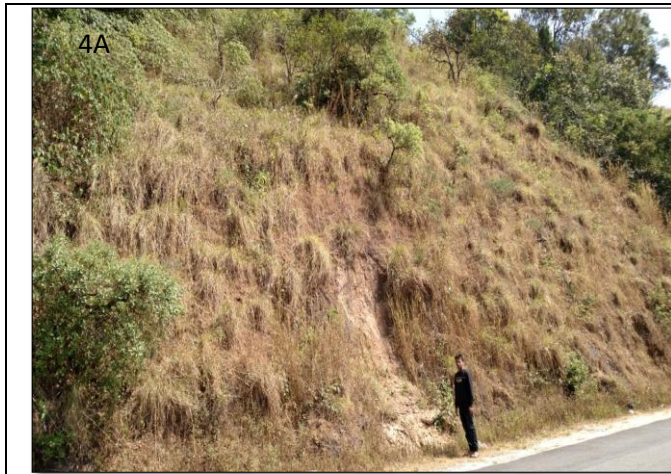
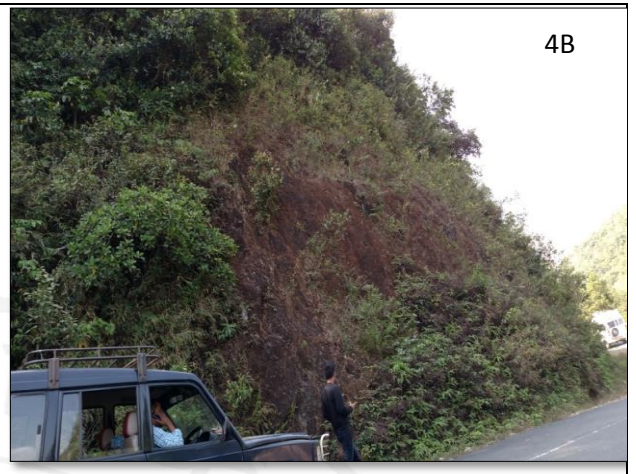
**Photo 4A & Photo 4B:: Field Photographs showing Extensive Cut Slope on Mudigere- Kotegehara road section**

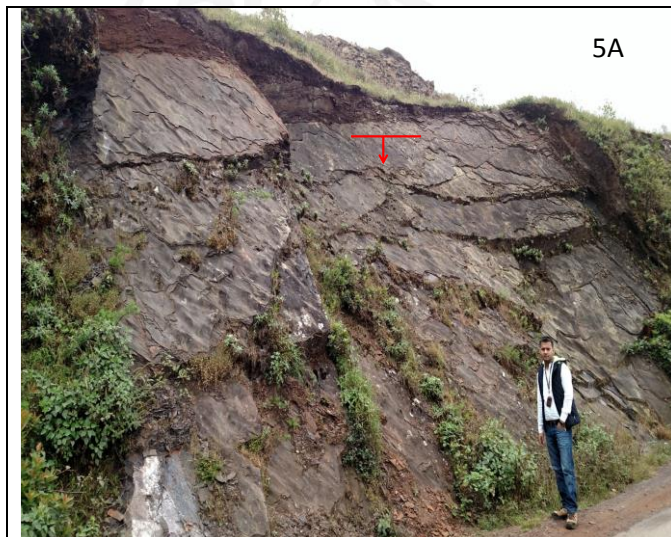
**Lat:13°20'14"N Long:75°33'42.60"E**

**Photo 5A: Shallow Planar failure in BIF near Kavikalgundi Village**

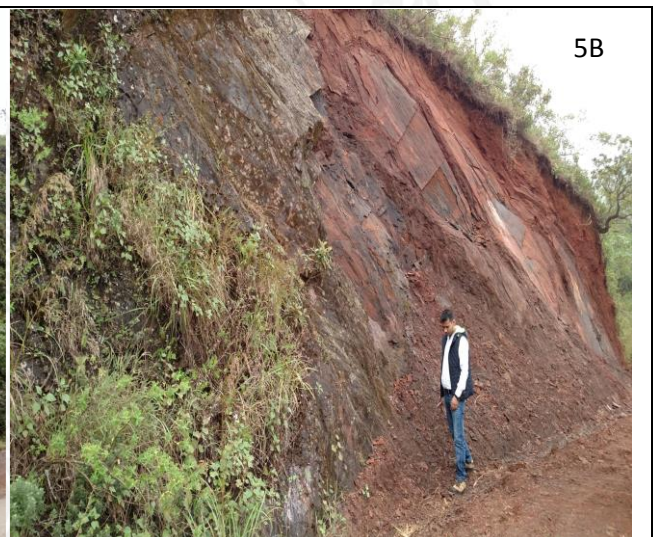
**Lat:13°24'19.93"N Long:75°44'34.47"E**

**Photo 5B :Shallow Planar failure in BIF near Kavikalgundi Village**
