**Macro scale (1:50,000) Landslide Susceptibility Mapping in parts of  
Toposheets Nos. 48J/12 and 48J/16, Uttara Kannada  
and Shimoga Districts, Karnataka**

Item No.: M4LSSM/NC/SR/SU-KG/2018/20207

Final report for field season 2018-19

**K. Senthil Kumar, Geologist and Salu S, Senior Geologist (PT)**

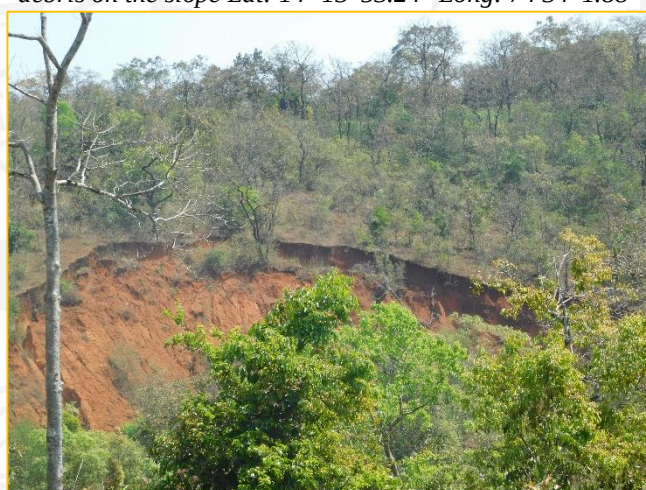
between the 0-35°. Most of the slides (photo no: 3.3a, 3.3b, 3.3c, 3.3d) are soil slide and larger in dimension when compared to the road cut failure and it exhibits maximum regolith thickness in the scarp faces and both flank of the slide.

*Photo 3. 3a1, Soil slide  
Lat: 14° 01' 23.98" Long: 74° 51 11.25"*

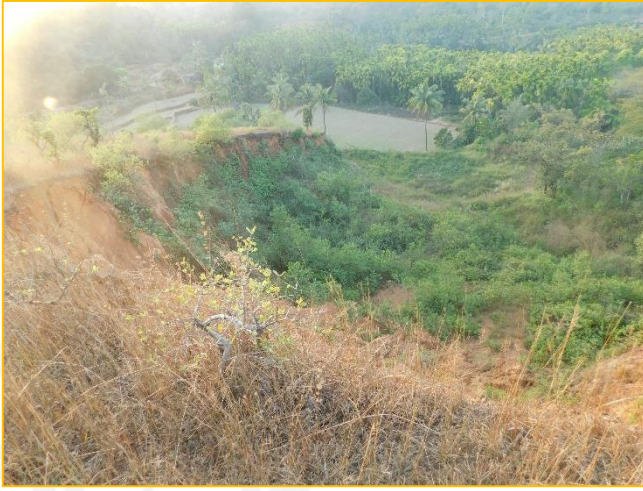
*Photo 3. 3c, Soil slide*  
Lat: 14°4' 37.36 "Long: 74° 48' 42.21"

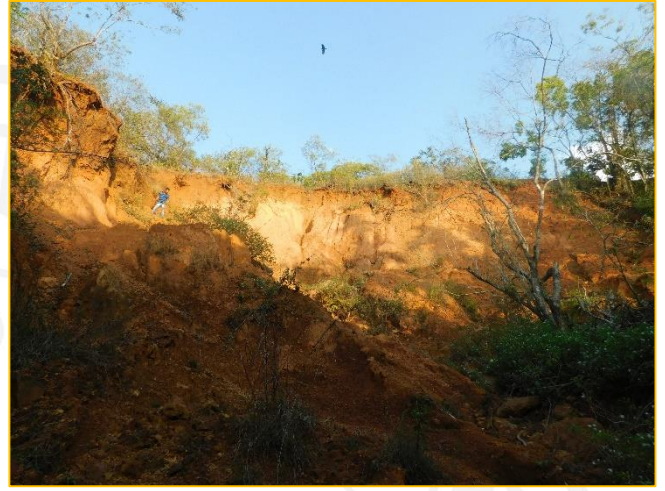
*Photo 3. 3d, Soil slide*  
Lat: 14°4' 46.78 "Long: 74° 48' 42.22"

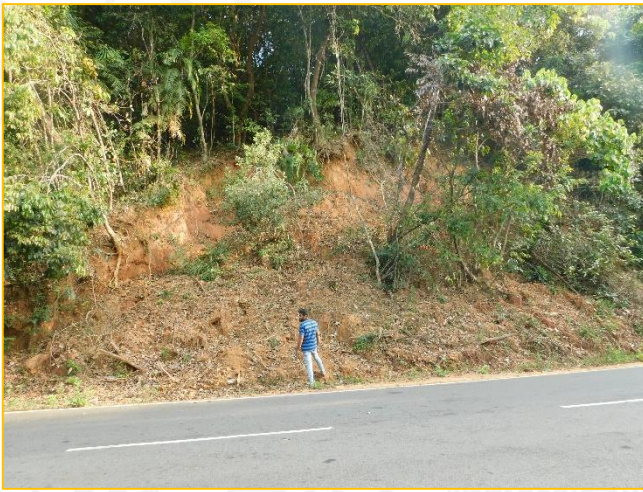
Few landslides (photo no: 3.4a, 3.4b) were documented along the NH-206 (Honnavar-Jog road section) and Bhatkal to Jog road section which is passing nearly undulating terrain. The documented landslides are initiated due to modification of the slope for road extension. Weak slope forming material and thickness of regolith which is more than 5m coupled with absence of proper drainage facilities are main causes of slides in this stretch. The construction of gabion wall is to be provided or else slope grading. A road leading to SRVP power station which is moderate to high susceptible zone because of high slope angle, vertical cutting of the toe for road construction and weak slope forming material. It is recommended to construct retaining wall, proper maintenance of toe drain and construction of adequate culvert in the valley side. Vicinity to the power station (left hand side) debris slide noticed. In this area chances of sliding are there if prolonged rainfall happens during monsoon. To prevent the slope from the future slide it may recommend that channelizing all stream around this area and divert the surface runoff by constructing contour drain. Just above the power station right side of the penstock area small soil slide observed due to weak slope forming material, indecorous maintenance of the surface runoff and impulsive slope modification. For this area it may be recommended that easing of the slope by multiple benching, divert the surface runoff and maintenance of earlier hill side drain. It is also recommended that the detailed study to be carried in and around the power station to avoid future slope failure. Road leading to Mahatma Gandhi power station, the road protected by constructing iron crib walls (Photo no: 3.5) along the road section to prevent the slide material do not come across the road.

*Photo 3. 4a, Soil slide along NH-206*  
Lat: 14°13' 44.85 "Long: 74° 48' 58.51"

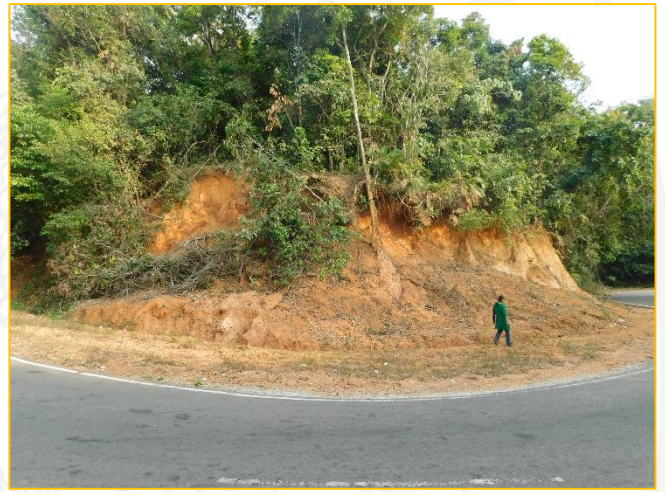
*Photo 3. 4b, Soil slide along NH-206*  
Lat: 14°13' 43.31"Long: 74° 48' 56.64"

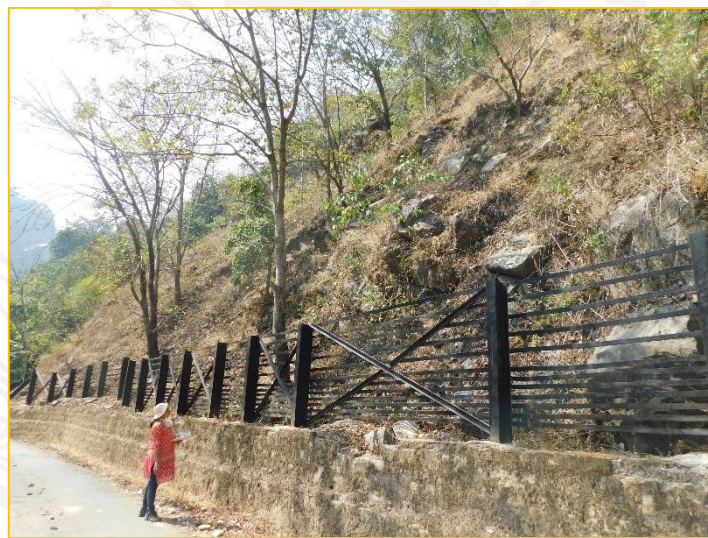
*Photo 3. 5, Towards Mahatma Gandhi power station- Iron crib wall to prevent the rock slides.*

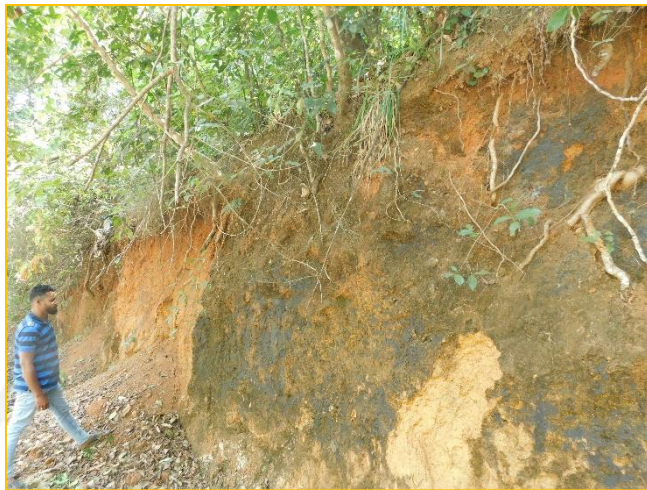
excavation. The slope forming material is broadly divided into bedrock part and overburden part. Around 65.61% of the area comes under the insitu soil (**Photo no: 4g, j**) followed by water body and Hornblende actinolite chlorite schist with 11.5% and 10.49% respectively (**Fig 4.6**). Transported soils (**photo no: 4l**) are those that are usually found over gentle slope of wide valleys. Transported material is considered to be a mixture of alluvial and colluvial origin lying over gentle slopes and are relatively assessed to be less susceptible to landslides. Loose slide material (**Photo no: 4k**) observed in large slide areas and maximum weightage given to the loose slide material.

*Photo 4.i, Insitu soil*

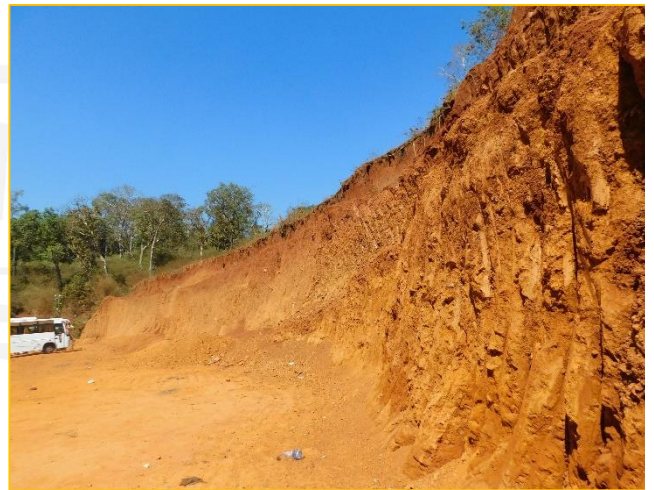
*Photo 4.j, Insitu soil*

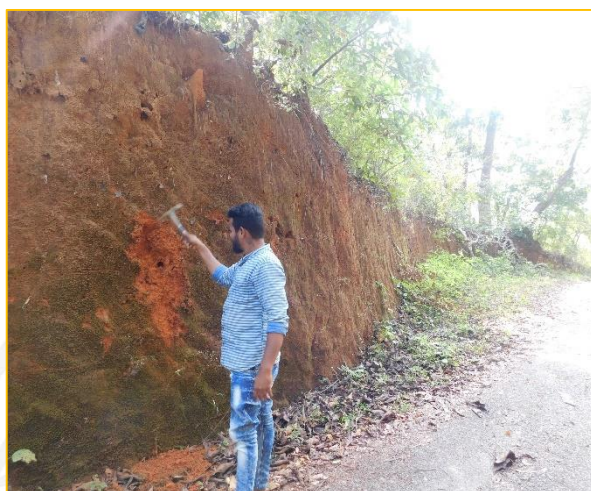
*Photo 4.m, Regolith thickness 0.5-5m*  
 Lat: 14°2' 31.2" Long: 74° 36' 18"

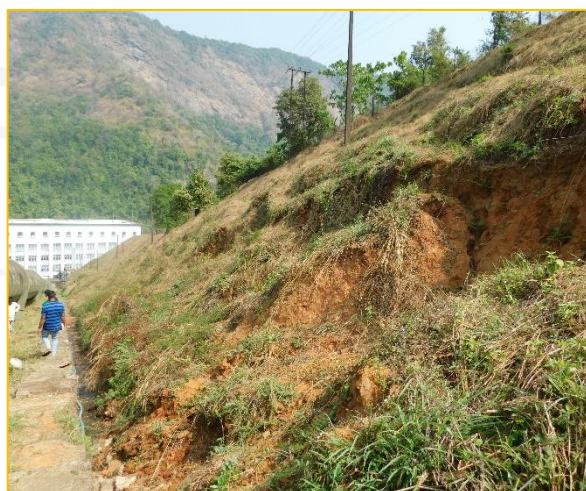
*Photo 4.n, Regolith thickness 5-10m*  
 Lat: 14°14' 3.10" Long: 74° 46' 5.36"

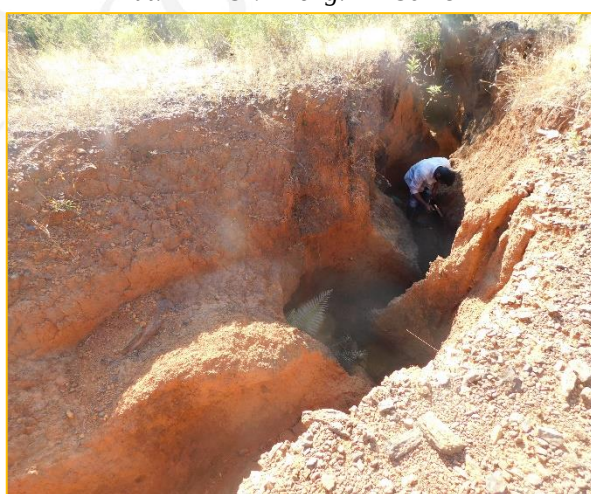
*Photo 4.o, Regolith thickness >10*  
 Lat: 14°3' 20.02" Long: 74° 47' 28.06"

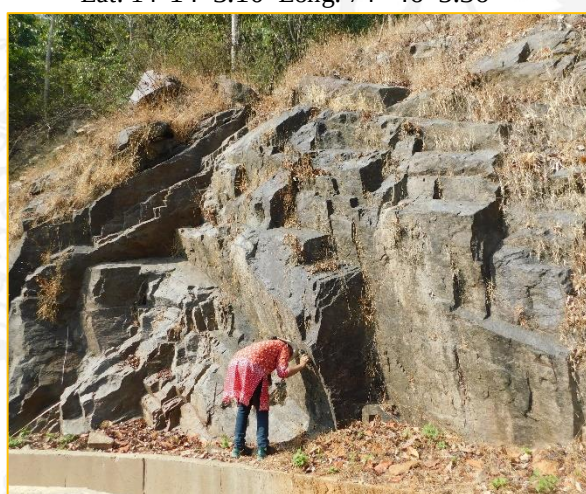
*Photo 4.p, Regolith thickness <0.5m*  
 Lat: 14°13' 21.74" Long: 74° 46' 52.11"

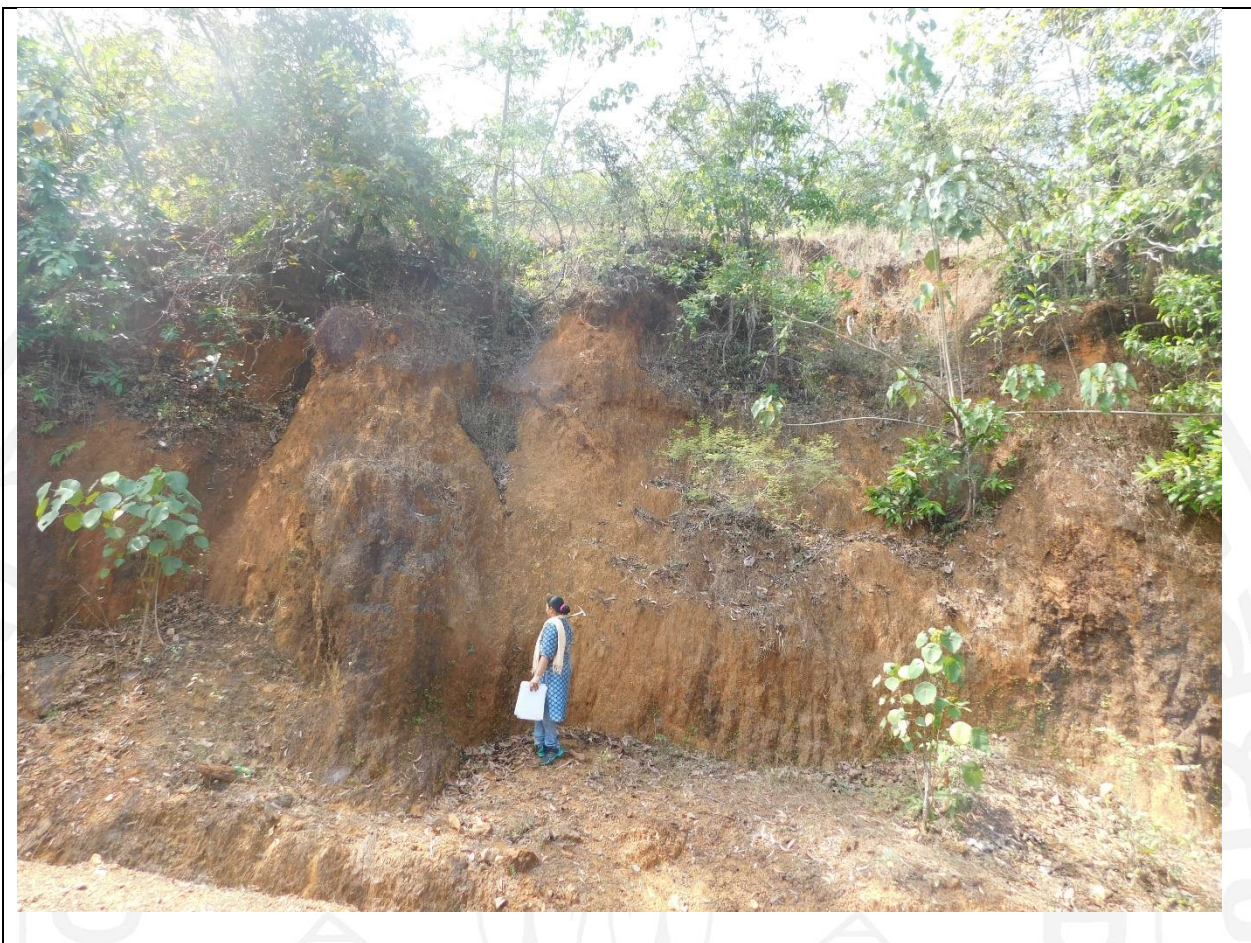
| 22 | Failure Mechanism | Shallow Translational Failure |
| 37 | Geo-Scientific Causes | Vertical cutting of the slope for the road construction without any toe support. Poor slope forming material coupled with continuous rain fall may leads to increase of the pore pressure. |
| 41 | Category | Category-III |

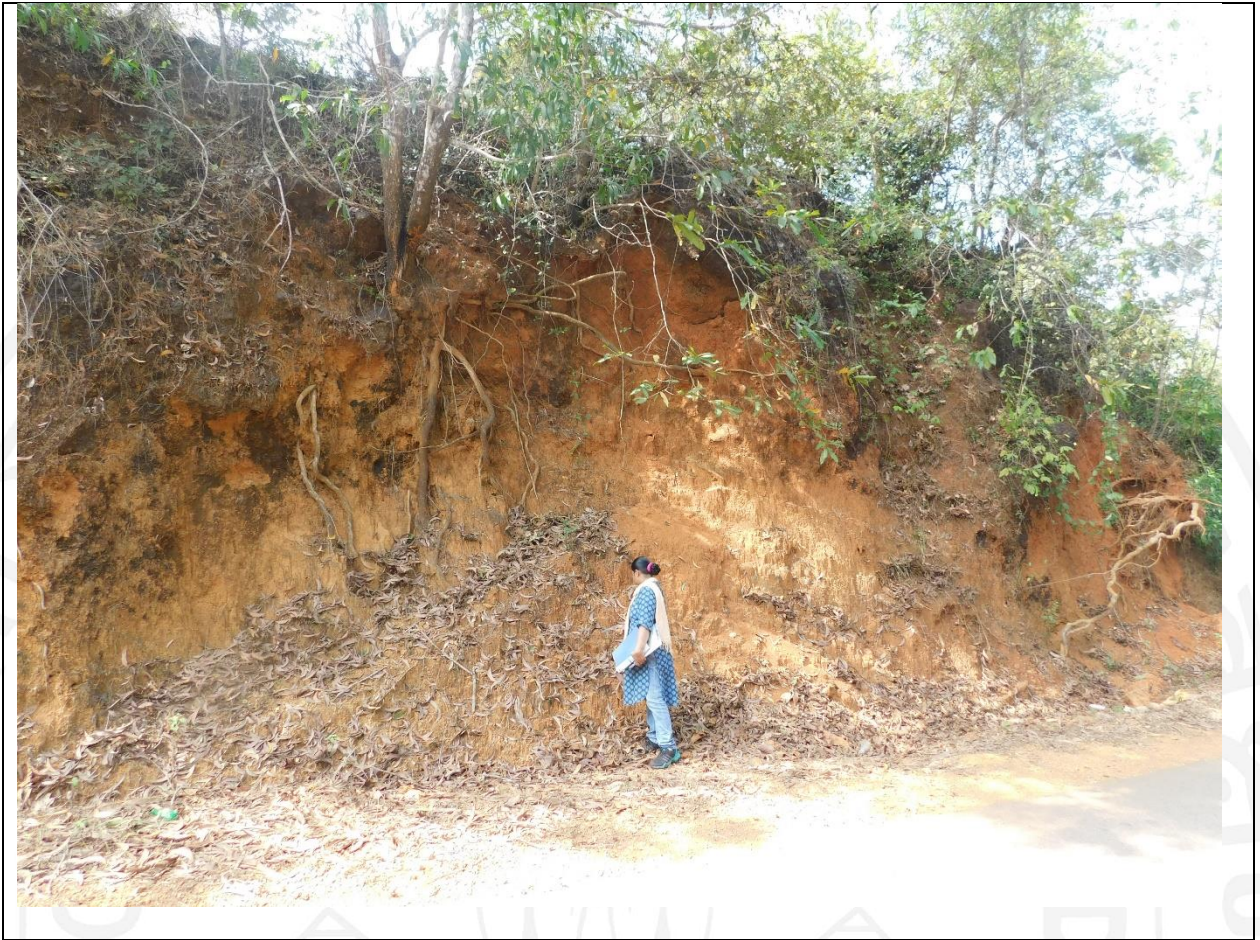
| 22 | Failure Mechanism | Shallow Translational Failure |
| 37 | Geo-Scientific Causes | Vertical cutting of the slope for the road construction without any toe support. Poor slope forming material coupled with continuous rain fall may leads to increase of the pore pressure. |
| 41 | Category | Category-III |

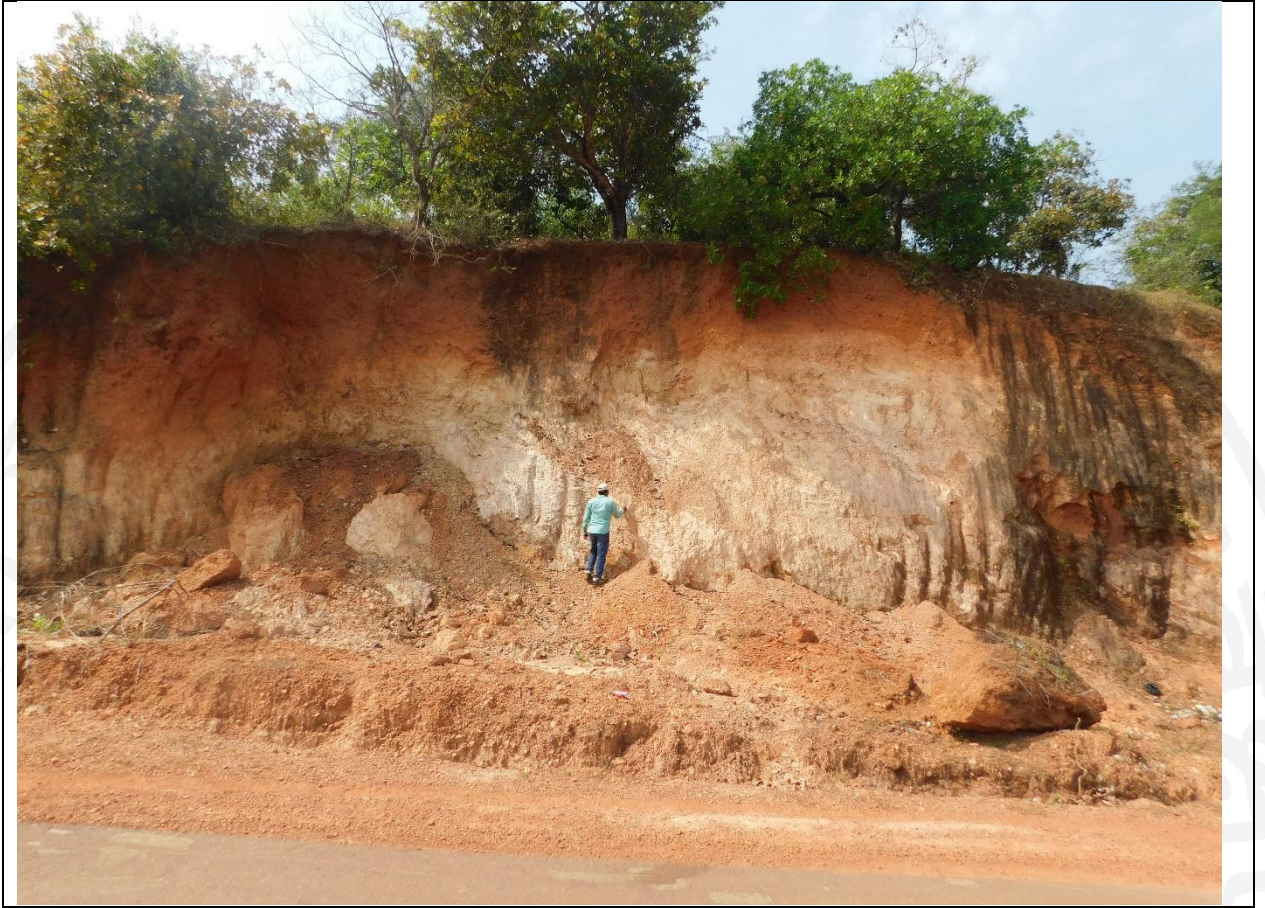
| 22 | Failure Mechanism | Shallow Translational Failure |
| 37 | Geo-Scientific Causes | Vertical cutting of the slope for the road construction or road widening without any toe support. Poor slope forming material coupled with continuous rain fall may leads to increase of the pore pressure. |
| 39 | Remarks | Cutting of trees and loose rolled boulders are observed in the upslope. |
| 41 | Category | Category-III |

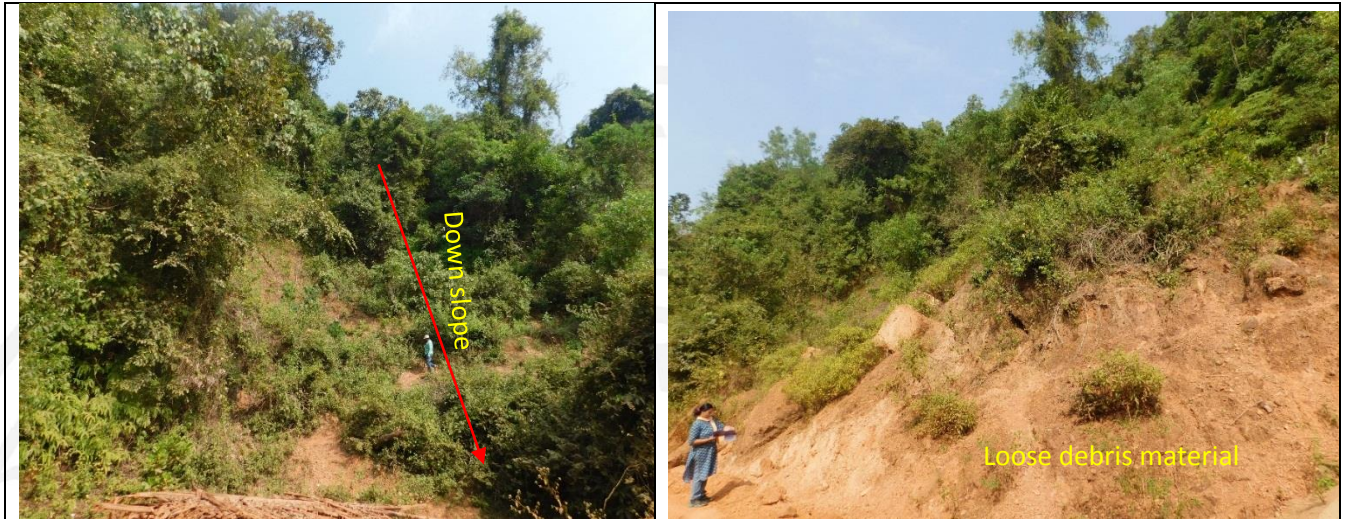
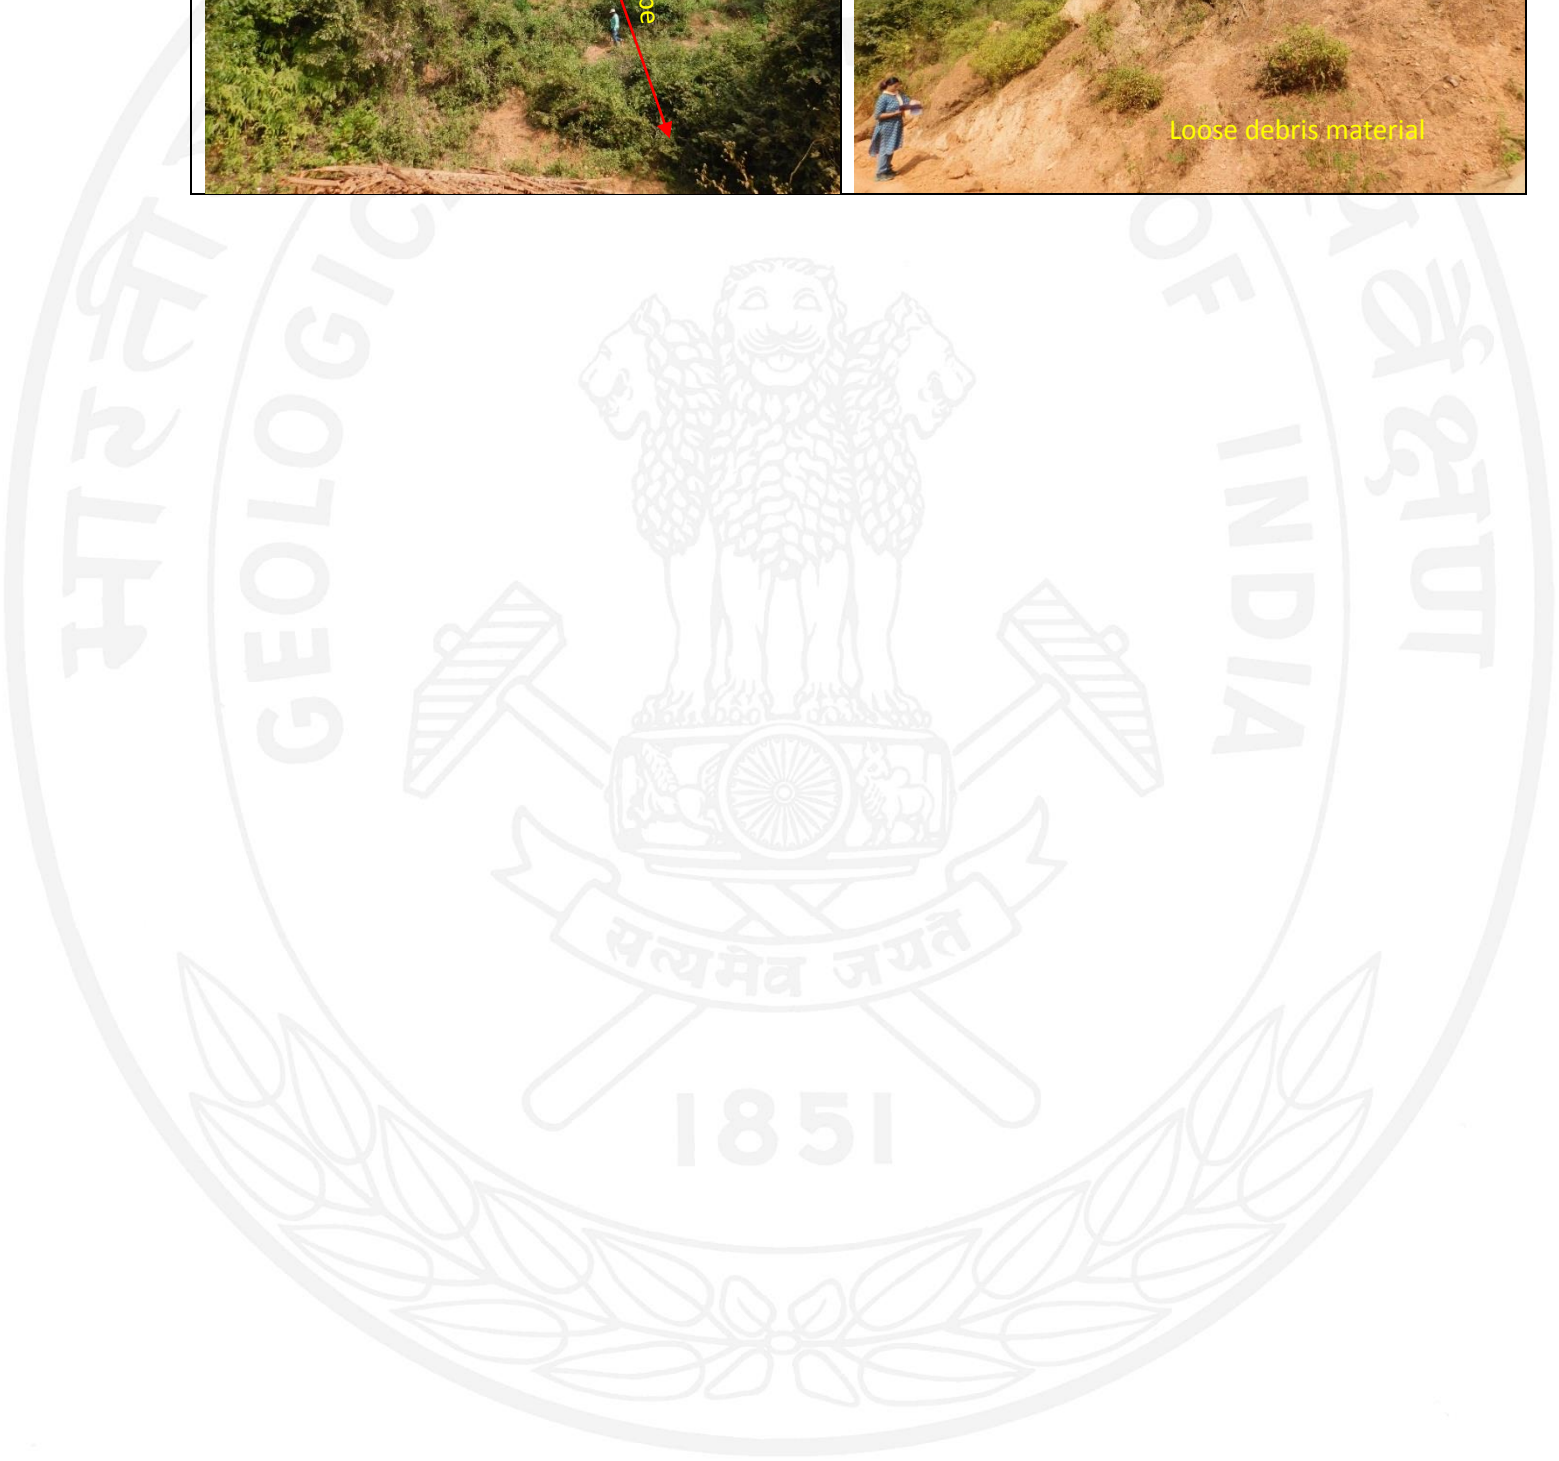
| 22 | Failure Mechanism | Shallow Translational Failure |
| 37 | Geo-Scientific Causes | Highly weathered rock mass coupled with steep slope prolonged rain fall may cause the improvement of local hydrostatic pressure Cutting of the slope for the road widening and poor slope forming material. |
| 39 | Remarks | Slide material not removed presently there is no any significant movement observed. |
| 41 | Category | Category-II |

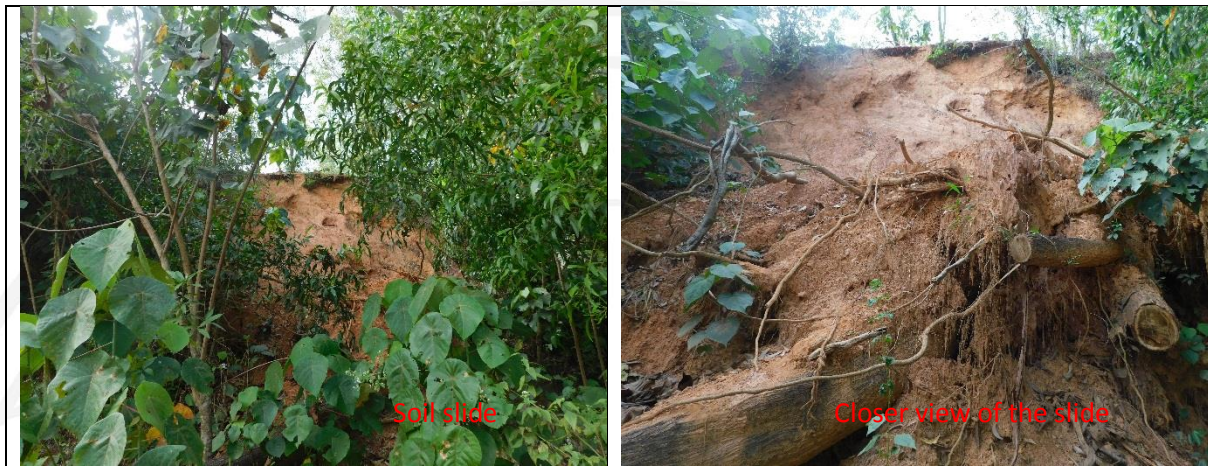
| 22 | Failure Mechanism | Shallow Translational Failure |
| 37 | Geo-Scientific Causes | Thick over burden material coupled with incessant rainfall may cause for the slides soil losses its strength due to increase in pore pressure |
| 40 | Summary | Soil slide occurred on 2017. Thick over burden material coupled with incessant rainfall may cause for the slides soil losses its strength due to increase in pore pressure. Removal of the debris easing of the slope and maintenance of culvert to be done properly. |

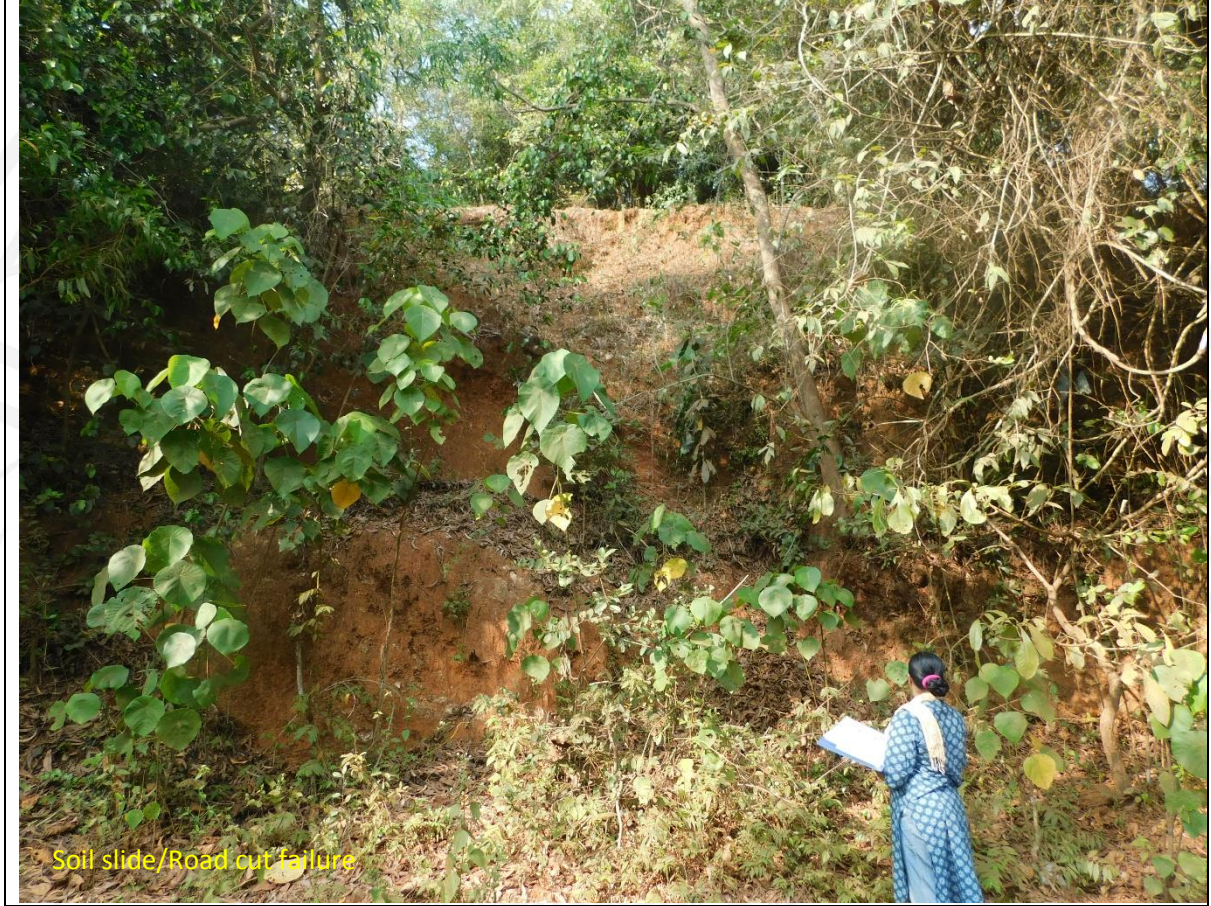
| 22 | Failure Mechanism | Shallow Translational Failure |
| 37 | Geo-Scientific Causes | Cutting of the slope for the road widening highly weathered rock and increase in the pore pressure. |
| 39 | Remarks | At present condition there is no any visible movement |

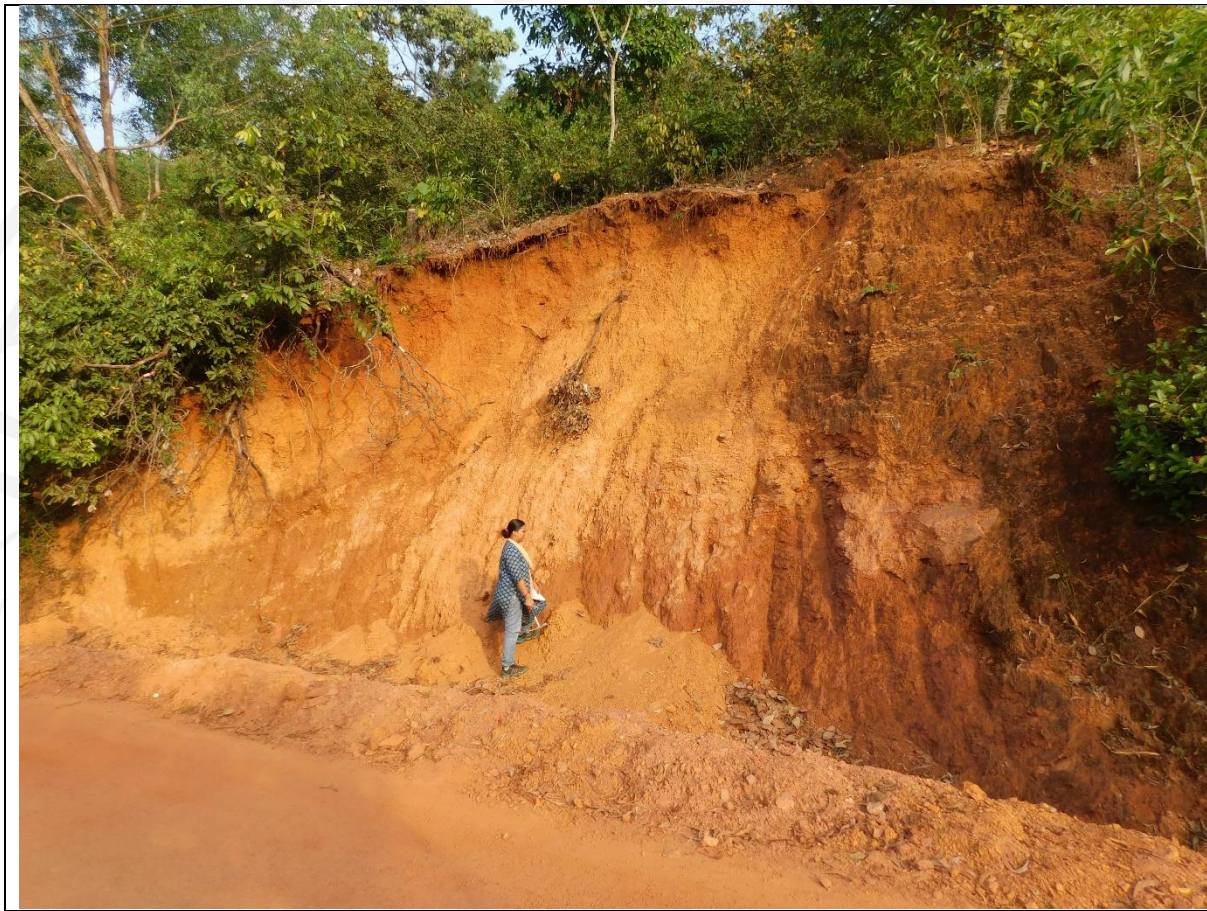
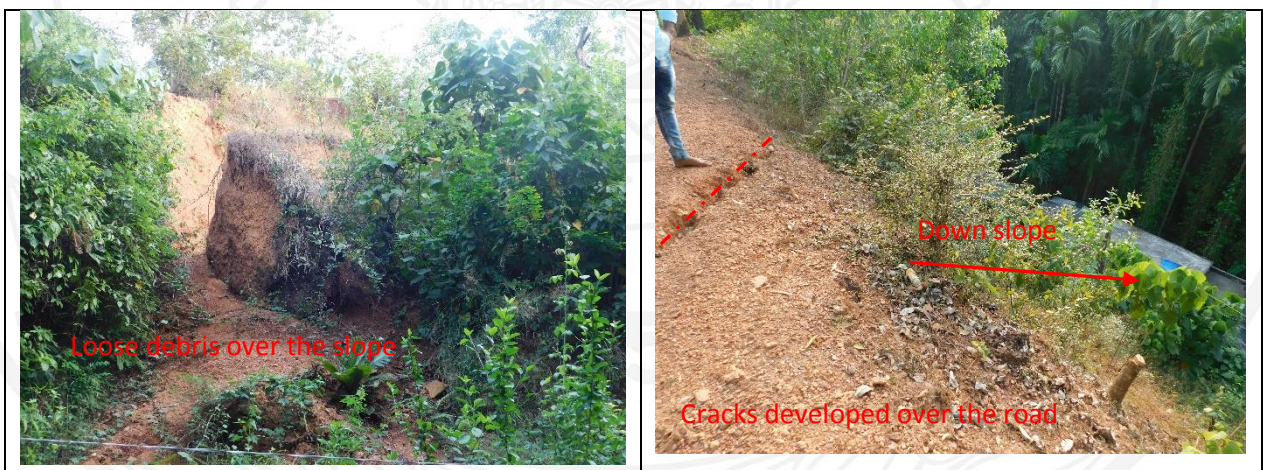
| 22 | Failure Mechanism | Shallow Translational Failure |
| 37 | Geo-Scientific Causes | Incessant rain fall may cause to increase the pore pressure and vertical toe cut for road construction weak slope forming material. |
| 40 | Summary | Soil slide occurred on Aug-2018. Very smaller dimension and occurred due to incessant rain fall may cause to increase the pore pressure and vertical toe cut for road construction weak slope forming material. During the rainy season slide occurred over the road bench and cracks developed over the road bench. Road the road bench slope having an angle of 30-45 degree. Further down the slope 2-3 settlement situated. Loose debris are lying over the slope. The cracks may reactivate in the future rainfall and it may damage the settlement. |

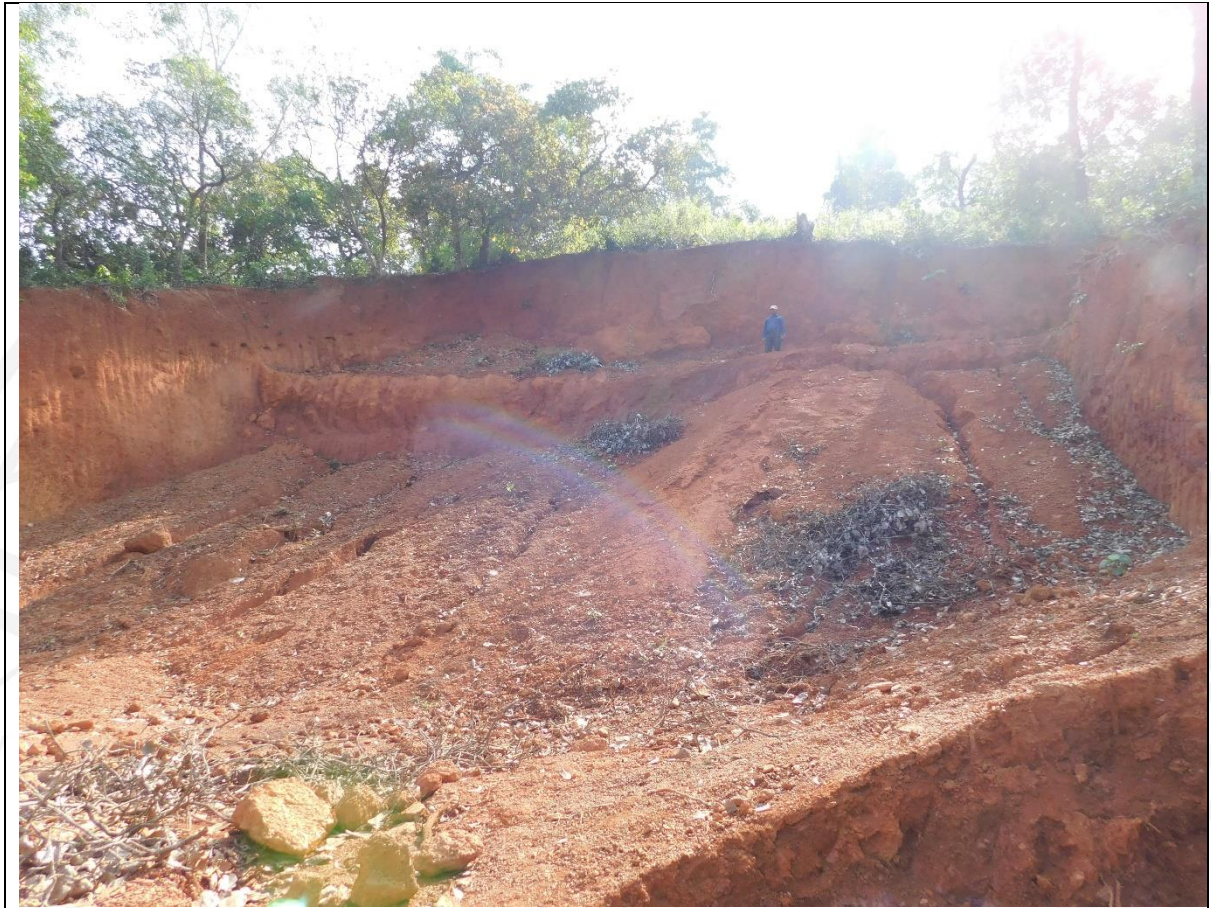
| 22 | Failure Mechanism | Shallow Translational Failure |
| 37 | Geo-Scientific Causes | Vertical cut slope for settlement construction. Weak slope forming material incessant rainfall. |
| 39 | Remarks | Above the road bench the vertical toe cut observed. If any slope failure above the hills that will affect the settlement which is located below the road bench. it is reported that during the rain time the slide occurred and surface cracks developed down |

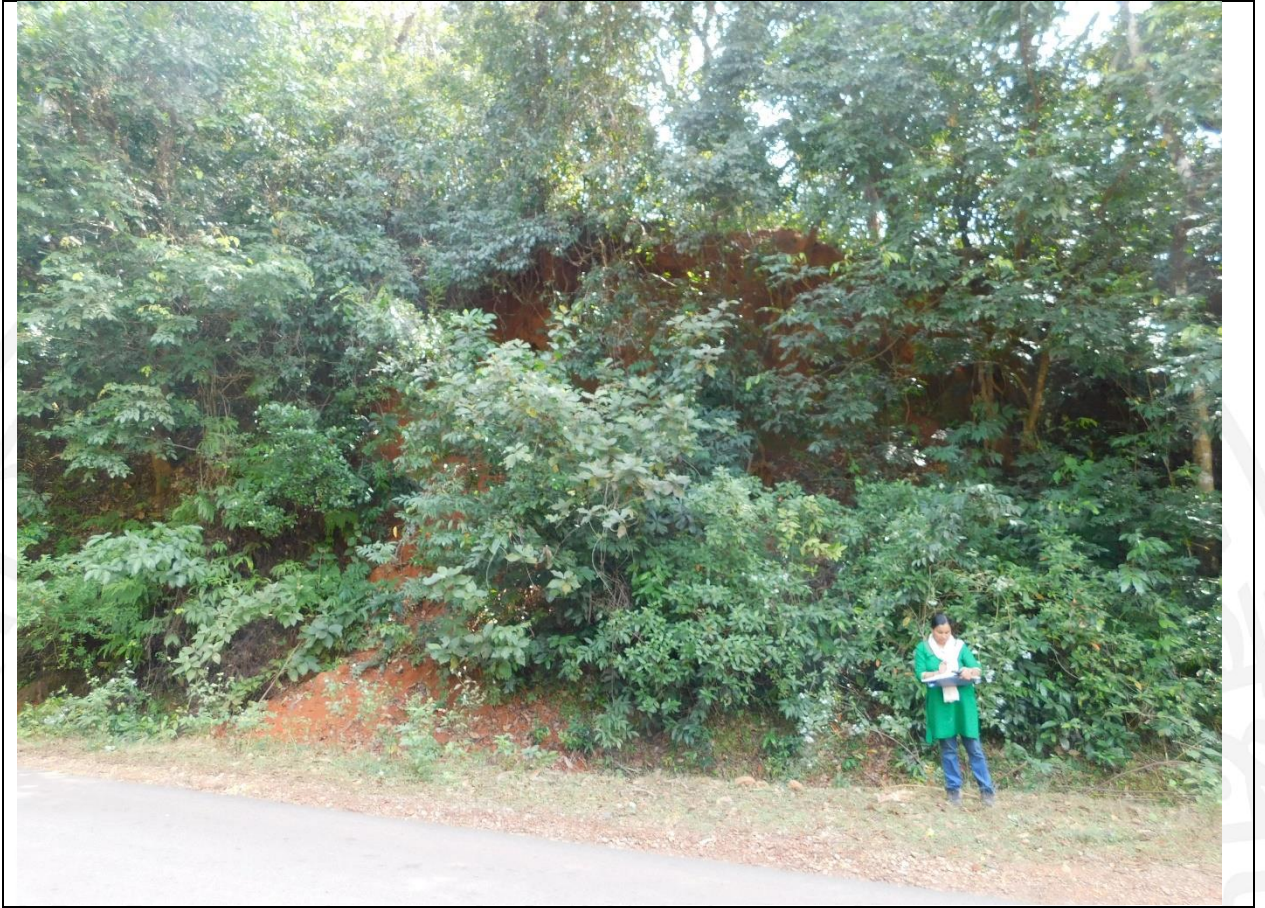
| 22 | Failure Mechanism | Shallow Translational Failure |
| 37 | Geo-Scientific Causes | Vertical to cut for road construction and weak thick slope forming material on the slope. |

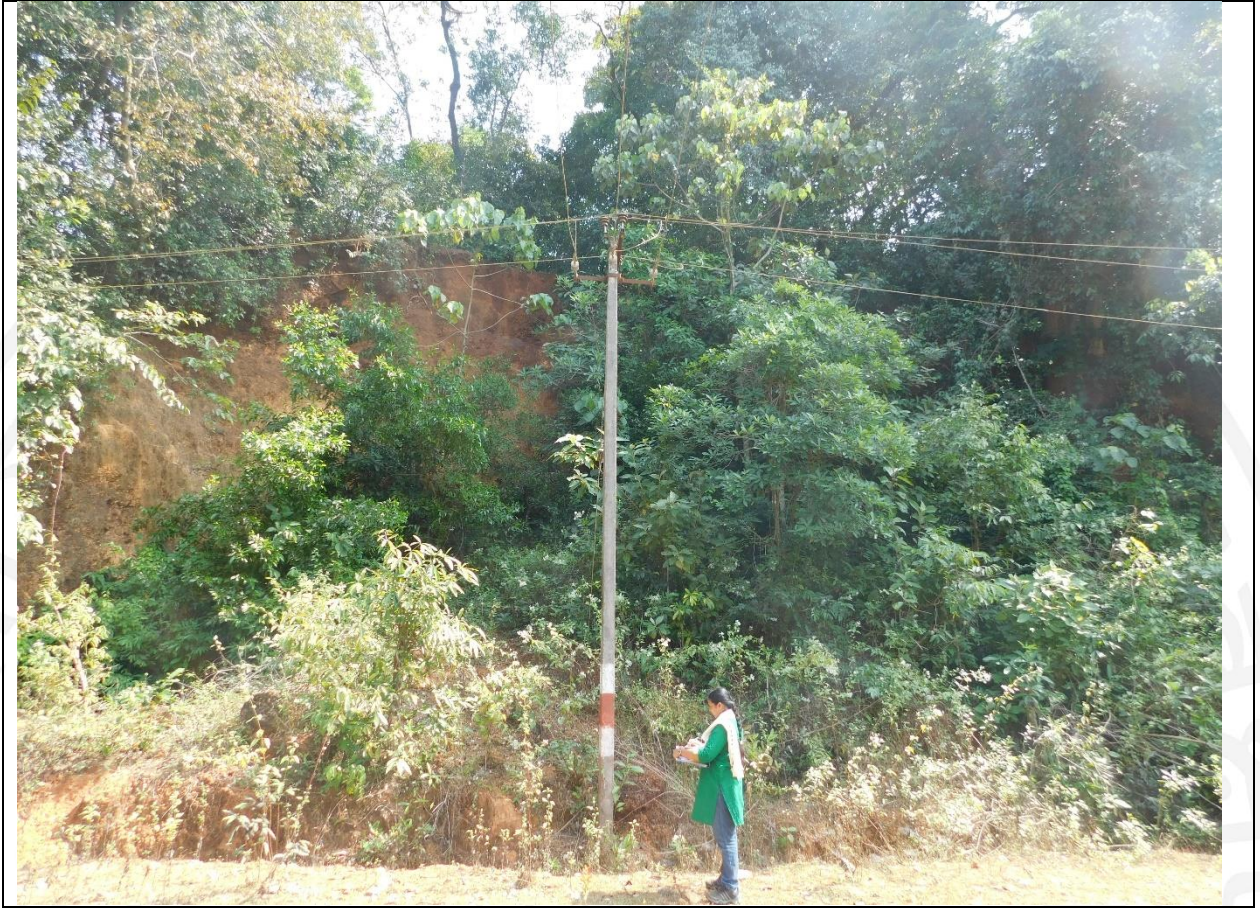
| 22 | Failure Mechanism | Shallow Translational Failure |
| 37 | Geo-Scientific Causes | Thick insitu soil associated with rainfall may increase the pore pressure and the soil losses its strength. |
| 40 | Summary | Cut slope failure occurred due to thick insitu soil associated with rainfall may increase the pore pressure and the soil losses its strength. |

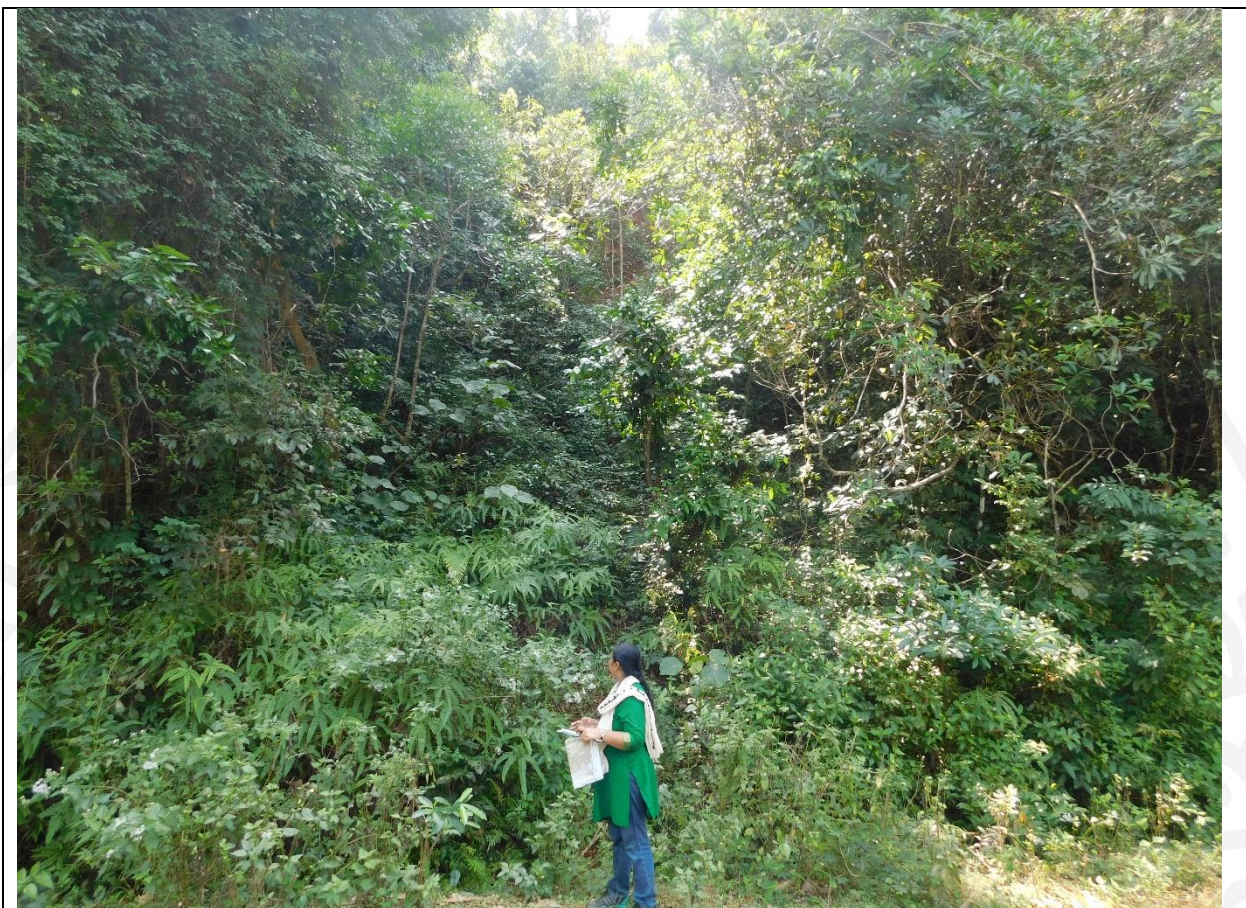
| 22 | Failure Mechanism | Shallow Translational Failure |
| 37 | Geo-Scientific Causes | Vertical slope cut for road construction. Incessant rain fall may cause the improvement of local hydrostatic or pore pressure. |
| 40 | Summary | Vertical slope cut for road construction. Incessant rain fall may cause the improvement of local hydrostatic or pore pressure. Reducing the slope angle and construction of toe drain. |

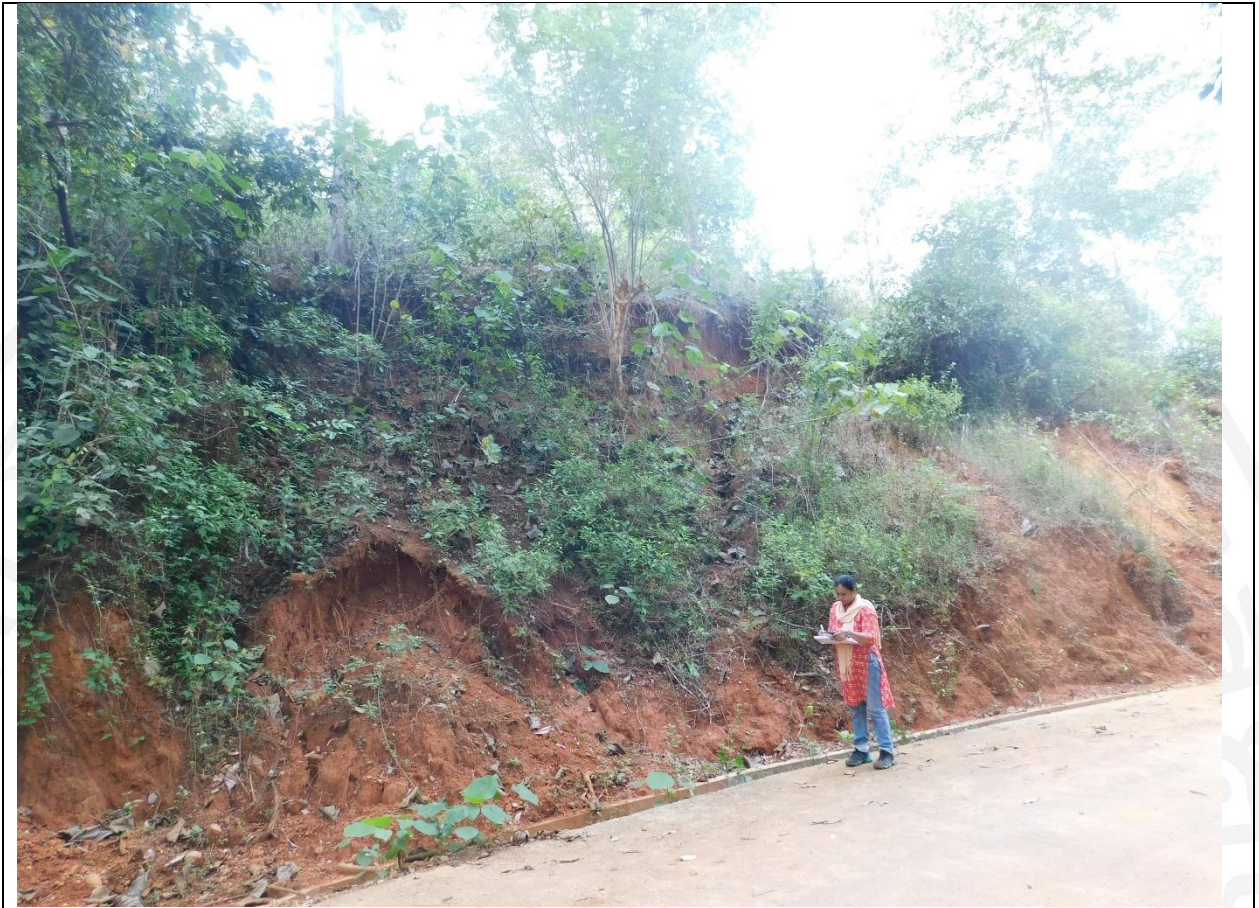
| 22 | Failure Mechanism | Shallow Translational Failure |
| 37 | Geo-Scientific Causes | Vertical toe cut for the road construction and poor slope forming material continuous rainfall may cause for the increase of the pore pressure. |

| 38 | Remedial Measures | Applying geo jute to avoid the slope failure. Construction of toe drain and proper maintenance. |

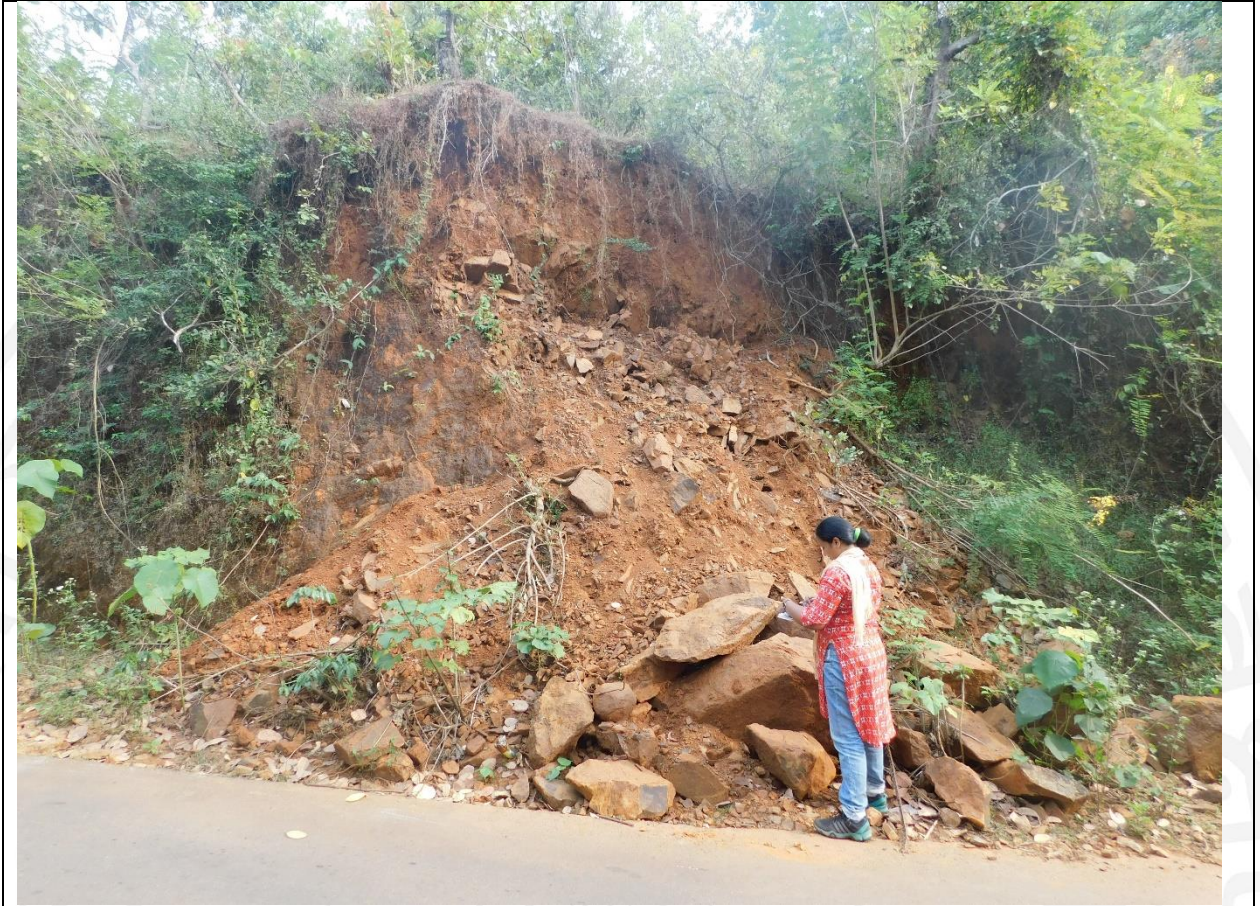
| 22 | Failure Mechanism | Shallow Translational Failure |
| 37 | Geo-Scientific Causes | Toe cut for road construction. |
