**Macro scale (1:50,000) Landslide Susceptibility Mapping in parts of  
Toposheets Nos. 48J/12 and 48J/16, Uttara Kannada  
and Shimoga Districts, Karnataka**

Item No.: M4LSSM/NC/SR/SU-KG/2018/20207

Final report for field season 2018-19

**K. Senthil Kumar, Geologist and Salu S, Senior Geologist (PT)**

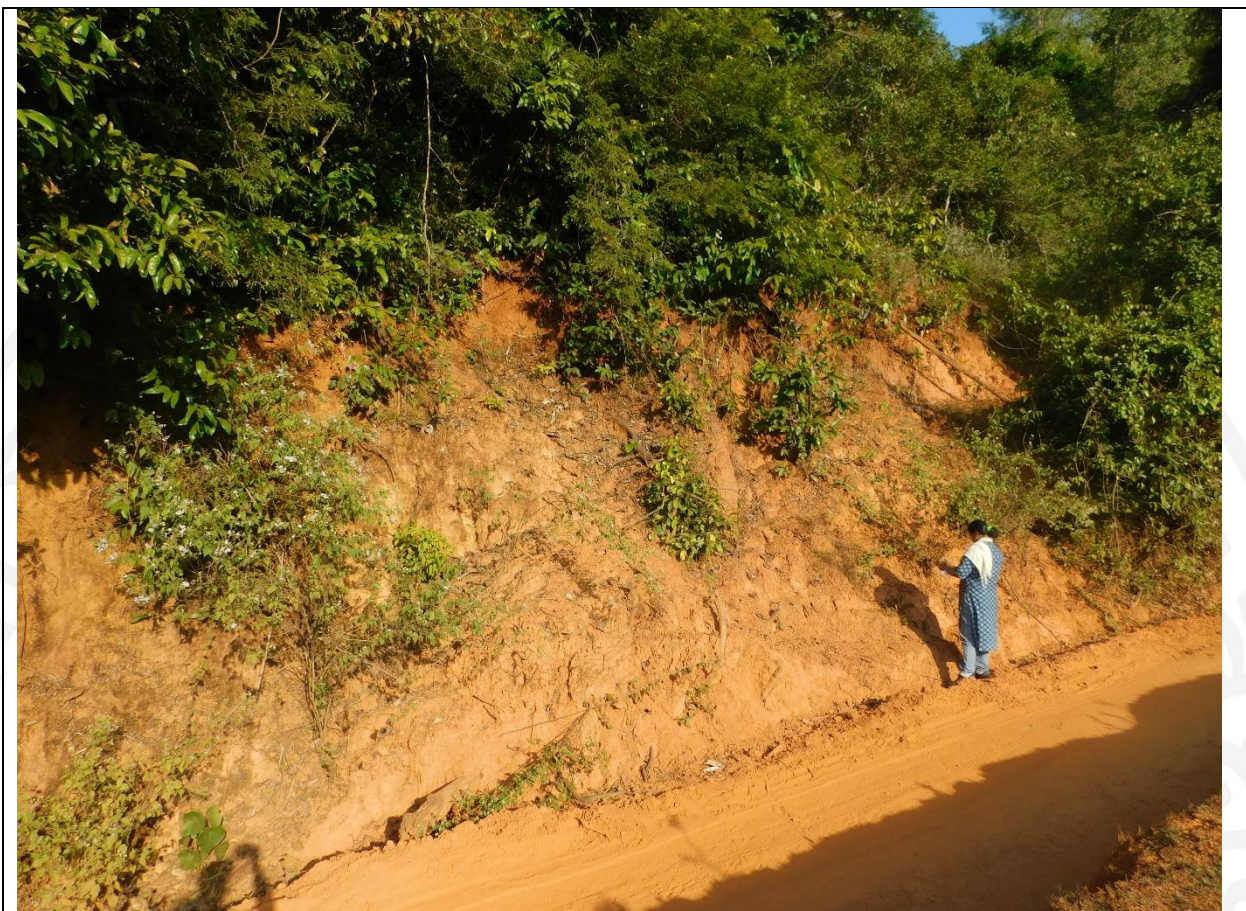
| 22 | Failure Mechanism | Shallow Translational Failure |
| 37 | Geo-Scientific Causes | Vertical road cut for road construction and weak slope forming material. |

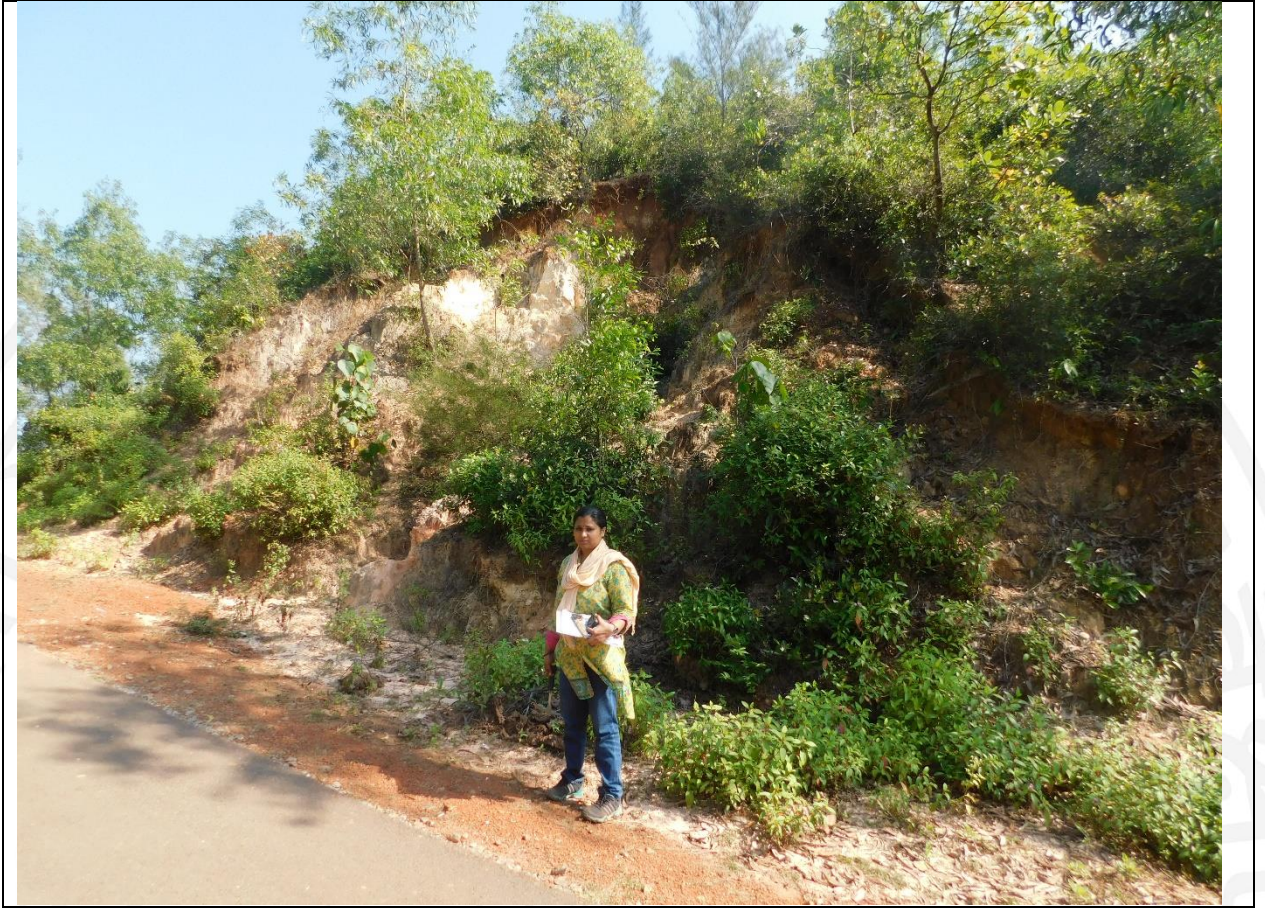
| 22 | Failure Mechanism | Shallow Translational Failure |
| 37 | Geo-Scientific Causes | Weak slope forming material and toe cut for road construction incessant rainfall may cause for the slide. |
| 40 | Summary | Weak slope forming material and toe cut for road construction incessant rainfall may cause for the slide. Removal of debris material and construction of hill side drain. |

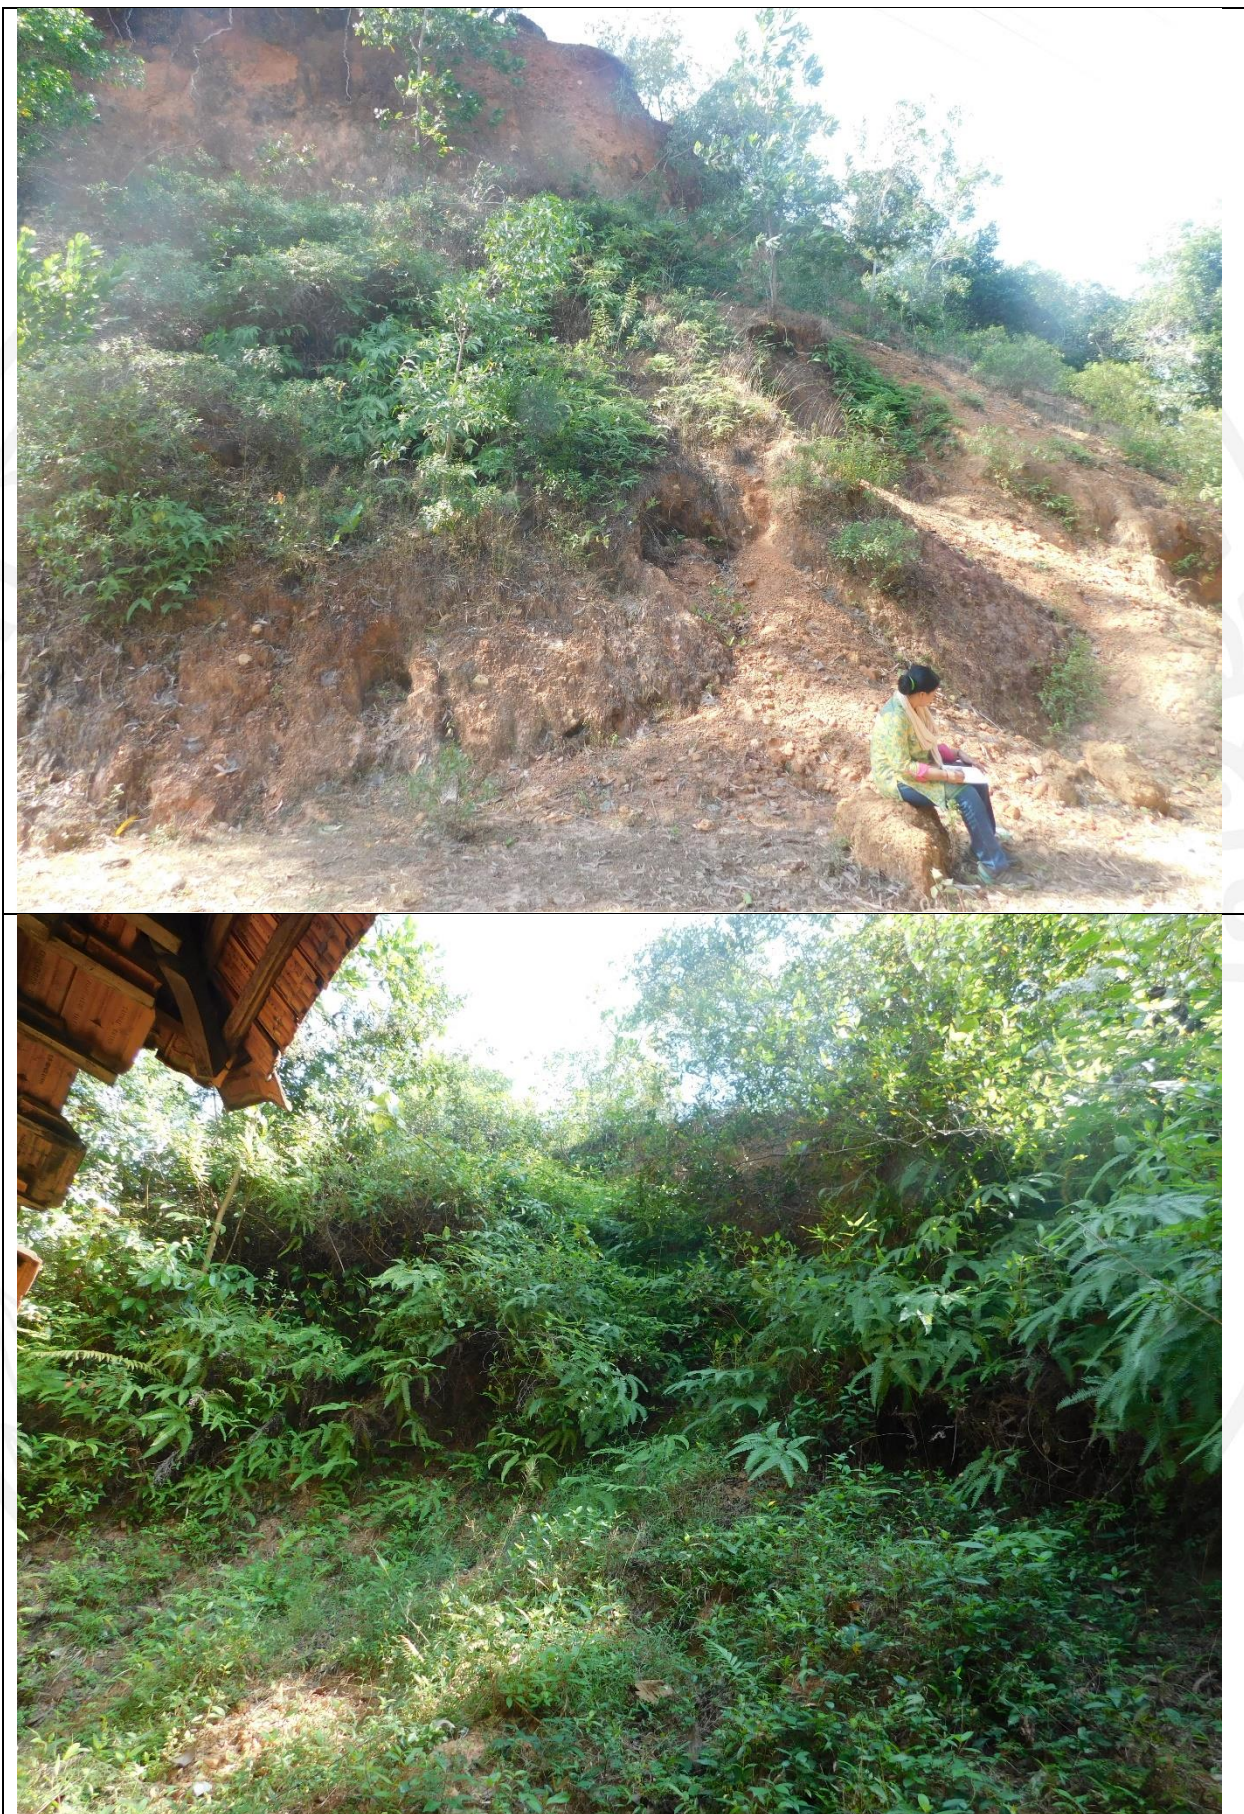
| 22 | Failure Mechanism | Shallow Translational Failure |
| 37 | Geo-Scientific Causes | Steep slope coupled with vertical cut for the settlement construction and weak slope forming material. Incessant rain fall may cause for the increment of pore pressure in the soil. |

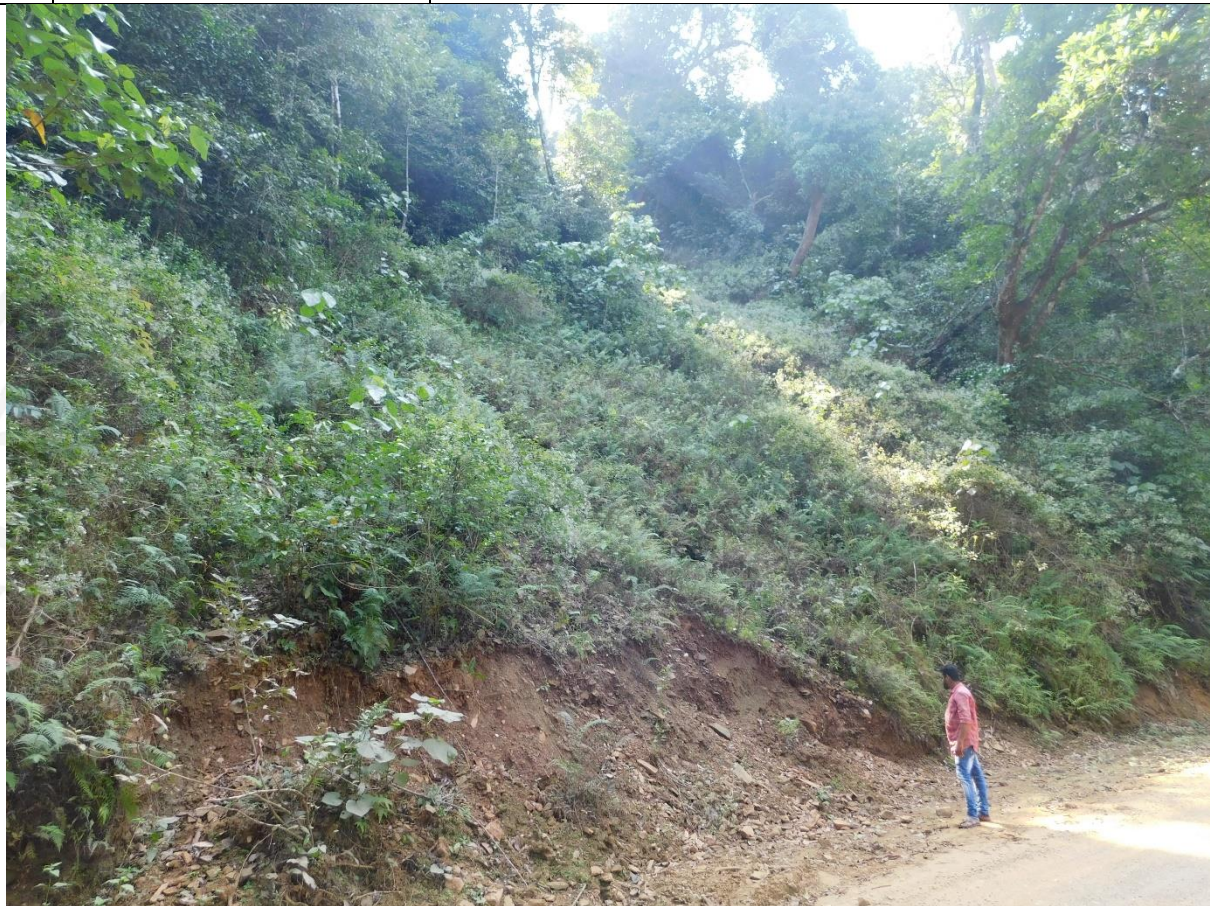
| 40 | Summary | Weak geological formation/highly weathered rock. Cutting of the toe for road benching. Over saturation of weak overburden material due to continuous rainfall and development of local hydrostatic pressure in the weak slope forming material which leads to failure of the slope. Constructing of hill side drainage and proper maintenance. Easing of the slope by multiple benching and construction of retaining wall. |

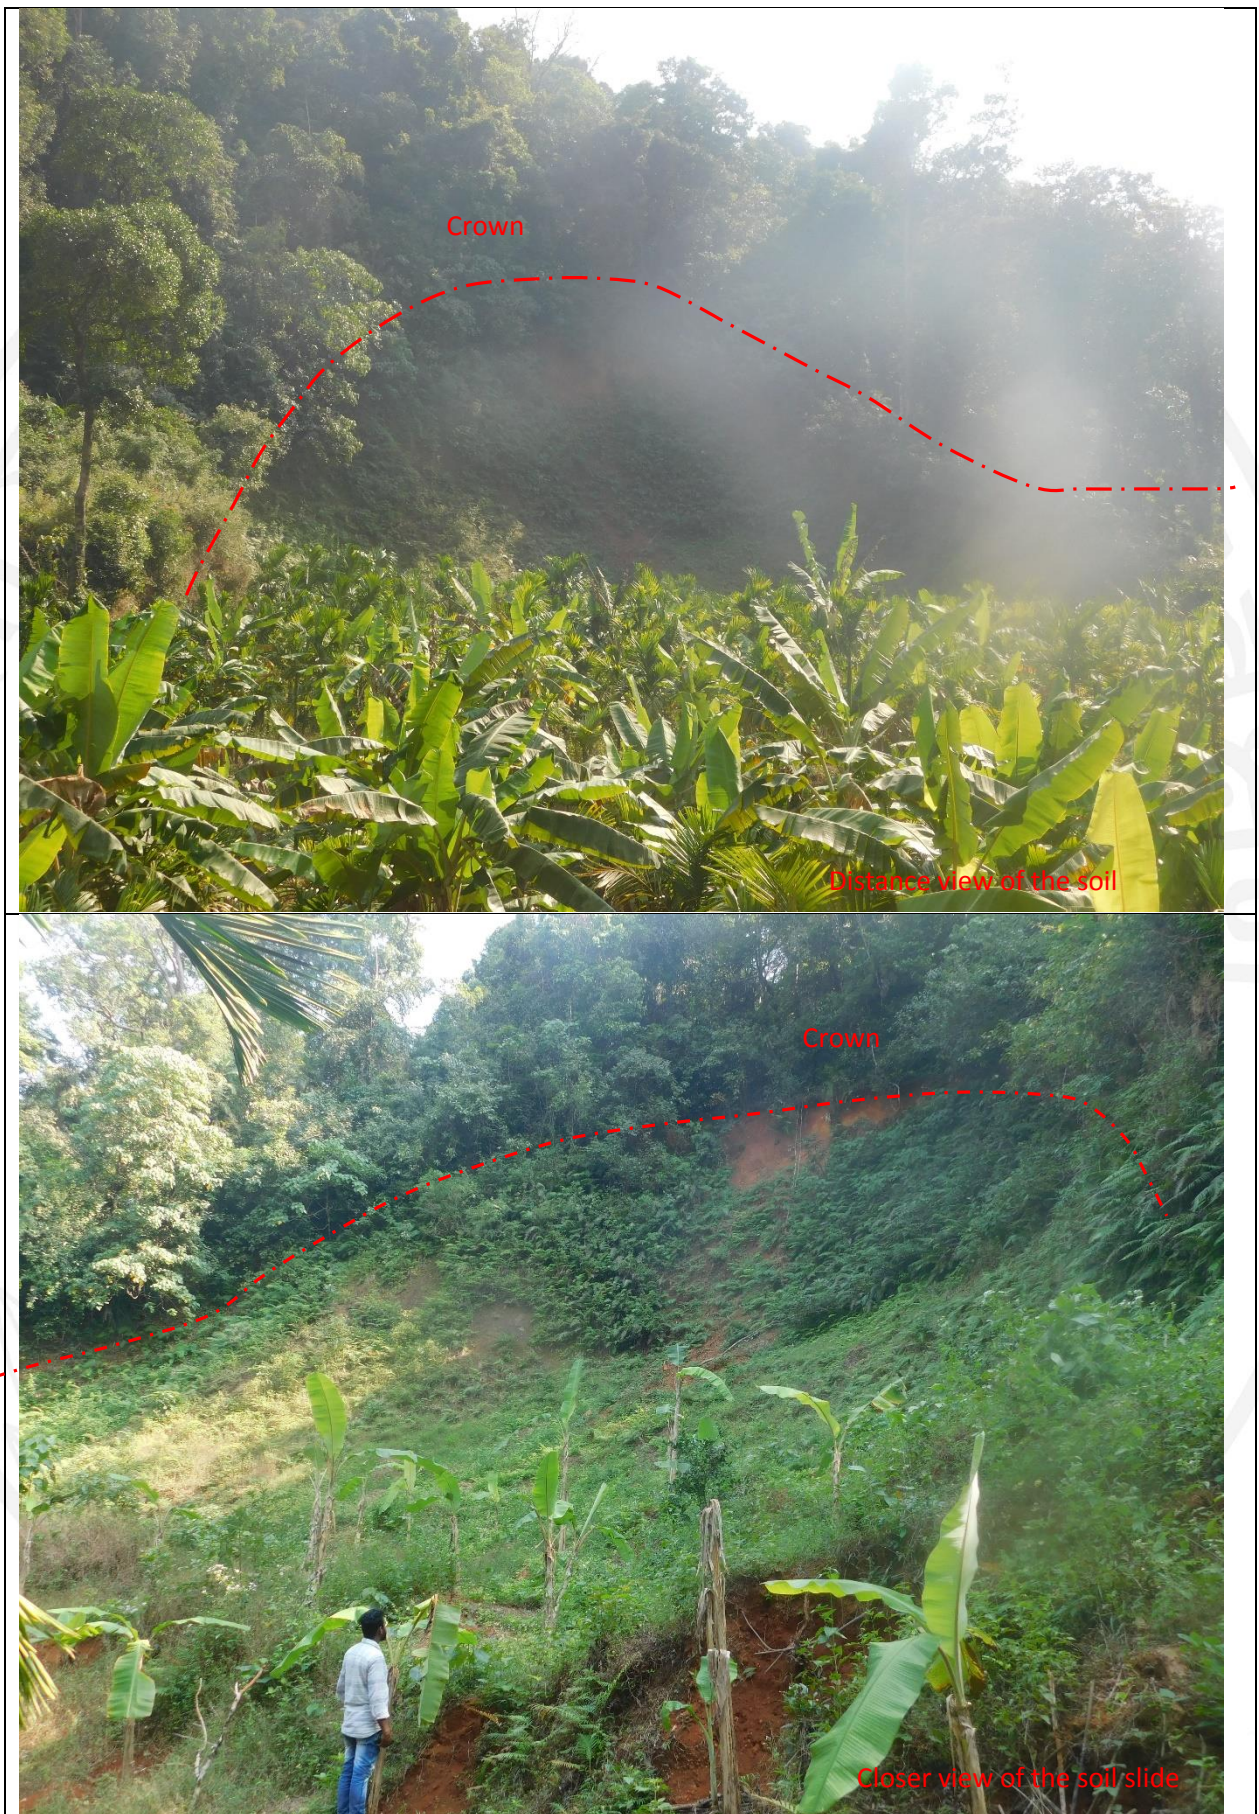
| 22 | Failure Mechanism | Deep Translational Failure |
| 37 | Geo-Scientific Causes | Natural slope modified by cutting of the steep slope for plantation purpose presence of weak thick slope forming material delighed and it increase the surficial erosion during the rainfall. |
| 41 | Summary | The slide occurred on 2018 and the natural slope modified for agricultural purpose by multiple benching. During the monsoon season the rainwater percolated in soil and it increased the pore pressure. Due to which the soil strength reduced and the material failed. Easing of the slope both the flank as well as crown portion and further modification of slope to be avoided at the adjoining area recommended to avoid the future land slide in this area. |

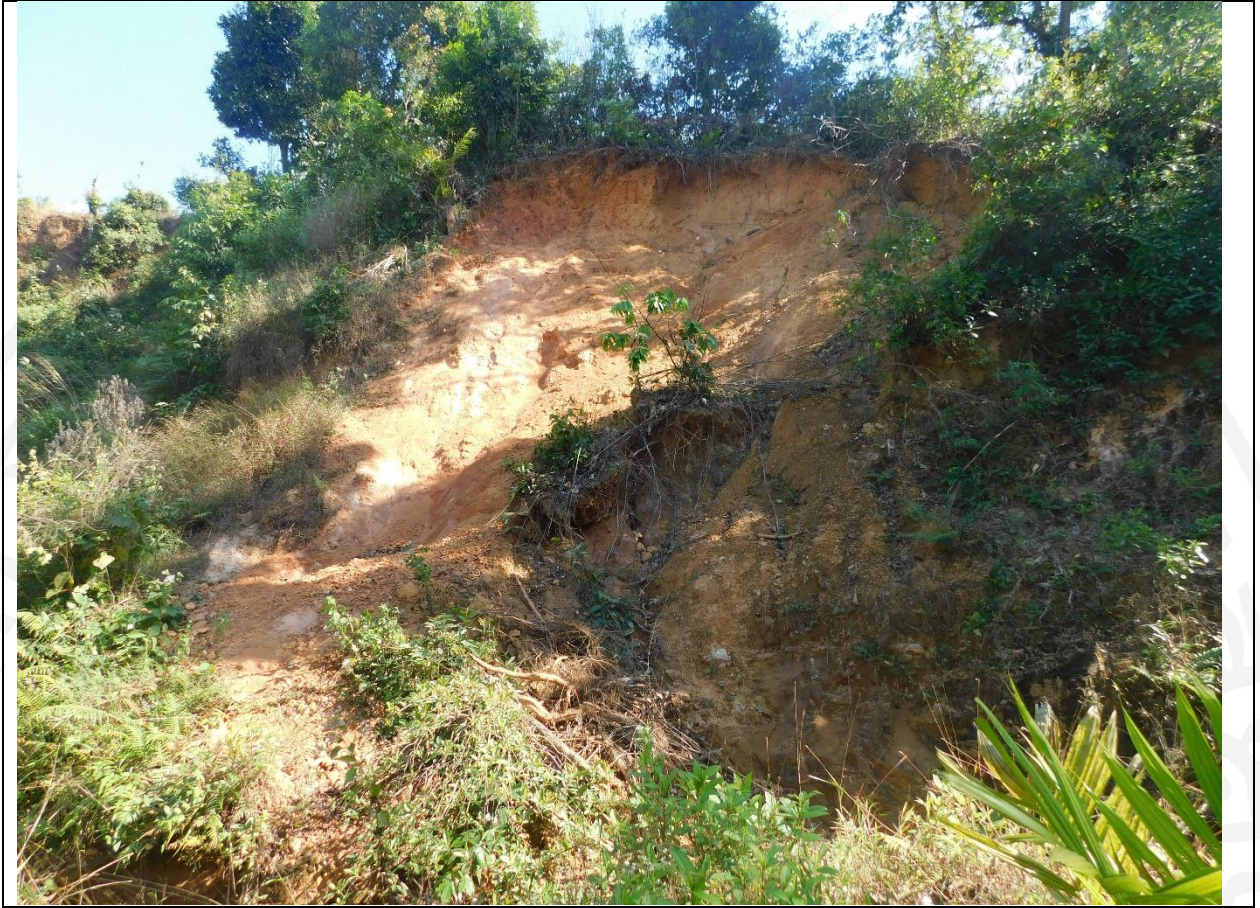
| 1 | Slide No. | KAR/SMG/48J/12/2018-19/35 |

| 22 | Failure Mechanism | shallow Translational Failure |
| 37 | Geo-Scientific Causes | Poor slope forming material coupled with incessant rainfall. |

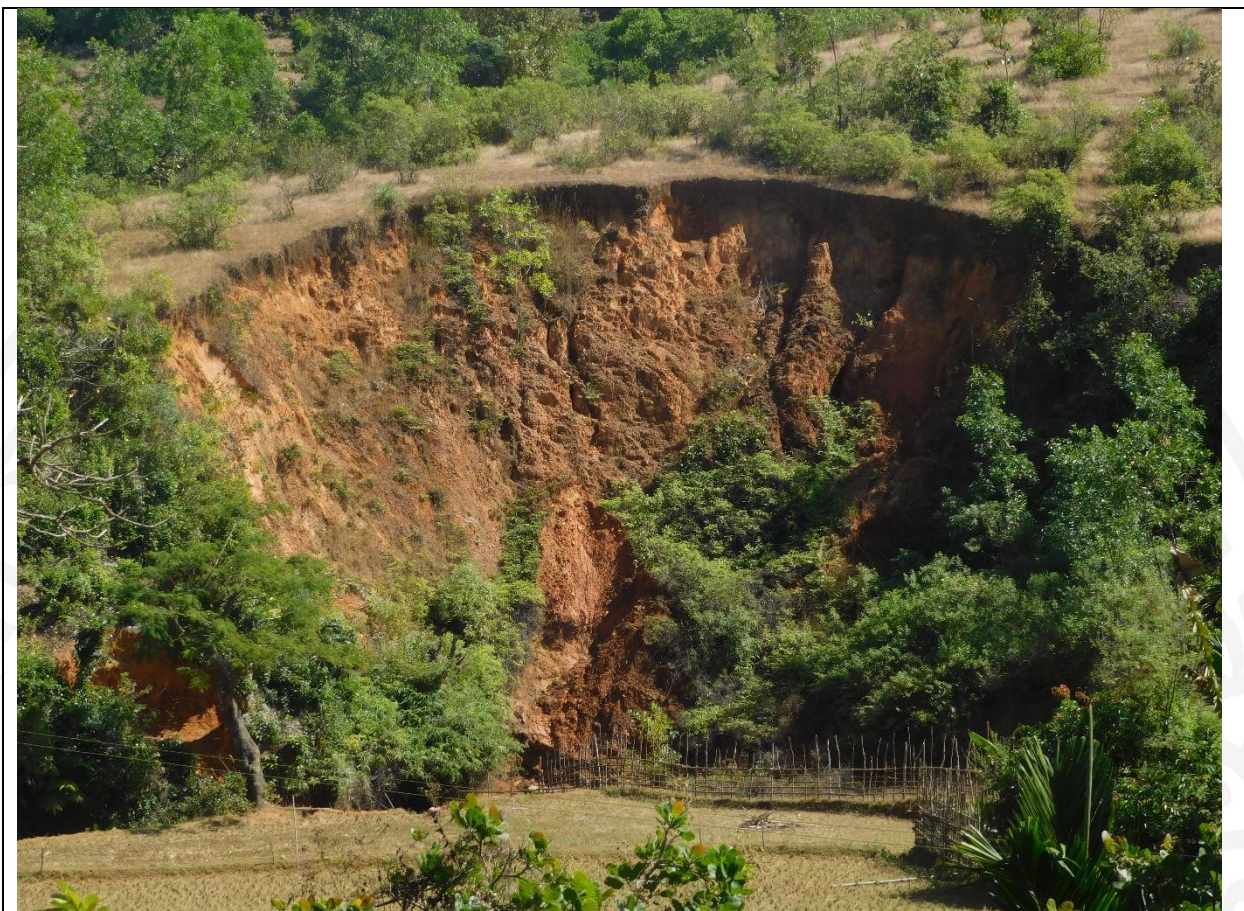
| 1 | Slide No. | KAR/SMG/48J/16/2018-19/36 |

| 22 | Failure Mechanism | shallow Translational Failure |
| 37 | Geo-Scientific Causes | Thick slope forming material coupled with incessant rainfall and toe cut by small stream. |

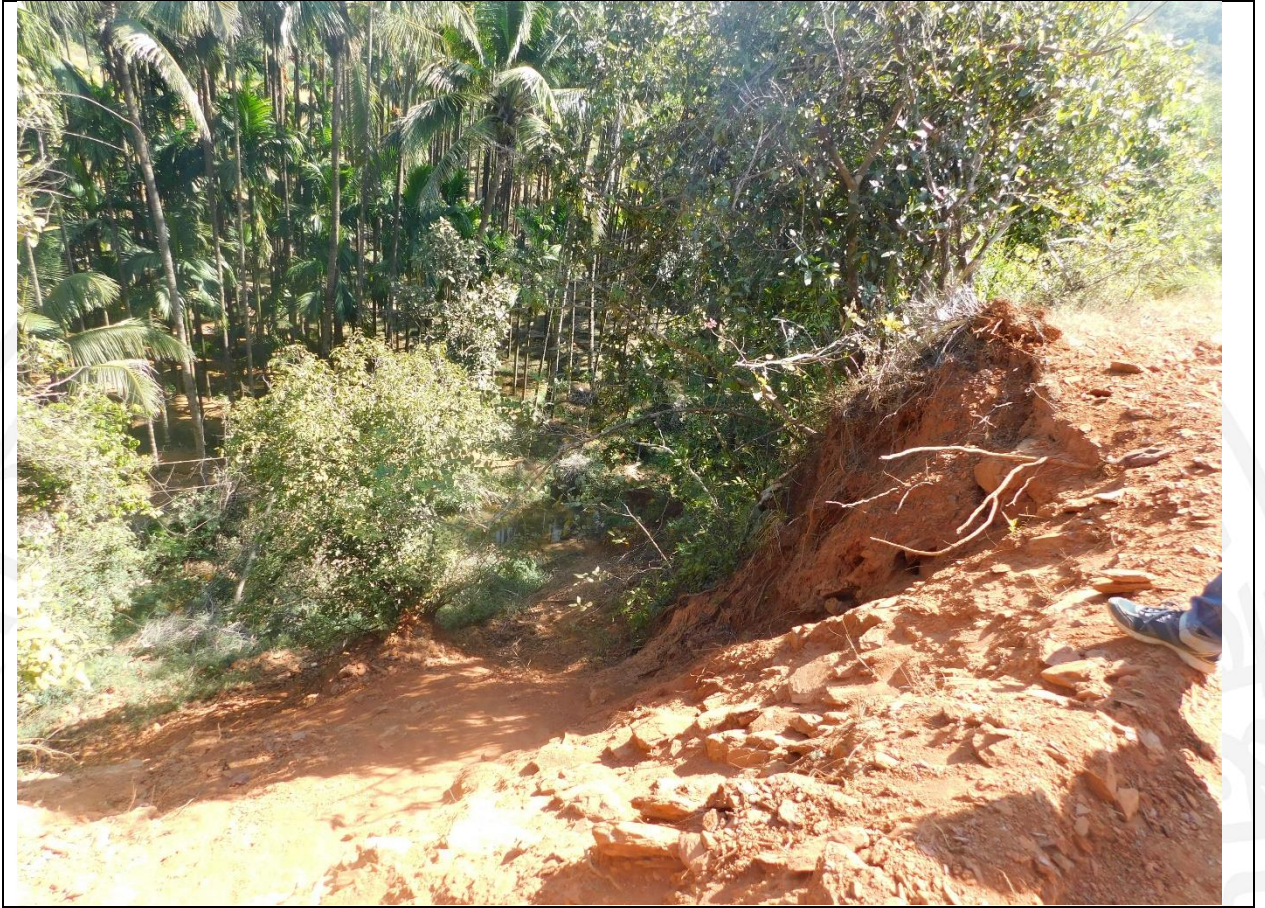
| 1 | Slide No. | KAR/SMG/48J/16/2018-19/37 |

| 22 | Failure Mechanism | Shallow Translational Failure |
| 37 | Geo-Scientific Causes | Weak geological formation highly weathered rock local improvement of pore pressure. |

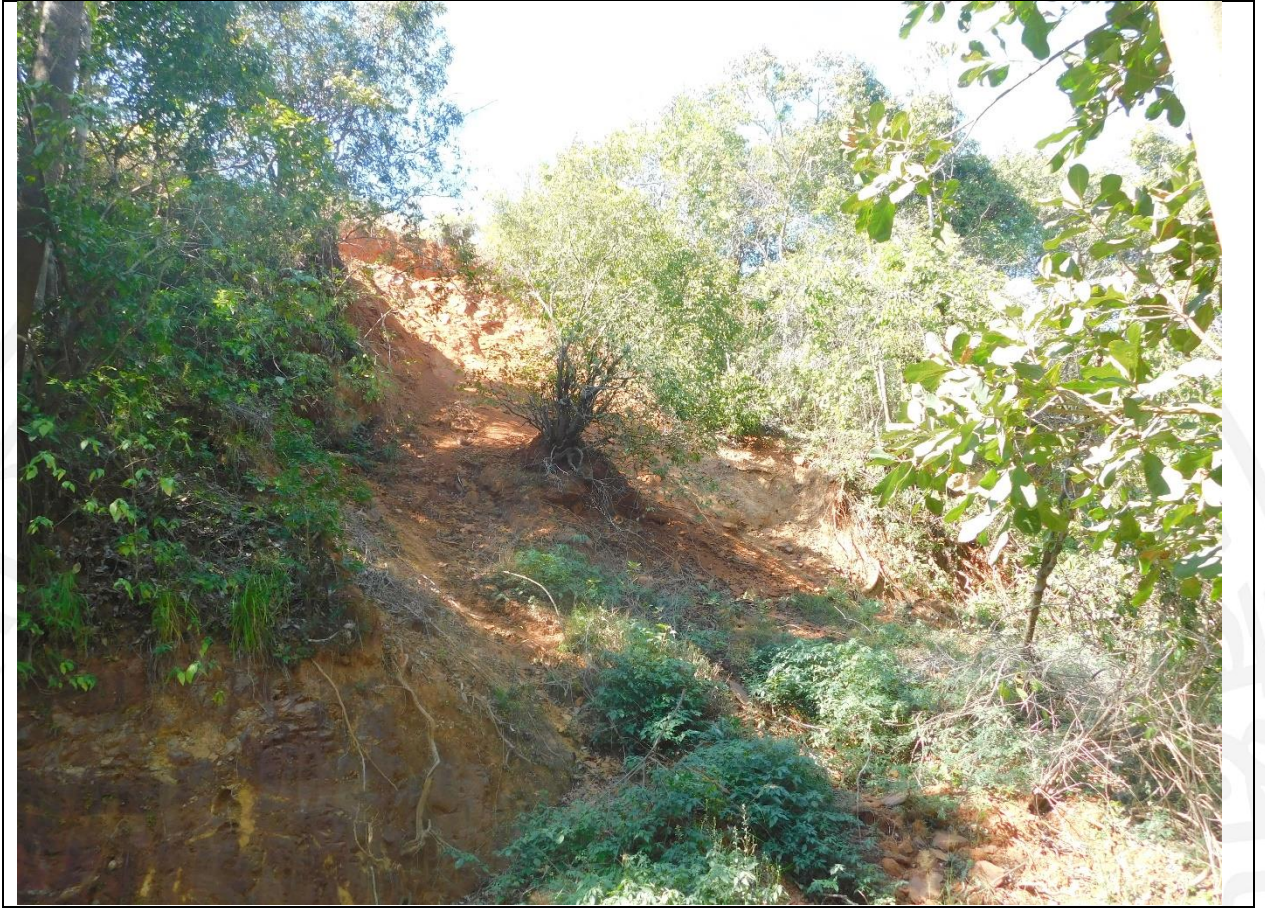
| 1 | Slide No. | KAR/SMG/48J/16/2018-19/38 |

| 22 | Failure Mechanism | Shallow Translational Failure |
| 37 | Geo-Scientific Causes | Weak slope forming material and toe cut for road construction incessant rainfall may cause for the slide. |

| 39 | Remarks | Above adjacent to the slide road was observed that should be shifted towards the hill side. |

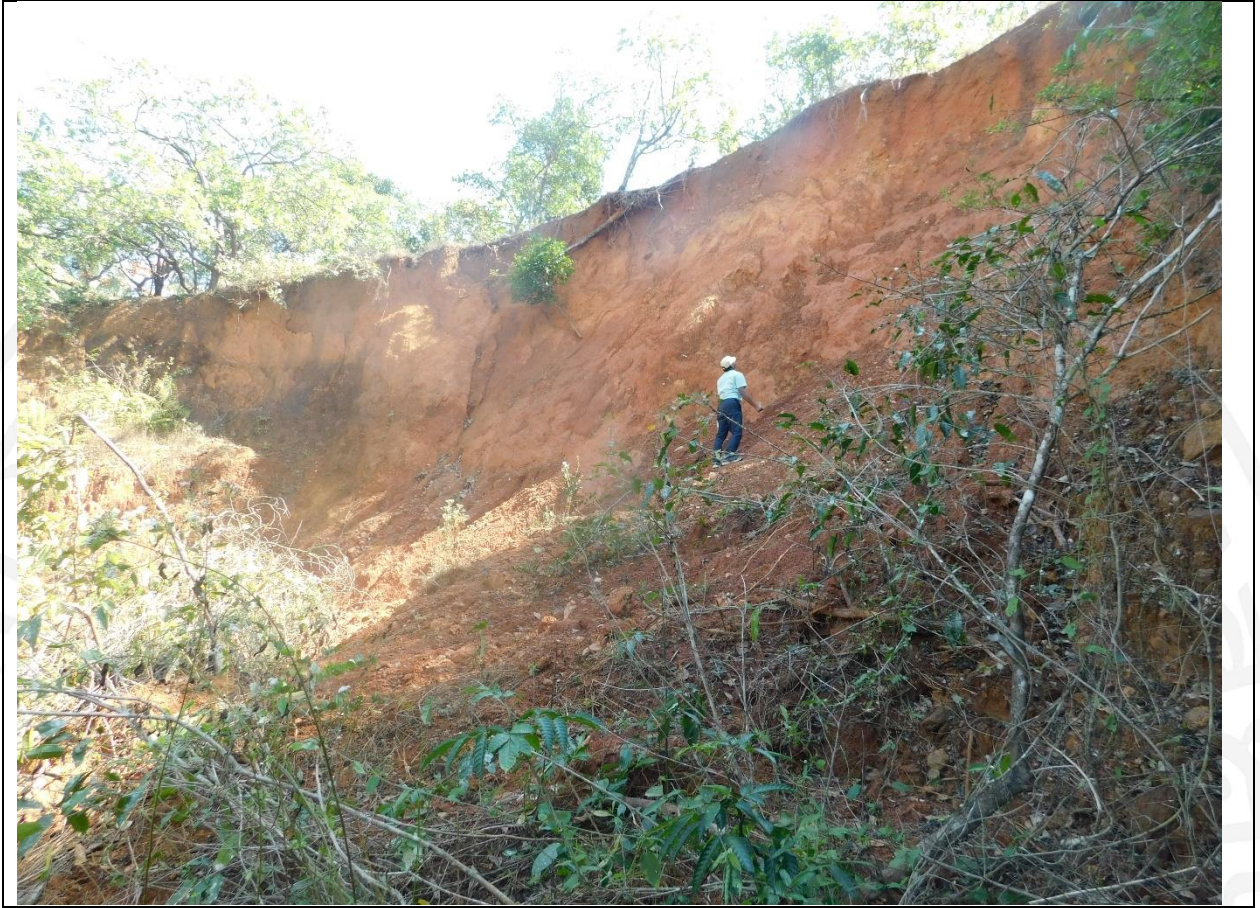
| 1 | Slide No. | KAR/SMG/48J/16/2018-19/39 |

| 22 | Failure Mechanism | Shallow Translational Failure |
| 37 | Geo-Scientific Causes | Weak slope forming material cut by flowing of the stream and incessant rainfall also cause for the landslide. |
| 40 | Summary | Weak slope forming material cut by flowing of the stream and incessant rainfall also cause for the landslide. Removal of the debris and easing of the slope and lining of the stream. |

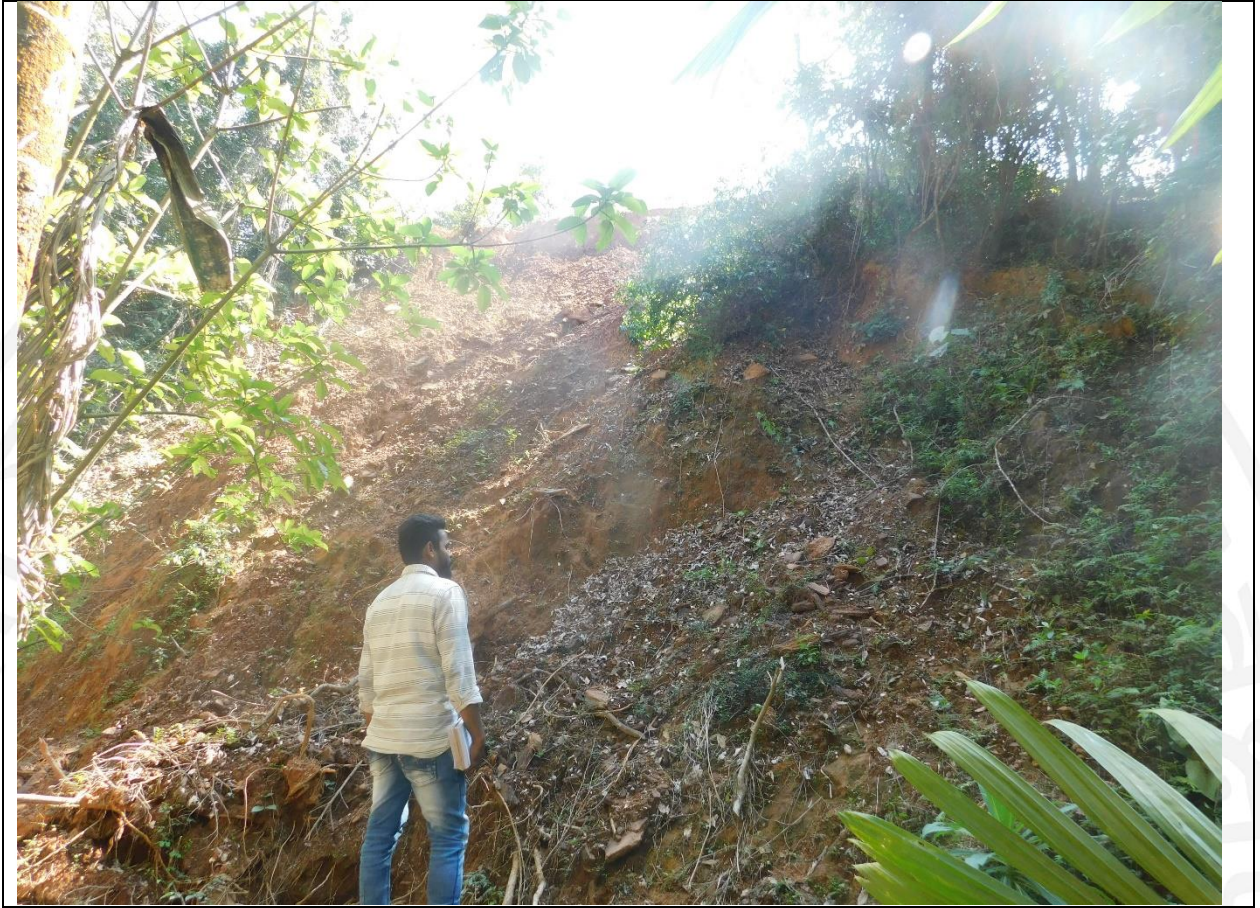
| 1 | Slide No. | KAR/SMG/48J/16/2018-19/40 |

| 22 | Failure Mechanism | Shallow Translational Failure |
| 37 | Geo-Scientific Causes | Steep slope coupled with weak slope forming material and incessant rainfall. Toe cut by flowing stream. |

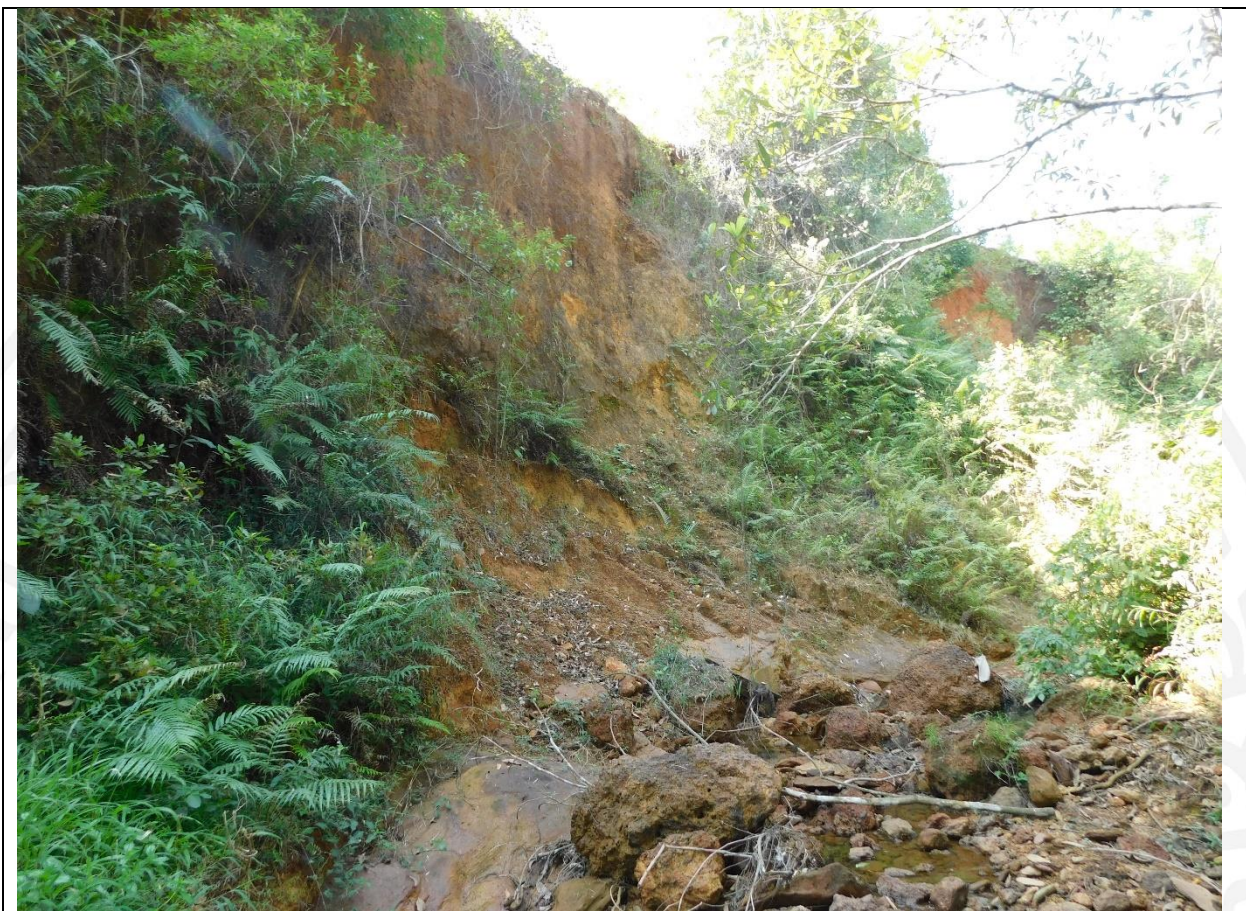
| 1 | Slide No. | KAR/SMG/48J/16/2018-19/41 |

| 22 | Failure Mechanism | Shallow Translational Failure |
| 37 | Geo-Scientific Causes | weak slope forming material cut by flowing stream |

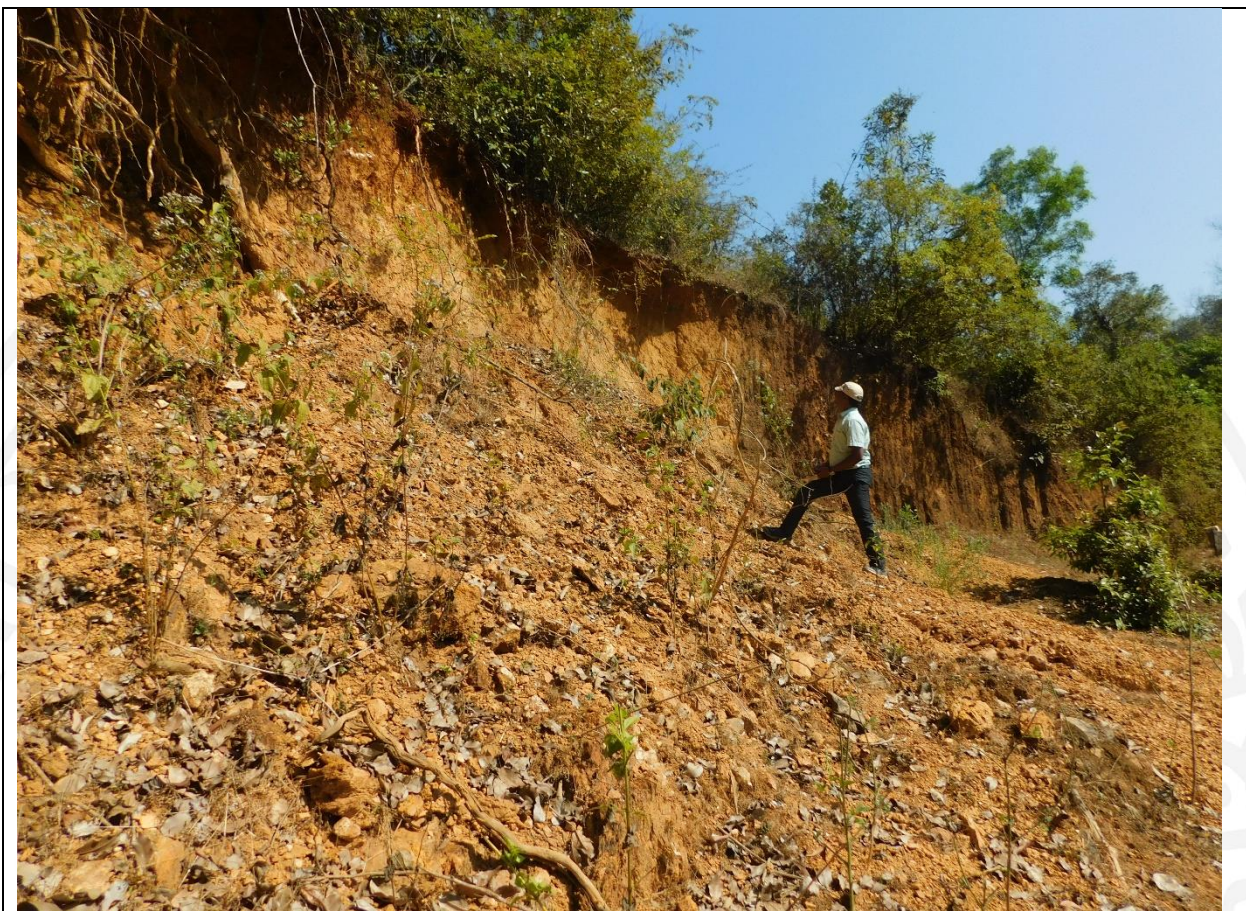
| 1 | Slide No. | KAR/SMG/48J/16/2018-19/42 |

| 22 | Failure Mechanism | Shallow Translational Failure |
| 37 | Geo-Scientific Causes | Weak geological formation incessant rain fall may cause increase of pore pressure |

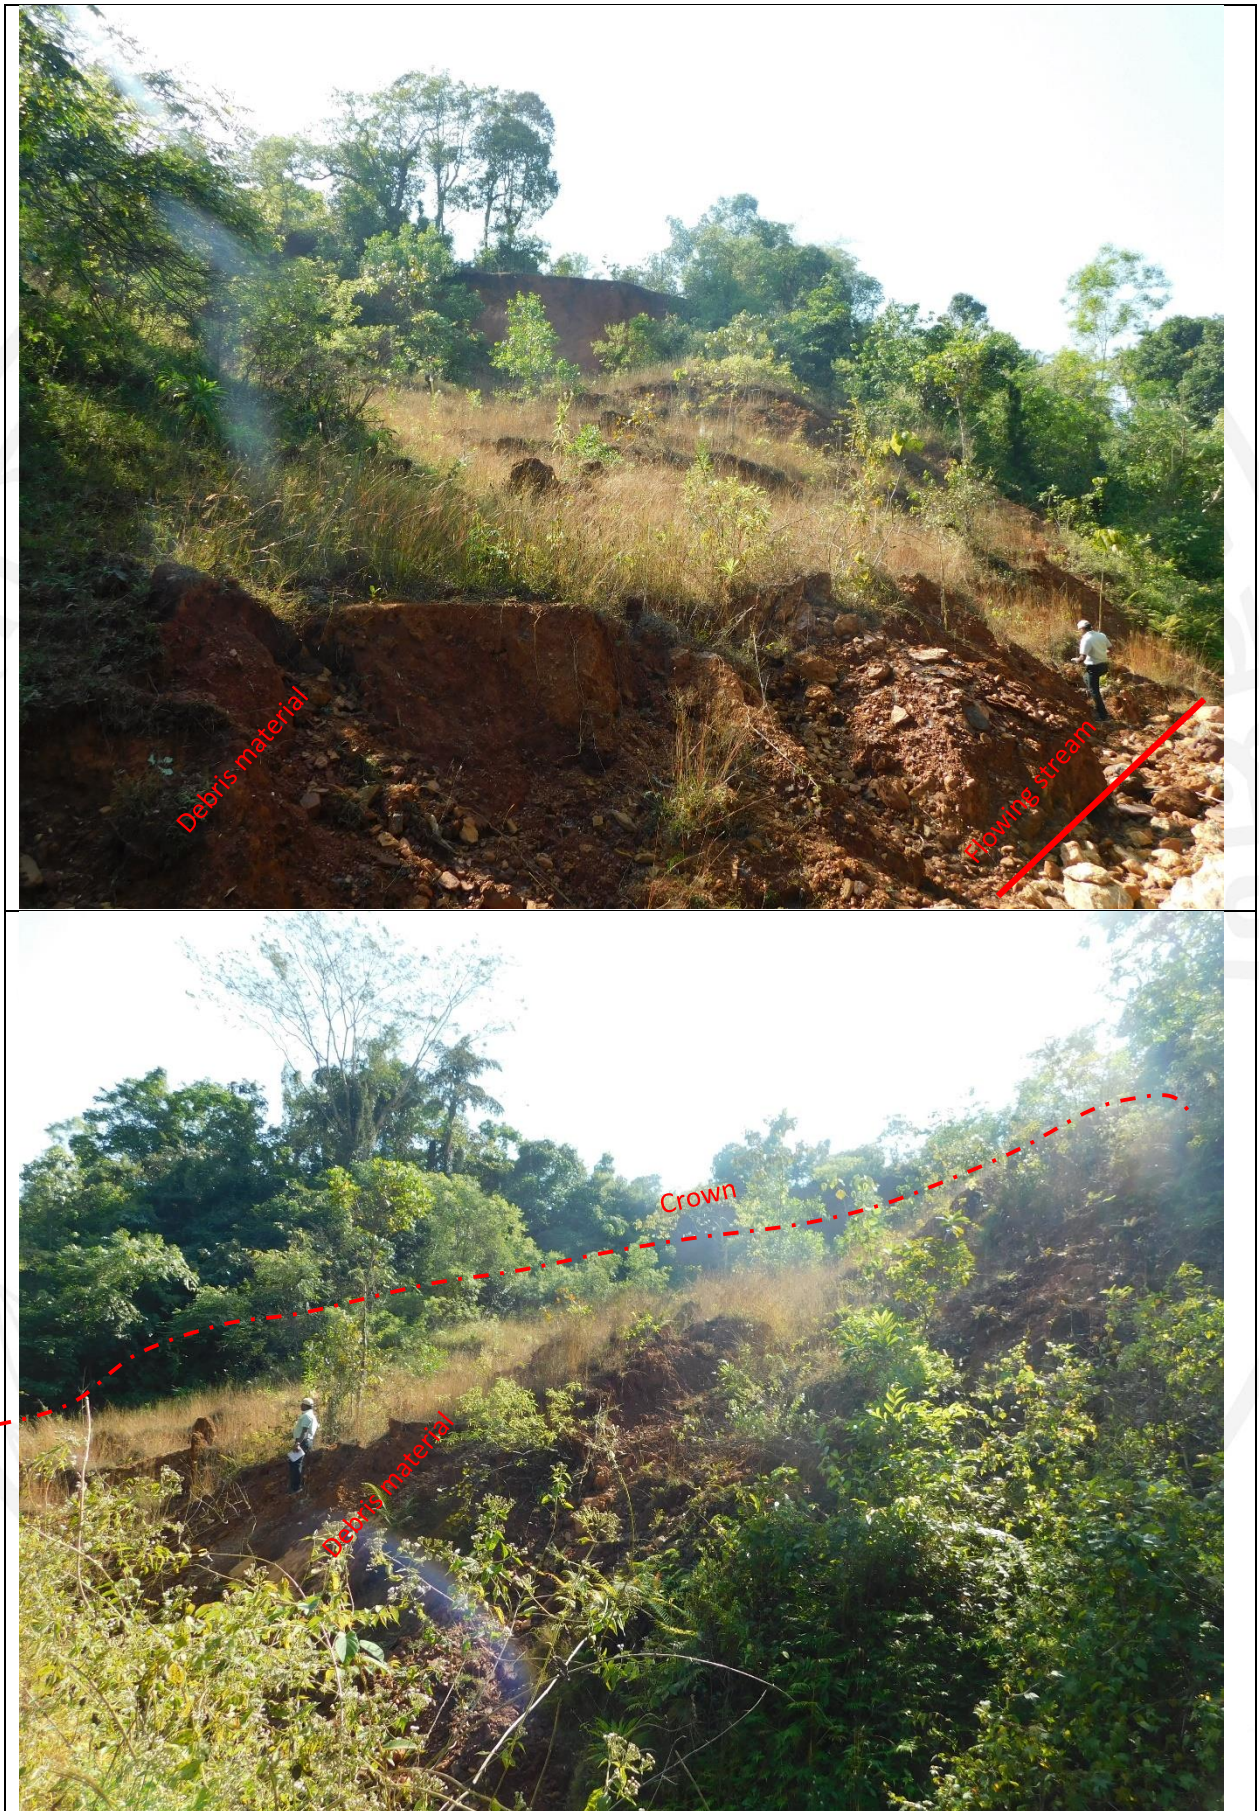
| 1 | Slide No. | KAR/SMG/48J/16/2018-19/43 |

| 22 | Failure Mechanism | Shallow Translational Failure |
| 37 | Geo-Scientific Causes | Weak geological formation steep slope coupled incessant rainfall local improvement of pore pressure and toe cut by flowing stream. |

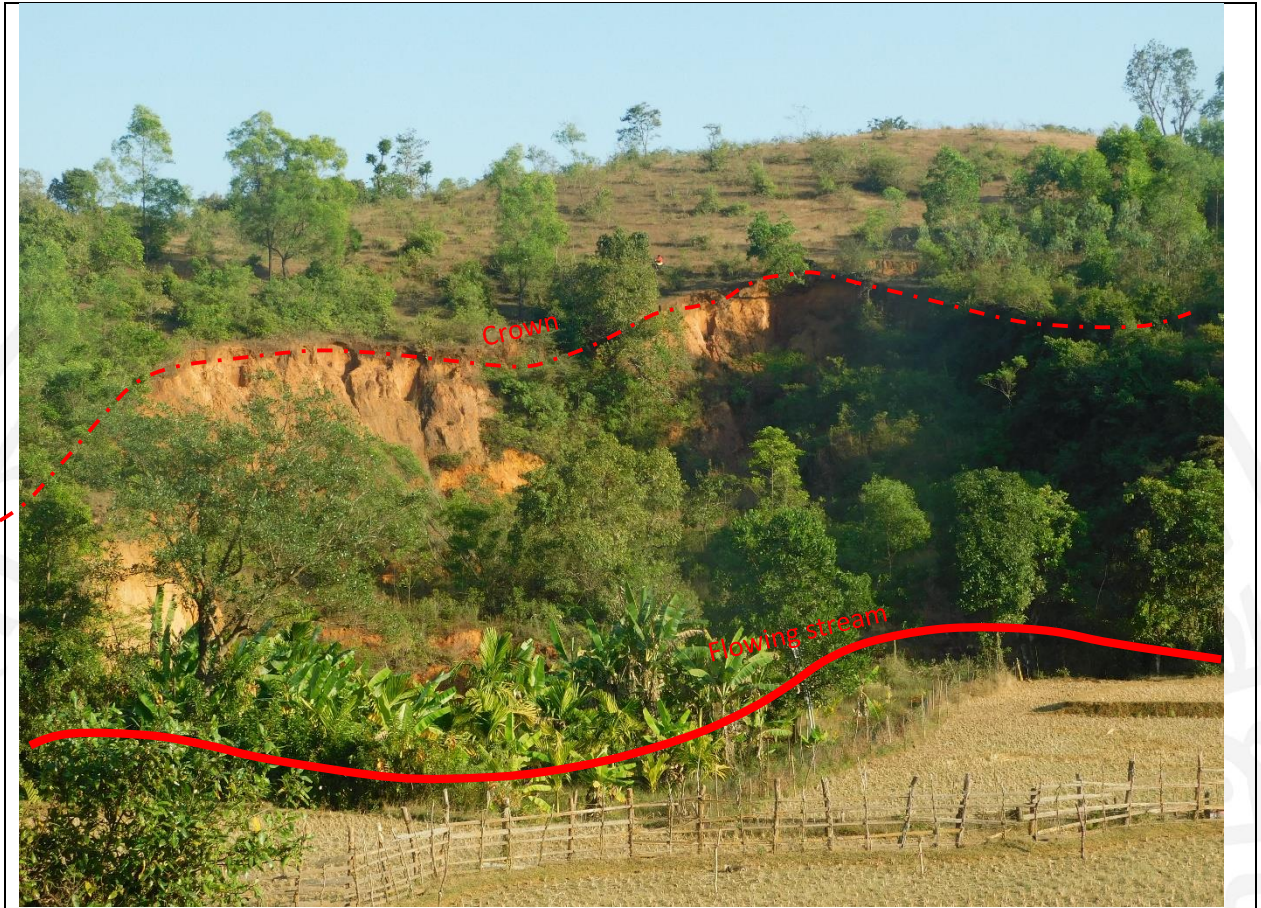
| 1 | Slide No. | KAR/SMG/48J/16/2018-19/44 |

| 22 | Failure Mechanism | Deep Translational Failure |
| 37 | Geo-Scientific Causes | Steep slope and weakly slope forming material local improvement of pore pressure. Toe cut by the stream. |

| 39 | Remarks | Above the crown one road was observed that road should be shifted to hill side. |

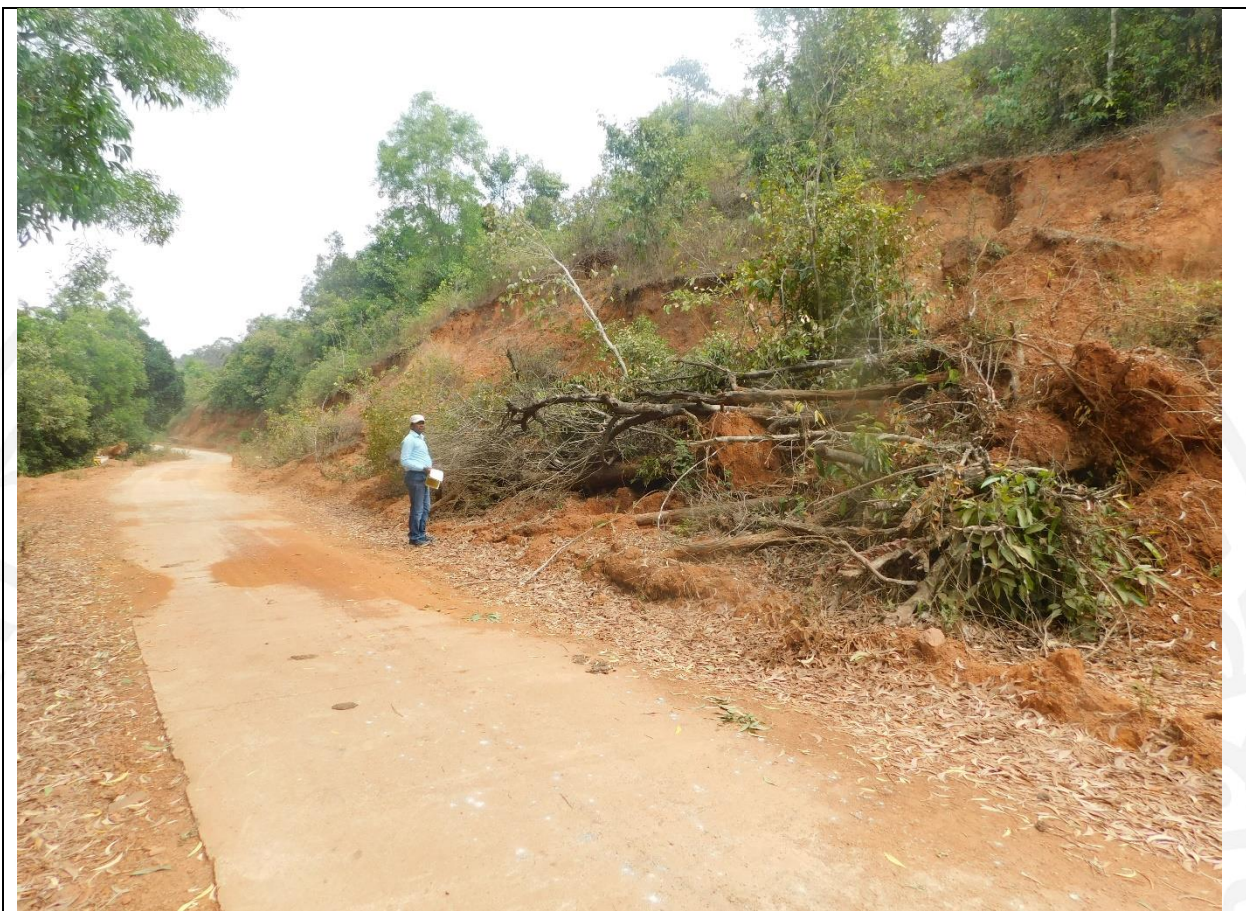
| 22 | Failure Mechanism | Shallow Translational Failure |
| 37 | Geo-Scientific Causes | Huge thickness of weak slope forming material failed due to cutting of the slope for road construction and the slide aggravated by incessant rainfall. |
