**Macro scale (1:50,000) Landslide Susceptibility Mapping in parts of  
Toposheets Nos. 48J/12 and 48J/16, Uttara Kannada  
and Shimoga Districts, Karnataka**

Item No.: M4LSSM/NC/SR/SU-KG/2018/20207

Final report for field season 2018-19

**K. Senthil Kumar, Geologist and Salu S, Senior Geologist (PT)**

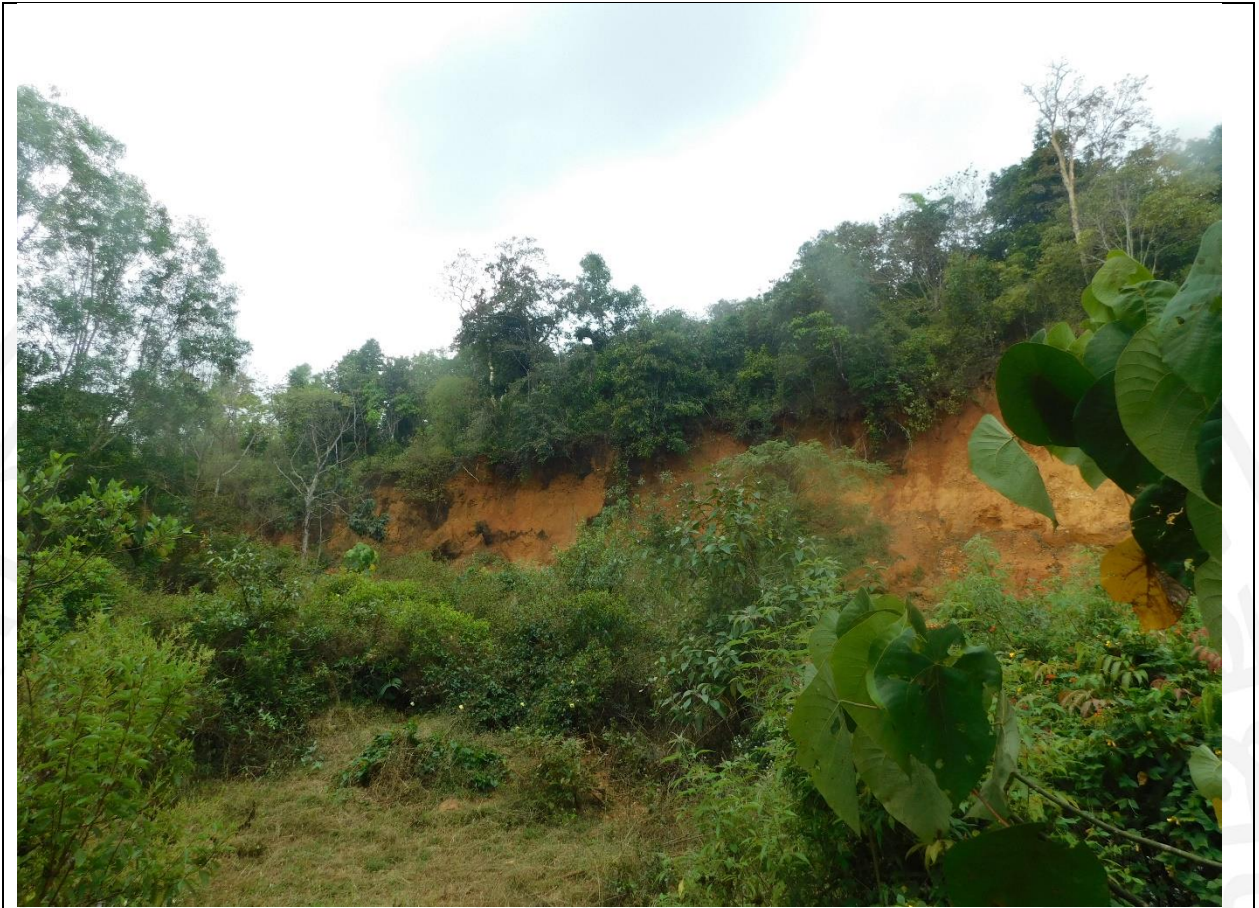
| 1 | Slide No. | KAR/SMG/48J/16/2018-19/46 |

| 22 | Failure Mechanism | Shallow Translational Failure |
| 37 | Geo-Scientific Causes | Poor slope forming material failed due to toe cut by stream. Incessant rainfall also played a major role by increasing the pore pressure. |

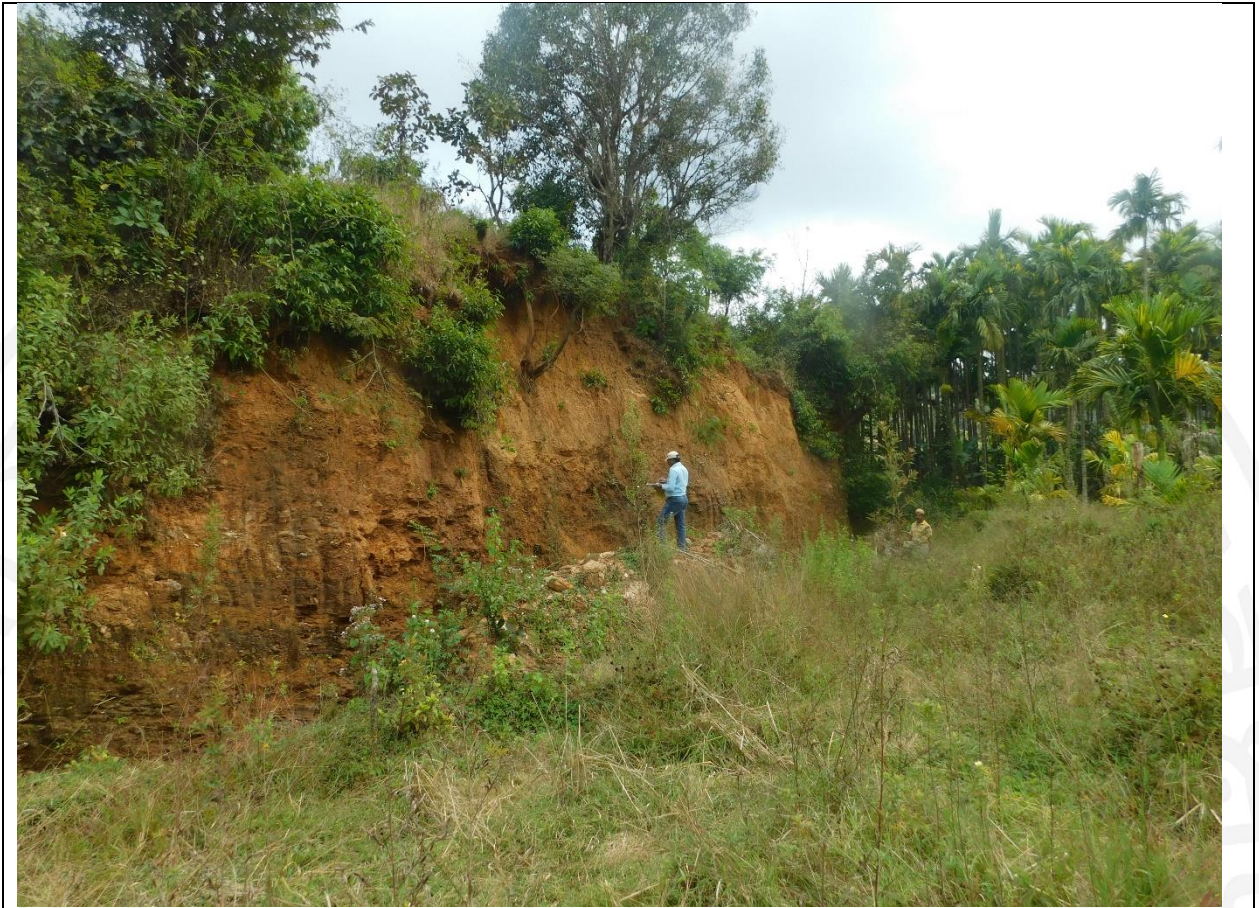
| 1 | Slide No. | KAR/SMG/48J/16/2018-19/47 |

| 22 | Failure Mechanism | Shallow Translational Failure |
| 37 | Geo-Scientific Causes | Weak slope forming material which is eroded by the stream coupled with incessant rainfall may leads to increase the pore pressure locally. |

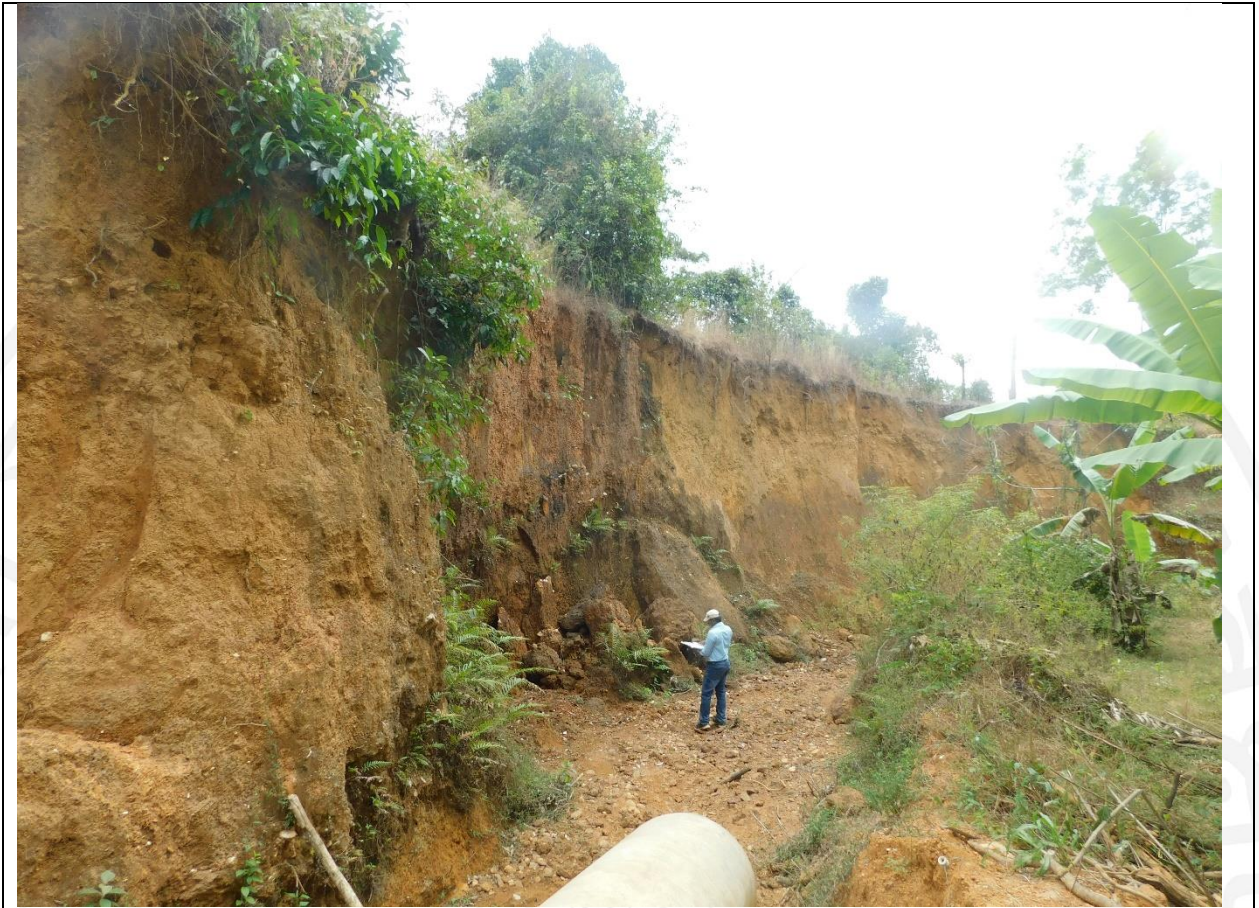
| 1 | Slide No. | KAR/SMG/48J/16/2018-19/48 |

| 22 | Failure Mechanism | Shallow Translational Failure |
| 37 | Geo-Scientific Causes | Weak slope forming material which is eroded by the stream coupled with incessant rainfall may leads to increase the pore pressure locally. |

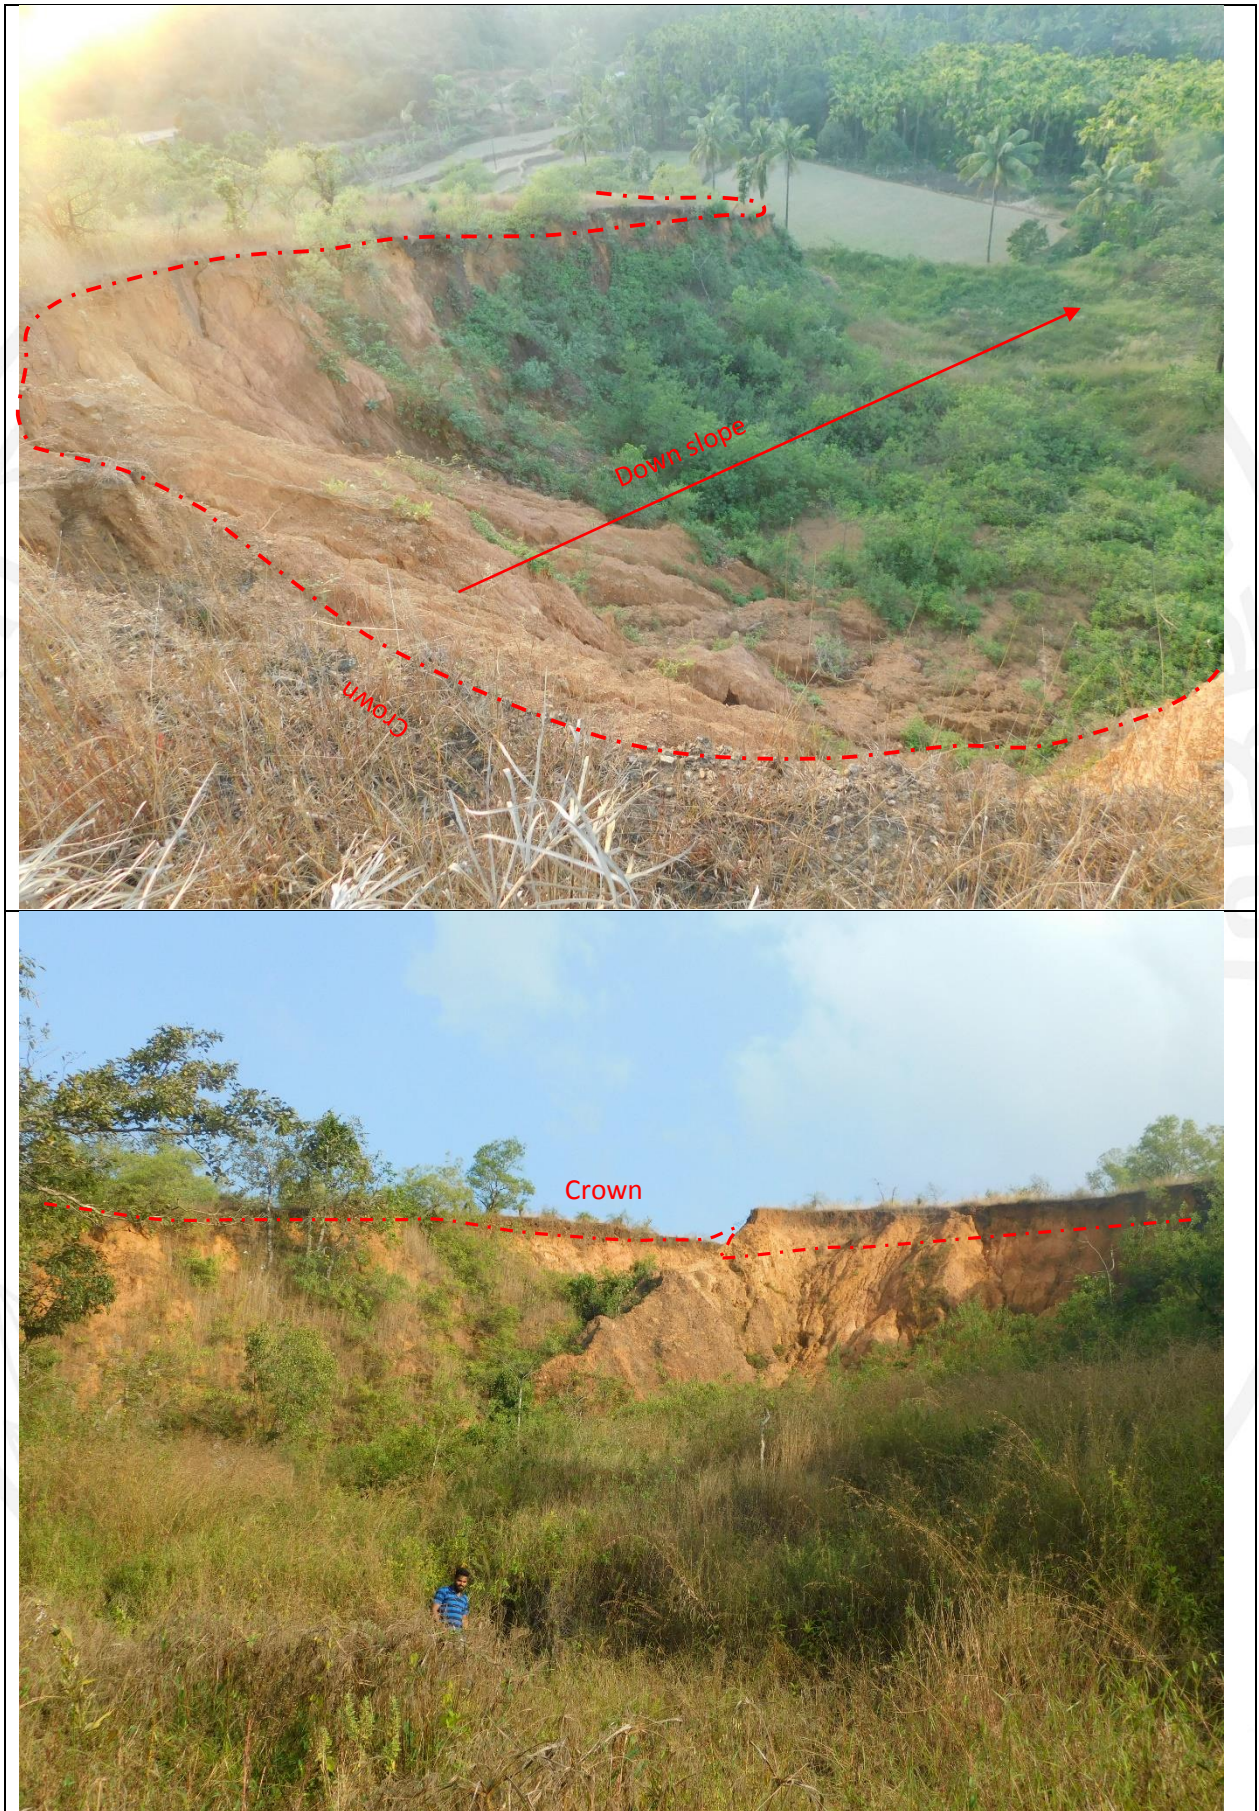
| 22 | Failure Mechanism | Deep Translational Failure |
| 37 | Geo-Scientific Causes | Steep slope with weak slope forming material and incessant rain fall may cause the increase of pore pressure and its leads to failure of the slope. |
| 40 | Summary | Soil slide occurred near to Banukuli village and the length, width and height is 12, 30 and 10m respectively. This slide is deep translational slide. Steep slope with weak slope forming material and incessant rain fall may cause the increase of pore pressure and its leads to failure of the slope. Divert the surface runoff around the slide area and easing of the slope from the crown as well as flank. Applying geo jute also helpful to reduce the soil erosion. |

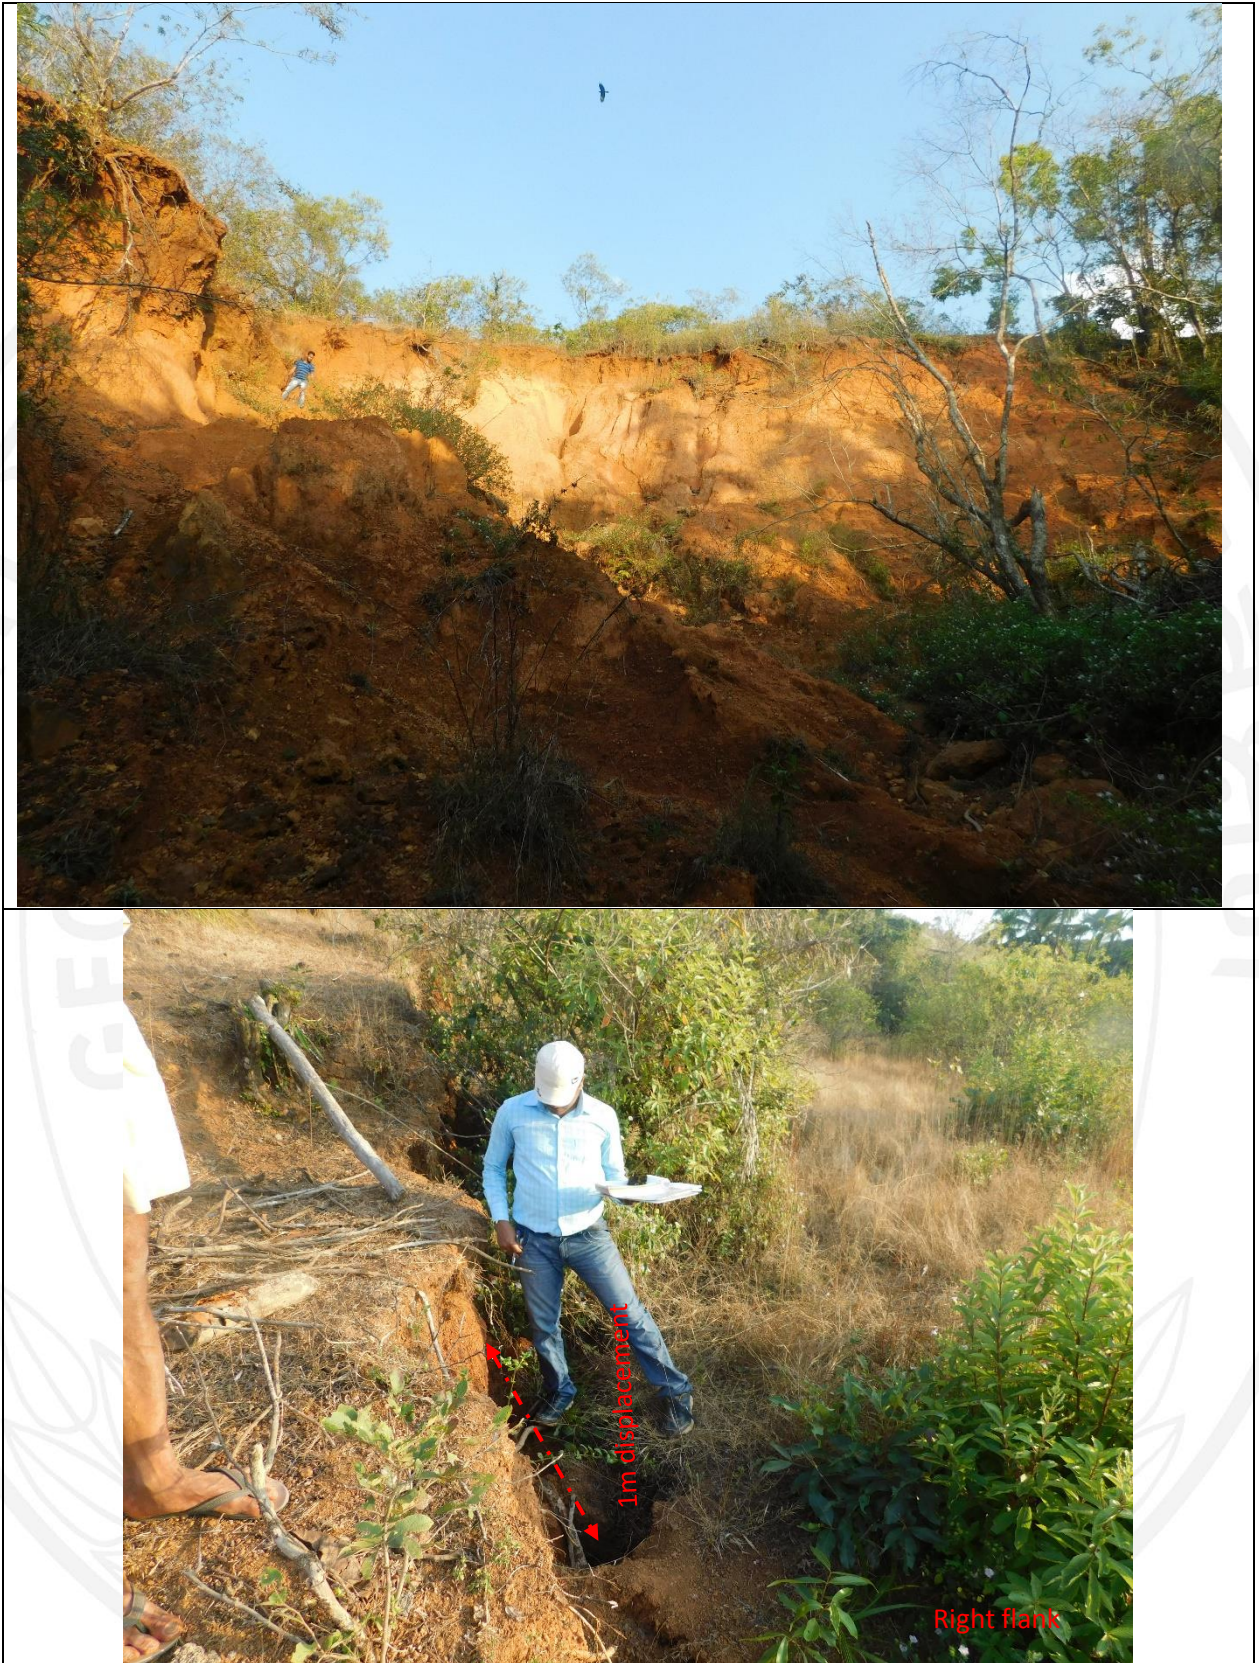
| 22 | Failure Mechanism | Shallow Translational Failure |
| 37 | Geo-Scientific Causes | Steep slope coupled with weak slope forming material and incessant rain fall may cause increase of local pore pressure. |
| 39 | Remarks | Crown cracks and displacement observed and they are very persistent. Well-developed successive cracks are seen in the field. |
| 40 | Summary | Soil slide occurred near to Banukuli village. Steep slope coupled with weak slope forming material and incessant rain fall may cause increase of local pore pressure are main cause for the slide . Slide material to be removed and easing of the slope and construction of retaining wall flowing stream to be lined to reduce the toe erosion. |

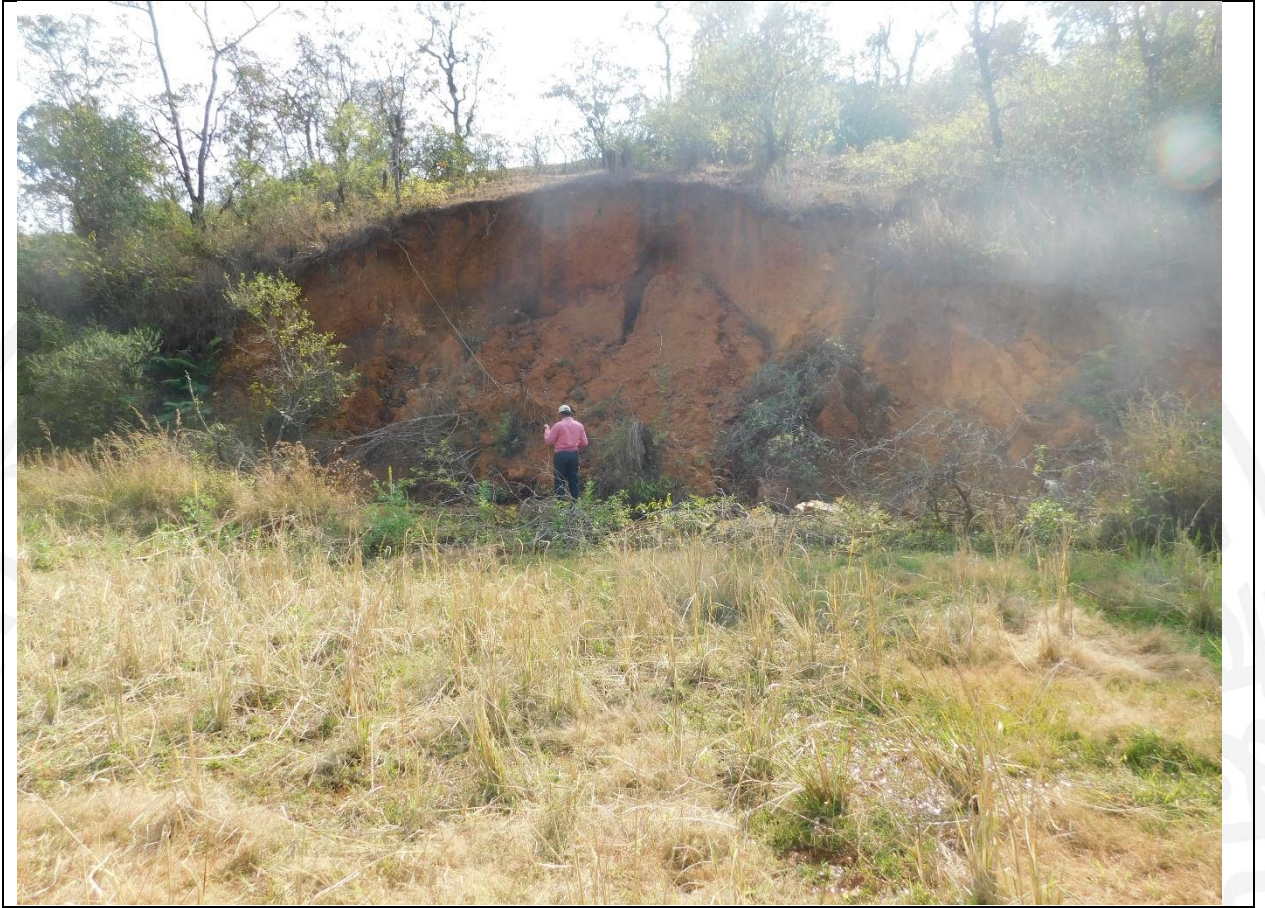
| 22 | Failure Mechanism | Shallow Translational Failure |
| 37 | Geo-Scientific Causes | Weak slope forming material which is eroded by the stream coupled with incessant rainfall may leads to increase the pore pressure locally. |

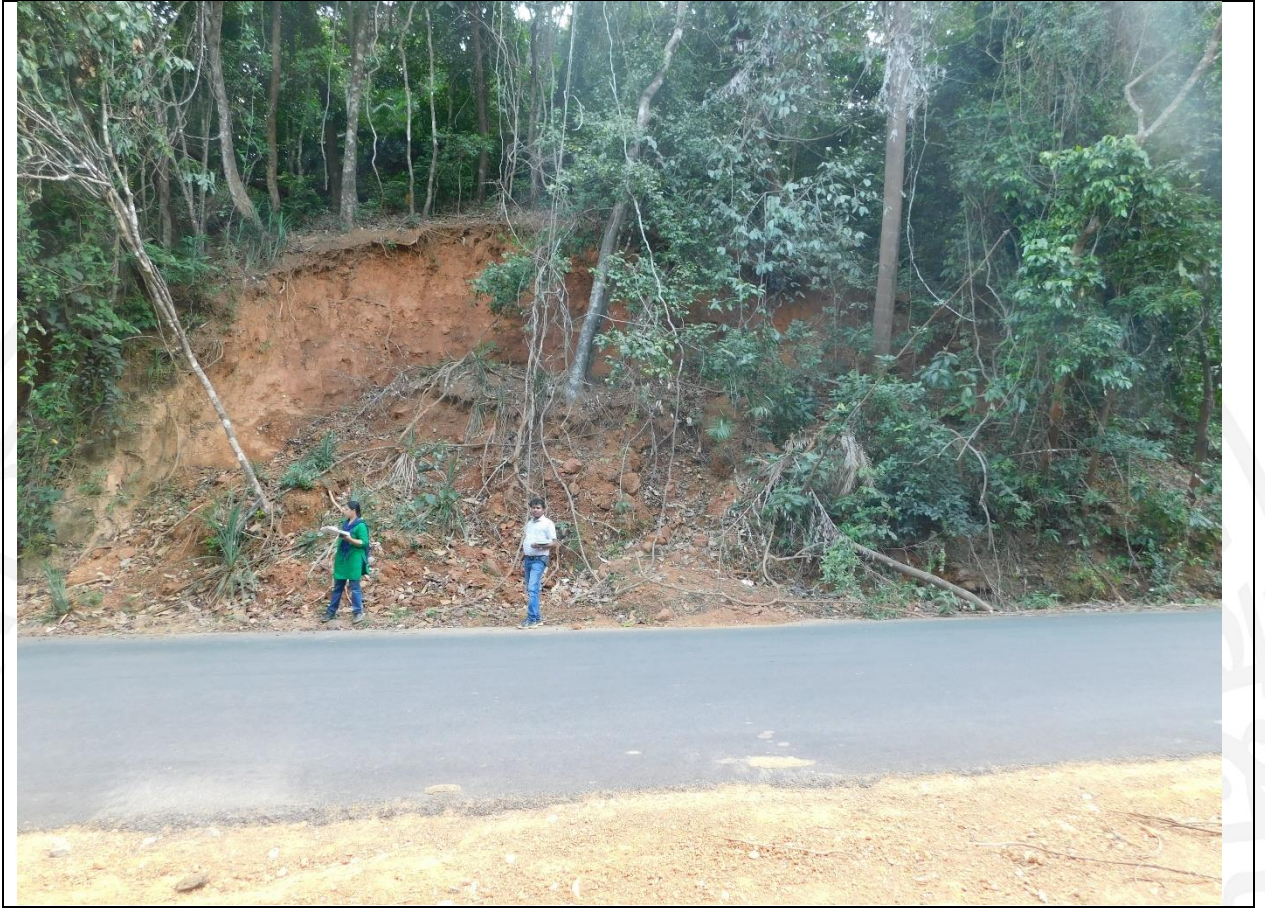
| 22 | Failure Mechanism | Shallow Translational Failure |
| 37 | Geo-Scientific Causes | Weak slope forming material coupled with incessant rainfall may leads to increase the pore pressure locally. Toe cut for construction of road. |

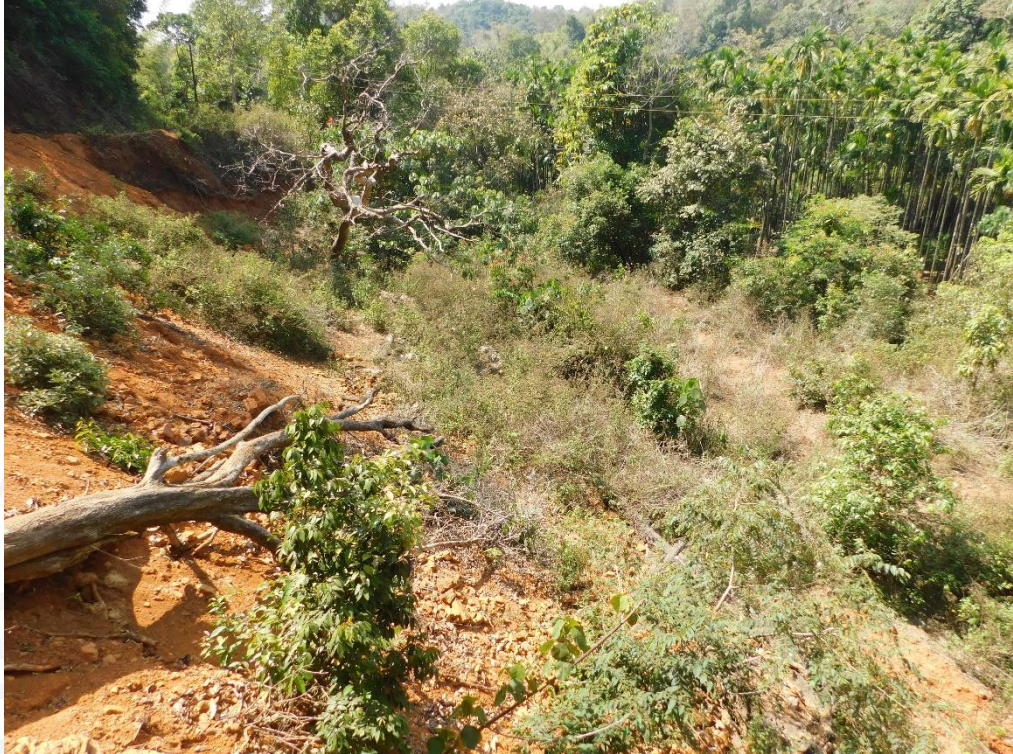
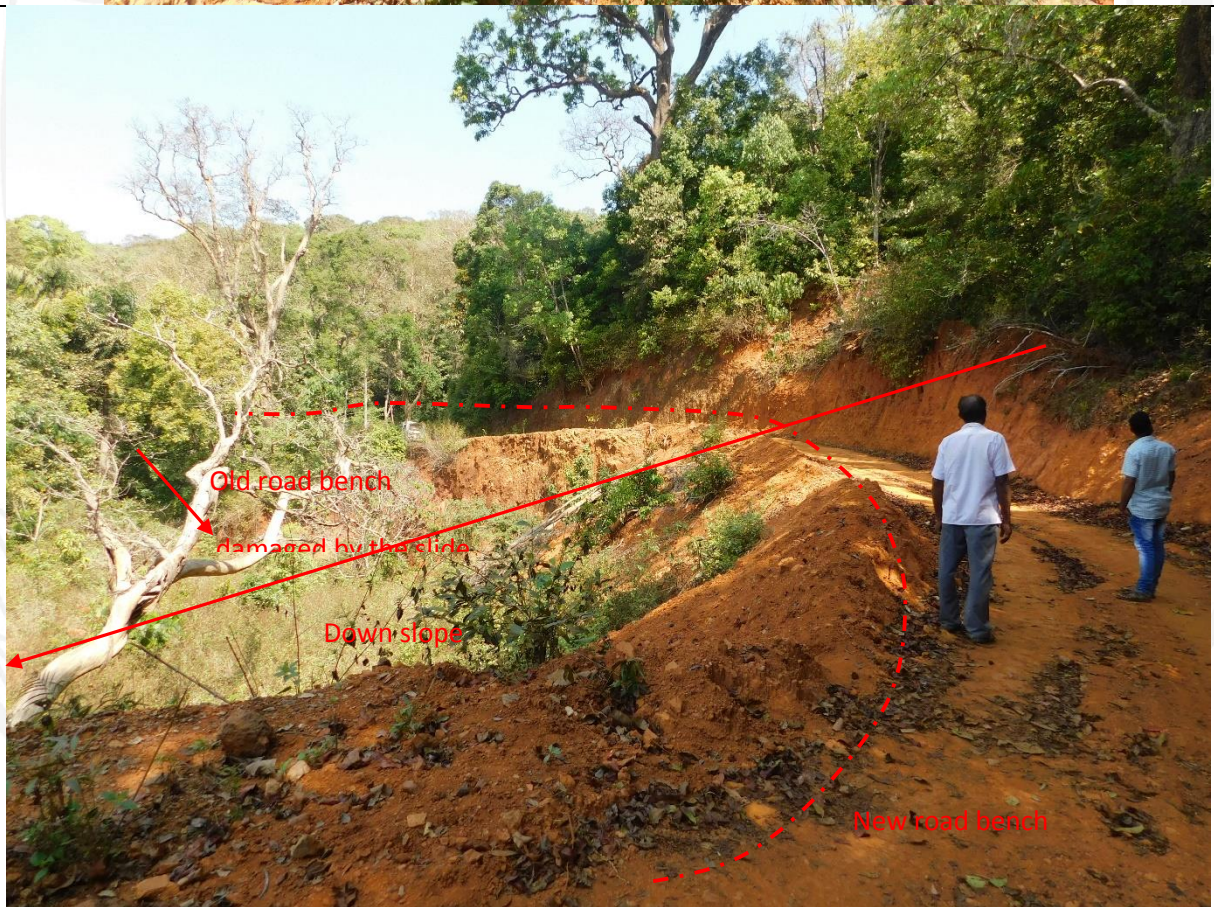
| 40 | Summary | Slide occurred near to Aravadi village. The length width and height of the slide is 40, 40 and 25m respectively. Vertical toe cut for the road construction and poor slope forming material continuous rainfall may cause for the increase of the pore pressure. Slide material to be removed and easing of the slope. Surface water flow to be diverted or toe drain to be constructed to avoid the infiltration of rainwater in the slide area. Easing of the crown portion and removal of the trees over the crown portion. |

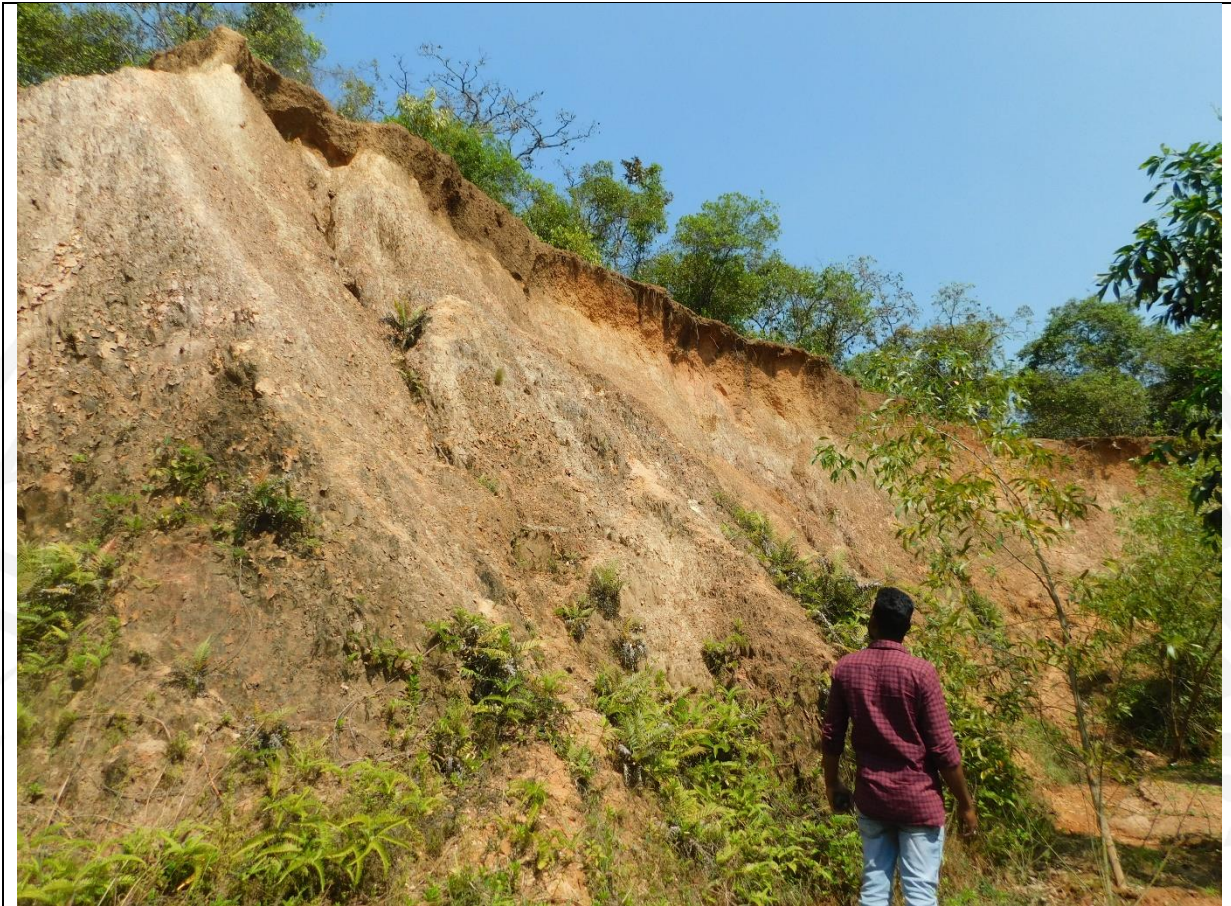
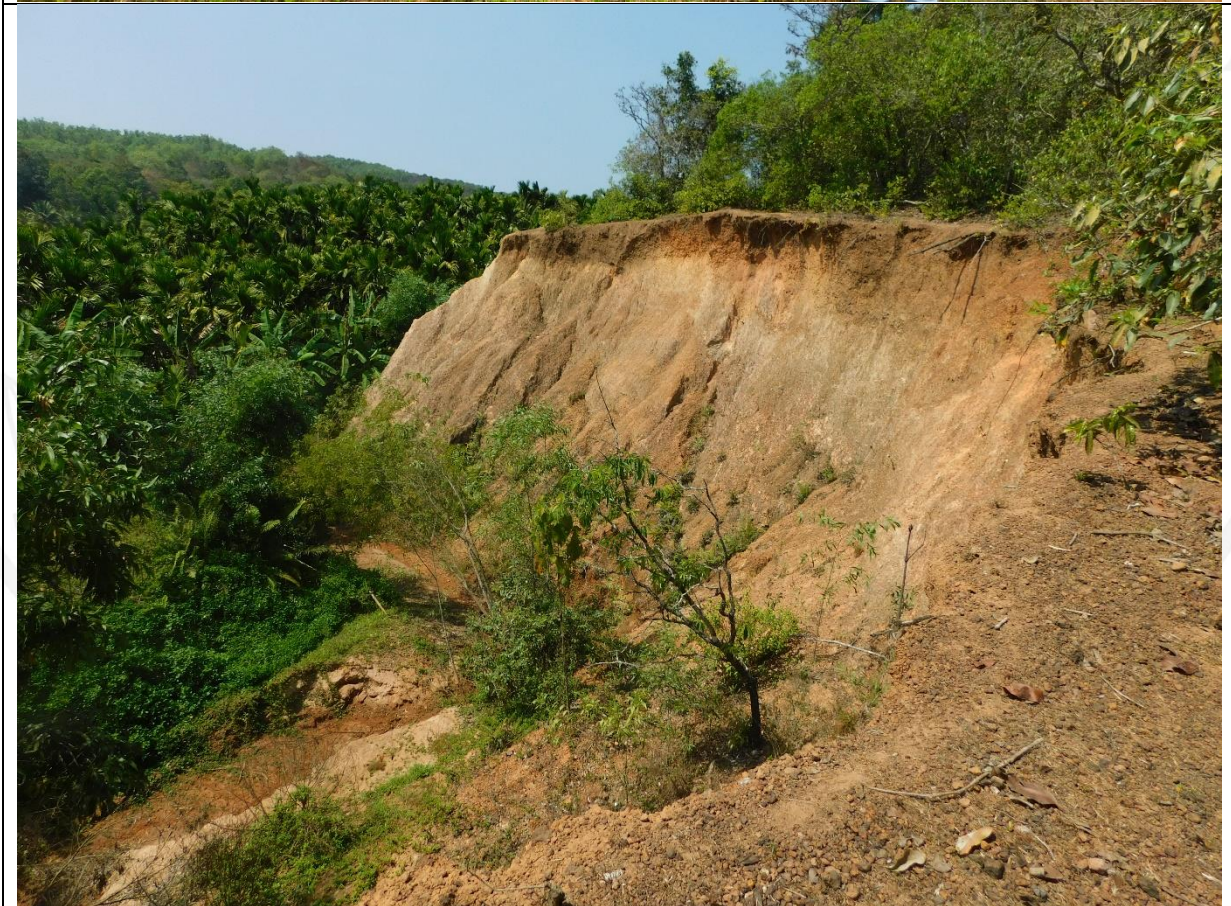
| 1 | Slide No. | KAR/SMG/48J/16/2018-19/71 |

| 22 | Failure Mechanism | Shallow Translational Failure |
| 37 | Geo-Scientific Causes | Presence of clayey soft slope forming material and incessant rainfall cause for this landslide. |
| 39 | Remarks | Rill erosion observed over the presence of soft clayey materials. |
| 40 | Summary | The soil slide occurred in and around Bramanakeppige and the dimension of the slide is 12 m length, 55 width and 11 m height. The slide initiated due to presence of clayey soft slope forming material and incessant rainfall cause for this landslide. |
| 41 | Category | Category-II |

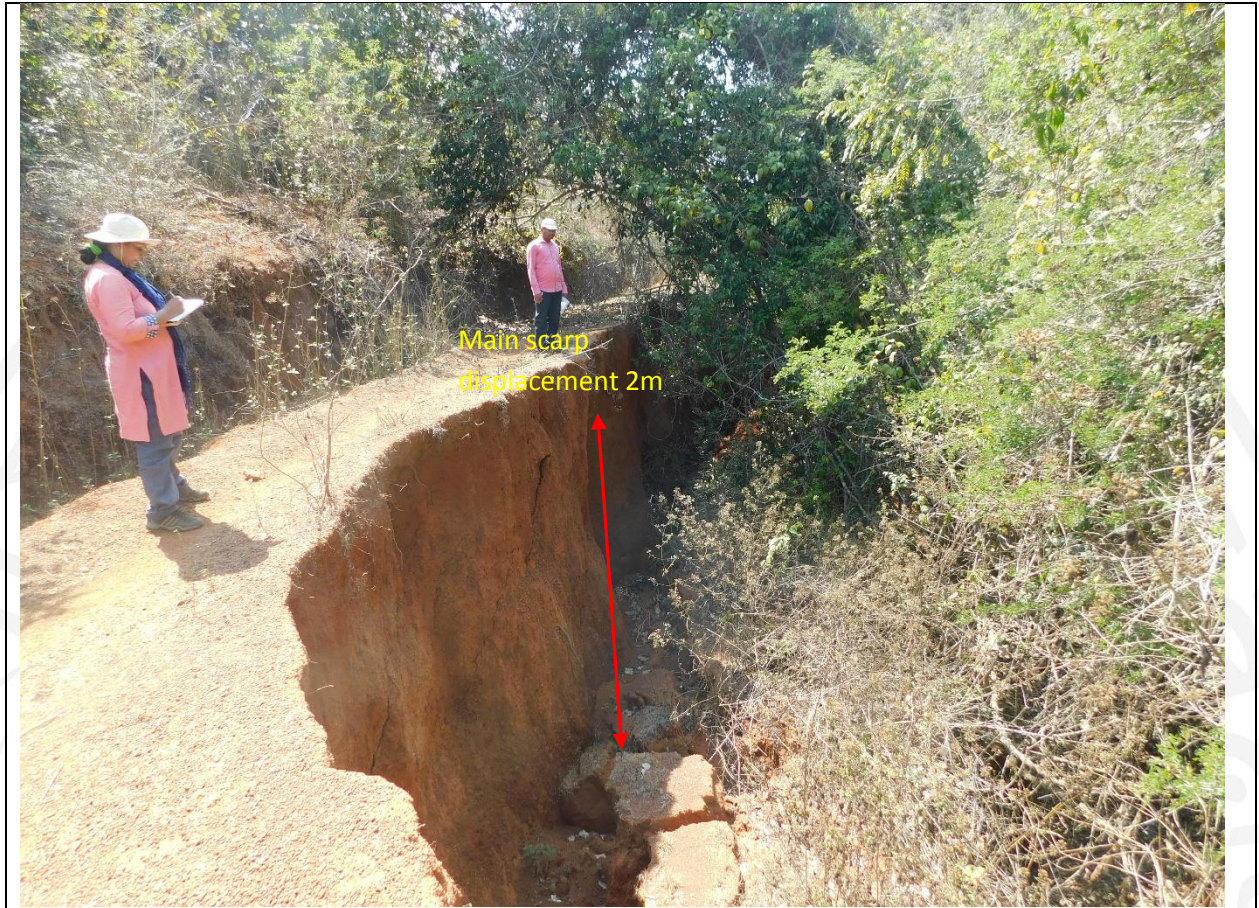
| 22 | Failure Mechanism | Deep Translational Failure |
| 37 | Geo-Scientific Causes | Presence of weak slope forming material with huge thickness of overburden. Incessant rainfall aggravated the landslide by increasing of the local pore pressure. |
| 40 | Summary | The soil slide occurred in and around Bramanakeppige and the dimension of the slide is 30 m length, 80 width and 27 m height. Geo scientific cause for the slide is presence of weak slope forming material with huge thickness of overburden. Incessant rainfall aggravated the landslide by increasing of the local pore pressure. |
| 41 | Category | Category-II |

| 38 | Remedial Measures | Slide material to be removed and easing of the slope to be done. Surface runoff to be diverted from the crown portion to avoid the infiltration of rain water. |

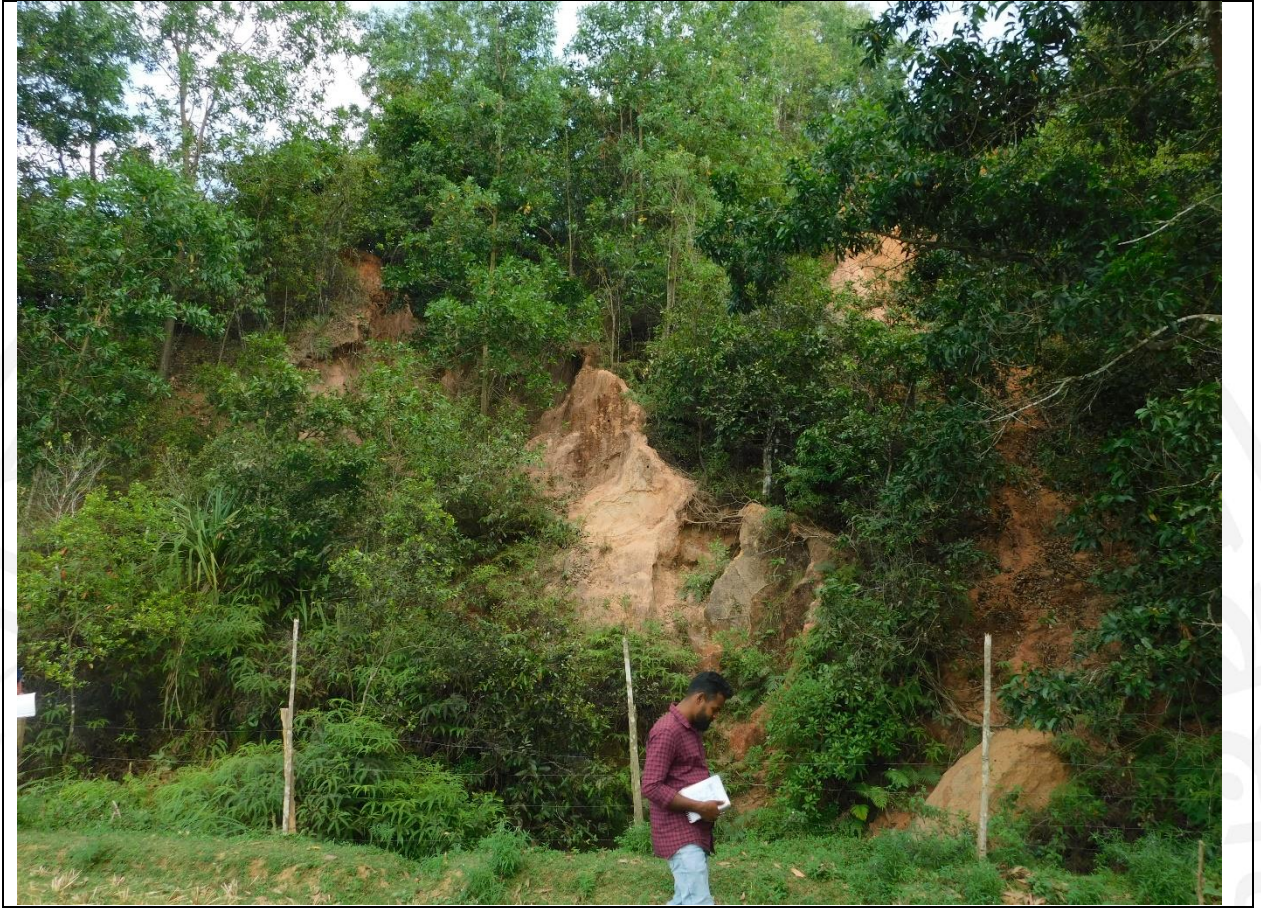
| 1 | Slide No. | KAR/SMG/48J/16/2018-19/73 |

| 22 | Failure Mechanism | Shallow Translational Failure |
| 37 | Geo-Scientific Causes | Presence of weak slope forming material with huge thickness of overburden cut by flowing stream. Incessant rainfall aggravated the landslide by increasing of the local pore pressure. |
| 41 | Category | Category-III |

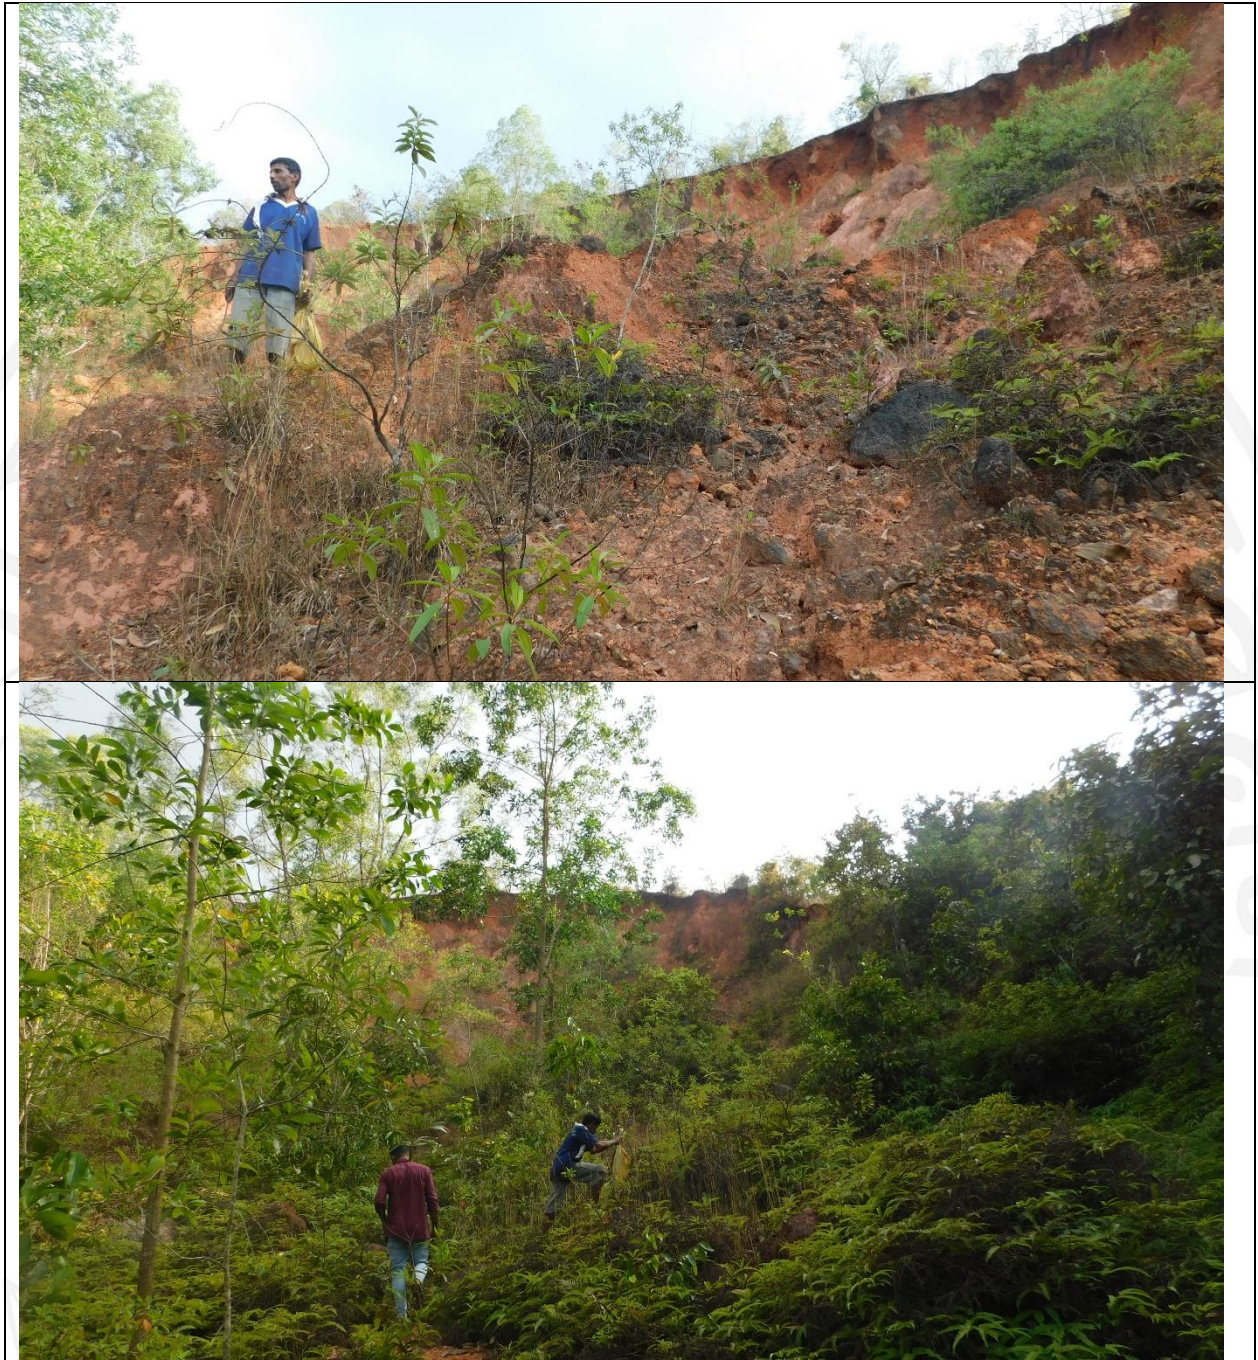
| 1 | Slide No. | KAR/SMG/48J/16/2018-19/74 |

| 22 | Failure Mechanism | Deep Translational Failure |
| 37 | Geo-Scientific Causes | Steep slope presence of weak slope forming material having huge thickness of soil. The slide aggravated by incessant rain fall. |
| 41 | Category | Category-III |

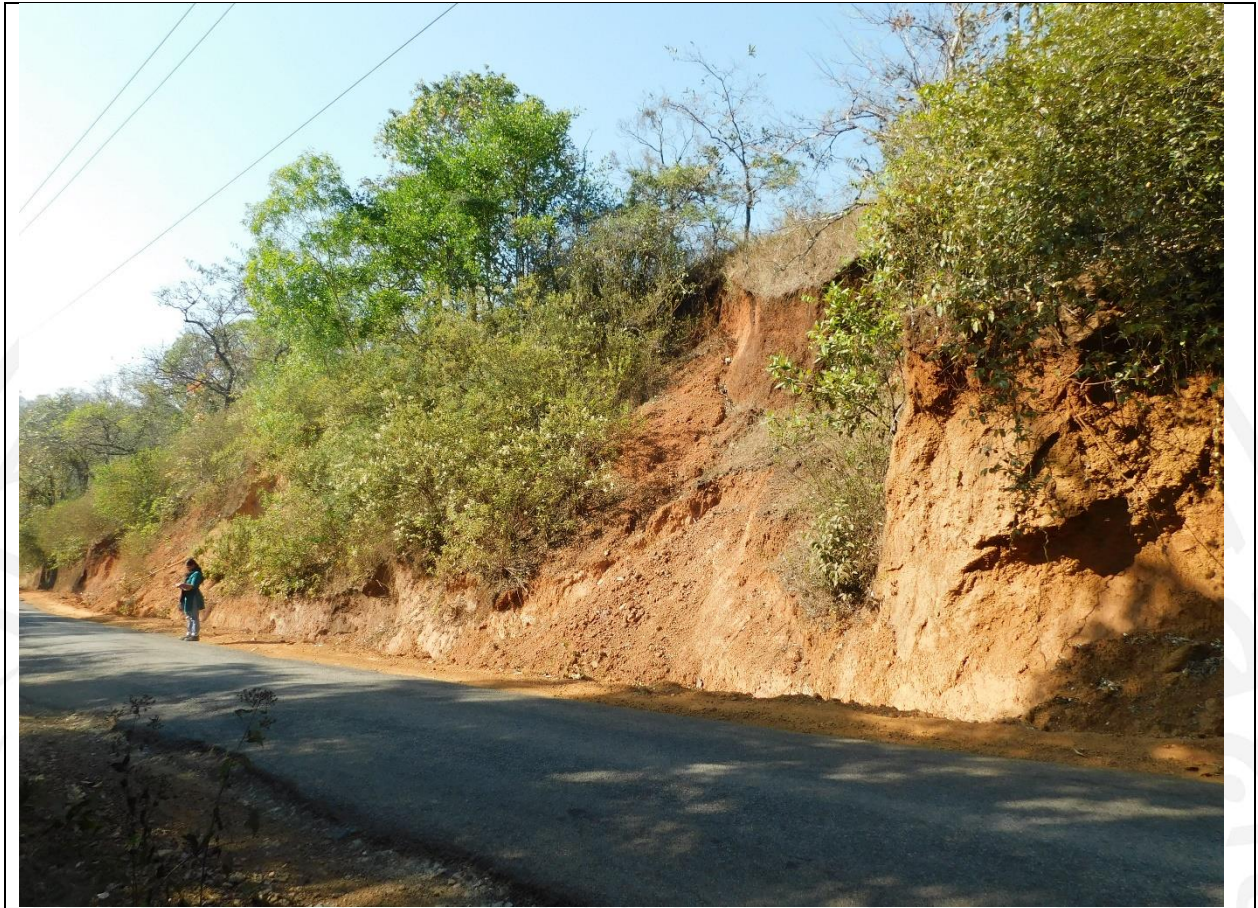
| 1 | Slide No. | KAR/SMG/48J/16/2018-19/75 |

| 22 | Failure Mechanism | Shallow Translational Failure |
| 37 | Geo-Scientific Causes | Thick overburden toe cut for road construction and incessant main cause for the slide. |
| 40 | Summary | The slide documented near to Samase village. The dimension of the slide is 9 m length, 30 width and 8 m height. Geo scientific cause for the slide is presence of thick overburden toe cut for road construction and incessant main cause for the slide. |
| 41 | Category | Category-III |

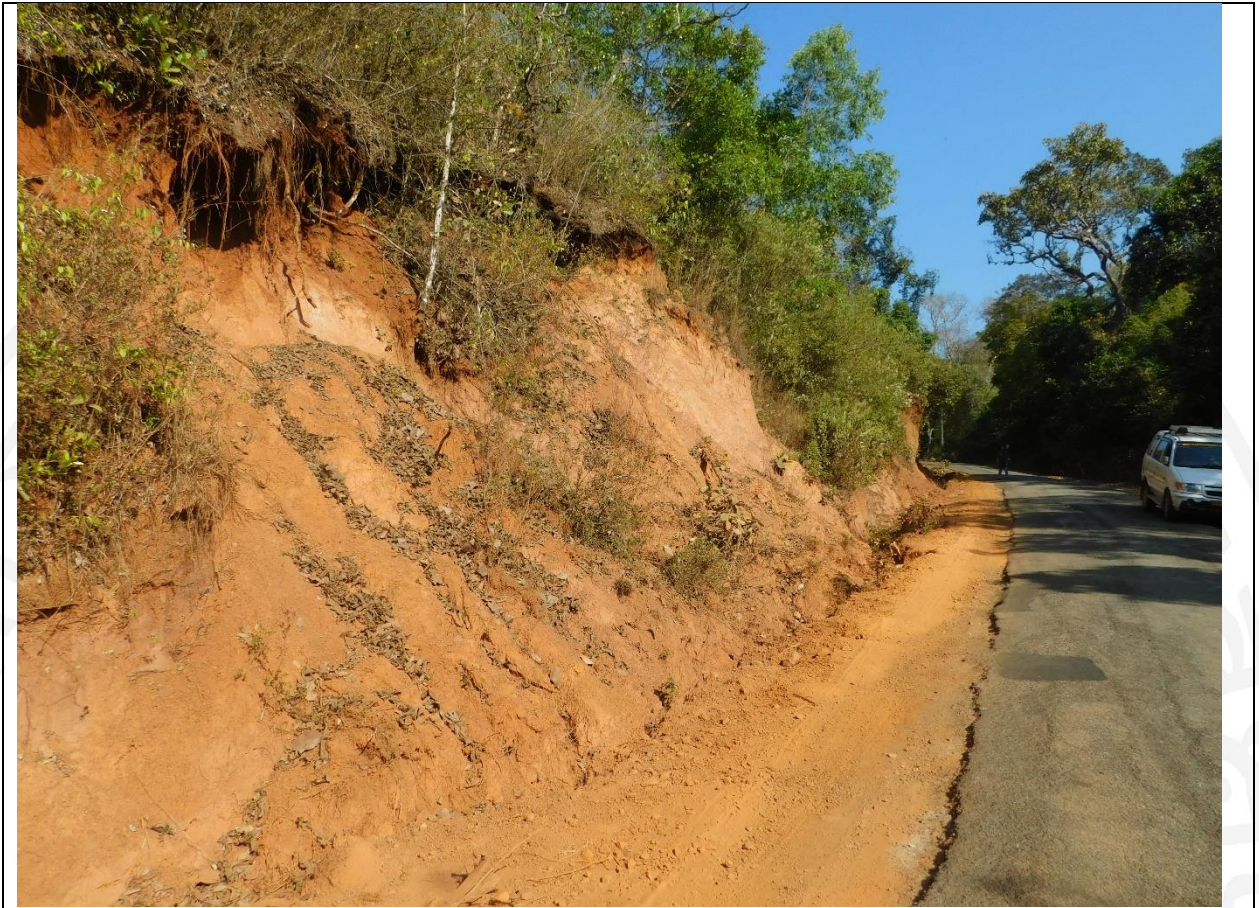
| 1 | Slide No. | KAR/SMG/48J/16/2018-19/76 |

| 22 | Failure Mechanism | Shallow Translational Failure |
| 37 | Geo-Scientific Causes | Thick overburden material and toe cut by the stream vibration of the vehicle and incessant rainfall major cause for the landslide. |
| 40 | Summary | The slide documented near to 0.3Km SW of Samase village. The dimension of the slide is 20 m length, 18 width and 40 m height. Geo scientific cause for the slide is presence of thick overburden toe cut for road construction and incessant main cause for the slide. |
| 41 | Category | Category-III |
