**Macro scale (1:50,000) Landslide Susceptibility Mapping in parts of  
Toposheets Nos. 48J/12 and 48J/16, Uttara Kannada  
and Shimoga Districts, Karnataka**

Item No.: M4LSSM/NC/SR/SU-KG/2018/20207

Final report for field season 2018-19

**K. Senthil Kumar, Geologist and Salu S, Senior Geologist (PT)**

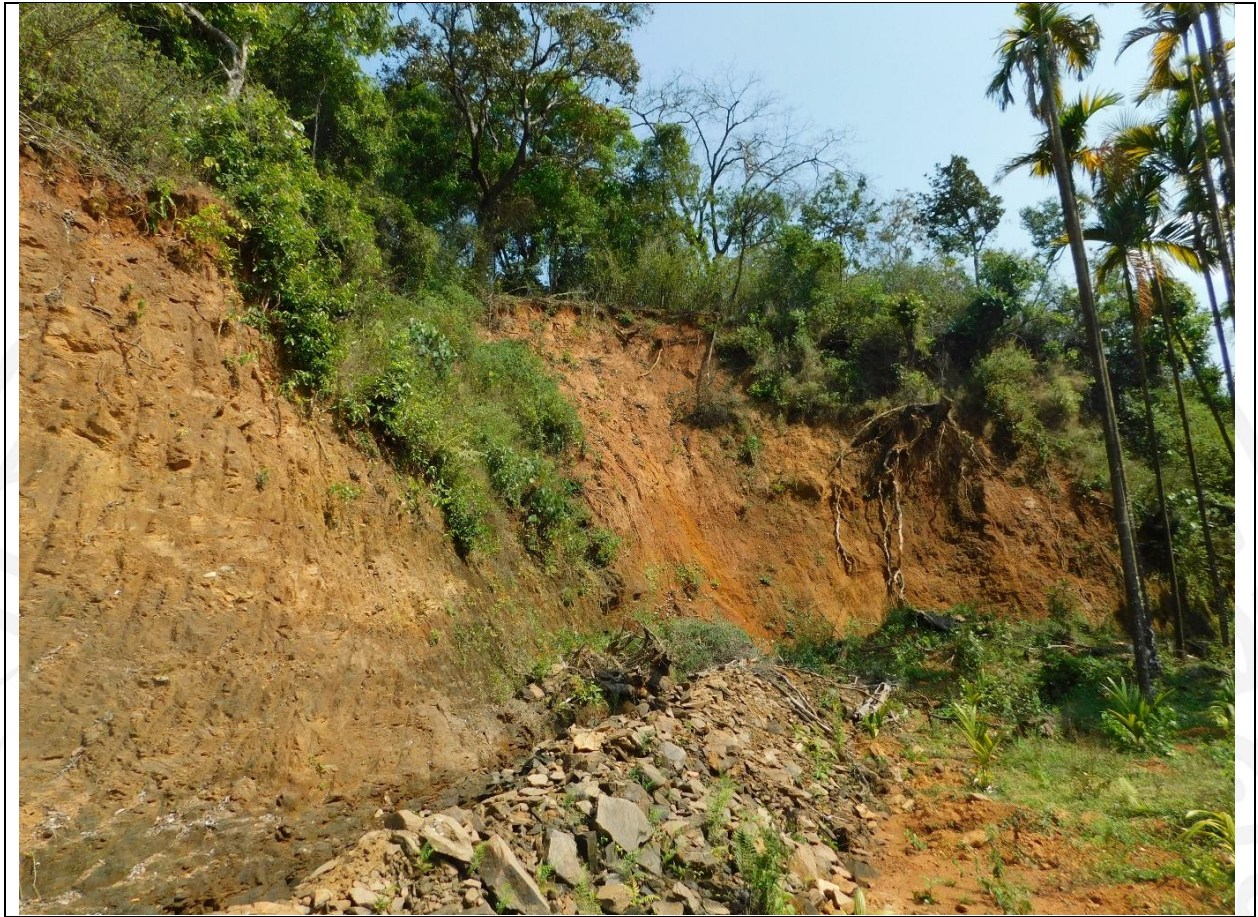
| 22 | Failure Mechanism | Deep Translational Failure |
| 37 | Geo-Scientific Causes | Presence of thick over burden material losses its strength by increasing local pore water pressure due to incessant rainfall and toe cut by flowing stream. |
| 40 | Summary | The slide documented near to Kandavalli village. The dimension of the slide is 25 m length, 120 m width and 18 m height. Geo scientific cause for the slide is presence of thick over burden material losses its strength by increasing local pore water pressure due to incessant rainfall and toe cut by flowing stream. |
| 41 | Category | Category-III |

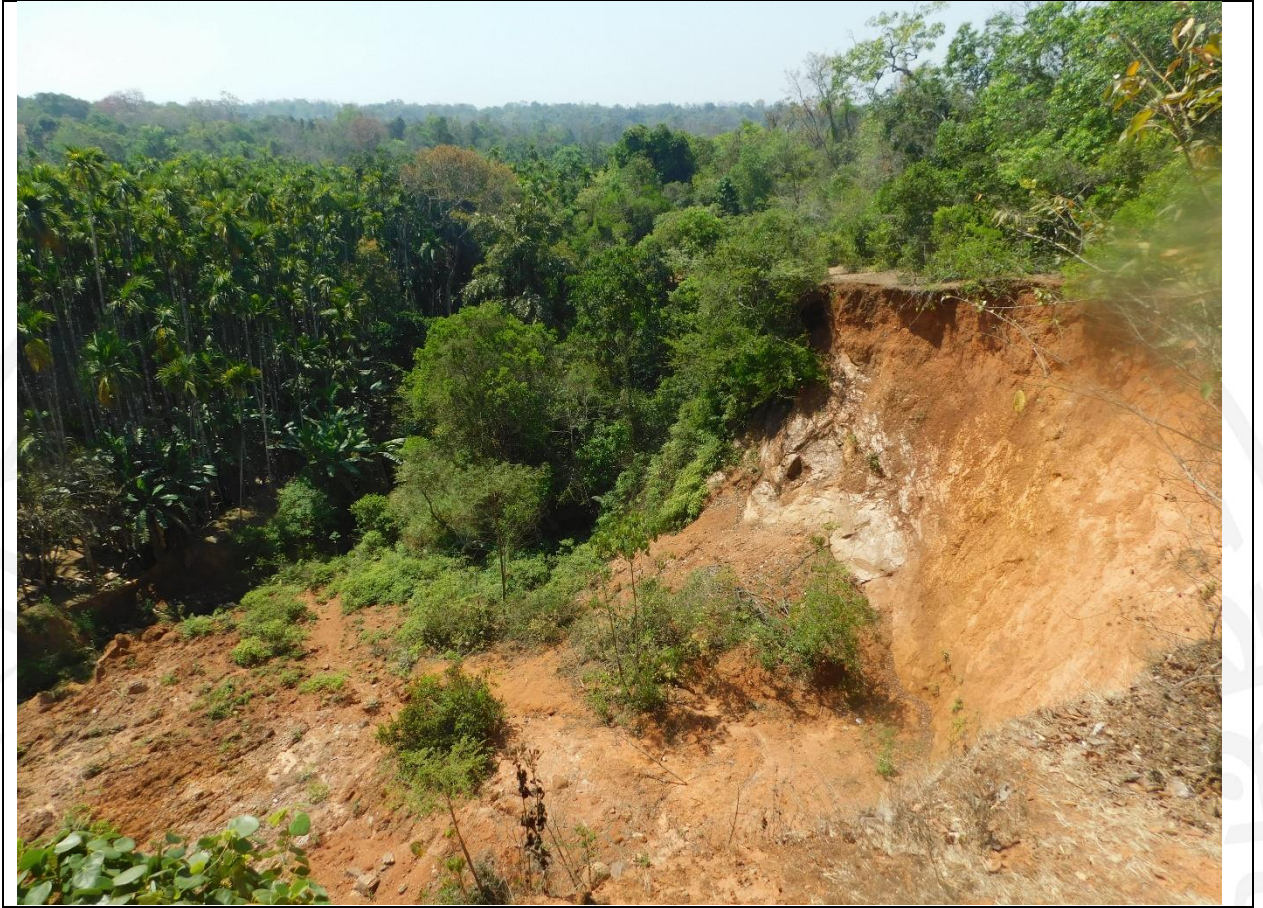
| 22 | Failure Mechanism | Deep Translational Failure |
| 37 | Geo-Scientific Causes | Steep slope coupled with incessant rainfall and toe cutting by stream and weak slope forming material. |
| 40 | Summary | The slide documented near to Vaddahalli village. The dimension of the slide is 30 m length, 45 m width and 28 m height. Geo scientific cause for the slide is presence of Steep slope coupled with incessant rainfall and toe cutting by stream and weak slope forming material. |
| 41 | Category | Category-II |

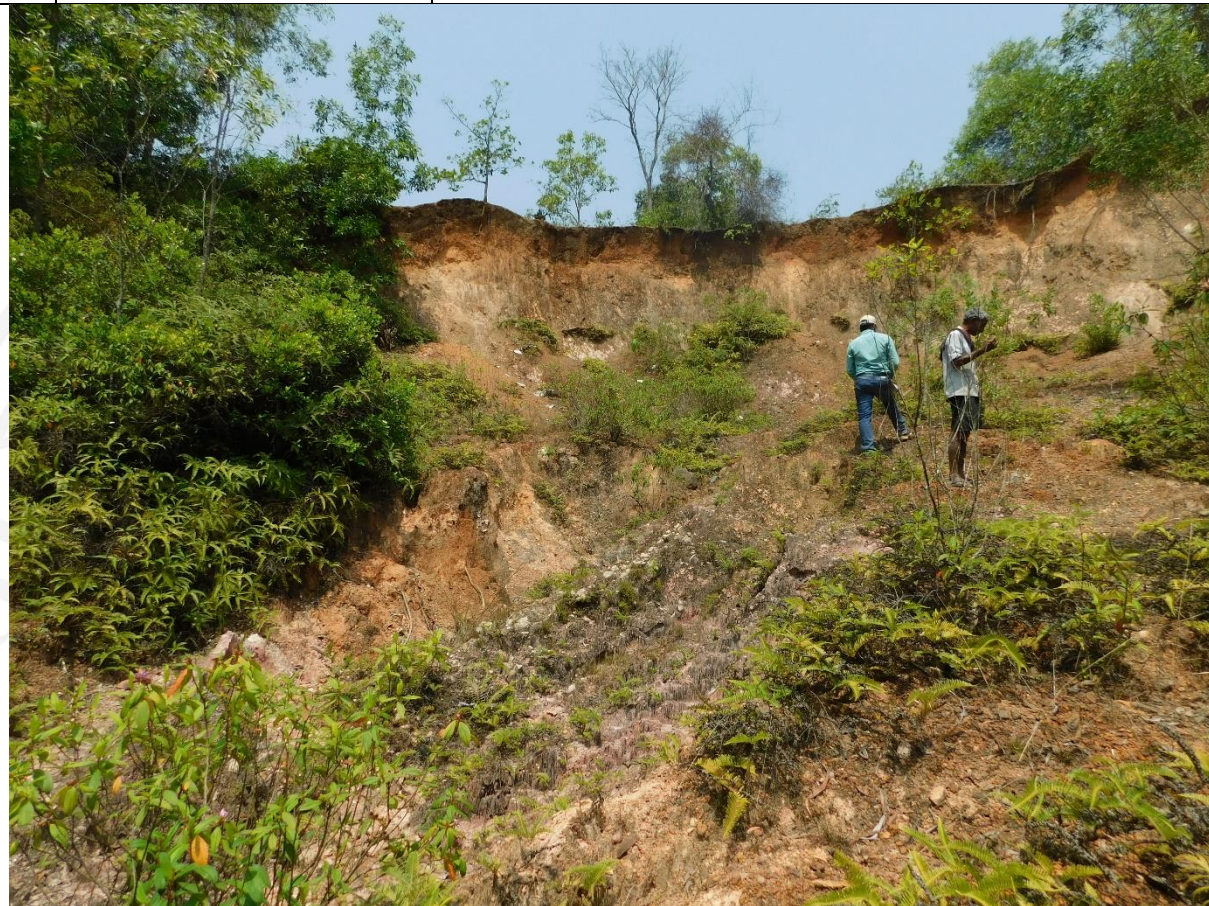
| 40 | Summary | The slide documented near to Marakatte village. The dimension of the slide is 25 m length, 35 m width and 15 m height. Steep slope and weak slope forming material (soft clay) coupled with incessant rainfall may leads to increase the hydrostatic pressure locally. Excess rainwater in the stream which cut the toe and it leads to failure of the slope. |
| 41 | Category | Category-II |
