**Macro-scale (1:50,000) Landslide Susceptibility Mapping in parts of Toposheets nos. 48I/05, 48I/06, & 48I/07 Belgaum, Uttar Kannada districts, Karnataka and North Goa & South Goa districts, Goa.**

टोपोशीट सं./ Toposheet No.: 48I/05, 48I/06, 48I/07  
मद संख्या: M4LSSM/एनसी/एस आर/SU-KG/2018/18717  
Item no.: M4LSSM/NC/SR/SU-KG/2018/18717

**कार्य सत्र 2018-19 का अंतिम प्रतिवेदन**  
**Final report for field season 2018-19**

**नेहा कुमारी, भू-वैज्ञानिक एवं कमल कुमार, भू-वैज्ञानिक**  
**Neha Kumari, Geologist And Kamal Kumar, Geologist**

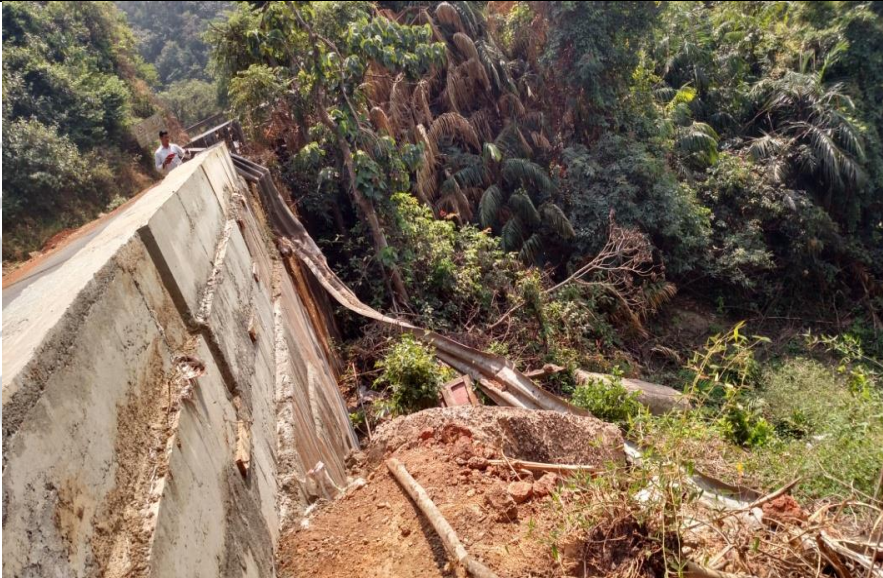
| No | Field | | Description |
|---|---|---|---|
| 38 | Remarks, if any | : | Road subsidence occurred due to loading on upslope. |

| 40 | Summary/Abstract | : | The road subsidence has resulted in upslope and material slid in the downward direction. The high height breast wall with weep holes should be constructed for toe support with proper drainage. The subsidence of road occurred in convex curve of the road. |

| No | Field | | Description |
|---|---|---|---|
| 37 | Remedial measures | : | In Down slope of road subsidence high height retaining wall/breast wall with weep holes should be constructed to provide toe support and proper drainage on slope. |

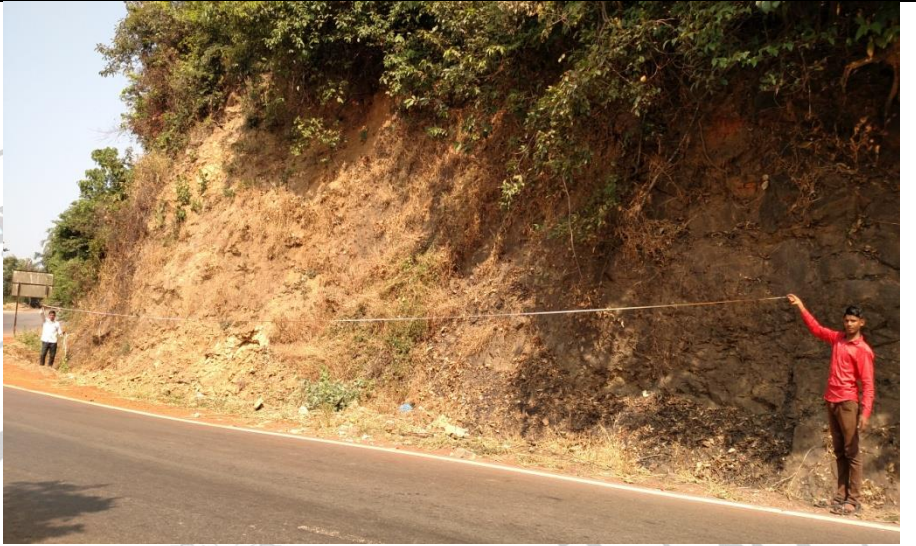
| No | Field | | Description |
|---|---|---|---|
| 38 | Remarks, if any | : | At present the risk is Moderate. |

| 40 | Summary/Abstract | : | The road subsidence has resulted in upslope and material slided in the downward direction. The high height breast wall with weep holes should be constructed for toe support with proper drainage. The subsidence of road occurred in convex curve of the road. |

| No | Field | | Description |
|---|---|---|---|
| 37 | Remedial measures | : | Slope regradation is required. |

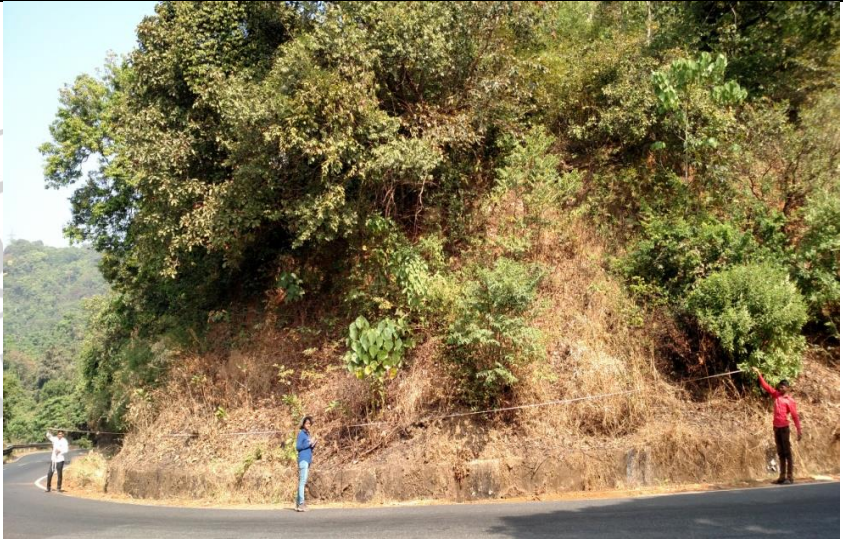
| No | Field | | Description |
|---|---|---|---|
| 38 | Remarks, if any | : | The risk factor is low as the zone is stable. |

| 40 | Summary/Abstract | : | The sliding zone is in the convex curve of the ghat road section. At present the sliding zone is stable covered with dense vegetation. |

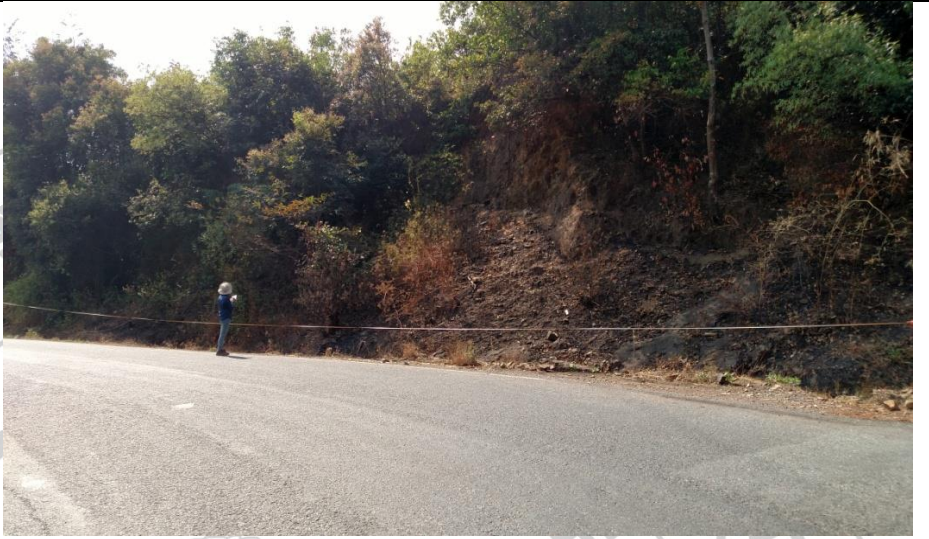
| No | Field | | Description |
|---|---|---|---|
| 38 | Remarks, if any | : | At present the area can be demarcated as unstable zone. |

| 40 | Summary/Abstract | : | The shallow debris slide occurred due to weathering and erosion of the slope forming material. At present the zone is susceptible for landslips. |

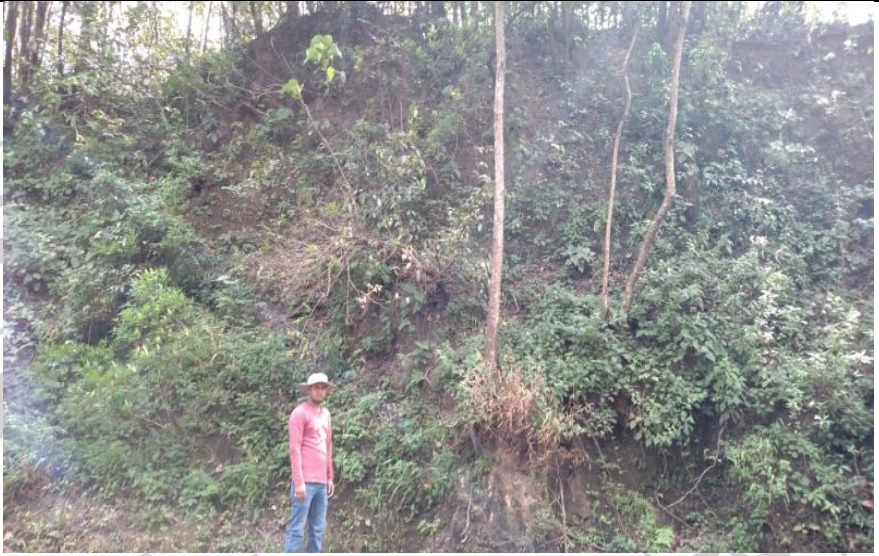
| No | Field | | Description |
|---|---|---|---|
| 38 | Remarks, if any | : | Adjacent to 1 <sup>st</sup> order drainage the area has undergone intense weathering and erosion. |

| 40 | Summary/Abstract | : | The slide is retrogressive in nature; the lateritization indicates the water saturation, weathering and erosion of slope forming material along the 1st order nala that saturated the slope during the monsoon along the weaker section along the nala. |

| No | Field | | Description |
|---|---|---|---|
| 37 | Remedial measures | : | Lined drainage at toe part is required to avoid toe erosion. |

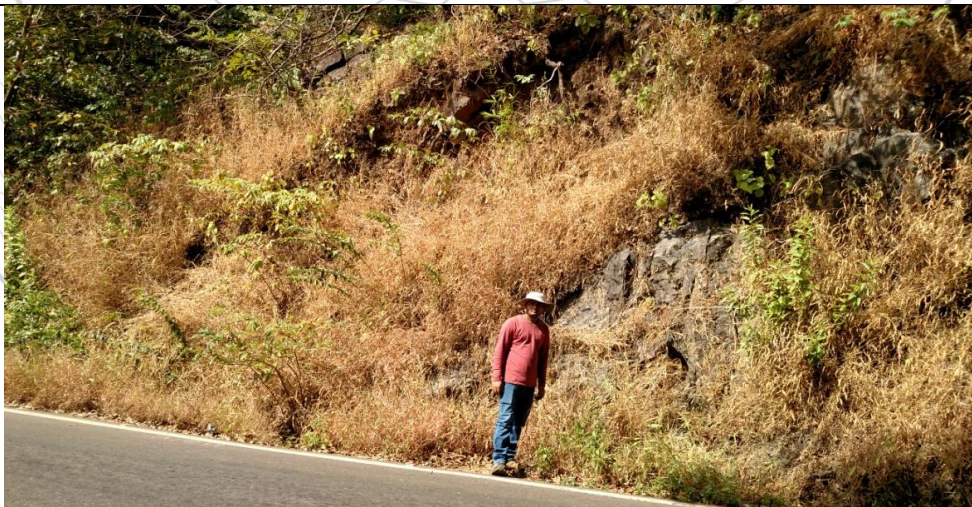
Photo 3

**Photo3: Field Photographs showing Extensive Cut Slope along Anmod-mollem Ghat road NH-4A**

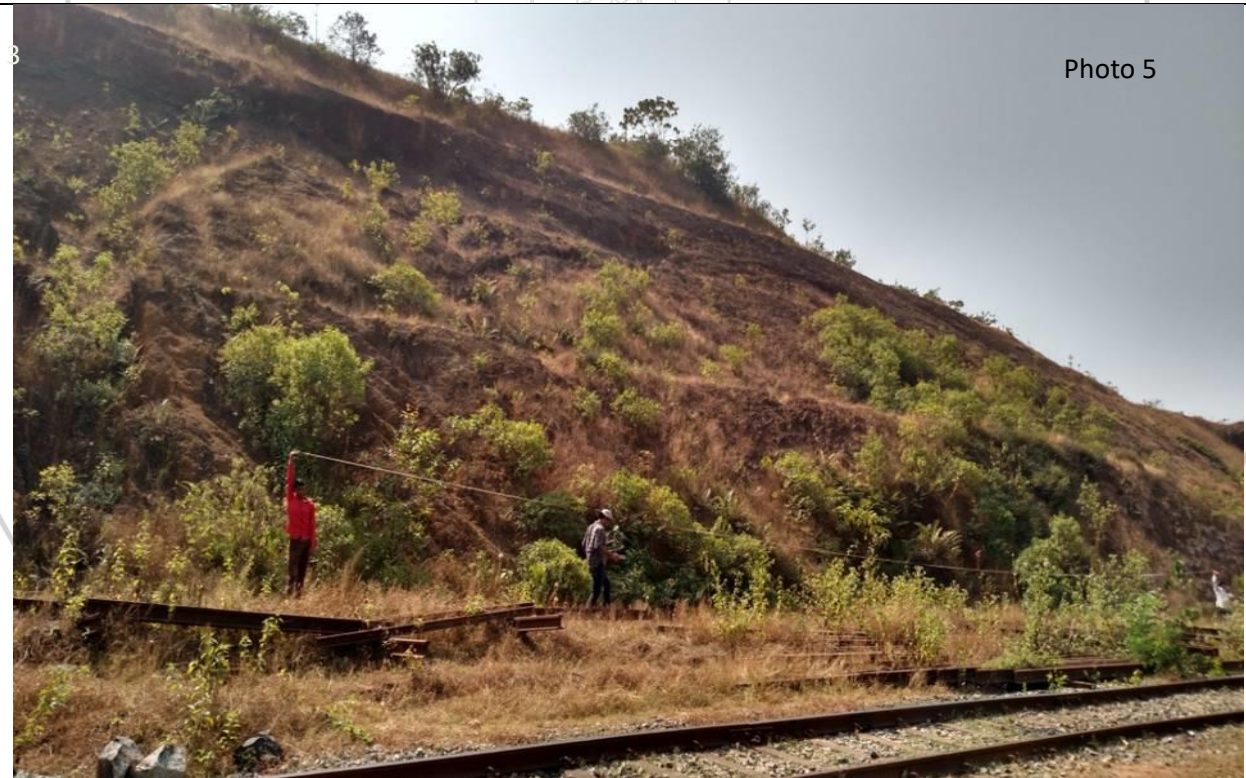
Photo 5

**Photo 5: Field Photographs showing Extensive Cut Slope on Castle rock Railway line section**
