**MACRO-SCALE (1:50,000) LANDSLIDE SUSCEPTIBILITY MAPPING IN PARTS  
OF TOPOSHEET NOS. 48O/1, 48O/5 AND 48N/8 SHIMOGA AND CHIKMAGALUR  
DISTRICTS, KARNATAKA**

Item no.: M4LSSM/NC/SR/SU-KG/2019/25180

कार्य सत्र: 2019-20/Field Season 2019-20

रस्या रघु, वरिष्ठ भूवैज्ञानिक/Resya Reghu, Senior Geologist  
सेंतिलकुमार. के, भूवैज्ञानिक/Senthilkumar.K, Geologist

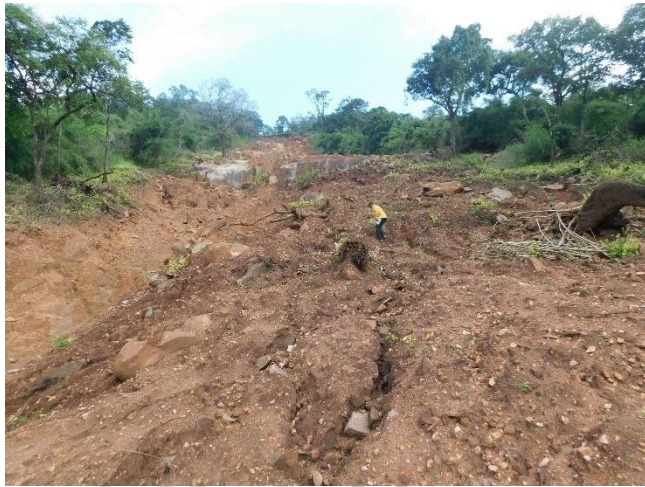
Natural landslides are very less in the toposheet no 48O/5 area. Large debris flows **(Photo 3.1a, 3.1b, 3.1c and 3.1d)** documented in the forest areas near Alase, Hanigeri, Hegalatti, Vemali Gutta and Devara Gudda of Toposheet no.48O/5. The causative factor is heavy rainfall during the fortnight of August 2019.

**Photo 3. 1a** Debris flow near Hegalathi village  
(Lat:13° 50'7.27" Long: 74° 27'1 49.20")

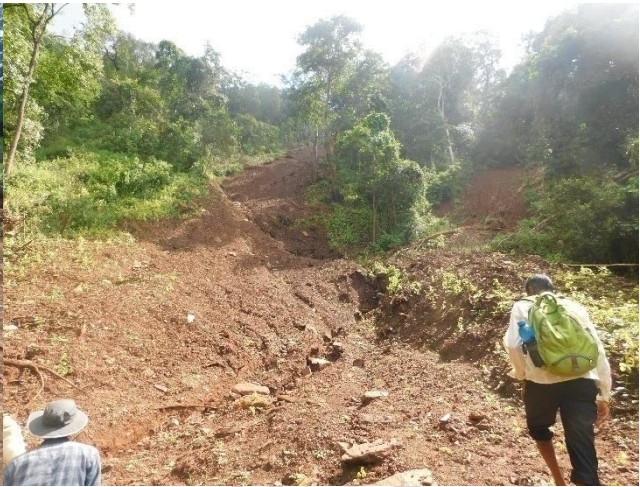
**Photo 3. 1b** Debris flow near Hanigeri village (Lat: 13° 51' 13.71" Long: 75° 25' 21.87")

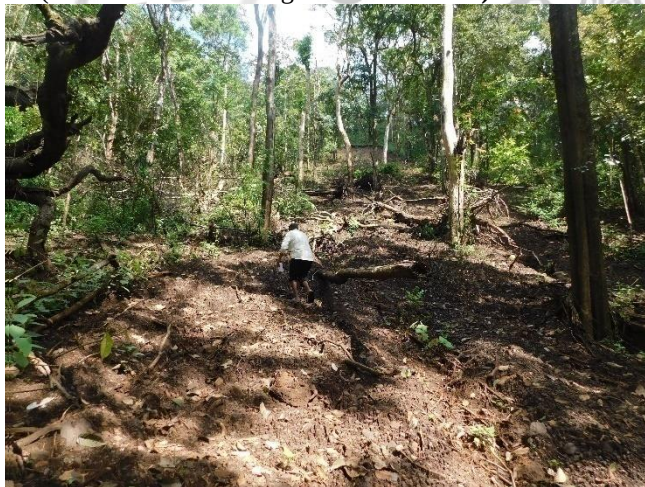
**Photo 3. 1c** Debris flow near Hanigeri village  
(Lat: 13° 51' 0.47" Long: 75° 25' 20.02")

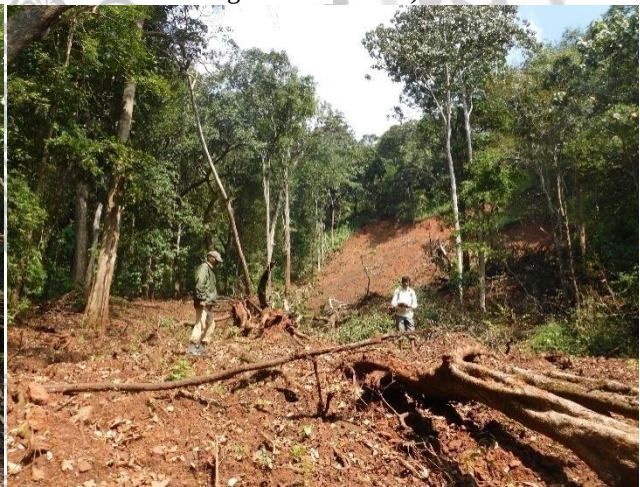
**Photo 3. 1d** Debris flow near Hanigeri village  
Lat: 13°51' 58.88" Long: 75° 25' 8.30")

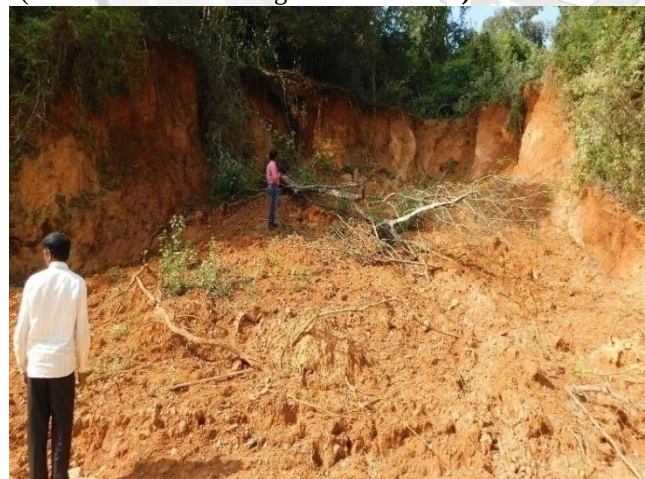
**Photo 3. 2a** Debris slide near Nagarakudige village  
(Lat: 13° 51' 8.36" Long: 75° 05'59.39")

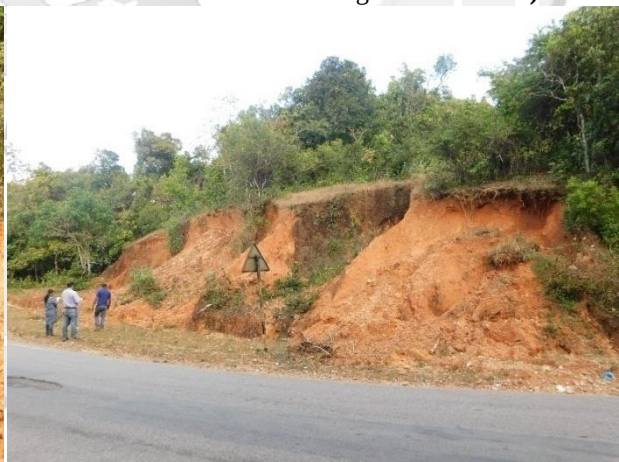
**Photo 3. 2b** Debris slide along SH-52  
(Lat: 13°50'55.98" Long: 75°03'50.04")

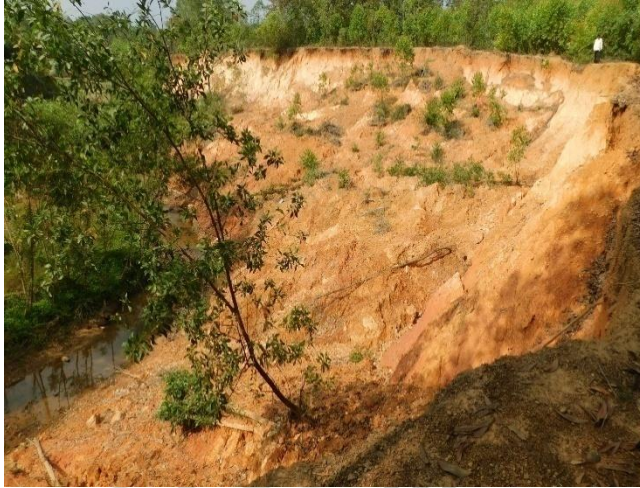
**Photo 3. 2c** Debris slide near Borikoppa village  
(Lat: 13°50'36.78"Long: 75° 08' 31.77")

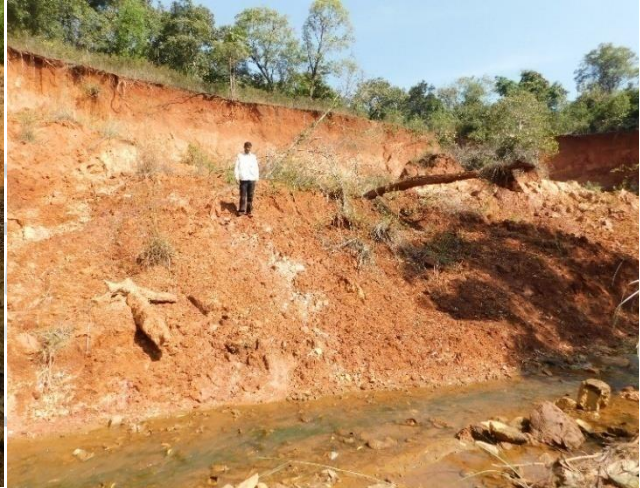
**Photo 3. 2d** Debris slide near Kannuru village  
(Lat: 13°55'6.1"Long: 75°11'01")

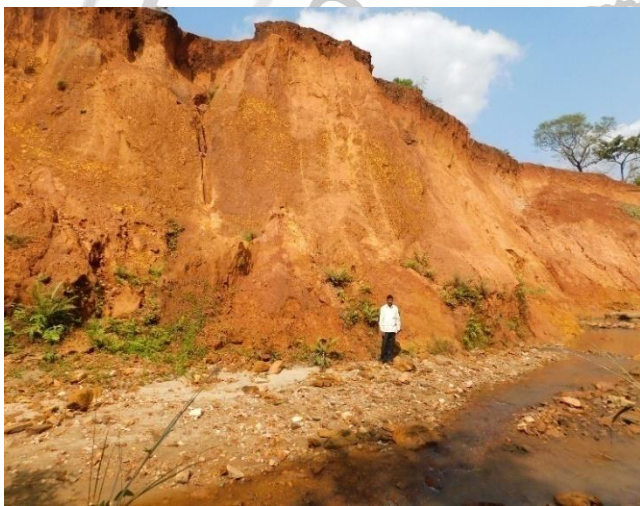
**Photo 3. 2e** Debris slide near Kannuru village  
(Lat: 13°55' 6.1"Long: 75° 11' 01")

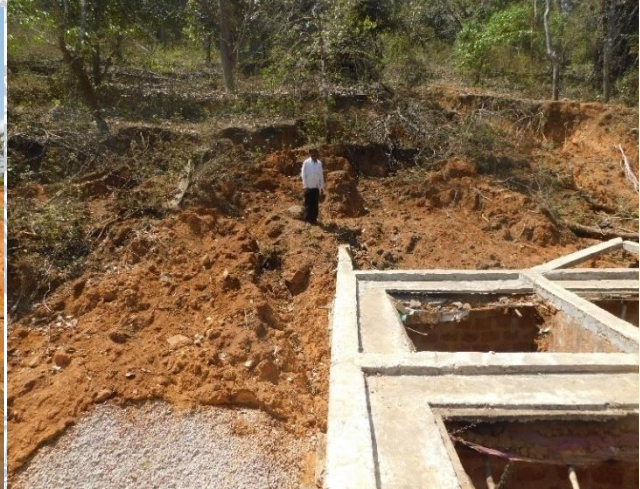
**Photo 3. 2f** Debris slide near Barahmeswara village  
(Lat: 13°57'15.49"Long: 75°04'44.32")

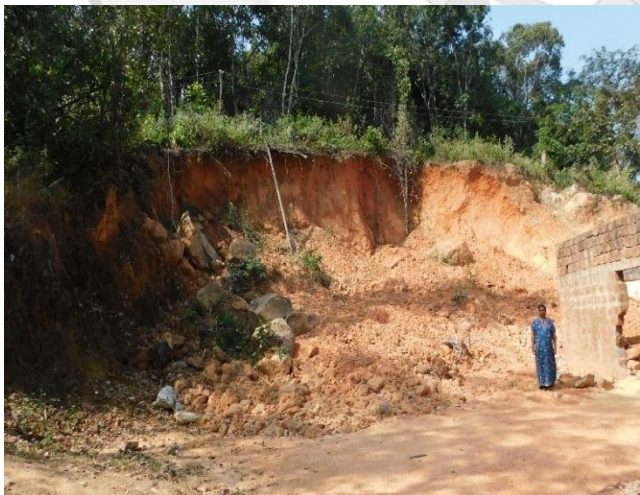
**Photo 3. 2g** Debris slide near Surugodu village  
Lat: 13°49'28.77"Long: 75°03'23.02"

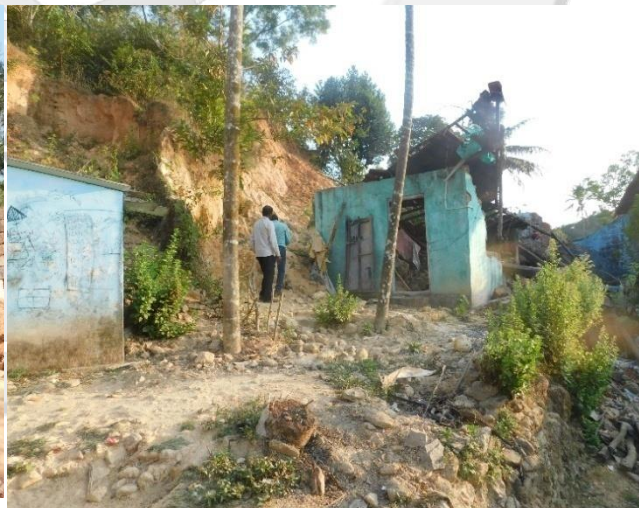
**Photo 3. 2h** Debris slide near Nagara village  
(Lat: 13°49'6.26"Long: 75° 01'44.56")

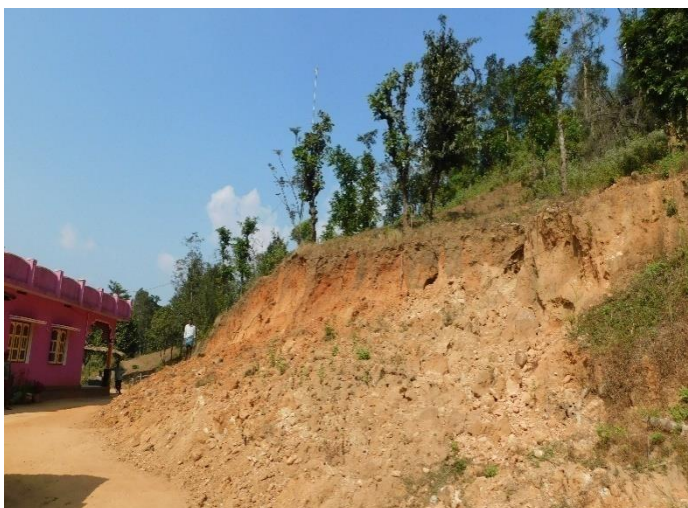
**Photo 3. 2i** Debris slide near Kodurutenkabailu village  
(Lat: 13°47'9.16" Long: 75° 06'54.13")

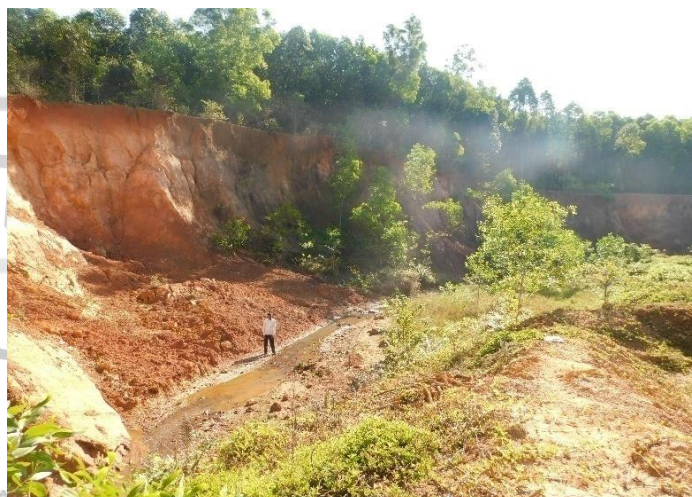
**Photo 3. 3a** Soil slide near Karagodu village  
(Lat: 13°55'37.41" Long: 75°12'19.90")

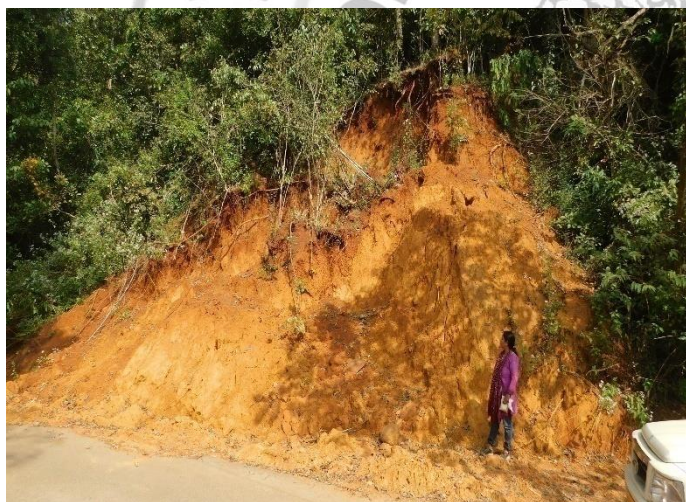
**Photo 3. 3b** Soil slide near Hiregadde village  
(Lat: 13° 48' 33.11" Long: 75° 7' 34.77")

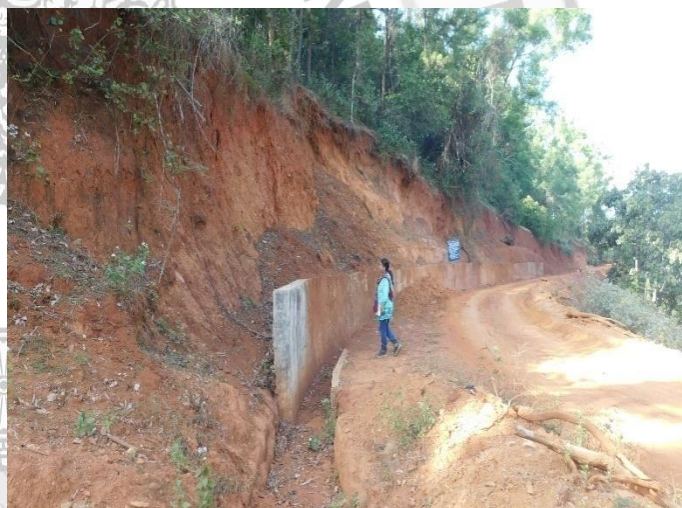
**Photo 3. 3c** Soil slide near Hosatota village  
(Lat: 13°47'35.9" Long: 75° 10' 19.3")

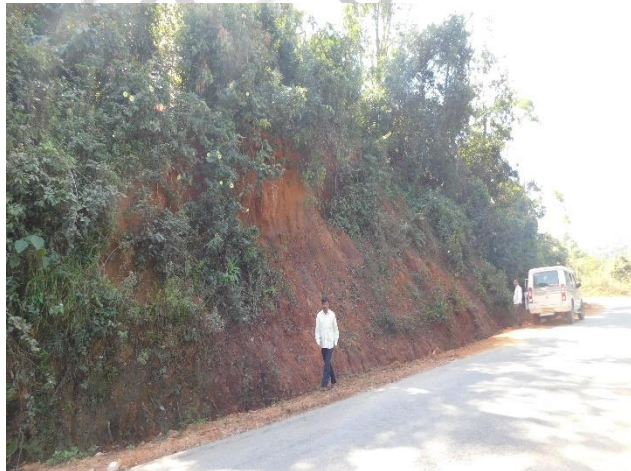
The most of the slope failures identified in the area are confined to the extensive slope cut for roads or adjacent to the cultivation where slope modified. Maximum weightage of 9 given to extensive slope cut category (**Table 4.2**). Area percentage wise distributions of various LULC categories in the study area are given in **Fig 4.4**. Nearly half of the landslide incidence is over thickly vegetated and high height plantation area (62.50%), **Fig 4.5**. This is due to the encroachment of cultivated area towards hill slide by modifying the slope. The Fig 4.4 shows the percentage of landslide incidence over different LULC categories

**Photo 4.1c** Extensive slope cut  
(Lat: 13°50'55.98" Long: 75° 03'50.04")

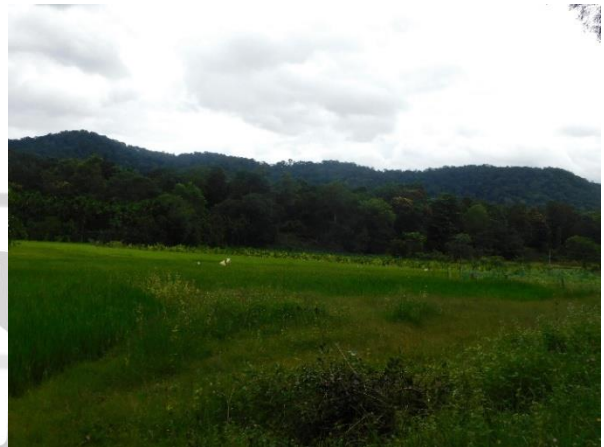
**Photo 4.2b** Pediplain pediment complex  
(Lat: 13°47'10" Long: 75° 24'28.09")

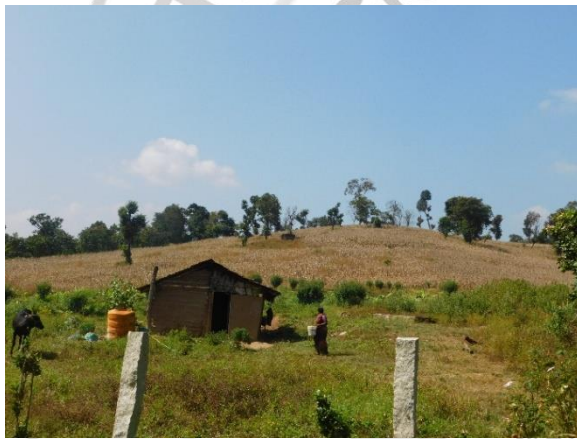
**Photo 4.2c** Rolling plain  
(Lat: 13°06'30.8" Long: 75° 19'7.7")

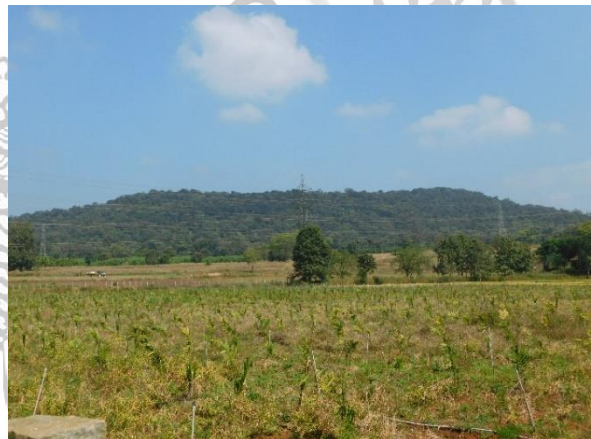
**Photo 4.1d** Lowly dissected slope  
(Lat: 14°4'7.2" Long: 75° 16'00.4")

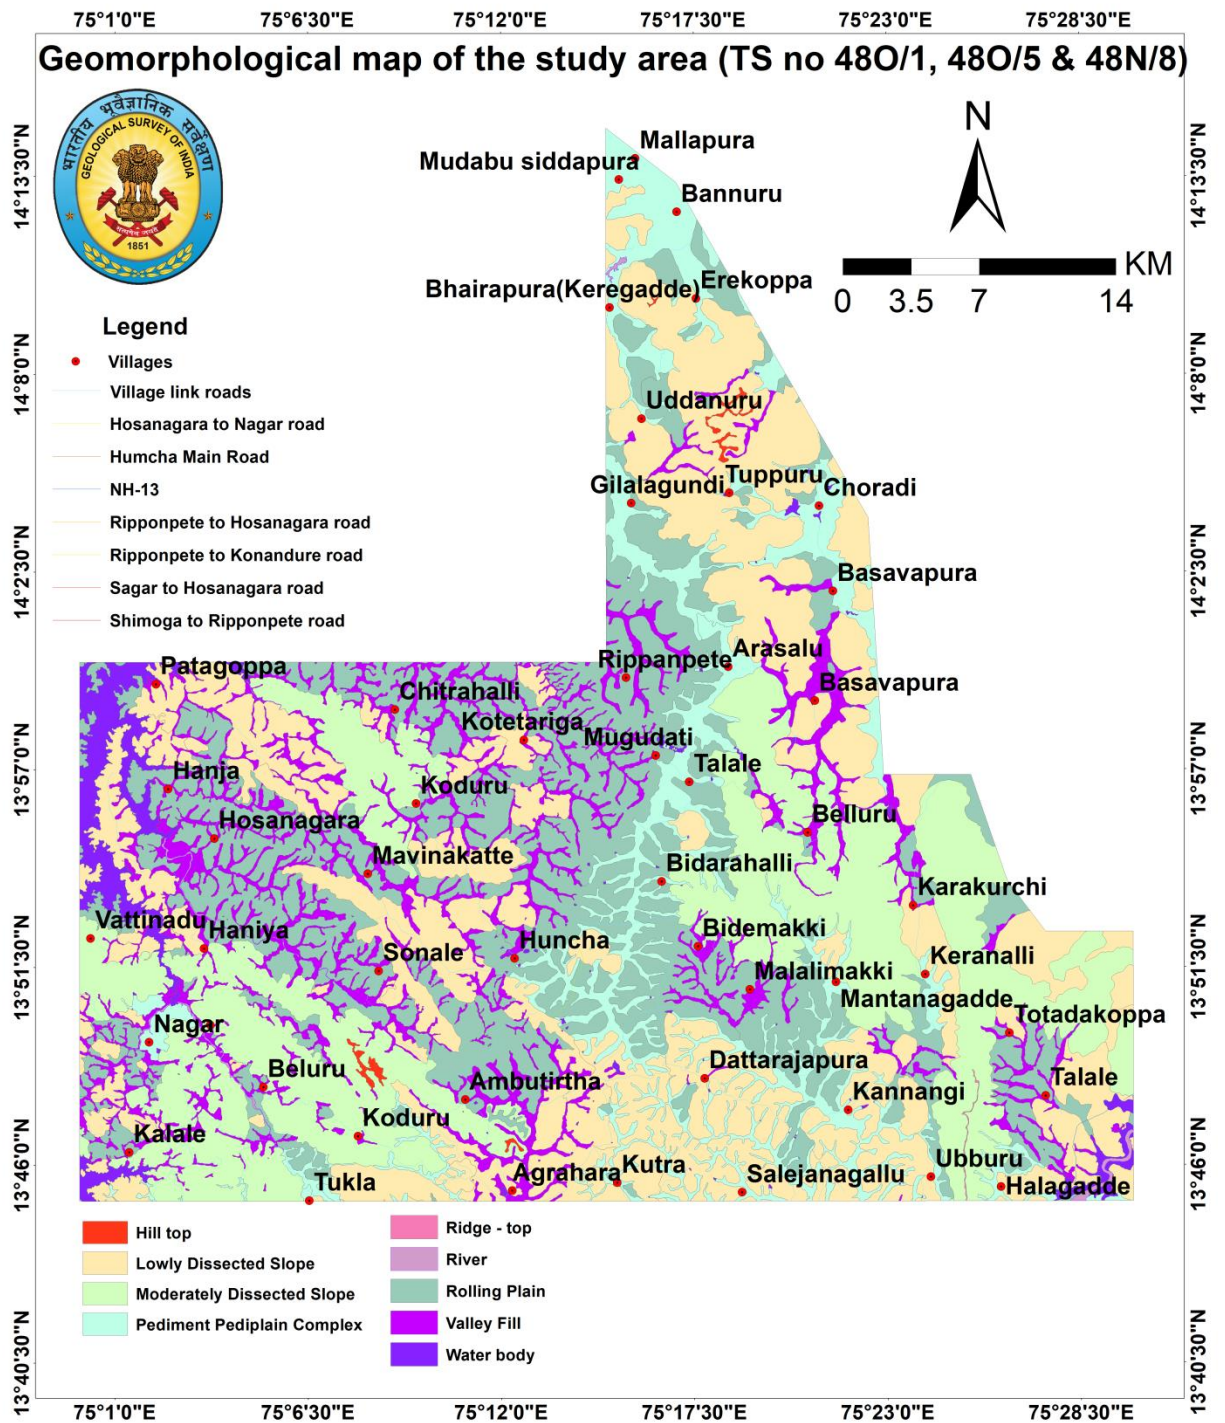
Plate 4.5

Pre-field Geomorphology map was prepared in ArcGIS through visual interpretation of latest available Google Earth imagery as base map. NGLM data supplied by GHRM cell was also taken into account while preparing this map. This pre-field geomorphology map was validated at all accessible locations during field work and necessary modifications were incorporated in the final input geomorphology map (**Plate 4.5**).

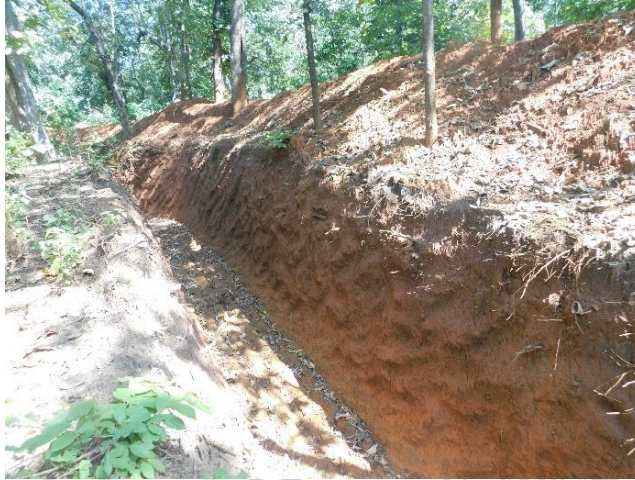
**Photo 4.3a** Insitu soil  
(Lat: 13°49' 23.3" Long: 75° 15'27.2")

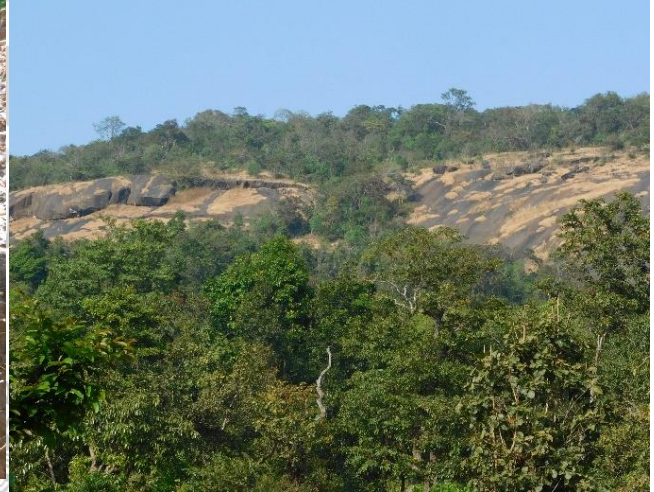
**Photo 4.3b** Granite Gneiss  
(Lat: 13°46'52.7" Long: 75° 05'42.2")

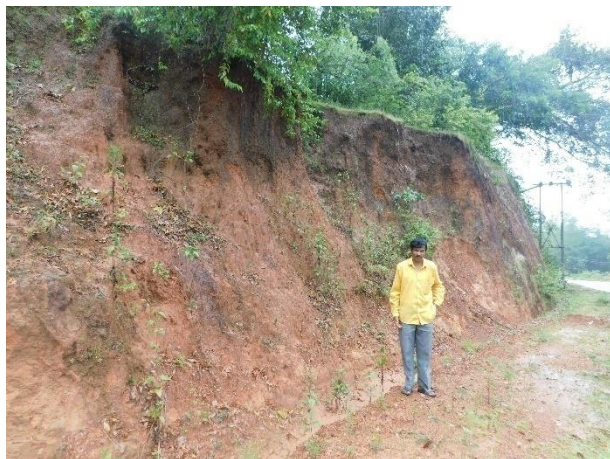
**Photo 4.4a** Regolith thickness 0.5-5m  
(Lat: 13°47'3.1"Long: 75° 20'54.6")

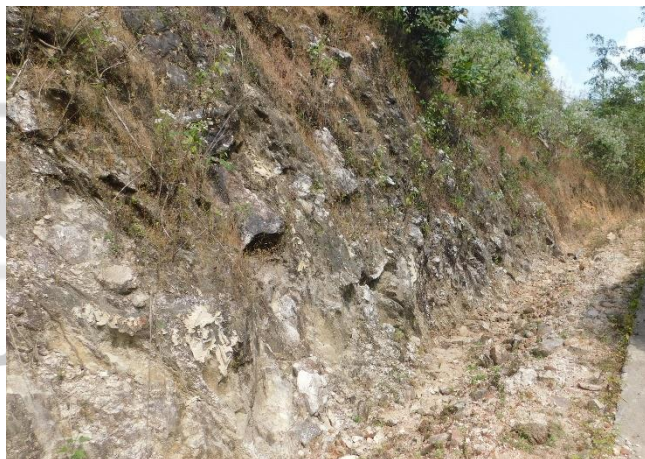
**Photo 4.4b** Regolith thickness <0.5m  
(Lat: 13°49'45.57"Long: 75° 7'2.20")

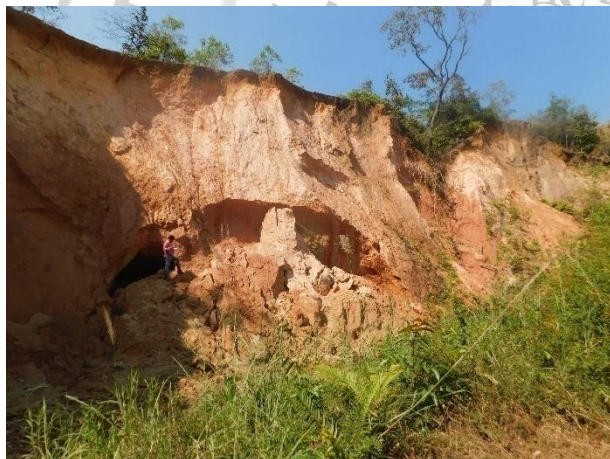
**Photo 4.4c** Regolith thickness 5-10m  
(Lat: 13°51'17.64"Long: 75° 09'88.84")

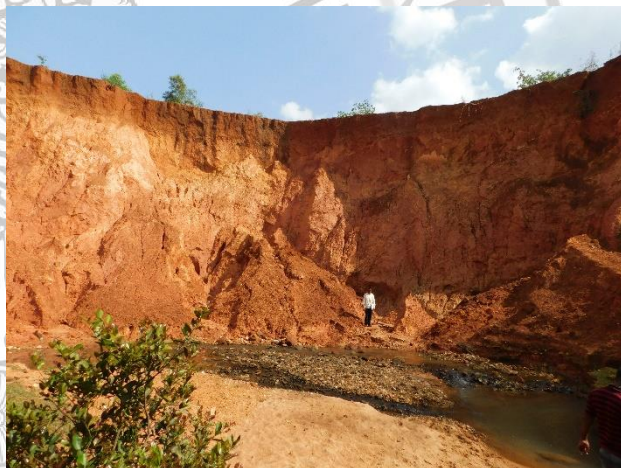
**Photo 4.4d** Regolith thickness >10m  
(Lat: 13°53'26.22"Long: 75° 10'16.25")

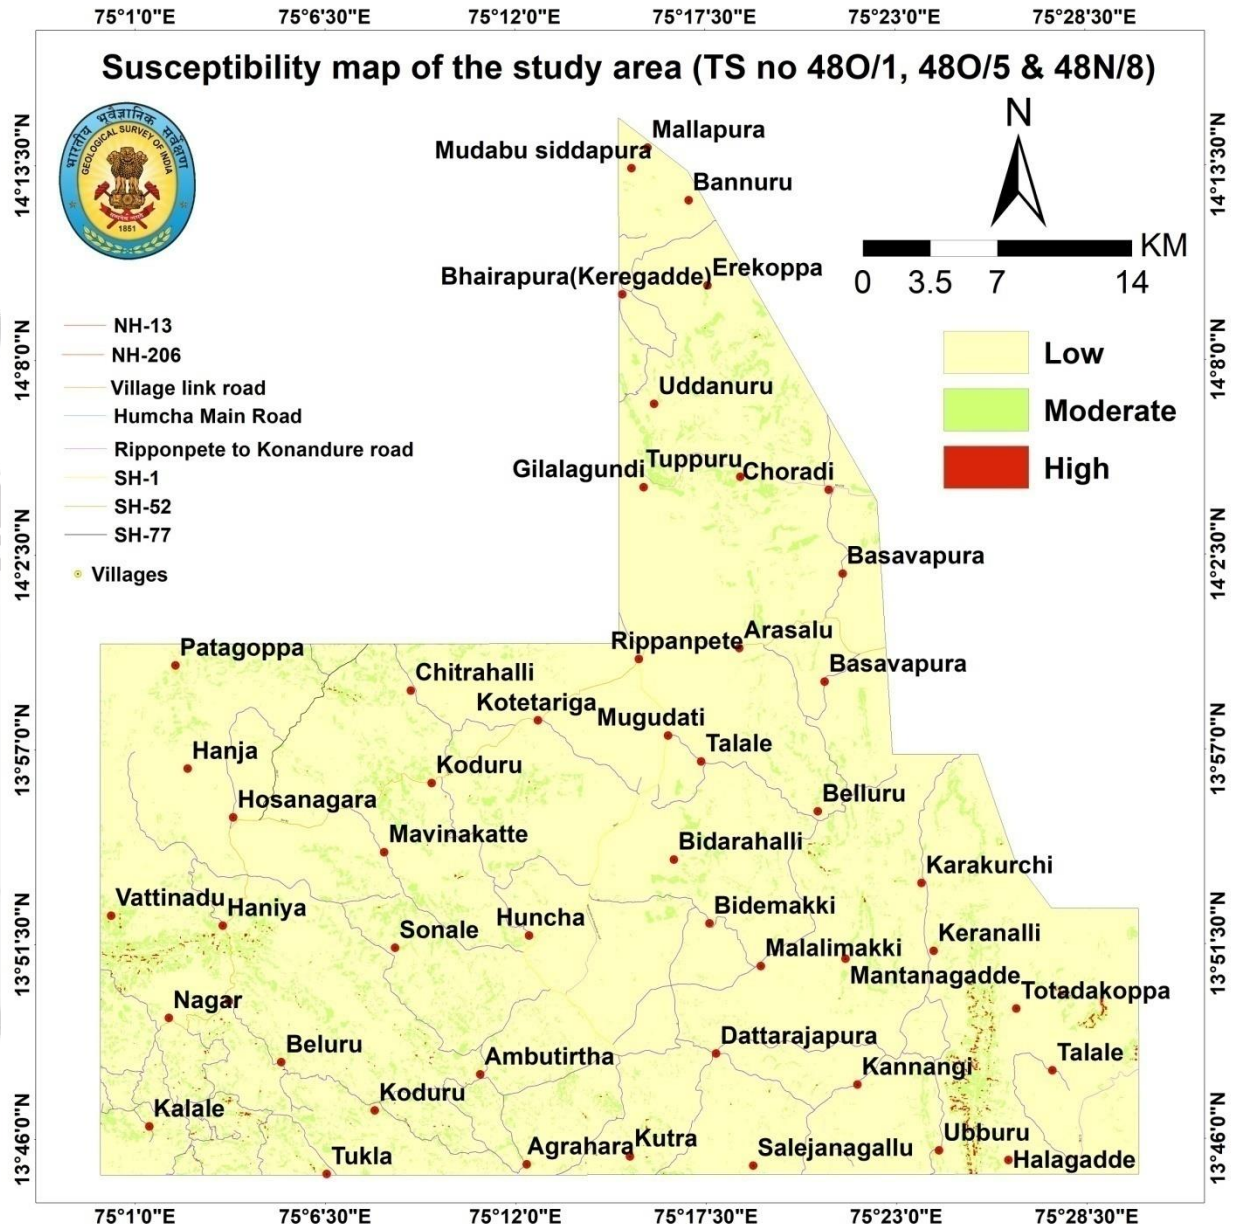
Plate 5.1

Weighted Multiclass Index Overlay (WMIO) method was used to obtain the landslide susceptibility map (**Plate 5.1**) of TS nos. 48O/1, 48O/5 and 48N/8 which give the relative slope stability of the study area. The map provides fair idea of the slope susceptibility to failure of any type in response to the interaction of the considered geo-environmental factors.

As observed, the high susceptible area is very less in the study area. The high susceptible areas are mostly confined to the localized stretches of road sections and hill ranges. Similarly, the spatial distribution of moderately susceptible slopes is found associated with steep slopes and extensive slope cuts along road corridors. In addition, moderately susceptible slopes area also observed along the steep slopes of Vemalai Gudda, Balekal Gudda, Devara Gudda and Budi Gudda of toposheet no 48O/5 and Hittinavara AneGudde of toposheet no 48O/1. The low susceptible area accounting for 87.95 % (1421.84 km<sup>2</sup>) is primarily because about 90% of the area comes under slope angle 0°-15° which have minimum rating and therefore minimum Landslide Occurrence Favourability Score. And since the slope has the highest integer weight among all the themes considered in the study area, the low rated slope classes have higher influence to give low susceptibility to the slopes.

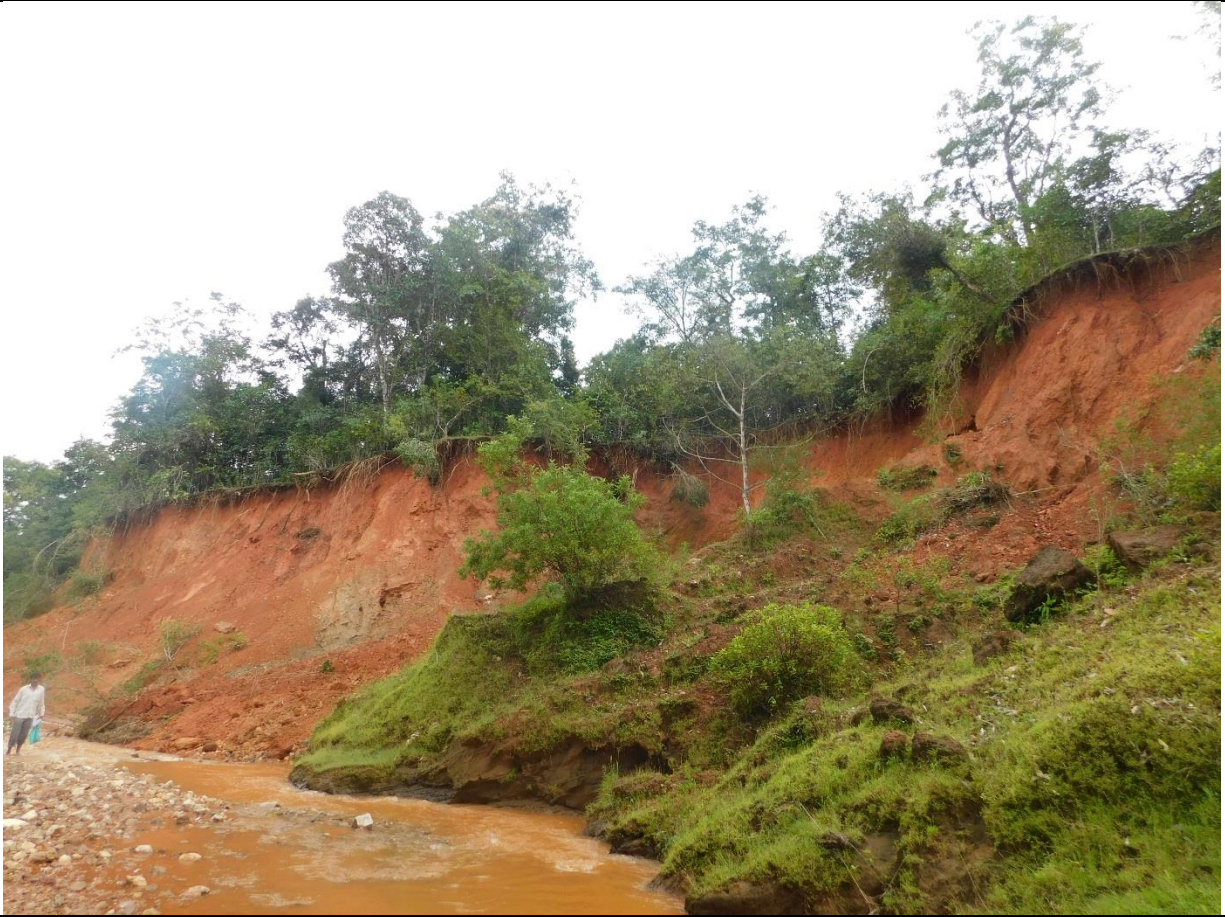
| 22 | Failure mechanism | Shallow translational Failure |
| 36 | Geo-scientific Causes | Steep slope coupled with incessant rainfall caused the increase of the pore water pressure and the soil lost its strength. During the rainfall excess water in the stream cut the adjacent slopebank. Presence of thick insitu soil is also one of the reasons. |

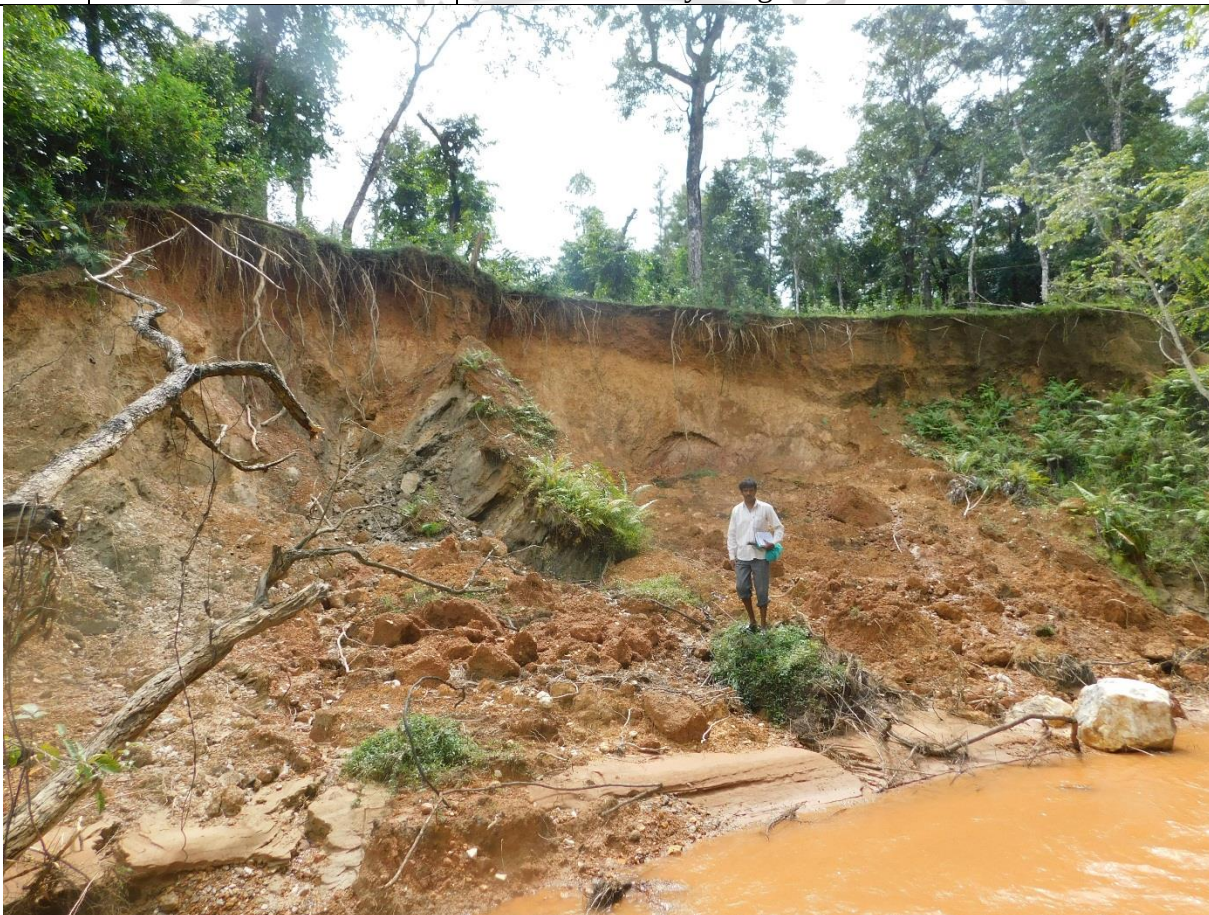
| 22 | Failure mechanism | Shallow translational Failure |
| 36 | Geo-scientific Causes | Toe cut for the road construction and presence of saprolite layer on slope and incessant rainfall. |

| 37 | Remedial measures | Construction of retaining wall with weep holes and hill side drain may reduce the further failure. |

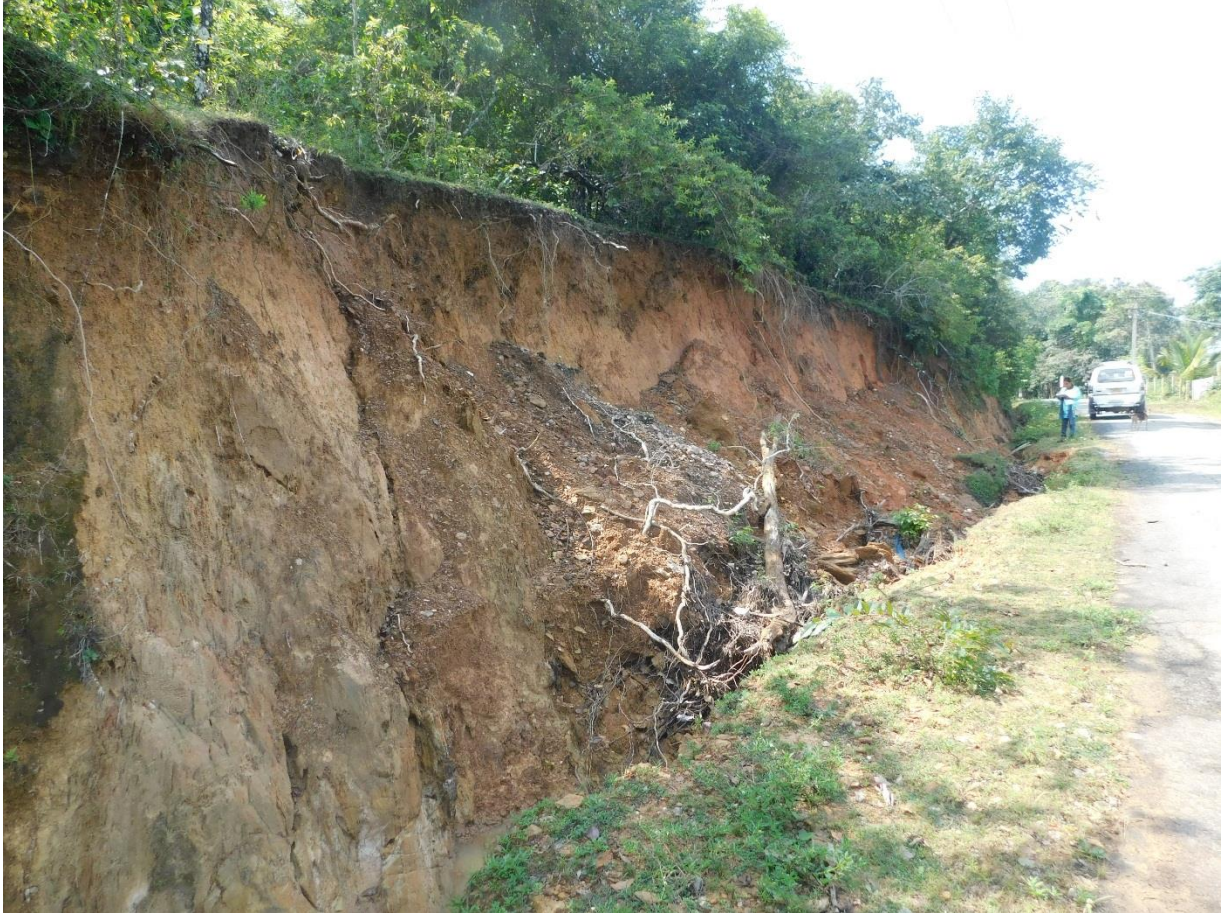
| 1 | Slide No. | KAR/SG/48O5/2019/20 |

| 22 | Failure mechanism | Shallow translational Failure |
| 36 | Geo-scientific Causes | Slope angle ranges from 25-35 degree and the interface between the overburden and bed rock is very less along the flow direction. At fewplaces the overburden thickness ranges from 2-3m. Incessant rainfall is also one of the |

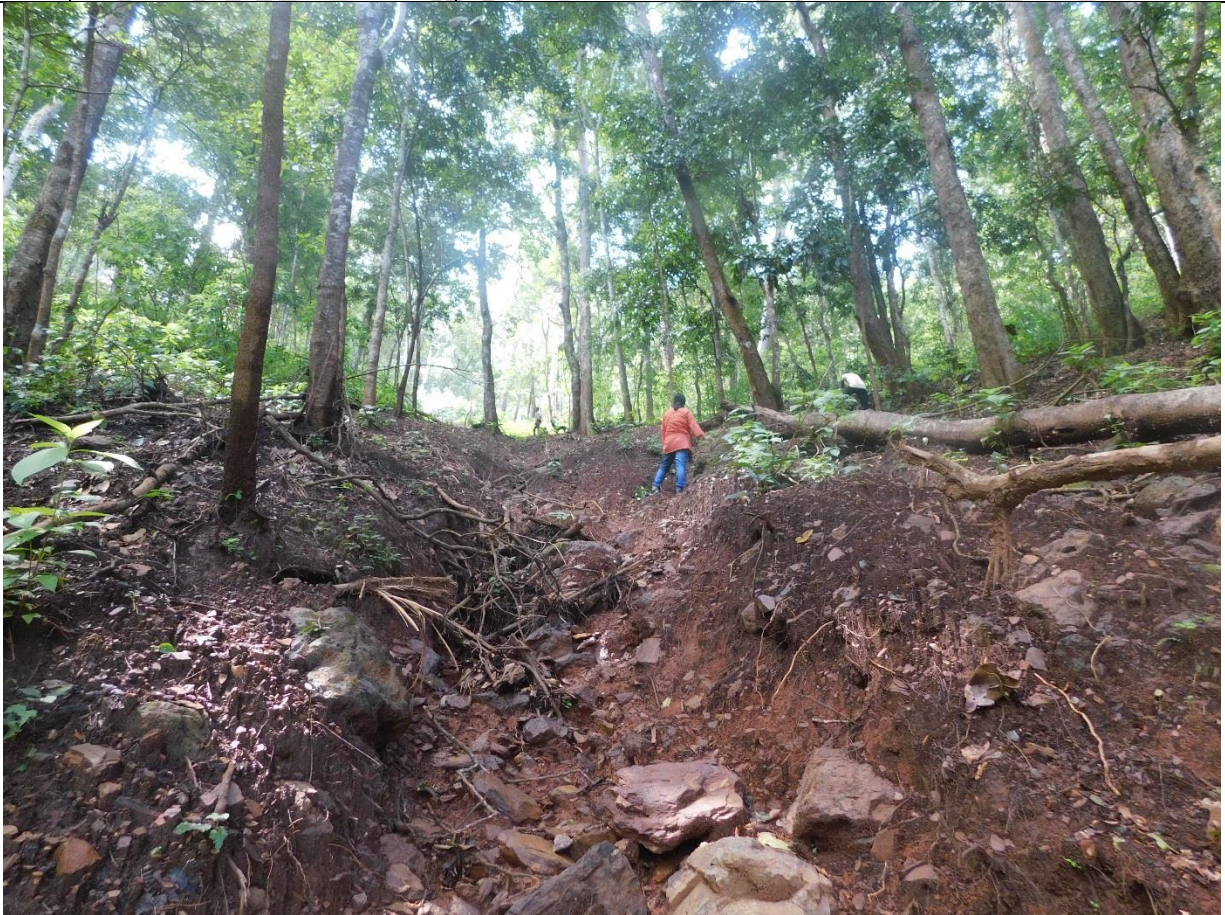
| 1 | Slide No. | KAR/SG/48O5/2019/21 |

| 22 | Failure mechanism | Shallow translational Failure |
| 36 | Geo-scientific Causes | Toe cut for the road construction without proper remedial measures and leaving the slope vertically unstable. Weak slope forming material and incessant rainfall may have caused increase of pore water pressure locally. |

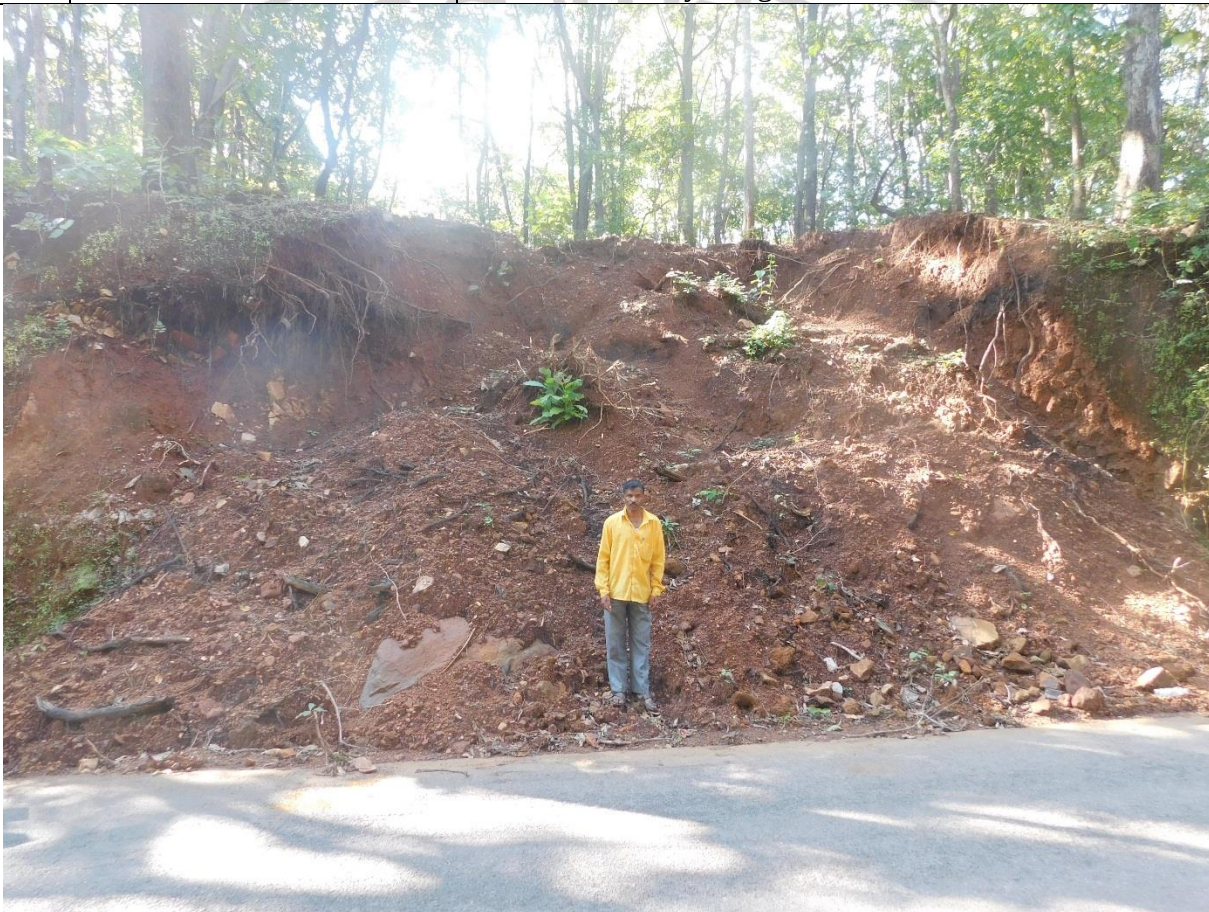
| 1 | Slide No. | KAR/SG/48O5/2019/22 |

| 22 | Failure mechanism | Shallow translational Failure |
| 36 | Geo-scientific Causes | vertical slope coupled with thick overburden and incessant rainfall are the main geo-scientific causes for the slide |

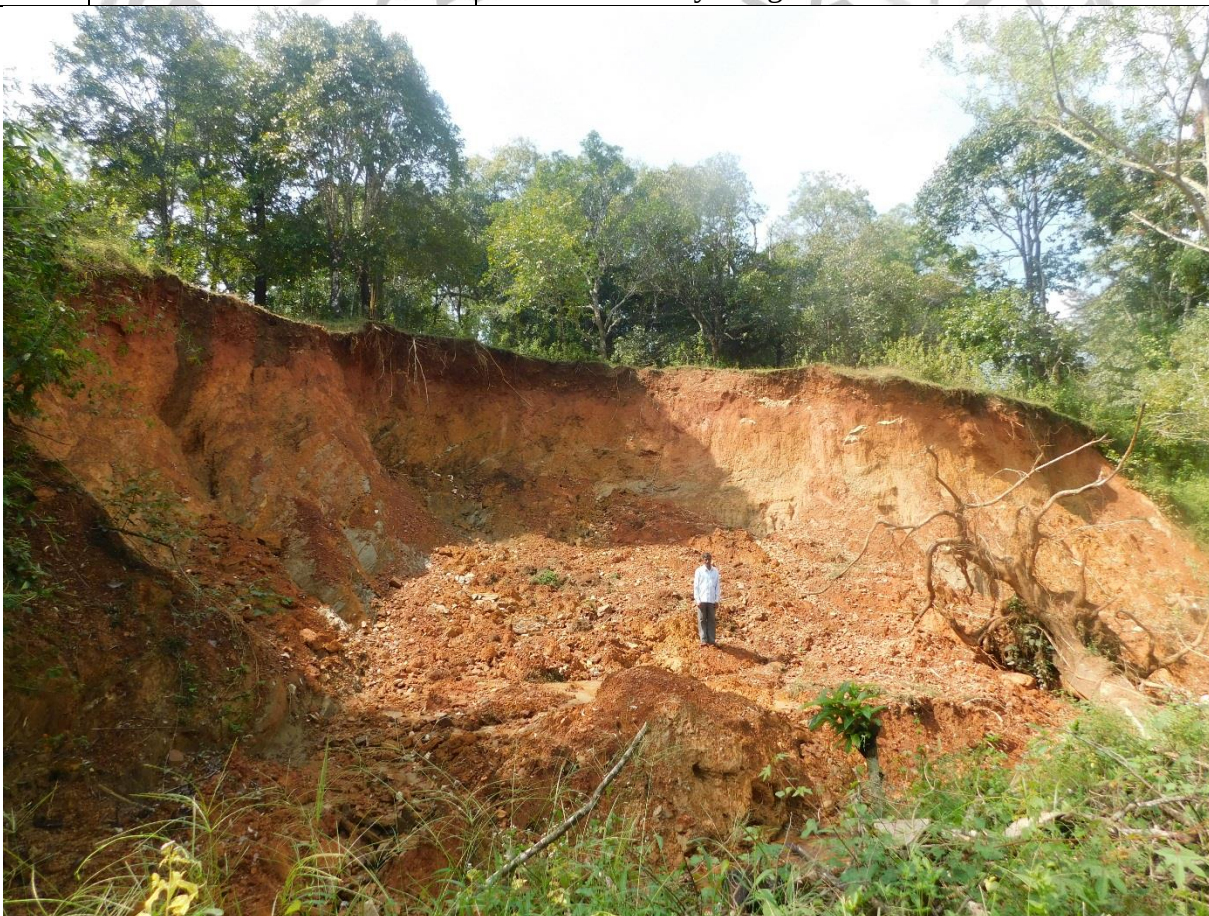
| 1 | Slide No. | KAR/SG/48O5/2019/23 |

| 22 | Failure mechanism | Shallow translational Failure |
| 36 | Geo-scientific Causes | Steep slope and the interface between the overburden and bedrock is very less. Continuous rainfall may have reduced the shear strength of the soil. |

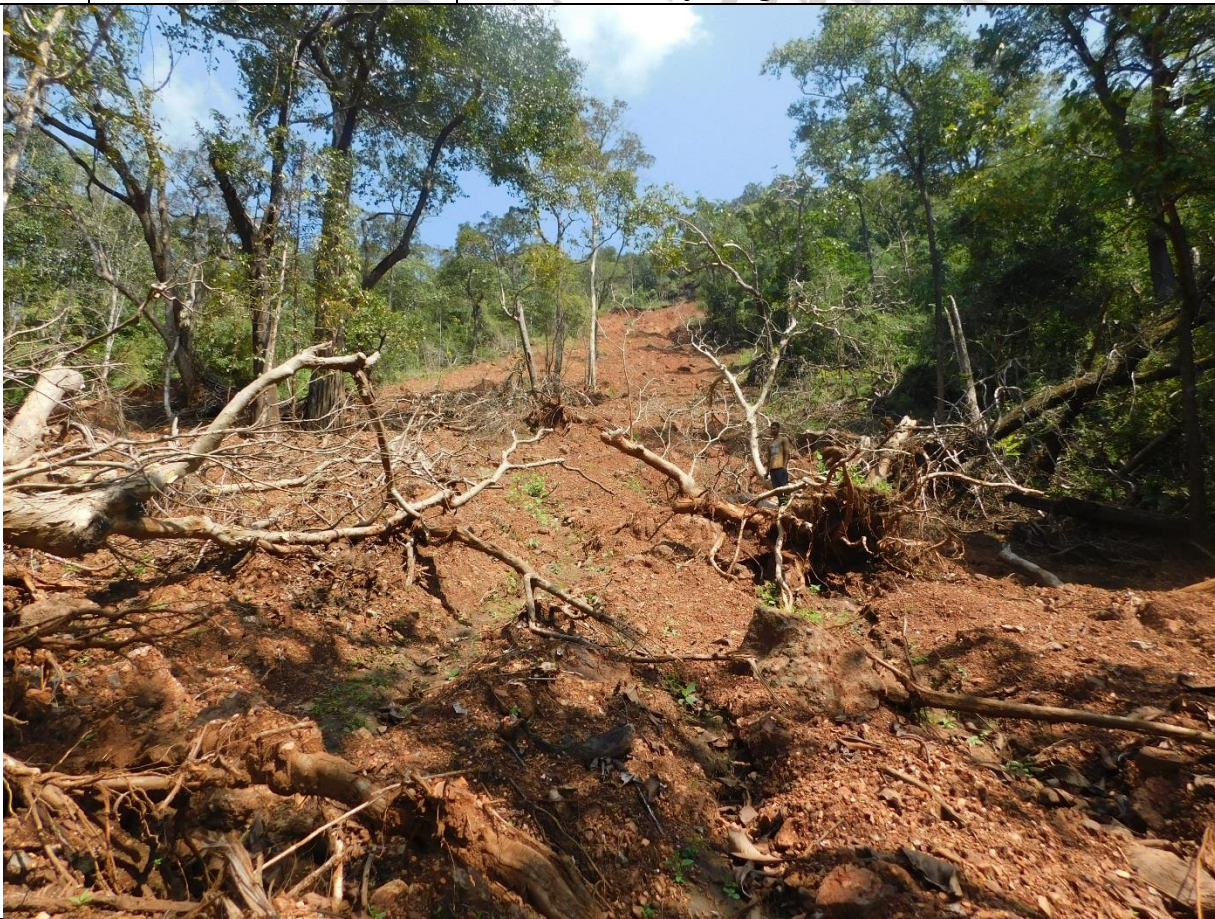
| 1 | Slide No. | KAR/SG/48O5/2019/24 |

| 22 | Failure mechanism | Shallow translational Failure |
| 36 | Geo-scientific Causes | Incessant rainfall and steep slope are the major causes for the slide. The interface between the overburden and bed rock is very less. |

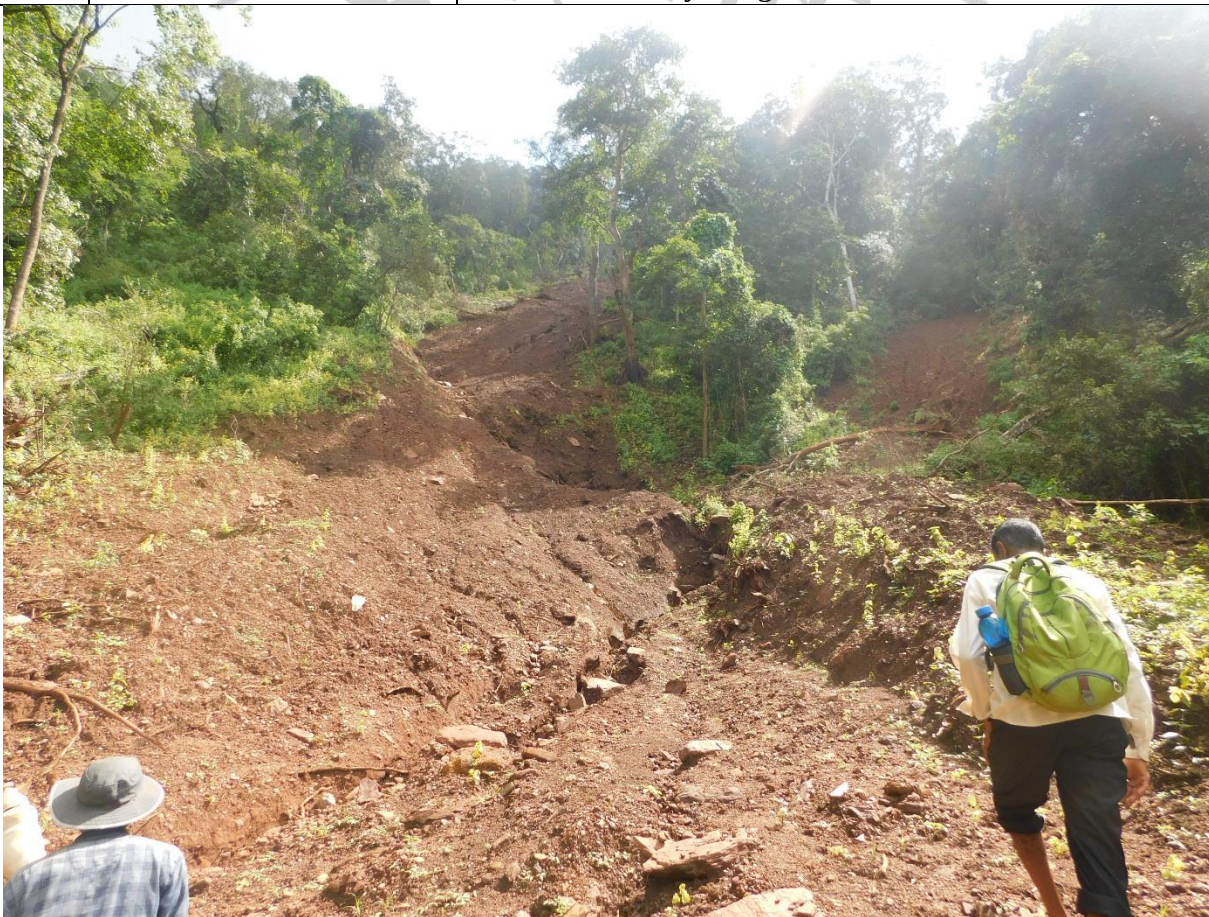
| 22 | Failure mechanism | Shallow translational Failure |
| 36 | Geo-scientific Causes | Continuous rainfall locally increased the pore water pressure and the soil along the steep slope lost its strength and failed. The failed material flowed towards the down slope by carrying adjacent materials. The slope gradient ranges from 30-40 degree. Interface between the |
