**MACRO-SCALE (1:50,000) LANDSLIDE SUSCEPTIBILITY MAPPING IN PARTS  
OF TOPOSHEET NOS. 48O/1, 48O/5 AND 48N/8 SHIMOGA AND CHIKMAGALUR  
DISTRICTS, KARNATAKA**

Item no.: M4LSSM/NC/SR/SU-KG/2019/25180

कार्य सत्र: 2019-20/Field Season 2019-20

रस्या रघु, वरिष्ठ भूवैज्ञानिक/Resya Reghu, Senior Geologist  
सेंतिलकुमार. के, भूवैज्ञानिक/Senthilkumar.K, Geologist

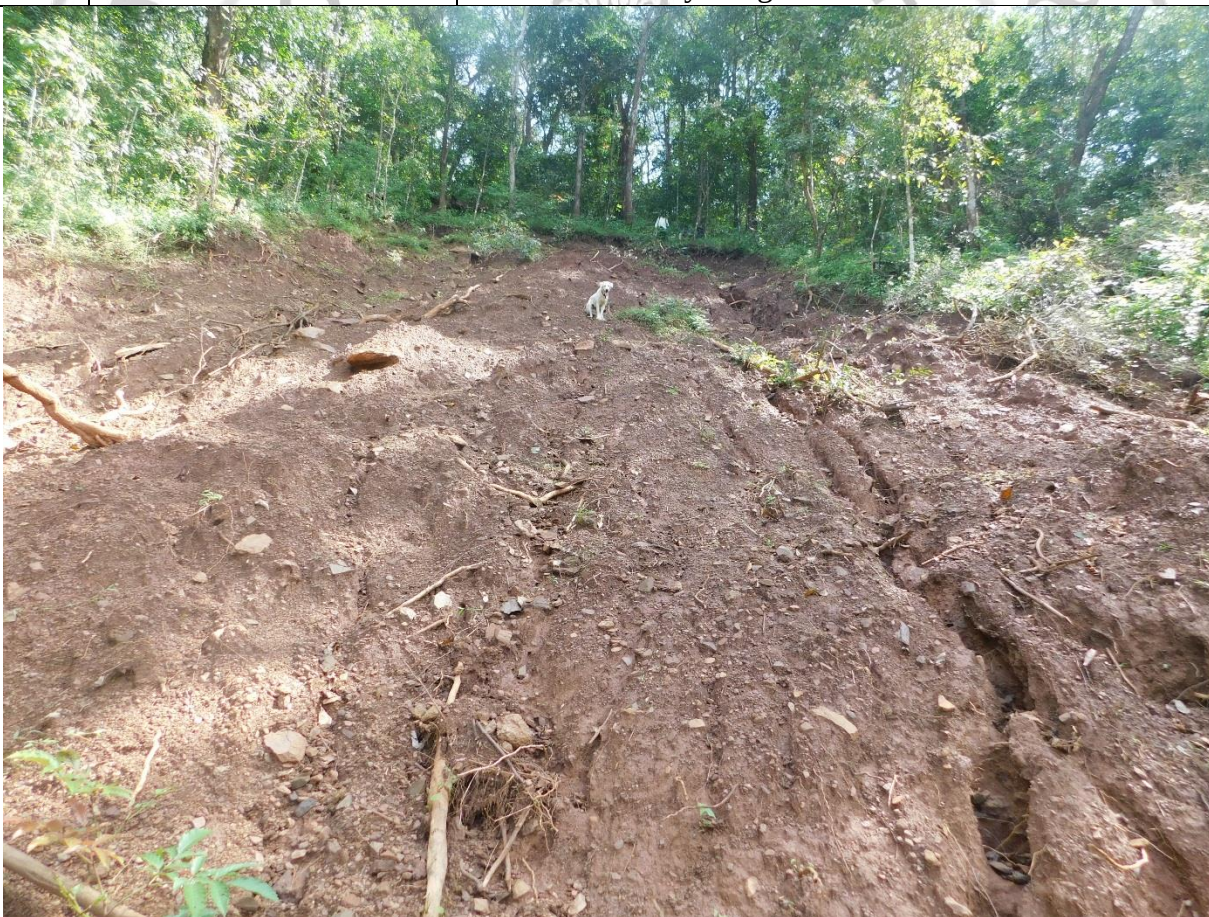
| 22 | Failure mechanism | Shallow translational Failure |
| 36 | Geo-scientific Causes | Interface between the overburden and bedrock is less. The slope gradient and continuous rainfall locally increased the pore water pressure and the soil along the steep slope lost its strength and failed. The failed material flowed towards the down slope by carrying adjacent |

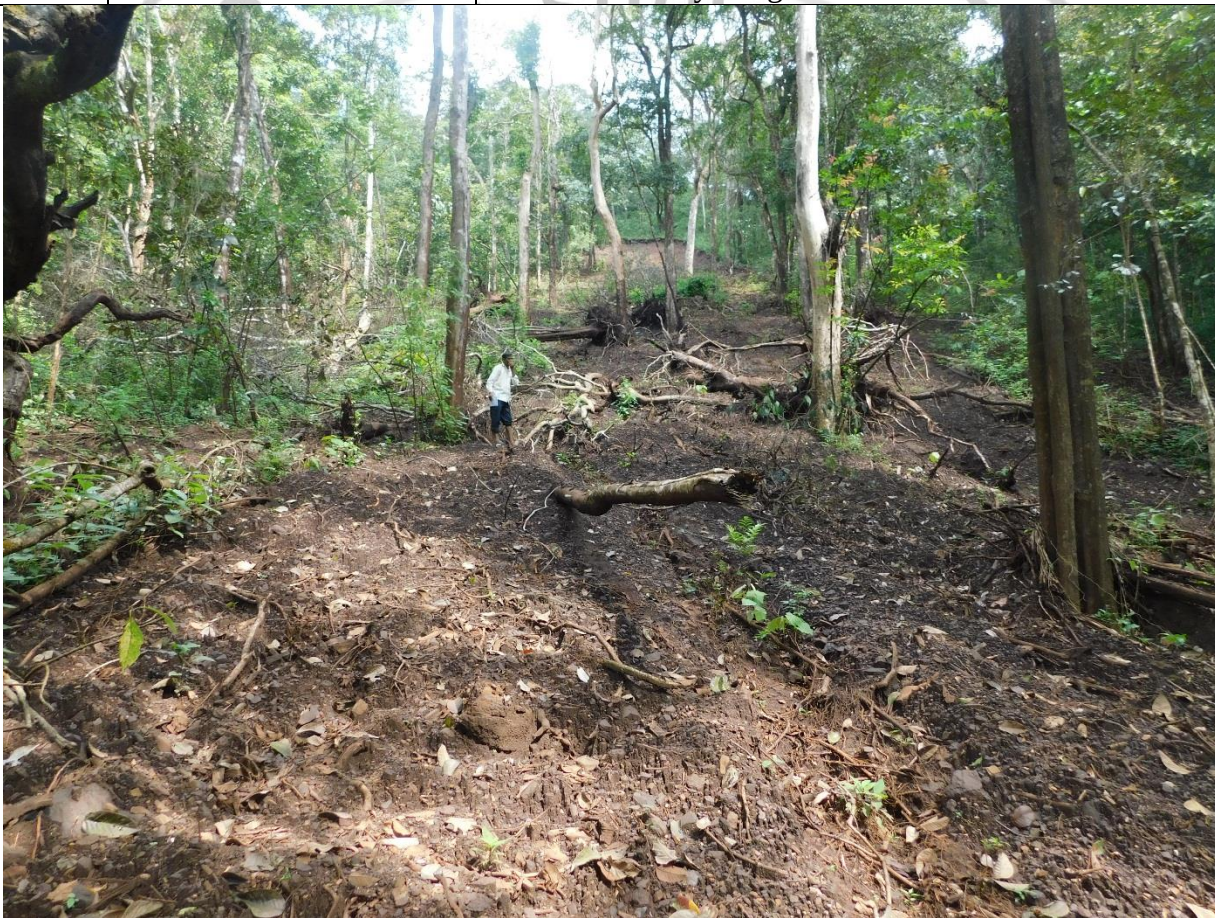
| 1 | Slide No. | KAR/SG/48O5/2019/27 |

| 22 | Failure mechanism | Shallow translational Failure |
| 36 | Geo-scientific Causes | Weak slope forming material and steep slope coupled with incessant rain. |

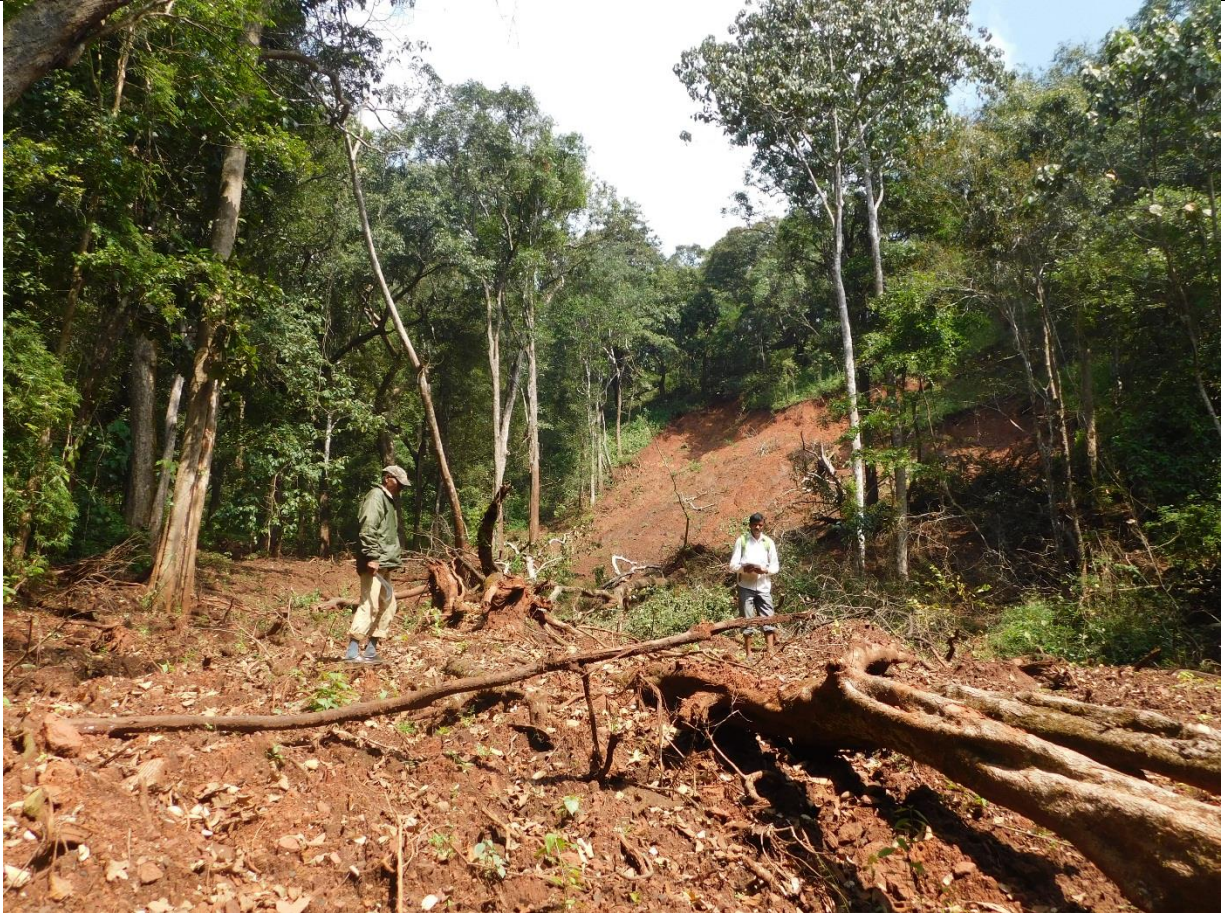
| 1 | Slide No. | KAR/SG/48O5/2019/28 |

| 22 | Failure mechanism | Shallow translational Failure |
| 36 | Geo-scientific Causes | Weak slope forming material and steep slope coupled with continuous rainfall increased the pore pressure in the overburden. |

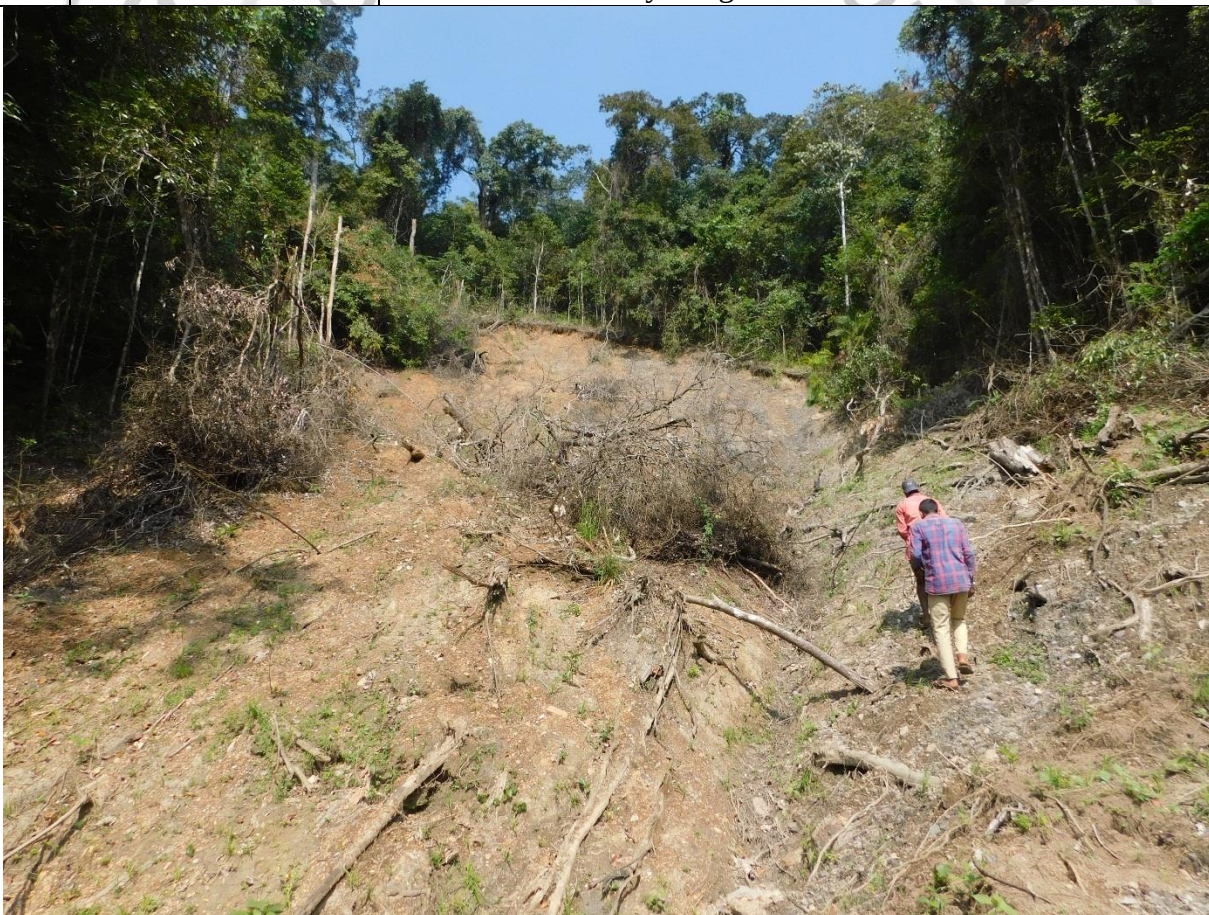
| 1 | Slide No. | KAR/SG/48O5/2019/29 |

| 22 | Failure mechanism | Shallow translational Failure |
| 36 | Geo-scientific Causes | Weak slope forming material and steep slope coupled with continuous rainfall increased the pore pressure in the overburden. The overburden material is highly weathered clayey material which leads to slippery of the material along the weaker plan. |

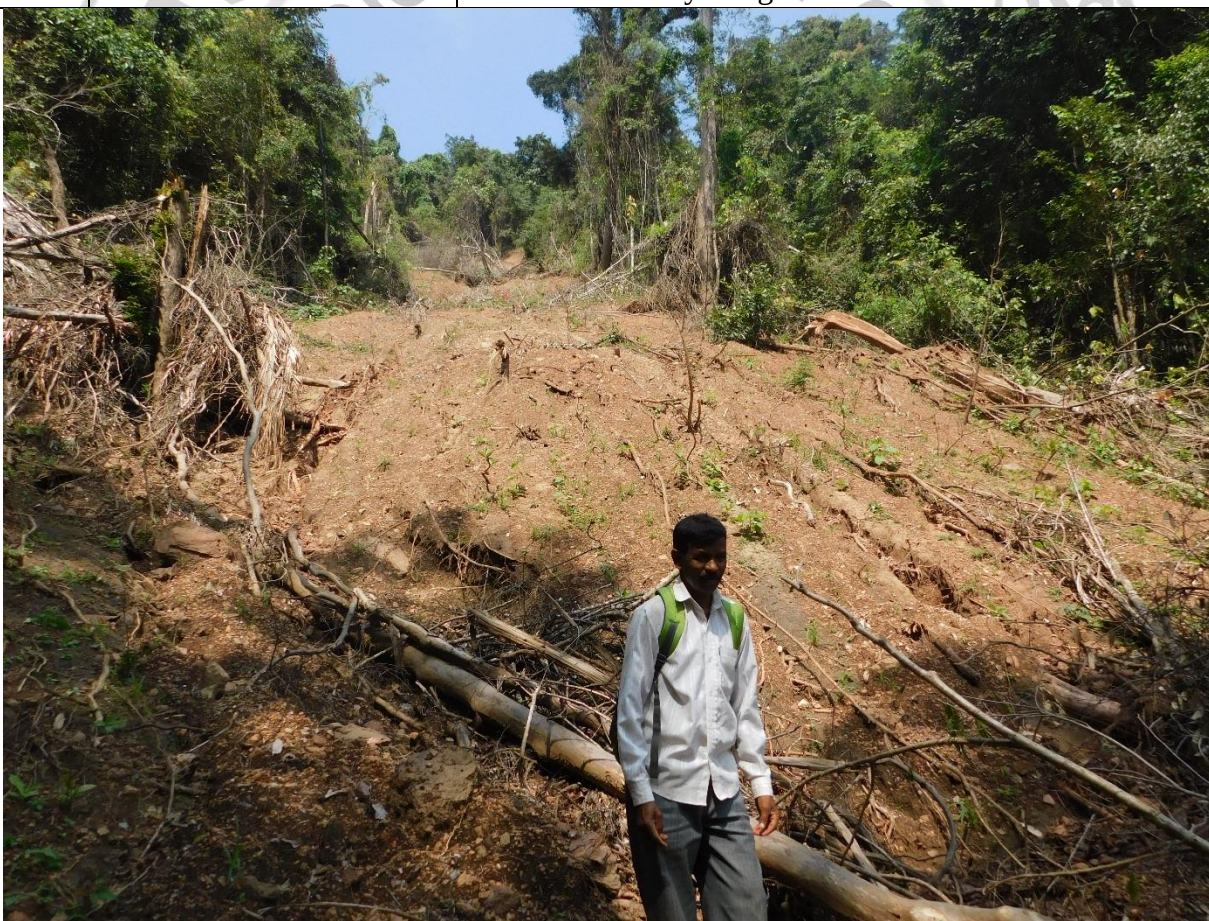
| 1 | Slide No. | KAR/SG/48O5/2019/30 |

| 22 | Failure mechanism | Shallow translational Failure |
| 36 | Geo-scientific Causes | The slope forming materials highly weathered and foliated. Water percolated along the weaker plane and materials failed along the surface of the weaker plane. |

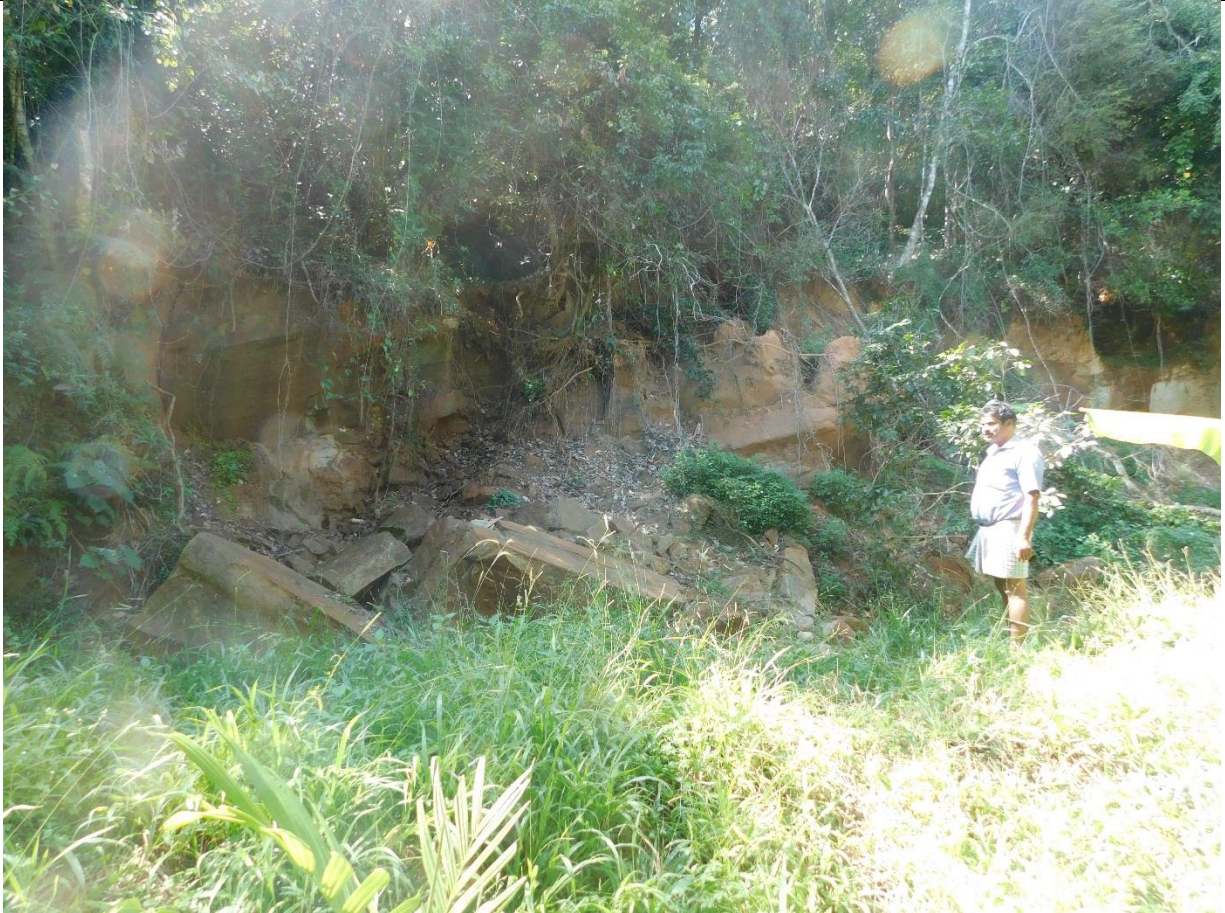
| 1 | Slide No. | KAR/SG/48O1/2019/45 |

| 22 | Failure mechanism | Deep translational Failure |
| 36 | Geo-scientific Causes | Steep slope and weak overburden material and incessant rain fall are the main factors. |
| 39 | Summary/Abstract | Main causes for the slide are steep slope and weak overburden material and incessant rain fall. Removal of |

| | | the debris and lining of the stream is recommended. |

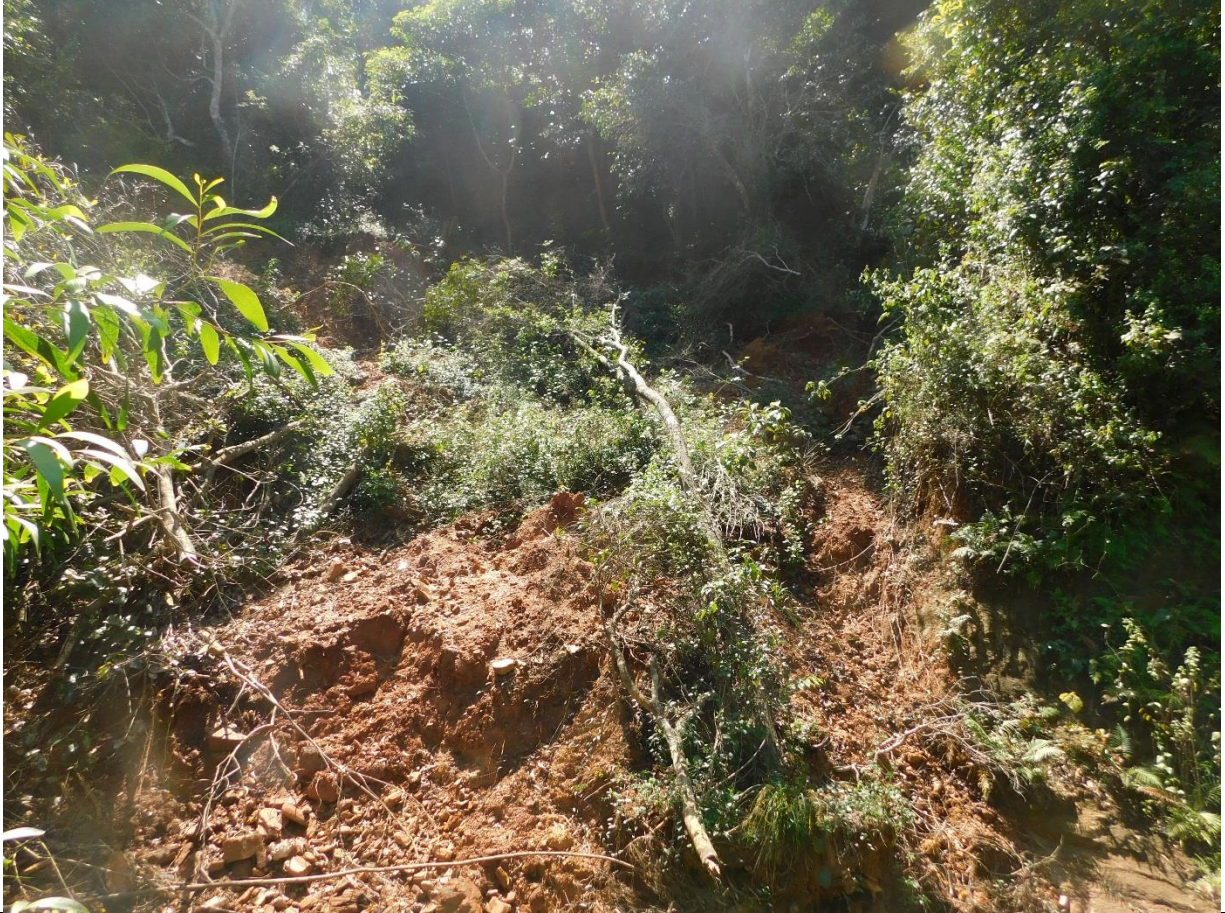
| 1 | Slide No. | KAR/SG/48O1/2019/46 |

| 22 | Failure mechanism | Shallow translational Failure |
| 36 | Geo-scientific Causes | Incessant rainfall, thick overburden in the steep slope and toe cut by drainage. |

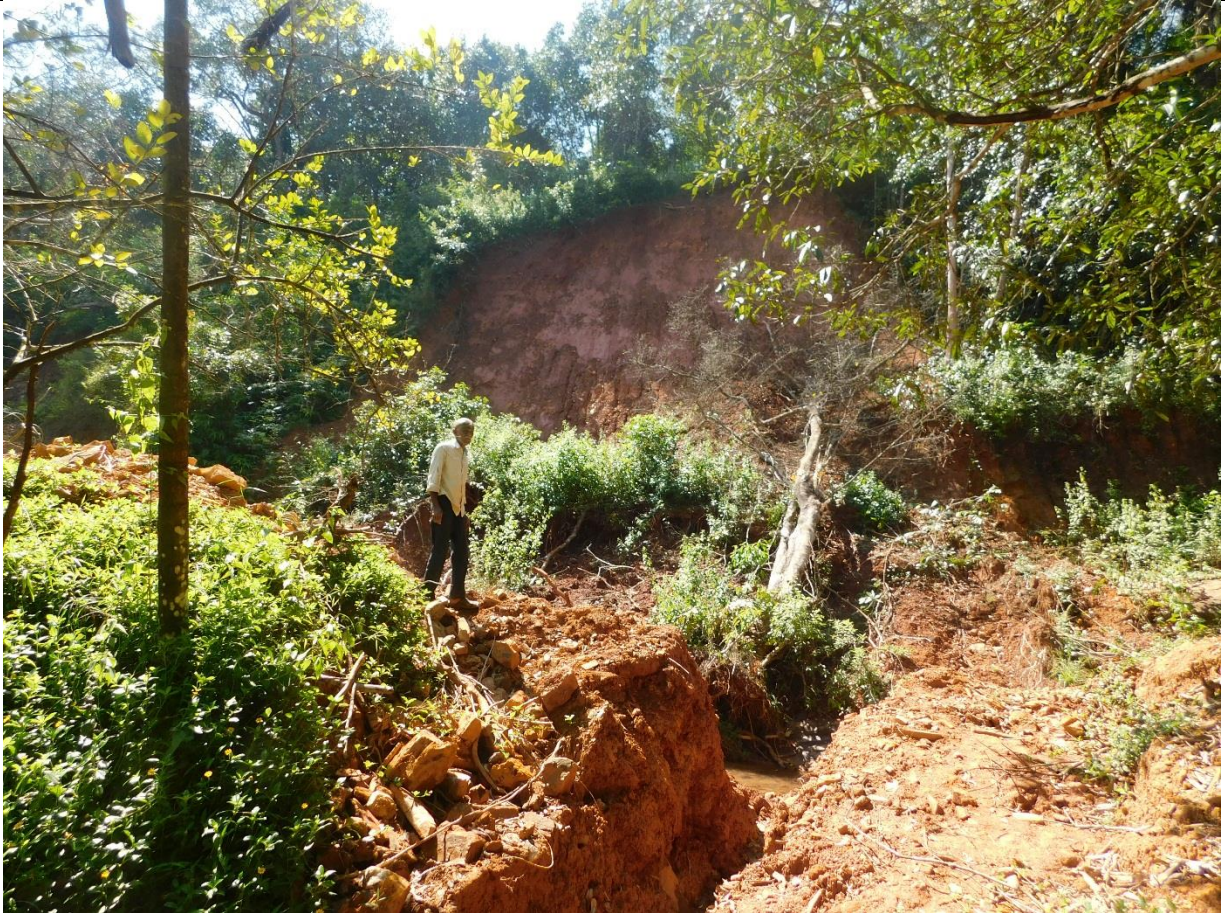
| 1 | Slide No. | KAR/SG/48O1/2019/47 |

| 22 | Failure mechanism | Shallow translational Failure |
| 36 | Geo-scientific Causes | Incessant rainfall, thick overburden in the steep slope and toe cut by drainage. |

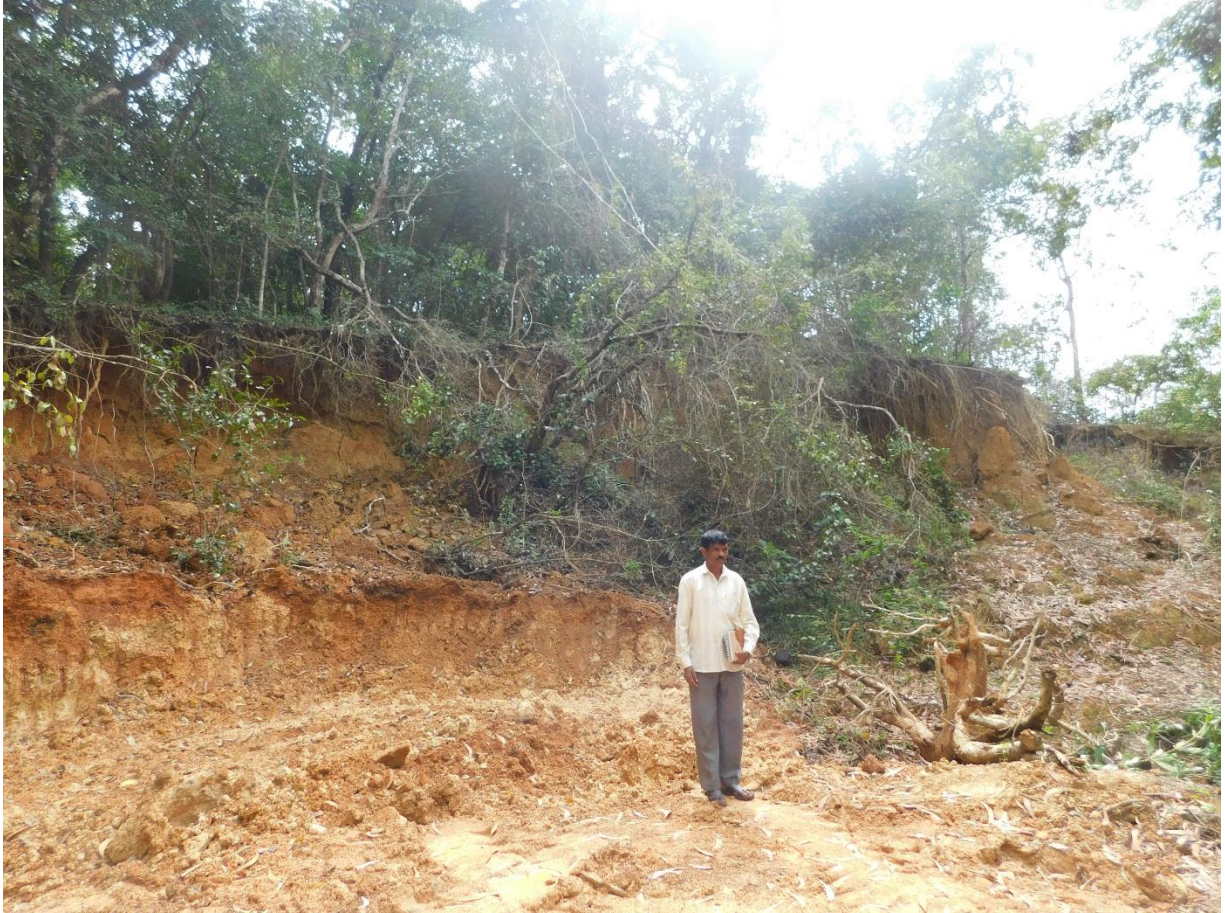
| 1 | Slide No. | KAR/SG/48O1/2019/48 |

| 22 | Failure mechanism | Shallow translational Failure |
| 36 | Geo-scientific Causes | Continuous rainfall, weak slope forming material, steep slope and toe cut are the main causative factors. |

| 39 | Summary/Abstract | The debris slide initiated due to incessant rainfall and toe cut by the stream. To reduce the failure it is recommended that lining of stream, easing of the slope. |

| 37 | Remedial measures | Maintain the original stream course, the debris should be cleaned and easing of the slope will reduce the future failure. |

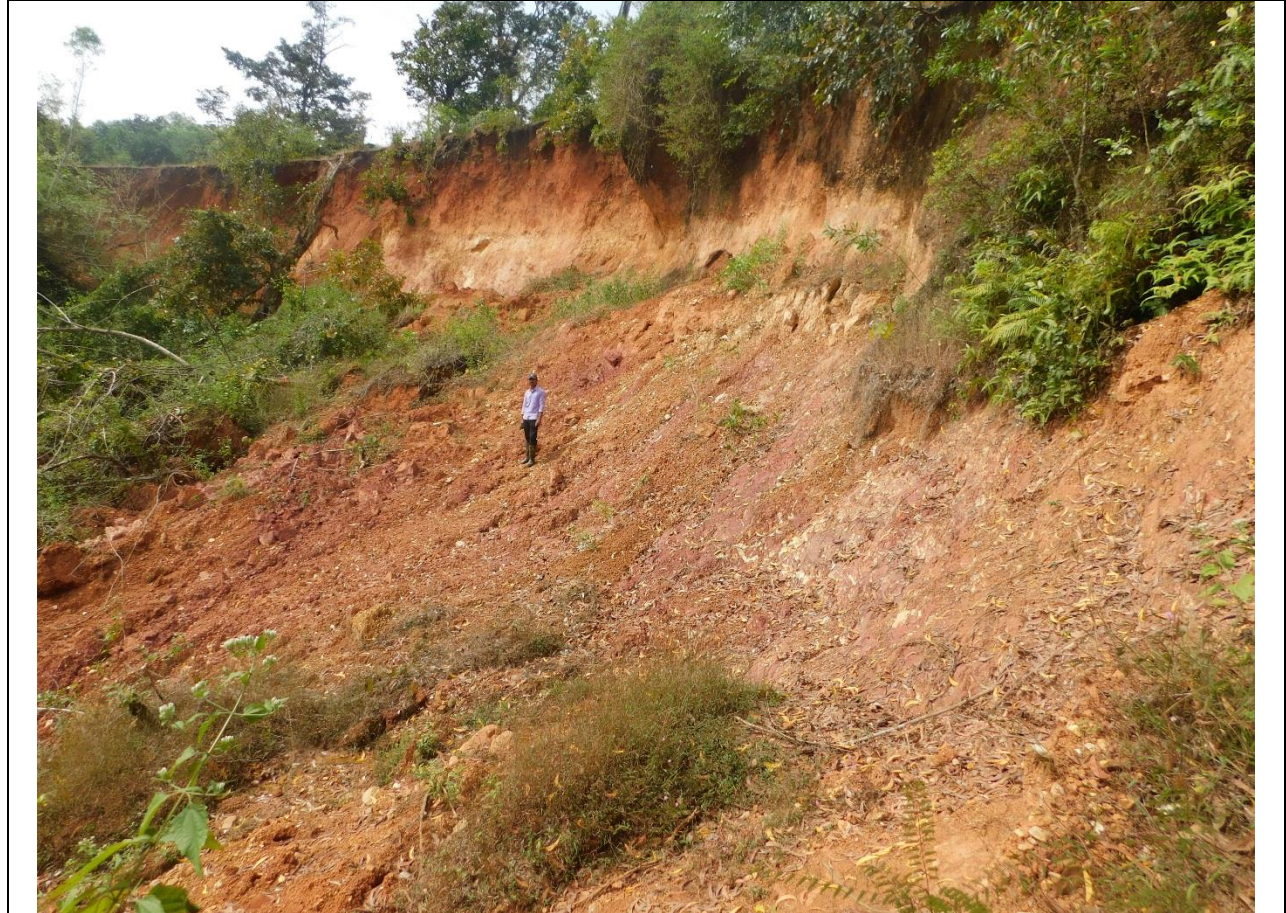
| 1 | Slide No. | KAR/SG/48O1/2019/49 |

| 22 | Failure mechanism | Shallow translational Failure |
| 36 | Geo-scientific Causes | Toe cut by the stream, continuous rainfall, and weak thick overburden in the steep slope. |

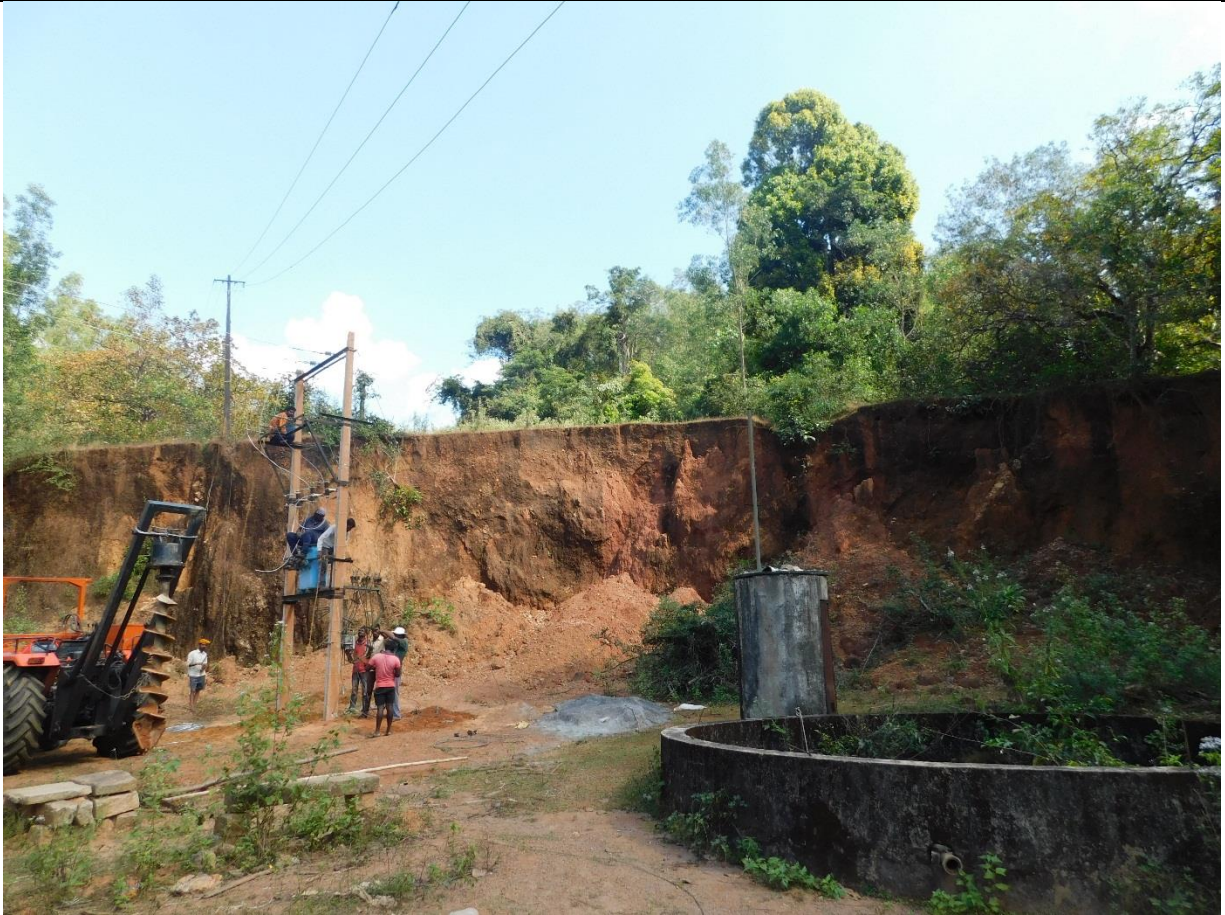
| 1 | Slide No. | KAR/SG/48O1/2019/52 |

| 22 | Failure mechanism | Shallow translational Failure |
| 36 | Geo-scientific Causes | Slope angle modified for the road construction. |

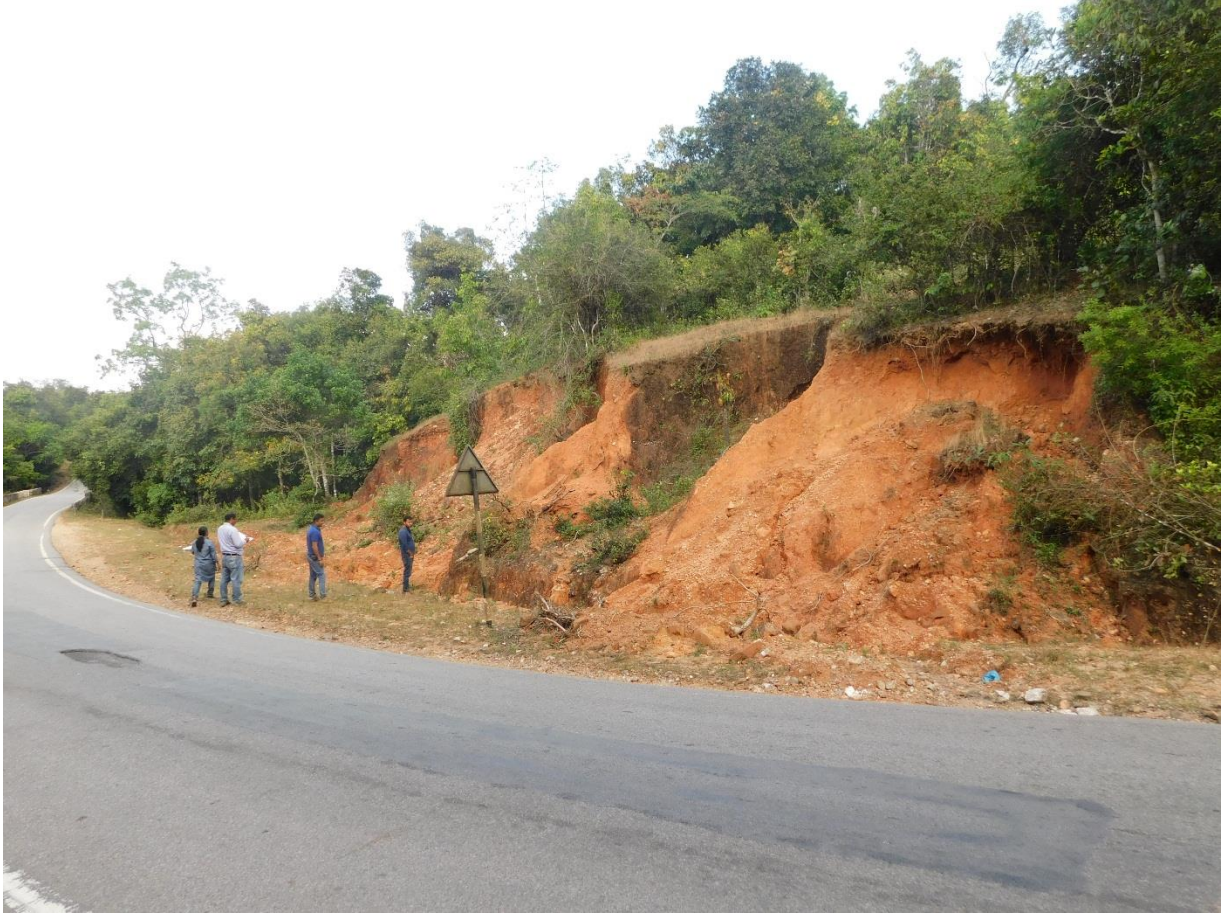
| 1 | Slide No. | KAR/SG/48O1/2019/53 |

| 22 | Failure mechanism | Shallow translational Failure |
| 36 | Geo-scientific Causes | Slope angle modified for the road construction. |

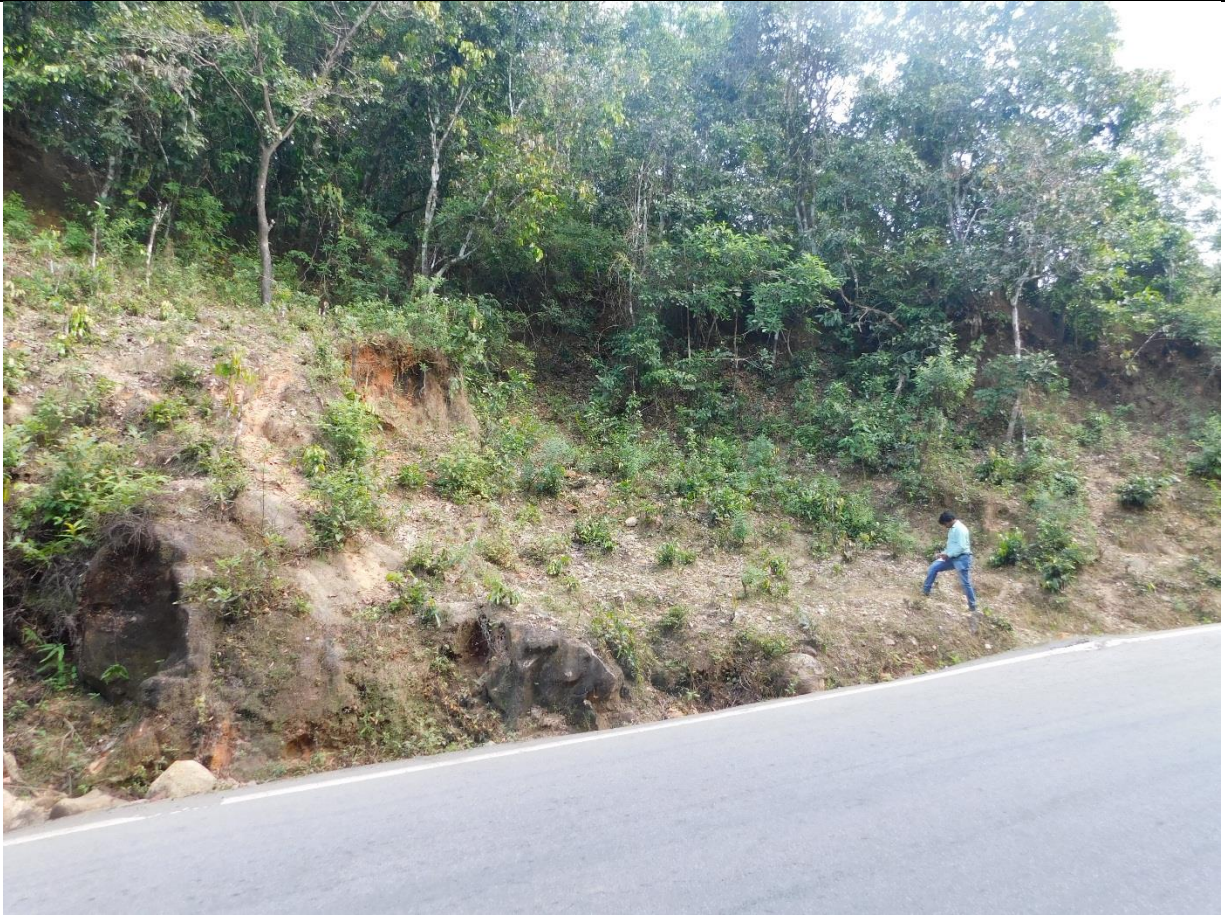
| 1 | Slide No. | KAR/SG/48O1/2019/54 |

| 22 | Failure mechanism | Shallow translational Failure |
| 36 | Geo-scientific Causes | Slope angle modified for the road construction. |

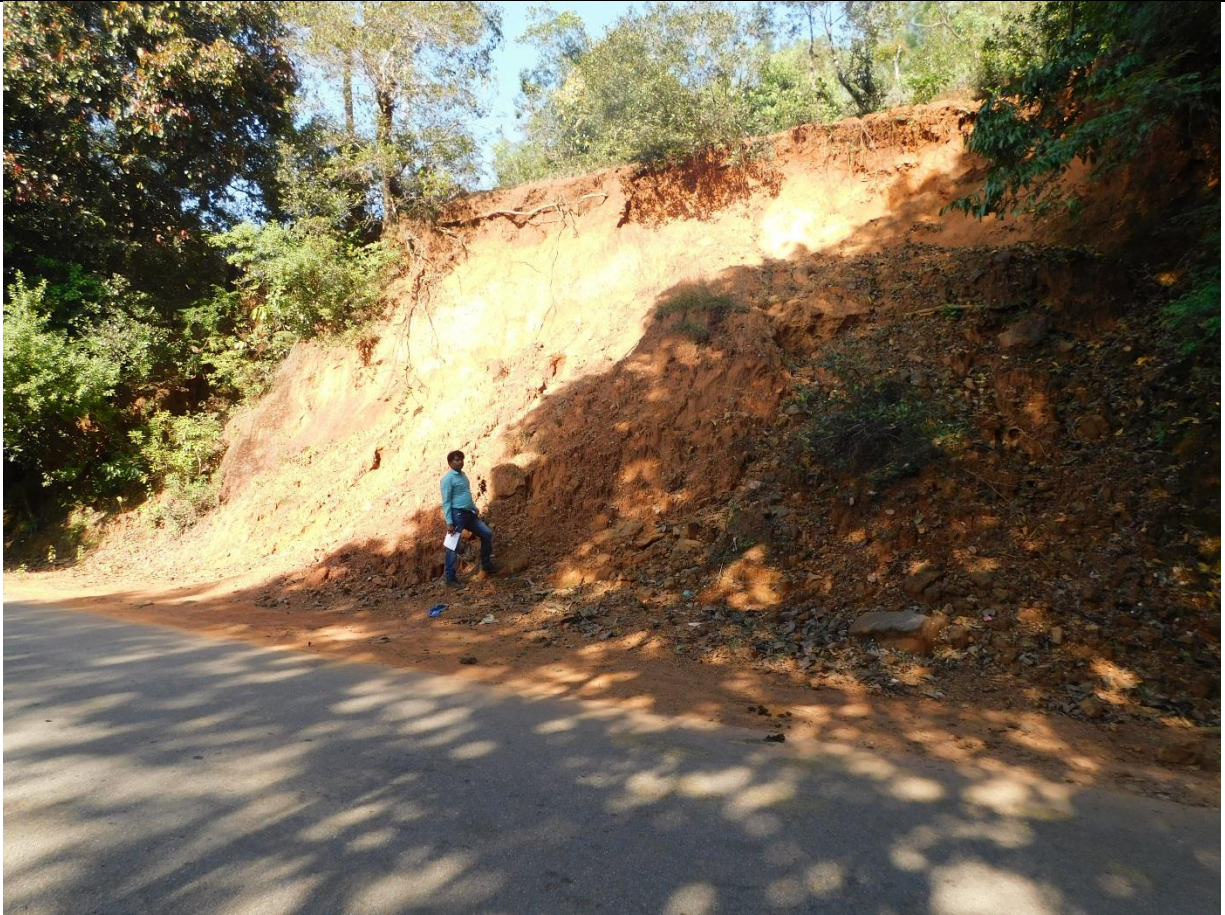
| 1 | Slide No. | KAR/SG/48O1/2019/55 |

| 22 | Failure mechanism | Shallow translational Failure |
| 36 | Geo-scientific Causes | Steep slope, thick overburden in the vertical slope, increase of the pore water pressure and toe cut by the Drainage. |

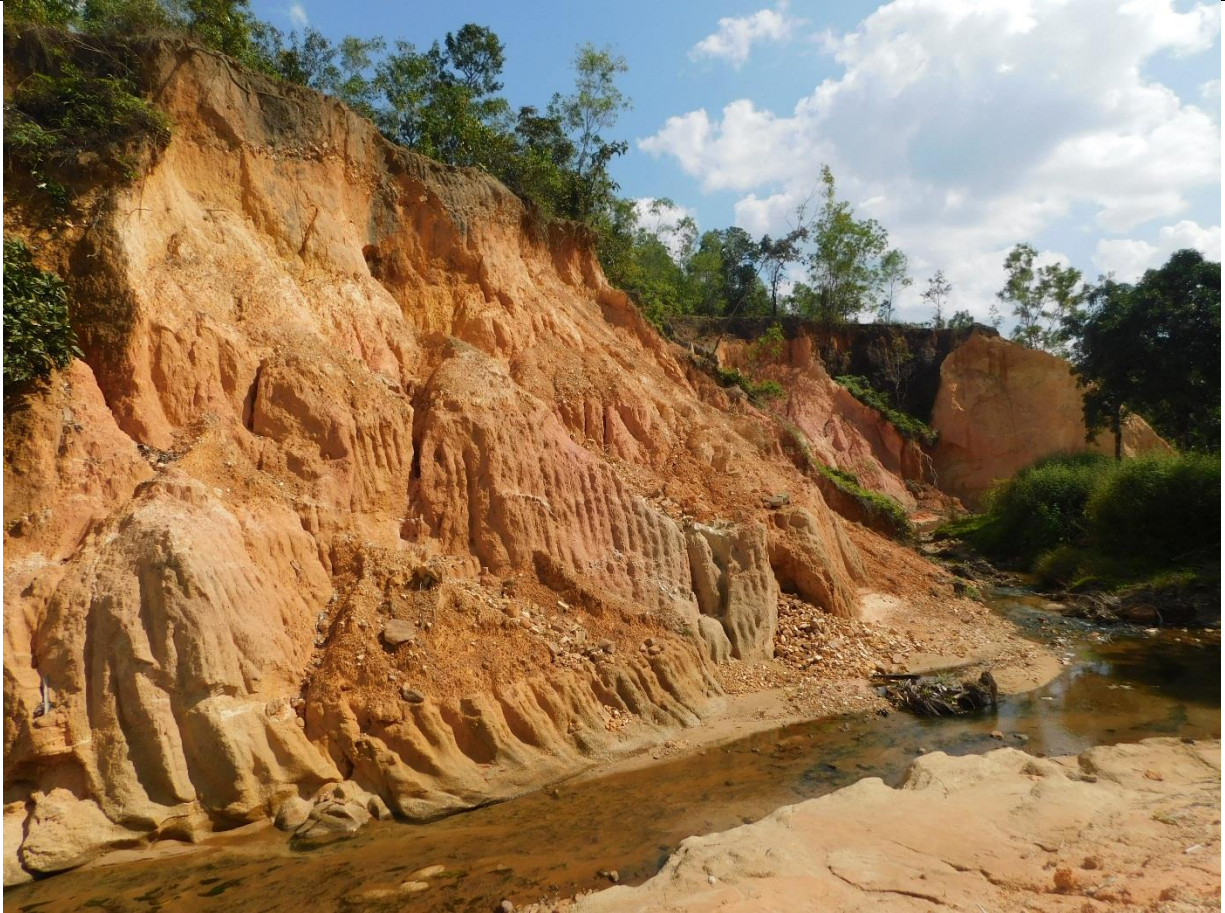
| 1 | Slide No. | KAR/SG/48O1/2019/56 |

| 22 | Failure mechanism | Shallow translational Failure |
| 36 | Geo-scientific Causes | Toe cut by the stream and pore pressure development in the soil due to incessant rain fall. |

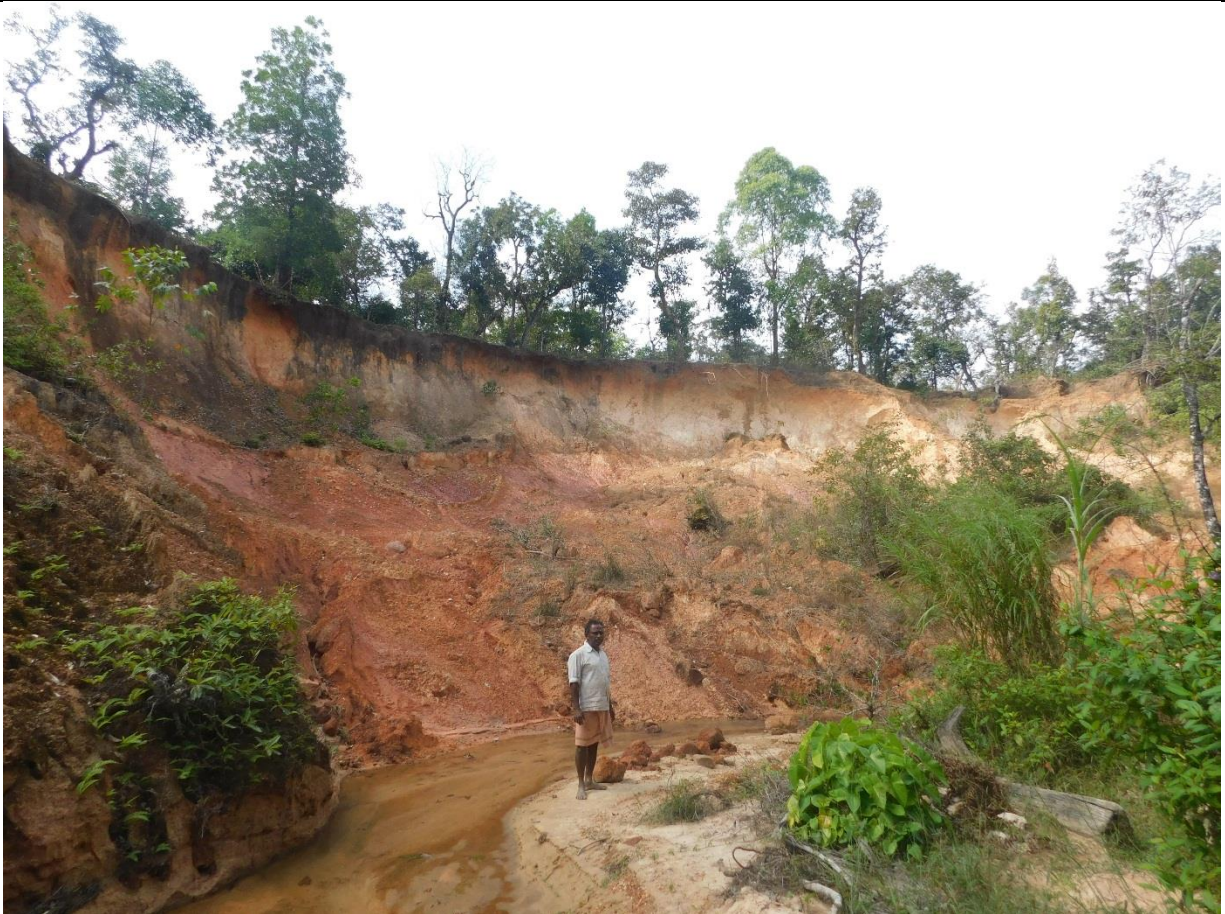
| 1 | Slide No. | KAR/SG/48O1/2019/58 |

| 22 | Failure mechanism | Shallow translational Failure |
| 36 | Geo-scientific Causes | Toe cut by the stream and pore pressure development in the soil due to incessant rain fall. Thick overburden on the steep slope. |

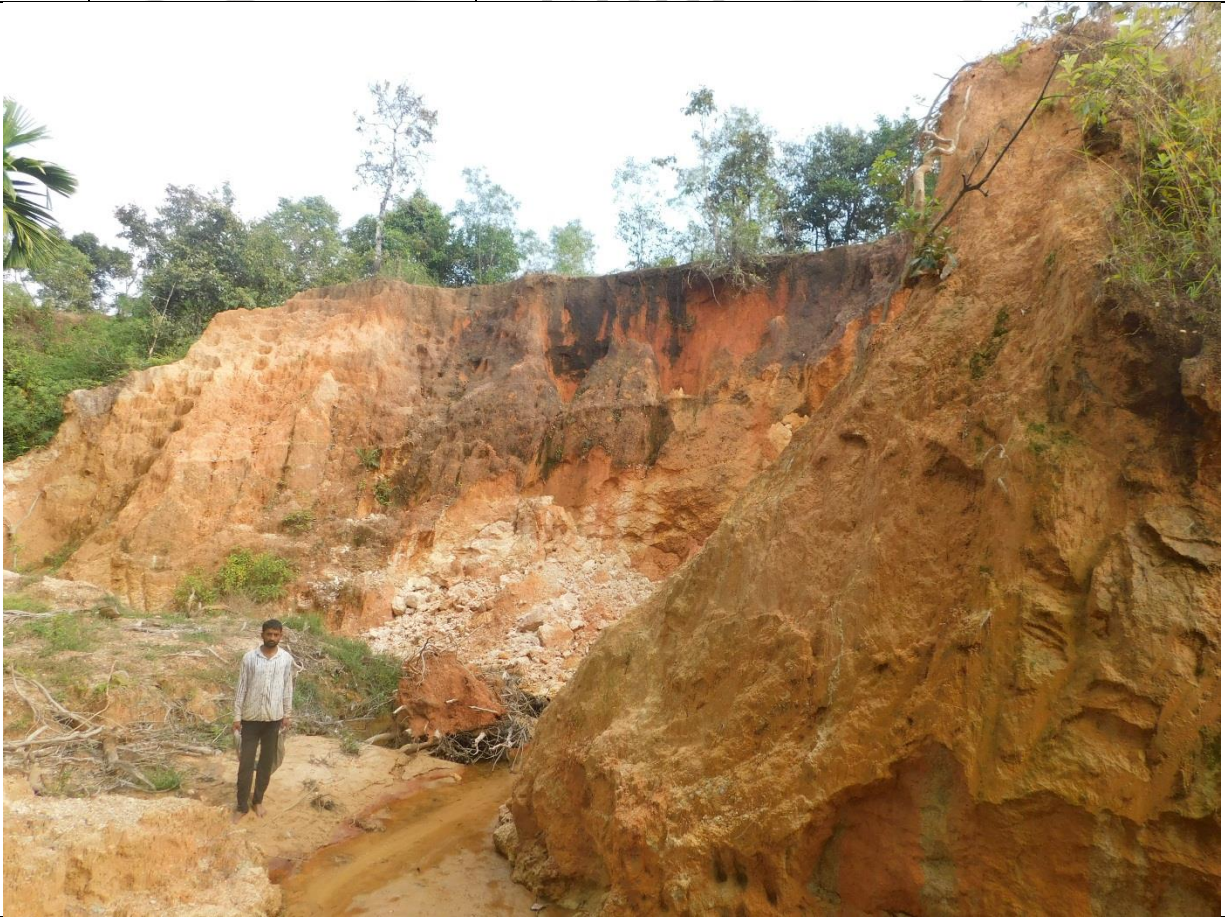
| 1 | Slide No. | KAR/SG/48O1/2019/59 |

| 22 | Failure mechanism | Deep translational Failure |
| 36 | Geo-scientific Causes | Weak slope forming material and incessant rainfall caused the pore water pressure development. |

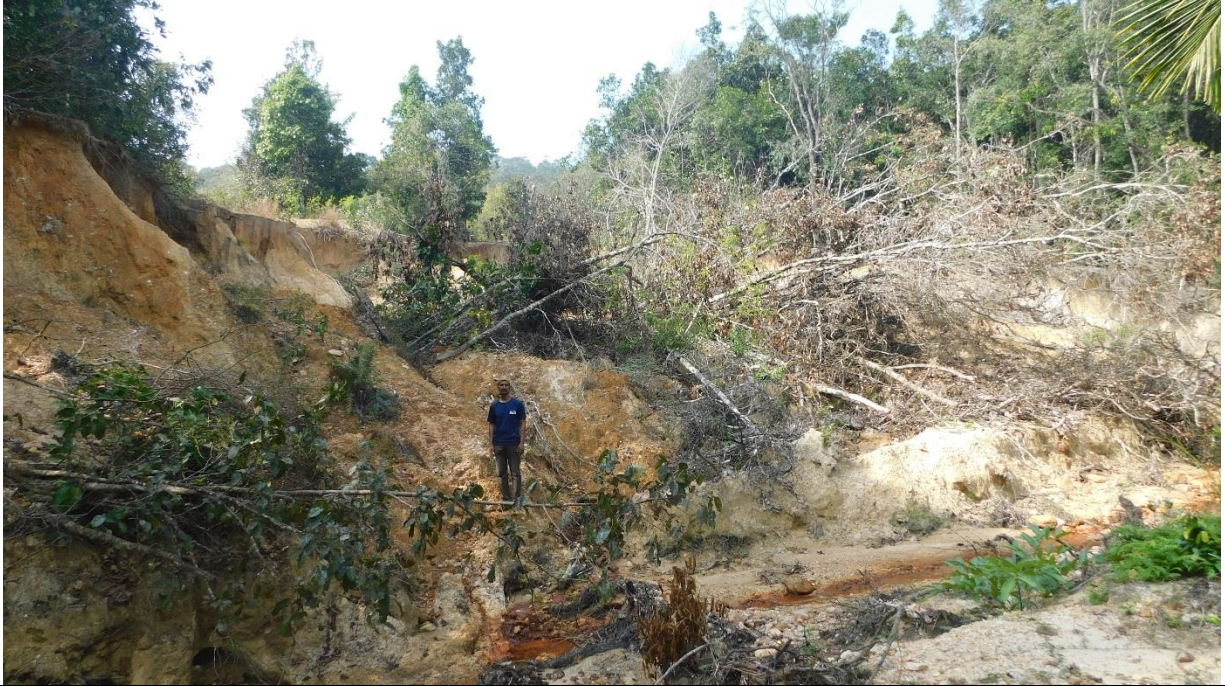
| 1 | Slide No. | KAR/SG/48O1/2019/60 |

| 22 | Failure mechanism | Shallow translational Failure |
| 36 | Geo-scientific Causes | Slope angle modified for the road construction. |

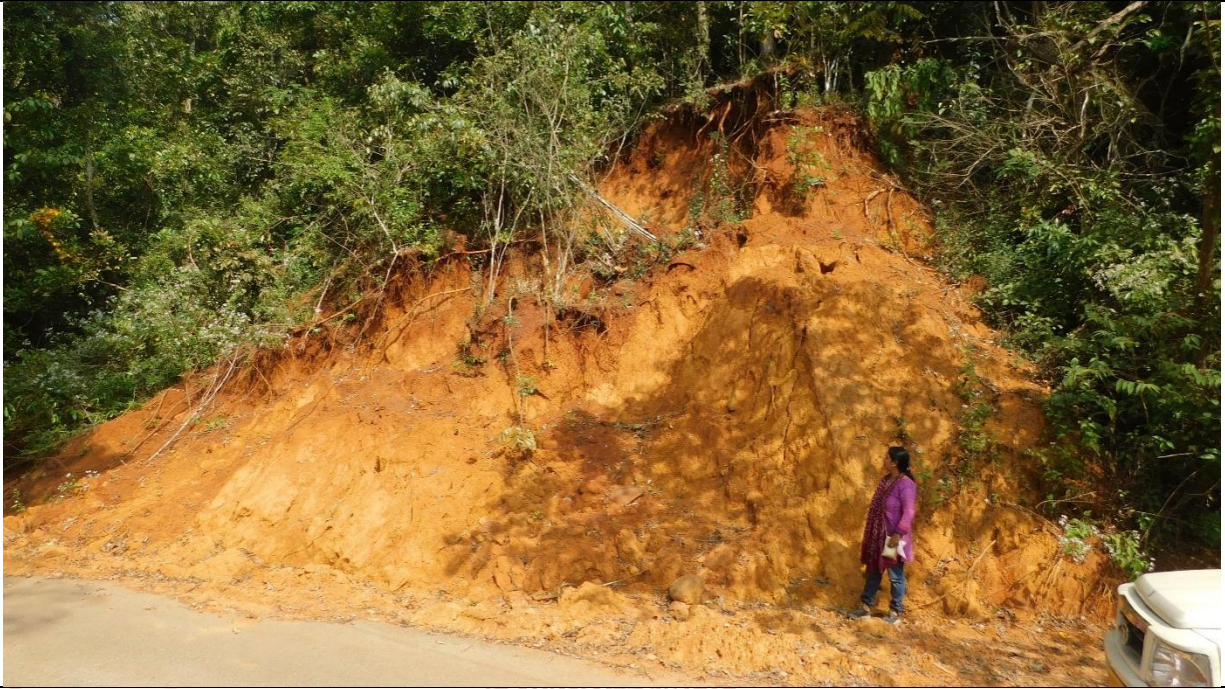
| 1 | Slide No. | KAR/SG/48O1/2019/61 |

| 22 | Failure mechanism | Shallow translational Failure |
| 36 | Geo-scientific Causes | Weak slope forming material disturbed for extension for road construction and the slope left vertically without any support. Incessant rainfall increased the pore pressure in the soil |
| 38 | Remarks, if any | Rill erosion observed on the slide material. |

| 37 | Remedial measures | Construction of retaining wall or toe drain recommended. |

| | | cutting of slope for construction of road. Construction of retaining wall or toe drain recommended. |

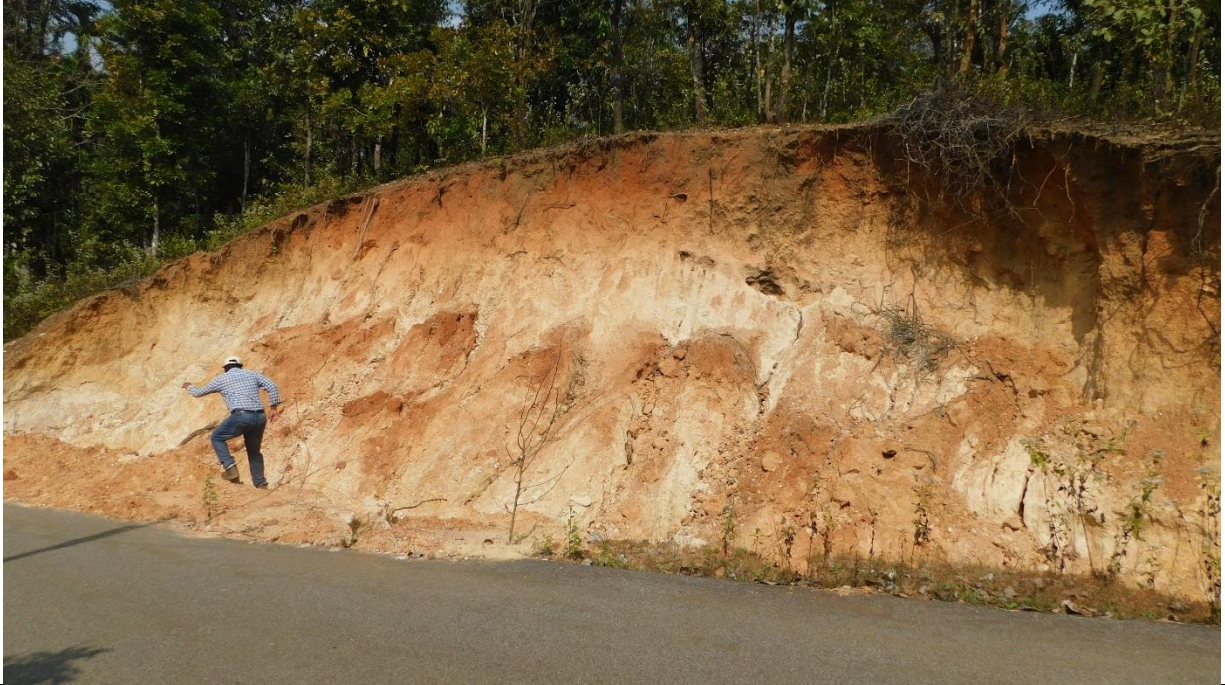
| 1 | Slide No. | KAR/SG/48O1/2019/62 |

| 22 | Failure mechanism | Shallow translational Failure |
| 36 | Geo-scientific Causes | Thick and weak slope forming material exposed on the vertical slope and the SFM eroded by stream during the incessant rainfall. |
