**MACRO-SCALE (1:50,000) LANDSLIDE SUSCEPTIBILITY MAPPING IN PARTS  
OF TOPOSHEET NOS. 48O/1, 48O/5 AND 48N/8 SHIMOGA AND CHIKMAGALUR  
DISTRICTS, KARNATAKA**

Item no.: M4LSSM/NC/SR/SU-KG/2019/25180

कार्य सत्र: 2019-20/Field Season 2019-20

रस्या रघु, वरिष्ठ भूवैज्ञानिक/Resya Reghu, Senior Geologist  
सेंतिलकुमार. के, भूवैज्ञानिक/Senthilkumar.K, Geologist

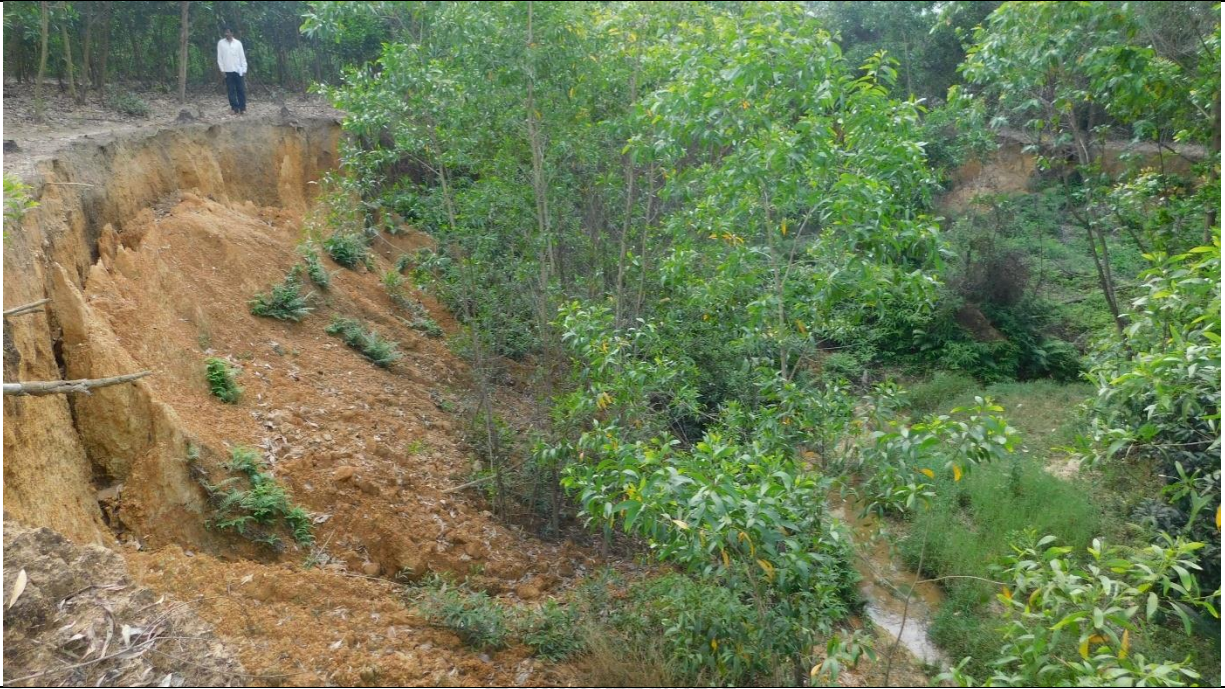
| 1 | Slide No. | KAR/SG/48O1/2019/67 |

| 22 | Failure mechanism | Shallow translational Failure |
| 36 | Geo-scientific Causes | Weak slope forming material and toe cut by the stream. |
| 39 | Summary/Abstract | Presence of thick slope forming material in the steep slope and toe cut by the stream are the causes for slide. |

| | | Removal of the debris and hanging trees, regularizing the stream flow, easing of the slope can minimize the slope failure. |

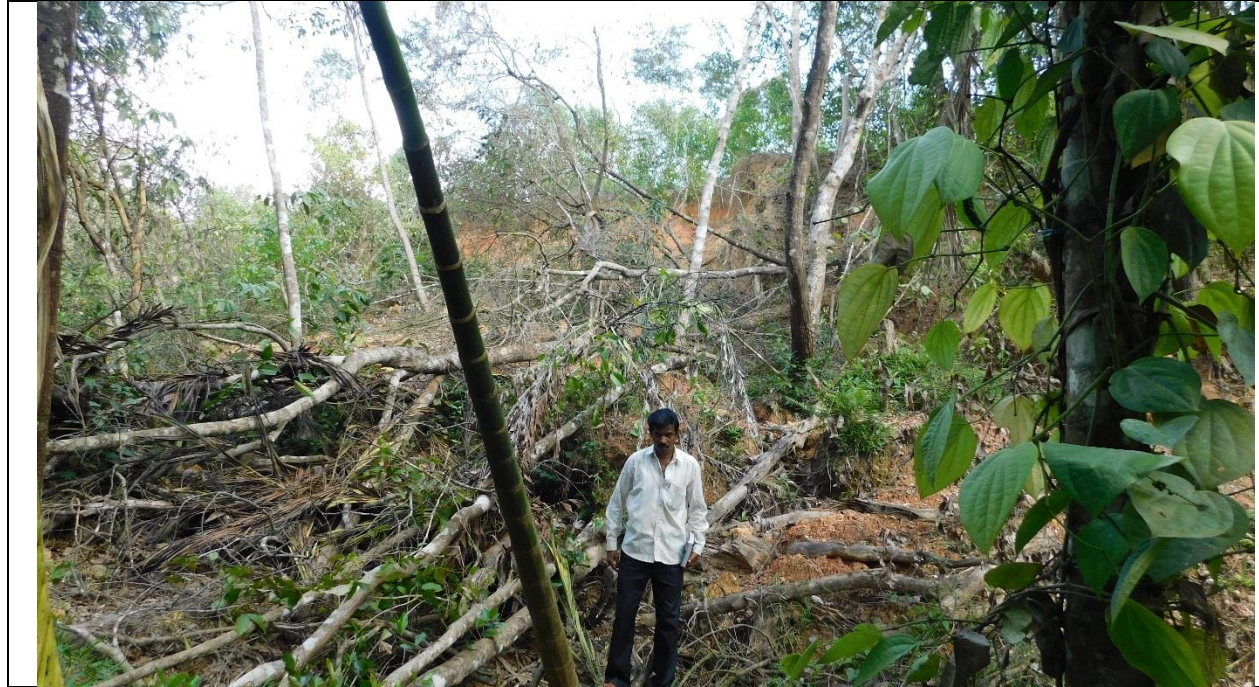
| 1 | Slide No. | KAR/SG/48O1/2019/68 |

| 22 | Failure mechanism | Deep translational Failure |
| 36 | Geo-scientific Causes | Incessant rainfall increased the pore pressure in thick weak slope forming material which is exposed on vertical slope. |

| 37 | Remedial measures | Avoid disturbing of the slope and construction of channel wall will reduce the further slope failure. |

| 39 | Summary/Abstract | Slope modification should be avoided and construction of channel wall will reduce the further slope failure. |

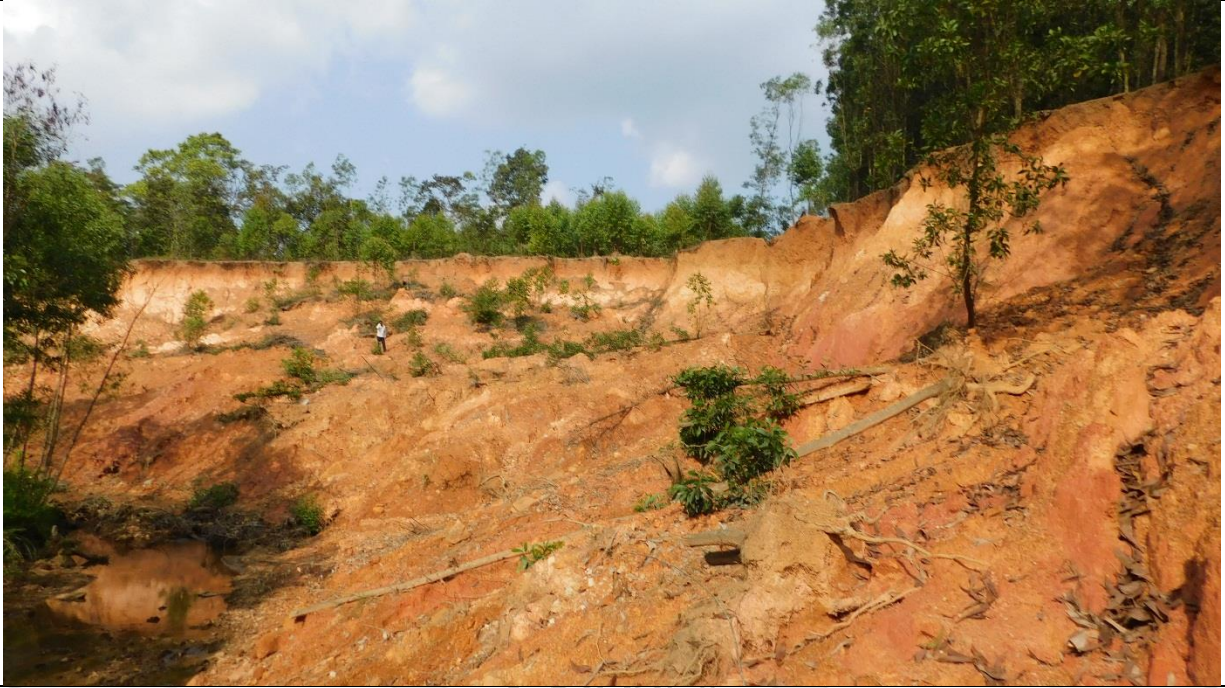
| 1 | Slide No. | KAR/SG/48O1/2019/69 |

| 22 | Failure mechanism | Shallow translational Failure |
| 36 | Geo-scientific Causes | Thick weak slope forming material in the vertical slope which was toe cut/scoured by stream, due to incessant rainfall the pore pressure increased and the slope failed. |

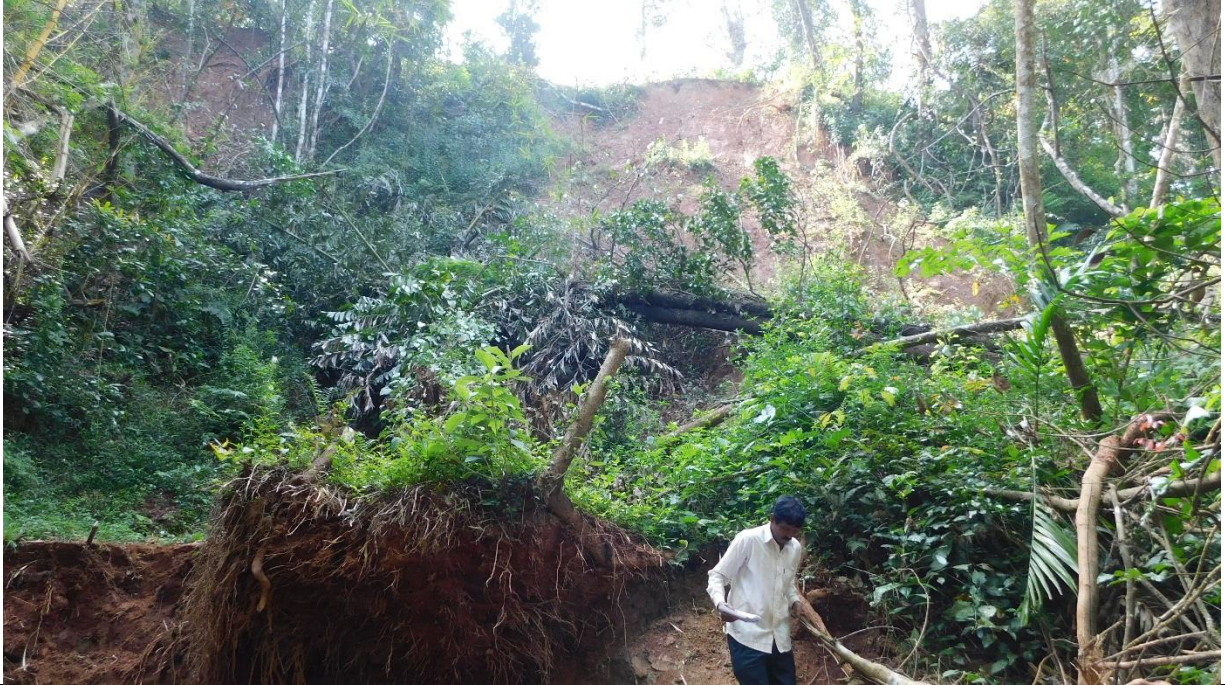
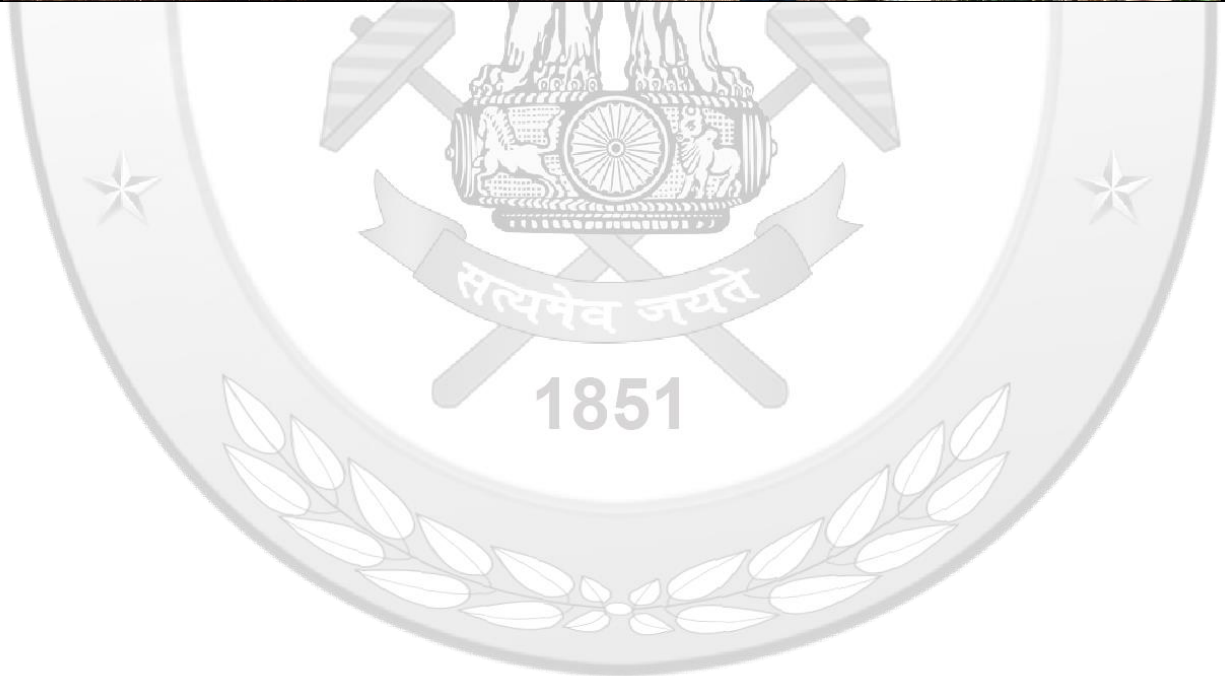
| 1 | Slide No. | KAR/SG/48O1/2019/70 |

| 22 | Failure mechanism | Shallow translational Failure |
| 36 | Geo-scientific Causes | The slope modified for settlement and slope left as vertically without any remedial measures. |

| 37 | Remedial measures | Construction of Retaining wall with proper weep holes and toe drain is recommended. |

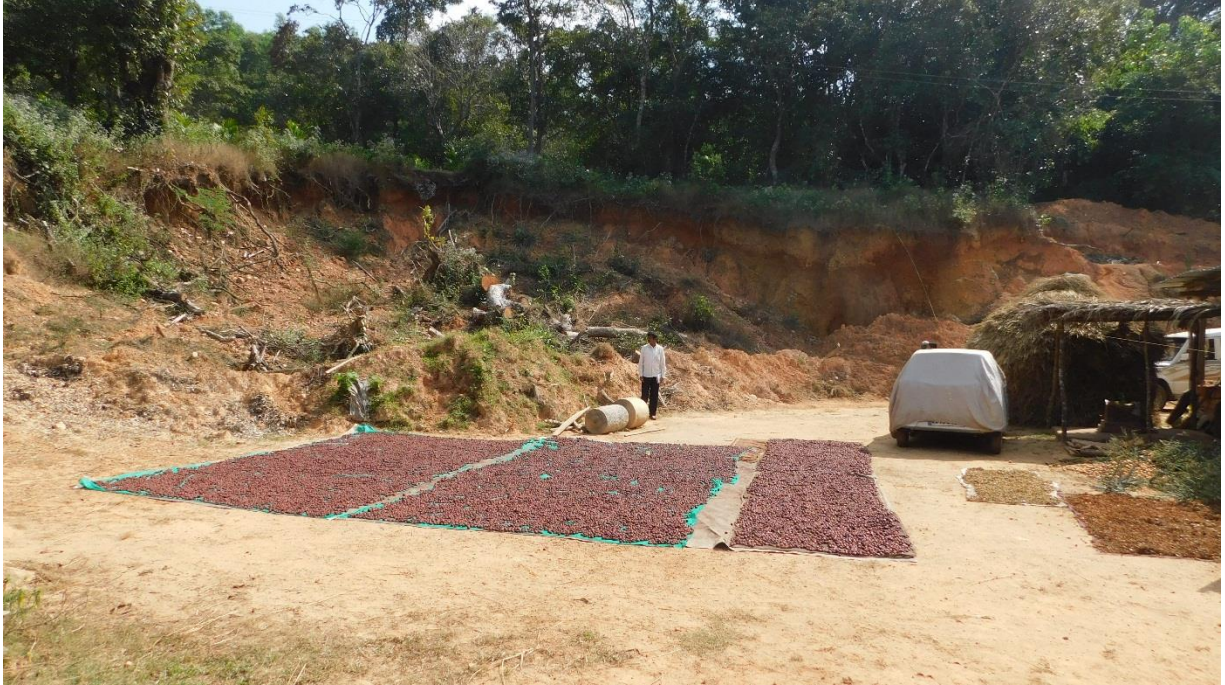
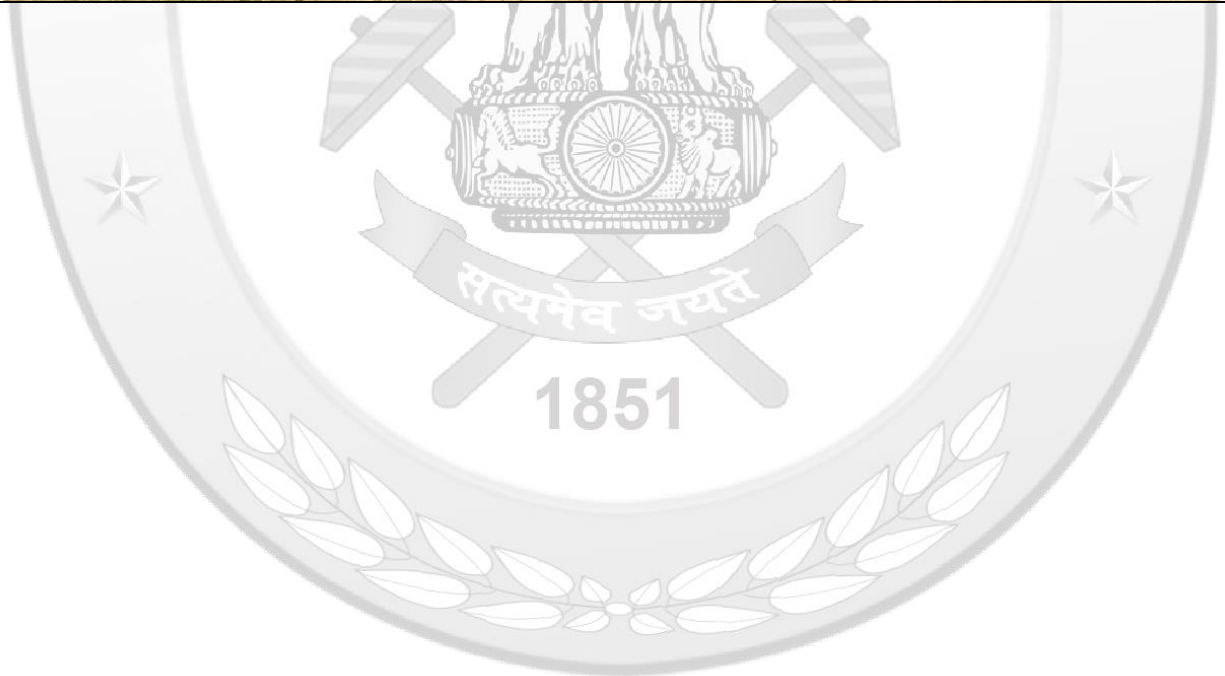
| 1 | Slide No. | KAR/SG/48O1/2019/71 |

| 22 | Failure mechanism | Shallow translational Failure |
| 36 | Geo-scientific Causes | Weak slope forming material disturbed for extension for road construction and the slope left as vertical cut without any support. Incessant rainfall increased the pore pressure in the soil |

| 39 | Summary/Abstract | Debris slide occurred on the lowly dissected slope due to cutting of slope for construction of road. Construction of retaining wall or toe drain recommended. |

| 37 | Remedial measures | Removal of the material, construction of retaining wall or toe drain recommended. |

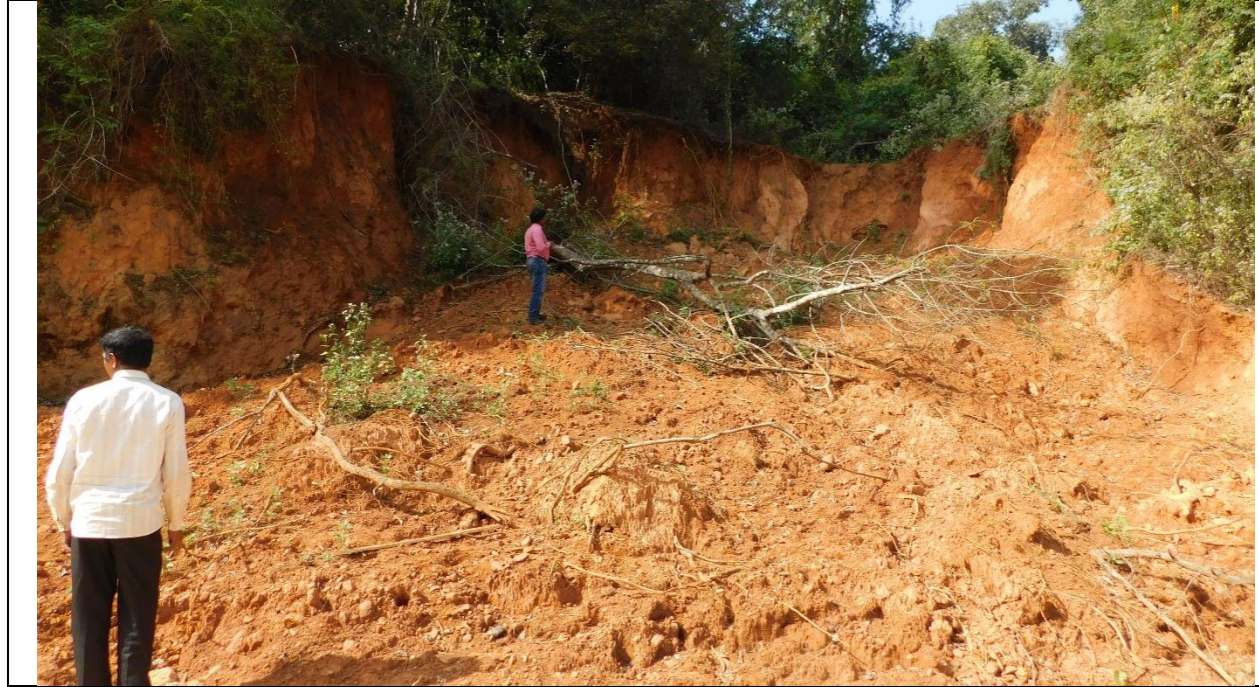
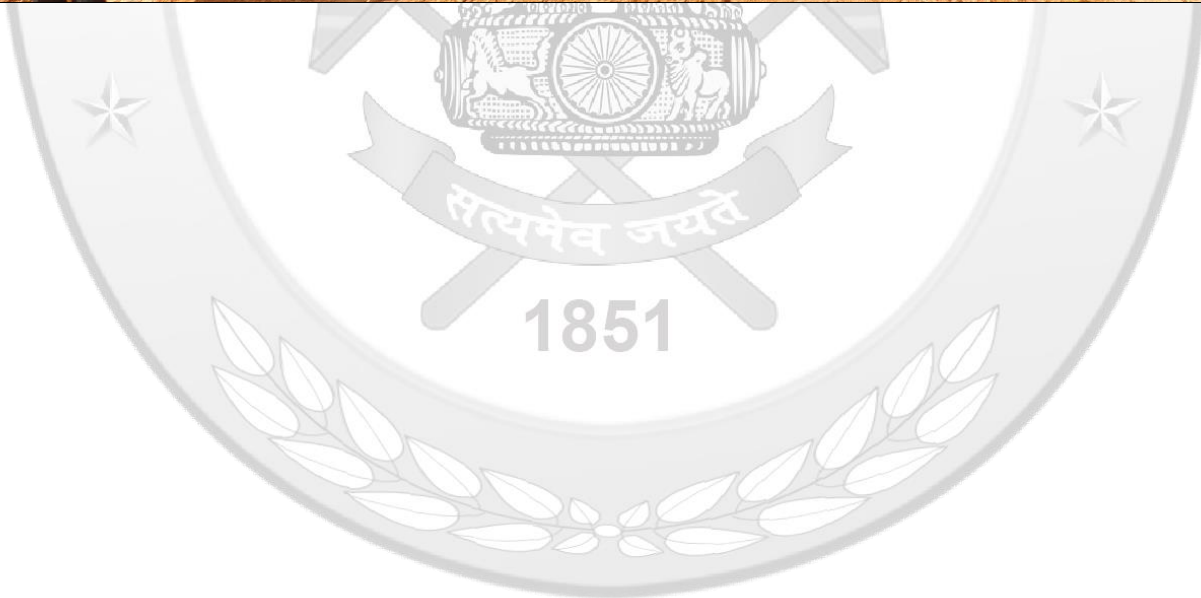
| 1 | Slide No. | KAR/SG/48O1/2019/72 |

| 22 | Failure mechanism | Shallow translational Failure |
| 36 | Geo-scientific Causes | Thick weak slope forming material in the vertical slope which was toe cut/scoured by stream, due to incessant rainfall the pore pressure increased and the slope failed. |
| 38 | Remarks, if any | At the top of the slide cracks are observed. It may |

| 39 | Summary/Abstract | Failure happened on the very gentle slope. The dimension of the slide is very less and it is initiated adjacent to the cultivation. |

| 37 | Remedial measures | Construction of channel wall will reduce the further slope failure. |

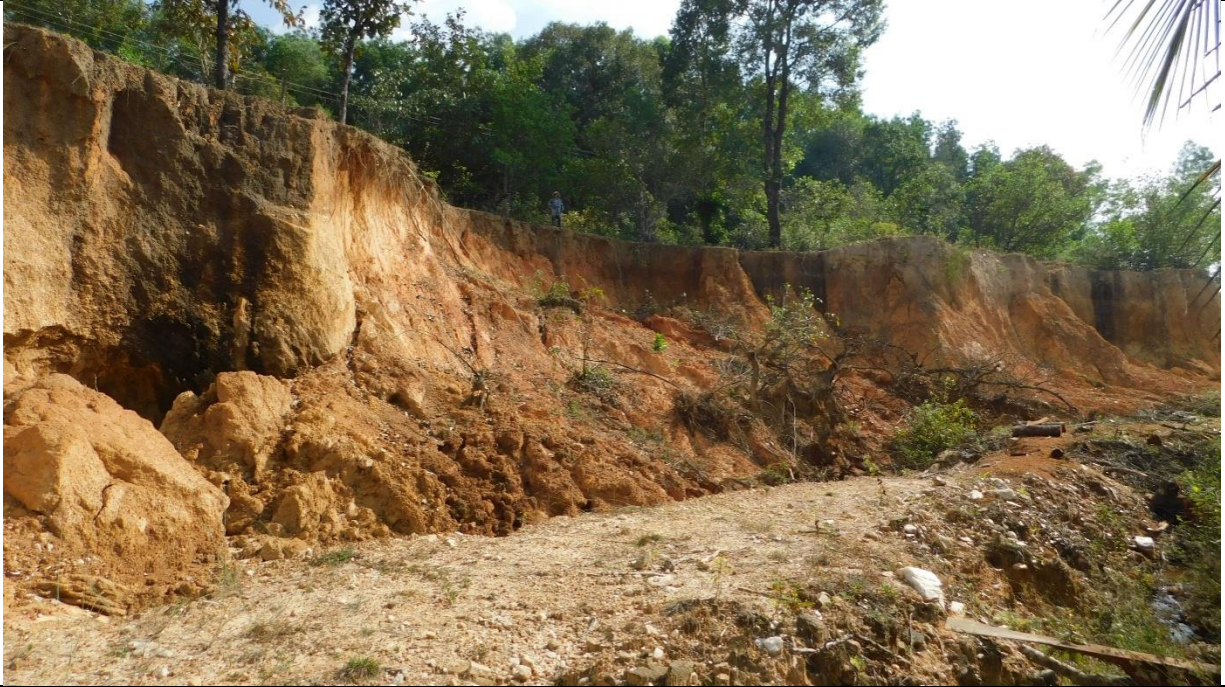
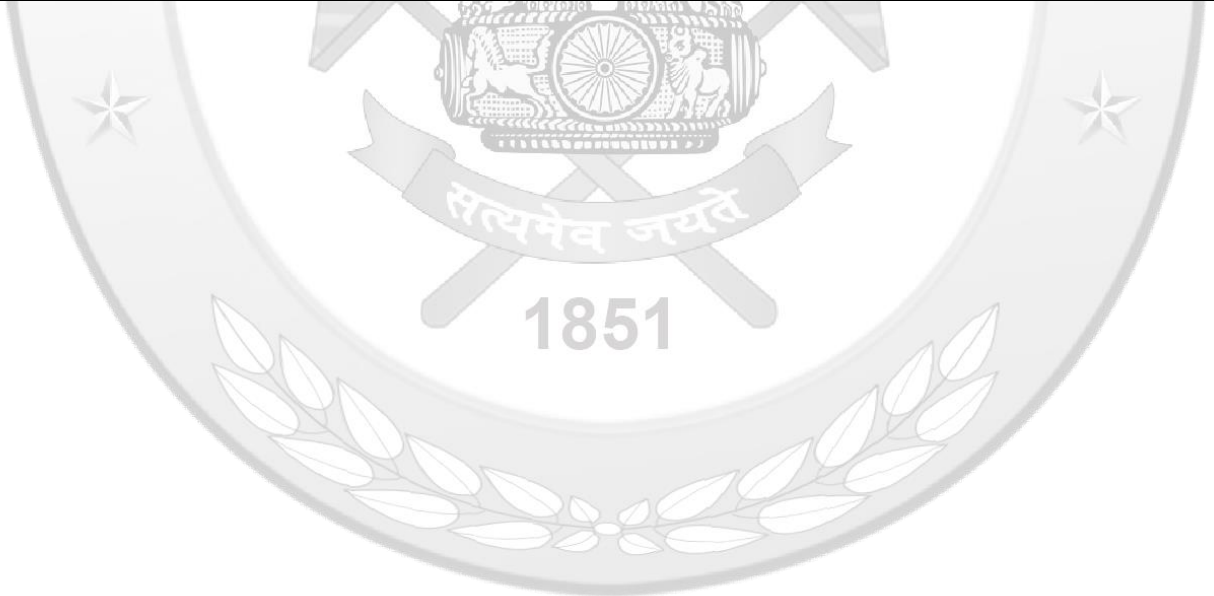
| 1 | Slide No. | KAR/SG/48O1/2019/73 |

| 22 | Failure mechanism | Shallow translational Failure |
| 36 | Geo-scientific Causes | Highly weathered rock exposed on the steep slope coupled with the incessant rainfall and toe cut are the causes for the slide |

| 39 | Summary/Abstract | Highly weathered rock exposed on the steep slope coupled with the incessant rainfall and toe cut are the causes for the slide. Construction of channel wall and easing of the slope will reduce the further slope failure. |

| 37 | Remedial measures | Construction of channel wall and easing of the slope will reduce the further slope failure. |

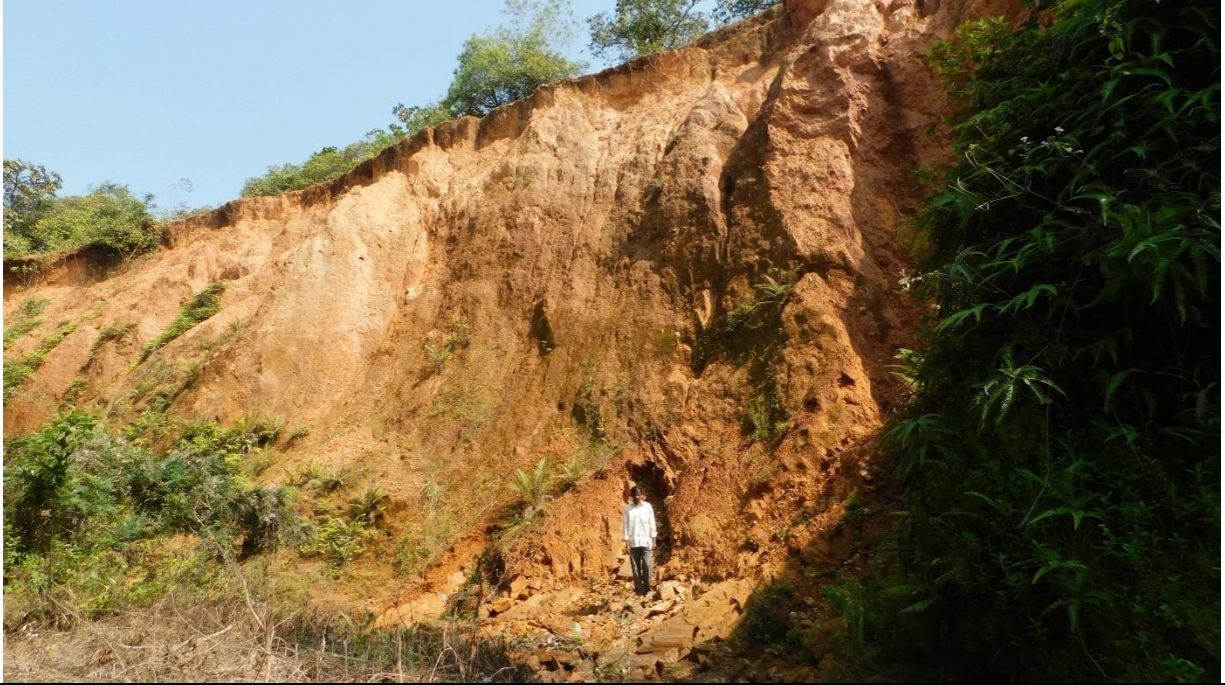
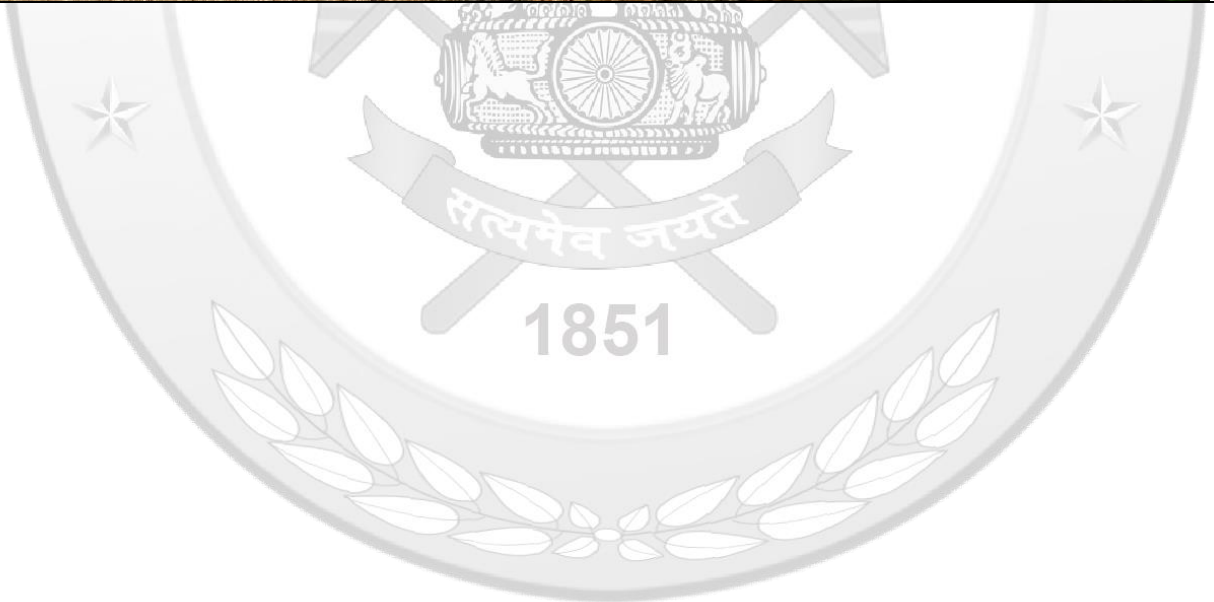
| 1 | Slide No. | KAR/SG/48O1/2019/74 |

| 22 | Failure mechanism | Shallow translational Failure |
| 36 | Geo-scientific Causes | The lowly dissected slope modified for settlement and slope left as vertical cut without any remedial measures. |

| | | slope left as vertical cut without any remedial measures. Easing of the slope, construction of retaining wall with proper weep holes and toe drain is recommended. |

| 37 | Remedial measures | Easing of the slope, construction of retaining wall with proper weep holes and toe drain is recommended. |

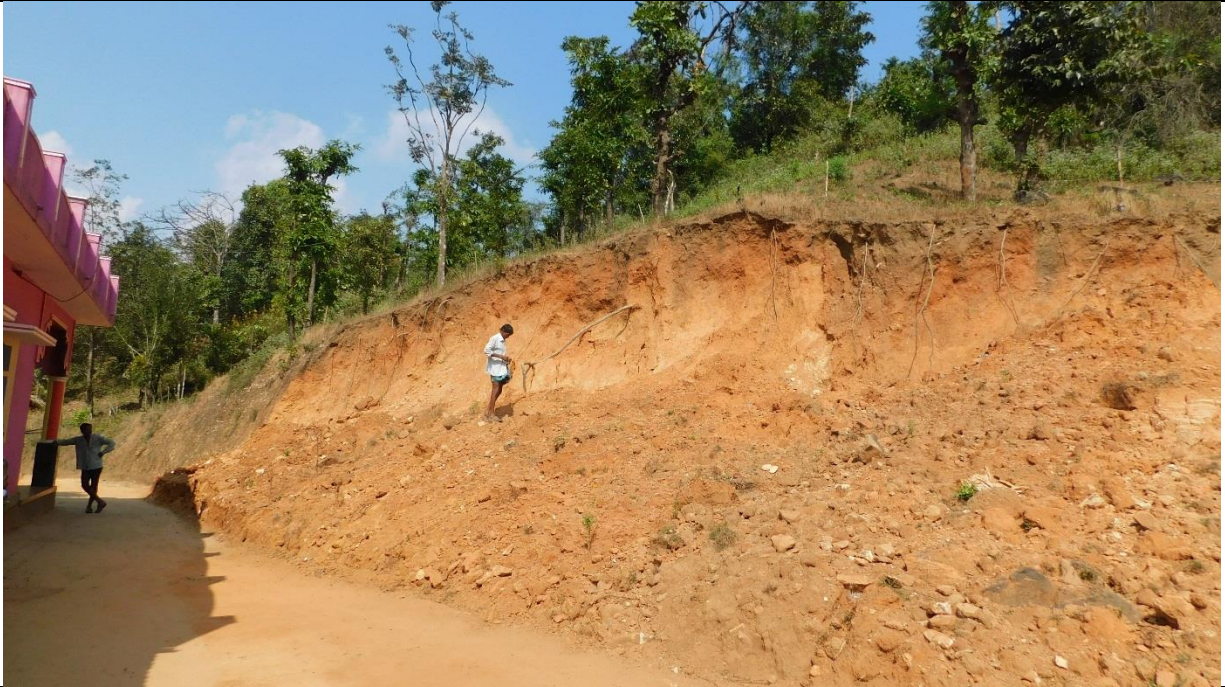
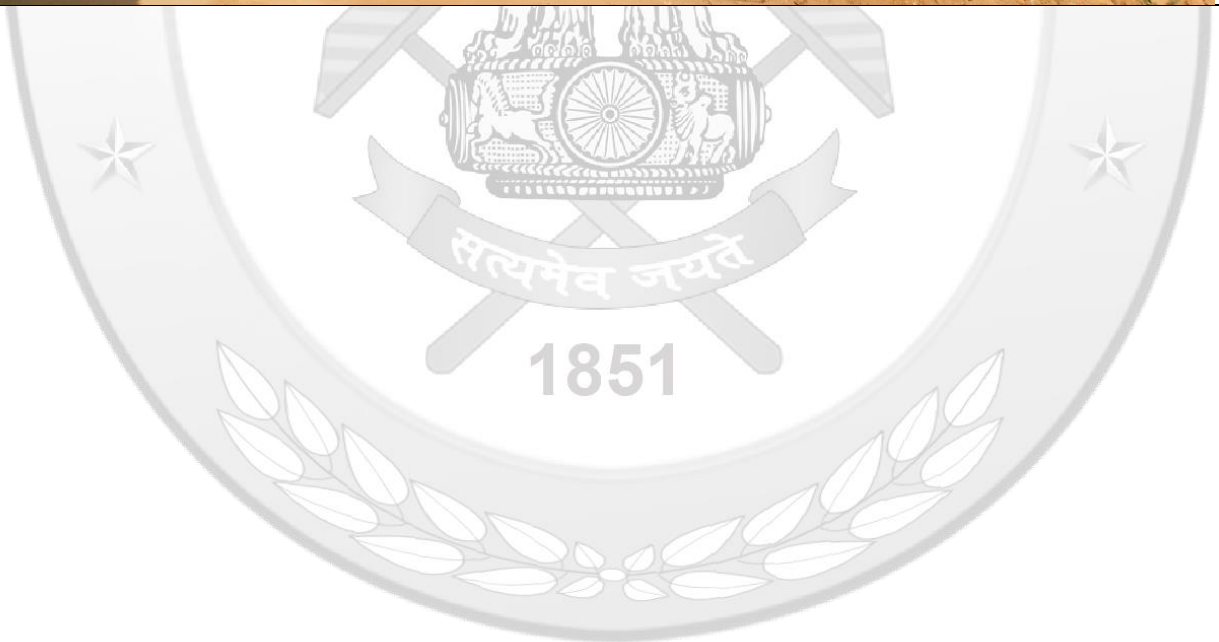
| 1 | Slide No. | KAR/SG/48O1/2019/75 |

| 22 | Failure mechanism | Shallow translational Failure |
| 36 | Geo-scientific Causes | Weak slope forming material, incessant rainfall and toe cut by the stream. |

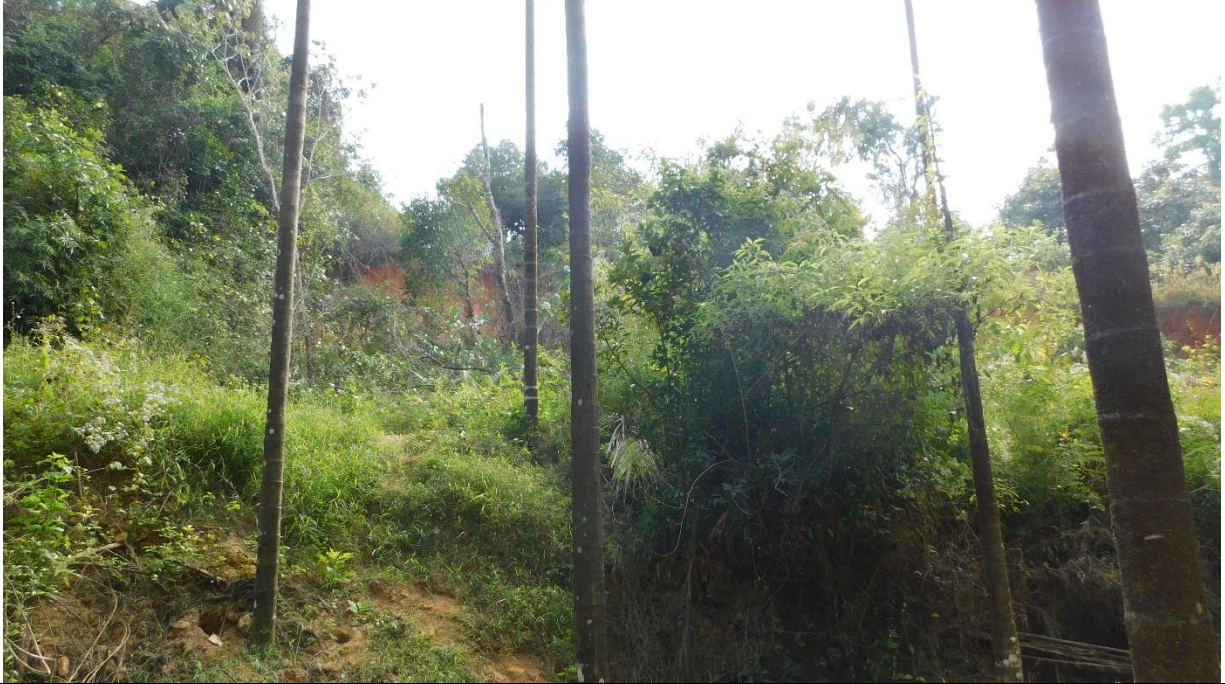
| 1 | Slide No. | KAR/SG/48O5/2019/76 |

| 22 | Failure mechanism | Shallow translational Failure |
| 36 | Geo-scientific Causes | Weak slope forming material disturbed for extension of road construction and the slope left as vertical cut without any support. Incessant rainfall increased the pore pressure in the soil. |

| 37 | Remedial measures | Removal of the material, Construction of retaining wall or toe drain recommended. |

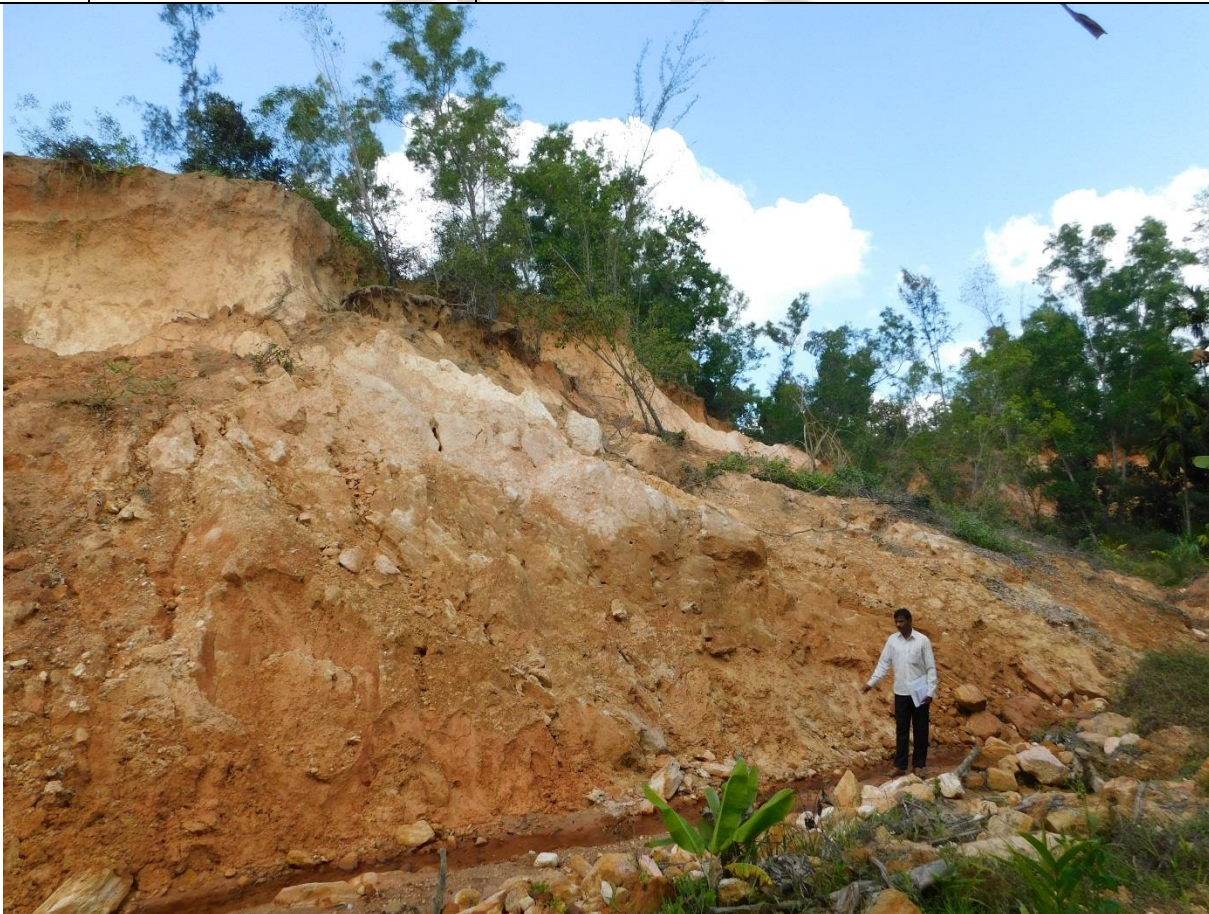
| 1 | Slide No. | KAR/SG/48O1/2019/89 |

| 22 | Failure mechanism | Shallow translational Failure |
| 28 | Hydrological condition | Damp |
| 36 | Geo-scientific Causes | Continuous rainfall increased the pore water pressure and increased the water level in the channel which lead to loss of strength by soil and toe cut/ scouring by the stream. |

| 37 | Remedial measures | Construction of Channel wall is recommended. |

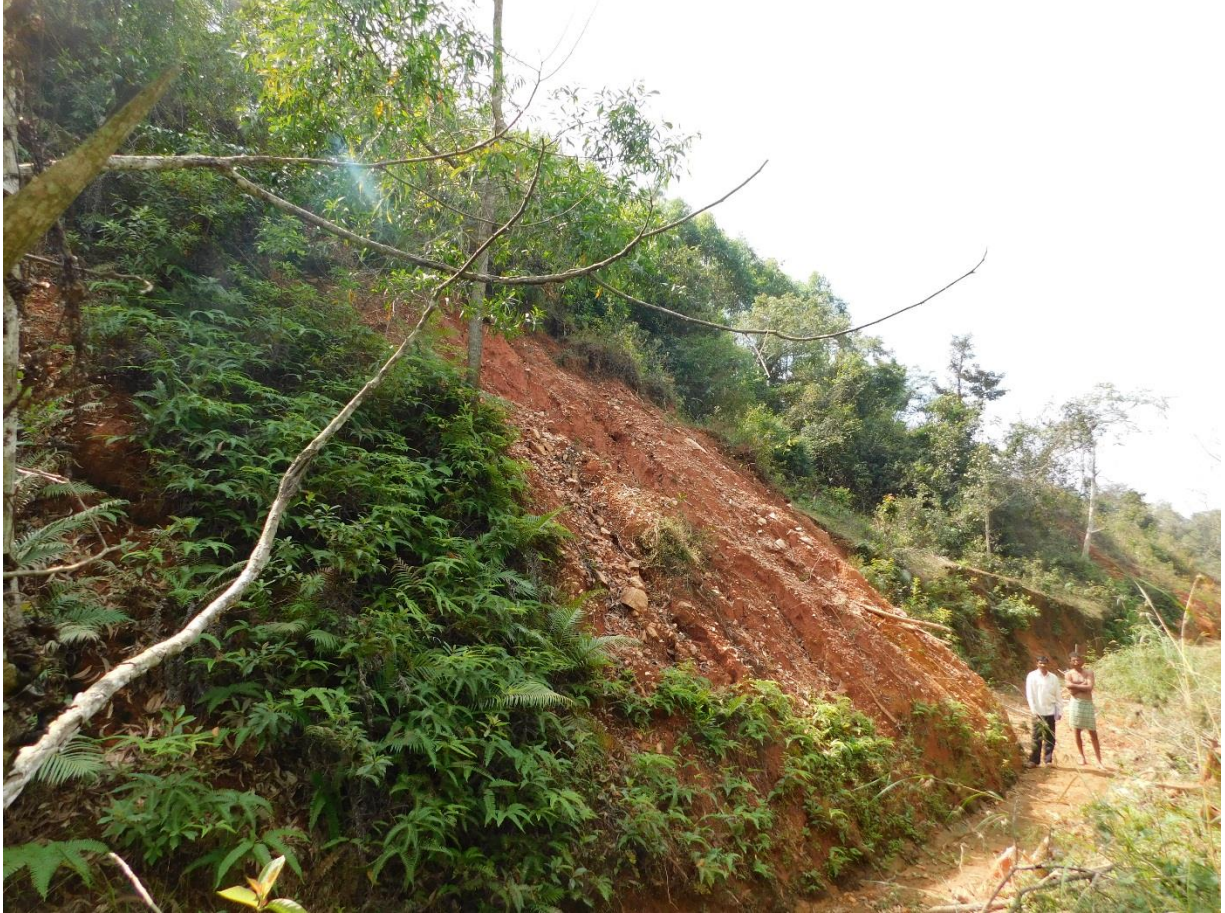
| 1 | Slide No. | KAR/SG/48O1/2019/90 |

| 22 | Failure mechanism | Shallow translational Failure |
| 36 | Geo-scientific Causes | Continuous rainfall may have increased the pore water pressure in the thick overburden which is exposed on the vertical slope. |

| | | Aug 2019. Continuous rainfall may have increased the pore water pressure in the thick overburden which is exposed on the vertical slope. Construction of Channel wall is recommended. |

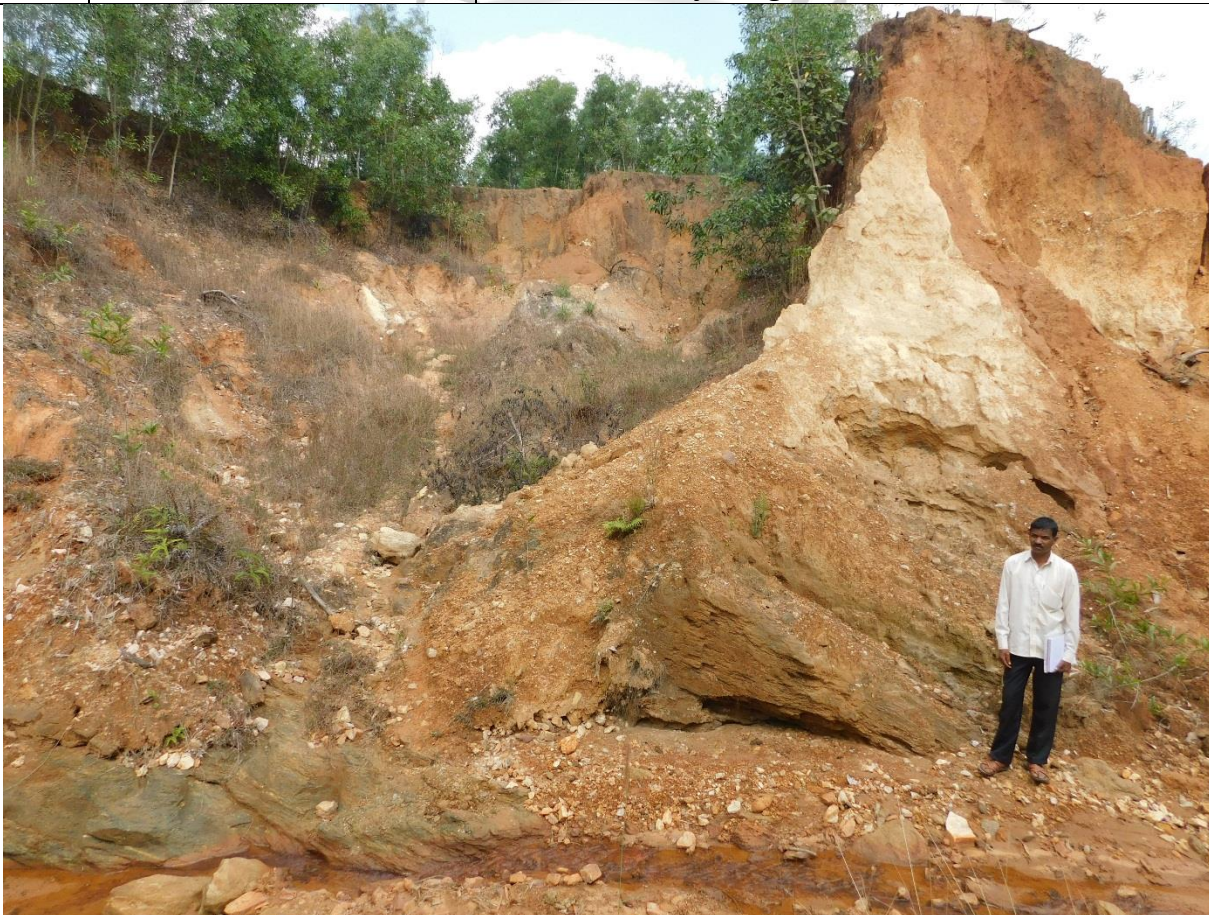
| S. No. | Slide No. | 92 |

| 22 | Failure mechanism | Shallow translational Failure |
| 36 | Geo-scientific Causes | Continuous rainfall may have increased the pore water pressure in the thick overburden which is exposed on the vertical slope. Increase of the water level in the channel which lead to toe cut/scouring by the stream |

| 38 | Remarks, if any | Initiation of the slide was in 2006. Since then the slide has reactivated every year and above the crown many houses are situated. Many crown cracks are observed and they are extending for very long distance having a width of 10-20 cm and depth of about 1m. Next monsoon this area will definitely fail. The upslope is dipping towards the slide direction. |

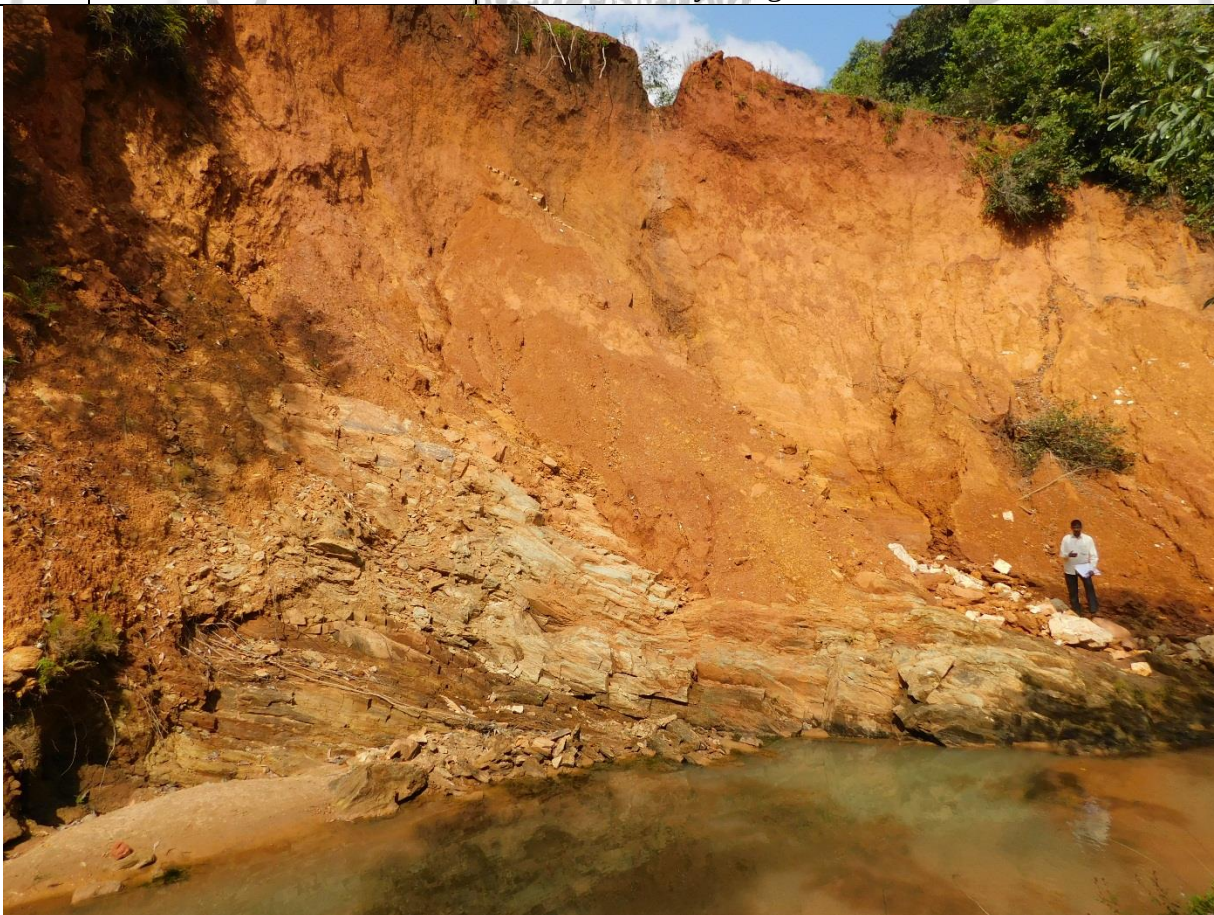
| 1 | Slide No. | KAR/SG/48O1/2019/93 |

| 22 | Failure mechanism | Shallow translational Failure |
| 36 | Geo-scientific Causes | Continuous rainfall may have increased the pore water pressure in the thick overburden which is exposed on the vertical slope. Increase of the water level in the channel which leads to toe cut/scouring by the stream. |
| 38 | Remarks, if any | Cracks observed on the crown portion. The flowing |

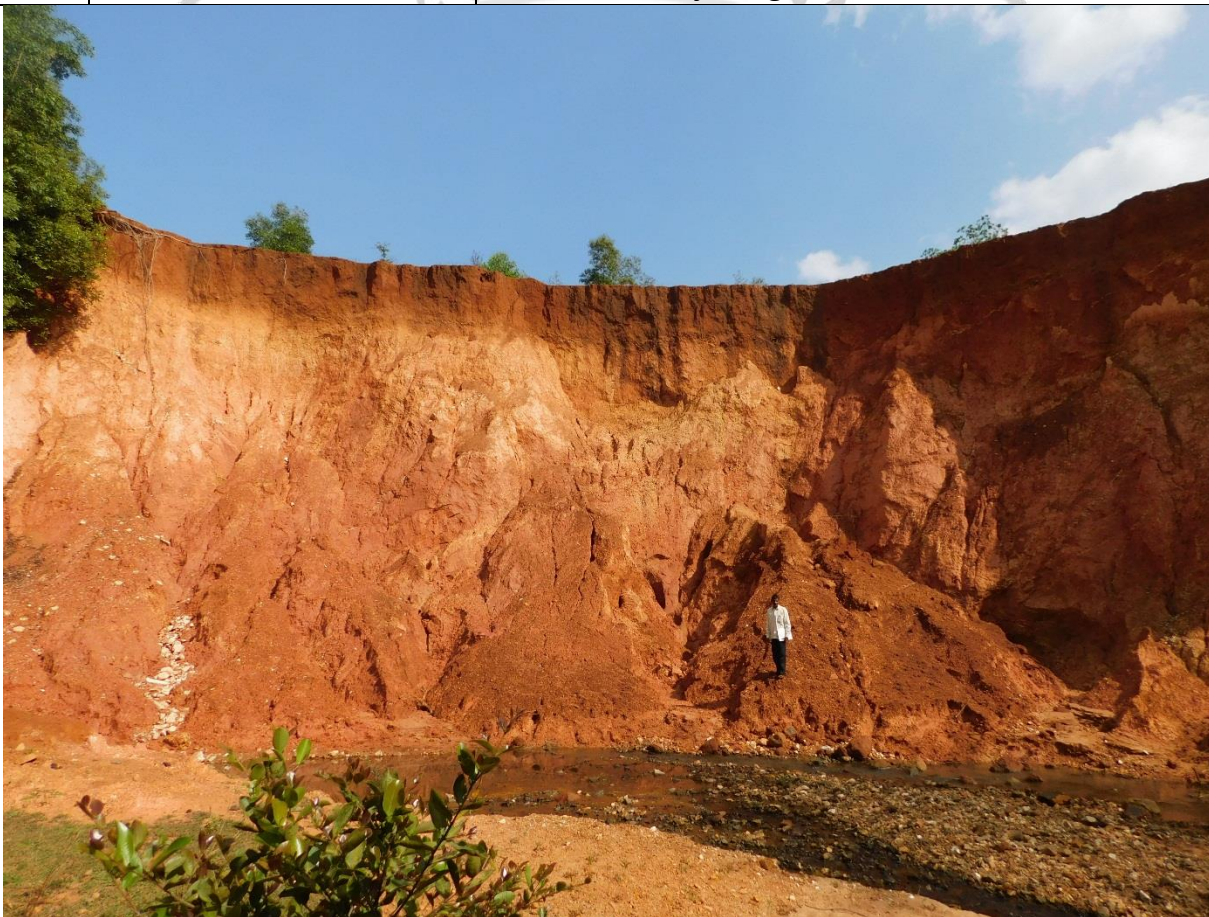
| S. No. | Slide No. | 94 |

| 22 | Failure mechanism | Shallow translational Failure |
| 36 | Geo-scientific Causes | Continuous rainfall may have increased the pore water pressure in the thick overburden which is exposed on the vertical slope. Increase of the water level in the channel which leads to toe cut/scouring by the stream. |

| 39 | Summary/Abstract | The slide initiated in 2010 since then every year it gets reactivated. Continuous rainfall and toe cut by stream are the main causes for the slide. Removal of the debris to regularize stream flow and construction of channel wall is recommended. |

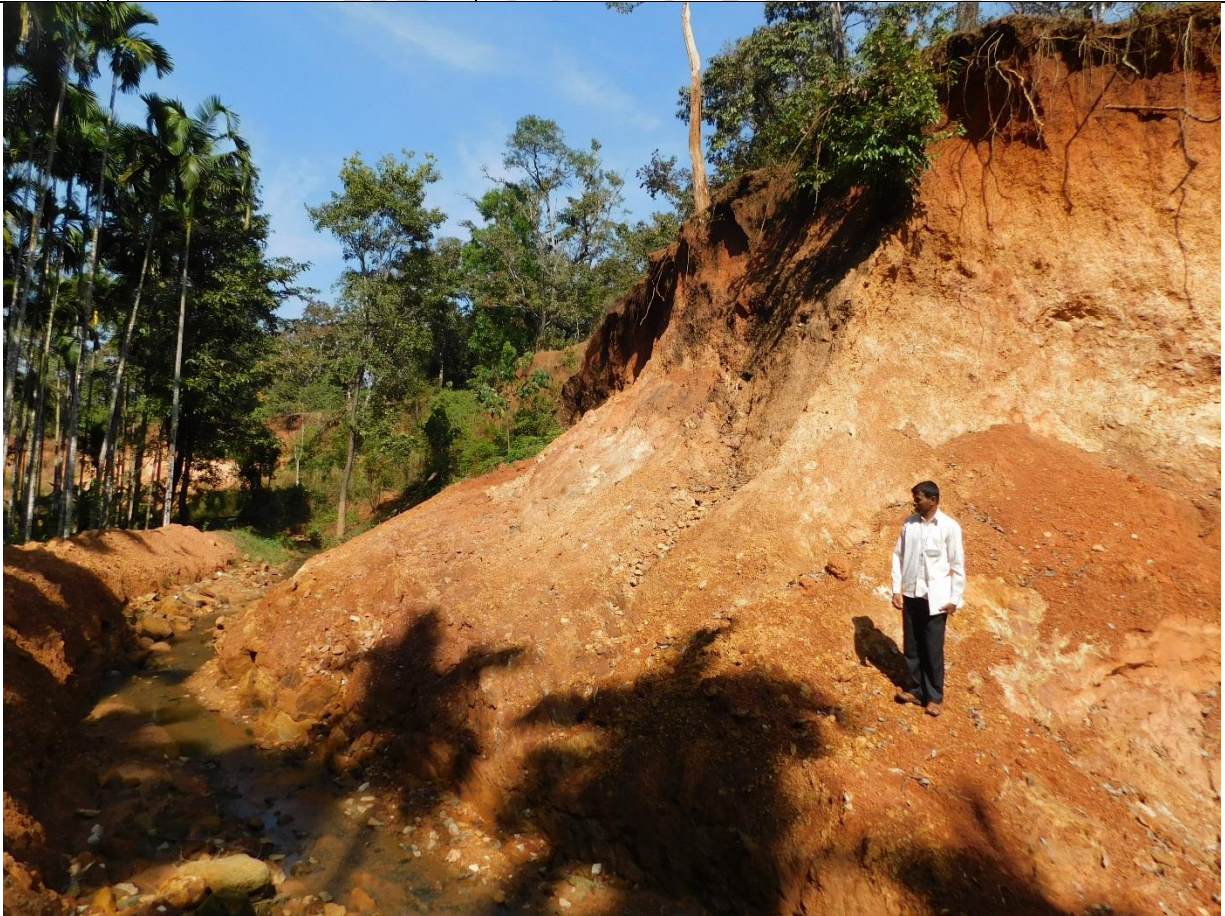
| S. No. | Slide No. | 95 |

| 22 | Failure mechanism | Shallow translational Failure |
| 36 | Geo-scientific Causes | Continuous rainfall may have increased the pore water pressure in the thick overburden which is exposed on the vertical slope. Increase in the water level in the channel which leads to toe cut/scouring by the stream. |

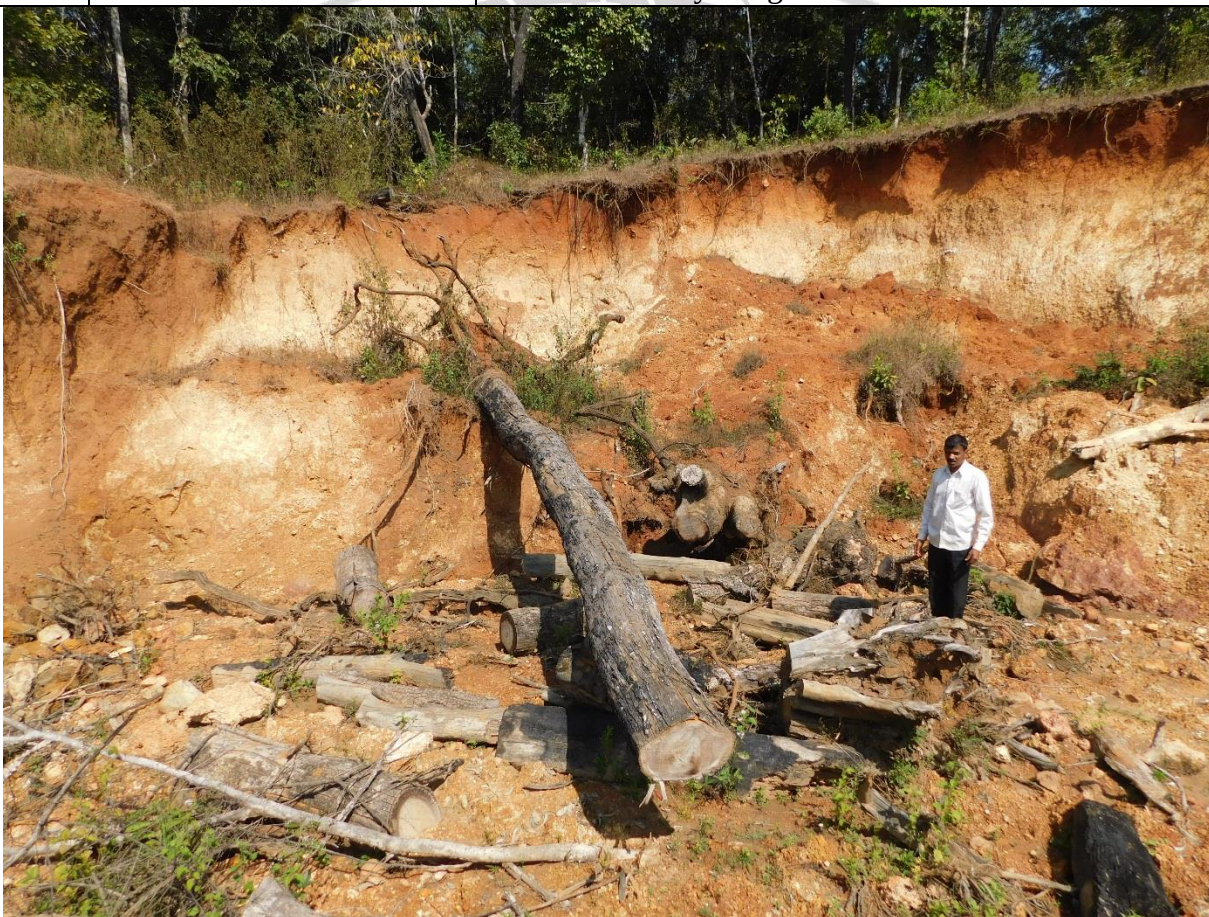
| 1 | Slide No. | KAR/SG/48O1/2019/96 |

| 22 | Failure mechanism | Shallow translational Failure |
| 36 | Geo-scientific Causes | Incessant rainfall, thick overburden in the steep slope and toe cut by drainage are the main causes. |
