**MACRO-SCALE (1:50,000) LANDSLIDE SUSCEPTIBILITY MAPPING IN PARTS  
OF TOPOSHEET NOS. 48O/1, 48O/5 AND 48N/8 SHIMOGA AND CHIKMAGALUR  
DISTRICTS, KARNATAKA**

Item no.: M4LSSM/NC/SR/SU-KG/2019/25180

कार्य सत्र: 2019-20/Field Season 2019-20

रस्या रघु, वरिष्ठ भूवैज्ञानिक/Resya Reghu, Senior Geologist  
सेंतिलकुमार. के, भूवैज्ञानिक/Senthilkumar.K, Geologist

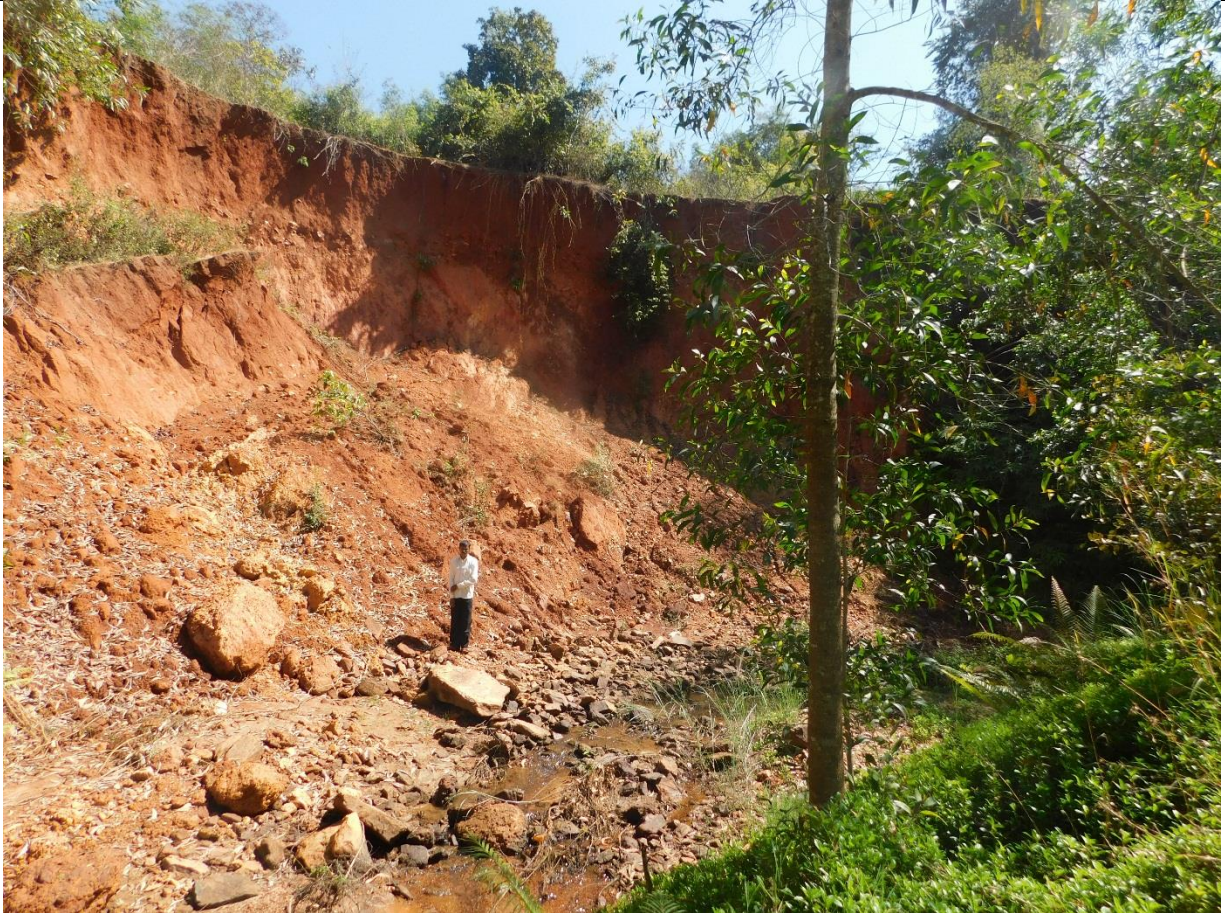
| 1 | Slide No. | KAR/SG/48O1/2019/111 |

| 22 | Failure mechanism | Shallow translational Failure |
| 36 | Geo-scientific Causes | Toe cut by stream, incessant rainfall and thick overburden in the vertical slope are the main causes. |

| 37 | Remedial measures | Easing of the slope and maintaining of the drainage are recommended. |

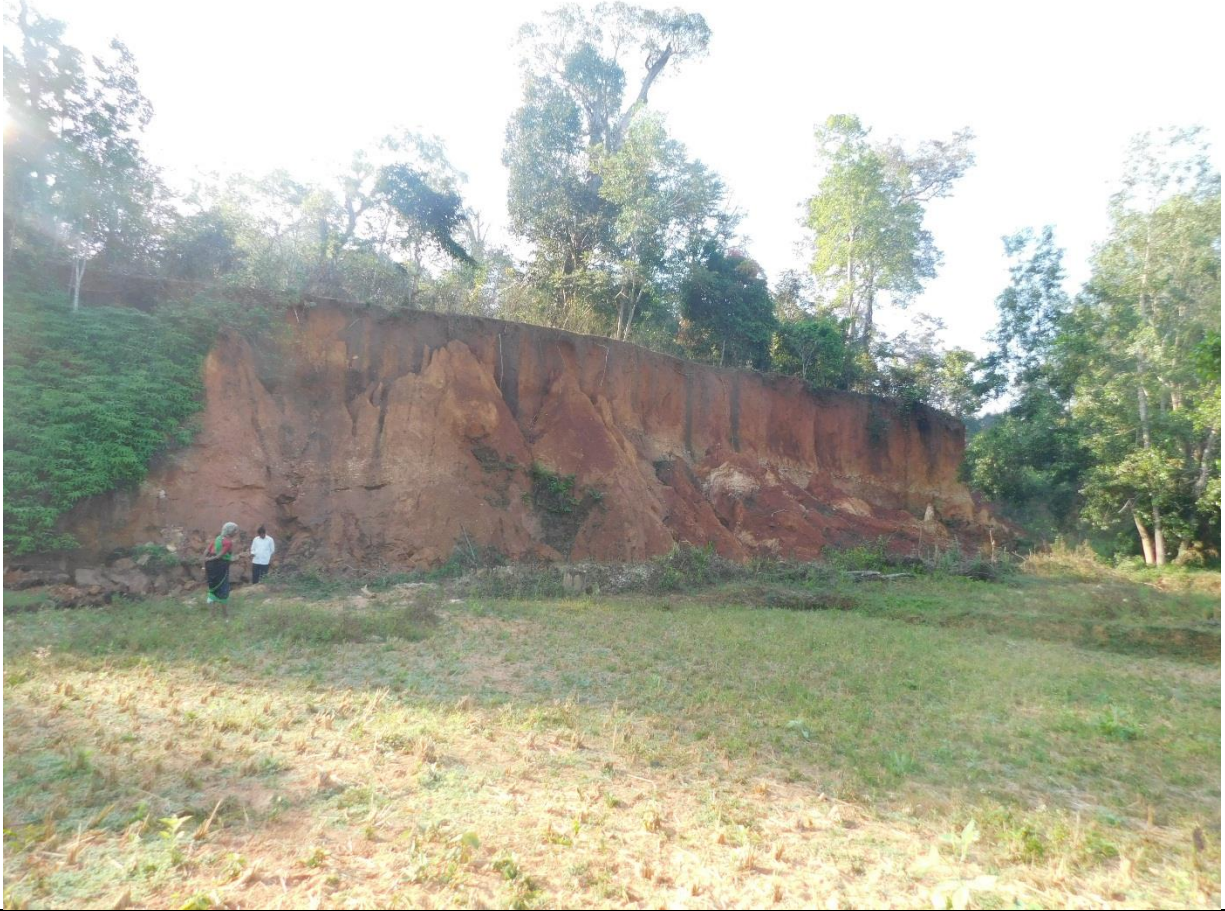
| 1 | Slide No. | KAR/SG/48O1/2019/112 |

| 22 | Failure mechanism | Shallow translational Failure |
| 36 | Geo-scientific Causes | Incessant rainfall. |

| 37 | Remedial measures | Maintaining of the drainage is recommended. |

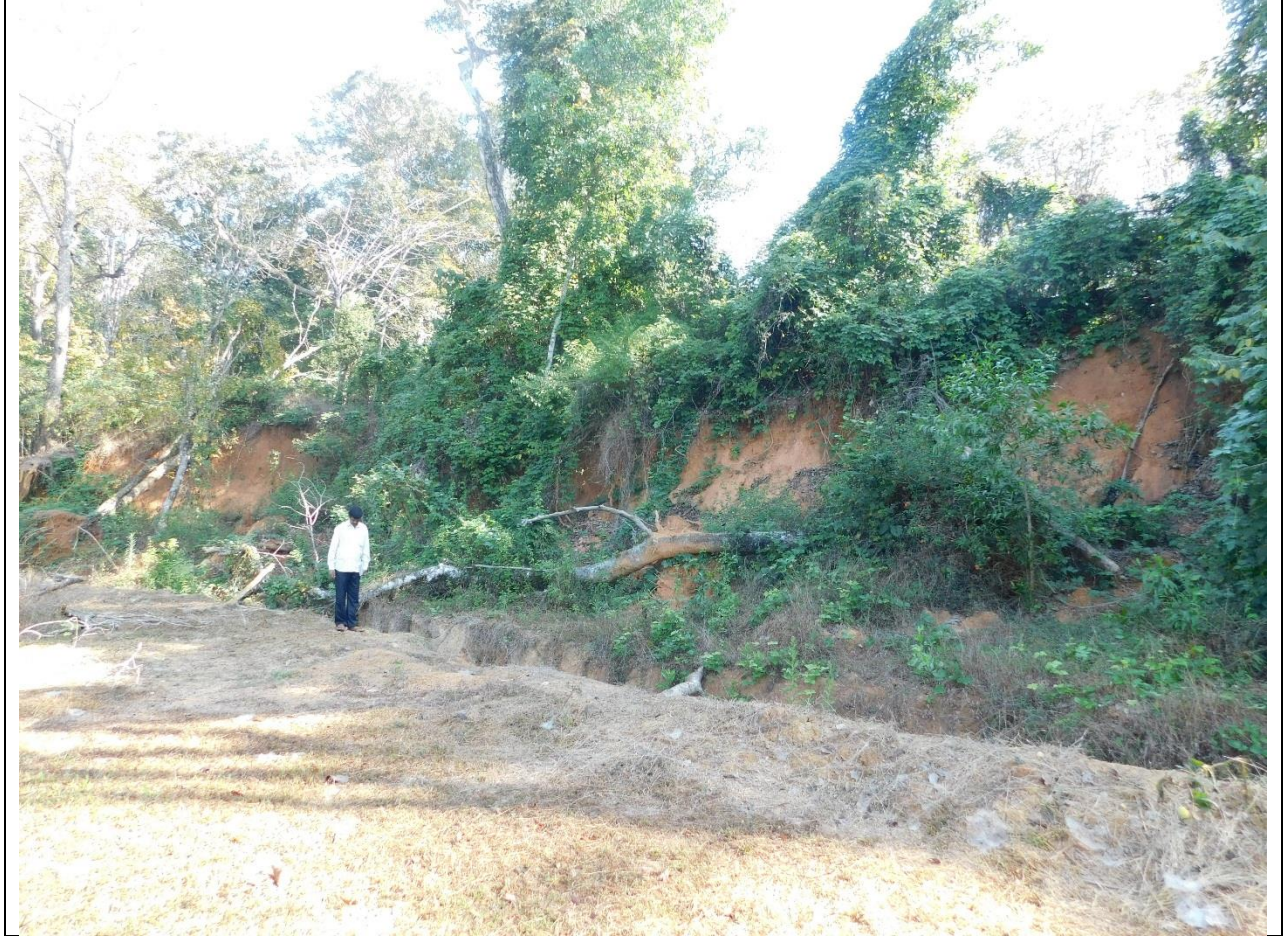
| 1 | Slide No. | KAR/SG/4801/2019/113 |

| 22 | Failure mechanism | Shallow translational Failure |
| 36 | Geo-scientific Causes | Incessant rainfall and toe cut by nala. |

| 37 | Remedial measures | Maintaining of the drainage is recommended. |

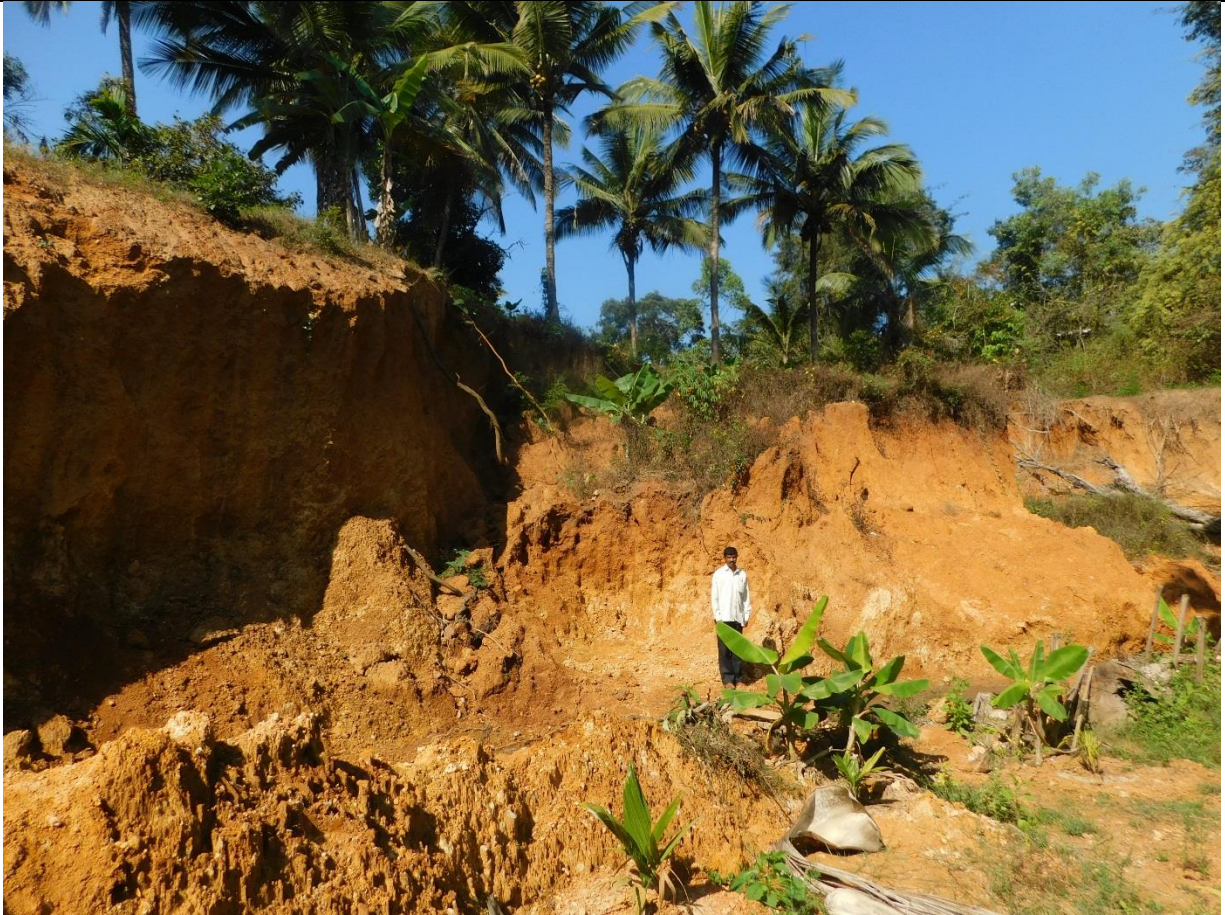
| 1 | Slide No. | KAR/SG/48O1/2019/114 |

| 22 | Failure mechanism | Shallow translational Failure |
| 36 | Geo-scientific Causes | Incessant rainfall and toe cut by drainage. |

| 37 | Remedial measures | Removal of the debris, Maintaining of the drainage are recommended. |

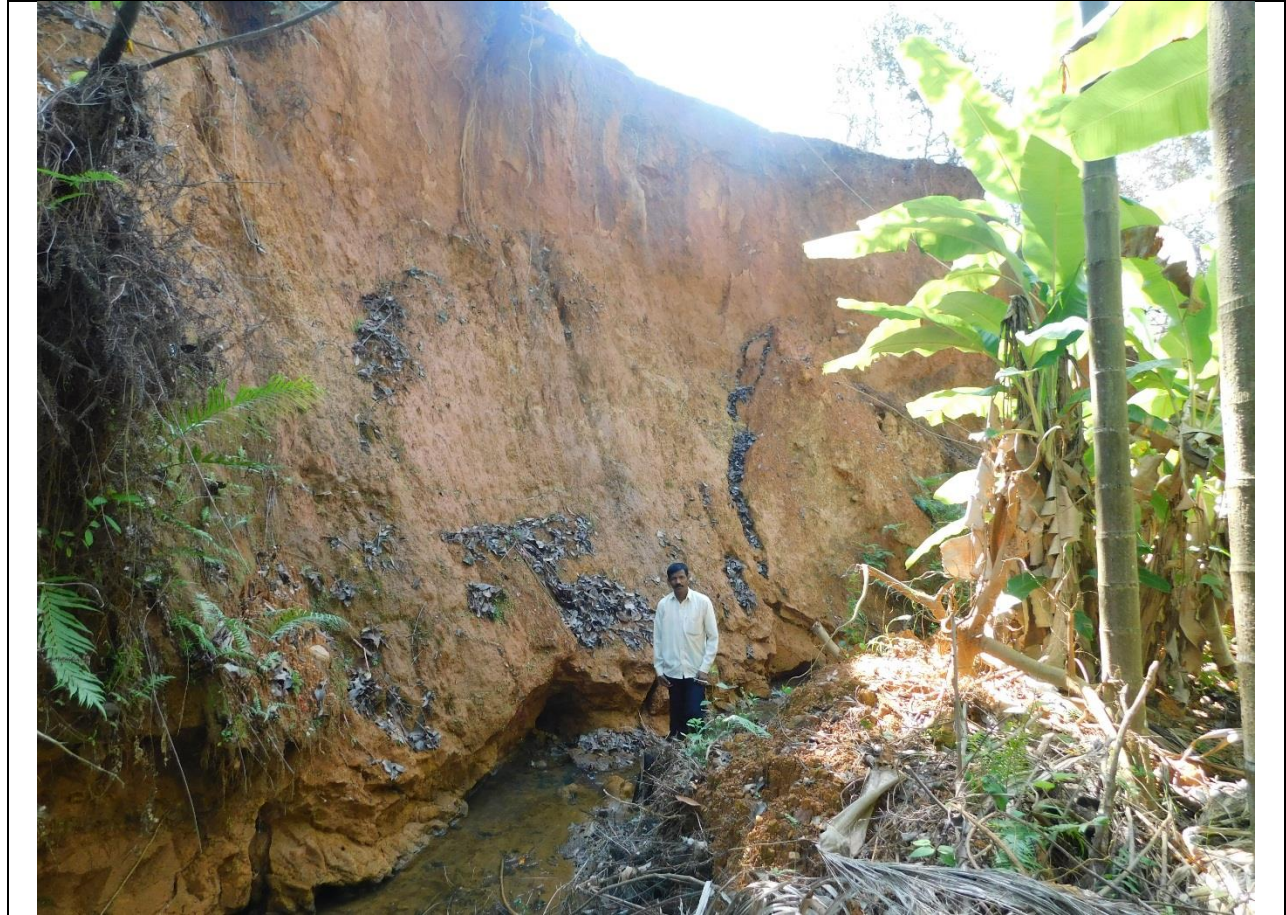
| 1 | Slide No. | KAR/SG/48O1/2019/117 |

| 22 | Failure mechanism | Shallow translational Failure |
| 36 | Geo-scientific Causes | Incessant rainfall and toe cut by drainage. |

| 37 | Remedial measures | Maintaining of the drainage is recommended. |

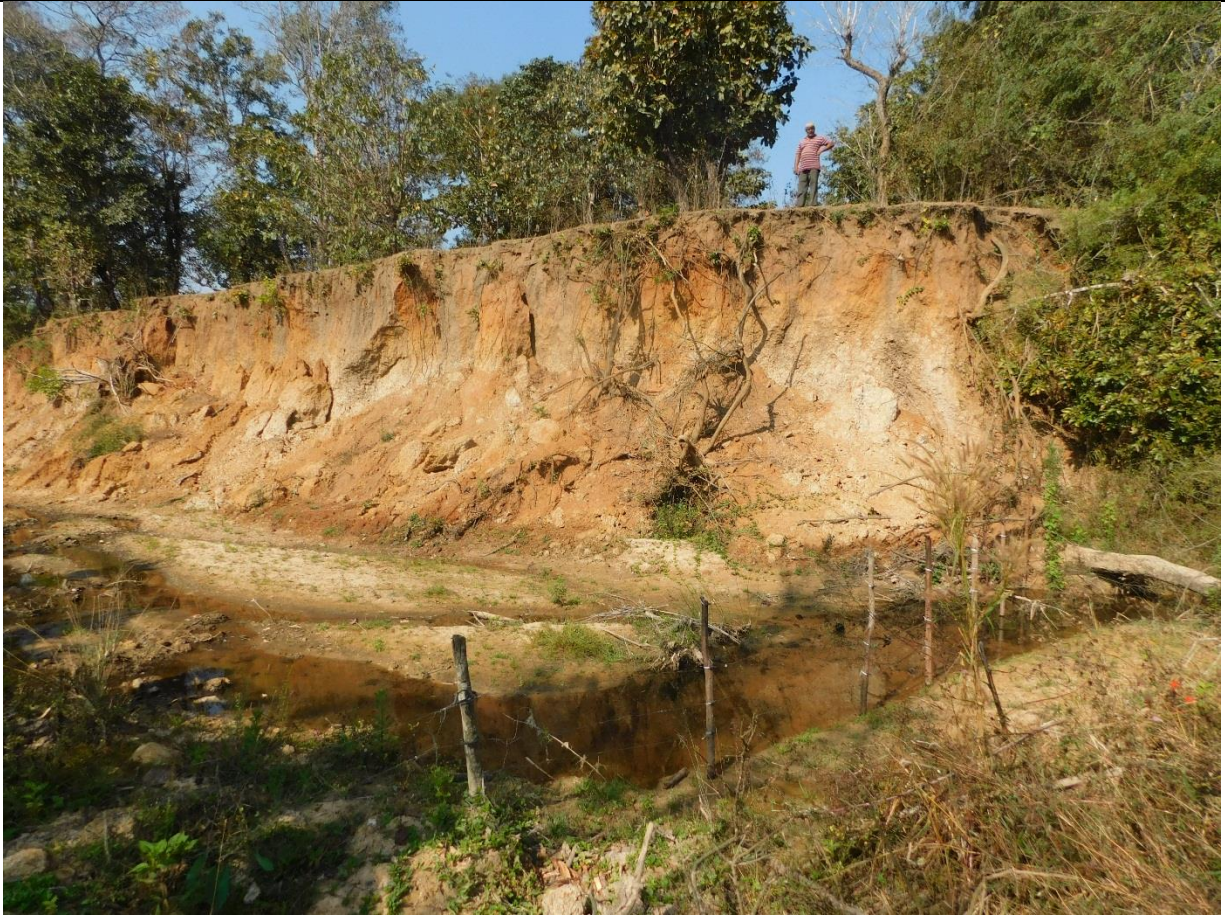
| 1 | Slide No. | KAR/SG/48O1/2019/118 |

| 22 | Failure mechanism | Shallow translational Failure |
| 36 | Geo-scientific Causes | Thick over burden in the vertical slope and incessant rainfall caused the increase of pore water pressure. Toe cut by the stream. |

| 37 | Remedial measures | Removal of the debris and easing of the slope and lining of the stream are recommended. |

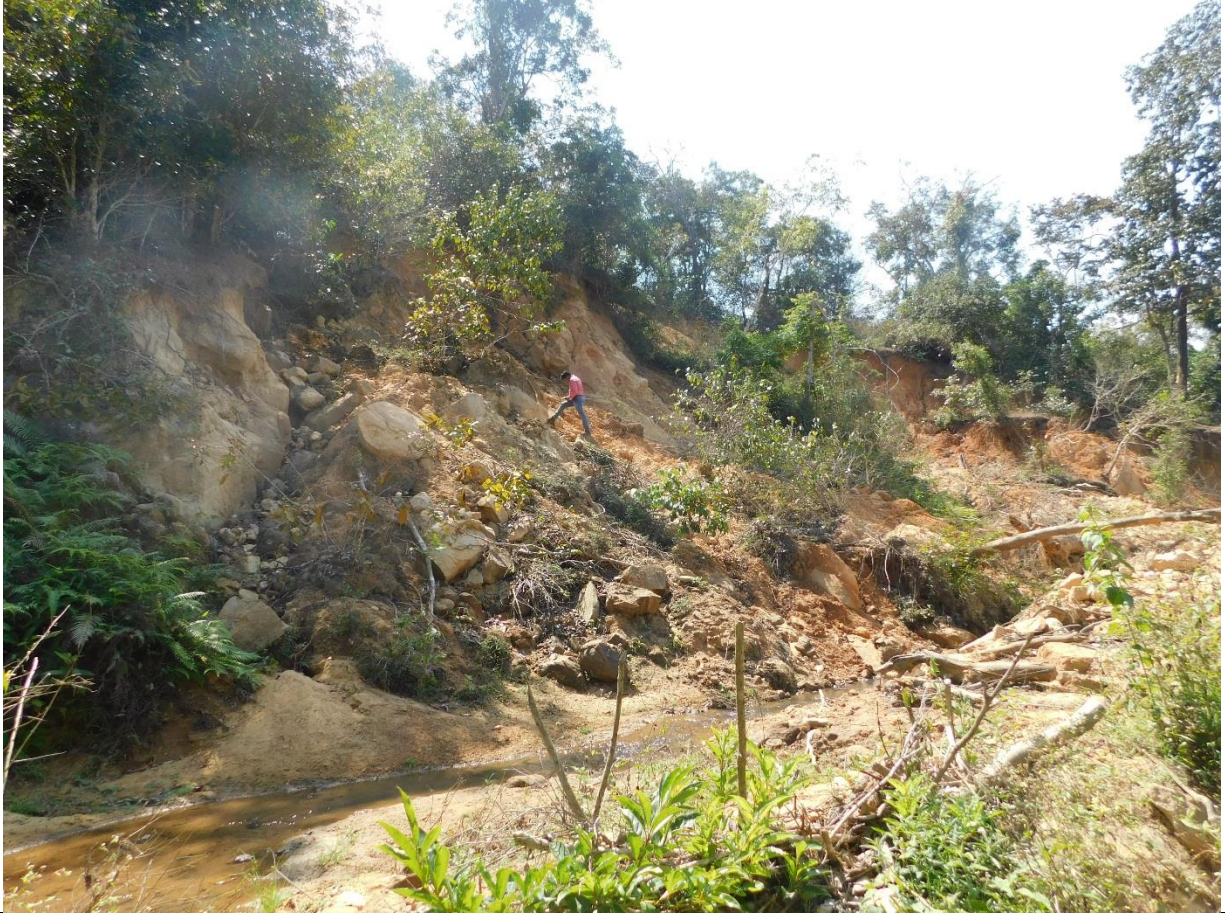
| 1 | Slide No. | KAR/SG/48O1/2019/119 |

| 22 | Failure mechanism | Shallow translational Failure |
| 36 | Geo-scientific Causes | Thick over burden in the vertical slope and incessant rainfall caused the increase of pore water pressure. Toe cut by the stream. |

| 37 | Remedial measures | Removal of the debris and easing of the slope and lining of the stream are recommended. |

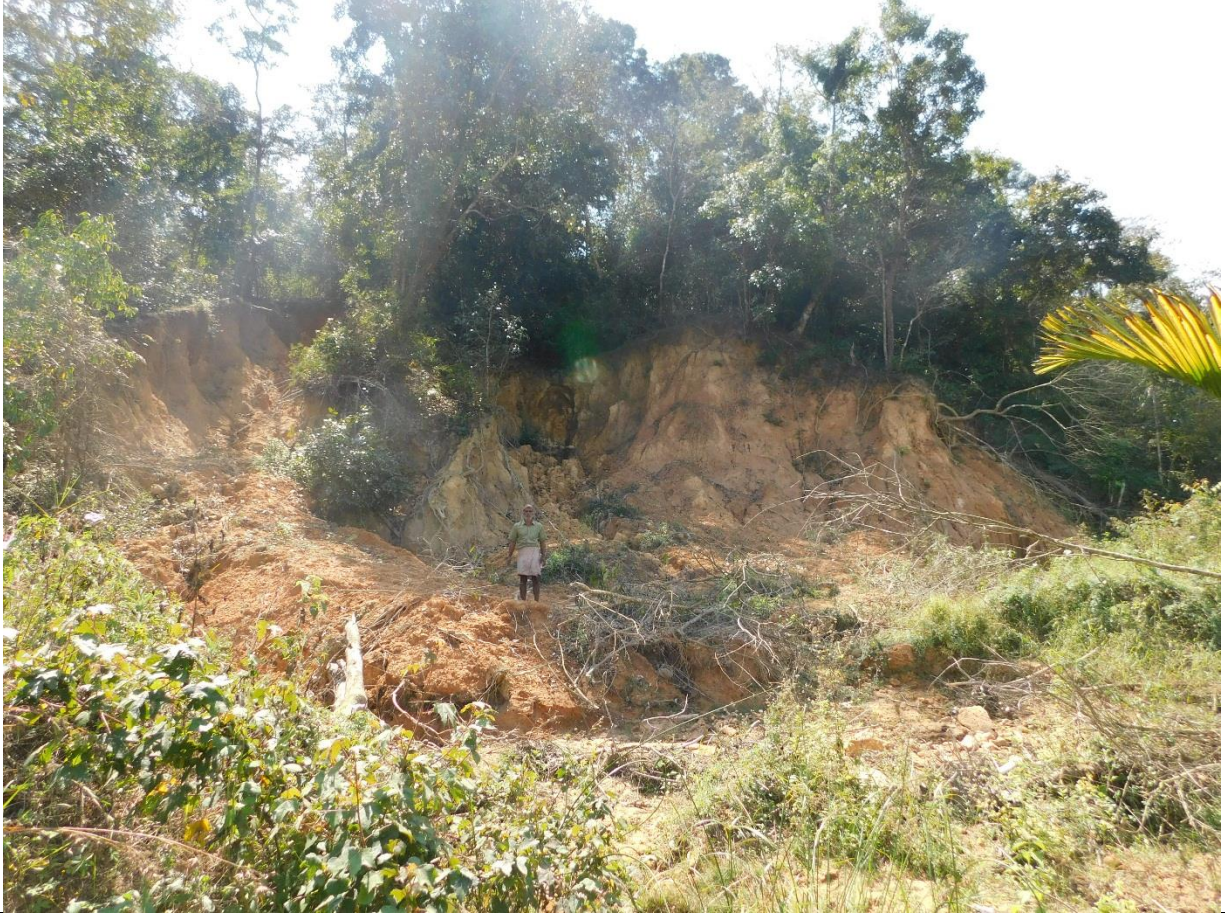
| 1 | Slide No. | KAR/SG/48O1/2019/120 |

| 22 | Failure mechanism | Shallow translational Failure |
| 36 | Geo-scientific Causes | Highly jointed rock and incessant rain fall are the main cause for the slide |

| 37 | Remedial measures | Removal of the debris and maintaining of the drainage are recommended. |

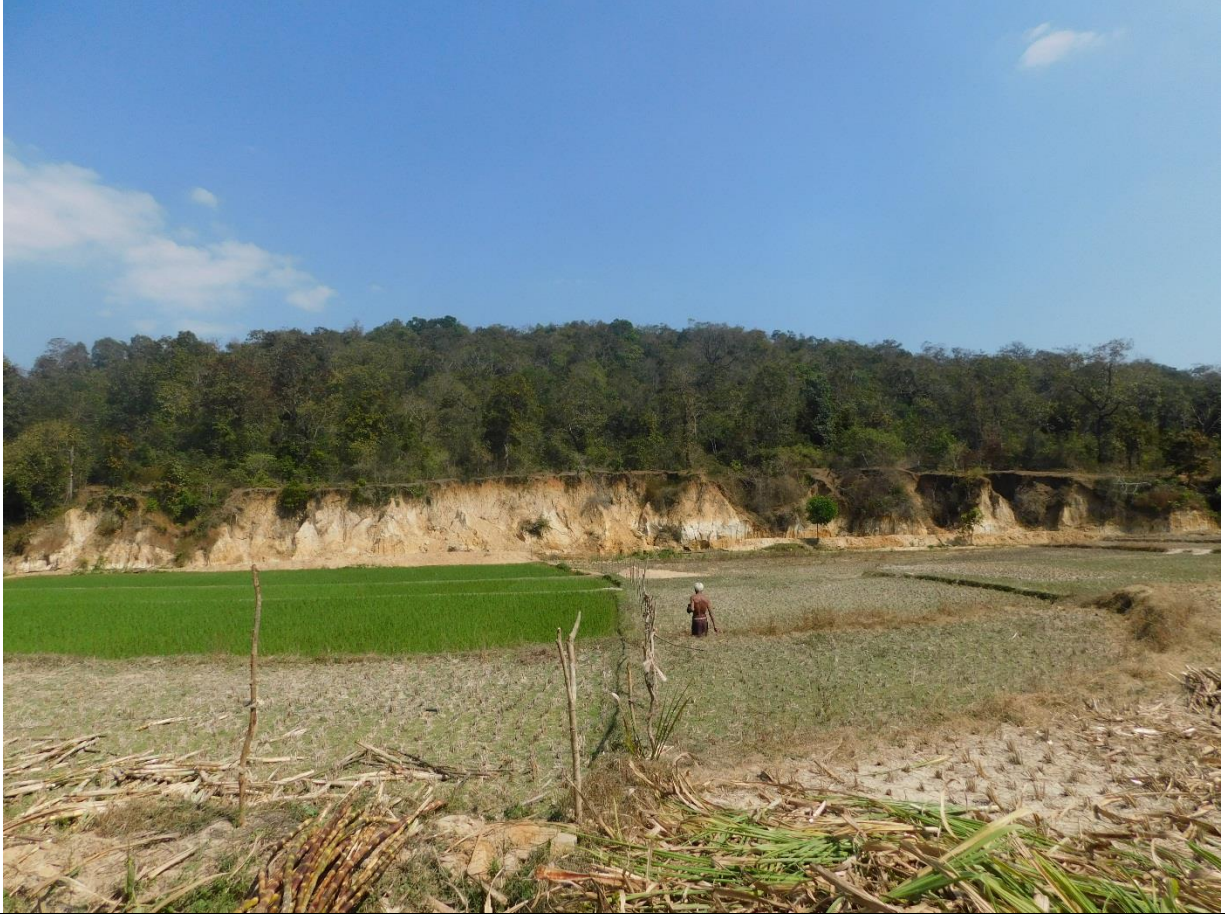
| 1 | Slide No. | KAR/SG/48O1/2019/122 |

| 22 | Failure mechanism | Shallow translational Failure |
| 36 | Geo-scientific Causes | In the vertical steep slope weak and thick overburden disposed, incessant rainfall increased the pore water pressure and stream eroded the toe. |

| 37 | Remedial measures | Removal of the debris, easing of the slope may reduce the further failure. |

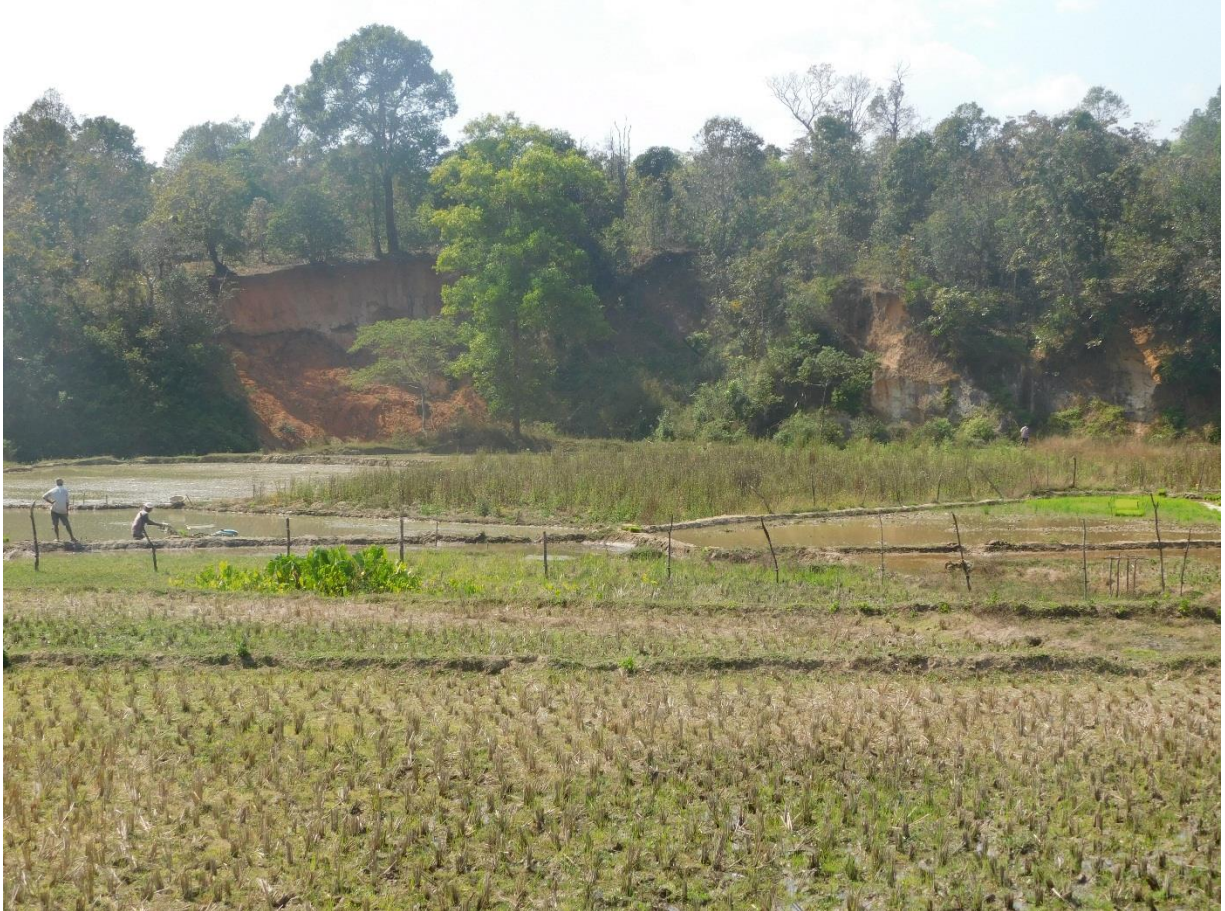
| 1 | Slide No. | KAR/SG/48O1/2019/123 |

| 22 | Failure mechanism | Shallow translational Failure |

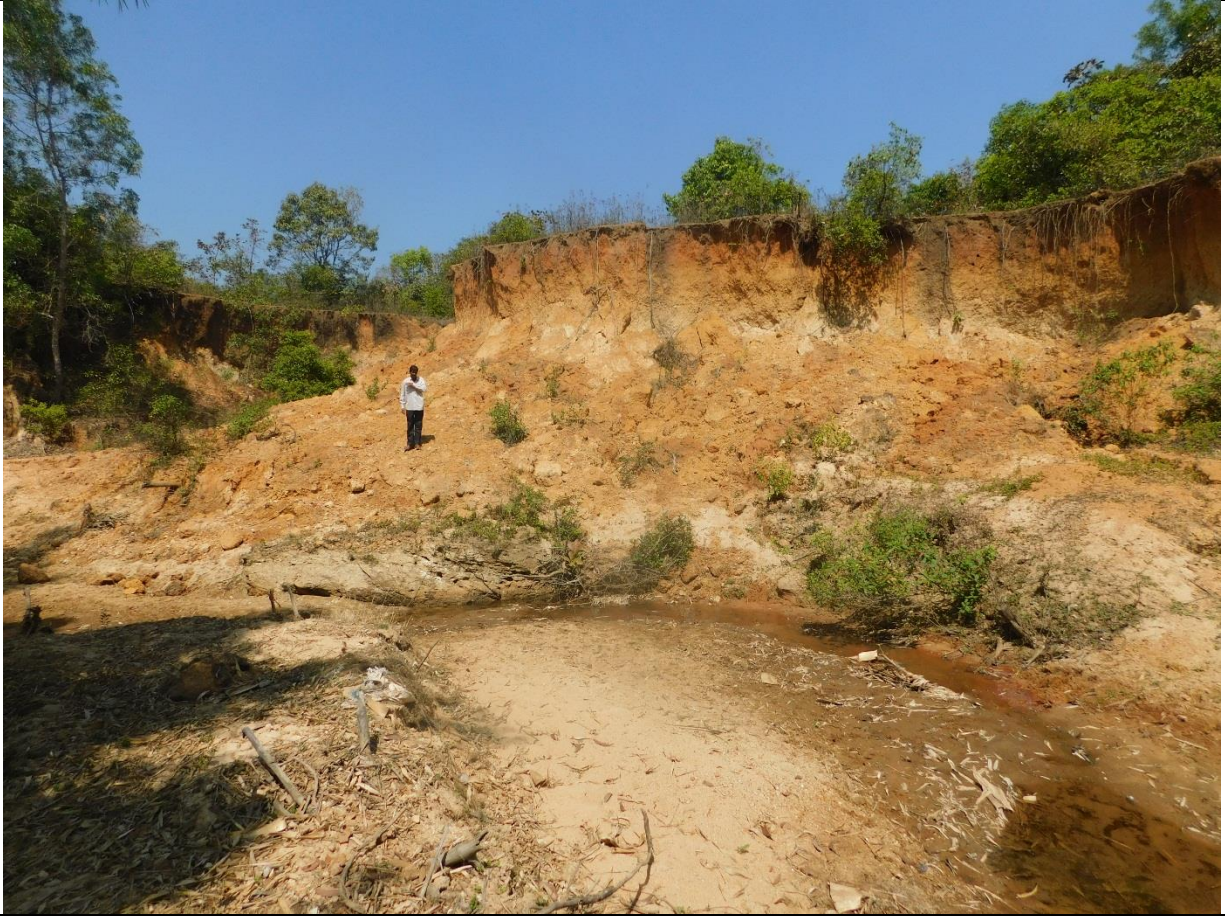
| S. No. | Slide No. | 132 |

| 22 | Failure mechanism | Shallow translational Failure |
| 36 | Geo-scientific Causes | Thick overburden, vertical slope, incessant rainfall, toe cut by the stream are the causes for the slide. |

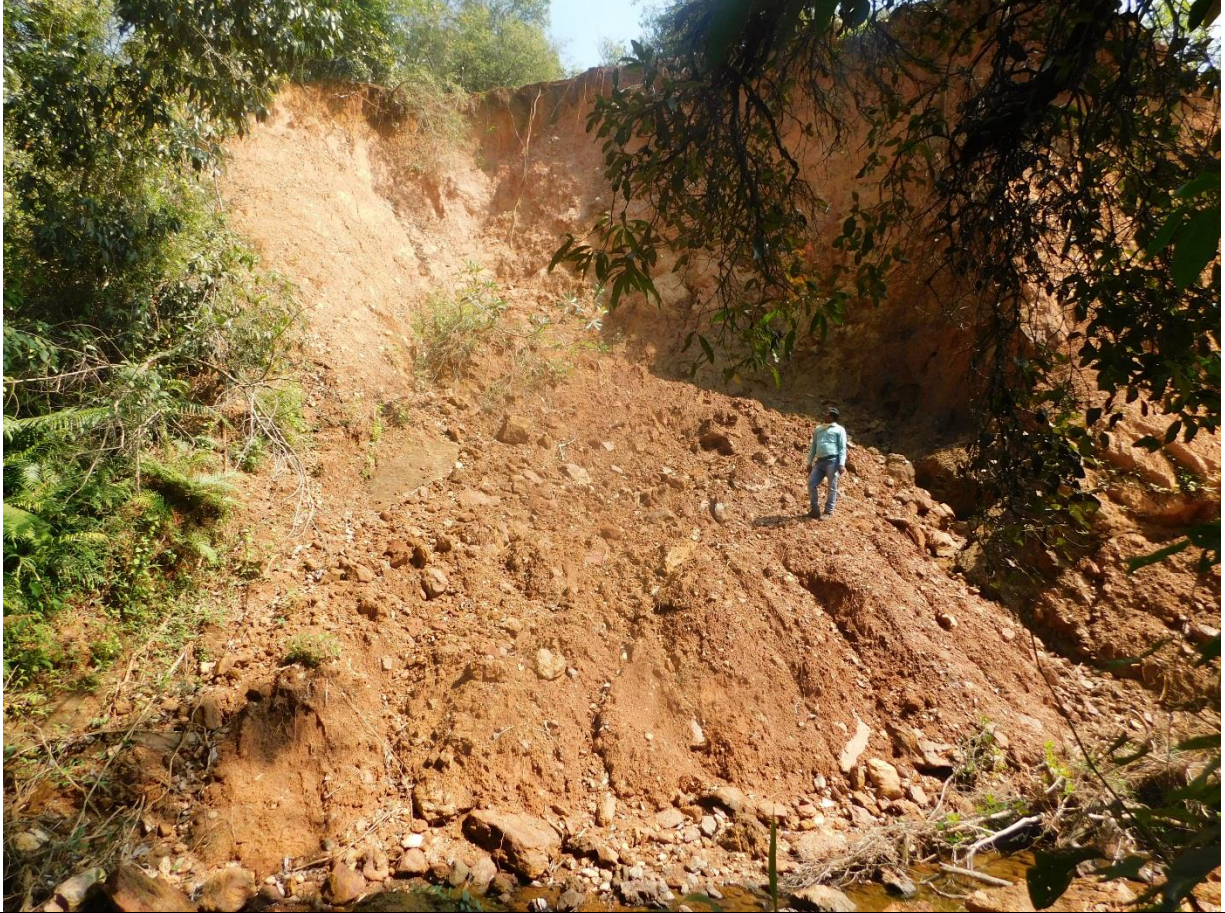
| S. No. | Slide No. | 133 |

| 22 | Failure mechanism | Shallow translational Failure |
| 36 | Geo-scientific Causes | The slope modified for road construction by way of trenching. |

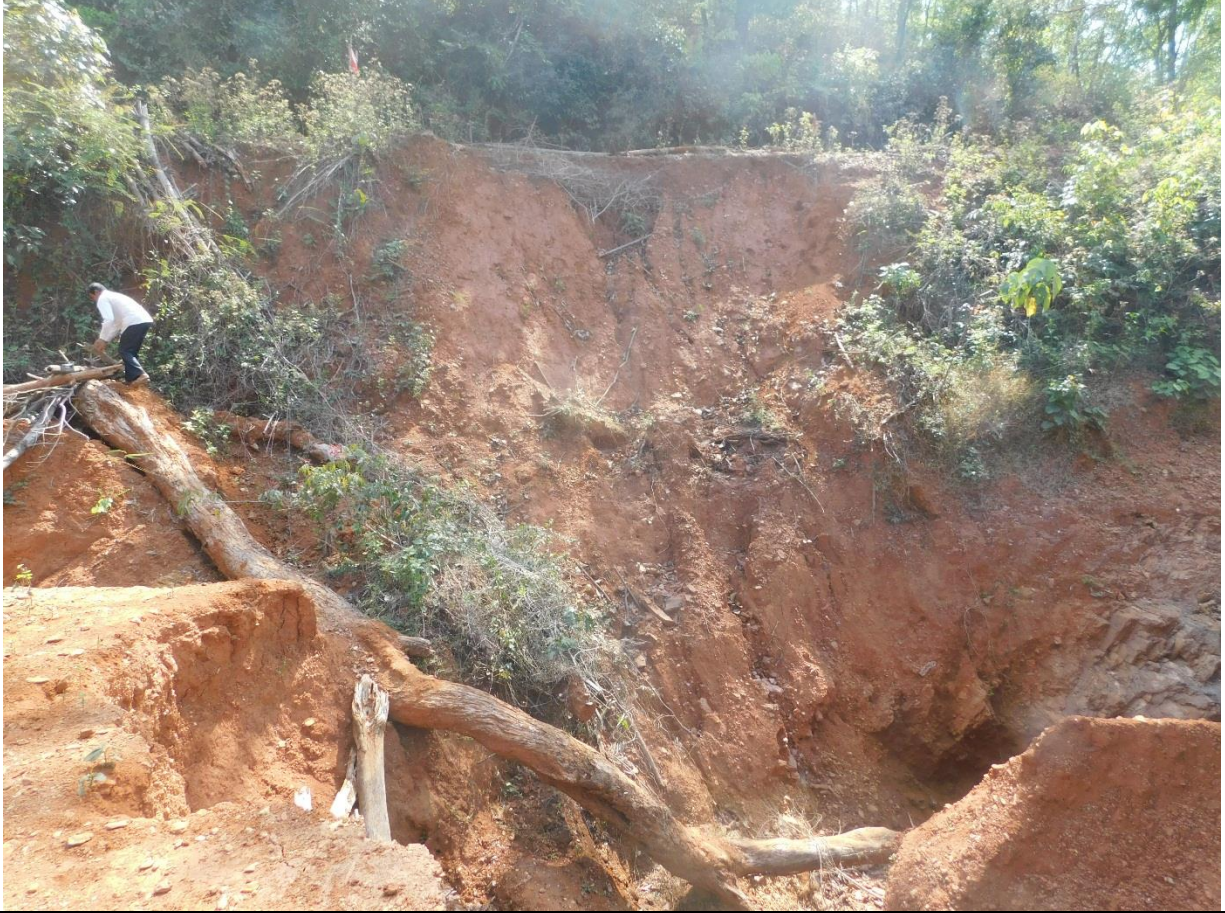
| S. No. | Slide No. | 134 |

| 22 | Failure mechanism | Shallow translational Failure |
| 36 | Geo-scientific Causes | Steep slope and incessant rainfall. |

| 37 | Remedial measures | Easing of the slope and maintaining of the slope are recommended. |

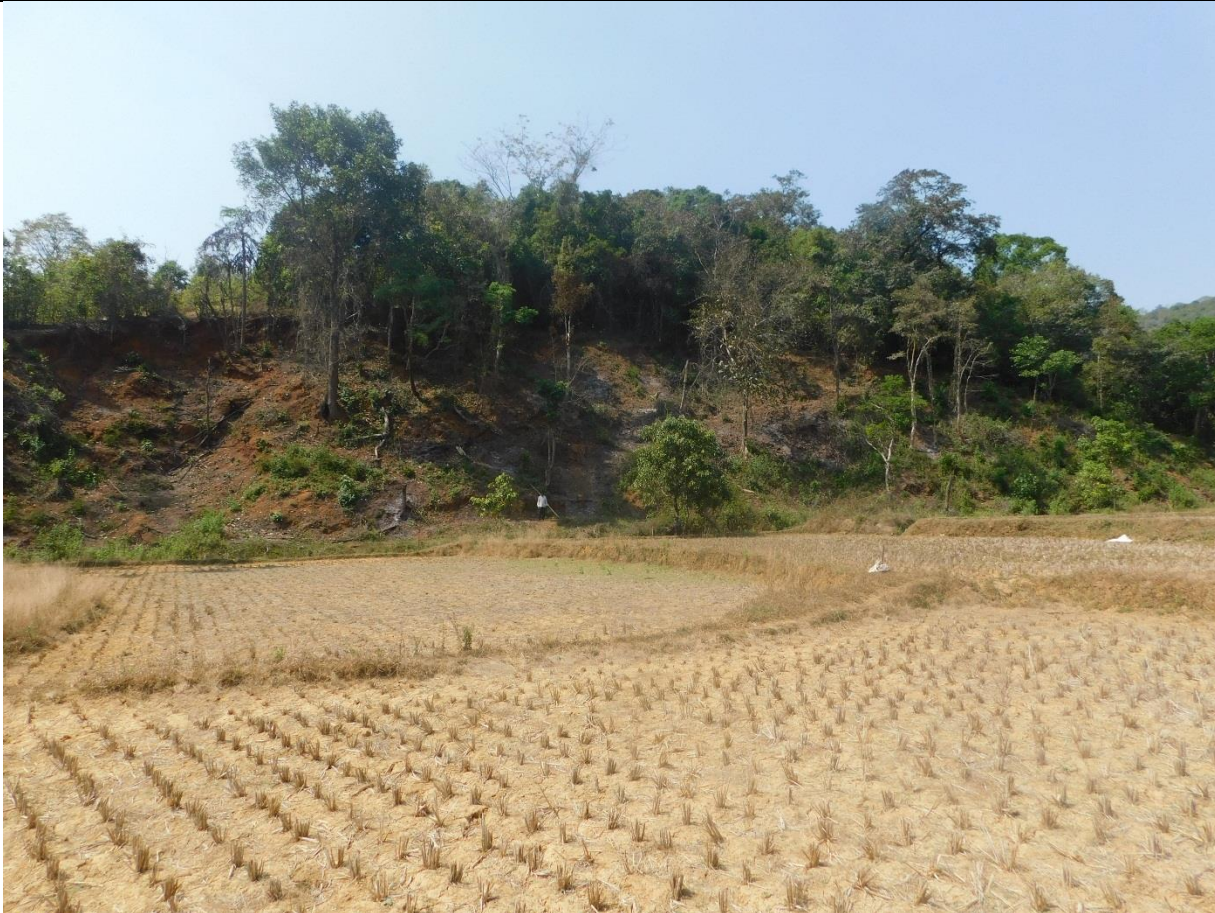
| S. No. | Slide No. | 135 |

| 22 | Failure mechanism | Shallow translational Failure |
| 36 | Geo-scientific Causes | Vertical slope coupled with incessant rainfall, toe cut are the main causes for the slide. |

| 37 | Remedial measures | Removal of the debris, easing of the slope and construction of channel drain are recommended. |

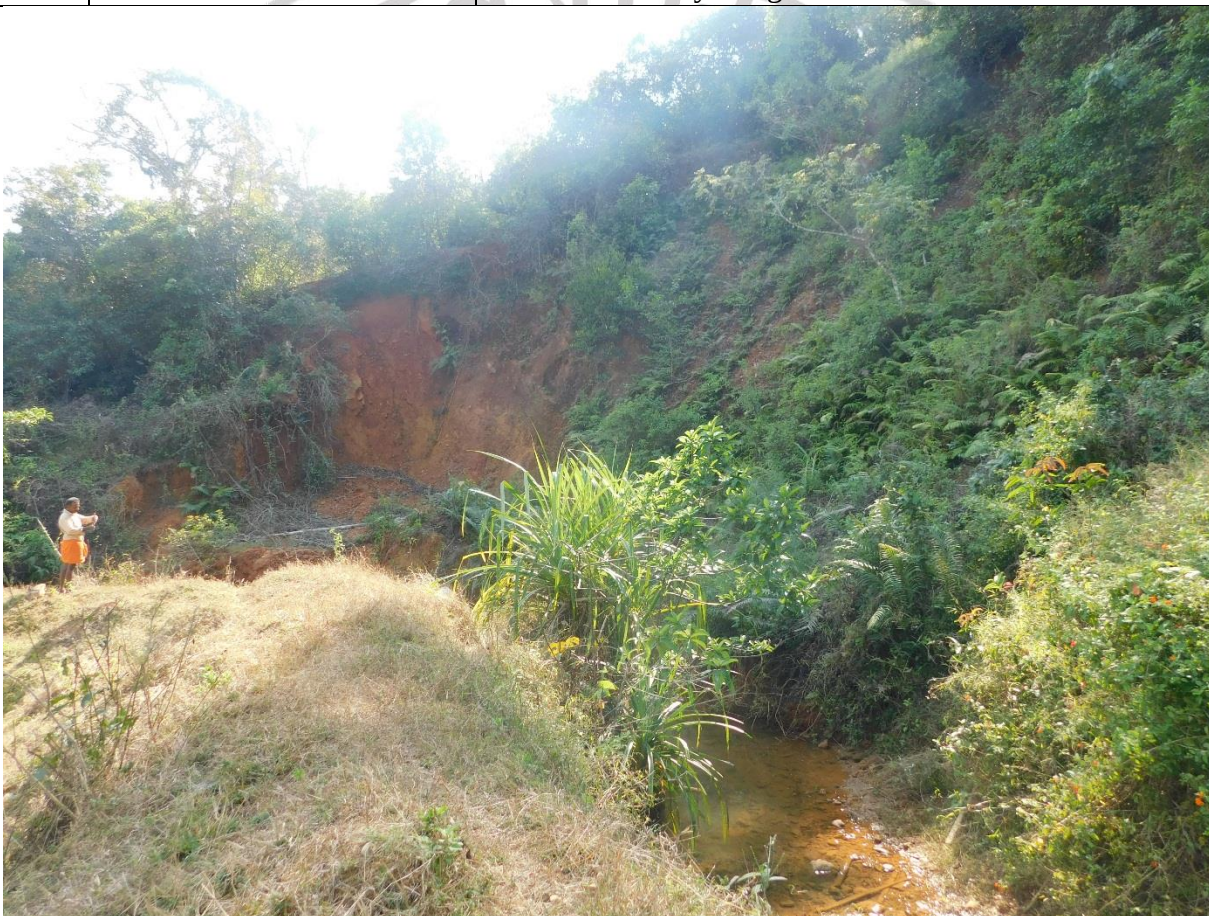
| S. No. | Slide No. | 137 |

| 22 | Failure mechanism | Shallow translational Failure |
| 36 | Geo-scientific Causes | Vertical slope coupled with incessant rainfall, toe cut are the main causes for the slide. |

| 37 | Remedial measures | Removal of the debris, easing of the slope and construction of channel drain are recommended. |

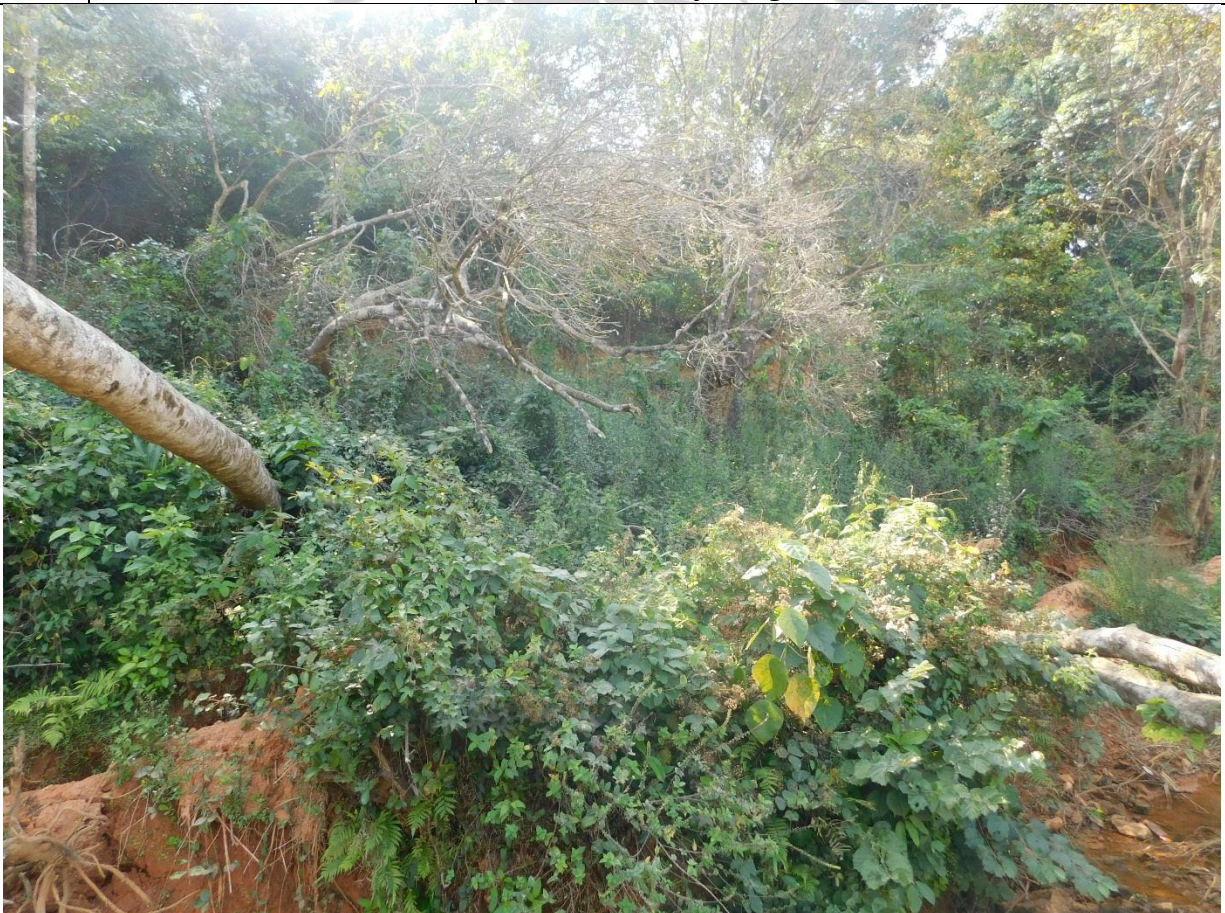
| S. No. | Slide No. | 138 |

| 22 | Failure mechanism | Shallow translational Failure |
| 36 | Geo-scientific Causes | Vertical slope coupled with incessant rainfall increased the pore pressure, toe cut and weak slope forming material in the steep slope are the main causes for the slide. |

| 39 | Summary/Abstract | The soil slide initiated since 2015 and since then reactivated every year. Vertical slope coupled with incessant rainfall increased the pore pressure, toe cut and weak slope forming material in the steep slope are the main causes for the slide. Removal of the debris, easing of the slope are recommended |

| 37 | Remedial measures | Removal of the debris and easing of the slope is recommended. |

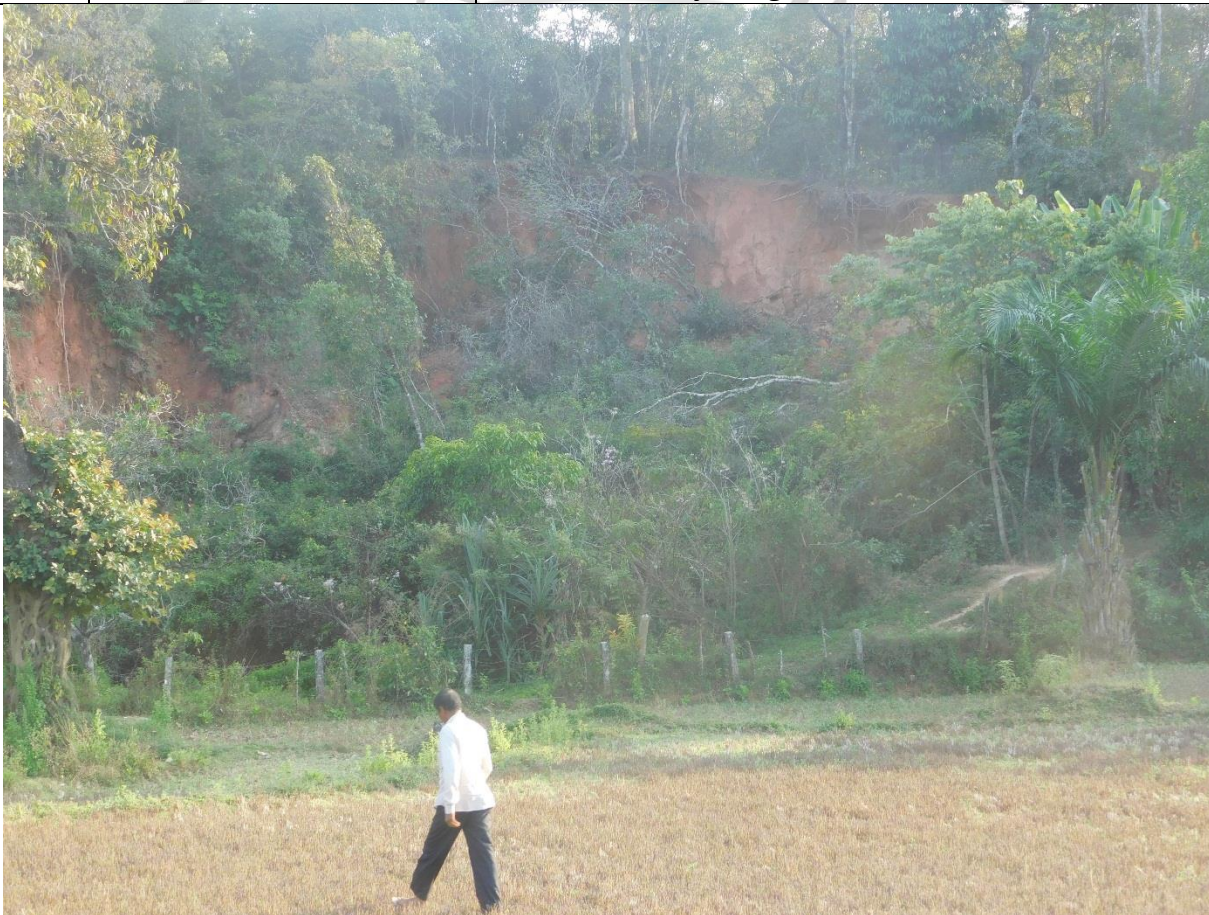
| S. No. | Slide No. | 139 |

| 22 | Failure mechanism | Shallow translational Failure |
| 34 | Infrastructure | 1 house totally damaged and 3 house partially damaged |
| 36 | Geo-scientific Causes | The slope modified to construct the settlement and the slope left as vertical cut without any toe support. |
| 38 | Remarks, if any | 1 house totally damaged and 3 houses partially damaged. |

| 37 | Remedial measures | Shifting of the house recommended and easing of the slope, construction of retaining wall is also recommended. |
