Macro-scale (1:50,000) Landslide Susceptibility Mapping in parts of Toposheets nos. 48O/2, O/6 Chikmangaluru, Shimoga, Dakshin Kannada districts, Karnataka.

टोपोशीट सं./ Toposheet Nos.: 48O/2, 48O/6

कार्य सत्र 2019-20 का अंतिम प्रतिवेदन  
Final Report for Field Season 2019-20

PROJECT: NLSM / परियोजना: एनएलएसएम

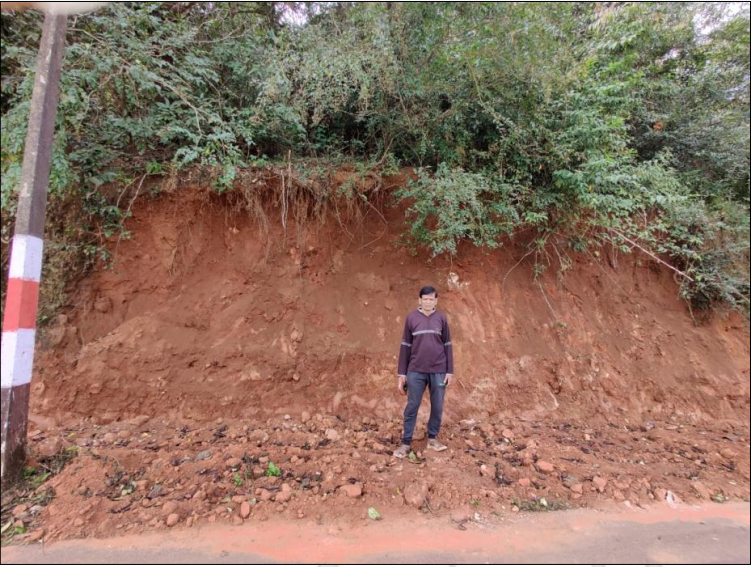
| No | Field | | Description |
|---|---|---|---|
| 38 | Remarks, if any | | The area is identified as slumping zone and is demarcated as meta-stable zone susceptible to slope failure during rainfall. The electric power line nearby is at risk. |

| 40 | Summary/Abstract | : | The small dimension debris slide observed on lowly dissected hillslope at road bench level due to unscientific way of removal of soil by toe cutting of hillslope for road development. The vertical cut leads to slope transformation that opens up new way for water seepage & slope saturation that destabilize the slope. The slope is susceptible to failure during monsoon rainfall. So, the lined drainage with properly designed culvert is the remedial measures suggested for effective drainage and to minimize toe erosion. |

| No | Field | | Description |
|---|---|---|---|
| 37 | Remedial measures | : | The lined drainage and culvert should be designed at road bench level to channelize or discharge excess water downslope at suitable location. The debris should be removed to unclog the drainage. |

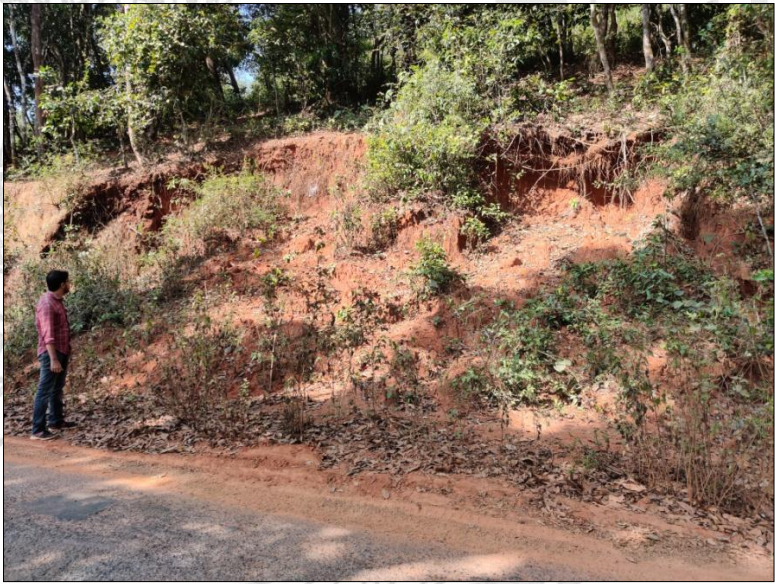
| 38 | Remarks, if any | : | The area is demarcated as meta-stable zone. |
| 40 | Summary/Abstract | : | The small dimension debris slide observed on lowly dissected hillslope at road bench level due to unscientific way of removal of soil by toe cutting of hillslope for road development. The vertical cut leads to slope transformation that opens up new way for water seepage & slope saturation that destabilize the slope. The slope is susceptible to failure during monsoon rainfall. So, the lined drainage with properly designed culvert is the remedial measures suggested for effective drainage and to minimize toe erosion. |

| 37 | Remedial measures | : | The lined drainage and culvert should be designed at road bench level to channelize or discharge excess water downslope at suitable location. |

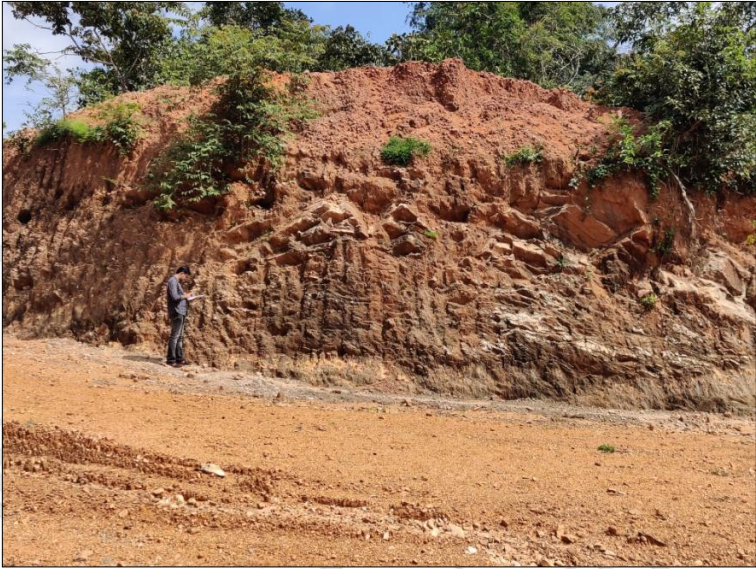
| No | Field | | Description |
|---|---|---|---|
| 38 | Remarks, if any | : | The area is demarcated as meta-stable zone. |

| 40 | Summary/Abstract | : | The small dimension debris slide occurred on extensive cut slope observed on lowly dissected hillslope at road bench level. The slope disturbance is observed due to unscientific way of modification of natural slope for road construction. The slope transformation opened up new pathway for water infiltration & slope saturation. The increased pore water pressure and pronounced weathering reduced the shear strength of the slope forming material during heavy rainfall. The lined drainage and culvert should be designed at road bench level to channelize or discharge excess water downslope at suitable location in order to minimise slope saturation, toe erosion and subsequent slope failure. |

| No | Field | | Description |
|---|---|---|---|
| 37 | Remedial measures | : | The lined drainage and culvert should be designed at road bench level to channelize or discharge excess water downslope at suitable location in order to minimise slope saturation, toe erosion and subsequent slope failure. |

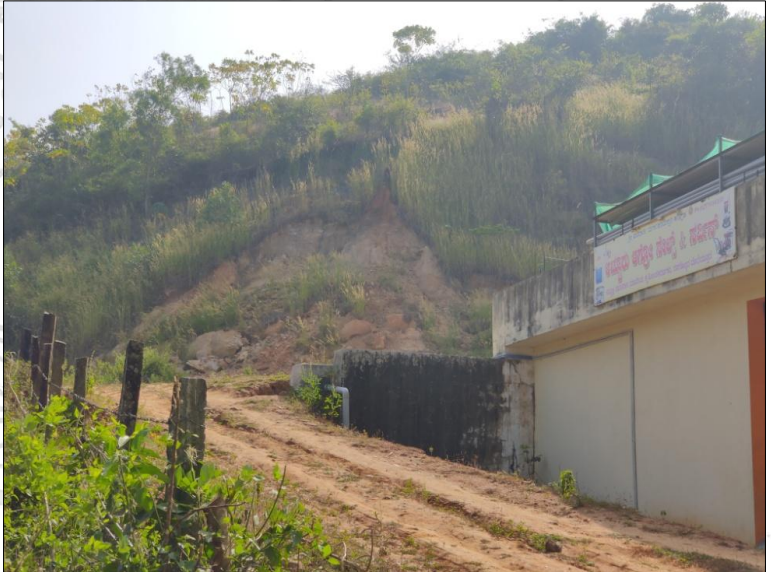
| 38 | Remarks, if any | : | The area is demarcated as unstable zone. The houses in vicinity are constructed on vulnerable location. |

| 40 | Summary/Abstract | : | Debris slide was recorded along the court road near Tirthahalli town. The old slide scars and reactivation of old slide are observed on disturbed hillslope. The weathered granite gneiss constitutes the slope forming material. The toe cutting of hillslope lead to slope transformation that opened up new way of erosion, water seepage & slope saturation. Thus increased water infiltration destabilized the slope due to increased pore water pressure that reduces the shear strength of the slope forming material during heavy rainfall. Easing of slope and construction of retaining wall is suggested as remedial measure to avoid loss to life and property. |

| 37 | Remedial measures | : | Easing of hillslope and retaining wall with weep holes should be constructed. Monitoring of hillslope during rainy season should be done on priority. |

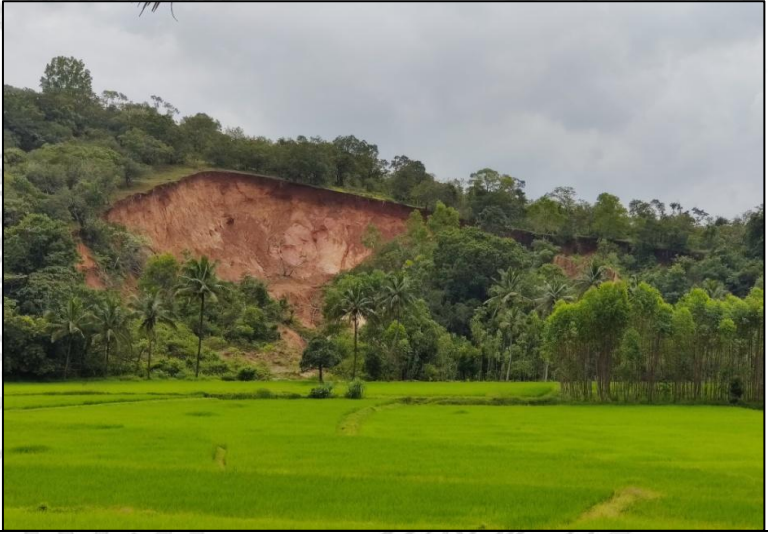
| 38 | Remarks, if any | : | The area is demarcated as unstable zone. The debris flow may lead to loss of crop (Paddy) & Agriculture land in monsoon. |
| 40 | Summary/Abstract | : | Earth Slide occurred on lowly dissected slope with moderate to sparse vegetation. In present scenario the landslide is active & retrogressive in nature. The slope disturbance resulted due to unscientific way of removal of soil by toe or piedmont cutting of the hillslope for widening the agricultural land and excavation of soil for arecanut plantation. In an addition the natural or man-made drainage network for irrigation purpose in adjoining paddy field further exaggerated toe erosion and removal of toe support. The water saturation due to water infiltration on exposed cut section during rainfall provides new pathway for extensive weathering that reduced shear strength of slope forming material due to over saturation of hill slope further the natural or man-made drainage network for |

| | | | irrigation purpose in adjoining paddy field resulted in toe erosion and removal of toe support. The flowing stream at toe part contributes to toe erosion and removal of toe support. The debris flow may results in loss of crop (Paddy) & agriculture land. The construction of gabion wall with wire mesh should be provided at foot of hill slope as protective remedial measures. |

| 37 | Remedial measures | : | Easing of slope should be done. Construction of gabion wall with wire mesh should be provided at foot of hill slope adjoining paddy field as protective remedial measures .The plantation should be done on failed mass to stabilize the slope. |

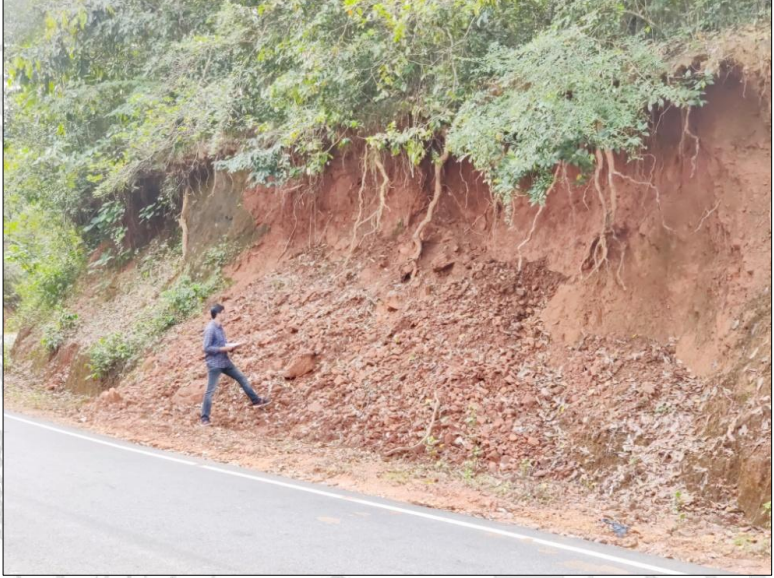
| 38 | Remarks, if any | | The modified hill slope is demarcated as meta-stable zone susceptible to slope failure during rainfall. |
| 40 | Summary/Abstract | : | The debris slide with multiple slope failures and slumps were observed on the concave curvature of the road cut on lowly dissected hill slope. The slope forming material consists of weathered rock and loose soil that failed during rainfall. The increased pore water pressure and pronounced weathering reduced the shear strength of the slope forming material during heavy rainfall. The low height lined drainage and culvert should be designed at road bench level to channelize or discharge excess water downslope at suitable location. The loose debris may block the road communication during heavy rainfall. |

| 37 | Remedial measures | : | The low height lined drainage and culvert should be designed at road bench level to channelize or discharge excess water downslope at suitable location. |

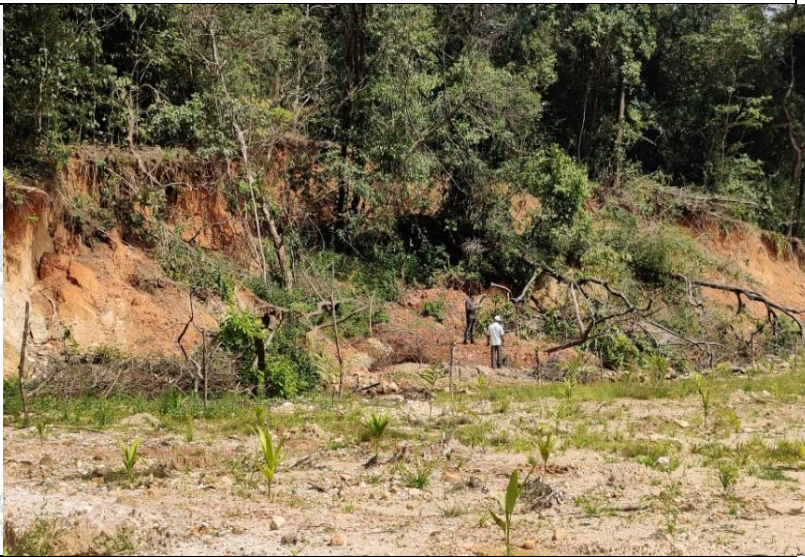
| 40 | Summary/Abstract | : | Debris landslide occurred on lowly dissected slope with moderate vegetation. In present scenario the landslide is active & retrogressive in nature. The slope disturbance resulted due to unscientific way of removal of soil by toe or piedmont cutting of the hillslope for widening the agricultural land. The natural 3 <sup>rd</sup> order stream flowing at foot slope beside agriculture land resulted in toe erosion and removal of toe support. The water seepage and water saturation at toe part reduced shear strength of slope forming material and removal of toe support by scouring by flowing stream failed the hillslope. The debris flow resulted in loss of crop (Paddy) & agriculture land. The construction of gabion wall with wire mesh should be provided all along flowing stream channel at foot of hill slope as protective remedial measures. |

| 37 | Remedial measures | : | Easing of slope should be done. Construction of gabion wall with wire mesh should be provided at foot of hill slope adjoining paddy field as protective remedial measures for toe support. Plantation should be done on failed mass to stabilize the slope. |

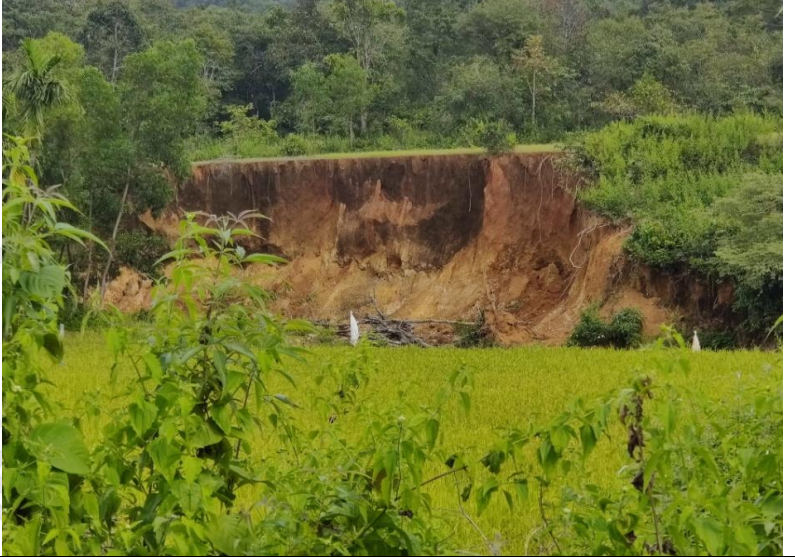
| 36 | Geo-scientific Causes | : | The slope disturbance resulted due to unscientific way of removal of soil by toe or piedmont cutting of the hillslope for widening of the agricultural land and excavation of soil for arecanut plantation. In an addition the natural or man-made drainage network for irrigation purpose in adjoining paddy field further exaggerated toe erosion and removal of toe support. The water saturation due to water infiltration on exposed cut section during rainfall provided new pathway for extensive weathering that reduces shear strength of slope forming material due to over saturation of hill slope further the natural or man-made drainage network for irrigation purpose in adjoining paddy field resulted in toe erosion and removal of toe support. |

| 40 | Summary/Abstract | : | Debris landslide occurred on lowly dissected slope with moderate vegetation. In present scenario the landslide is active & retrogressive in nature. The slope disturbance resulted due to unscientific way of removal of soil by toe or piedmont cutting of the hillslope for widening of the agricultural land. The natural 3 <sup>rd</sup> order stream flowing at foot slope beside agriculture land resulted in toe erosion and removal of toe support. The extensive seepage and water saturation at toe part reduced shear strength of slope forming material and removal of toe support by scouring by flowing stream failed the hillslope. The mass failure resulted in loss of crop (Paddy) & agriculture land. Easing of slope should be done. Construction of gabion wall with wire mesh should be provided at foot of hill slope adjoining paddy field as protective remedial measures for toe support and to prevent mass movement. Plantation should be done on failed mass to stabilize the slope. |

| 37 | Remedial measures | : | Easing of slope should be done. Construction of gabion wall with wire mesh should be provided at foot of hill slope adjoining paddy field as protective remedial for toe support and to prevent mass movement. Plantation should be done on failed mass to stabilize the slope. |

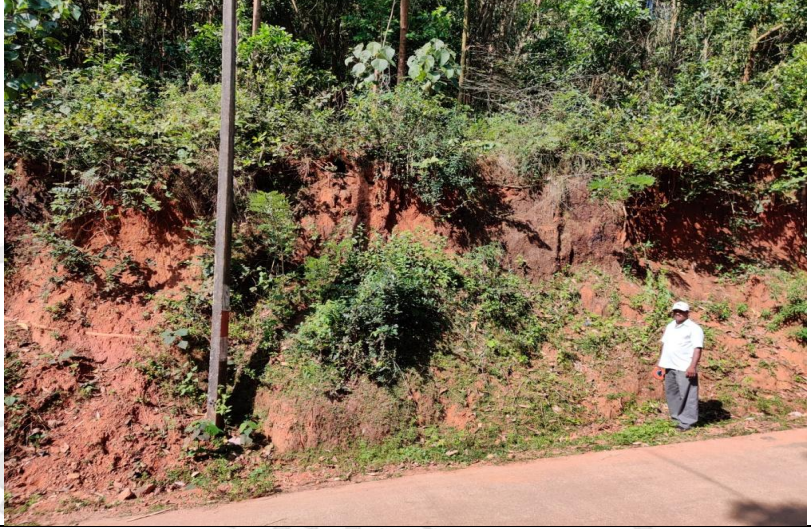
| 36 | Geo-scientific Causes | : | The slope disturbance is observed due to unscientific way of modification of slope & removal of soil for road construction. & settlement purposes. The vertical cut and toe cutting of hillslope made for road development leads to slope transformation that opened up new way of water seepage & slope saturation. Thus increased water infiltration saturated and increased the pore water pressure that destabilized the slope during heavy rainfall. The failure plane is governed by the contact plane of Quartz chlorite schist and Quartz sericite schist. |
| 38 | Remarks, if any | : | The area is identified as slumping zone and is demarcated as meta-stable zone susceptible to slope failure during rainfall. Electric Power line nearby is at risk. |

| 40 | Summary/Abstract | : | The debris slump resulted due to unscientific way of modification of natural slope for road construction & settlement purposes. The vertical cut and toe cutting of hillslope made for road development leads to slope transformation that opened up new way of water seepage & slope saturation. Thus increased infiltration destabilized the slope due to over water saturation during heavy rainfall. The failure plane is governed by the contact plane of Quartz chlorite schist and Quartz sericite schist. The slope forming material consists of in-situ soil with overburden thickness varies between 5-10m and >10m. The area is identified as slumping zone and is demarcated as meta-stable zone susceptible to slope failure during rainfall. |

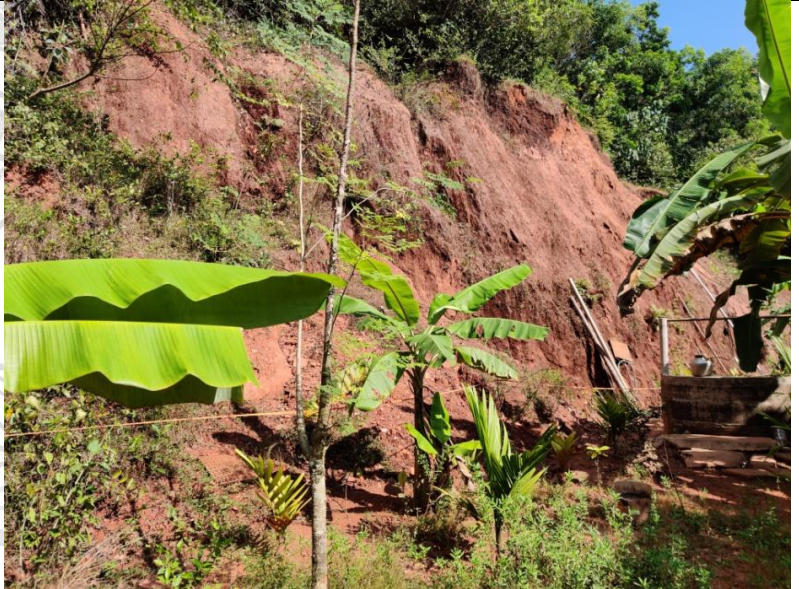
| 36 | Geo-scientific Causes | : | The unscientific way of modification of natural slope & removal of soil for settlement purposes. The vertical cut made on slopes leads to slope transformation that opened up new way of water seepage & slope saturation. Thus water infiltration increases the pore water pressure that destabilized the hillslope during heavy rainfall. The slope failure was more pronounced due to highly weathered Quartz sericite schist. |
| 40 | Summary/Abstract | : | The multiple slope failures were recorded on extensive cut slope made for settlement purposes. The unscientific way of modification of natural slope & removal of soil for settlement purposes. The vertical cut made on slopes leads to slope transformation that opened up new way of water seepage & slope saturation. Thus water infiltration increased the pore |

| | | | water pressure that destabilizes the hillslope during heavy rainfall. The slope failure more pronounced due to highly weathered Quartz Sericite Schist. The slope forming material consists of in-situ soil having overburden thickness of 5-10m and >10m. Turfing of slope face and slope gradation is recommended as cost effective measures, further retaining wall with weep holes must be provided to prevent slope failure. The slope should be monitored during heavy rainfall. The slope failure is prone during heavy rainfall and the hillslope is demarcated as meta-stable zone susceptible to slope failure during rainfall. |

| 37 | Remedial measures | : | Turfing of slope face and slope gradation is recommended as cost effective measures, further retaining wall with weep holes must be provided to prevent slope failure. |

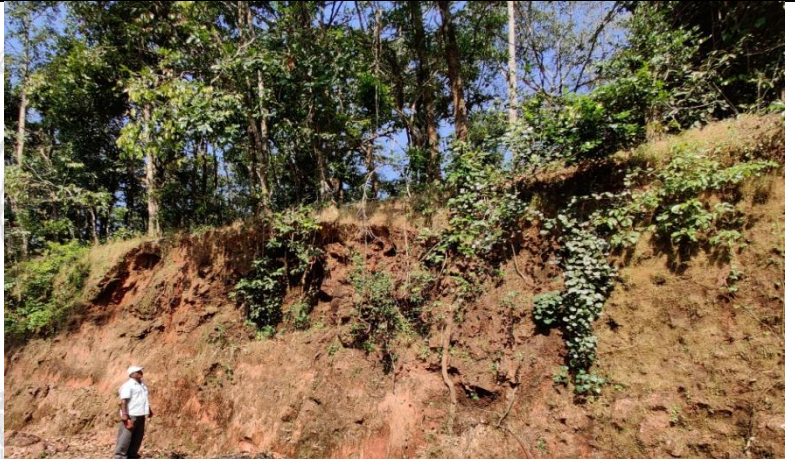
| 36 | Geo-scientific Causes | : | The unscientific way of modification of natural slope & removal of soil for settlement purposes. The extensive vertical cut made on slopes leads to slope transformation that opened up new way of water seepage & slope saturation. Thus increased infiltration and pore water pressure destabilizes the slope during heavy rainfall. The slope failure is pronounced at highly weathered Quartz Sericite Schist. |
| 38 | Remarks, if any | : | The hillslope is demarcated as unstable zone susceptible to slope failure during rainfall. The settlements built up on modified slope in Tudige village are at risk. |
| 40 | Summary/Abstract | : | The slope failures were recorded on vertical extensive cut slope made for settlement purposes. The slope forming material consists of in-situ soil having overburden thickness of >10m. Slope gradation is recommended as cost effective measures and retaining wall with weep holes must be provided to prevent slope failure. Slope should be monitored during heavy rainfall. |

| 37 | Remedial measures | : | Slope gradation is recommended as cost effective measures and retaining wall with weep holes must be provided to prevent slope failure. The vertical slope cut of 7m height is also present at road bench level. So, breast wall with weep holes is suggested as a preventive measure to avoid landslips |

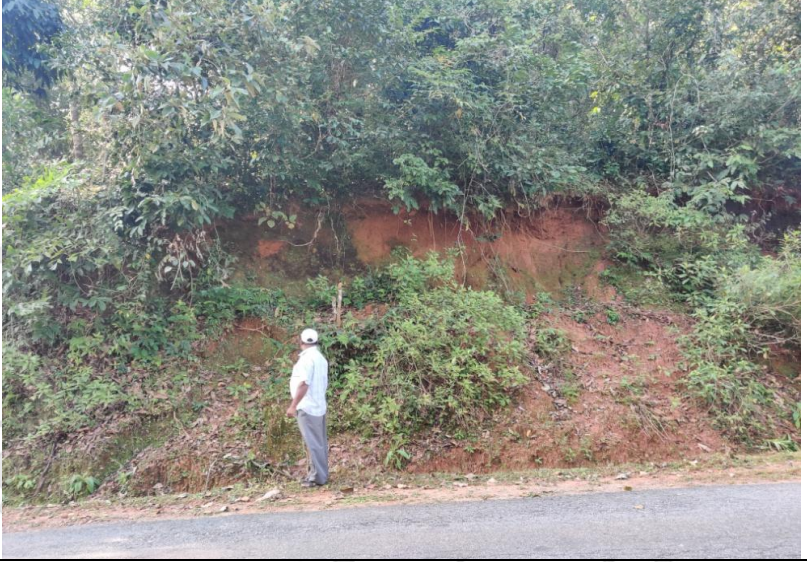
| 36 | Geo-scientific Causes | : | The slope disturbance is observed due to unscientific way of modification of slope & removal of soil for road construction. & settlement purposes. The vertical cut and toe cutting of hillslope made for road development leads to slope transformation that opened up new way of water seepage & slope saturation. Thus increased water infiltration saturated and increased the pore water pressure that destabilized the slope during heavy rainfall. |
| 38 | Remarks, if any | : | The area is identified as slumping zone and is demarcated as meta-stable zone susceptible to slope failure during rainfall. |

| 40 | Summary/Abstract | : | The small dimension debris slump occurred on lowly dissected hillslope at road bench level. The slope disturbance is observed due to unscientific way of modification of slope & removal of soil for road construction & settlement purposes. The vertical cut and toe cutting of hillslope made for road development leads to slope transformation that opened up new way of water seepage & slope saturation. Thus increased water infiltration saturates and increased the pore water pressure that destabilized the slope during heavy rainfall. The slope is susceptible to failure during monsoon rainfall. So, lined drainage and culvert should be made at suitable location is the remedial measure for effective drainage during rainy season. |

| 37 | Remedial measures | : | The lined drainage should be made at toe of the hill slope and culvert should be designed at proper site suitable for discharge of excess water on upslope to minimize pore water pressure and seepage down the slope. The effective drainage is necessary to avoid slope saturation, toe erosion and subsequent landslips. |

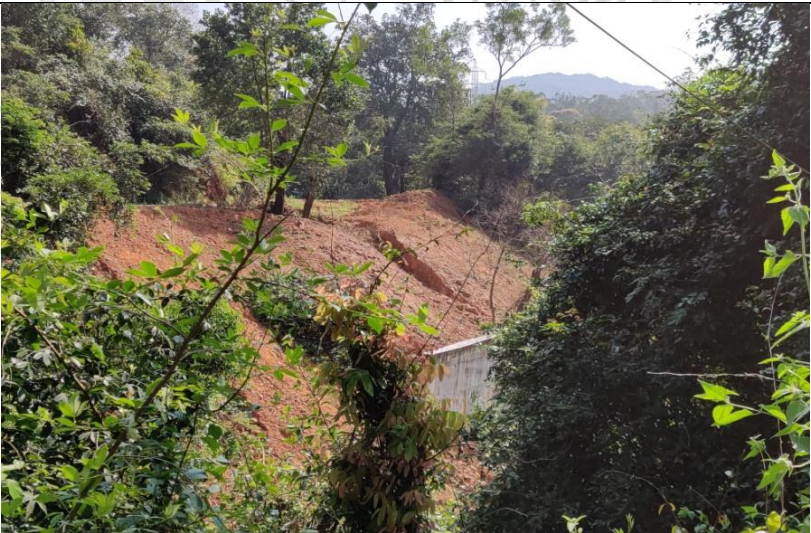
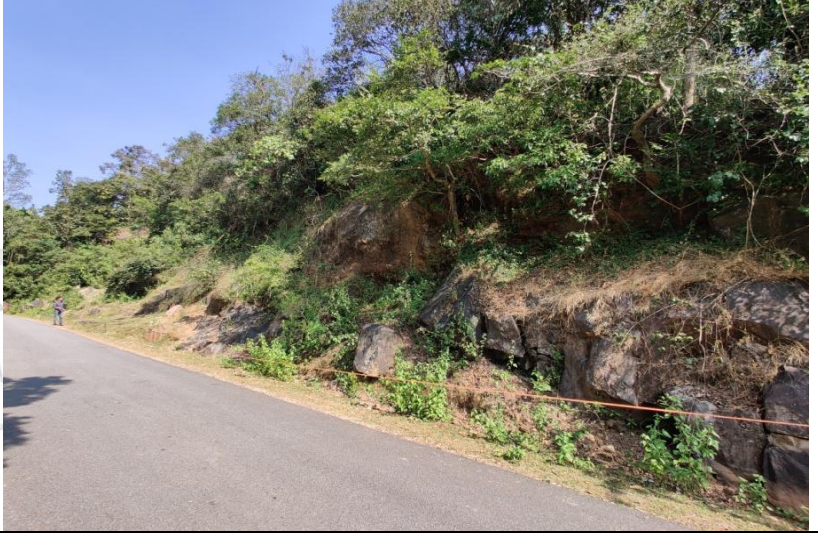
| 36 | Geo-scientific Causes | : | The closely fractured granite gneiss provided the weaker plane that facilitates infiltration of water. The prolonged infiltration along the fracture plane resulted in increased stress and pore water pressure. The higher order stream channel in downslope eroded the toe part of the hill slope subsequently resulted in slope failure and road subsidence in downslope direction. |

| 40 | Summary/Abstract | : | The shallow translational debris slide observed at convex curvature of on road in 660 m SW of Kavaledurga village area on lowly dissected slope. The slope failure is ~130m wide occurred on fractured and jointed granite gneiss along road. The closely fractured granite gneiss provides the weaker plane that facilitates infiltration of water. The prolonged infiltration along the fracture plane resulted in increased stress and pore water pressure. The higher order stream channel in downslope eroded the toe part of the hill slope sub subsequently resulted in slope failure and road subsidence in downslope direction. The lined drainage should be made at toe of the hill slope so, that water can be channelized through culvert designed/constructed at suitable location is suggested as remedial measure for effective drainage to avoid toe erosion and subsequent slope failure and subsidences in downslope direction. The precarious rock boulders should be removed for safety purpose as precautionary measure. The high retaining wall of 12m constructed in downslope for toe support and has reduced the chances of abrupt slope failure. |

| 37 | Remedial measures | : | The lined drainage should be made at toe of the hill slope so, that water can be channelized through culvert designed/constructed at suitable location is suggested as remedial measure for effective drainage to avoid toe erosion and subsequent slope failure and subsidences in downslope direction. The precarious rock boulders should be removed for safety purpose as precautionary measure. |
| 38 | Remarks, if any | : | Taking into consideration the risk factor, the lined should be provided at toe part at road bench level in upslope to prevent water seepage and saturation. The precarious rock boulders should be removed for safety purpose as precautionary measure. The area is demarcated as unstable zone. |

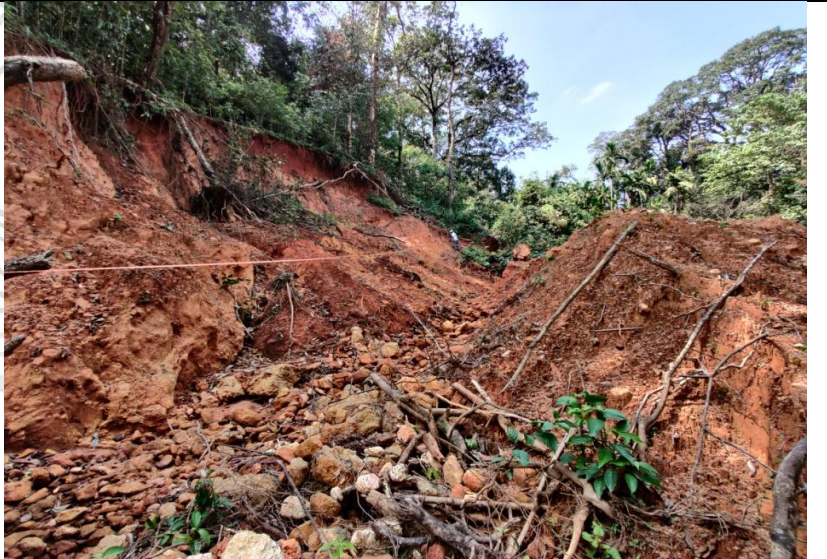
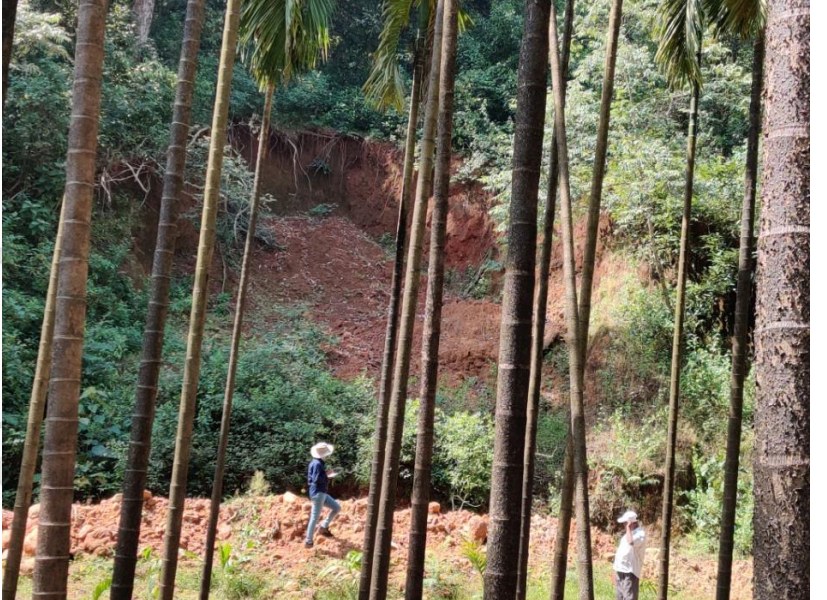
| 39 | Photos. Sketch of Plan & section of the slide | : | |

| 36 | Geo-scientific Causes | : | The unscientific way modification and removal of soil for arecanut plantation resulted in removal of toe support. The toe erosion by flowing stream at toe part saturated and reduced the cohesive and shear strength of the slope forming material. |

| 40 | Summary/Abstract | : | The shallow multiple translational debris slide observed in south of Mekkeri village on lowly dissected slope with moderate vegetation cover in vicinity of arecanut plantation. In present scenario the landslide zone is active, widening and enlarging in nature. The landslide zone is ~65m wide with overburden thickness of ~11m. The crown cracks were visible. The causative factors for slope failure are removal of toe support by removal of soil from hillslope for arecanut plantation as well as toe cutting and erosion by drainage at foot slope. The gabion wall with wire mesh at toe part of hillslope should be made as preventive measures to avoid soil slips during rainfall. Easing of slope and afforestation on degraded slope should be done. |

| 37 | Remedial measures | : | The gabion wall with wire mesh at toe part of hillslope should be made to prevent soil slips and scouring of hillslope during heavy discharge of water during heavy rainfall. The slope gradation is required. |

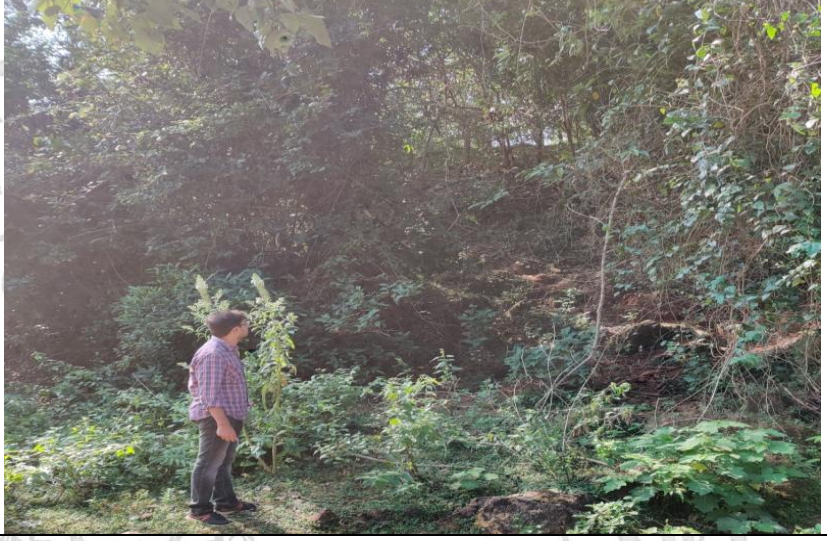
| 39 | Photos. Sketch of Plan & section of the slide | : | |

| No | Field | | Description |
|---|---|---|---|
| 36 | Geo-scientific Causes | : | The Debris slide occurred on hillslope due to intense weathering and erosional activities. |

| 38 | Remarks, if any | : | The area is meta-stable zone. |
| 40 | Summary/Abstract | : | The shallow debris slide occurred on highly weathered and loose soil on hillslope. The wet condition resulted in decrease in cohesive strength of slope forming material. The slumping zone ~75m on either side is observed. |

| 37 | Remedial measures | : | The lined drainage should be provided at toe part to avoid toe erosion. The effective drainage measures at road bench level will avoid the probability of road subsidence due to sub-surface weathering and erosion. |

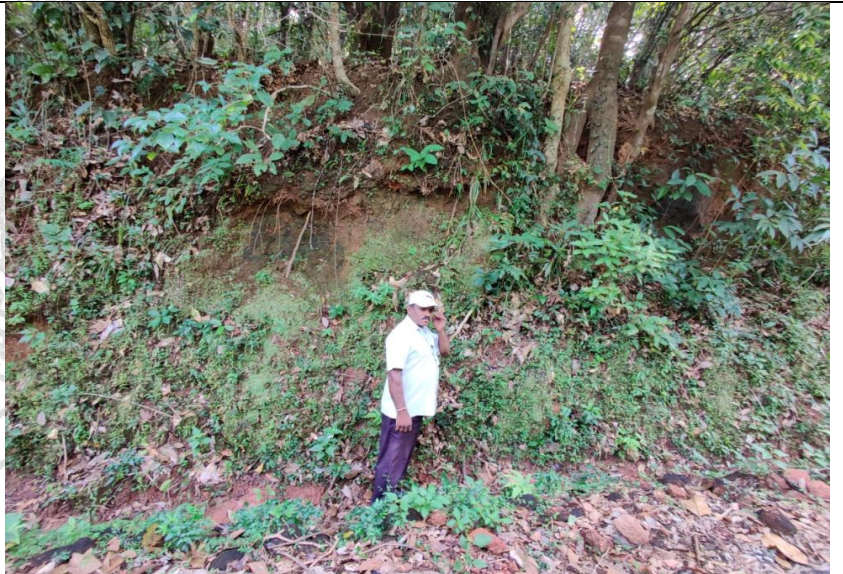
| 39 | Photos. Sketch of Plan & section of the slide | : | |

| 36 | Geo-scientific Causes | : | The Debris slump occurred on hillslope due to intense weathering and erosional activities. |
| 38 | Remarks, if any | : | The area is demarcated as slumping and unstable zone. |
| 40 | Summary/Abstract | : | The Debris slump occurred on hillslope at road bench level due to intense weathering and erosional activities. The slope saturation can be minimized by effective drainage provisions. |

| 37 | Remedial measures | : | The lined drainage should be provided at toe part to avoid toe erosion. The culvert of suitable dimension should be constructed for discharge of excess water downslope as effective drainage measures at road bench level which will avoid the probability of road subsidence due to sub-surface seepage, weathering and erosion. |

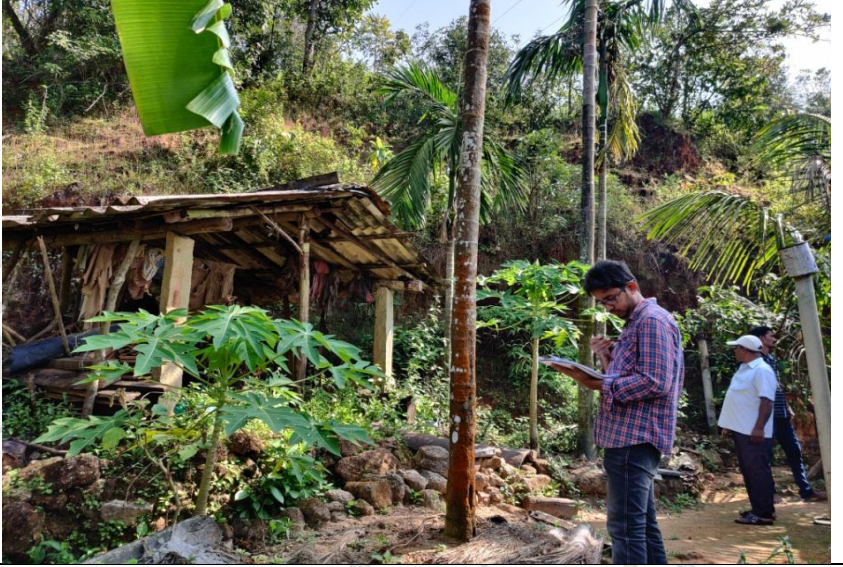
| 39 | Photos. Sketch of Plan & section of the slide | : | |

| No | Field | | Description |
|---|---|---|---|
| 36 | Geo-scientific Causes | : | The unscientific way of modification of natural slope & removal of soil for settlement purposes. The vertical cut made on slopes leads to slope transformation that opened up new way of water seepage & slope saturation. Thus increased infiltration and pore water pressure destabilized the slope during heavy rainfall. The slope failure is pronounced at highly weathered Quartz sericite schist. |
| 38 | Remarks, if any | : | The hillslope is demarcated as meta-stable zone susceptible to slope failure during rainfall. |

| 40 | Summary/Abstract | : | The multiple slope failures were recorded on extensive cut slope made for settlement purposes. The slope should be monitored during heavy rainfall. The slope failure is prone during heavy rainfall and the hillslope is demarcated as meta-stable zone susceptible to slope failure during rainfall. |

| No | Field | | Description |
|---|---|---|---|
| 37 | Remedial measures | : | Turfing of slope face and slope gradation is recommended as cost effective measures and retaining wall with weep holes must be provided to prevent slope failure. |

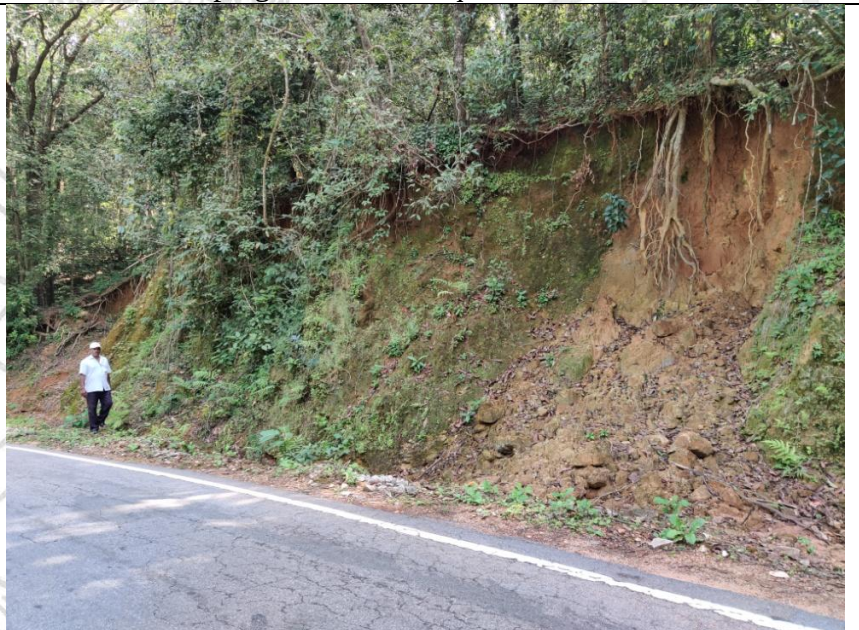
| 39 | Photos. Sketch of Plan & section of the slide | : | |

| 36 | Geo-scientific Causes | : | The Debris slump occurred on hillslope due to intense weathering and erosional activities. |
| 38 | Remarks, if any | : | The area is slumping zone and are quite unstable zone. |
| 40 | Summary/Abstract | : | The Debris slump occurred on hillslope at road bench level due to intense weathering and erosional activities. The slope saturation can be minimized by effective drainage provisions. |

| 37 | Remedial measures | : | The lined drainage should be provided at toe part to avoid toe erosion. The culvert of suitable dimension should be constructed for discharge of excess water downslope as effective drainage measures at road bench level which will avoid the probability of road subsidence due to sub-surface seepage, weathering and erosion. |

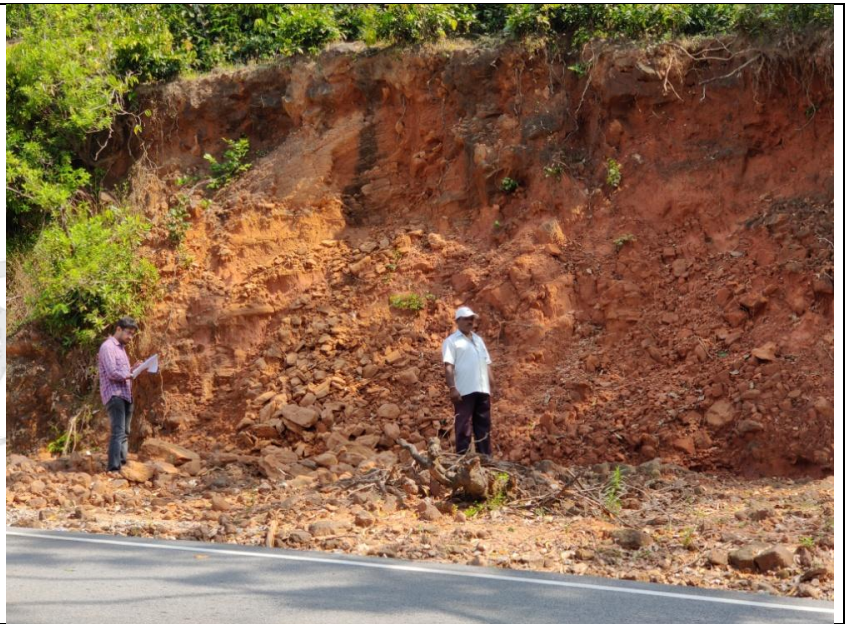
| 38 | Remarks, if any | : | The area is unstable zone. |

| 40 | Summary/Abstract | : | The shallow translational debris slide observed along road section North of Ulakoppa village on lowly dissected slope with sparse vegetation cover. In present scenario the landslide zone is active, retrogressive, widening and enlarging in nature. The landslide zone is ~65m wide. The slope disturbance resulted due to unscientific way of removal of soil by toe cutting of the hillslope for road construction and communication network. The seepage and infiltration along the weaker plane i.e. closely jointed and fractured granite gneiss resulted in intense weathering and slope saturation. The differential weathering at contact of two-different litho-units was observed. |

| 37 | Remedial measures | : | The lined drainage should be provided at toe part to avoid toe erosion and effective drainage at road bench level to avoid road subsidence due to sub-surface weathering and erosion. The water should be diverted through proper culvert to drain excess water for the safety of settlements build in downslope direction in long run. |

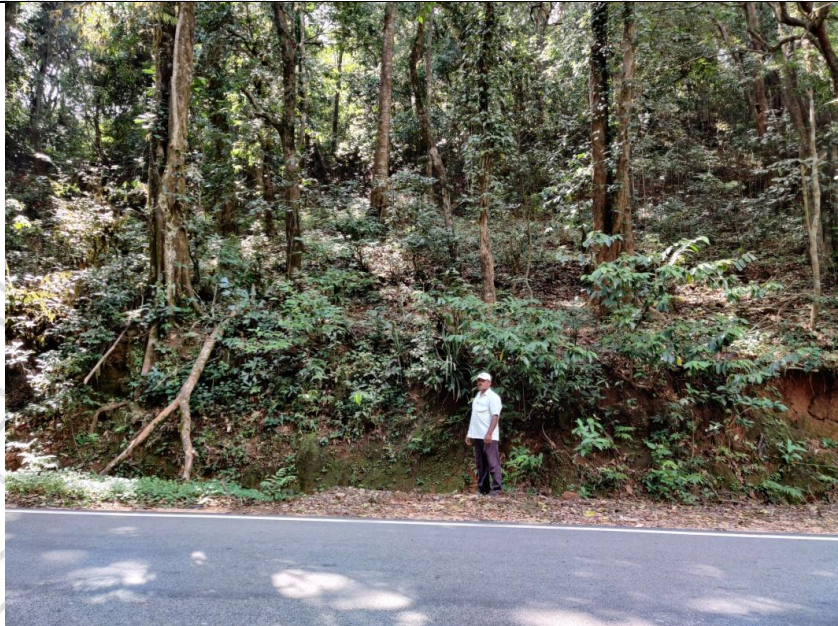
| 38 | Remarks, if any | : | The area is unstable slumping zone. |
| 40 | Summary/Abstract | : | The old scars of shallow translational debris slide observed on lowly dissected hillslope. The slide is suspended in present scenario; afforestation on slope has stabilized the slope. The slope disturbance resulted due to unscientific way of removal of soil by toe cutting of the hillslope for road construction and communication network. Thus increased water infiltration increased pore water pressure and reduced the shear strength of the slope forming material during heavy rainfall. In long term lined drainage should be provided at toe part to minimize toe erosion and culvert should be designed for effective drainage at road bench level to avoid road subsidence due to sub-surface weathering and erosion. |

| 37 | Remedial measures | : | The lined drainage should be provided at toe part to minimize toe erosion and culvert should be designed for effective drainage at road bench level to avoid road subsidence due to sub-surface weathering and erosion. |

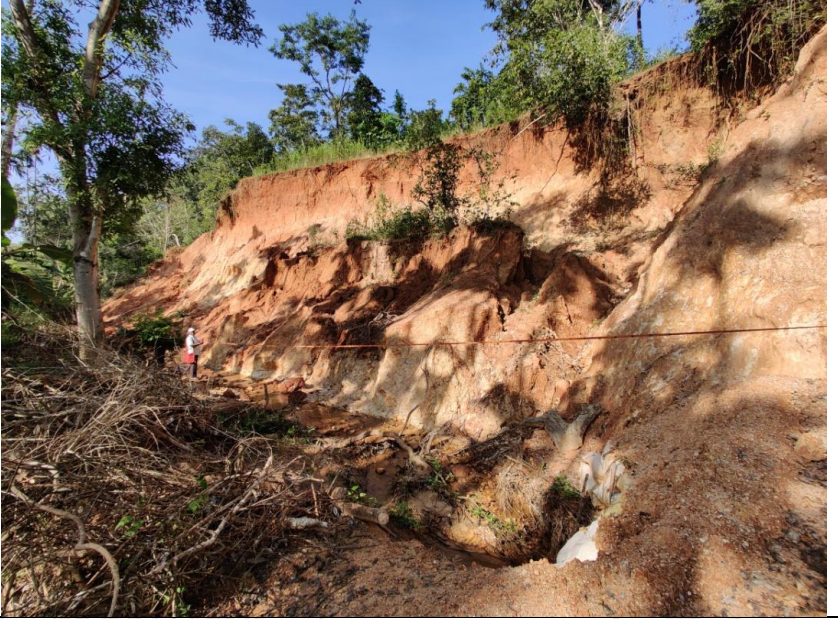
| 38 | Remarks, if any | : | The area is demarcated as unstable zone. |
| 40 | Summary/Abstract | : | The shallow debris slide occurred on hill slope in vicinity of agricultural land. The slope got failed along kaolinised highly weathered Quartz sericite schist and Quartz chlorite schist. The slope is unstable and likely to fail during intense rainfall. The excavation of soil destabilizes the hillslope. The slope disturbance resulted due to unscientific way of removal of soil by piedmont/toe cutting of the hillslope for widening the agricultural land and getting soil for arecanut plantation. The vertical cut made for removal of soil opened up new way of erosion, water seepage & slope saturation. Thus increased water infiltration destabilized hillslope due to increased pore water pressure that reduced shear and cohesive strength of slope forming material during heavy rainfall. The open well on upslope saturated the hillslope and drainage at toe part for supplying water in paddy field for irrigation purpose resulted in toe erosion and removal of toe support. |

| 37 | Remedial measures | : | The open well at upslope should be lined and protective wall should be constructed at failed soil mass for preventing loss of crop and agriculture land during monsoon. |

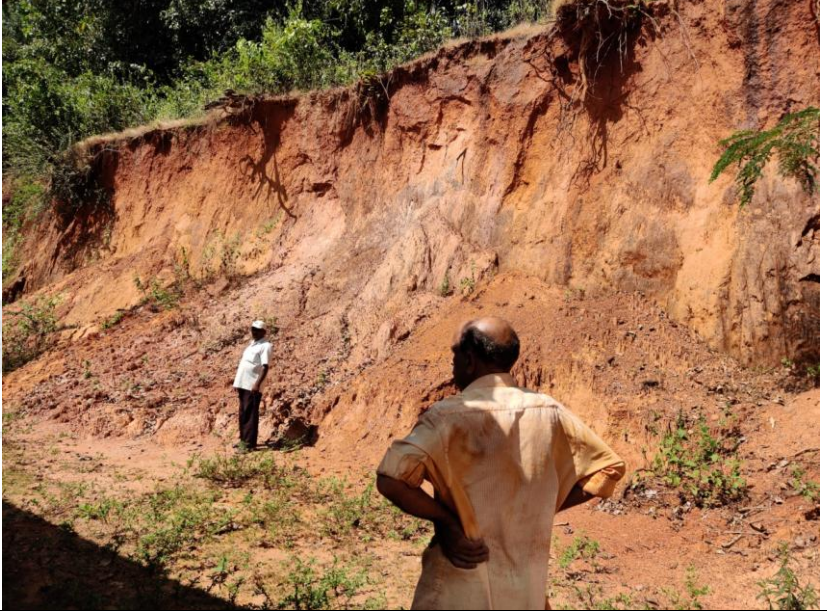
| 38 | Remarks, if any | : | The area is unstable zone and settlement at nearby at risk. |

| 40 | Summary/Abstract | : | The slope failure occurred on extensive cut slope made on lowly dissected hill slope. The slope got failed on kaolinized weathered granite gneiss. Thus increased water infiltration reduced the shear strength of the slope forming material during heavy rainfall. The slope gradation should be done on modified hillslope. |

| 37 | Remedial measures | : | Slope gradation is required. |

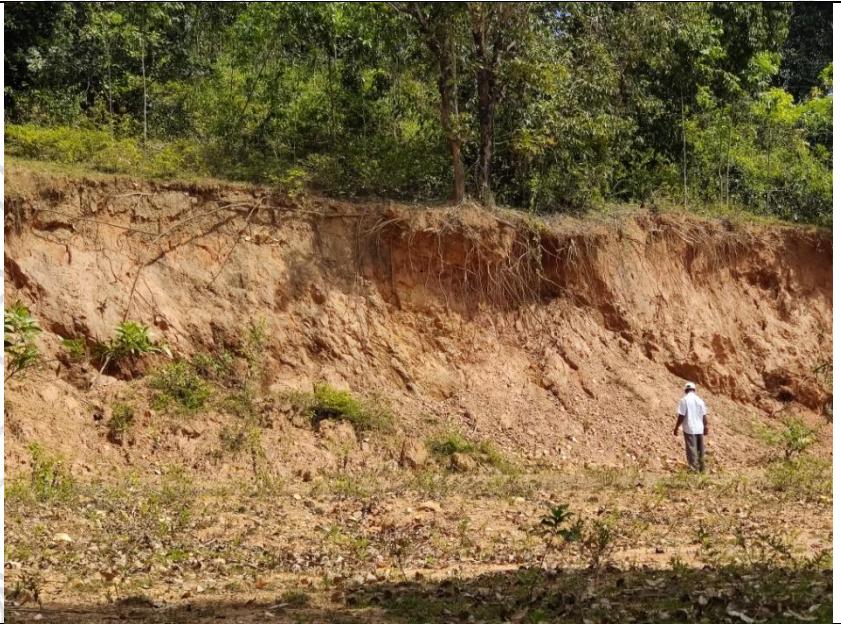
| 36 | Geo-scientific Causes | : | The slope failure occurred due to increased pore pressure which has reduced the shear and cohesive strength of the soil due to over saturation of weathered rock and soil during heavy rainfall. |
| 38 | Remarks, if any | : | The area is meta-stable. |
| 40 | Summary/Abstract | : | The debris slide occurred on lowly dissected hillslope due to increased pore pressure and reduction in shear and cohesive strength of the soil due to over saturation of weathered rock and soil during heavy rainfall. The slope gradation is required. |

| 37 | Remedial measures | : | Slope gradation is required. |

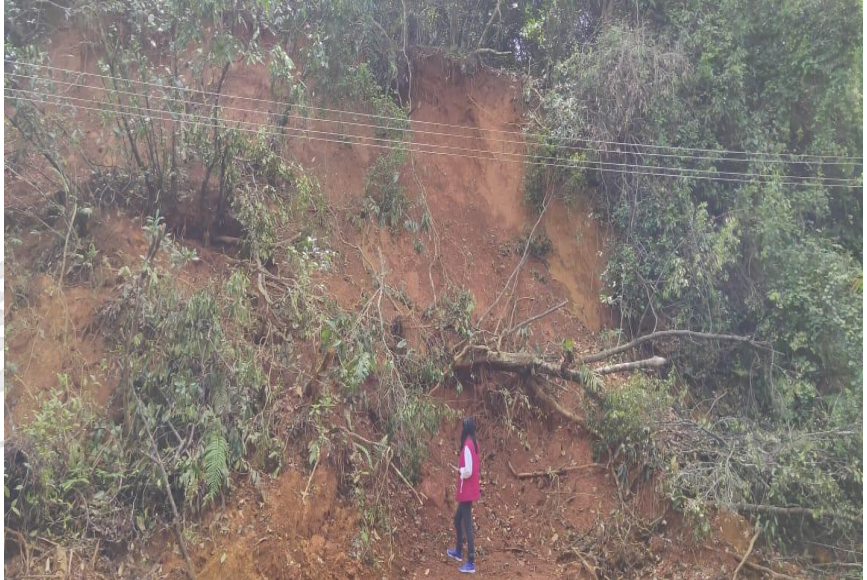
| No | Field | | Description |
|---|---|---|---|
| 36 | Geo-scientific Causes | : | The slope disturbance is observed due to unscientific way of modification of slope & removal of soil for road construction. The vertical cut transformed the slope and opened up new way of erosion, water seepage & slope saturation that increased the pore water pressure and reduced the shear strength of the slope forming material during heavy rainfall. |
| 38 | Remarks, if any | : | The area is demarcated as meta-stable zone susceptible to slope failure during rainfall. |

| 40 | Summary/Abstract | : | The debris slide initiated during heavy rainfall on lowly dissected hill slope with moderate vegetation cover. The slope disturbance is observed due to unscientific way of modification of slope & removal of soil for construction of road. The vertical cut made leads to slope transformation that opened up new way of water seepage & runoff pattern. The concrete retaining wall with weep holes at the toe of the slide with proper lined drainage is required. |

| No | Field | | Description |
|---|---|---|---|
| 37 | Remedial measures | : | Easing of slope required. The lined drainage and retaining wall with weep holes is recommended to be constructed at the site to avoid toe erosion and landslips on kaolinized, lateritic and highly weathered rock. |

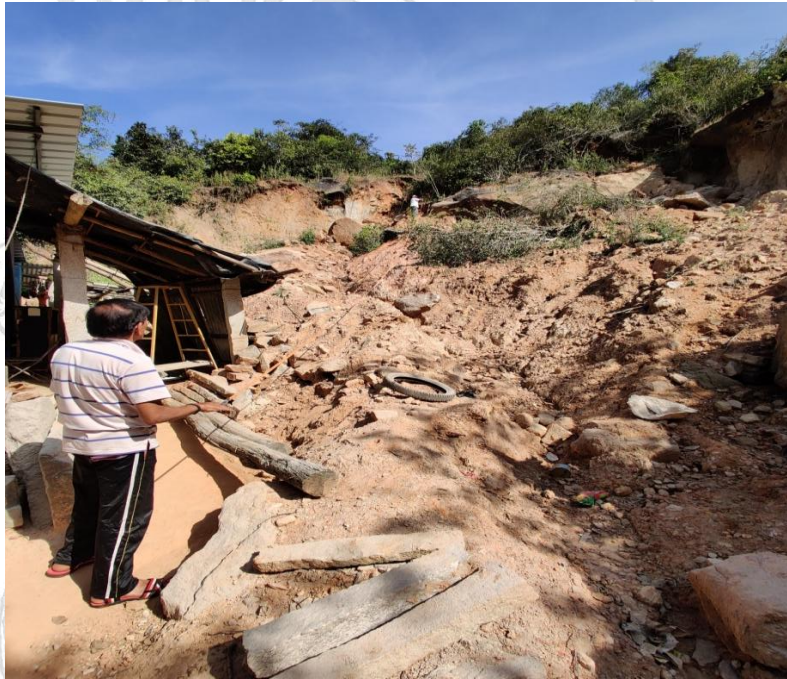
| No | Field | | Description |
|---|---|---|---|
| 36 | Geo-scientific Causes | : | The slope disturbance is observed due to unscientific way of |

| | | | modification of slope & removal of soil for construction purposes on other side of quarry section on the same hillslope. The vertical toe cutting of hill slope leads to slope transformation that opened up new pathway of water seepage & slope saturation in fractured granite. The adjacent rock quarries further widened up the crevices and provided the way for increased infiltration on slope. |
| 38 | Remarks, if any | | The area is demarcated as un-stable zone susceptible to slope failure during rainfall. The house in vicinity should be shifted permanently to safer location. |
| 40 | Summary/Abstract | : | The shallow rock failure occurred on lowly dissected hill slope with sparse vegetation cover. The slope disturbance is observed due to unscientific way of modification of slope & removal of soil for construction. The vertical cut made for settlement purpose lead to slope transformation that opened up new pathway for water seepage & runoff pattern. Thus increased infiltration destabilized the slope due to over water saturation during heavy rainfall. The slope forming material consists of in-situ soil and weathered rock. The overburden thickness varies between 5-10m. The concrete retaining wall with weep holes at the toe of the slide with proper lined drainage is required. |

| 37 | Remedial measures | : | The retaining wall with weep holes should be constructed for effective drainage at road bench level and to avoid toe erosion and subsequent slope failure. |

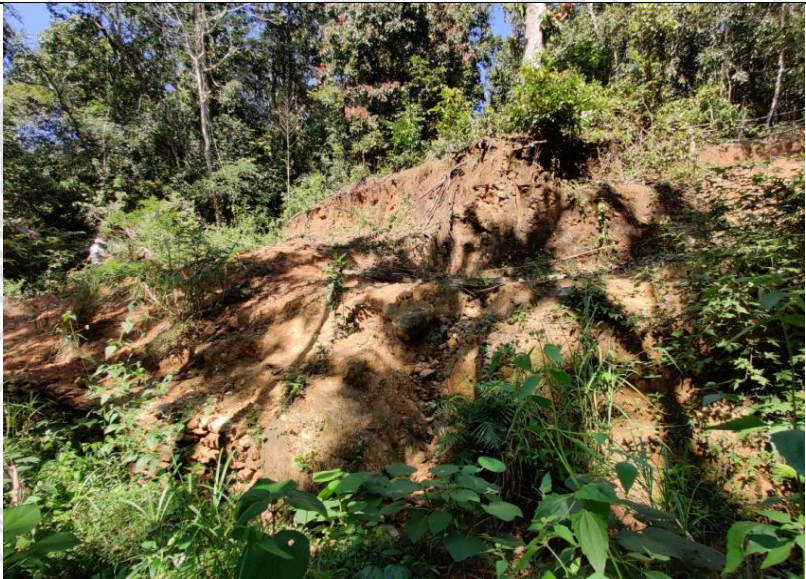
| 38 | Remarks, if any | : | The area is meta-stable zone. |
| 40 | Summary/Abstract | : | The slope failure occurred on lowly dissected hill slope due to unscientific way of removal of soil for plantation that lead to slope transformation that opened up new pathway for water seepage & slope saturation. The increase in pore water pressure reduced the shear & cohesive strength of the slope forming material during heavy rainfall. Easing of slope is required. The area is meta-stable zone. |

| 37 | Remedial measures | : | Easing of slope is required. |
